Gisborne Region Fish Passage

**Barriers to Fish Passage in the Gisborne
Region**

JULY 2008

ISSN 1175-026 X Technical Support Series No. 27

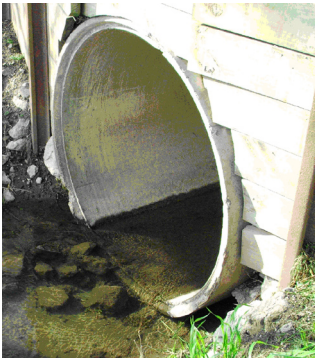
Perched inlet

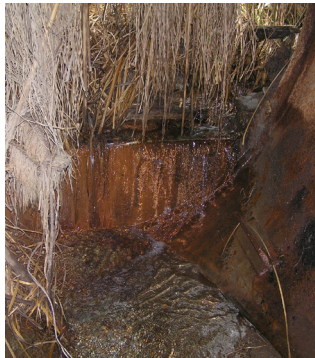
Inlet Falls

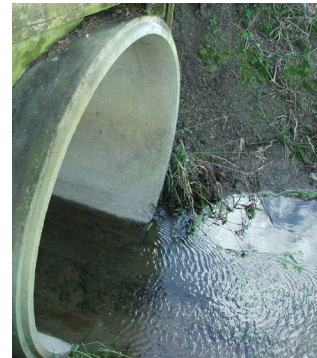
Flat

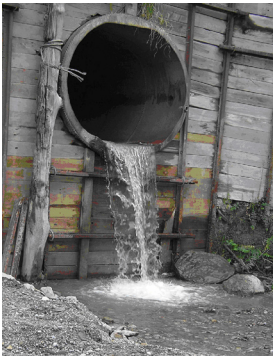
Perched outlet

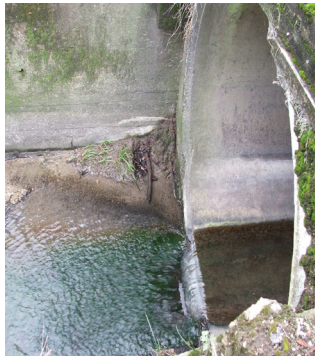
Perched outlet

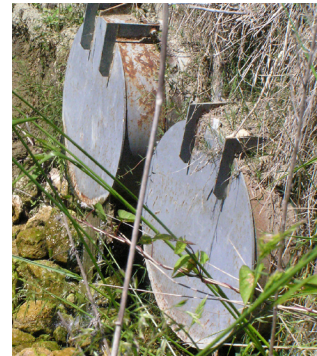
Floodgates on culvert

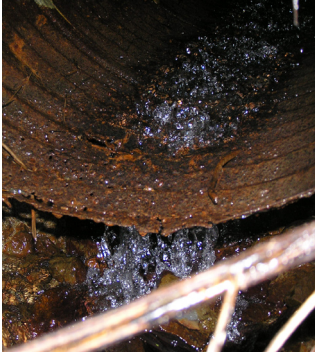
Poor maintenance

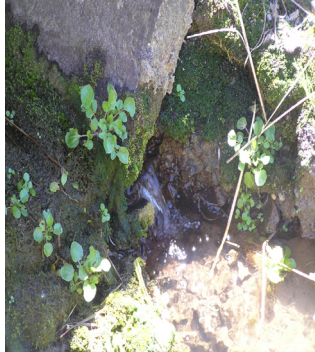
Poor maintenance

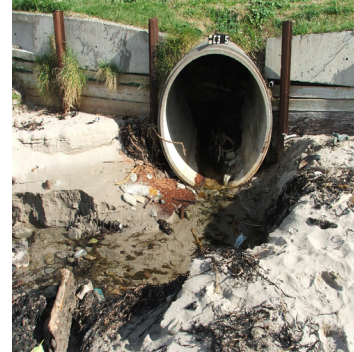
Sand at outlet

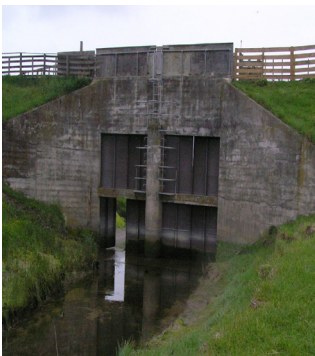
Floodgates

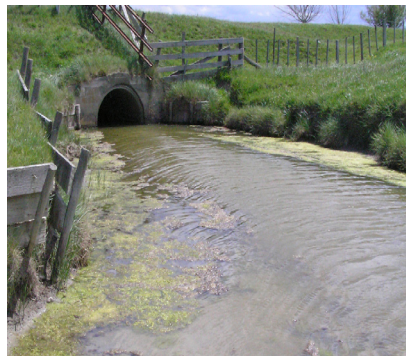
Inlet narrower than stream

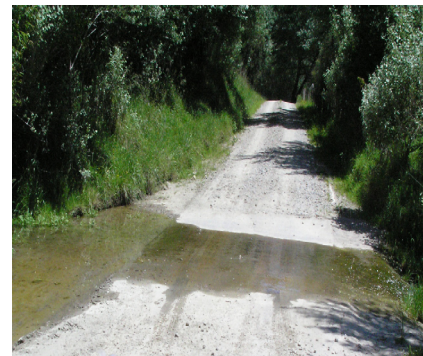
Ford
