## Appendix One

### Images from helicopter flight

### **Managatokerau Stream Traverse Images**

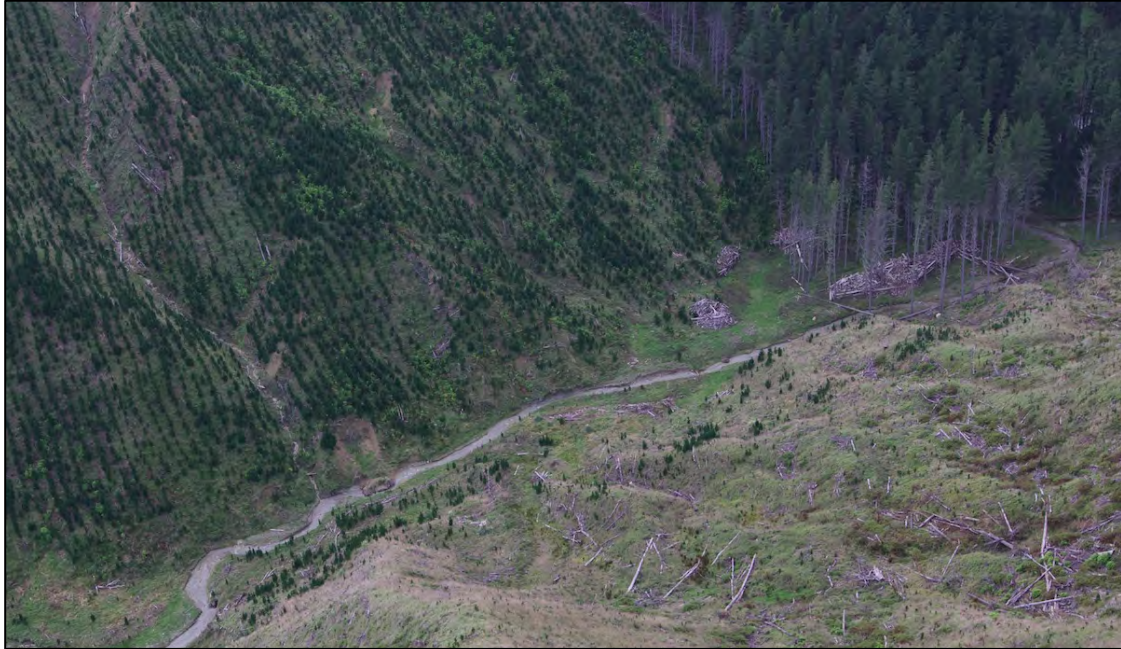
Image 1D1A0553 Waimanu Forest. Slash within standing pine, slash piles on flood plain, minor lower slope slipping, some movement mid slope gully.

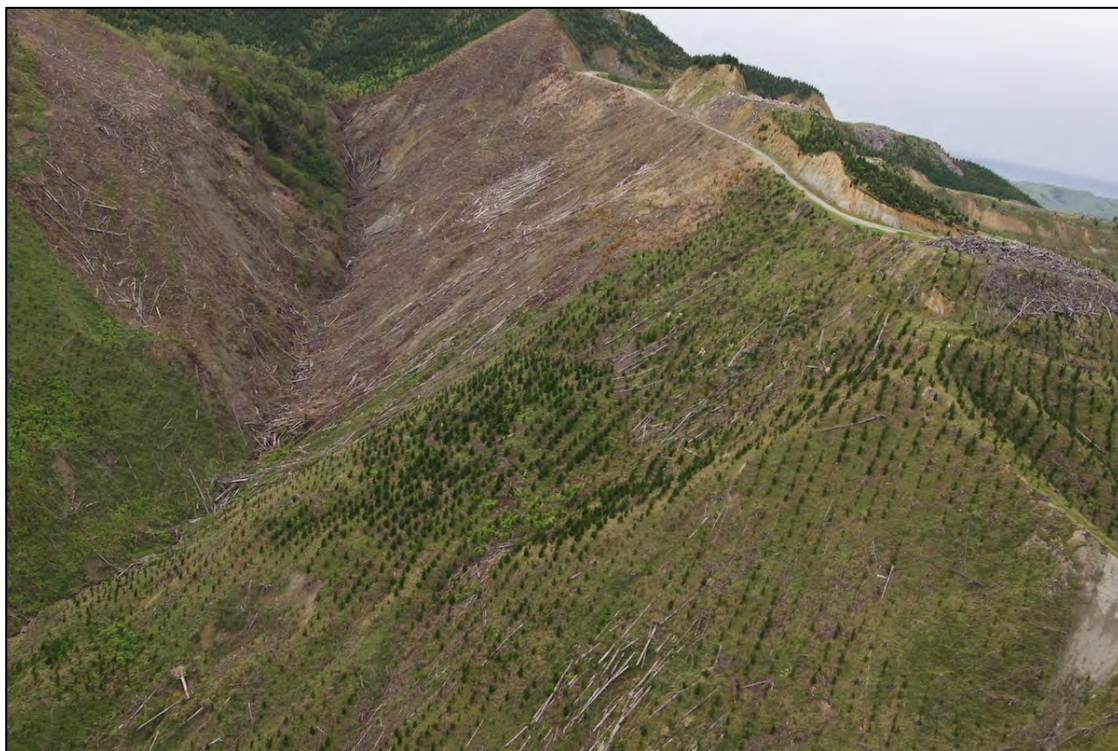
Image 1D1A0591Waimanu Forest, Slash in gullies and on unstable slopes, some mid slope failures.

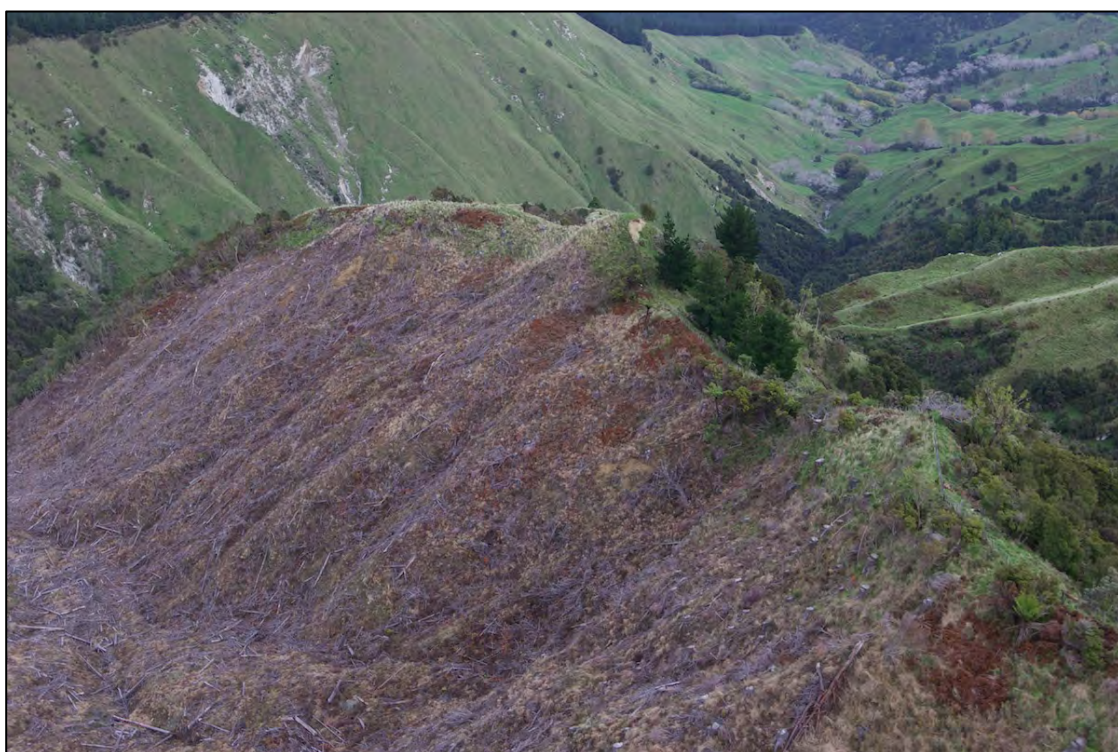
Image 1D1A0599. Waimanu Forest, slash on slopes and valley floor.

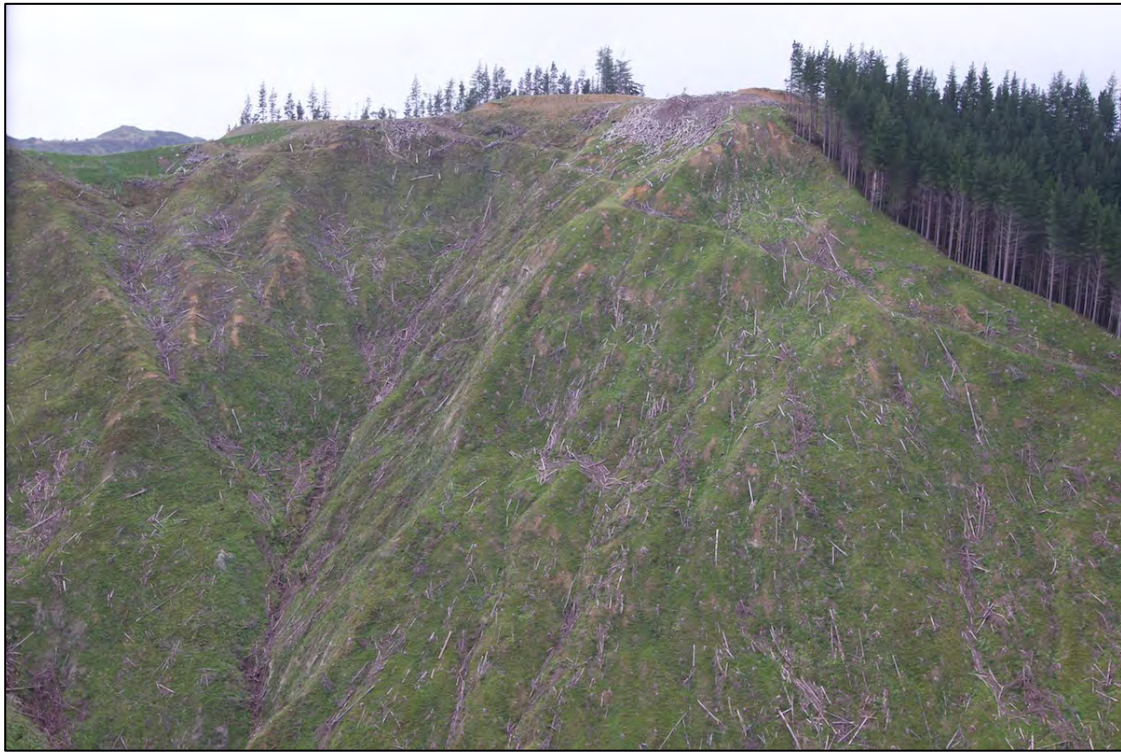
Image 1D1A0612. Extensive slash in gullies.

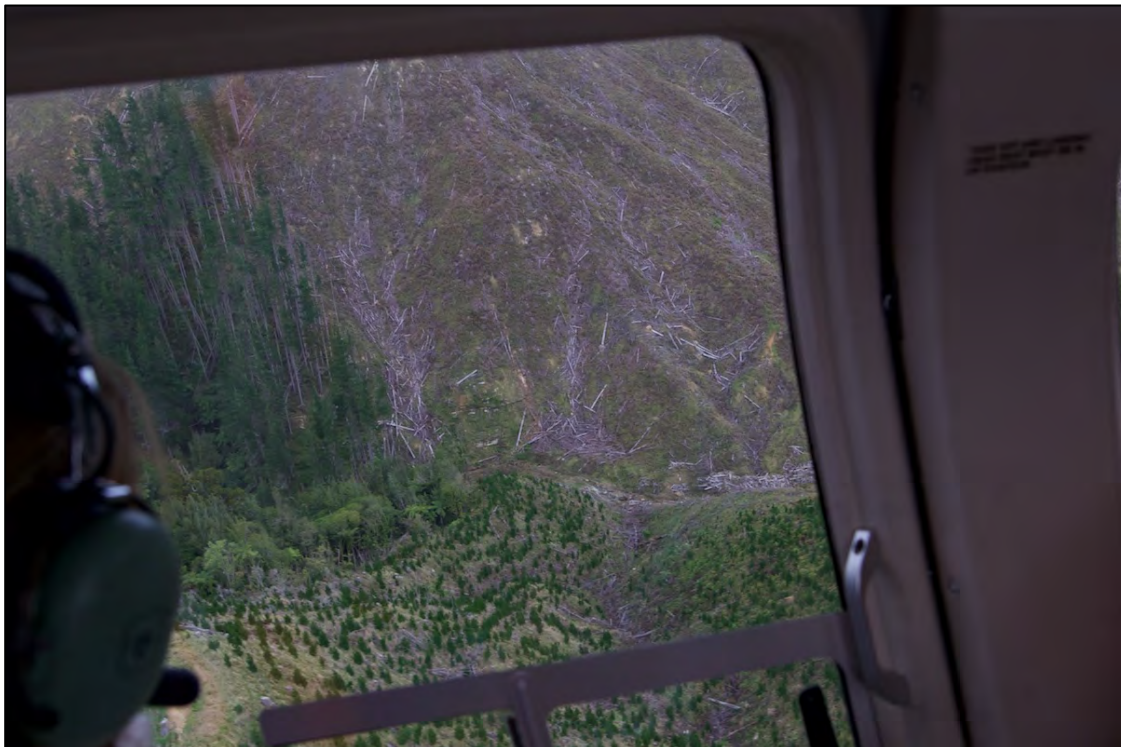
Image 1D1A0617. Makahakaha Stream. Extensive slash in gullies and in valley floor.

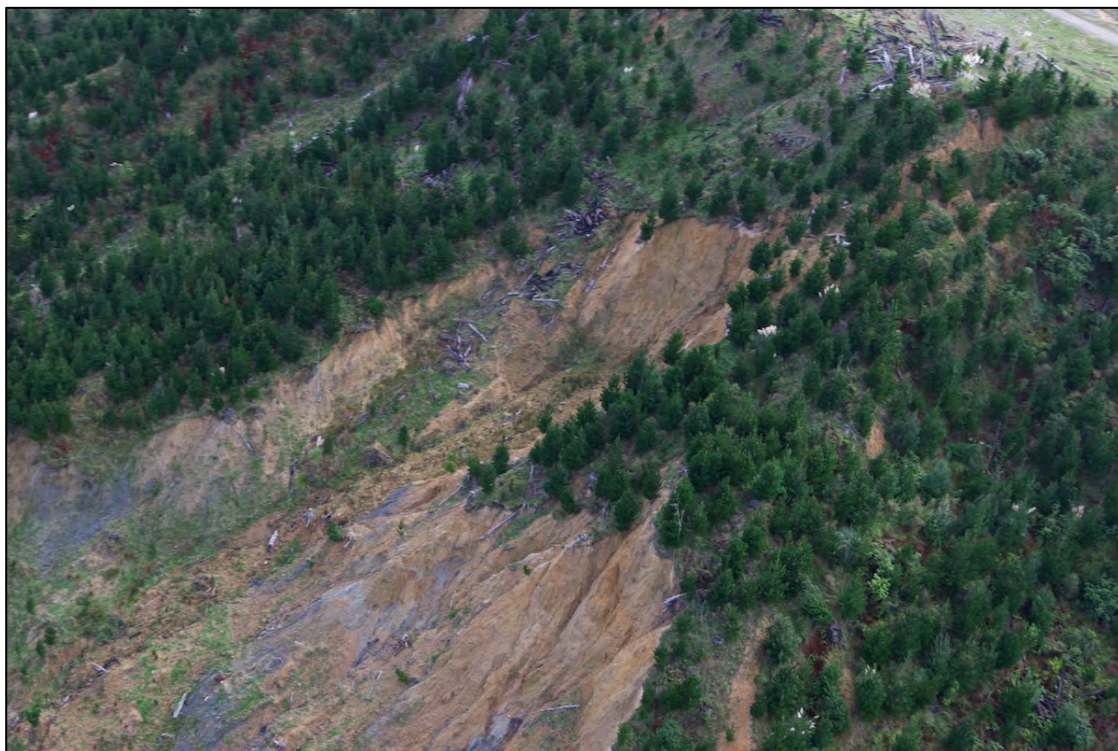
Image 1D1A0657. Waimata Valley near Duncan Road. Fresh scarring on existing mid slope slips.

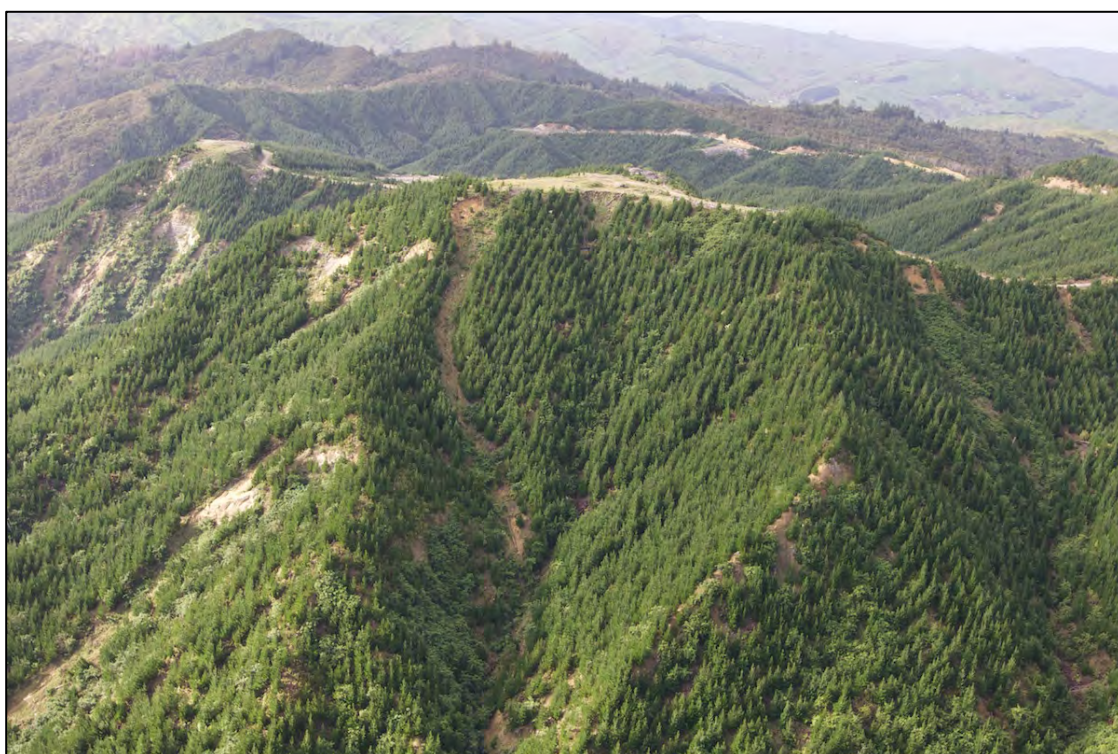
Image 1D1A0687. Waimata Valley north of Duncan Road. Small headwall failure in existing debris flow channel.

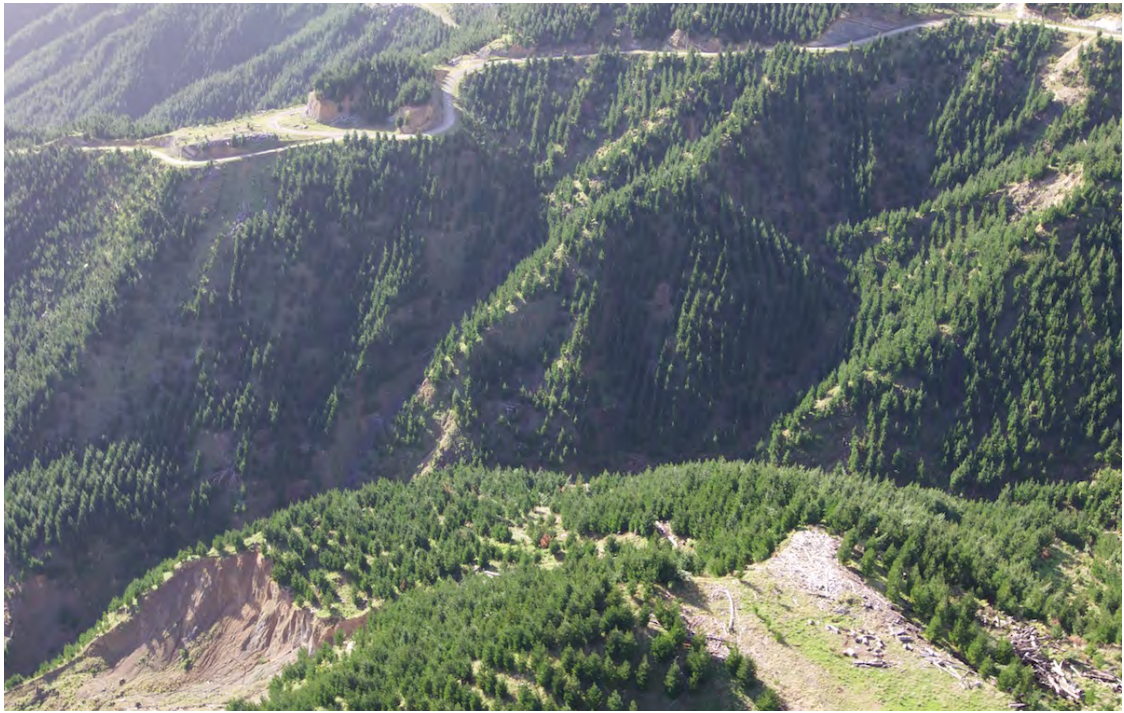
Image 1D1A0692. Waimata Valley Fresh headwall movement in pre-existing slip.

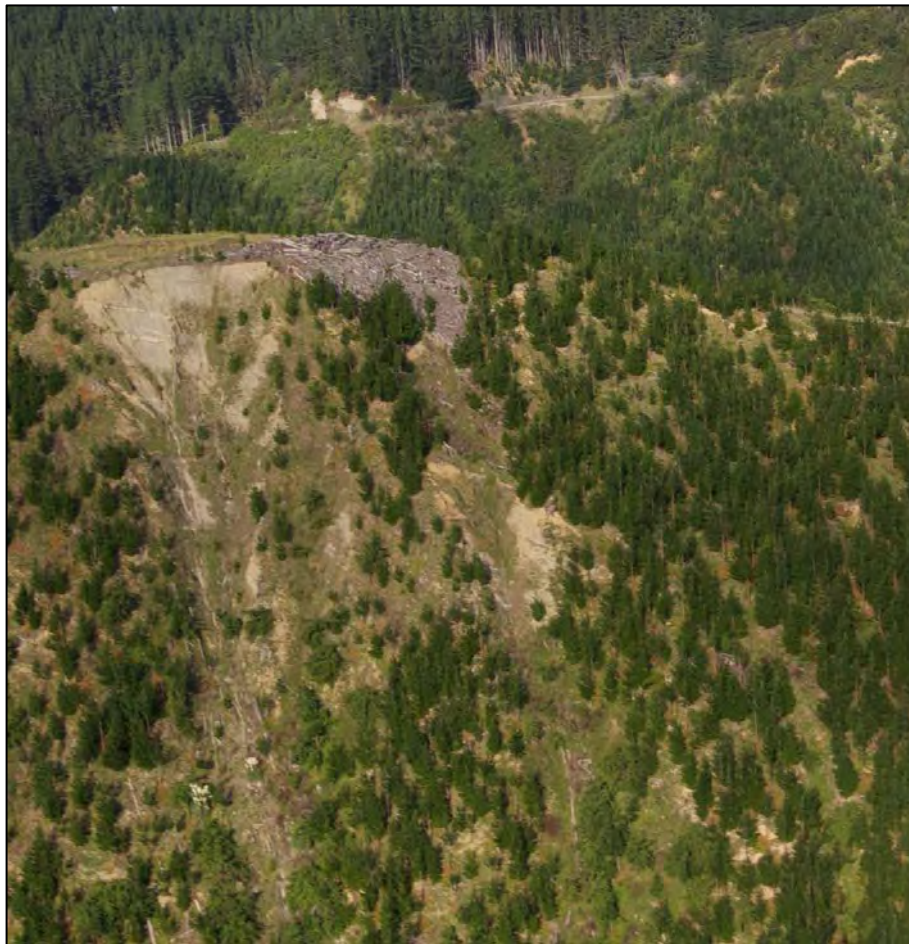
Image 1D1A0780. Near Tauwhareparae Road. Pre-existing headwall failure off old forestry access road to landing.

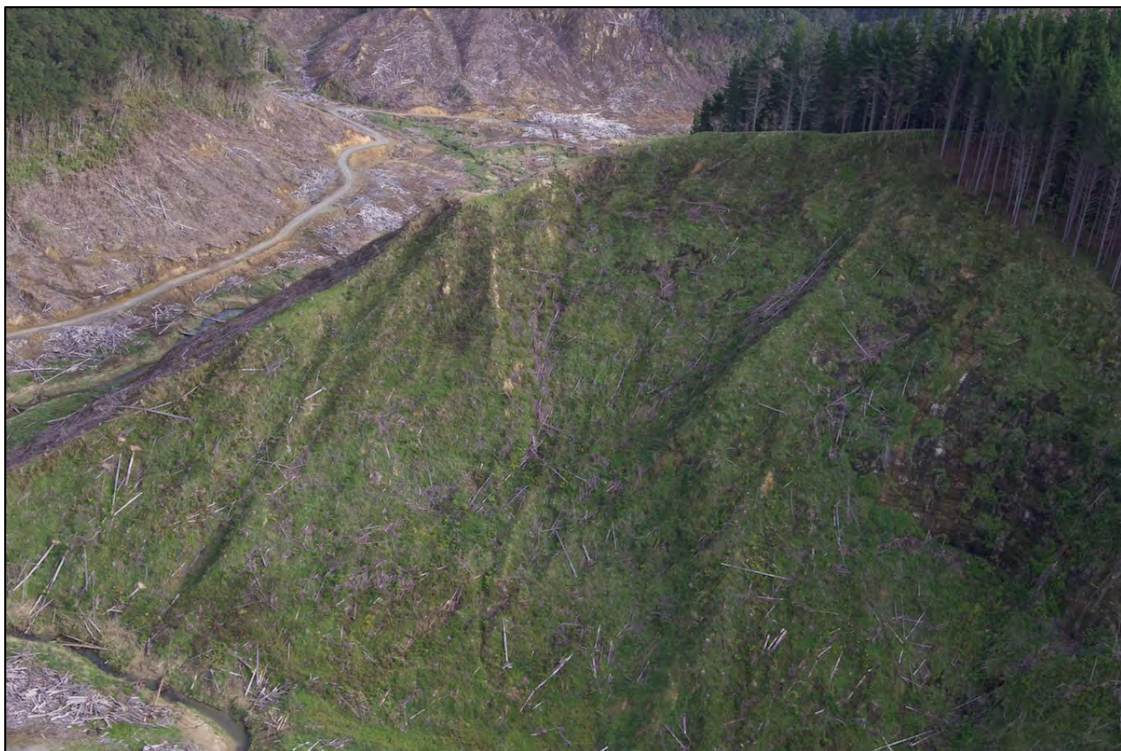
Image 1D1A1007. Tapuae Stream, slash in stream and on flood plain close to river.

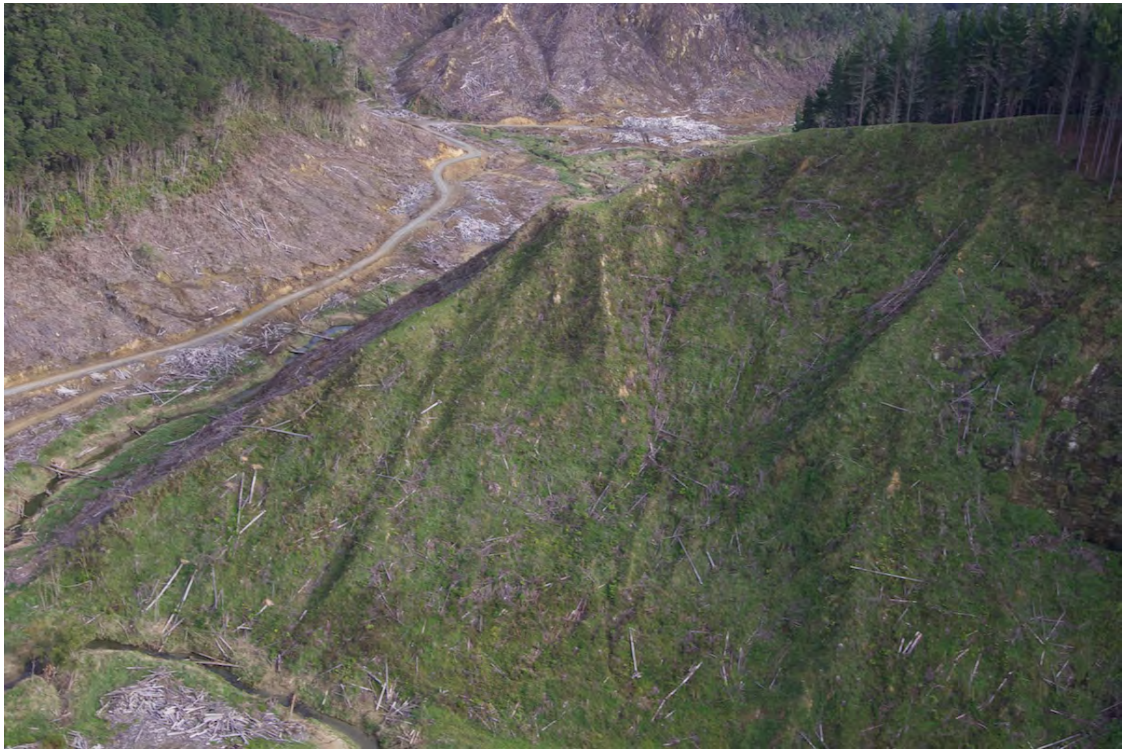
Image 1D1A1008. Tapuae Stream, slash in stream and on flood plain close to river.

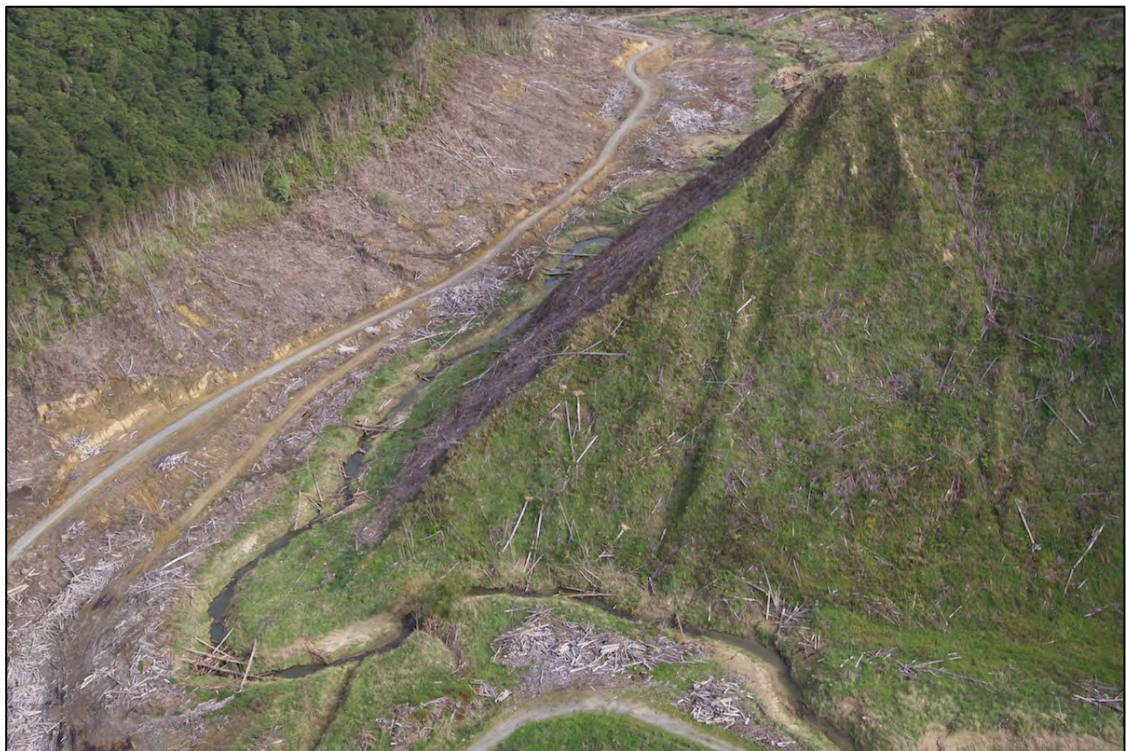
Image 1D1A1011. Tapuae Stream, slash in stream and on flood plain close to river.

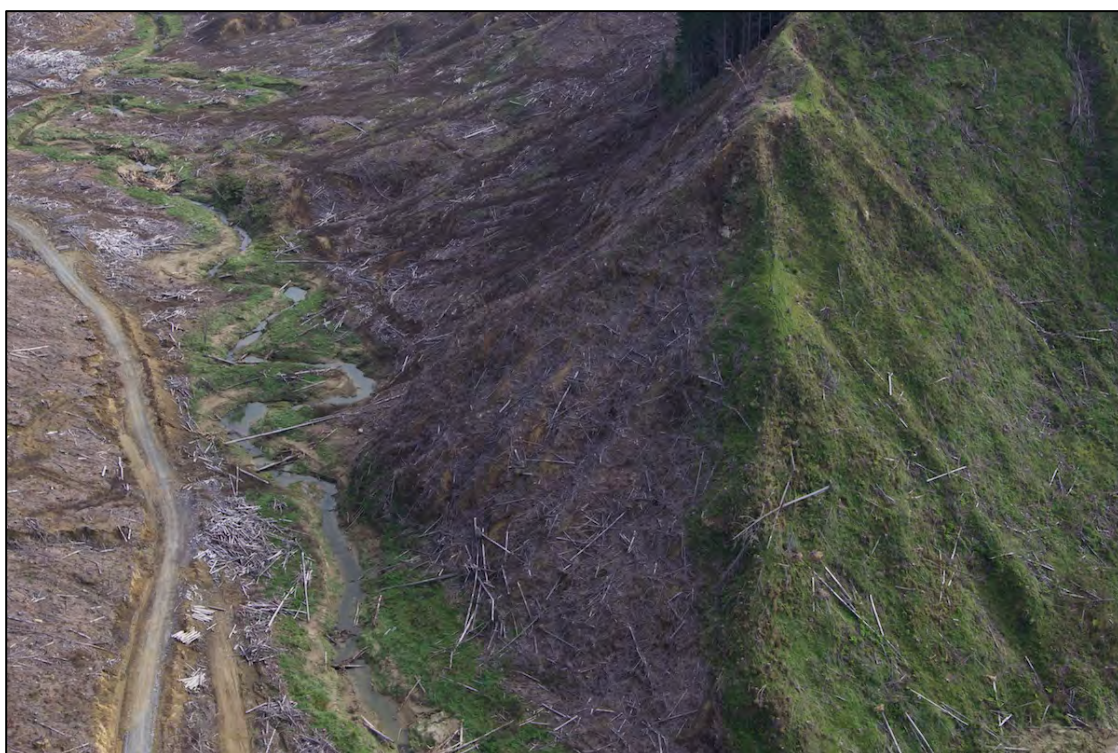
Image 1D1A1030. Tapuae Stream, slash in stream and on flood plain close to river.

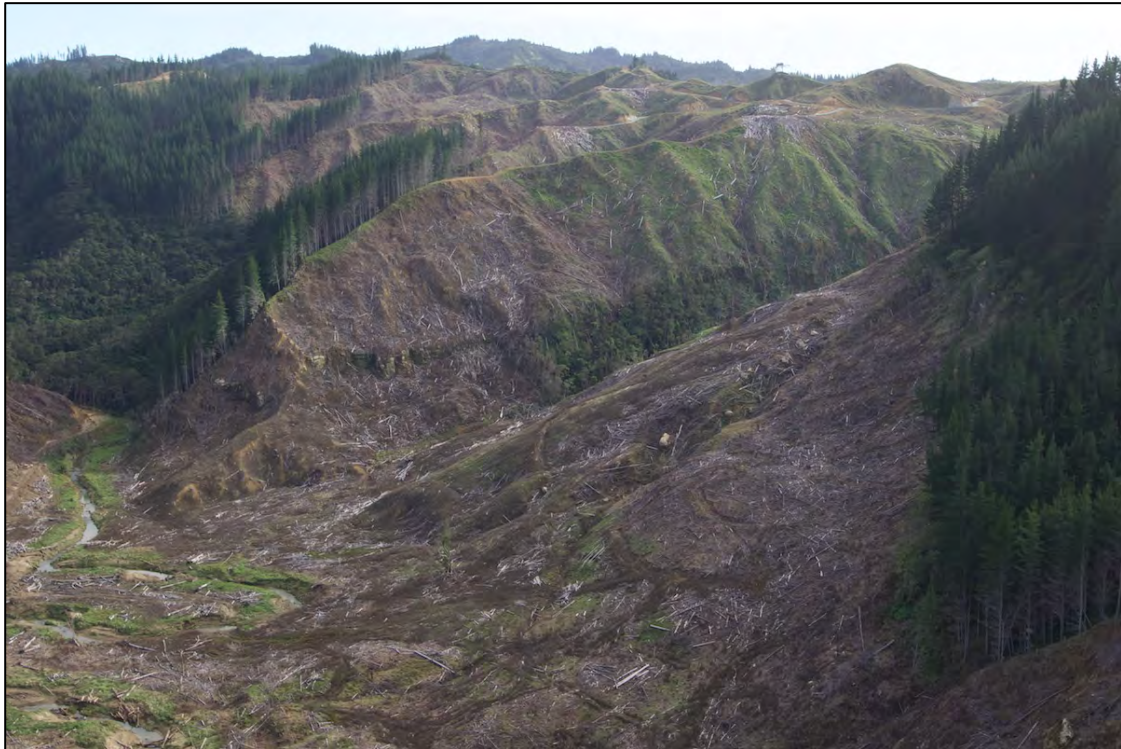
Image 1D1A1045. Tapuae Stream, extensive slash in stream and on flood plain close to river.

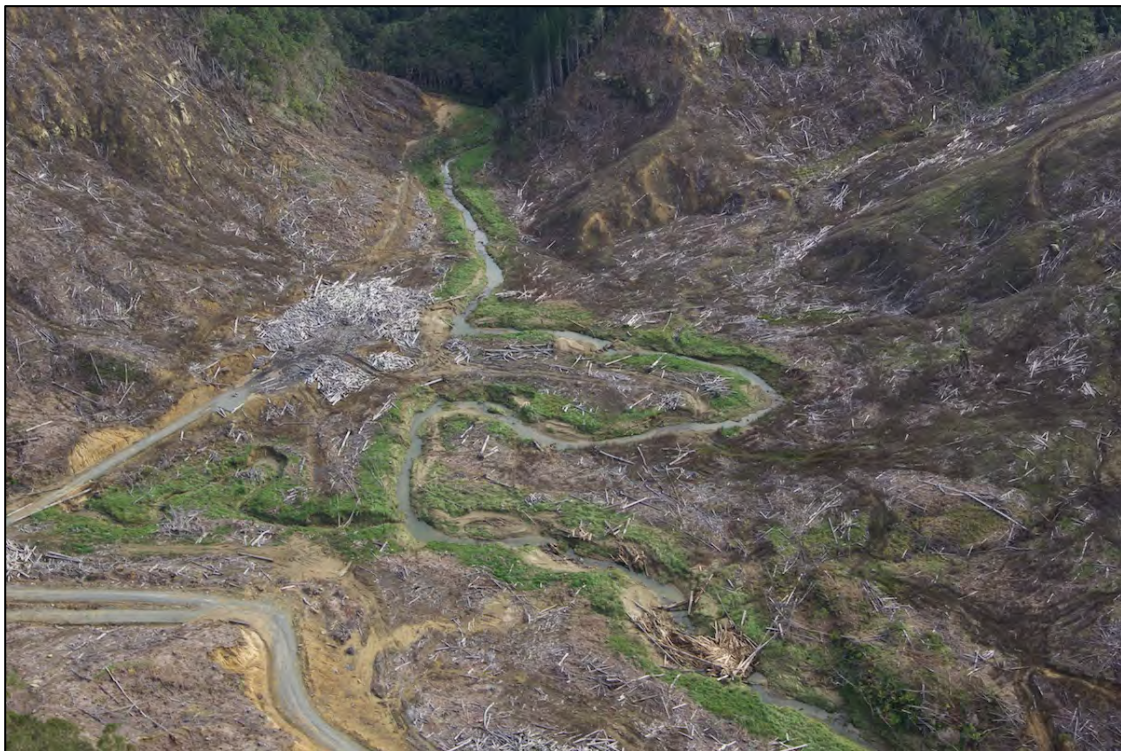
Image 1D1A1058. Tapuae Stream, extensive slash in stream and on flood plain close to river. Messy landing vulnerable to severe flooding.

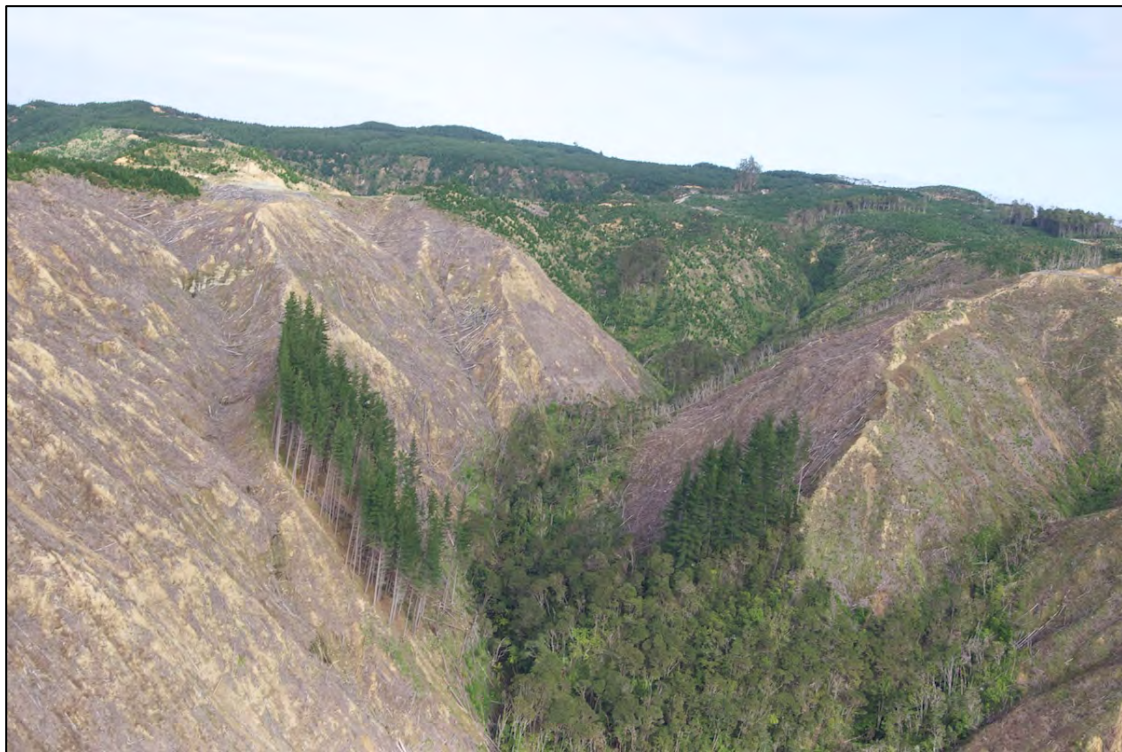
Image 1D1A1069. Tapuae Stream, extensive slope scarring from forestry operations.

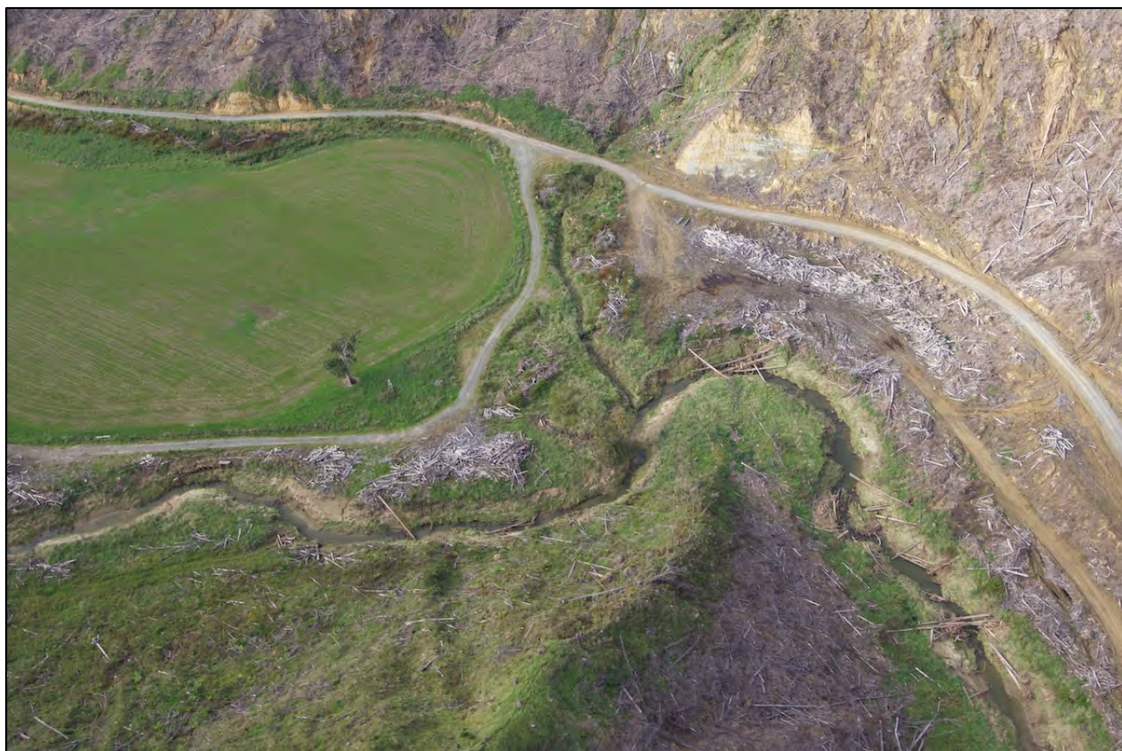
Image 1D1A1073. Tapuae Stream, slash in stream and on flood plain close to river.

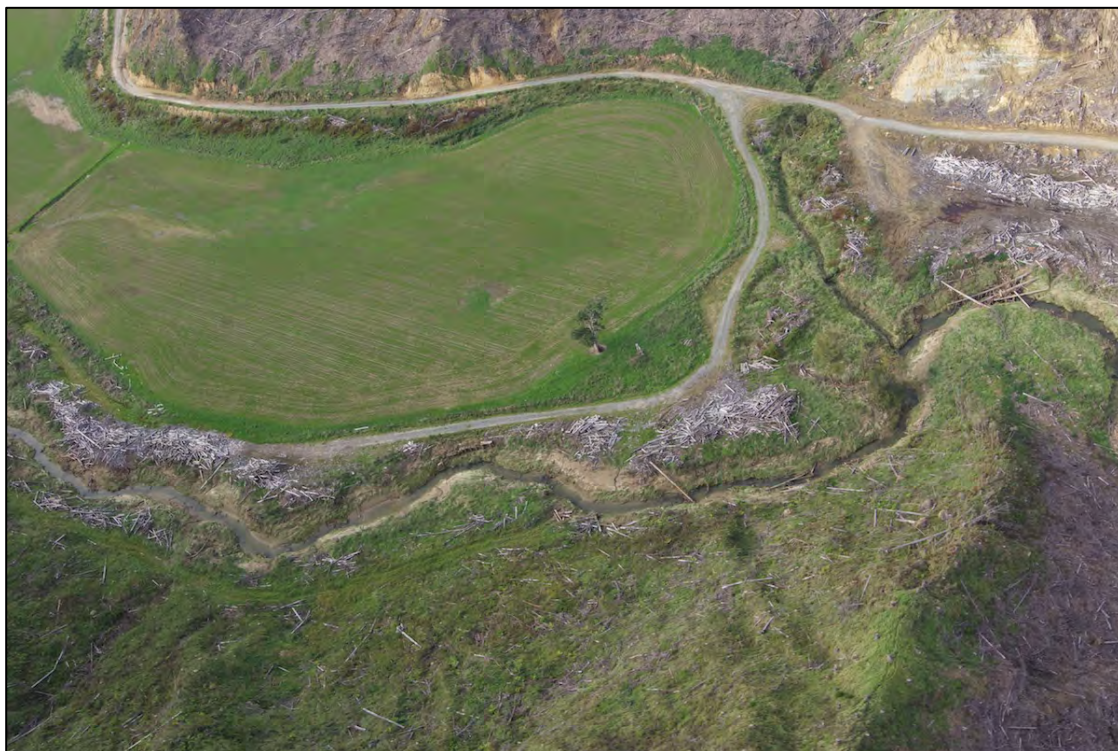
Image 1D1A1075. Tapuae Stream, slash in stream and on flood plain close to river.

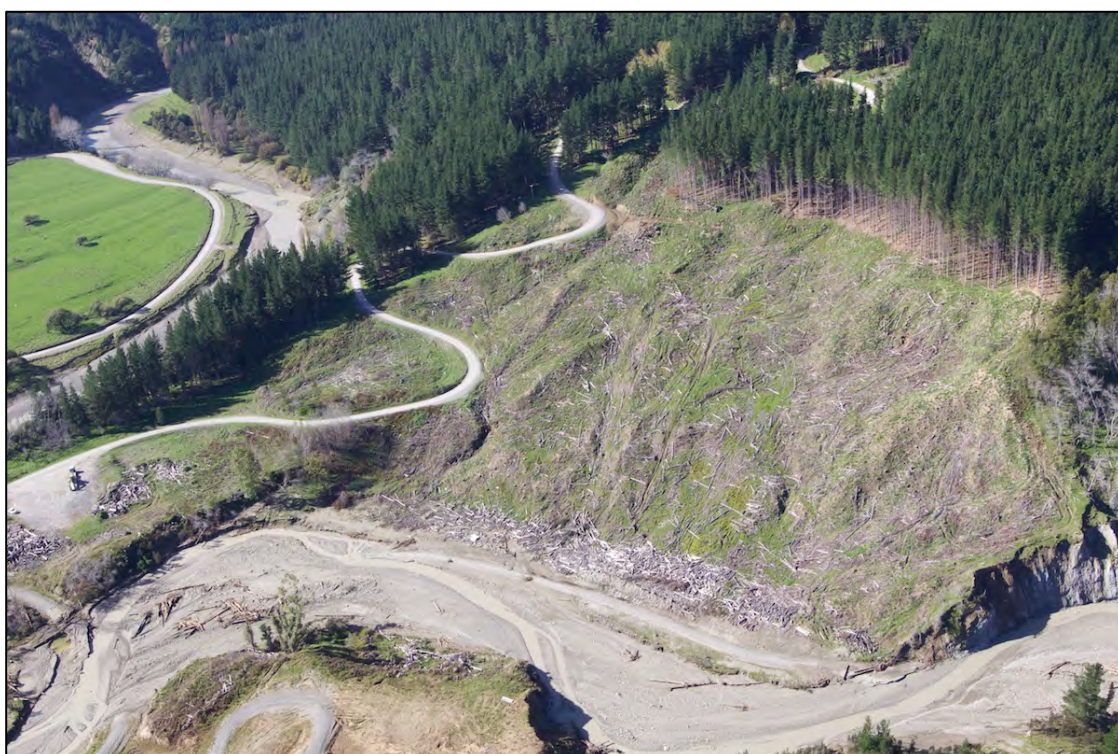
Image 1D1A1708. Whakoau stream showing recently harvested area upstream of Bremmer Bridge, landing on flood plain and slash within riverbed.

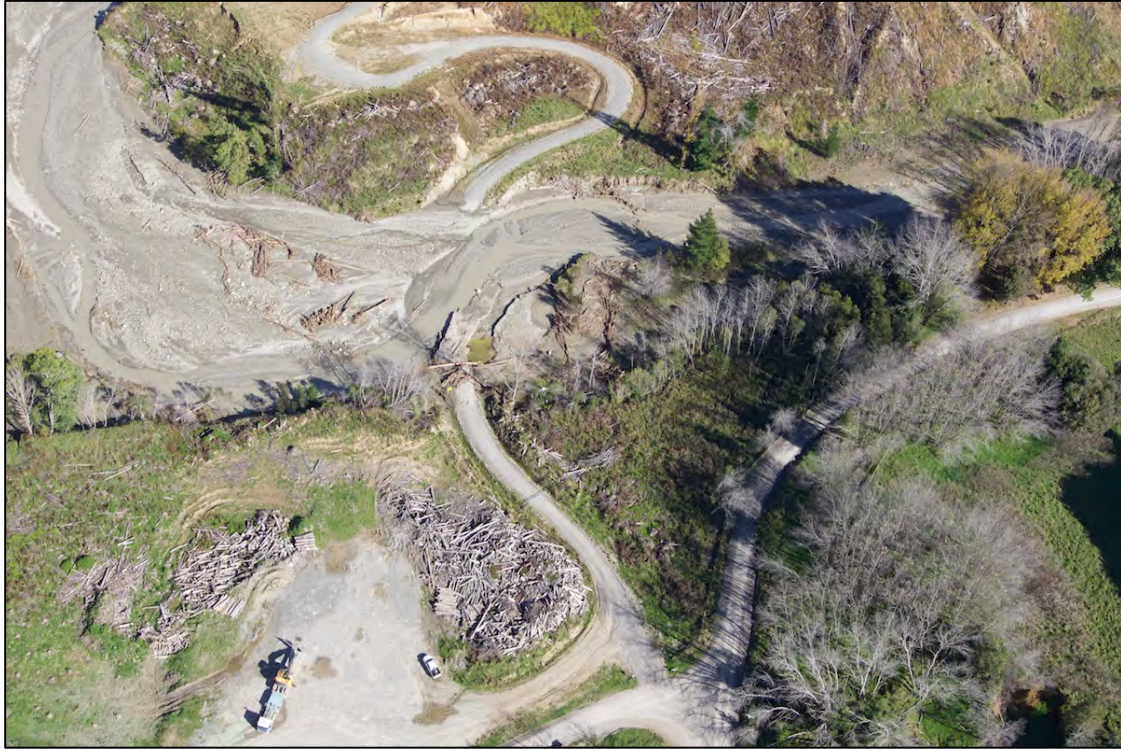
Image 1D1A1723. River crossing at Whakaou Stream showing slash inriverbed and blocking river crossing.

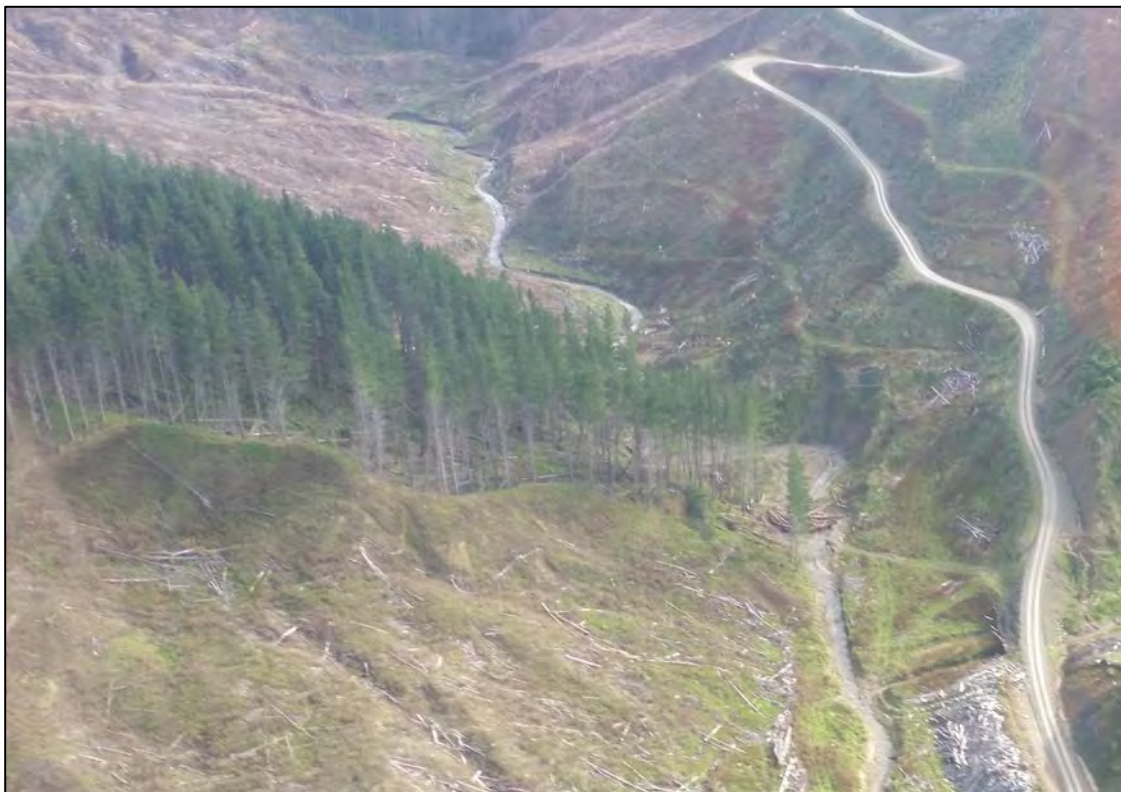
Image 092913 Mangatoitoi Stream cellphone image looking upstream towards operational area showing birdsnest of logs in stream and slash stowed adjacent to flood plain on both banks.

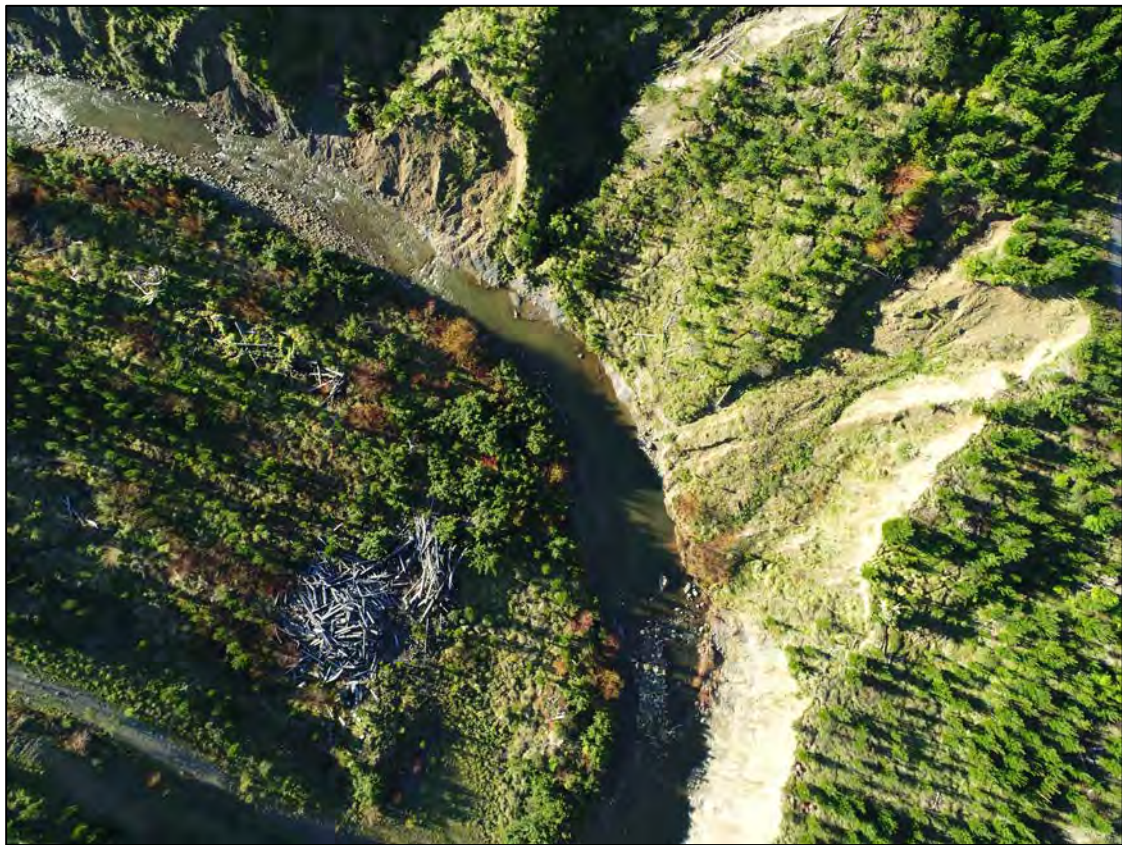
Image DJI0202. Drone image from Mangaheia River upper Tauwhareparae Road showing slash pile on river terrace, fresh slipping from edge of forestry roadway (far right) and slumping of river banks.

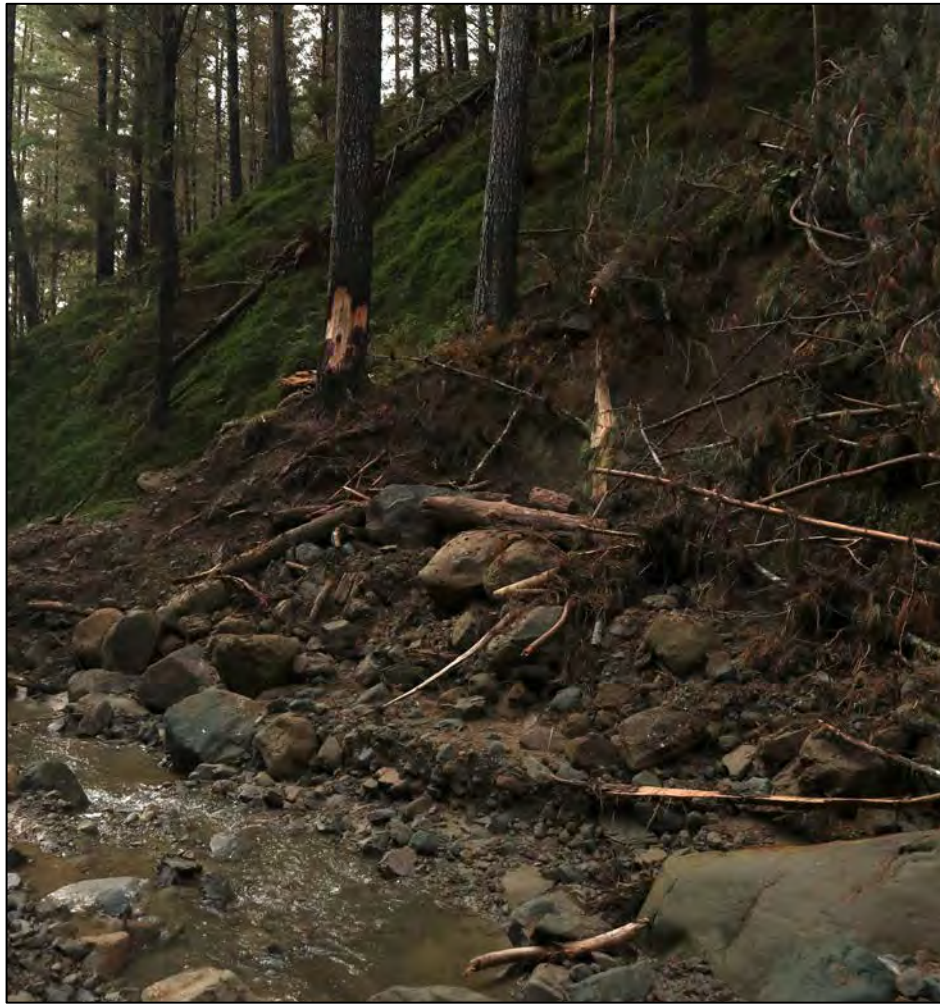
View of damage to standing tree trunk from force of debris flow in Waterfall Creek.

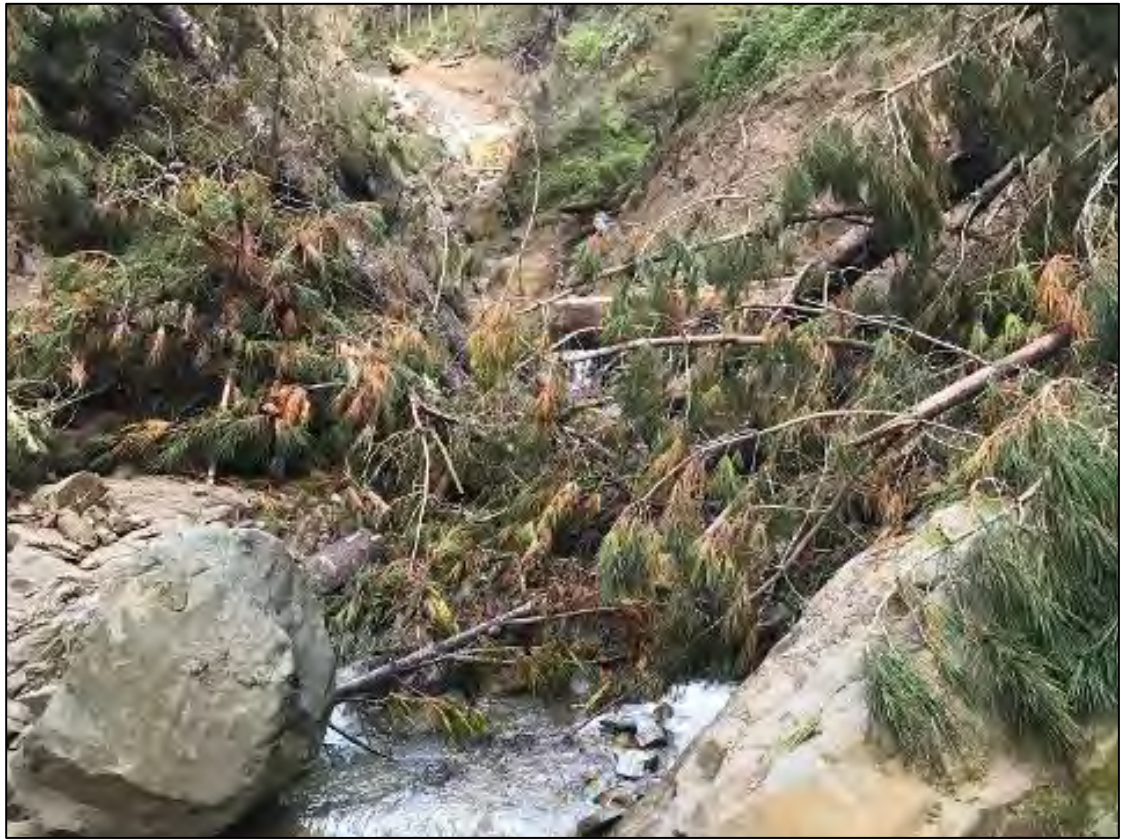
Collapsed fresh pine as a result of stream wall erosion during debris flow.

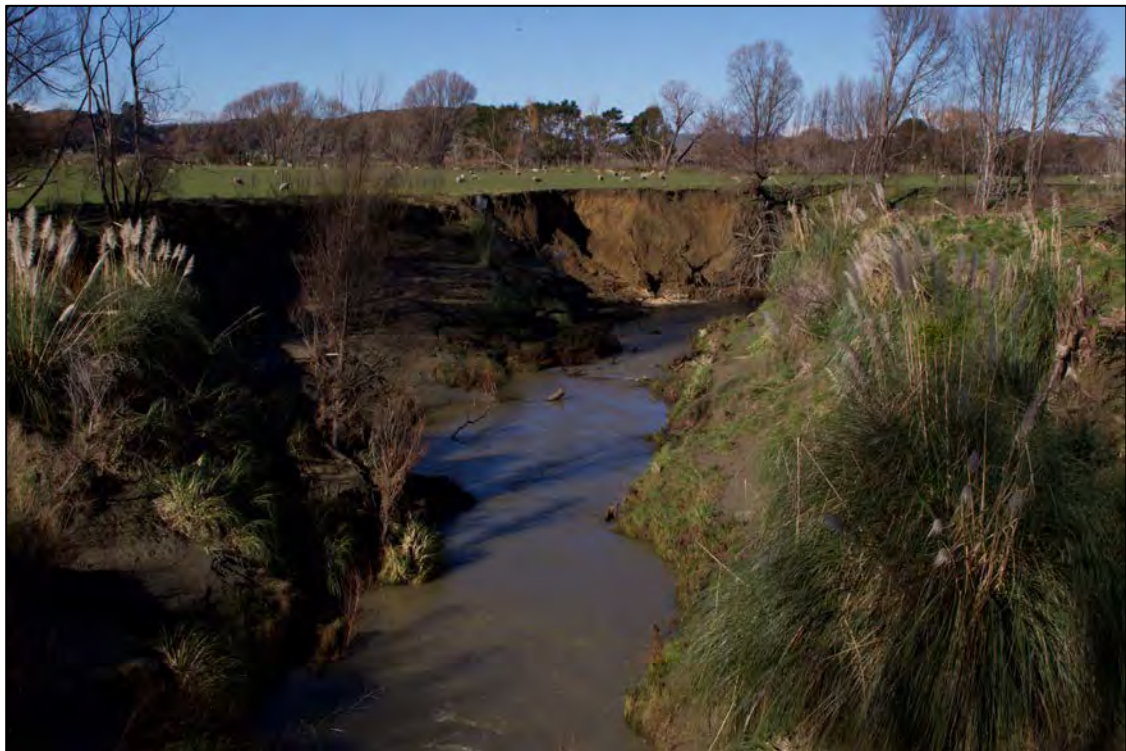
Mangatokerau Stream below bridge (11<sup>th</sup> July) showing failure of river bank.

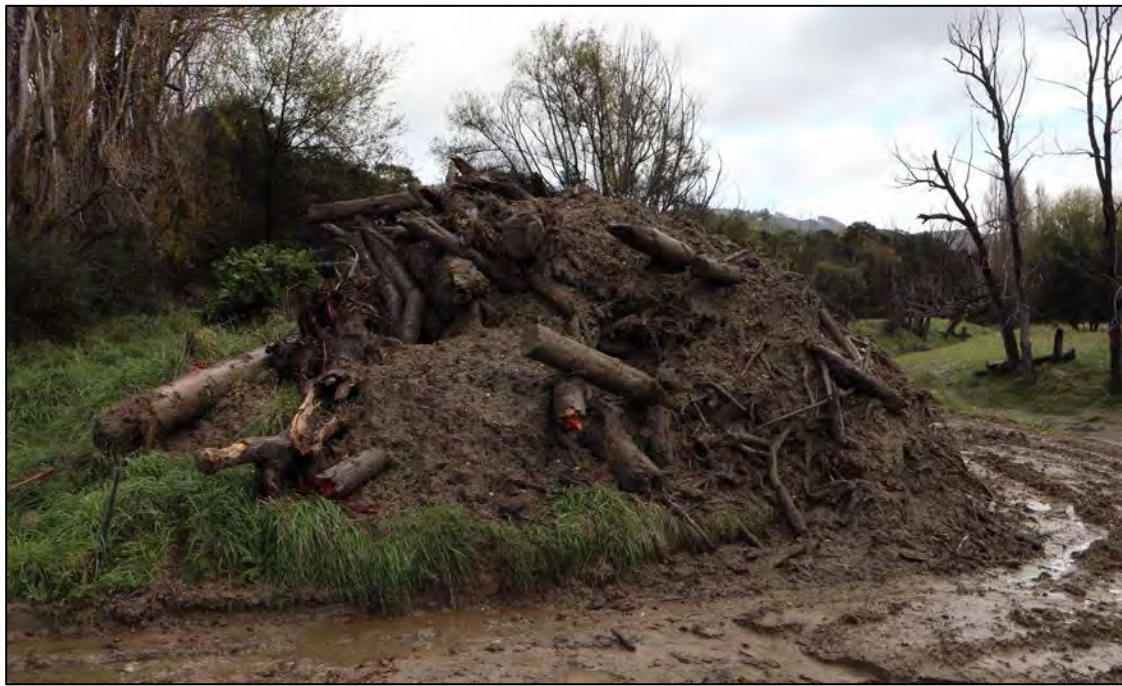
Image\_0089 Slash pile above Wigan bridge prior to deconstruction showing cut logs and muddy debris. It was not possible to accurately determine overall proportion of woody debris types without pulling the pile apart.
