## Appendix One

### Images from helicopter flight

### **Managatokerau Stream Traverse Images**

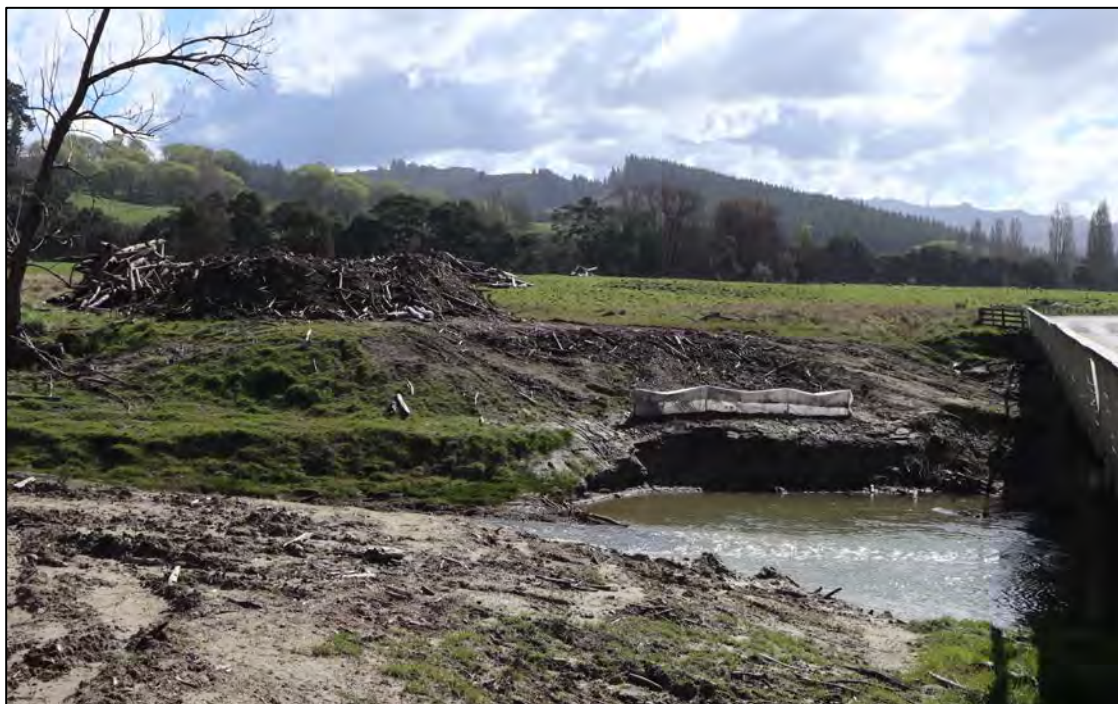
Poorly configured silt fence installed at Wigan Bridge.
