# An assessment of Woody Material on Tikapa Beach after the July 2020 storm and potential sources within the Waiapu

**Final report v3.5**

**Dr Murry Cave**  
Principal Scientist  
Gisborne District Council  
January 2021

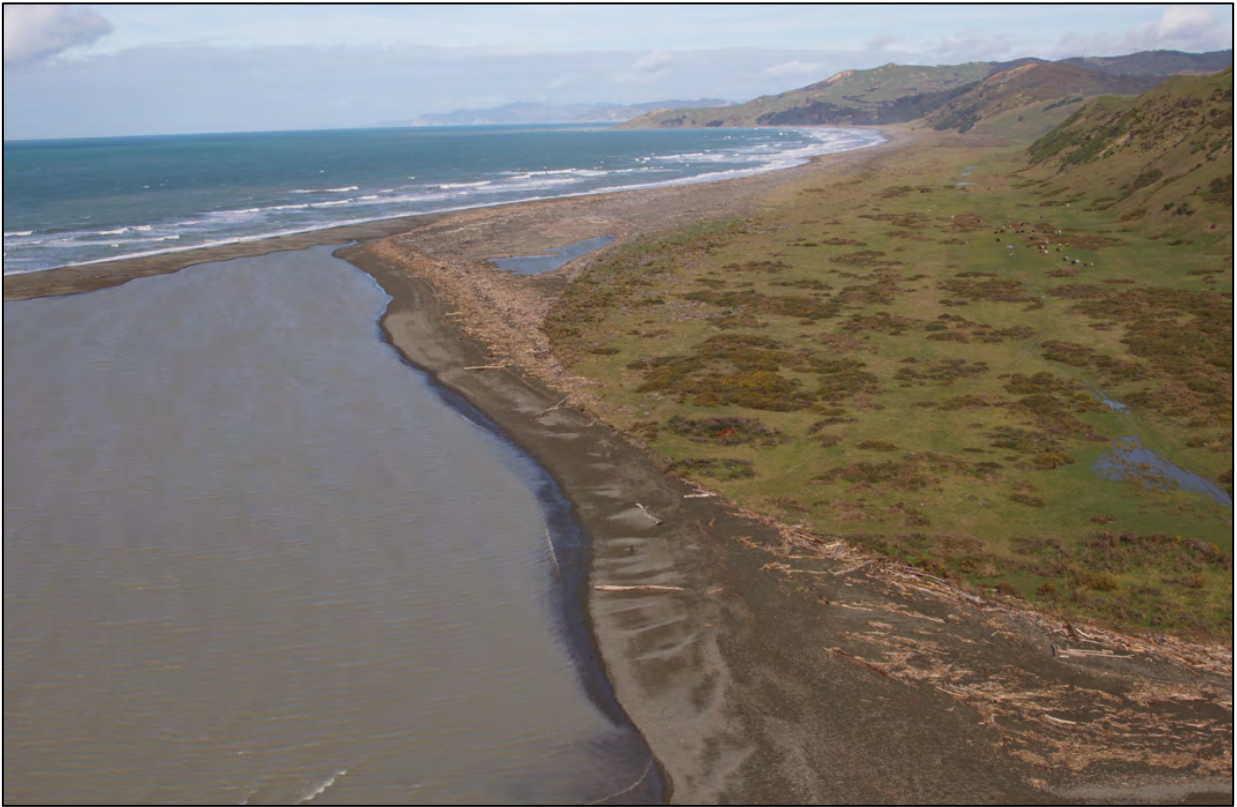
**Figure Six.** View of the beginning of Tikapa Beach from the Waiapu River mouth showing extensive woody debris which from its brown colour will have been recently deposited.

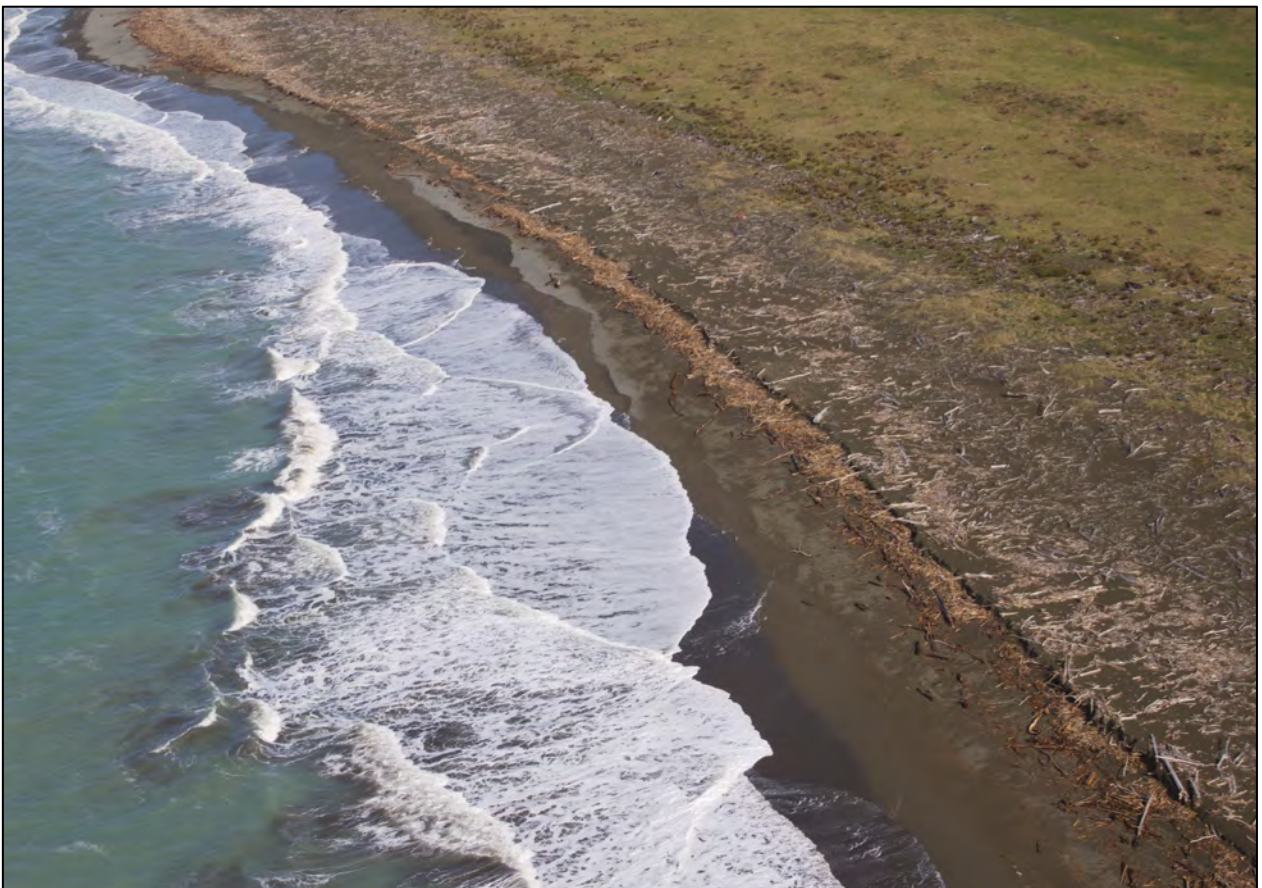
**Figure Seven.** View of Tikapa Beach midway between the river mouth and the Tikapa roadend showing a thin strip of woody debris below a trimline with more extensive debris in the south.

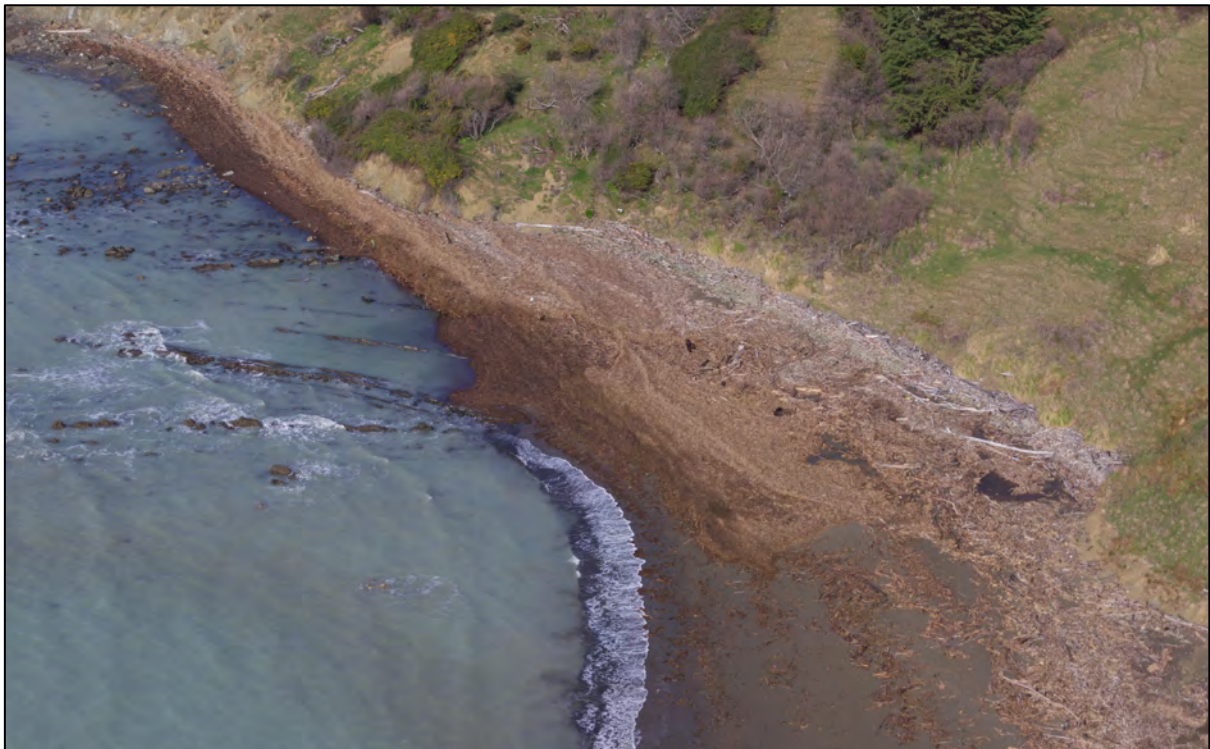
**Figure Eight.** The south end of Tikapa Beach near Whakariki Point showing the broad area of fine grained wood waste (“dross”).

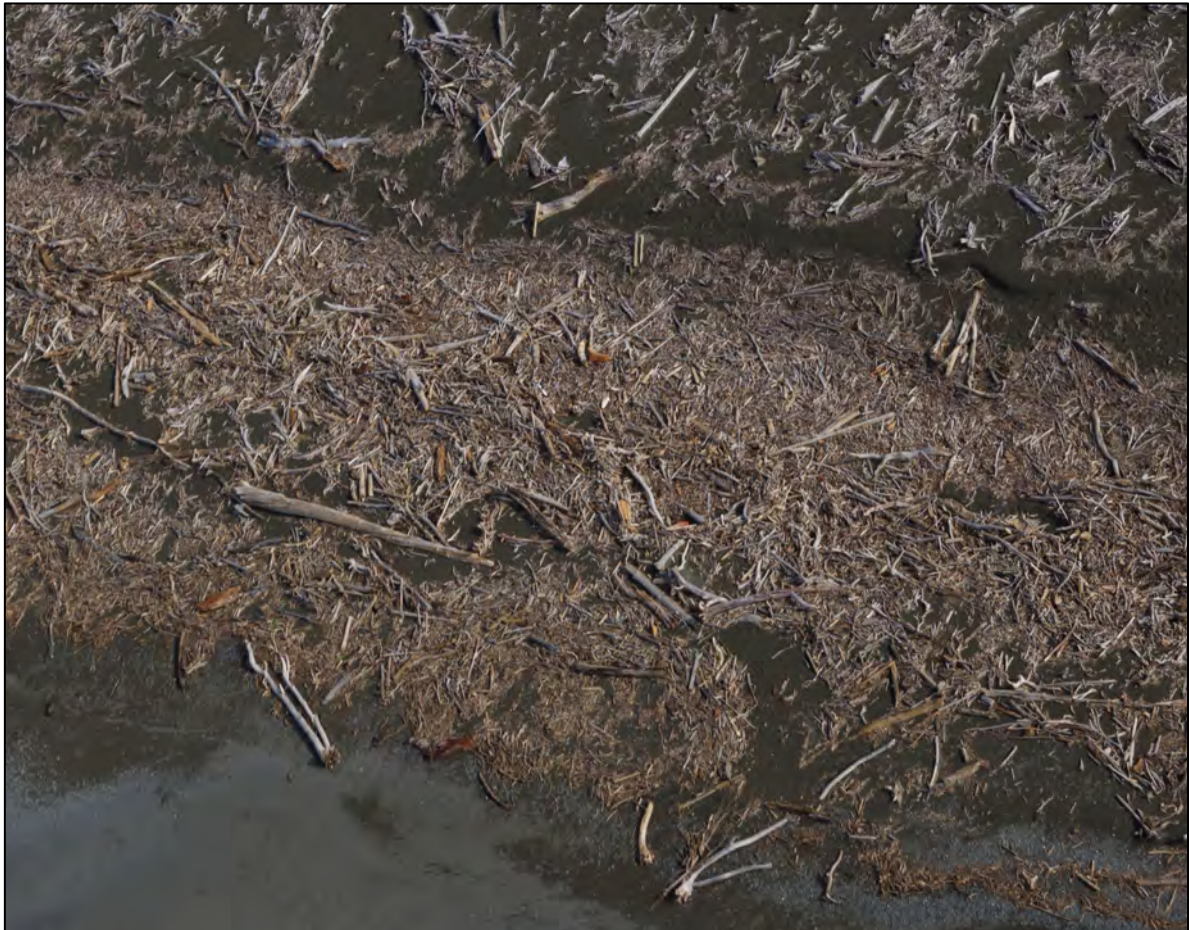
**Figure Nine.** *View of the beach approximately one third of the way from the river mouth to the Tikapa roadend showing the mix of material present.*

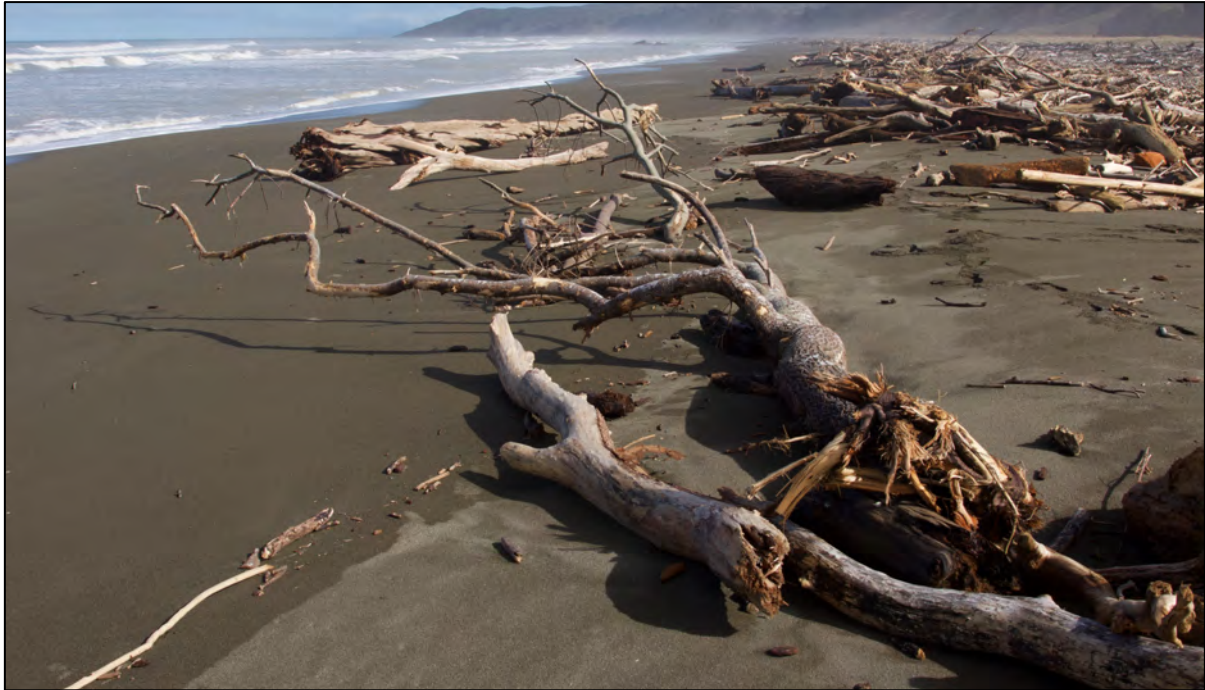
**Figure Twelve.** View on large wood waste at the Tikapa roadend showing primarily willow logs in the foreground with one small indigenous log at bottom right, a large indigenous log above close to the sea and other smaller indigenous pieces at middle right of the image.

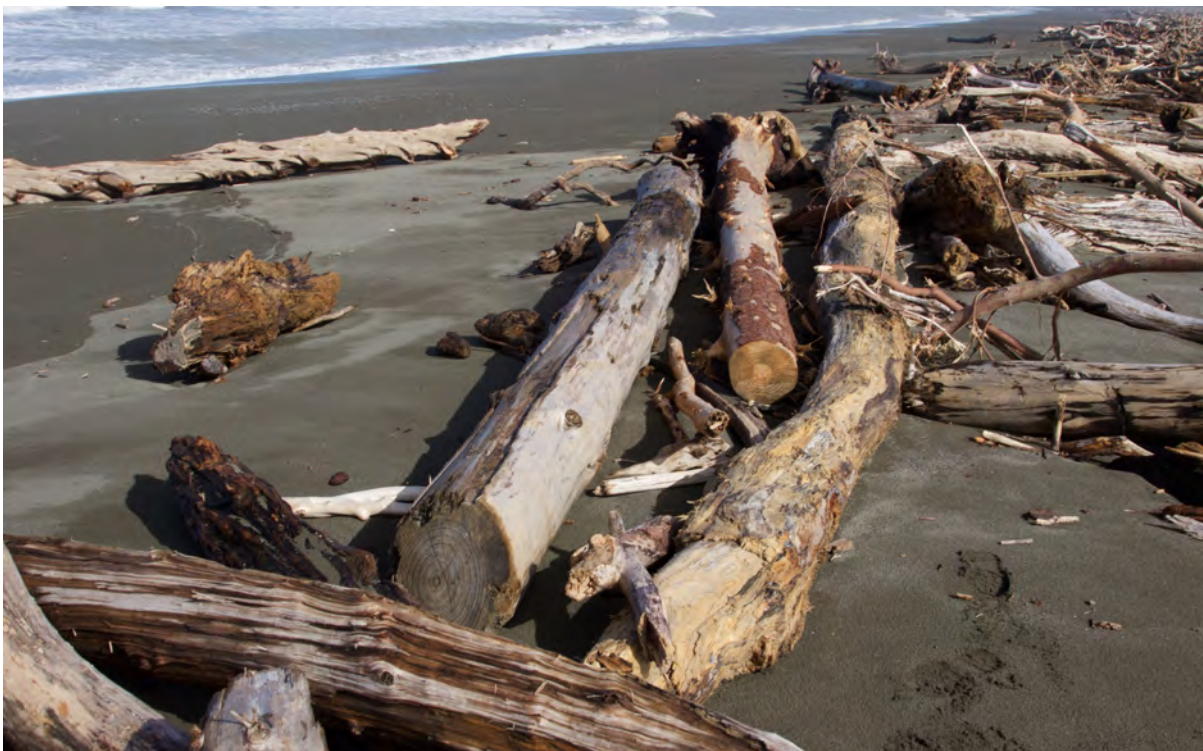
**Figure Thirteen.** View on large wood waste at the Tikapa roadend showing cut pine logs prominent in the foreground and an indigenous log on the right of those and a long-resident pine log further on the right of the image. Foreground logs are a mix of indigenous and willow with a large indigenous log in the background.

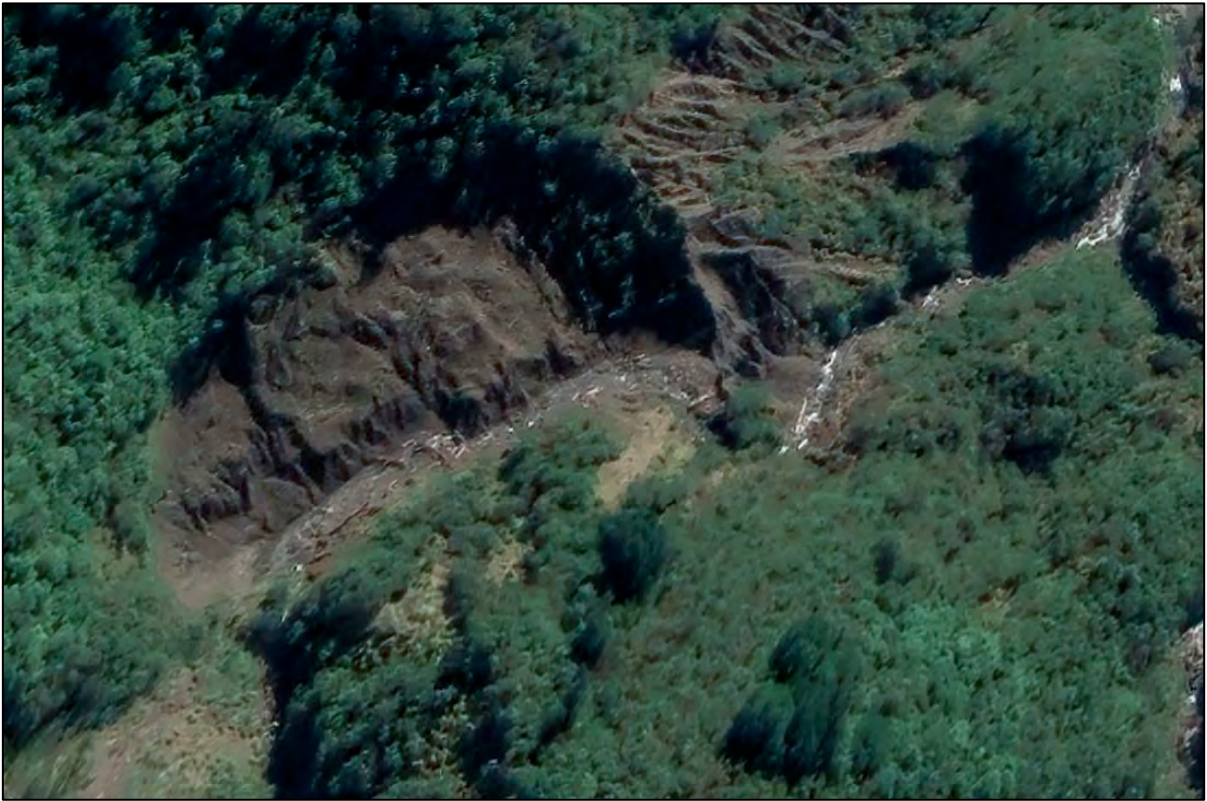
**Figure Thirty.** View of slip immediately downstream of the gully in Mangarata Stream showing a significant volume of indigenous logs in the streambed. Logs are also visible on the face of the slip.

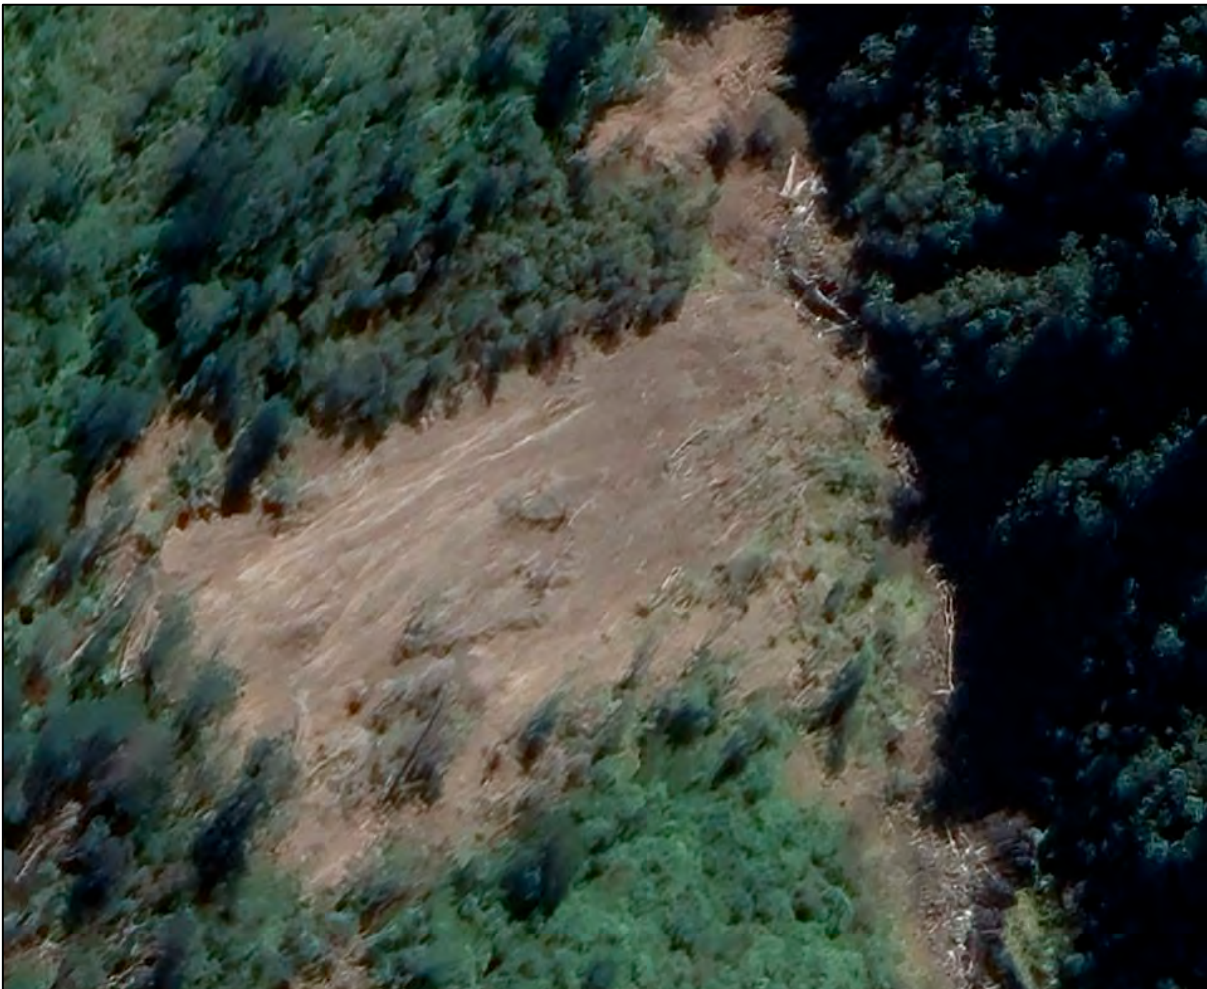
**Figure Thirty One.** View of an adjacent tributary of the gully in Mangarata Stream showing indigenous logs in the streambed. Logs are also visible on the face of the slip.

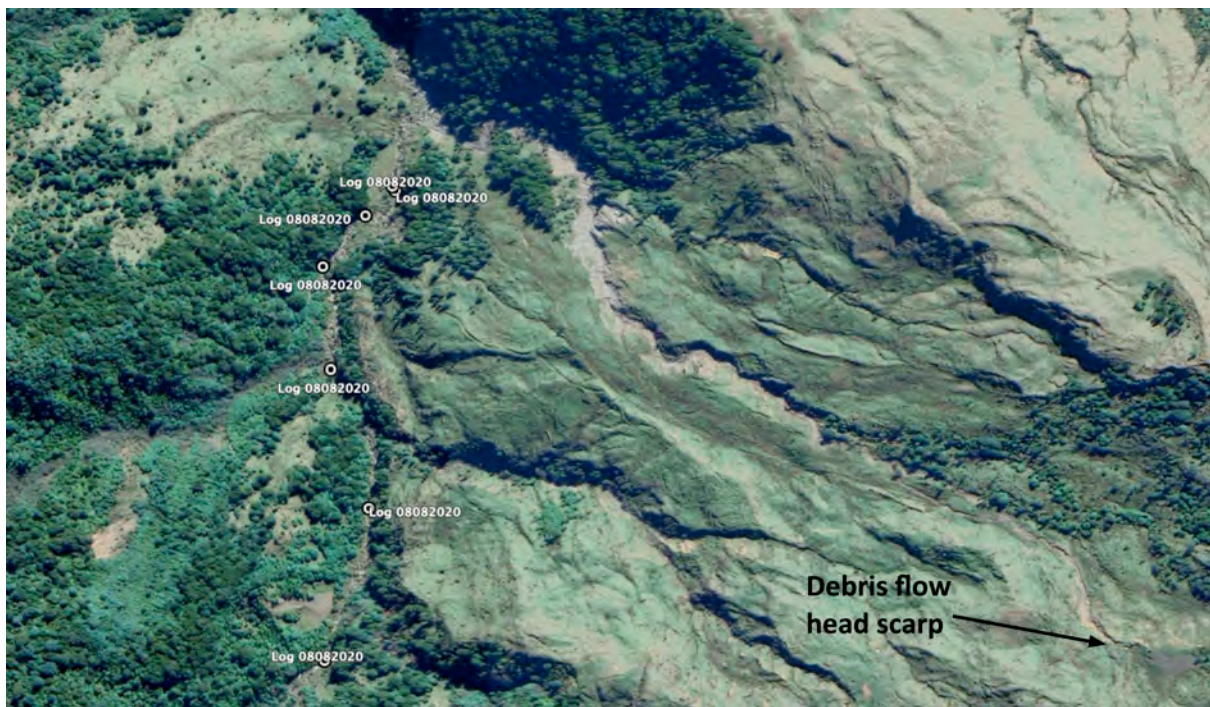
**Figure Thirty Three.** View of a debris flow at the headwaters of Mangatoitoi Stream.

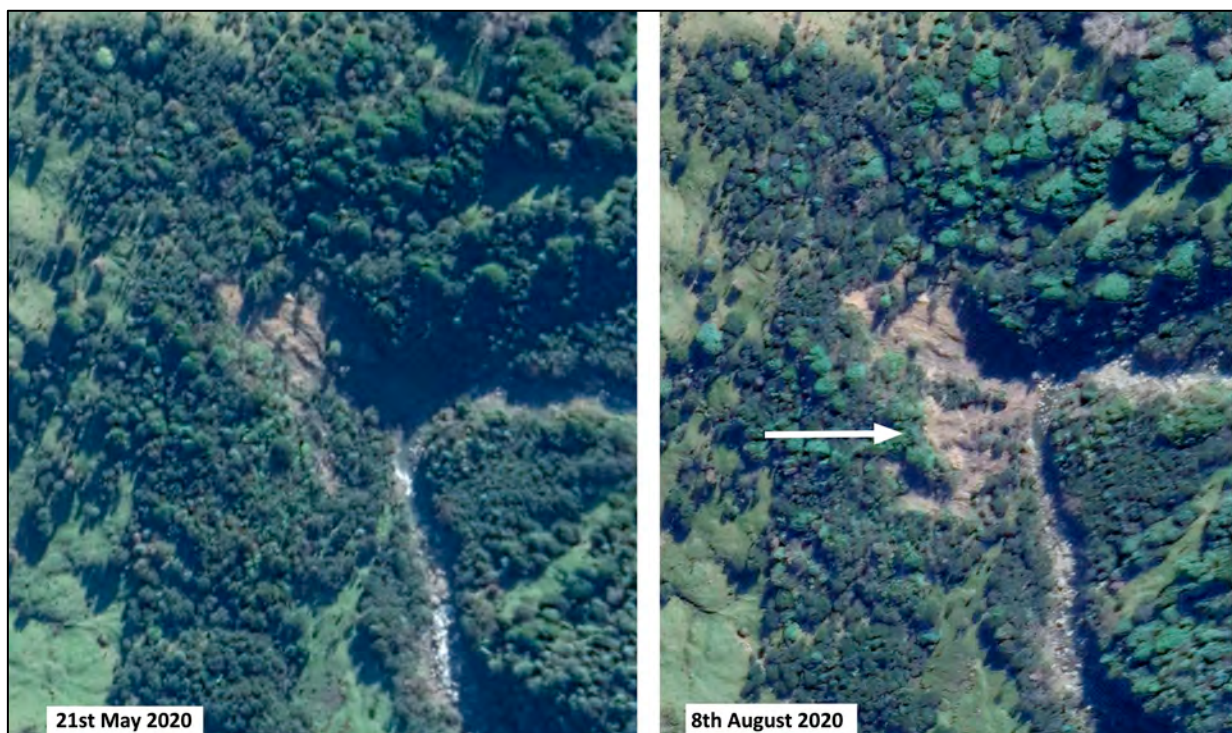
**Figure Thirty Four.** View of a slip in Mangatoitoi Stream that was enlarged during the July 2020 storms.

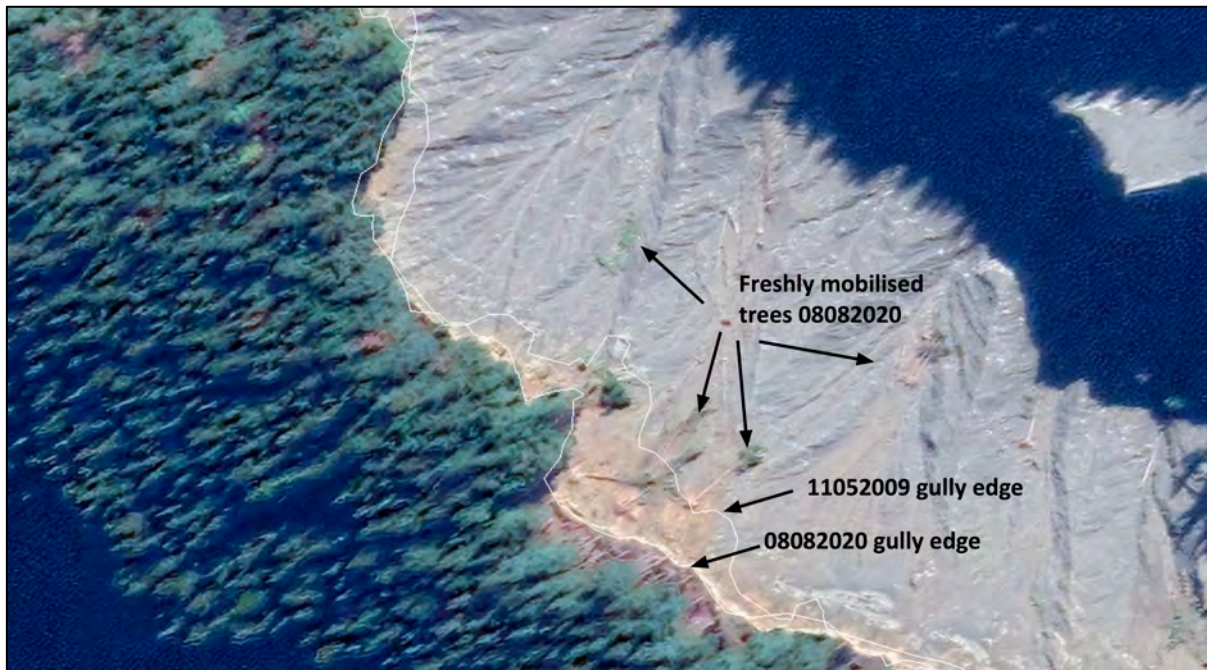
**Figure Thirty Six.** View of a 7.85 ha gully on the true right of Mangapekepeke Stream in the Tapuaeroa sub catchment in 2002 showing the extent of gully enlargement between 2009 and 2020, and signs of fresh erosion of soil with mobilised fresh trees in August 2020.

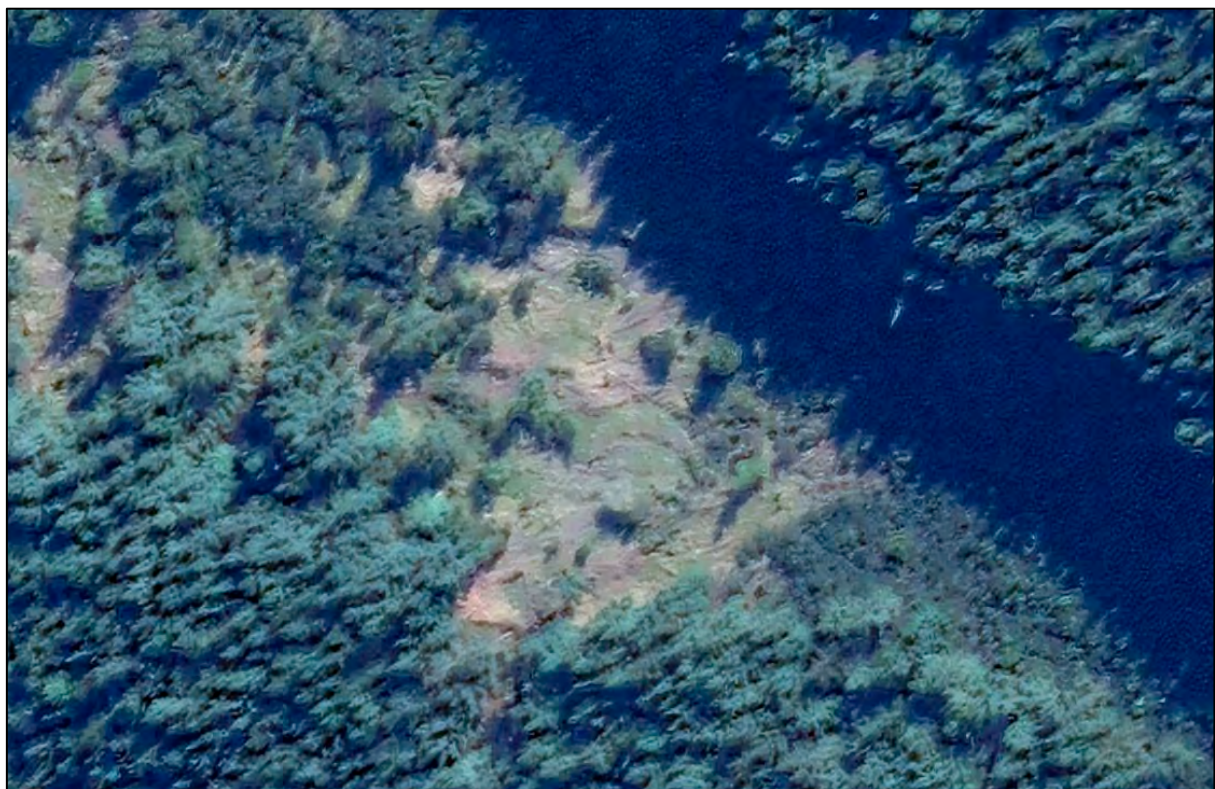
**Figure Thirty Seven.** View of a partially revegetated gully on the true left of Mangapekepeke Stream showing signs of recent movement in August 2020 with mobilised pine trees.

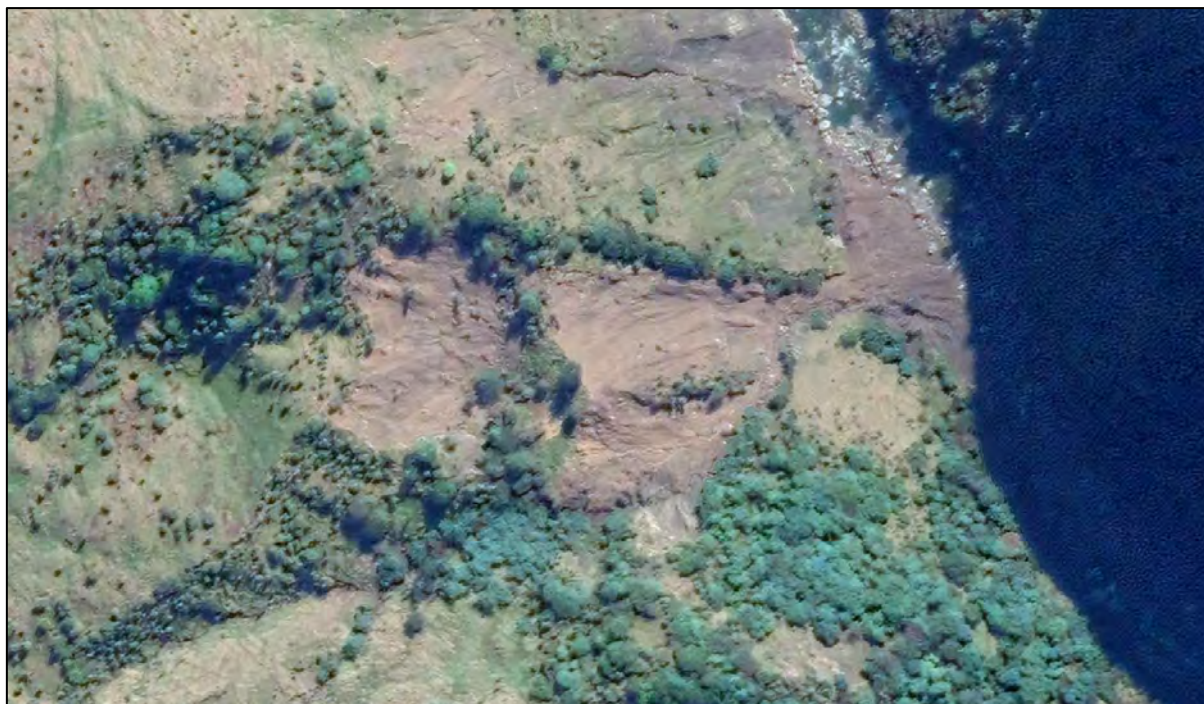
**Figure Thirty Nine.** 8<sup>th</sup> August 2020 satellite imagery of a large fresh landslide in the Waingata Stream tributary of the Waitahaia River.

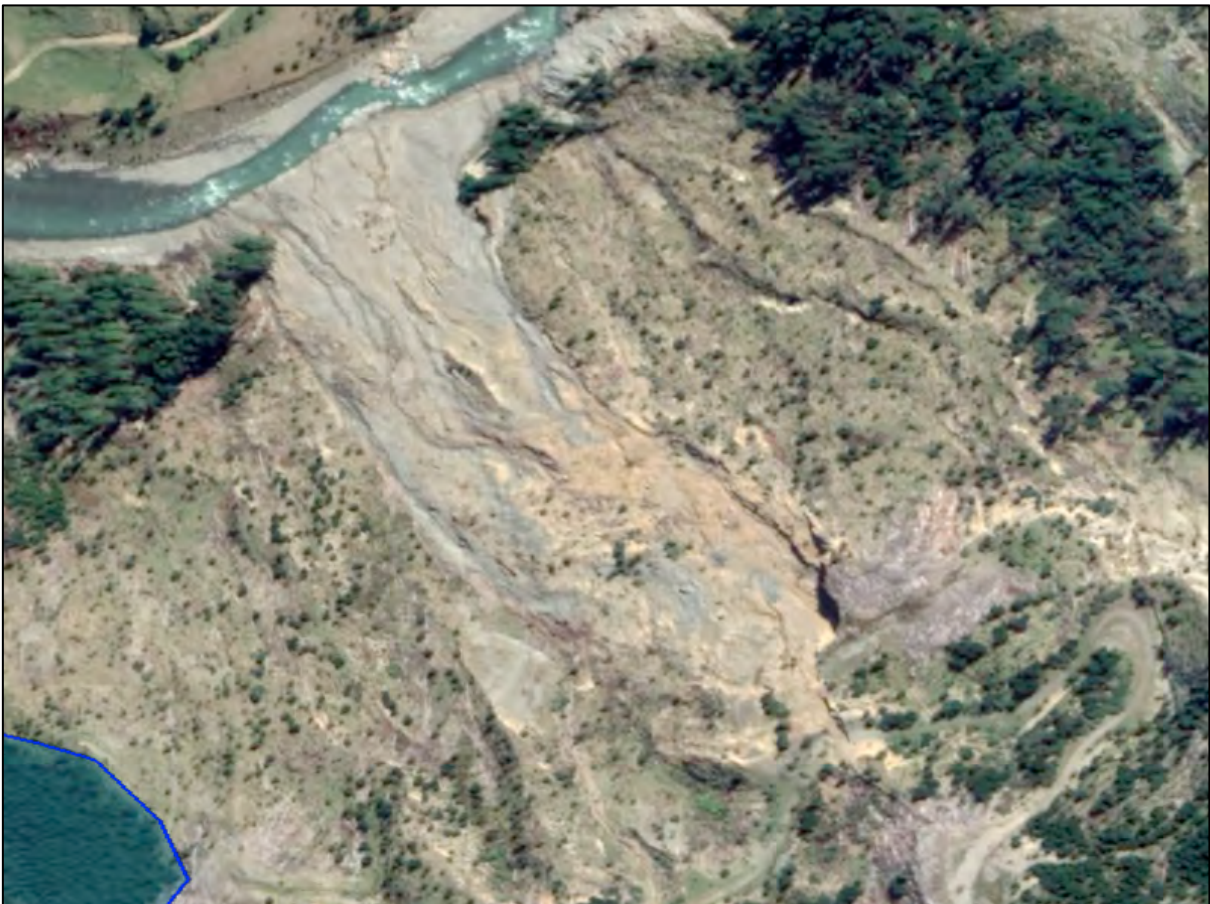
By the 8<sup>th</sup> of August 2020, the skid site has failed resulting in a slip to the river occupying approximately 4.5Ha. Assessment of low resolution Sentinel satellite data indicates that the failure occurred at some stage between the 14<sup>th</sup> of June and the 11<sup>th</sup> of July 2020. A more precise timing of this failure is not possible, however, since the visible spectrum images between those dates are obscured by heavy cloud.

**Figure Forty Three.** Satellite image of the same landing in the Waitahaia River dated 8<sup>th</sup> August 2020 showing the collapse of the landing with a significant slope failure to river level.

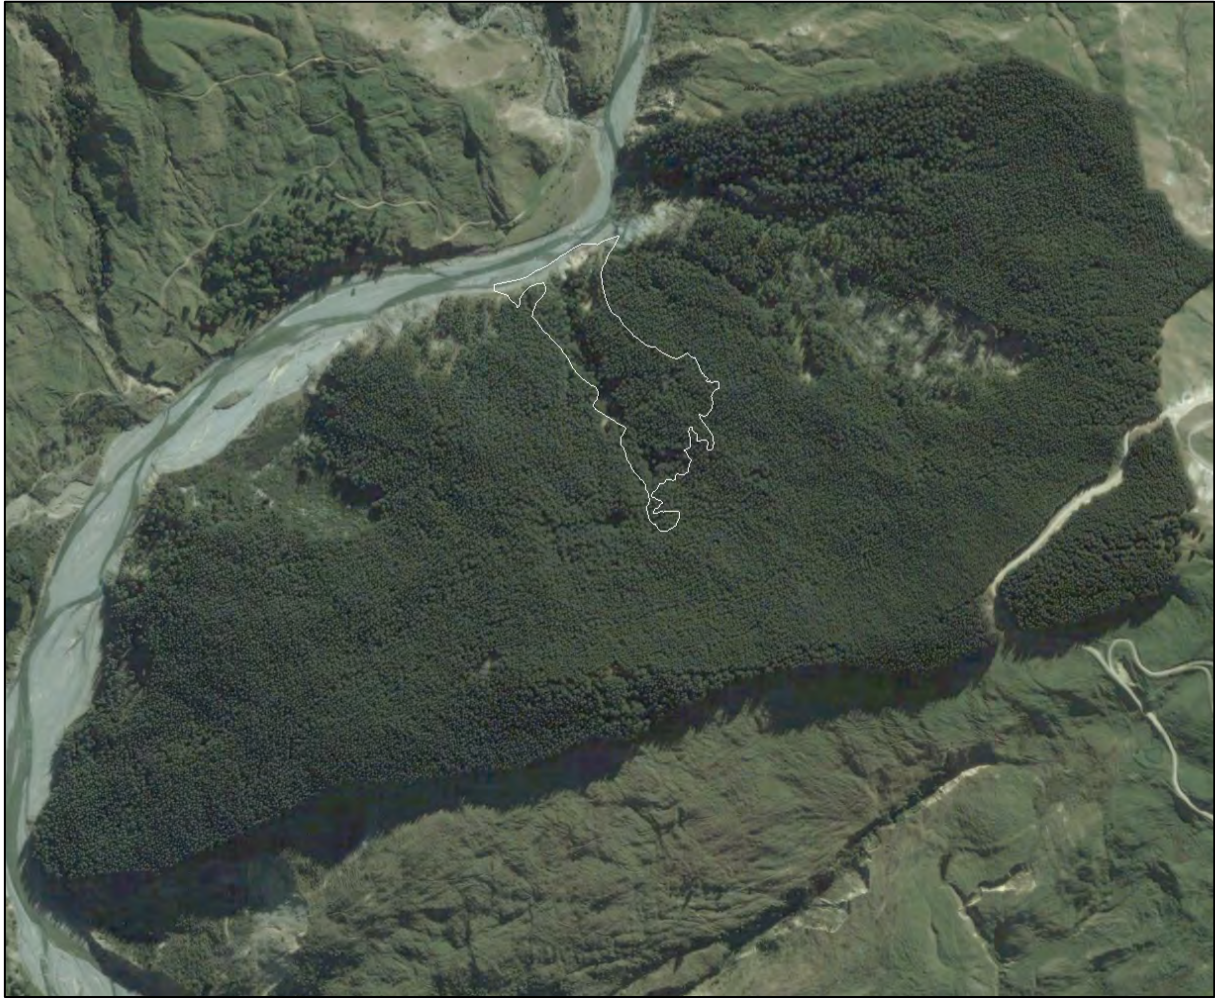
Analysis of available satellite imagery dating back to the 5<sup>th</sup> of May 2007 shows that the mature pine forest had been planted on a former area of instability (**Figure Forty Four**). Aerial photographs from 1981 show that the site was a large active slip with an obvious headscarp. It is likely that constructing a roadway and skid on a highly vulnerable site would have been a contributing factor in this site failure and that it would be appropriate for landslide risk assessments to be routinely used during the design of harvesting infrastructure and assessed in the consenting process.

**Figure Forty Four.** *Satellite image of the site of the landing failure that occurred in the Waitahaia River between 21<sup>st</sup> May 2020 and 8<sup>th</sup> of August 2020. This shows the outline of the slope failure that occurred during the storms of July 2020 with signs of the earlier slope failure marked by an area of poor growth. Other areas of instability with poor pine cover are evident on either side of the 2020 failure.*

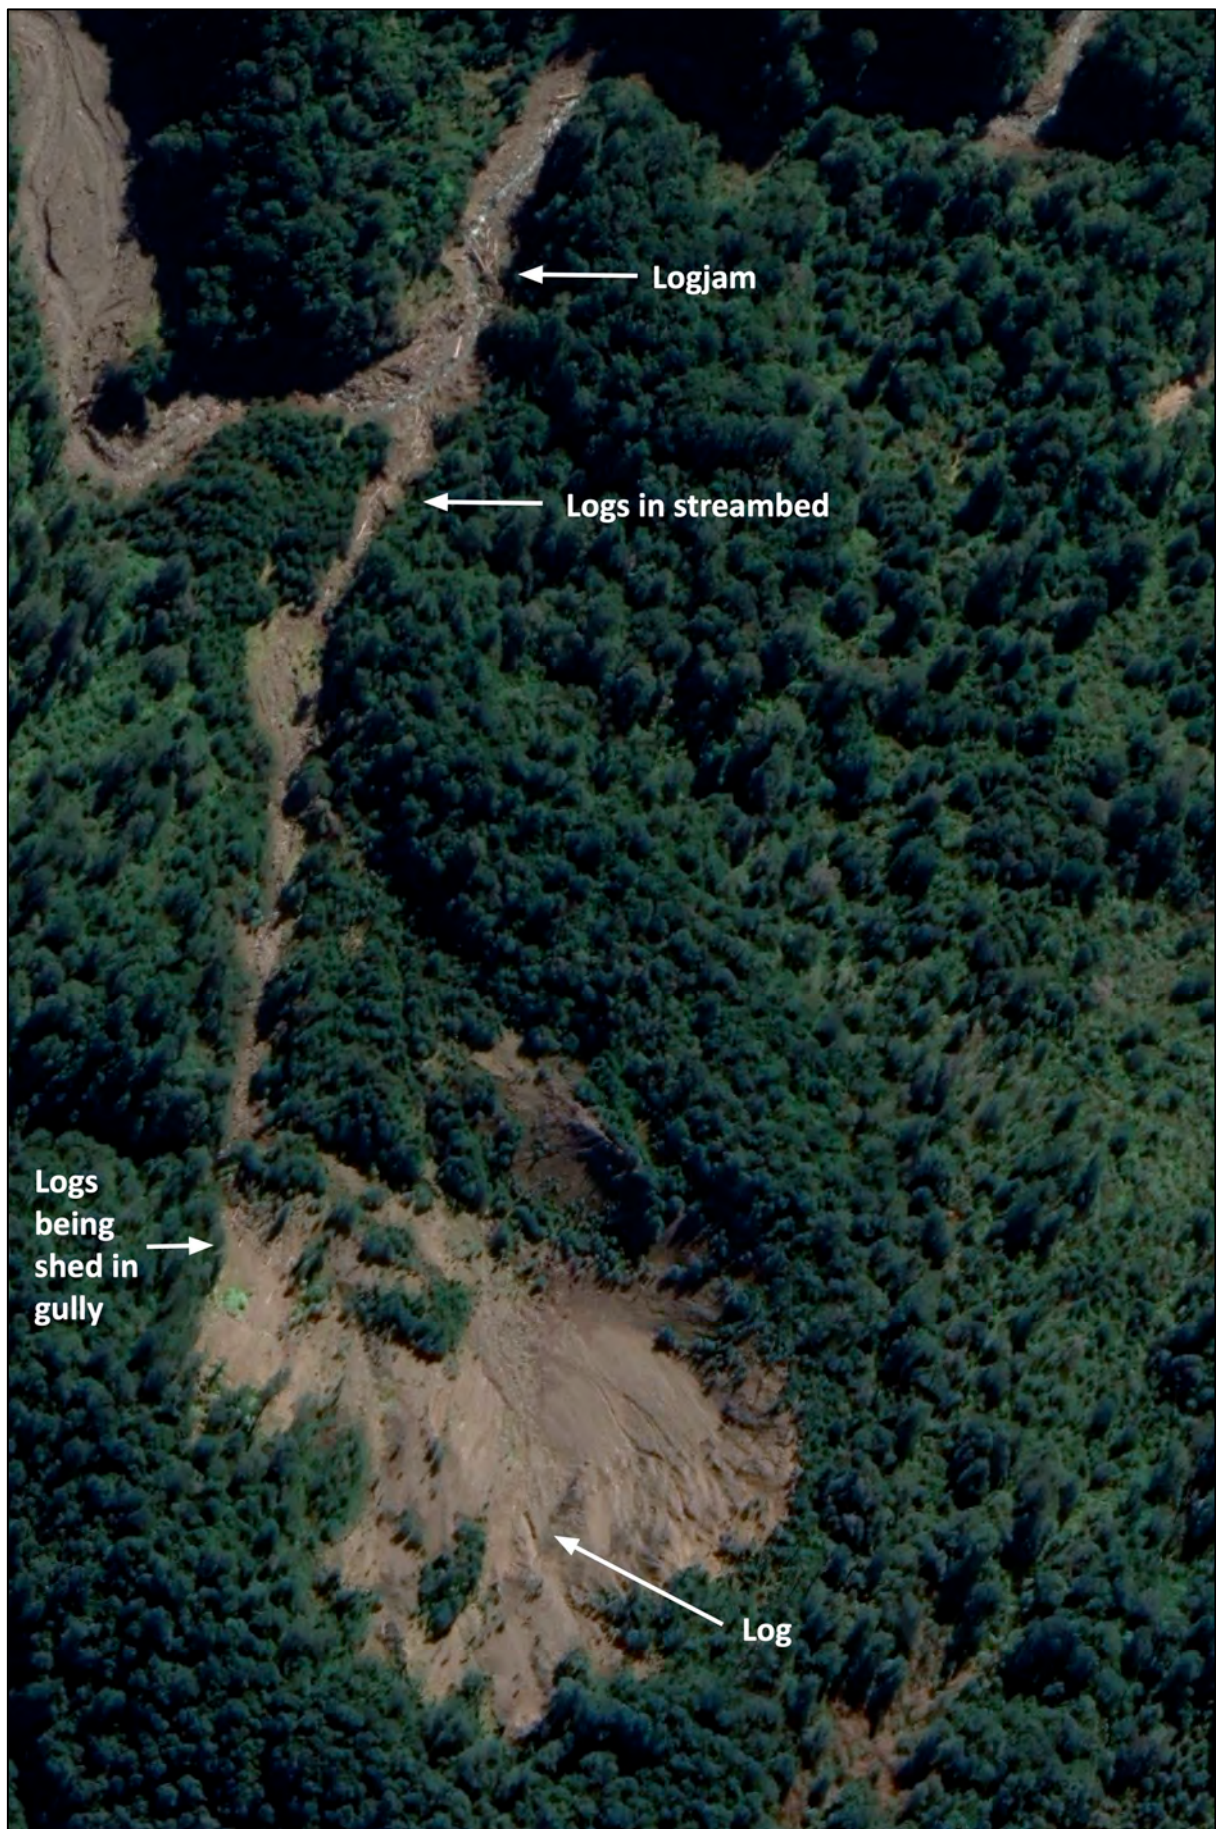
**Figure Forty Five.** Satellite imagery dated 13<sup>th</sup> September 2020 showing an active gully in indigenous forest shedding logs to Waingakia Stream.

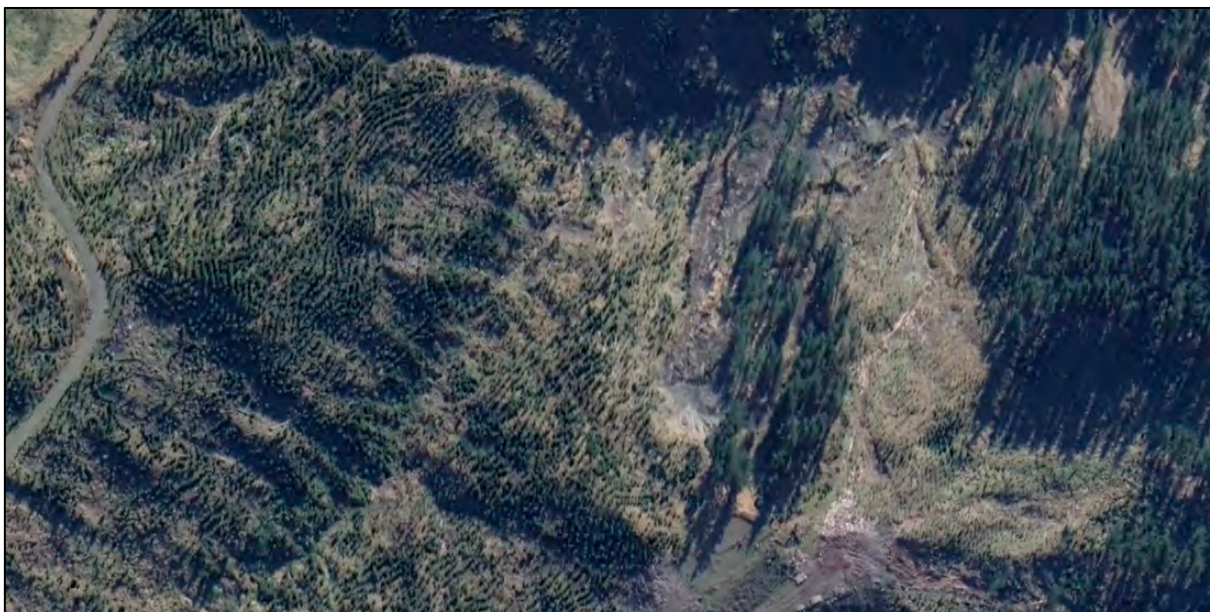
**Figure Forty Seven.** Satellite image dated 13<sup>th</sup> of July 2018 showing a recently activated landslide on the lefthand side of the landing and a debris flow on the righthand side. Note mature pine left standing below the landing.

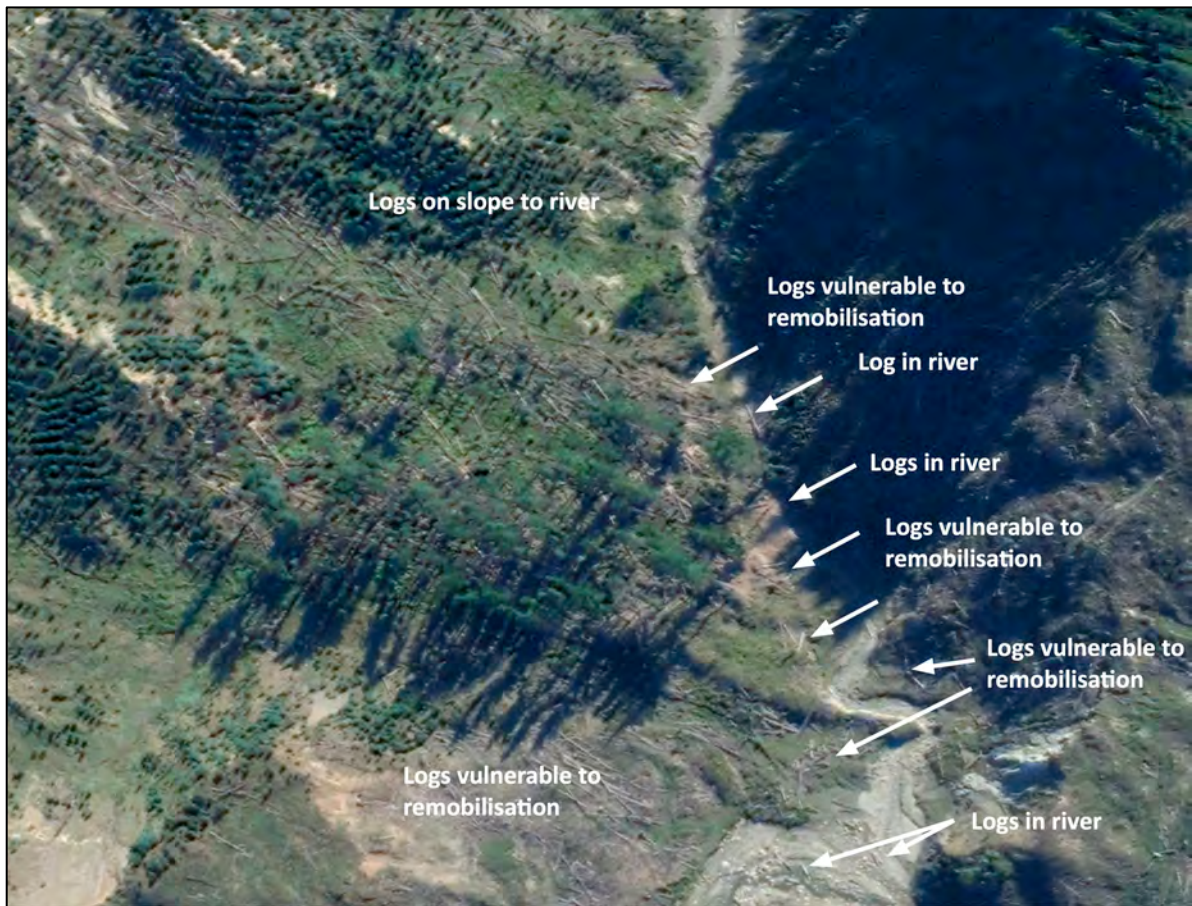
**Figure Forty Nine.** Satellite image of the Whakoau Stream upstream from near Bremnar Bridge (15<sup>th</sup> April 2018) showing the presence of a vulnerable slope with many logs from prior harvest distributed between a landing out of picture at top left as well as the position of logs in the area downstream.

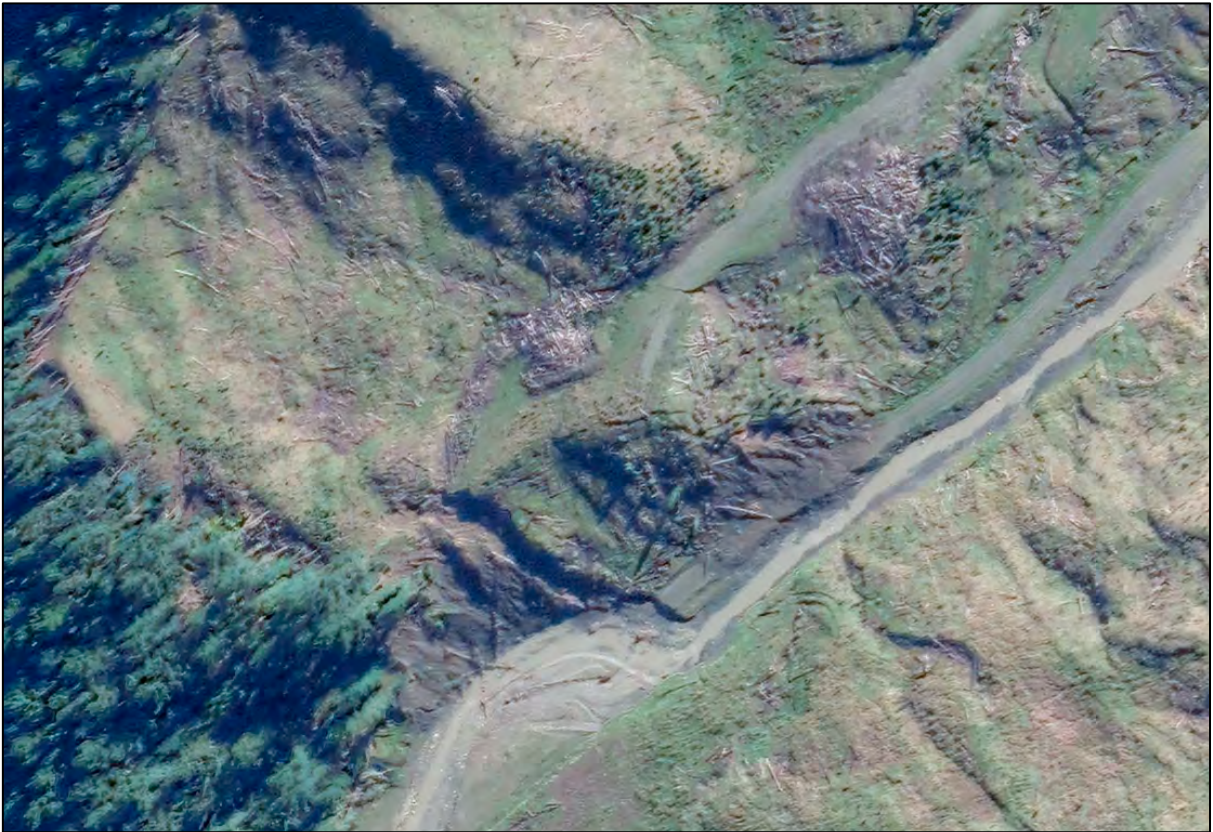
| Sources | Vegetation class | Watercourse |
|---|---|---|
| Significant tension cracks mobilising logs on skid site. | Recent pine harvest | <a href="#">Whakoau Stm, Mata River</a> |

**Figure Fifty Two.** Satellite image of the same landing in Whakoau Stream dated 8<sup>th</sup> of August 2020 showing tension cracks and signs of logs mobilised from the slope below the landing after the 21<sup>st</sup> May 2020 sitting below the landing on the flood plain. Note also displaced trees from the standing forest on the left of the image.

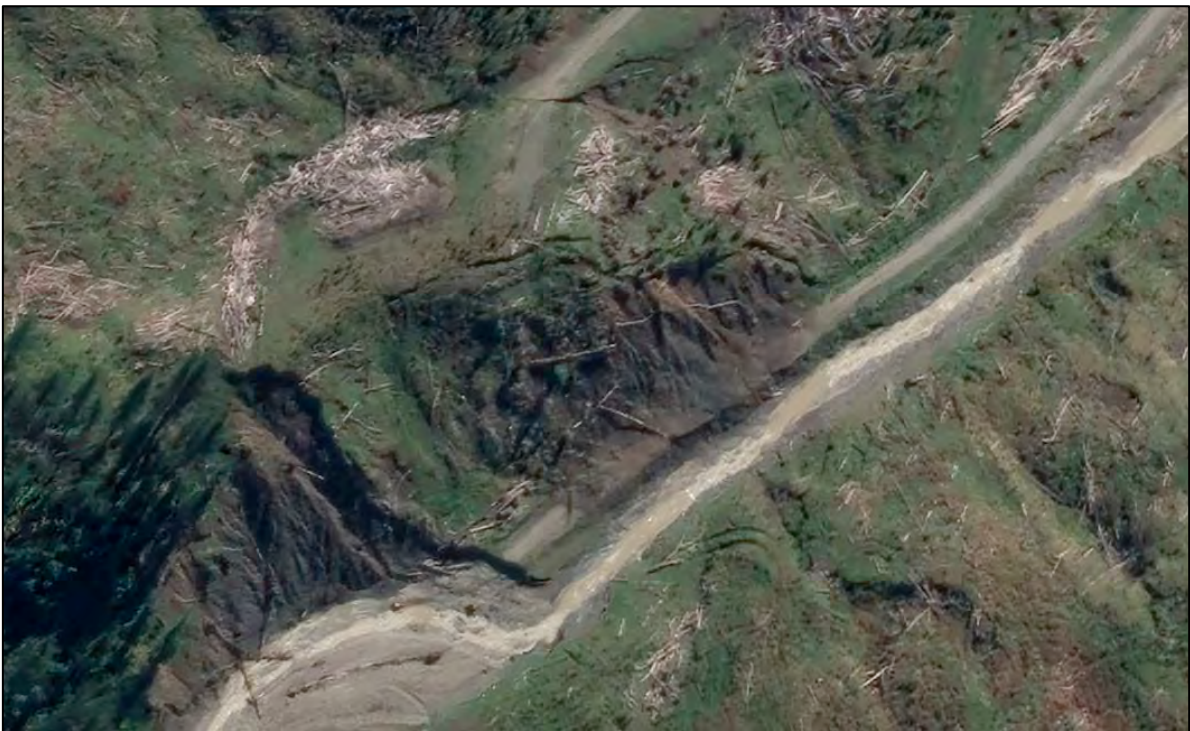
**Figure Fifty Three.** Satellite image of the same landing dated 16<sup>th</sup> of September 2020 showing the slumping at the site in more detail (with less shadow than the 8<sup>th</sup> of August image). Note the collapsed trees on the slip face and in the river at the toe of the slip upstream of the landing.
