# An assessment of Woody Material on Tikapa Beach after the July 2020 storm and potential sources within the Waiapu

**Final report v3.5**

**Dr Murry Cave**  
Principal Scientist  
Gisborne District Council  
January 2021

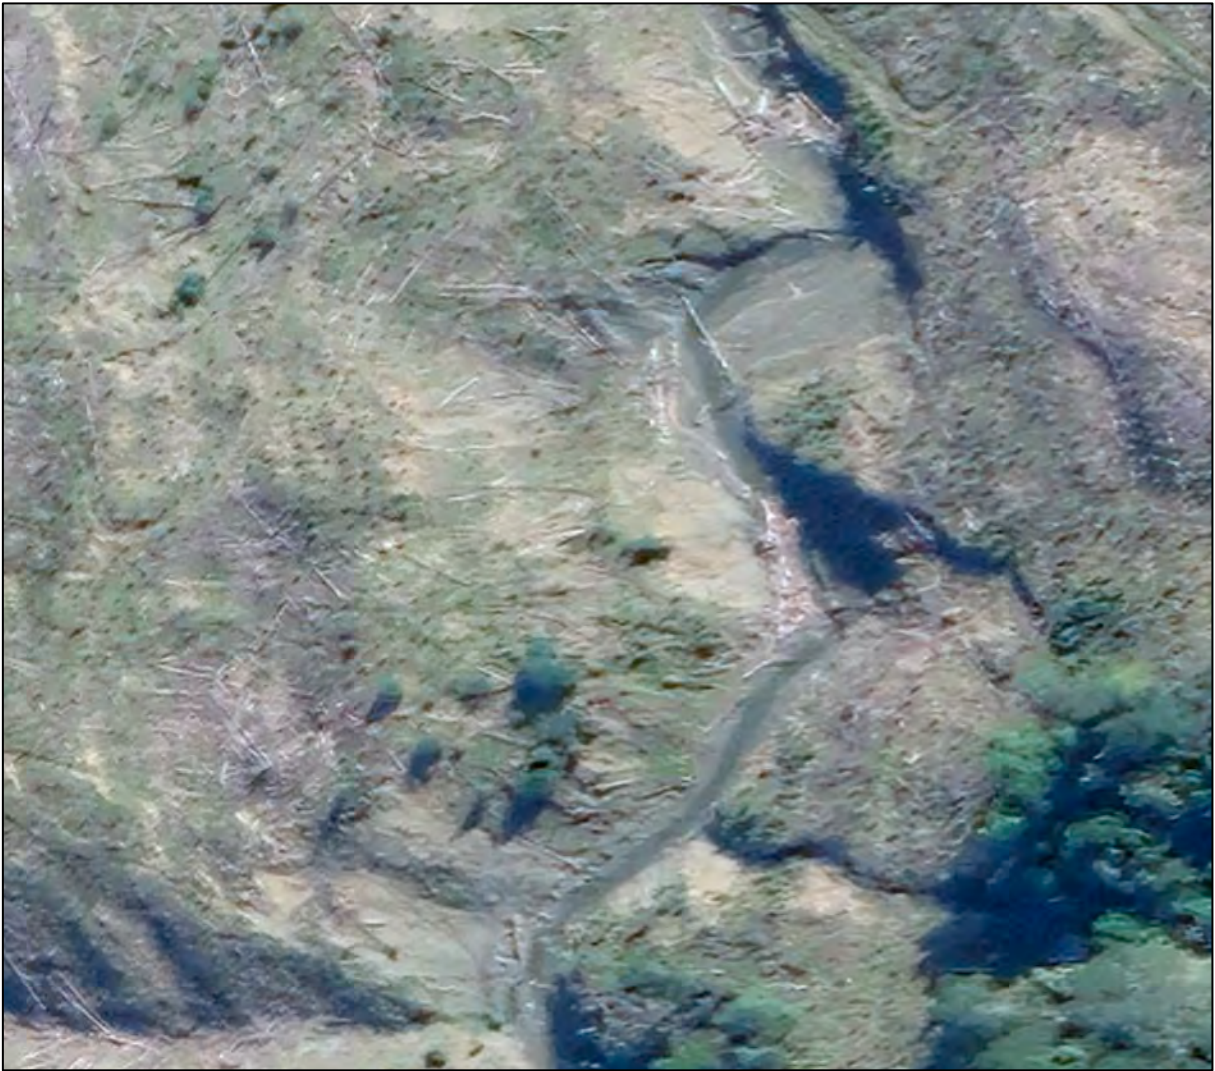
**Figure Fifty Five.** Satellite image of Mangahaweone Stream 27<sup>th</sup> August 2020 showing the log jams in the main stem.

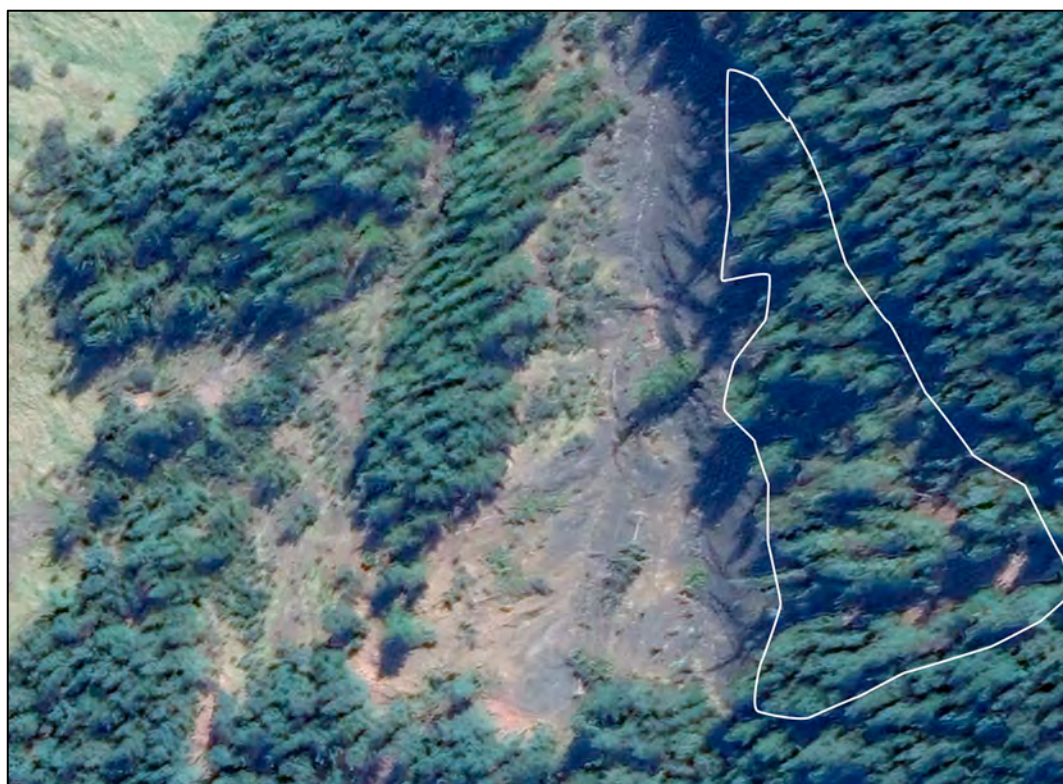
**Figure Sixty.** Satellite image of gully WTR1 in the Waitahaia River dated 8<sup>th</sup> of August 2020 showing the earthflow affected pines on the right and trees mobilised from the lefthand side of the eroding headscarp.

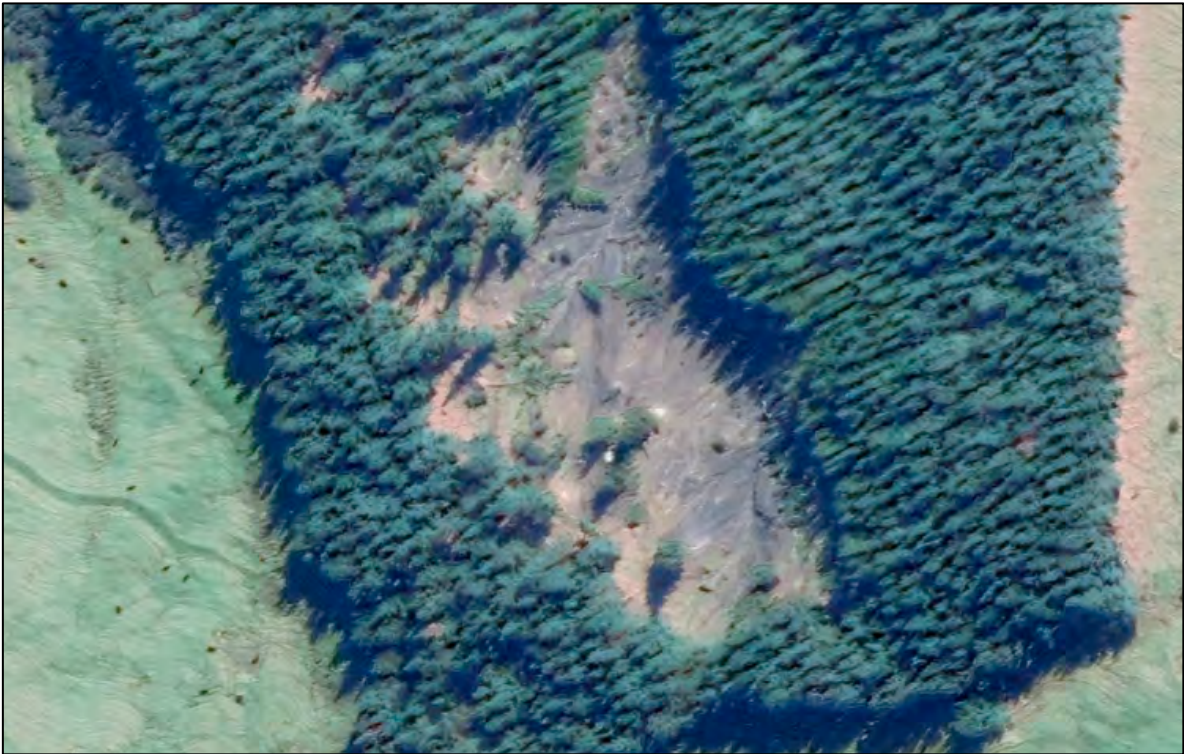
**Figure Sixty One.** Satellite image of gully WTR3 in the Waitahaia River dated 8<sup>th</sup> of August 2020 showing trees that have collapsed from the eroding headscarp on the left of the gully.

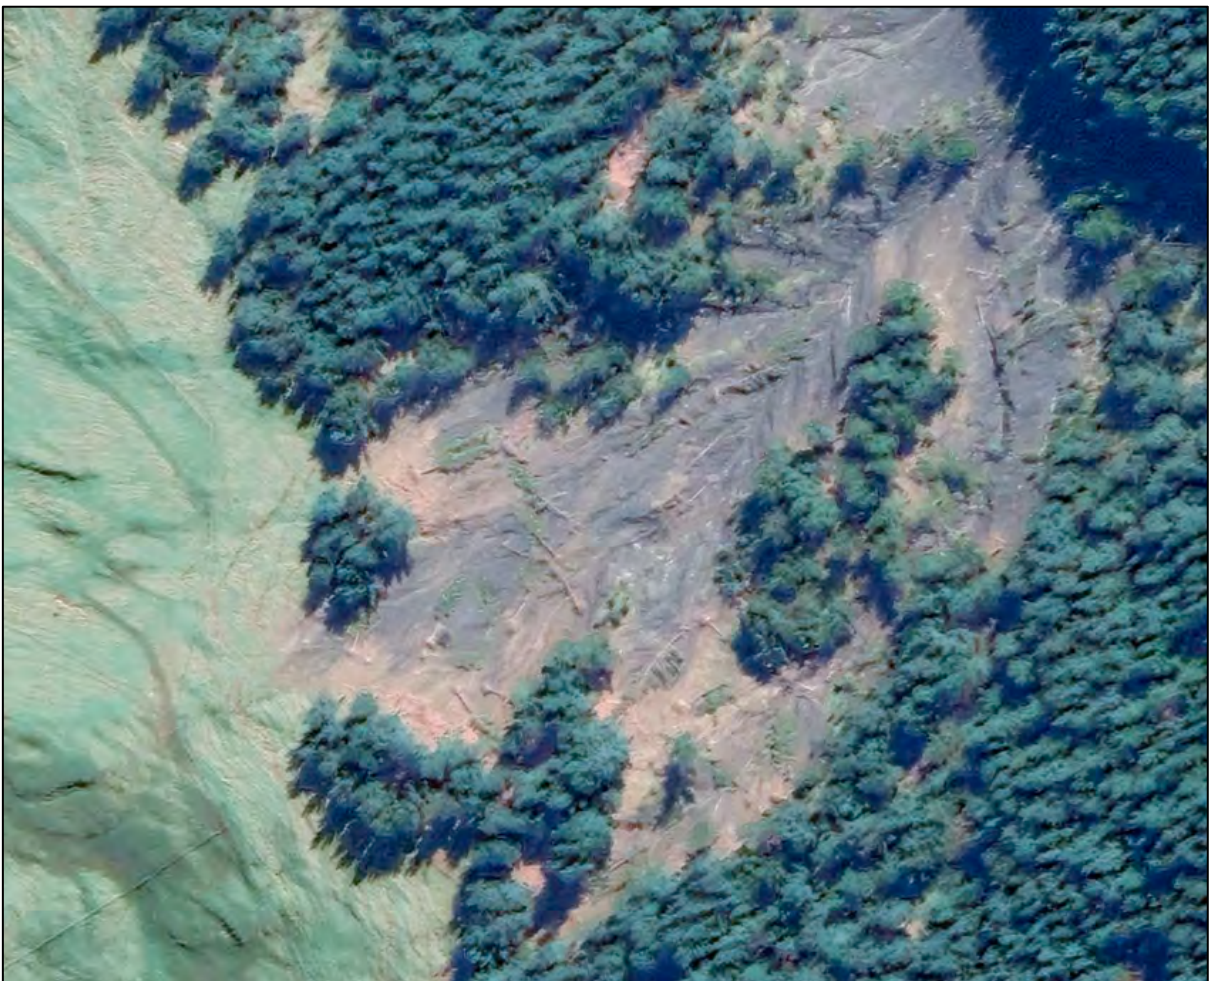
**Figure Sixty Two.** Satellite image of gully WTR4 in the Waitahaia River dated 8<sup>th</sup> of August 2020 showing significant number of trees mobilised from the eroding headscarp on the left side of the gully.

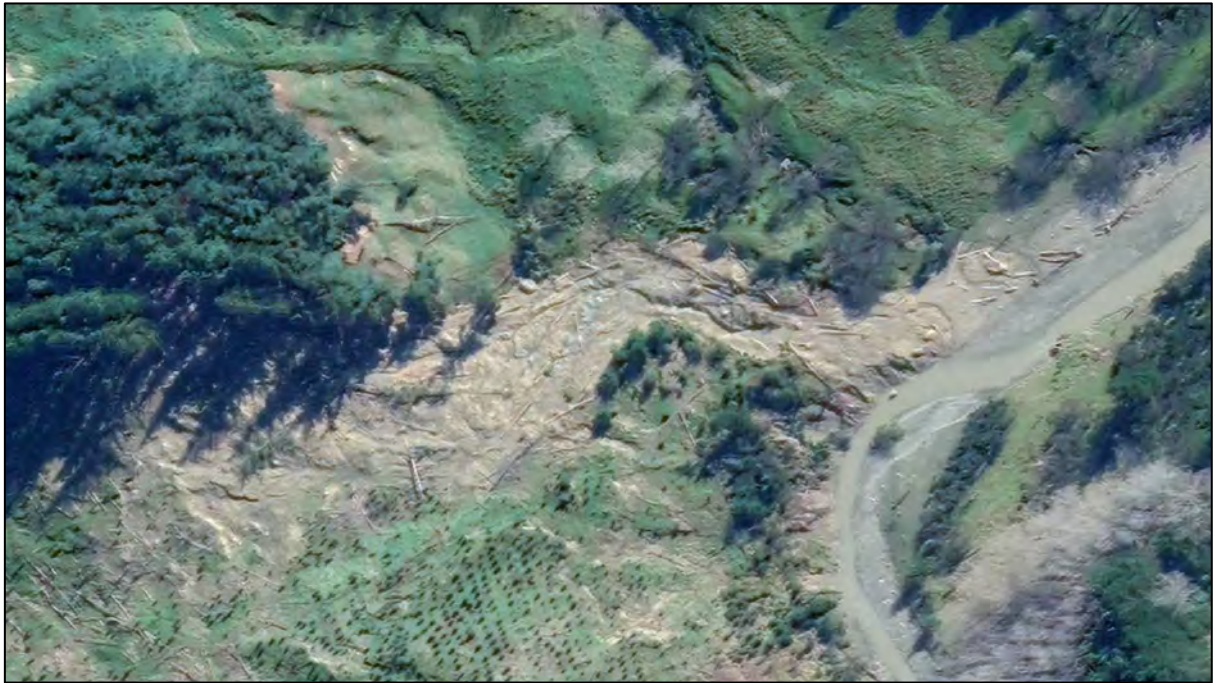
**Figure Sixty Four.** Satellite image dated 8<sup>th</sup> August 2020 showing a large slope failure on recently replanted slope that has shed a large volume of logs to the Whakoau Stream at Bremnar bridge.
