Cyclone Cook Slash Investigation

Dr Murry Cave Principal Science Advisor GDC
Nicki Davies, James Langford GDC Land & Soil Team

October 2017

Executive Summary

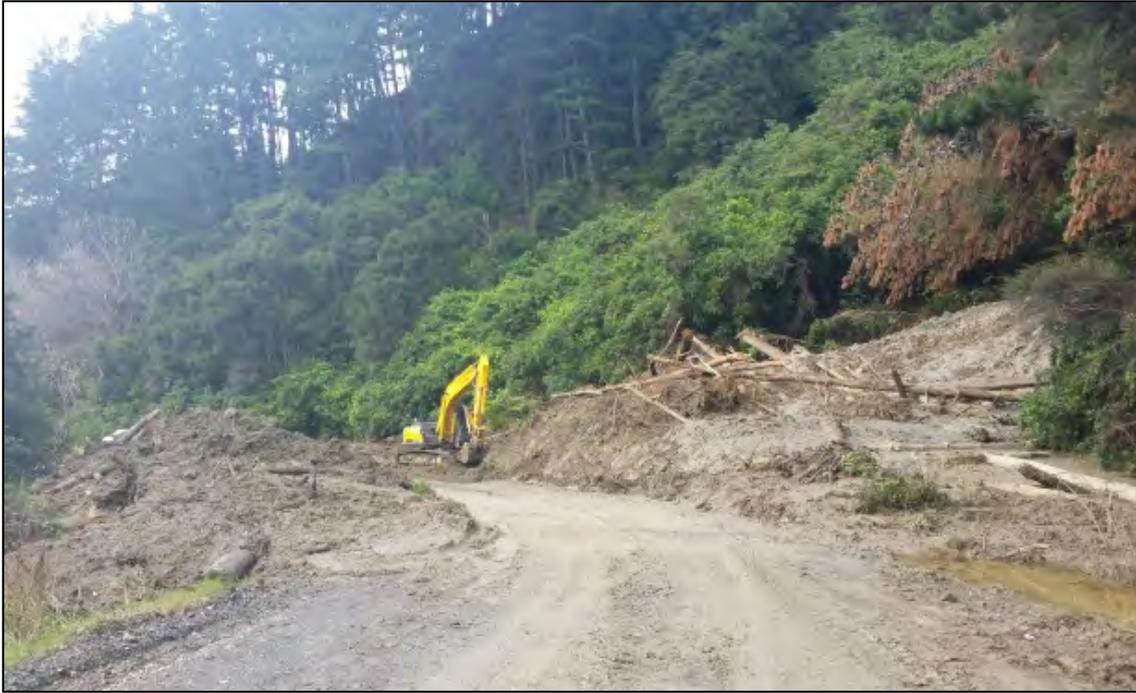
Figure 11. View of Doonholm Landslide during clearing operations.

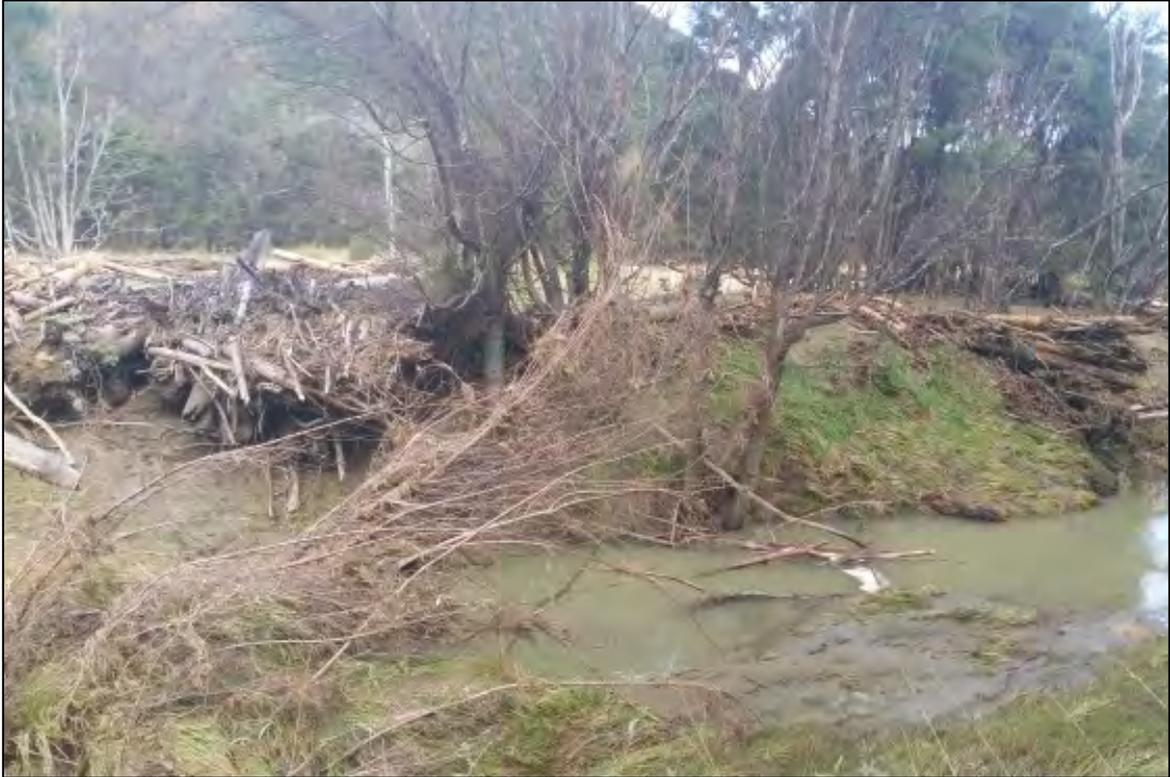
Figure 15. Pine logs and fine woody dross caught up against willows on the banks of the Mangatokerau River, with fresh silt deposition also evident.

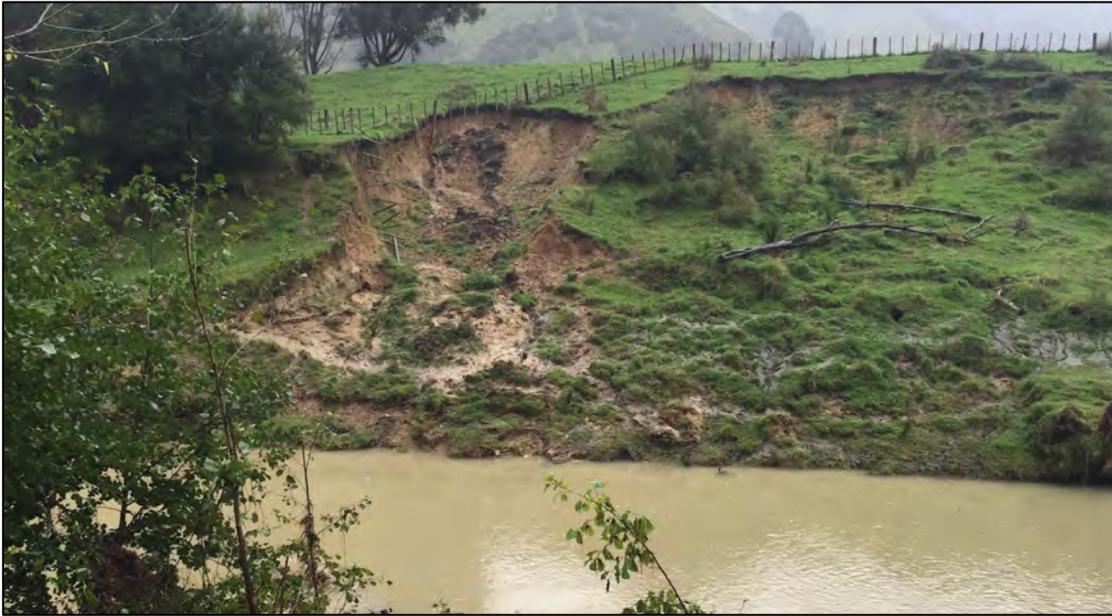
Figure 17. Slumping of the banks of the Waimata river after Cyclone Cook.

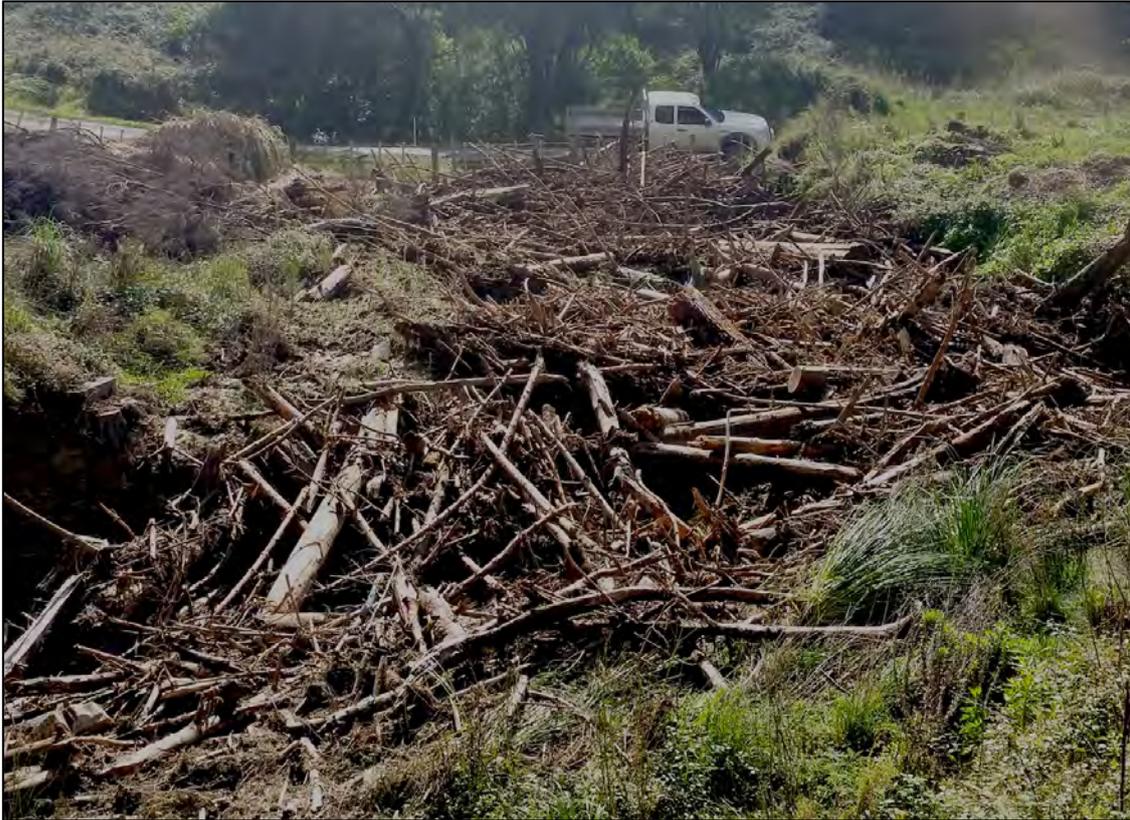
Figure 21. Photo of north-facing slope above Cave Road showing slash filled gully.

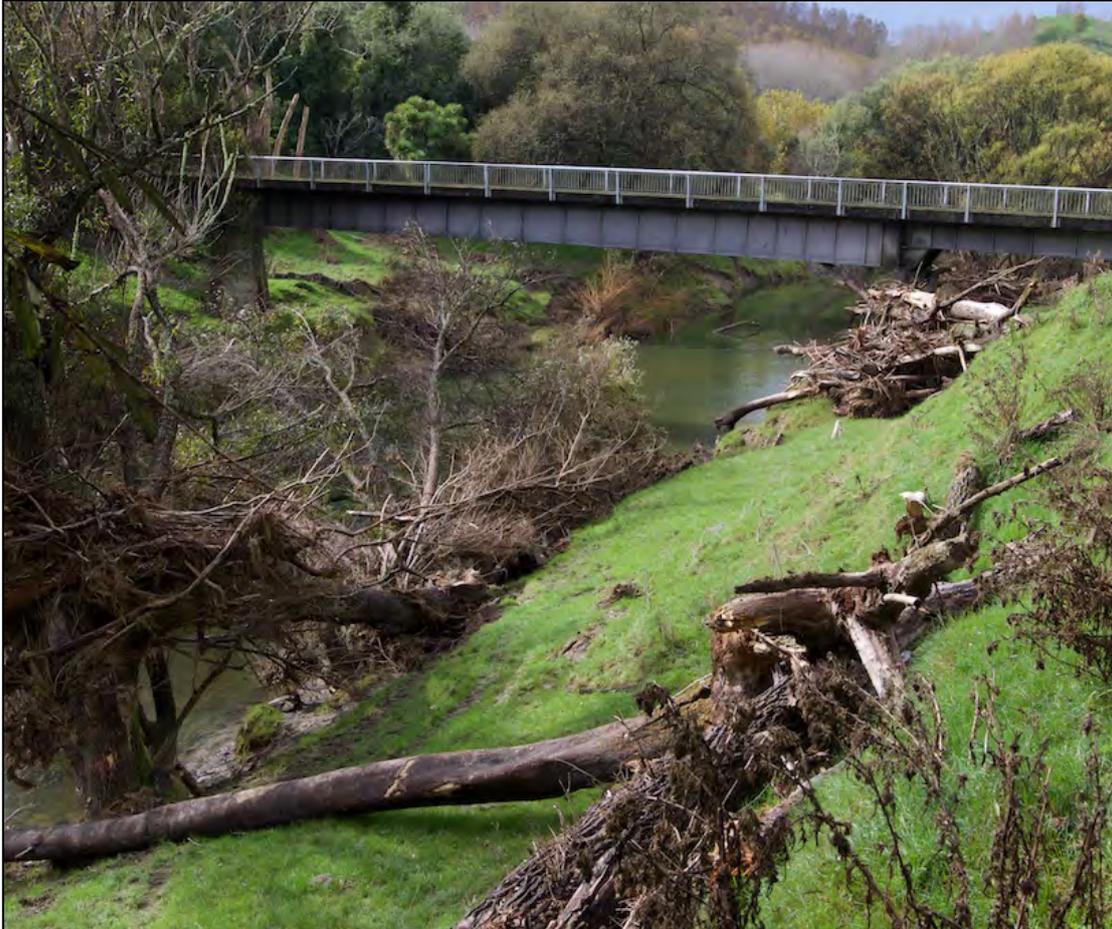
Figure 22. Windthrown and river-borne willow on the banks of the Hangaroa River by Ellmers Road.

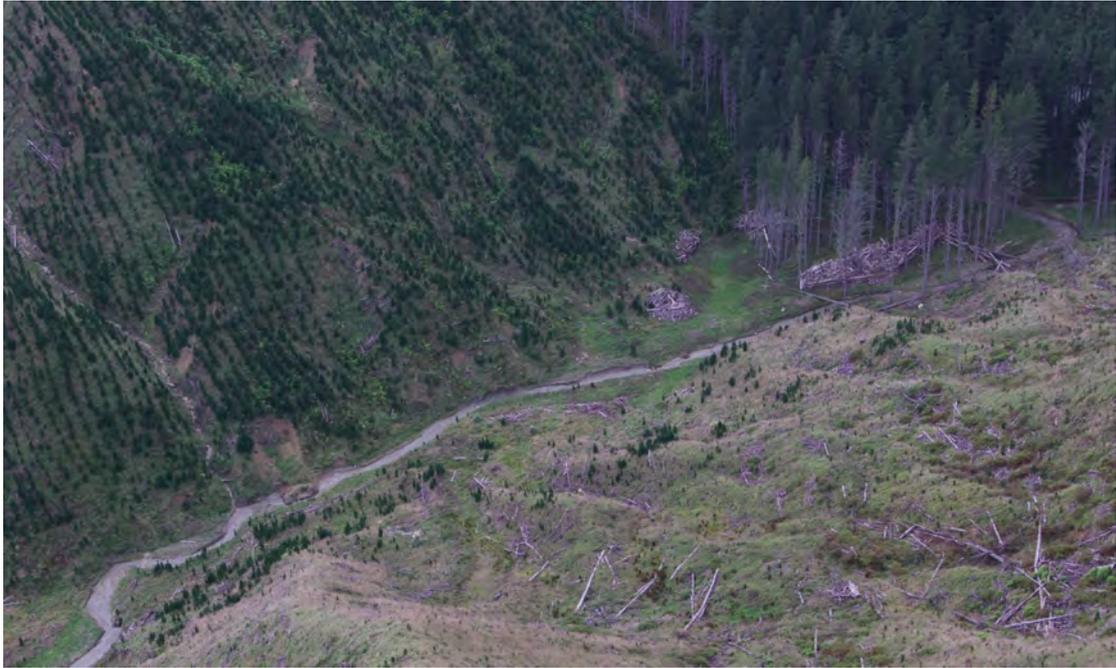
Figure 26. View of Tarewarewa Stream showing slash piles caught in standing pine trees and logs bridging stream (far right) as well as slash piles on the flood plain and slumping (Middle left).

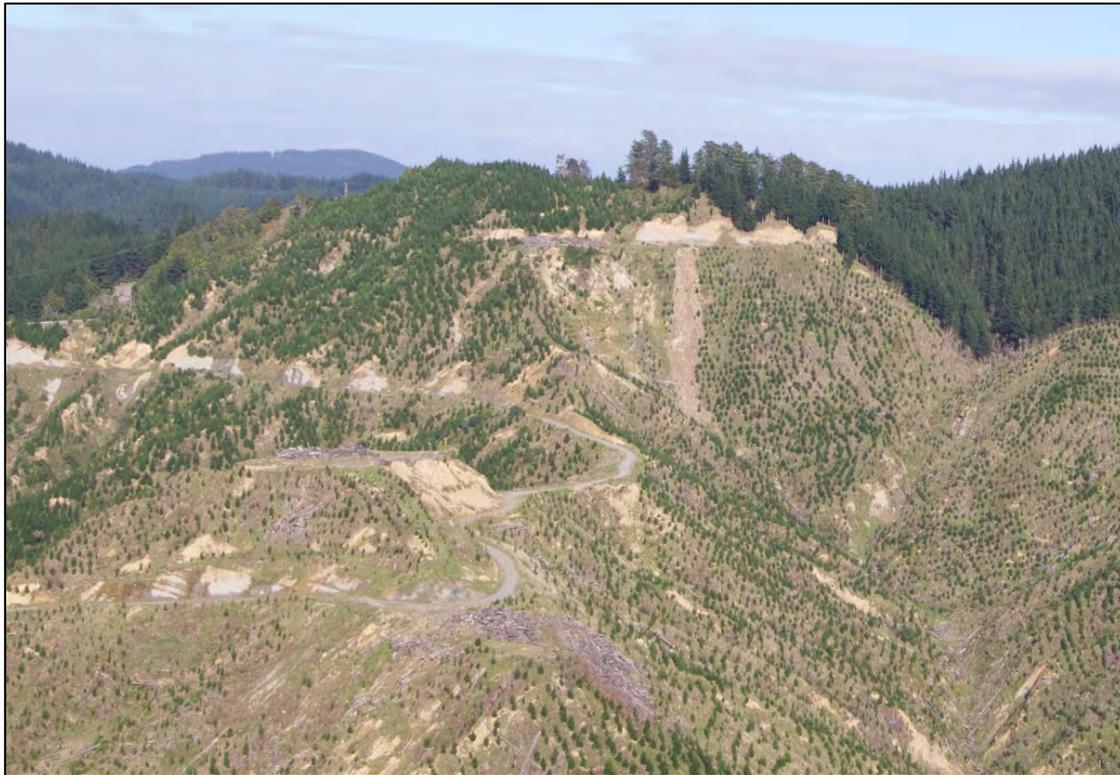
Figure 30. Landslide at the edge of a forestry road just north of the Tauwhareparae Road (middle top). Note the slash on the slope below the landing in the middle foreground

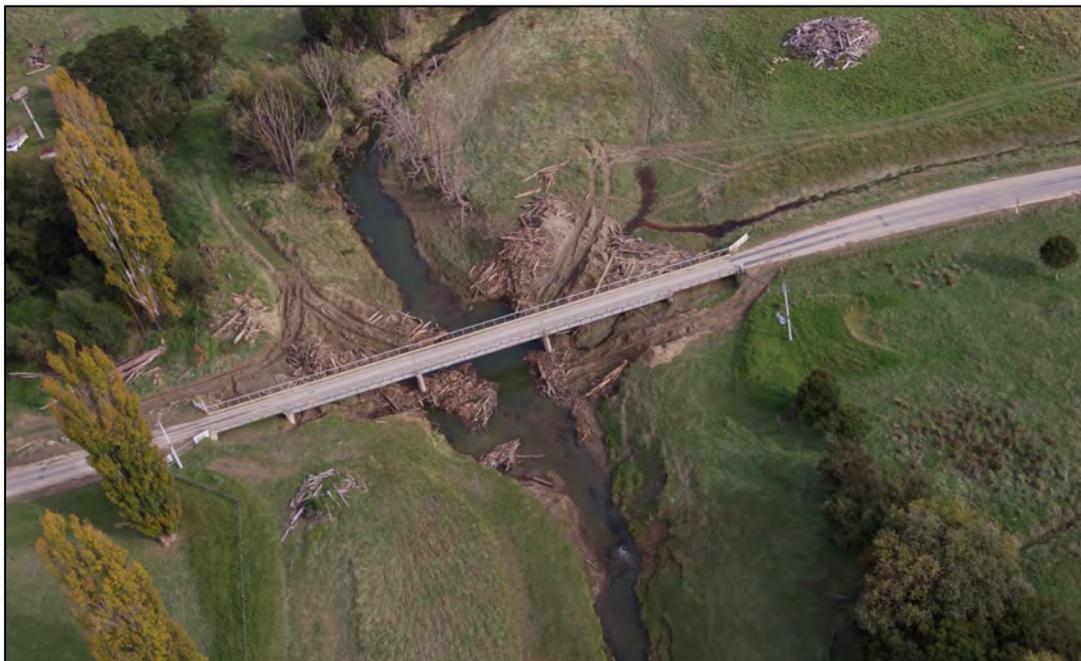
Figure 34. Wigan Bridge on the 21st of April showing the remaining woody debris as well as slash piles from an earlier event in 2015. Much of the debris was “released” into the river downstream.

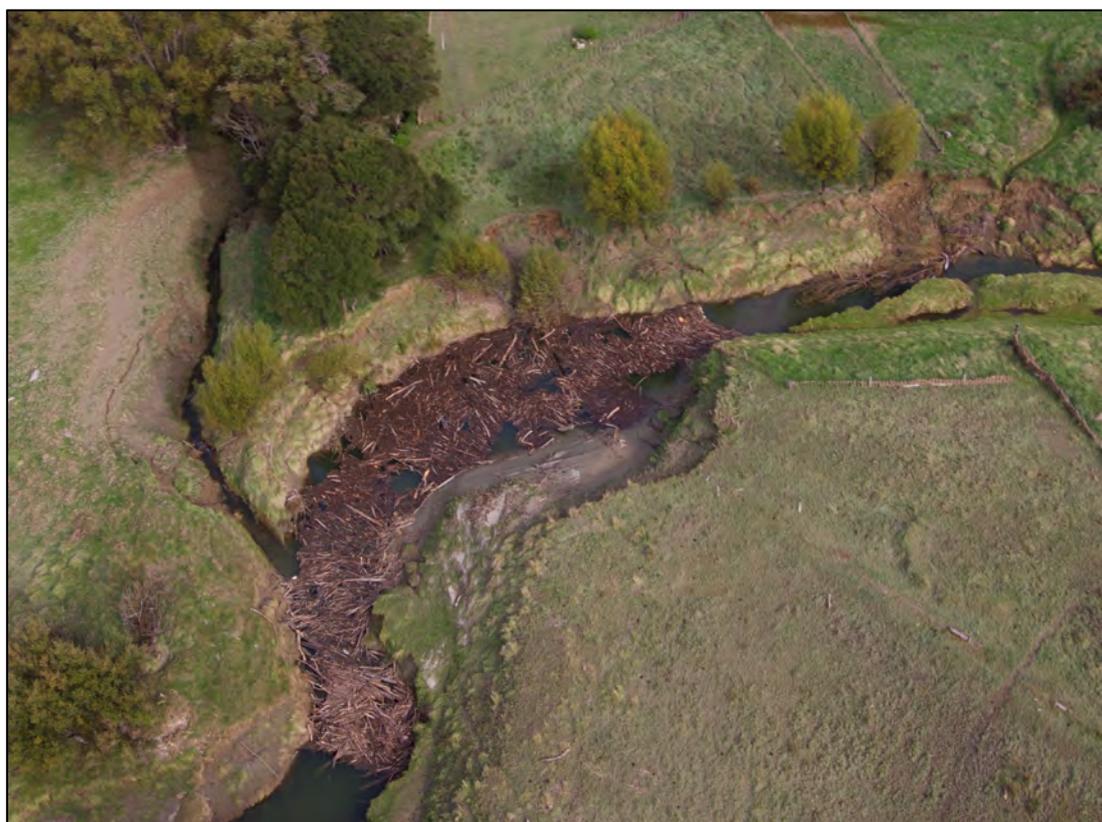
Figure 35. Slash caught in a meander loop 500m below Wigan Bridge. .

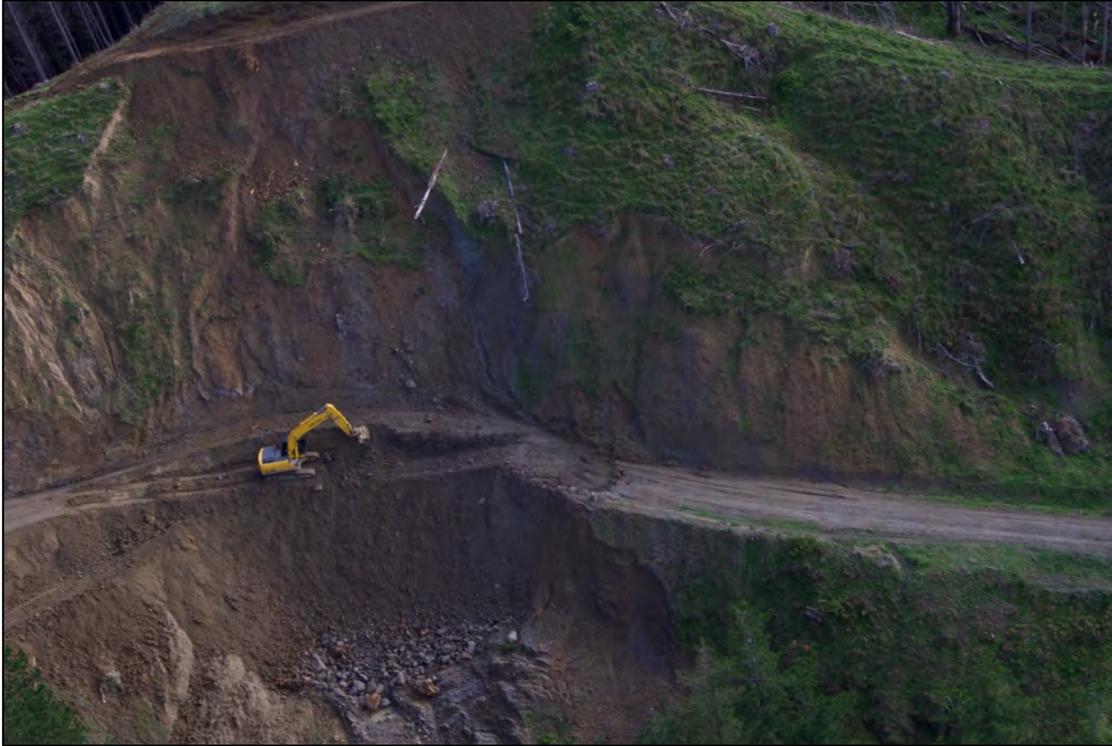
Figure 37. View of a digger working to repair a forestry road after a landslide.

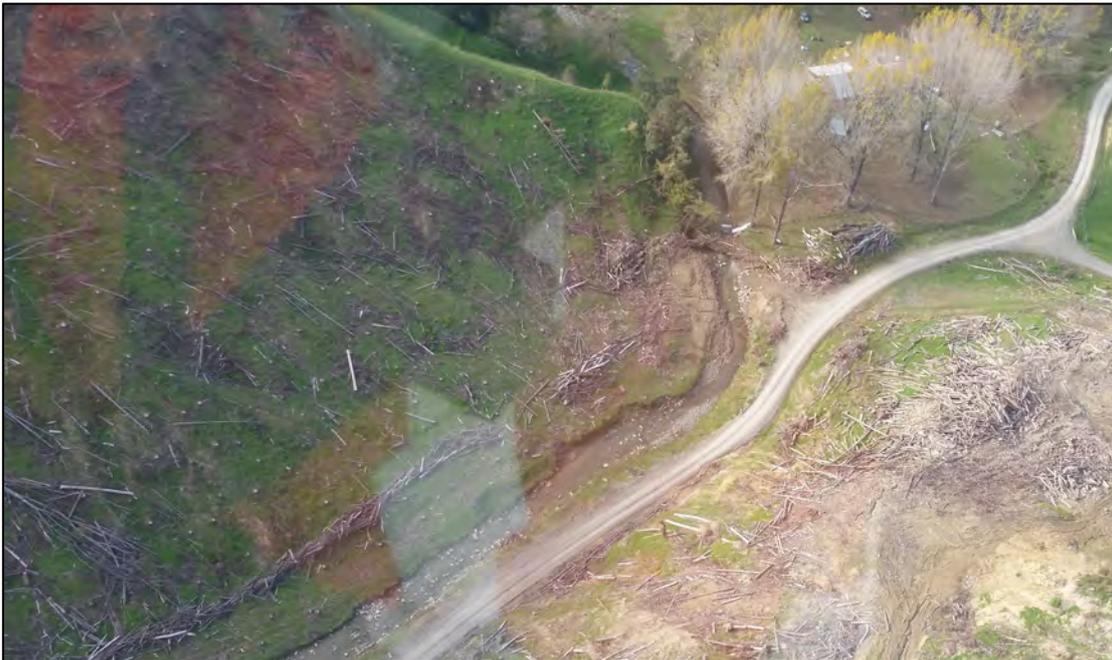
Figure 38. View of the bottom end of the Mangateao Stream showing the slash catcher with debris jam (just above willows), a pile of slash on the true left of the stream above the level of the catcher and levees of slash on both sides of the river.

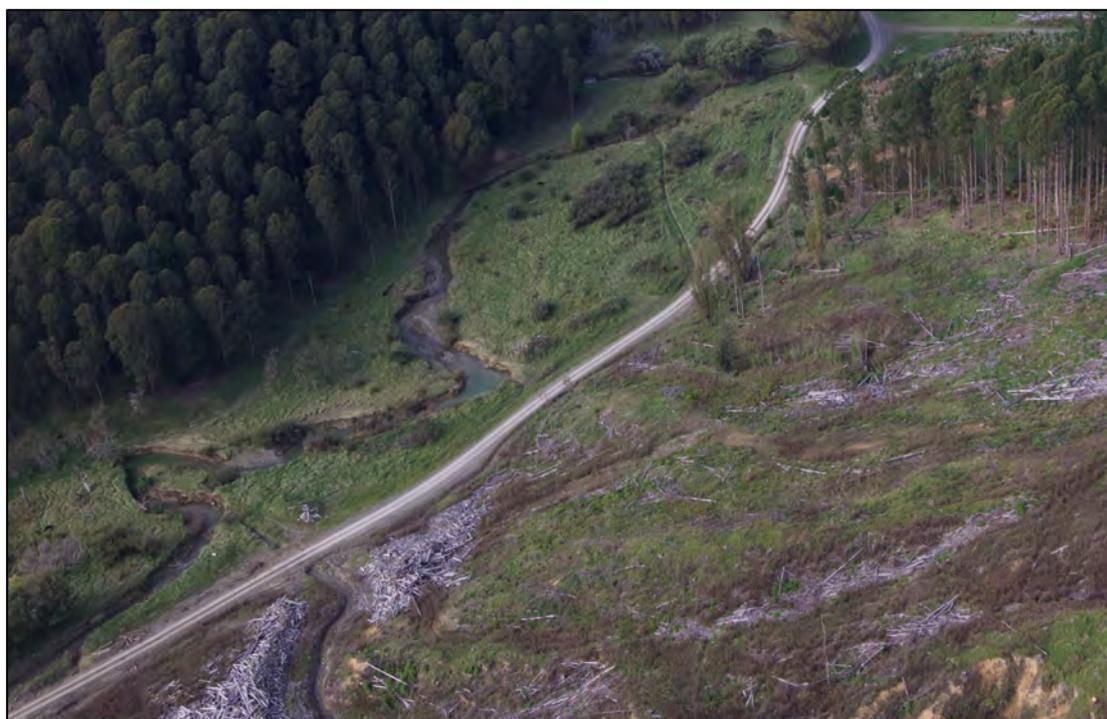
Figure 39. View of the lower Mangatoitoi River showing the pale texture resulting from flattened grass on the flood plain and scattered logs on the lefthand side of the road (bottom left).

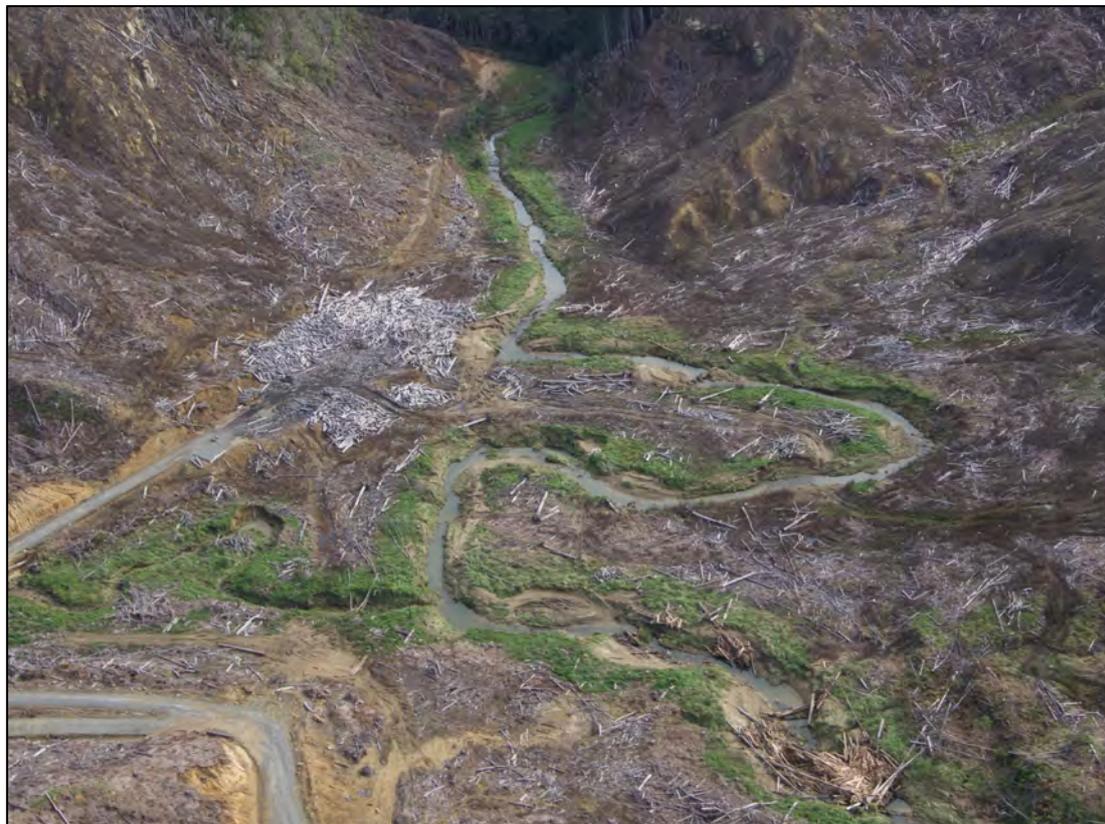
Figure 43. Upper reaches of harvest area in Tapuae Stream showing a birds-nest of slash damming the watercourse and generally high levels of slash either scattered or stored in vulnerable locations on the flood plain.

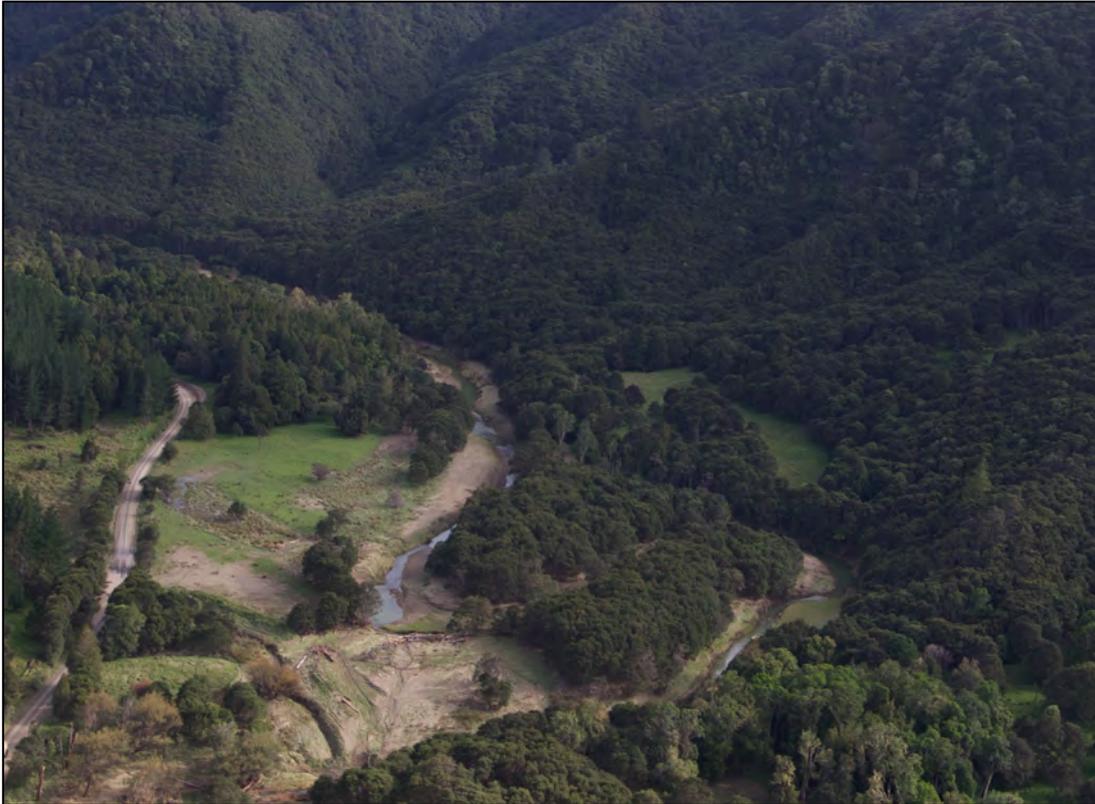
Figure 45. View looking upstream in the Mangatokerau (image 1D1A1097) showing silt and woody debris deposition.

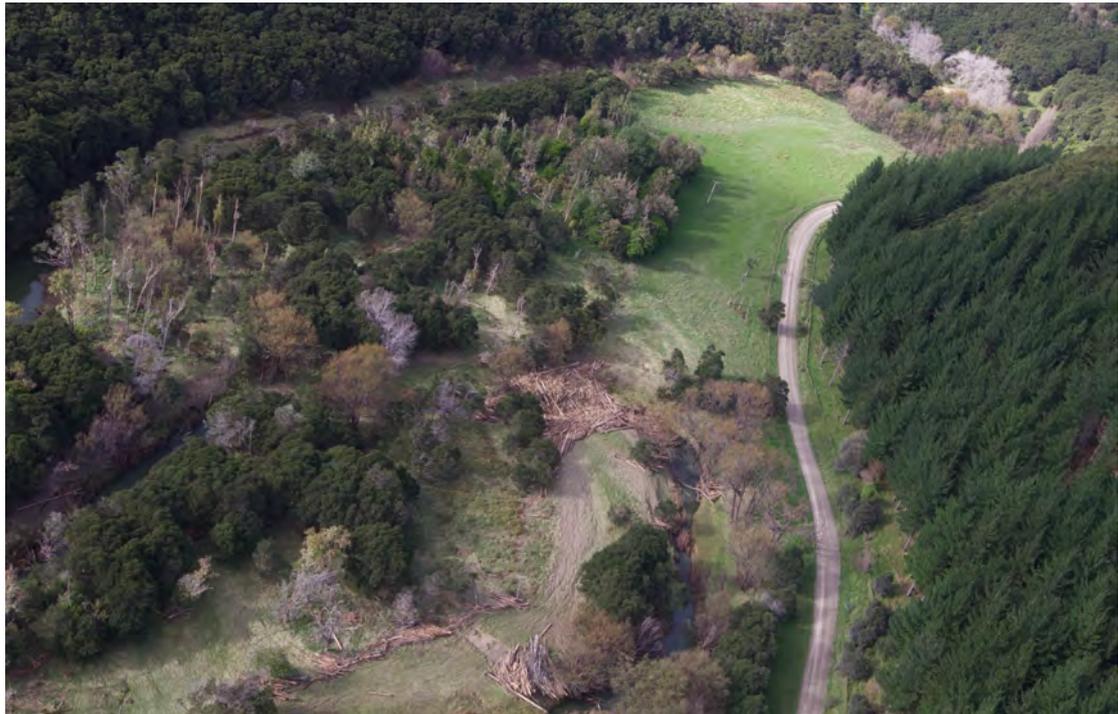
Figure 46 . Image 1D1A1114 showing the view downstream of Figure 45. The full width of the valley extent of the flood is evident from the discolouration and grass texture of the paddocks. The large piles of slash and silt deposition are also evident in the foreground.

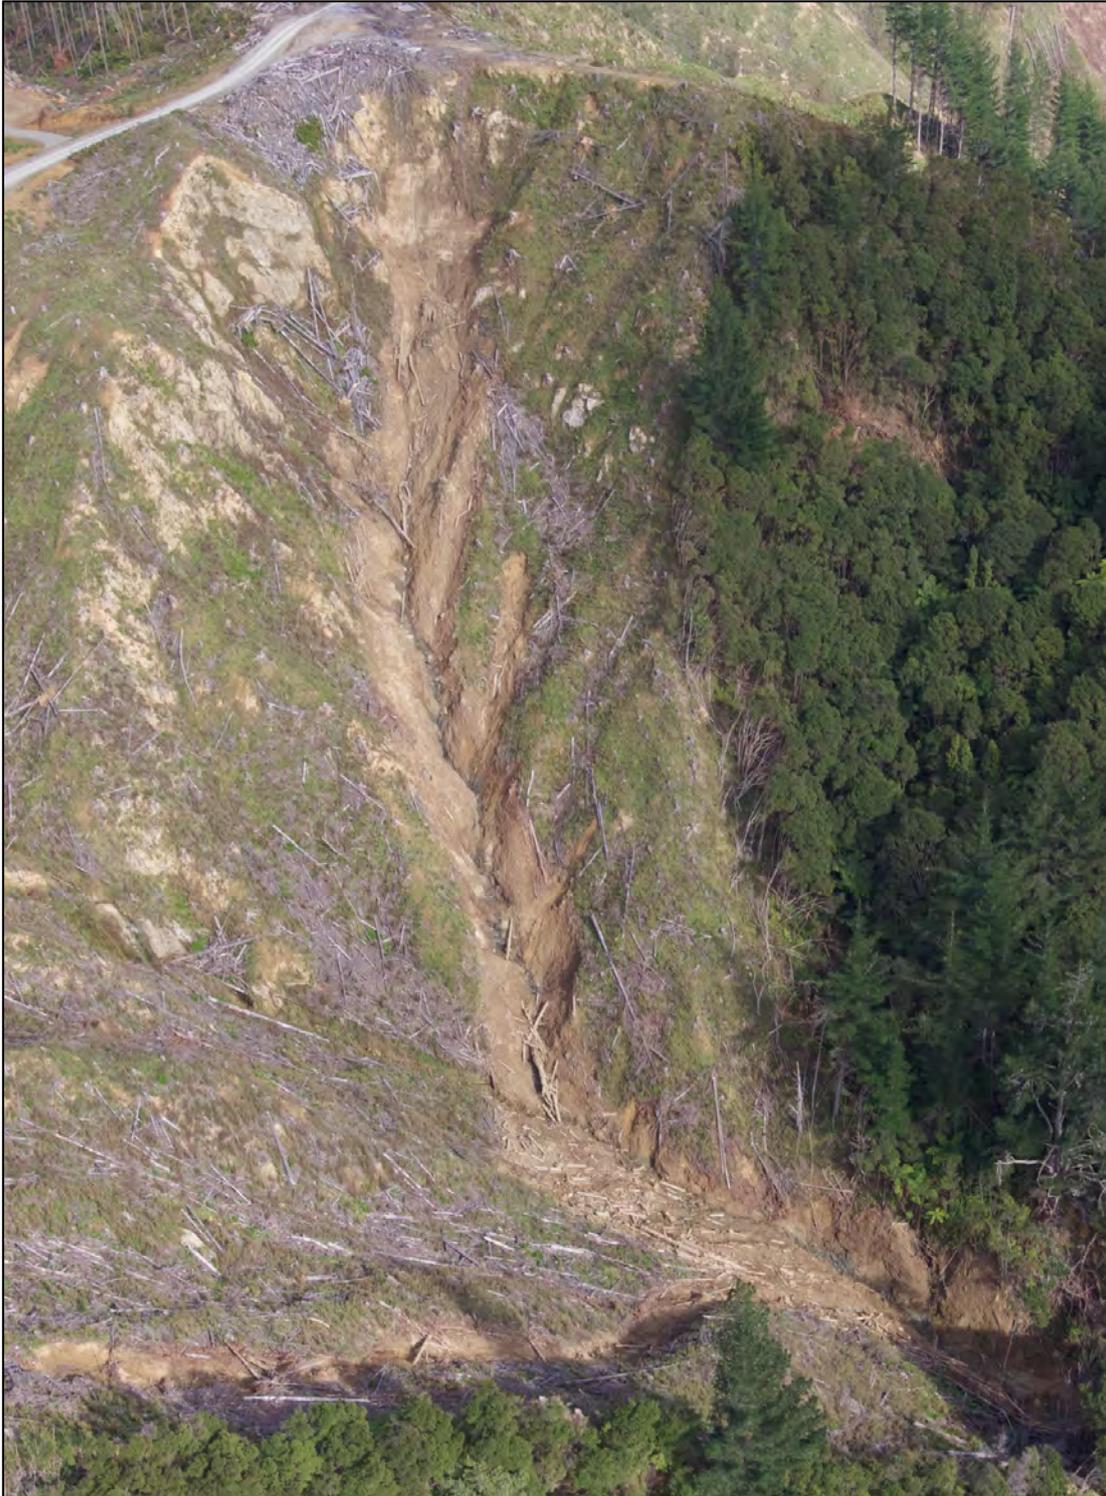
The Waterfall Creek debris flow was generated at a landing on Spenser Road and there were several other landings that showed signs of edge collapse in the vicinity. Another area where landings were an issue is where they were placed close to river level making them vulnerable to flooding. Storing of slash on floodplains is also common and in a number of instances these have resulted in mobilisation from flood waters.

Figure 48. View of the Mangatokerau debris flow in “Waterfall Creek” with a headscarp adjacent to a landing and with a secondary debris flow path at the bottom of the image. There is indigenous vegetation at the base of the image below the debris flow and on the right of the photograph. The debris flow was, however, entirely within the cut over pine slopes and the indigenous vegetation was unaffected.

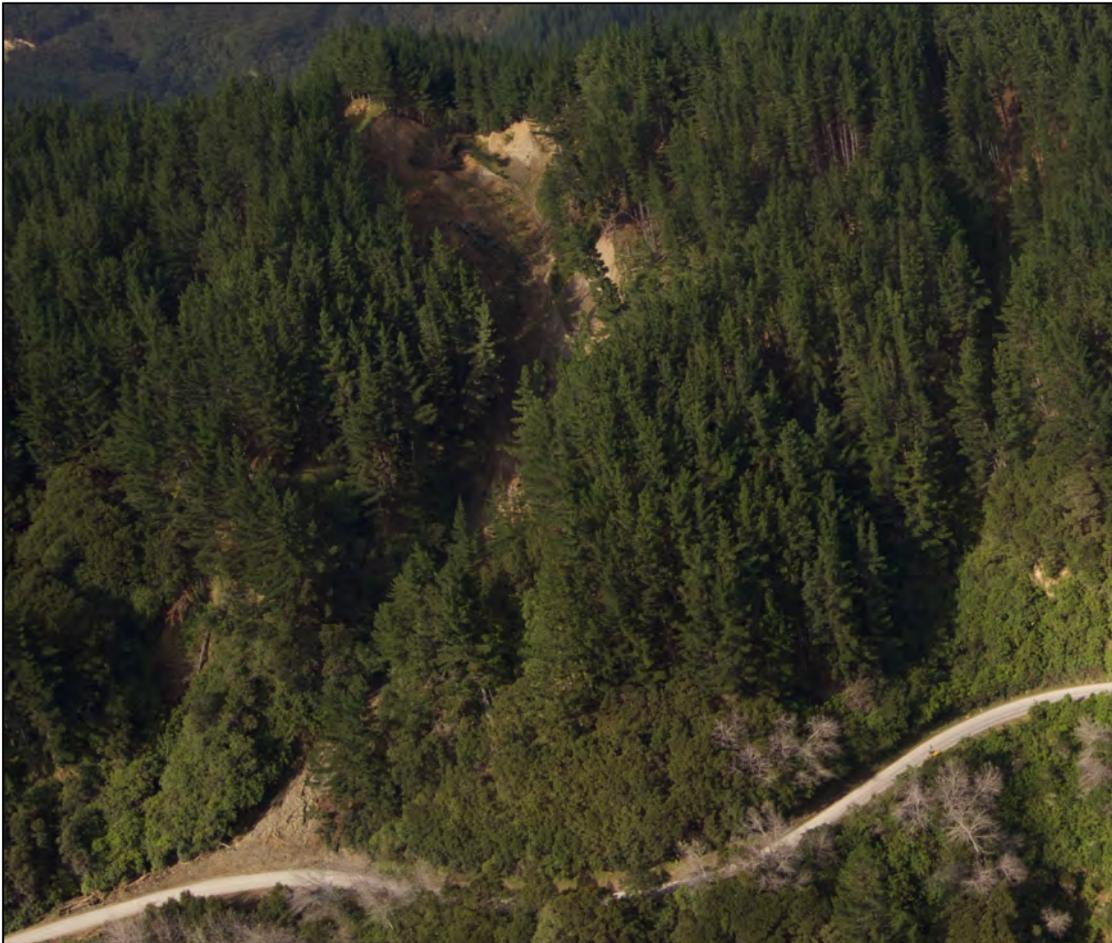
Figure 55. View of Doonholm landslide showing both the head scarp and the depositional zone post clean up by Tairwahiti Roads.

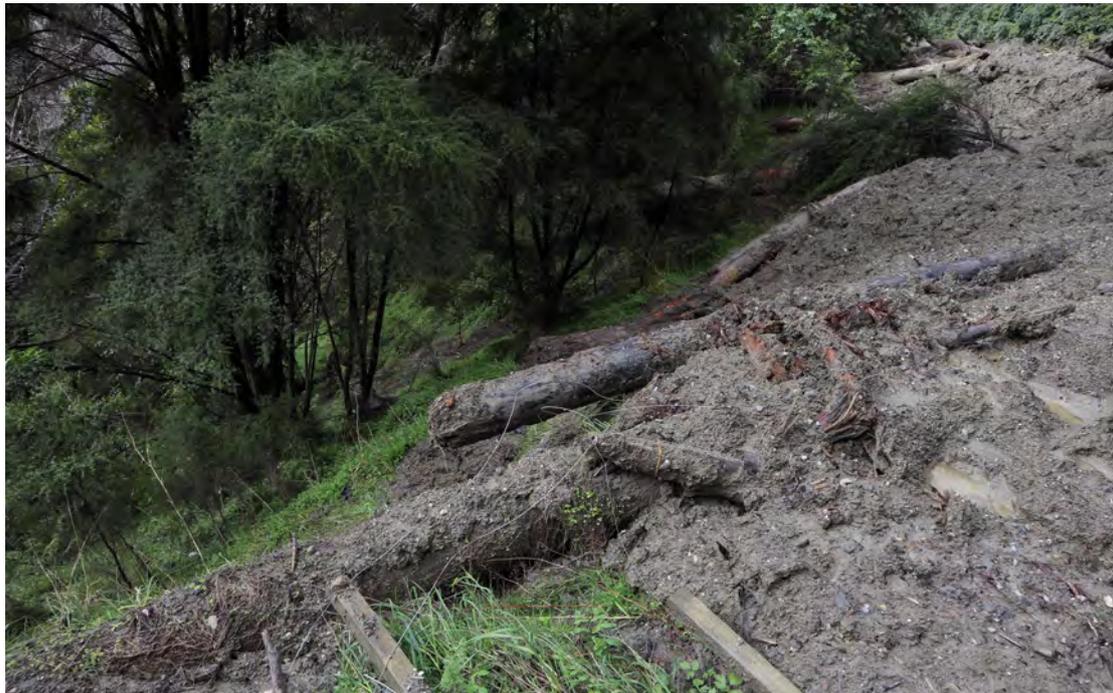
Figure 56. View of the Doonholm landslide debris below the Tauwhareparae Road. Note the lack of mud or debris below the road other than that moved during road clearing operations.

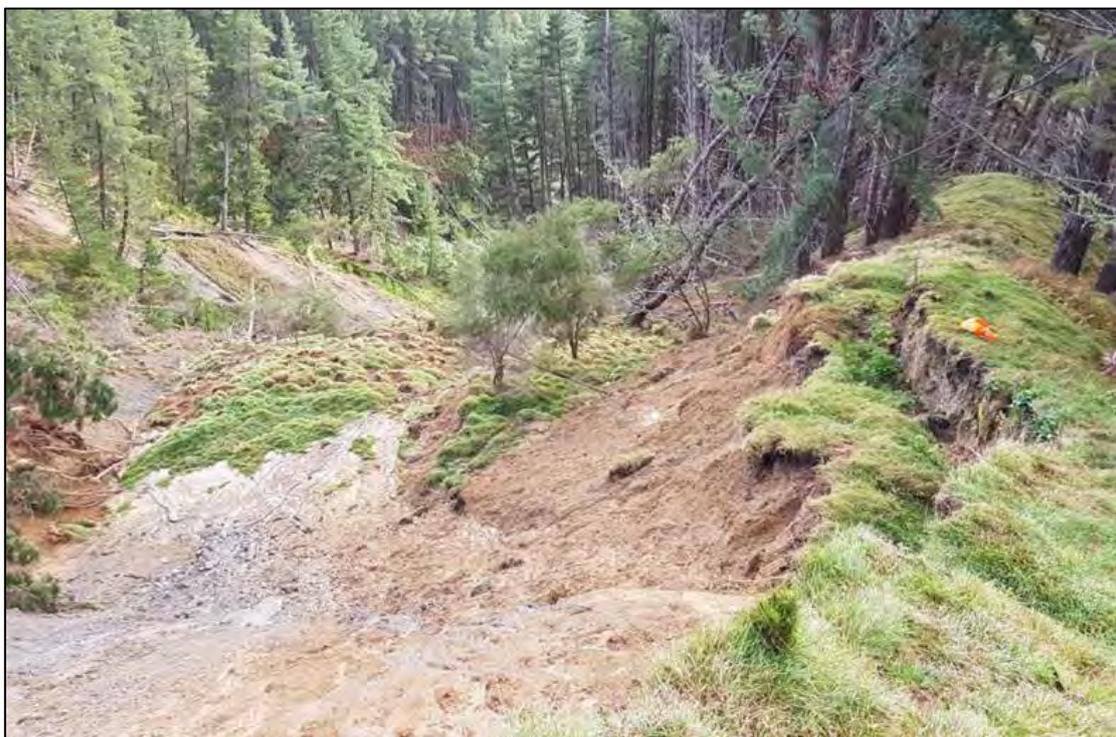
Figure 57. View of the headscarp of Doonholm landslide. This shows that failure was initiated by slumping at the headscarp with this material some initial coherence but triggering chaotic flow in the gully below.

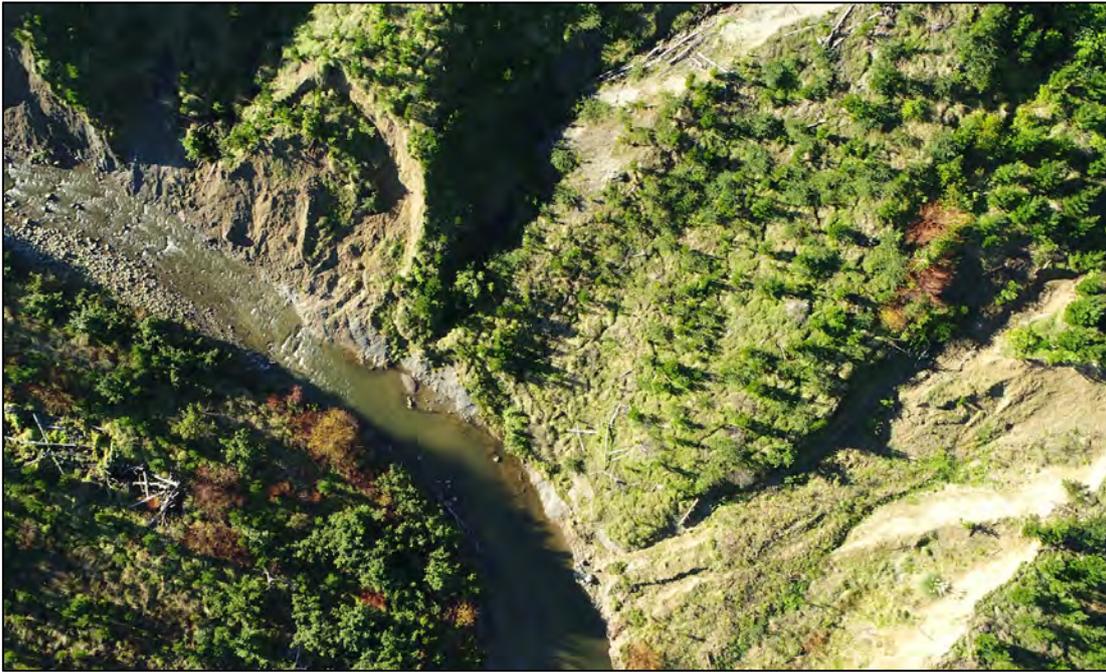
Figure 59. Detail of an individual drone flight image (DJI_0202) showing riverside slumping and unmobilised slash within an area of replanted pines.

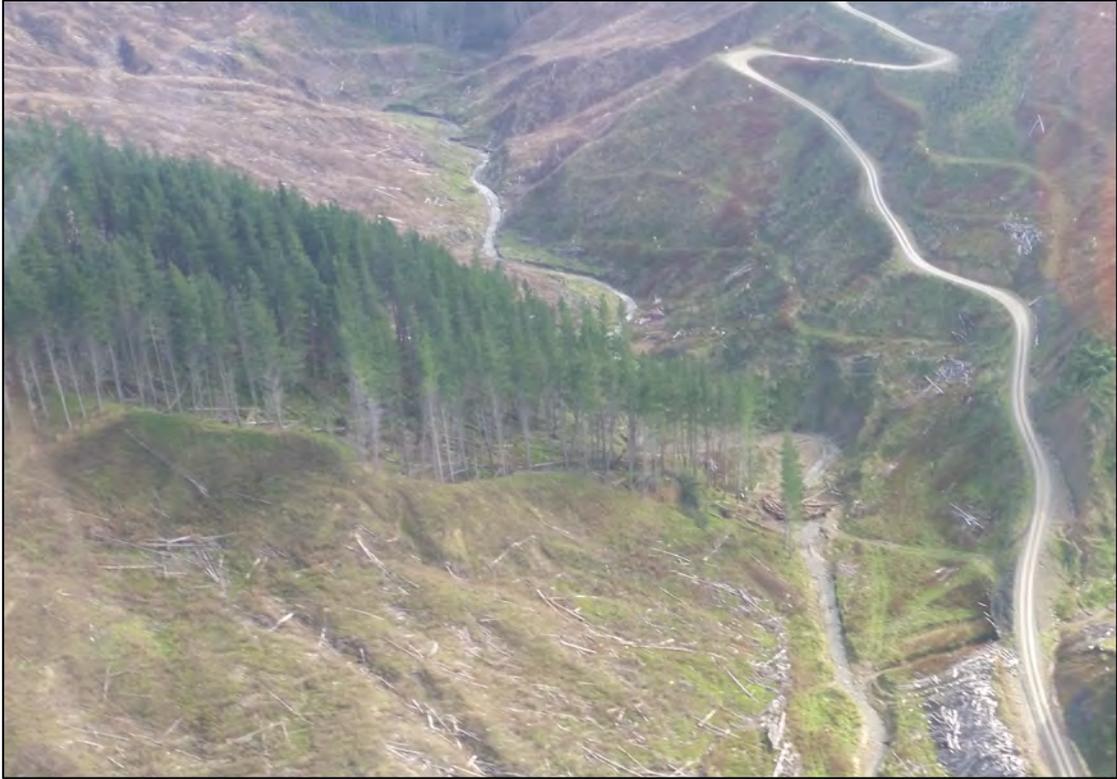
Figure 65. View looking up the Mangatoitoi Stream showing the levee of slash in the foreground and a birds-nest of slash caught up in the slash catcher further upstream. At bottom right the stored slash remained largely intact with some erosion of the base. In the background is the operational area with no signs of significant slope failures.

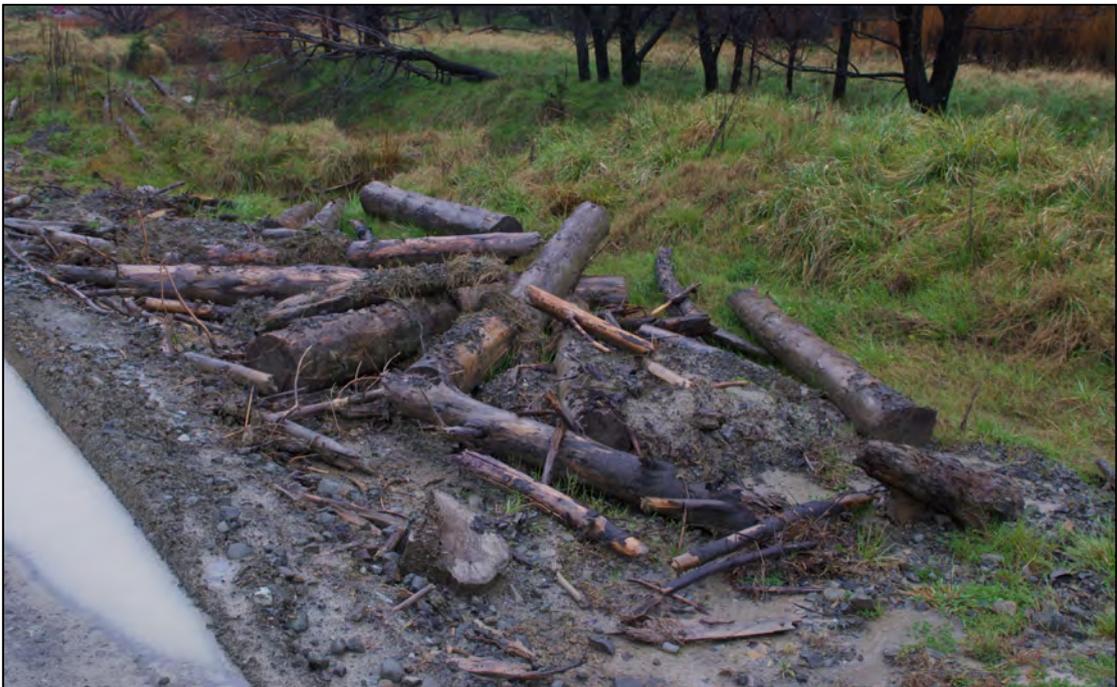
Figure 66. View of mobilised slash on the lefthand side of the forestry access road in the Mangatoitoi Valley. This material comprises fresh cut pine logs along with fine dross along with silt.

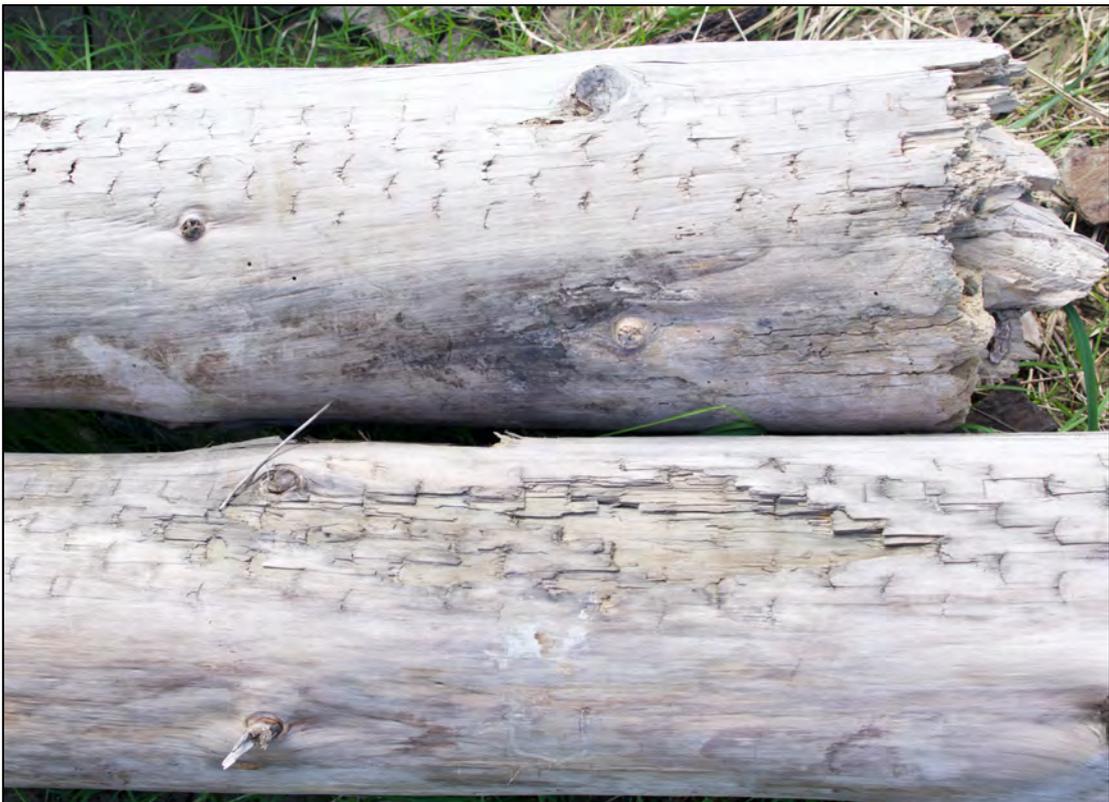
Figure 83. Abraded pine logs above Wigan Bridge with Waratah markings.

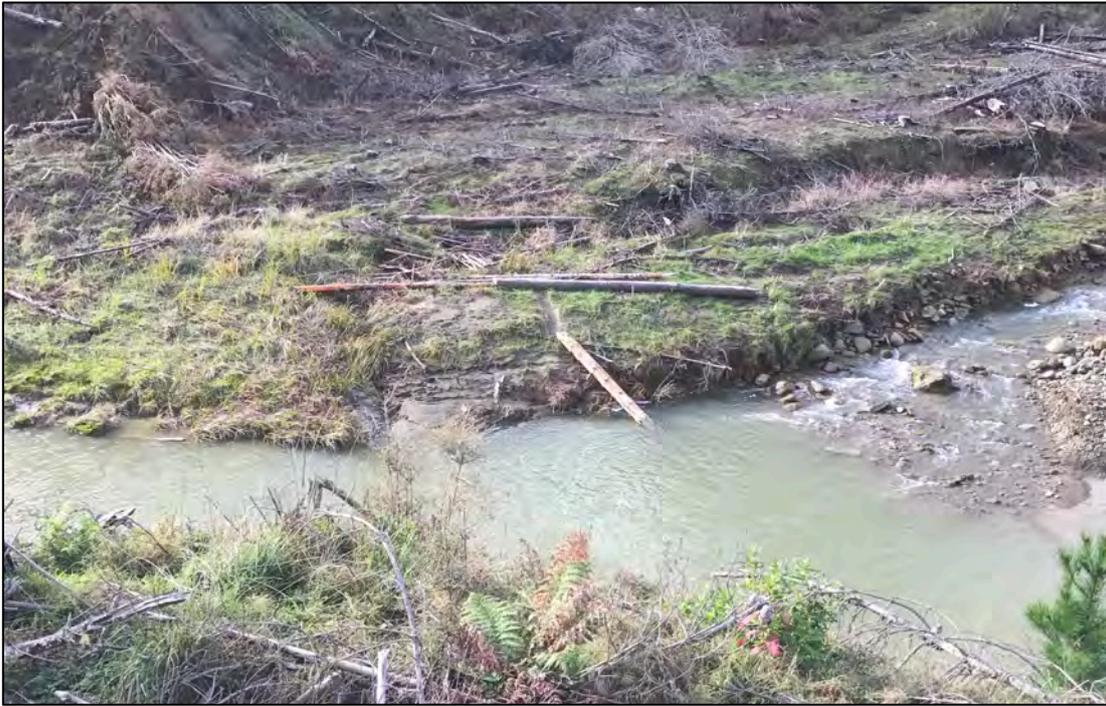
Figure 91. Typical situation with scattered slash on the flood plain in the Mangatokerau River.

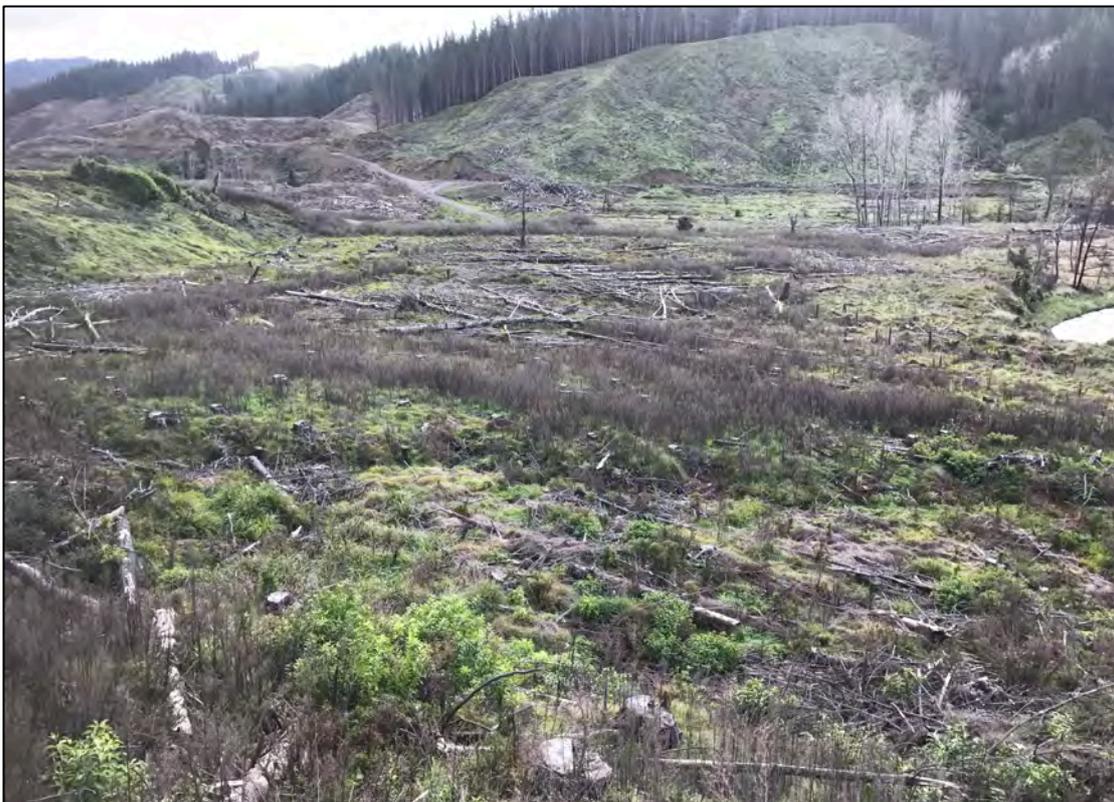
Figure 92. Extensive scattered slash on the Mangatokerau River flood plain.
