Cyclone Cook Slash Investigation

Dr Murry Cave Principal Science Advisor GDC
Nicki Davies, James Langford GDC Land & Soil Team

October 2017

Executive Summary

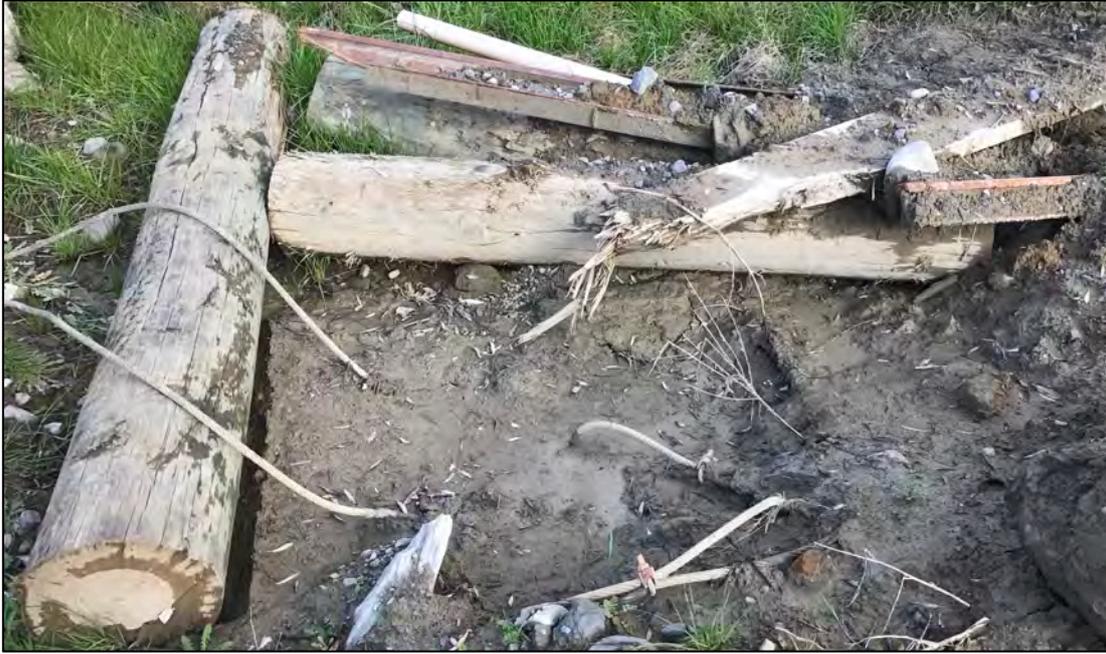
Figure 93. View of cut logs and a failed slash catcher at the base of Te Kokokakahi Stream.

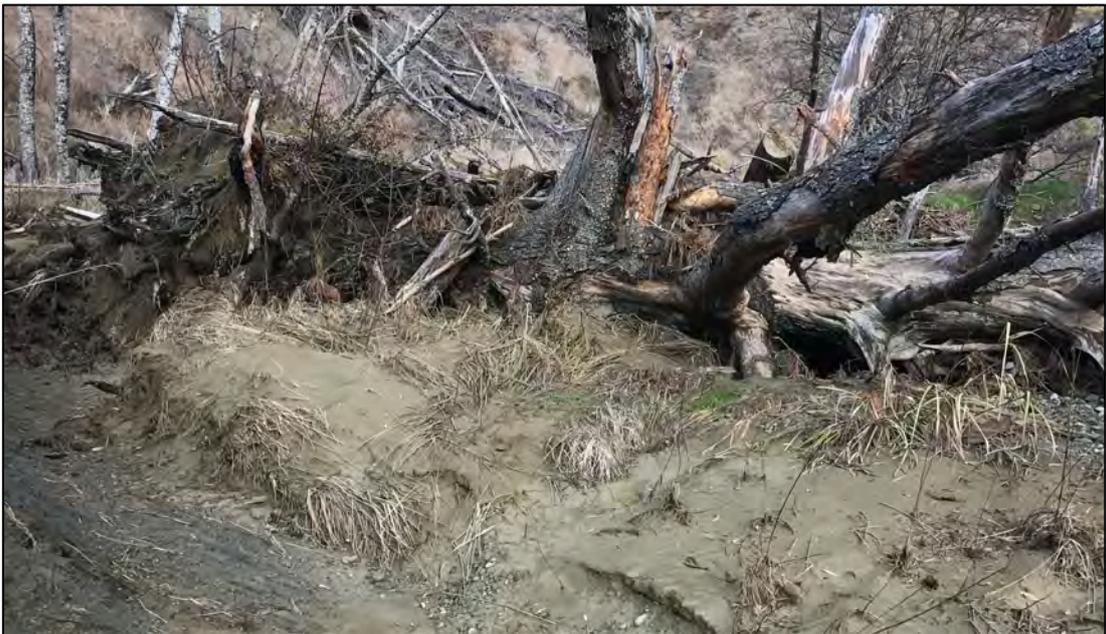
Figure 94. View of collapsed willow a short distance up Te Kokokakahi Stream with fine dross and high silt load, and an obvious cut pine log on the middle right of the photograph.

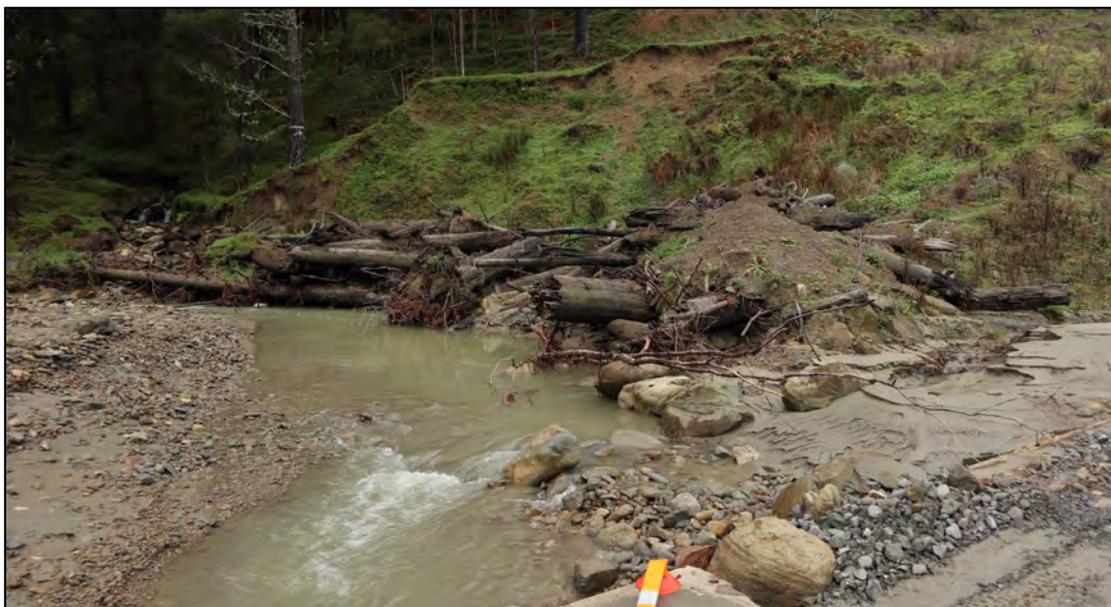
Figure 96. View of the ford at Staircase showing the log pile, significant silt deposition, and post clean-up silt piles.

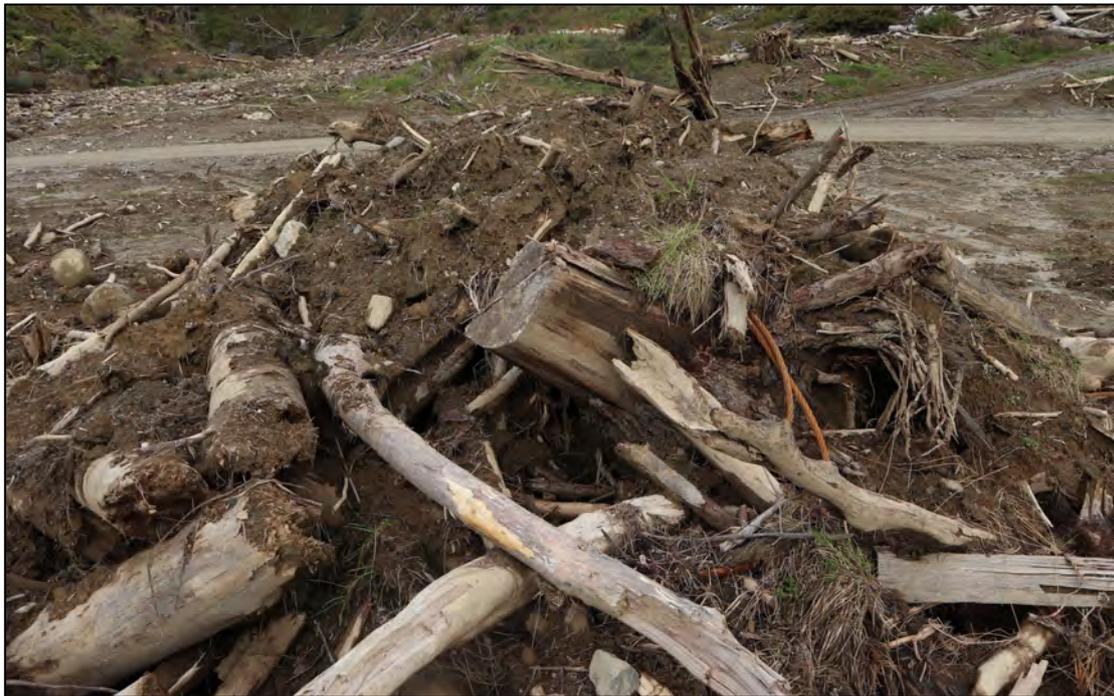
Figure 97. View of slash pile at Waterfall Creek showing a cut log as well as broken pine logs

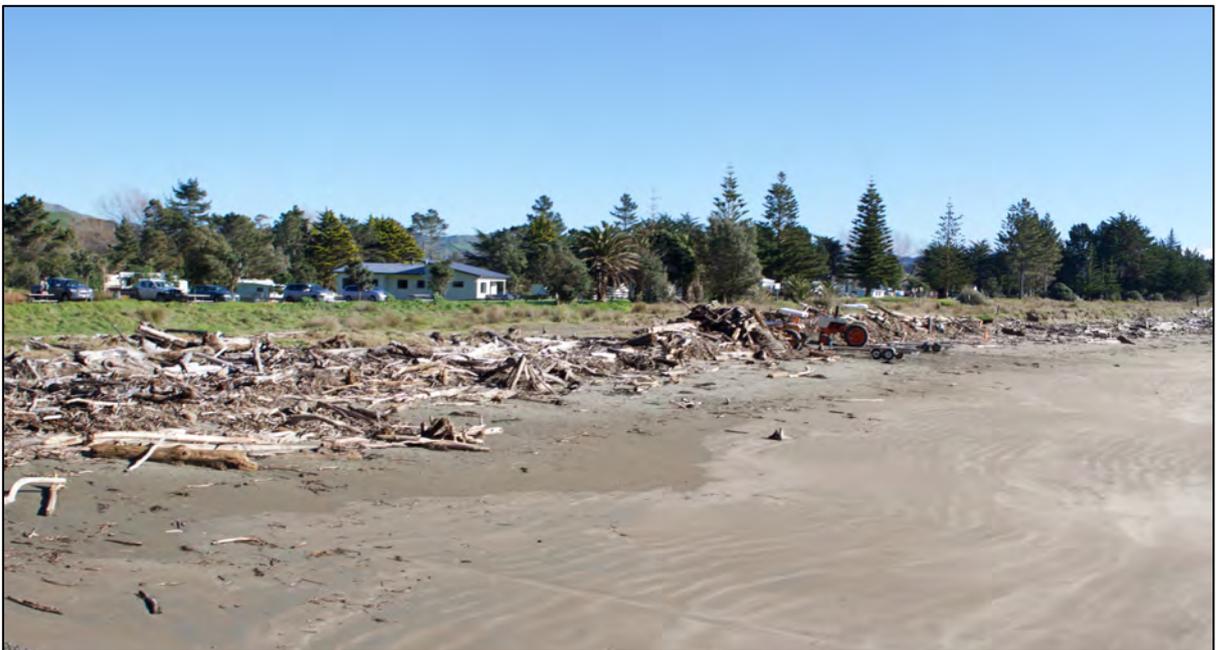
Figure 109. Photograph taken from approximately the same point as Figure 108 showing the extent of deposition of additional woody debris as a result of Cyclone Cook.

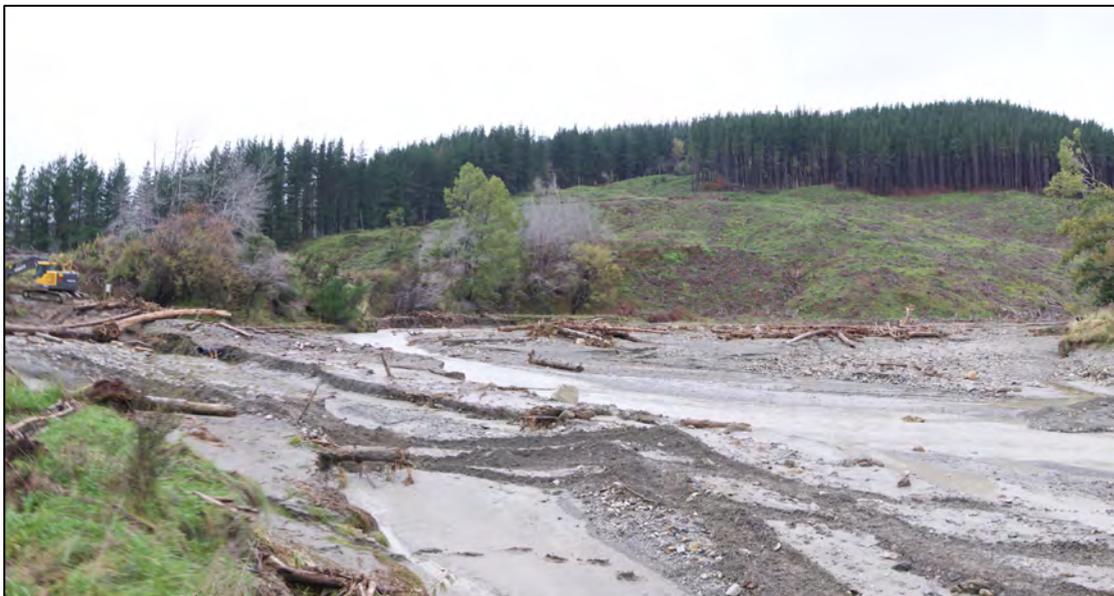
Figure 112. Looking upstream from the slash catcher towards the landing showing the debris and high silt load mobilised during Cyclone Cook.

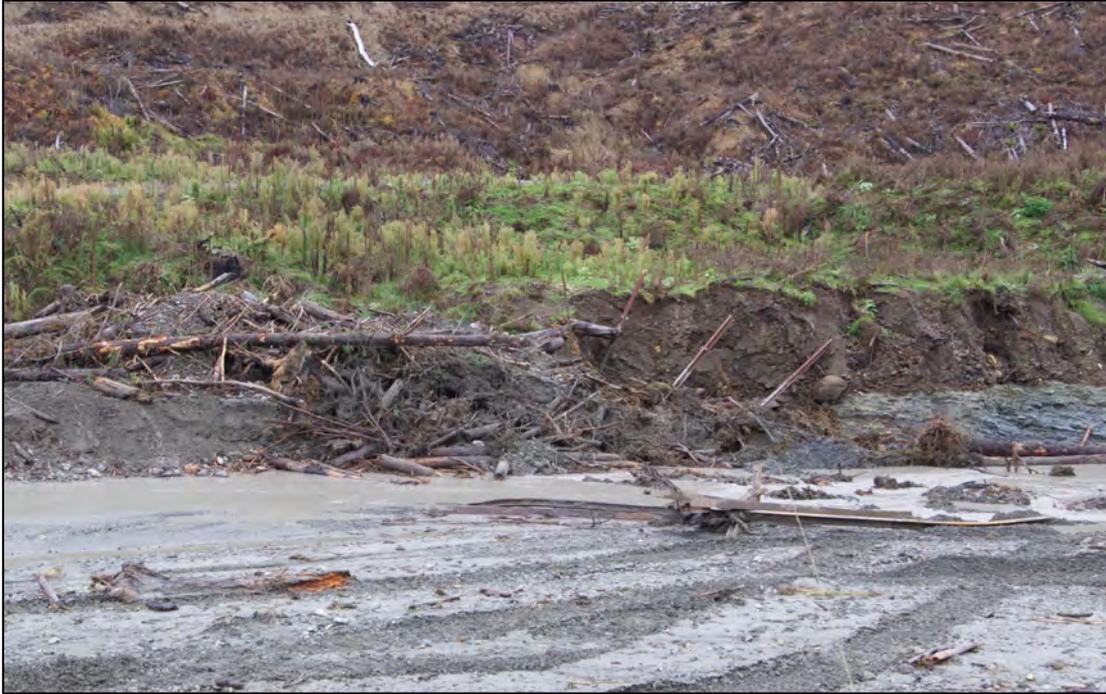
Figure 113. View of failed slash catcher and forestry slash caught on the river bank.

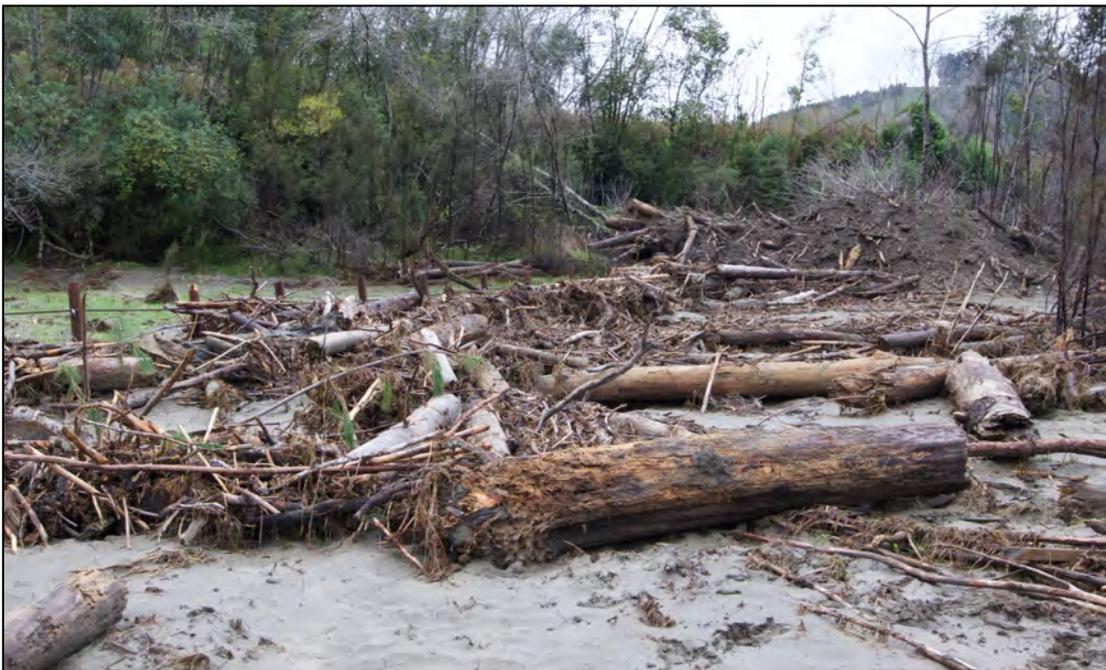
Figure 114. View of the slash catcher in the Whakoau River at the beginning of River Road. In the background are logs that overtopped the slash catcher, and in the foreground are logs that had been arrested by the catcher. It is clear that the material caught against the catcher comprise cut pine logs as well as smaller dross but no willows, poplars, or wind-throw logs and considerable silt deposition.

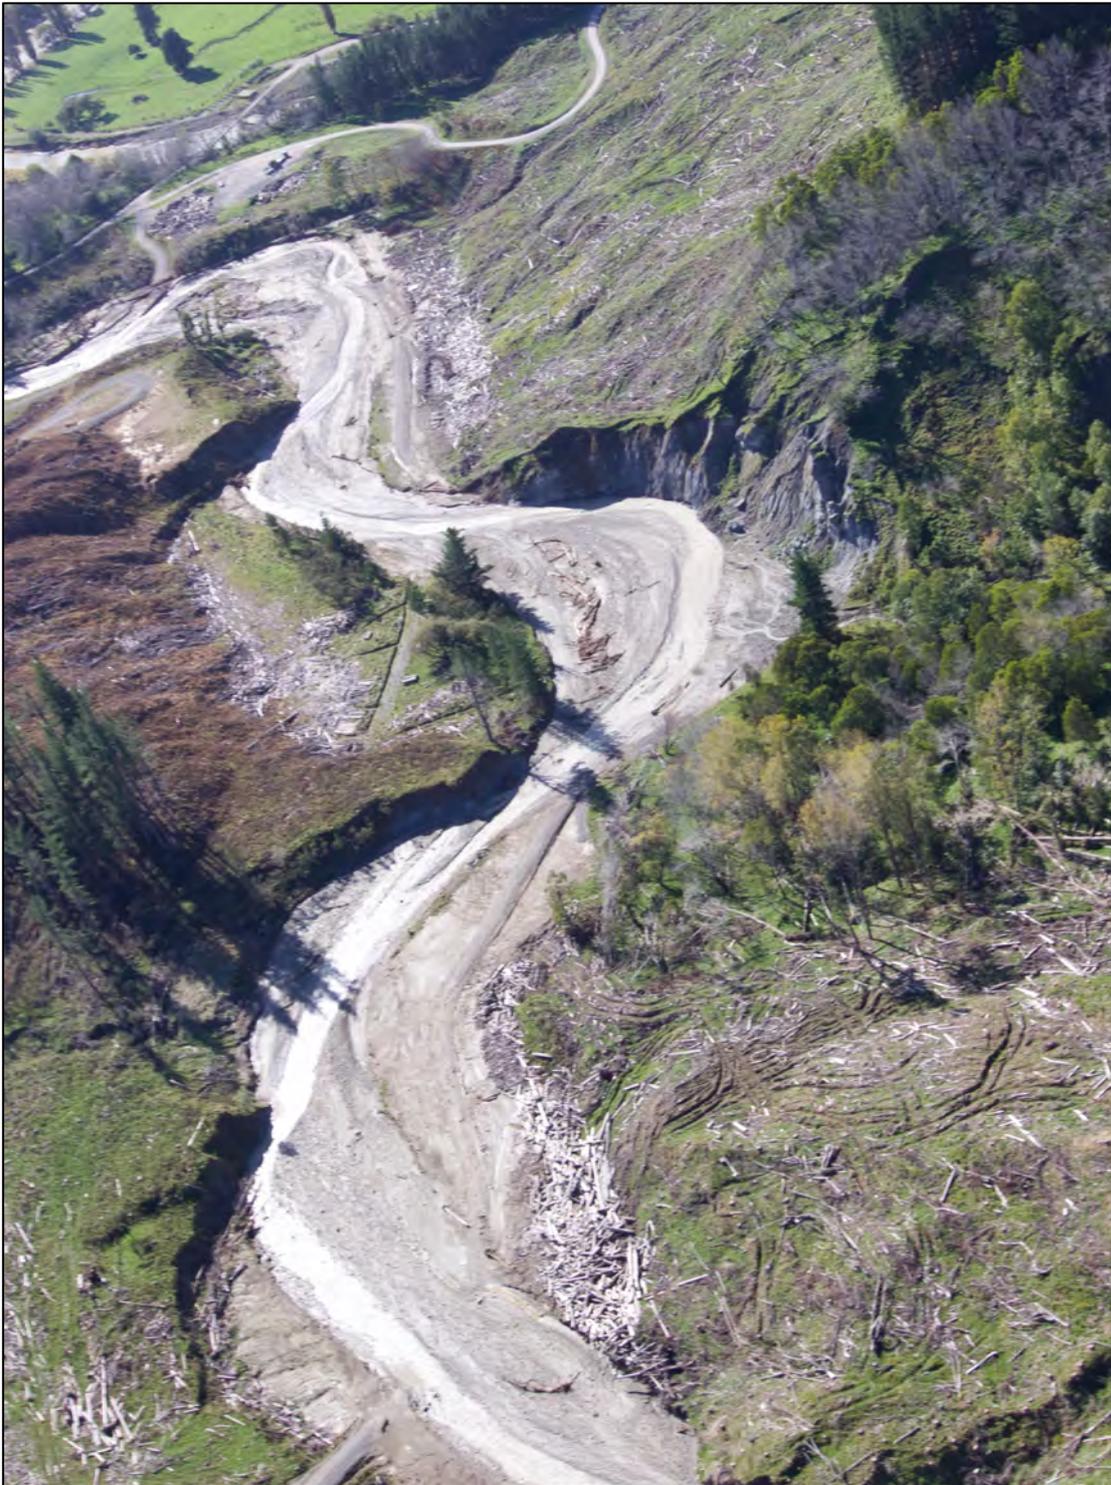
Figure 115. View of the Whakoau river upstream of the failed slash catcher showing slash caught against the river bank on the true left, within the river channel (middle background) and two areas of slash stored on the flood plain.

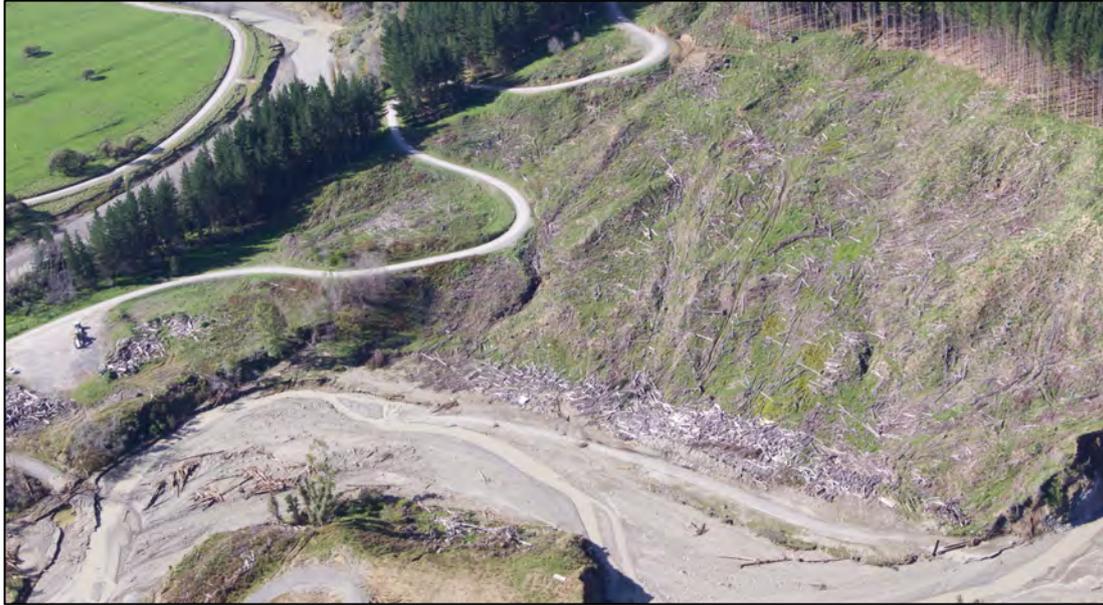
Figure 116. View of the slash catcher site and the area immediately upstream showing slash stored on the flood plain on the true right bank of the river.

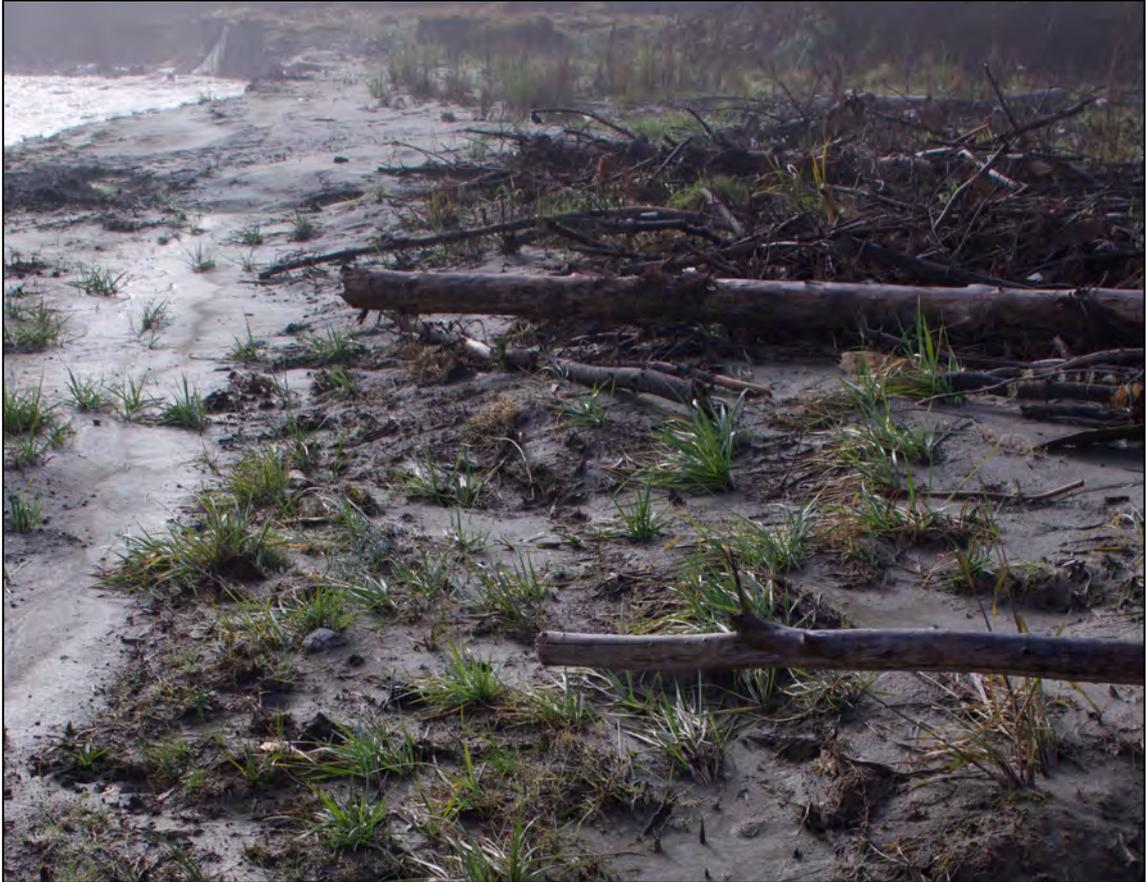
Figure 119. Eastern end of the flood plain immediately upstream of the slash catcher showing silt deposition and vegetation bent over by floodwaters.

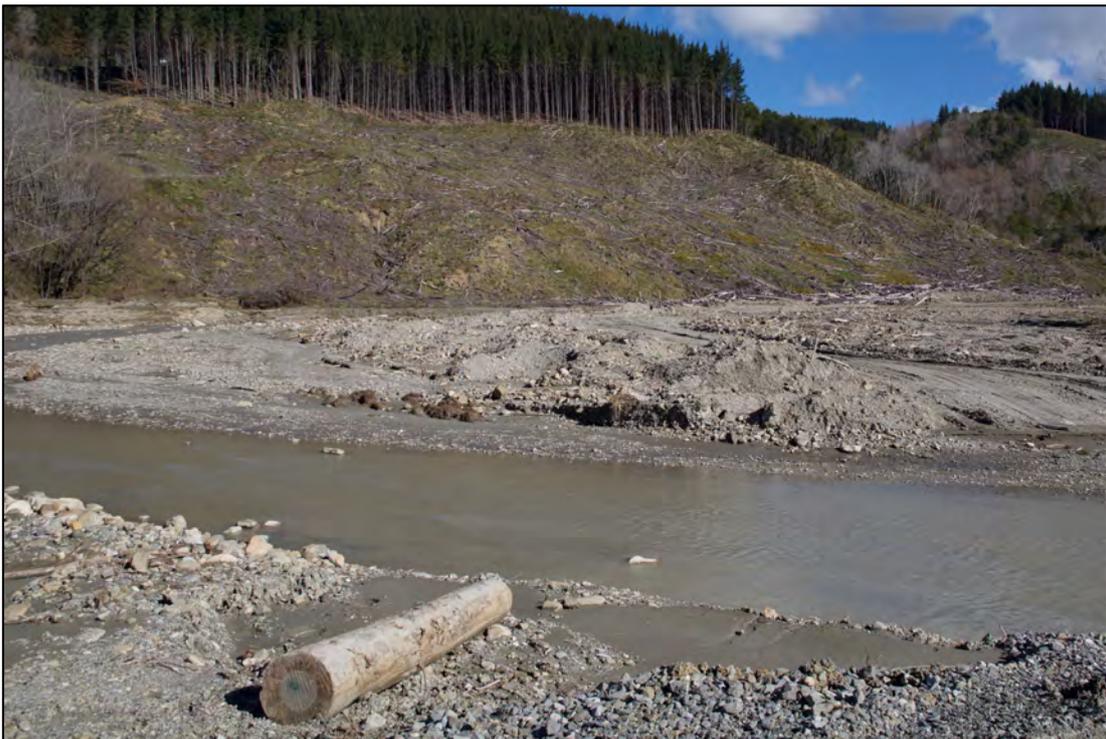
Figure 122. Fresh Cut log with paint mark in the Whakoau River upstream of the new slash catcher.

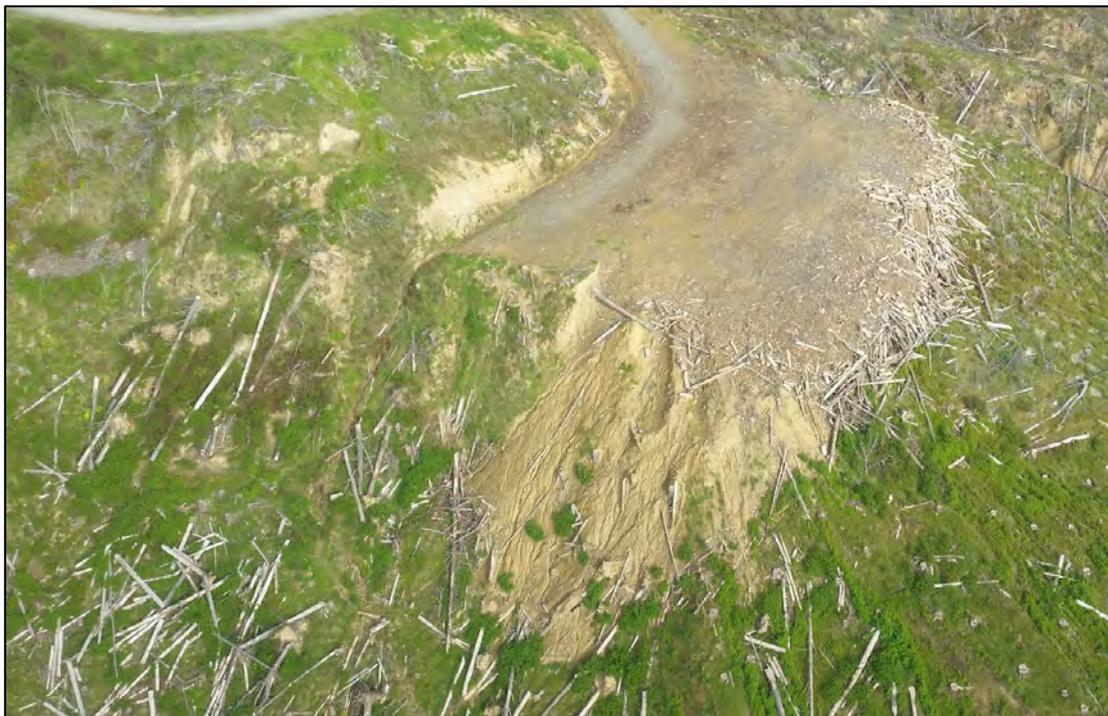
Figure 123. Typical edge failure on a landing in the Mangatokerau valley.

8. That ridge top or spur landings are placed in such a way as to eliminate risk of landing edge failure and that suitable areas are established for storing of slash in areas where the risk of mobilising slash into gullies and flood plains is minimised (Back Hauling). This is being developed for future consents.

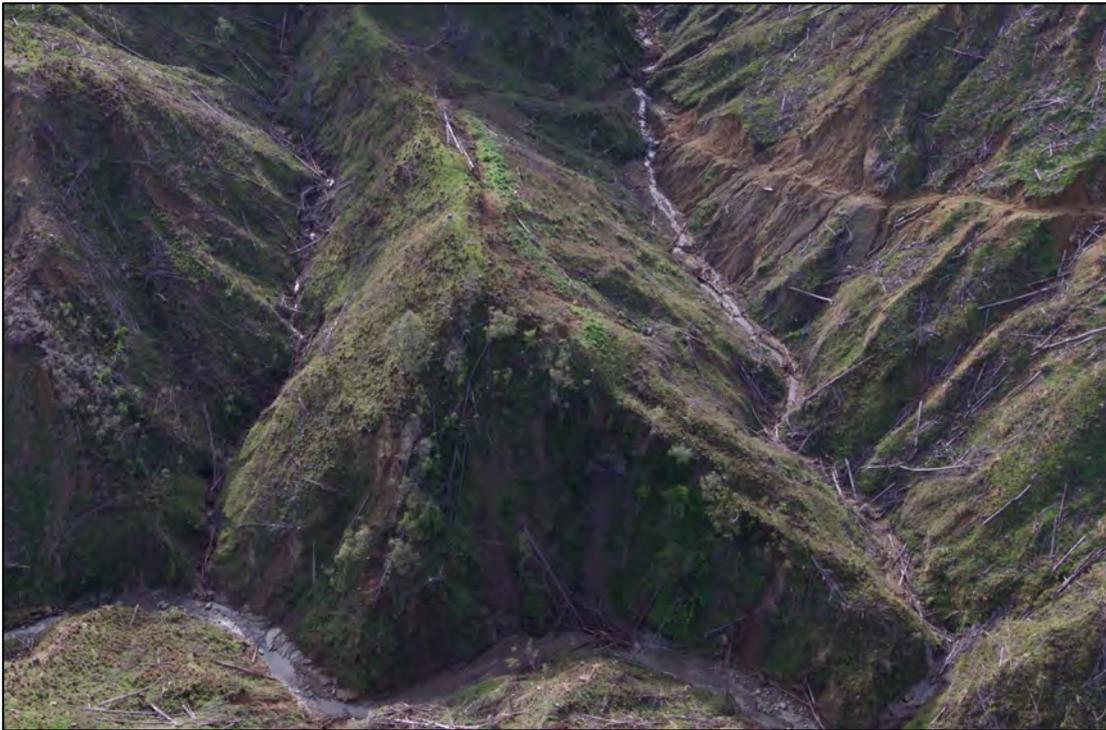
It was found that while not regionally extensive or numerous, those relatively small landslides that did occur were frequently associated with forestry roads. This is exemplified by extensive slipping associated with an access track cut in steep land in a west-facing slope in a side creek of Manganui Stream in the Mangatokerau sub-catchment.

Figure 124. View of west facing slope in a side tributary of Manganui Stream showing landslides associated with the track as well as extensive slash within the side stream and Manganui Stream itself and its flood plain.

6. That permanent-semi permanent roads within forests, haulroads and tracks are designed to a standard that minimises risk of failure, with sidecasting avoided as much as practicable and where used, are protected using engineered stabilisation methods and consistent with the NES.
