Gisborne District Council

## **PRELIMINARY SITE INVESTIGATION (PSI)**

Te Karaka Stopbank

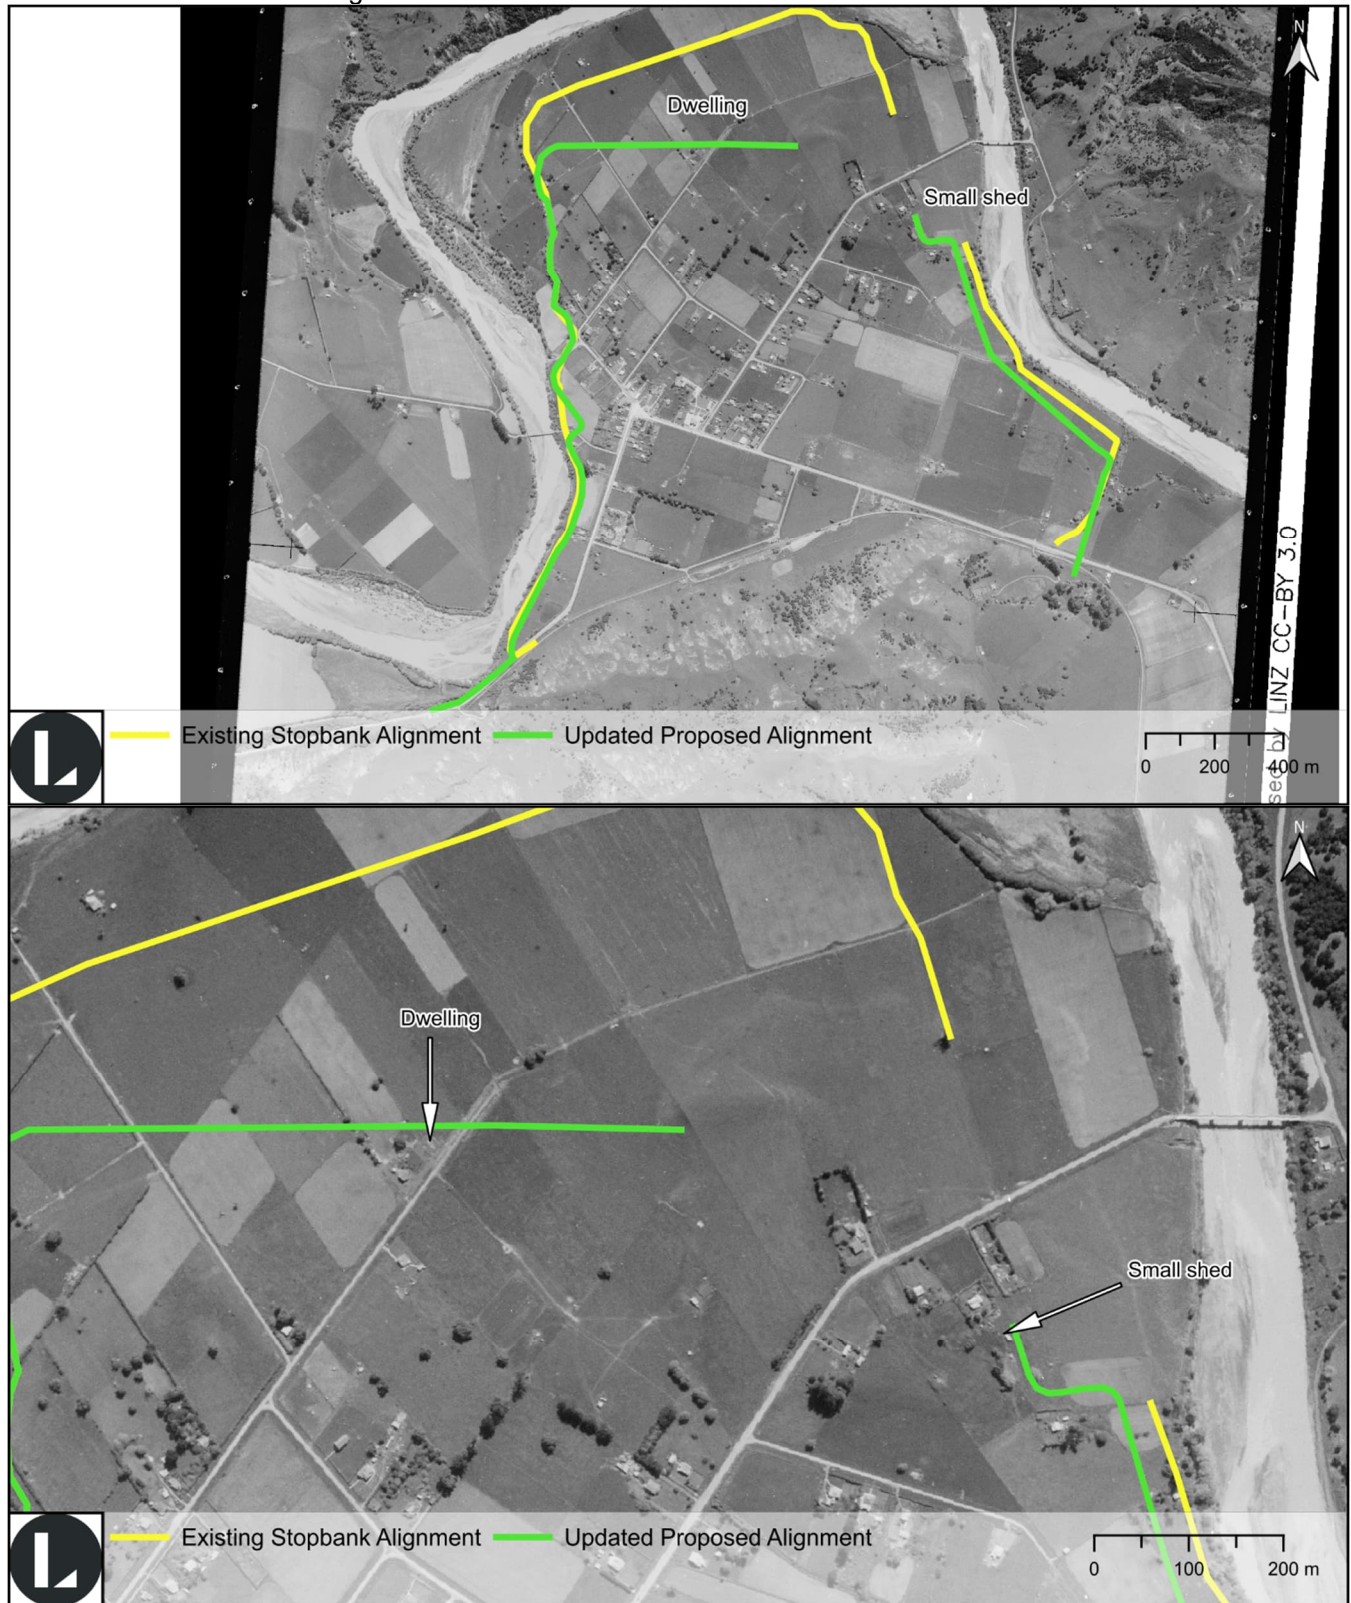
**1949:** The majority of the proposed and exiting stopbank alignments pass through pasture. A single dwelling to the north and a small shed to the east are the only visible structures the proposed alignment crosses. The tunnel located south of the western-most alignment extent is visible in this historic aerial.

Figure 5. Aerial imagery 1949. Full (top) and Zoomed-in (bottom) aers. Sourced from Retrolenz.nz and licensed by LINZ (annotated image).

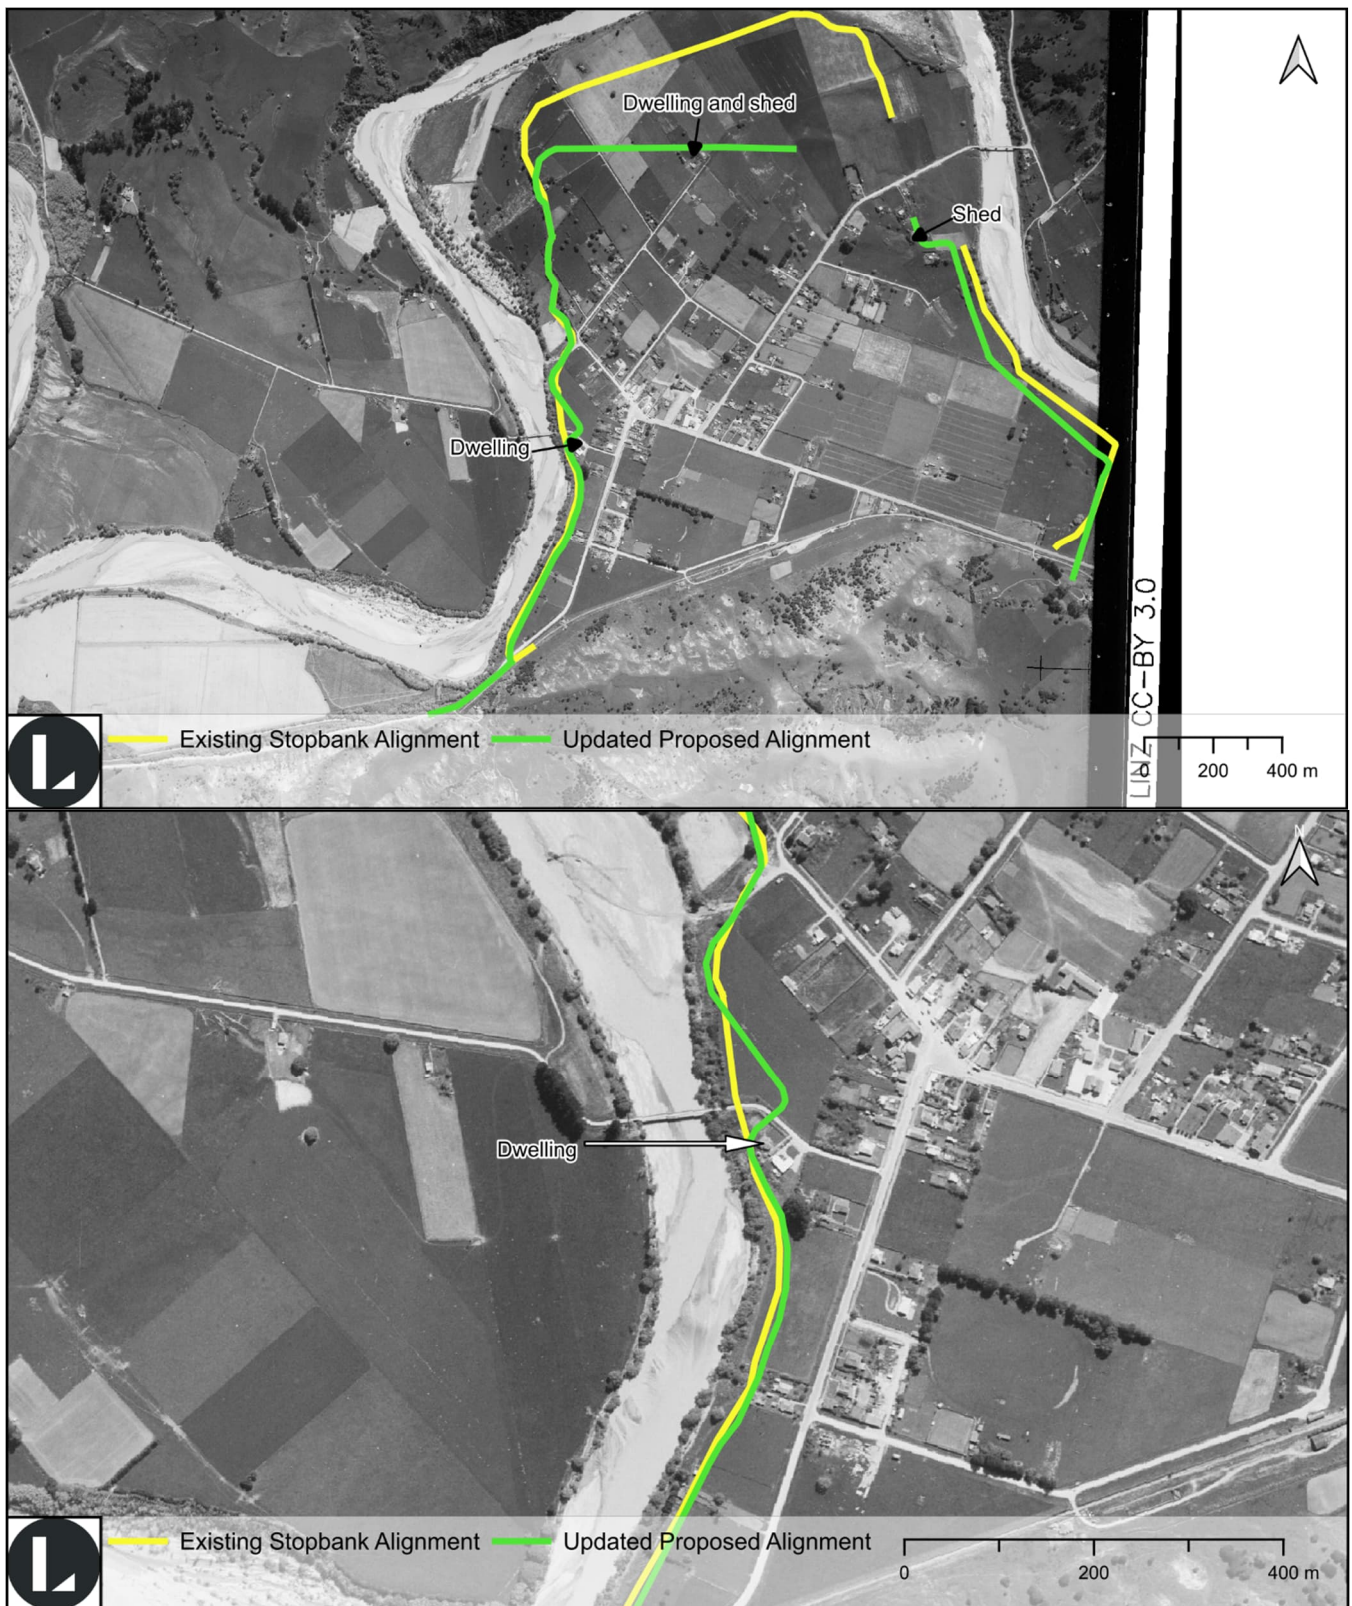
**1952:** A second dwelling has been constructed along the proposed alignment route to the west. The remainder of the proposed alignment is unchanged.

Figure 6. Aerial imagery 1952. Full (top) and Zoomed-in (bottom) aerals. Sourced from Retrolenz.nz and licensed by LINZ (annotated image).

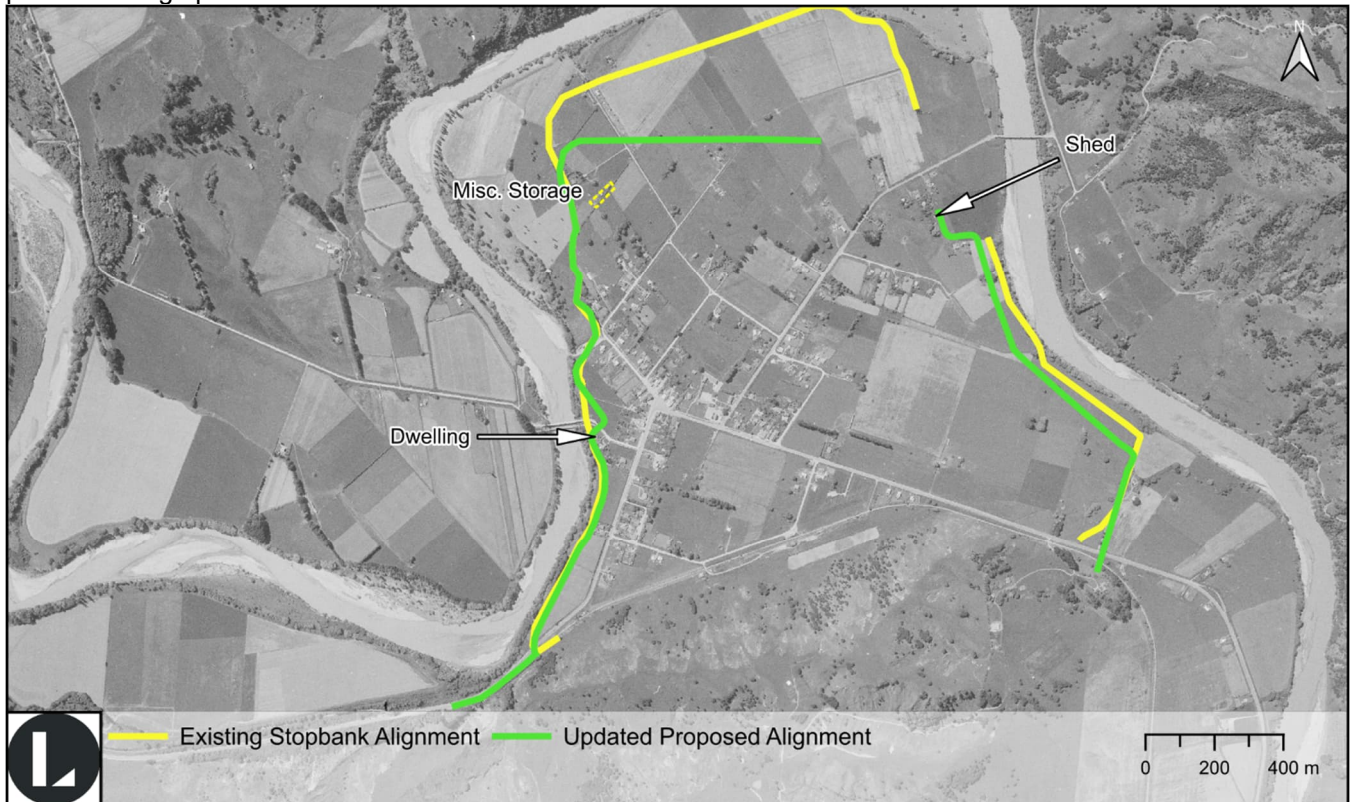
**1960:** The dwelling and shed to the north of the proposed alignment have been removed. Miscellaneous storage, possible timber, is visible close to the northern bend of the proposed alignment. The remaining proposed alignment passes through pasture.

Figure 7. Aerial imagery 1960. Sourced from Retrolenz.nz and licensed by LINZ (annotated image).

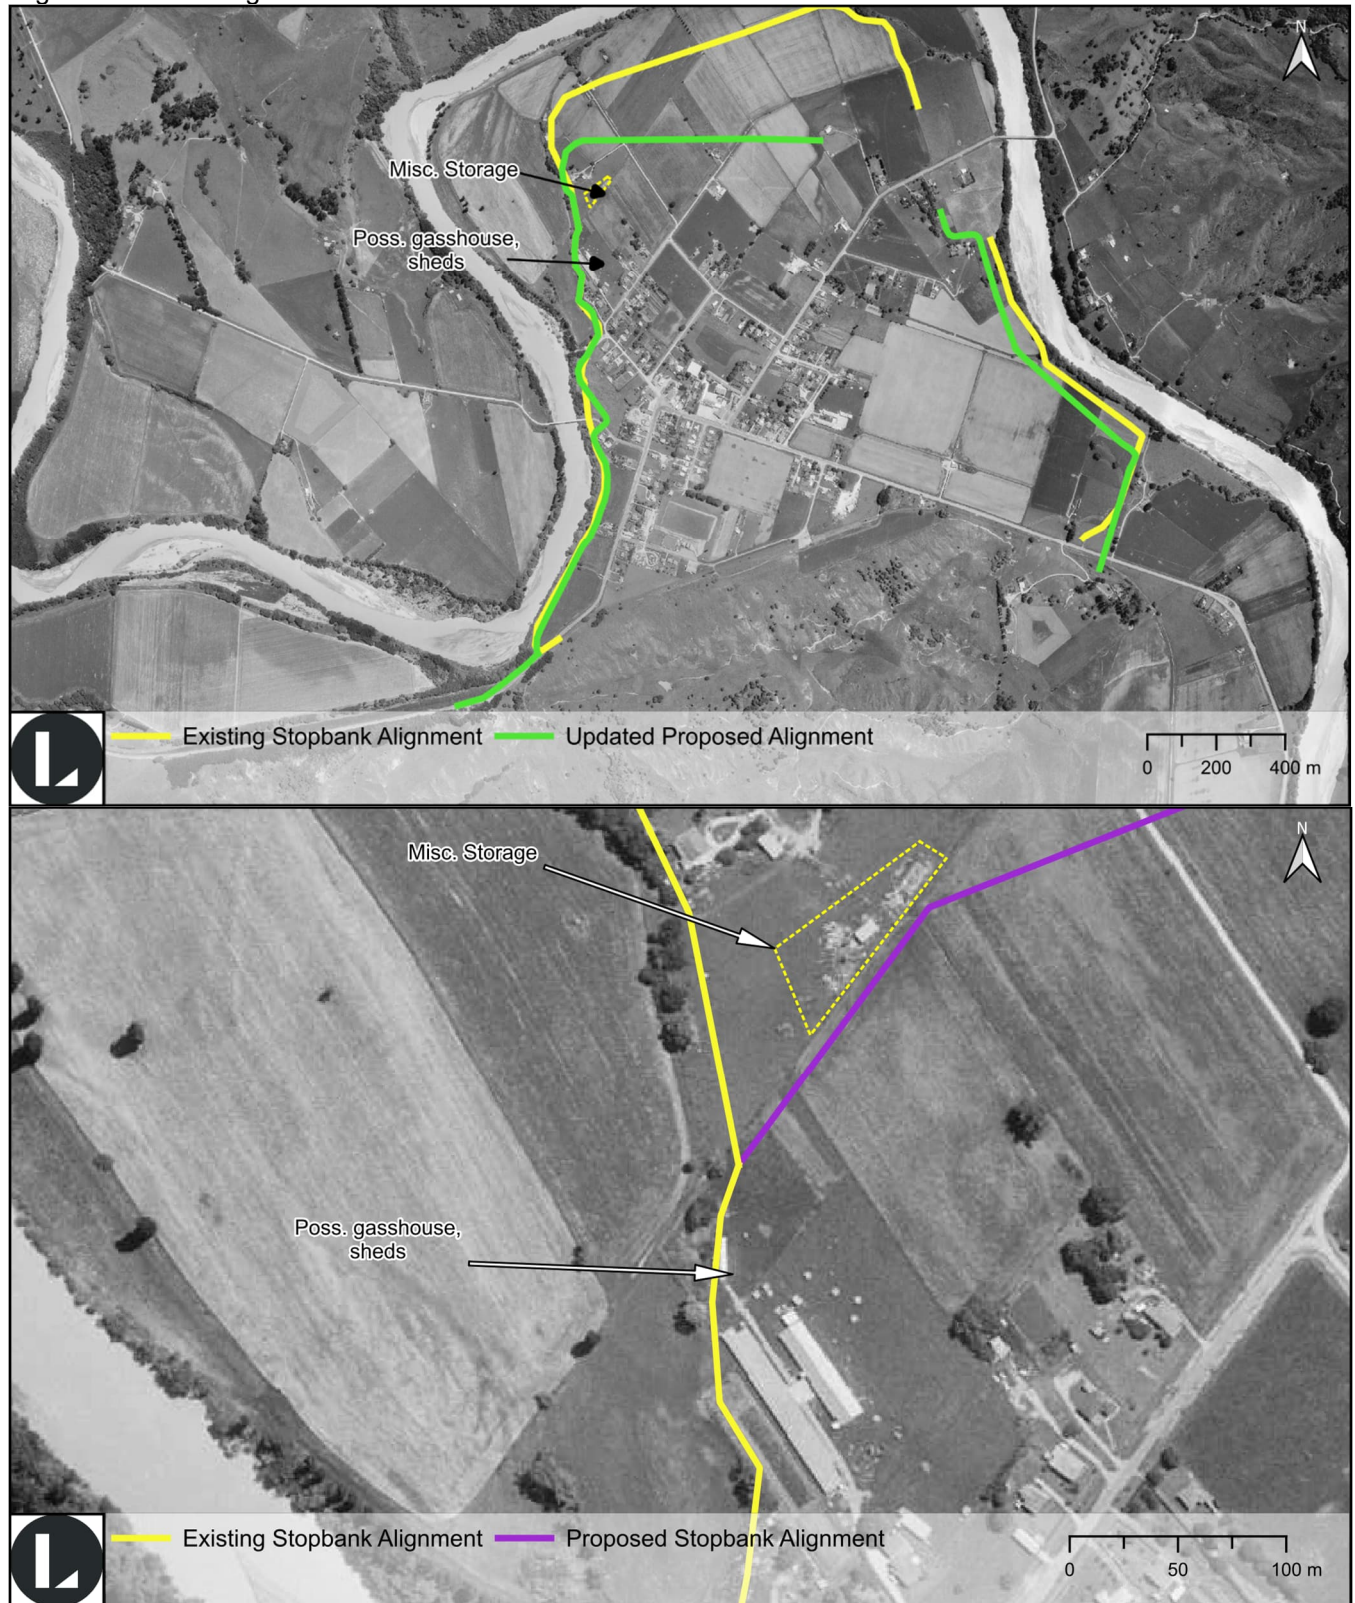
**1974:** Miscellaneous storage, possibly timber, is present adjacent to the proposed alignment. A series of large sheds or glasshouses have been constructed to the west adjacent to the proposed alignment. The remaining proposed alignment is unchanged.

Figure 8. Aerial imagery 1974. Full (top) and Zoomed-in (bottom) aeriels. Sourced from Retrolenz.nz and licensed by LINZ (annotated image).

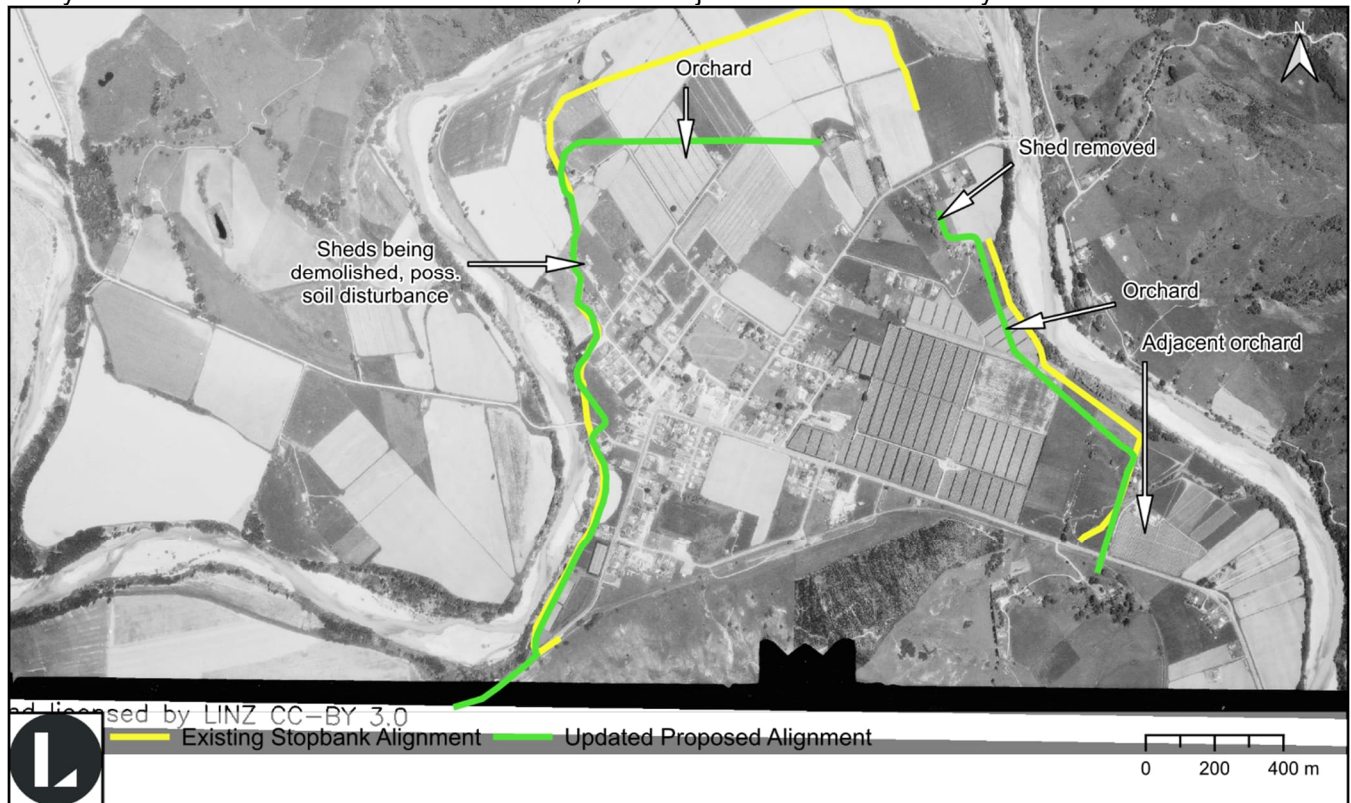
**1982:** Sheds / glasshouses along the NW proposed alignment are being removed. The alignment crosses several newly established orchards in the north and east, and is adjacent to another recently established orchard in the SE.

Figure 9. Aerial imagery 1982. Sourced from Retrolenz.nz and licensed by LINZ (annotated image).

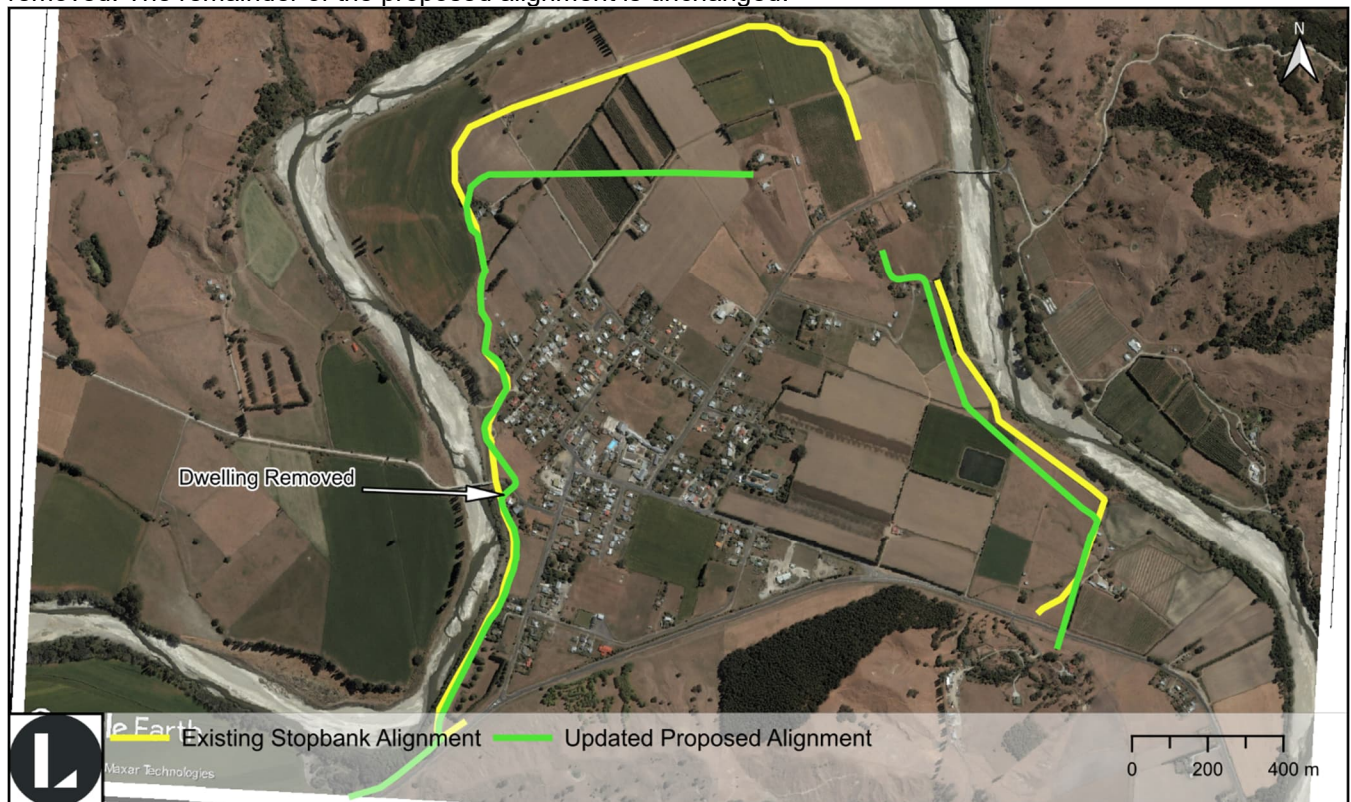
**2003:** The existing stopbank has been constructed. A dwelling close to the Rangatira Road bridge has been removed. The remainder of the proposed alignment is unchanged.

Figure 10. Aerial imagery 2003. Sourced from Google Earth (annotated image).

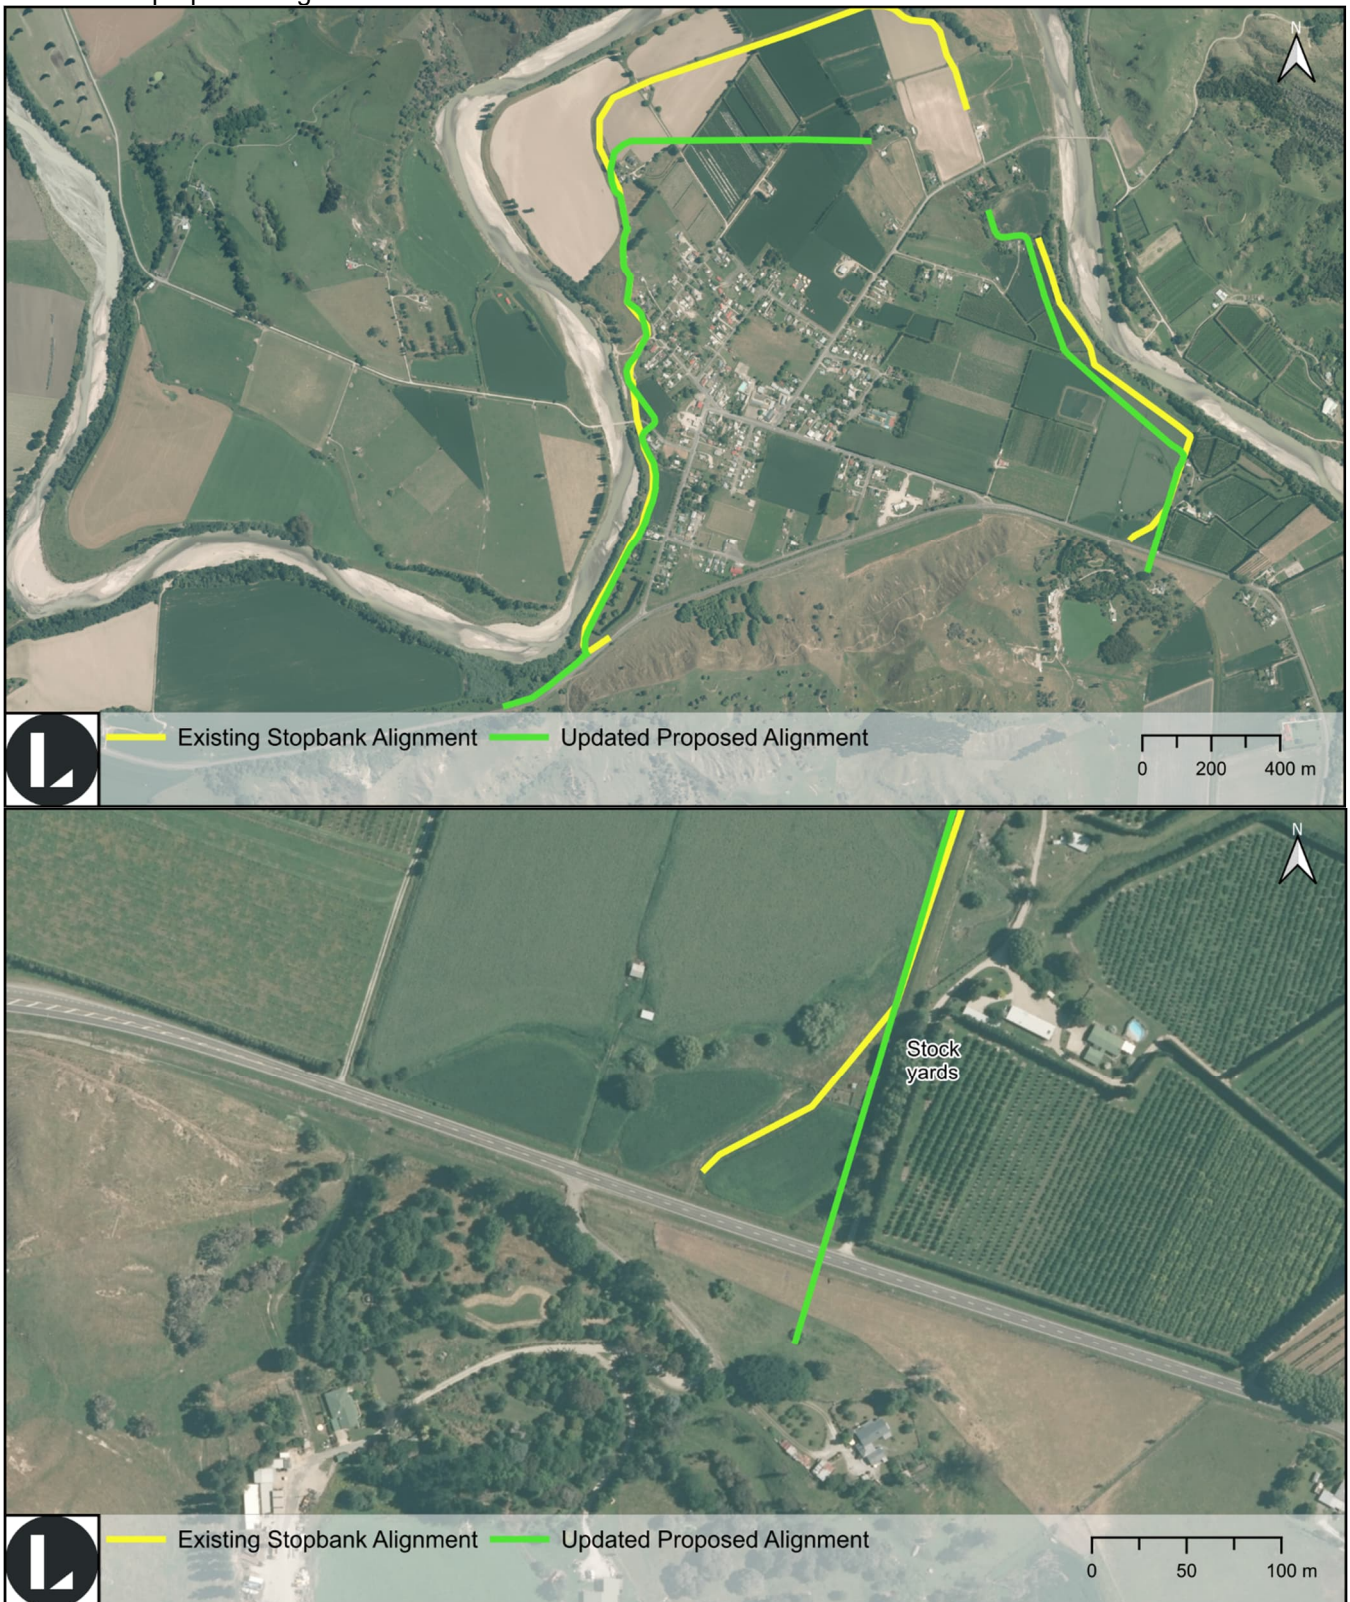
**2013:** The majority of the proposed alignment remains unchanged. A stock yard or possible sheep dip is present near the SE proposed alignment.

Figure 11. Aerial imagery 2013. Zoomed-in aerial shown below to highlight possible dip along the proposed alignment. Sourced from LINZ (annotated image).

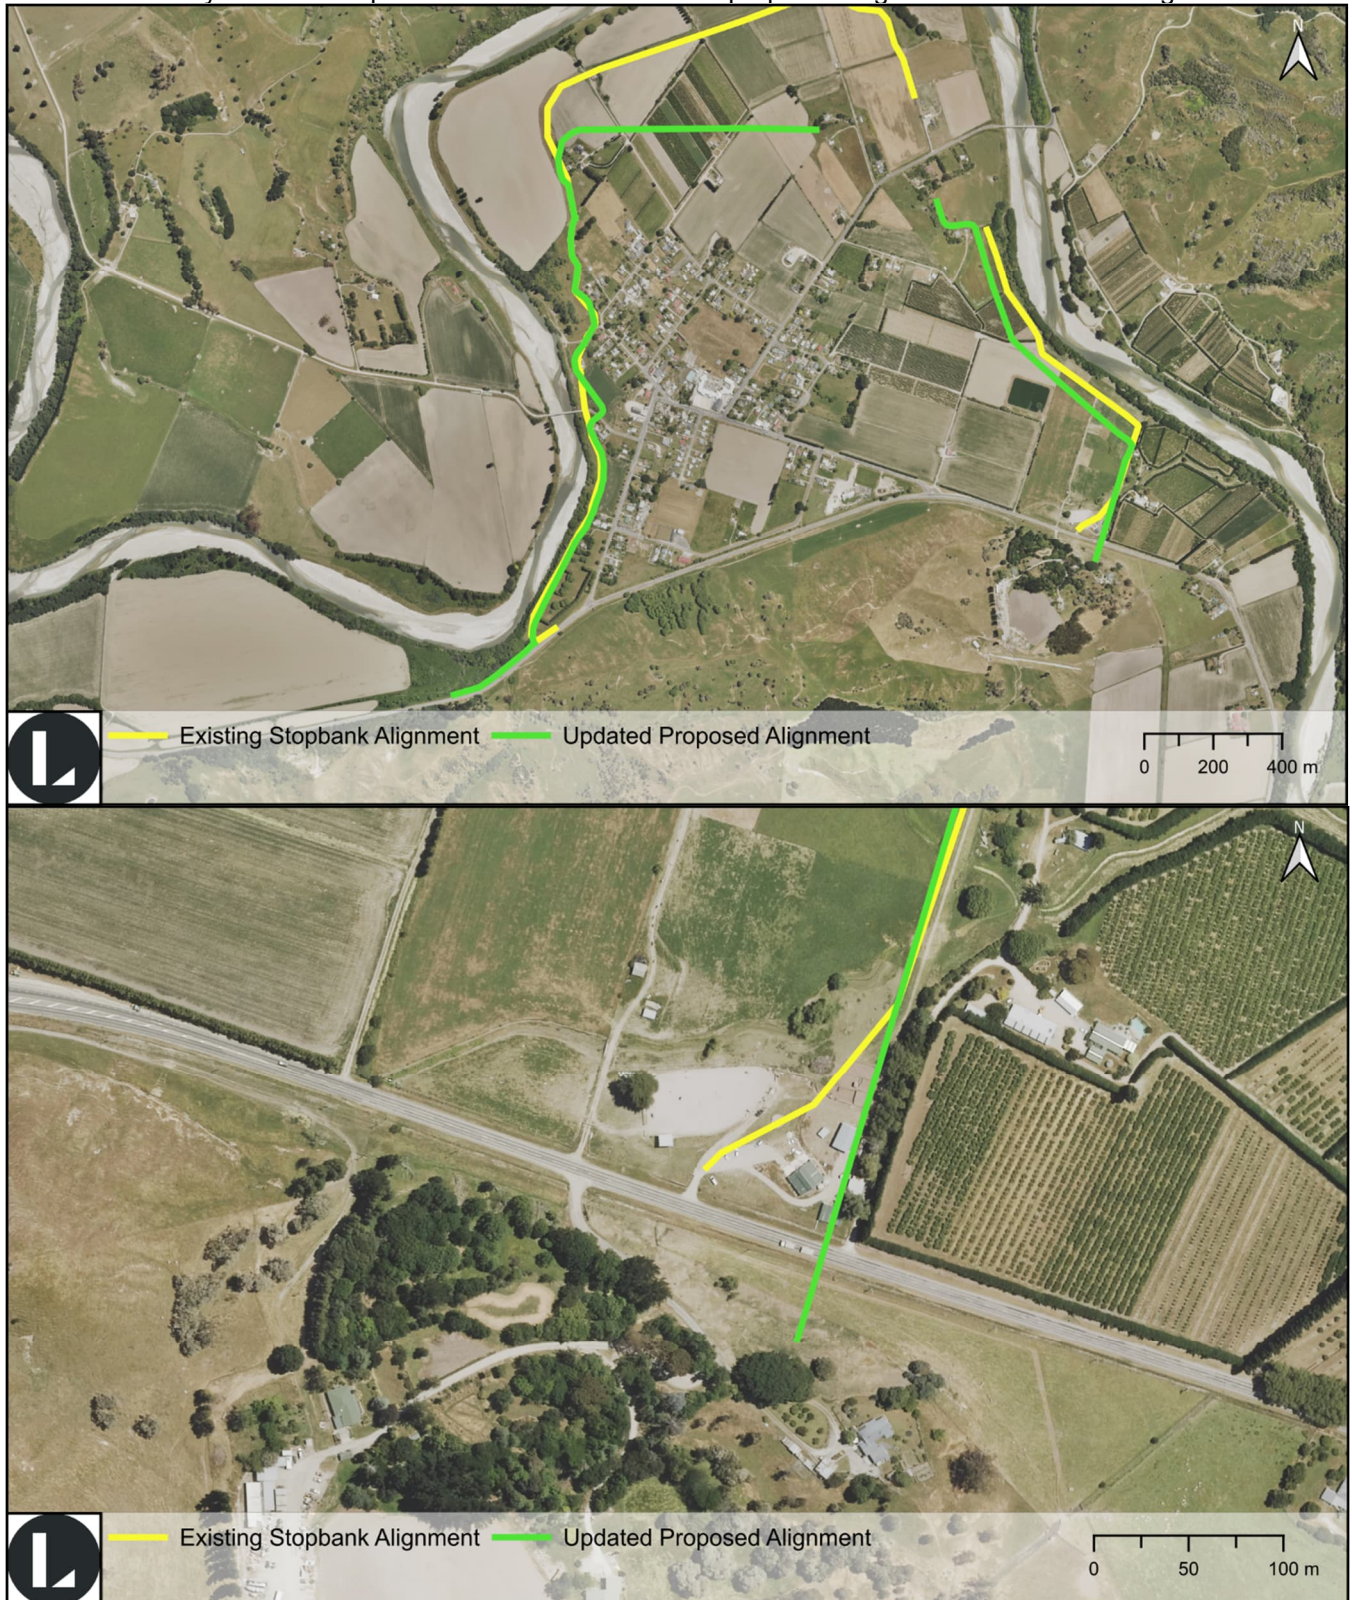
**2019:** The stock yards have expanded. The remainder of the proposed alignment remains unchanged.

Figure 12. Aerial imagery 2019. Zoomed-in aerial shown below to highlight expansion of stock yards along the proposed alignment. Sourced from LINZ (annotated image).

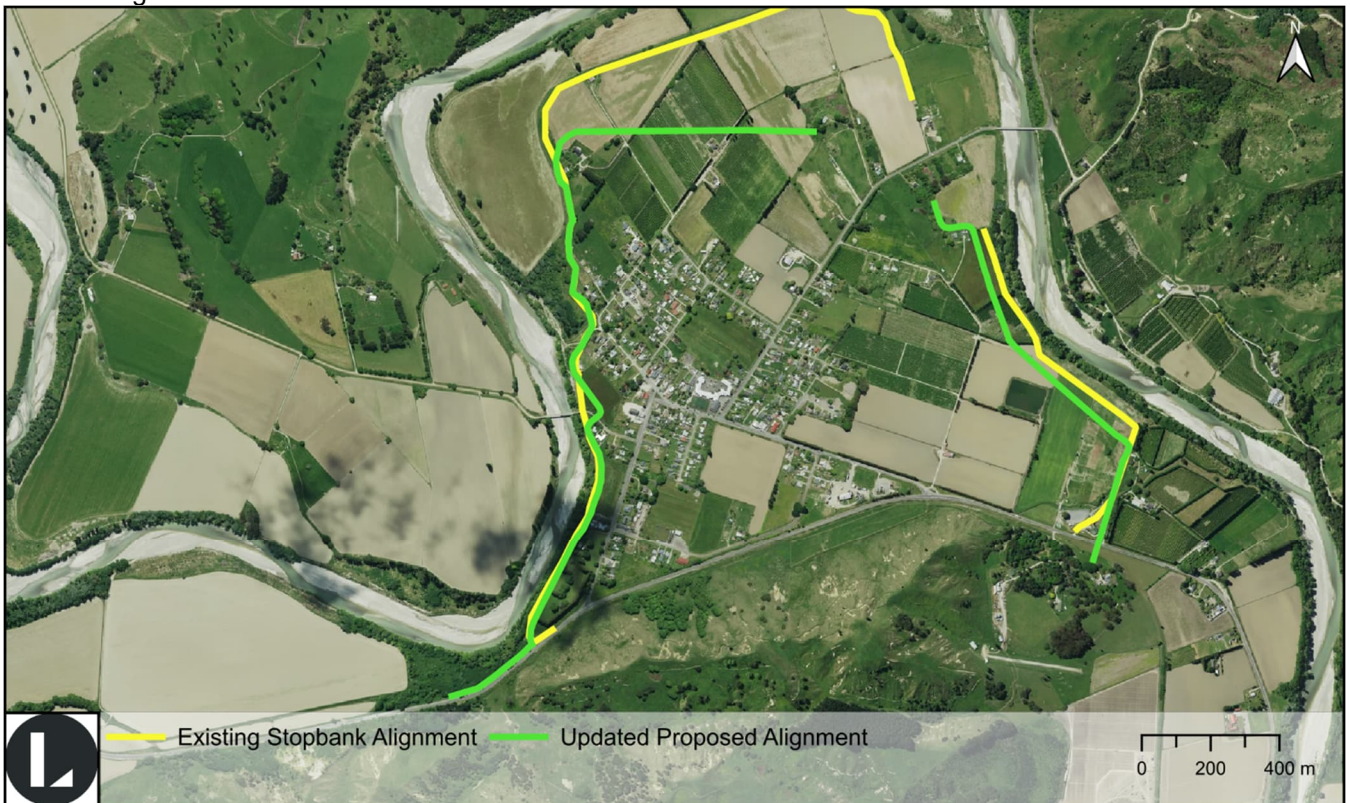
**2024:** The majority of the proposed alignment remains unchanged. The proposed alignment crosses a small area of silt storage to the north.

Figure 13. Aerial imagery 2024. Sourced from Tairawhiti Maps<sup>2</sup>.

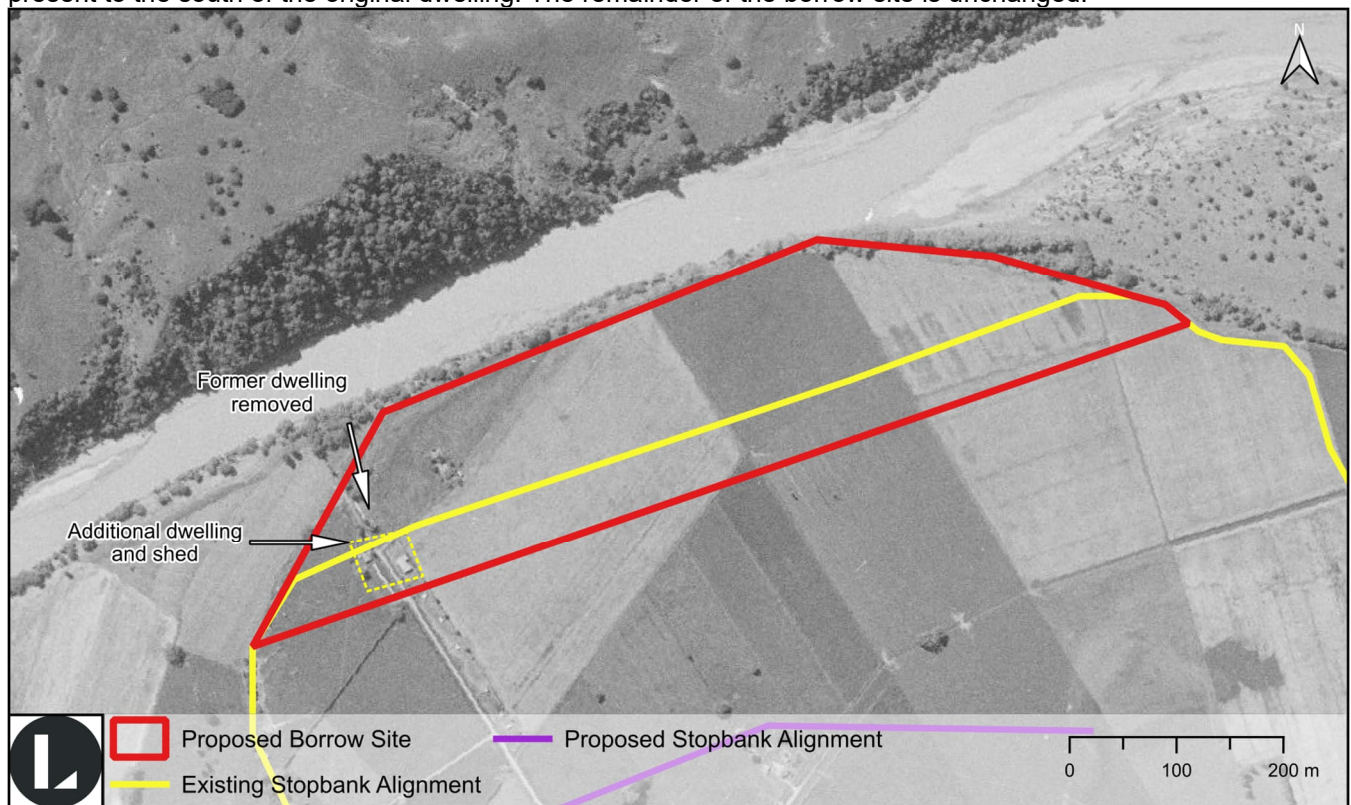
**1960:** The additional dwelling present in the 1952 aerial has been removed. An additional dwelling and shed are present to the south of the original dwelling. The remainder of the borrow site is unchanged.

Figure 16. Aerial imagery 1960. Sourced from Retrolenz.nz and licensed by LINZ (annotated image).

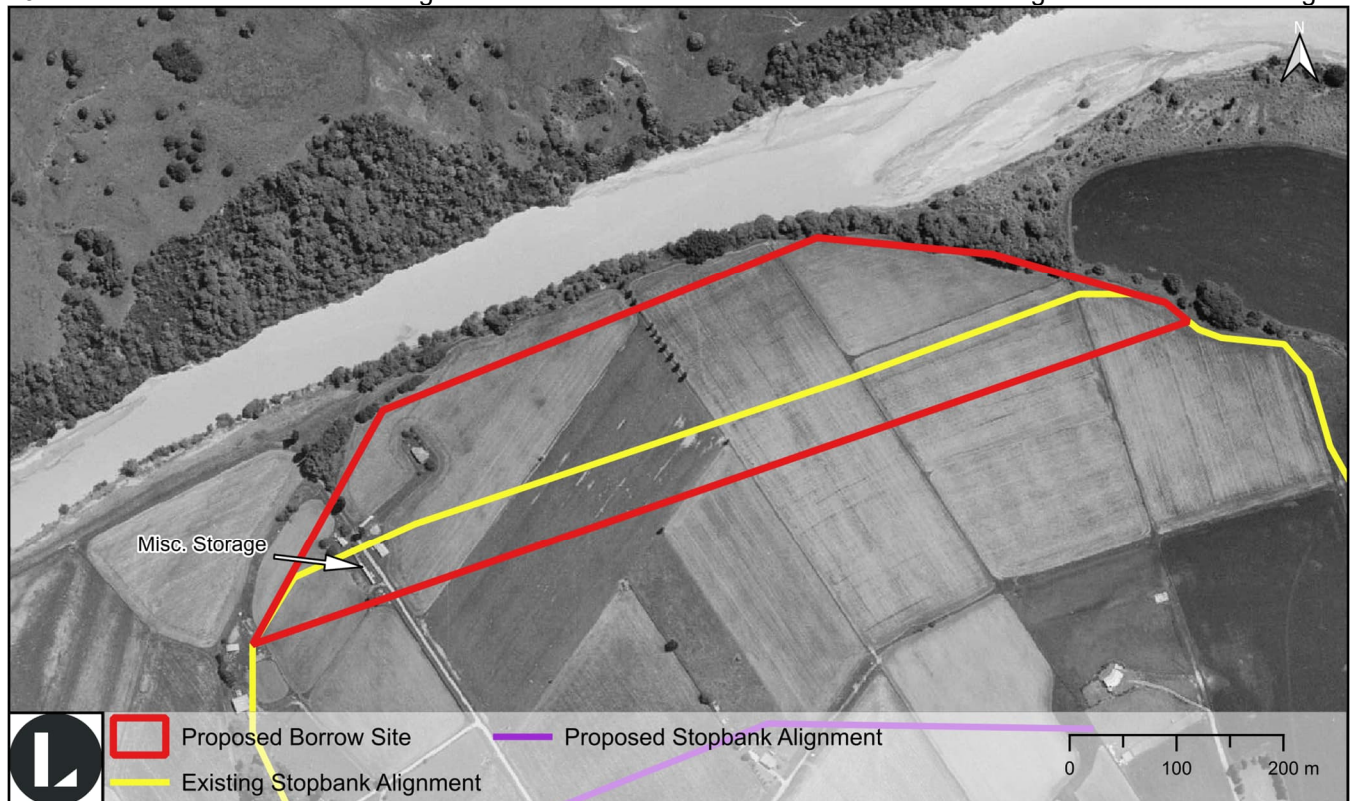
**1974:** A row of miscellaneous storage is noted to the west of Morris Road. The remaining borrow site is unchanged.

Figure 17. Aerial imagery 1974. Sourced from Retrolenz.nz and licensed by LINZ (annotated image).

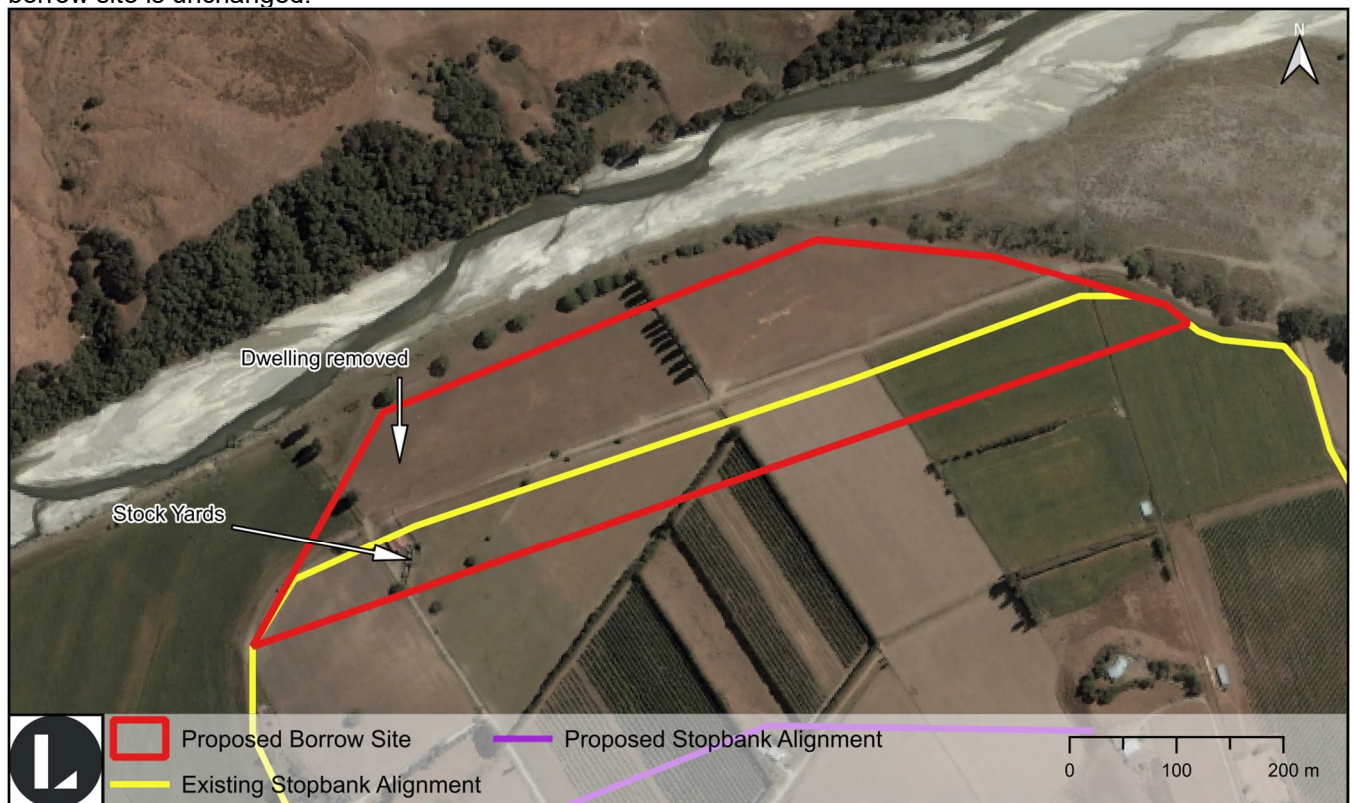
**2003:** The existing stopbank has been constructed through the borrow site. The original dwelling from 1949 has been removed. Stock yards are visible adjacent to the dwelling south of the existing stopbank. The remainder of the borrow site is unchanged.

Figure 19. Aerial imagery 2003. Sourced from Google Earth (annotated image). Approximate site boundary shown in yellow.

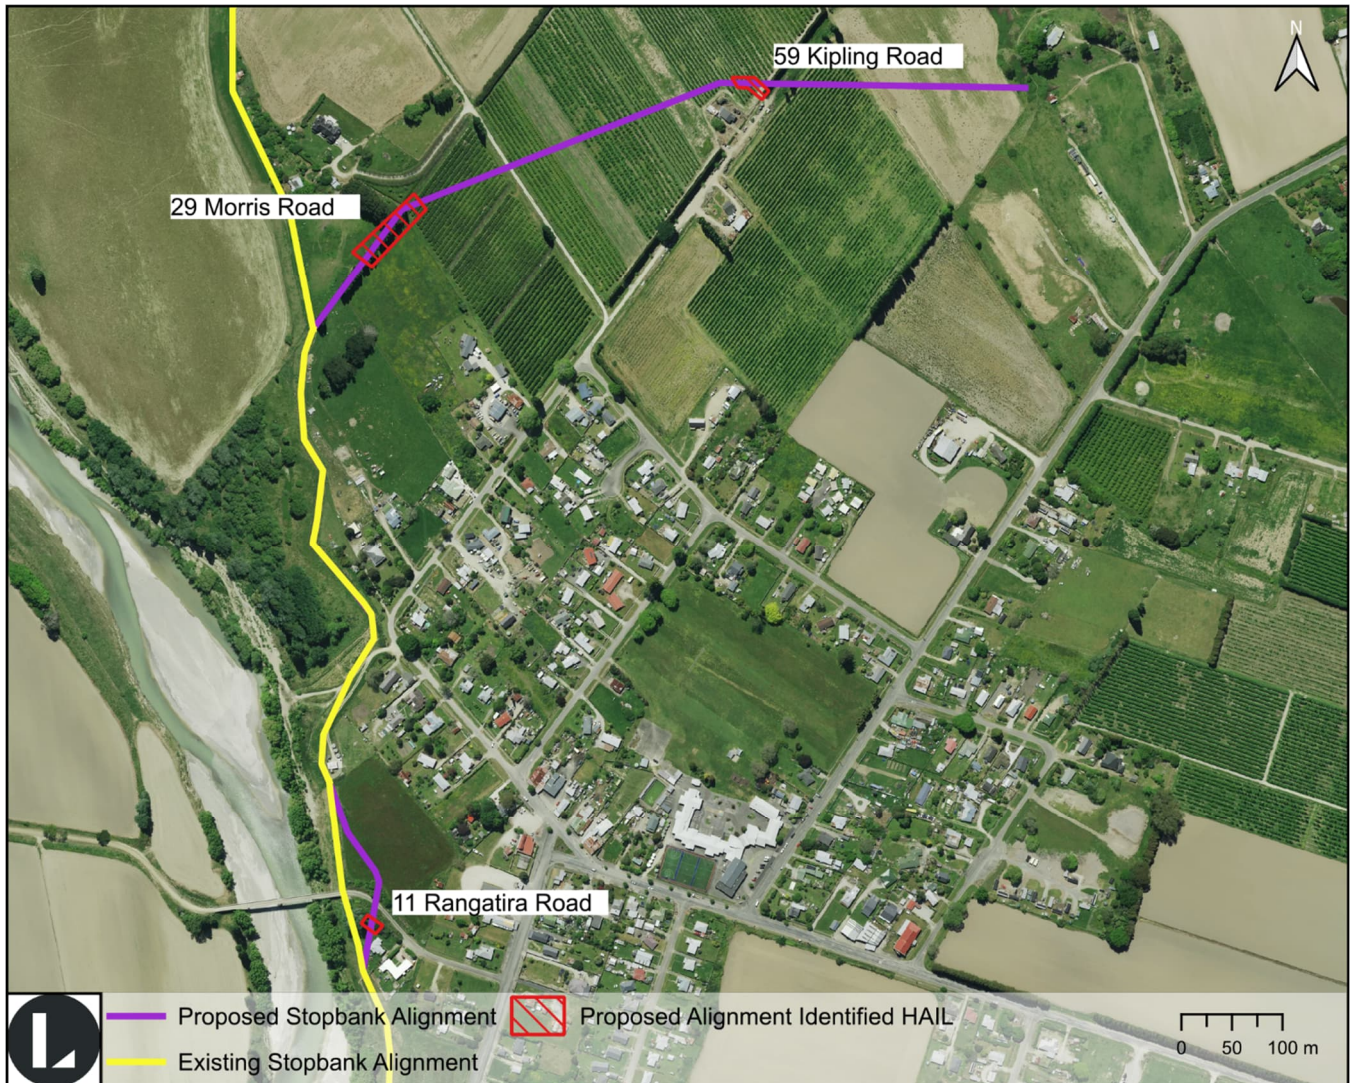
| HAIL, Potential Contaminants and Location | Receptors | Potential Pathways |
|---|---|---|
| <b>HAIL A10 – Persistent pesticide bulk storage or use including sports turfs, market gardens, orchards, glass houses or spray sheds.</b><br><br>Along proposed alignment – various orchards noted since 1982 onwards. | Construction workers | Exposure via inhalation of contaminated dust or ingestion and skin contact (dermal). |

Figure 24. Summary plan showing location of identified HAIL sites along the proposed stopbank alignment. HAIL A10 also identified at various orchards along the proposed alignment. Refer to Figure 25 for zoomed-in plan. No additional HAIL sites were identified following the updates to the proposed alignment (March 2026).

A detailed site investigation (DSI) is recommended to establish if soil contamination exceeds the applicable standard to determine if the site is a restricted discretionary or controlled consent under the NESCS. Soil sampling is proposed to be undertaken within the identified HAIL locations, as well as systematic sampling along the proposed alignment where orchards are or were historically present.
