Gisborne District Council

## **PRELIMINARY SITE INVESTIGATION (PSI)**

Te Karaka Stopbank

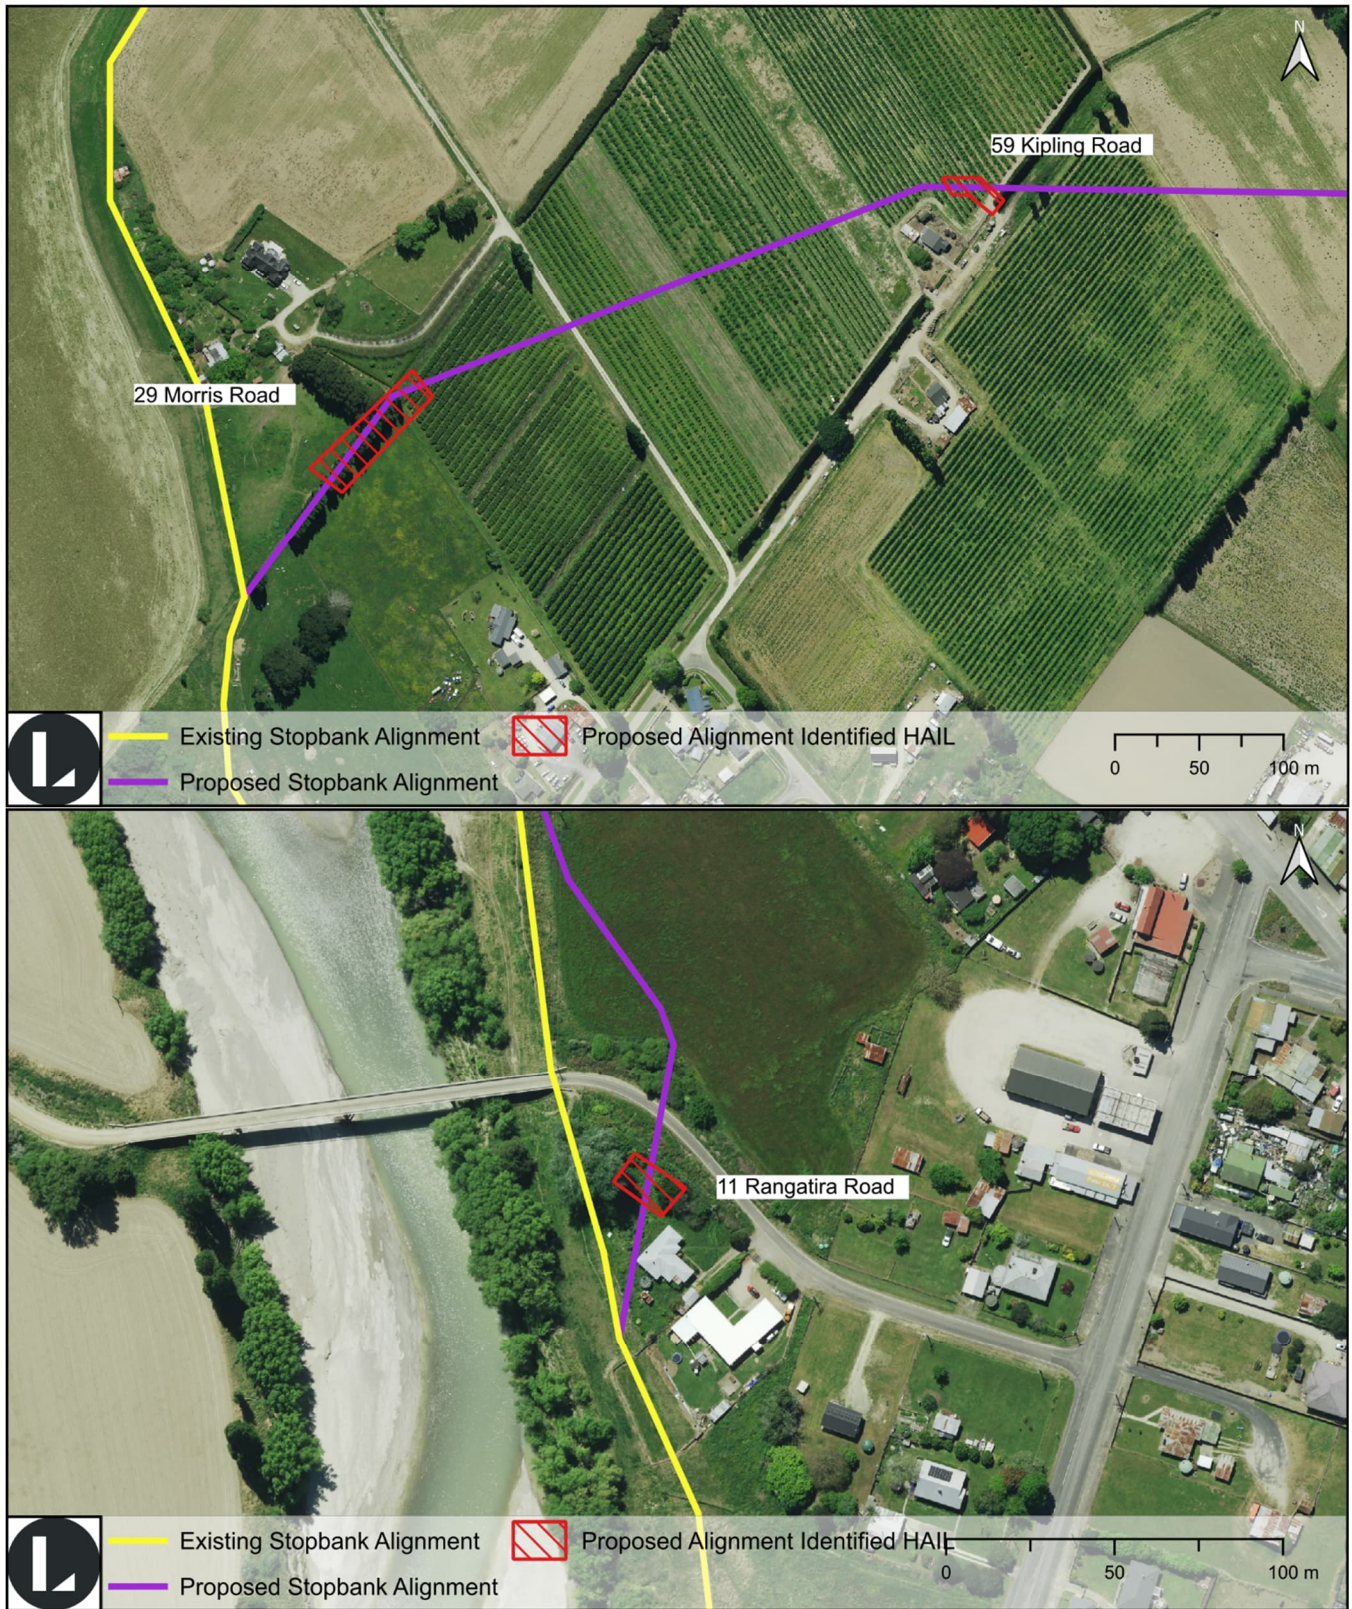
Figure 25. Zoomed-in plans showing identified HAIL locations along proposed stopbank alignment. No additional HAIL sites were identified following the updates to the proposed alignment (March 2026).

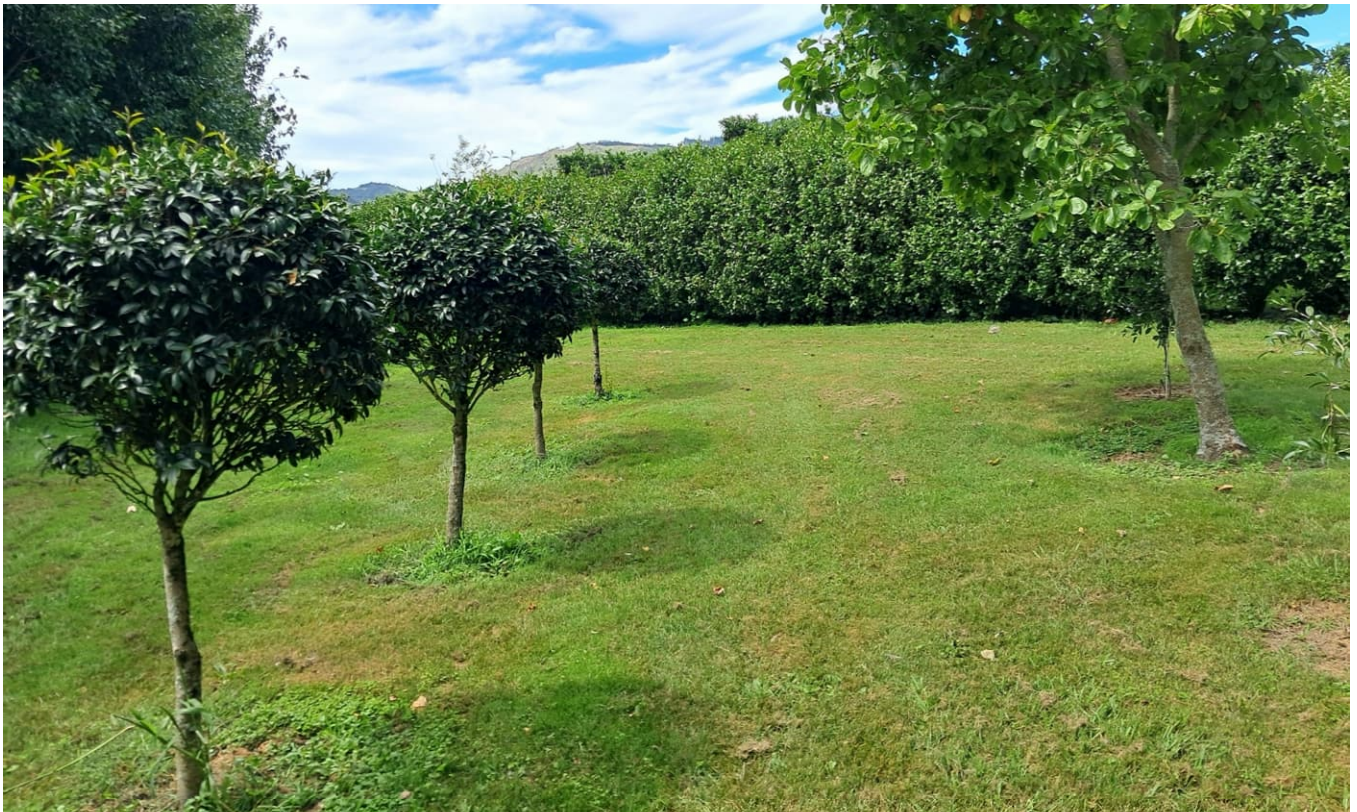
Rows of crops, including apples, citrus, corn, beets are present along the proposed alignment length.

Figure 6. Various crops / orchards visible along the proposed alignment.

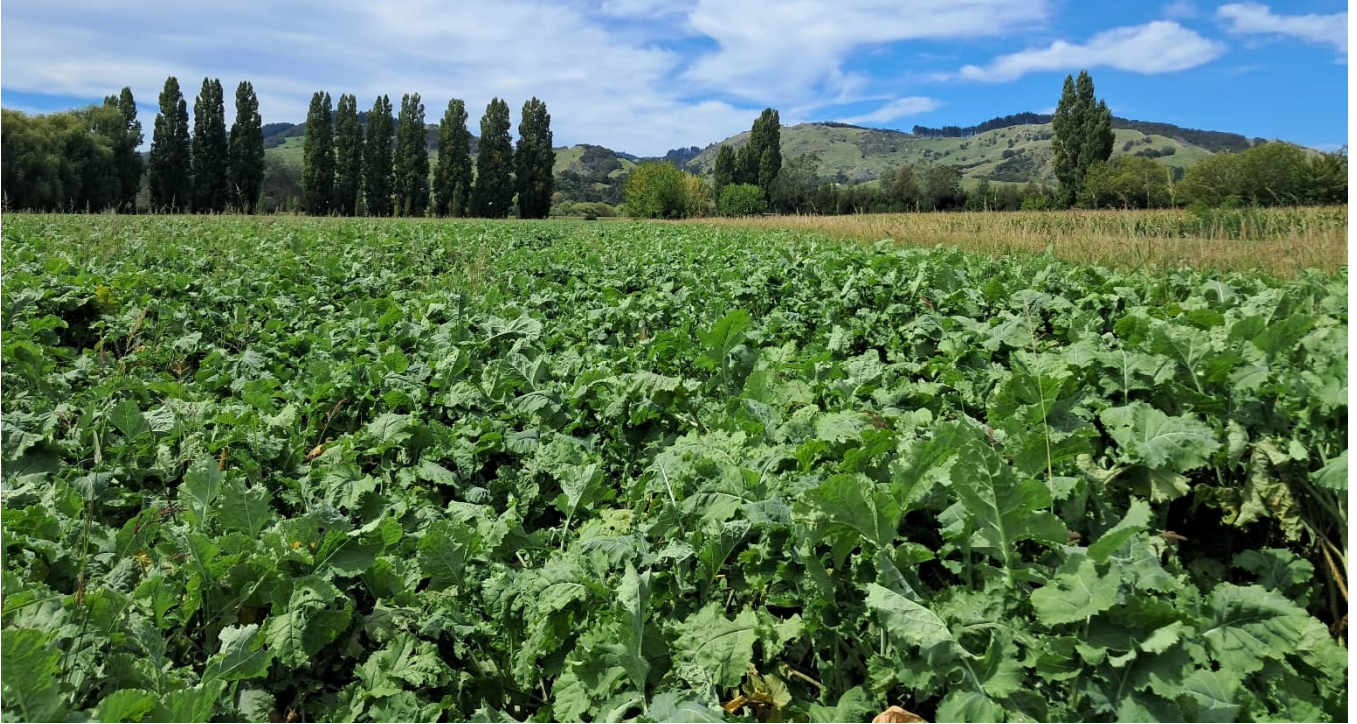
Figure 7. Various crops visible along the proposed alignment.

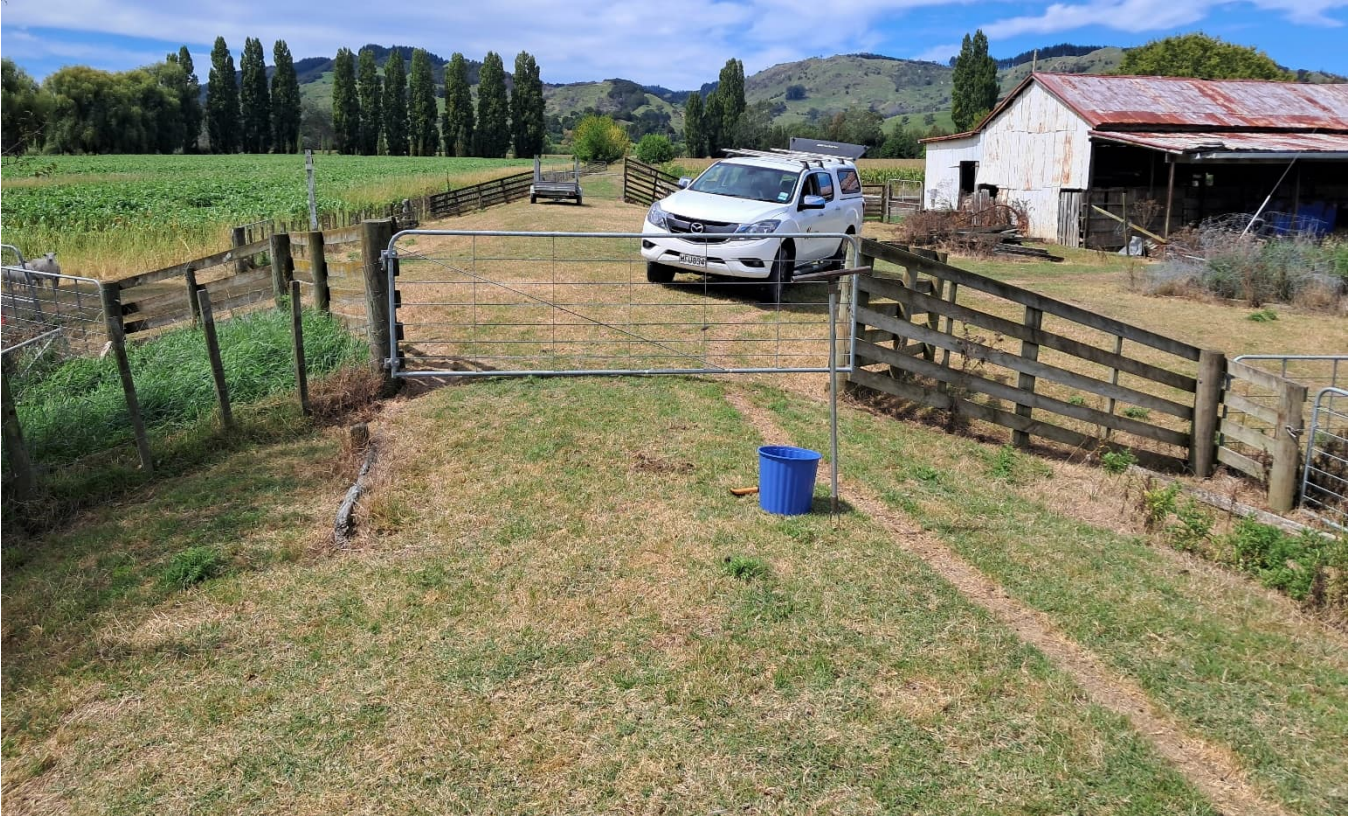
Figure 9. Farm shed at 44 Morris Road – proposed borrow site. Piles of fencing wire visible.

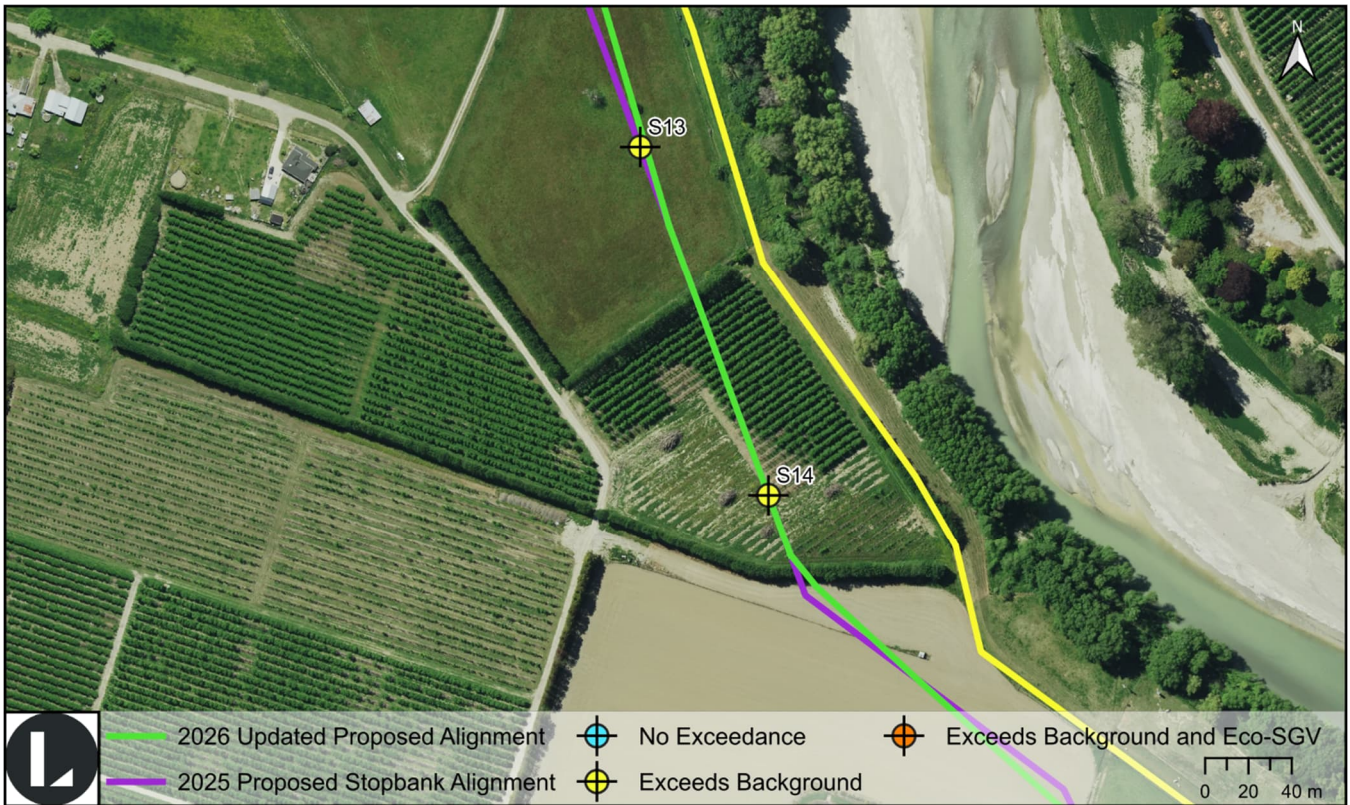
Figure 16. Soil sample results for samples S13-S14 along the proposed stopbank alignment.

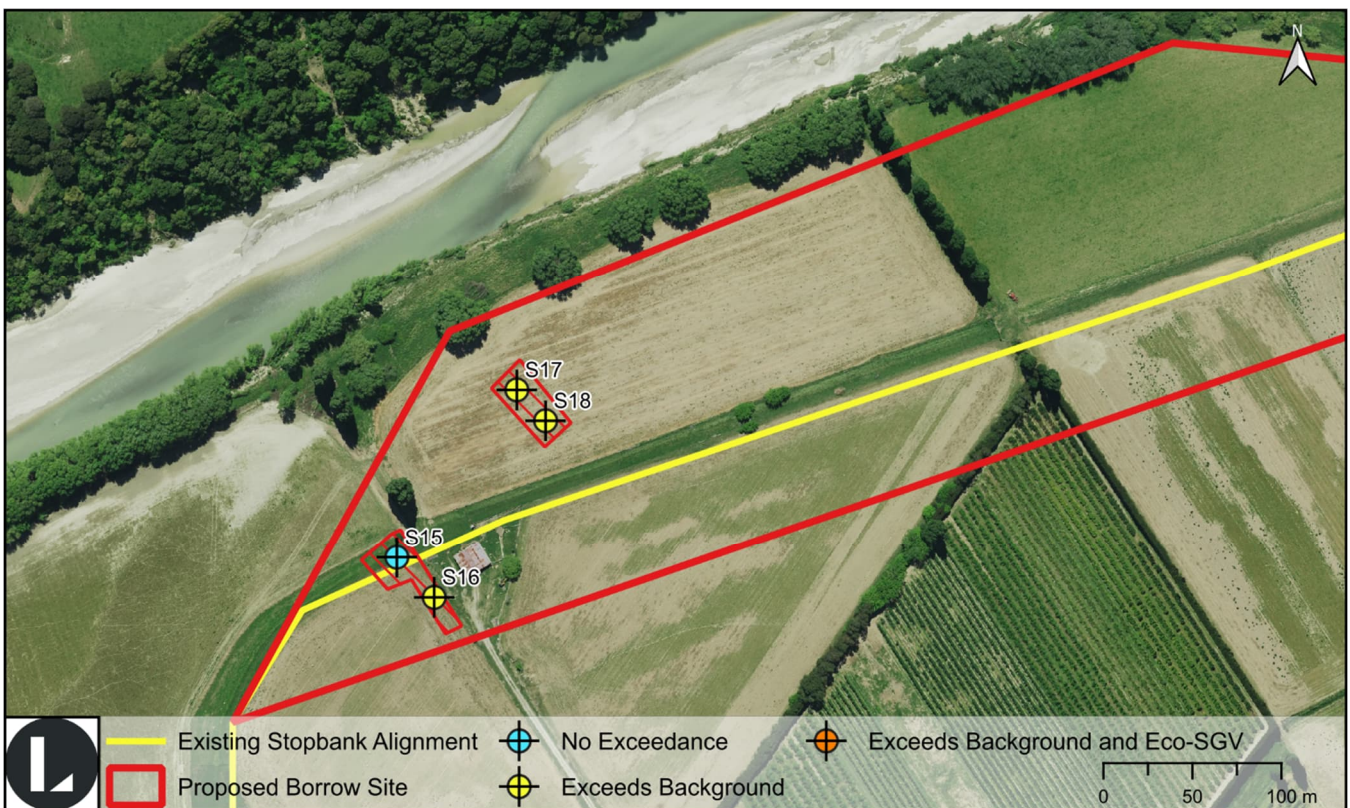
Figure 17. Soil sample results for samples S15-S18 within the proposed borrow site.
