Client:	Journeys - Gisborne District Council
From:	LDE Ltd.
Subject:	Tiniroto Road RP35.03, 35.88 & 37.03 Bluff inspection 2/2 and ROC
Date:	01/08/23
Project Ref:	19442
Document ID:	350144
Revision Status:	B

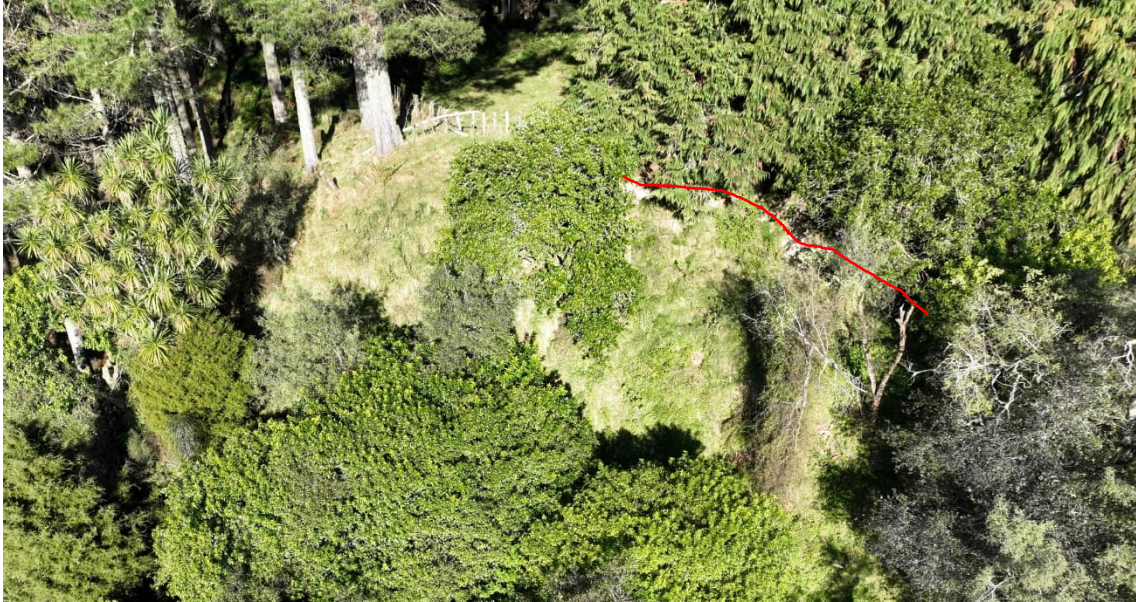
- Increased displacement was observed across tension cracks at the crest of the slope. Additionally, new tension cracks have formed where previously none were observed (e.g., Figure 2).
- The soil overburden, which covers the upper slope, exhibits signs of further movement/ deformation (refer Figure 3).
- Fresh boulders were present at the base of the slope, on the road, and on the opposite side of the road from the bluff. Boulders were sized approximately 100-600 mm in diameter.
- Seepage on the western side of the bluff has decreased, seepage on the eastern side remains unchanged.

Figure 2: Tension cracking near the crest of Bluff 1 (marked by red line) exacerbated by recent low intensity rainfall.

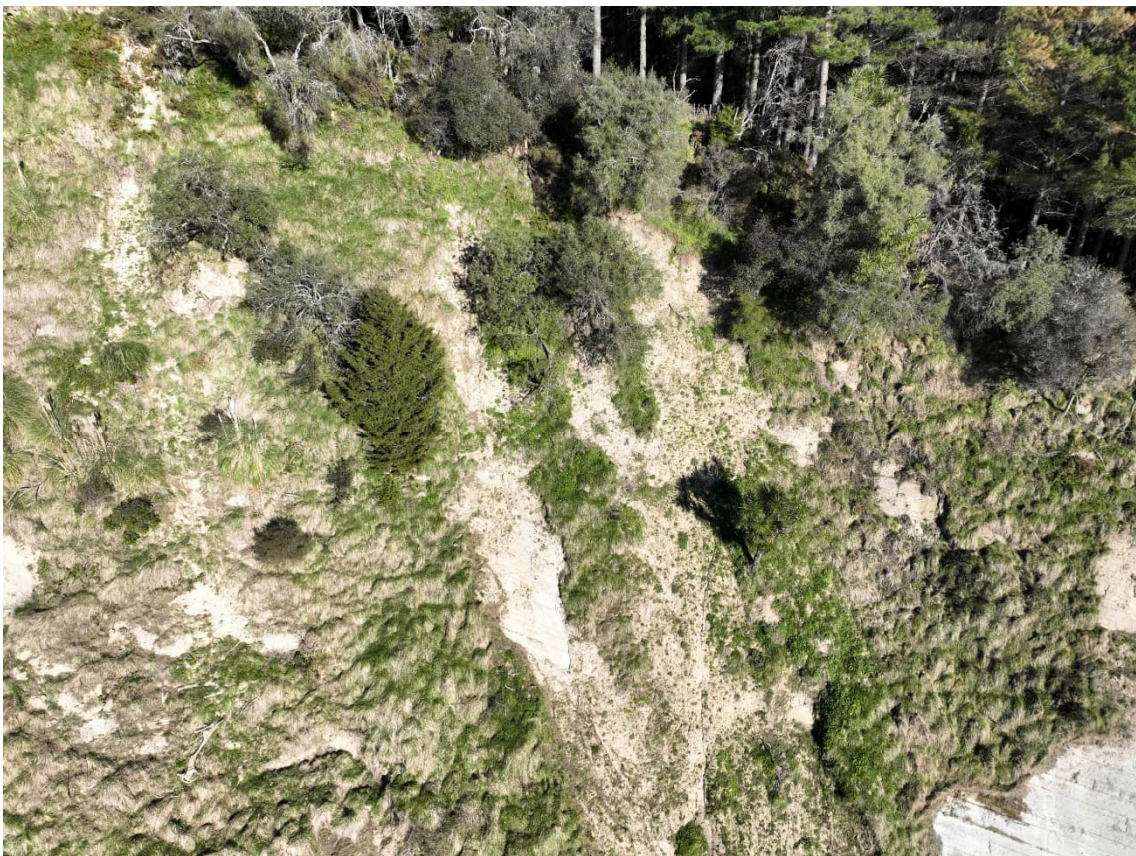
Figure 3: Soil overburden in the upper slopes.

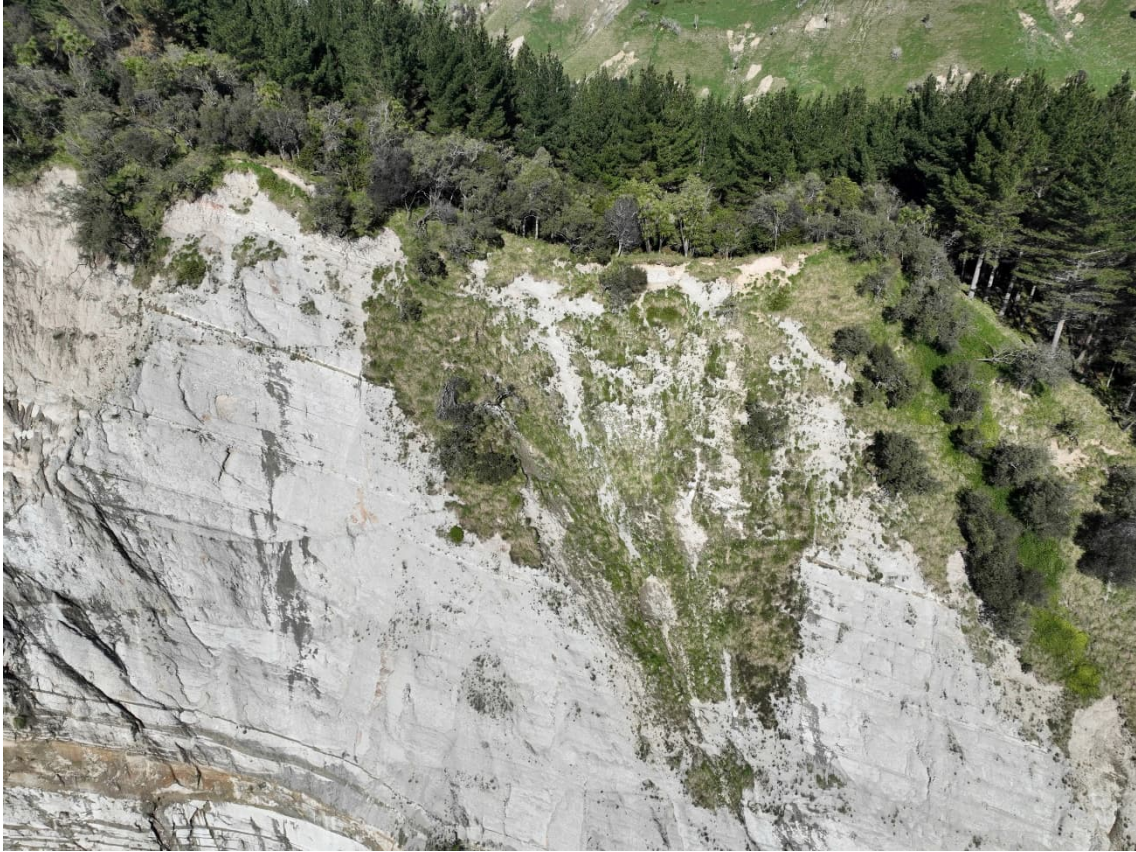
- The soil overburden which covers the upper slope, and the flanks of Bluff 2 exhibits signs of further movement/deformation and tension cracking has been exacerbated (refer Figure 4 and Figure 5).
- Seepage across Bluff 2 has decreased significantly.
- Fresh boulders were present at the base of the slope, on the road, and on the opposite side of the road from the bluff. Boulders were sized approximately 400mm to 800 mm in diameter.
- The quantity of talus at the base of the slope has only increased marginally.

Figure 4: A portion of the soil overburden at the top of Bluff 2.

We understand that a business case to bypass Bluffs 1 and 2 is well advanced by GDC. We recommend this option be pursued in earnest, given the inherent level of risk with Bluffs 1 and 2.

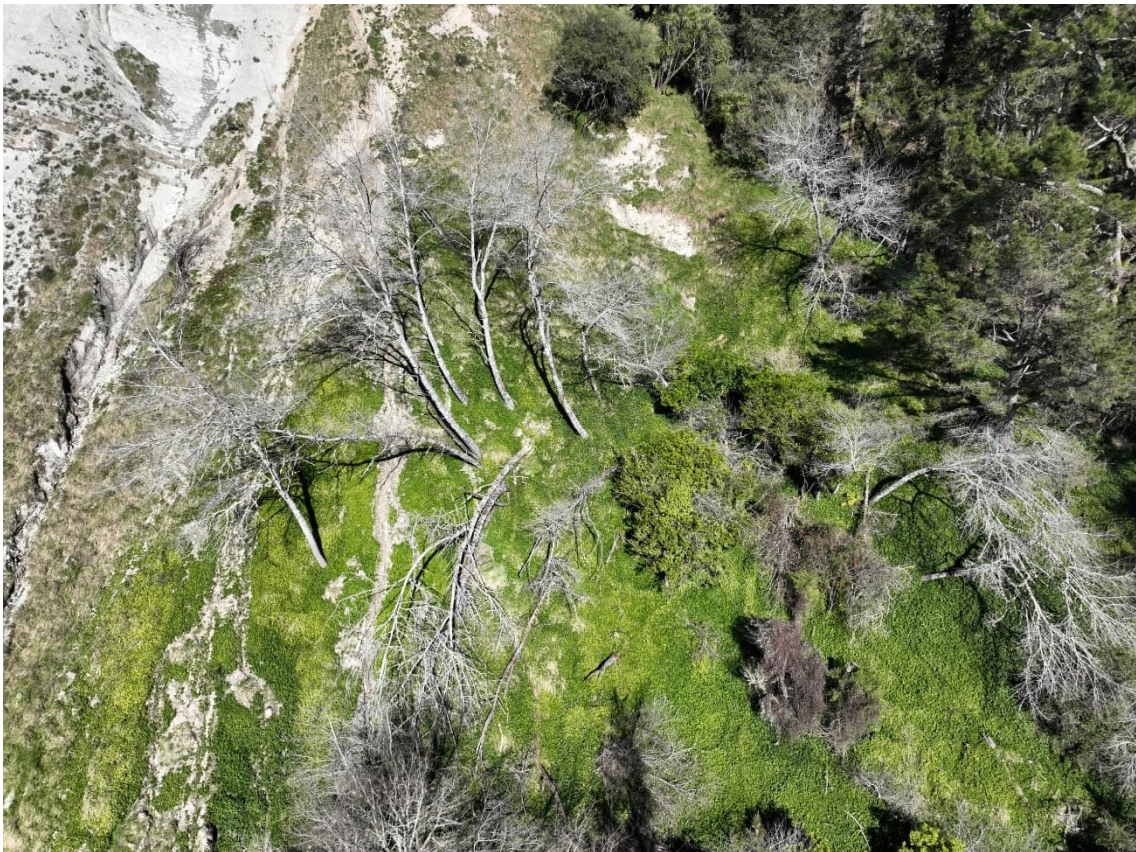
Figure 5: A portion of the soil overburden on the true-left flank of Bluff 2.

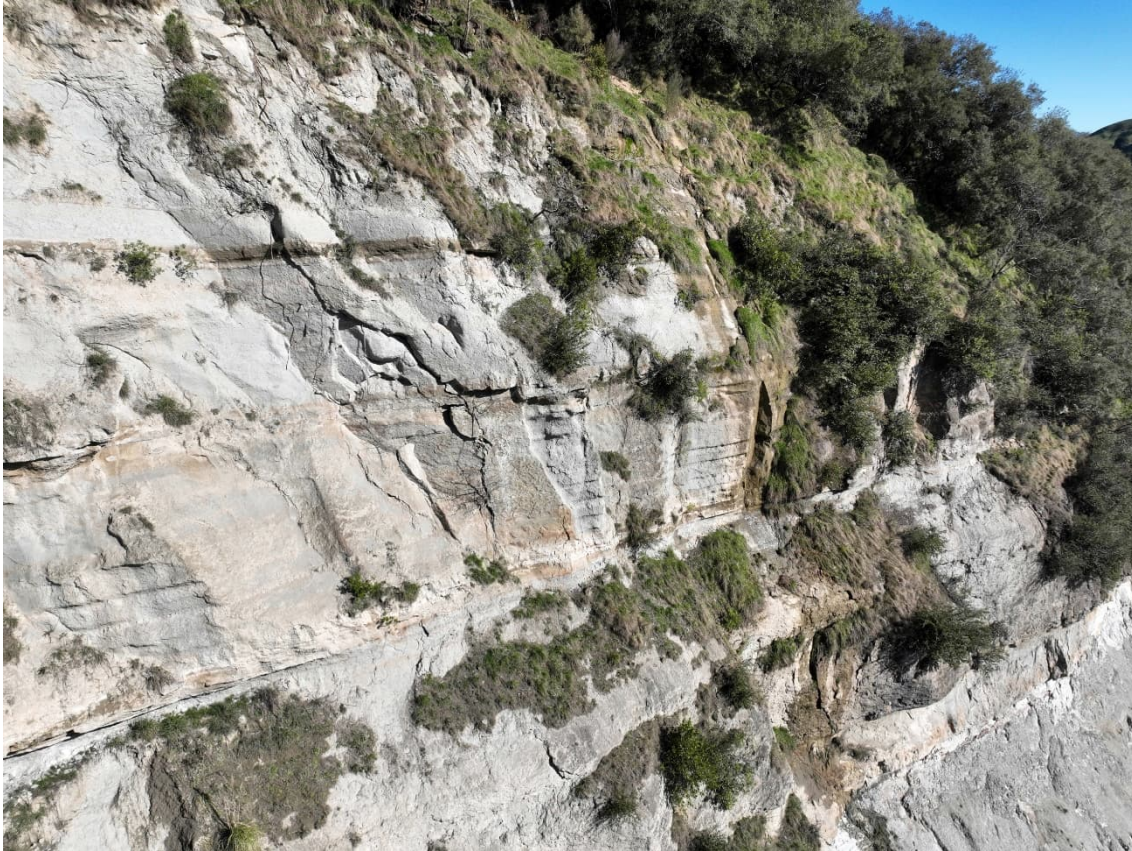
- Cracks through and above two of the unstable blocks have dilated further and new cracks were observed in the surrounding rock mass (refer Figure 6). Apertures within the dilated joints are in the order of 100mm to 200mm suggesting a release of rock from the face is imminent.
- Seepage across Bluff 3 has decreased significantly.

Figure 6: Dilated cracks and defects through and surrounding an unstable block.

We recommend Option 2c, the attenuator/hybrid fence, for the mitigation of Bluff 3 due to the relatively favourable balance between cost, residual risk and resilience.
