Gisborne District Council  
P.O. Box 767  
GISBORNE

## **Wainui Beach Management Strategy - Review**

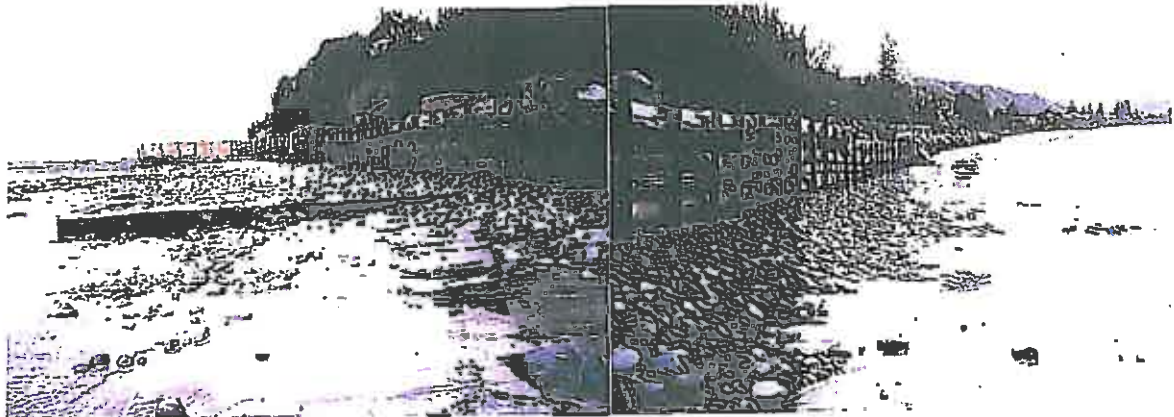
Log-piled walls shown in Photo 1 (see Appendix B) with rock behind, were only visible at the Tuahine Crescent beach access on the day of our site visit. The piles are old steel railway irons which we understand are severely corroded in places. The WBMS describes them as "ugly and becoming dangerous as they break up, leaving jagged edges". As can be seen from the photographs there is a large quantity of rock placed behind the log-piled wall extending back to the current extent of the shoreline.

The railway irons protrude above the logs and when the sand level approximately matches the level of the top log the railway iron and the steel ties between them are a hazard to beach users. When the sand level is low the vertical exposed face of the log wall reflects wave energy and causes increase sand undercutting in front of the wall lowering the beach levels. When the sand is low the extent of the rock behind the log wall occupies a large area of beach adjacent to the cliff backshore.

When the sand is low with these walls partially exposed the protruding rail irons represent a significant danger to swimmers and board riders. At mid to high tide levels with waves breaking over these structures and washing up the rock revetments swimmers or board riders caught in this area could be seriously injured. We therefore recommend all walls with vertical rail irons protruding above the surrounding structures should be removed with high priority.

Photo 1: Log-pile wall with rock revetment behind, with beach levels low

We recommend all existing vertical rail iron be removed from all structures on the beach to improve health and safety risks to beach users, and to improve the visual amenity of the beach when beach levels are low. Existing strategies should be strengthened to include removal of all vertical rail irons as priority works, as Council finances permit. This will require reconstruction of a number of existing structures as anticipated in the WBMS.

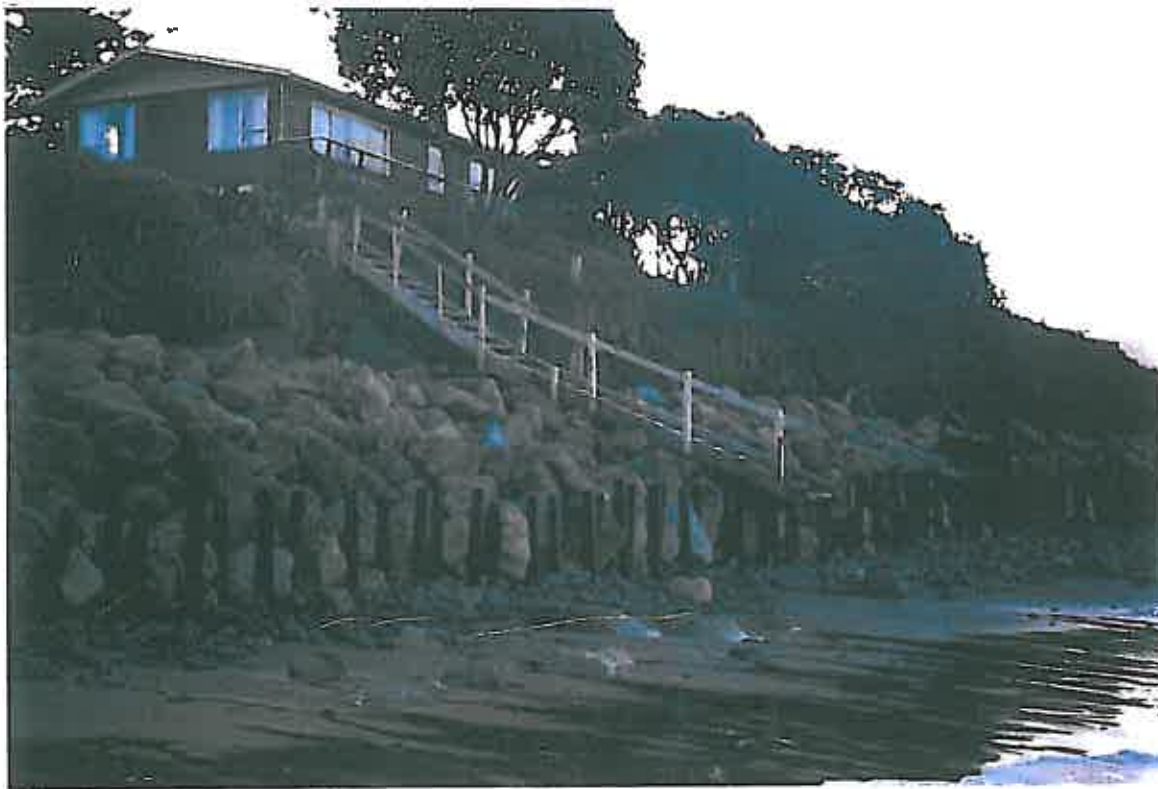
Photo 2: Rock revetment with rail on top, with beach levels low

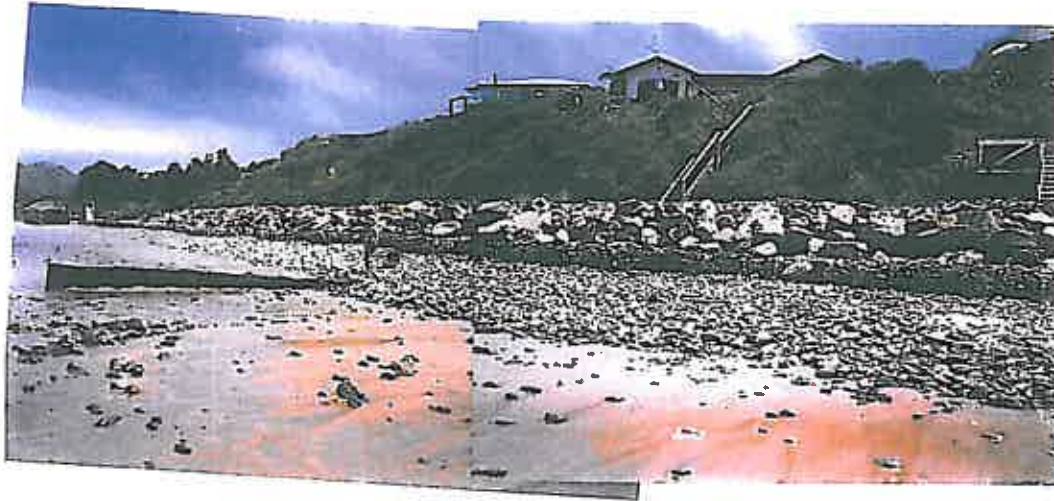
The main problem with the type of construction is the hazard the railway irons present when sand is low, and the short term deterioration of the gabions which are protecting the revetment toe. If they fail the revetment could slide and unravel. Due to the Health and Safety risk to beach users (both swimmers and pedestrians), we recommend these walls be replaced with high priority.

Photo 3: Rock revetment with gabion and rail ion toe, with beach levels low

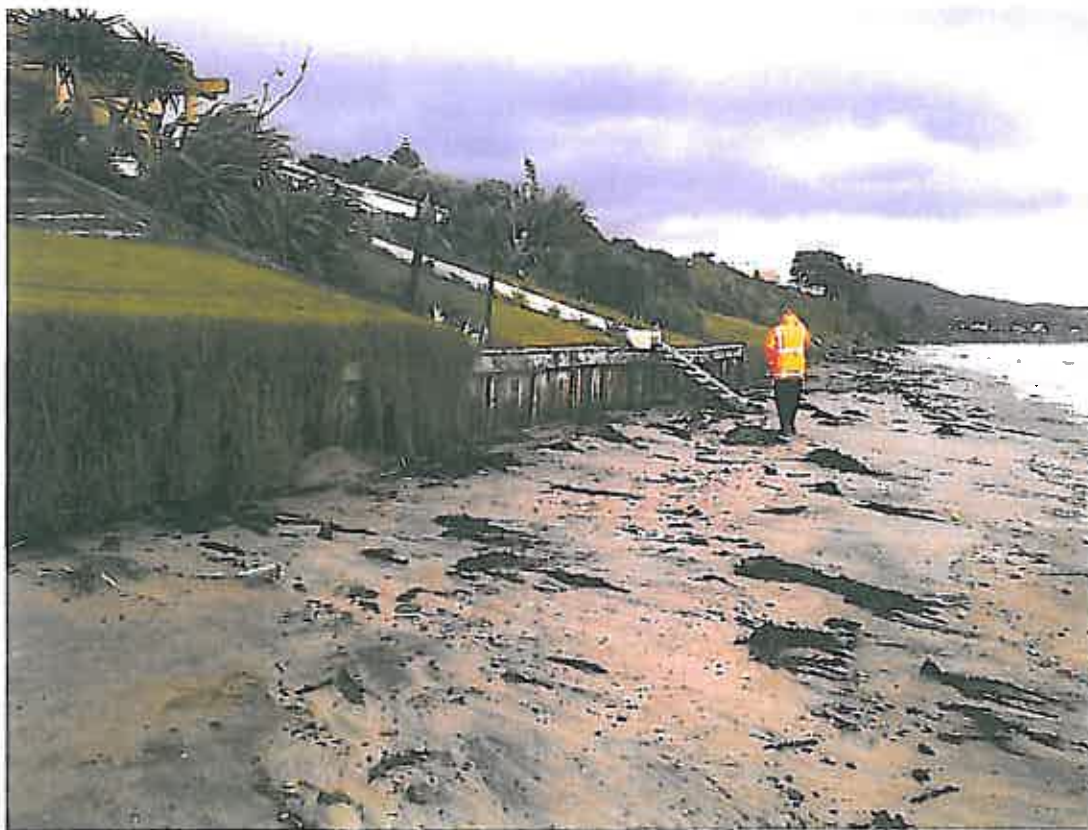
Photo 4: Timber wall with buried gabions toe, with beach levels high

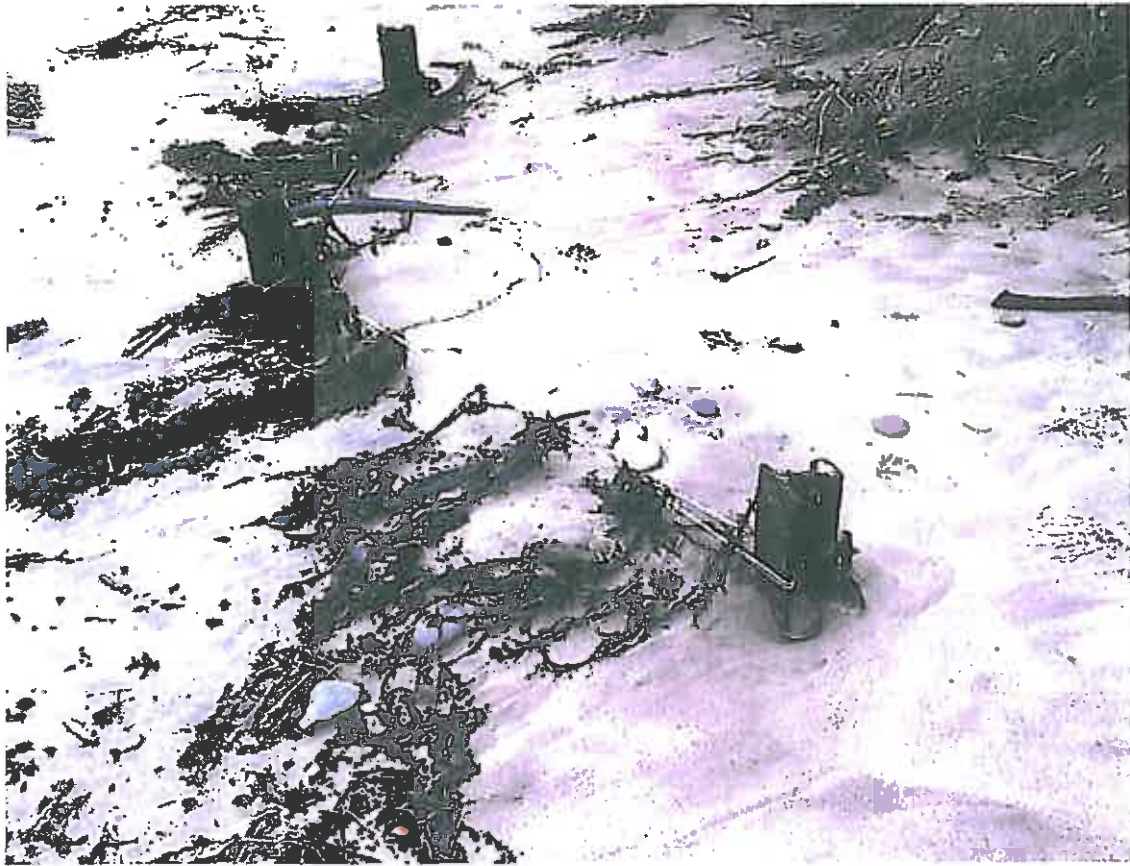
Photo 5: Railway lons trip hazard, beach levels high

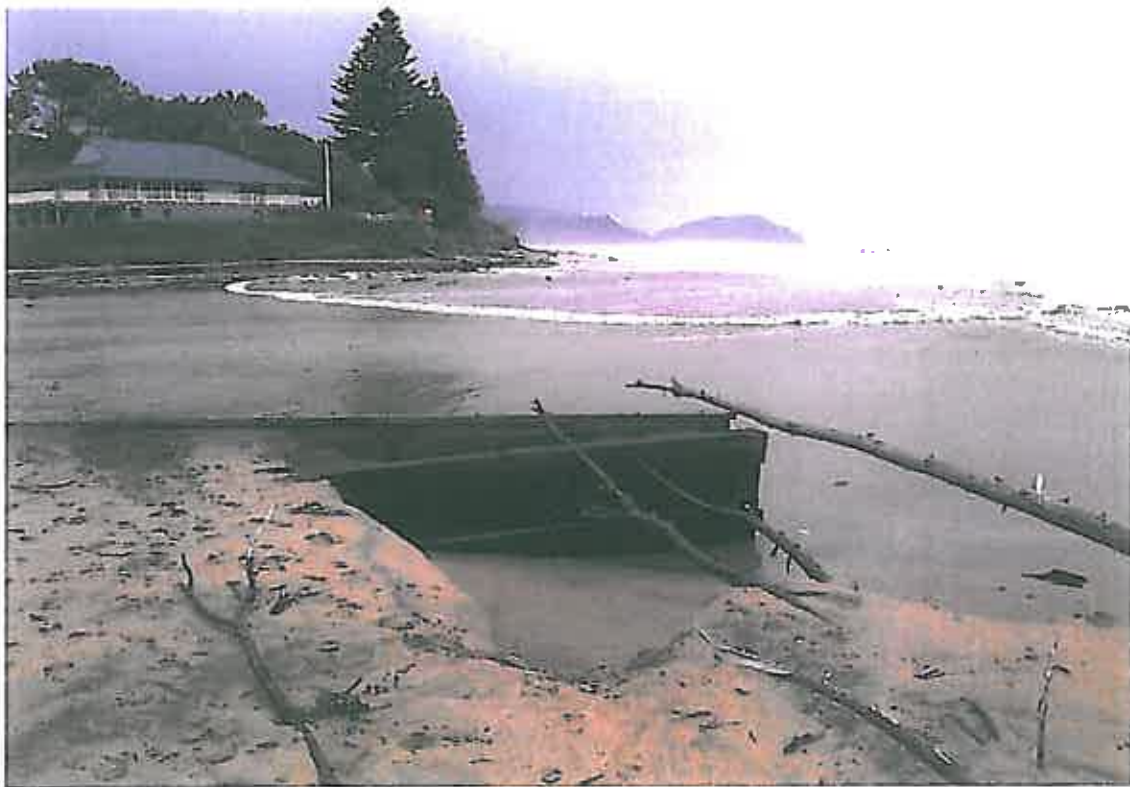
There is a large timber groyne on the southern side of Hamanatua Stream which assists in guiding the stream toward the sea and prevents it meandering southward and eroding the incipient dune. The seaward end of this groyne is shown in Photo 6. A full inspection of this groyne wasn't possible due to tide and wave conditions, however this groyne is a significant structure in assisting the growth of the incipient dune to its south. Its condition should be monitored and a full inspection of the condition of the timber should be made with the view to programming maintenance of the structure and possible replacement when maintenance is no longer economic.

Photo 6: Groyne at Hamanatua Stream

Groyne no. 1 on the southern side of Hamanatua Stream is an important structure for protecting the incipient dune south of the groyne. The groyne’s condition should be monitored and maintenance of

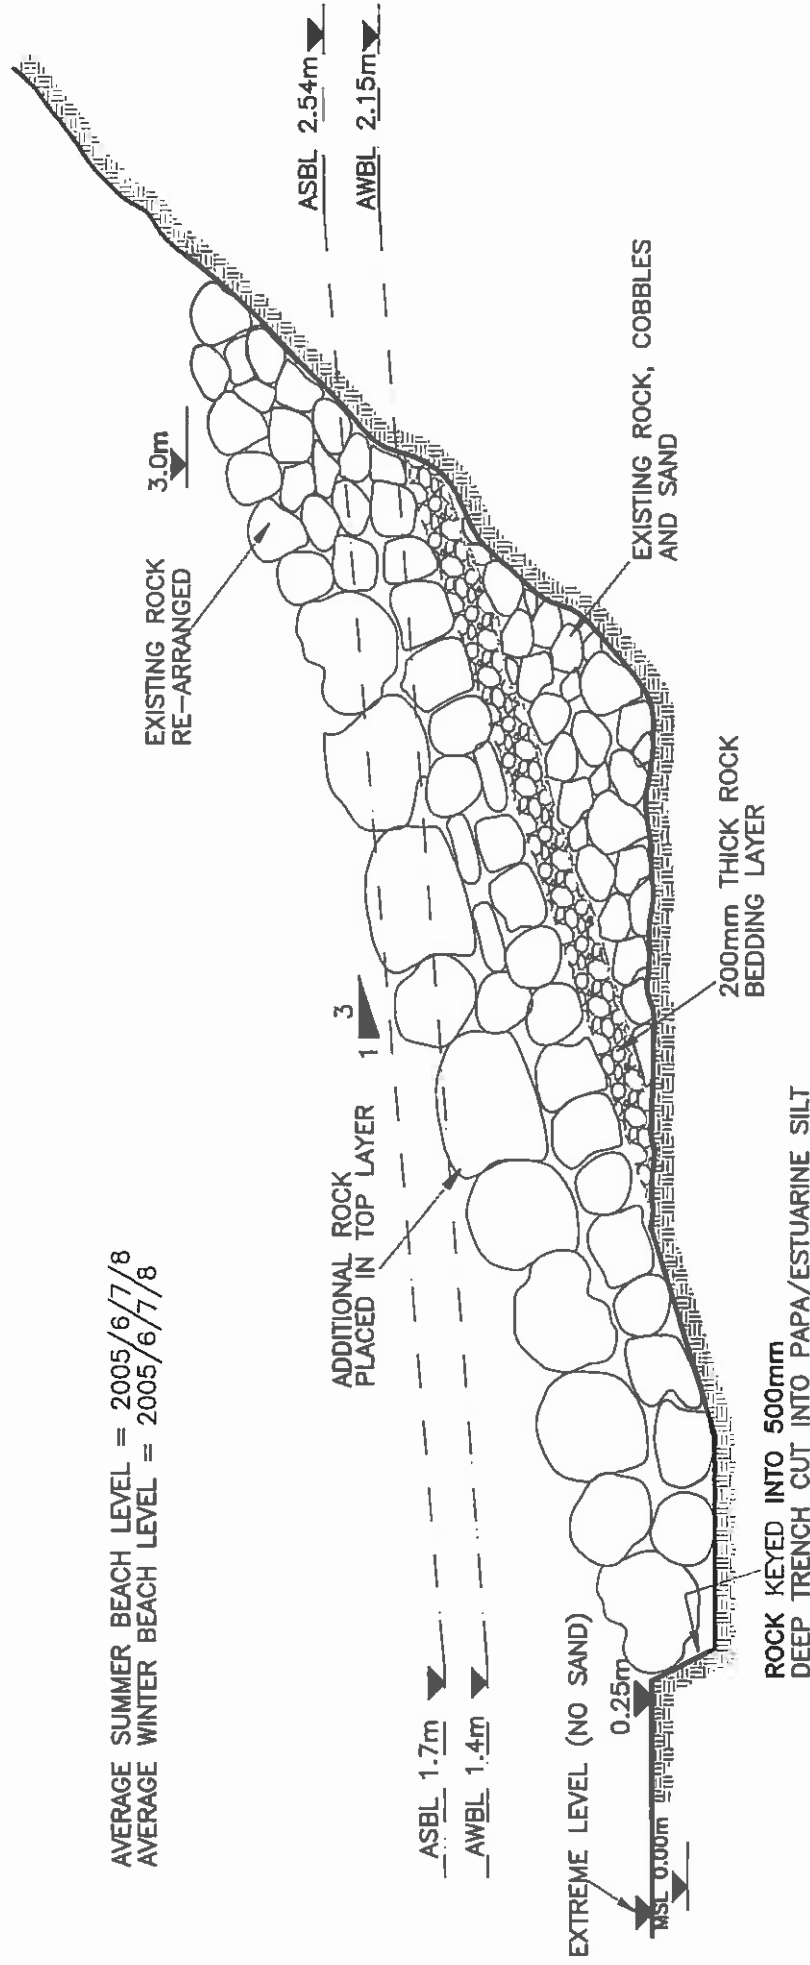
<b>GISBORNE DISTRICT COUNCIL</b>	<b>CONCRETE GROUYNE 28 TO WAINUI STREAM          PROPOSED SLOPING ROCK REVETMENT          TYPICAL SECTION</b>				SCALE : 1:50	TRACED	PLAN NUMBER
	DESIGNED	R.BUDD	10/09				<b>EW300-2</b>
	DRAWN	D.HEMM	10/09

The new sloping rock revetment should be suitably designed, and we note that the existing proposed design has some limitations. These are discussed in Section 6 of this report, and we also note that the design was questioned by the Resource Consent Commissioners in the recent consent hearing.

Generally we agree with the solutions proposed in the WBMS for beach sections 2 and 3, however the currently proposed sloping rock revetment design needs to be modified to include the details discussed in Section 6.1 above. We have not completed a detailed design of the revetment but recommend that this be done together with a detailed assessment of near-shore wave climate, allowing for predicted sea level rise, prior to finalising the preferred revetment design.
