Analysis of landslide events in the Wakaroa and Makiri Forests, and adjacent areas

This report forms two parts. Firstly it provides a spatial analysis of the number and distribution of landslides within the study area, and secondly an analysis of the types of failures and the mechanisms driving the failures.

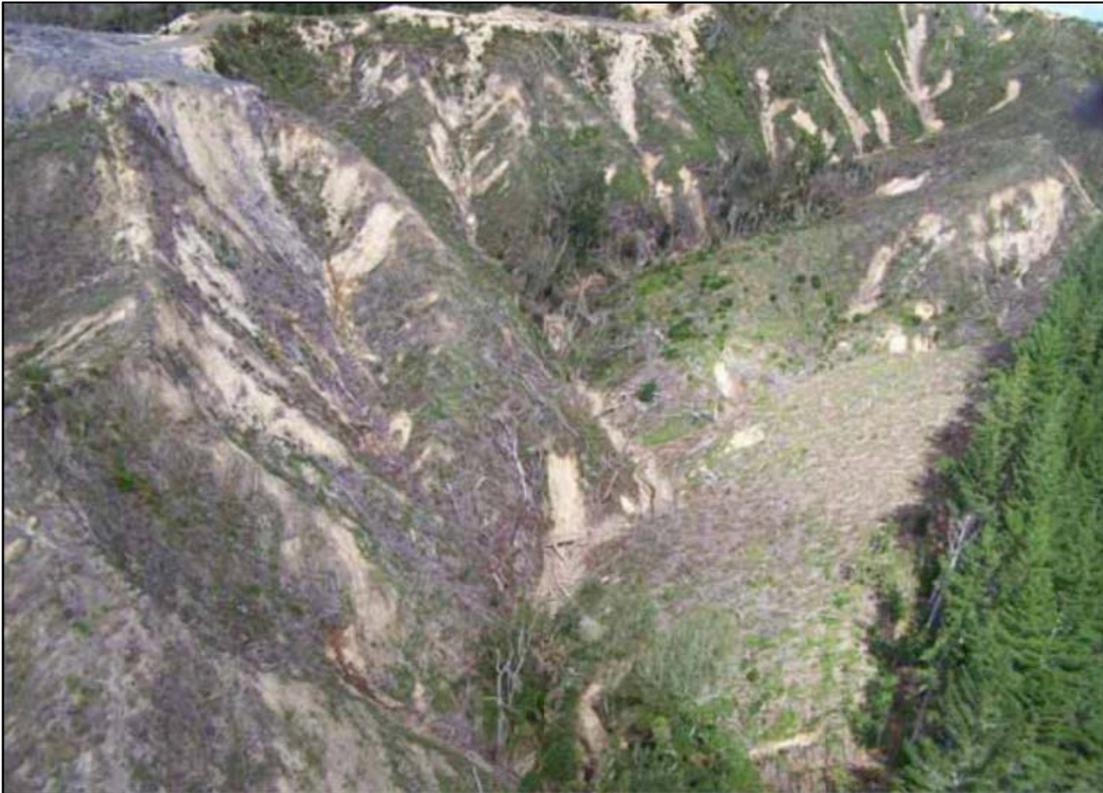
Photo 1: Typical mid slope failure in the lower Whakatane catchment which has light volcanic soils known as Kaharoa ash over lapilli.

Figure Twenty Two. Reproduction of Photo 1 from Douglas et al (2011) showing what is described as mid slope failure but also showing significant toe and ridgeline failures associated with infrastructure.

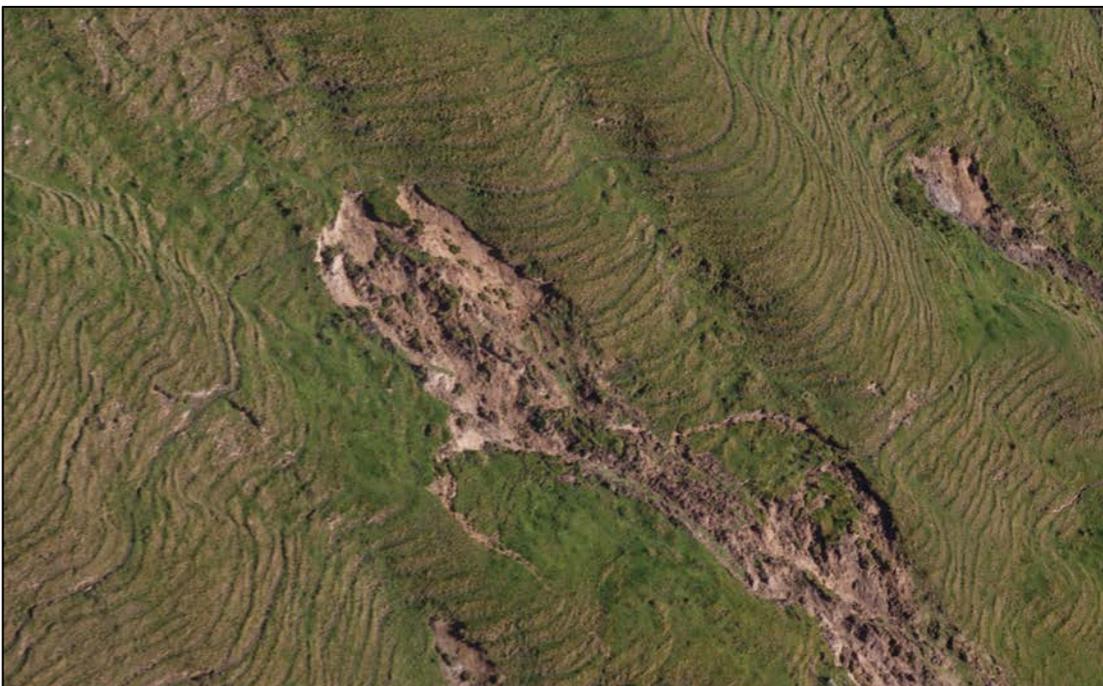
Figure Twenty Three. Example of mid slope landslides on farmland, Te Arai Valley, July 2018. Mid slopes can be identified by the lack of connection to either streams at the toe or infrastructure on ridgelines (Photo GNS).

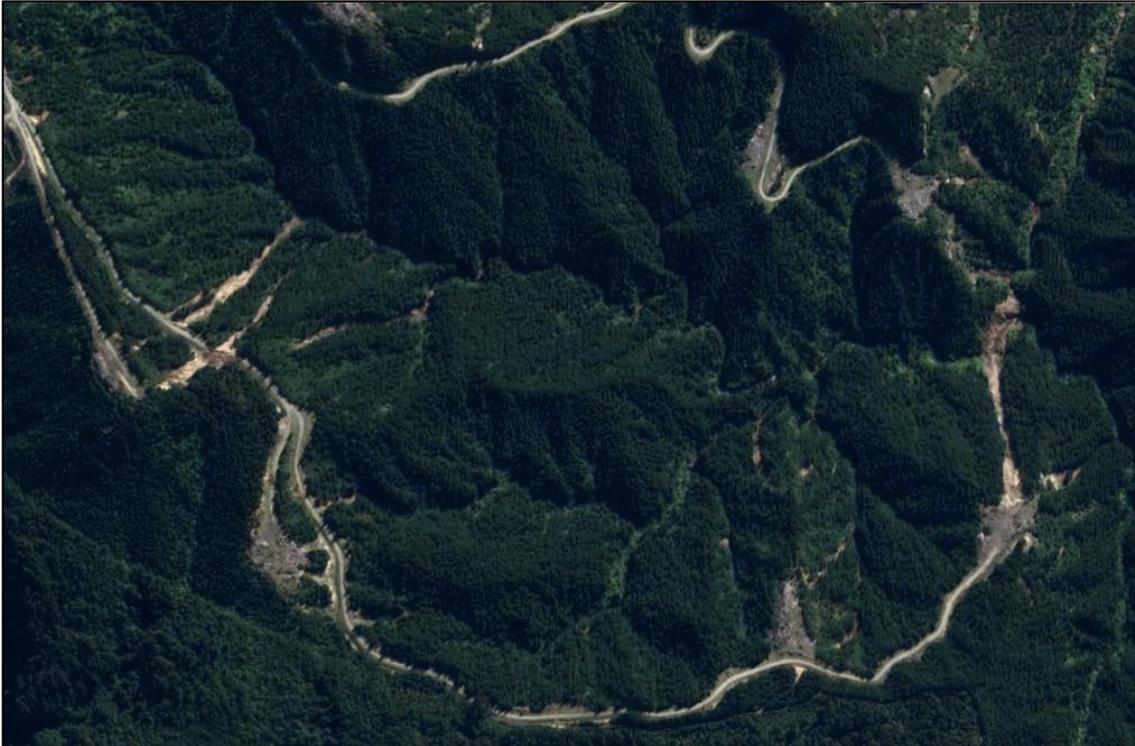
The type of landslide activity arising from the June 2018 storms in closed canopy forest is shown in the satellite imagery below (**Figure Twenty Four**) and detailed in the following figures.

Figure Twenty Four. Typical closed canopy landslide activity visible in the August 2018 satellite imagery and not present in the 2017-18 aerial imagery, northern Wakarua Forest. The landslides are typified by being full ridgetop to valley floor and generally originate from roadways for forestry landings.

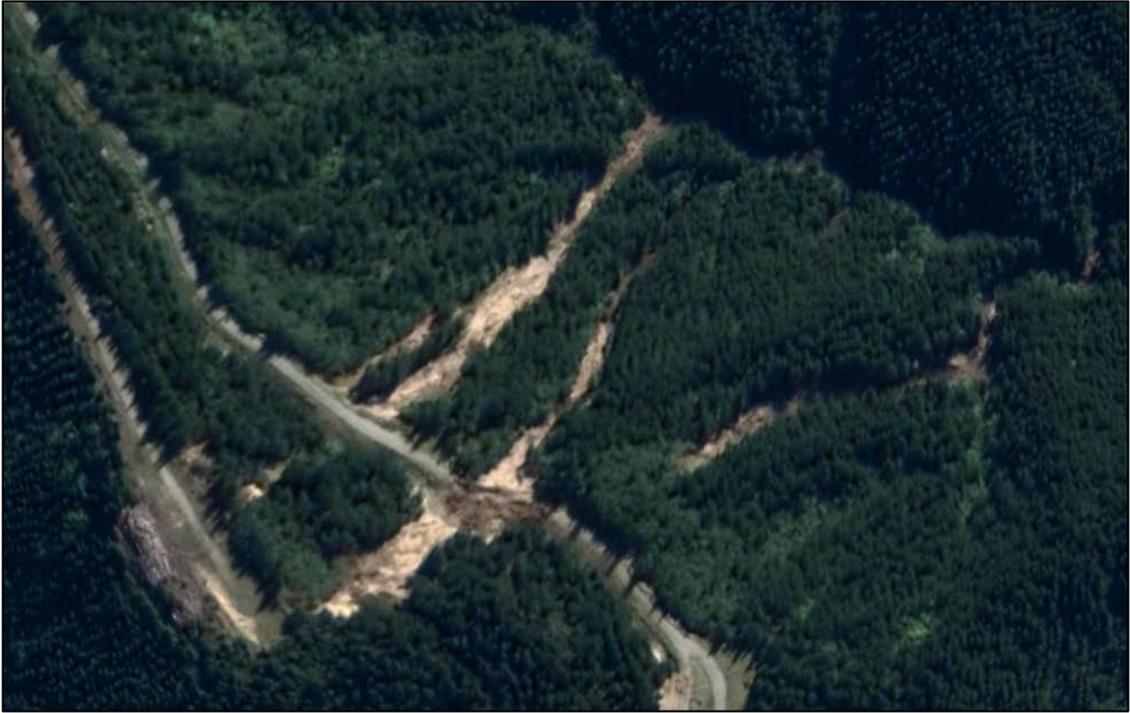
The landslides at the western end of **Figure Twenty Four** are shown in **Figure Twenty Five** below. This shows three landslides originating at a forestry roadway while another occurs at the end of an old skid site. One further landslide may perhaps be classed as a mid slope failure as the headwall is not connected with the roadway above. The toe of this landslide is at river level downstream of the other landslides, however, and a toe failure is more likely.

Figure Twenty Five. Landslides in closed canopy forest associated with forestry roads.

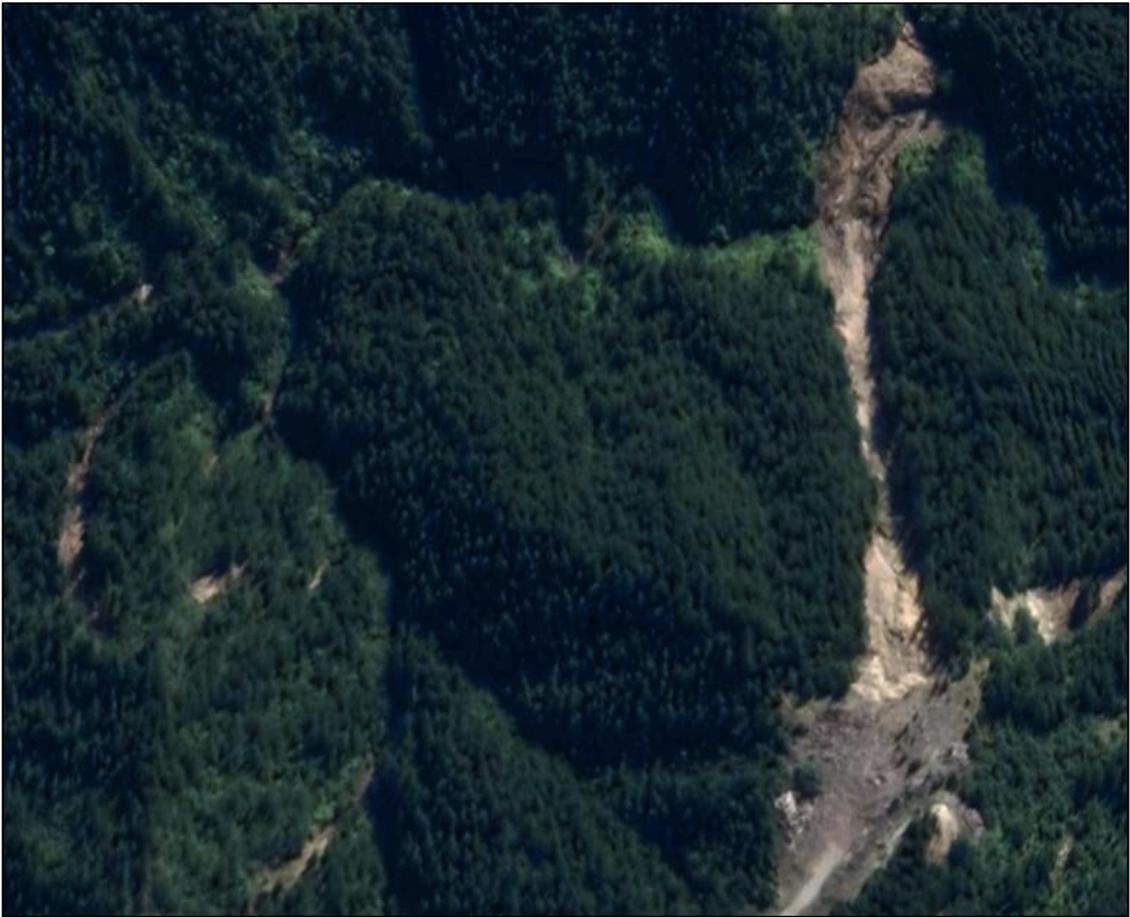
Landslides at the eastern end of **Figure Twenty Four** are shown in **Figure Twenty Six** below. There are a number of small slips occurring on the middle of slopes below a ridgeline disconnected with any infrastructure. The most significant landslide, however, is clearly associated with the collapse of a skid site

Figure Twenty Six. Minor midslope failures below a ridgeline (left) and a significant landslide resulting from the collapse of a forestry landing.

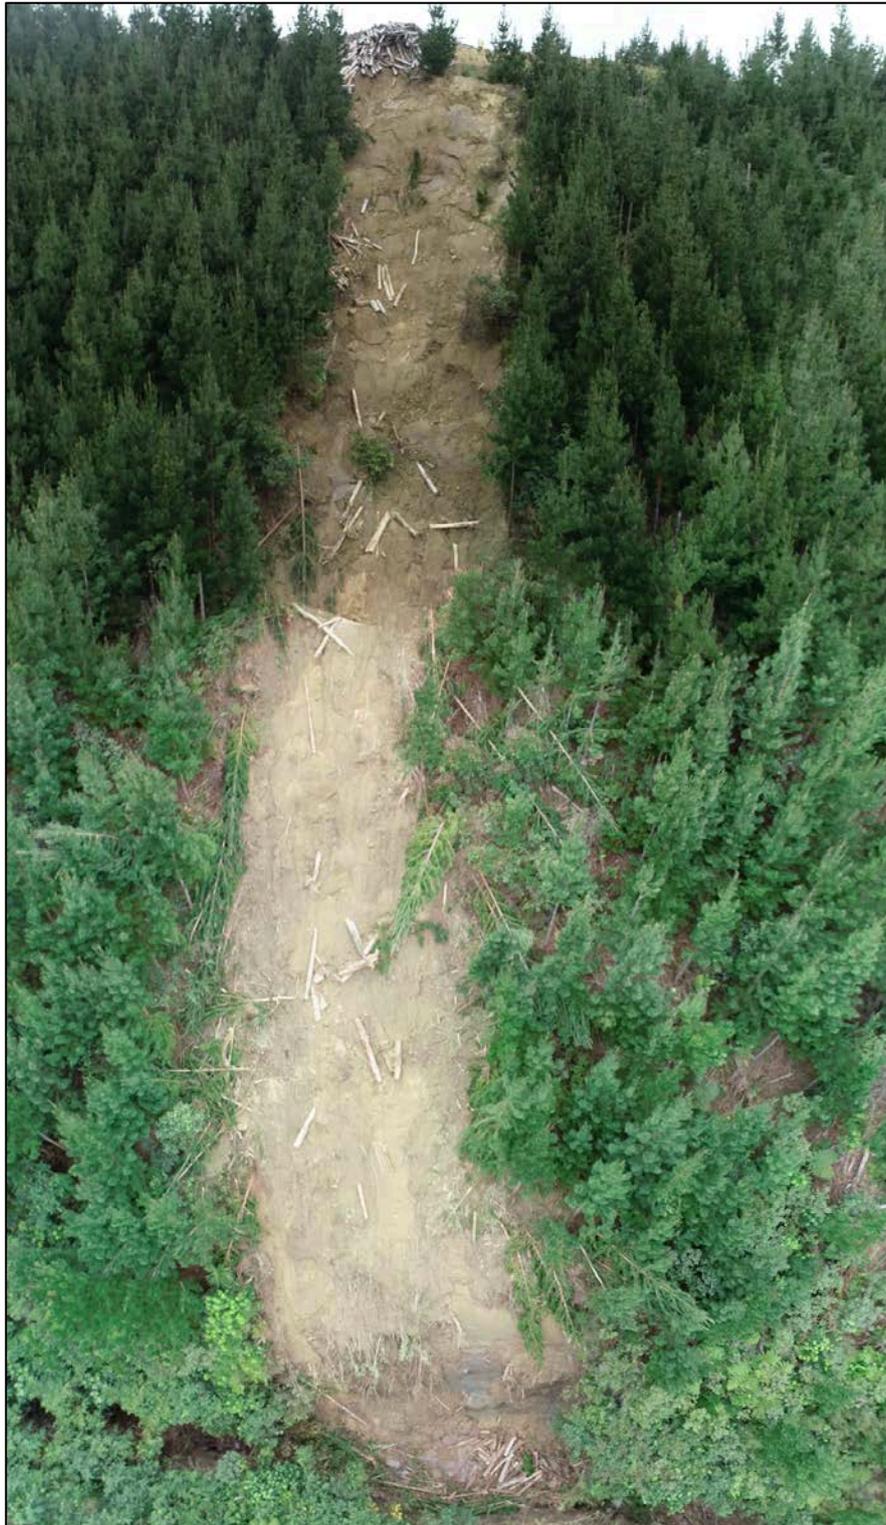
A largely closed canopy debris flow failure has been examined in some detail at Site 3 (GDC reference) on Woolshed Road (**Figure Twenty Seven**). This landslide is described in some detail in Cave (2018c) which noted the role of poor drainage design and loading of the landing edge as causes of the failure.

Figure Twenty Seven. Composite image (drone video screenshots) of the western side of Site Two debris flow from the headscarp to the toe of the slope in a deeply incised gorge in a tributary of Mangahouku Stream.

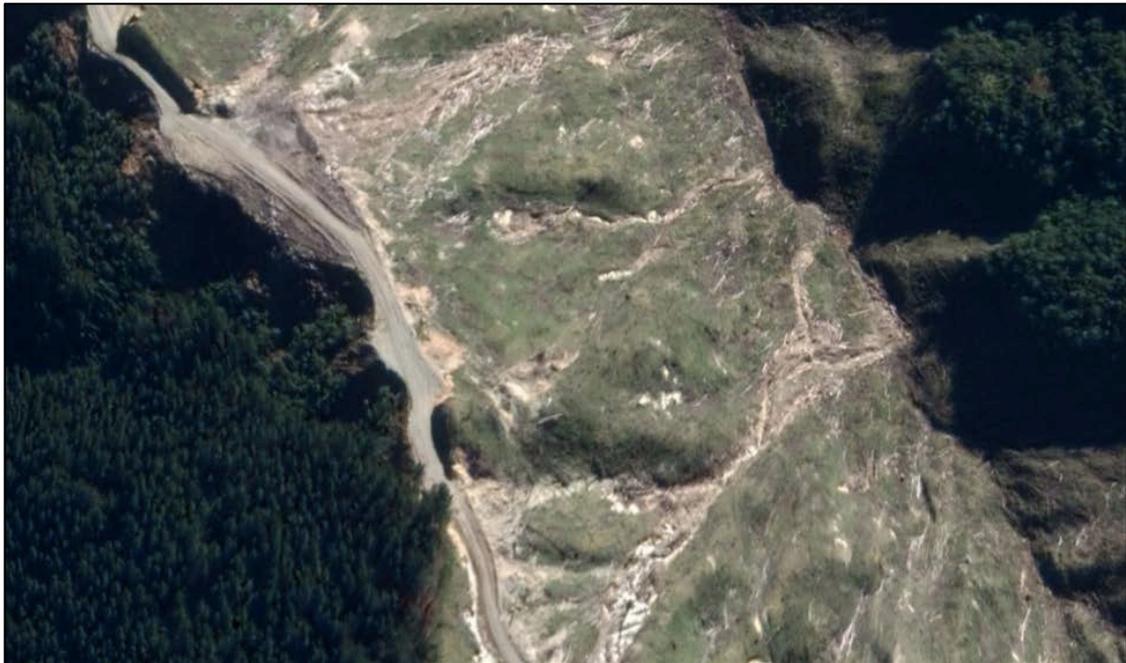
The landslide activity arising from the June 2018 storms in recently harvested forest were typically debris flows originating from skid sites, forestry roadways or as a result of toe failure. This area was extensively assessed on the ground as well as by drone and helicopter(**Figure Twenty Eight**). This figure shows a series of landing collapses in Makiri Forest and **Figure Twenty Nine** shows the on-ground down-slope view of the eastern side of the failure at Landing 8 shown in the top of **Figure Twenty Eight**.

Figure Twenty Eight. *Satellite imagery August 2018 showing the post-storm event landslide activity with failures occurring at roadways and landings. The landing collapse at top (Landing 8) is shown in **Figure Twenty Nine** below.*

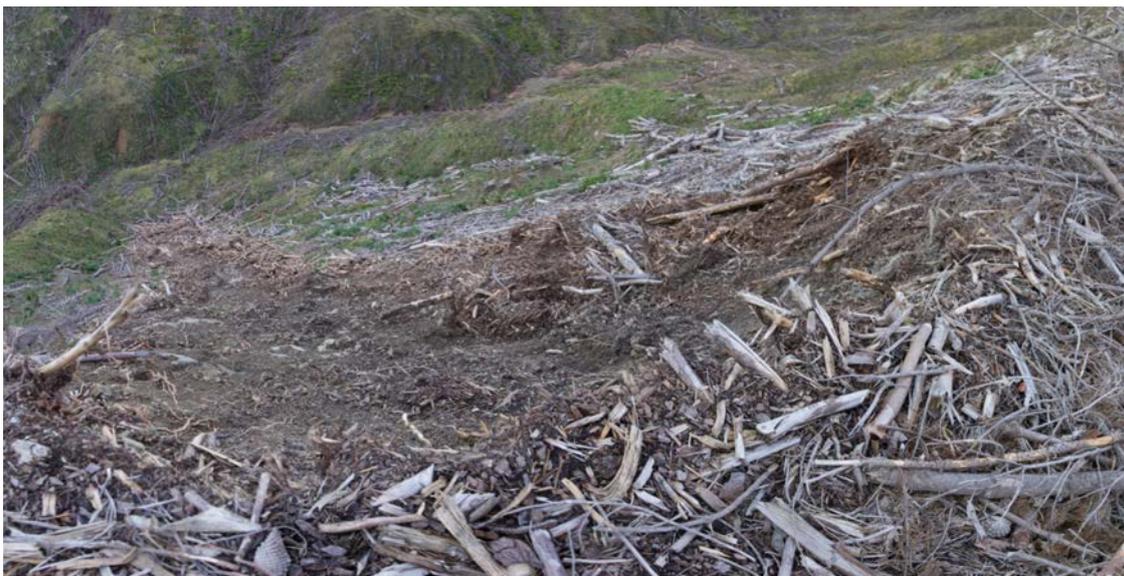
Figure Twenty Nine. *Photo of the landing collapse shown at the top of **Figure Twenty Seven**. The landing collapse has generated a debris flow with an obvious levee on the righthand side.*

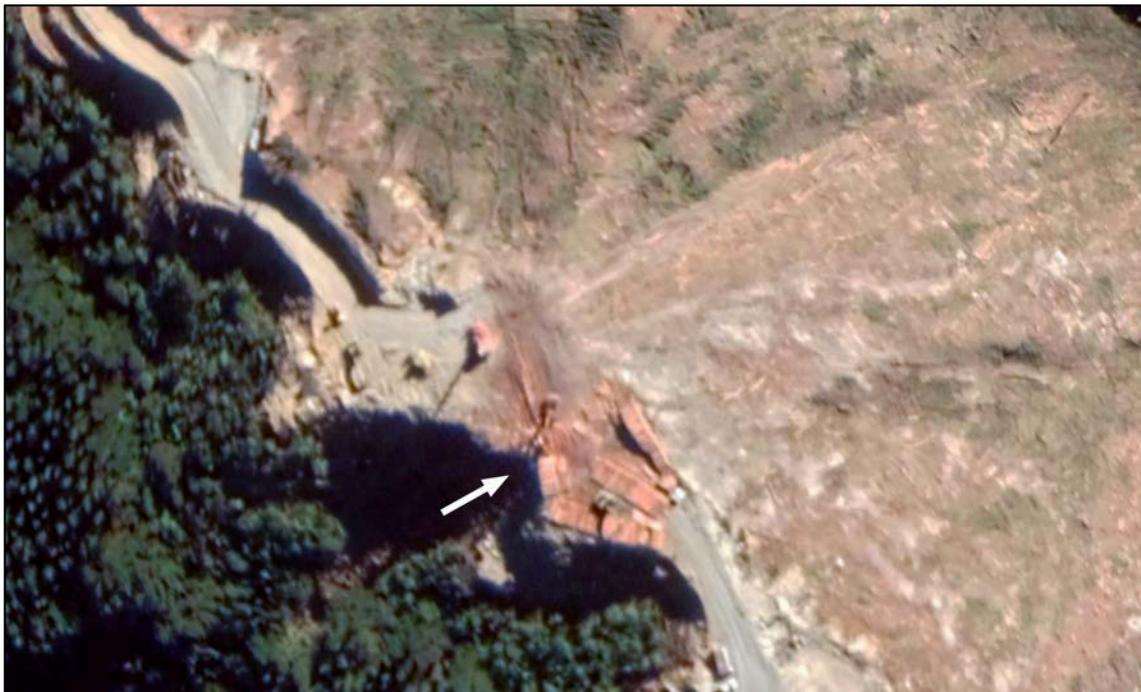
A series of satellite images have been used to further assess the slope failures at Landing 8 in Makiri Forest. The site was being actively used in August 2017 and Figure Thirty shows the shape of the landing and the activity underway at 17th August 2017.

Figure Thirty. View of Landing 8 in Makiri Forest dated 17th August 2017. A key feature of this image is the right angle bend on the south western edge of the landing (arrowed) along with the confined state of the landing with logs stacked along both the south western and north eastern edge of the landing.

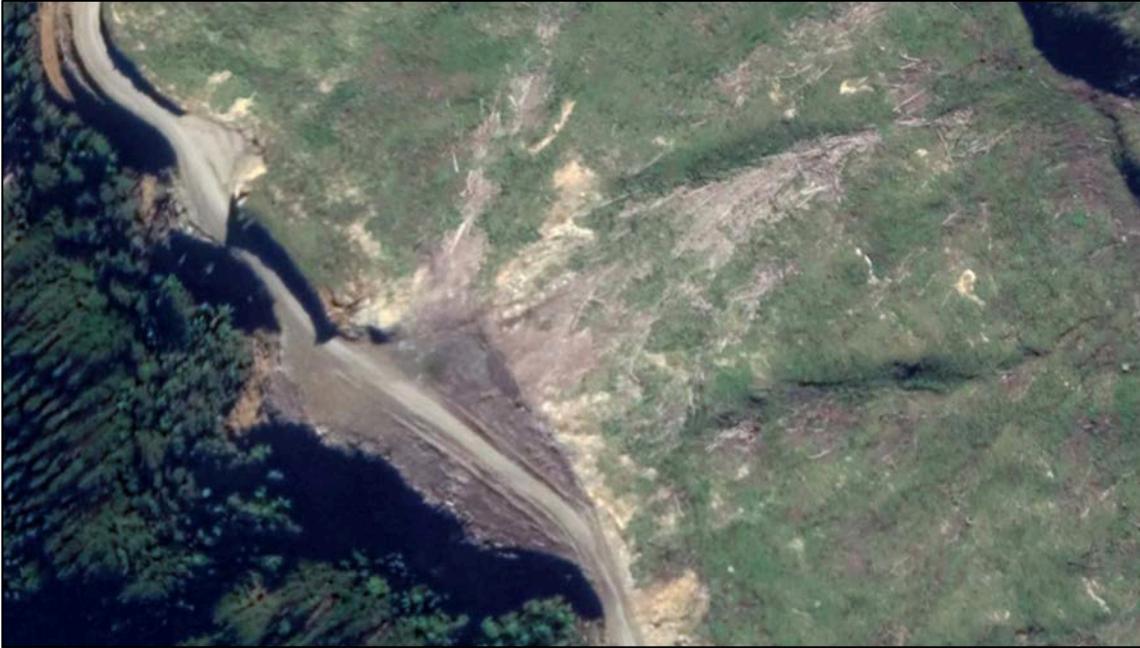
A further satellite image of Landing 8 is available for the 17th of May 2017 shortly before the Queens Birthday storms. By this stage operations at the site had been completed but notably the obvious right angle bend noted in **Figure Thirty** is absent. Also notable is the presence of significant harvest residues and some a failure of the edge of the landing on the north eastern side of the landing (**Figure Thirty One**).

Figure Thirty One. View of landing 8 Makiri Forest dated 17th May 2018 showing the change in edge shape on the southern western side, and the harvest waste and landing collapse on the north eastern side.

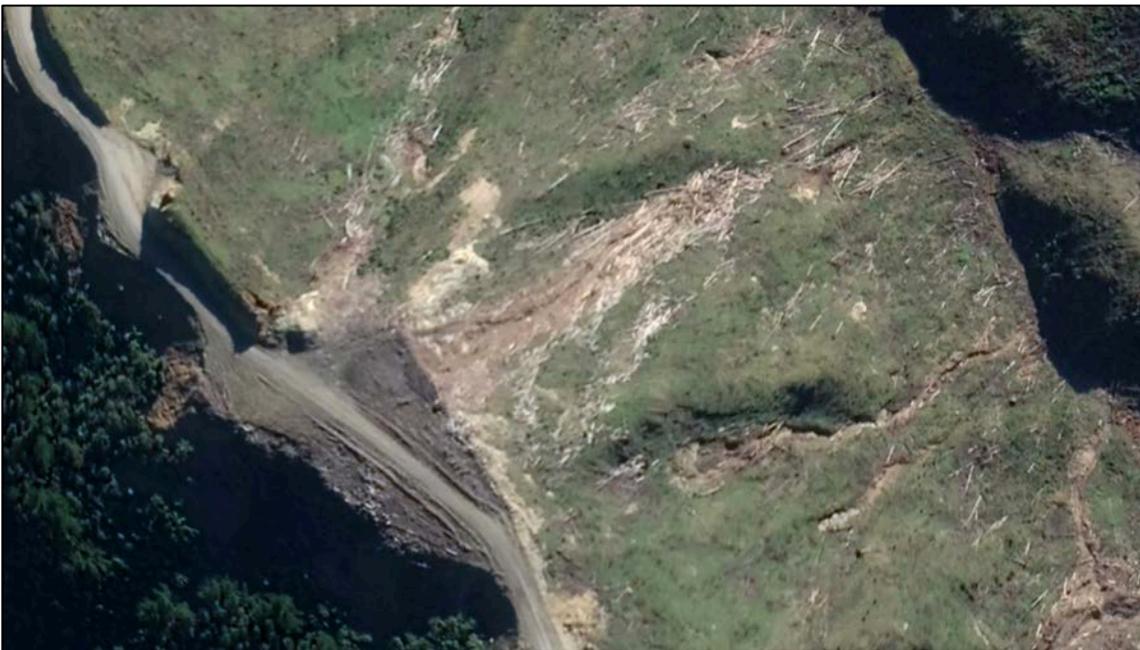
Satellite imagery is also available from shortly after the Queens Birthday storms (13th July 2018) showing the changes that occurred at Landing 8 since May 2018 (**Figure Thirty Two**). This shows a pronounced tension crack at the northern end of the south western side of the landing and a more extensive failure of the landing on the north eastern side (see also Figure **Twenty Nine**) but any changes to the south western edge are otherwise subtle at the scale shown in the imagery.

Figure Thirty Two. View of landing 8 Makiri Forest dated 13th June 2018 showing only subtle changes in edge shape on the southern western side, and the more extensive harvest waste and landing collapse on the north eastern side.

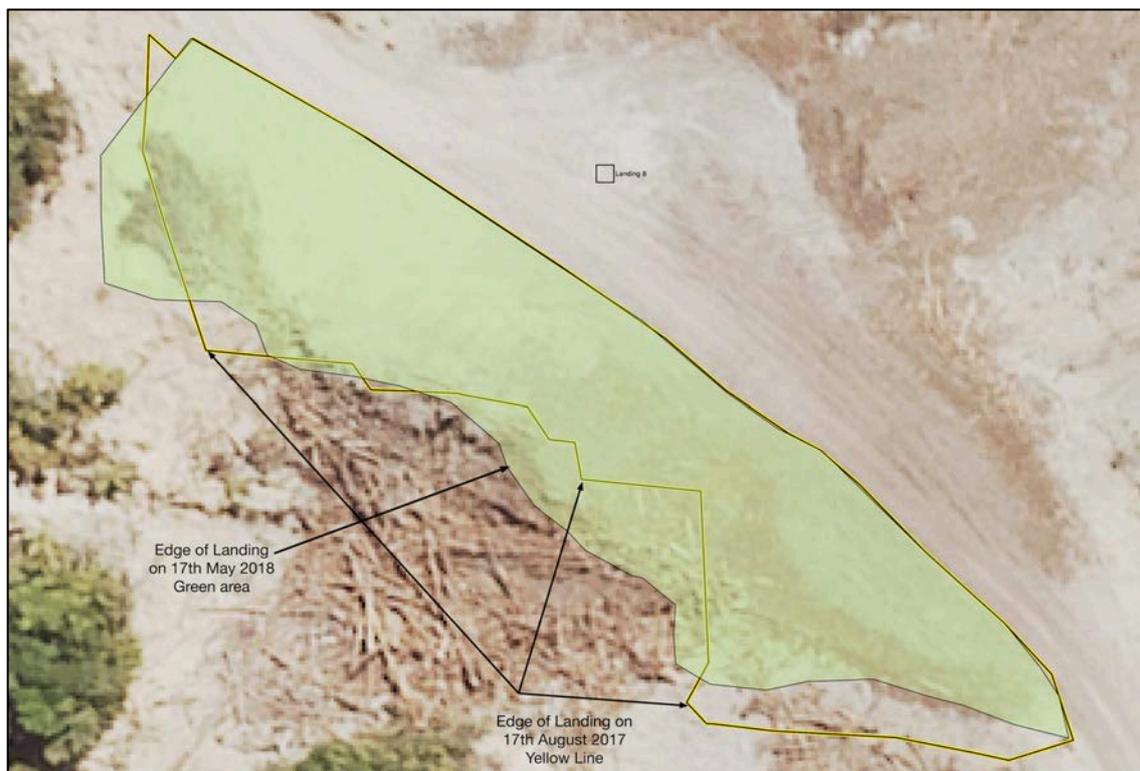
Figure Thirty Three A. The digitised edge of Landing 8 dated 17th of August 2017 (yellow) compared with the landing edge on the 17th of May 2018 showing where the landing has been extended out over harvest waste (green).

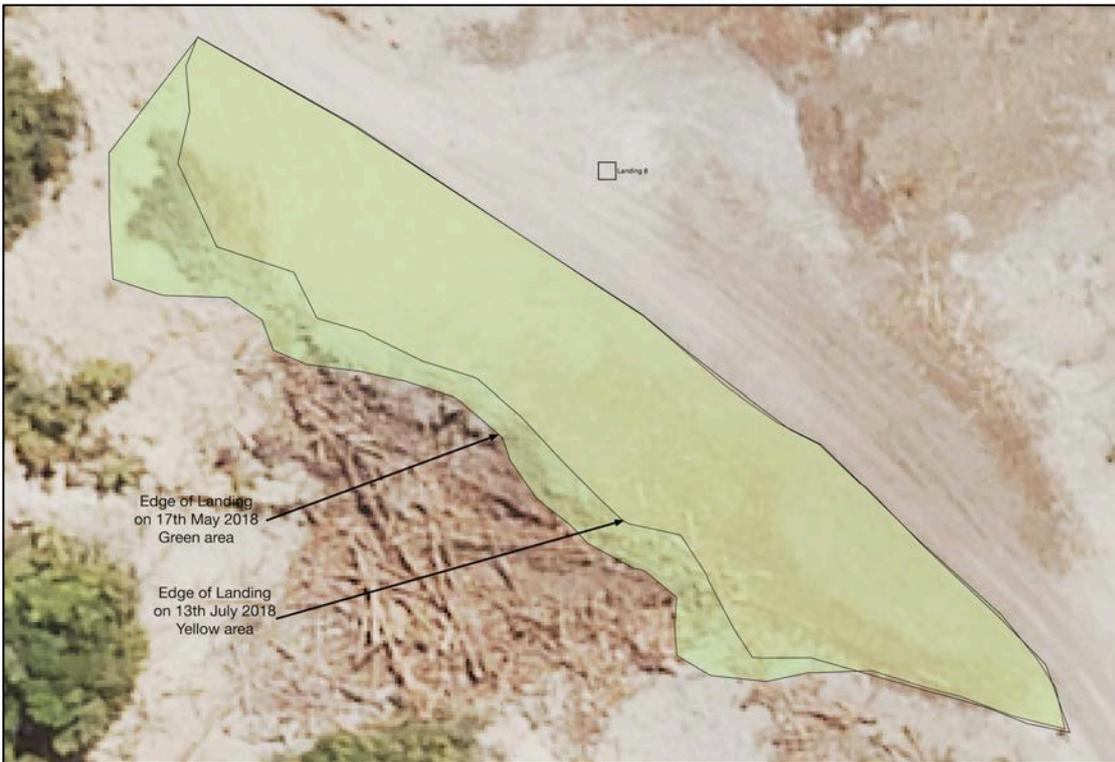
The change between the 17th of May 2018 and the 13th of July 2018 is shown in **Figure Thirty Three B**. This shows that the edge of the landing has retreated by an average 4.9 metres between May and July 2018.

Figure Thirty Three B. The digitised edge of Landing 8 dated 17th of May 2018 (green) compared with the landing edge on the 13th of July 2018 (pale yellow) showing that the landing has retreated by an average of 5 metres.

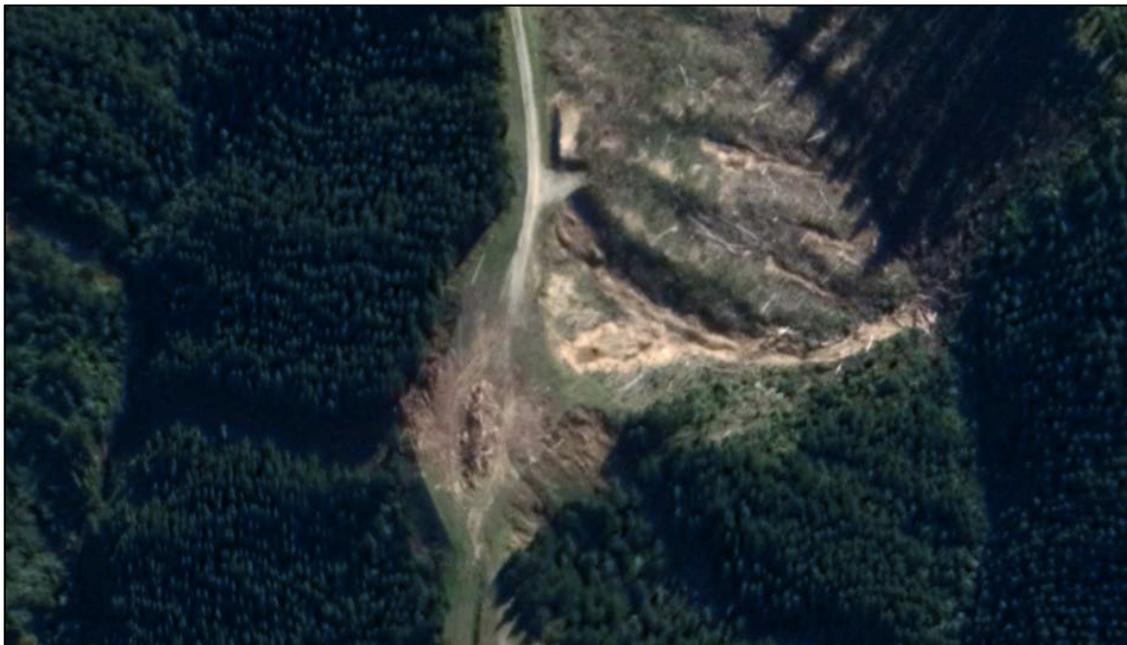
Figure Thirty Four. Landslide activity at site 3 Woolshed road, Wakaroa Forest showing a translational landslide (left hand side) in full canopy forest resulting from a birdsnest collapse while the right hand side shows a debris flow that resulted from water being directed from the landing across sidecast material.

On the right hand side of **Figure Thirty Four** is a translational landslide occurring in full canopy forest and caused by the collapse of the slash birdsnest that had been stowed on the edge of the landing. On the right hand side of **Figure Thirty Four** is a significant debris flow that resulted from drainage channels on the landing directing water onto sidecast material. This debris flow is also shown in **Figure Thirty Five**.

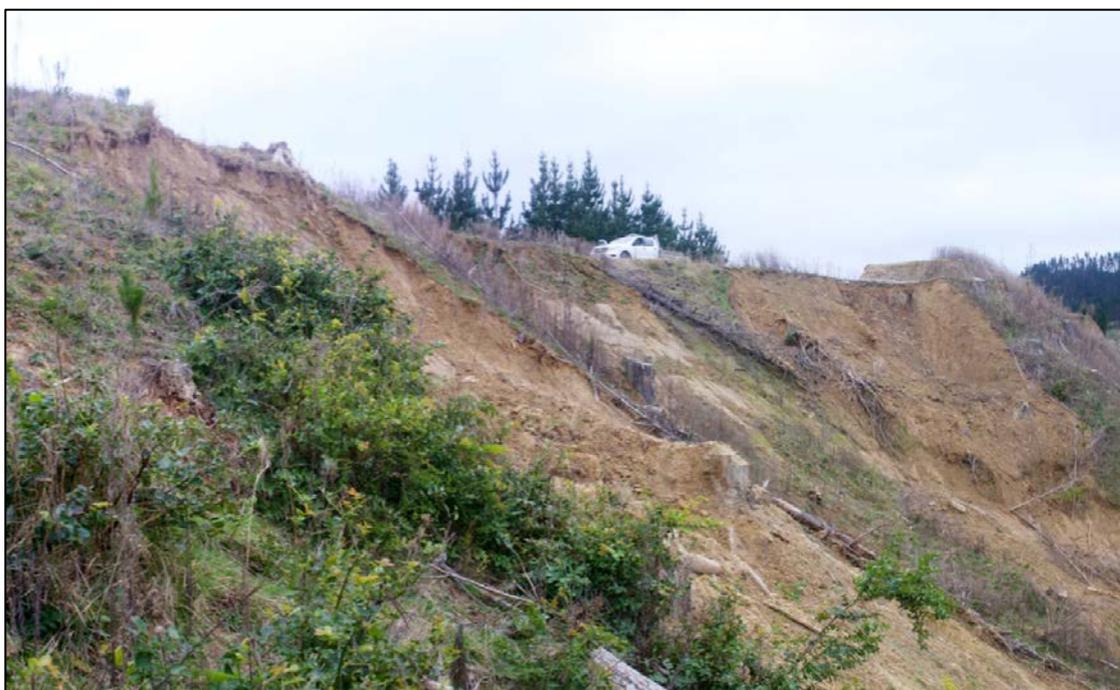
Figure Thirty Five. View of debris flow at site 3, Woolshed Road, Wakaroa Forest

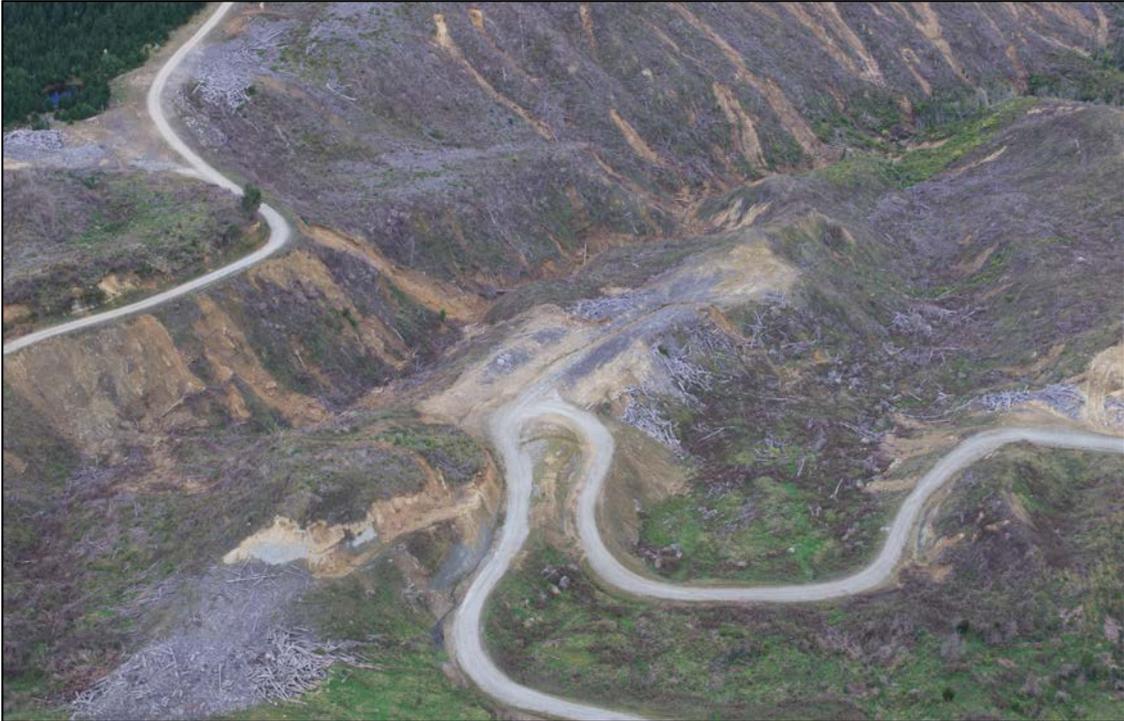
The area in the vicinity of site 11 in Wakaroa Forest is described in detail in Cave (2018c) and is shown in the middle ground of **Figure Thirty Six**. This landing had a large translational landslide resulting from the collapse of a birdsnest stowed on the eastern edge of the landing. This failure then formed a debris flow at its lower end where the initial collapse impacted onto a natural bench.

A feature of this landing was the installation of a longitudinal channel cut through the landing to direct water from the road leading to the landing across the landing. This had the effect of concentrating water on the landing adjacent to a perched birds nest of slash that then failed. **Figure Thirty Six** also shows the nature of the extensive landsliding adjacent to site 11. These are typified by being connected with infrastructure on the ridgelines or with the base of gullies or streams. **Figure Thirty Seven** shows the extensive nature of the scouring within the streambed below Site 11.

Figure Thirty Six. View of Site 11 Wakaroa Forest (Cave 2018c). Evident on this landing is a large grove cut longitudinally from the top to bottom of the landing. This resulted in significant water being concentrated at the birds nest located on the eastern side of the landing. Note the extensive full slope length landsliding connected to roadways and toe failures. It is most likely that the collapse of the landing and the roadways at middle left exacerbated the effect of high stream flow in the creek downstream resulting in a significant number of toe failures.

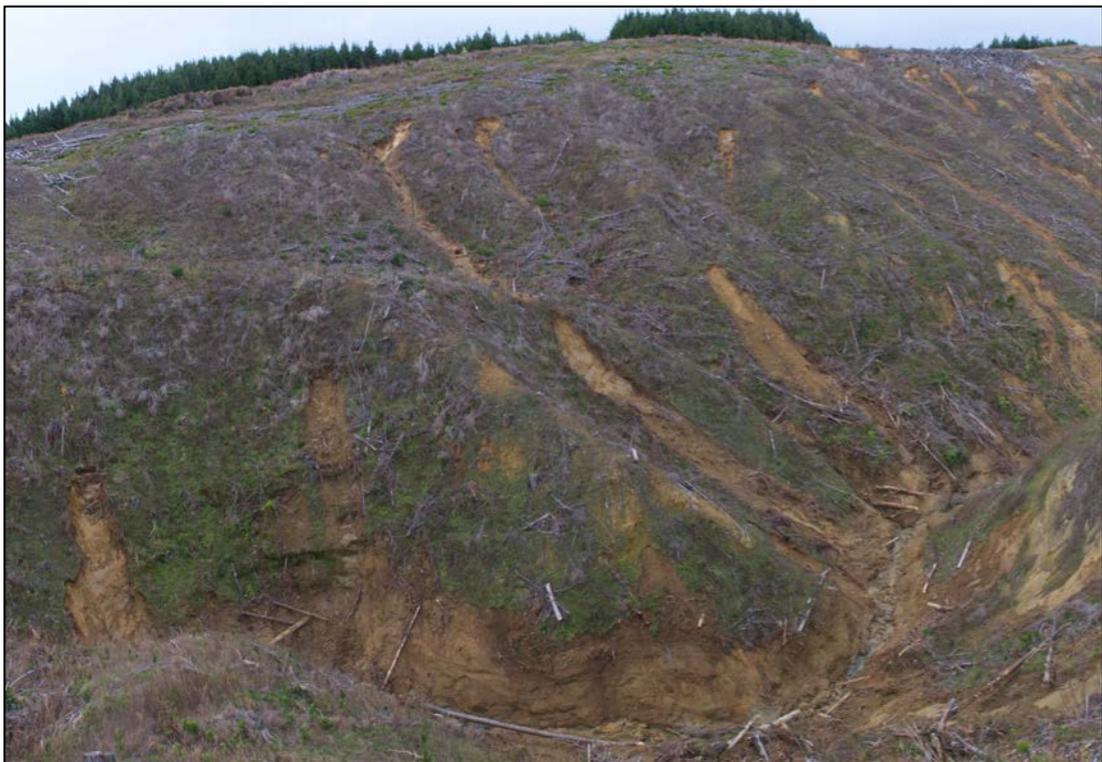
Figure Thirty Seven. Extensive scouring and toe failures in the creek bed below site 11.

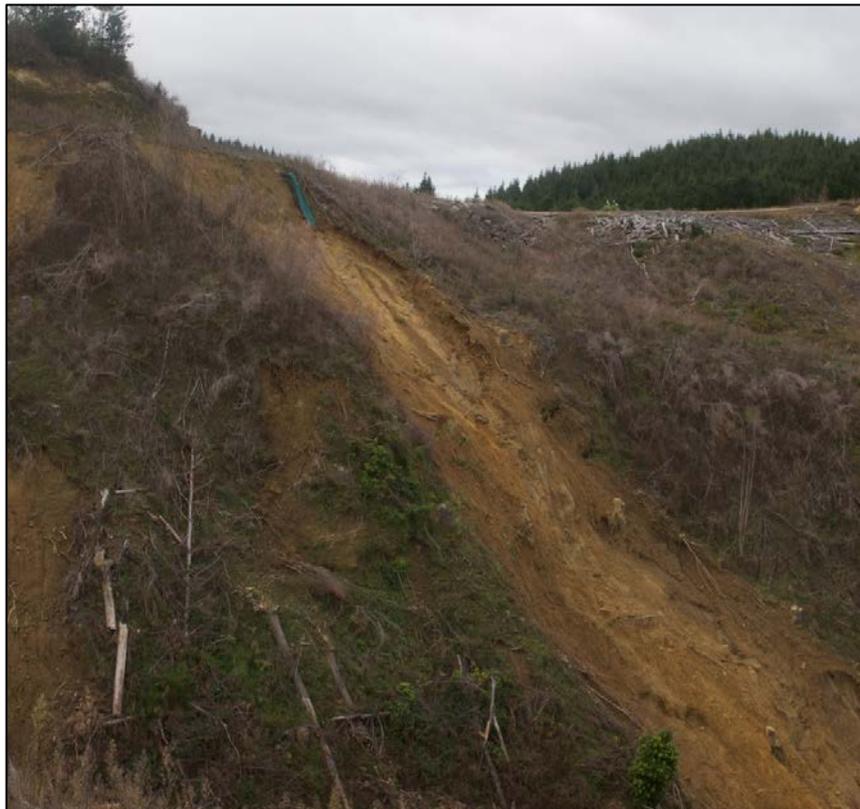
The impact that poor drainage controls can have on slope stability is well demonstrated in **Figure Thirty Seven** below. This shows an debris flow landslide on Bush Road immediately east of site 11 in Wakarua Forest.

Figure Thirty Eight. *Landslide resulting from water from a culvert and short sock being discharged onto a steep slope*

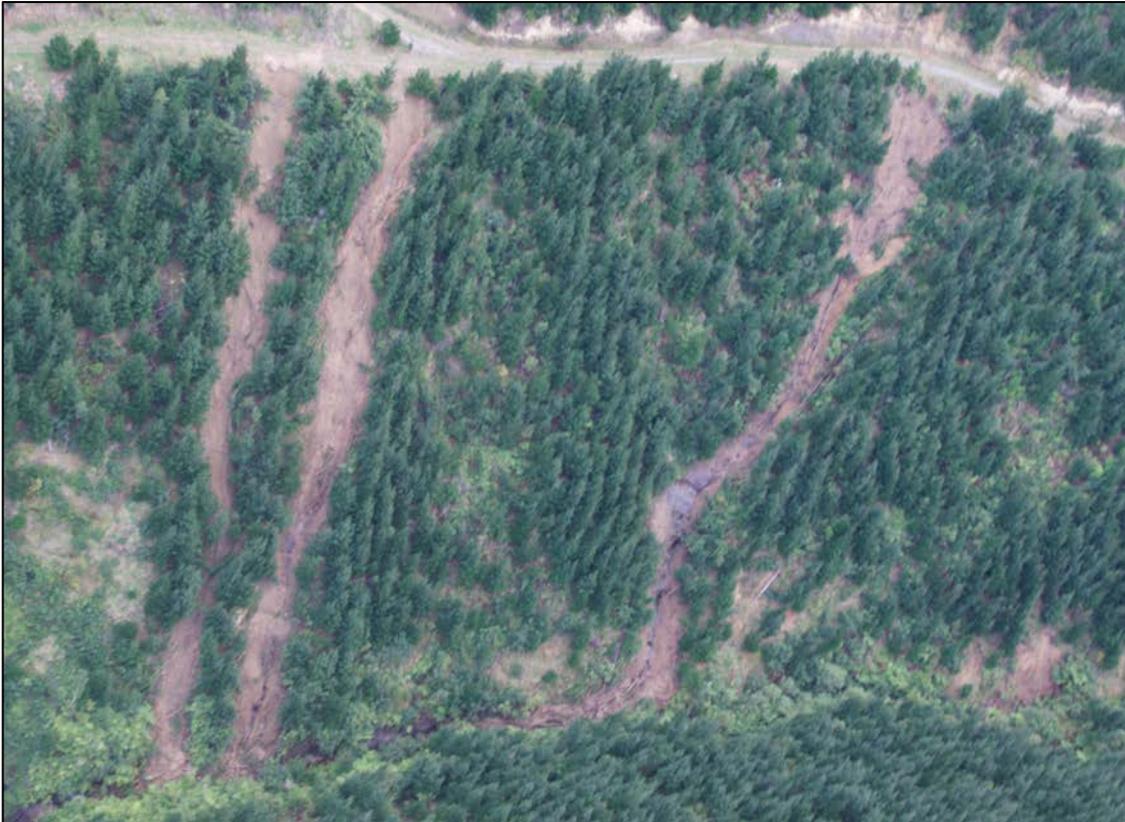
Typical landsliding in open canopy forest is shown in **Figure Thirty Eight** below. These are full slope length debris flows connected to forestry roadways at the top of the slope and the creek bed at the base. The lack of extensive scouring of the creek bed compared with **Figure Thirty Six** suggests that the primary cause of these landslides was water being directed onto vulnerable slopes from inadequate roadway water controls. The on-ground inspections outlined in Cave (2018c) highlighted the lack of adequate water controls on roadways in this forest exacerbated by poor maintenance.

Figure Thirty Nine. Full length debris flow landslides in open canopy forest at Wakarua.

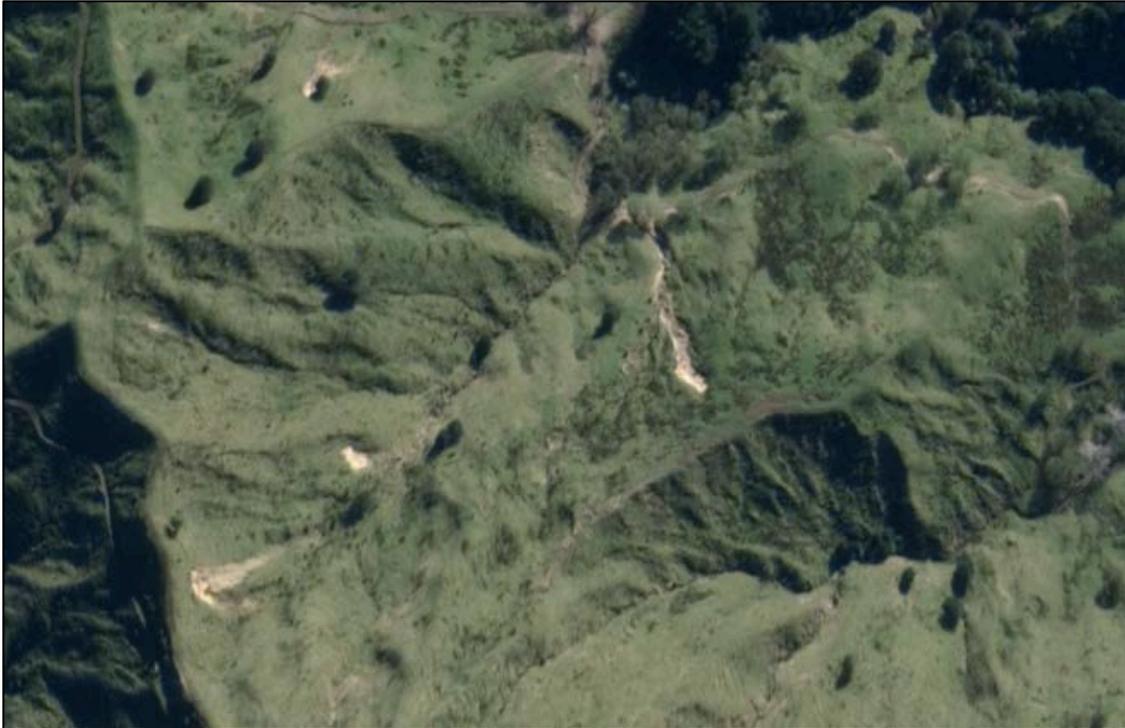
Figure Forty. August 25th 2018 Satellite imagery of farmland immediately south of Wakaroa Forest showing typical landslide activity arising from the June storms.

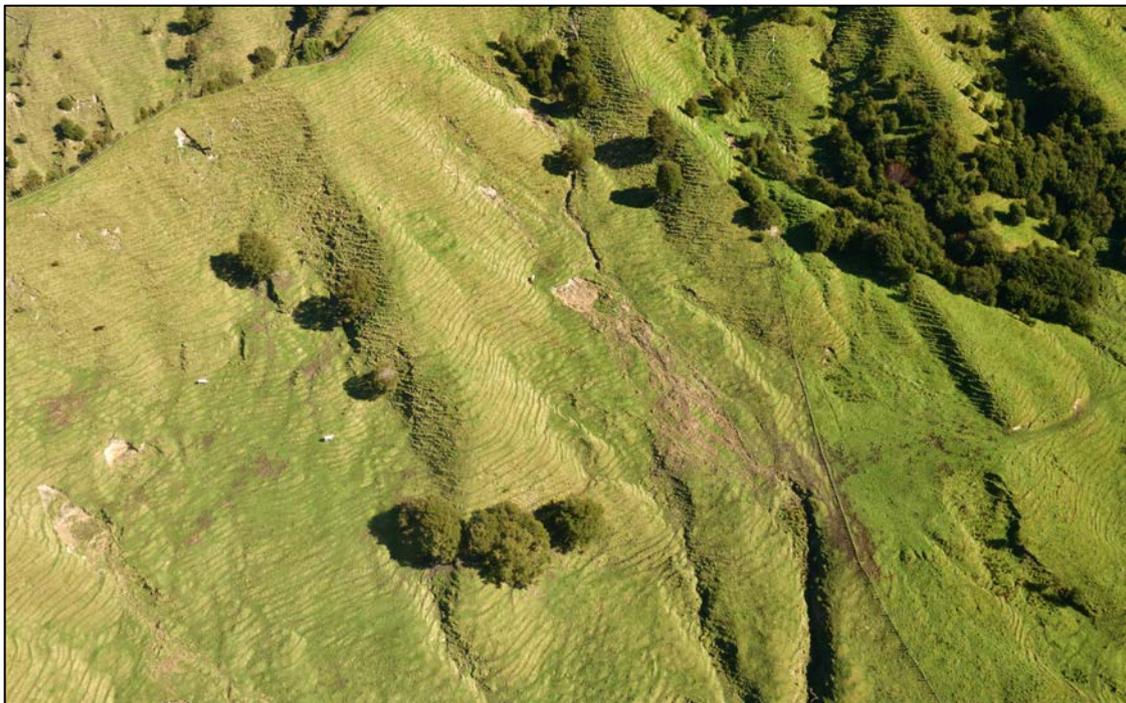
Figure Forty One. Typical small-scale earthslide type landslides occurring on farmland immediately south of the Wakaroa Forest. Those in the middle ground appear to have occurred where gullies or swales on the slope above have concentrated overland water flow.

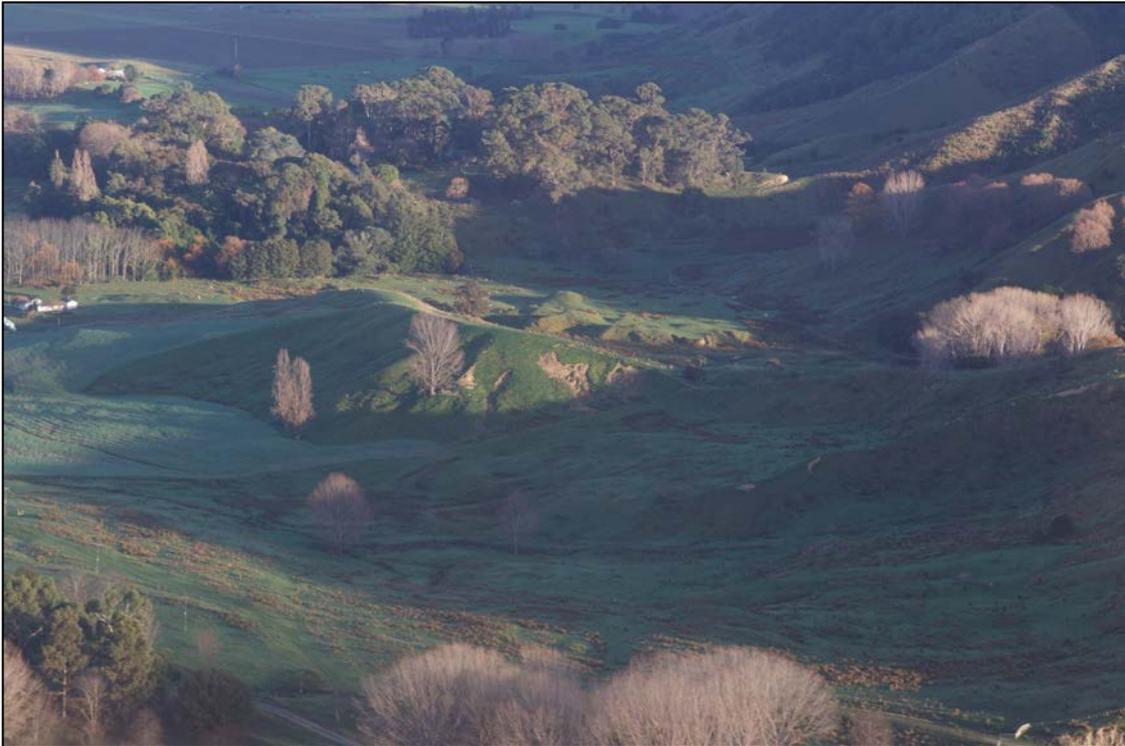
Figure Forty Two. Recent landslides within the diapiric zone upper Waimata Valley immediately south of Wakaroa Forest.
