Hikurangi Forest Farms Wakaroa Forest, Upper Waimata 3 July 2018

Compliance visit to assess whether or not an investigation is required

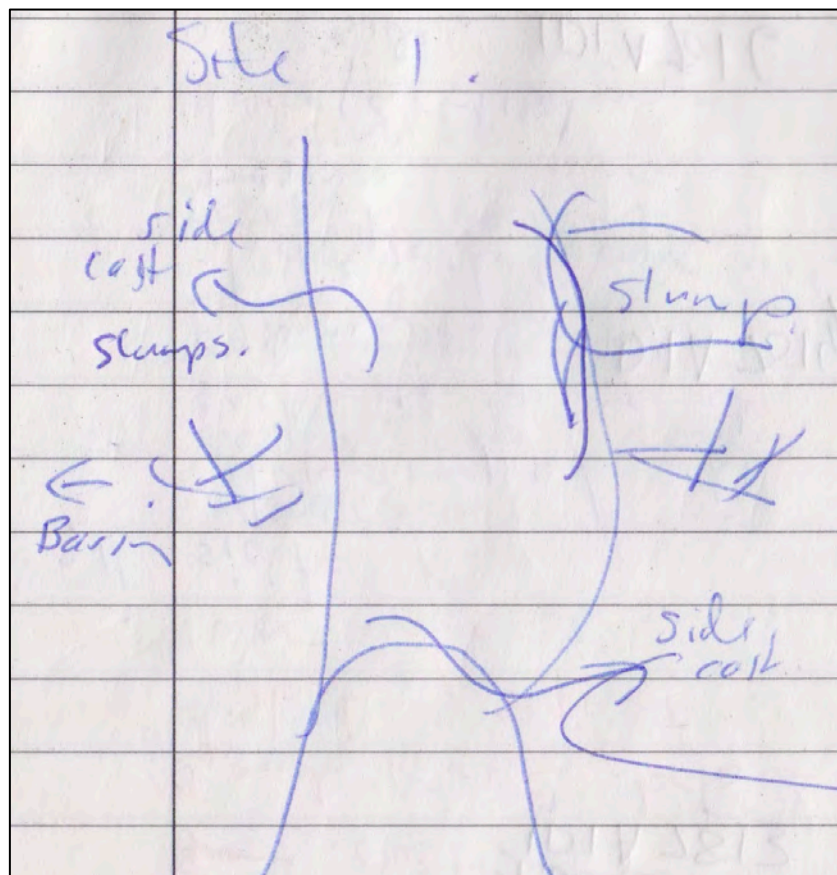
Figure Four. Sketch of Site One showing some key features. Slash and woody waste is stowed on the eastern edge of the skid site with slash used to form a bench below the material on the edge of the skid (Image 1D1A7812) but there is considerable woody material comprising a mix of slash and cut logs below this bench that have slumped into the basin below. The western side of the site does not have a pile of woody material perched on the edge but considerable material has been displaced into the basin below (See **Figure Five**).

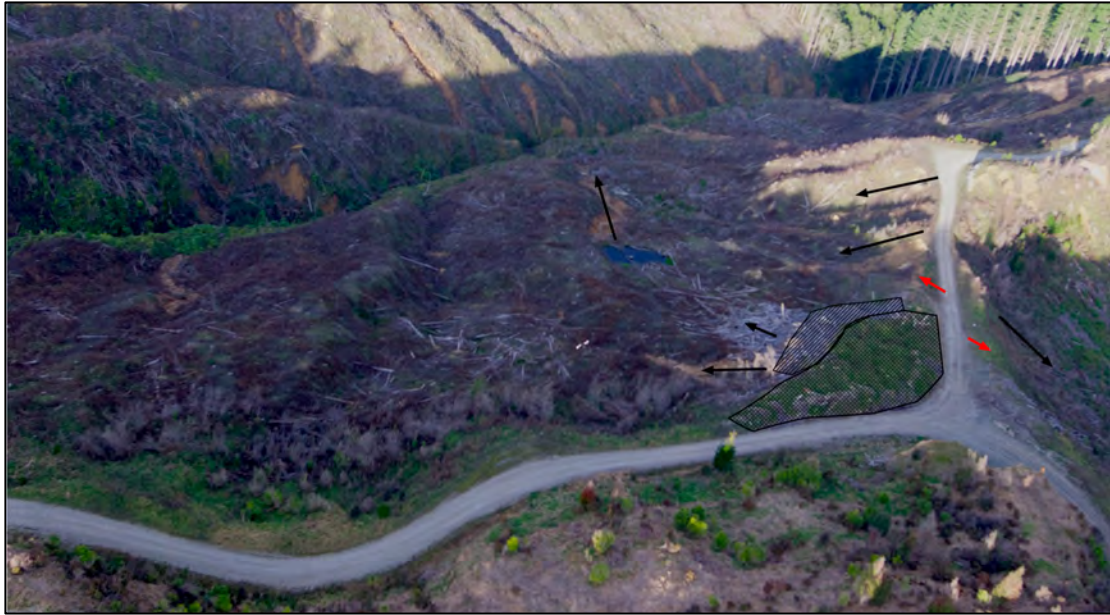
Figure Five. Aerial view of Site One looking south showing the slash pile on the eastern side of the site and the bench in slash beyond. Cut outs into side cast material are shown with the red arrows while slumps and slope failures are shown with the black arrows.

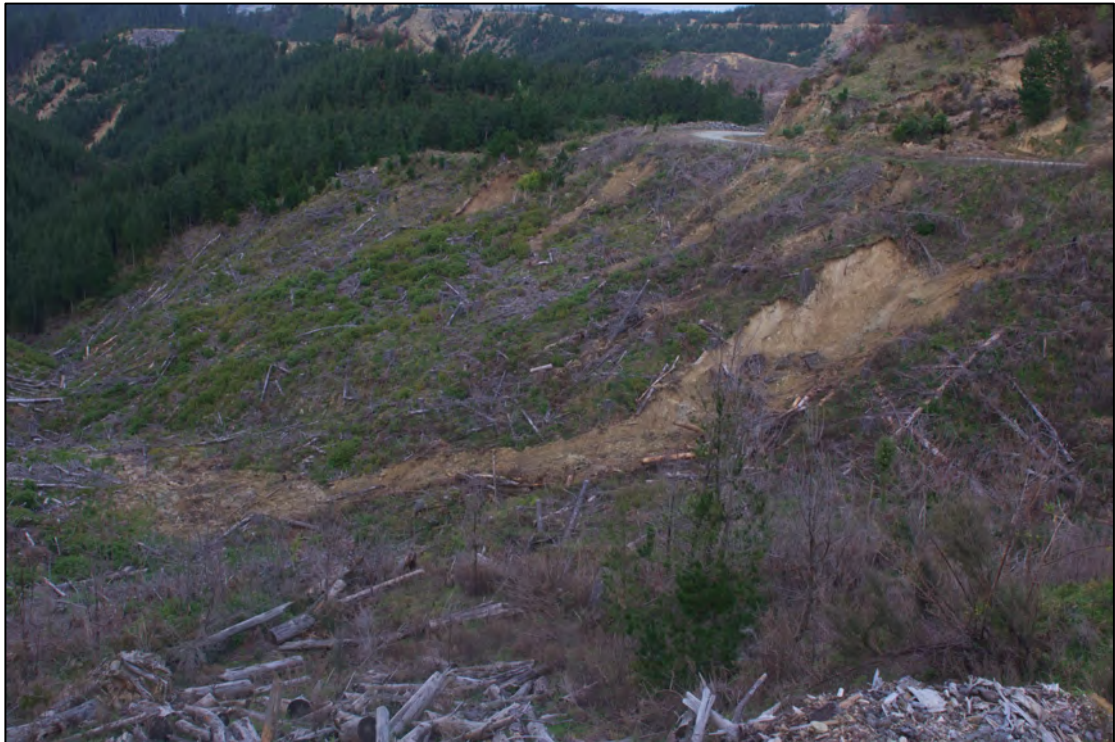
Figure Seven Image 1D1A7808. View looking south east along Woolshed road from the edge of the woody debris pile on the northern side of Site One showing multiple failures originating at road level with one large slip in the foreground.

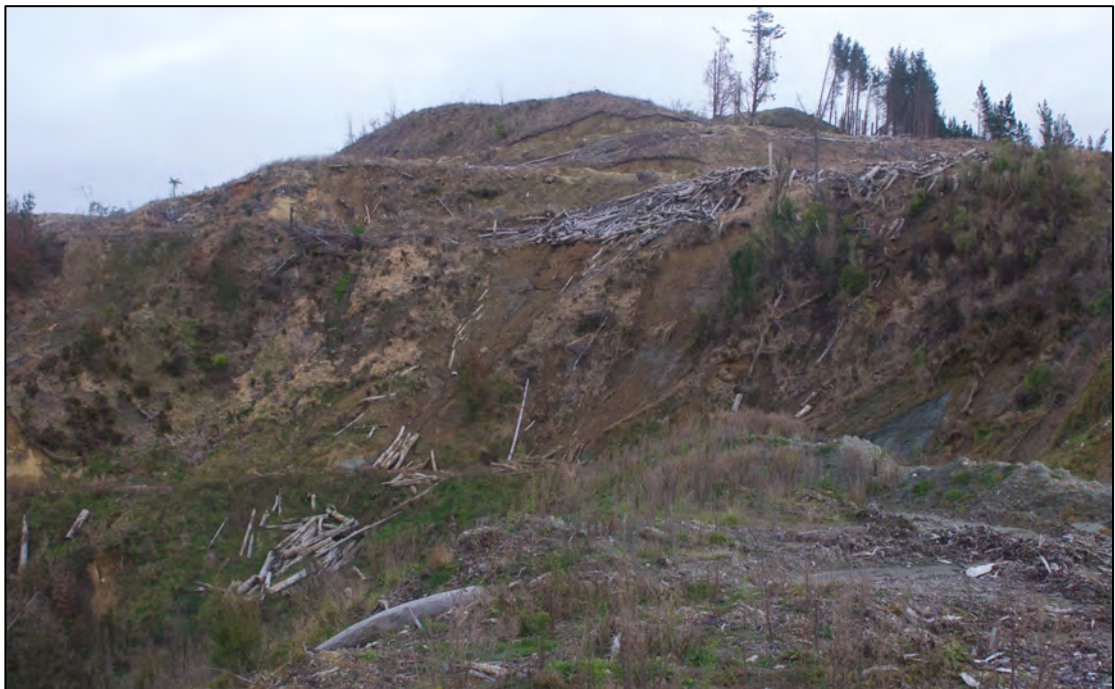
Figure Eight Image 1D1A7809. View looking west towards Duncan Road (top) and Bevan Road showing slope failure from log pile below Duncan Road to Bevan Road with logs blocking the lower Road.

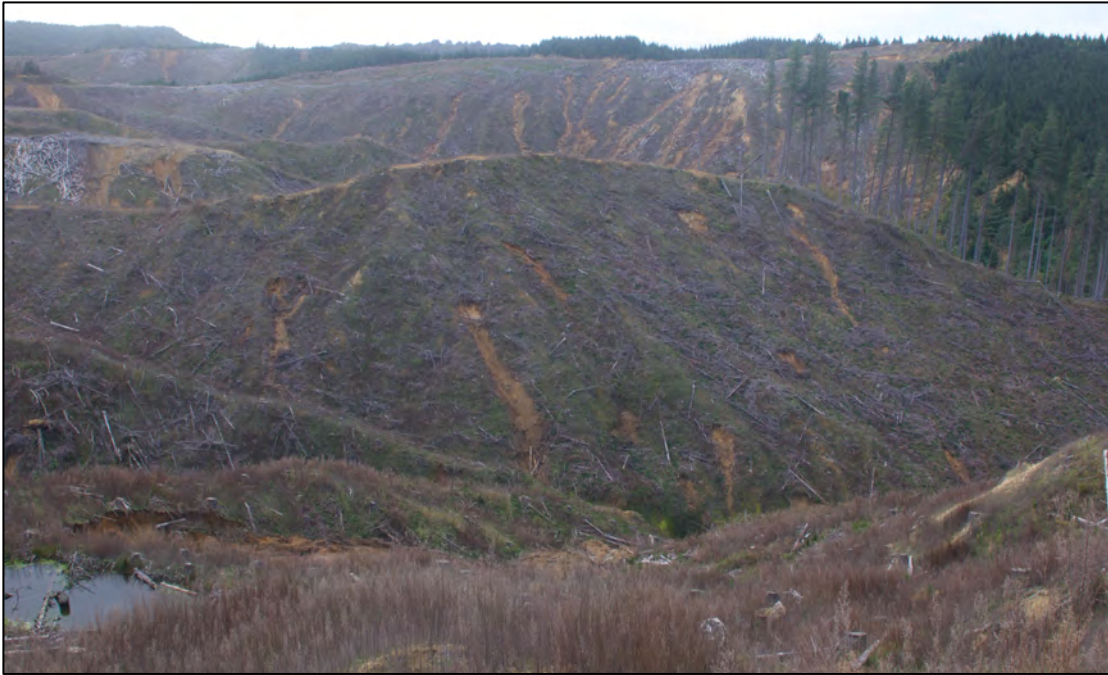
Figure Nine Image 1D1A7810 View looking east from eastern side of Site One showing a headscarp for a significant debris flow immediately below the water storage dam (bottom left), relatively small slips originating on the middle part of the slope (middle ground), significant failure of skid site 13 (Top left), and slips from adjacent to roadways (top).

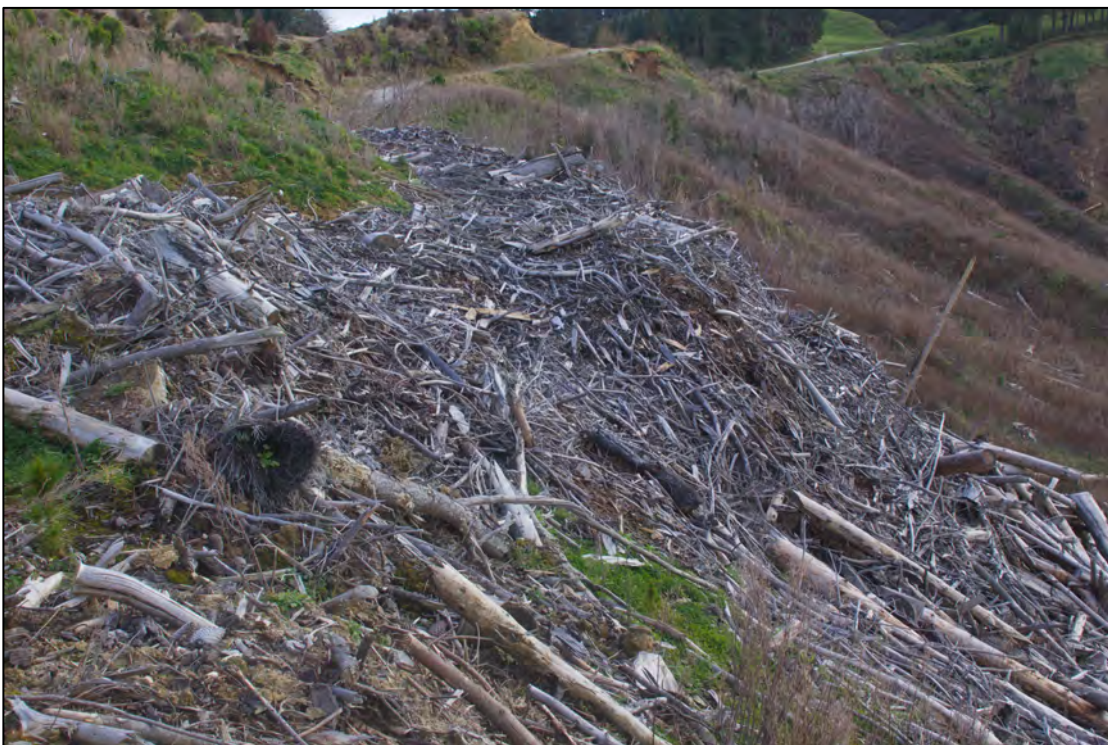
Figure Ten, Image 1D1A7812. View of eastern side of Site 1 showing slash material and logs perched below the skid. Failure from Herring Humming road is evident at top right.

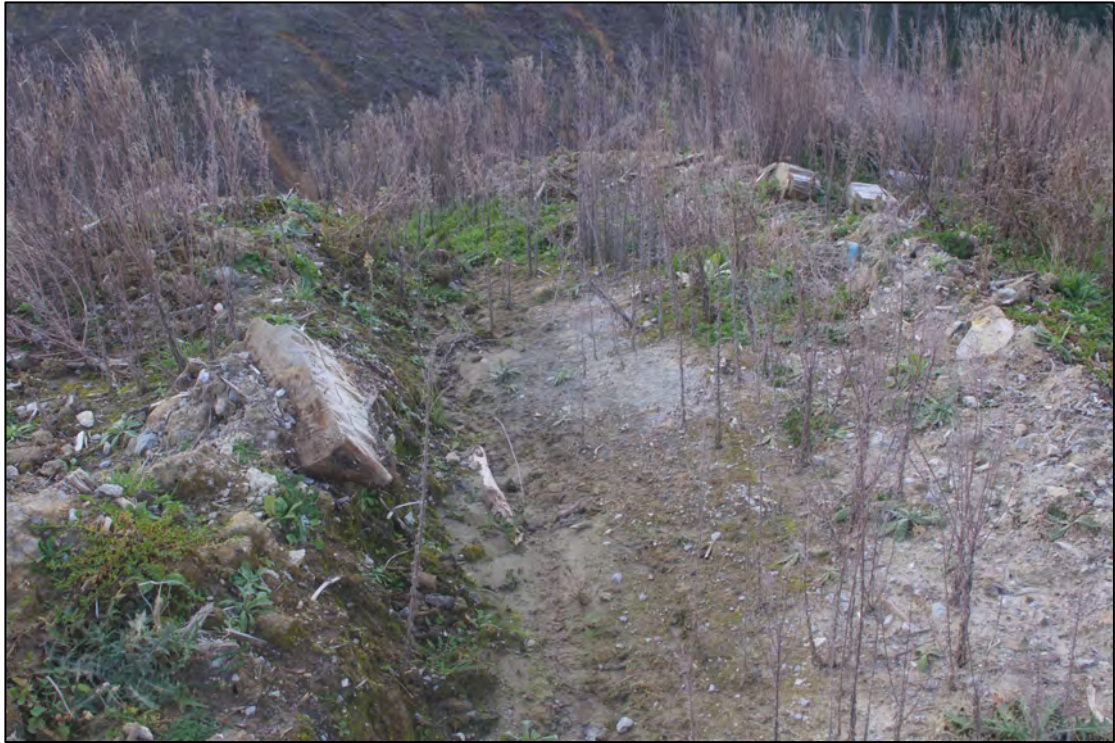
Figure Eleven Image 1D1A7813. View of cutout on east side of Site One draining onto sidecast material.

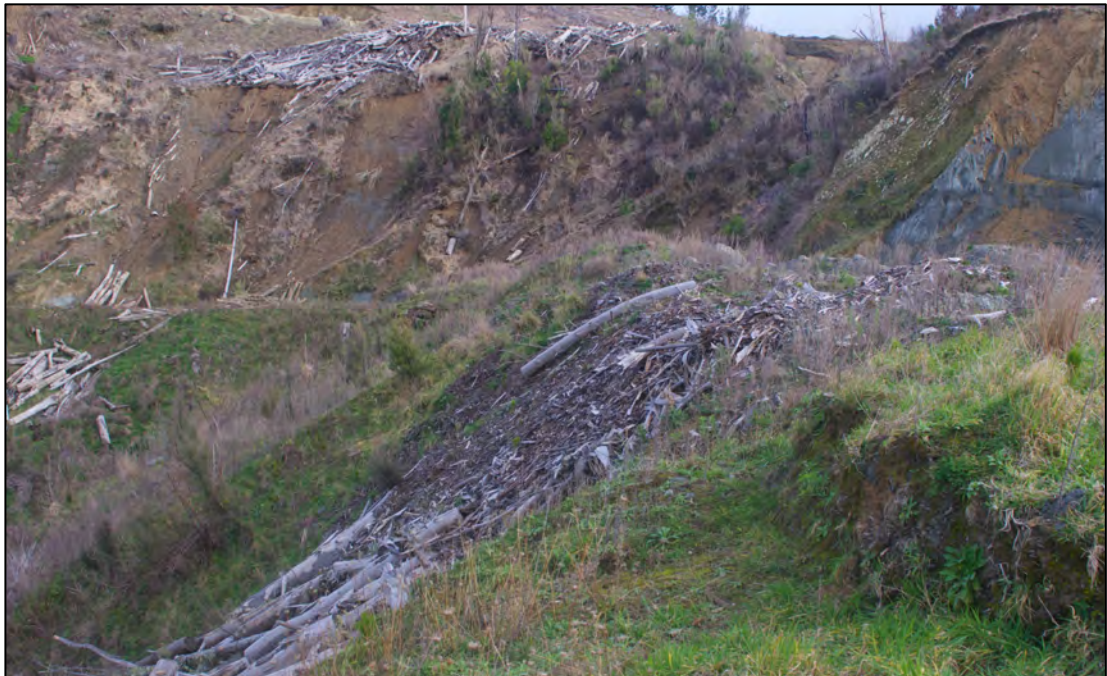
Figure Twelve. Image 1D1A7814. View of the western site of Site One showing slash woody debris that has collapsed into the basin below. In the foreground the edge of the skid has displaced by 50-70cm. Slips from slash pile on Duncan Road in the background (see also Image 1D1A7809).

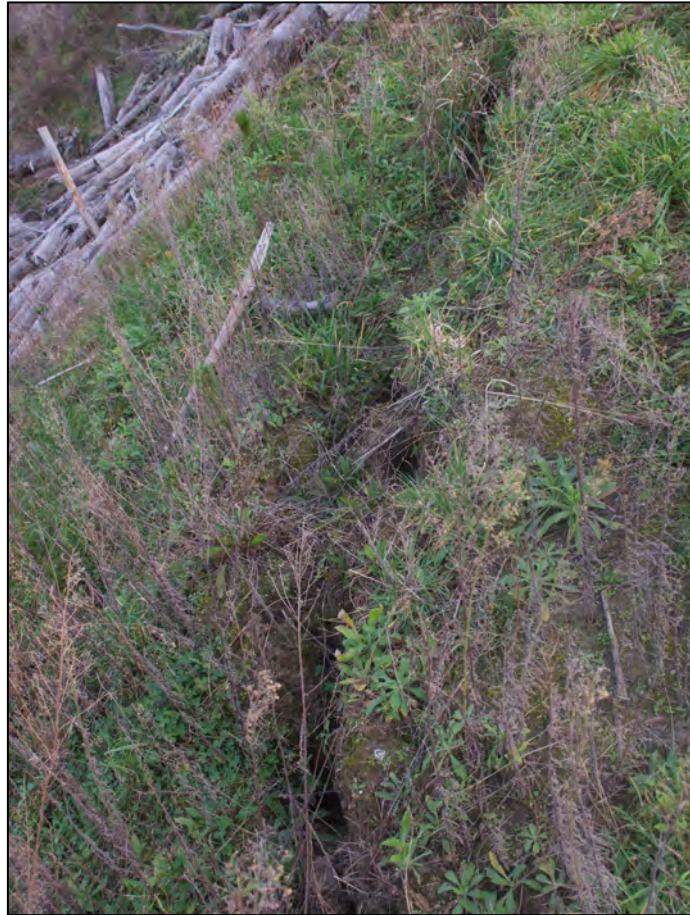
Figure Thirteen. Image 1D1A87815. View of large tension crack on the western side of Site One.

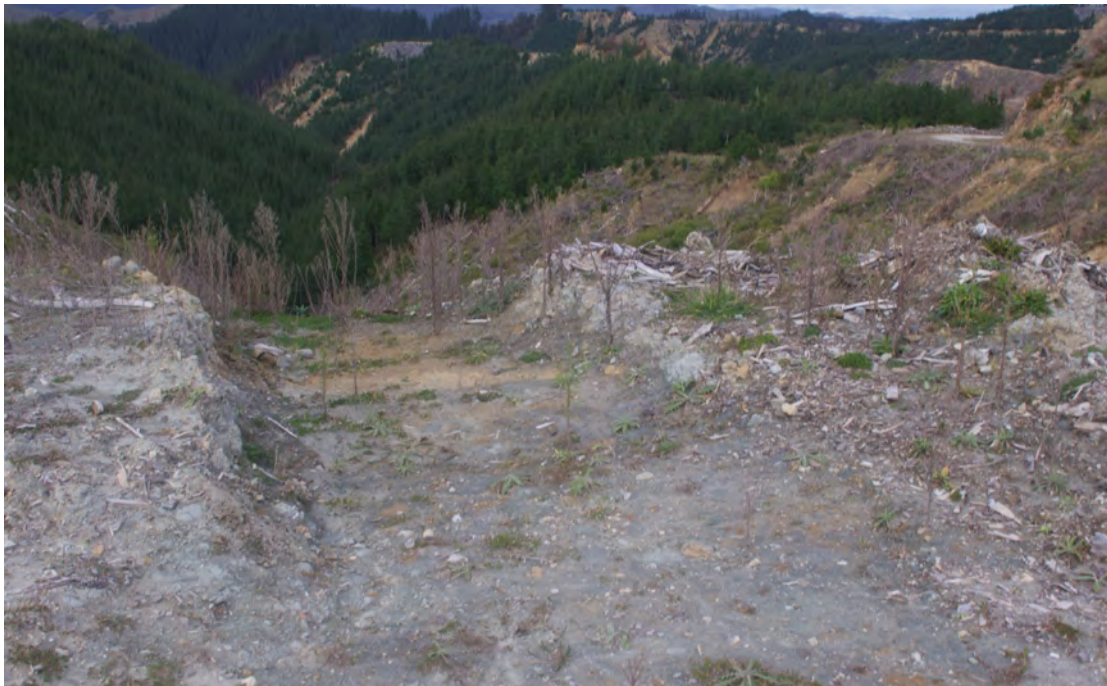
Figure Fourteen. Image 1D1A7816. View of cut out on western side of site one showing cut out directed onto side cast material. In the background (right) several slips originating from Woolshed Road are evident.

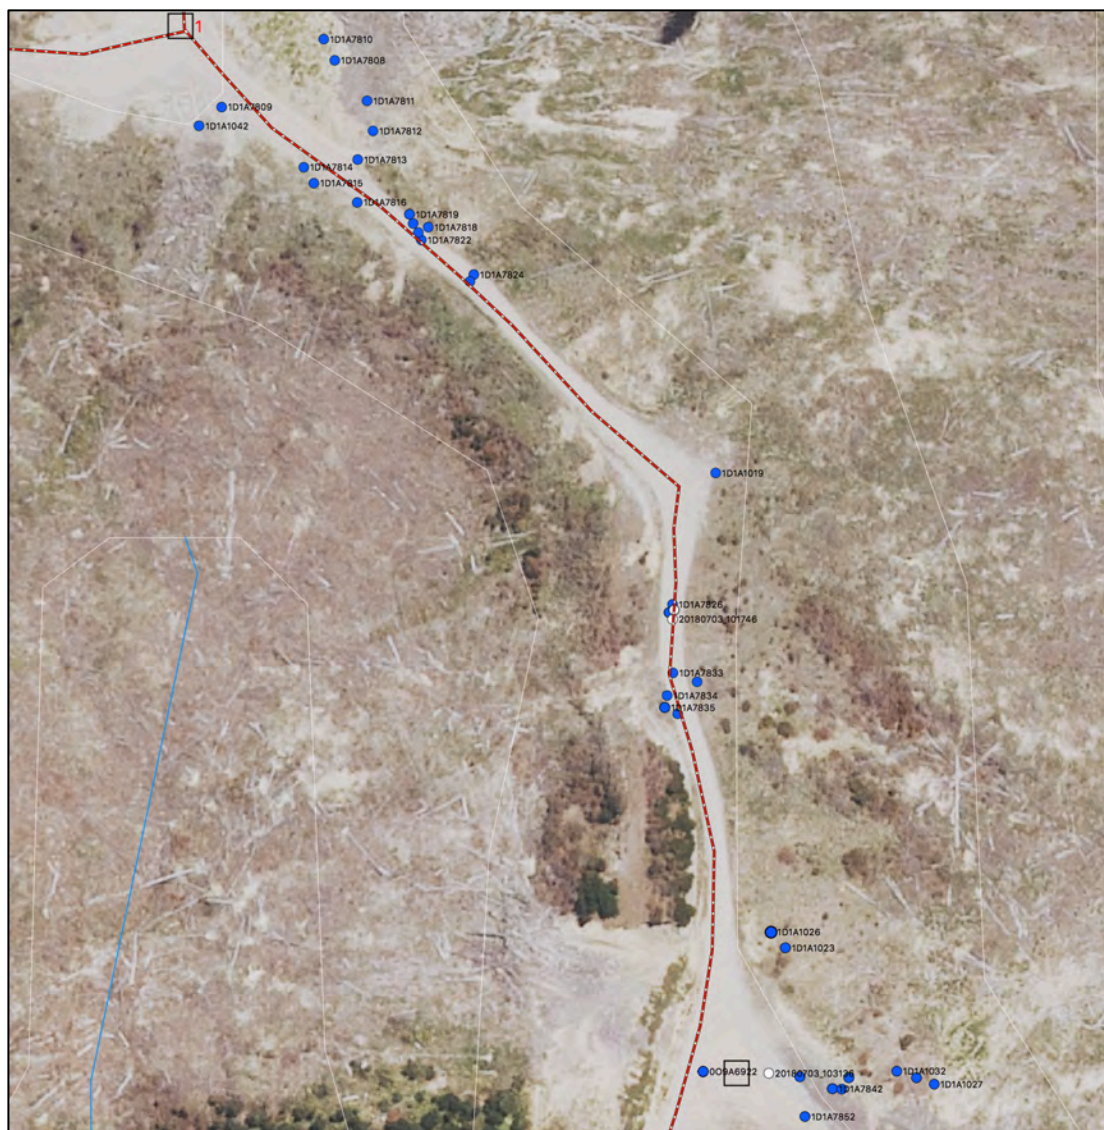
There are several slope failures evident immediately below the road south east of Site One (**Figure Fifteen**). No culverts were found between Site One and Site Two while watercourses were in poor condition, and blocked by vegetation and slope wash material. Cut outs directed water over side-cast materials. A large slope failure that has generated a debris flow extending towards the valley floor (**Figure Sixteen**) is evident around 80m from Site one. The failure occurred where a cut out had directed water onto side cast material (**Figure Seventeen**) while the blocked watercourse resulted in water flowing across the road surface contributing to the storm water being discharged onto the side cast material below the road.

Figure Fifteen. View of the area south east of Site One on Woolshed Road. No culverts were located along this part of the road.

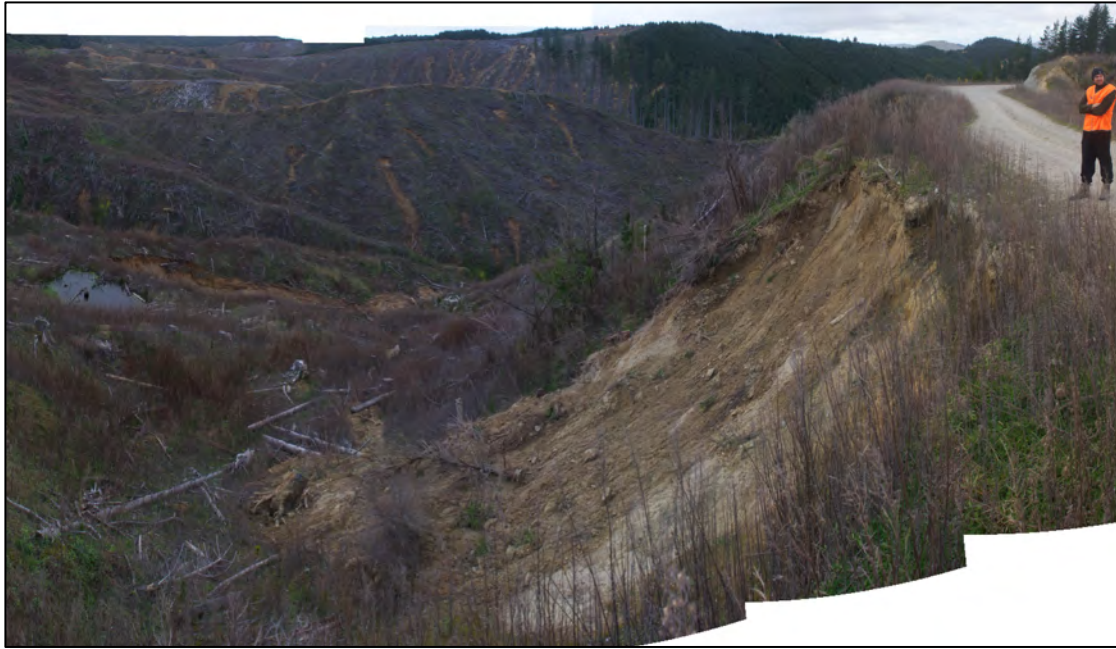
Figure Sixteen. Significant slope failure south east of Site One that has occurred where a cut out has directed water onto side cast material [Image is a stitched together composite of images 1D1A7818 to 1D1A7822].

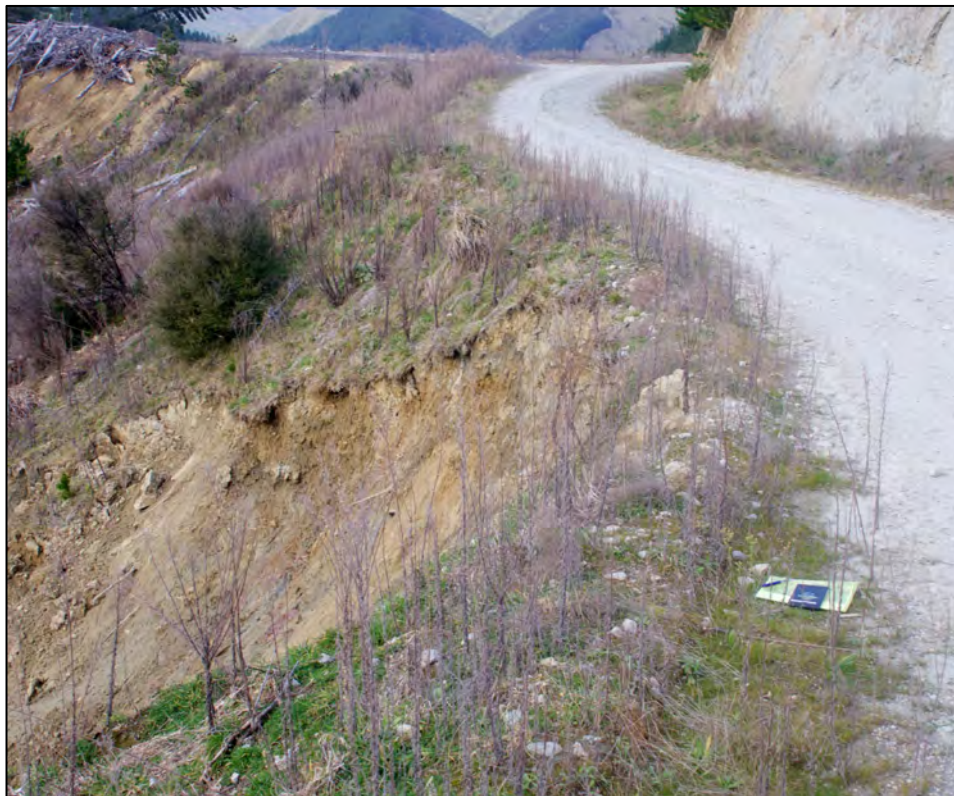
Figure Seventeen. View of headscarp of failure south of Site One on Woolshed Road. In the foreground some material has been placed to form a berm but where this berm is cut out water has been directed onto unstable side cast material leading to failure. On the opposite side of the water course has not been maintained and is full of vegetation and as a consequence water would have flowed across the road contributing to the failure. Site Two is visible in the background.

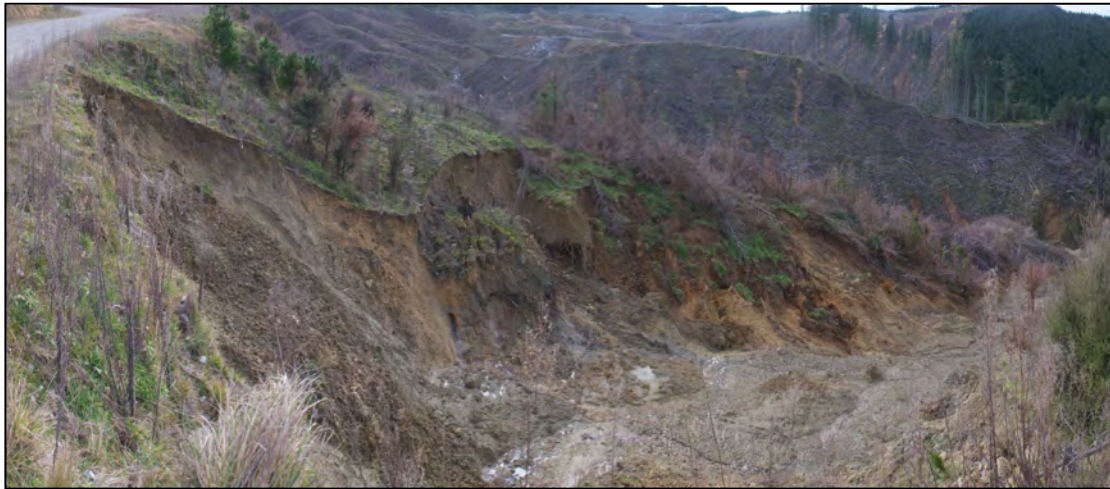
Another significant slope failure is present around 200m south east of Site One and as was the case for the slope failure shown in **Figure Eighteen** has occurred where a cut out has directed water over the eastern side of the road.

Figure Eighteen. Large slope failure around 200m south east of Site One resulting from water directed over the eastern side of the road. The image is a stitched composite of photographs 1D1A7834 to 1D1A7840.

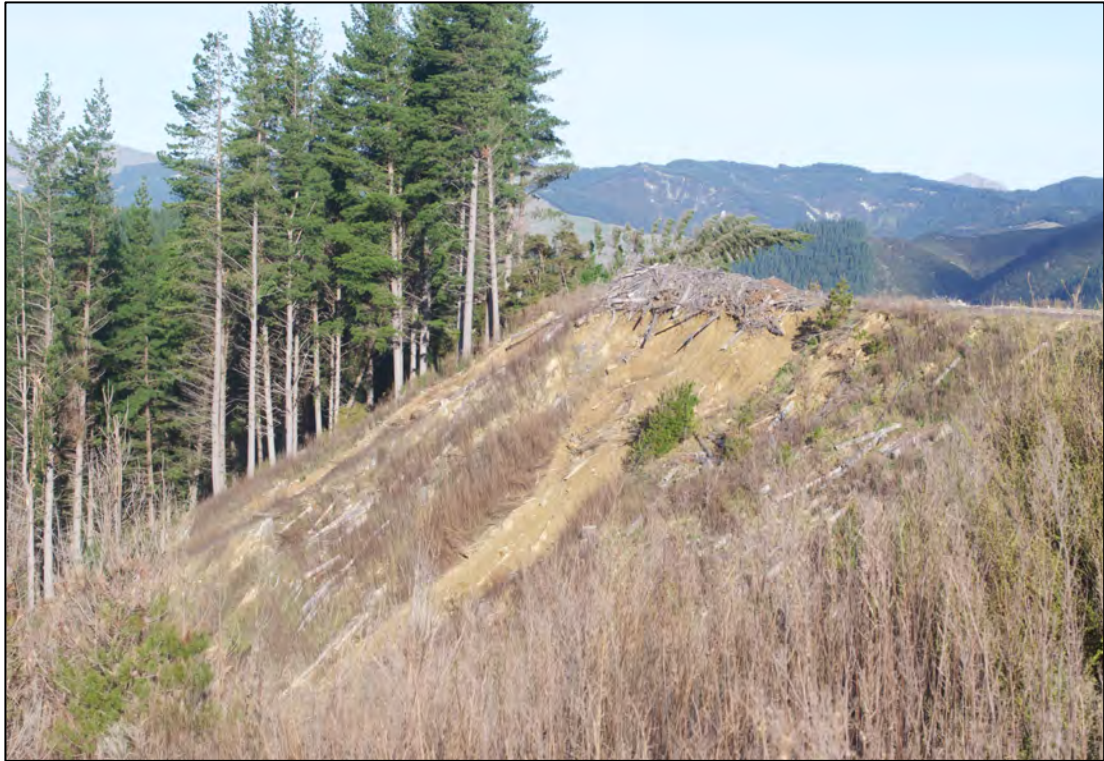
Site Two is around 500m south east of Site One and is located on a short spur leading off Woolshed Road. The site has a significant failure on the eastern side where a large pile of woody debris sits on the edge of the skid site (**Figures Nineteen & Twenty**).

Figure Twenty. Image 1D1A1019 showing skid Site Two from Woolshed Road showing the failure on the eastern side of the skid and the logging debris perched on the edge.

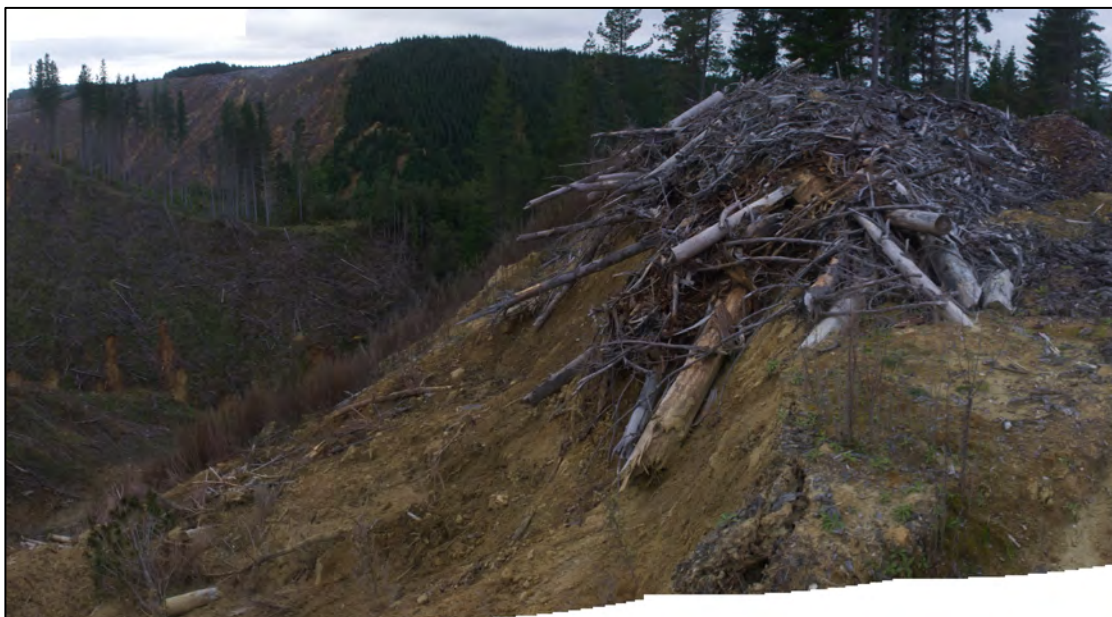
Closer examination of the site indicated that the pile of logging debris was overhanging the edge of the skid where the side cast material had collapsed below it. Tension cracks were also evident along the edge of the failed surface and these extended for some distance to the north (**Figure Twenty One**).

Figure Twenty One. Composite image (Images 1D1A7844 to 1D1A7847) showing the log pile overhanging the edge of the skid. A tension crack and part of the drainage channel is evident in the foreground.

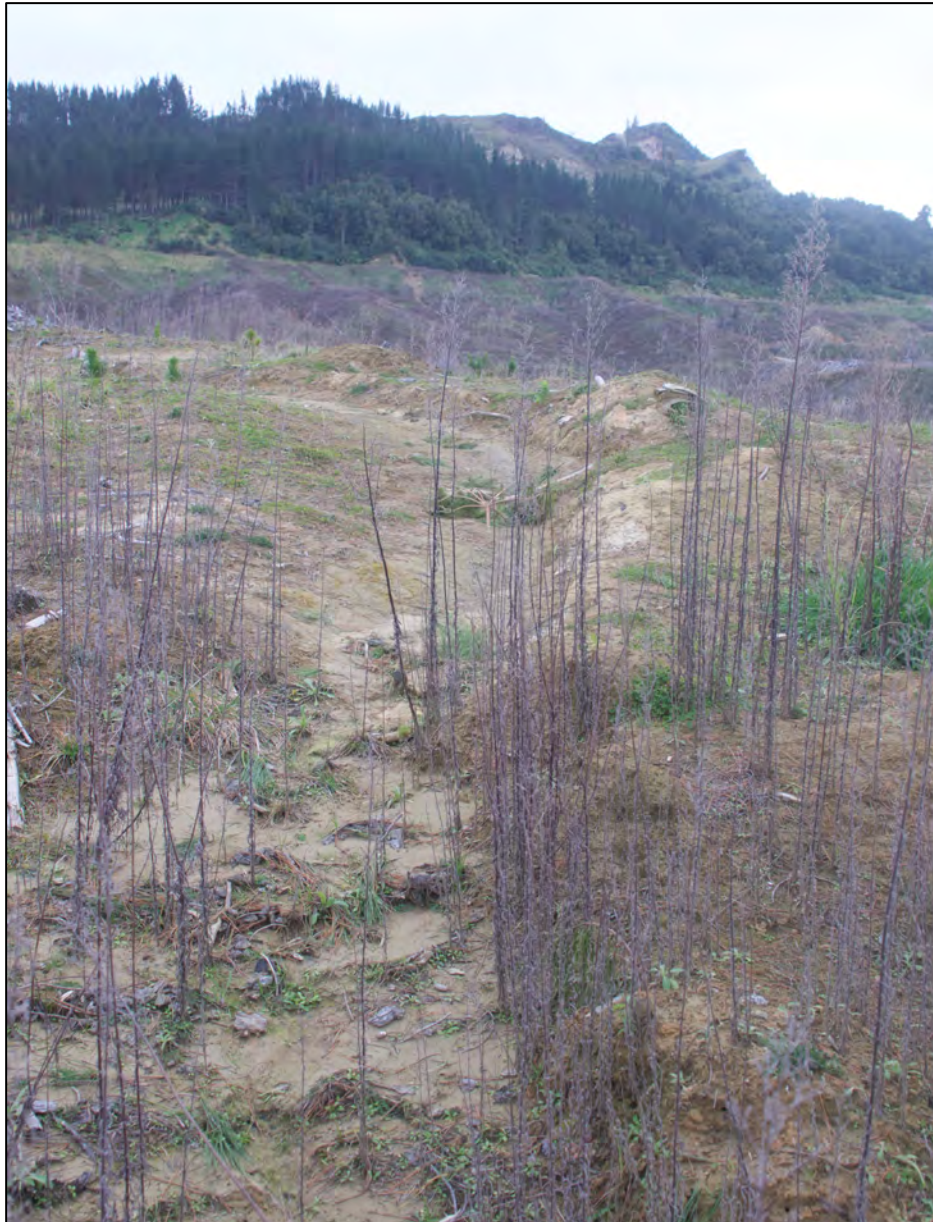
There was a large drain constructed on the skid site which directed water around the debris pile and onto the sidecast material on the eastern edge of the skid site on which the debris pile was perched (**Figure Twenty Two**). The other end of this drain directed water onto side cast material on the other end of the logging debris.

Figure Twenty Two. View of the skid with a drain directing water onto side cast material on the eastern and south eastern edge of the skid site.

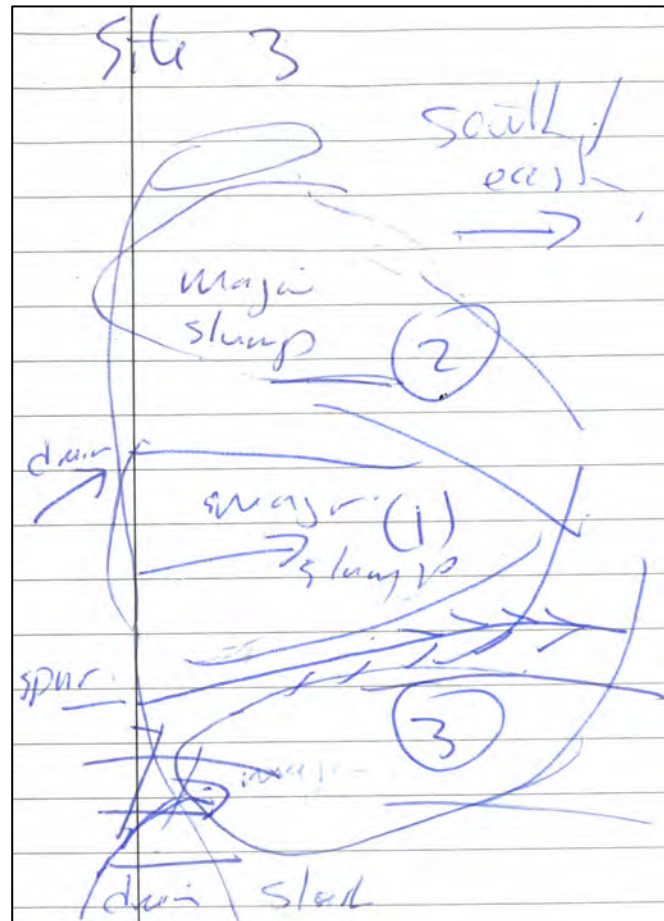
Figure Twenty Four. Sketch map of the eastern side of Site Three showing the three slope failures and drainage points.

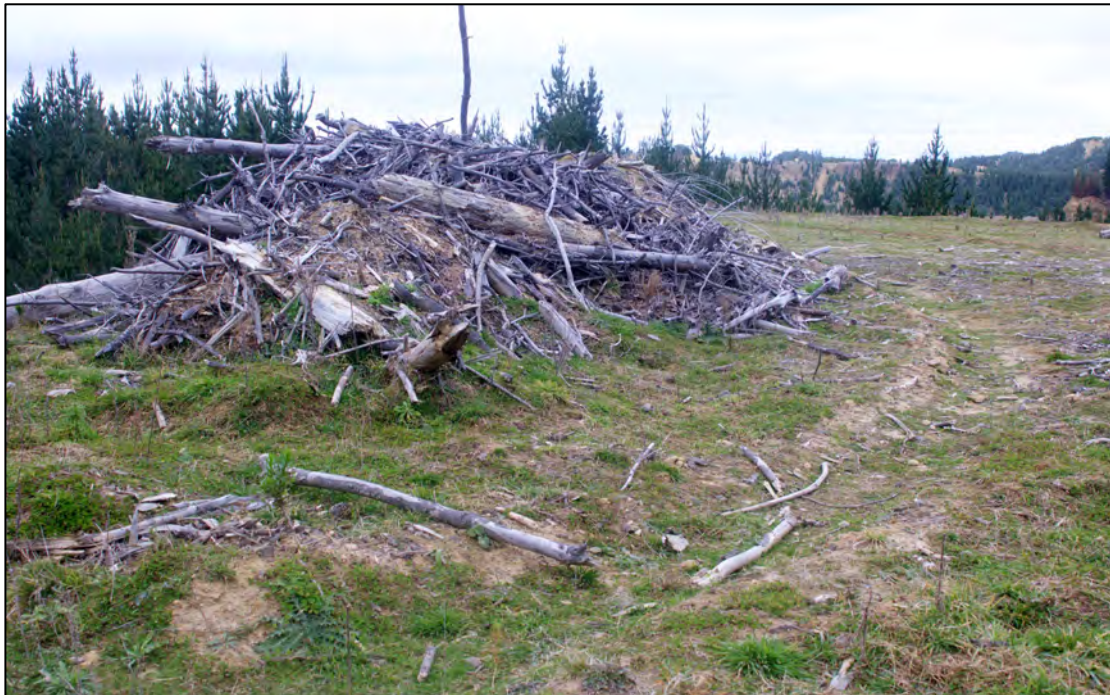
Figure Twenty Five. View of the logging debris pile perched on the eastern side edge of the skid at site 3 with a drain directing water onto side cast material.

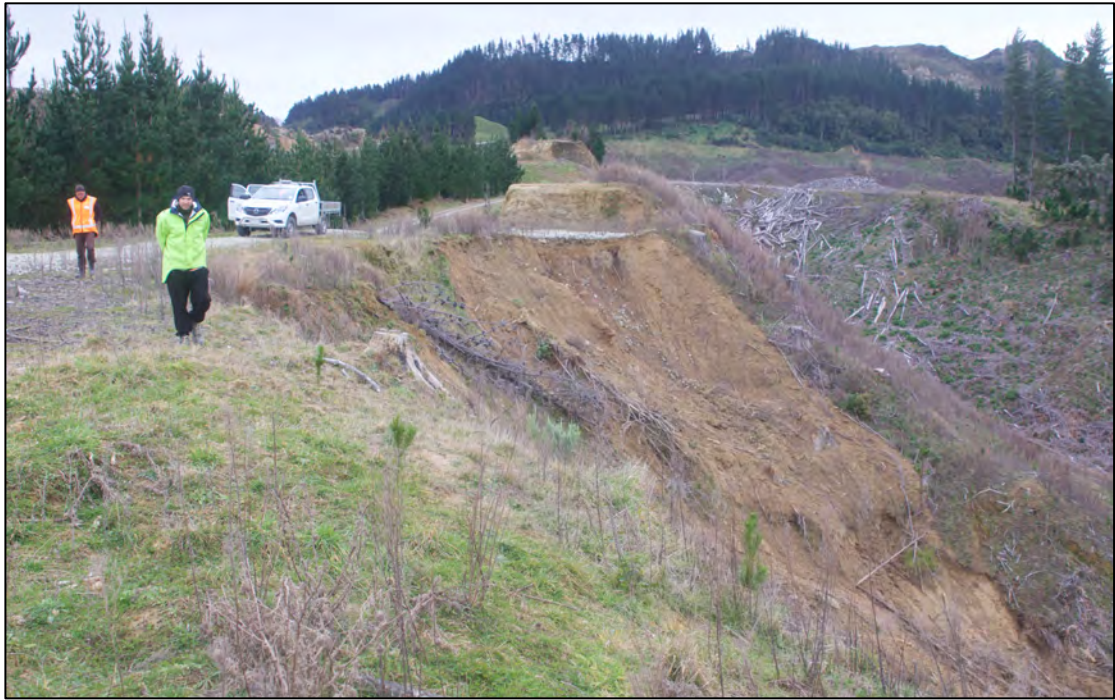
Figure twenty Six. Image 1D1A7858. View of eastern side of Site Three showing failure number 2 (background and failure 1 (obscured middle ground) with person standing at low point where water drains onto side cast material that has failed.

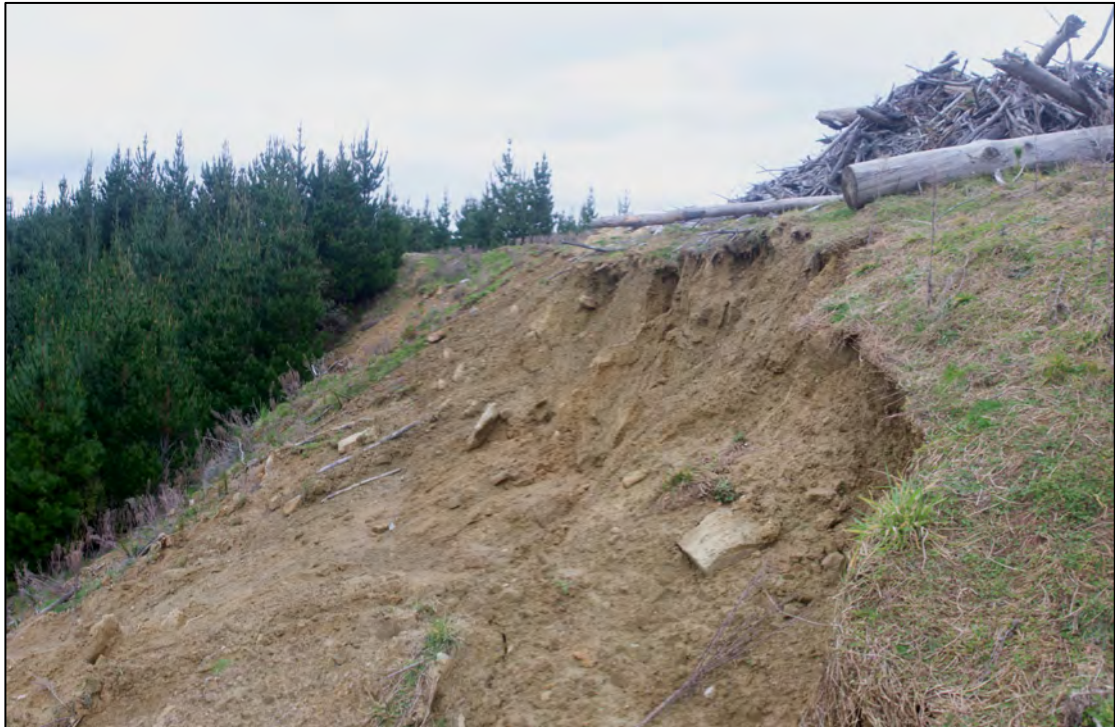
Figure Twenty Seven. Composite of images 1D1A7859 and 1D1A7860. View of the headscarp of failure 2 on eastern side of Site 3.

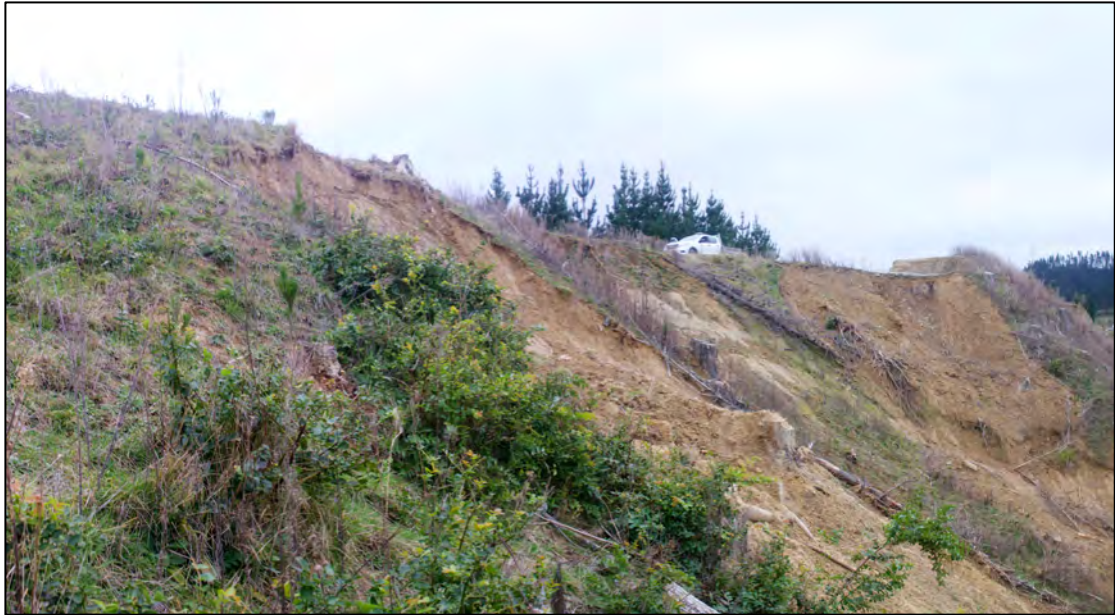
Figure Twenty Eight. Composite of Images 1D1A7868 to 1D1A77871 View looking north showing the extensive failures that have occurred from the eastern side of Site Three.

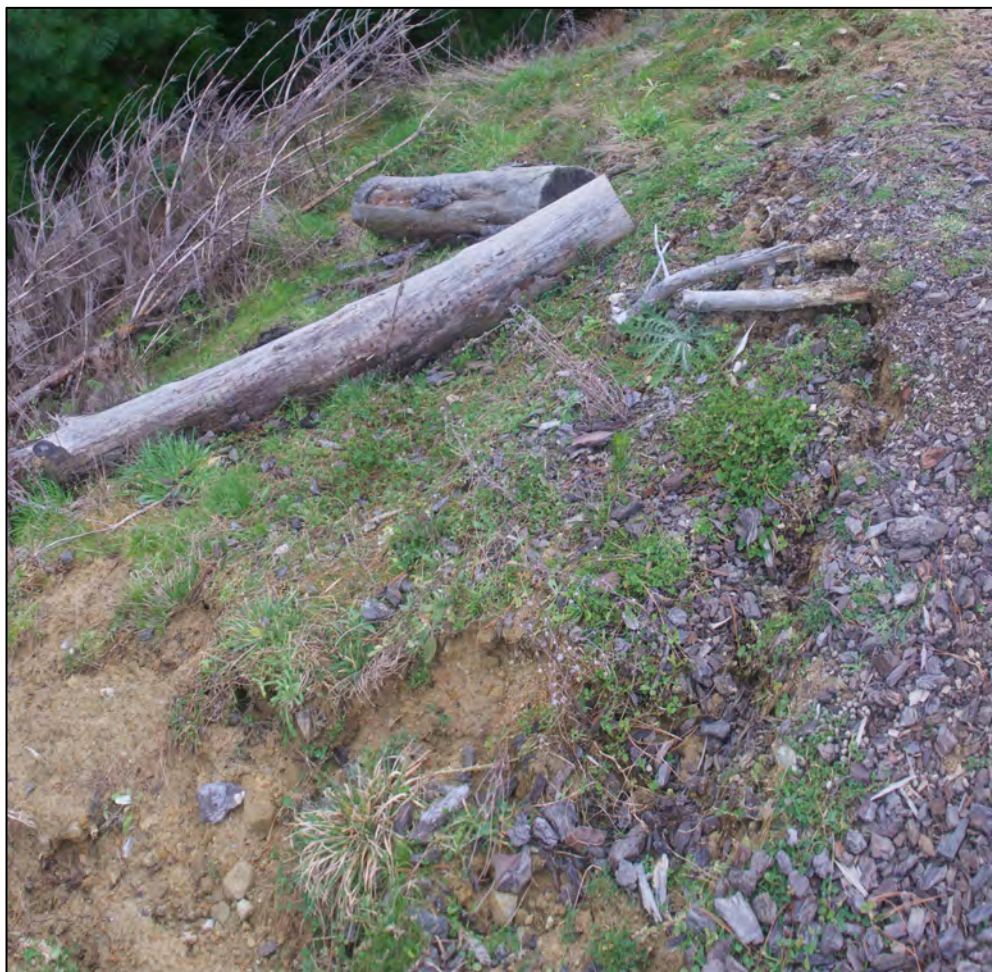
Figure Twenty Nine. Composite of Images 1D1A7880 and 1D1A7881 view showing a tension crack at the edge of the gravel pad on the eastern side of Site three. Note the presence of woody material caught up in the gravel pad and the tension crack leading to a slope failure. Such cracks act like a channel directing water onto the side cast.

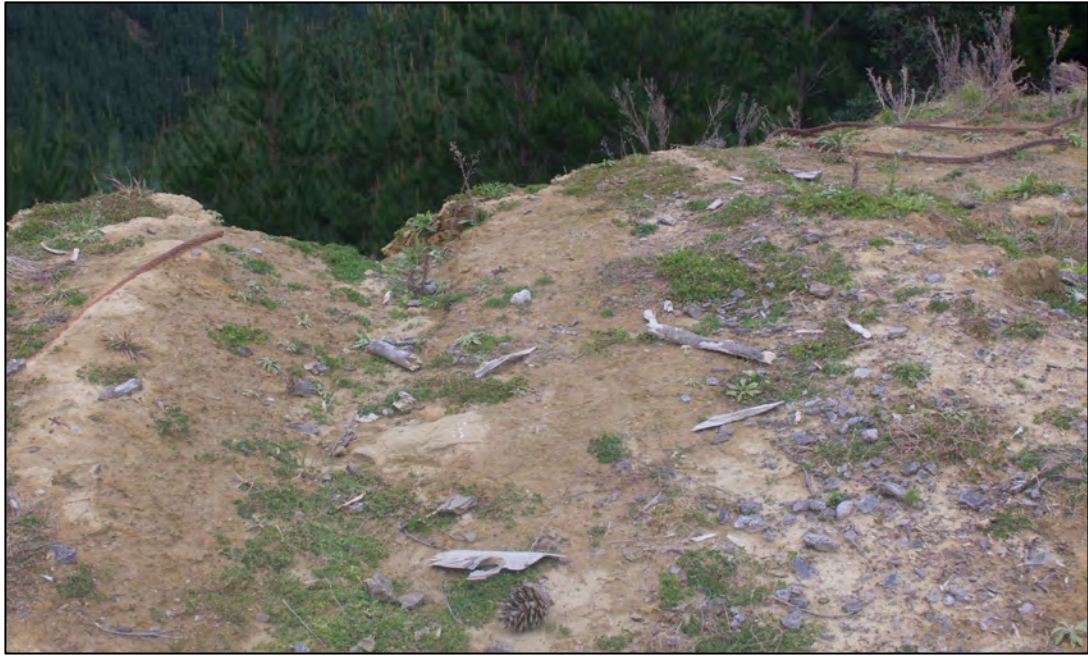
Figure Thirty. View of a drain cut through to side cast material on the south side of the skid. Note the poor house-keeping with wires left lying on the edge.

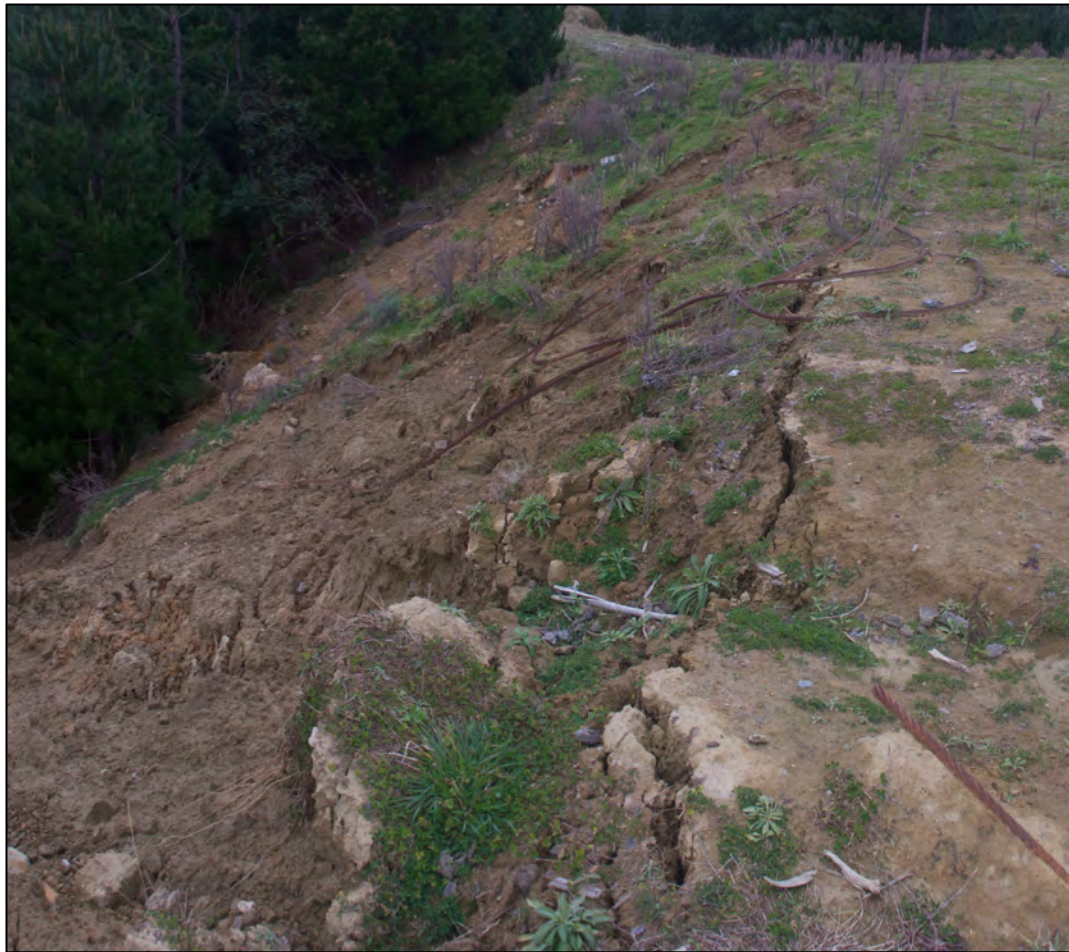
Figure Thirty One. View of the same area as in **Figure Thirty** showing the drain cut through to side cast material on the south side of the skid. Note the large tension crack cutting through the slope edge.

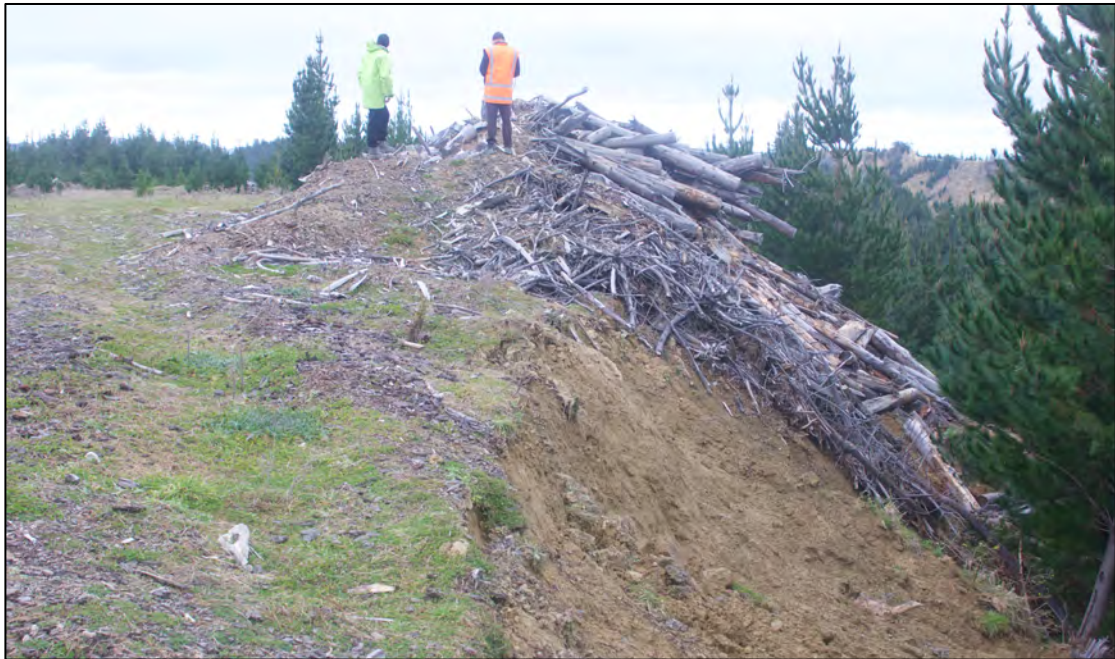
There is a large pile of logging debris perched on the west side of Site Three (see **Figure Twenty Three** for location). As is the case with other skid sites in this area, drains have been cut around the debris pile which results in water being directed onto side cast material at the north end resulting in a slope failure (**Figures Thirty One and Thirty Two**).

Figure Thirty One. Logging debris stowed on the western edge of Site Three with an obvious drain directing water over the edge of the skid onto side cast material in the foreground.
