Hikurangi Forest Farms Wakaroa Forest, Upper Waimata 3 July 2018

Compliance visit to assess whether or not an investigation is required

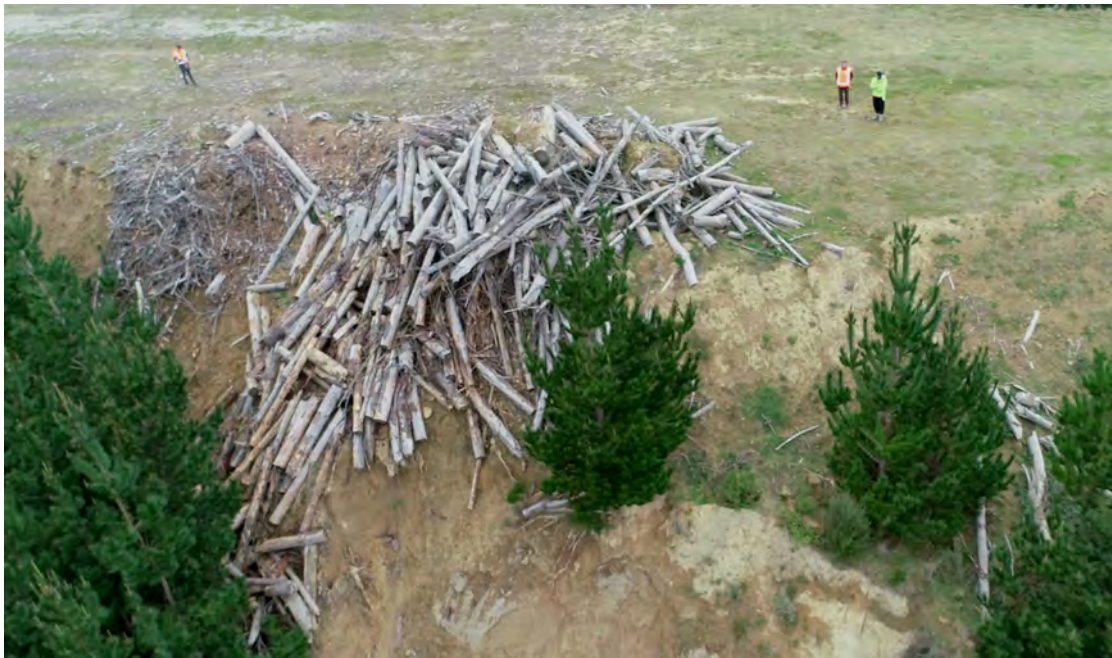
Figure Thirty Two. Drone footage of the slope failure and perched logs on the western side of Site Three.

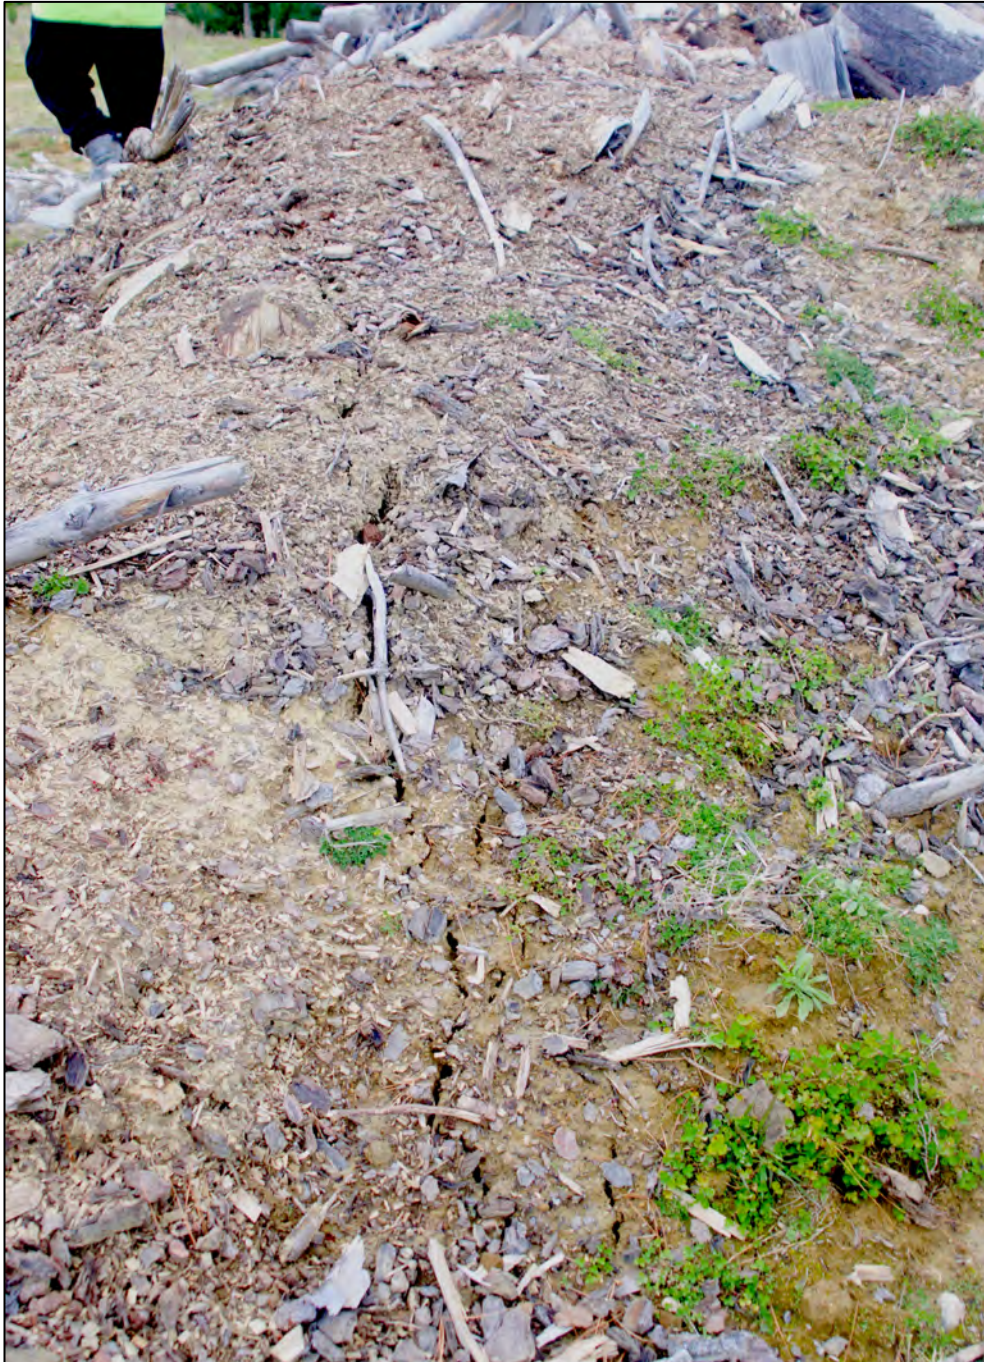
Close examination of the pile of logging debris showed that there was a large tension crack running through it's inside edge (**Figure Thirty Three**) and that it was at risk of failure making it too hazardous to estimate the extent of the debris flow on the ground. Consequently the GDC drone was used to provide a detailed view of the failure and assess whether or not it had migrated downstream from that point. This footage confirmed that large failure has generated a debris flow through 5-7 year old pines through to the valley floor (**Figure Thirty Four**) and that this had migrated downstream through the deeply incised gorge.

Figure Thirty Three. View of a deep-seated tension crack running through the inside edge of the log pile.

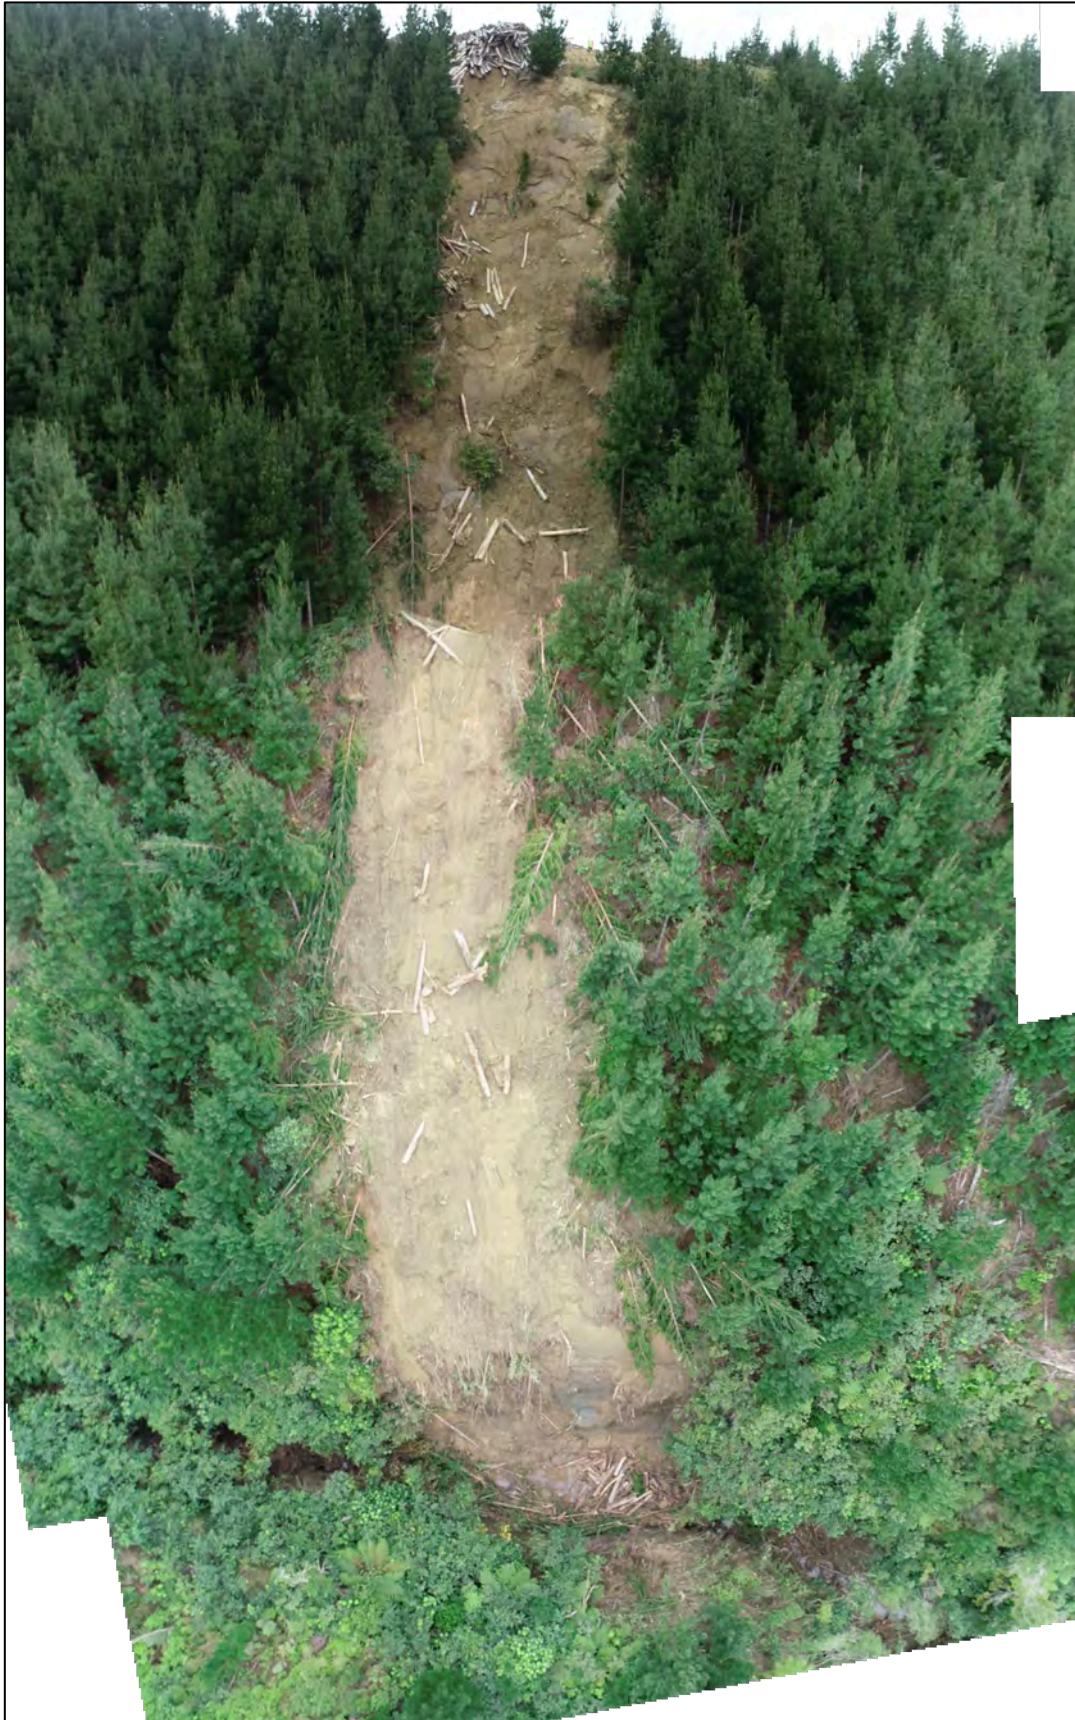
Figure Thirty Four. Composite image (drone video screenshots) of the western side of Site Two debris flow from the headscarp to the toe of the slope in a deeply incised gorge in a tributary of Mangahouku Stream.

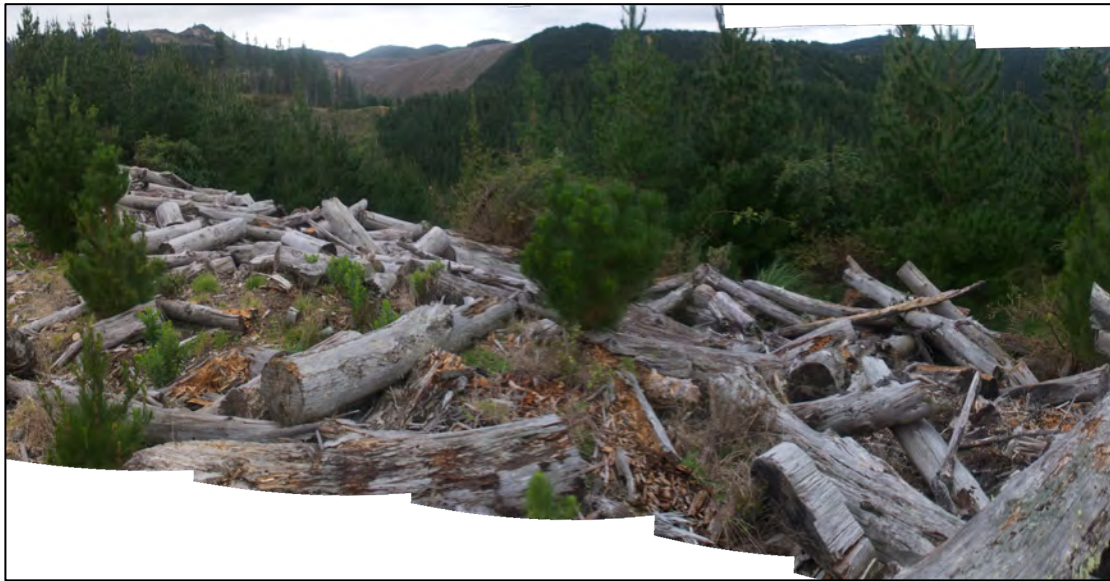
Site Four (see **Figure Twenty Three** for location) is around 130 metres south of Site Three and is located on a small spur track to Woolshed Road. There are log piles situated on either side of the skid site but that on the western side is perched over Woolshed Road which acts as a berm and thus attention was focused on the eastern side. As was the elsewhere within this forest, logging debris had been stowed on the edge of the skid site (**Figure Thirty Five**) and has generated a small slope failure (**Figure Thirty Six**).

Figure Thirty Five. Composite image (1D1A7902-1D1A7924) showing logs perched on the edge of Site Four.

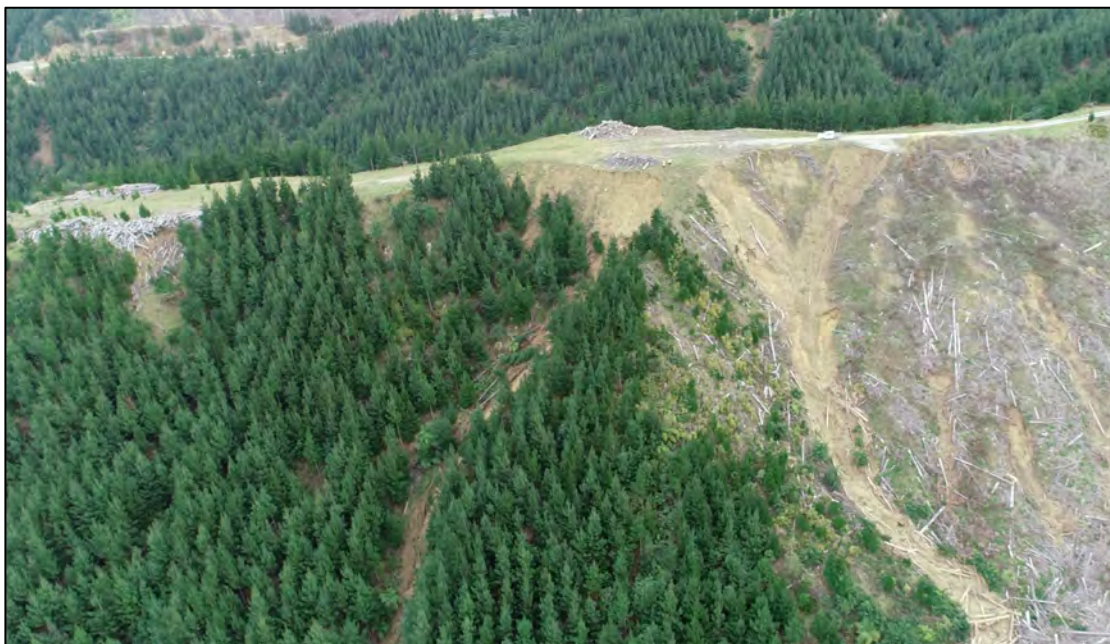
Figure Thirty Six. Screenshot from drone showing the Site Four failure (far left) and the three failures on the eastern side of Site Three.

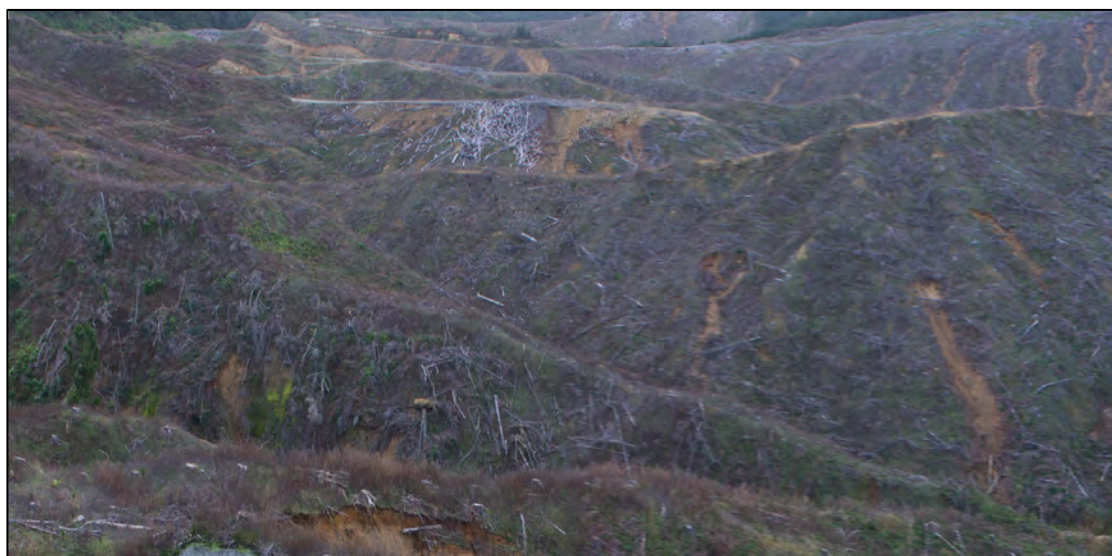
Figure Thirty Eight. View of eastern sites from Woolshed Road with Site Thirteen in the front and site Eleven behind.

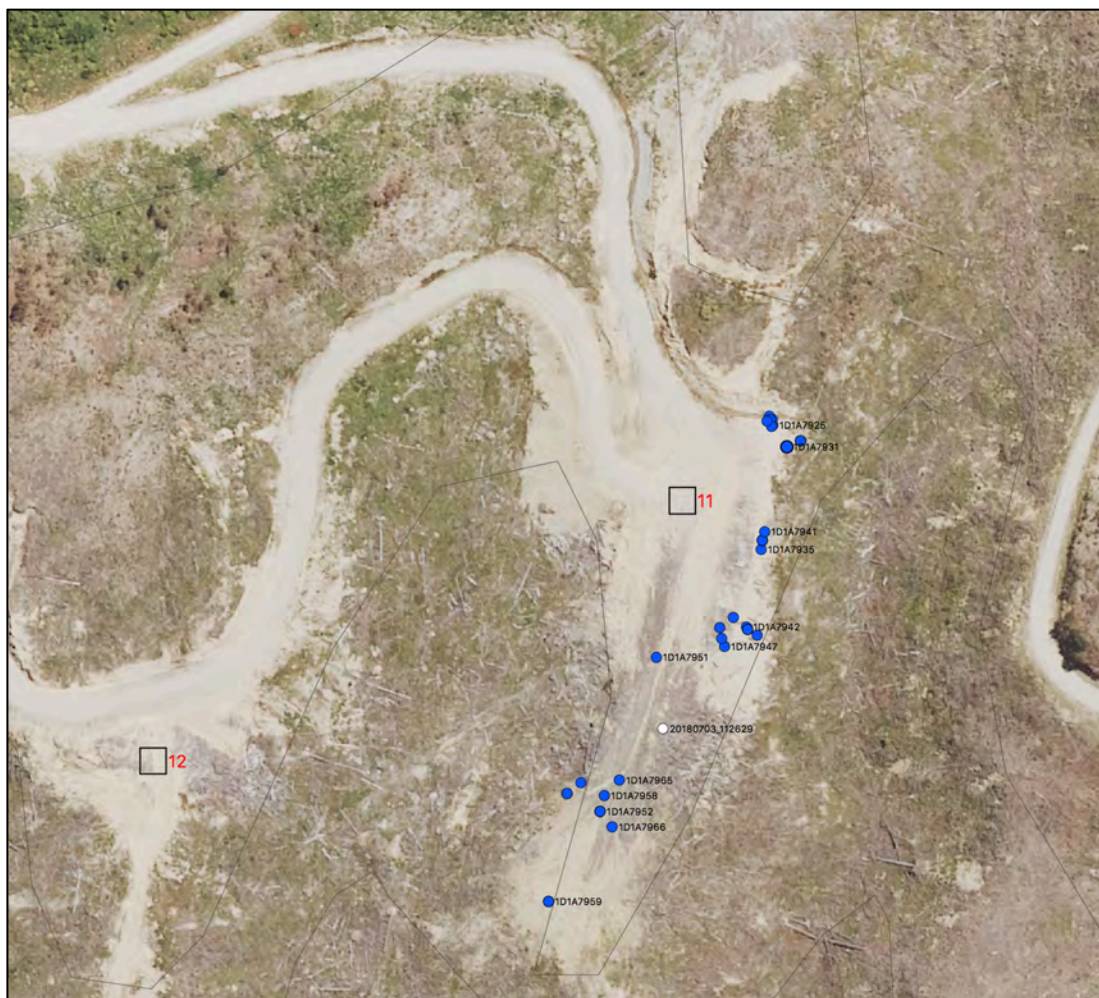
Figure Thirty Nine. Aerial photograph of Site Eleven showing at the top a large watercourse that discharges onto the slope on the right, a long white line where a drain has been cut from the watercourse directing water through the middle of the skid site discharging onto the slope on the bottom left of the skid site.

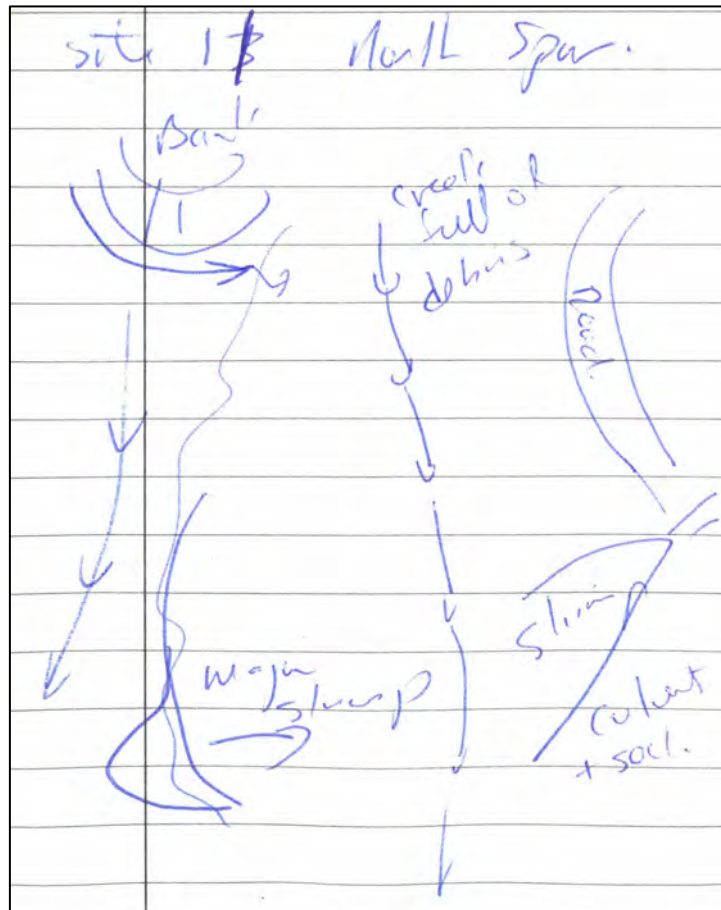
Figure Forty. Sketch of Site Eleven showing the main features of the site and the surrounding environment. The watercourse receiving water from the road above is shown at top left while the longitudinal drain is shown below this at left. The road on the right with slumping and culvert with sock is shown on the right.

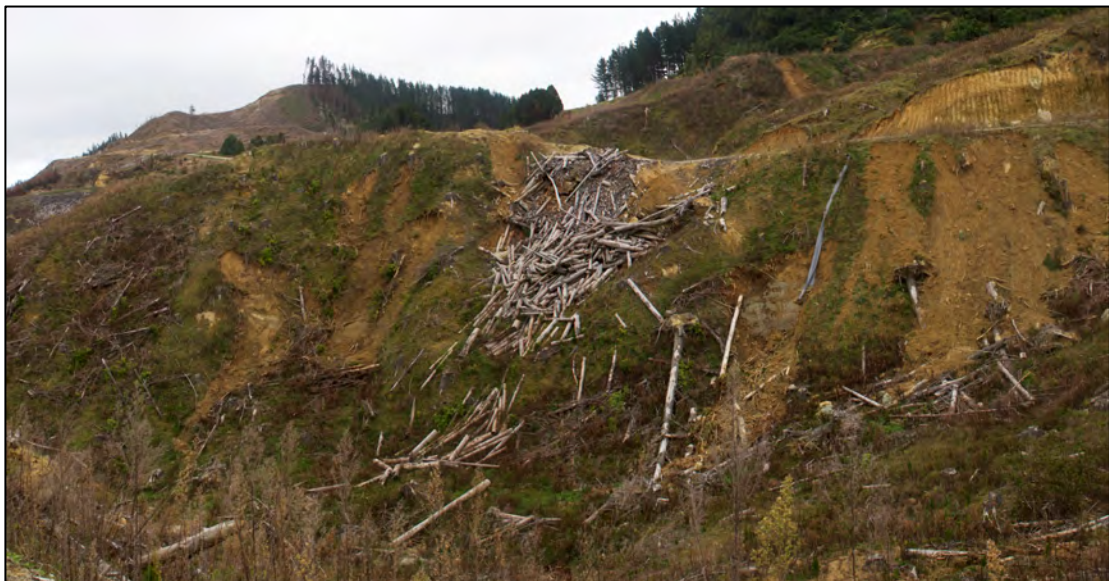
Figure Forty One. Composite Image (1D1A7958-1D1A7959) looking north west from Site Eleven showing a culvert with a sock directing stormwater onto slope materials which have washed away leaving bare rock. Further slope failures in side cast material is evident to the right of the culvert.

4. That HFF install or reinstate berms on the roadways to prevent the uncontrolled discharge of stormwater onto side cast or vulnerable ground.
5. The HFF repair existing culverts with adequate sided silt traps installed, and the socks are removed and replaced with fluming to hard ground.

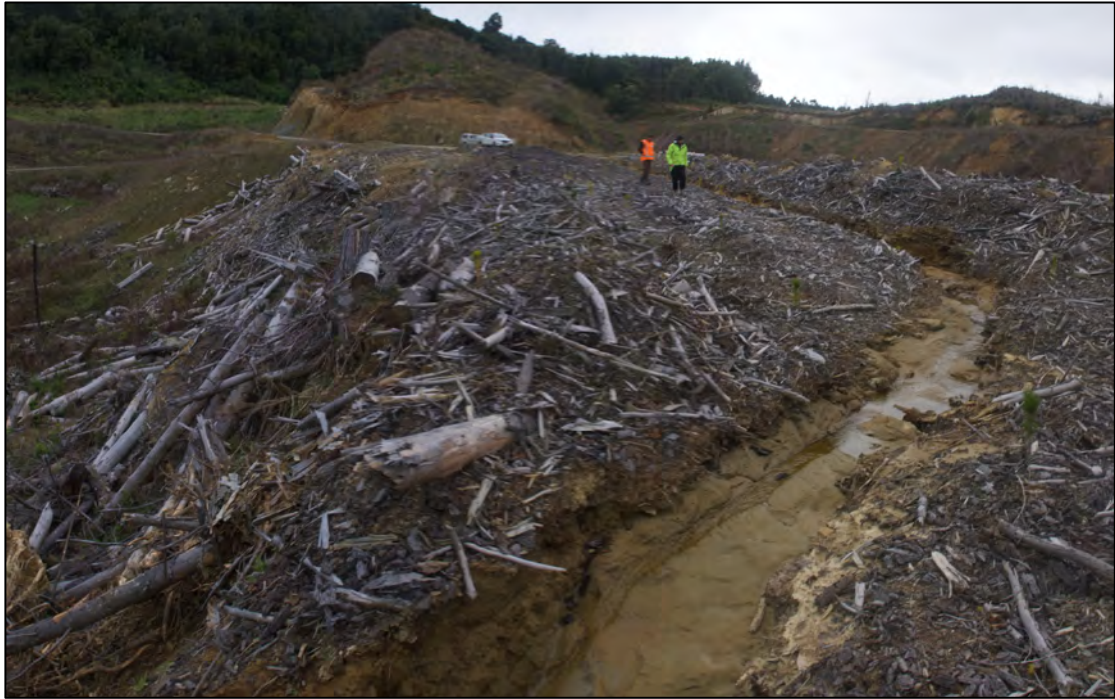
Figure Forty Two. View of the longitudinal drain cut through the middle of Site Eleven showing the deep incising through logging waste material.

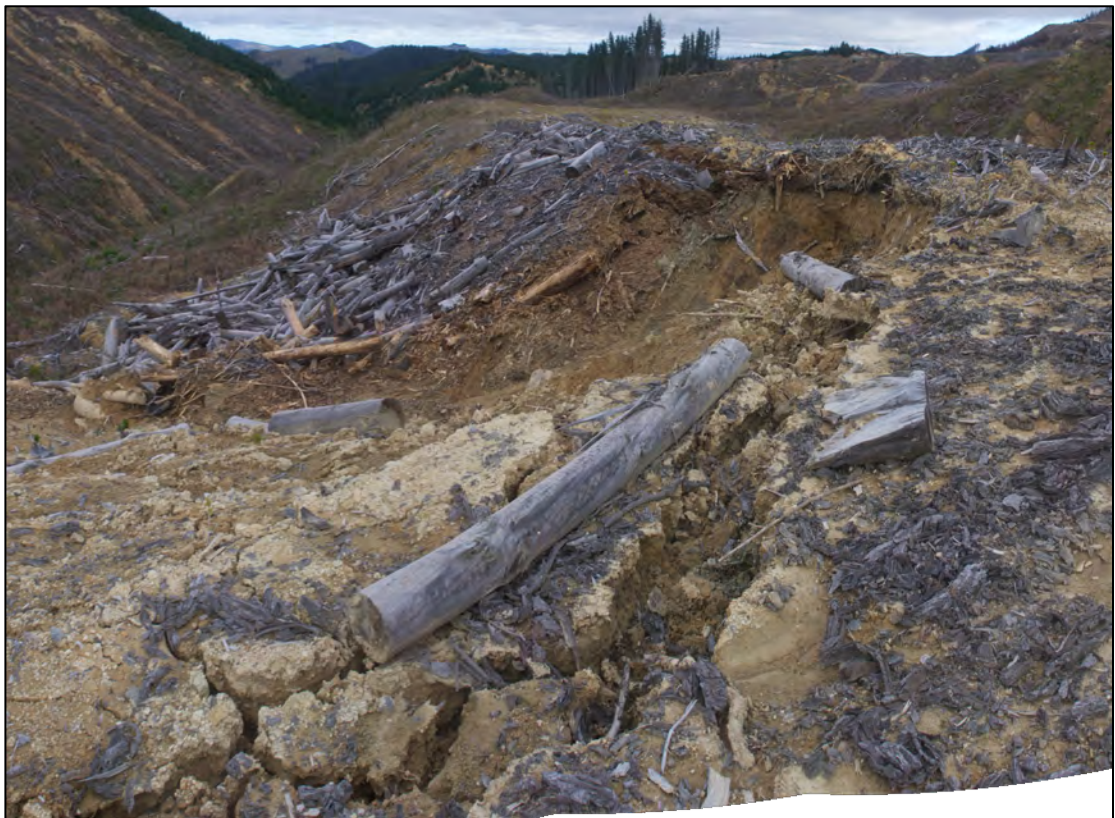
Figure Forty Three. Composite image (1D1A7942-1D1A7944) showing the major slump of logging waste on the eastern side of Site Eleven. The major tension crack in the foreground extends south into the pile of logging debris with indications of incipient failure within this pile.

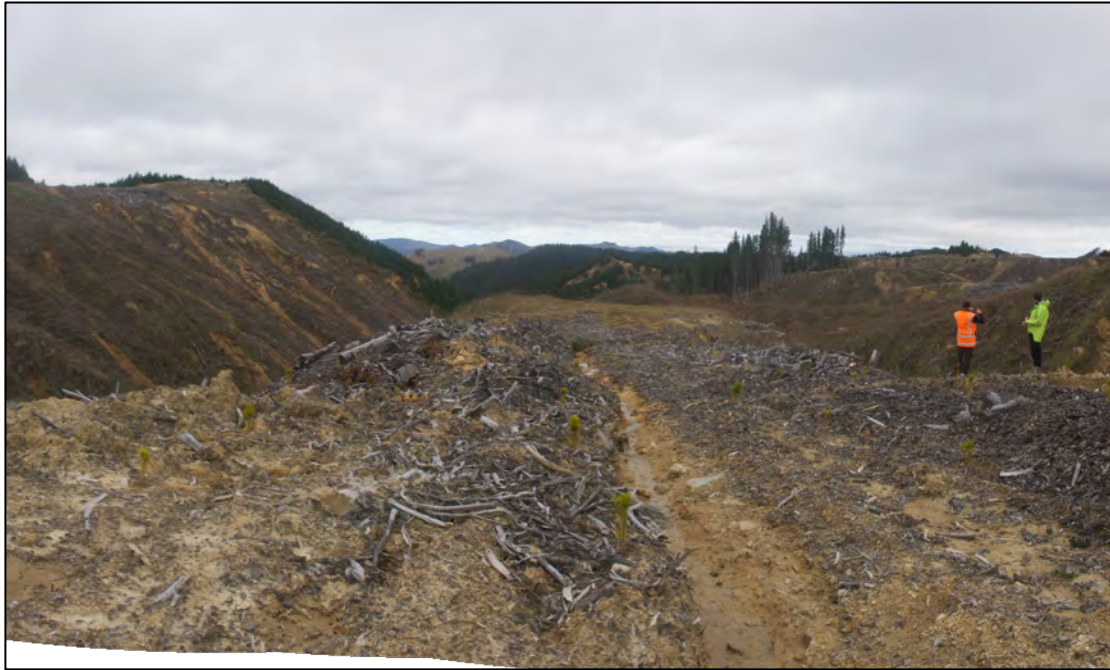
Figure Forty Four. Composite image (1D1A7947 to 1D1A7950) showing the longitudinal drain and the slumped material immediately to the east. Not the indications of standing water in the drain. During storm events this drain would carry significant volumes of water some of which would have been redirected across the skid site saturating the logging waste forming the base of the perched log pile that has slumped on the eastern side.

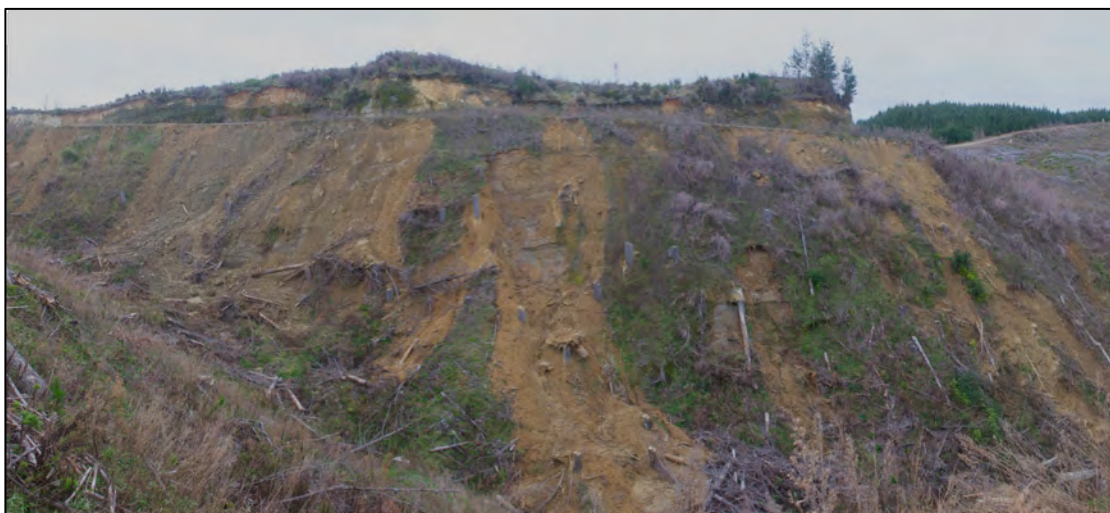
Site Eleven provides a good view of the area further east particularly Bush Road. There are a significant number of extensive slope failures on side cast material triggered at the road edge (**Figure Forty Five**). Further south on Bush road a culvert discharges onto side cast material (**Figure Forty Six**). This area hasn't been examined in detail but was flown over by drone and subsequently visited on the 10th of July.

Figure Forty Five. Composite image (1D1A7925 to 1D1A7930) showing the extent of slope failures in side cast material from Bush Road.

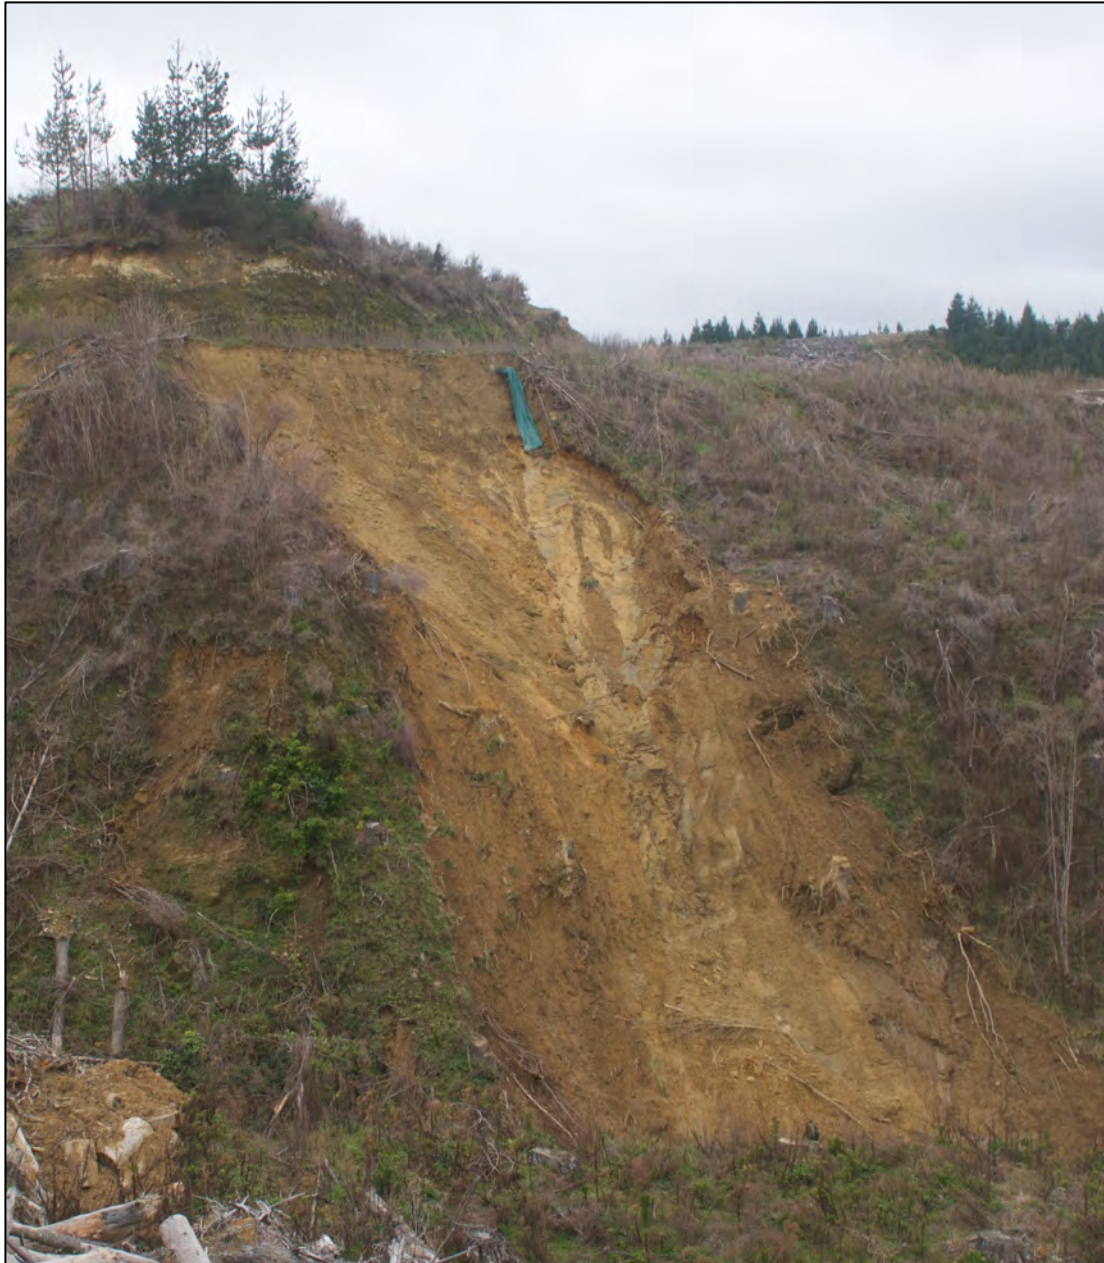
Figure Forty Six. Image 1D1A7965 showing a short section of sock from a culvert on Bush Road discharging water onto the top of side cast material on the slope resulting in the material failing.

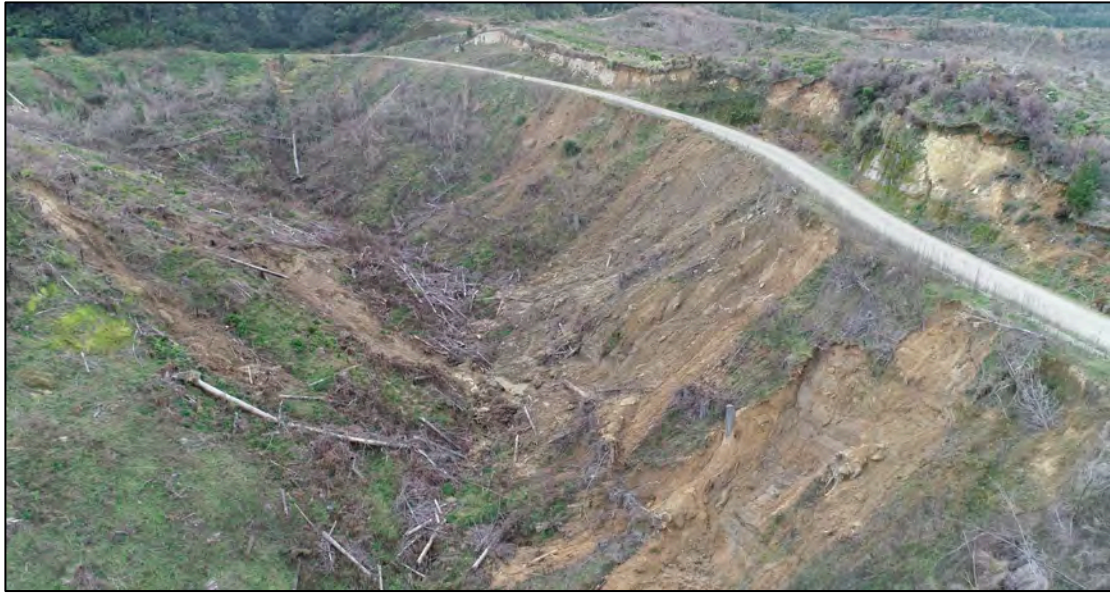
Figure Forty Seven. Oblique aerial image looking north with Site Eleven out of picture on the left and Bush Road on the right. Extensive slope failures originating from the road surface have reached the valley floor.

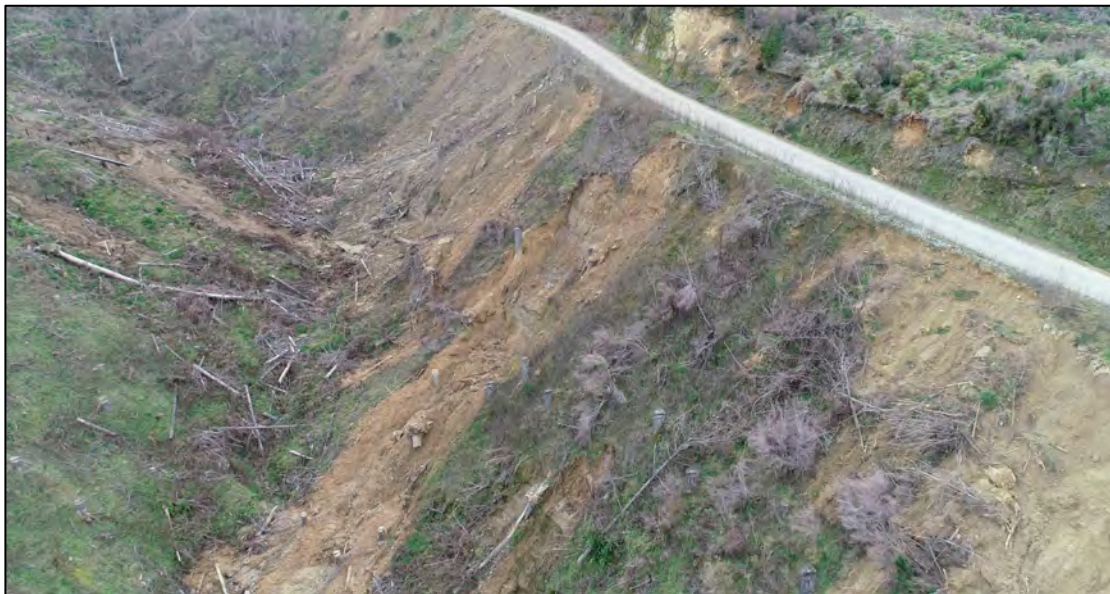
Figure Forty Eight. A similar view to **Figure Forty Seven** showing additional detail including the cut stump caught up in the slope failure middle ground. There are no culverts observable on this length of road.

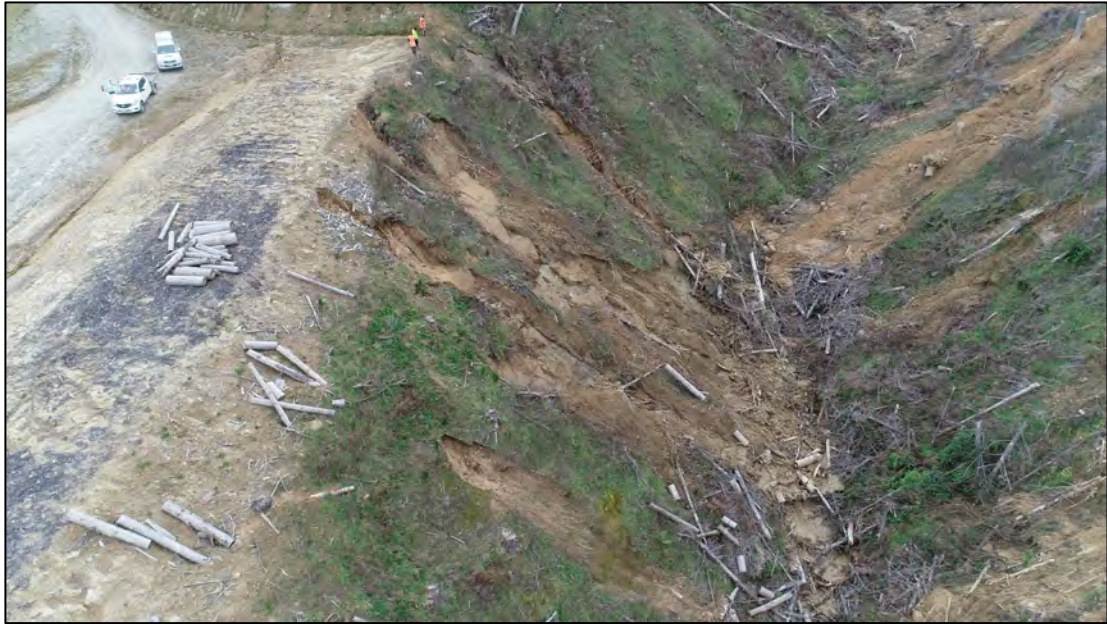
Figure Forty Nine. View of the north end of Site Eleven showing the watercourse at top the slope failures from the skid site and the longitudinal drain cutting south through the skid. The slope failures from the water course and that from Bush Road appear to the uppermost failures and have lead to significant erosion and downstream migration of logging debris and soil. Two of the Downstream slope failures appear to be toe failures.

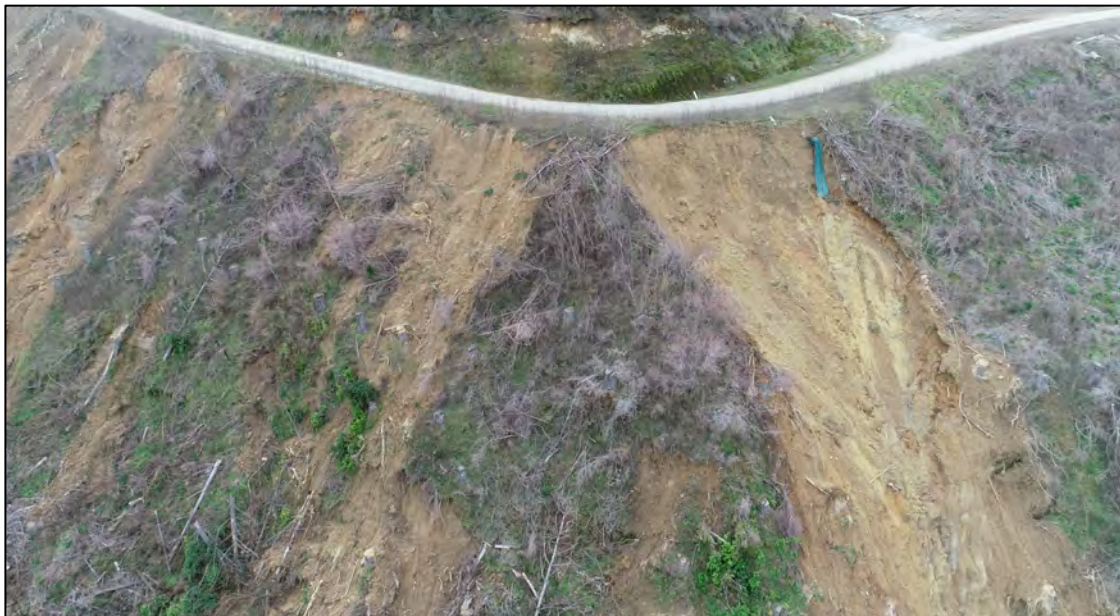
Figure Fifty. View of Bush Road showing the sock attached to a culvert south of the slope failures shown in **Figure Forty Seven**. The stump shown in **Figure Forty Nine** is visible far left.

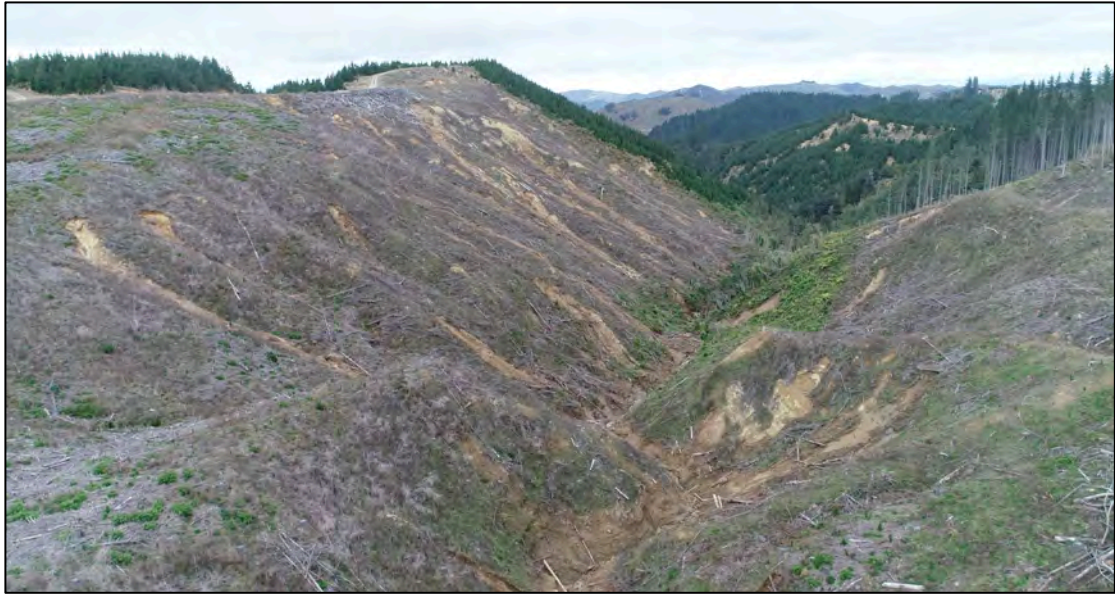
Figure Fifty One. View looking south with Bush Road out of picture on the left and Site Eleven out of picture on the right. Possible mid slope failures are shown but the valley floor has been highly cut out and the mid slope failures in the middle ground are connected to the valley floor and it is probably that these are toe failures resulting from when scouring on the valley floor undermined the slopes.

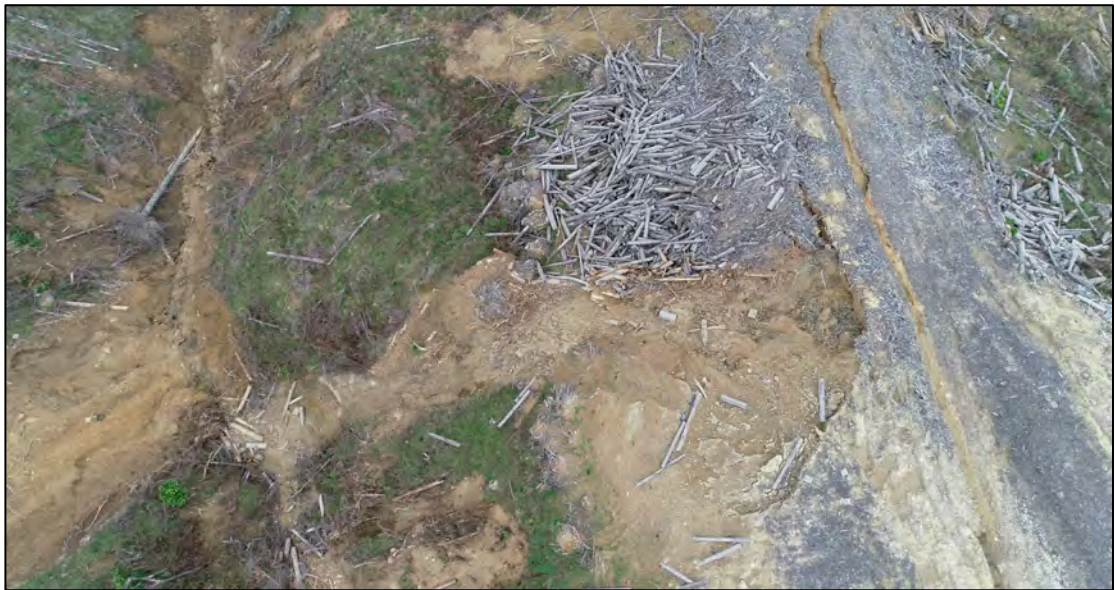
Figure Fifty Two. Near vertical shot of the middle part of Site Eleven showing the longitudinal drain adjacent to a major slope failure on the lefthand (east) side. A large tension crack is evident through the failed material and extends into the pile of logs at the top of the picture. It appears that the major mobilisation of debris down valley originated from this slope failure and the one adjacent but prior images also show failures to the valley floor upstream of this view and hence failure mechanisms may have been complex with a combination of headscarp and toe failures contributing.

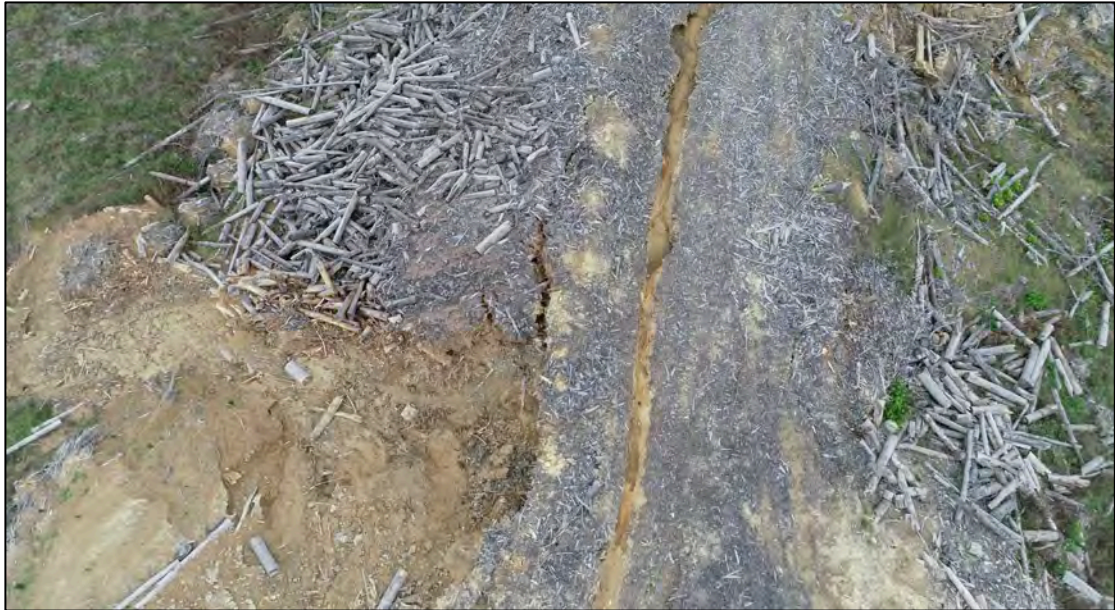
Figure Fifty Three. A similar view to Figure Fifty One but clearly showing the deeply incised longitudinal drain and an enlarged deeper part of the drain adjacent to the tension crack on the left (east). The largest slope failure is shown at the bottom of the image. The large amount of logging waste left (east) of the tension crack indicates that a greater volume of material is at risk of mobilising.

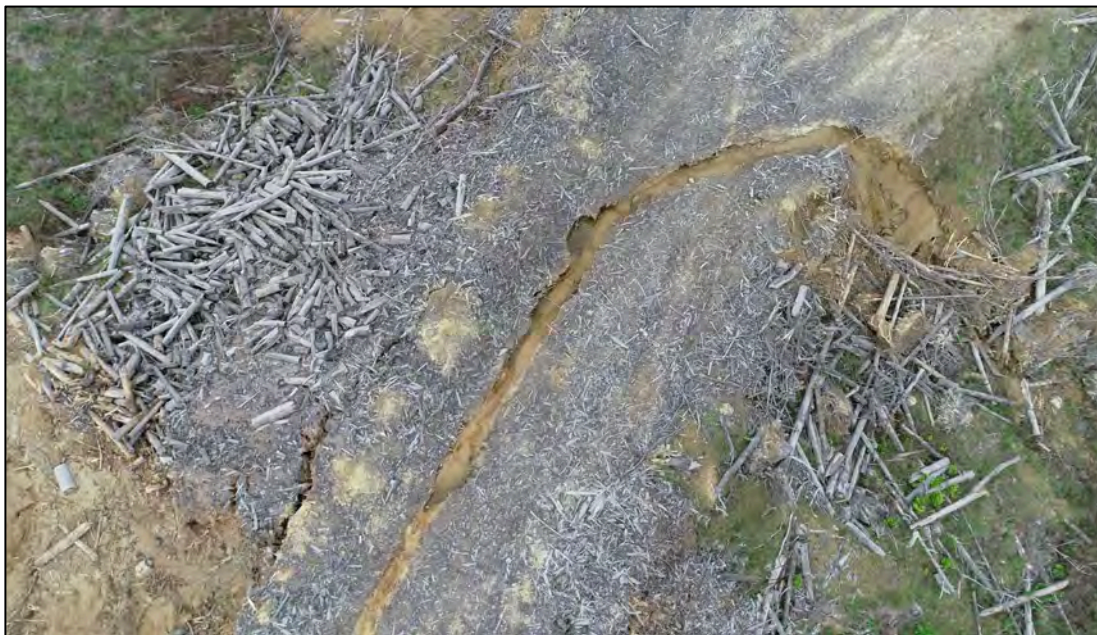
Figure Fifty Four. Vertical view of the tension crack at Site Eleven and the longitudinal drain discharging onto the slope on the right (west) resulting in some slumping of logging waste and soil. Two enlarged areas within the drain are evident; one adjacent to the tension crack and the other approximately halfway from there to the discharge point.

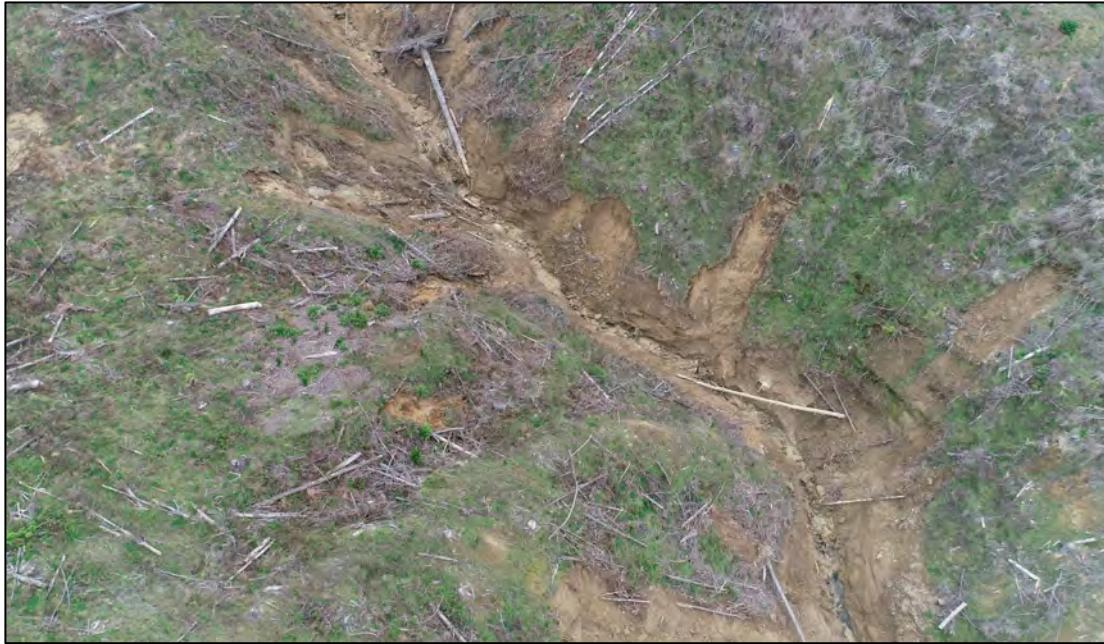
Figure Fifty Five. Extensive toe failures in the stream between Site Eleven and Bush Road.

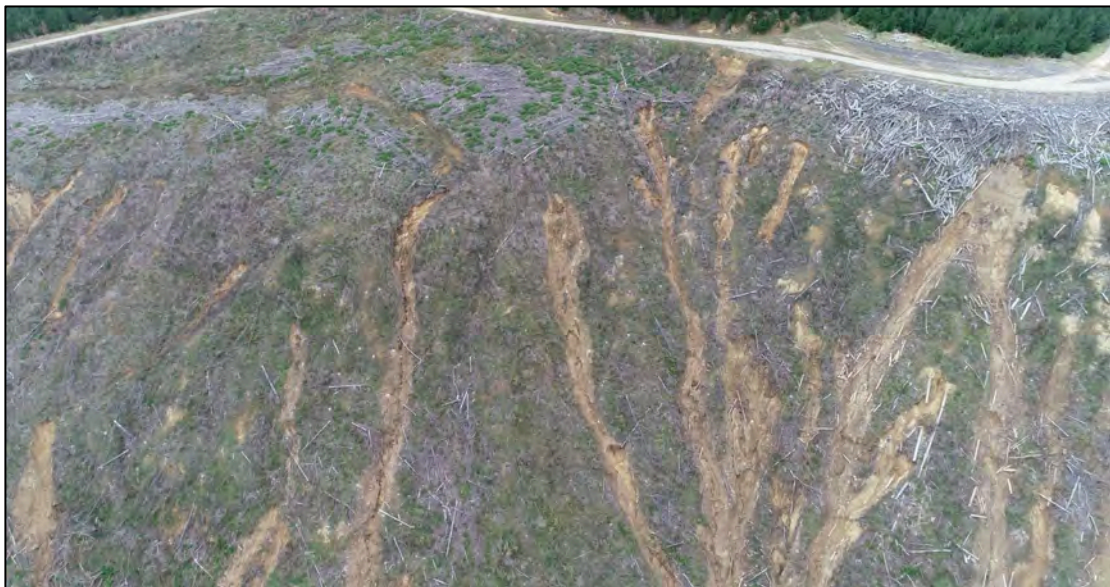
Figure Fifty Six. View of slope failure typically described as mid slope failures. The majority of these have headscarps associated with forestry activity. One at the middle left has originated from a rough track that cuts through the slash left on the slope and this will have directed water onto the area that failure. Right of that there are several slope failures where the headscarps coincide with the top of a bench and beyond that a failure from the edge of Bush Road. On the far right a large failure has occurred where a large volume of logging debris has been left perched on the top of the slope adjacent to Bush Road.

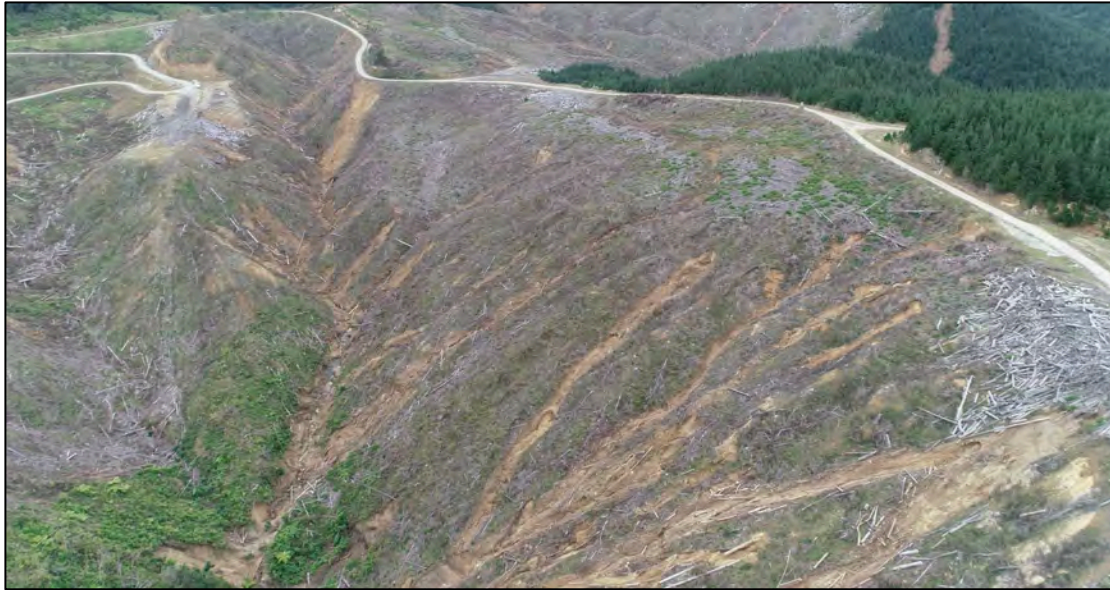
Figure Fifty Seven. Distant view looking north with Site Eleven on the left (west) and Bush Road on the right (east). The major failure that occurred where the culvert and short sock discharged onto side cast material is evident as the bright failure adjacent to Site Eleven while the failures shown in **Figure Fifty Six** are at bottom right. Extensive erosion of the valley floor and associated toe failures are also evident.
