Hikurangi Forest Farms Wakaroa Forest, Upper Waimata 3 July 2018

Compliance visit to assess whether or not an investigation is required

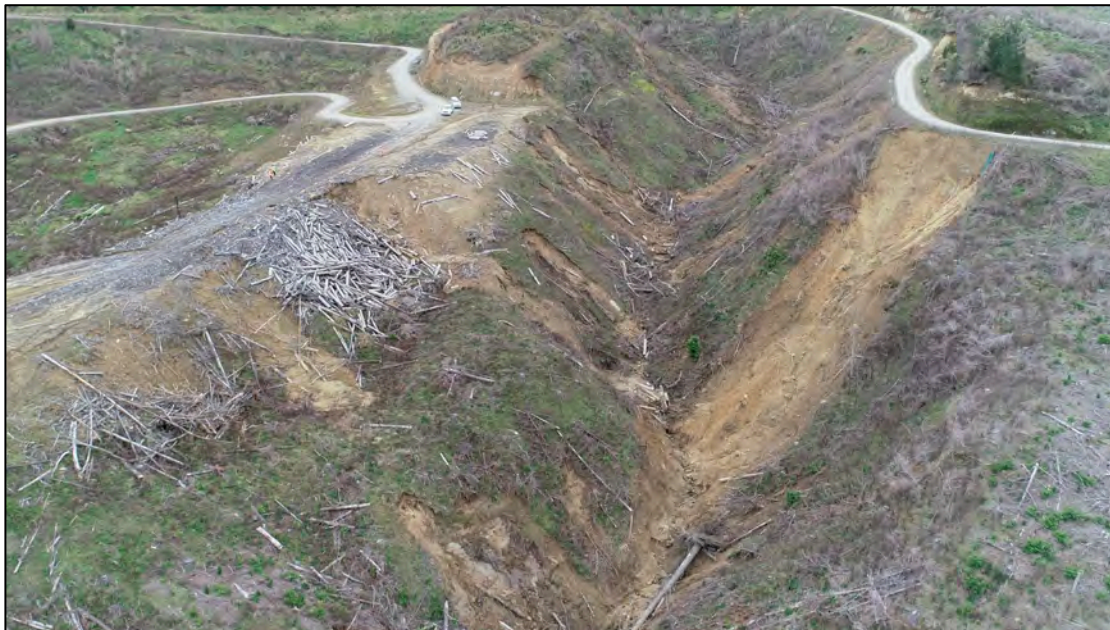
Figure Fifty Eight. A closer view of Site Eleven on the left and Bush Road highlighting the level of failures from Site Eleven and the bench below the perched material. On the far left the bench as caught the logging debris and has acted as an effective berm but in the middle ground the berm has not been an effective barrier and the slope failure has reached the valley floor. The major slope failure from the culvert and sock is on the right.

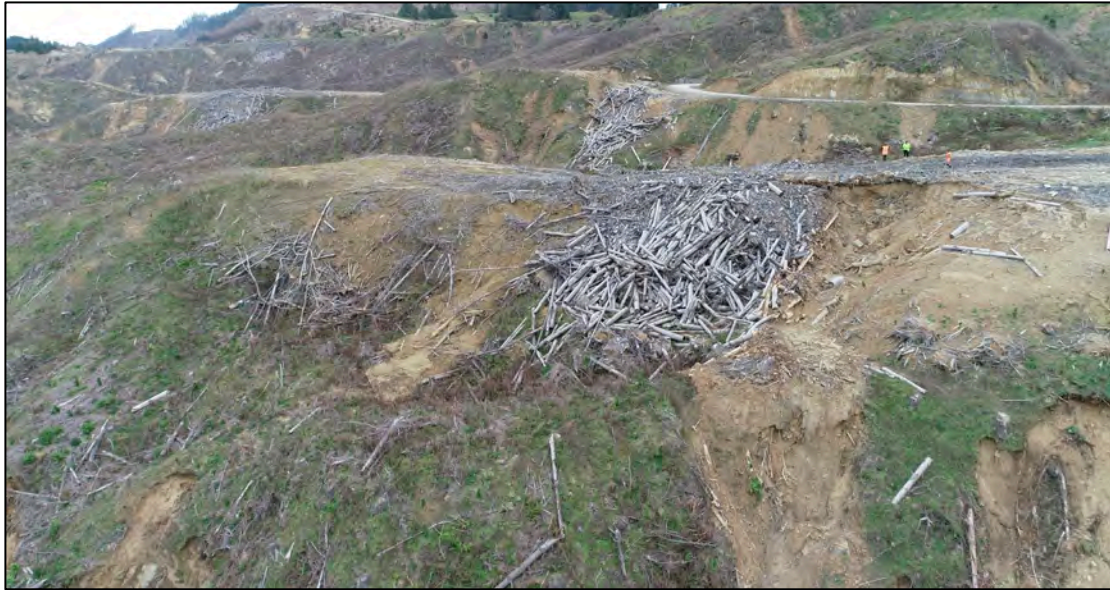
Figure Fifty Nine. View of Site Eleven with Site Twelve beyond and Site Thirteen at top left showing that similar failures on the roadway and skid sites to those at Site Eleven are present. This aspect provides a better view of the bench below Site Eleven and in particular suggests that there is a drainage flow line from the slip in the middle ground and the lower failure at bottom left. The undercutting of the surface of the skid site at the headscarp of the main failure is also evident at top right.

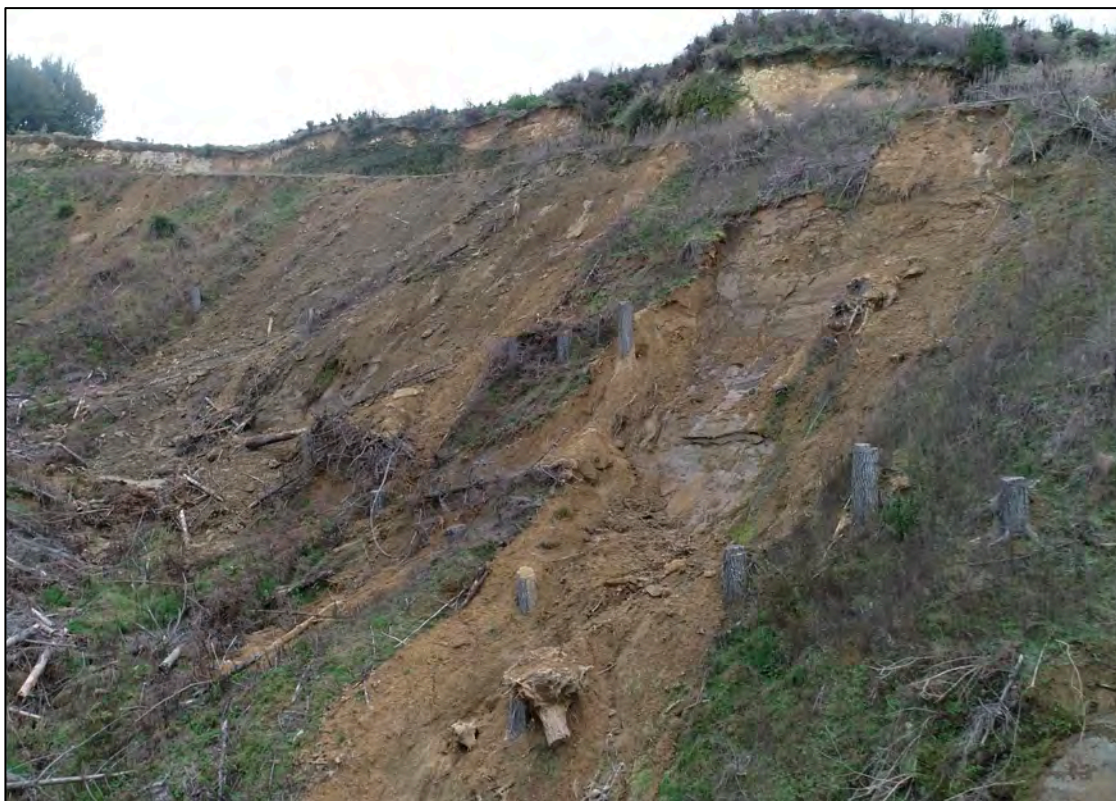
Figure Sixty. Close up view of the slope failure from Bush Road showing that this has occurred in side cast material as indicated by the soil caught up behind the trunks of the stumps at top middle.
