Gisborne District Council

# WAIHAU ROAD POST-SLIP RISK ASSESSMENT

7 DECEMBER 2023

## SITE VISIT PHOTOS – 15 NOVEMBER 2023

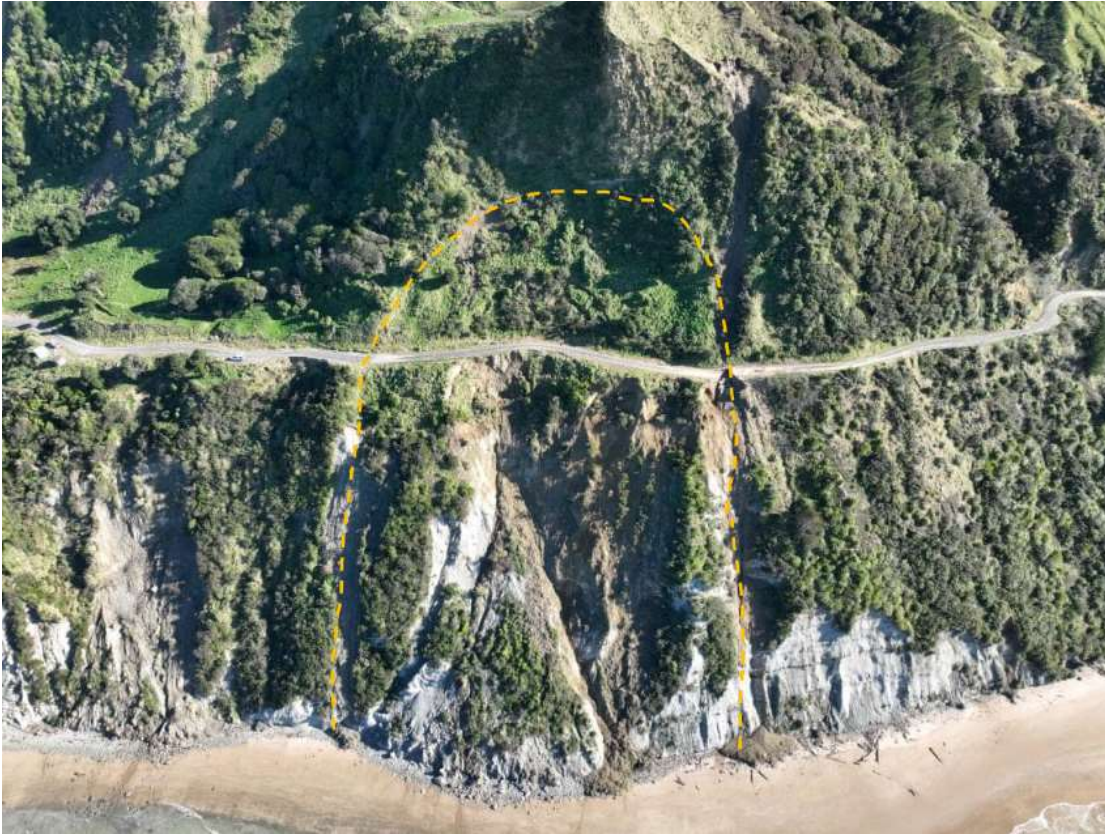
Photo 2: Aerial imagery captured by LDE in July 2023, with extent of larger landslide shown

The landslide and debris flow occurred at the northernmost extent of what appears to be a larger landslide feature, previously identified by LDE.

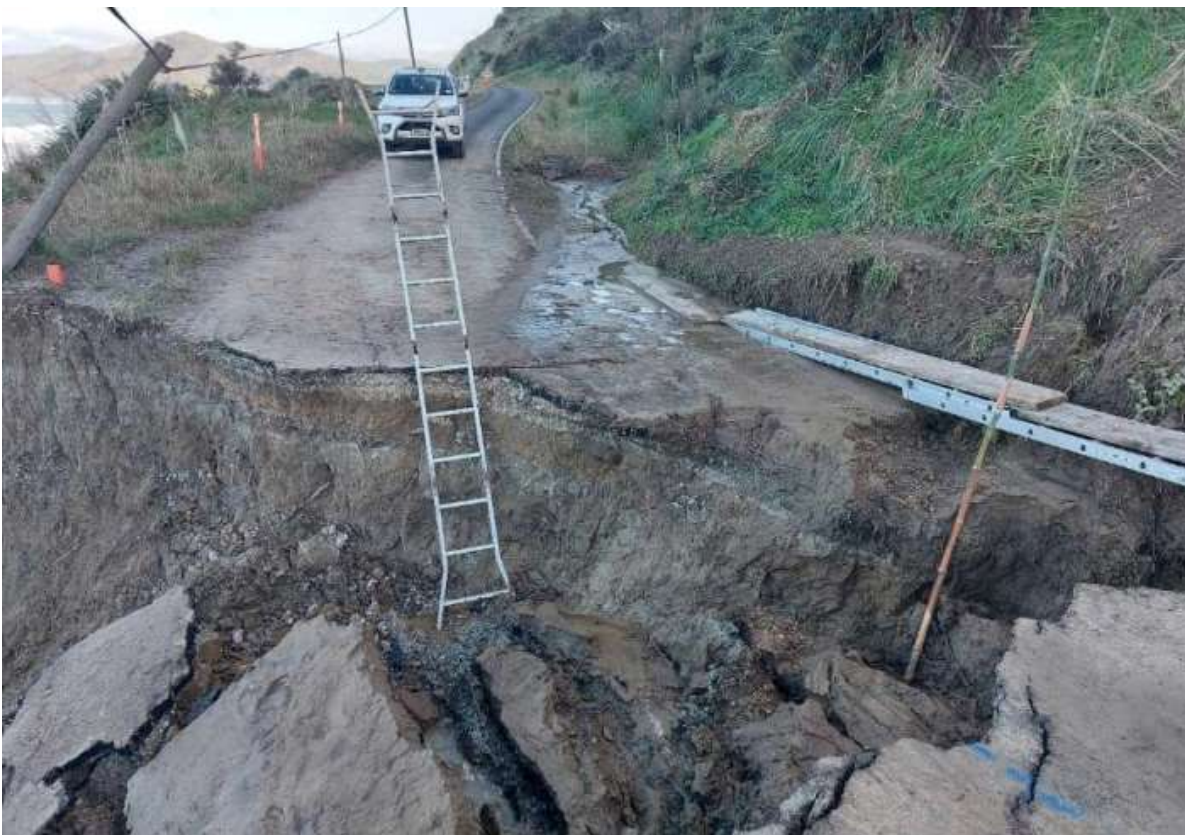
- A dropout, approximately 5m wide, occurred within the roadway and impacted the entire formed road width, refer Photo 3. A debris flow occurred from the slope directly above the dropout.
- The dropout is interpreted as being the northern most extent of a much larger landslide in the order of 110m wide. The landslide feature was identified by LDE during their initial inspection and later confirmed with aerial imagery, refer Photo 2.
- Cracking at several other locations along Waihau road within the landslide extent also occurred.
- A large wedge failure occurred within the bluffs beneath the road. Additionally, several cracks, defects and rock features were identified by LDE within the slopes and sandstone bluffs above the roadway.

Photo 3: Photo taken by LDE showing the dropout at Waihou Road (temporary foot access created by locals)

- The dropout has been repaired with bulk earthworks and a cantilevered timber pole retaining wall has been constructed at the toe of the dropout. The retaining wall is approximately 12m long and consists of 250mm dia. SED timber poles embedded in concrete footings. Two subsoil drain outlets can be seen at the toe of the retaining wall. The retaining wall has not been engineered.

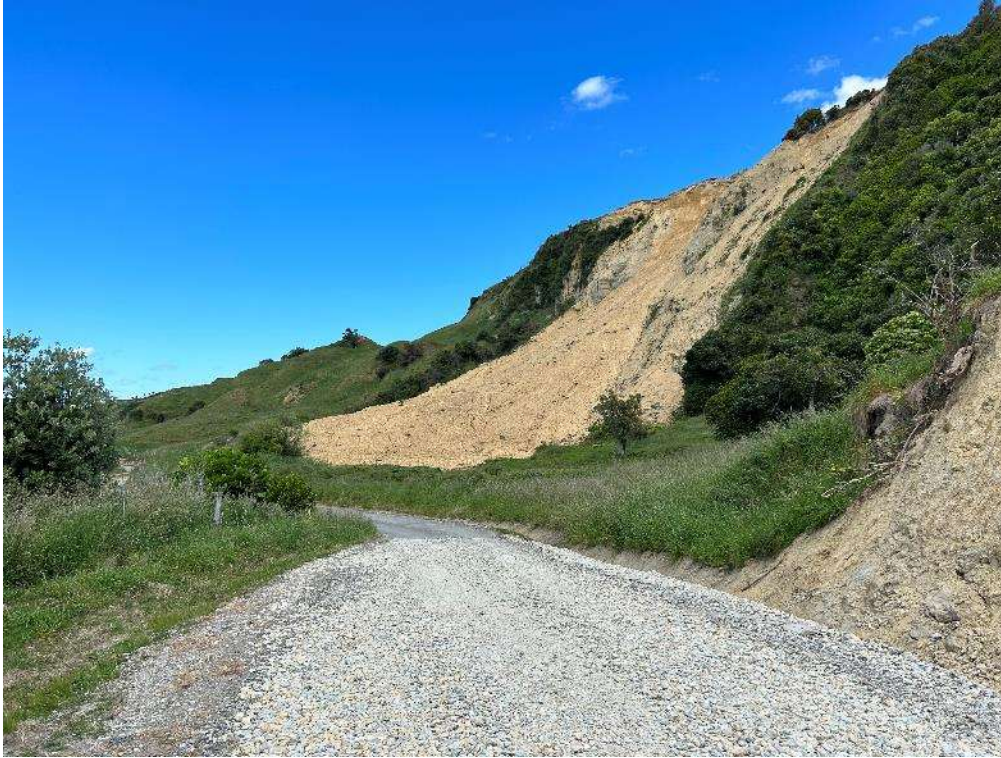
A large debris flow and several small dropouts on the seaward side of the road were observed along Waihau Road outside the extent of recently completed remedial works. Many of the dropouts look to pre-date the June 2023 rainfall event.

Photo 1: Debris flow hazard, outside extent of works, unrelated to landslide hazard discussed in this report. Typical of geotechnical hazards present along Waihau Road.

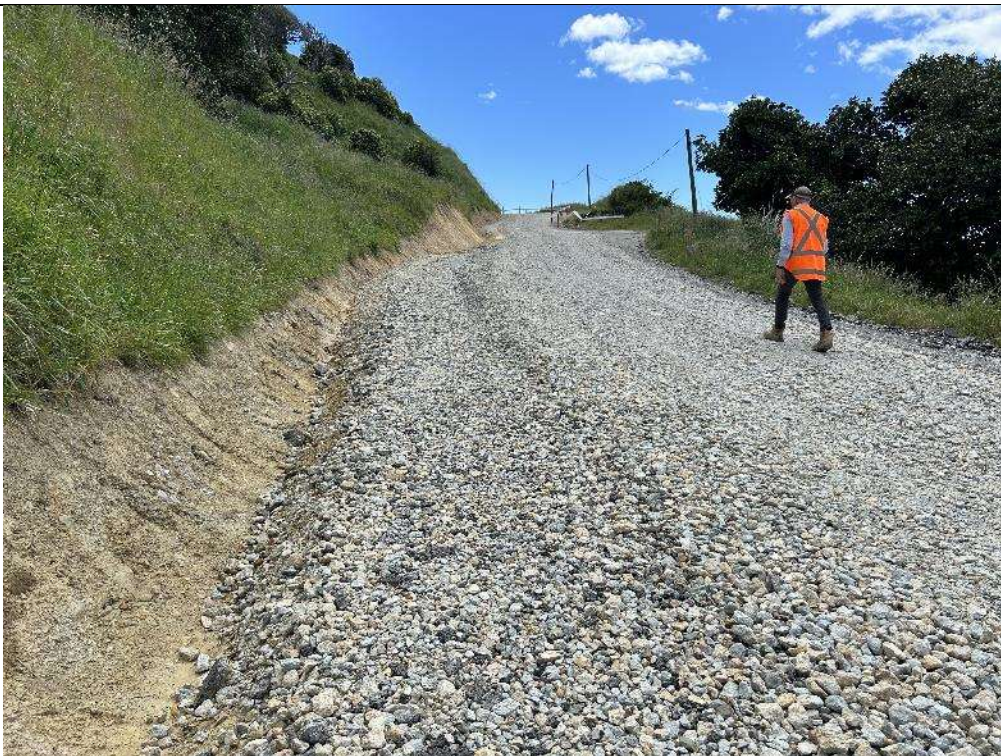
Photo 2: Road surface reinstated, minor excavation into landward slopes to form drainage channel

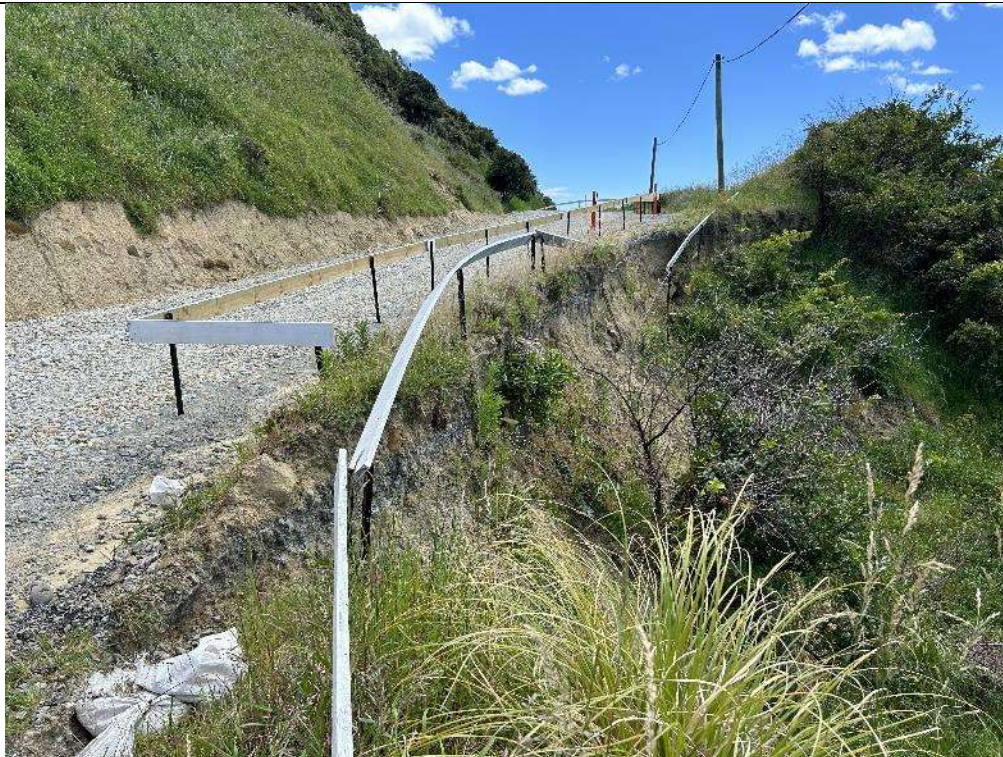
Photo 3: Sight rail reinstated above historic slip site (outside landslide feature extent discussed in this report)

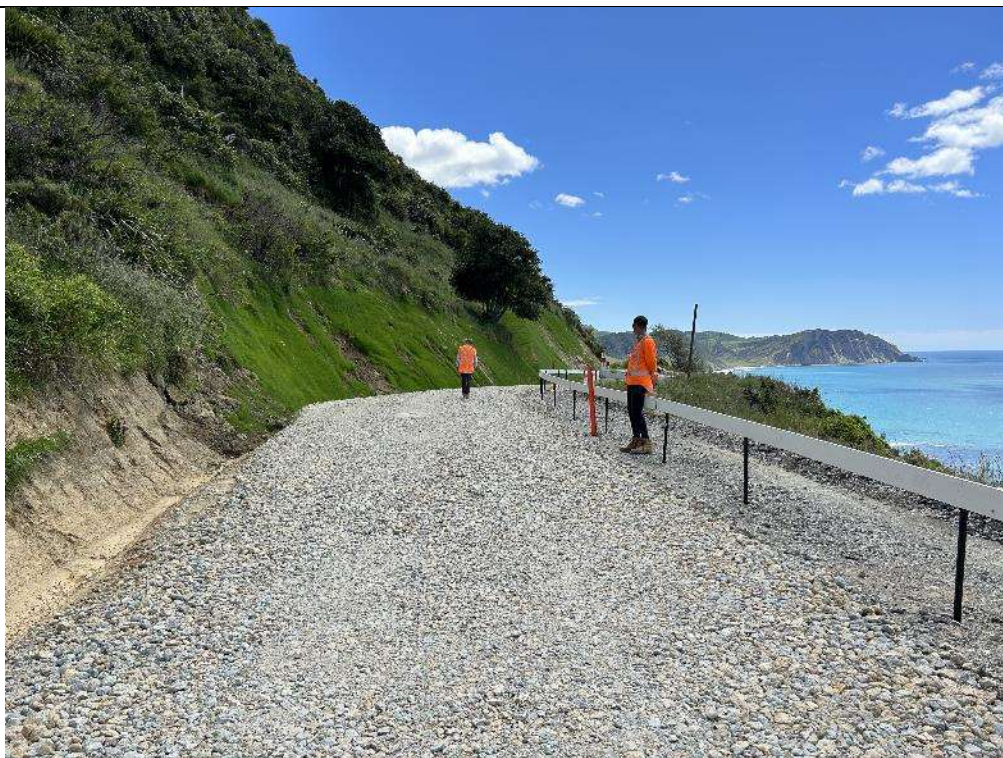
Cut slopes are steeper than would likely have been recommended if stability analysis had been completed, and therefore residual or existing Factors of Safety against global instability are likely to be less than 1.5 under static conditions. Shallow fretting of the cut slope will likely continue, as shown by the shallow failures observed on the cut slopes during the site inspection. Many of these shallow failures will be caught by the roadside drain. 'Shallow' in this instance is defined as a failure that only affects the near surface soils of the slope.

Photo 4: Road surface reinstated, road moved away from seaward cliffs, example of typical cut slope angles in the background recently hydroseeded.

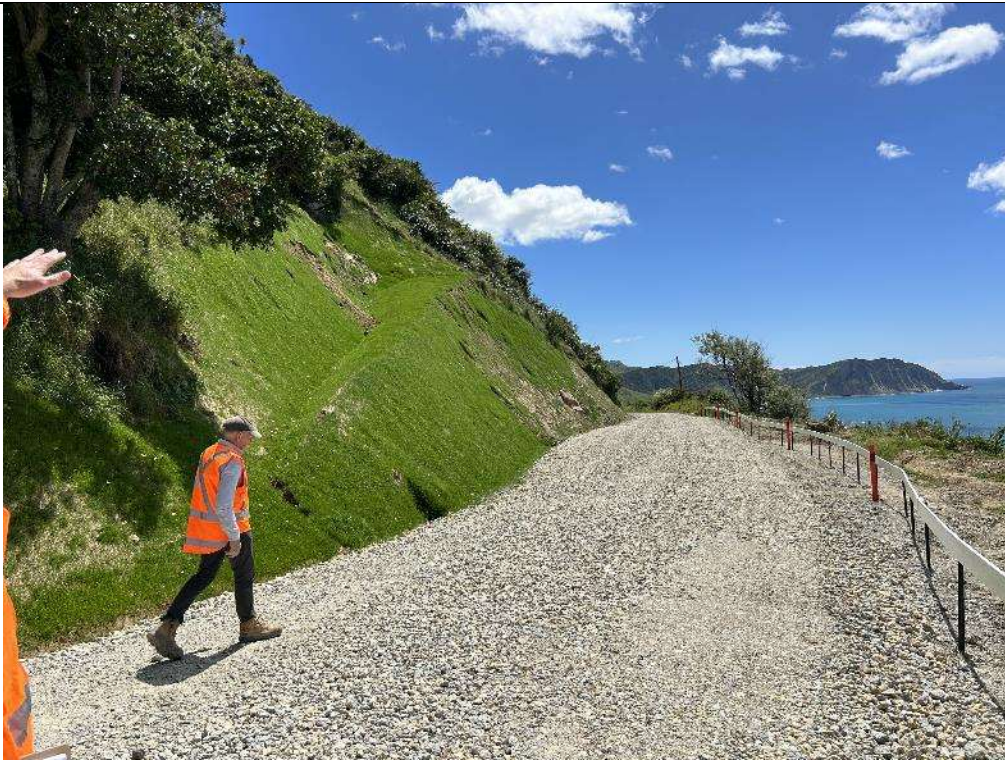
Drainage has been improved when compared to pre-June 2023 conditions but will need to be maintained to remain effective. Scour from the V-drain and fretting from the slopes will lead to blockage of the roadside drain and the new culvert if they are not maintained or periodically cleared.

Photo 5: Large V drain and cut slope constructed and hydroseeded, shallow slope failures evident on steep faces. Road is 1.5m to 2.0m away from seaward cliff crest.

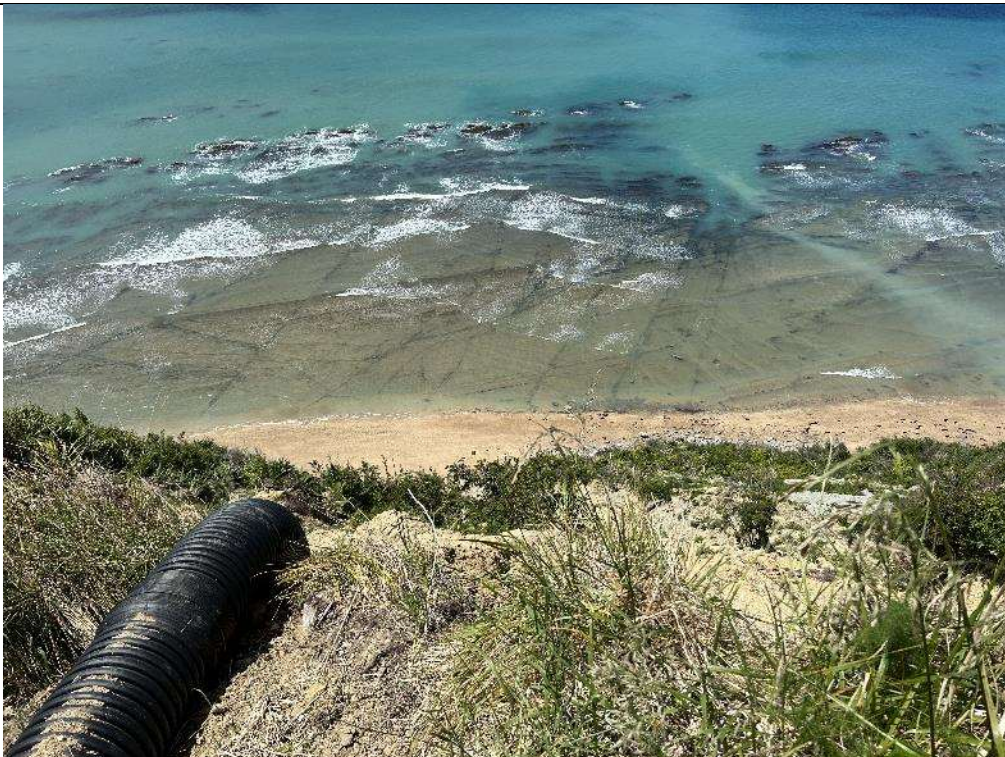
Photo 6: New culvert outlet with rigid flume over cliff edge.

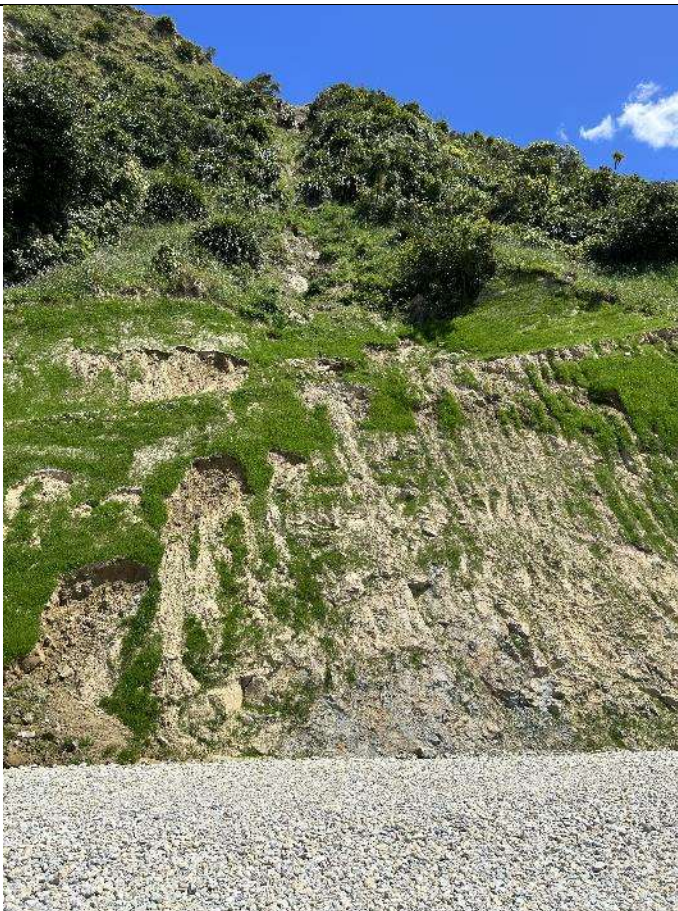
Photo 8: View towards source of debris flow, now directed by V-drain. Cut slope in extremely weathered sandstone/mudstone with surficial failures evident.

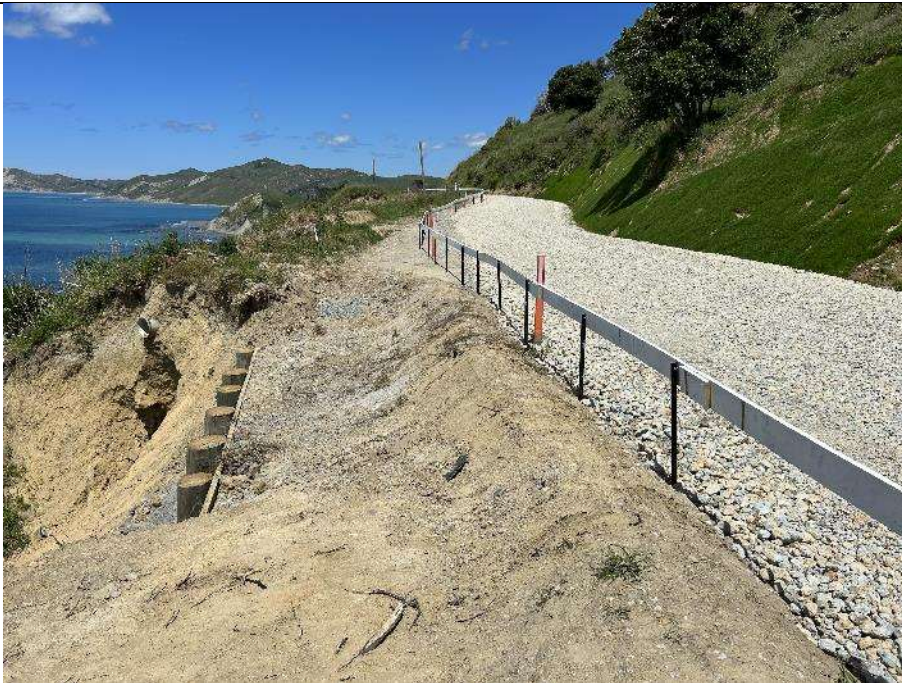
Photo 9: Road reinstated at drop out location, timber retaining wall at toe of reinstatement. Old culvert outlet visible in background, culvert is de-comissioned with no water outletting anymore.

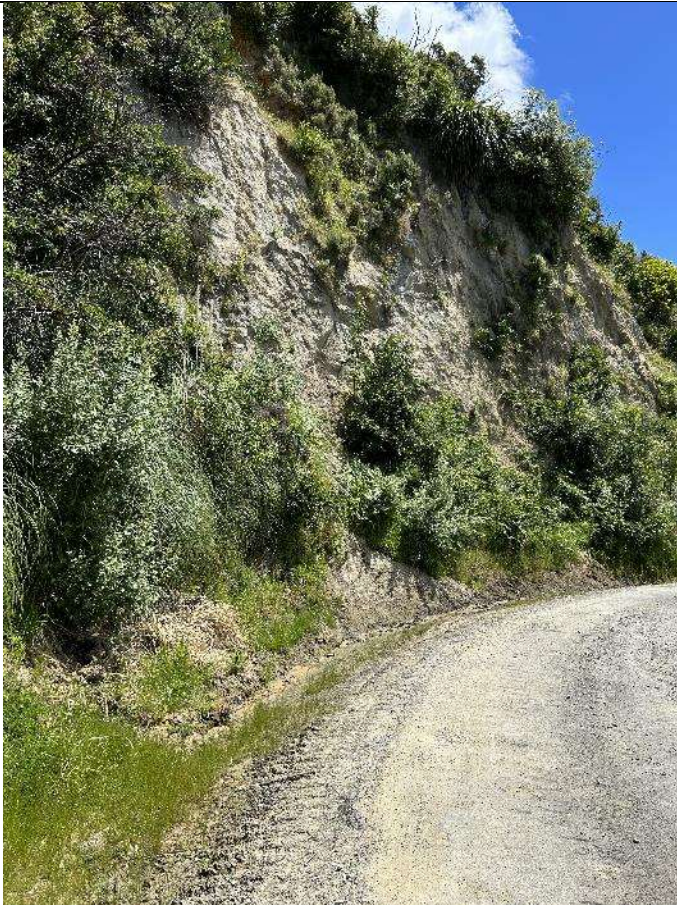
Photo 10: Cut slopes within similar material standing steeply just north of the site

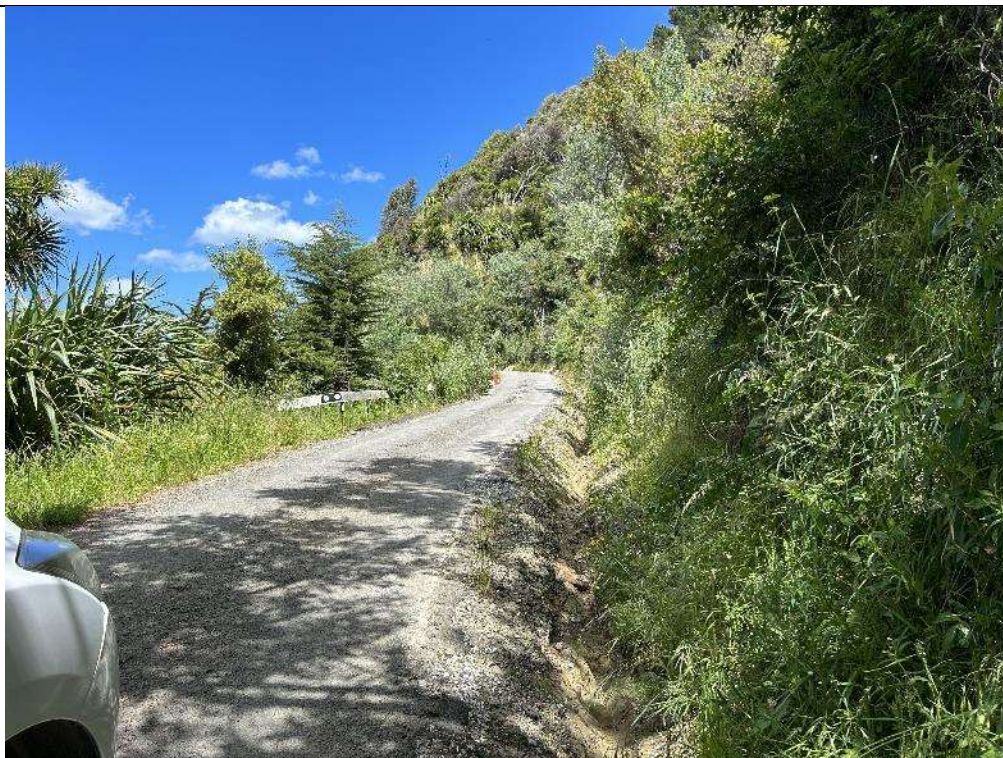
Photo 11: General road environment north of the extent of works, narrow road width with steep drop off to the coast below.
