GNS Overflight 18th July 2018 Wakarua Forest Waimata

On the 18th of July, Dr's Rosser and Townsend from the Institute of Geological and Nuclear Sciences (GNS) and Murry Cave from GDC undertook two flights to assess the regional landsliding impact from the Queens Birthday storm and the subsequent event one week later. This segment of flight one approached from the north, crossing the operational part of Wakarua Forest (Wakarua West and south). It then headed nor-north east to cover the area immediately west of inspected on the 3rd of July. The flight then traversed Mangahouku Stream enroute to Uttings Bridge. (Figures One and Two). The Wakarua forest covers two catchments; Waimata in the South East and Waipoa in the North West. The forest has been examined in detail since significant logging debris damaged the bridge at Uttings on the Waimata Road and this material has been traced back to this forest.

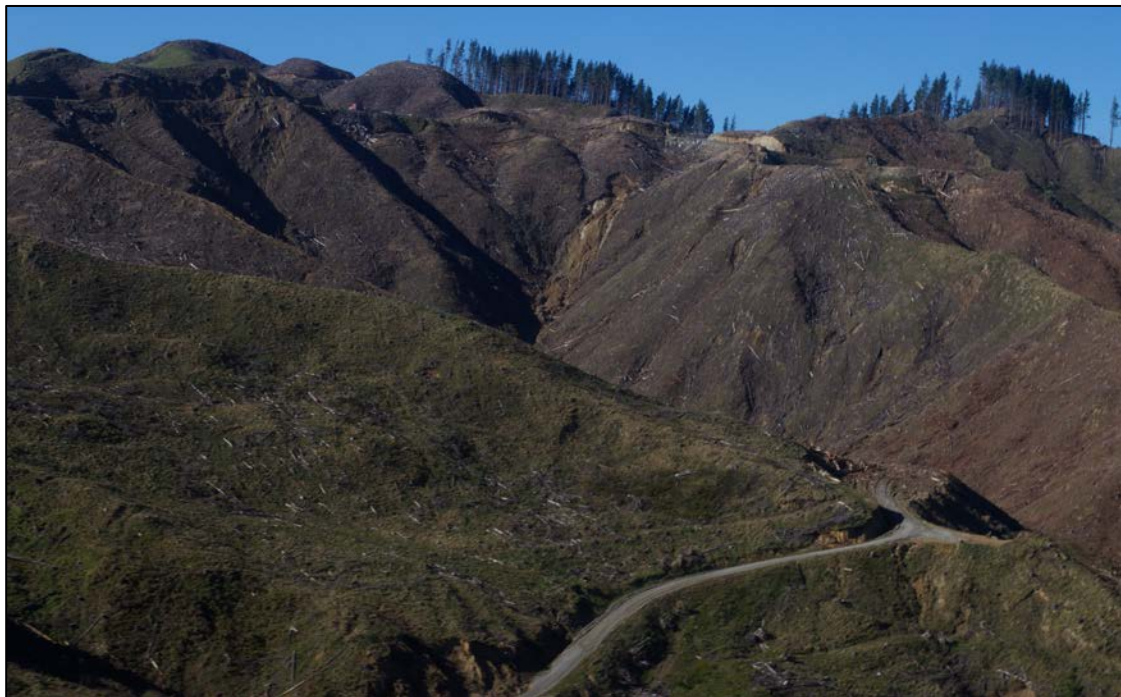
Image 009A9041

Figure Three. View looking east showing a significant debris flow from a roadway as well as a smaller failure from the end of a rough track.

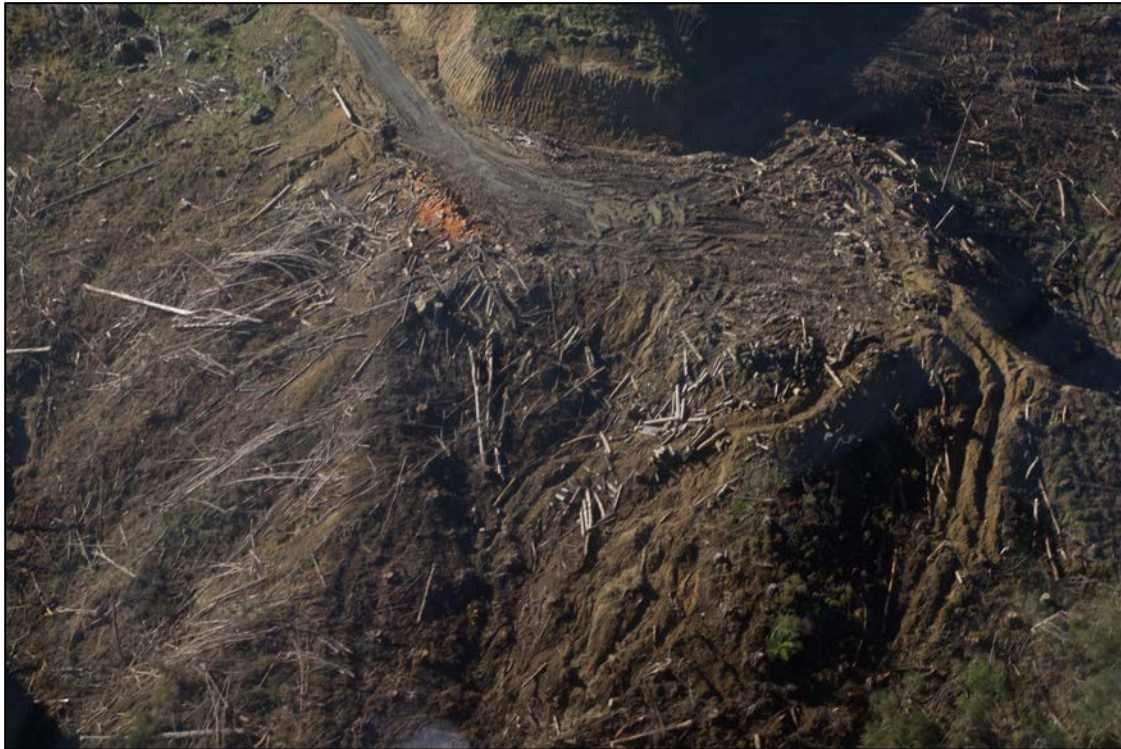
Image 009A9043

Figure Four. View looking east showing a skid site looking east showing a slope failure from a drainage channel cut at the edge of the skid site and generally messy housekeeping.

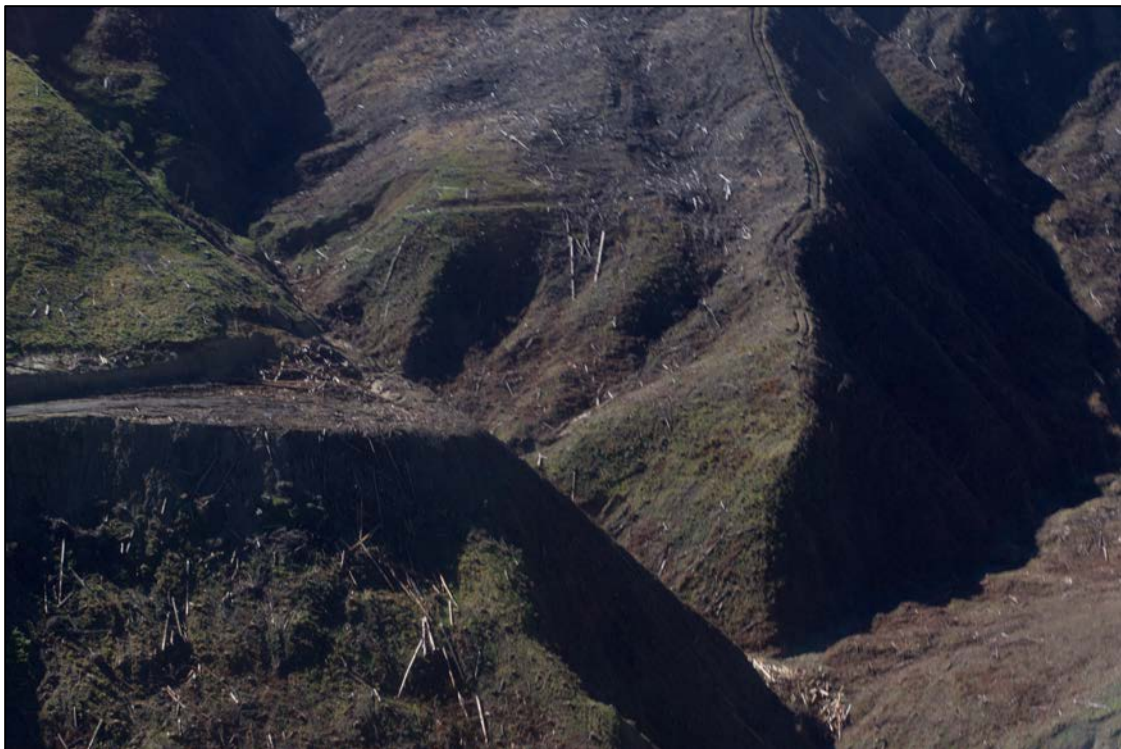
Image 009A9045

Figure Five. View looking east showing a skid site with logging debris in the watercourse and over the edge of steep slopes.

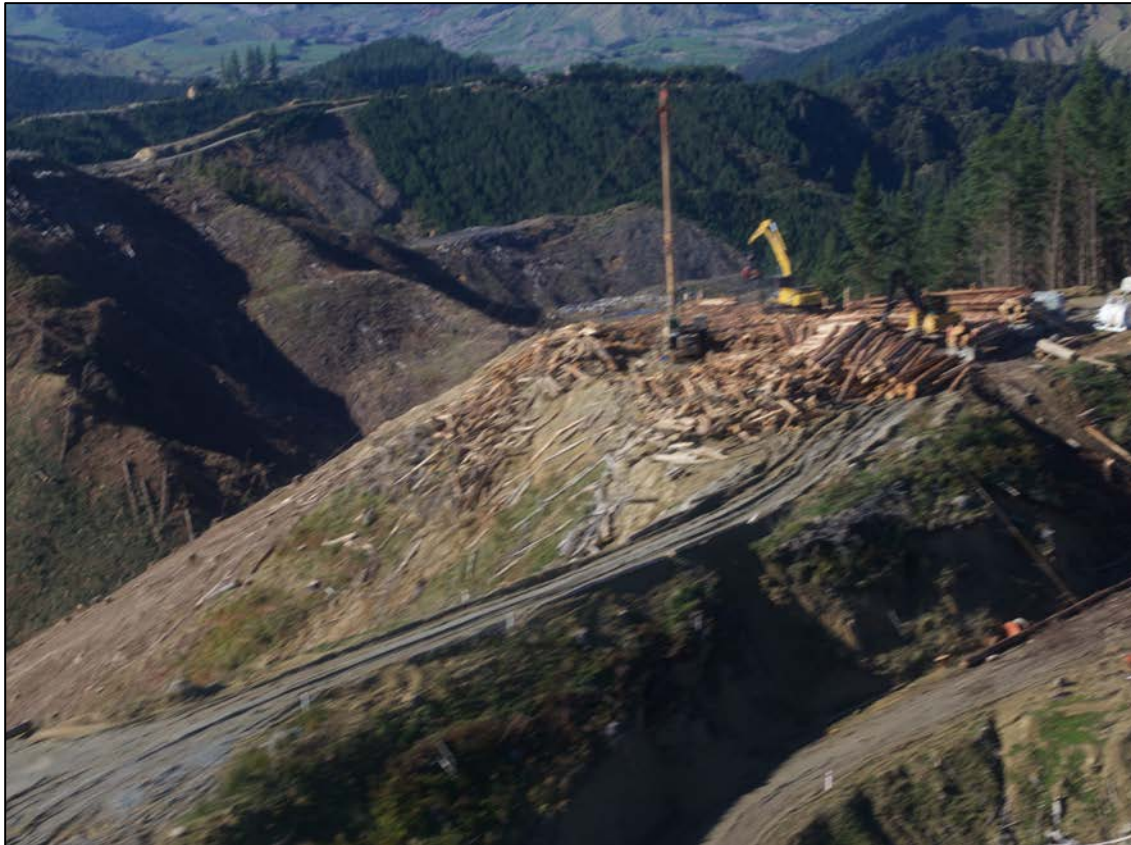
Image 009A9047

Figure Six. View of operational log hauler operation (blurred) showing two significant failures from the edge of the site.

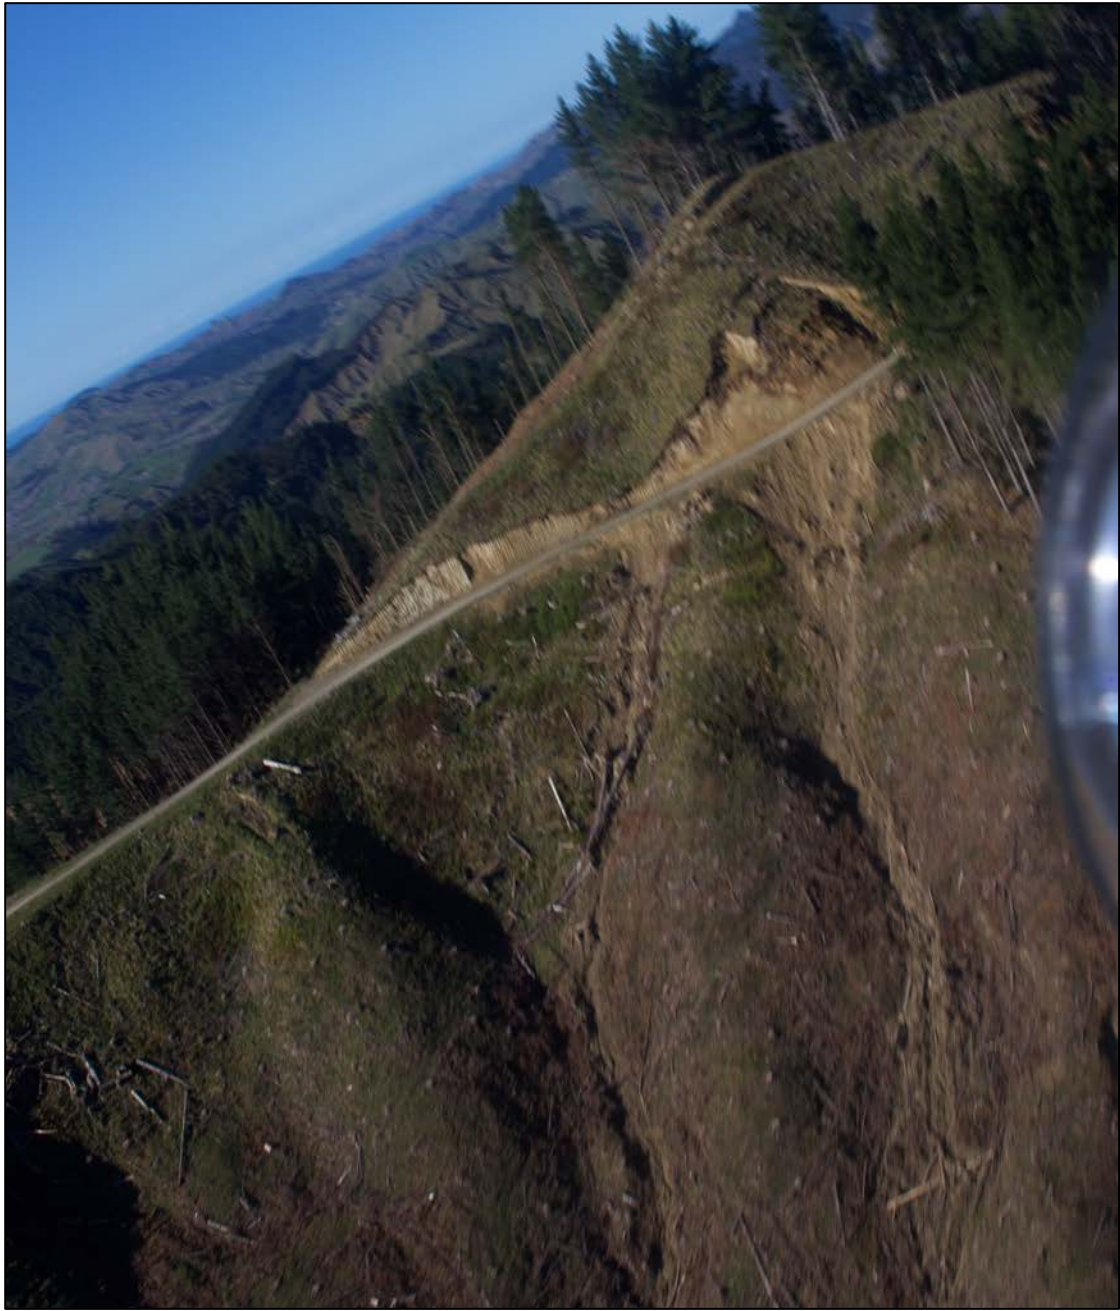
Image 009A9048

Figure Seven. View looking east showing two failures in side cast material originating from a roadway.

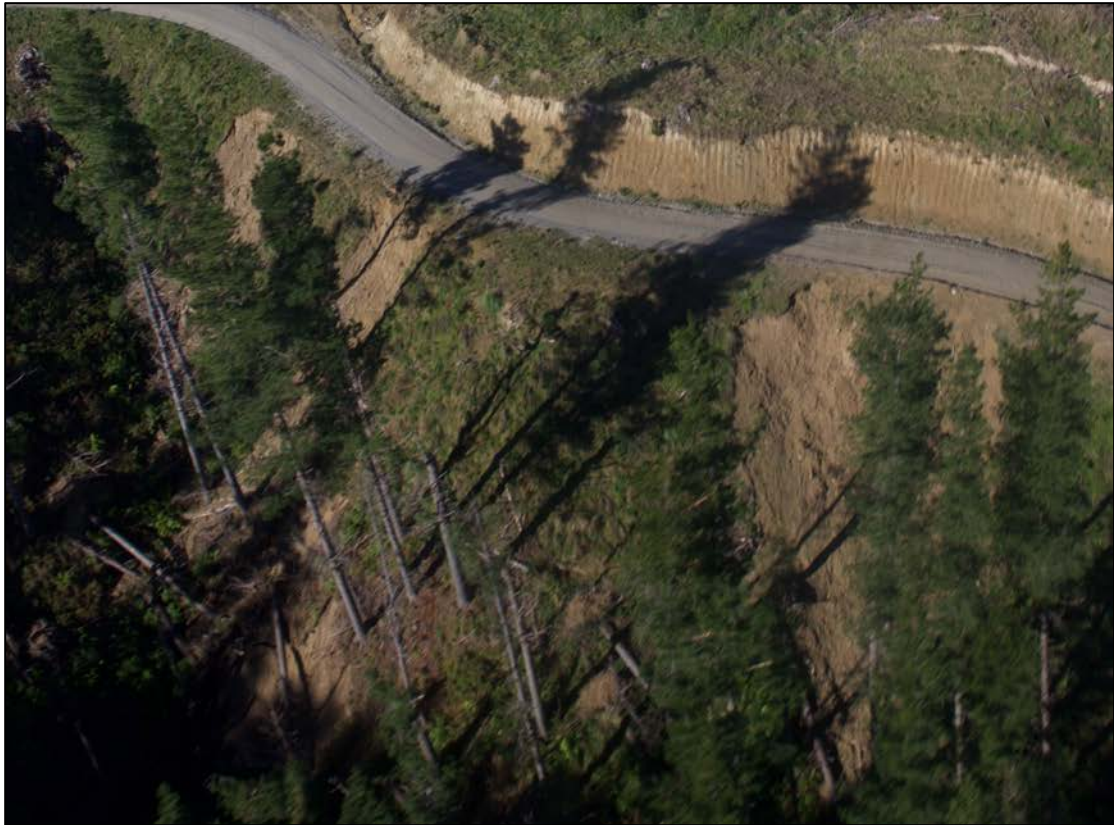
Image 009A9050

Figure Eight. View looking east towards several slope failures originating from a roadway.

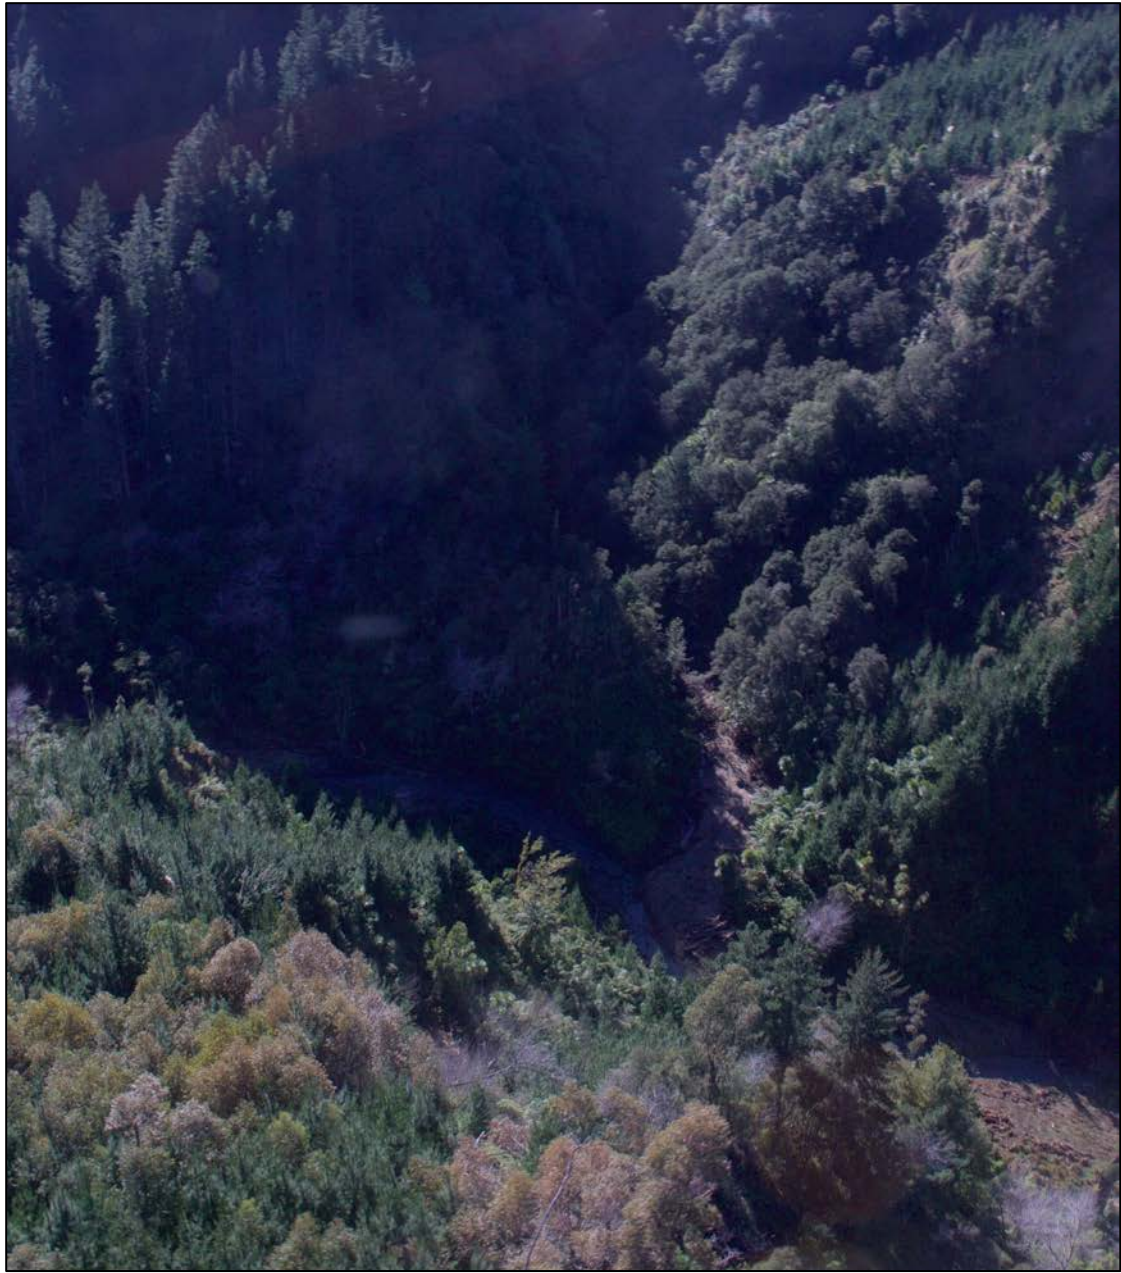
Image 009A9053

Figure Ten. View looking upstream into a tributary of the Mangahouku Stream showing logs and debris flow materials in the watercourse.

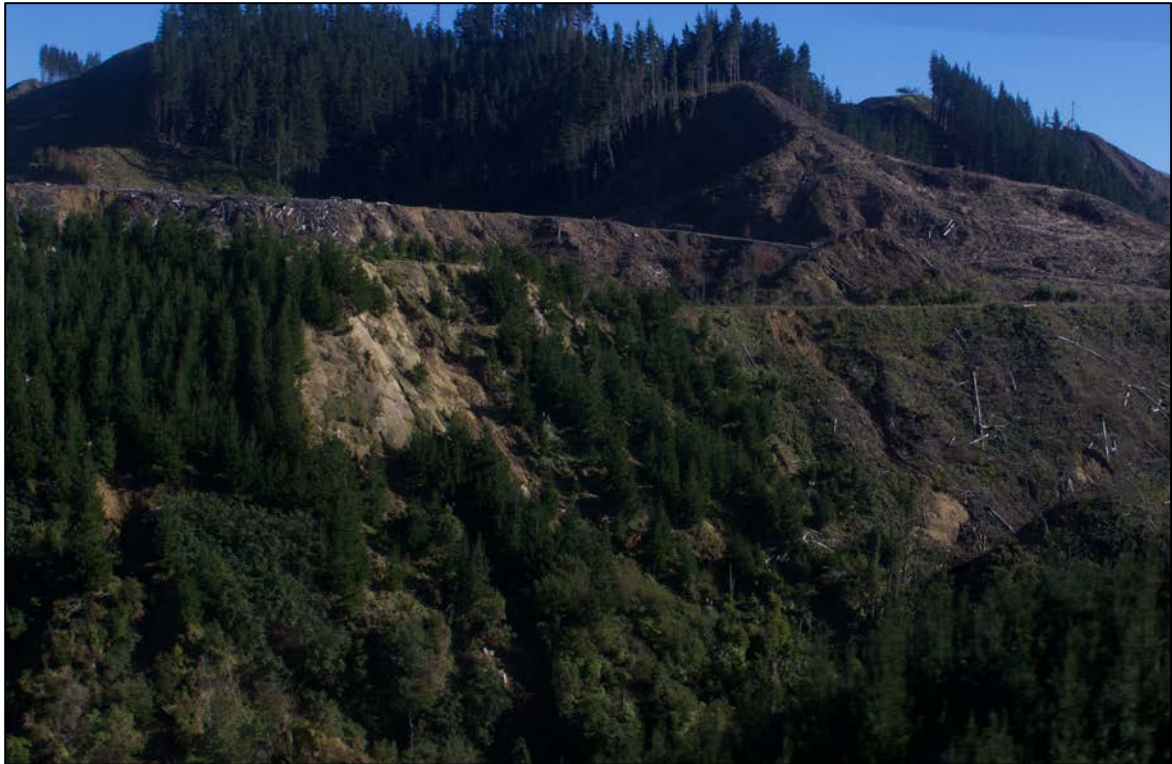
Image 009A9060

Figure Eleven. View looking north into the western end of the early harvest area in Wakarua Forest. At the far left a slope failure from the roadway has generated a debris flow which has migrated through 5+ year old pines towards the valley floor. Additional failures down to the rock base have also occurred from what appears to be a bench or rough track while on the right there is a slope failure from the edge of the roadway.

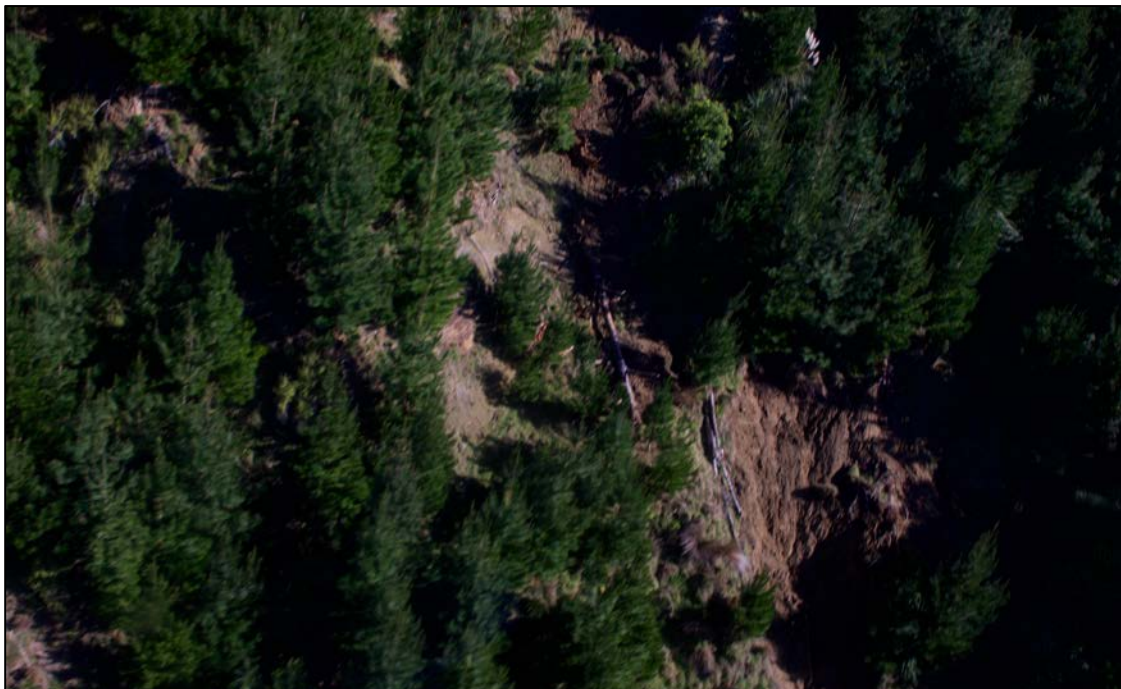
Image 009A9061

Figure Twelve. Detail view of the failure shown in Figure Eleven showing the path of the debris flow middle left and a subsequent failure on the right resulting from toe failure.

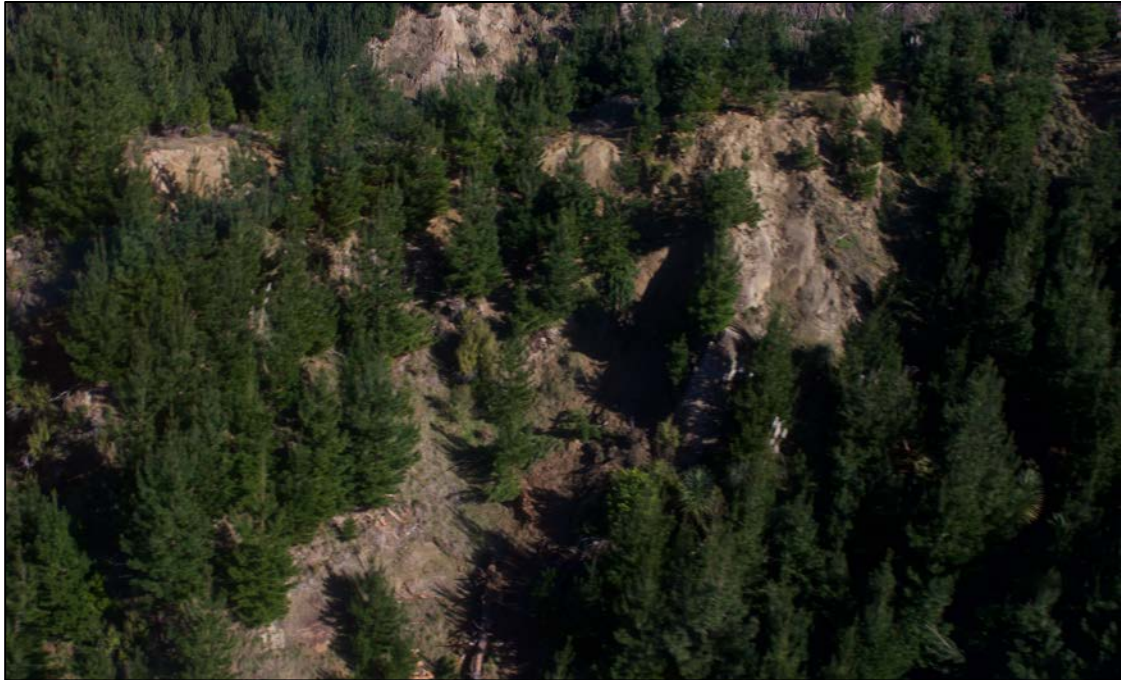
Image 009A9062

Figure Thirteen. View of the bench shown in Figure Eleven.

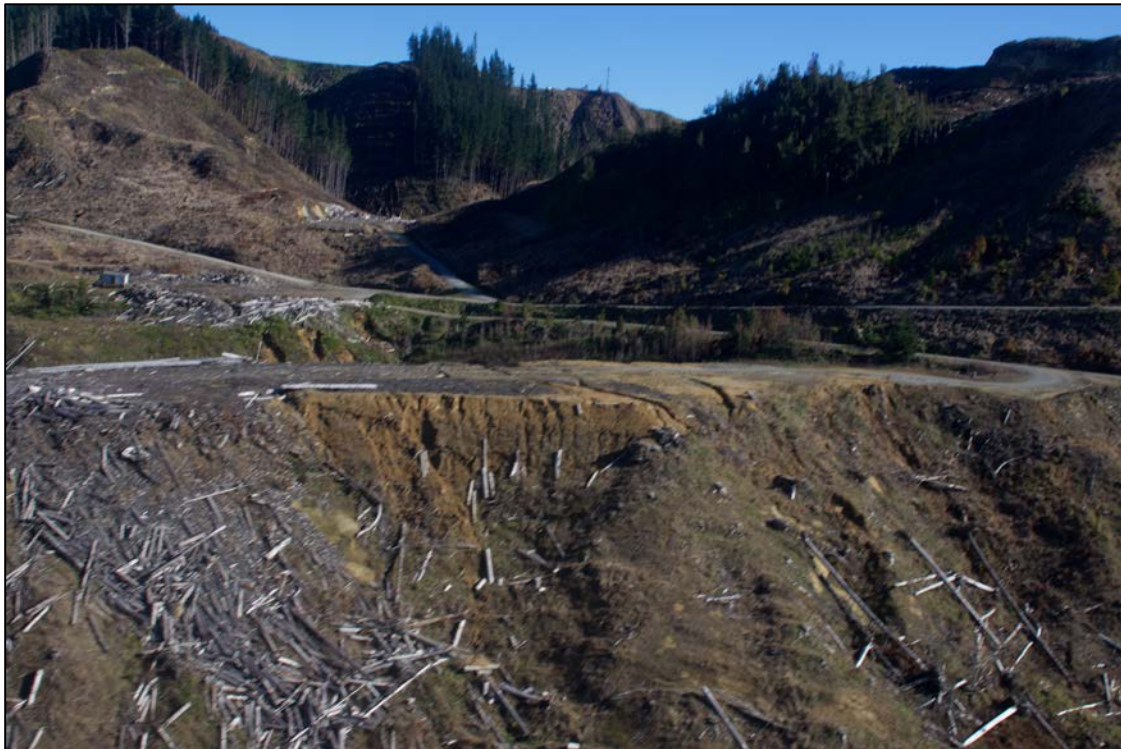
Image 009A9063

Figure Fourteen. View looking northwest towards a skid site on a spur off Bottom Road showing significant logging debris on the slopes and pronounced rilling in sidecast material.

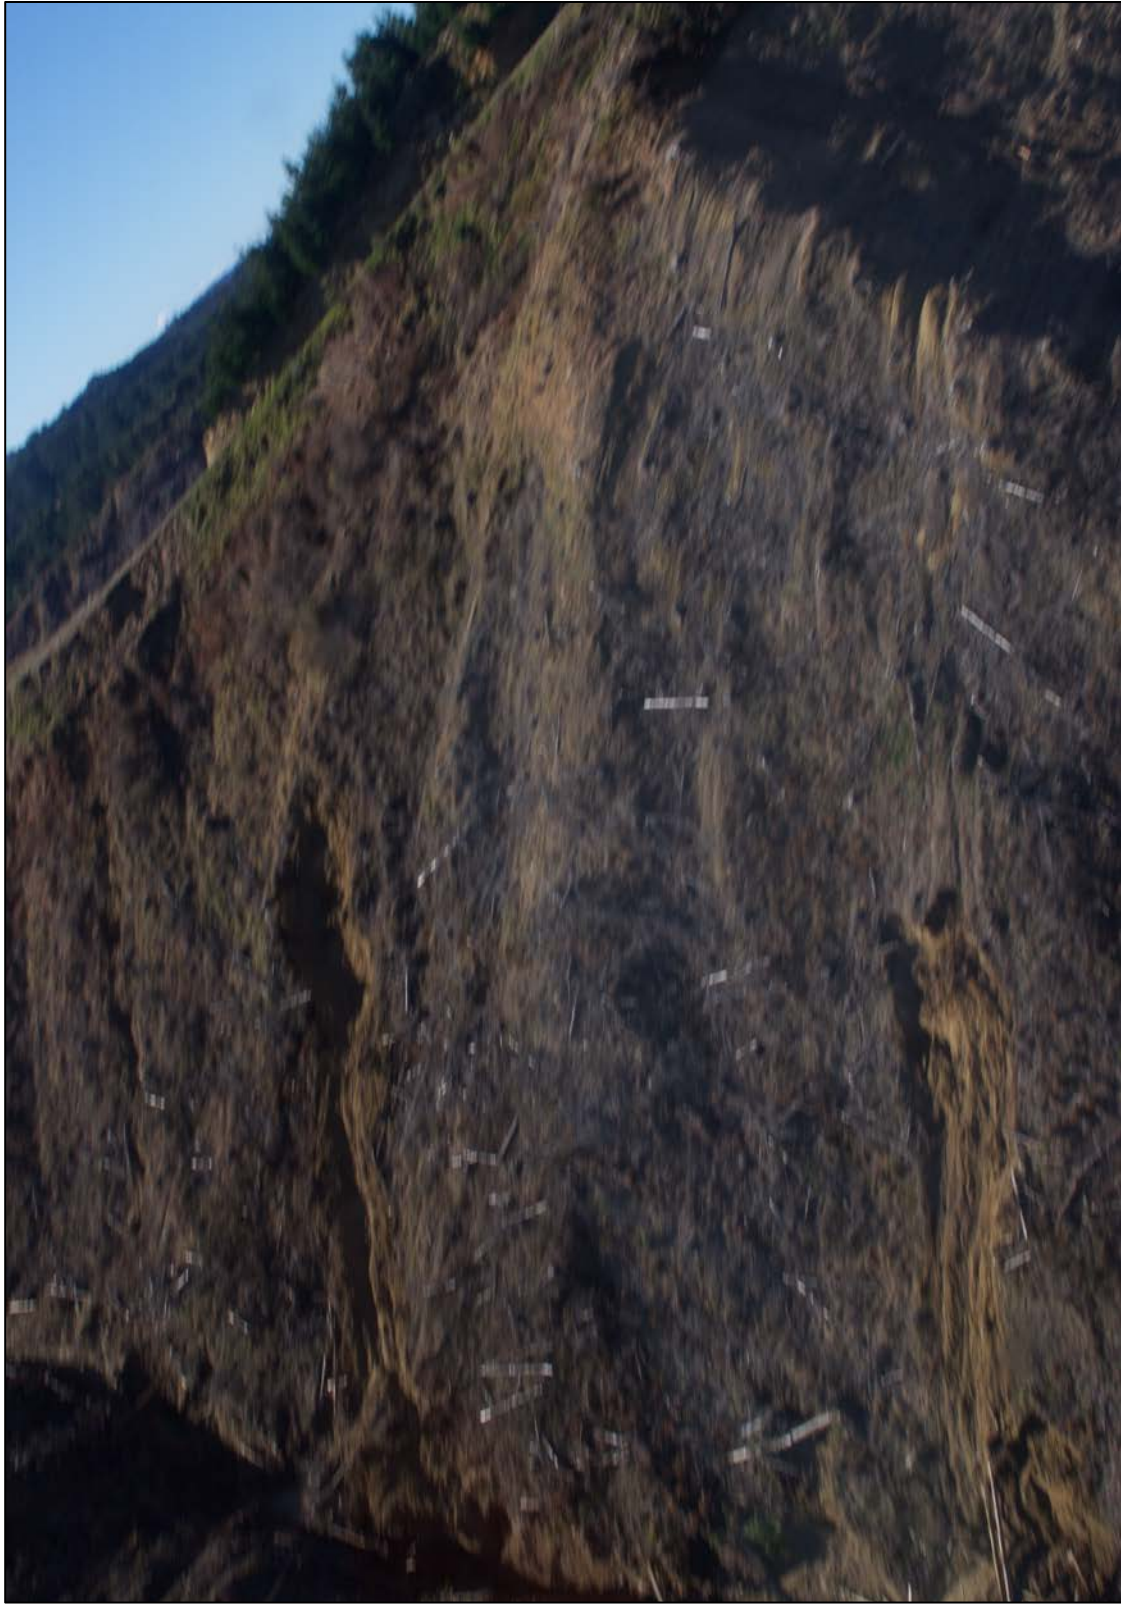
Image 009A9064

Figure Fifteen. Image quality is poor but shows a slope failure initiated from deep gouging from a log hauler line (right).

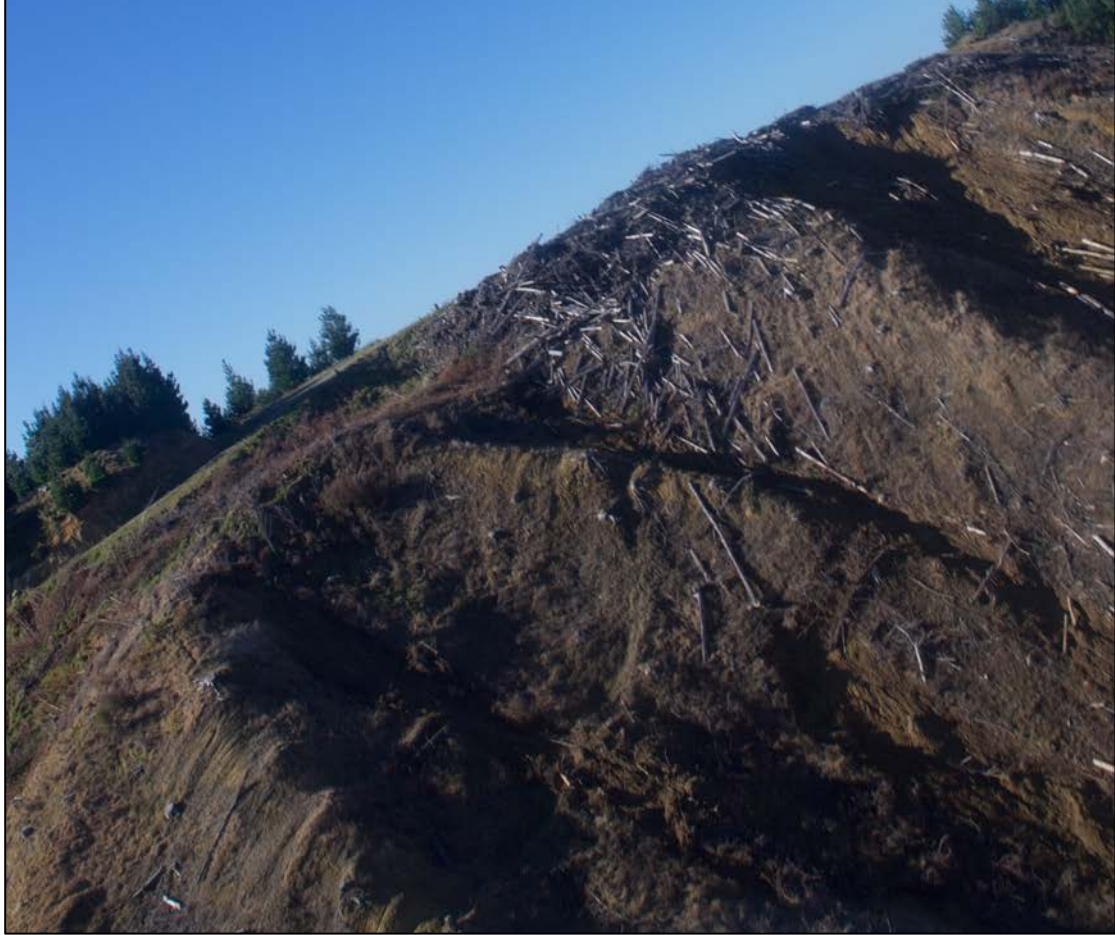
Image 009A9064

Figure Sixteen. View of skid site associated with the gouging shown in Figure Fifteen showing slash perched on the edge of the skid site as well as undercutting.

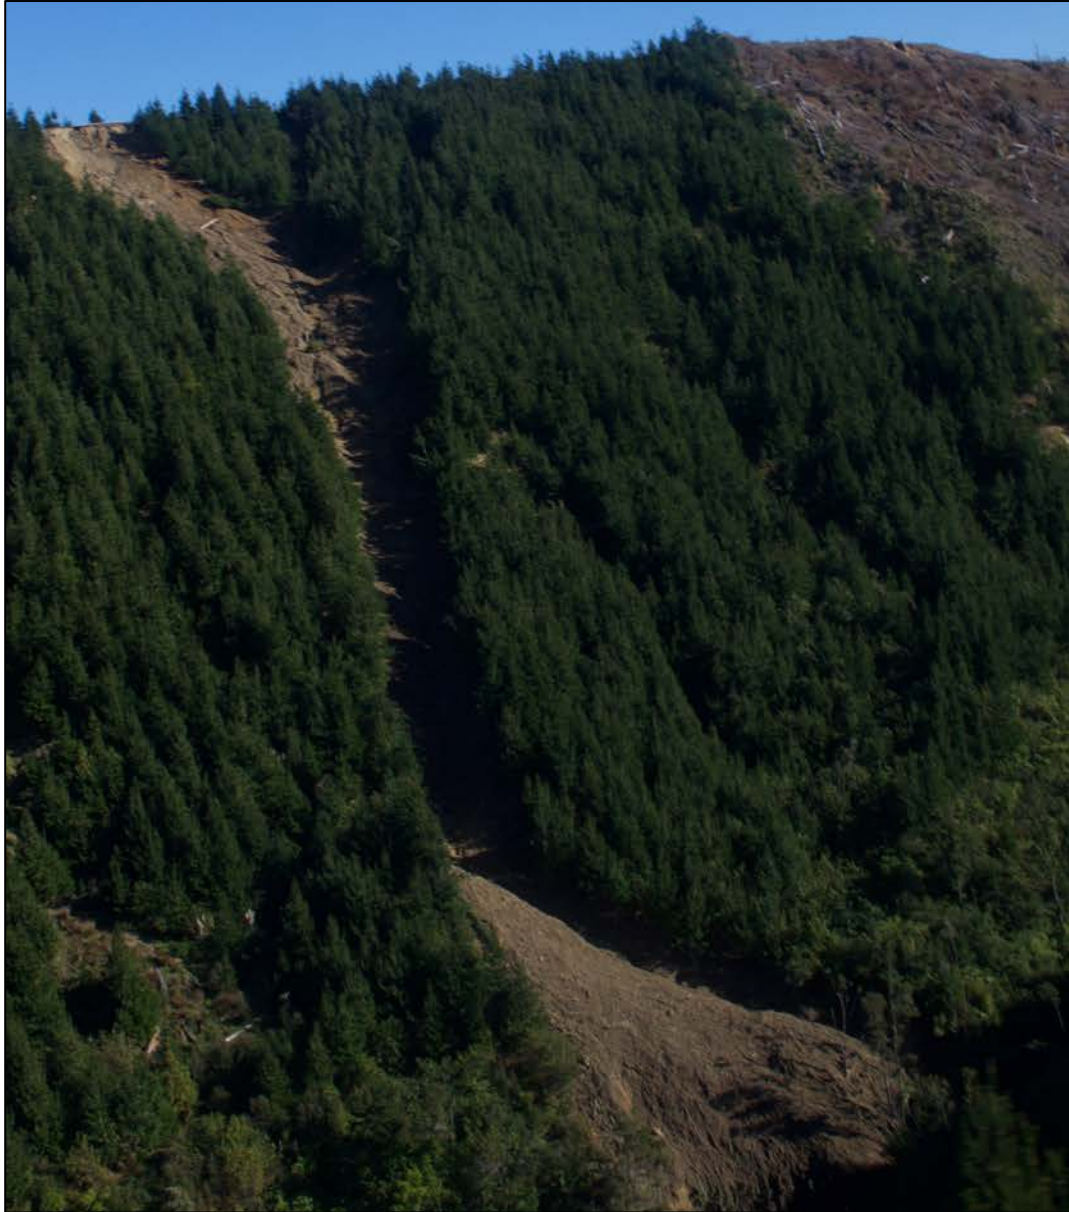
Image 009A9069

Figure Seventeen. View looking west of major debris flow from Goat Road.

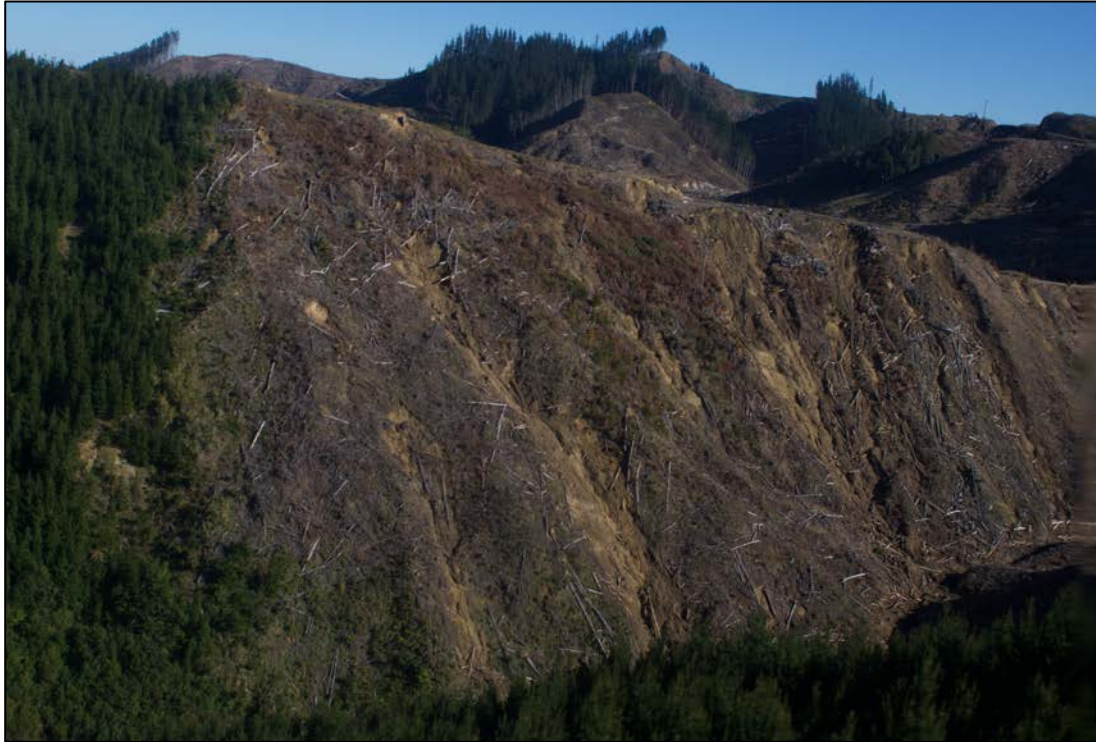
Image 009A9073

Figure Eighteen. View of slope failures on Goat road north of Figure Seventeen. On the right is a major failure where the edge of a skid site has failed, while on the left “mid slope” failures appear to connect to the valley floor and could be toe failures. On the right are “midslopes” clearly connected to the valley floor and thus most likely toe failures.

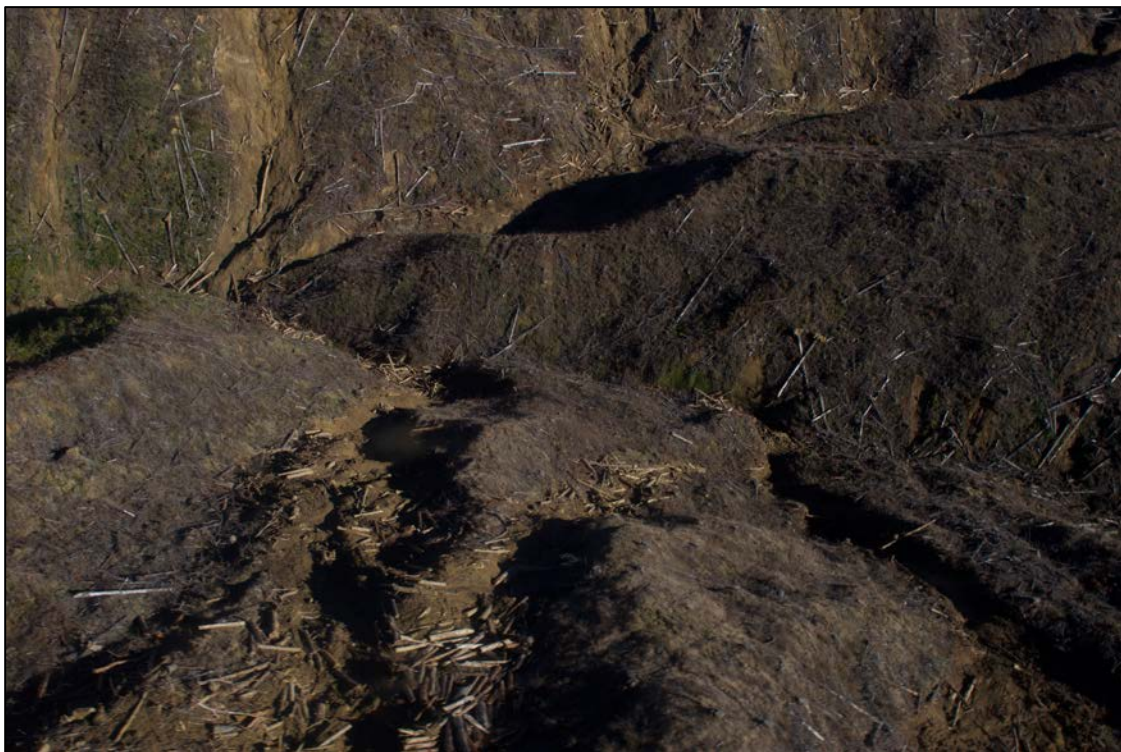
Image 009A9075

Figure Nineteen. View of debris flow from skid site on Homer Road. Note extensive toe failures in background.

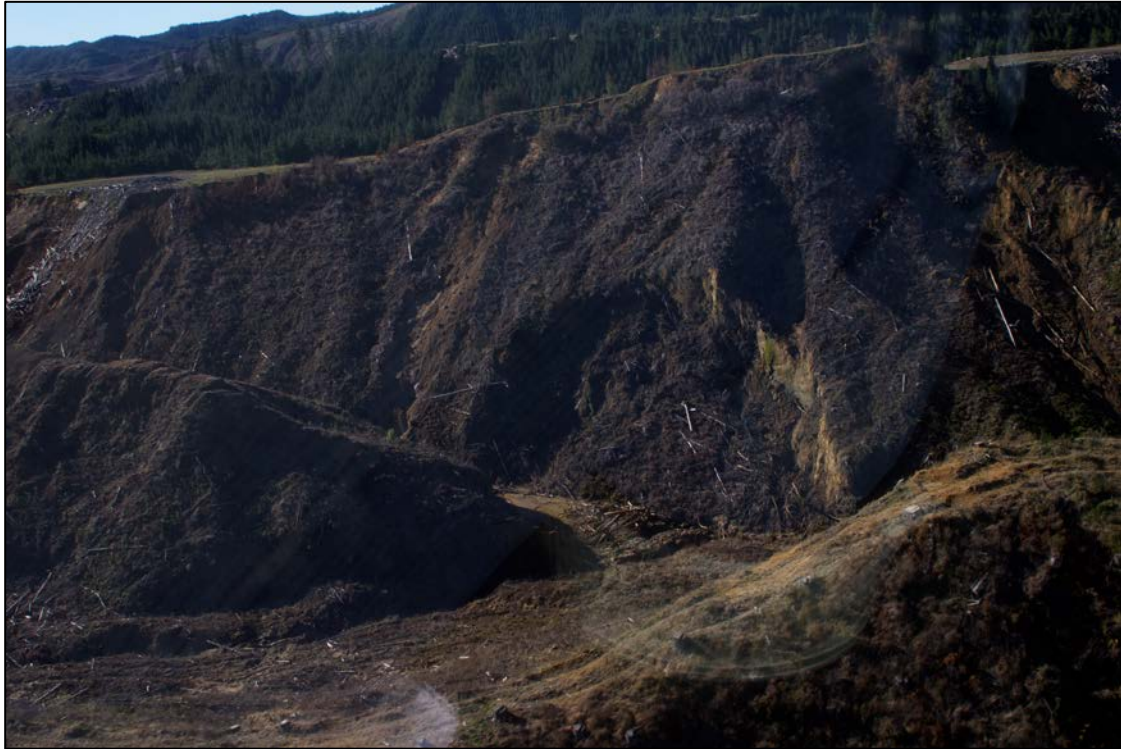
Image 009A9078

Figure Twenty. View of slash on slope at skid site on Bottom Road (left) with failure from skid site (partially obscured) on far right. Note volume of logs on valley floor and slips from the roadway in the middle ground.

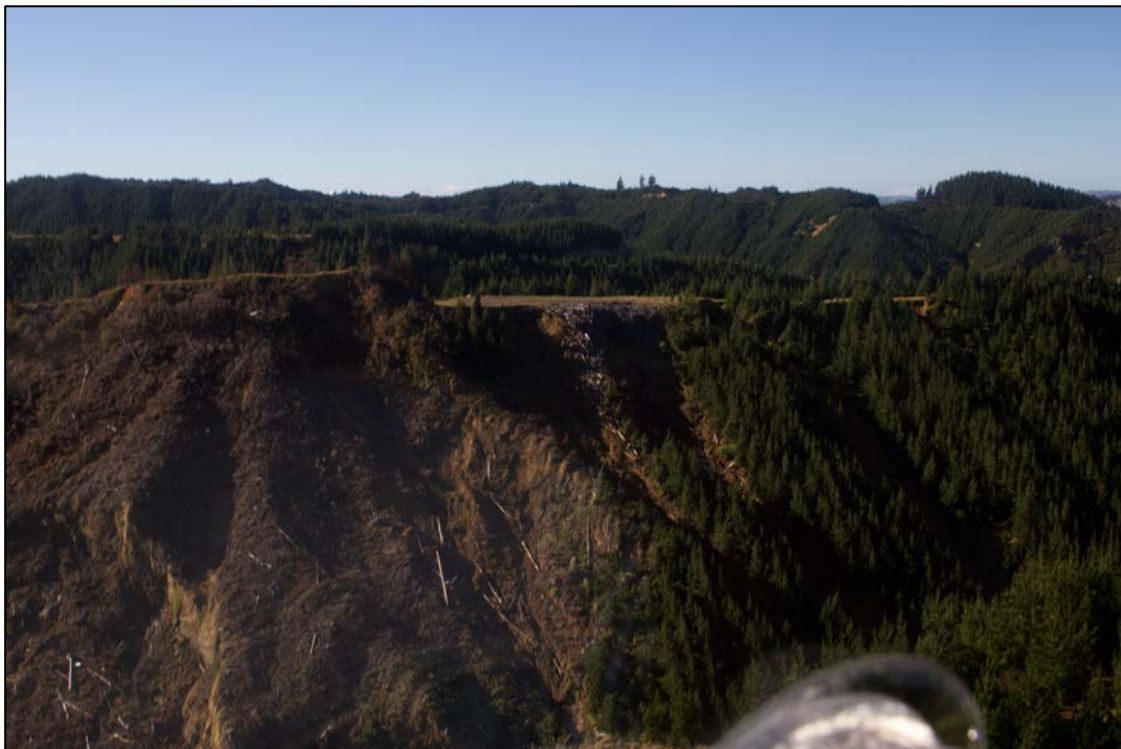
Image 009A9079

Figure Twenty One. View looking north east towards skid site on Bayllis road showing two main failures from a skid site.
