# Assessment of the 20<sup>th</sup> June 2021 Weather Event

# **Assessment of the 20<sup>th</sup> June 2021 Weather Event, v.2.2**

**Dr M. P. Cave  
Principal Scientist  
Gisborne District Council  
August 2021**

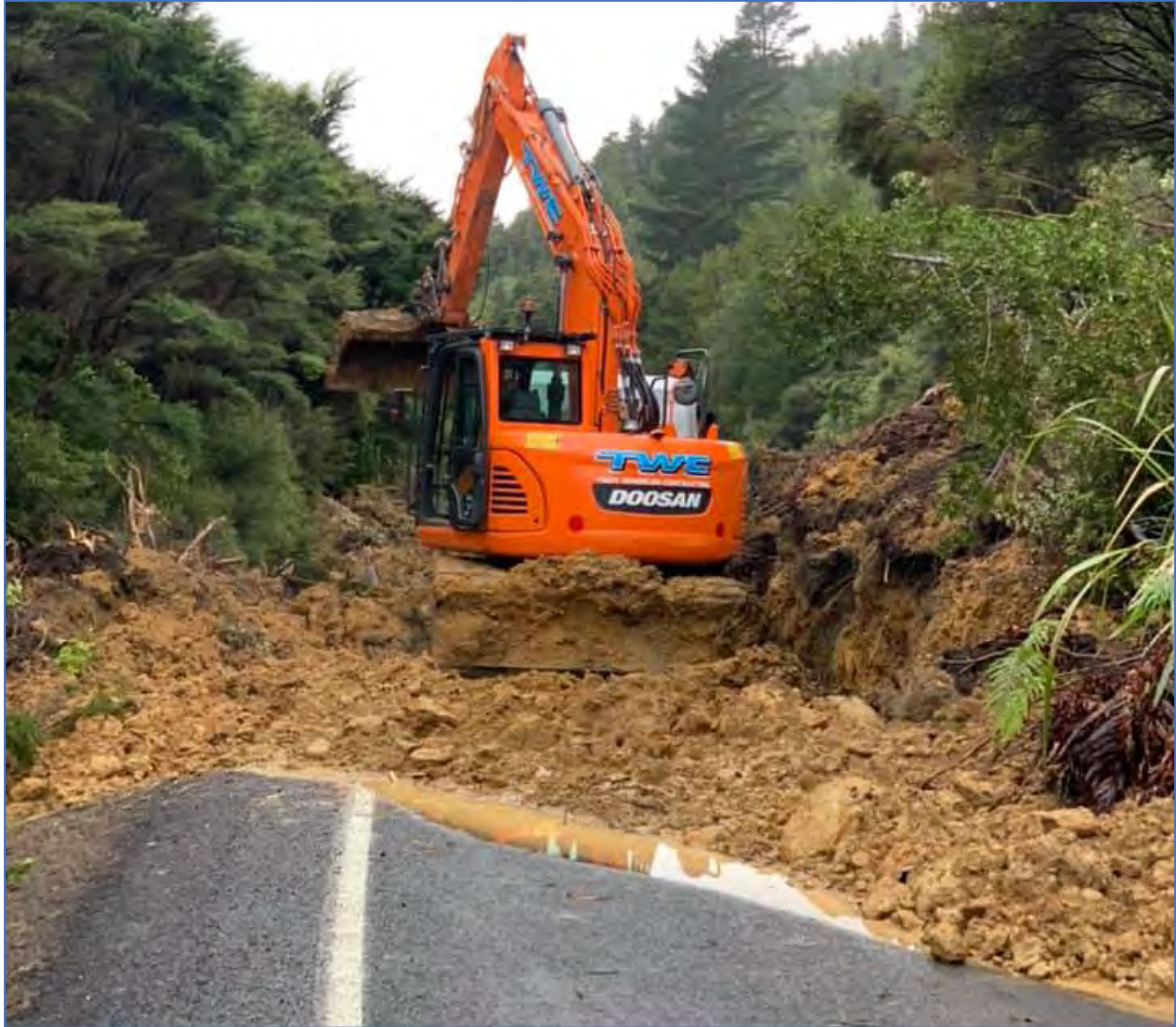
4. Surface flooding occurred widely from south of Tolaga Bay to Te Araroa but slips were only significant on the main highway at Oweka near the Lottin Point turnoff.

**Figure Six.** Clearing the significant slip blocking State Highway 35 at Oweka close to the Lottin Point turn off (photograph Rex Rongo Stainton).

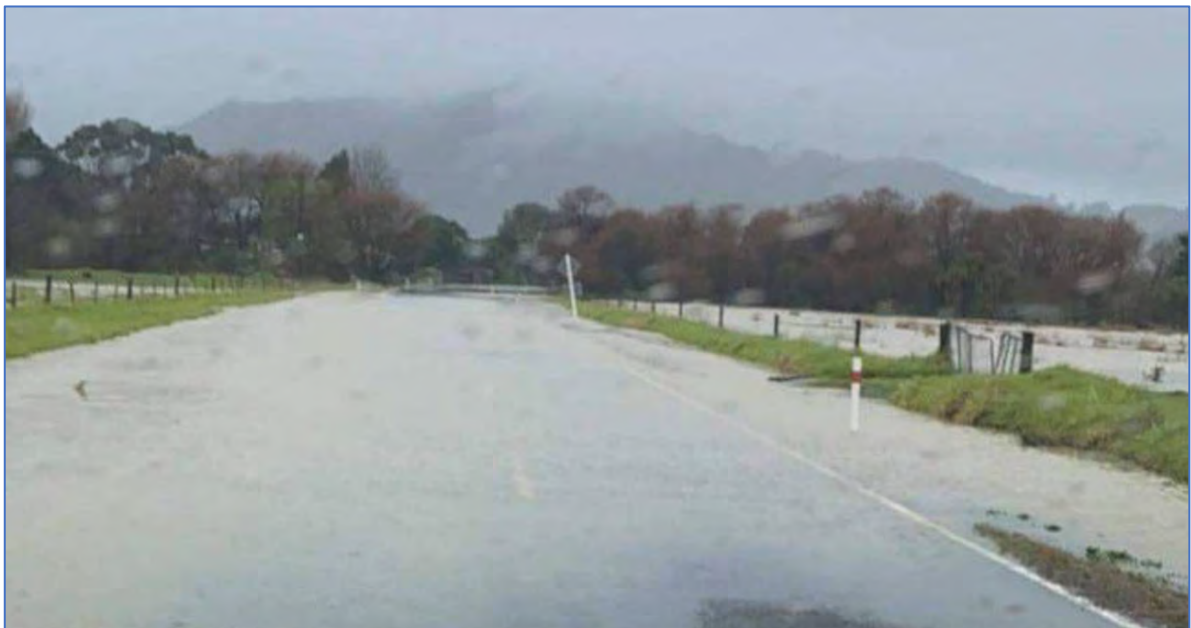
**Figure Seven.** Flooding on the road north of Te Araroa (Tairawhiti Civil Defence..).

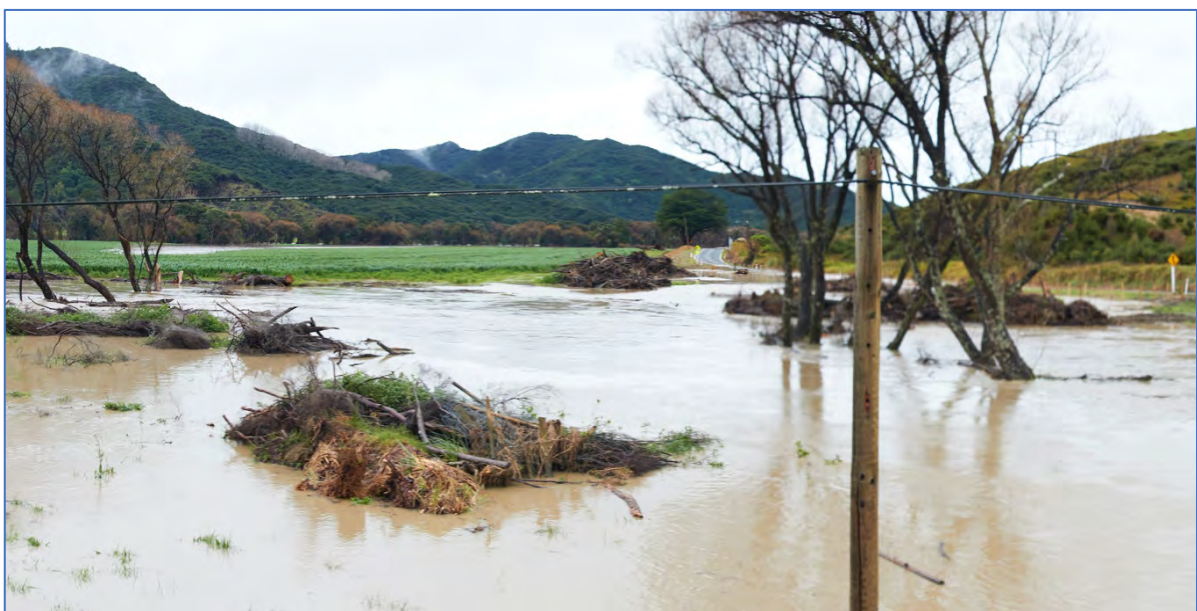
**Figure Eleven.** *Willow piles being eroded upstream of State Highway 35 Bridge, Mahanga Stream. These were observed migrating to the Hikuwai River.*

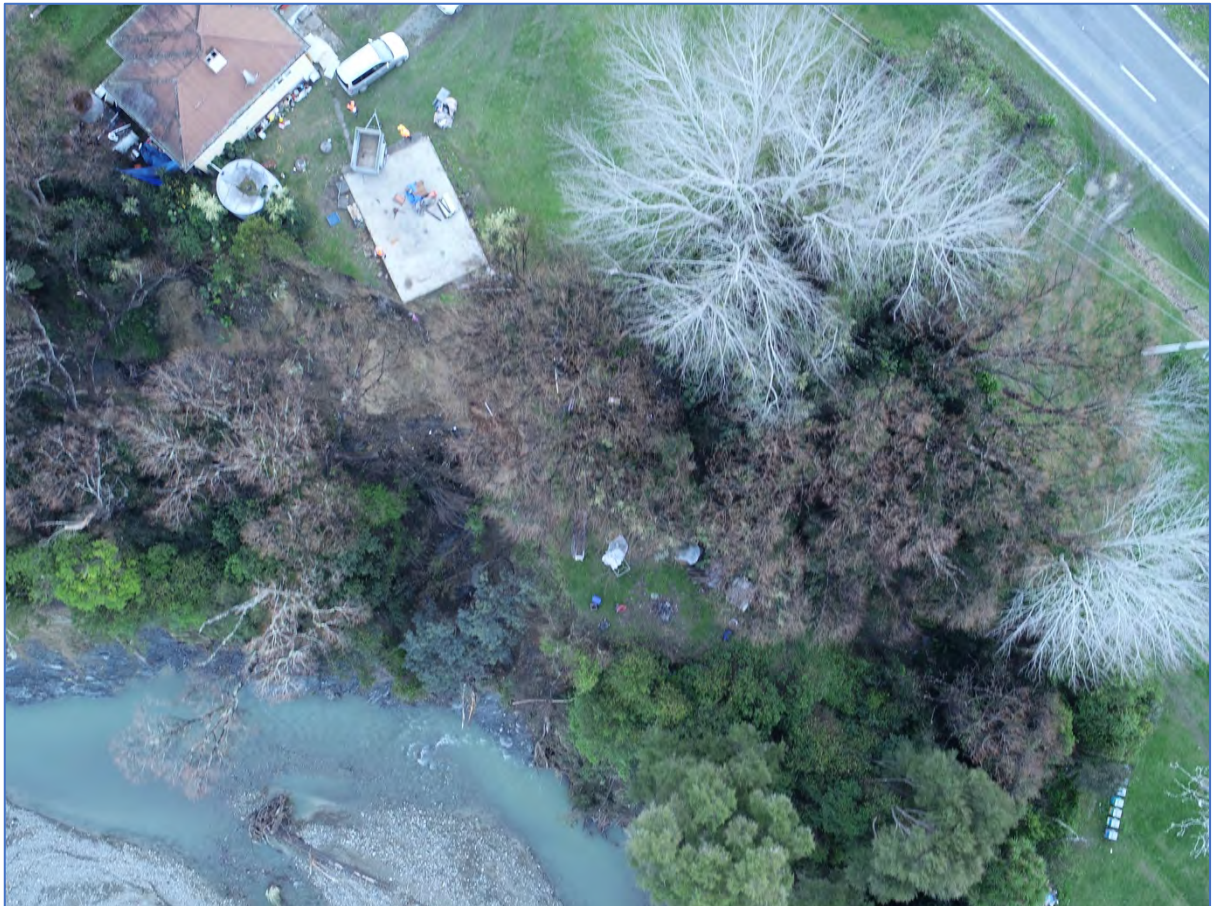
**Figure Twelve.** Drone footage of property at Hiruharama, south of Ruatoria where slipping from a side creek is threatening a house.

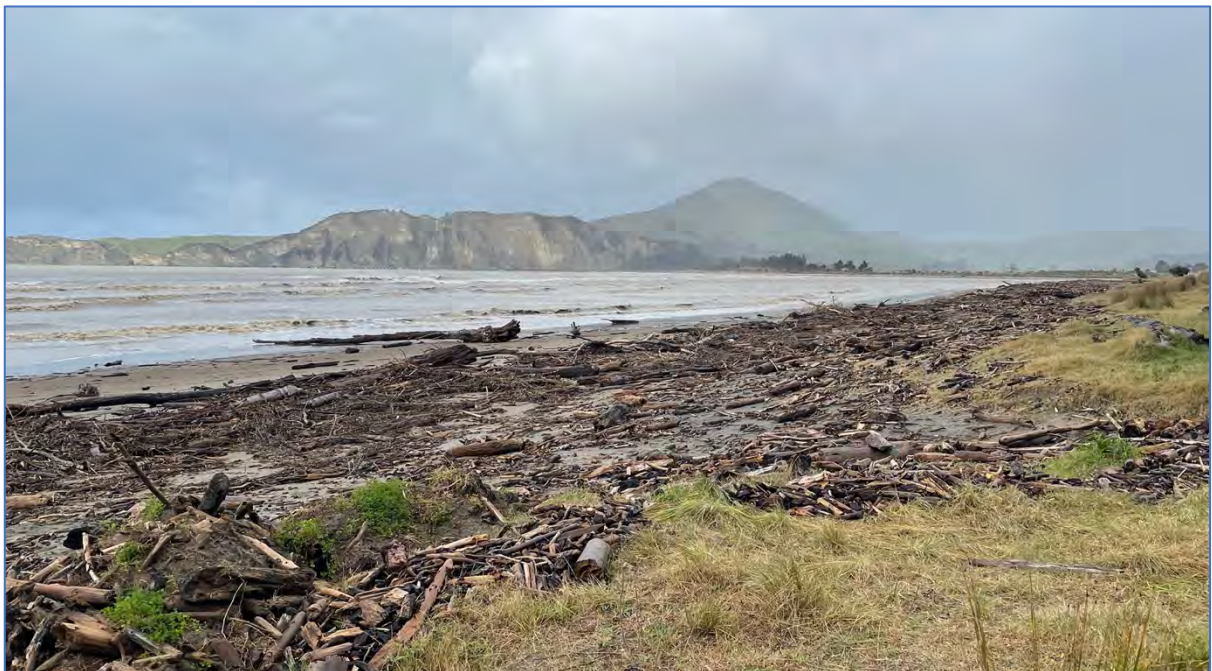
At Tolaga Bay<sup>2</sup>, the storm surge scoured the top of the north and south beaches and remobilised pine logs. An additional contribution of fresh willow debris on the north beach suggested that the willow piles observed being mobilised at the Anaura Bay turn-off migrated to the beach (**Figure Thirteen**).

**Figure Thirteen.** New woody debris deposited on Tolaga Bay north beach after the 20<sup>th</sup> June 2021 storm.

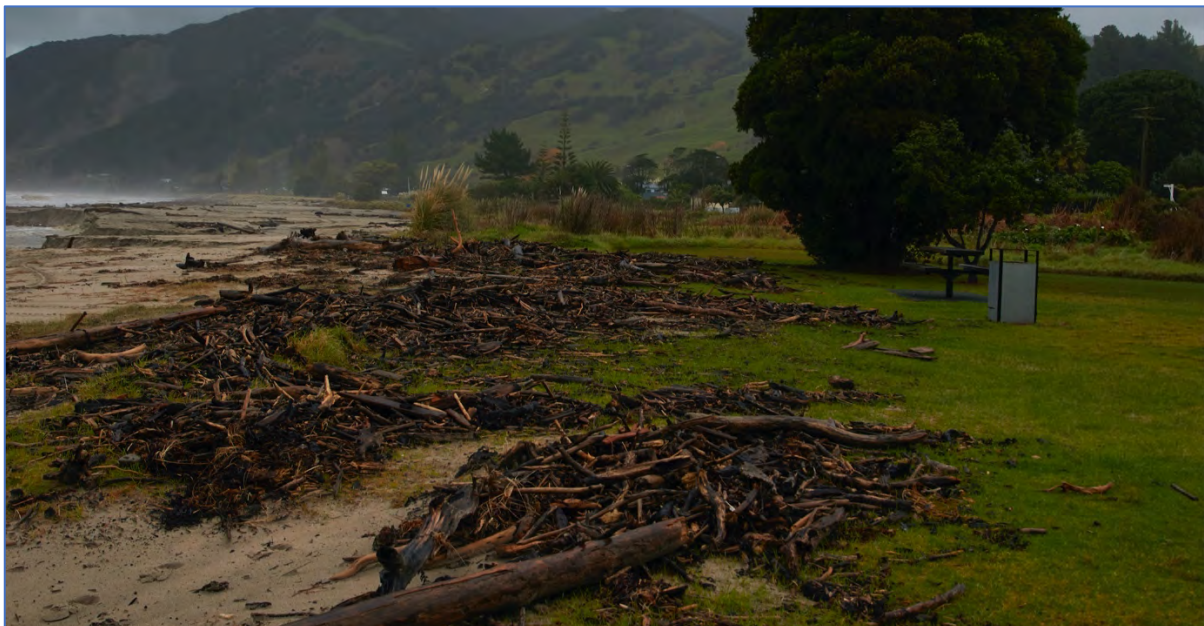
inspection, it was observed that there was a significant number of logs thrown onto the foreshore at the mouths of both the Waiotu and Mangahauini Rivers (**Figures Twenty Seven and Twenty Eight**). A high tide or storm surge can affect the impact of a flood in a coastal environment such as Tokomaru Bay by creating a barrier preventing flood flows from efficiently discharging to sea. The presence of the logs and erosion at the mouth of the Mangahauini indicates that there was a coastal influence but not whether or not it was due to the tide or the result of storm surge.

**Figure Twenty Seven.** Woody debris thrown up onto the freedom camping area south of the mouth of Waiotu Stream.

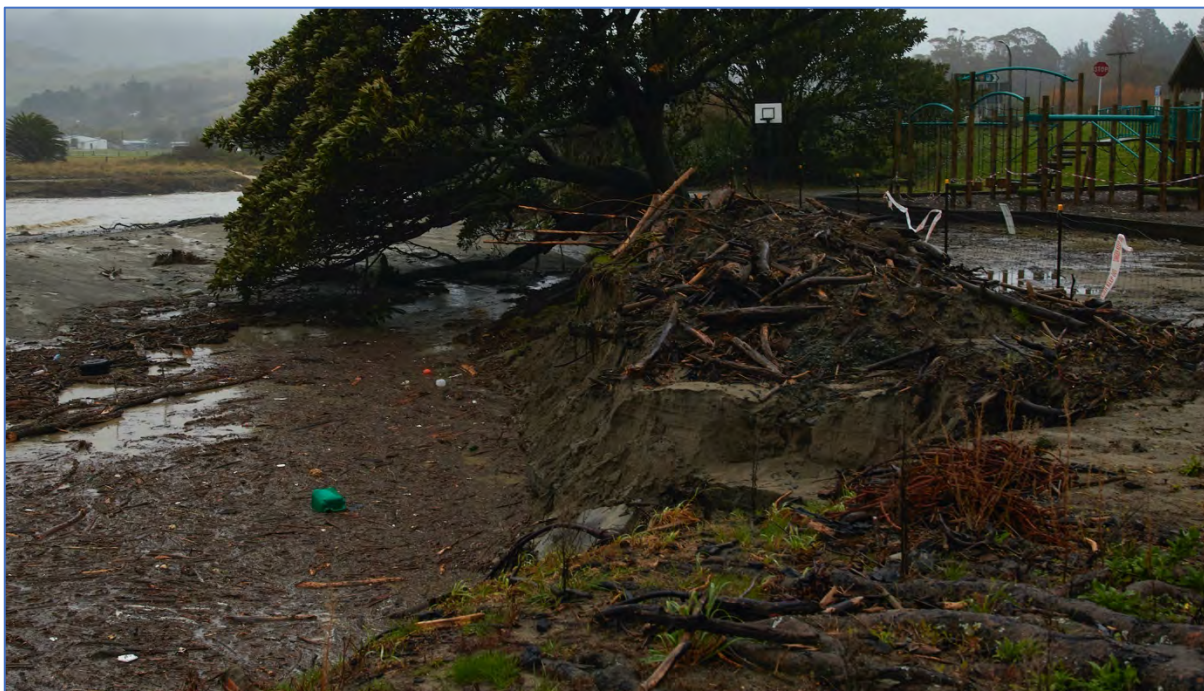
**Figure Twenty Eight.** Woody debris thrown up onto the reserve immediately north of the Mangahauini Stream. Also evident is the extent of erosion of the banks at the reserve.

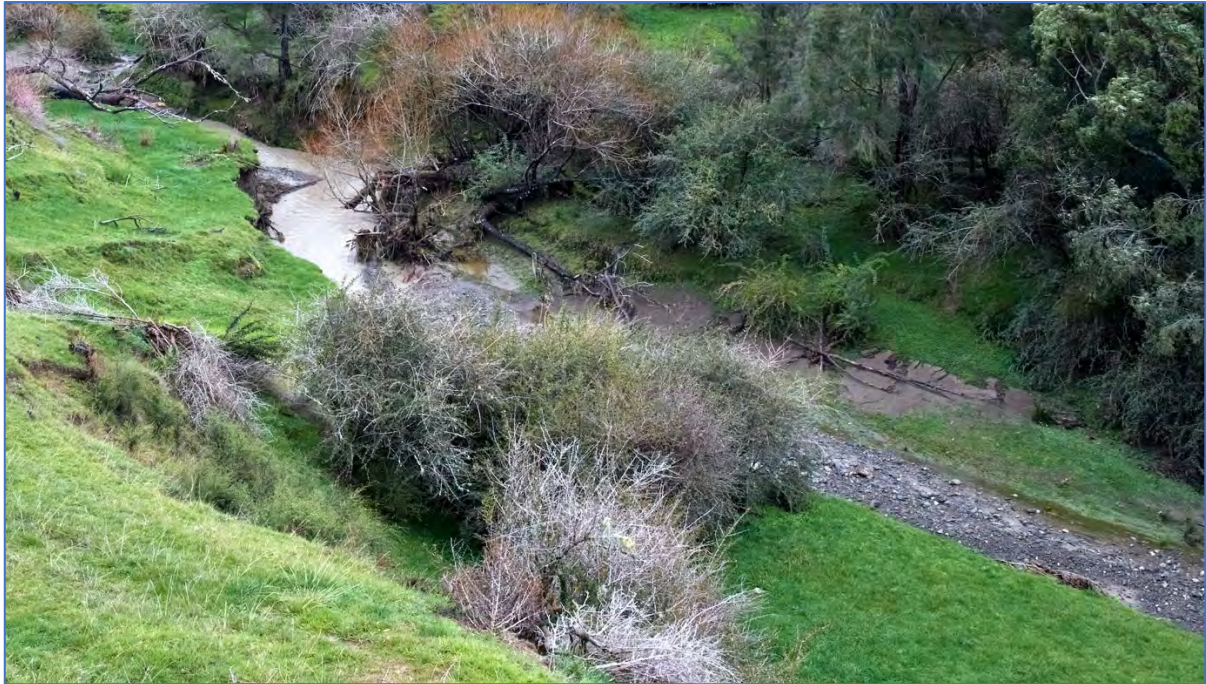
On the 22<sup>nd</sup> June, the reach of Waitou stream above the confluence with the Kaiawha were accessed from a variety of points. This did not reveal any signs of significant flooding. There was bank scour at a number of locations which caused some river bank trees to collapse into the river. Silt deposition was observed at one location very close to the normal riverbed level suggesting that relatively minor flooding occurred in the catchment (**Figure Thirty Three**).

**Figure Thirty Three.** View of Waiotu Stream upstream of the confluence with Kaiawha Stream showing signs of scour (top left) and silt deposition (middle right). The silt is very close to normal river level and there is no indication on inundation on the true right bank (bottom right).

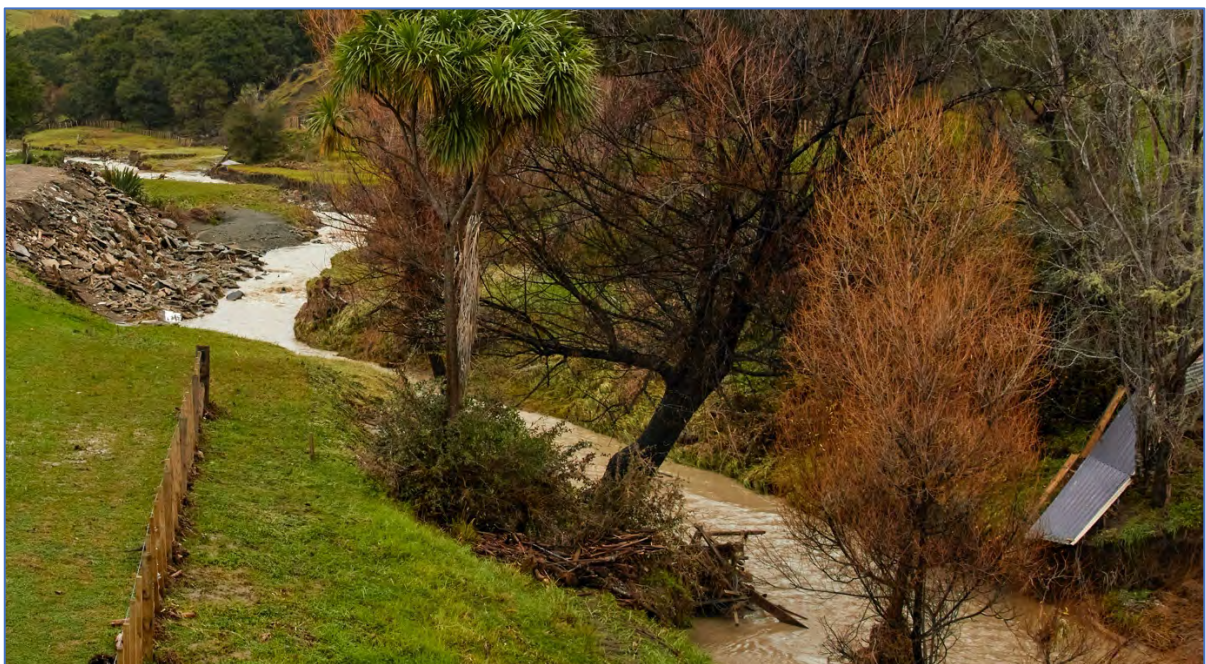
The Kaiawha River immediately upstream of the bridge on State Highway 35, however, showed more significant signs of flooding with the river a lot muddier, woody debris wedged against trees and a debris fence broken free from the true right bank (**Figure Thirty Four**). Mud and woody debris was observed wedged against the fence at the top of the bank indicating high flood levels (**Figure Thirty Five**).

**Figure Thirty Four.** Kaiawha Stream upstream of the SH 35 Bridge showing the damaged debris fence and woody debris caught against the trees.

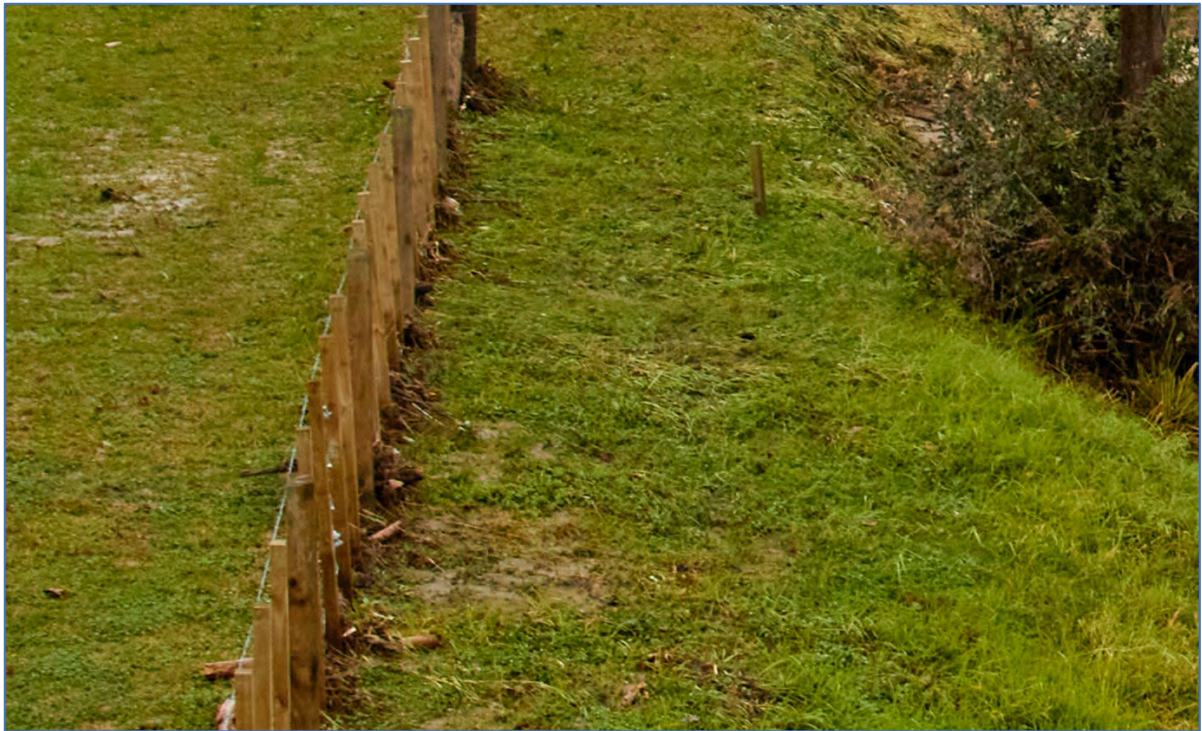
**Figure Thirty Five.** Fence at top of bank of Kaiawha Stream upstream of the SH 35 Bridge showing woody debris caught up in fence and mud deposited on the river side of the fence.

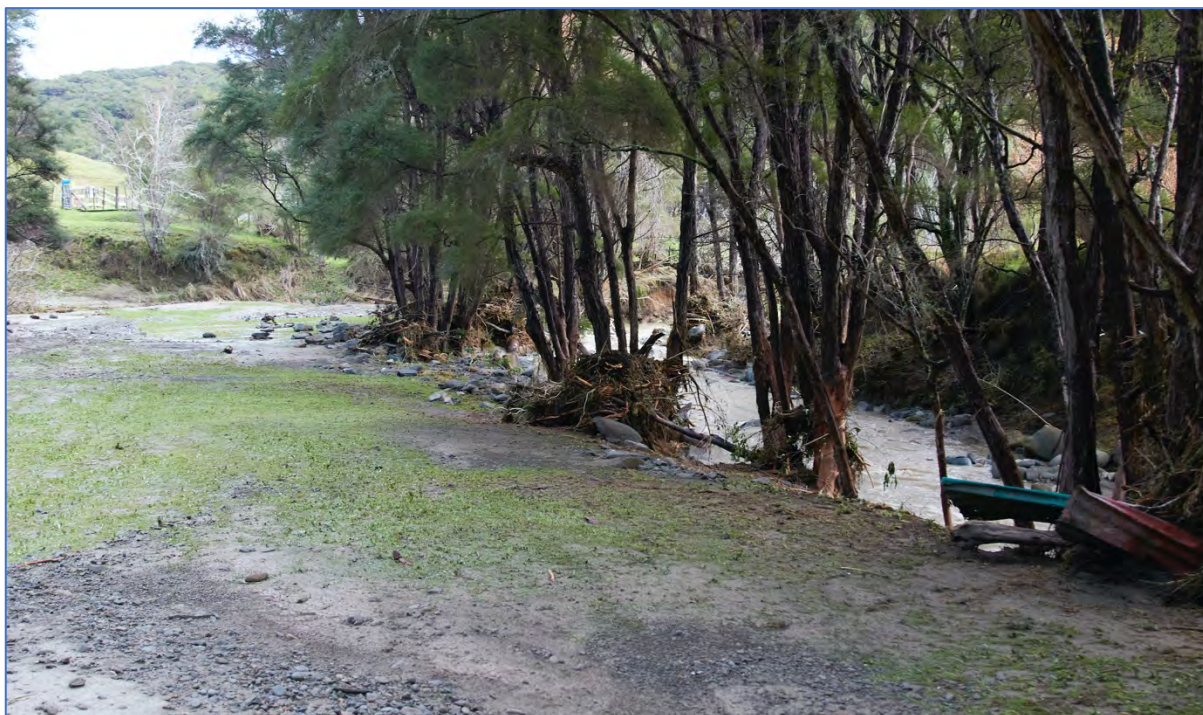
**Figure Thirty Eight.** Photograph upstream of the ford on Kaiawha Road showing debris caught up in the trees and mud deposited across the valley floor.

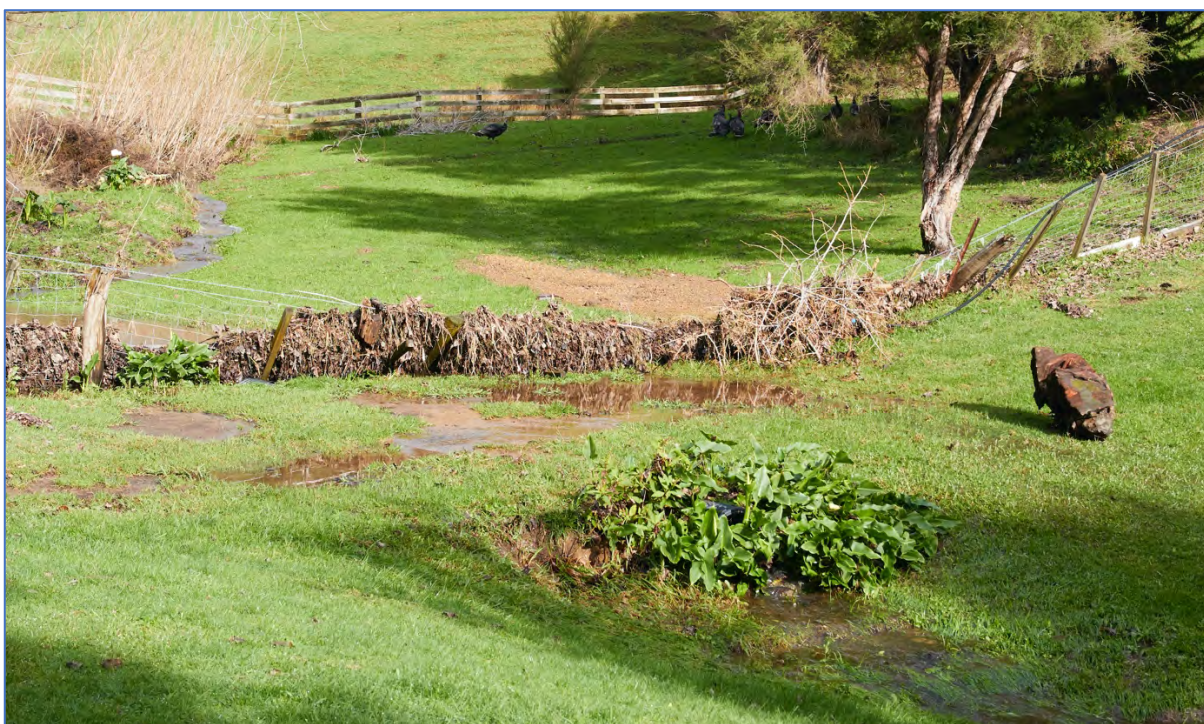
**Figure Forty.** Photograph upstream of the ford on Kaiawha Road showing mud deposition resulting from over-ground flow.

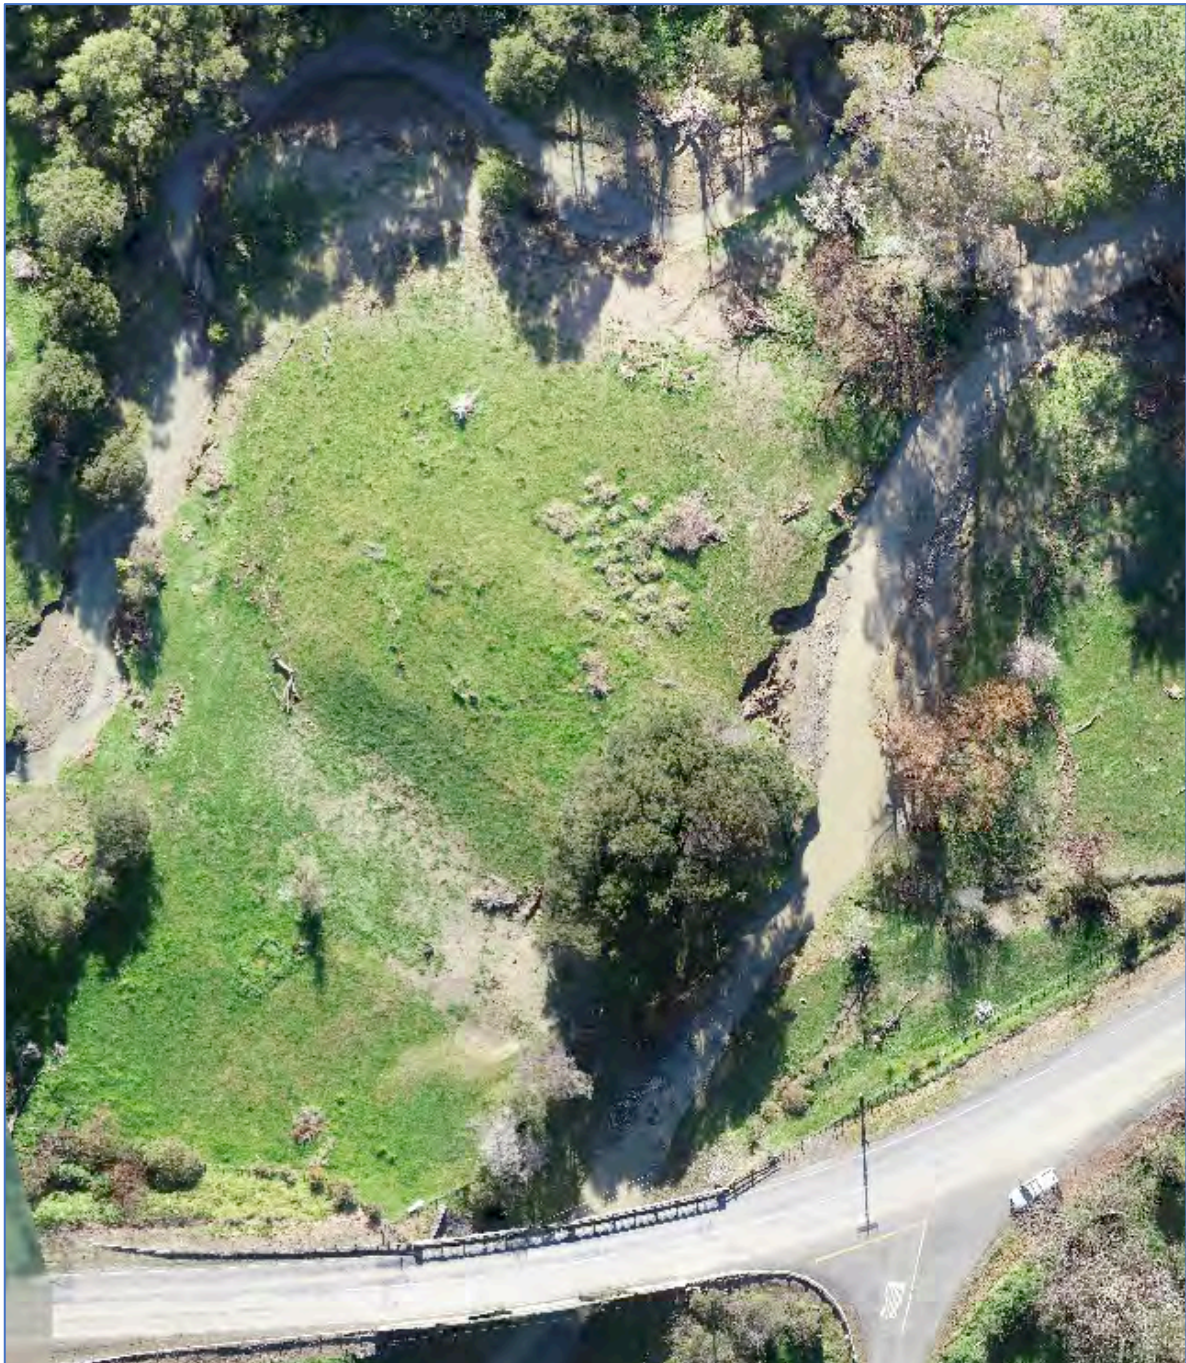
**Figure Forty One.** View of the Kaiawha Stream below the bridge on State Highway 35 showing the flood overtopping on the true left bank discharging into Waitotū Stream and the silt deposition downstream from there.

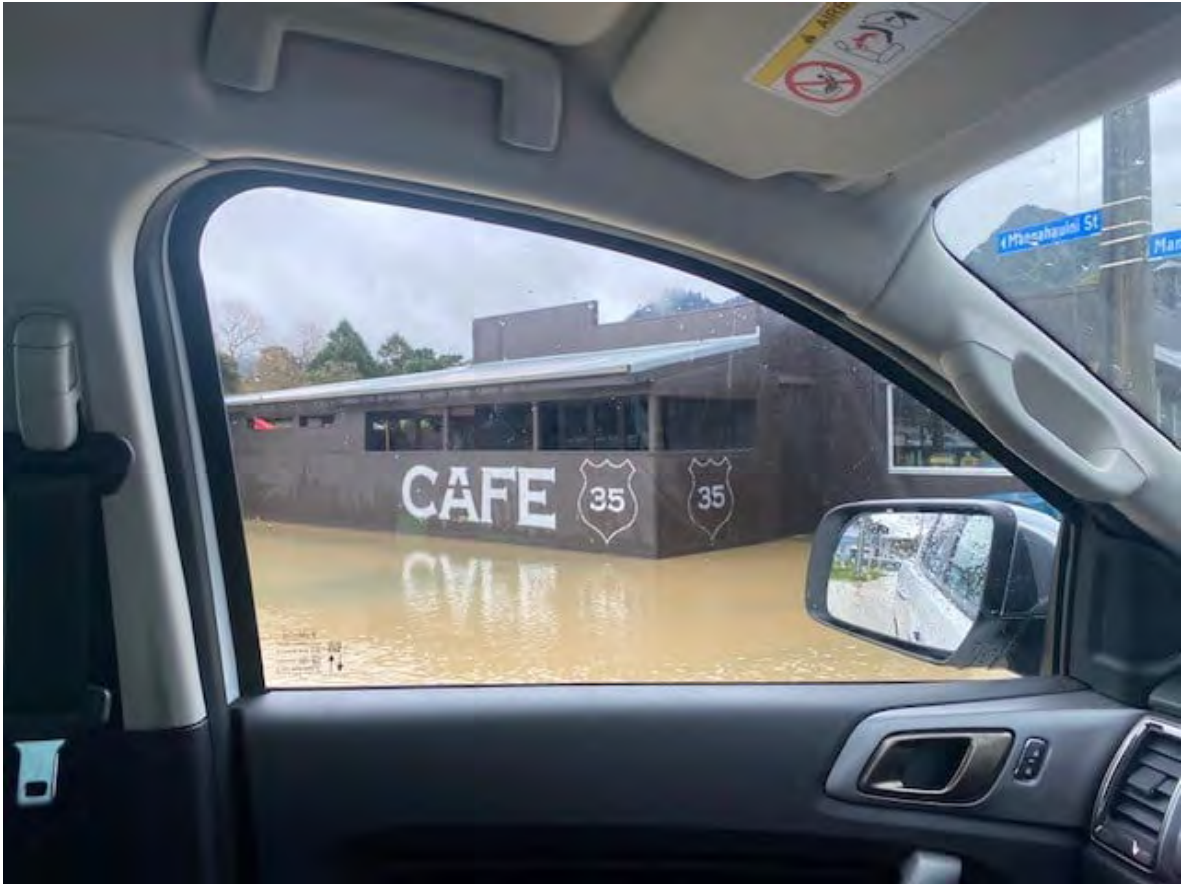
**Figure Forty Seven.** Flooding at café 35, Tokomaru Bay. It is assessment that the flooding here was the result of overland flow rather than flooding from the Mangahauini River (Source Facebook post).

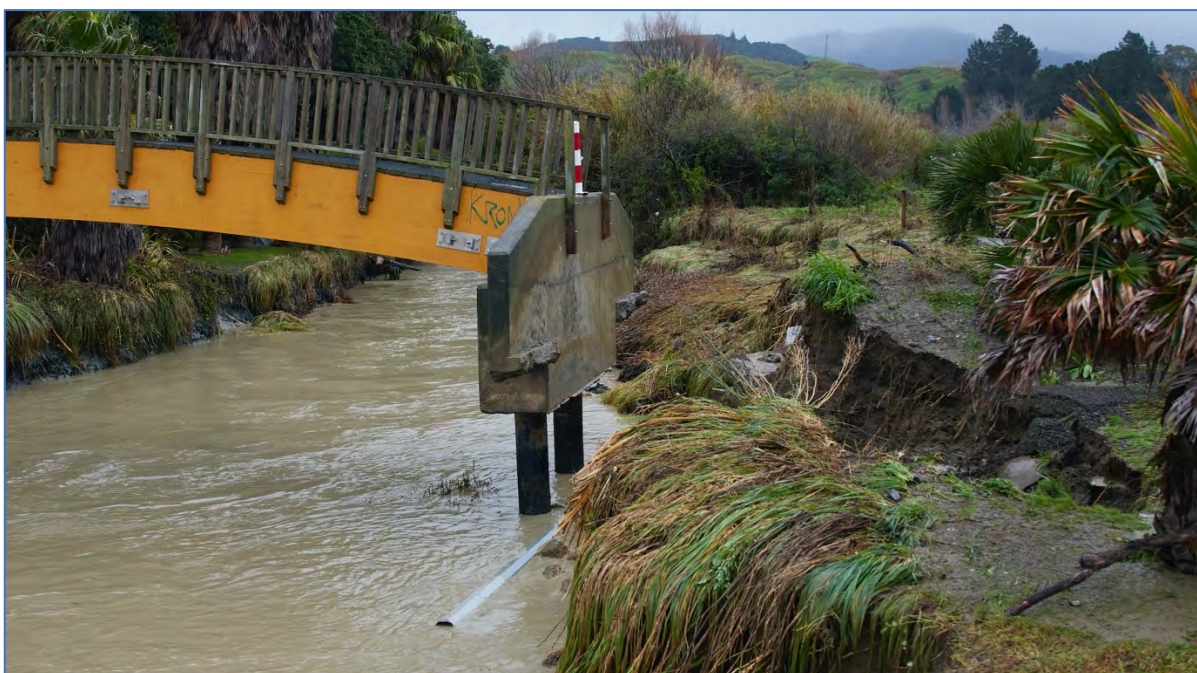
*Figure Forty Nine. The washed out abutment of the footbridge at the mouth of Waiotu Stream.*

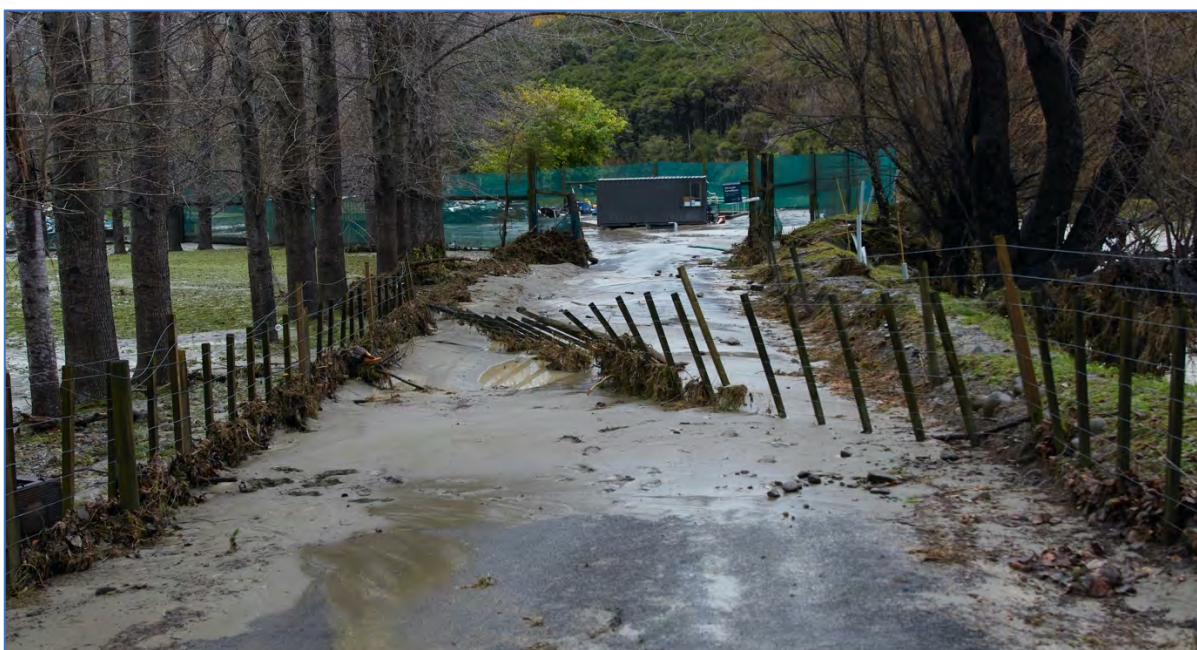
*Figure Fifty. Flood impacts at the Tokomaru Transfer Station.*

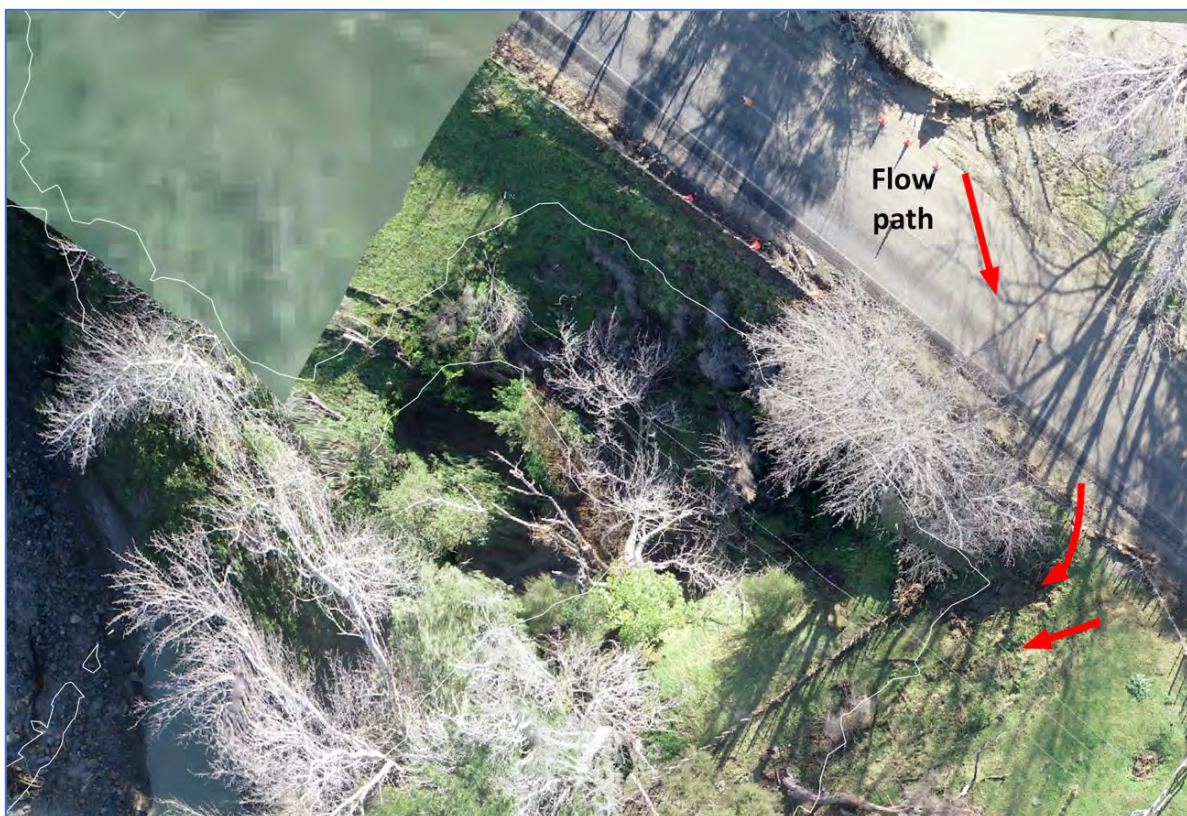
Reliable information on its pre-flood condition was difficult to come by although there were anecdotal reports from local residents suggesting it was blocked. This was confirmed by Waka Kotahi sometime after the event who advised that they were aware of the blockage but were also concerned that the culvert would immediately block again due to the volume of sediment in the tributary it drained. Accordingly they had initiated planning for a medium to long term solution but had arranged for contractors to clear the culvert but that was not done before the storm hit.

**Figure Fifty One.** drone footage of the blocked culvert on State Highway 35 showing the overland flow path to the creek downstream of the culvert.

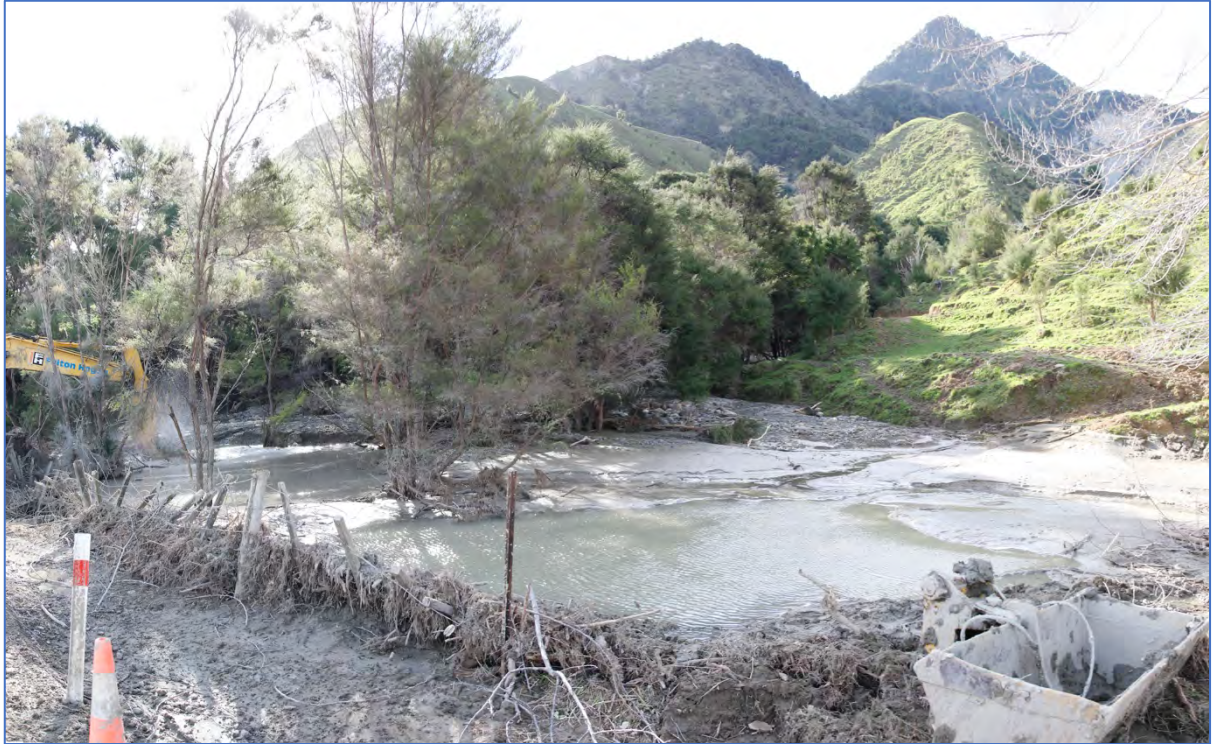
**Figure Fifty Two.** View of culvert on State Highway 35 north of Tokomaru Bay prior to clearing. Note the extensive infill of debris and the indications of overtopping on the fenceline.

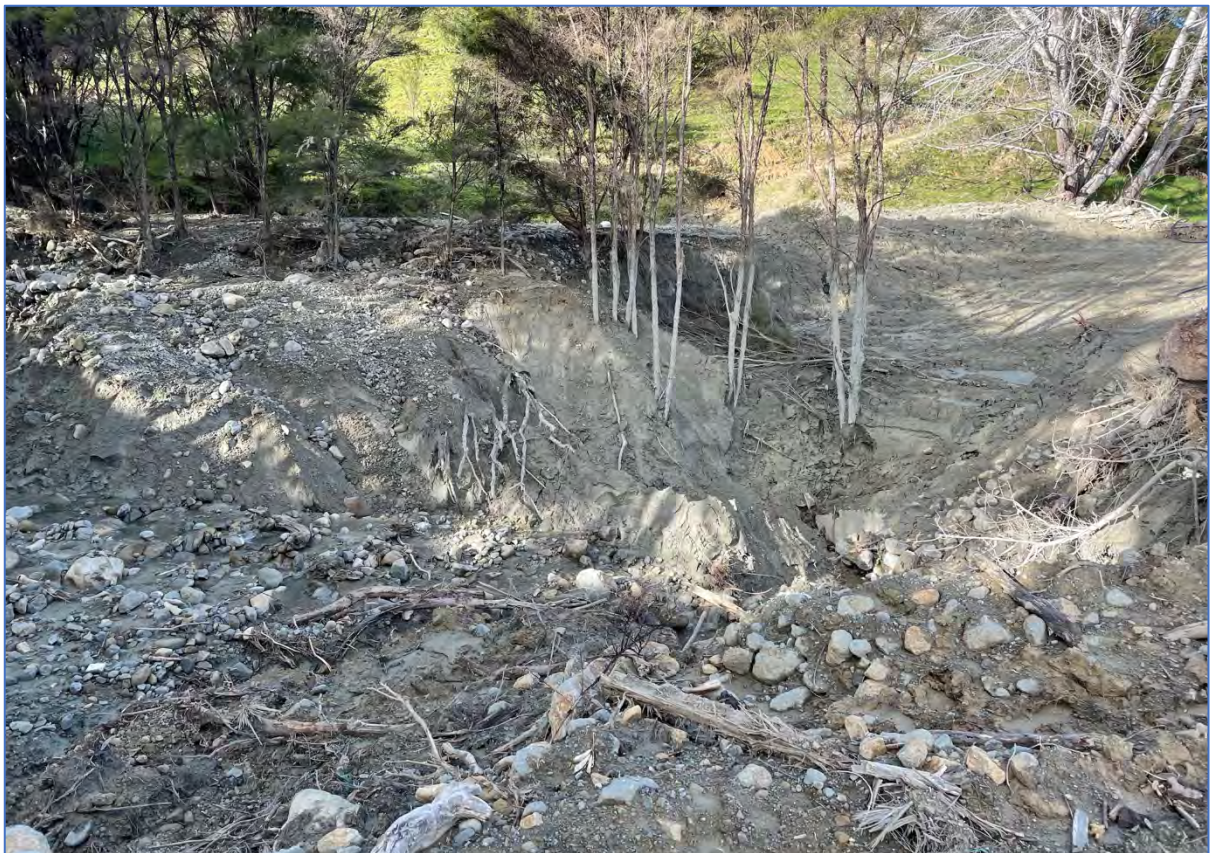
**Figure Fifty Three.** View of culvert on State Highway 35 north of Tokomaru Bay after clearing showing the considerable volume of debris remaining above the inlet.

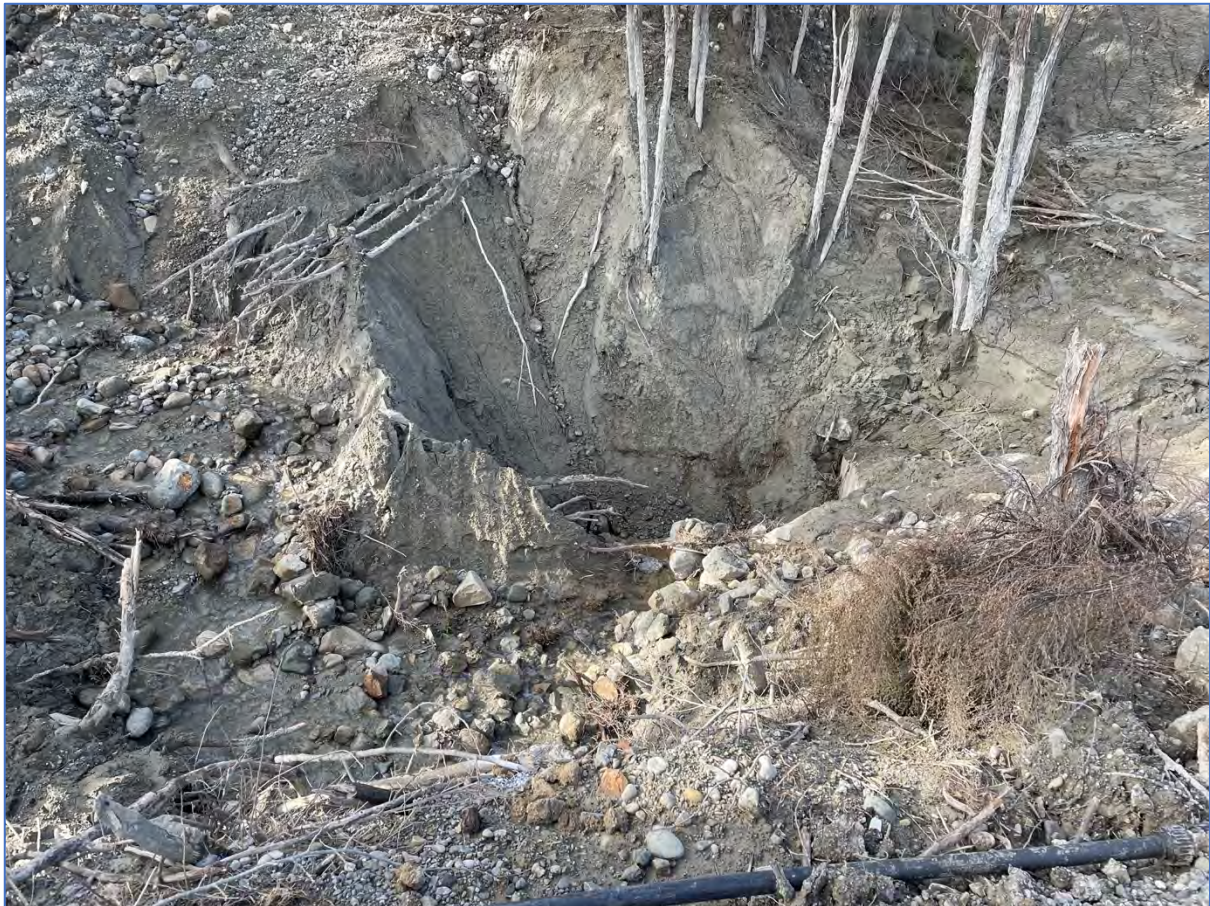
**Figure Fifty Four.** View of culvert on State Highway 35 north of Tokomaru Bay after clearing. This shows that only a small pit has been dug at the inlet to allow for drainage. It is understood that further clearance is planned and that an assessment is underway to increase culvert capacity.

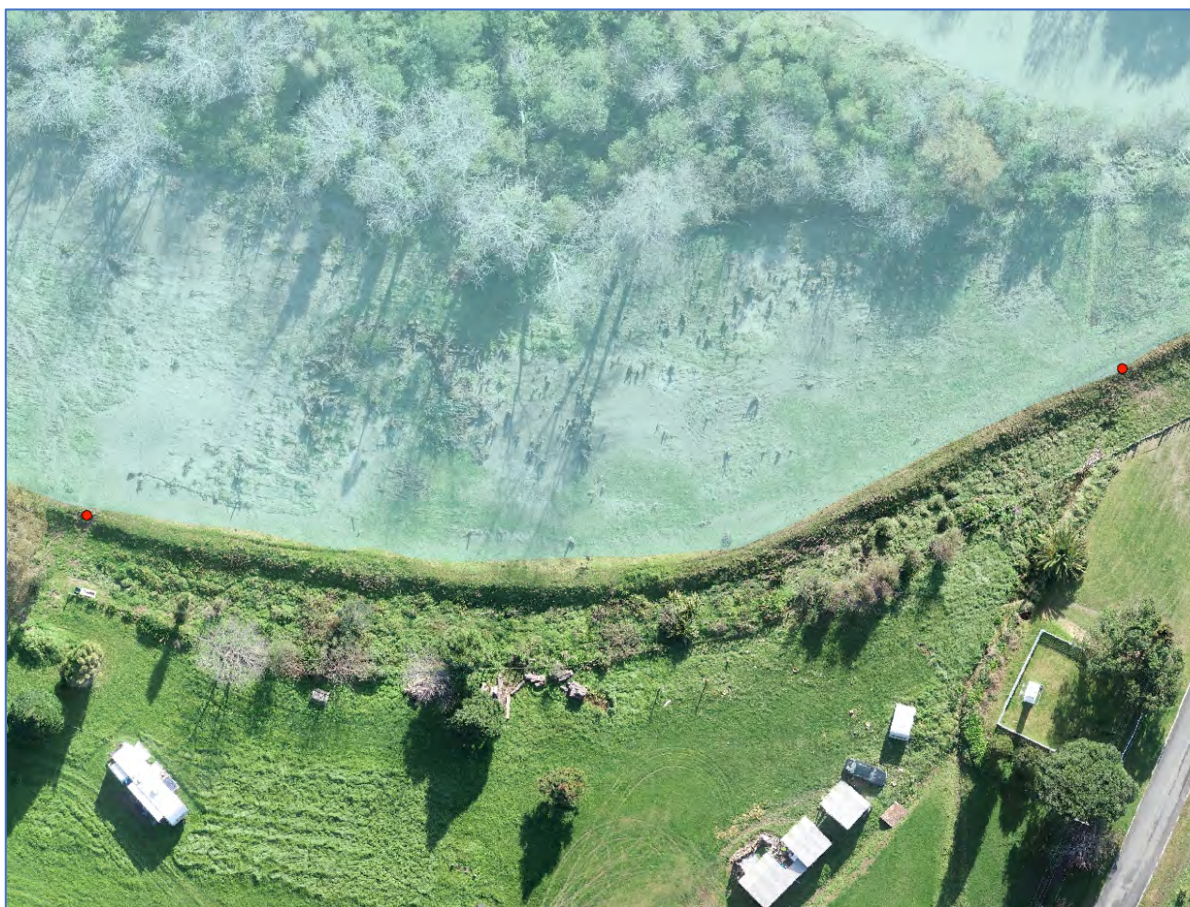
**Figure Fifty Six.** View of the lower true right bank of the Mangahauini showing the two overtopping points. The old road is shown at far right.

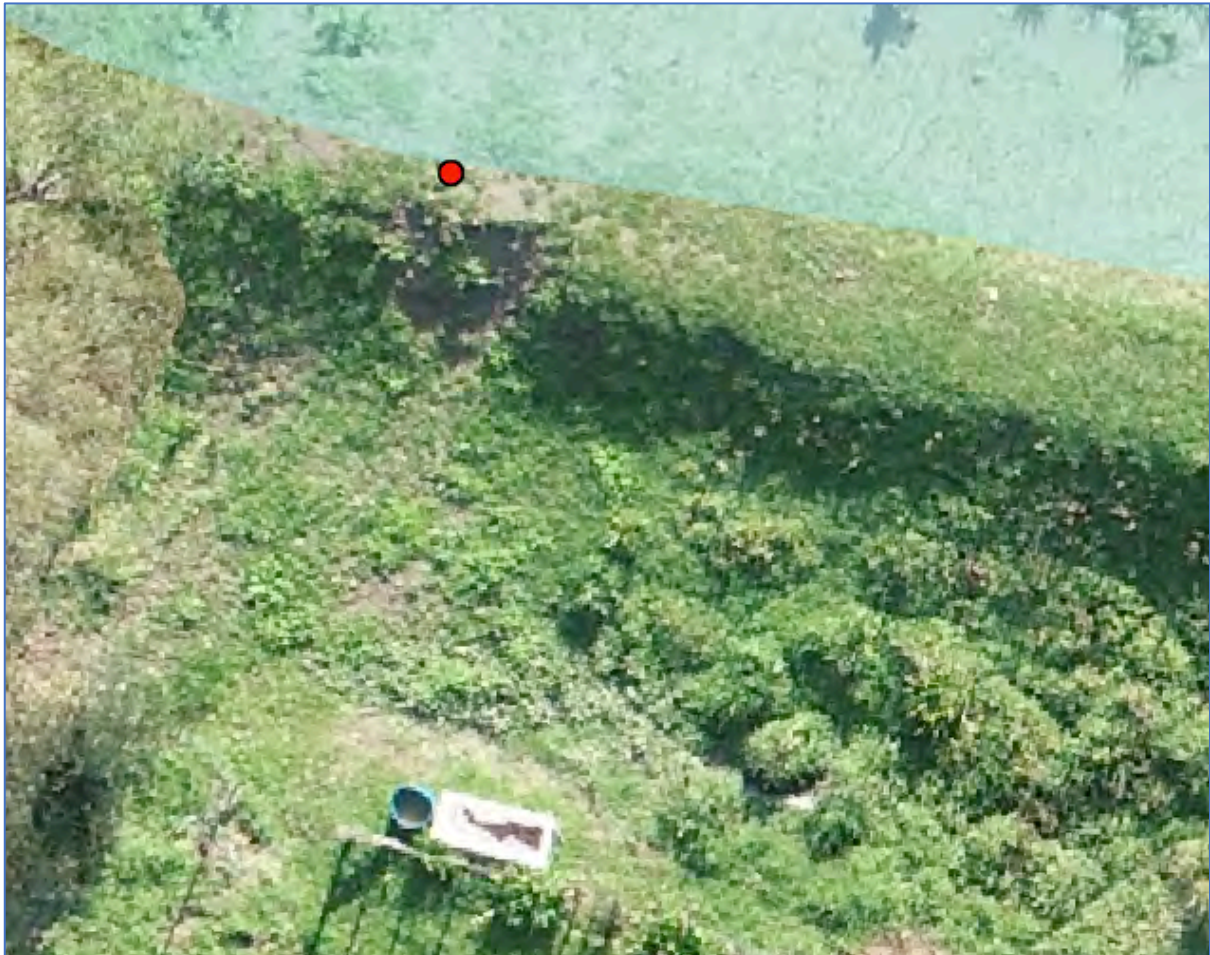
**Figure Fifty Seven.** View of the upper overtopping point showing the silt deposition and the indications of stopbank erosion.
