# Assessment of the 20<sup>th</sup> June 2021 Weather Event

# **Assessment of the 20<sup>th</sup> June 2021 Weather Event, v.2.2**

**Dr M. P. Cave  
Principal Scientist  
Gisborne District Council  
August 2021**

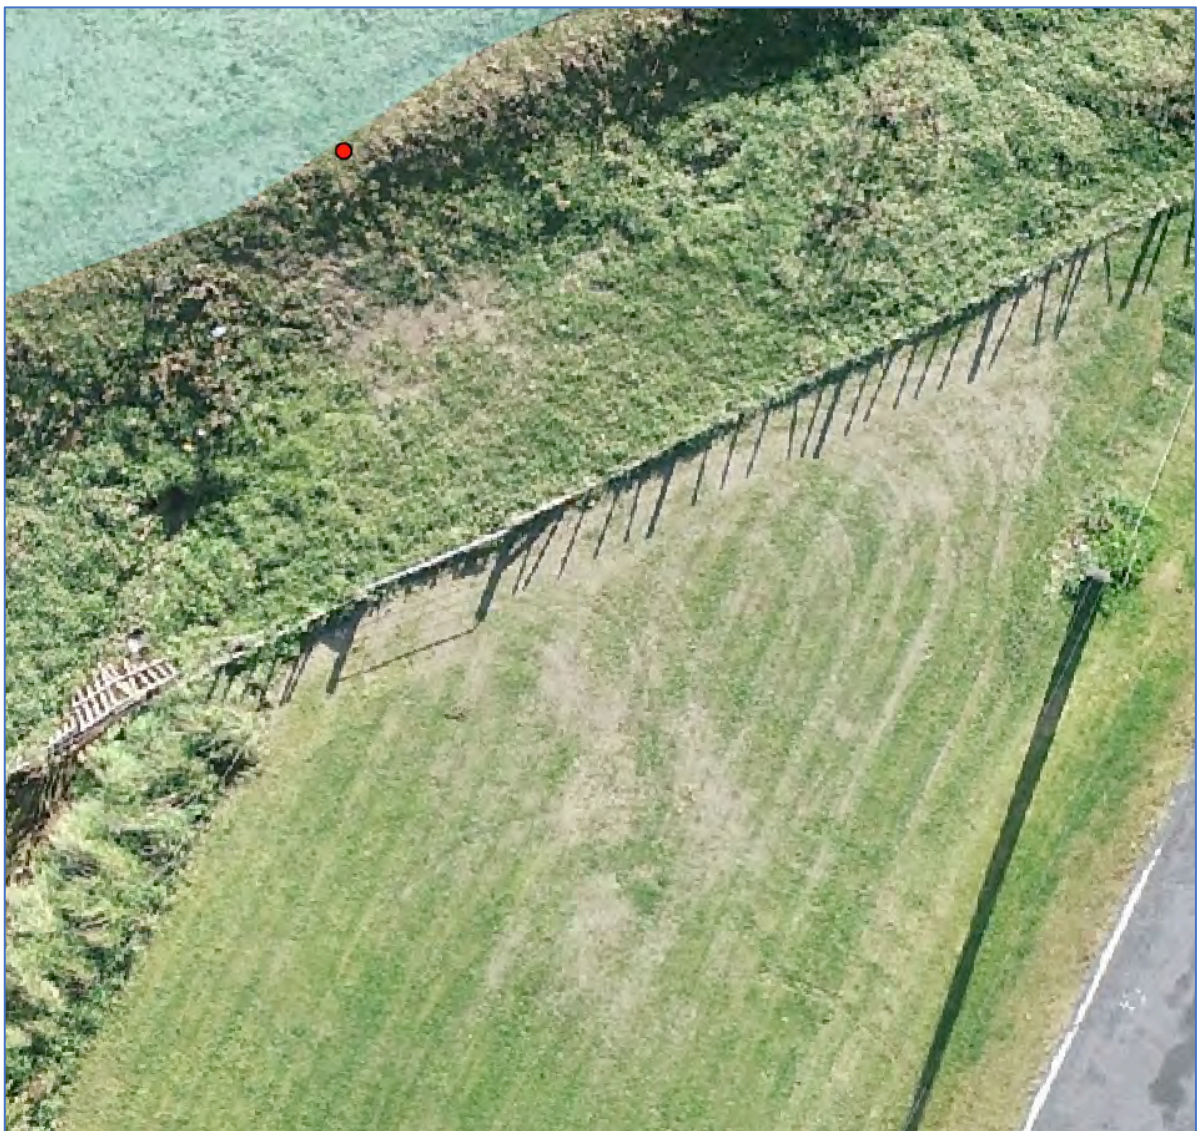
**Figure Fifty Eight.** View of the lower overtopping point showing the silt deposition extending out onto the low lying ground beyond. The imagery does not, however, suggest flood spread beyond 18m of the overtopping point.

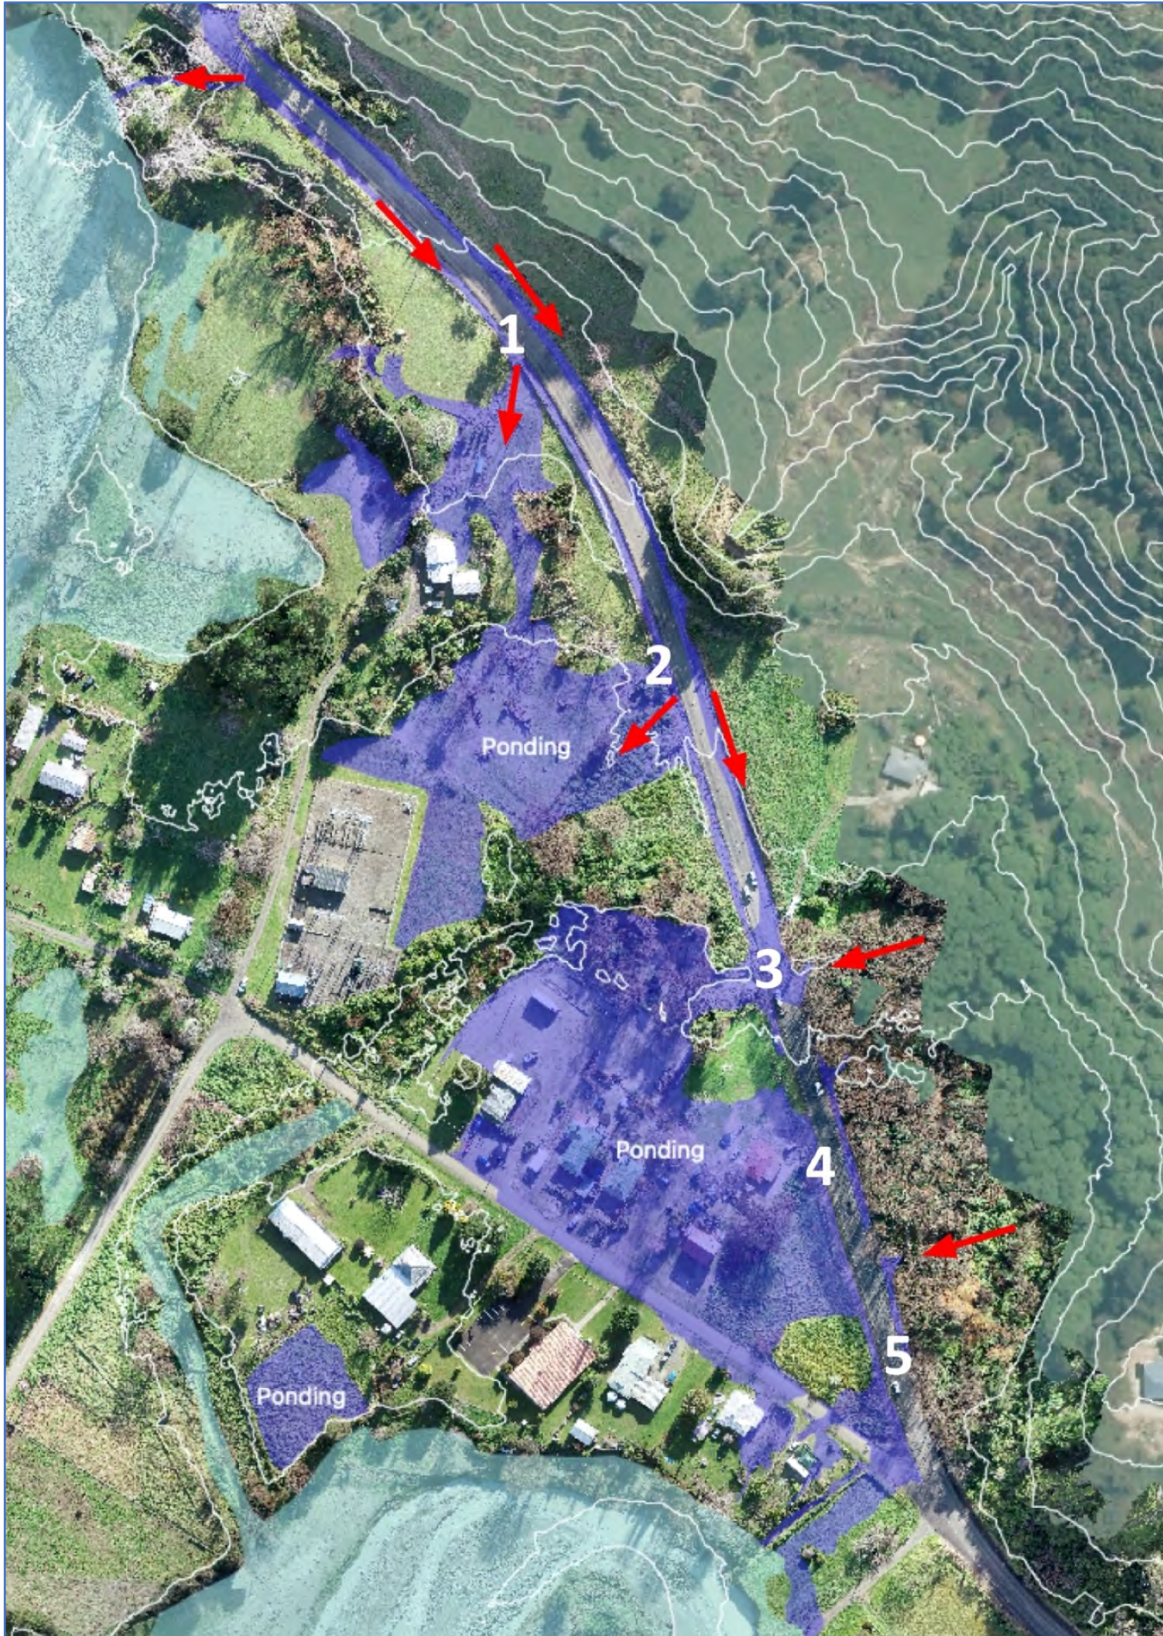
Overland flow off State Highway 35 was the primary cause the flooding at Toa Street rather than flooding from Mangahauini River. The *indicative*<sup>7</sup> flood spread resulting from the overland flow is shown in **Figure Fifty Nine** below. While the blocked culvert in the “Marotiri” tributary could have had an impact on the inundation at Toa Street it would not have been the only source of flooding. Indeed it has already been noted that some of the discharge from “Marotiri” tributary above the blocked culvert would have re-entered the creek immediately downstream. Still more of the flood from the “Marotiri” tributary appears to have discharged from the water table at two points

**Figure Fifty Nine.** Overland flow from SH 35 discharging above the house upstream of the substation (Point 1), the substation (Point 2), and ponding in the vicinity of Toa Street (Points 3-5). The overgrown culvert between points 2 and 3 constrained flood conveyance and exacerbated overland flow.

<sup>9</sup> It is noted that a significant portion of the flow from the blocked culvert may have exited the road surface before Toa Street having a more significant affect at locations 1 and 2 in **Figure Fifty Nine** than at Toa Street itself.

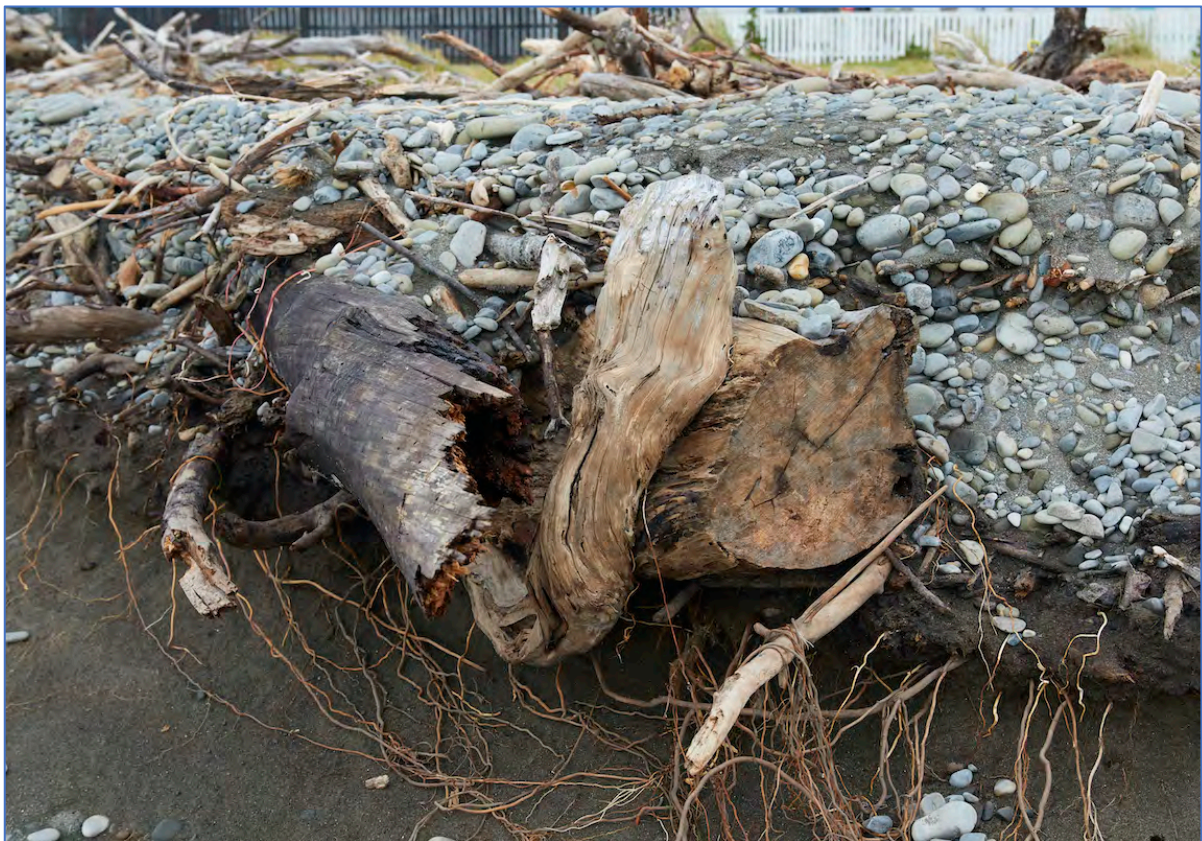
**Figure Sixty One.** Obvious erosional scour of the top of the beach that has exposed pre-existing driftwood. This is a mainly willow with some indigenous. The cuts look fresh and is probably due to being cut for firewood.

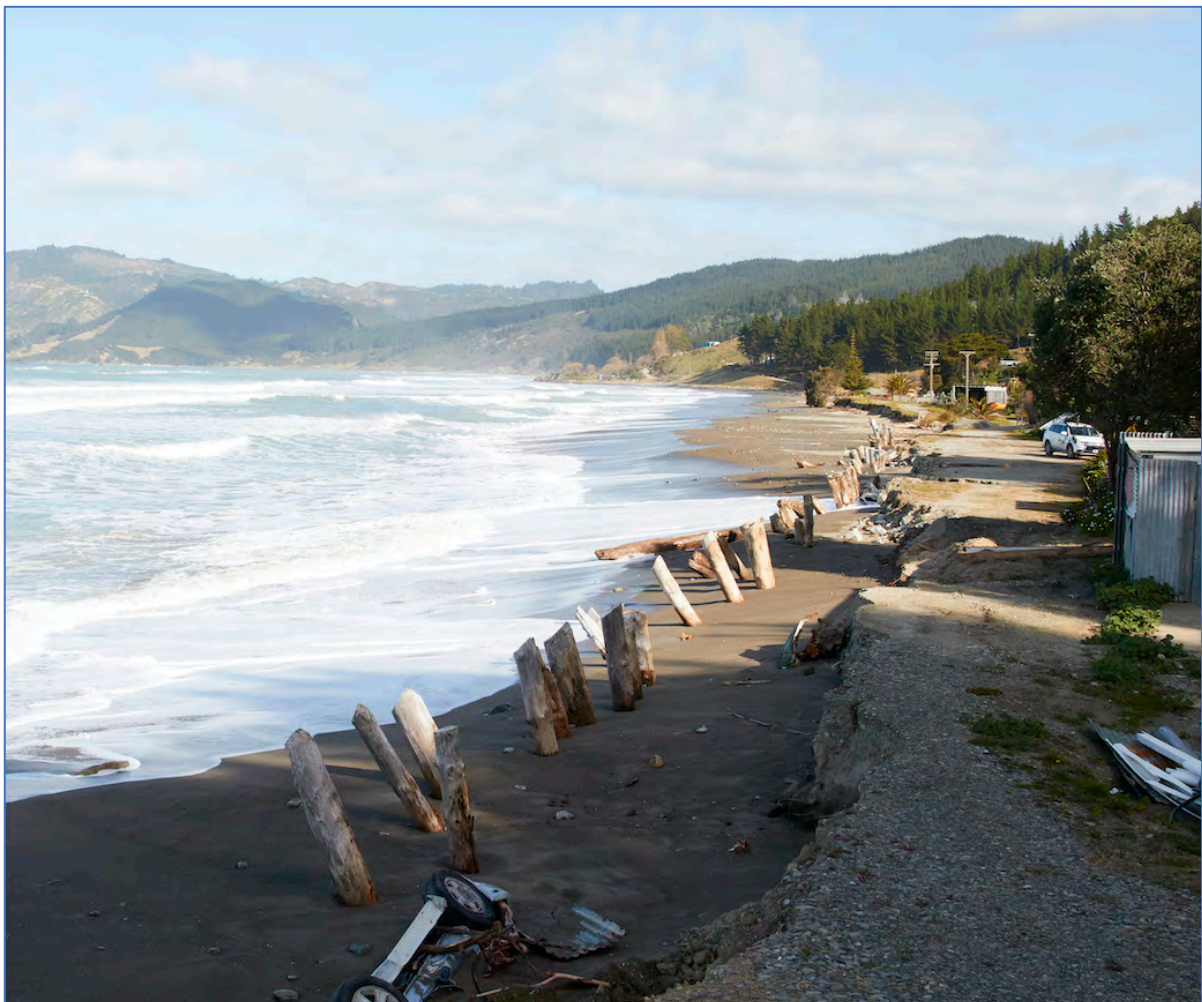
Waipiro Bay suffered from flooding with dropouts on Waikawa road and a washout on McIlroy Road at Taurapu Stream but the most significant damage due to storm surge was to the road beyond Taurapu Stream . Not all of the storm surge damage will have occurred on the 20<sup>th</sup> June but significant damage still occurred during that event. The extent of coastal erosion at this site is shown dramatically in **Figure Sixty Two** below with the line of pine logs pushed into the beach as a retaining wall showing the extent of recent erosion. Scour has resulted in channels cut into the road surface at the approaches to the last houses at Ohineakai (**Figure Sixty Three**). Beyond the houses at the end of the road in Waipiro Bay there's a track leading up to an isolated house. Erosion associated with a broken culvert (**Figure Sixty Four**) and tension cracks higher on the road (**Figure Sixty Five**) means that there is a high risk that this property will become inaccessible. It needs to be noted that the existing, now damaged road, has been constructed on fill within the coastal zone and will always have been at risk from coastal erosion. Future sea level risk will likely exacerbate this risk.

**Figure Sixty Two.** The extent of recent coastal erosion at the northern end of McIlroy Road marked by the pine logs that had been pushed into the sand as retaining posts.

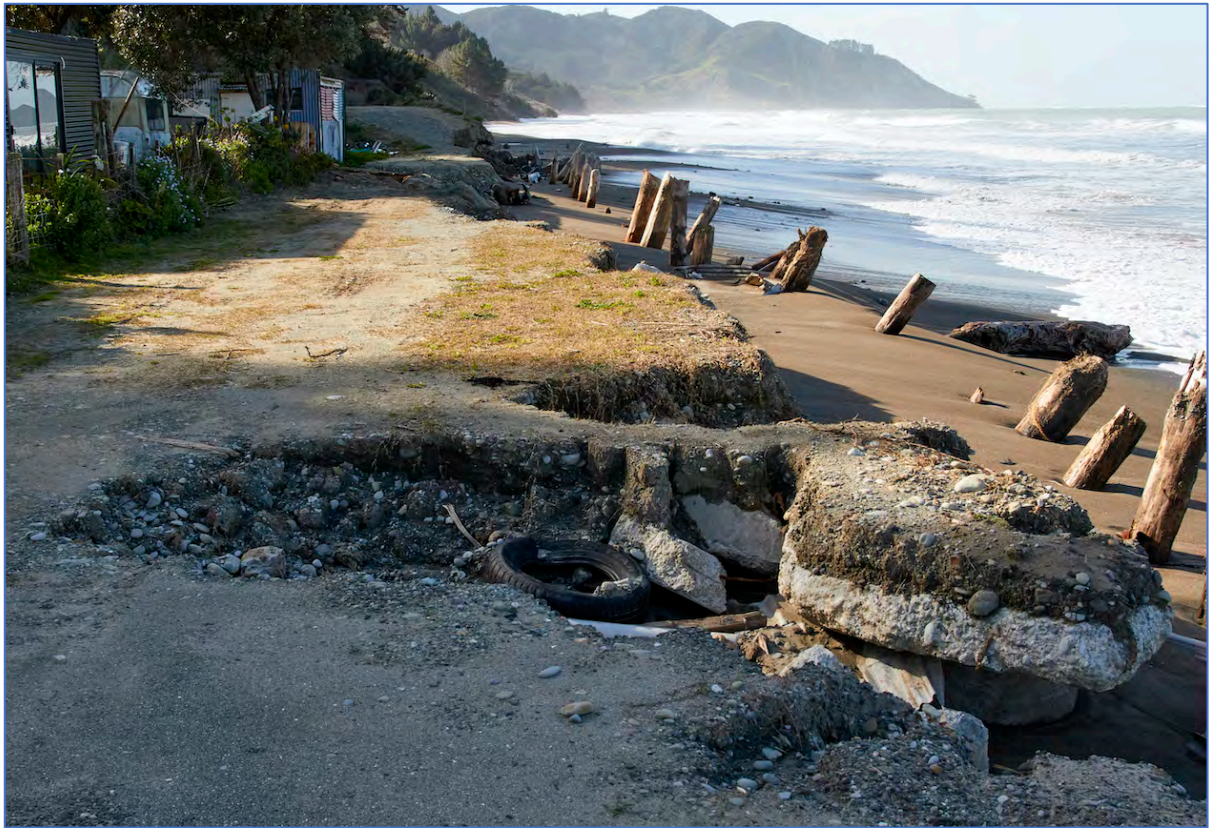
**Figure Sixty Three.** The extent of scouring and channelling of the road.

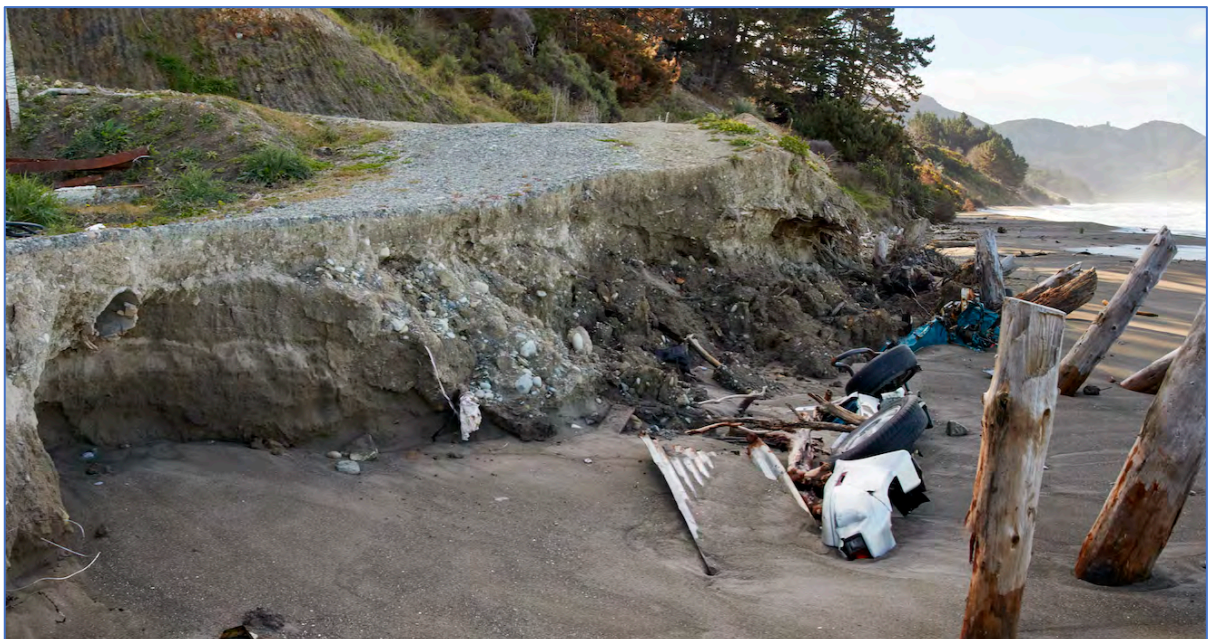
**Figure Sixty Four.** The road heading up to the last property at the end of McIlroy Road showing the scour and undercutting associated with the broken culvert, the car bodies and other debris used as armouring on the fill making up the access track and the “totem poles” used to buttress the slope. Note the over steepened face and overhangs.

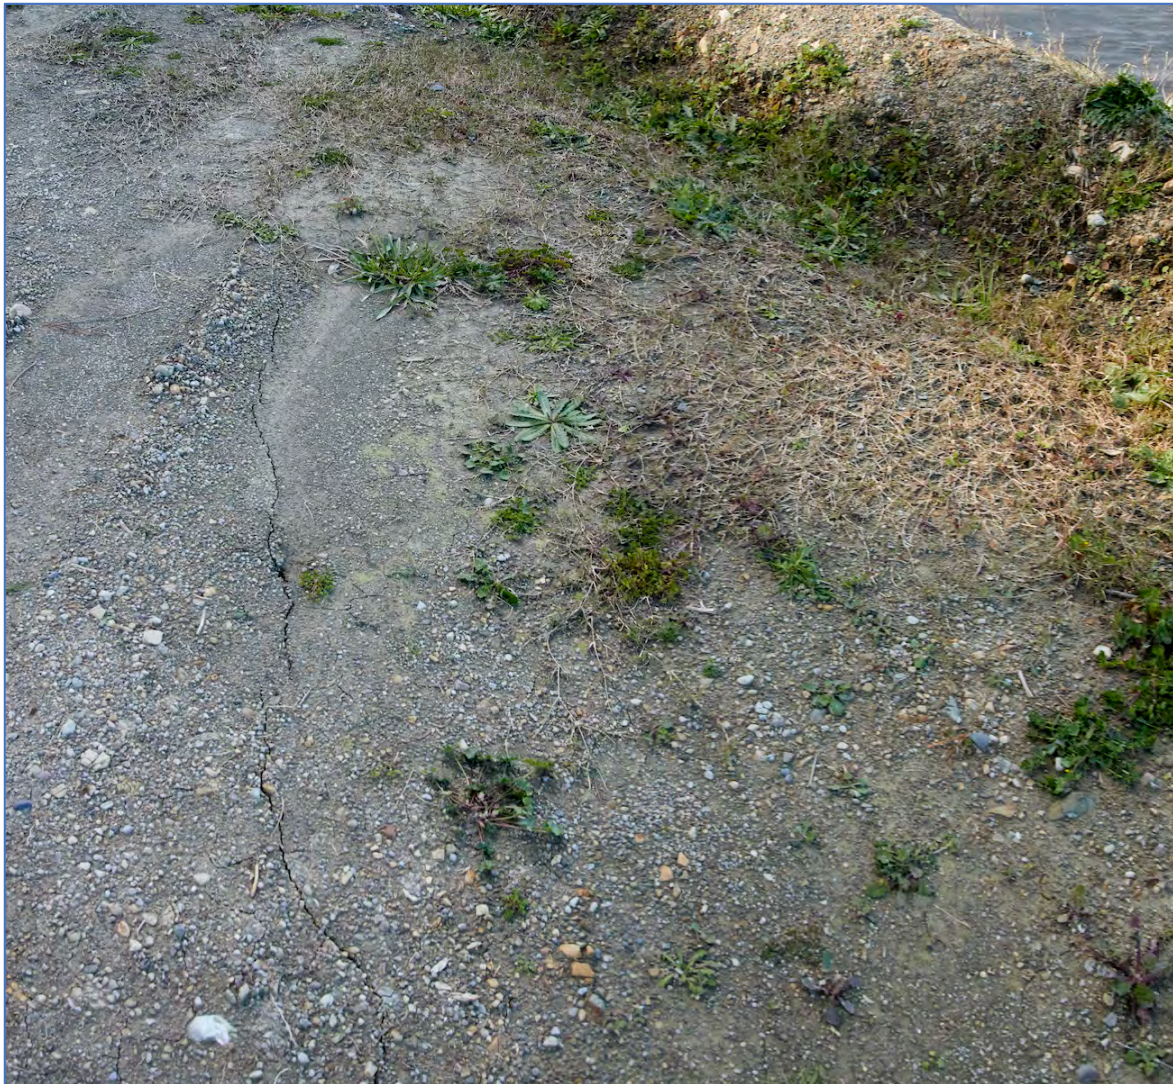
*Figure Sixty Five. Tension cracks on the bend in the road leading up to the last house.*

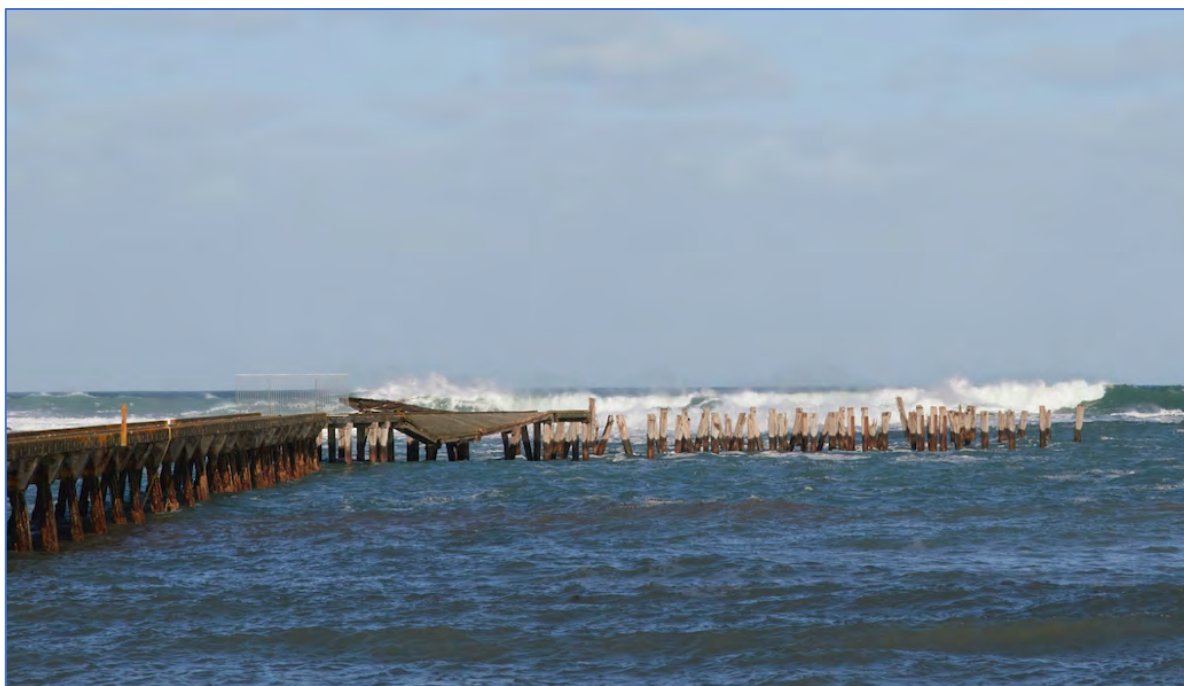
Storm surge damage was widespread along the length of Tokomaru Bay. At the north end of the bay, big seas caused further damage to the Tokomaru Bay wharf (**Figure Sixty Six**) and there was damage to the road near the Te Puka tavern. Extensive scour of the beach along with woody debris was evident at the mouth of Waiotu (**Figure Sixty Seven**) and more woody debris was thrown on the freedom camping site adjacent to Waiotu Road just to the south of the river mouth (**Figure Sixty Eight**).

**Figure Sixty Six.** Additional damage to the Tokomaru Bay wharf as a result of heavy seas

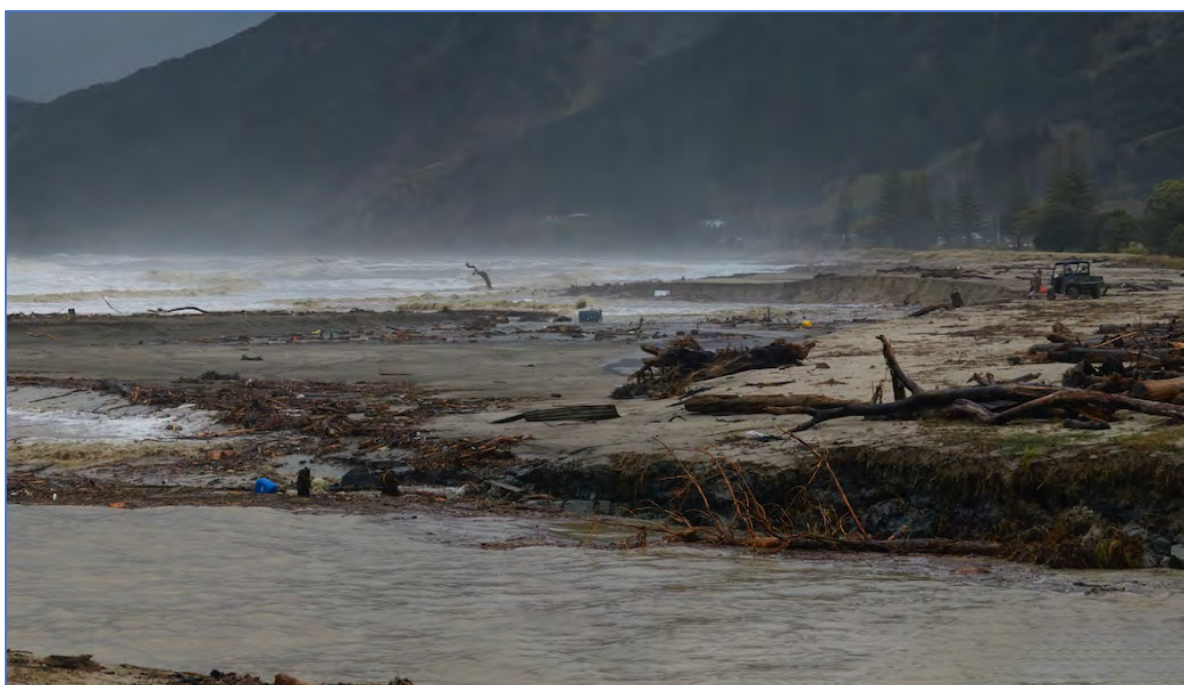
**Figure Sixty Seven.** Scour erosion of the top of the beach at the mouth of Waitutu Stream, with logs thrown up by the storm surge. Note the significant rubbish washed out by the flood.

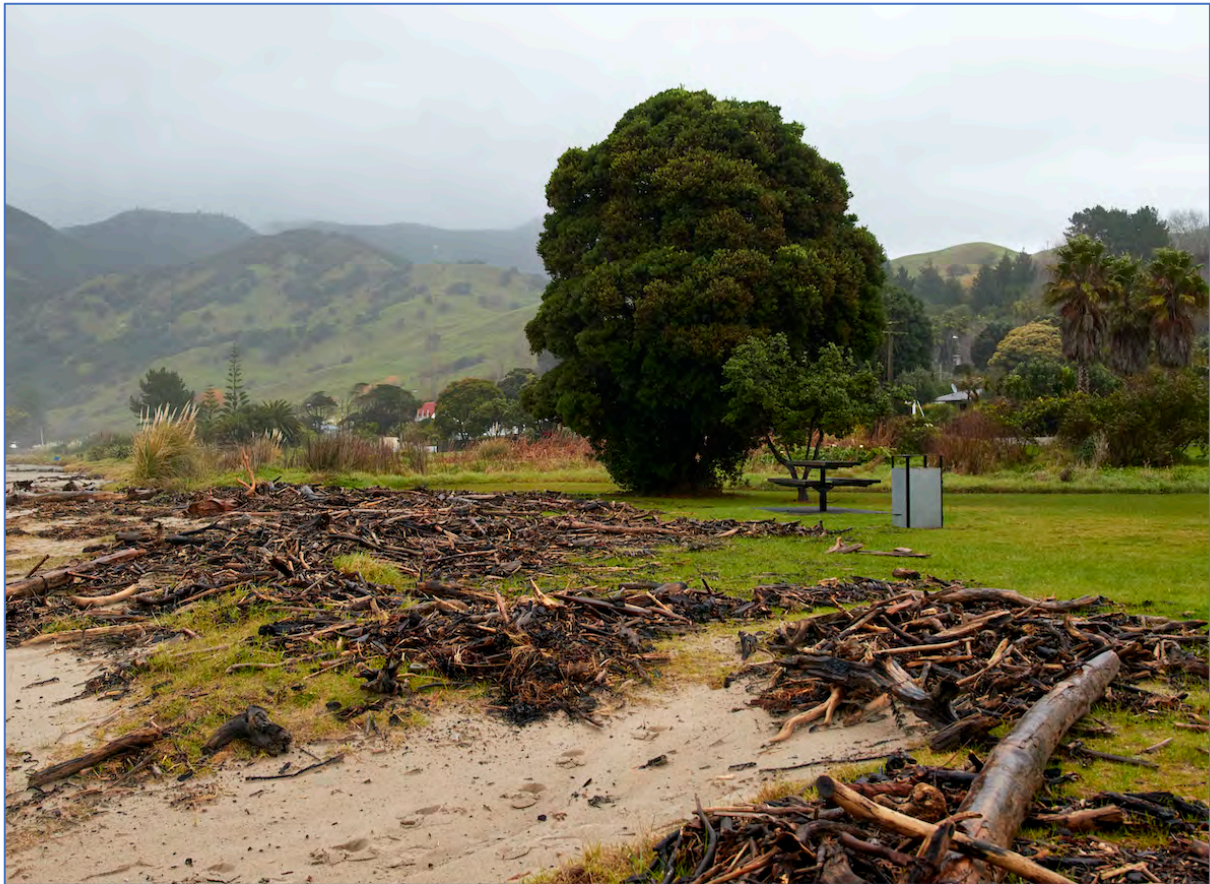
**Figure Sixty Eight.** A significant amount of woody debris was thrown up on the reserve south of the Waiotu Stream river mouth.

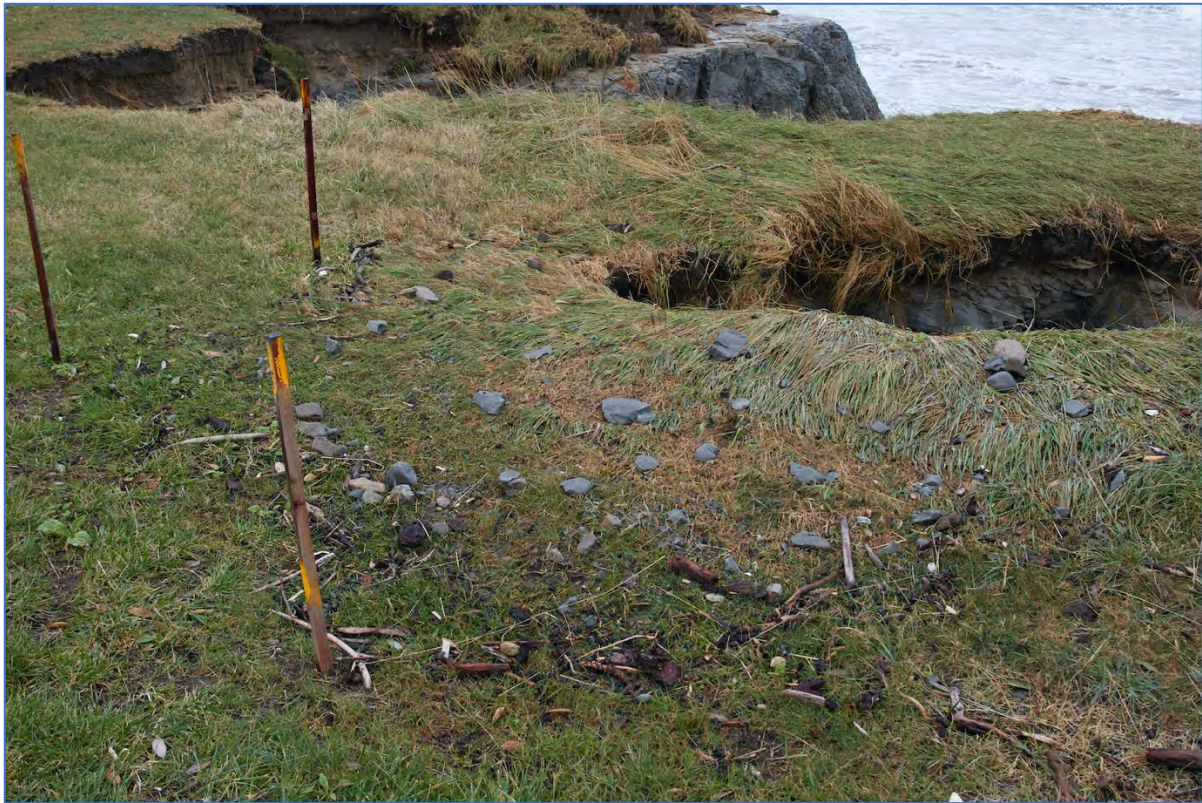
**Figure Seventy One.** Photograph taken 30<sup>th</sup> June 2021 showing the debris thrown up during the 20<sup>th</sup> June storm surge.

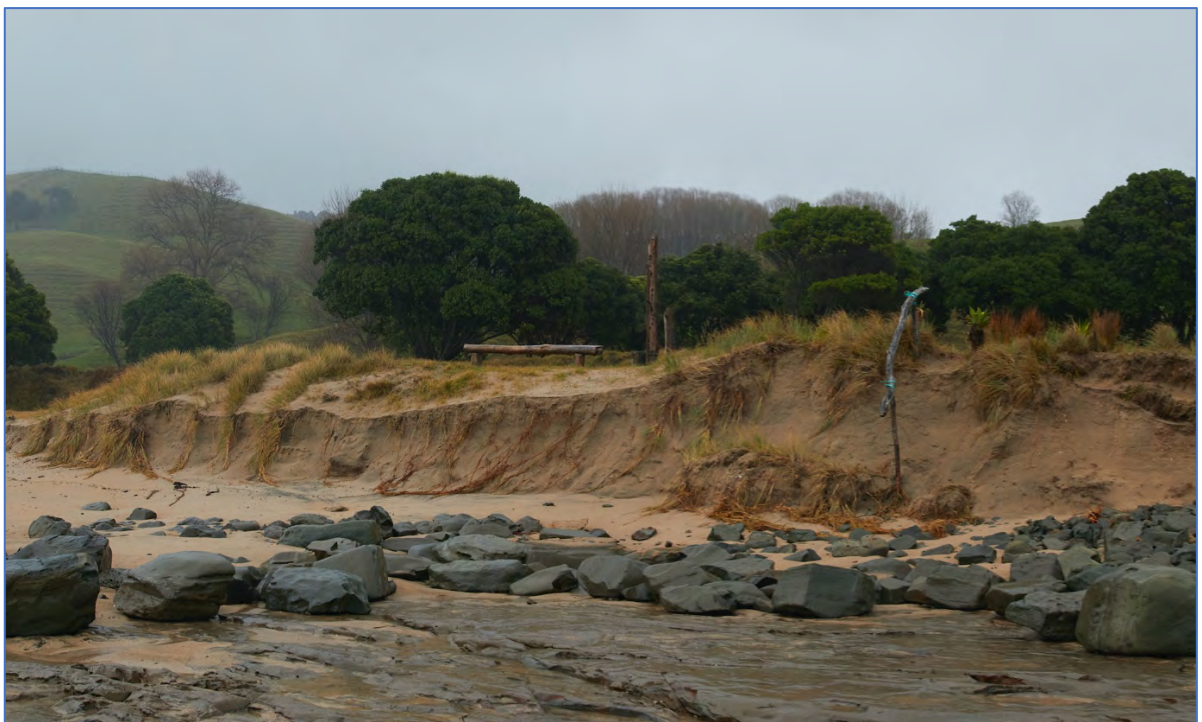
**Figure Seventy Two.** Photograph showing dune erosion on the beach north of Turihaua Point.

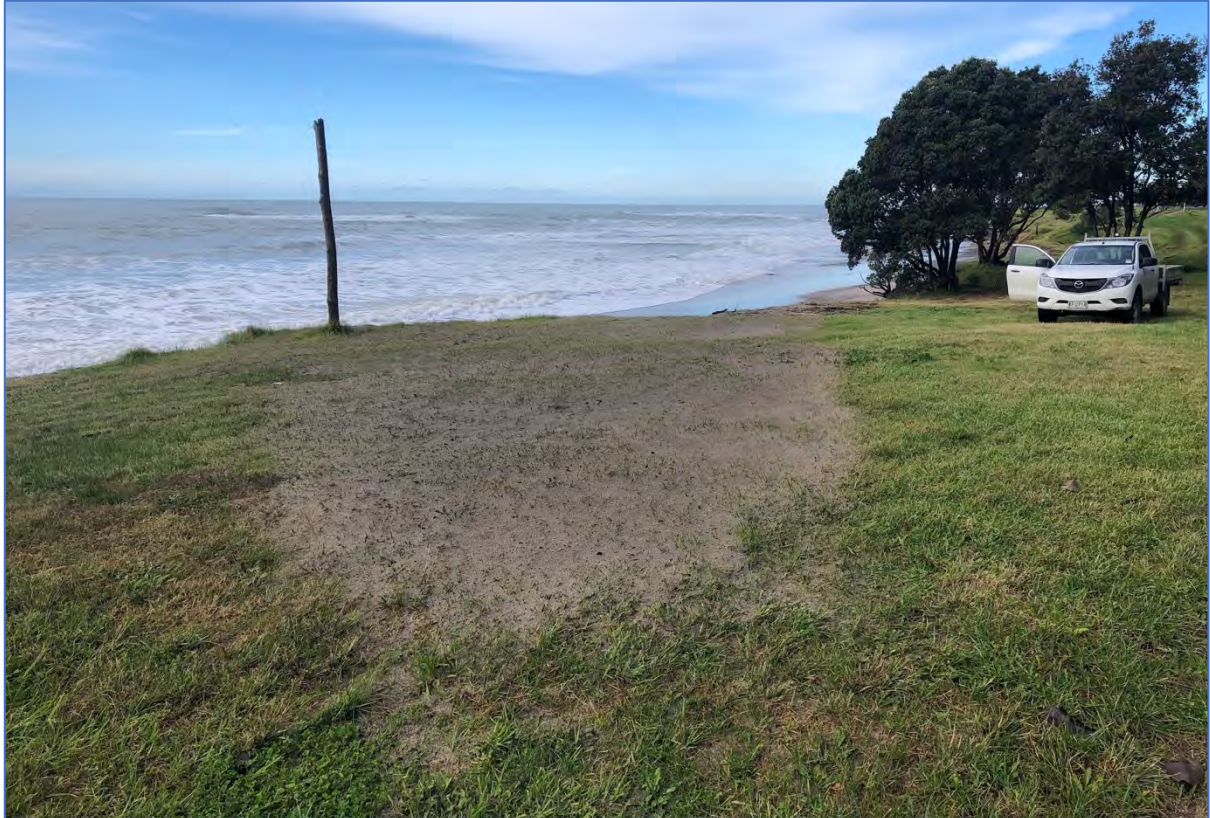
**Figure Seventy Three.** Photograph showing overtopping and deposition of sand north of Turihau Point. During the 2020-21 summer, campers occupied this site.

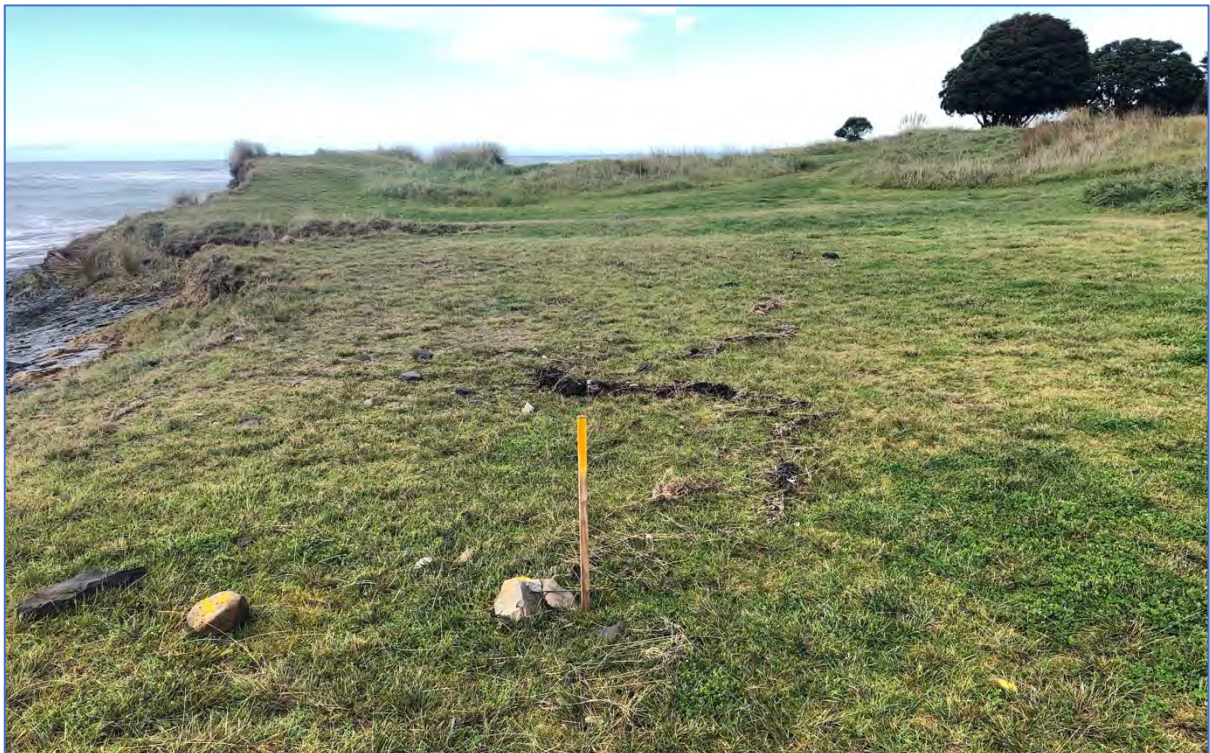
**Figure Seventy Four.** Photograph showing the debris line for the storm surge in June 2021. Grass beyond the debris line shows signs of salt burn indicating salt water inundation. Note that the large rocks were put there at 1 metre intervals to measure the extent of the surge.
