# Downstream Impacts of sediment and woody debris Inundation in the Mangaheia sub-catchment Uawa Catchment during the Queens Birthday Storm 2018

Dr Murry Cave  
Principal Scientist  
Gisborne District Council  
v.3.2 October 2022

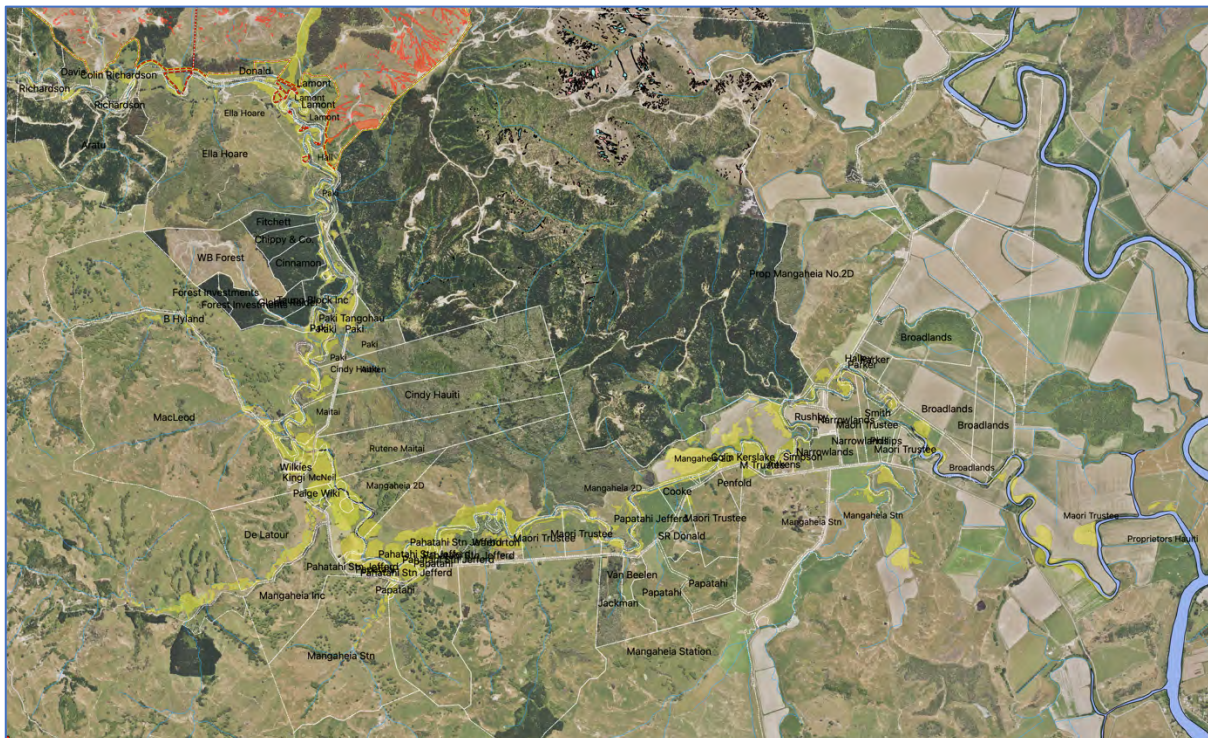
**Figure One.** Sediment deposition in the Mangaheia Catchment downstream of the Uawa Forest based on Sentinel and Maxar satellite imagery (in yellow).

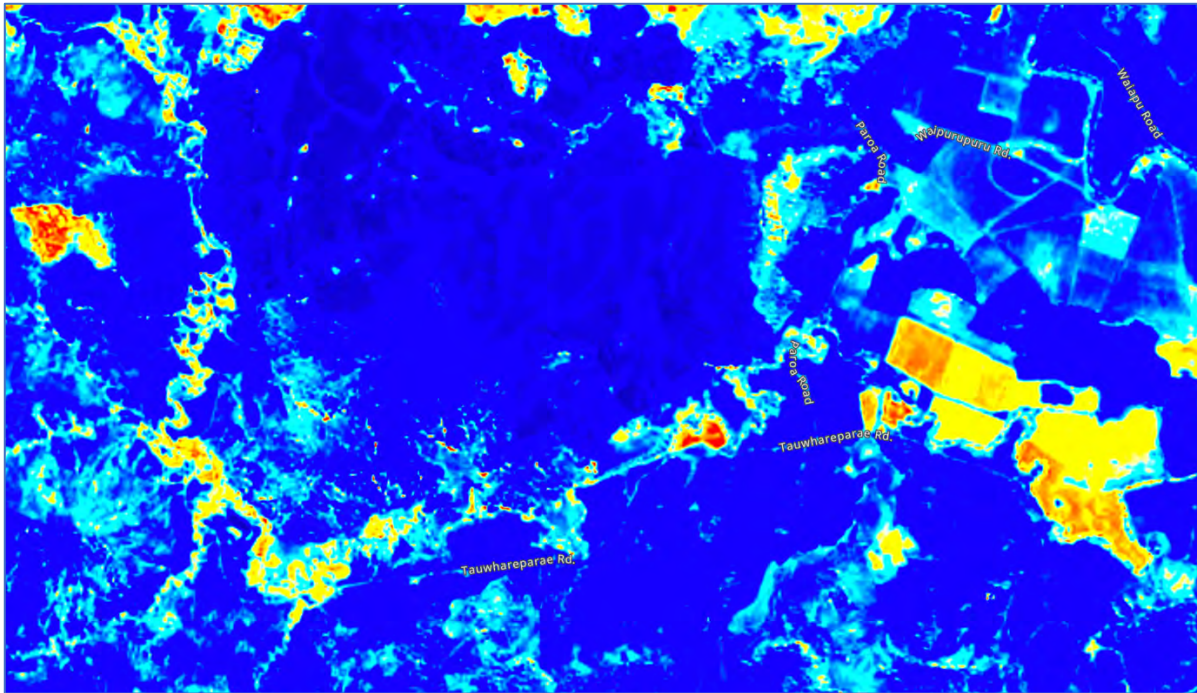
**Figure Two.** Sentinel image dated 15<sup>th</sup> June 2018 showing the moisture index (reds and yellows are bare ground) which equates to recent sediment on the flood plains while pale blue areas are areas of elevated moisture which equates approximately to the flood spread. As this indicates, most of the riverside properties in the Mangaheia still showed the residual impact of flooding a week or so later.

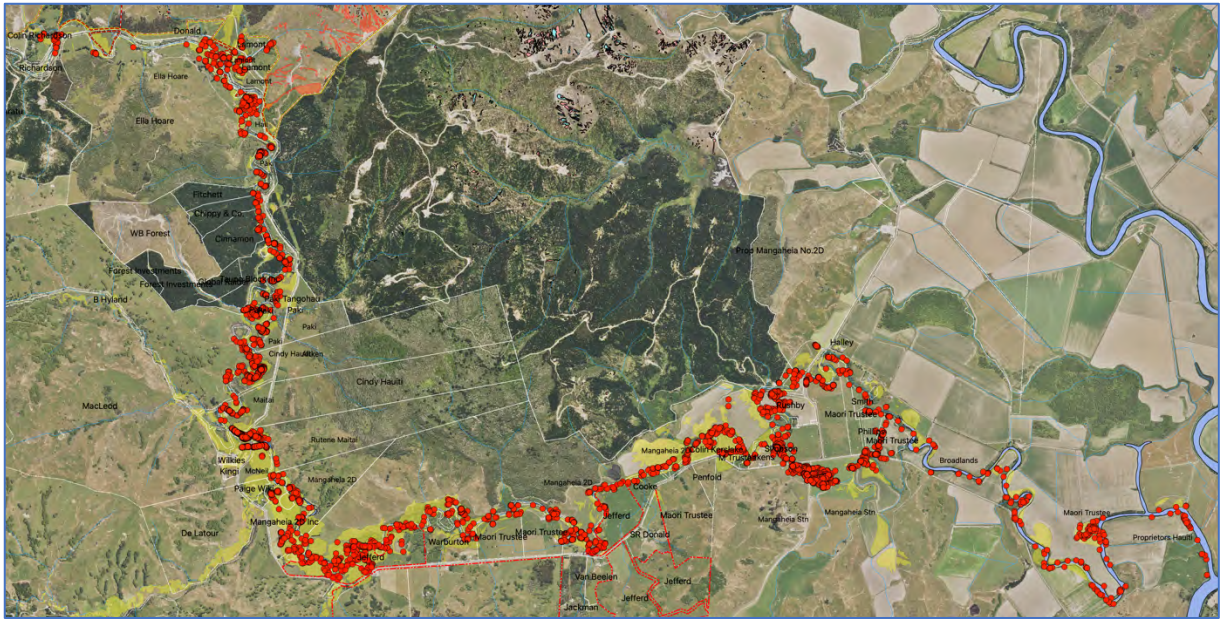
**Figure Four.** Woody debris distribution (red dots) and sediment deposition (yellow) in the Mangaheia Catchment downstream of the Uawa Forest based on Sentinel and Maxar satellite imagery. The various property owners are also shown and these are described in more detail below.

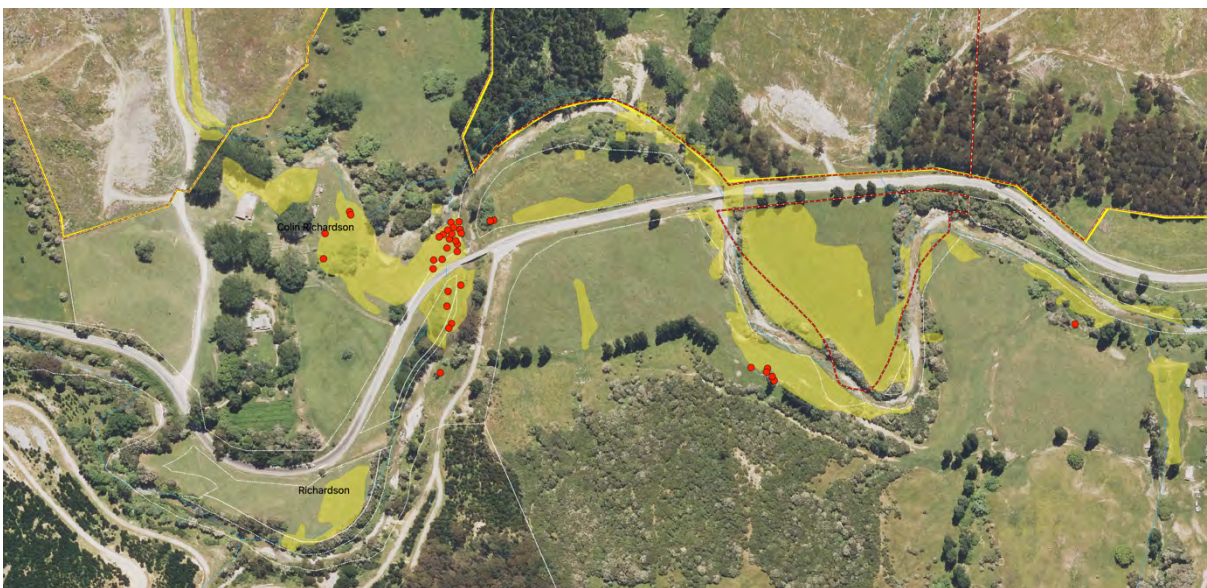
The Richardson property sites at the junction of the Mangateao stream with the Mangaheia River and experienced extensive damage because of an inundation of sediment and woody debris. The general extent of sediment deposition and woody debris distribution based on post event Sentinel and Maxar satellite imagery is shown in **Figure Five** below and documented further in **Figures Six to Eight** below.

**Figure Five.** View of the Richardson property on the confluence of the Mangateao and Mangaheia showing the sediment deposition and woody debris deposits based on Sentinel and Maxar satellite imagery.

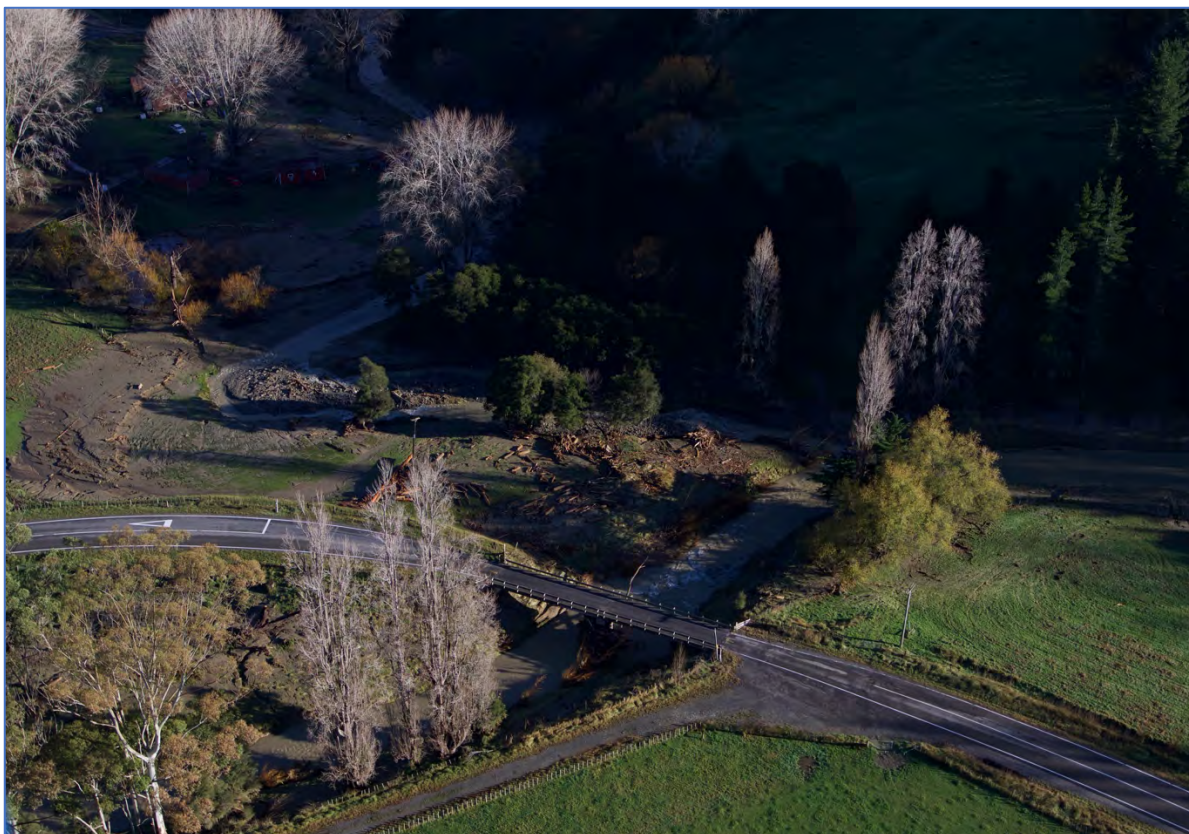
**Figure Six.** Aerial view of the east end of the Richardson property adjacent to the Tauwhareparae Road (6<sup>th</sup> June 2018) showing the extensive woody debris and sediment deposition.

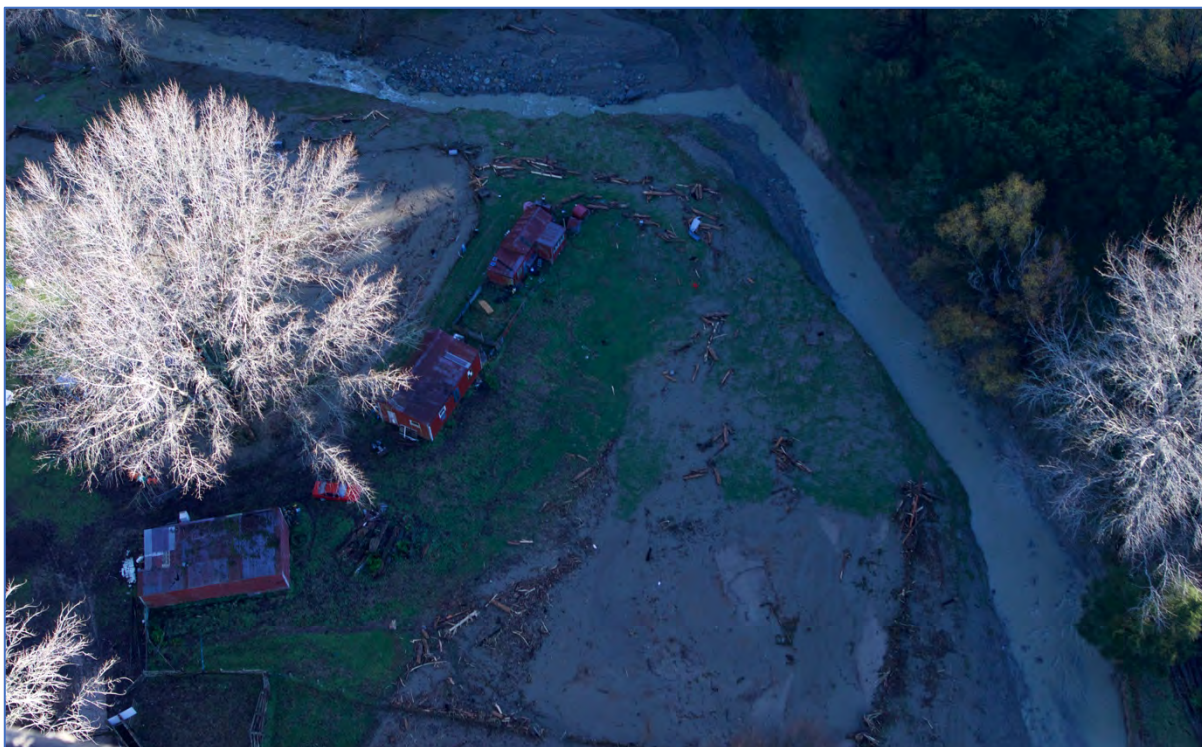
**Figure Seven.** Aerial view of Richardson property (6<sup>th</sup> June 2018) showing the extensive woody debris and sediment deposition. As noted above the flood height is more extensive than the sediment deposition and this image shows evidence of flood inundation through the buildings.

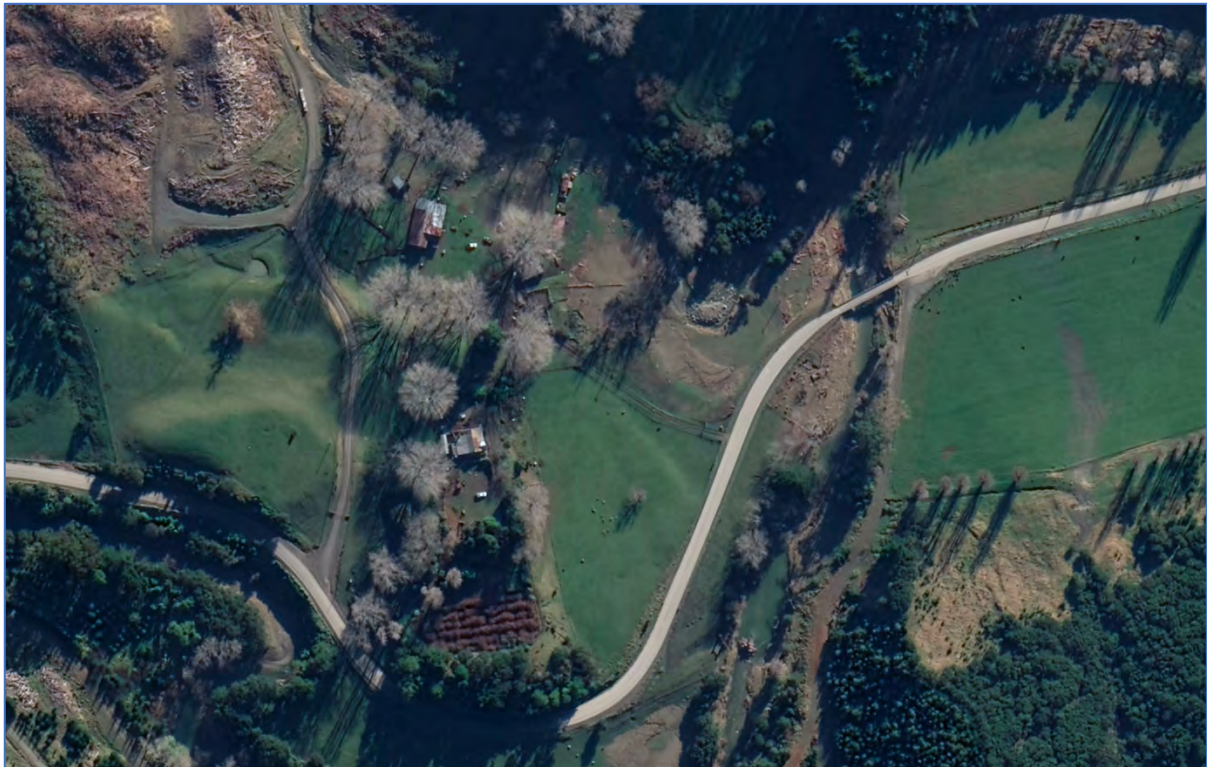
**Figure Eight.** 13<sup>th</sup> July 2018 Maxar Satellite image of the Richardson property showing the sediment deposition and woody debris distribution.

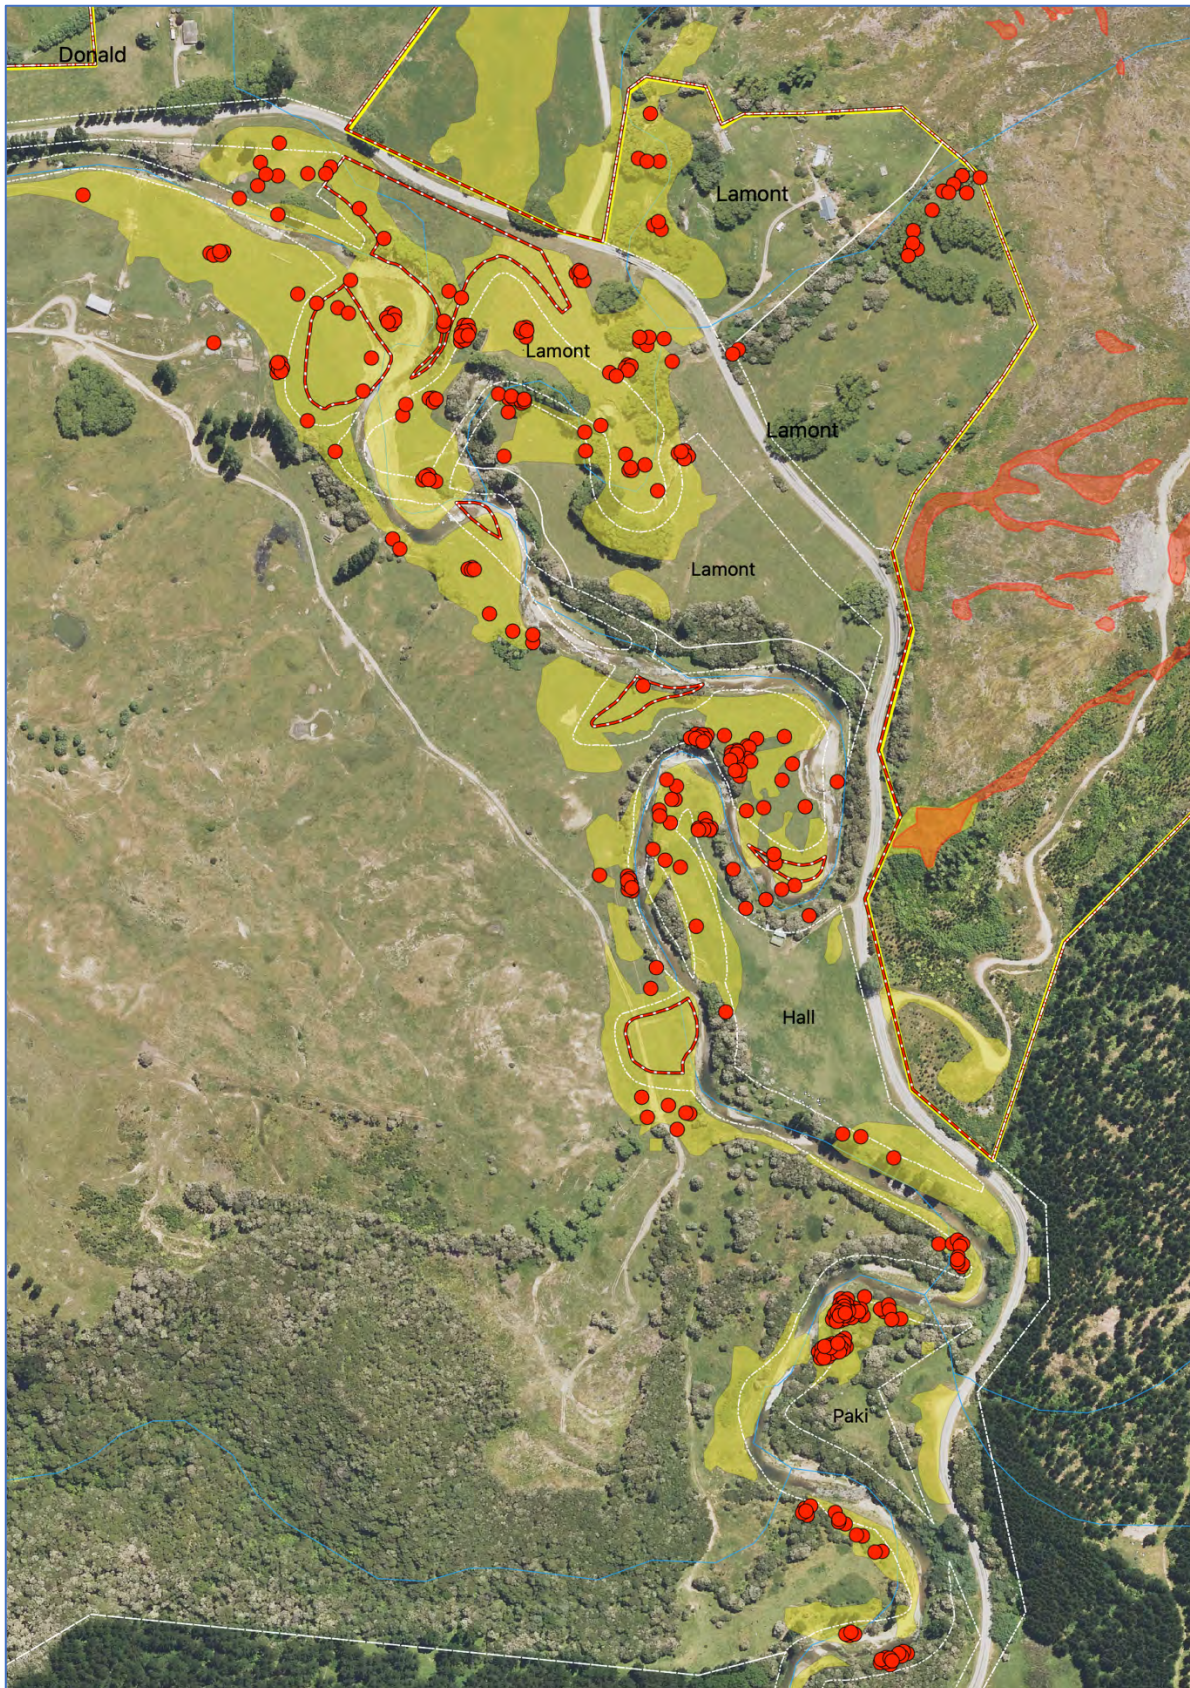
**Figure Nine.** Sediment deposition and woody debris distribution immediately downstream of the Mangatoitoi tributary. The Lamont property experienced significant woody debris deposition along with loss of pasture and damaged fences. Ella Hoare's property on the true right bank of the Mangaheia had extensive woody debris deposition.

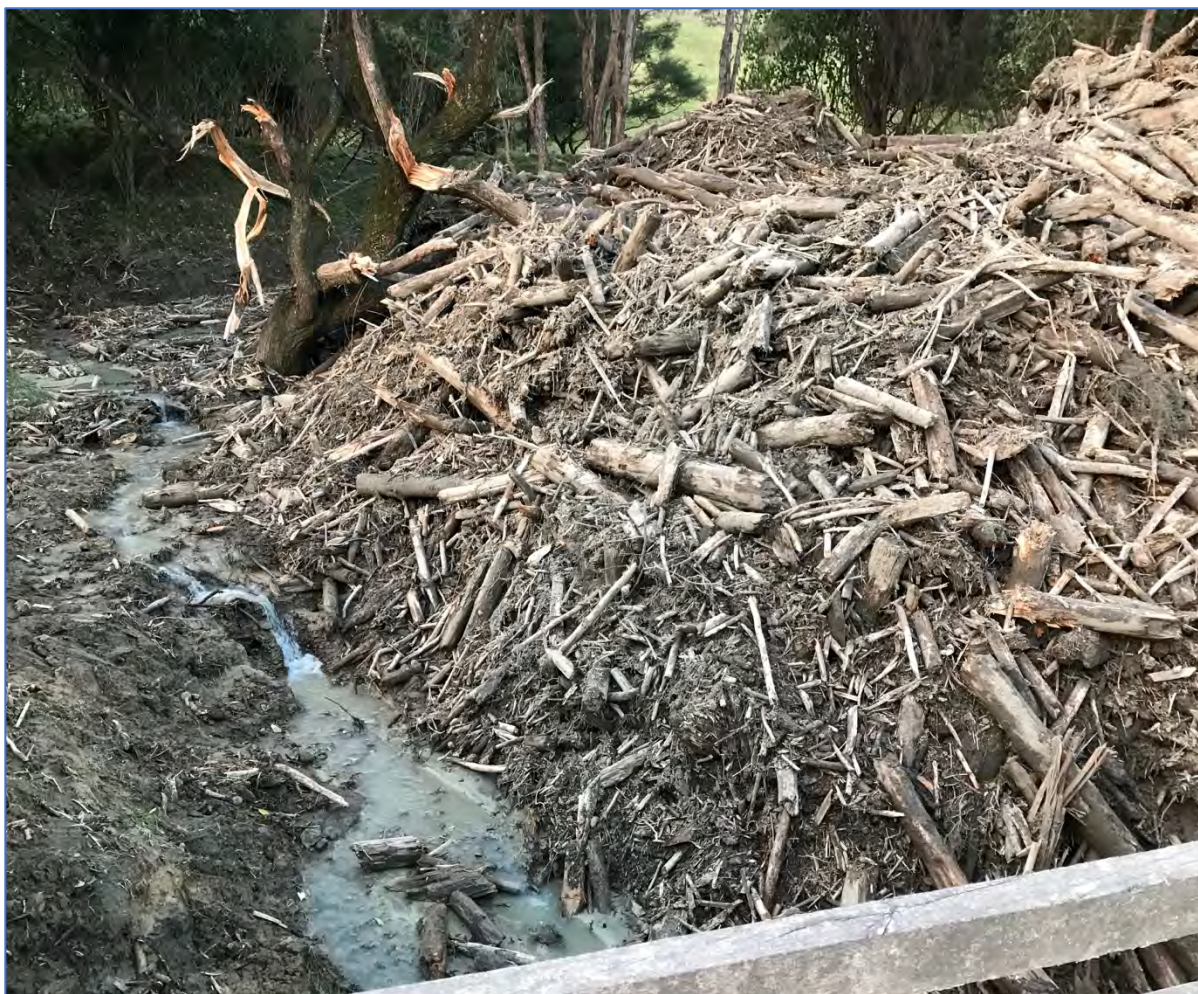
**Figure Ten.** Woody debris pulled back from small stream on Lamont property but perched in a vulnerable position rather than removed (30<sup>th</sup> June 2018).

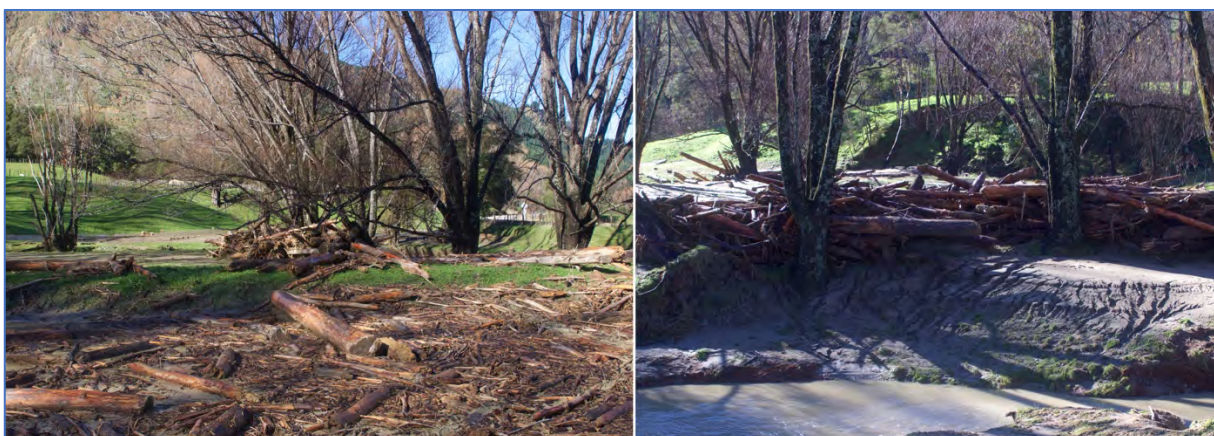
A considerable number of logs were also distributed through the property on the banks of the Mangatoitoi (**Figure Eleven**). These were put into piles within a month but not removed until some months later. Other woody debris on the hydro reserve and on the Hoare property was put into piles by July 2018 but not removed until early 2019 (**Figure Twelve**).

**Figure Eleven.** Woody debris on the banks of the Mangatoitoi stream, Lamont property 10<sup>th</sup> June 2018.

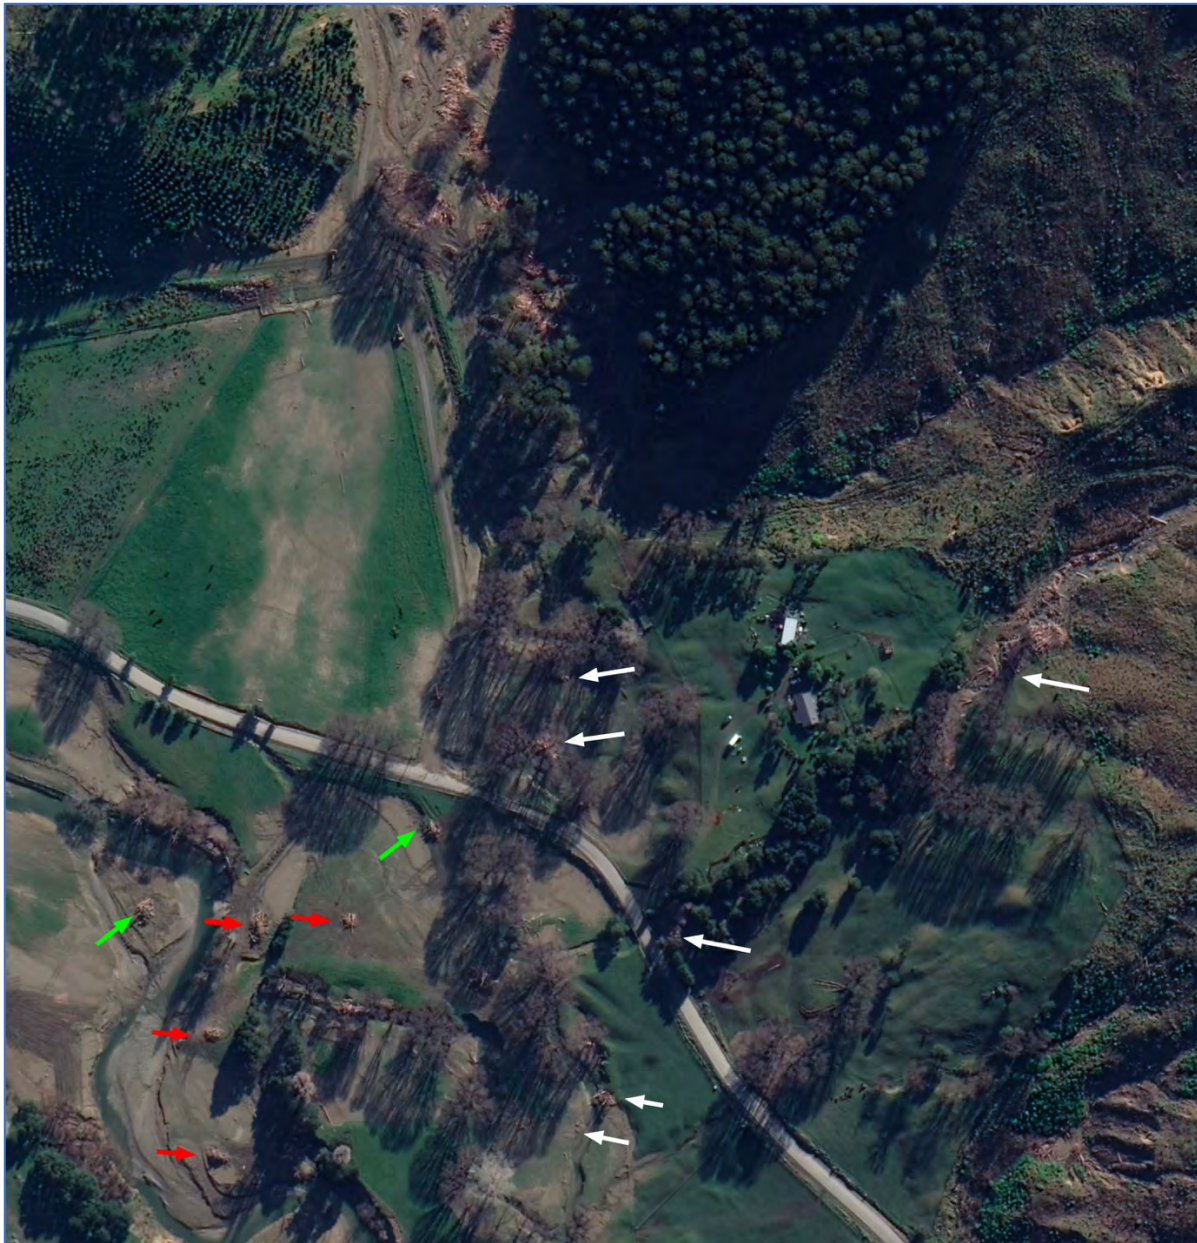
**Figure Twelve.** Satellite image of the confluence of the Mangatoitoi and Mangaheia dated 13<sup>th</sup> July 2018 showing the sediment deposition and areas of wood piles. Those marked by a white arrow are on the Lamont property, those in red on the Hoare property while those in green are on hydro reserve. Other wood piles at the top of the image and immediately above the white arrow on the right are within Uawa forest. The woody debris above the righthand white arrow along with the woody debris remain in place and remains a potential reservoir of woody material that can be remobilised in a subsequent storm.

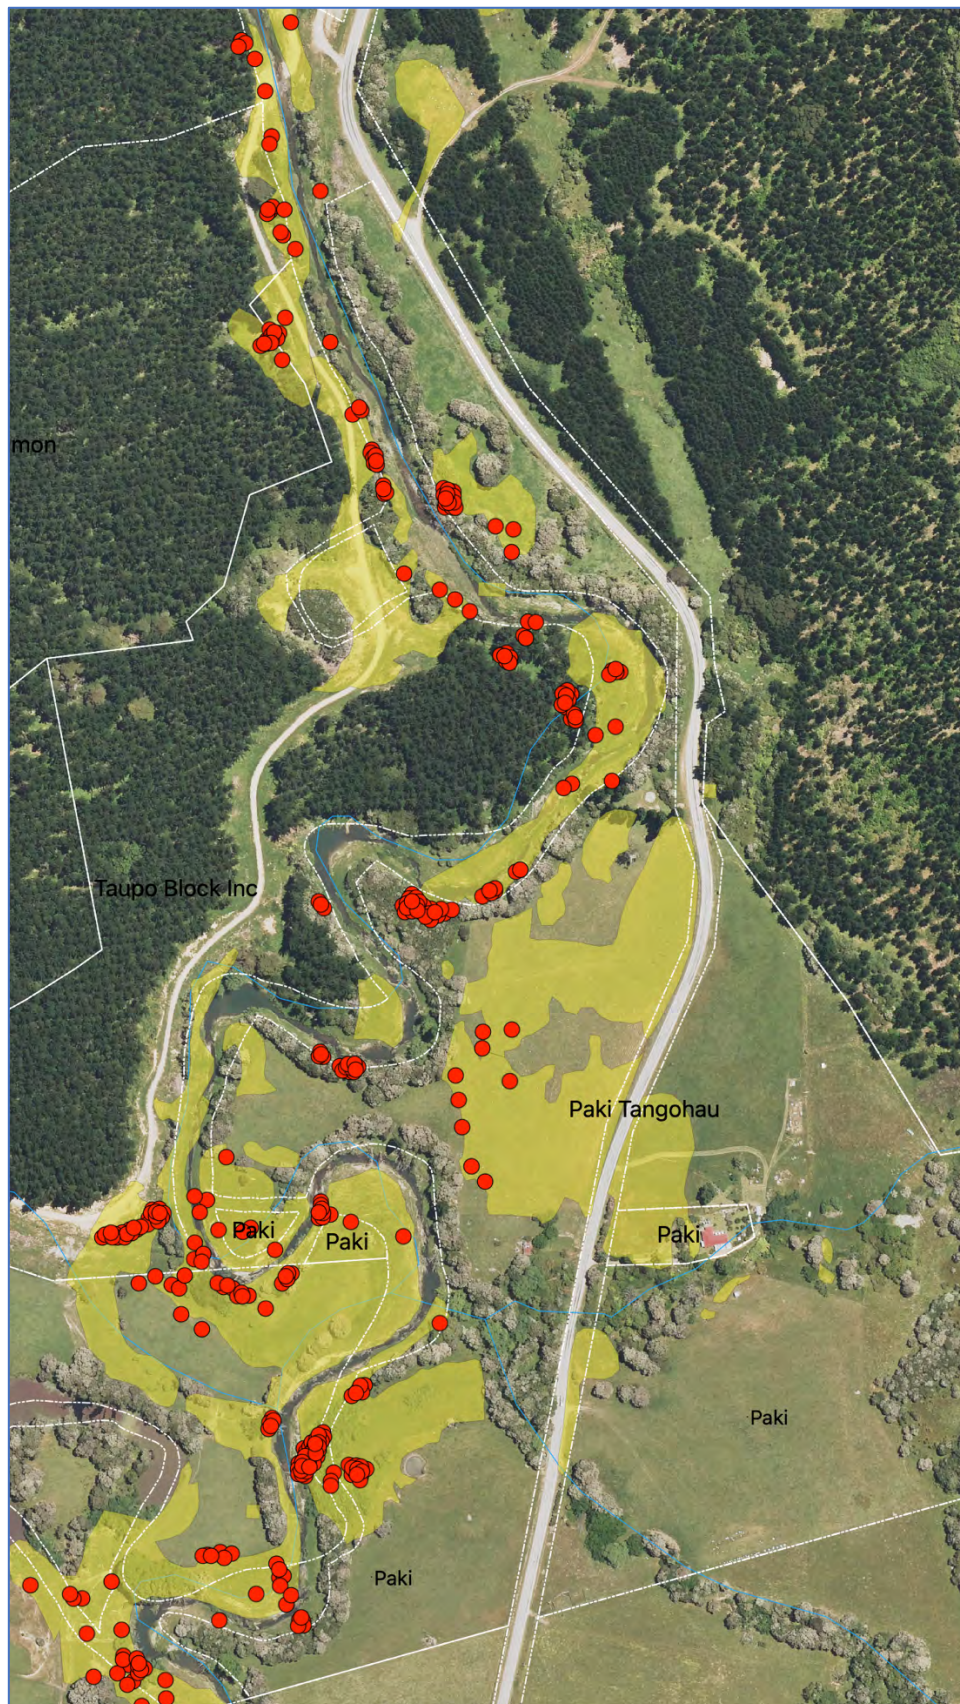
**Figure Thirteen.** Sediment deposition and woody debris distribution on Paki Tongohau property north of Wigan Bridge. Some of the woody debris bottom left is on the Hyland property. Flood water back up due to the Wigan bridge log jam and smaller log jams upstream exacerbated flood spread on the Tangohau property.

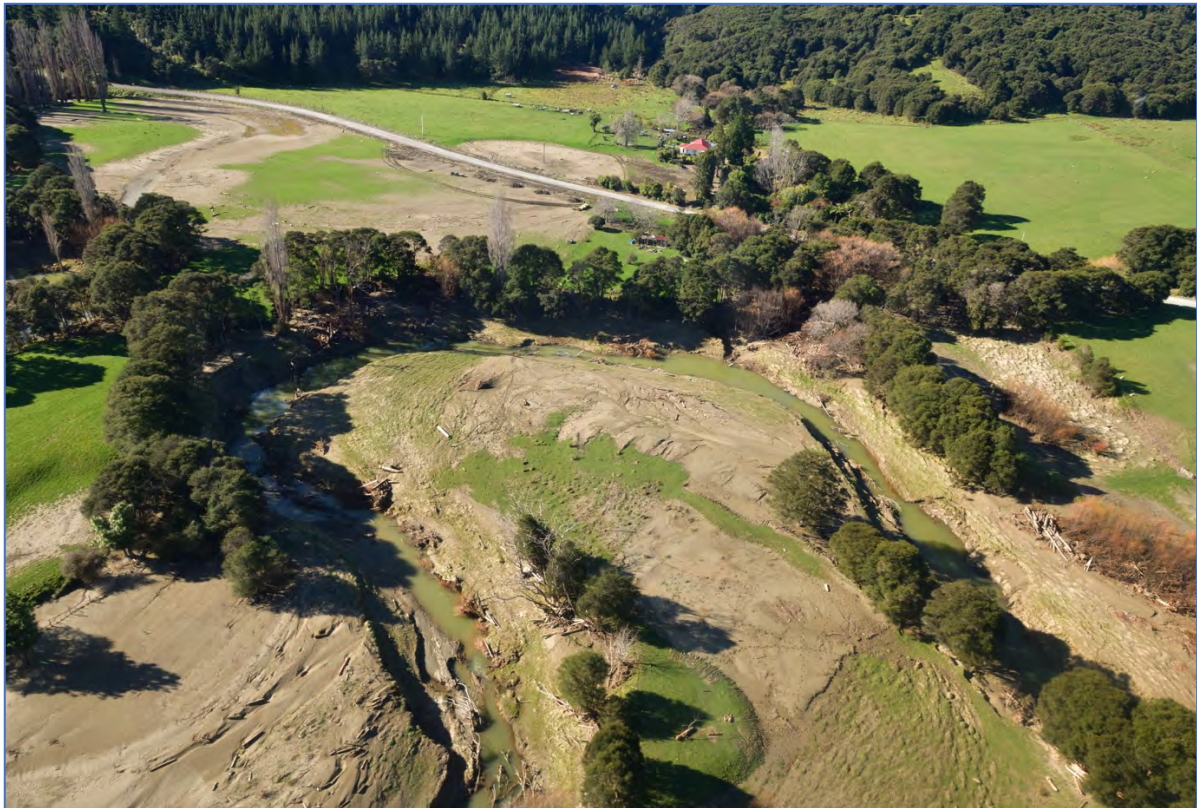
**Figure Fourteen.** Aerial view of the Tangohau property (17<sup>th</sup> July 2018). The thick sediment deposition is obvious as is the woody debris adjacent to the river (middle right) and elsewhere. Close to Tauwhareparae road some piles where woody debris has been cleared but at top left scattered woody debris remains.

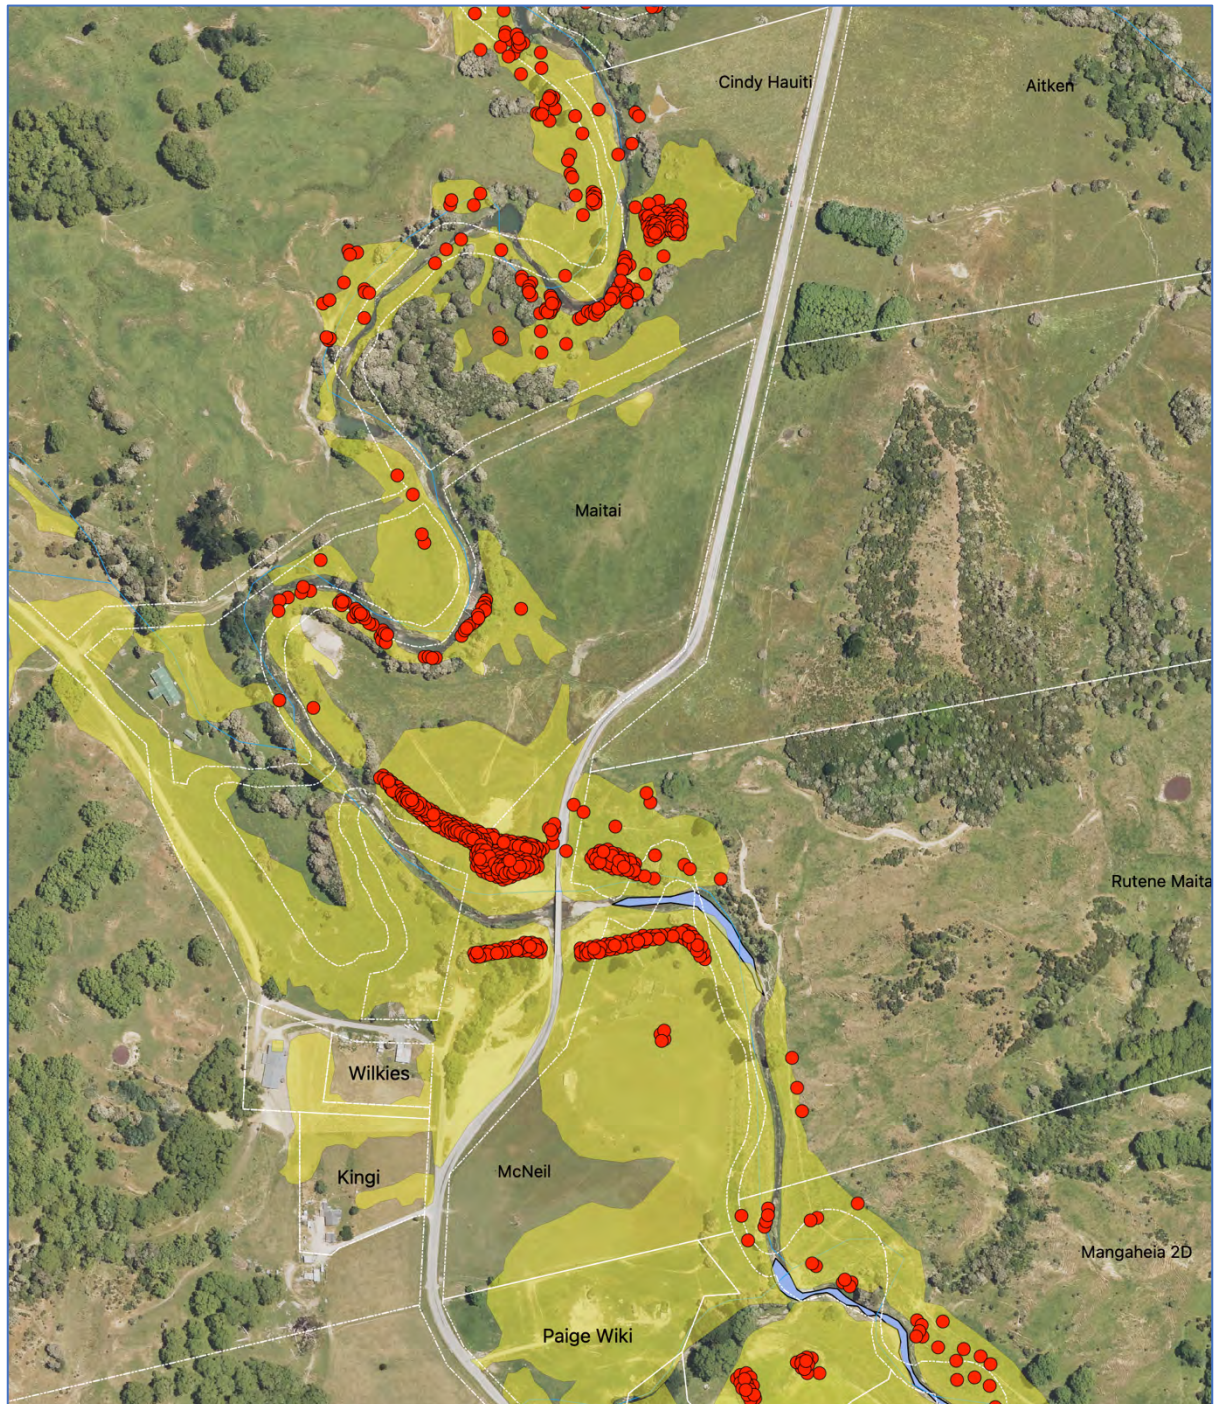
**Figure Fifteen.** View of the sediment deposition and woody debris in the vicinity of Wigan Bridge. A large volume of largely pine woody debris has been placed in piles on road reserve, and on the McNeil property downstream and on the Maitai property upstream. Woody debris on the Mangaheia 2D block is shown at bottom right and there is extensive woody debris on Cindy Hauiti's property at top

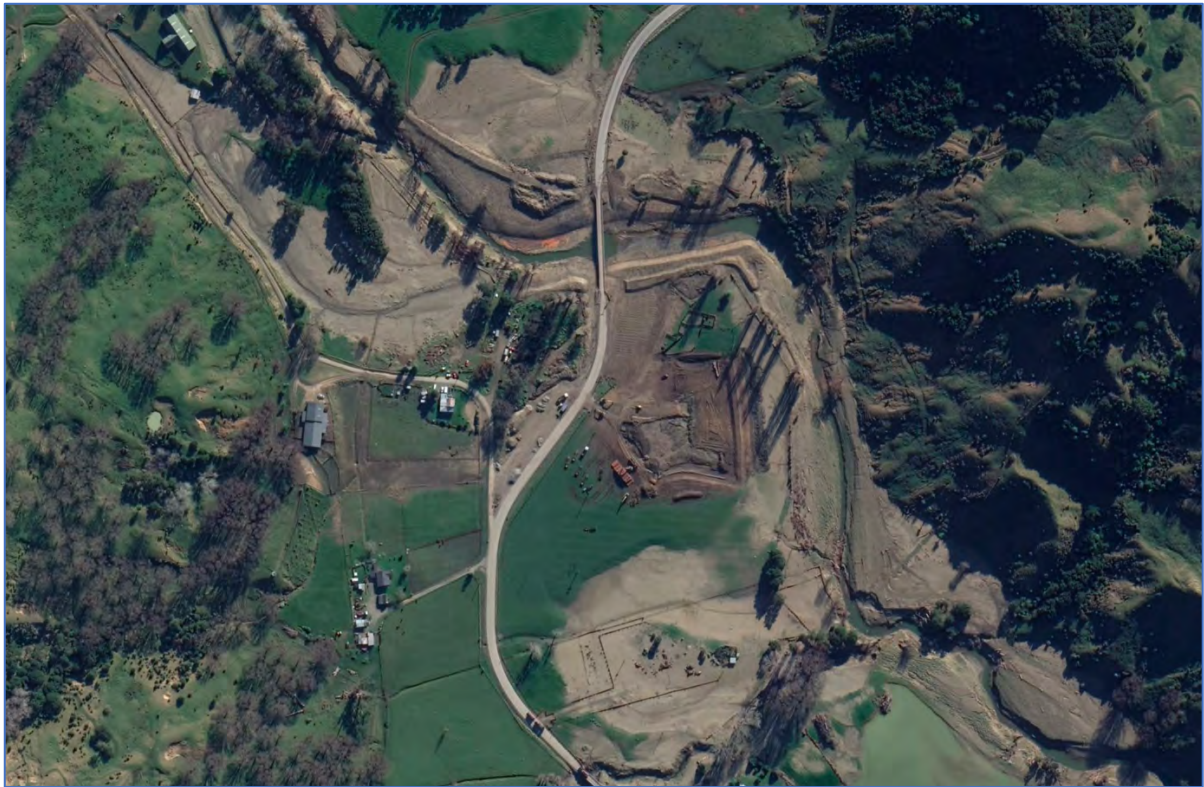
**Figure Sixteen.** Maxar satellite image of the Wigan Bridge area (13<sup>th</sup> July 2018) showing the extent of sediment deposition. The stopbanks above and below the bridge are areas of logs covered in sediment.

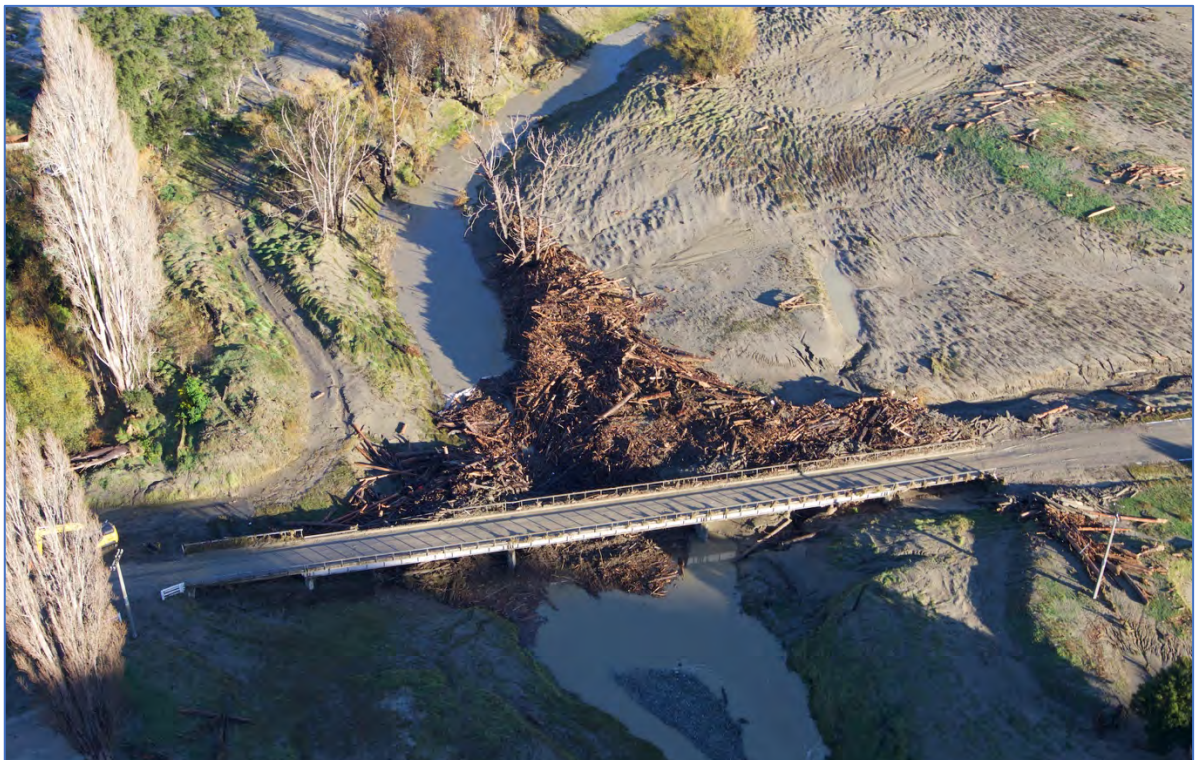
**Figure Seventeen.** Aerial image of Wigan Bridge (6<sup>th</sup> June 2018). Note the woody debris downstream at bottom right and left (in shadows).

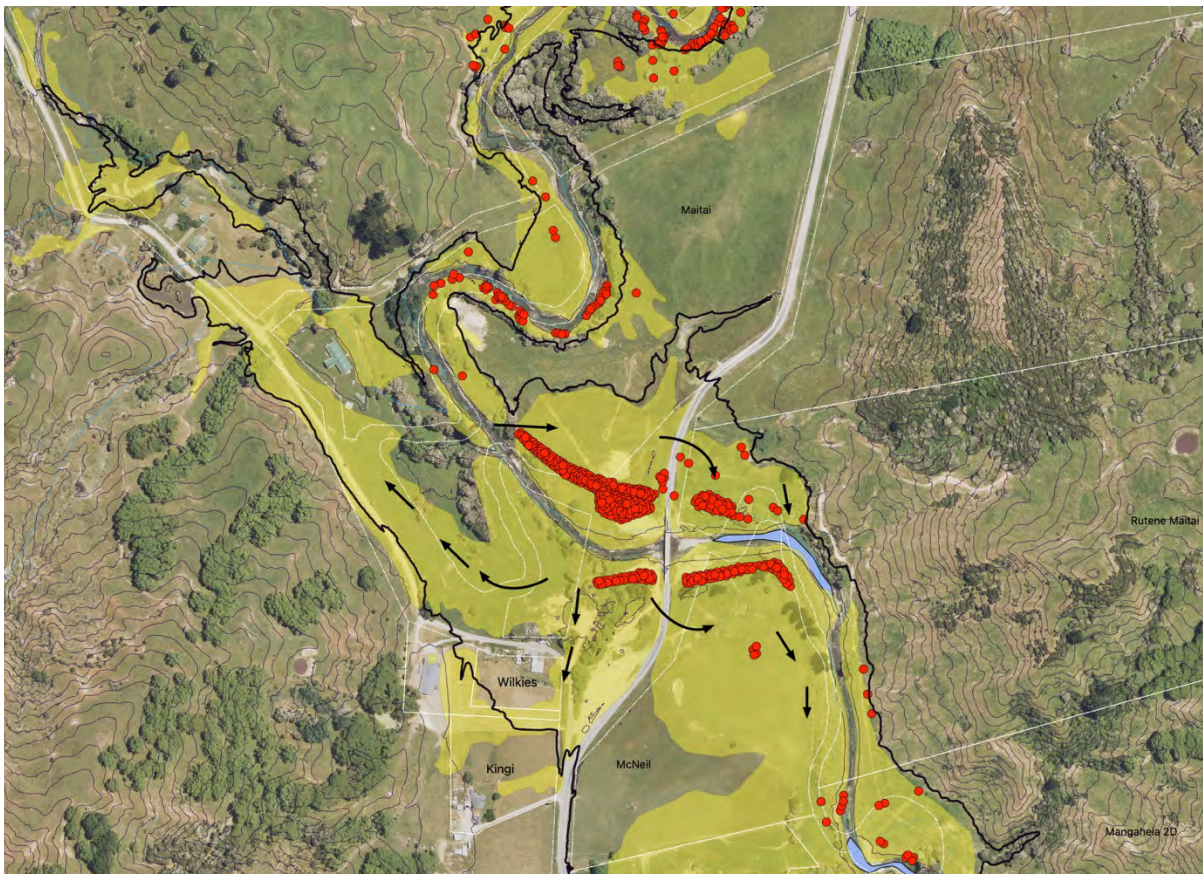
**Figure Nineteen.** Detail of Figure Fifteen with the LiDAR based contours (solid black line) which aligns closely with the sediment deposition at Wigan Bridge (the actual flood spread would have been more extensive) showing that the bridge would not have been effective in stopping woody debris migrating downstream. Afflux caused by the woody debris exacerbated back flooding in Takapau Road and lead to inundation of properties.

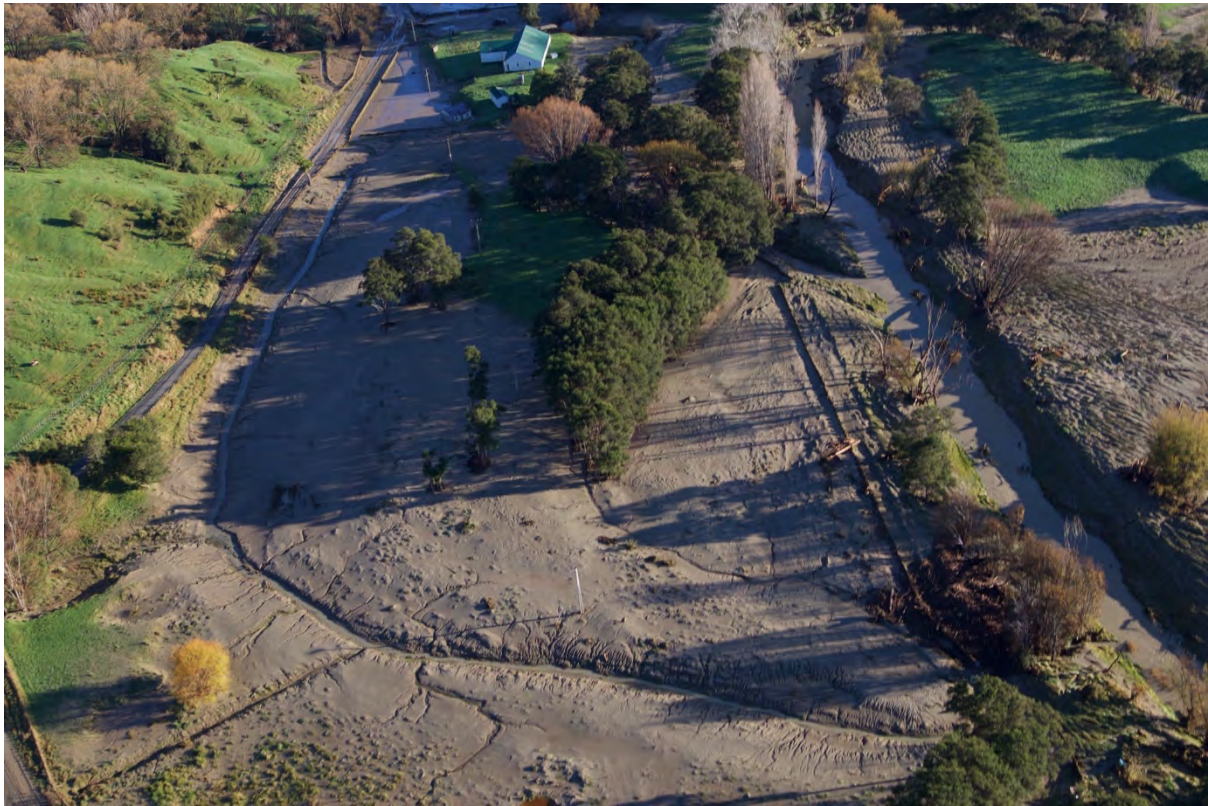
The back flooding on Takapau Road cause by the woody debris at Wigan Bridge is shown in **Figures Twenty** and **Twenty One** below while the flood bypass on the true left back at Wigan Bridge is shown in **Figure Twenty Two**.

**Figure Twenty.** Aerial view looking up Takapau Road from above Wigan Bridge (6<sup>th</sup> June 2018) showing the sediment deposition where the Mangaheia overtopped the bank and inundated low lying areas. Afflux due to the woody debris dammed against the bridge exacerbated flood inundation in this area.

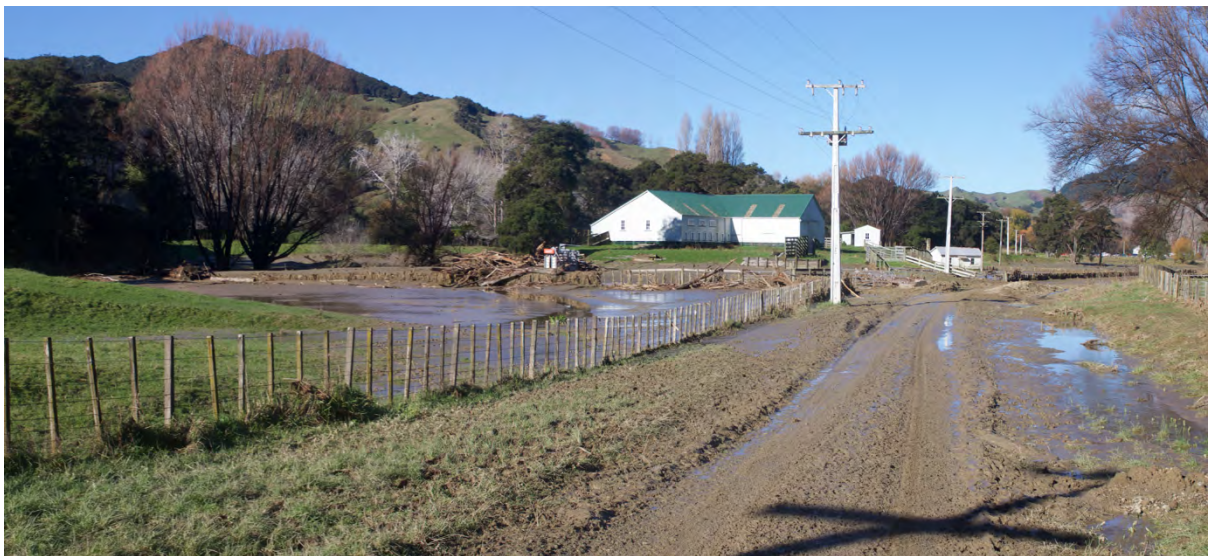
**Figure Twenty One.** View looking towards Wigan Bridge looking along Takapau Road (9<sup>th</sup> June 2018). One inundation pathway from the Mangaheia is on the far left. Woody debris transported from the Mangaheia is visible against the fence in middle ground. The low lying building (background right) was inundated during the storm.

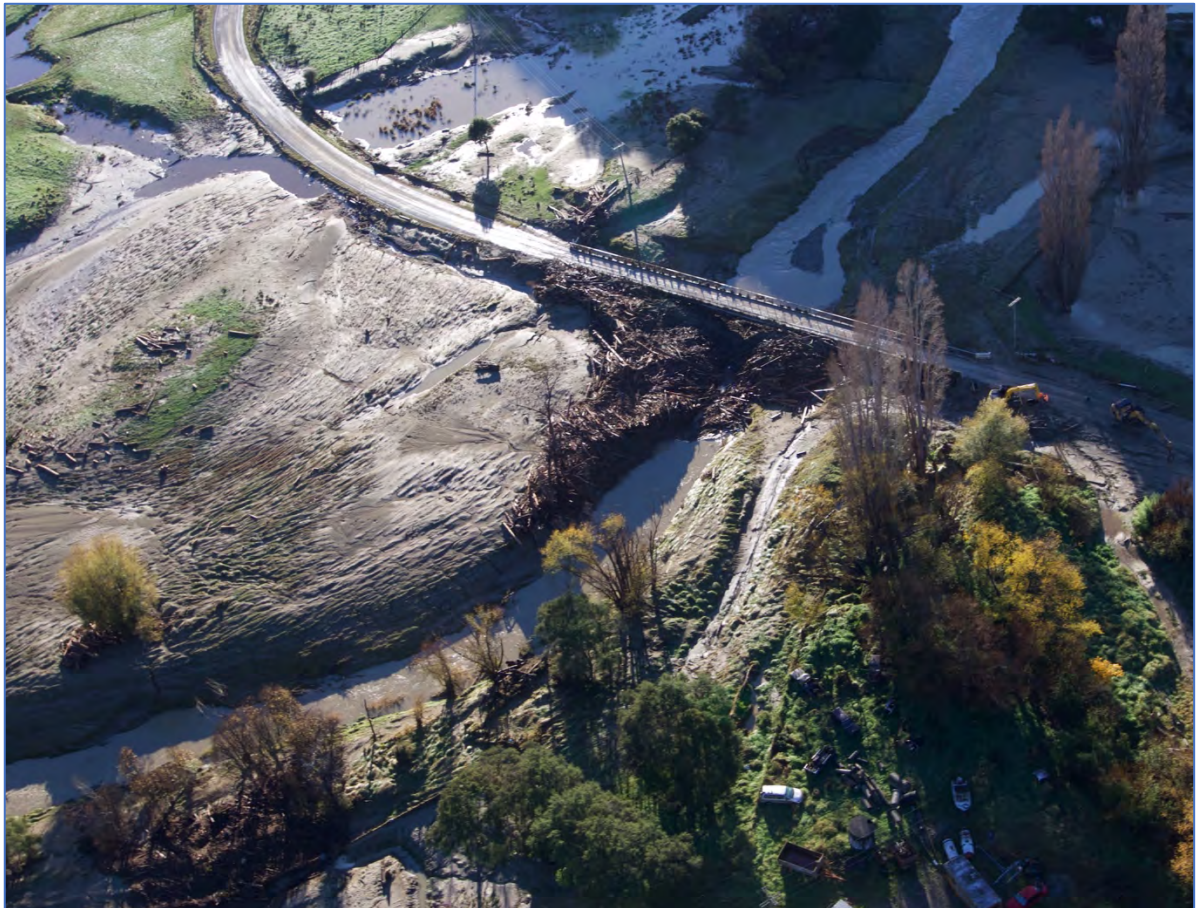
**Figure Twenty Two.** Aerial view showing Wigan Bridge (9<sup>th</sup> June 2018). The area on the true left bank of the river where overtopping allowed woody debris to migrate downstream.
