# Downstream Impacts of sediment and woody debris Inundation in the Mangaheia sub-catchment Uawa Catchment during the Queens Birthday Storm 2018

Dr Murry Cave  
Principal Scientist  
Gisborne District Council  
v.3.2 October 2022

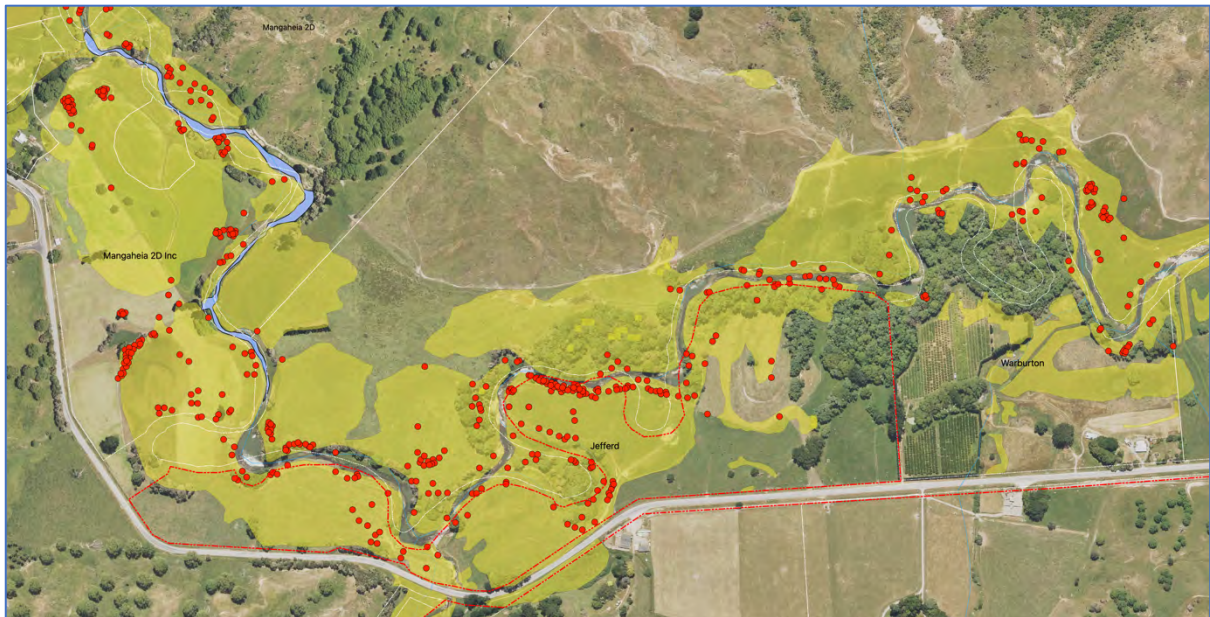
**Figure Twenty Three.** View of the area downstream of Wigan Bridge showing the sediment deposition and largely pine woody debris deposition on Mangaheia 2D Block (true left bank of the Mangaheia and bottom left, the Jefferd property (outlined in red), and the Warburton property (bottom right).

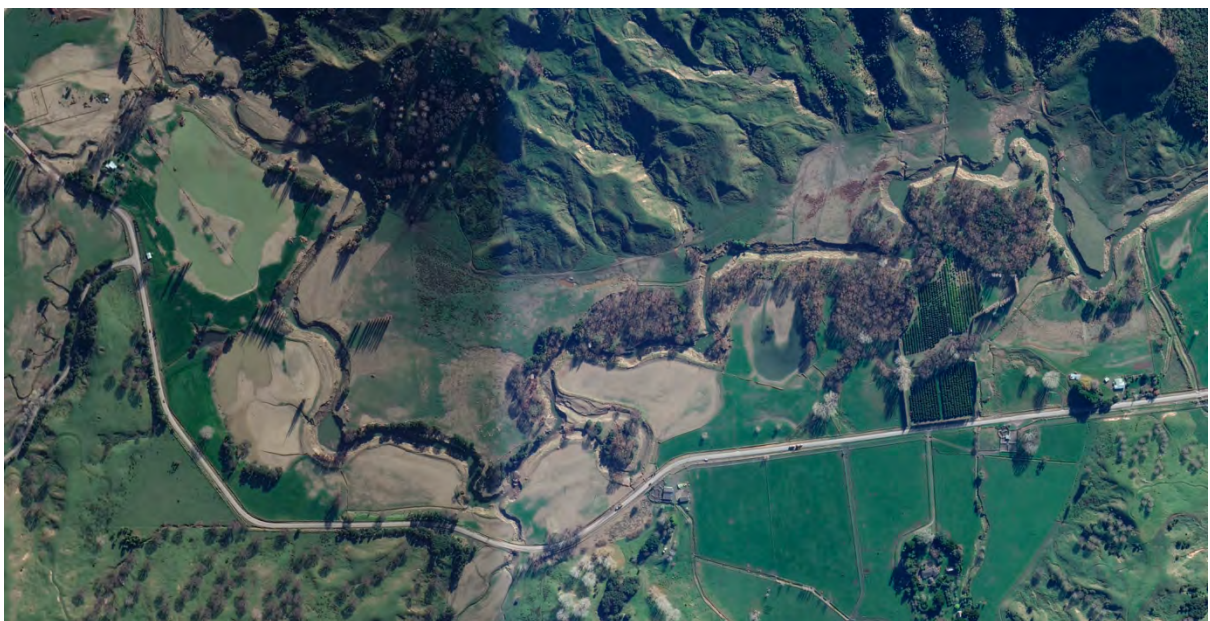
**Figure Twenty Four.** Maxar satellite imagery of the area shown in **Figure Twenty Two** showing the obvious sediment deposition from the Queens Birthday storm.

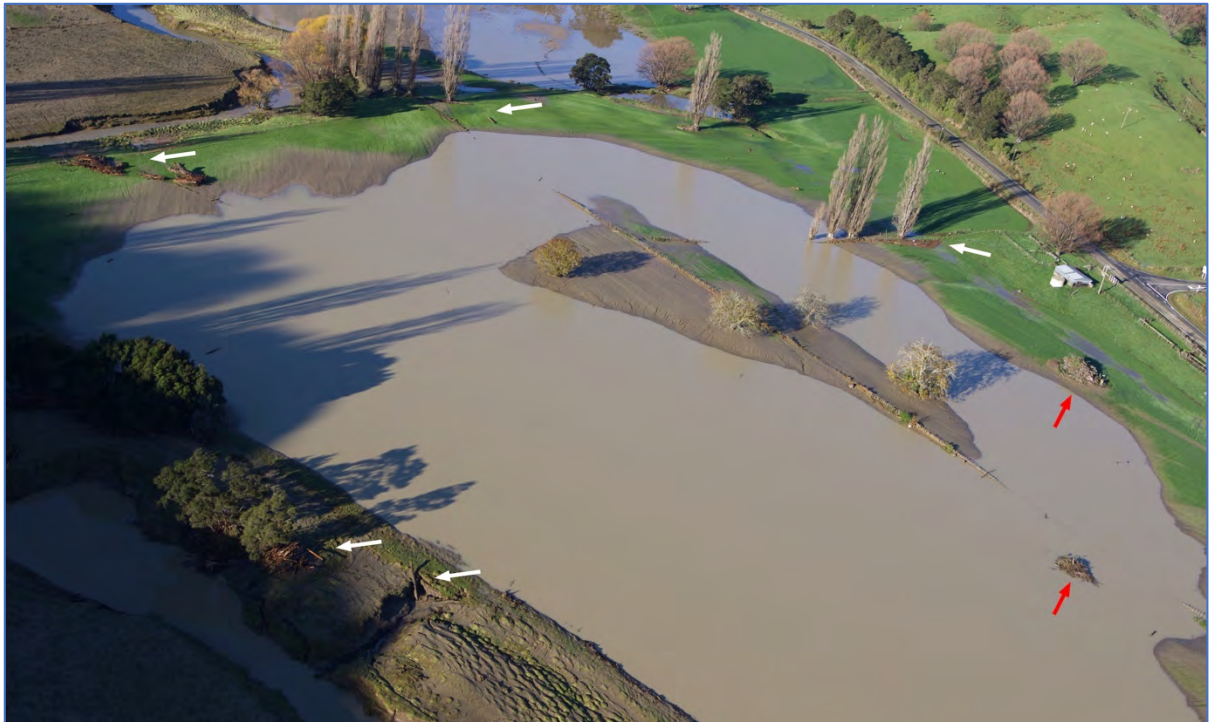
**Figure Twenty Five.** View of Mangaheia 2D land on the true right bank of the Mangaheia adjacent to Arakihi Road showing wood piles from Cyclone Cook in 2017 (red arrows) and woody debris from the Queens Birthday 2018 event (White arrows).

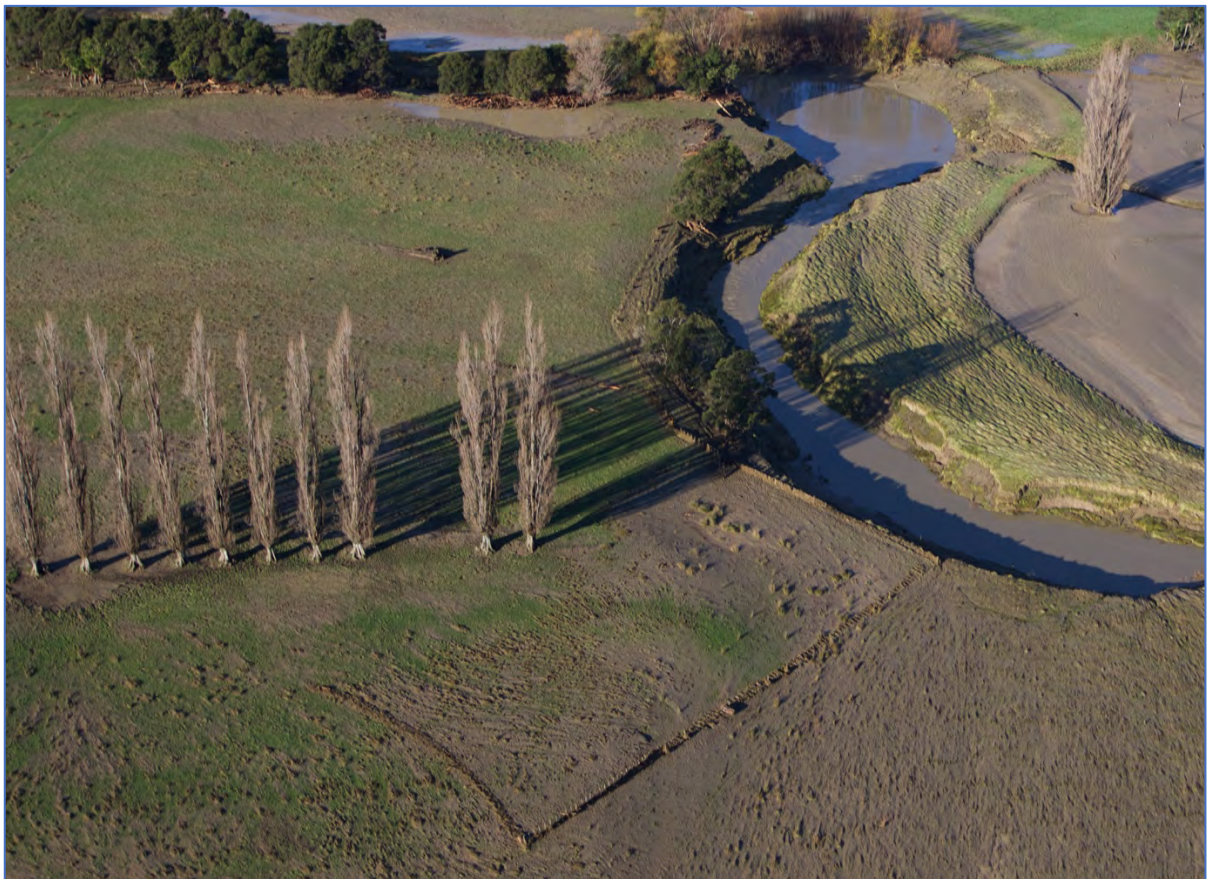
In **Figure Twenty Six**, an extensive area of flooding and sediment deposition is evident and there is a considerable amount of fresh woody debris caught up against willows on the river bank and notably there is a fence which has been severely damaged on Mangaheia 2D land.

**Figure Twenty Six.** View of a damaged fence (bottom middle) and woody debris caught against trees on the banks of the Mangaheia as well as sediment deposition on paddocks of Mangaheia 2D land. The line of poplars are 900m below Wigan Bridge (see middle left in **Figure Twenty Four**).

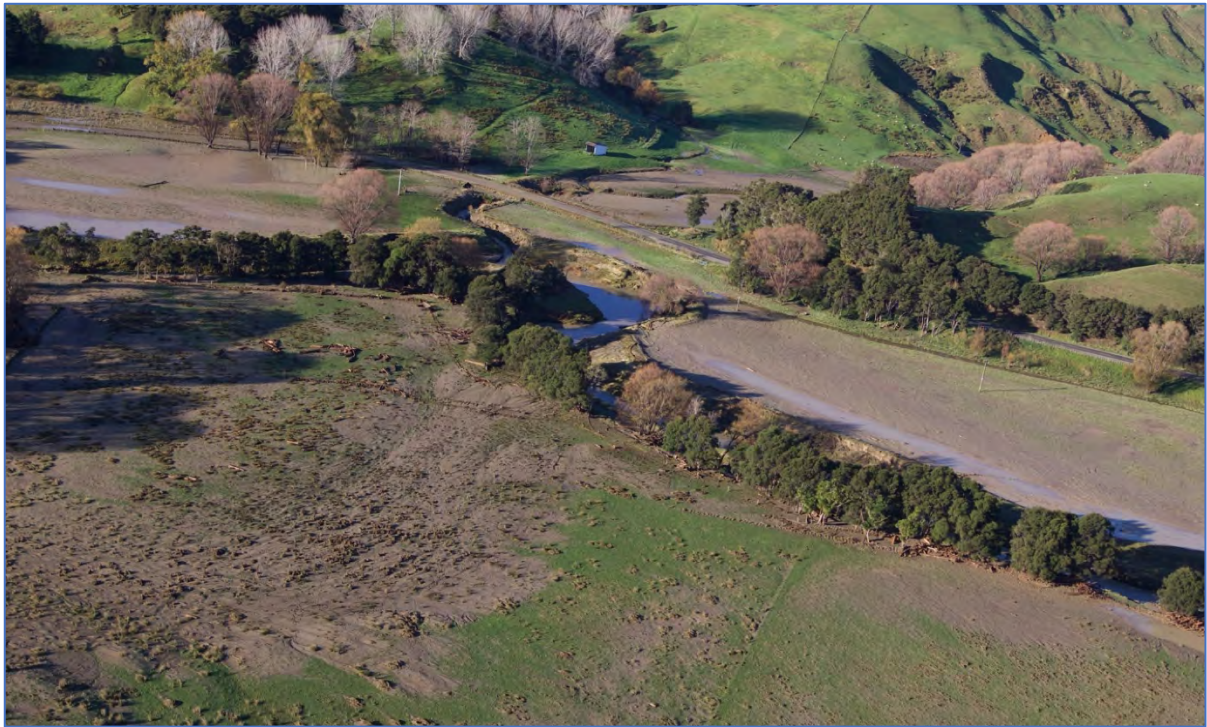
In **Figure Twenty Seven** downstream of the area in **Figure Twenty Six**, there is further fresh woody debris caught against Mangaheia 2D land as well as considerable sediment deposition and some woody debris on Papatahi Station now owned by the Jefferds. In **Figure Twenty Eight** details of sediment deposition along with woody debris and a damaged fence is evident on Papatahi Station. Sediment deposition and distributed woody debris on both Mangaheia 2D and Papatahi Station downstream of **Figure Twenty Eight** is shown in **Figure Twenty Nine** while **Figure Thirty** shows extensive fresh woody debris and sediment deposited on Mangaheia 2D land adjacent to the Warburton property. The Warburton's experienced sediment deposition with woody debris mainly adjacent to the river (**Figure Thirty One**).

**Figure Twenty Seven.** View further downstream from **Figure Twenty Six** showing woody debris and sediment deposition on Mangaheia 2D land (true left) and Jefferd property (true right) banks of the Mangaheia.

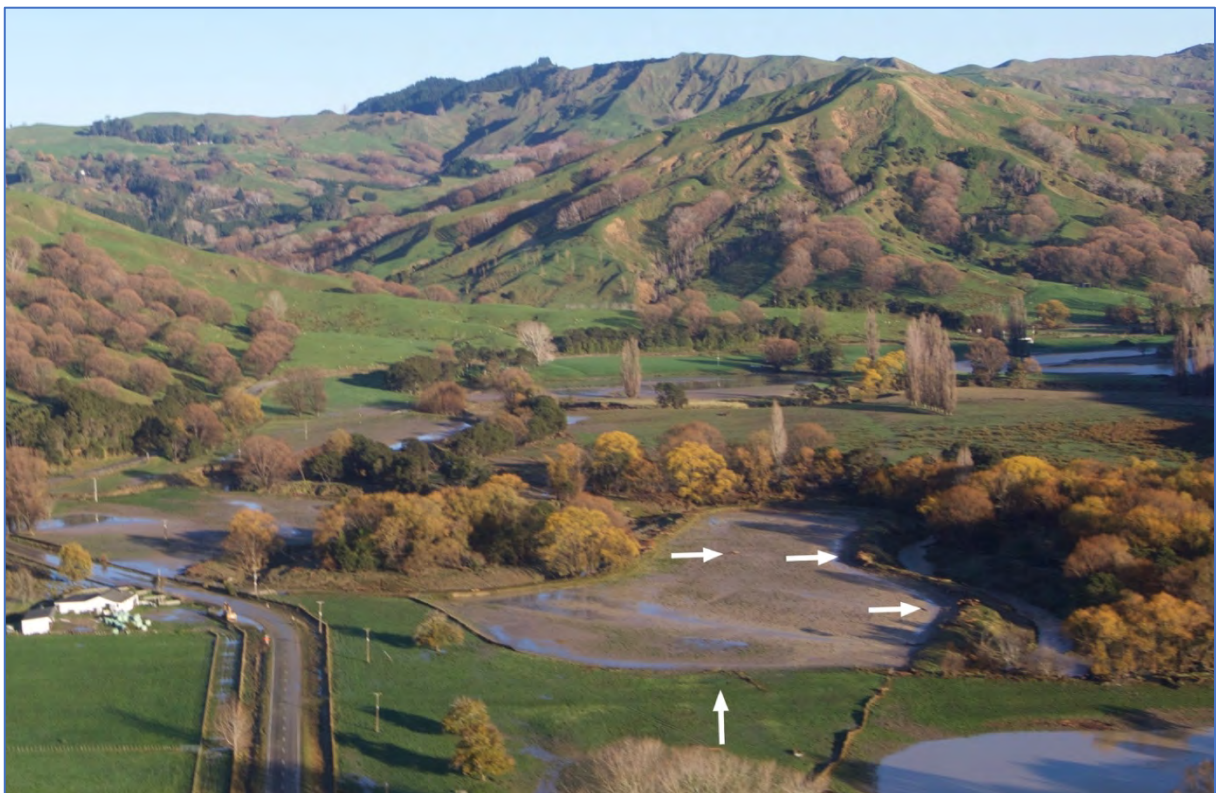
**Figure Twenty Eight.** View looking upstream from above Warburton property showing the sediment deposition, broken fence (bottom right arrow) and woody debris on the Jefferd property. The inundated area in **Figure Twenty Five** is visible at top right.

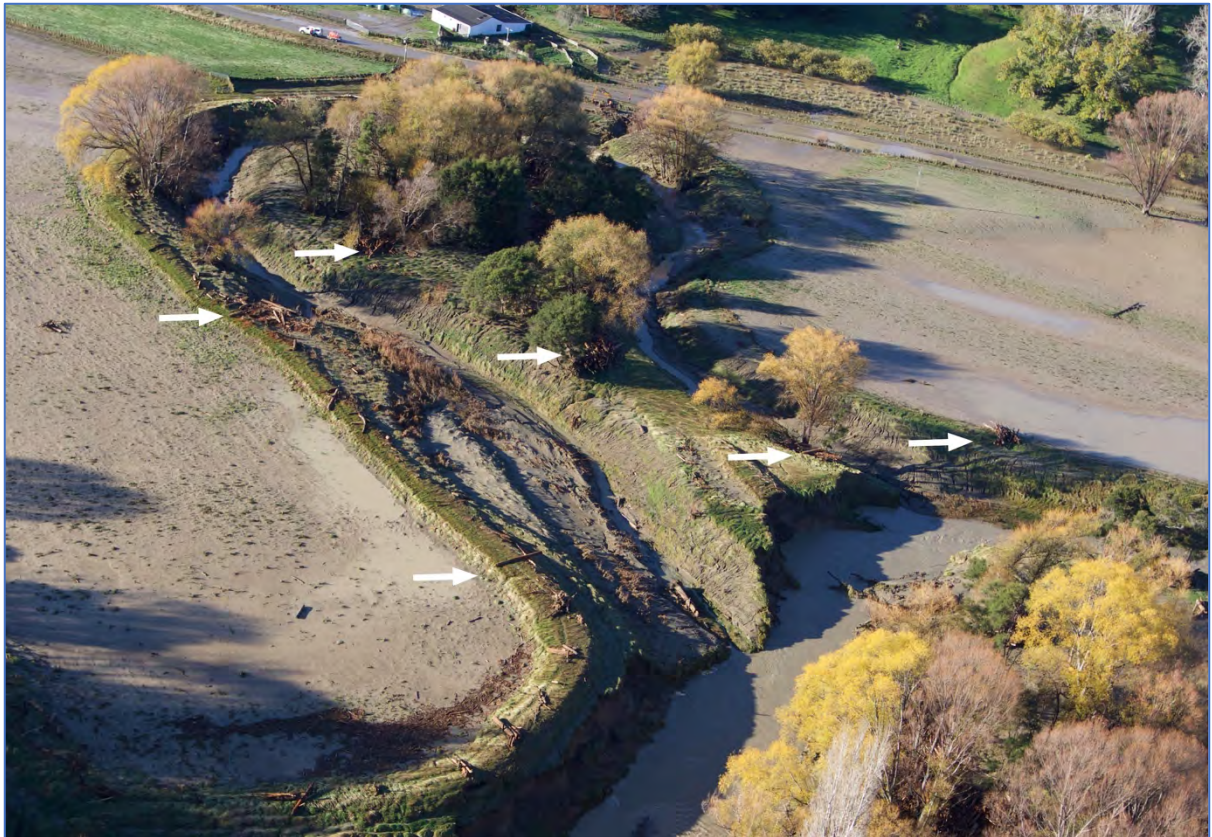
**Figure Twenty Nine.** View looking downstream with Tauwharepare Road at top showing sediment deposition and woody debris on the Jefferd property (Papatahi Station) and on Mangaheia 2D land in the abandoned meander loop (middle).

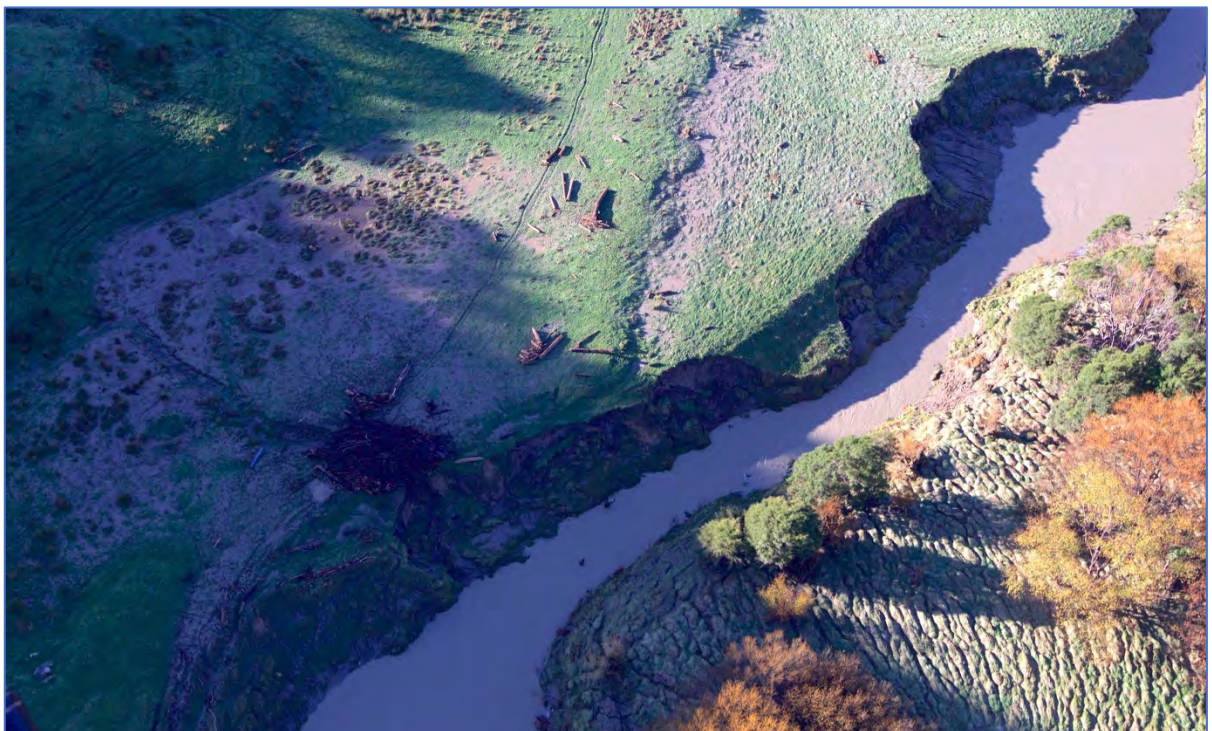
**Figure Thirty.** View of the true left bank of the Mangaheia adjacent to the Warburton property (true right) showing sediment deposition and woody debris.

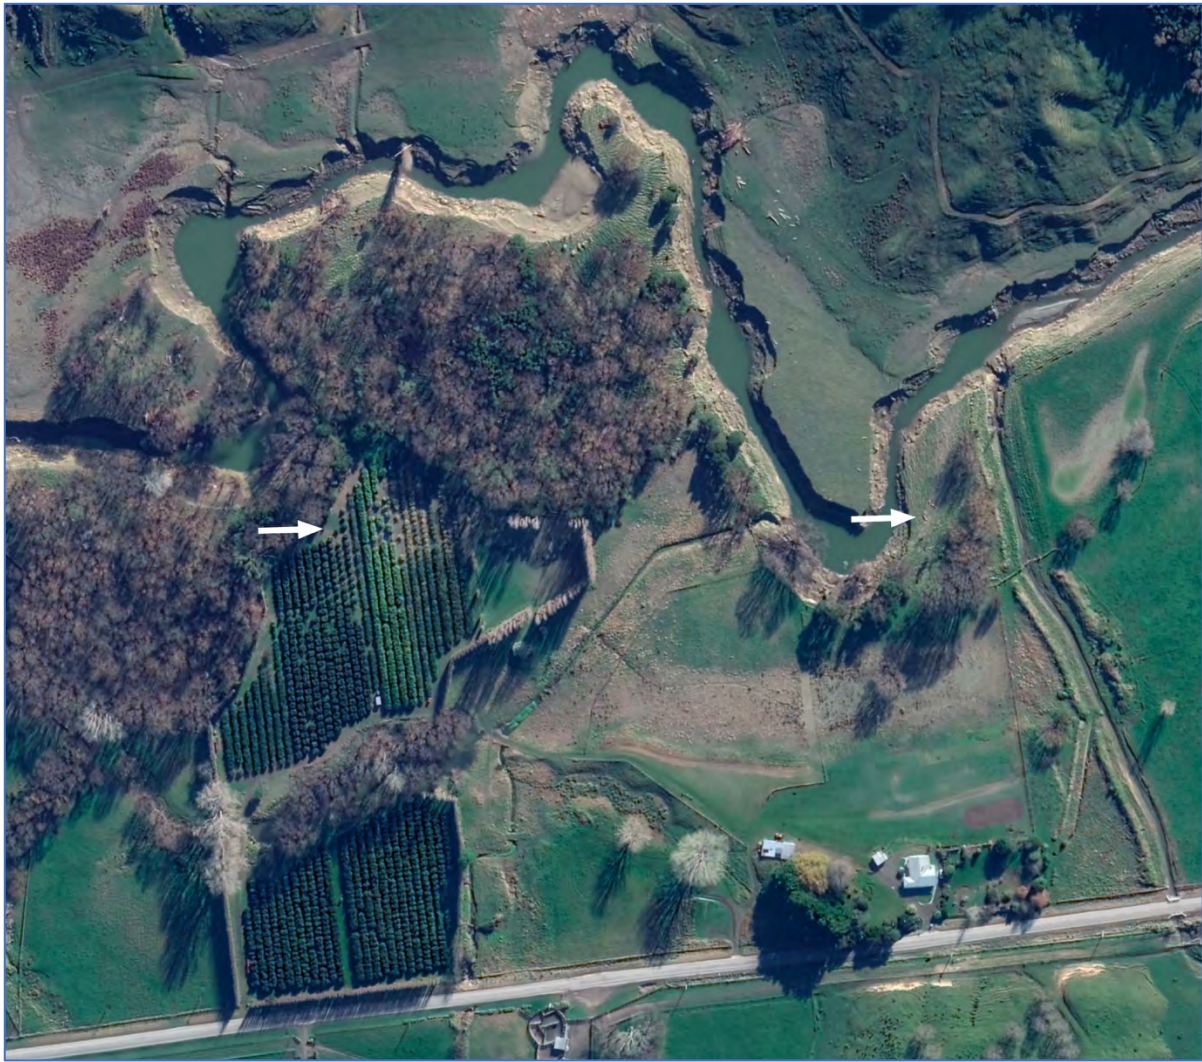
**Figure Thirty One.** View of the Warburton property (True right side of river) showing sediment deposition through the middle of the property and also through part of the citrus orchard (arrowed). Overall there is little woody debris evident except for at the downstream end of the property (arrowed) this is likely due to woody debris being caught up in the extensive willows on the banks of the river in this area.

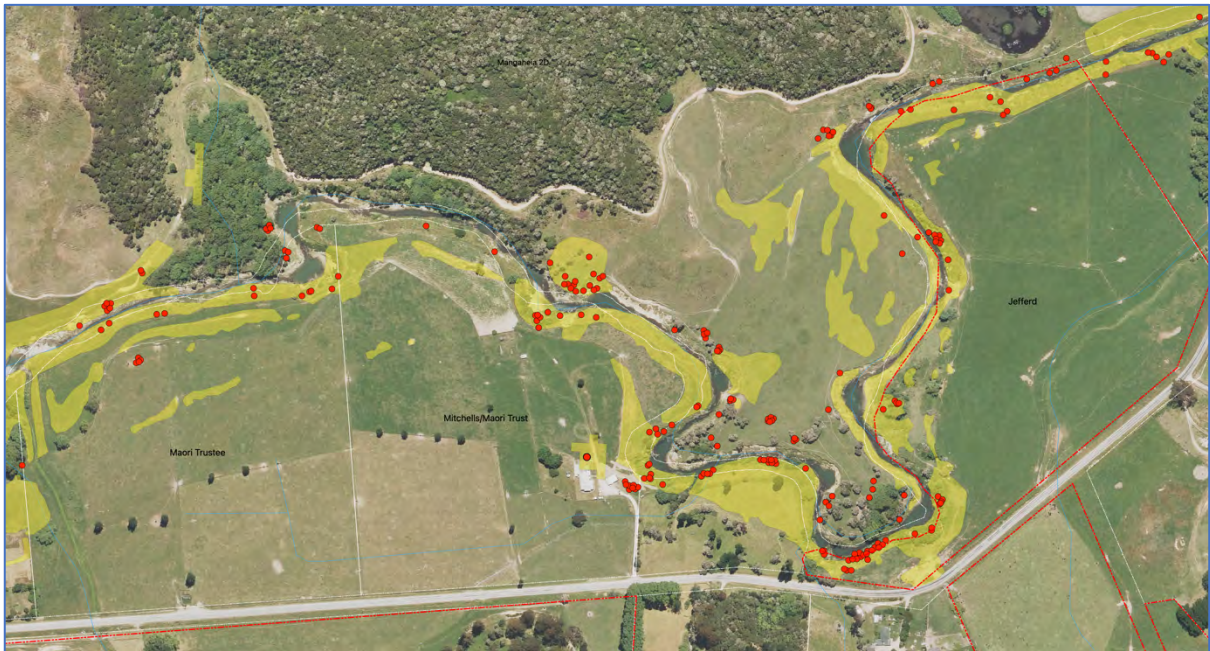
**Figure Thirty Two.** View of area between the Warburton properties and the downstream Cooke property showing the sediment deposition and woody debris deposited on the Mangaheia 2D block, the Jefford paddock and on land administered by the Maori trustee. The dwelling in the middle was occupied by the Mitchells.

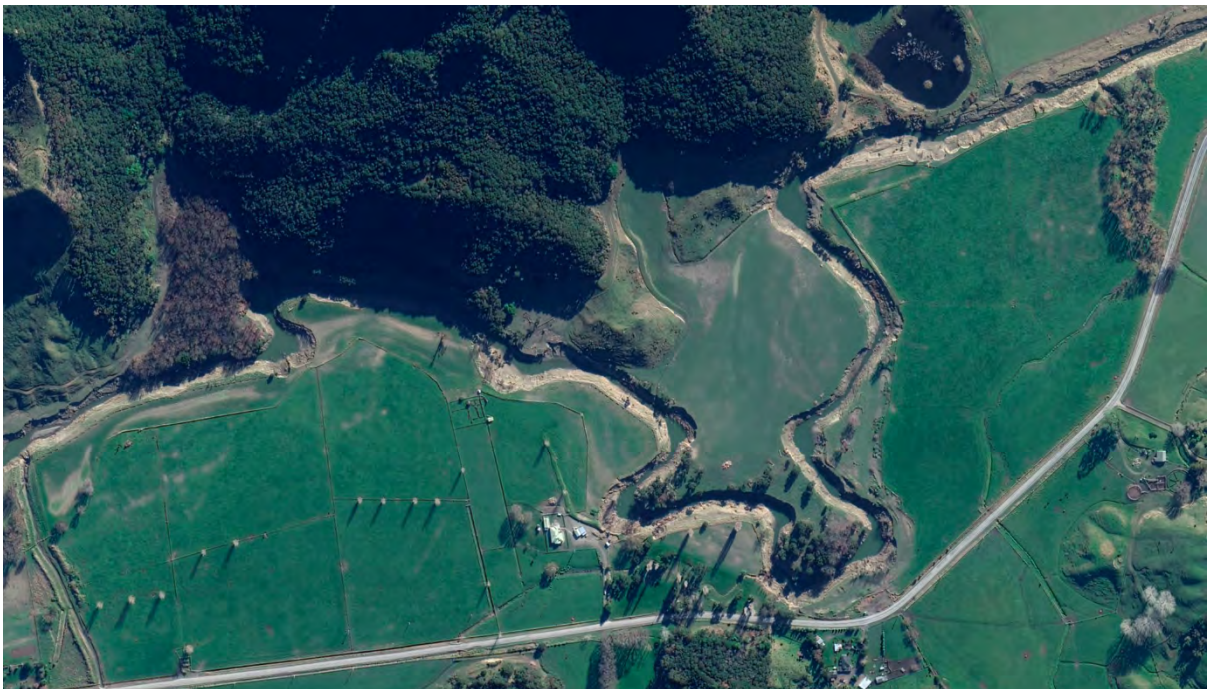
**Figure Thirty Three.** Maxar satellite image of the area shown in **Figure Thirty Two** showing the areas of sediment deposition. A wood pile can be seen close to the river in middle right. The dwelling in the middle of the image was occupied by the Mitchell family.

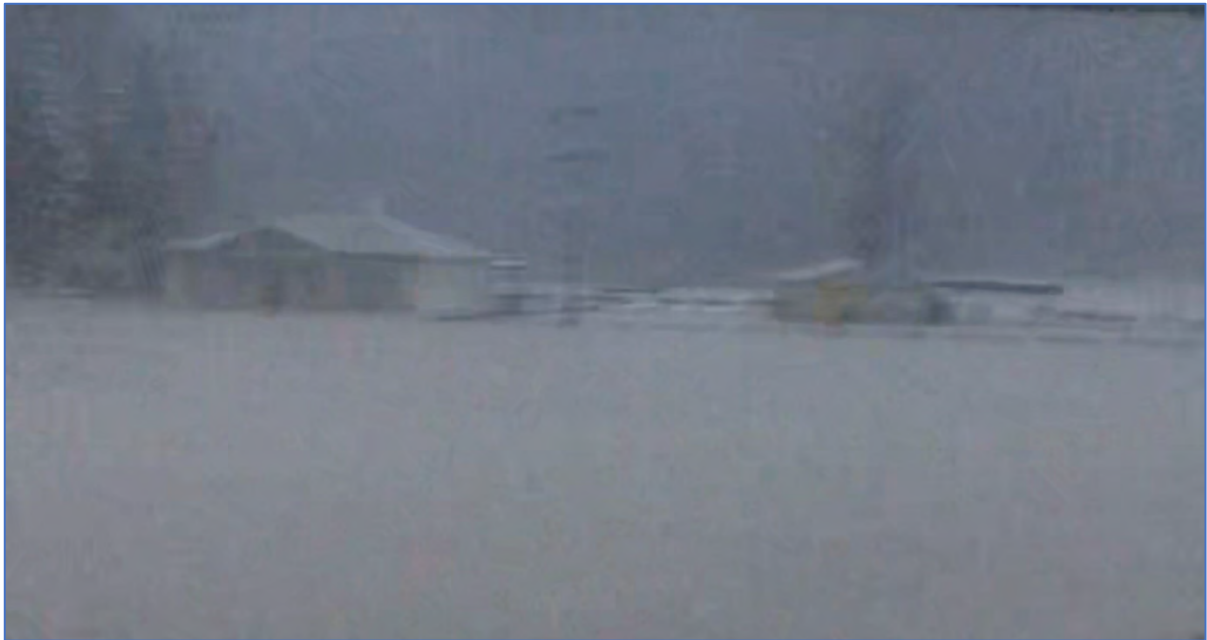
**Figure Thirty Four.** Screenshot from a video of the Mitchell dwelling taken during the rescue of the family showing the extent of flooding. Media reports indicated that the occupants were on the table to get above the water and were considering breaking into the ceiling to escape the flood waters when they were rescued.

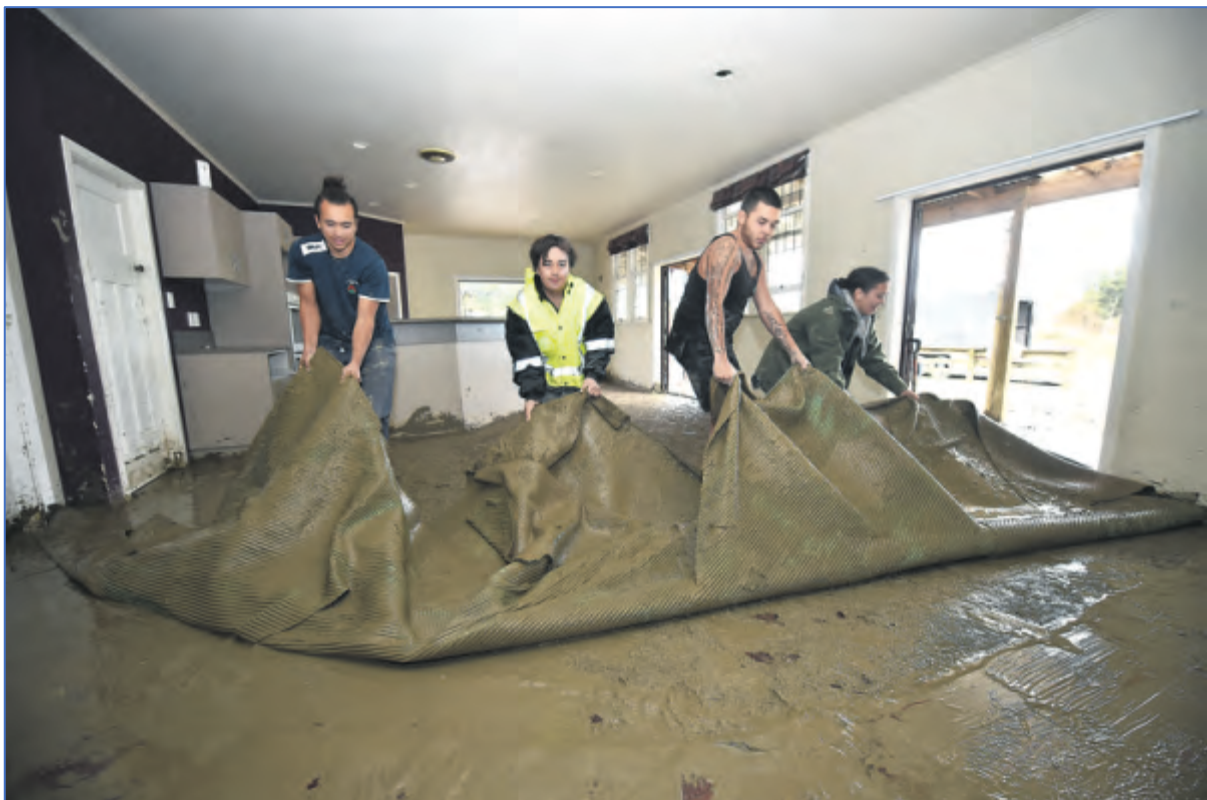
**Figure Thirty Five.** Photo of the Mitchell dwelling taken after the storm showing the extent of sediment deposition within the dwelling. (Photo. Gisborne Herald)

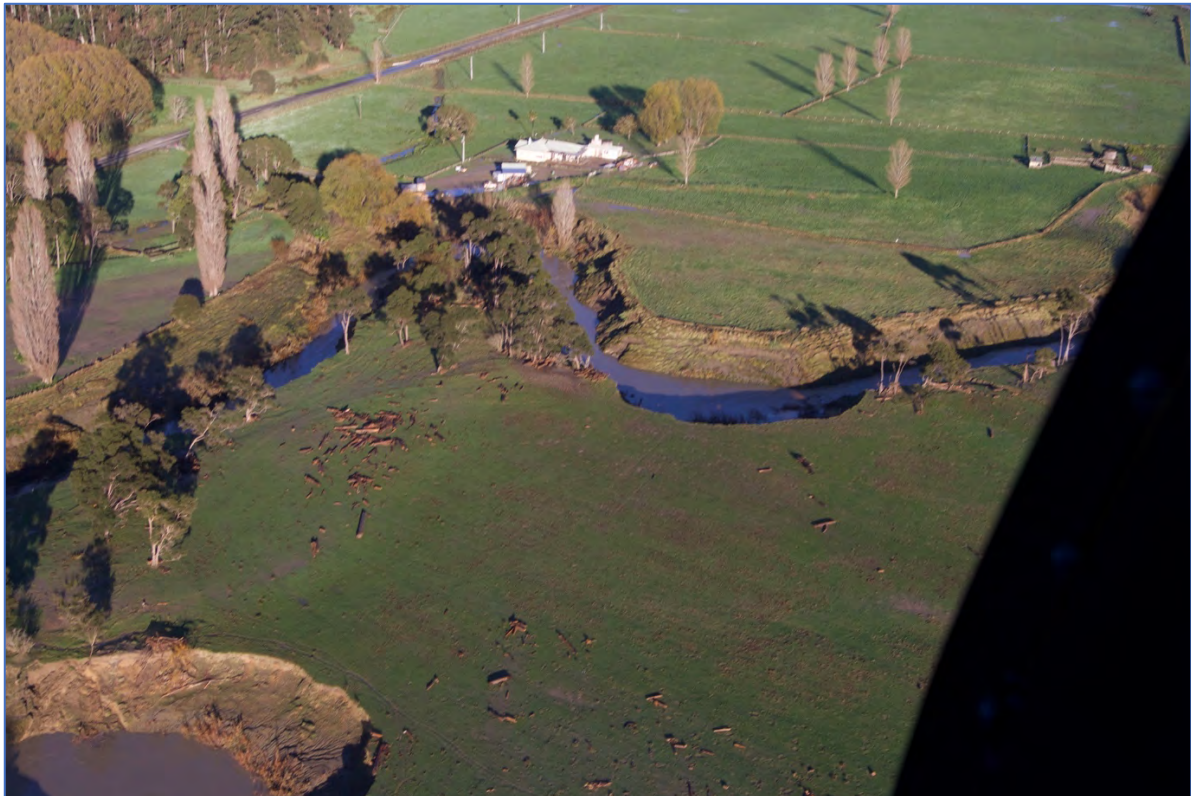
**Figure Thirty Six.** Aerial image (6<sup>th</sup> June 2018) looking upstream with the meander in the foreground (Mangaheia 2D) with considerable woody debris spread across the field. This material was subsequently gathered into the wood pile visible in **Figure Thirty Three**. The fields on the true right bank (top) do not appear to have been as significantly affected but there are still signs of sediment deposition and scattered individual logs. The Mitchell dwelling (top middle) experienced significant sediment deposition.

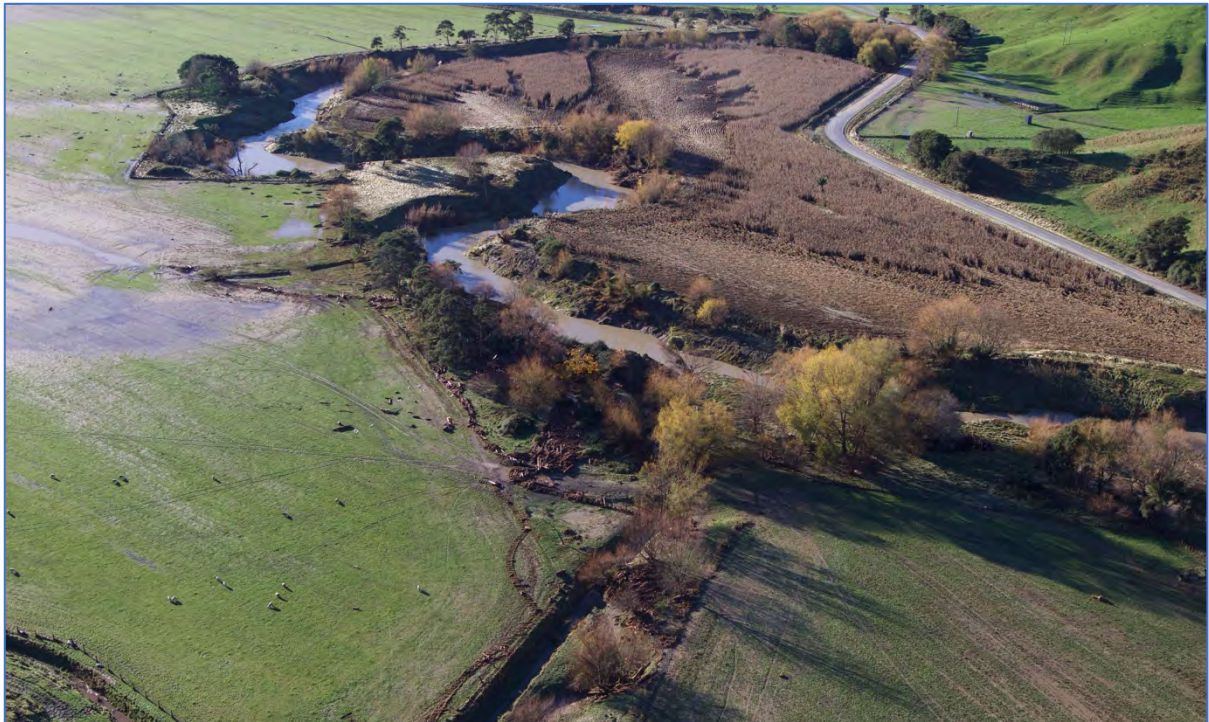
This section of river was significantly impacted by sediment deposition and woody debris. Inundation and sediment deposition damaged a maize crop on the Kerslake property on the true right bank (**Figure Thirty Seven**) while further downstream a significant discharge of woody debris occurred on the Simpson property. The Mangaheia 2D block on the true left bank experienced sediment deposition with some woody debris deposited while the Rushby property on the true right bank downstream of the Simpson property had both sediment deposition and a large amount of woody debris deposited. One property between the Simpsons and the Rushby properties, now known as Narrowlands appears to have had only minor impacts (**Figure Thirty Eight**).

**Figure Thirty Seven.** Aerial view dated 6<sup>th</sup> June 2018 of the Mangaheia 2D property (left and bottom) and the Kerslake property (top middle). Extensive sediment deposition has occurred on both properties and there is damage to maize crop on the Kerslake and small piles of woody debris are visible at top right.

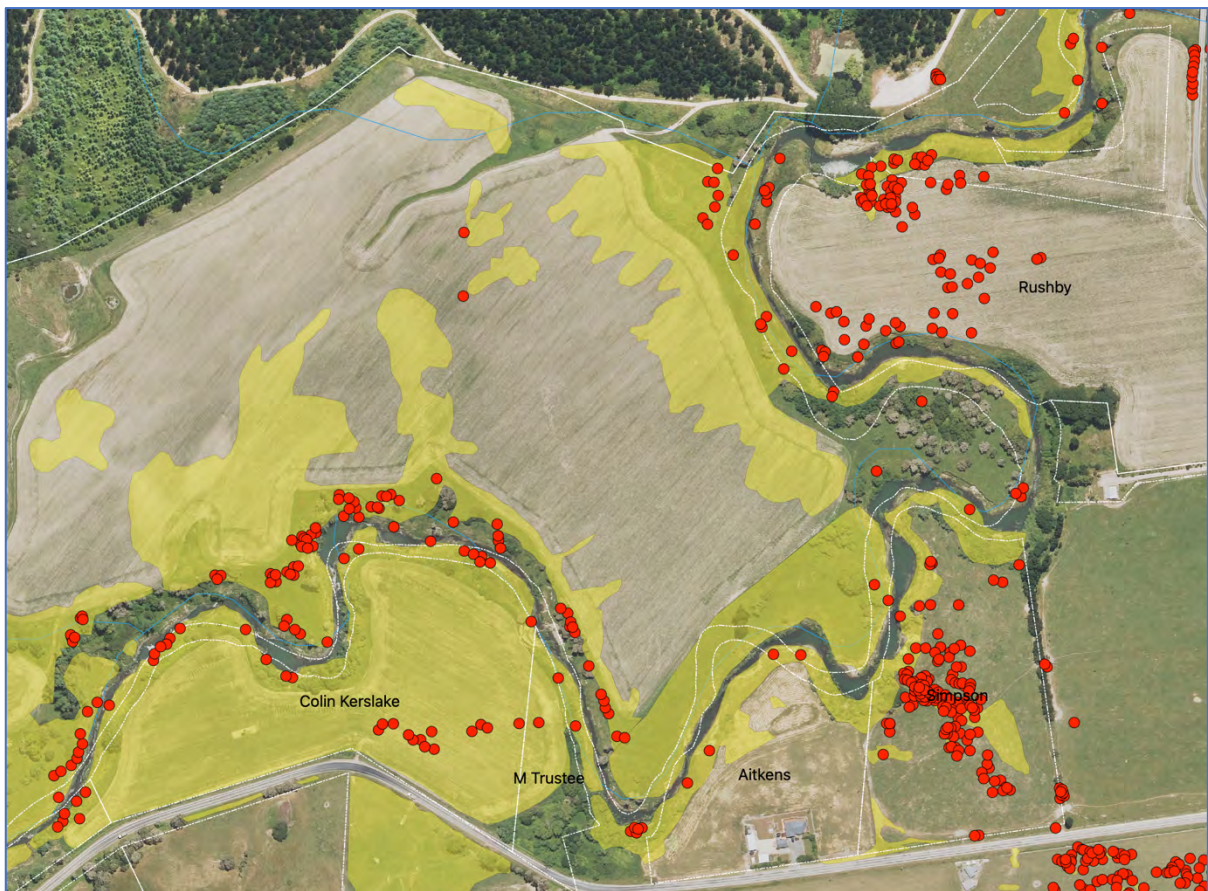
**Figure Thirty Eight.** Properties north of Mangaheia Station showing the sediment deposition and distribution of largely pine woody debris. There was a significant amount of largely pine woody debris deposited on the Simpson property (bottom right) with lesser woody debris on the Kerslake property.

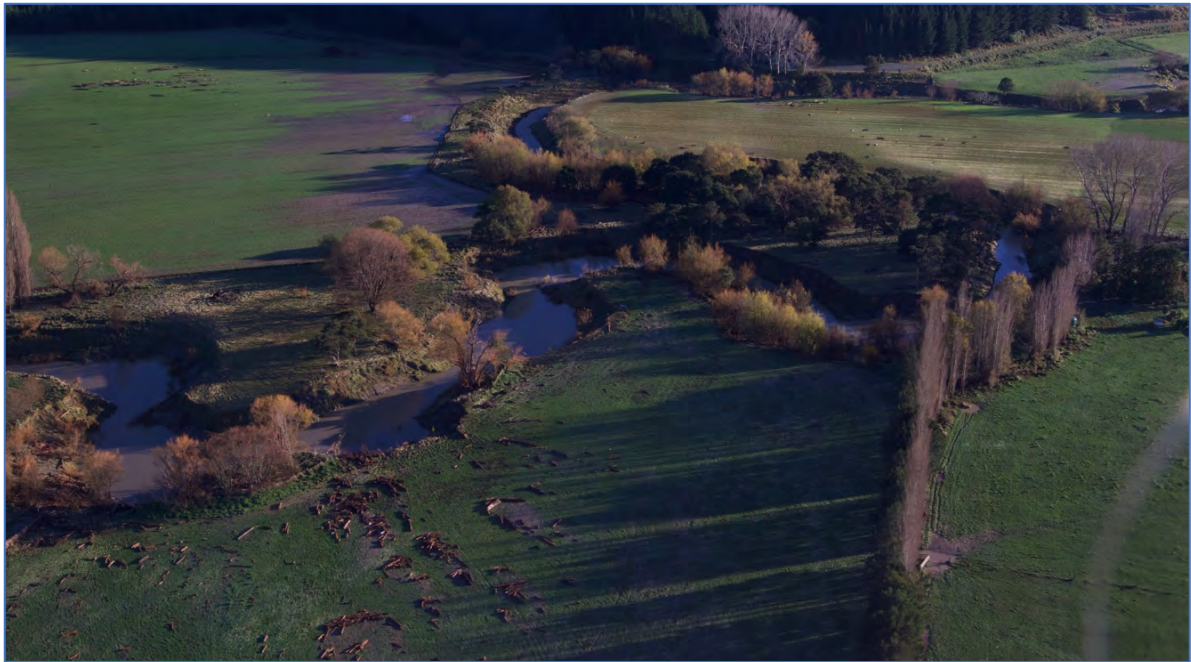
**Figure Thirty Nine.** Aerial view of the Simpson property (bottom left), and Rushby (top right) properties showing the distribution of largely pine woody debris. Sediment deposition and pine woody debris can be seen on the Mangaheia 2D Block. Flood flows may have been impeded by the tight meander and mature willows immediately downstream.

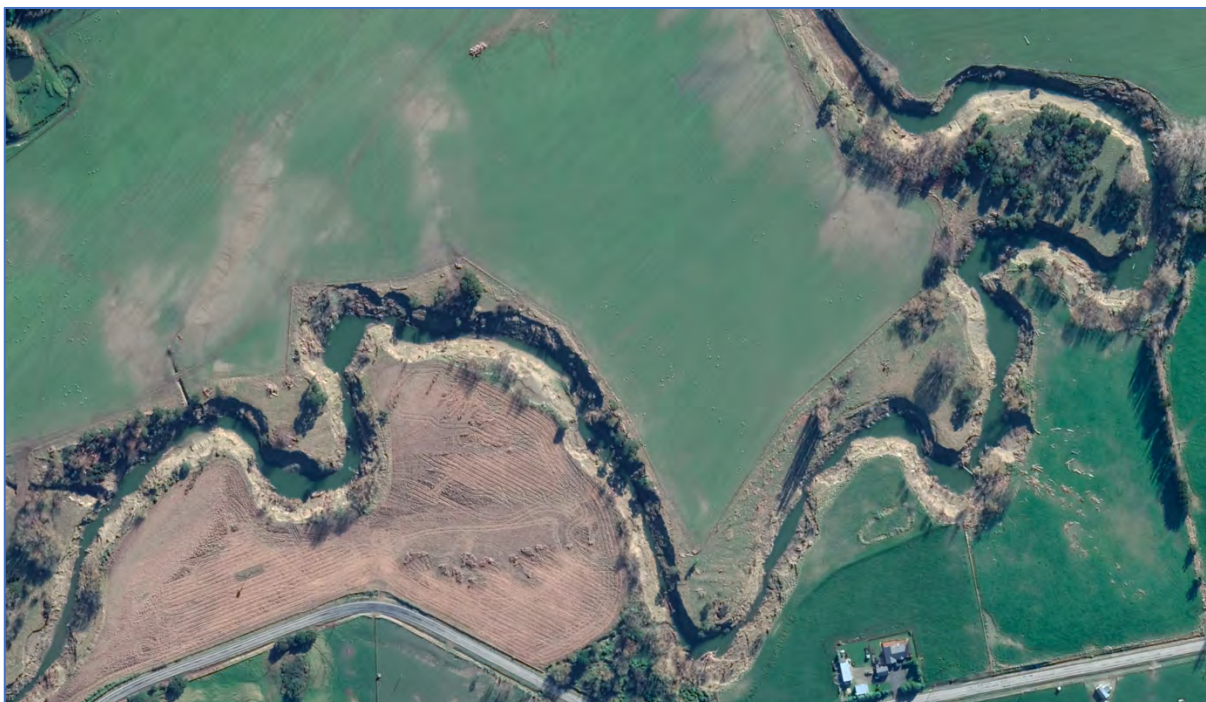
**Figure Forty.** Maxar satellite image dated 13<sup>th</sup> July 2018 of the Mangaheia 2D block (top), Kerslake property (bottom left), Aitken property (bottom middle) and Simpson Property (bottom right). Sediment deposition is evident particularly on the Mangaheia 2D block which also has two wood piles. The line of wood piles evident on the Kerslake property were cleared up following the harvest of the maize crop damaged during the storm event. Woody debris remains where it was deposited on the Simpson Property.

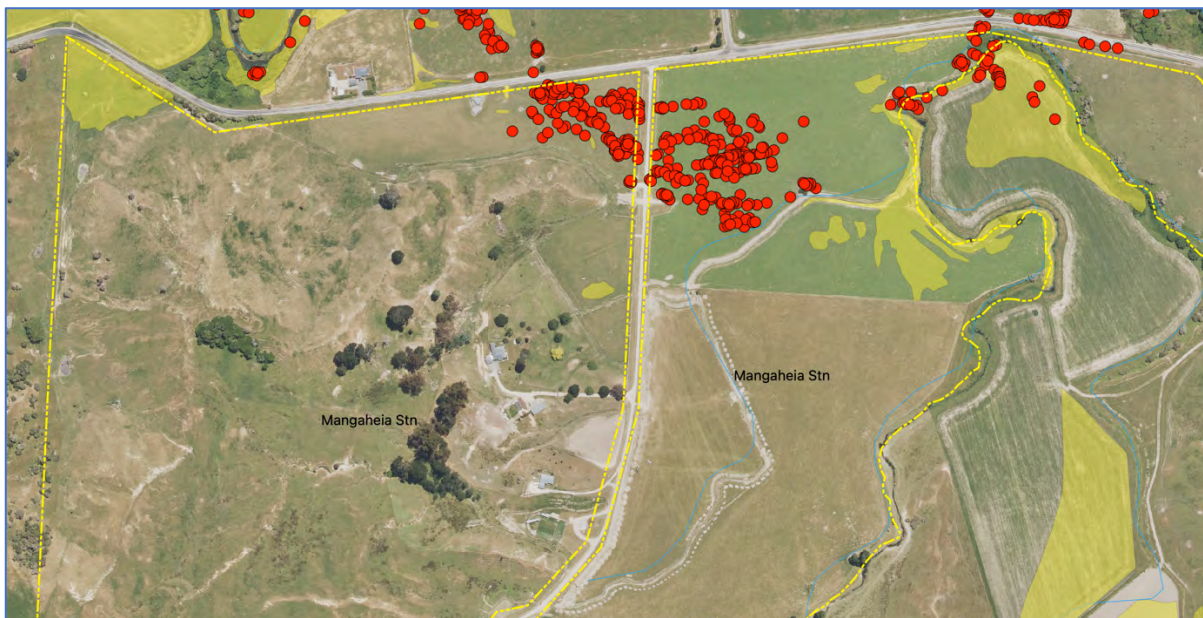
Mangaheia Station is situated on the south side of Tauwhareparae Road well away from the Mangaheia river but was still affected by a significant volume of woody debris which migrated from the river at the Simpson property (**Figure Forty One**). This woody debris damaged fences and the pasture experienced sediment deposition (**Figure Forty Two**).

**Figure Forty One.** Mangaheia Station showing the sediment deposition (yellow) and distribution of largely pine woody debris from the 2018 Queens Birthday storm.

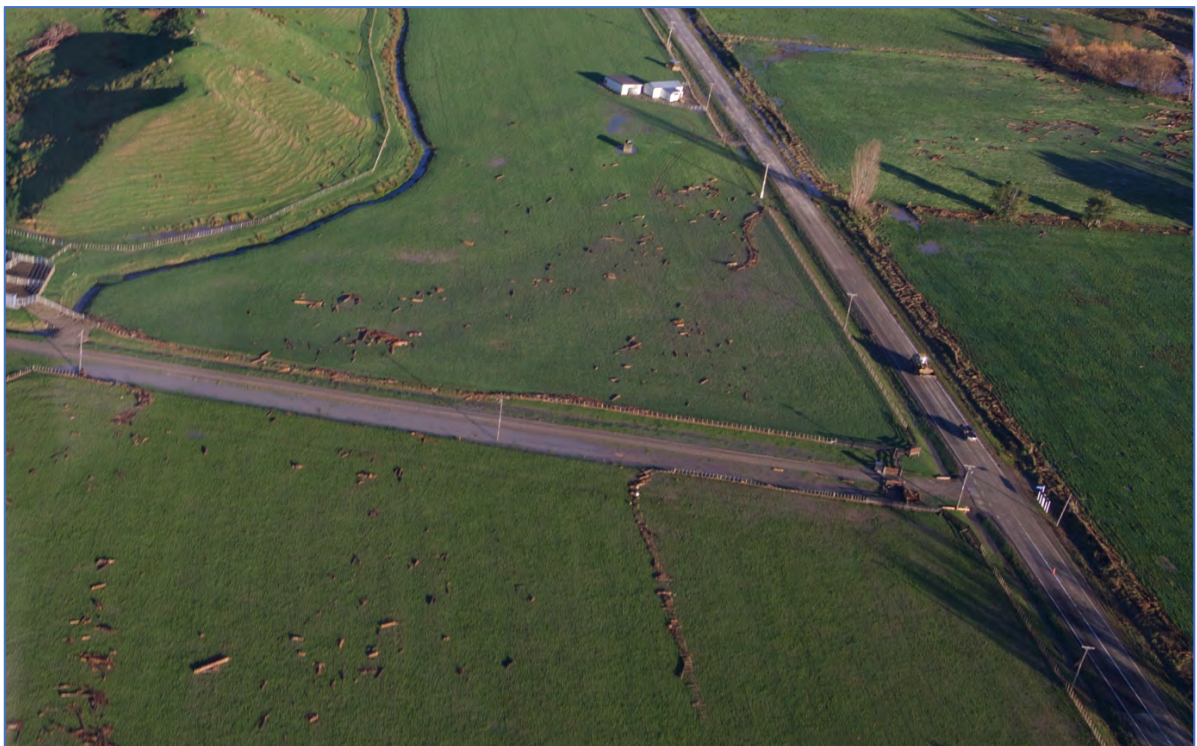
**Figure Forty Two.** Aerial view of Mangaheia Station on 6<sup>th</sup> June 2018 showing the woody debris across the paddocks. Note the destroyed fences.

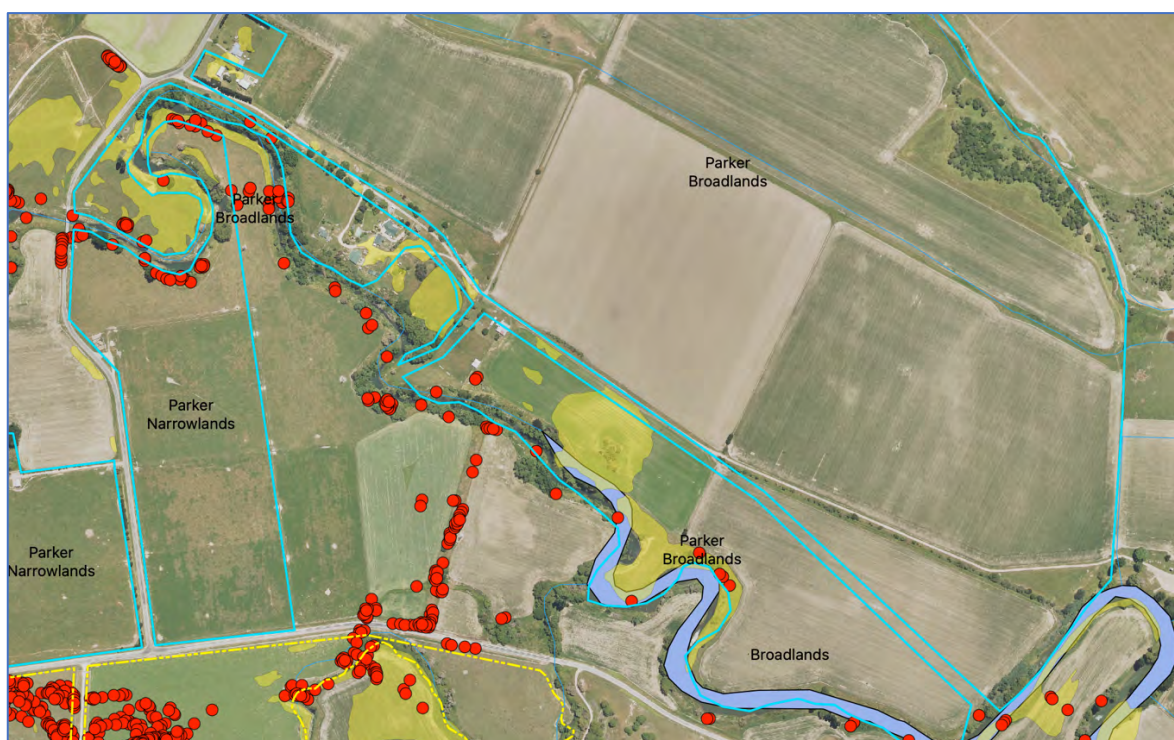
**Figure Forty Three.** Parker Properties; Broadlands and Narrowlands (purchased after 2018) showing sediment deposition and distribution of woody debris from the Queens Birthday storm. Sediment deposition occurred at the Halley property which was significantly inundated (top left) while the Parker property experienced sediment deposition around the farmhouse and in two former meander bends east of the house. Some woody debris was also deposited but not to the extent that occurred on the true right bank particularly along the boundary fence at the Phillips property.

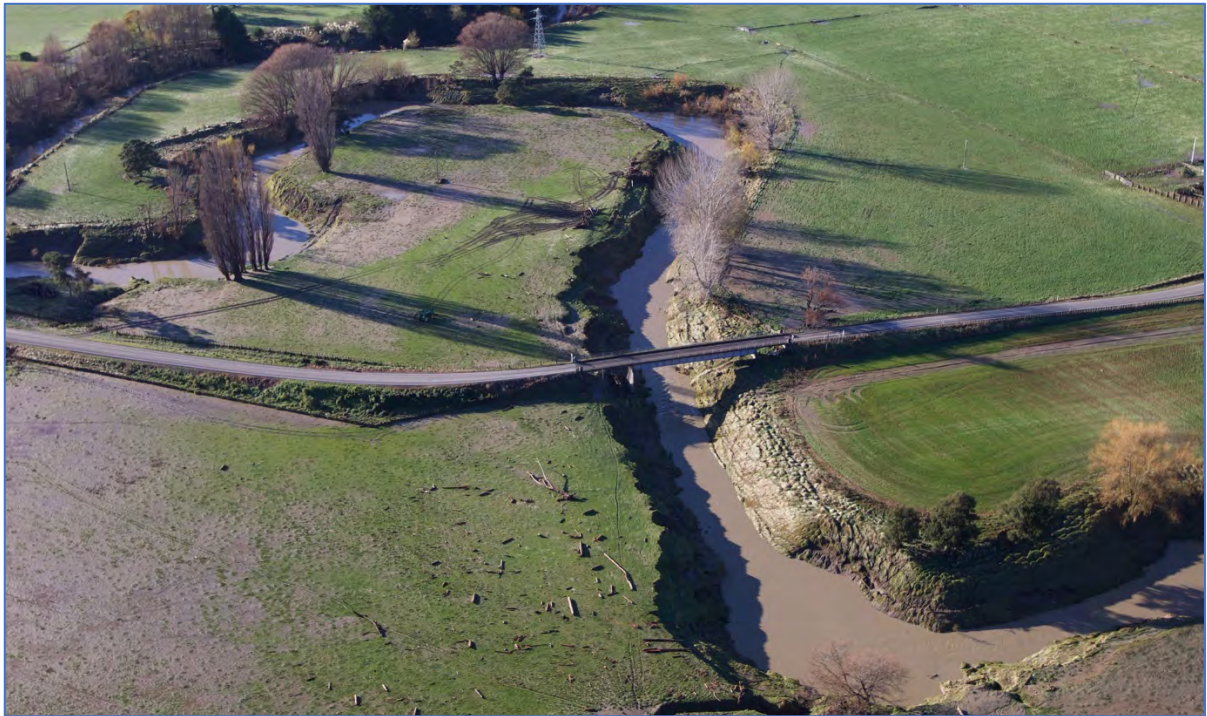
**Figure Forty Four.** Aerial view of the Paroa Road Bridge over the Mangaheia River (6<sup>th</sup> June 2018). There is no evidence of a log jam at the bridge. Sediment deposition at the left of the image suggests that this area is more low lying than at the bridge and thus there may have been a preferential path directing flood waters across the true left side of the flood plain.
