# Downstream Impacts of sediment and woody debris Inundation in the Mangaheia sub-catchment Uawa Catchment during the Queens Birthday Storm 2018

Dr Murry Cave  
Principal Scientist  
Gisborne District Council  
v.3.2 October 2022

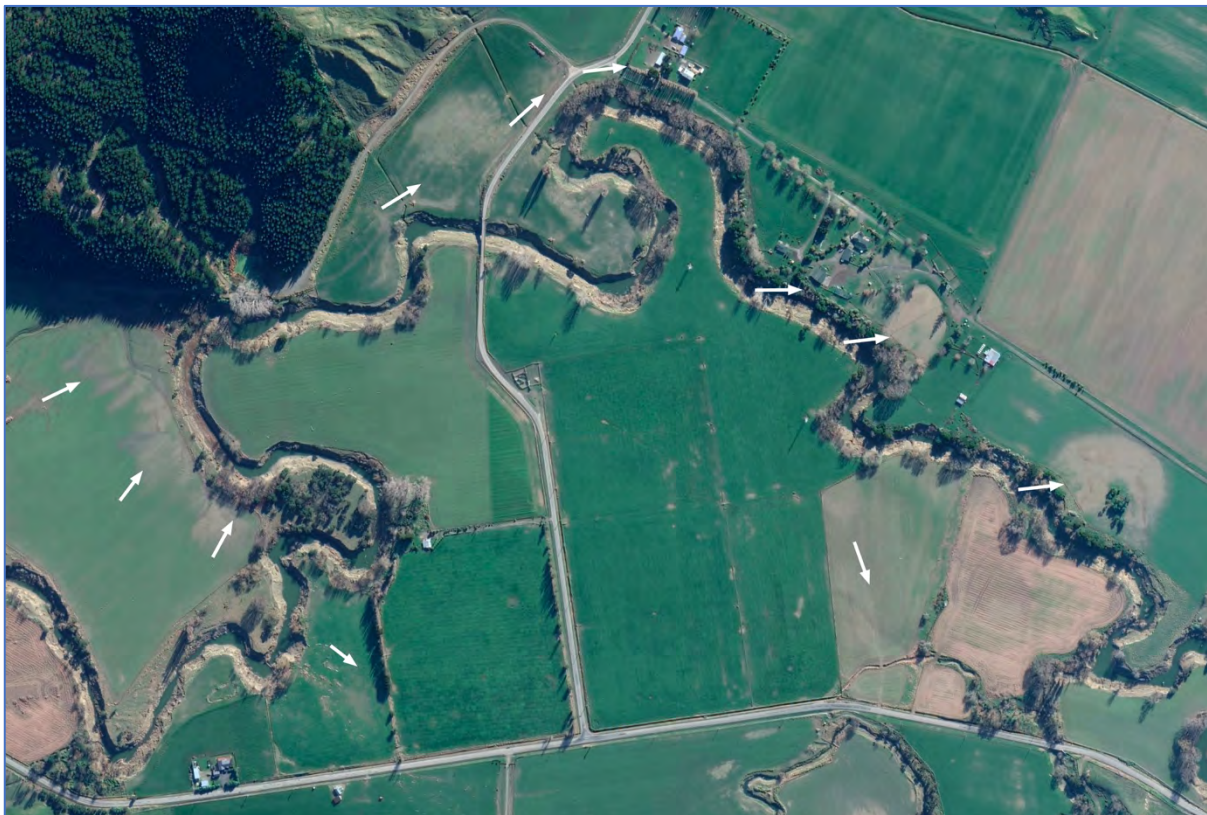
**Figure Forty Five.** Maxar satellite (13<sup>th</sup> July 2018) showing the areas of significant sediment deposition and likely flow paths resulting from reduced flood conveyance capacity in the meander loop upstream. Lower Reaches.

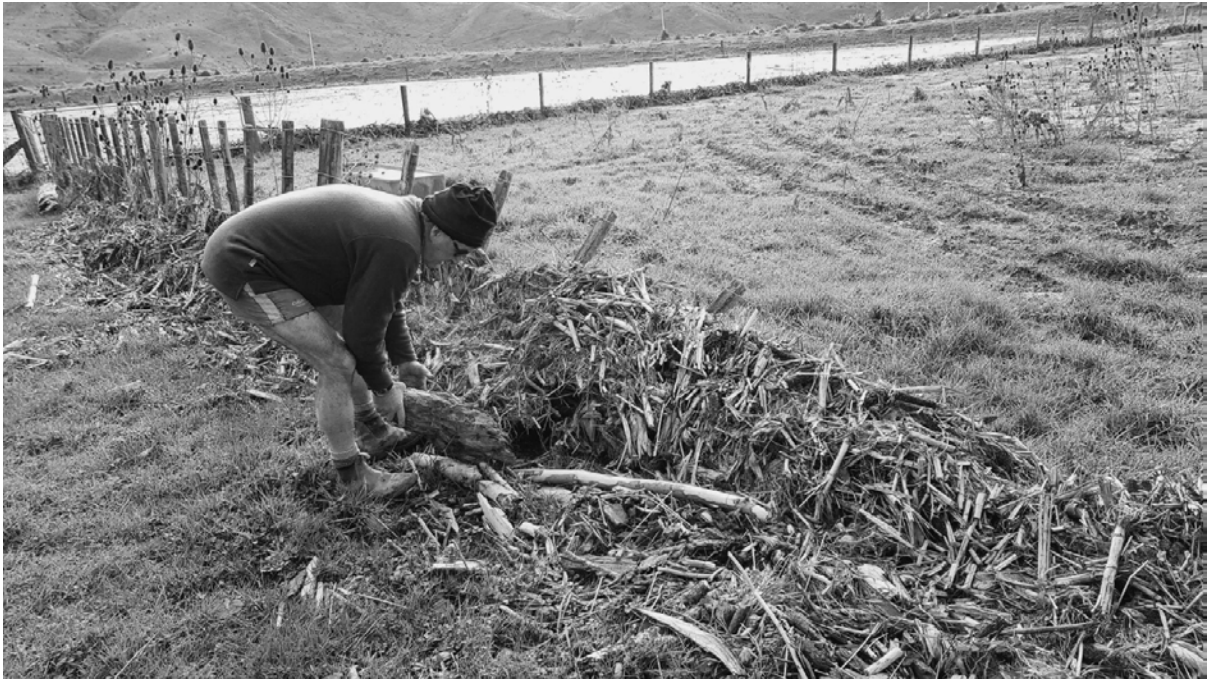
**Figure Forty Six.** Photograph (supplied) showing a fence damaged by slash and some larger woody debris on Broadlands.

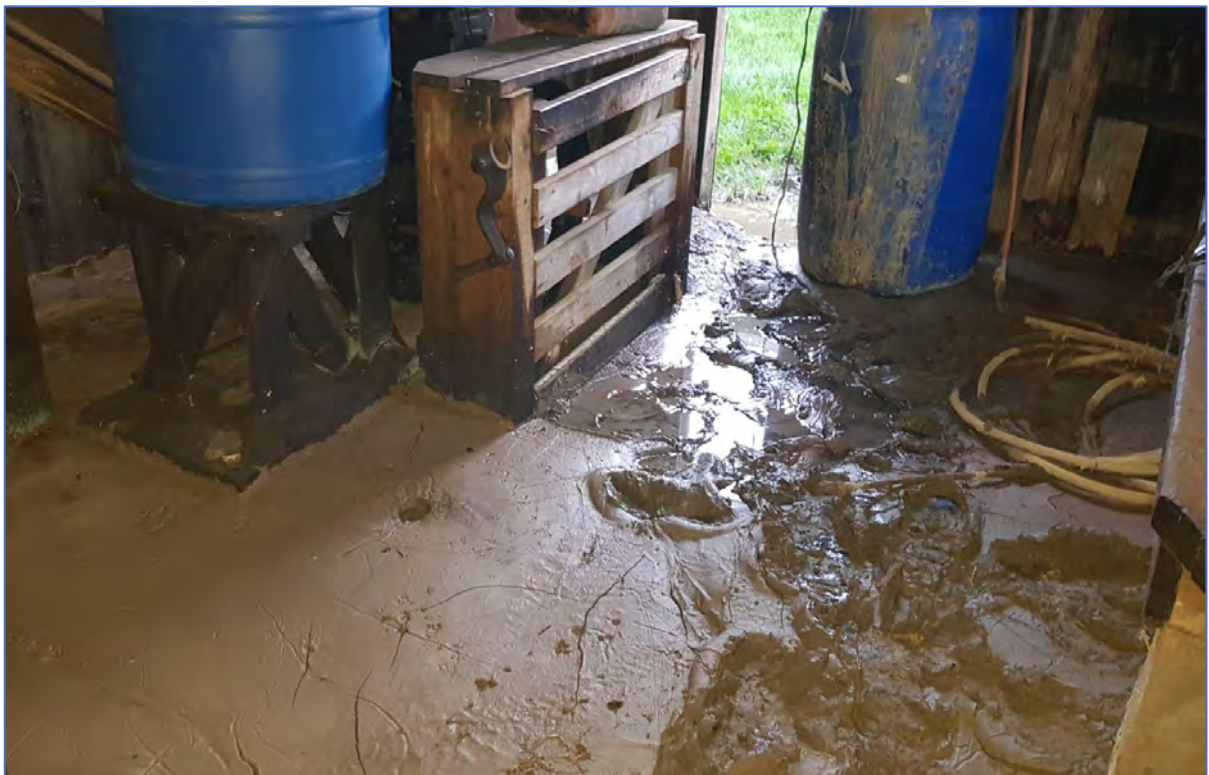
**Figure Forty Seven.** Photograph (supplied) showing sediment deposition within a farm shed at Broadlands Farm.

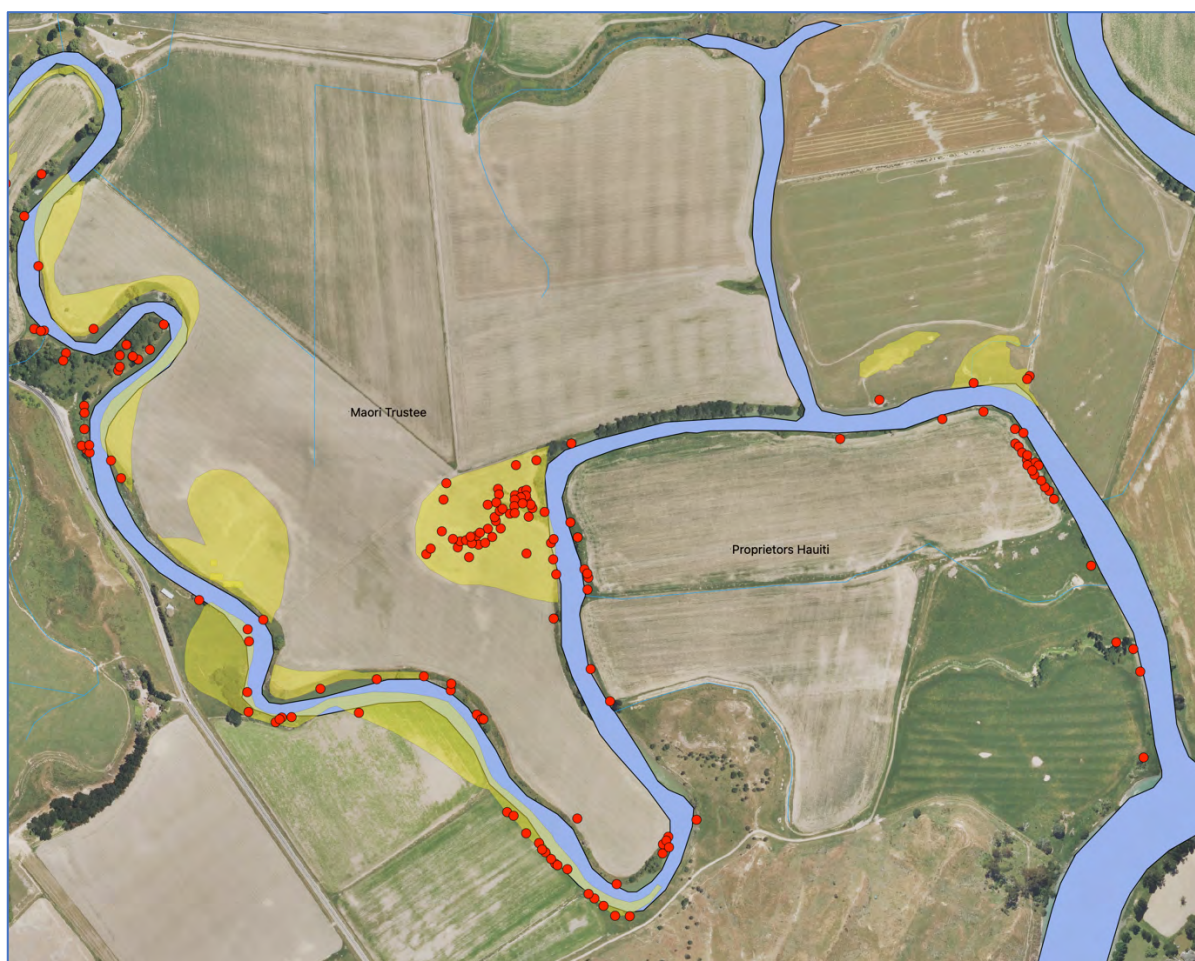
**Figure Forty Eight.** Map of the area downstream of the Broadlands property showing the areas of sediment deposition and the distribution of woody debris. It is likely that the lower 800m was affected by flooding from the Uawa main stem but above that

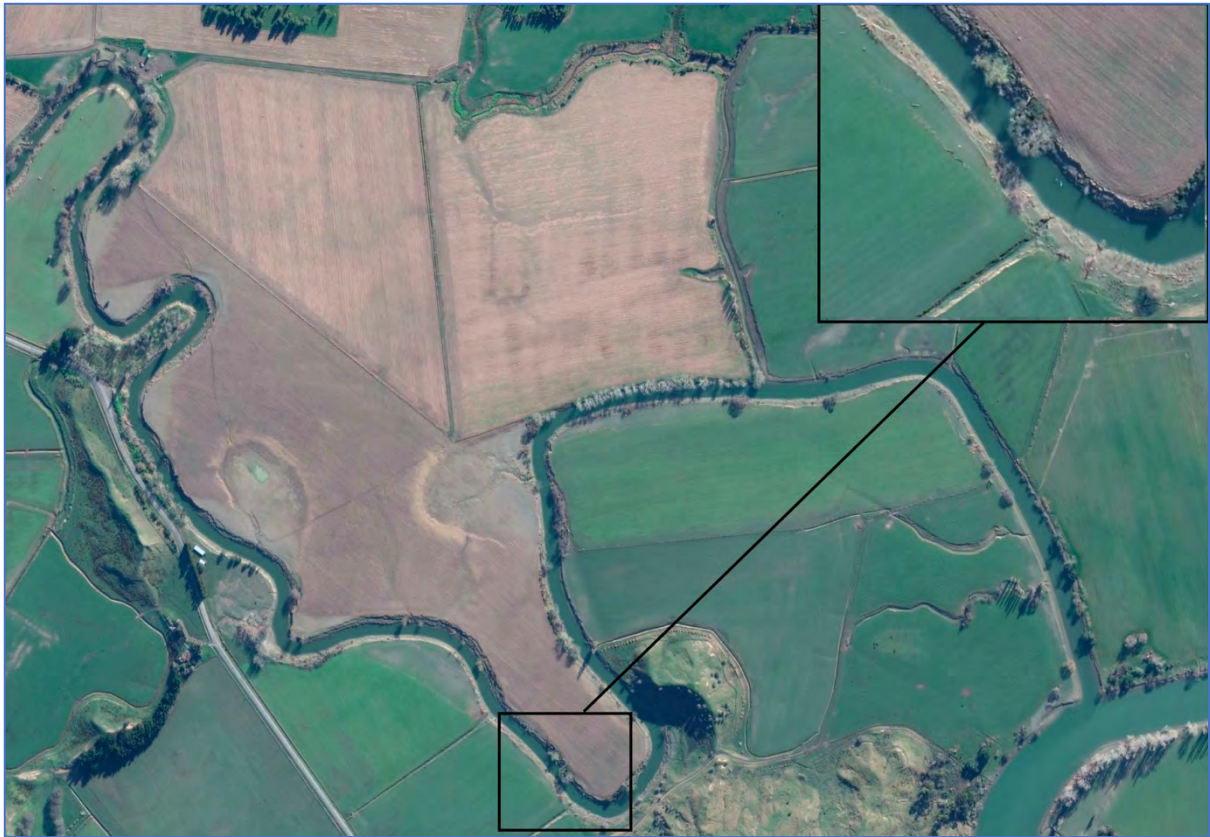
**Figure Forty Nine.** Maxar Satellite imagery of the lower reaches. Woody debris smothered by sediment is present in the abandoned meander loop (middle) and digger tracks through the deposited mud is visible leading from top left through to the abandoned meander loop. The inset (top right) shows detail for the meander loop bottom middle.

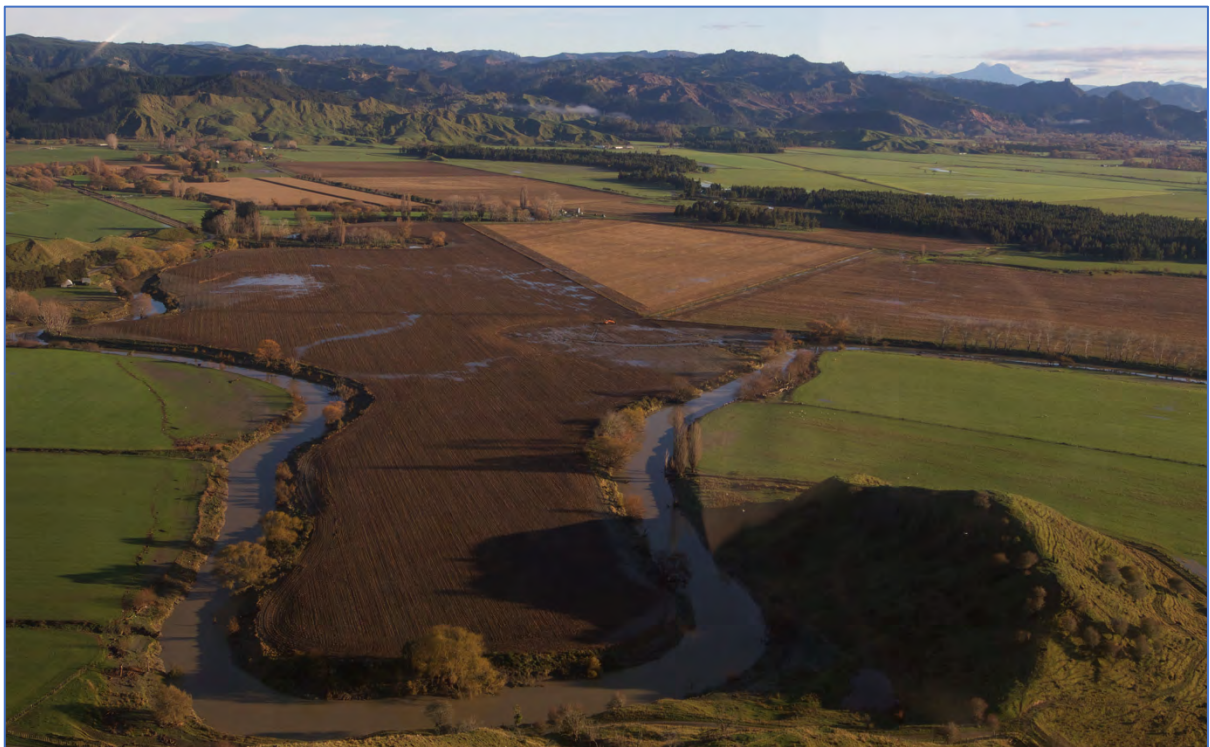
**Figure Fifty.** Aerial imagery of the meander loop shown in **Figure Forty Nine (inset)**. Woody debris is evident on the true right back (image far left).

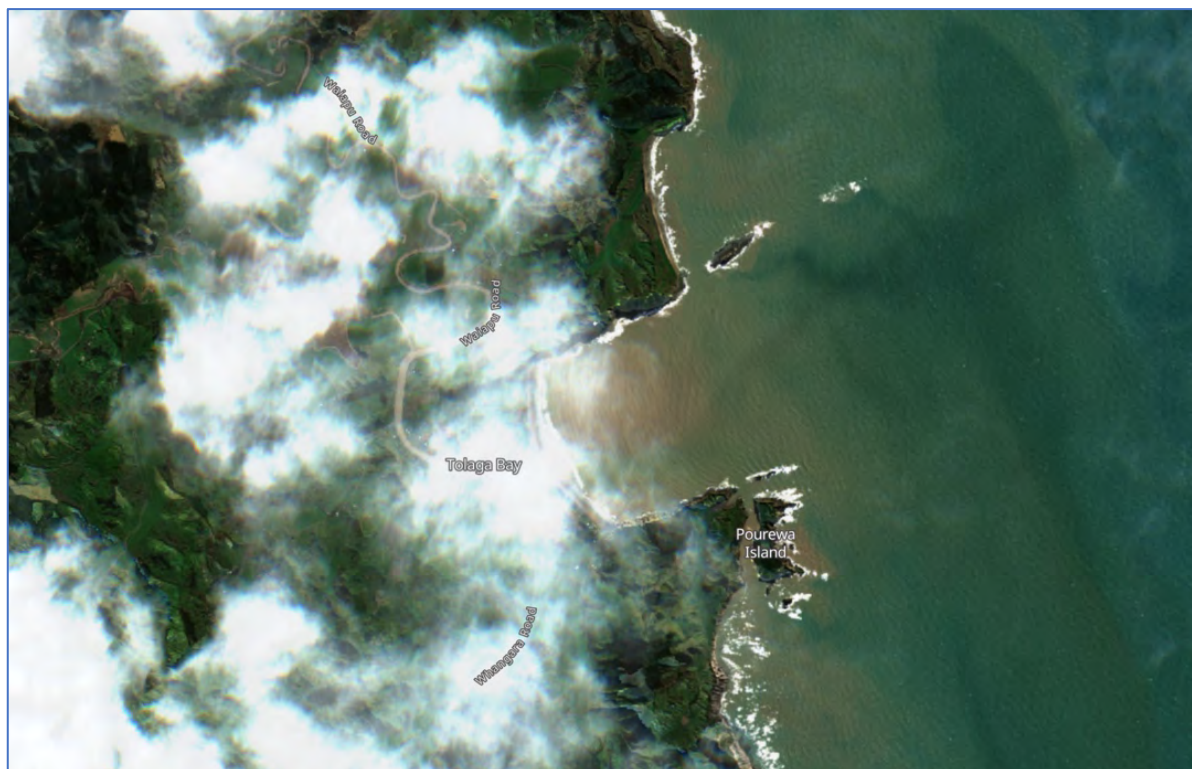
**Figure Fifty One.** Sentinel satellite imagery for the 12<sup>th</sup> June 2018 showing sediment discharge into Tolaga Bay.
