CIVIL DEFENCE EMERGENCY MANAGEMENT GROUP

DATE: Wednesday 11 May 2022

Civil Defence Emergency Management

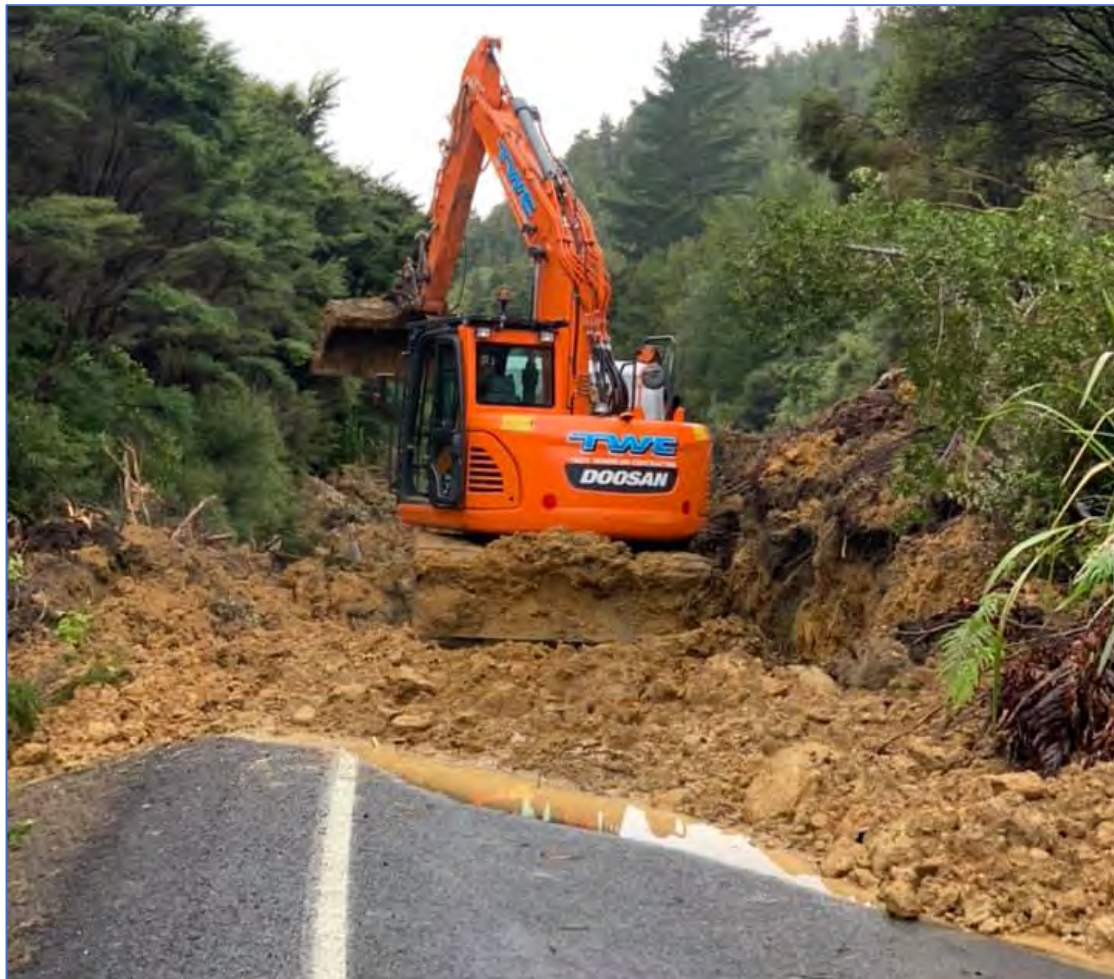
Figure Six. Clearing the significant slip blocking State Highway 35 at Oweka close to the Lottin Point turn off (photograph Rex Rongo Stainton).

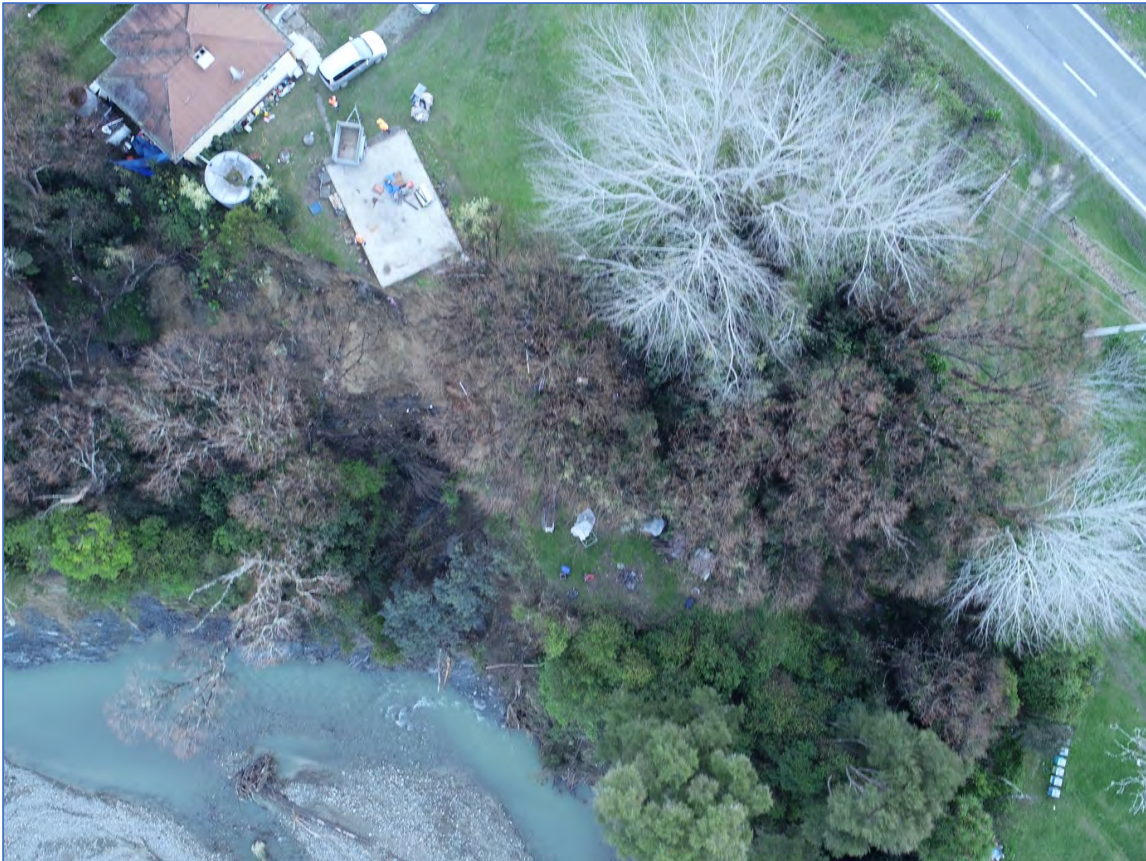
Figure Twelve. Drone footage of property at Hiruharama, south of Ruatoria where slipping from a side creek is threatening a house.

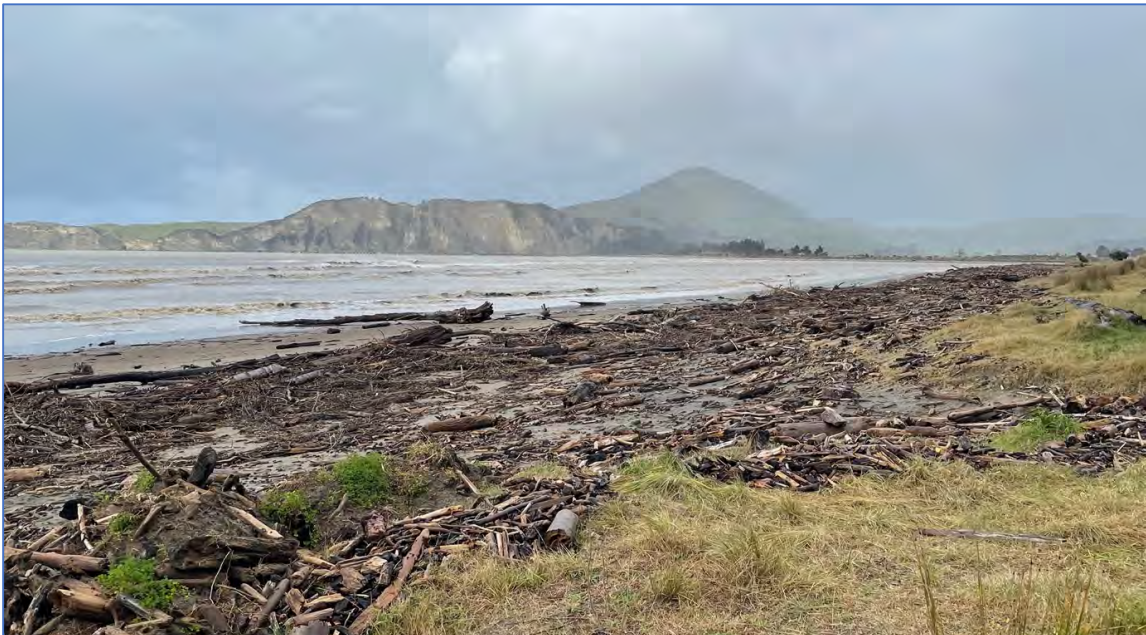
At Tolaga Bay², the storm surge scoured the top of the north and south beaches and remobilised pine logs. An additional contribution of fresh willow debris on the north beach suggests that the willow piles observed being mobilised at the Anaura Bay turn-off migrated to the beach (**Figure Thirteen**).

Figure Thirteen. New woody debris deposited on Tolaga Bay north beach after the 20th June 2021 storm.

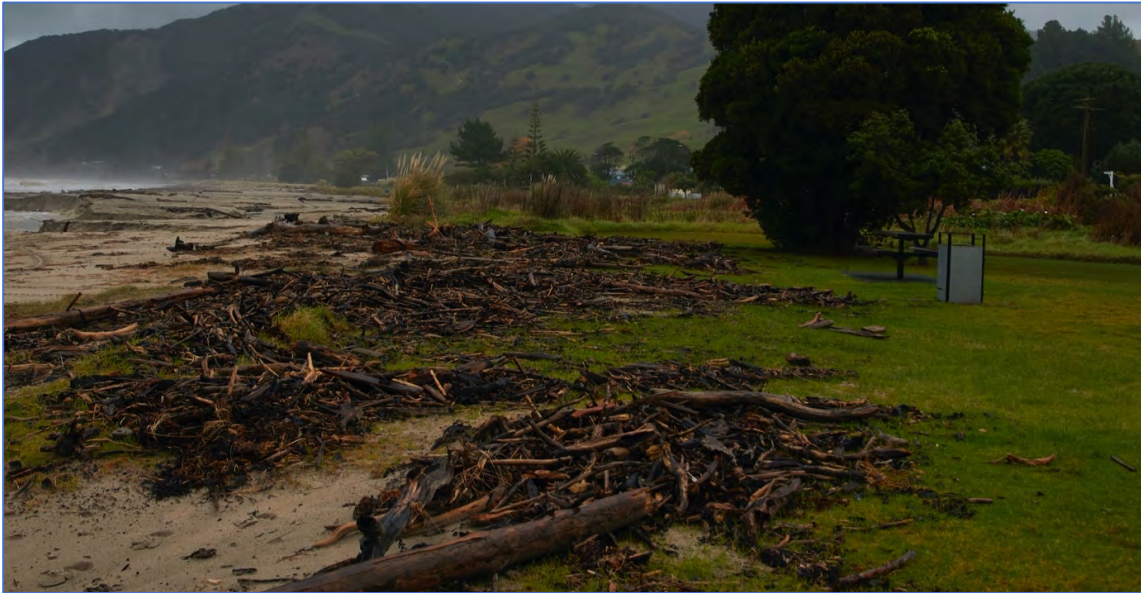
inspection on the 20th June, it was observed that there was a significant number of logs thrown onto the foreshore at the mouths of both the Waitutu and Mangahauini Rivers (**Figures Twenty Seven and Twenty Eight**). A high tide or storm surge can affect the impact of a flood in a coastal environment such as Tokomaru Bay by creating a barrier preventing flood flows from efficiently discharging to sea. The presence of the logs and erosion at the mouth of the Mangahauini indicates that there was a coastal influence but not whether or not it was due to the tide or the result of storm surge.

Figure Twenty Seven. Woody debris thrown up onto the freedom camping area south of the mouth of Waitutu Stream.

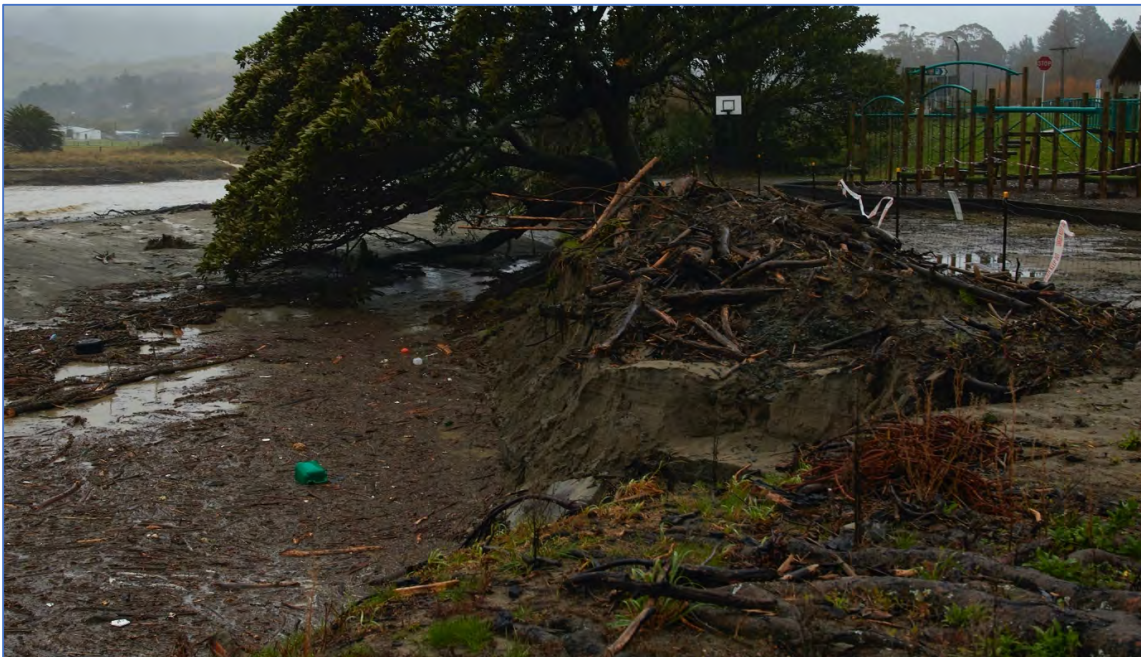
Figure Twenty Eight. Woody debris thrown up onto the reserve immediately north of the Mangahauini Stream. Also evident is the extent of erosion of the banks at the reserve.

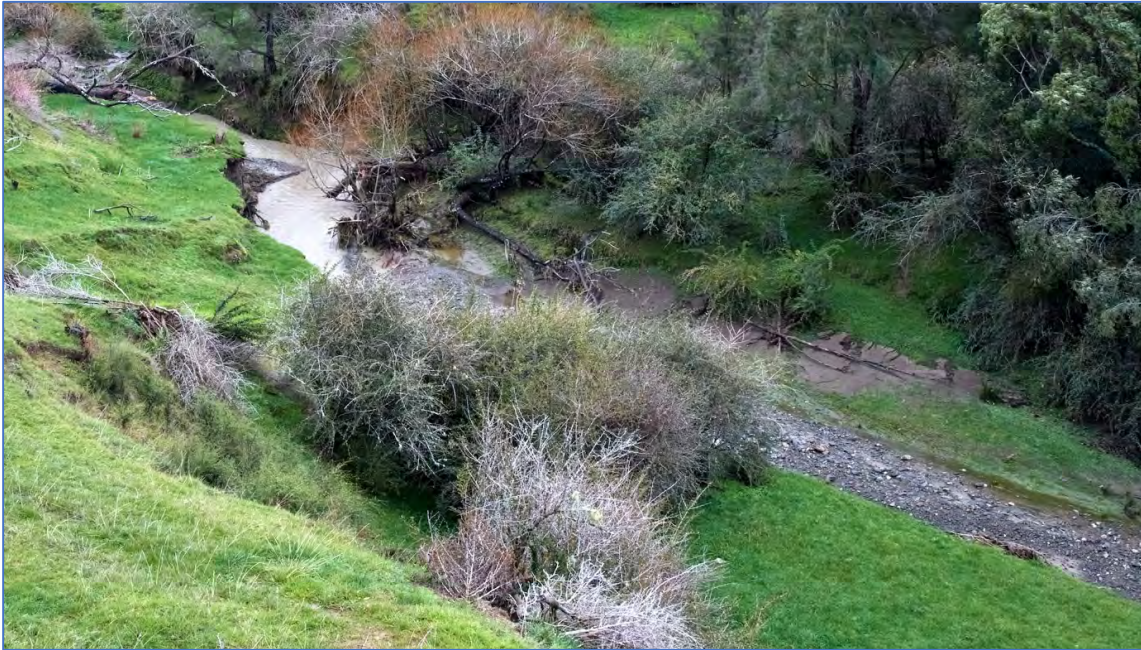
On the 22nd June, the reach of Waitou stream above the confluence with the Kaiawha were accessed from a variety of points. This did not reveal any signs of significant flooding. There was bank scour at a number of locations which caused some river bank trees to collapse into the river. Silt deposition was observed at one location very close to the normal riverbed level suggesting that relatively minor flooding occurred in the catchment (**Figure Thirty Three**).

Figure Thirty Three. View of Waiotu Stream upstream of the confluence with Kaiawha Stream showing signs of scour (top left) and silt deposition (middle right). The silt is very close to normal river level and there is no indication on inundation on the true right bank (bottom right).

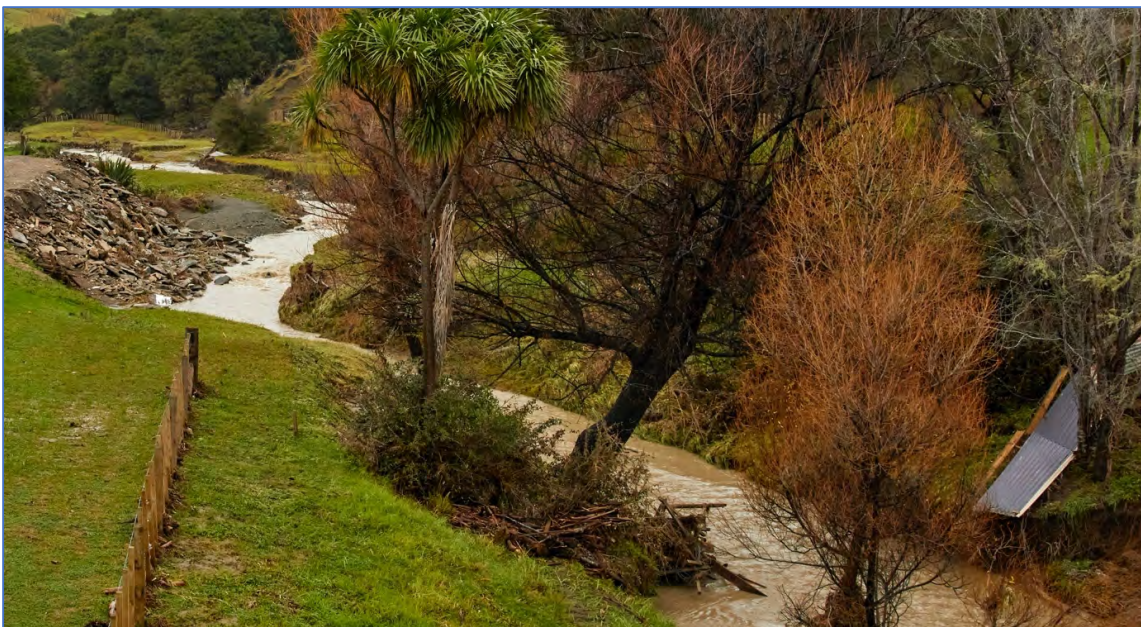
The Kaiawha River immediately upstream of the bridge on State Highway 35, however, showed more significant signs of flooding with the river a lot muddier, woody debris wedged against trees and a debris fence broken free from the true right bank (**Figure Thirty Four**). Mud and woody debris was observed wedged against the fence at the top of the bank indicating high flood levels (**Figure Thirty Five**).

Figure Thirty Four. Kaiawha Stream upstream of the SH 35 Bridge showing the damaged debris fence and woody debris caught against the trees.

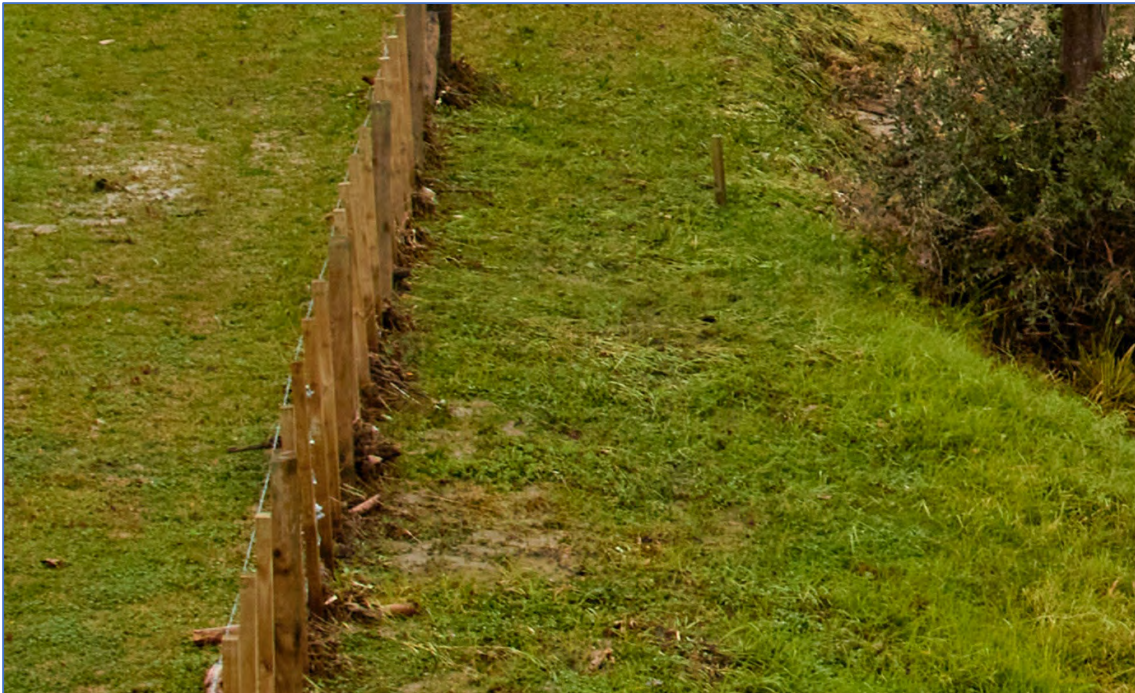
Figure Thirty Five. Fence at top of bank of Kaiawha Stream upstream of the SH 35 Bridge showing woody debris caught up in fence and mud deposited on the river side of the fence.

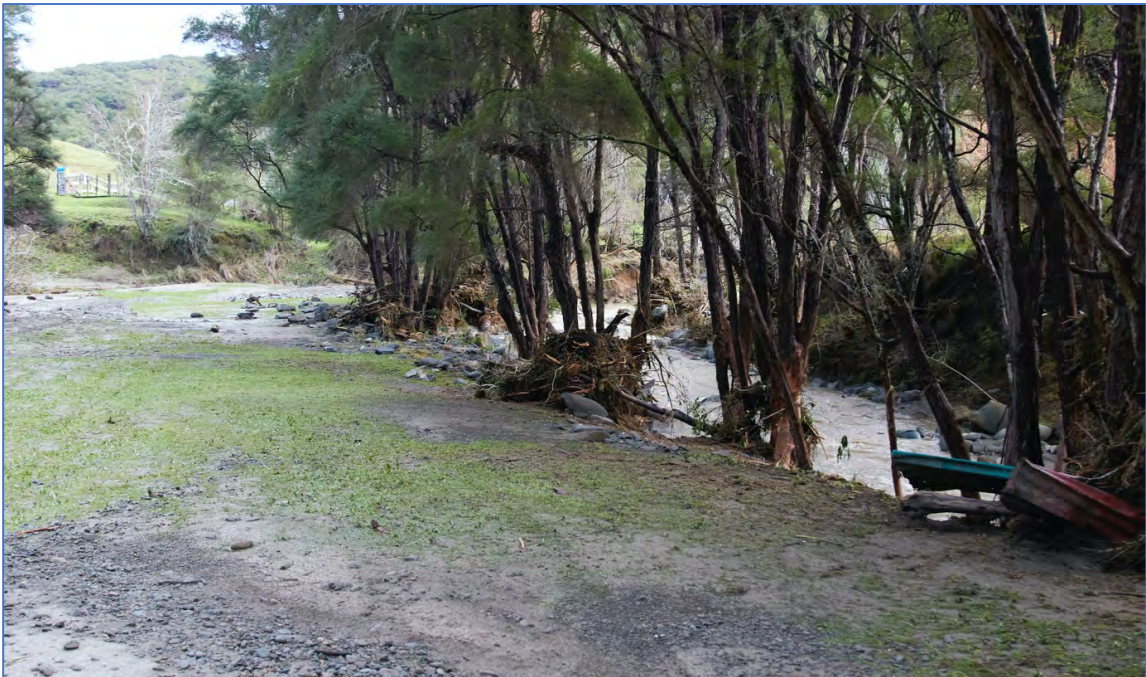
Figure Thirty Eight. Photograph upstream of the ford on Kaiawha Road showing debris caught up in the trees and mud deposited across the valley floor.

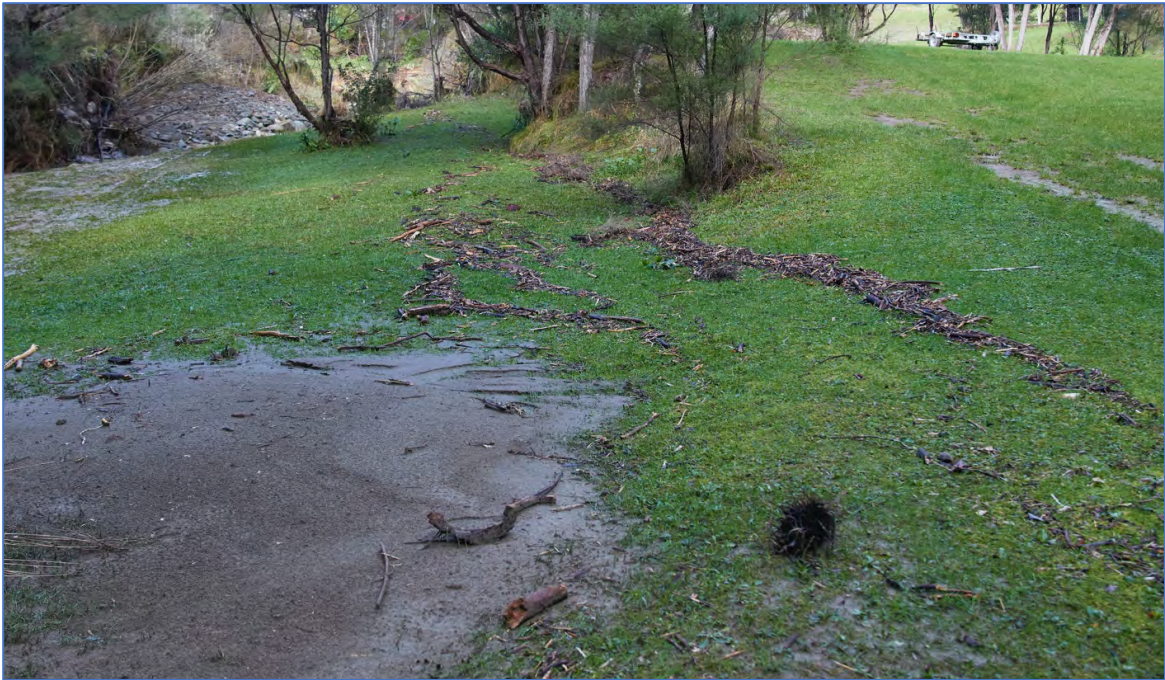
Figure Thirty Nine. Photograph upstream of the ford on Kaiawha Road showing the edge of the flood spread against higher ground.

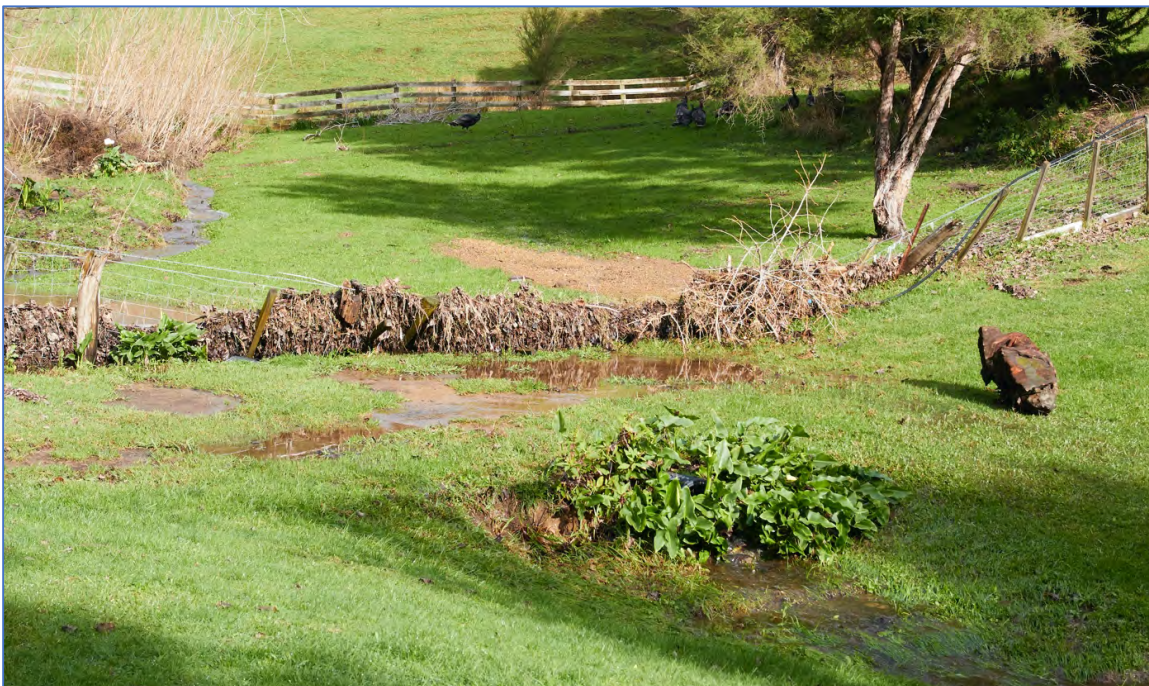
Figure Forty. Photograph upstream of the ford on Kaiawha Road showing mud deposition resulting from over-ground flow.

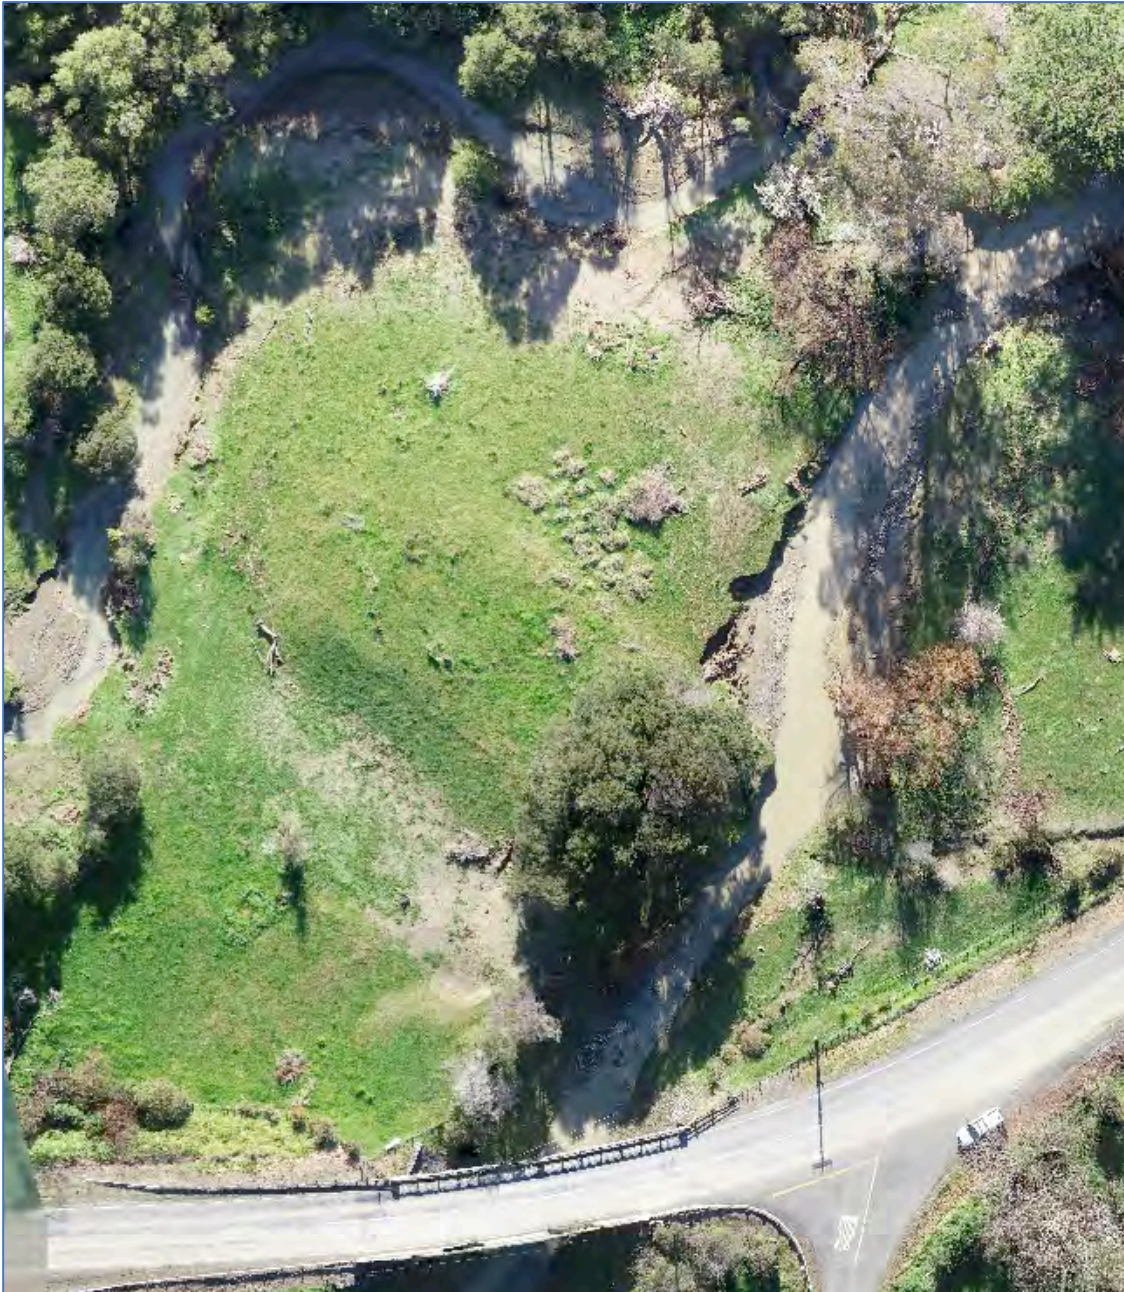
Figure Forty One. View of the Kaiawha Stream below the bridge on State Highway 35 showing the flood overtopping on the true left bank discharging into Waiotu Stream and the silt deposition downstream from there.

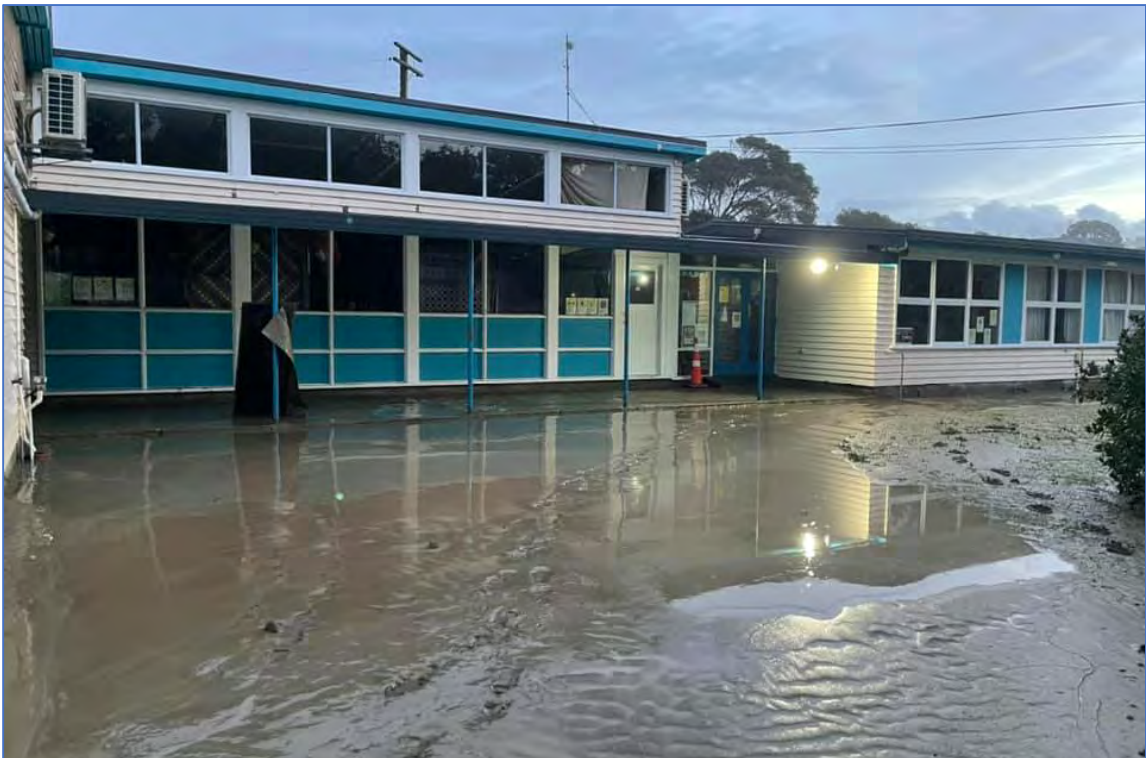
Figure Forty Six. Flooding and silt deposition at Hatea-A-Rangi School, Tokomaru Bay.

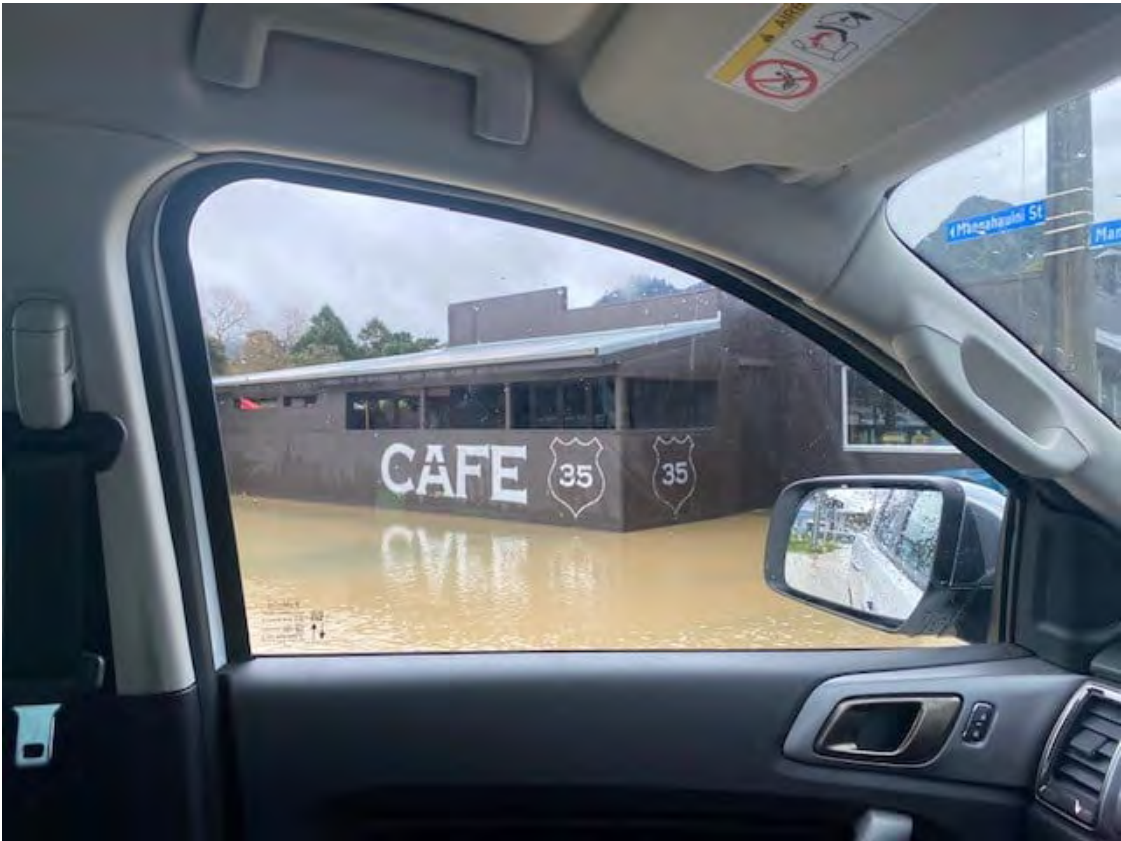
Figure Forty Seven. Flooding at café 35, Tokomaru Bay. It is assessment that the flooding here was the result of overland flow rather than flooding from the Mangahauini River.

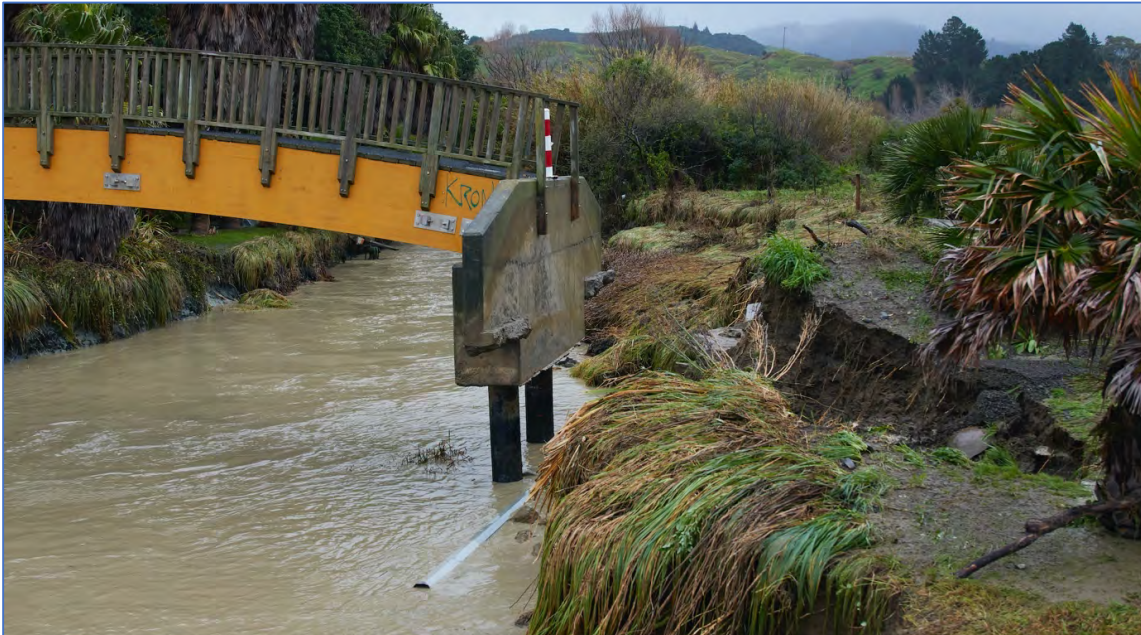
Figure Forty Nine. The washed out abutment of the footbridge at the mouth of Waiotu Stream.

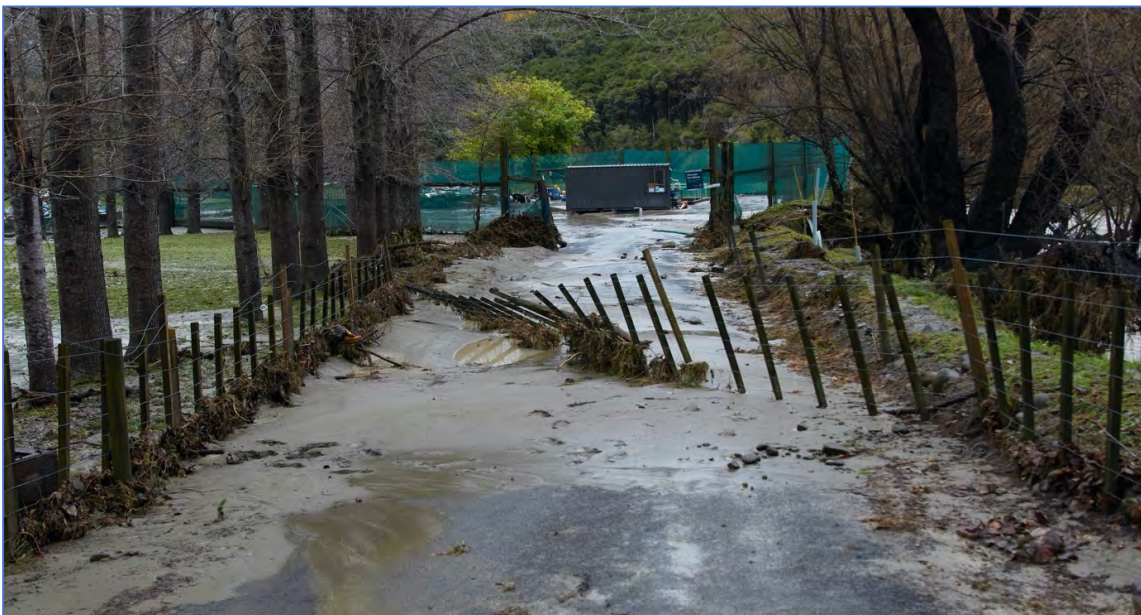
Figure Fifty. Flood impacts at the Tokomaru Transfer Station.

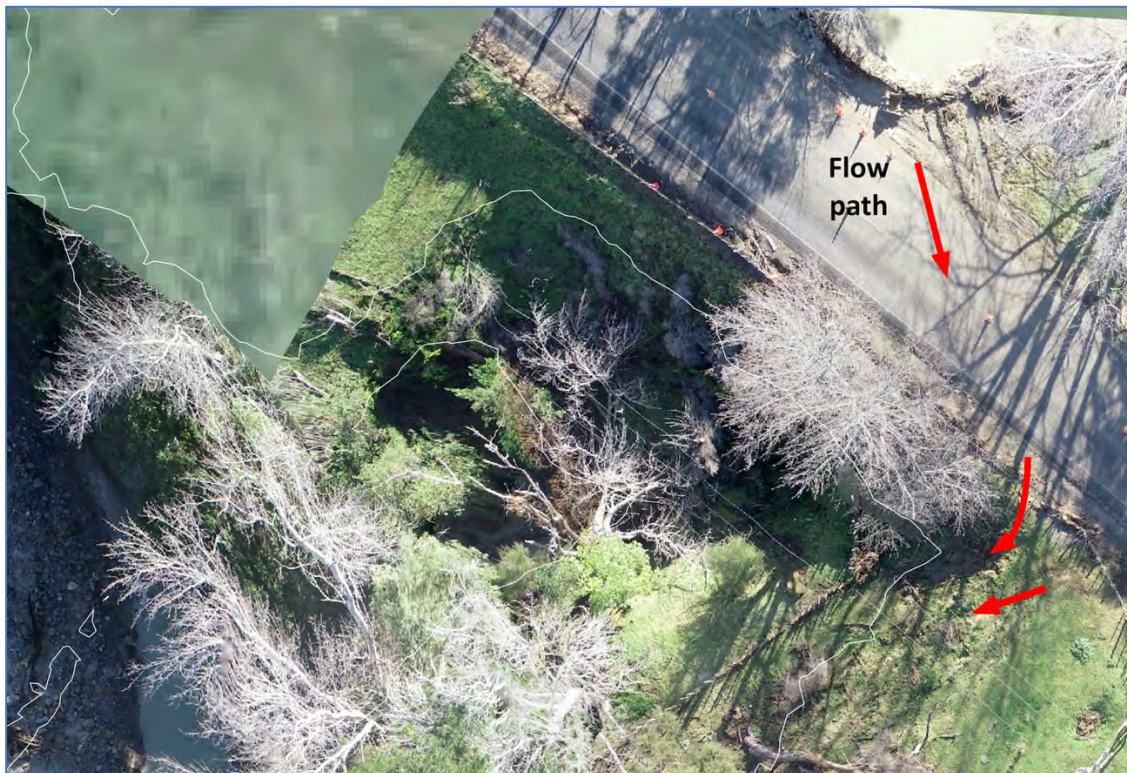
Reliable information on its pre-flood condition was difficult to come by although there were anecdotal reports from local residents suggesting it was blocked. This was confirmed by Waka Kotahi sometime after the event who advised that they were aware of the blockage but were also concerned that the culvert would immediately block again due to the volume of sediment in the tributary it drained. Accordingly they had initiated planning for a medium to long term solution but had arranged for contractors to clear the culvert but that was not done before the storm hit.

Figure Fifty One. drone footage of the blocked culvert on State Highway 35 showing the overland flow path to the creek downstream of the culvert.

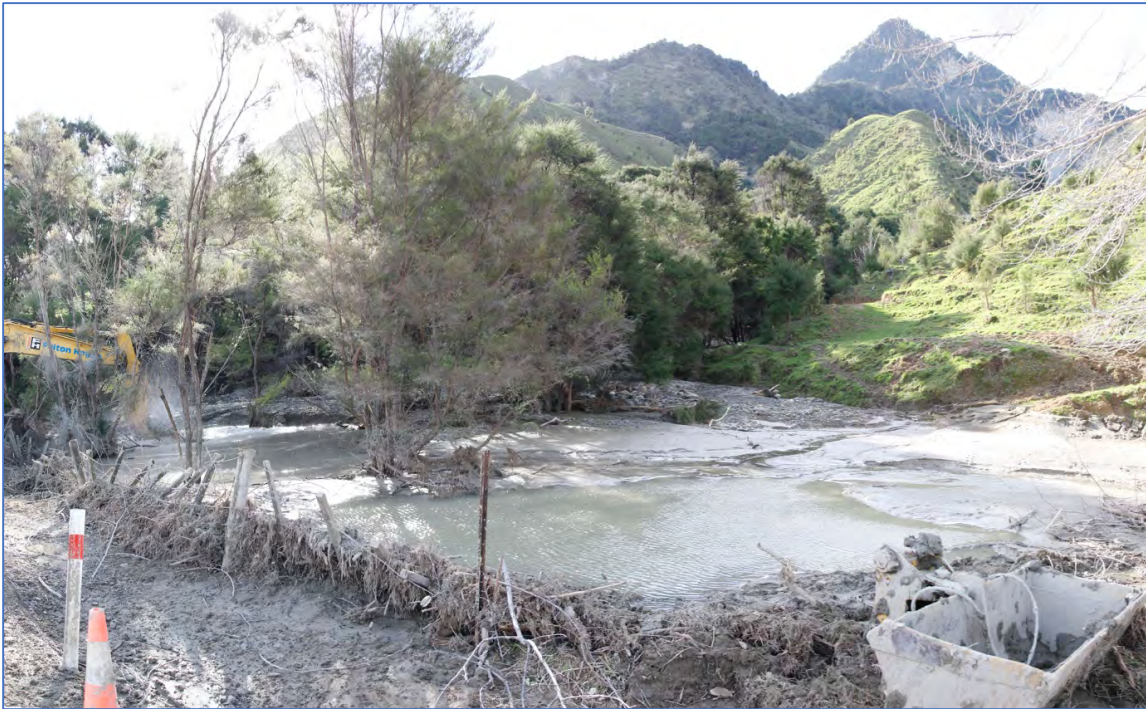
Figure Fifty Two. View of culvert on State Highway 35 north of Tokomaru Bay prior to clearing. Note the extensive infill of debris and the indications of overtopping on the fenceline.

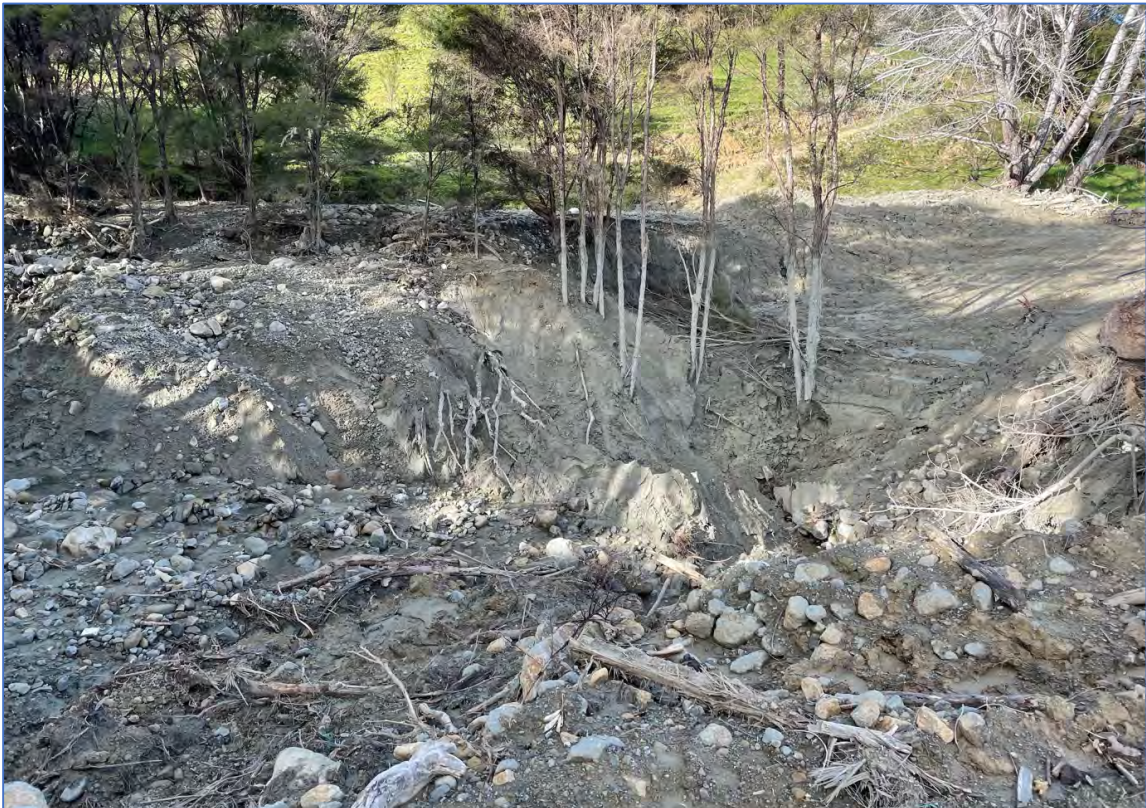
Figure Fifty Three. View of culvert on State Highway 35 north of Tokomaru Bay after clearing showing the considerable volume of debris remaining above the inlet.

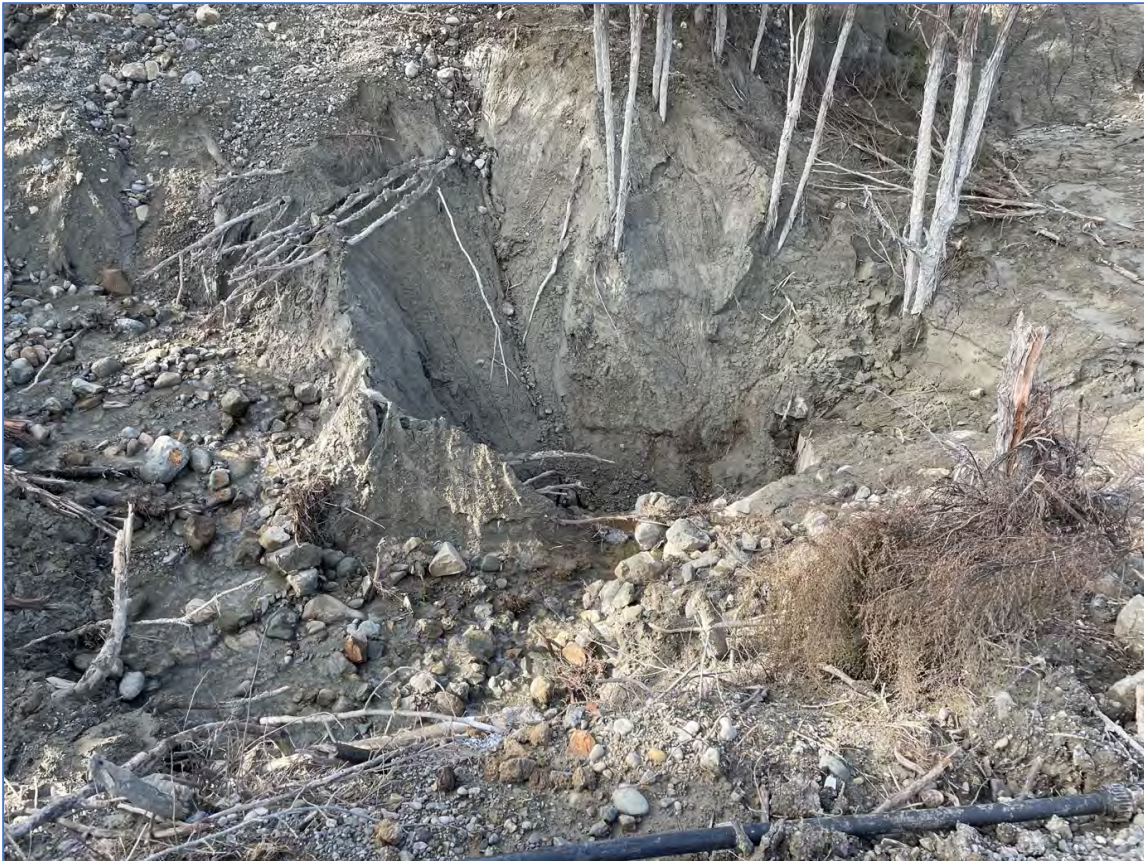
Figure Fifty Four. View of culvert on State Highway 35 north of Tokomaru Bay after clearing. This shows that only a small pit has been dug at the inlet to allow for drainage. It is understood that further clearance is planned and that an assessment is underway to increase culvert capacity.

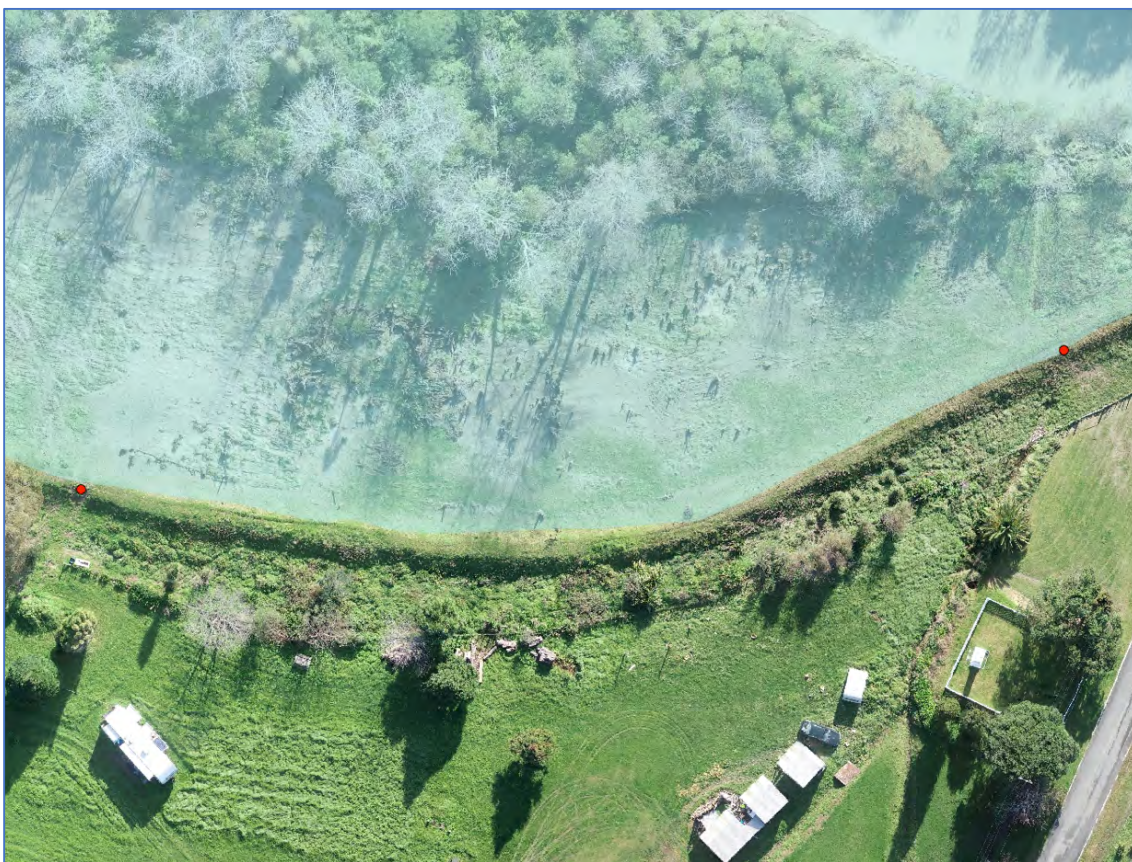
Figure Fifty Six. View of the lower true right bank of the Mangahauini showing the two overtopping points. The old road is shown at far right.

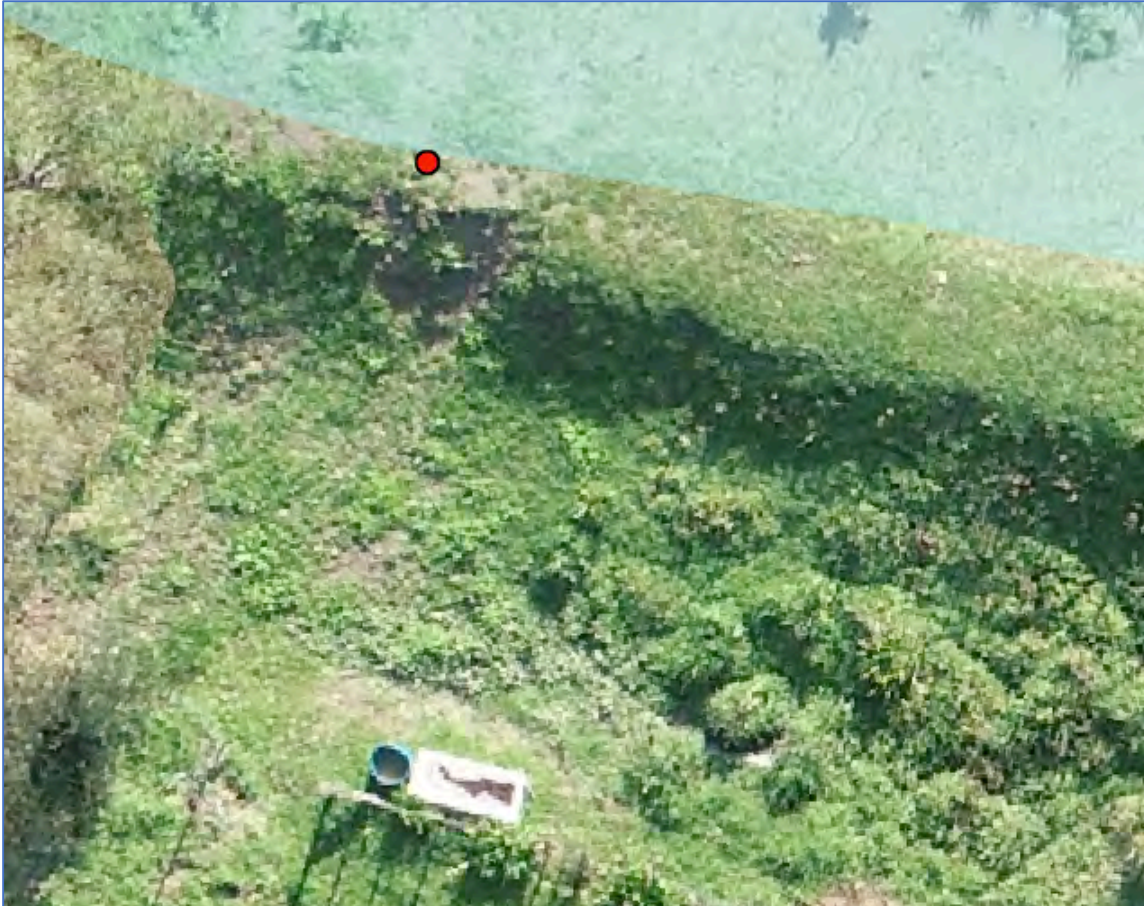
Figure Fifty Seven. View of the upper overtopping point showing the silt deposition and the indications of stopbank erosion.

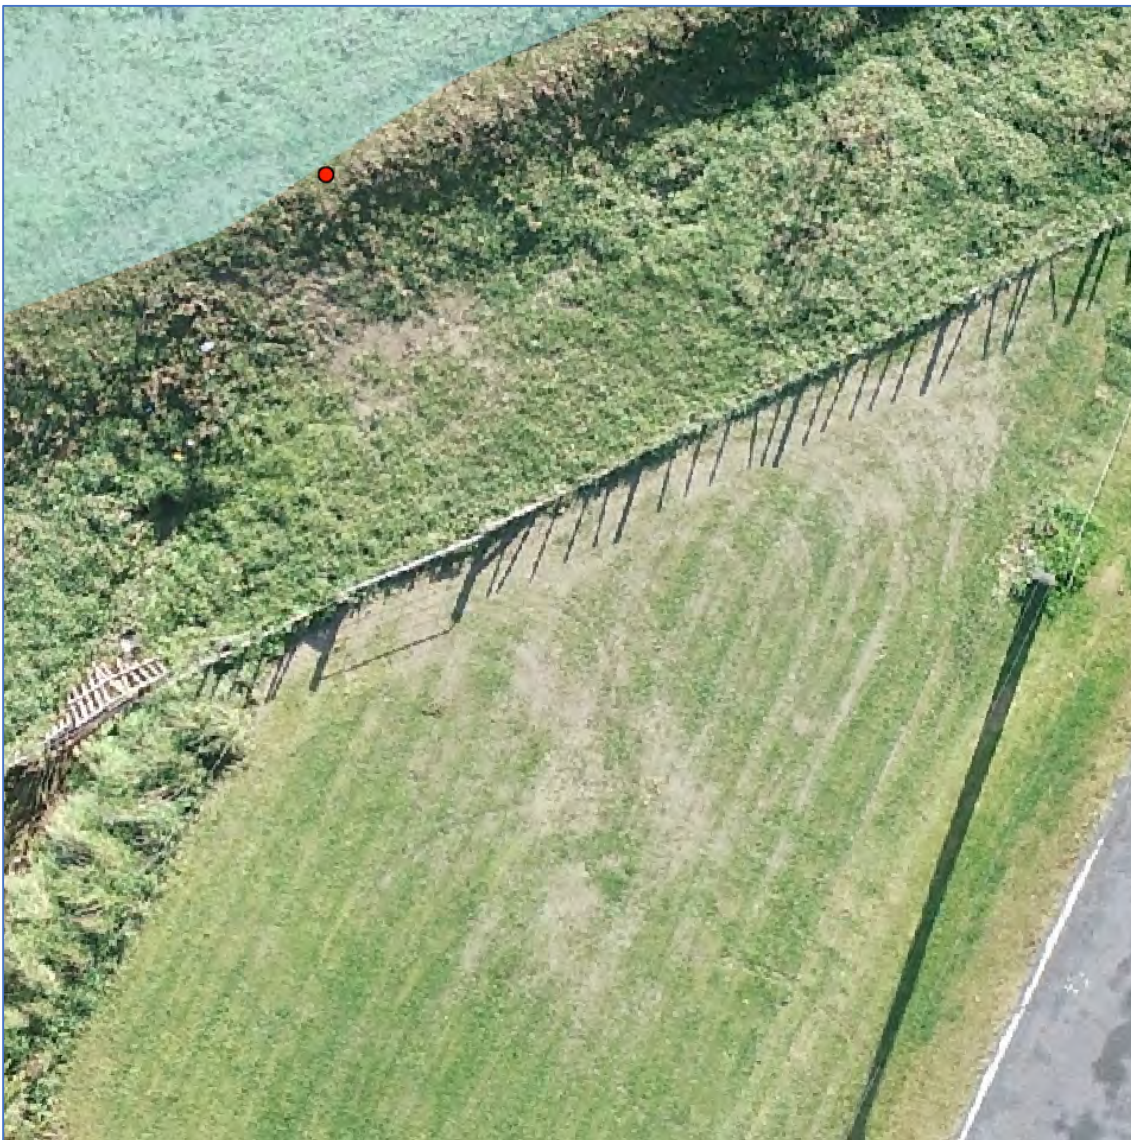
Figure Fifty Eight. View of the lower overtopping point showing the silt deposition extending out onto the low lying ground beyond. The imagery does not, however, suggest flood spread beyond 18m of the overtopping point.

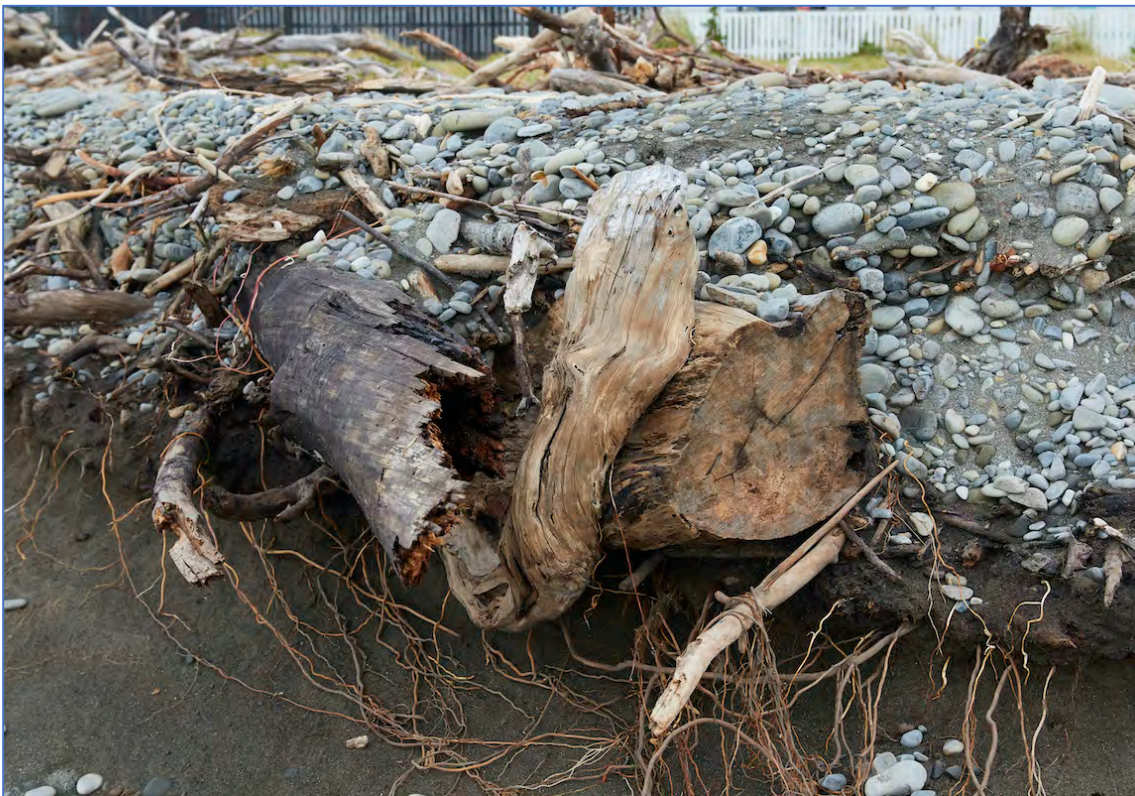
Figure Sixty One. Obvious erosional scour of the top of the beach that has exposed pre-existing driftwood. This is a mainly willow with some indigenous. The cuts look fresh and is probably due to being cut for firewood.
