CIVIL DEFENCE EMERGENCY MANAGEMENT GROUP

DATE: Wednesday 11 May 2022

Civil Defence Emergency Management

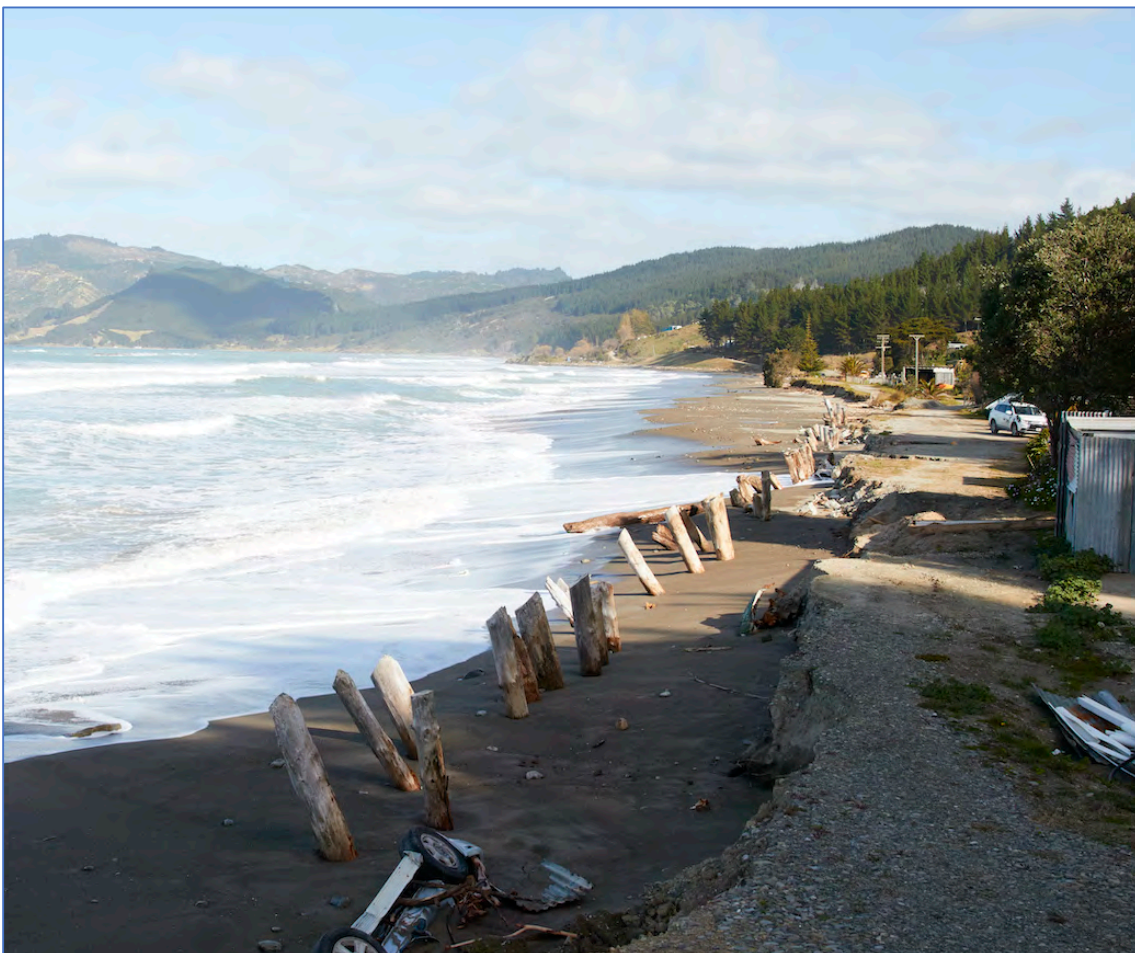
Figure Sixty Two. The extent of recent coastal erosion at the northern end of McIlroy Road marked by the pine logs that had been pushed into the sand as retaining posts.

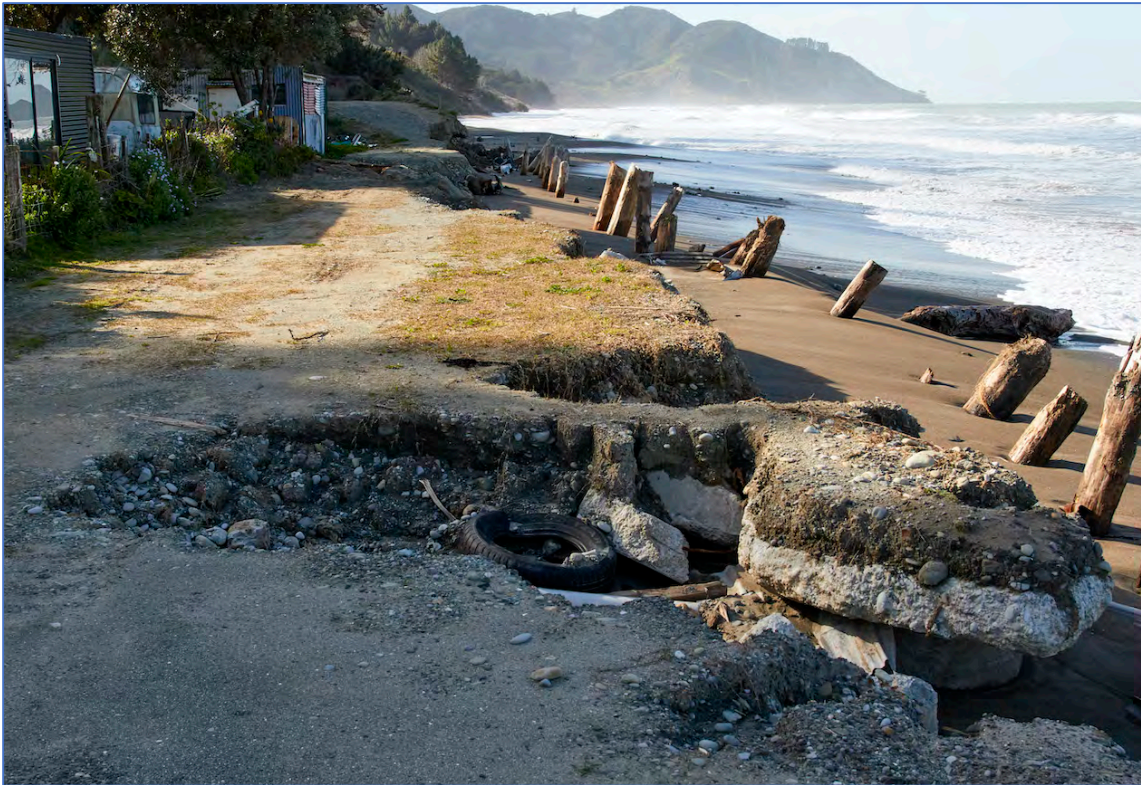
Figure Sixty Three. The extent of scouring and channelling of the road.

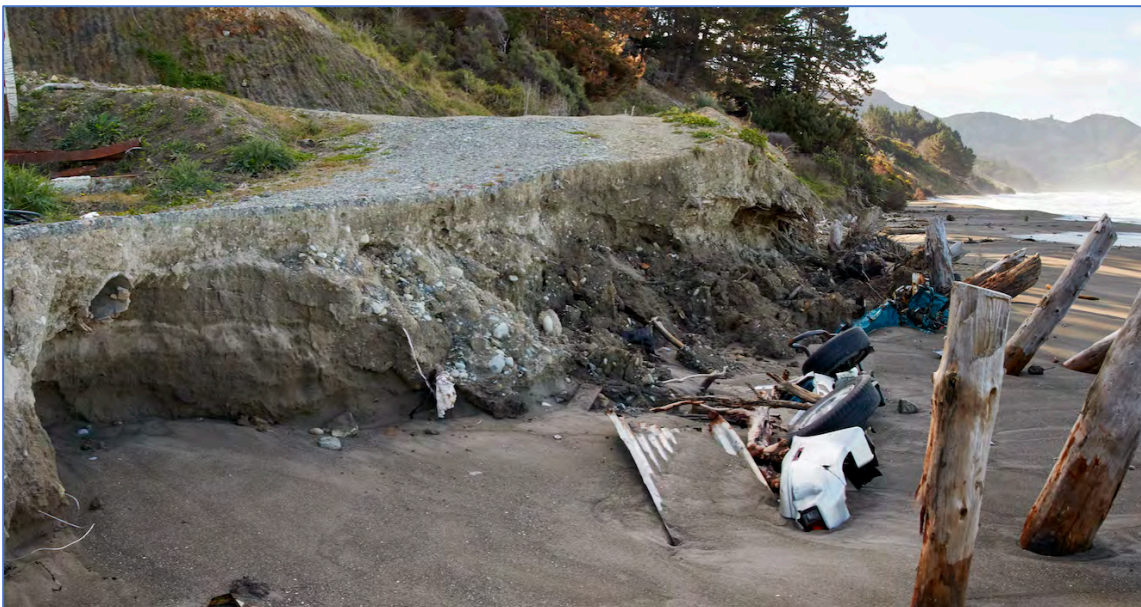
Figure Sixty Four. The road heading up to the last property at the end of McIlroy Road showing the scour and undercutting associated with the broken culvert, the car bodies and other debris used as armoring on the fill making up the access track and the “totem poles” used to buttress the slope. Note the over steepened face and overhangs.

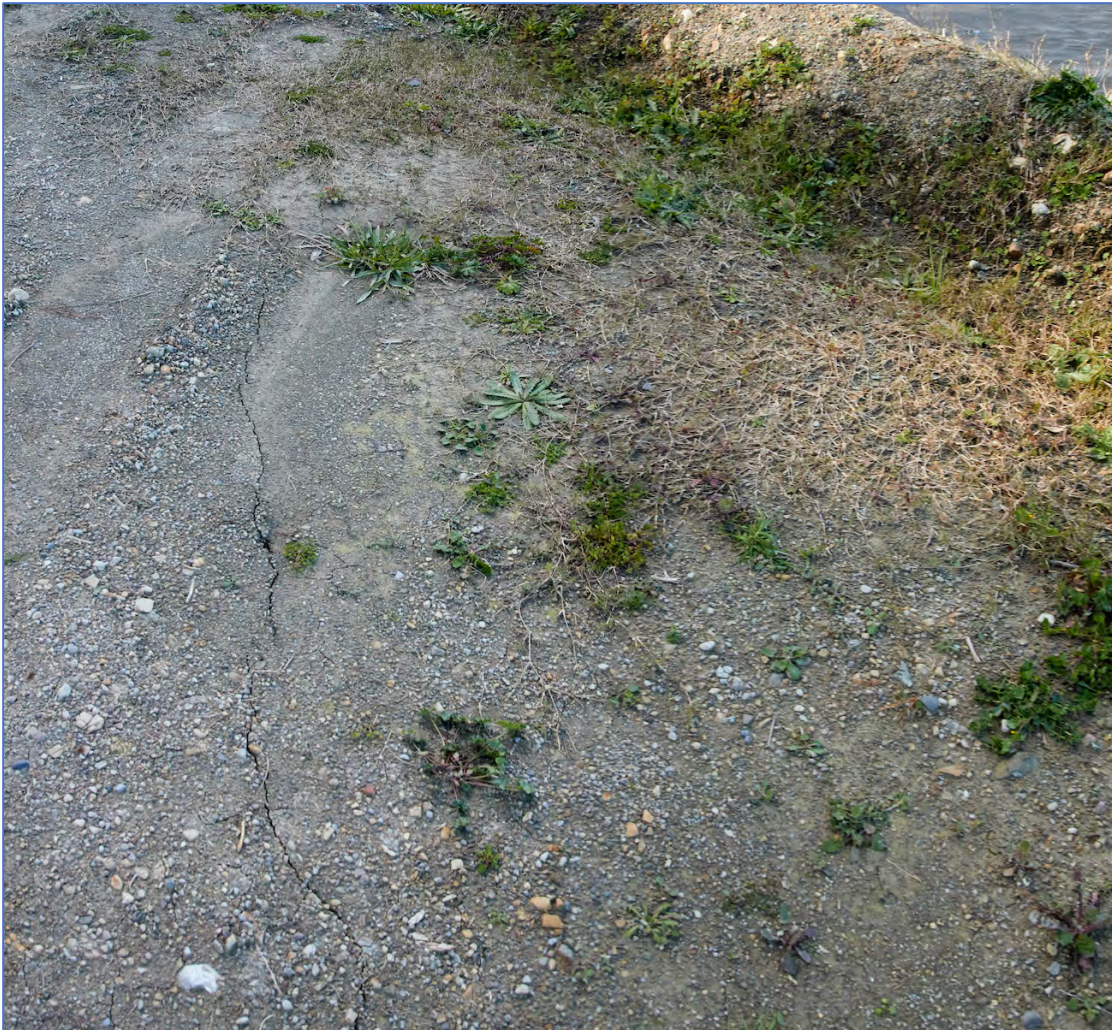
Figure Sixty Five. Tension cracks on the bend in the road leading up to the last house.

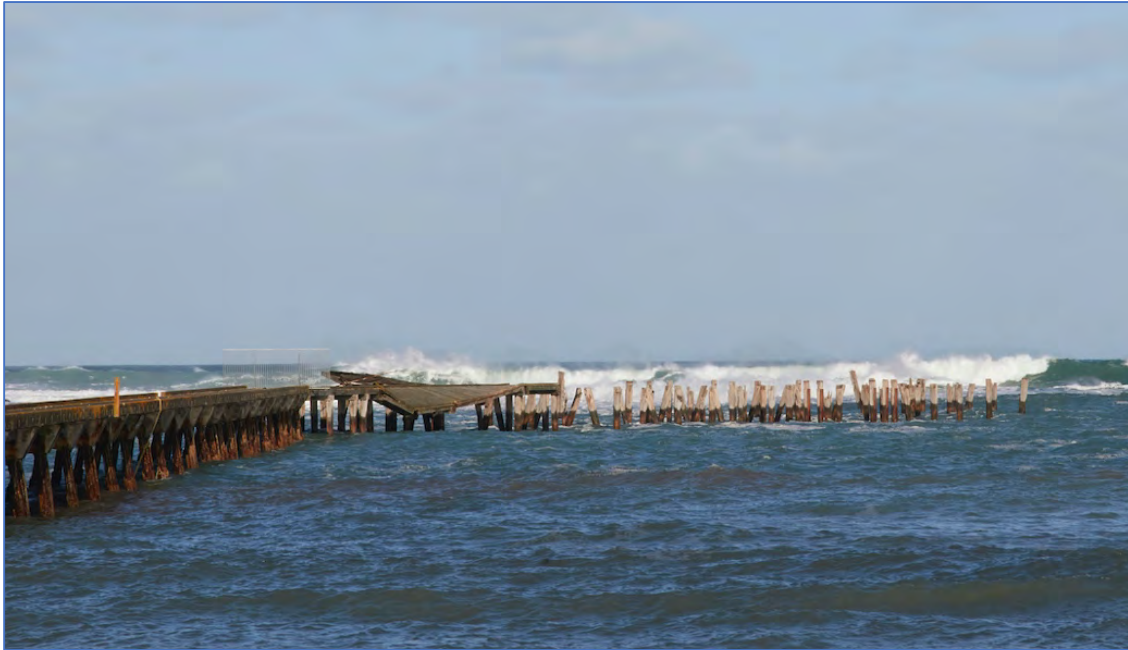
Figure Sixty Six. Additional damage to the Tokomaru Bay wharf as a result of heavy seas

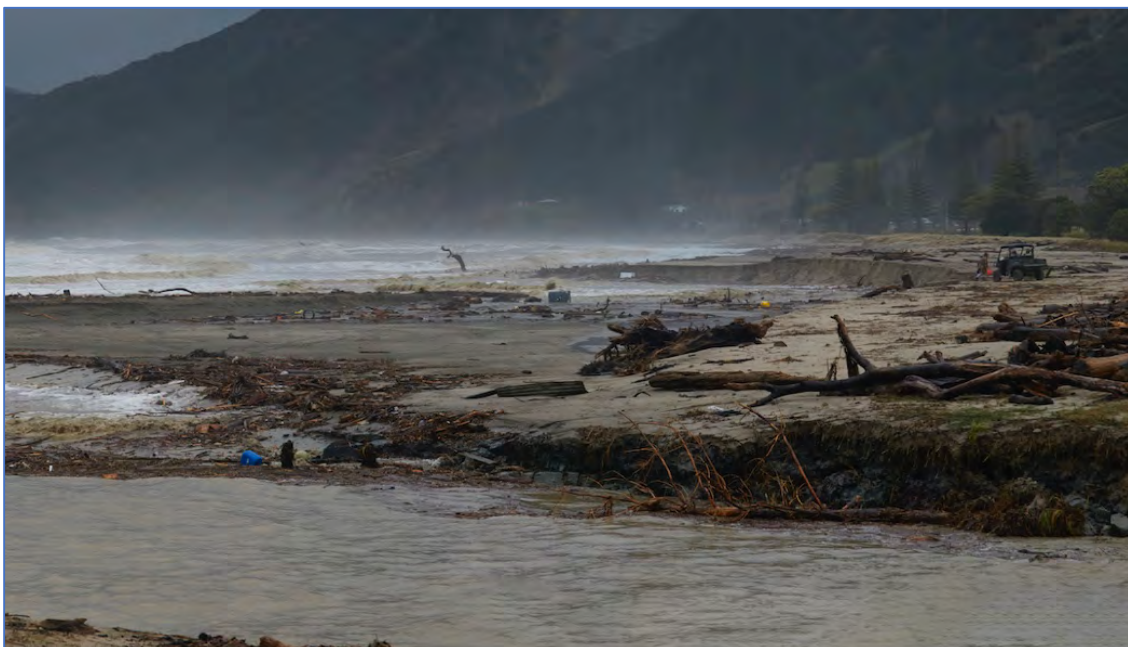
Figure Sixty Seven. Scour erosion of the top of the beach at the mouth of Waiotu Stream, with logs thrown up by the storm surge. Note the significant rubbish washed out by the flood.

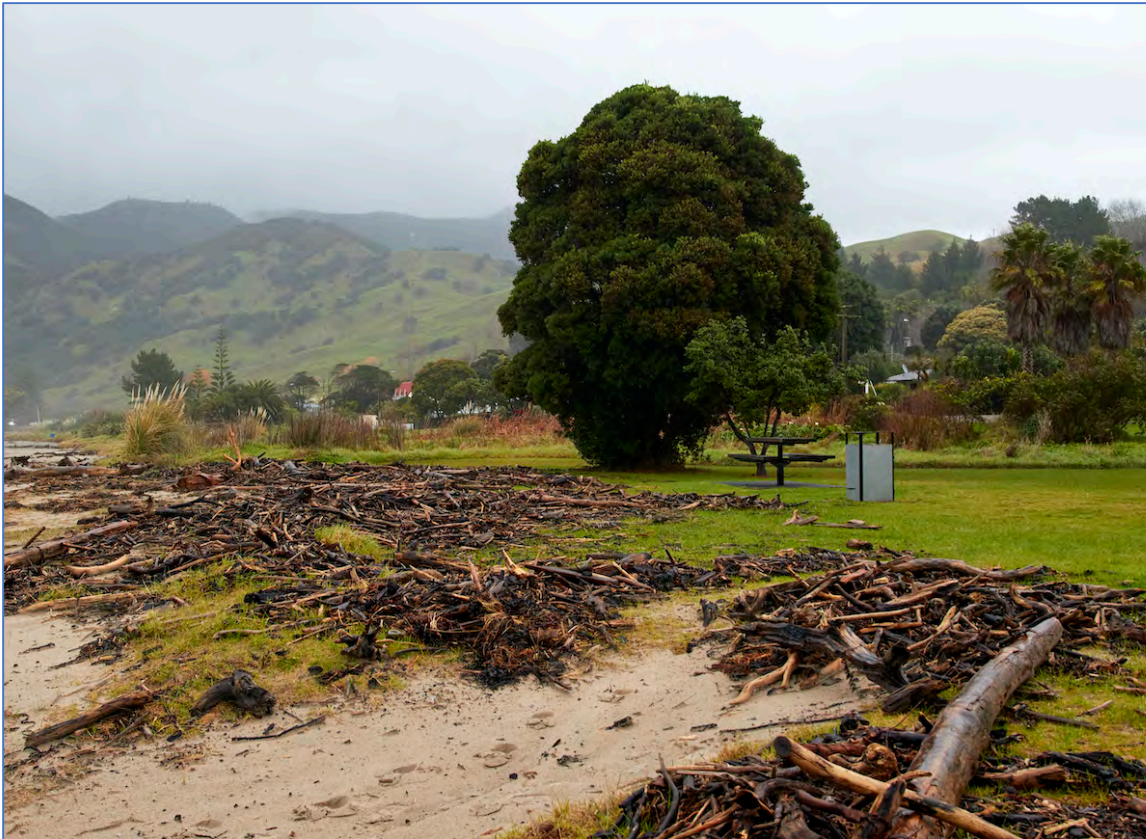
Figure Sixty Eight. A significant amount of woody debris was thrown up on the the reserve south of the Waiotu Stream river mouth.

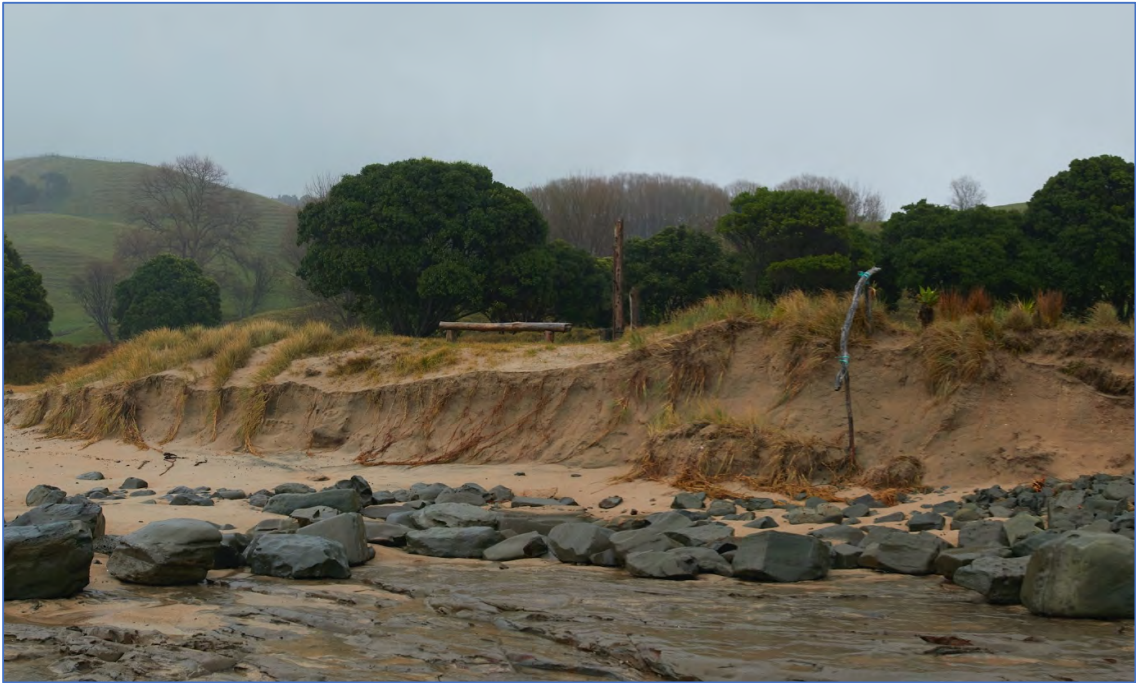
Figure Seventy Two. Photograph showing dune erosion on the beach north of Turihaua Point.

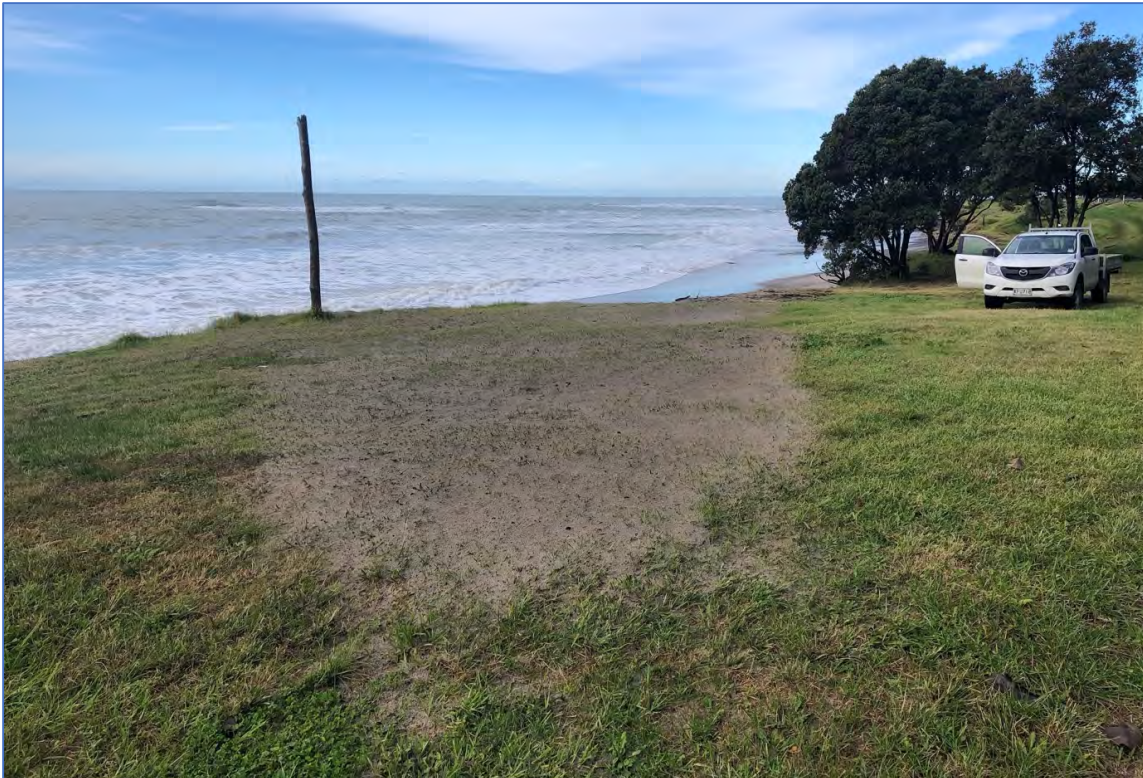
Figure Seventy Three. Photograph showing overtopping and deposition of sand north of Turihaua Point. During the 2020-21 summer, campers occupied this site.

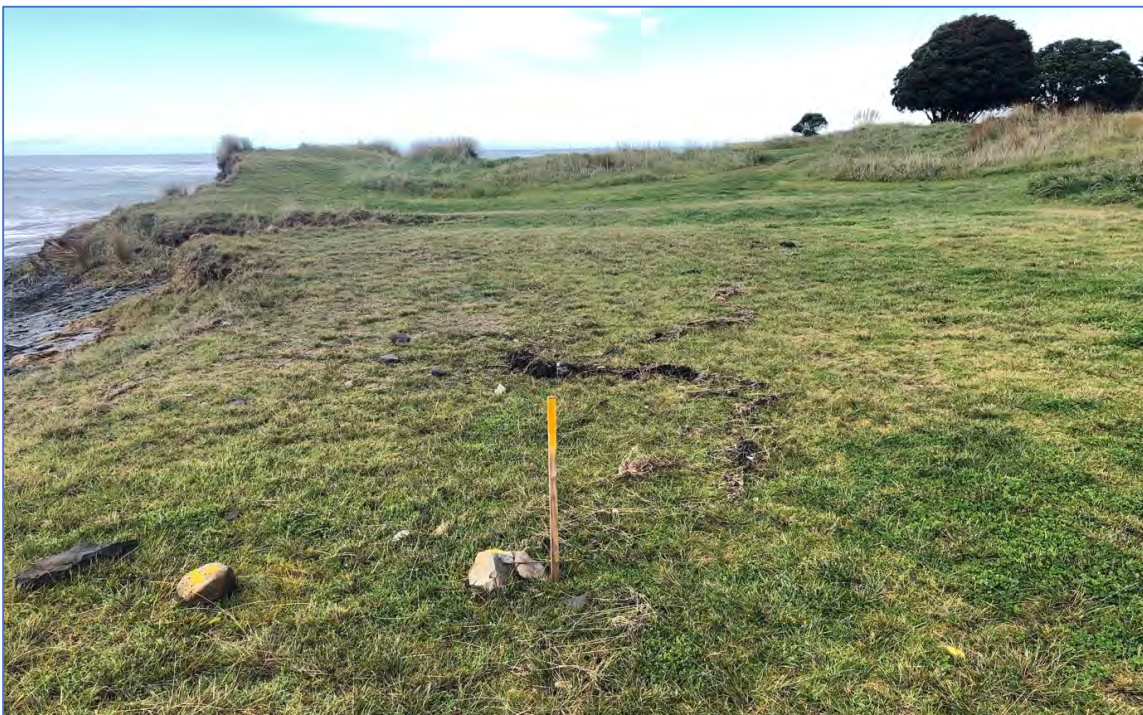
Figure Seventy Four. Photograph showing the debris line for the storm surge in June 2021. Grass beyond the debris line shows signs of salt burn indicating salt water inundation. Note that the large rocks were put there at 1 metre intervals to measure the extent of the surge.

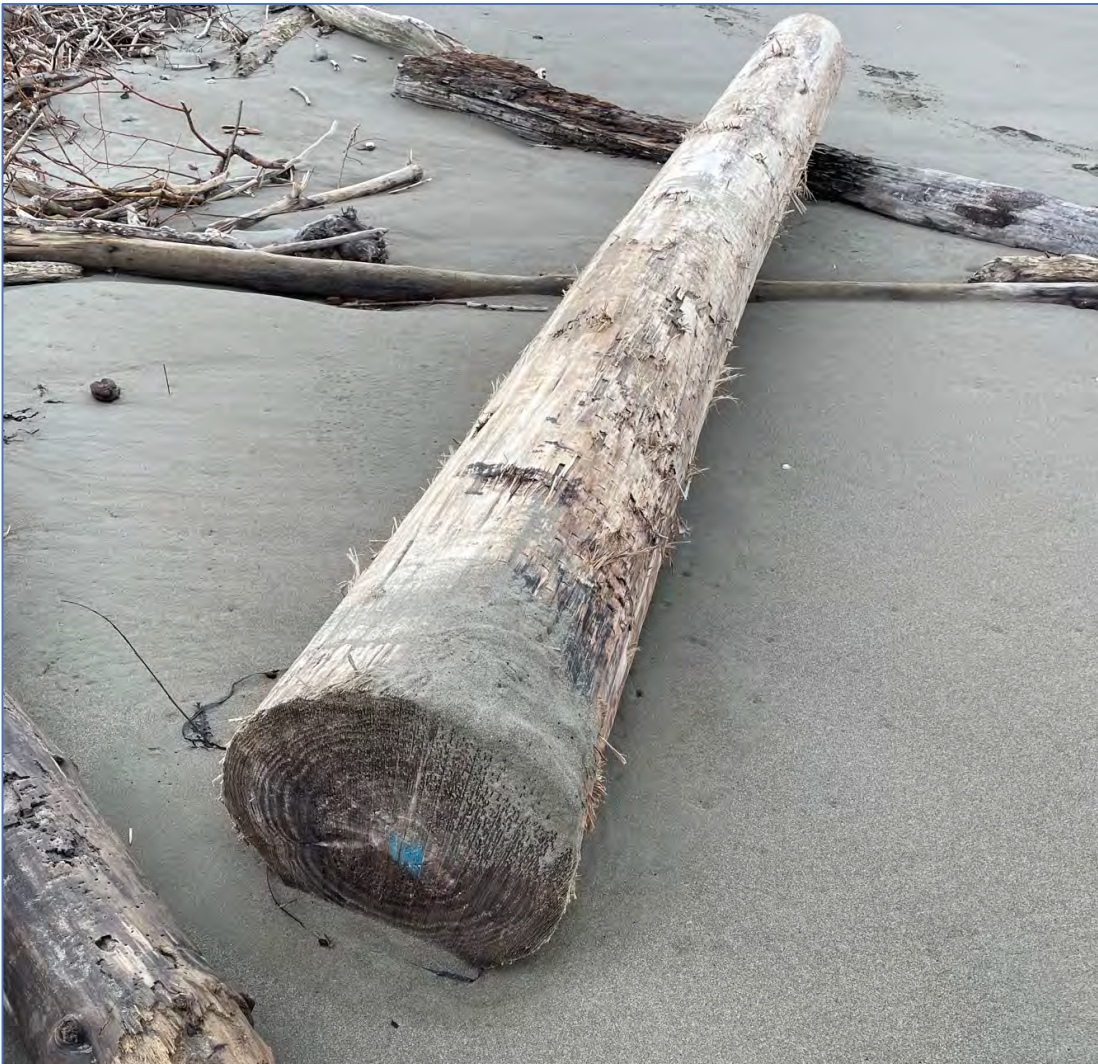
- a. Fresh cut forestry log on north Tolaga Beach. The presence of such a log indicates a failure at a forestry harvest site or landing as such logs would have been stowed ready for transport.
- b. Extensive willow woody debris washed up on Tolaga Bay beach on the 20th of June and was traced back to a recent clearance of willows at Mahanga Stream above where it crosses State Highway Thirty Five. This clearance was substantial and as was observed on the day the woody residues were stored in locations vulnerable to flood.
- c. The culvert of State Highway 35 immediately north of Tokomaru Bay was known to be blocked before the event and Waka Kotahi had planned to clear the blockage but this was not completed before the weather event. The scale of the event was such that the culvert would most likely have blocked in any event.

Figure Seventy Five. A fresh pine log on north Tolaga Bay Beach 20th June 2021.
