Estimates of Log Volumes on Tolaga, Kaiaua and Anaura Beaches

Summary

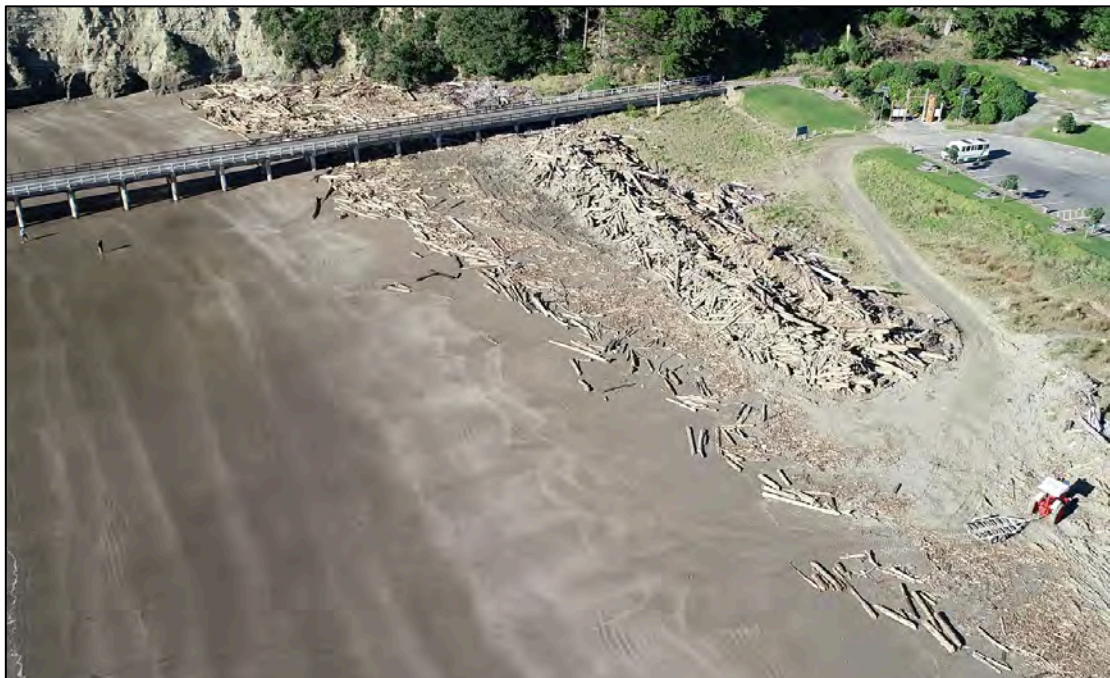
Figure One. Drone image of the south end of south Tolaga Beach showing the logs caught up south of the wharf, pile # 28, and the scatter logs introduced to the beach after the construction of the piles.

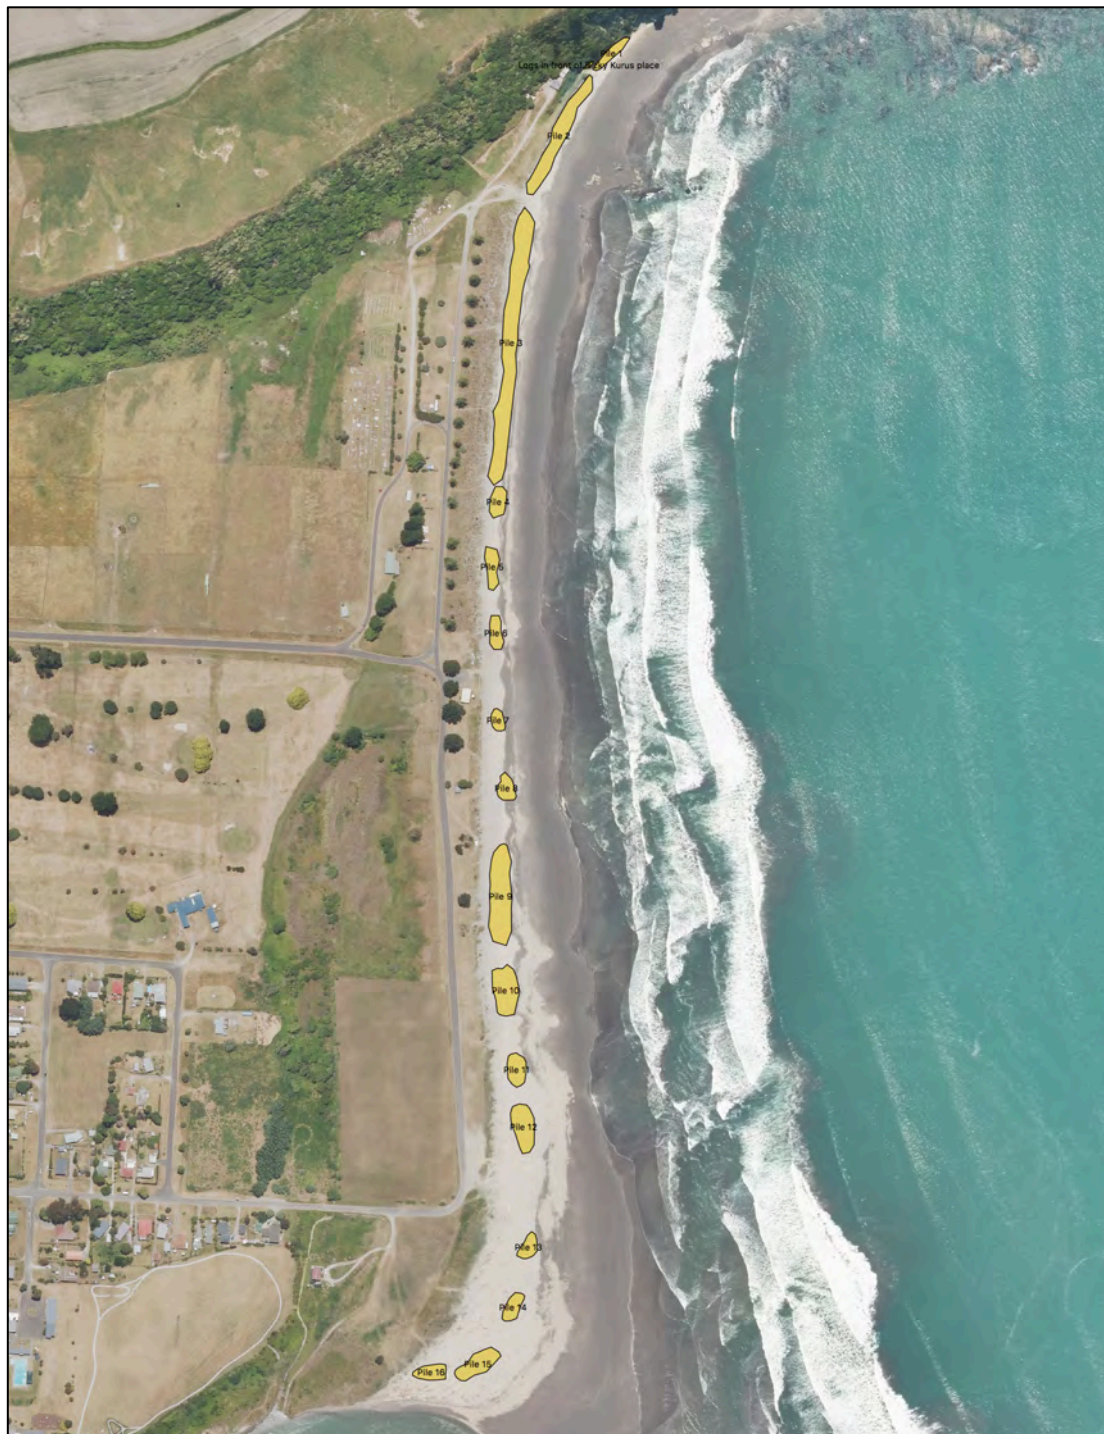
Figure Two. Orthomosaic image of North Tolaga Beach showing the plotted location of the log piles.

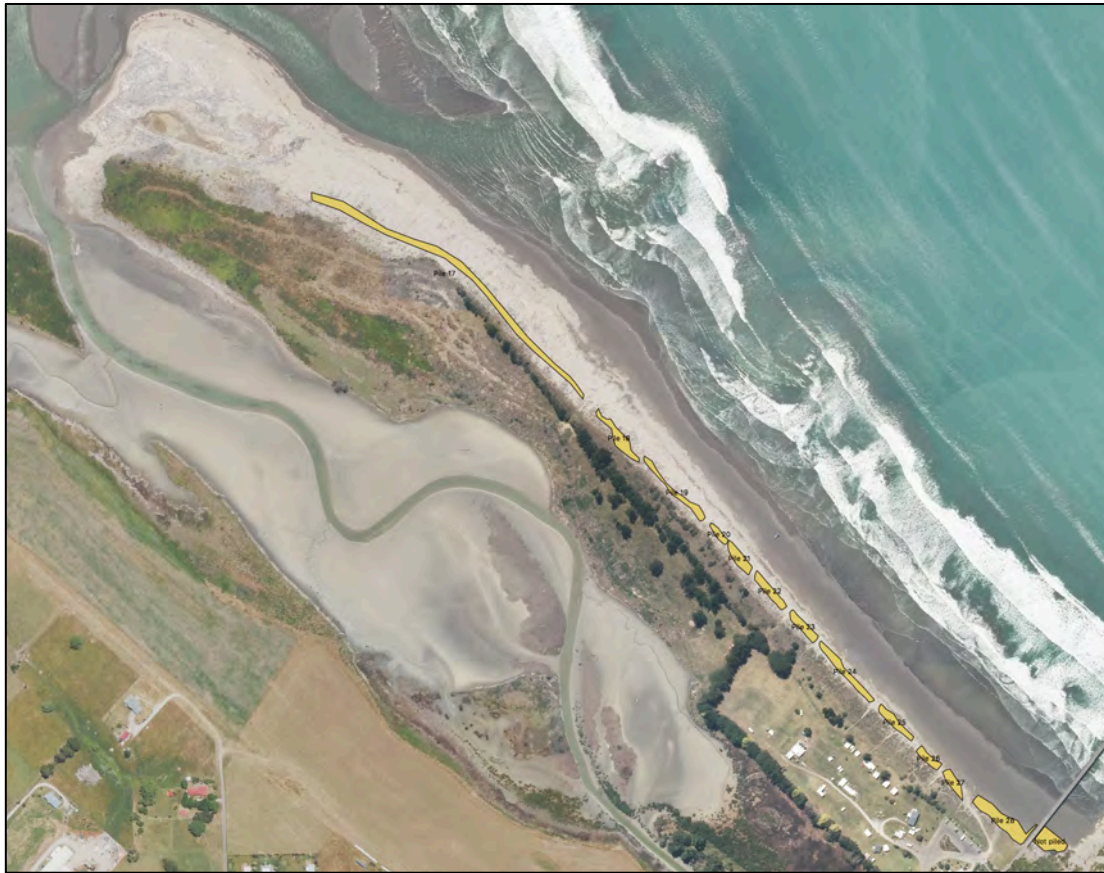
Figure Three. Orthomosaic image of South Tolaga Beach showing the plotted location of the log piles.

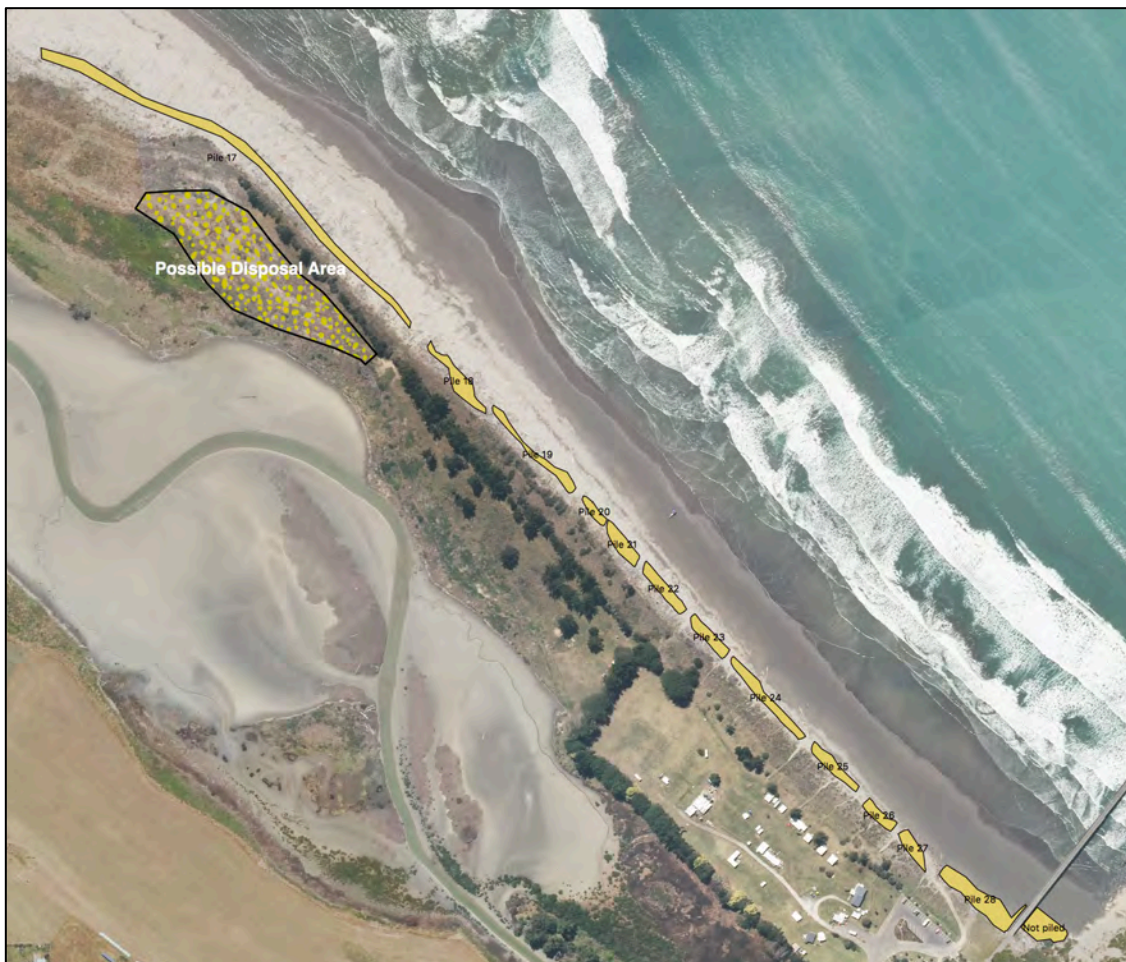
Figure Eight. Possible disposal area south Tolaga.

No solution is perfect, however, the most pragmatic solution for south Tolaga beach would be to relocate the debris to unused ground between the camping ground and the spit (**Figure Eight**). This land belongs to the proprietors of Huaiti Incorporation and full engagement with the incorporation and local iwi would be necessary. Burial or partial burial in this area would need to be carefully considered. Although this would reduce fire risk, contamination of ground water and other impacts would need to be risk assessed. Spreading the logs over the disposal area would reduce the visual impact and would also partially reduce the risk of fire compared with constructing a large pile since there would be a great volume in contact with the ground. Options for accelerated decomposition by compaction could be considered.

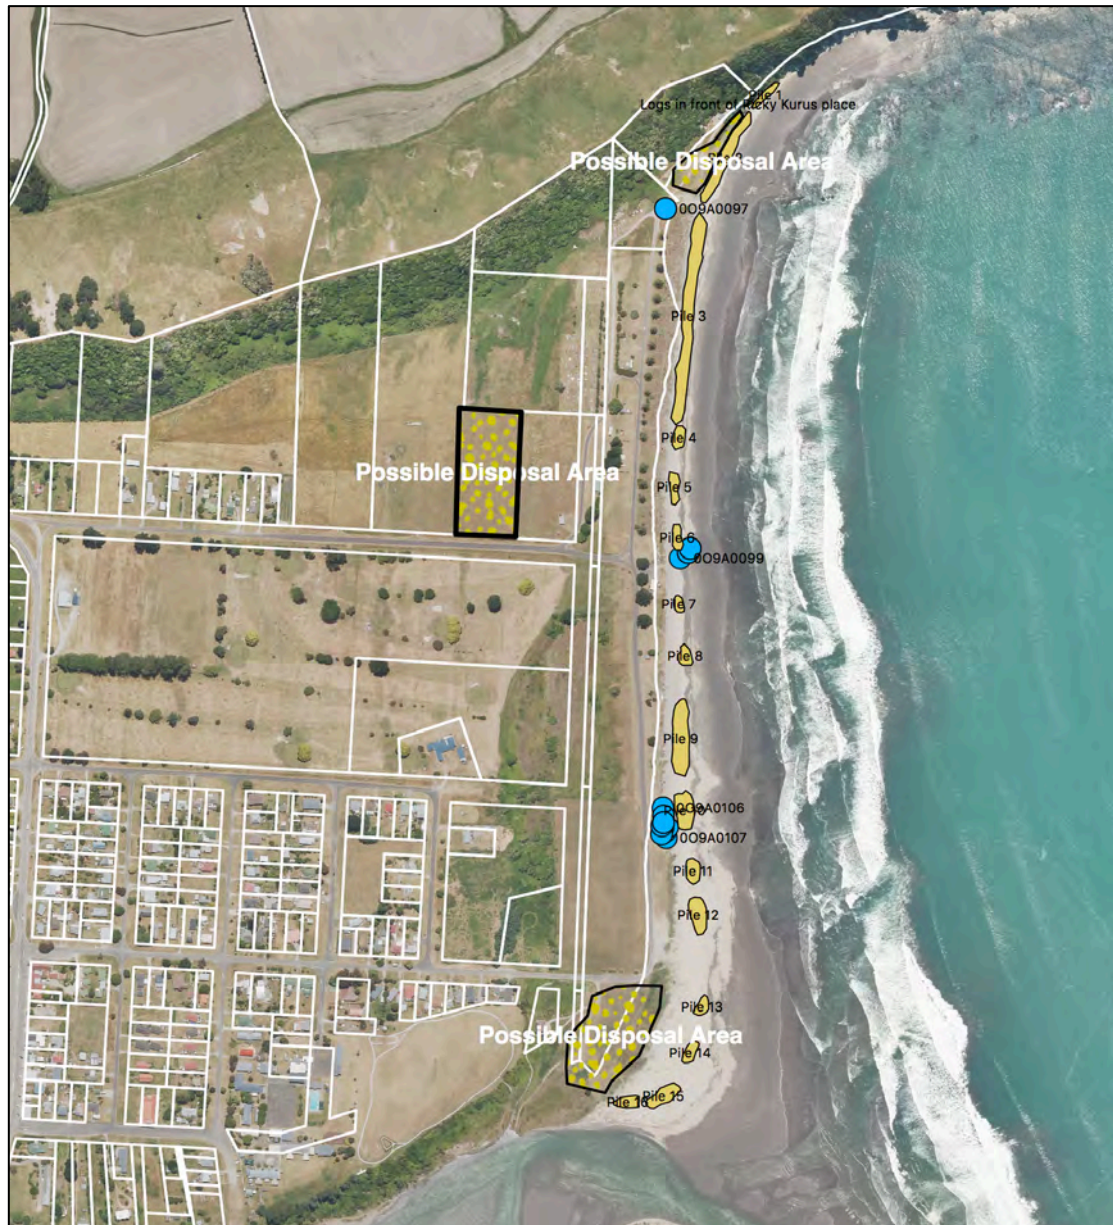
Figure Nine. Possible short to medium term disposal sites, north Tolaga.

A short term solution would be to relocate the logging debris to GDC reserve land at either end of the north Tolaga Beach (**Figure Nine**).

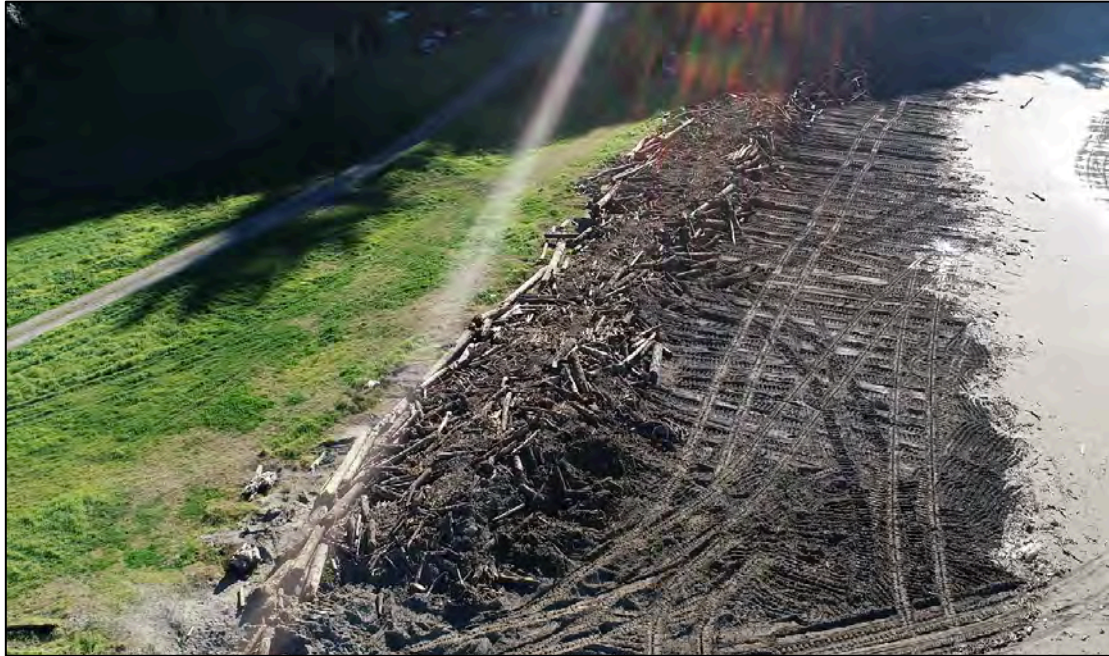
Figure Ten. GDC reserve land north end of Tolaga beach. This area may be large enough to hold the debris from Sites One to Three if the material is compacted and this site may be suitable for burial of material with soil placed over the top to mimic a dune form. Part of this land is presently informally occupied.

At the north end of the beach, this reserve land is presently informally occupied (**Figure Ten**) while in the south there would be a greater visual impact than would be the case for the south Tolaga. Another option would be to lease land at the northern end but this would ultimately necessitate double handling. As is the case for south Tolaga, burial in this area would need to be carefully considered. Although this would reduce fire risk, contamination of ground water and other impacts would need to be risk assessed. Spreading

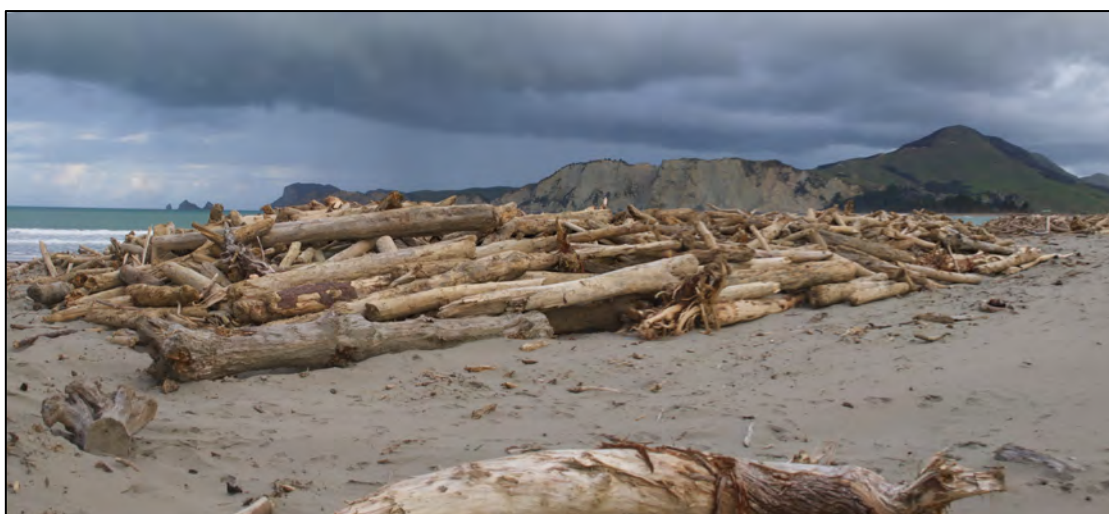
Figure Eleven. Clean logs on the landward side of Pile Site Six.

Other options at the north end of Tolaga Bay are more limited. Pile site Six may be a good candidate for an assessment of mulching options as it has a reasonable number of clean logs on the landward side (**Figure Eleven**).

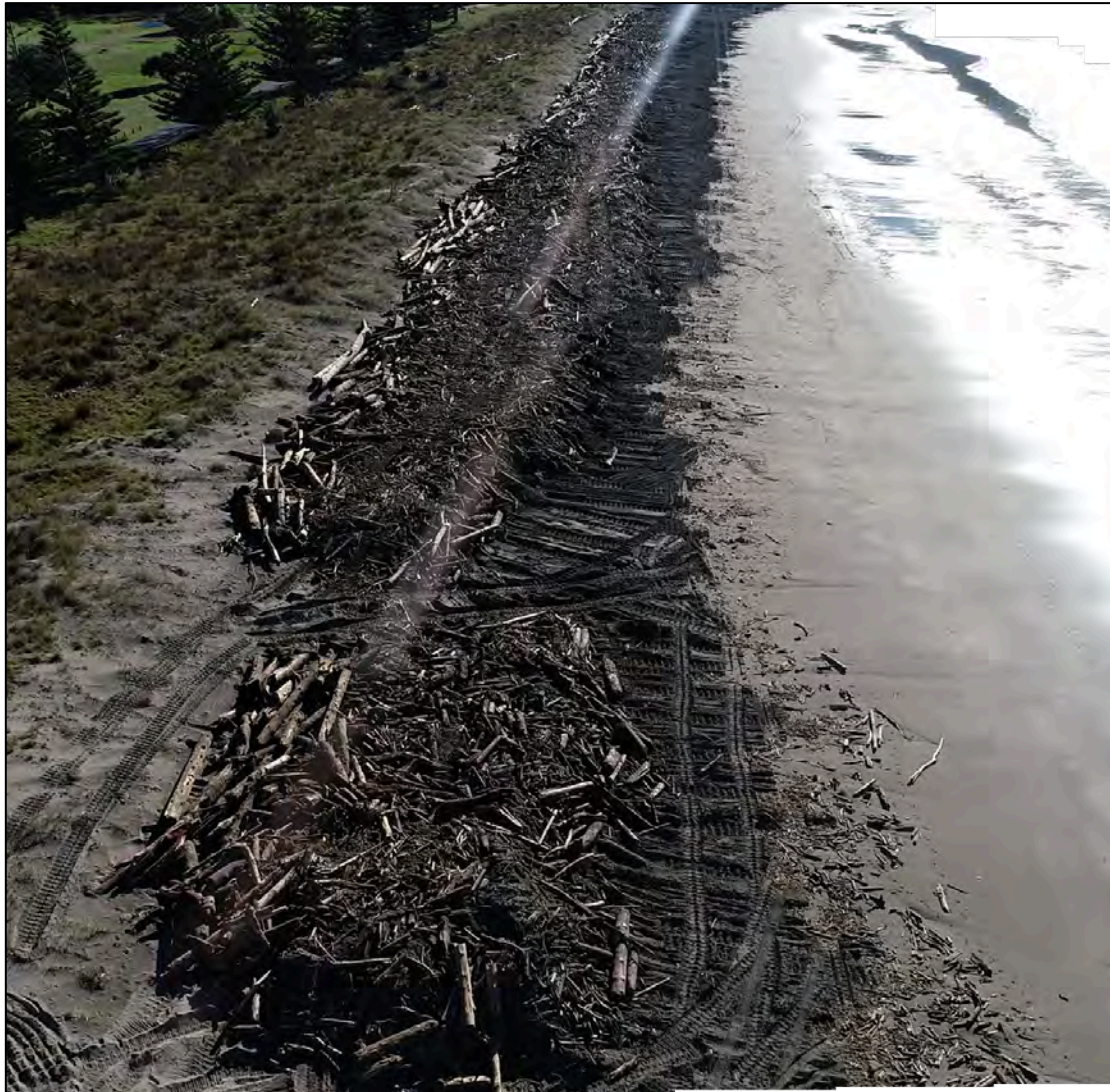
Figure Twelve. Linear log pile north of the BP Surf Rescue Building. While the pile looks large, there is a lot of sand mixed in due to a bulldozer being used to construct the pile and volumes would reduce if much of the large logs were pulled using a small bucket and thumb.

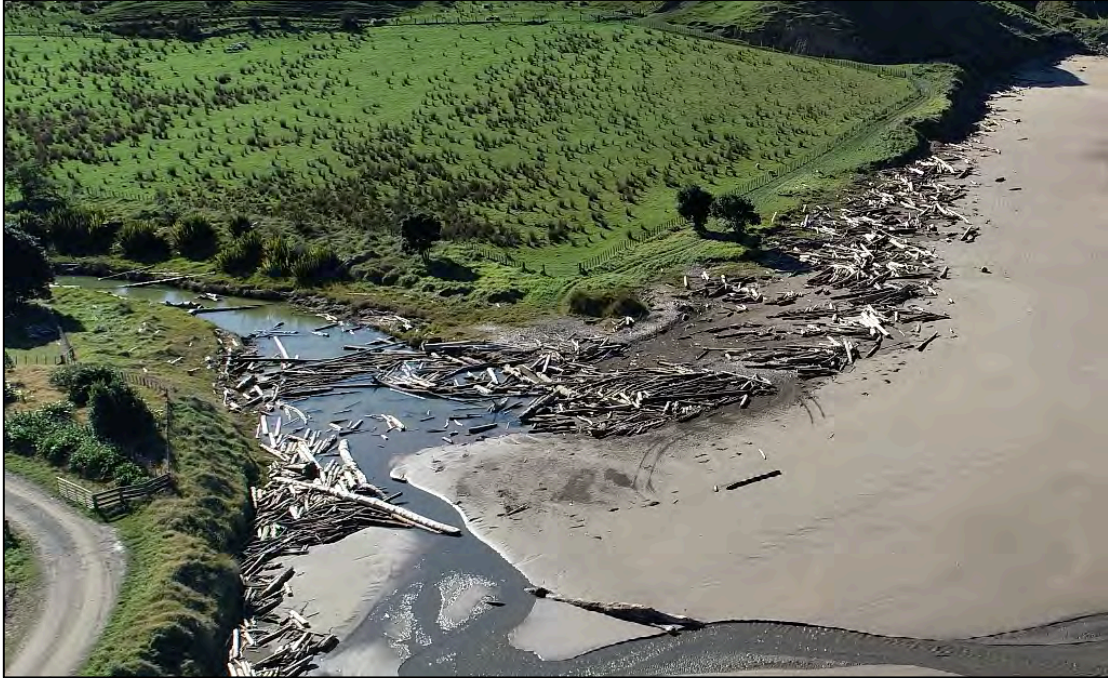
Figure Fourteen. Creek at Northern end of Kaiaua showing the logs concentrated in the creek mouth and to the north.

It is envisaged that a digger with a small bucket and thumb loading to a tractor with a large caged trailer would be able to move the material to an adjacent rough paddock for burial within ½ to 1 day. There is poor access to the beach just south of the creek but a better option would be via the farm and the north side of the creek. Access to the paddock for burial would, of course, need to be negotiated.

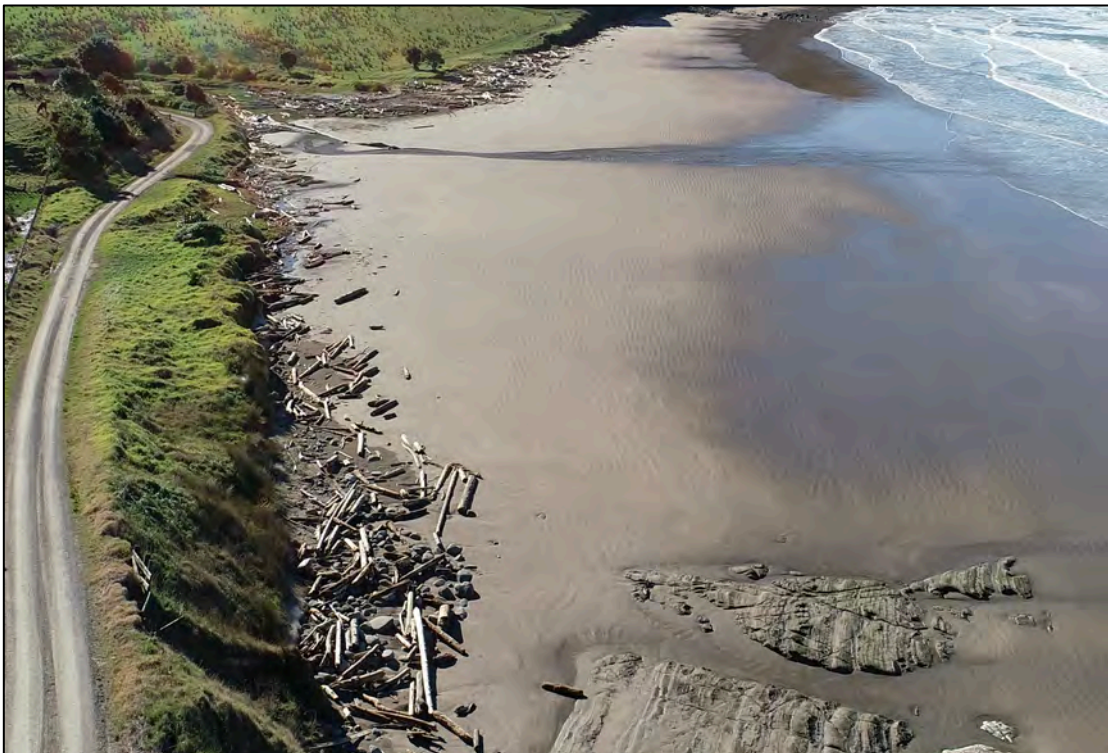
Figure Fifteen. Logs concentrated between headland and northern creek.

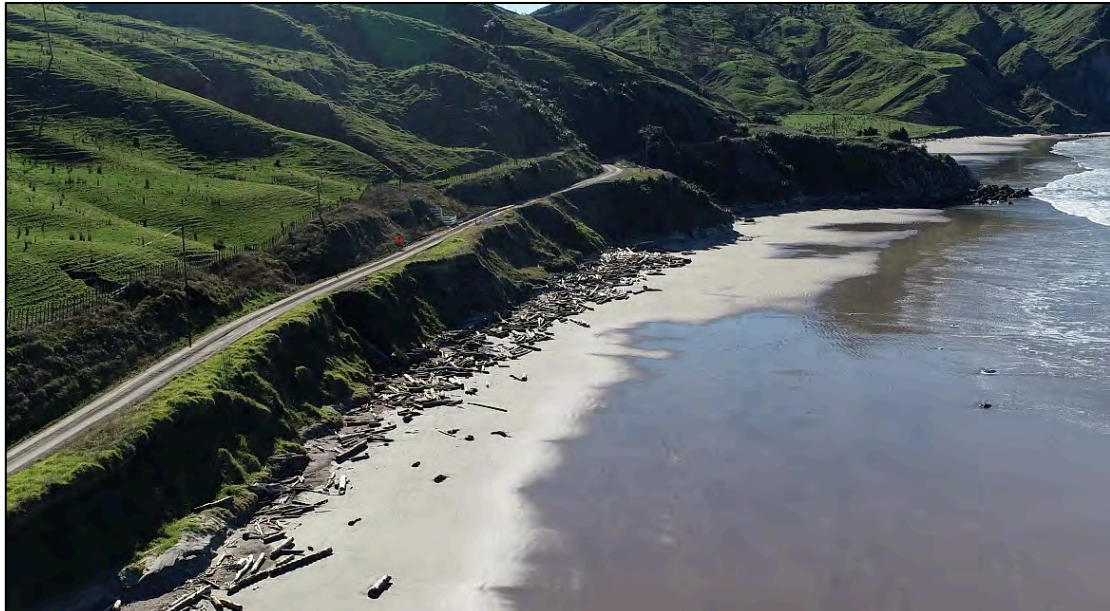
South of the headland noted in **Figure Fifteen** logs are again concentrated immediately before the headland but there are still significant numbers of logs scattered along the beach south of the headland (**Figure Sixteen**).

Figure Sixteen. A concentration of logs against the headland and scattered to the south.

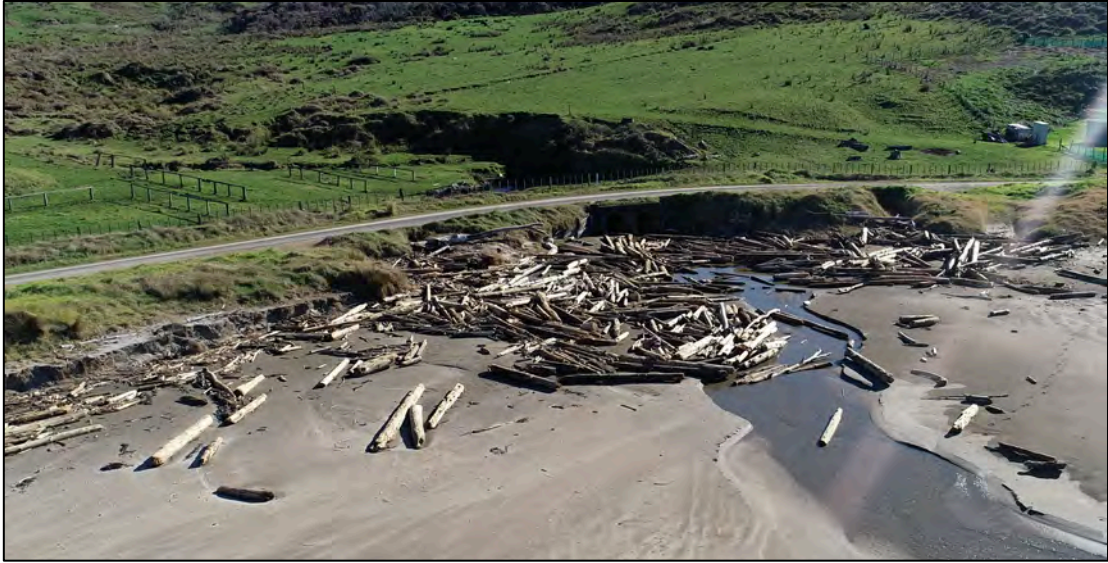
Figure Seventeen. Logs deposited at the creek mouth, middle Kaiaua beach.

There is another creek positioned in the middle of the bay (see **Figure Thirteen**) that also contains a significant volume of logs (**Figure Seventeen**). As was the case for the northern end, a digger with a small bucket and thumb loading to a tractor with a large caged trailer would be able to move the material to an adjacent rough paddock for burial within ½ to 1 day. Access to this site is good.

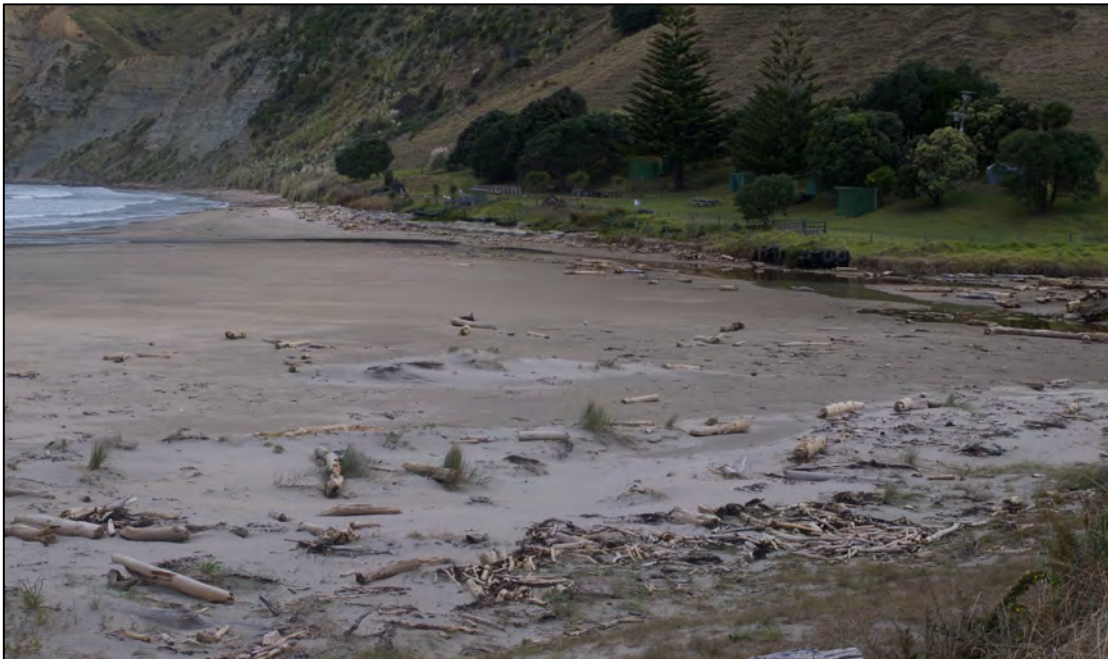
South of the access road to Kaiaua Beach there is a small concentration of logs (**Figure Eighteen**) and a similar number of logs accumulated against the banks from where the road meets the beach and the creek at the middle part of the beach (**Figure Nineteen**).

Figure Eighteen. *View looking south from the bend in the road immediately before it heads inland showing logs concentrated in an area south of the creek. Some logs are also concentrated at the creek itself but not as much as the middle and north parts of the beach.*

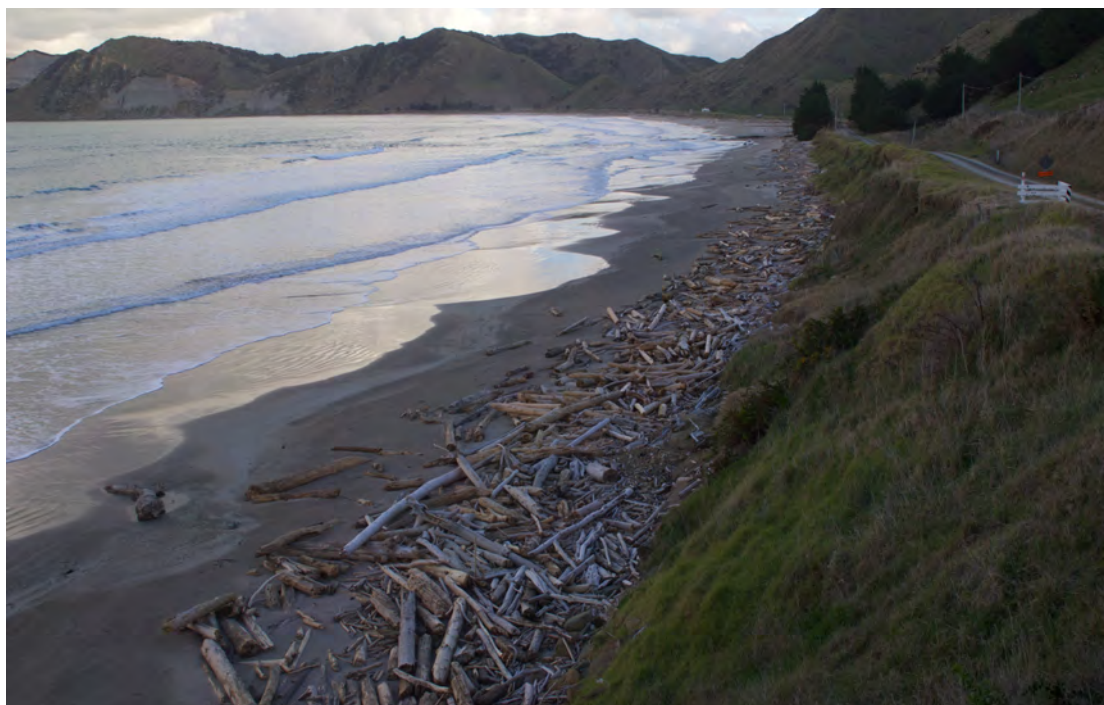
Figure Nineteen. Logs between the middle part of Kaiaua Beach and the southern creek.

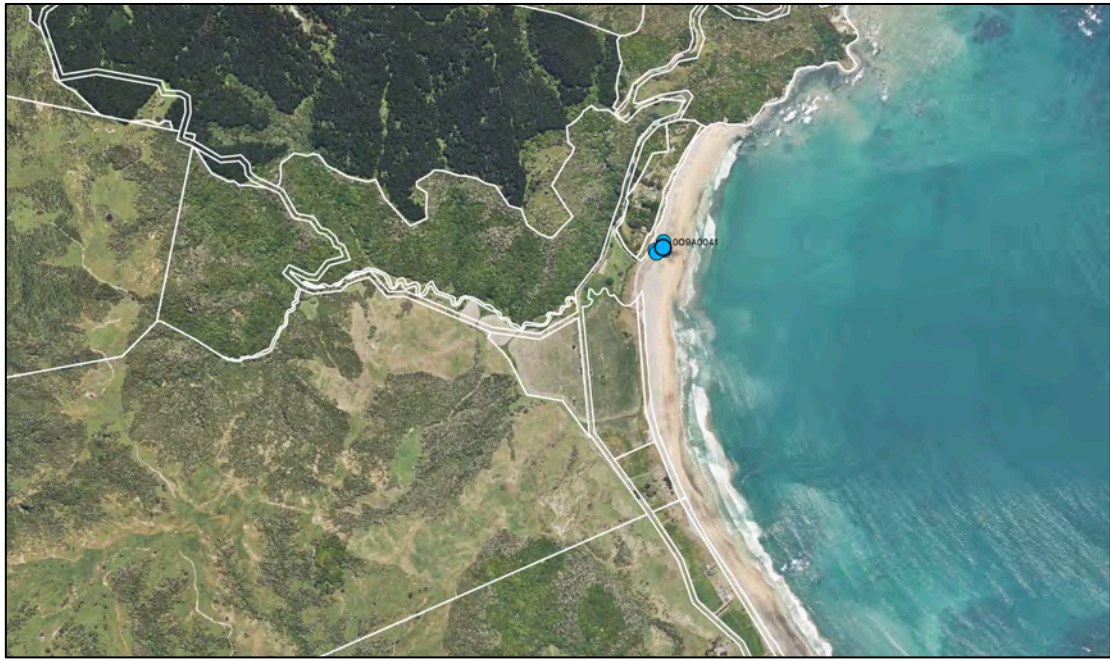
Anaura Beach was also assessed by a drone overflight and an on the ground inspection (**Figure Twenty**). The amount of debris on this beach is not significant and ordinarily there would be little justification to undertake a clean up of the logs. Only one obvious very short fresh cut pine log was noted (**Figure Twenty One**). In addition, the character of the material differs from Tolaga and Kaiaua with a general absence of large logs and those logs present being small long resident logs possibly from prior events (**Figures Twenty Two and Twenty Three**).

Figure Twenty. *Orthomosaic of Anaura Bay showing location of logging debris.*

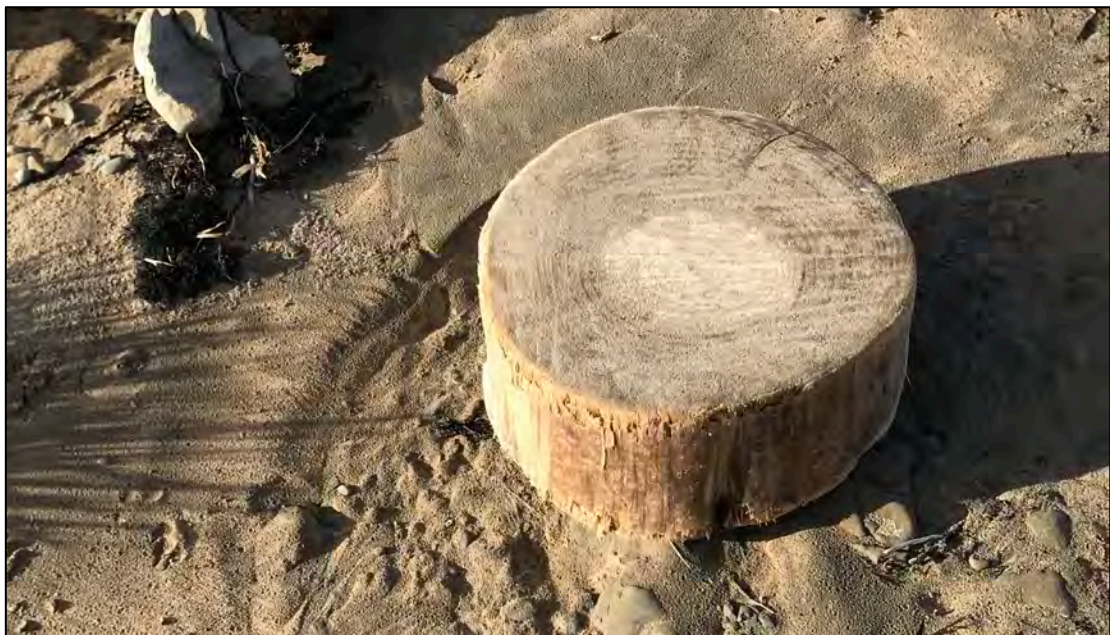
Figure Twenty One. *Short fresh cut pine butt.*

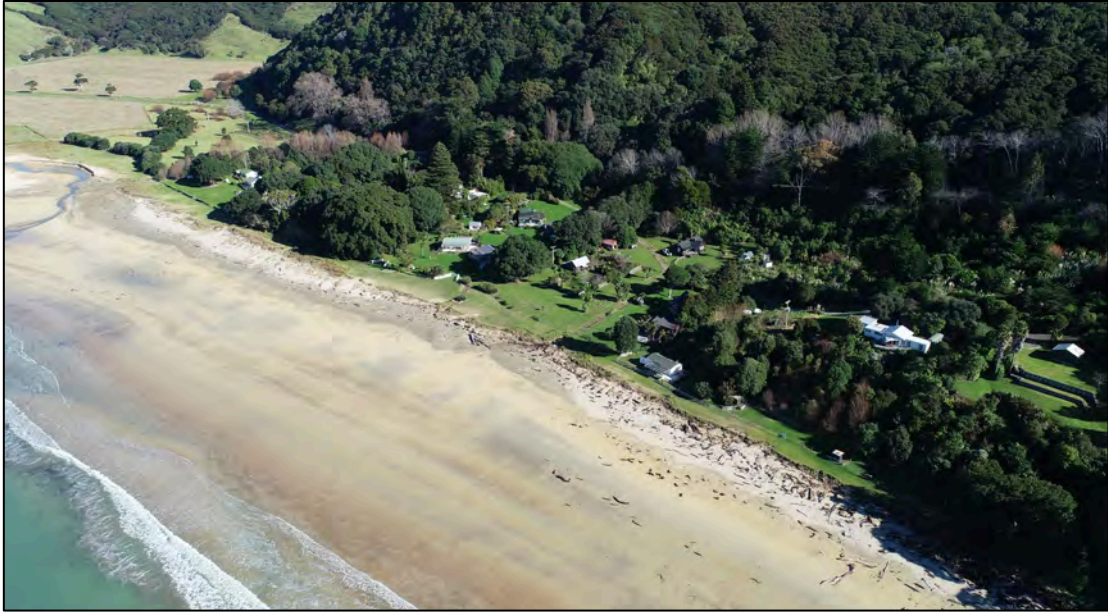
Figure Twenty Two. North end of Anaura Bay showing a small amount of scattered woody debris.

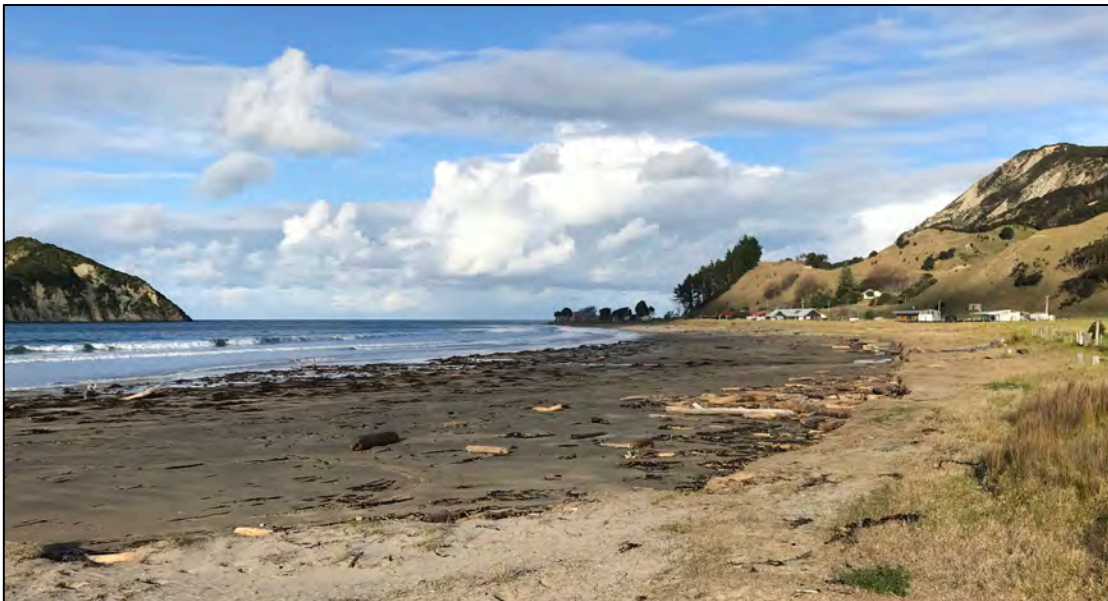
Figure Twenty Three. South end of Anaura Bay showing a small amount of scattered woody debris.
