Post Restorative Justice Conference Assessment Gough property, Paroa Road

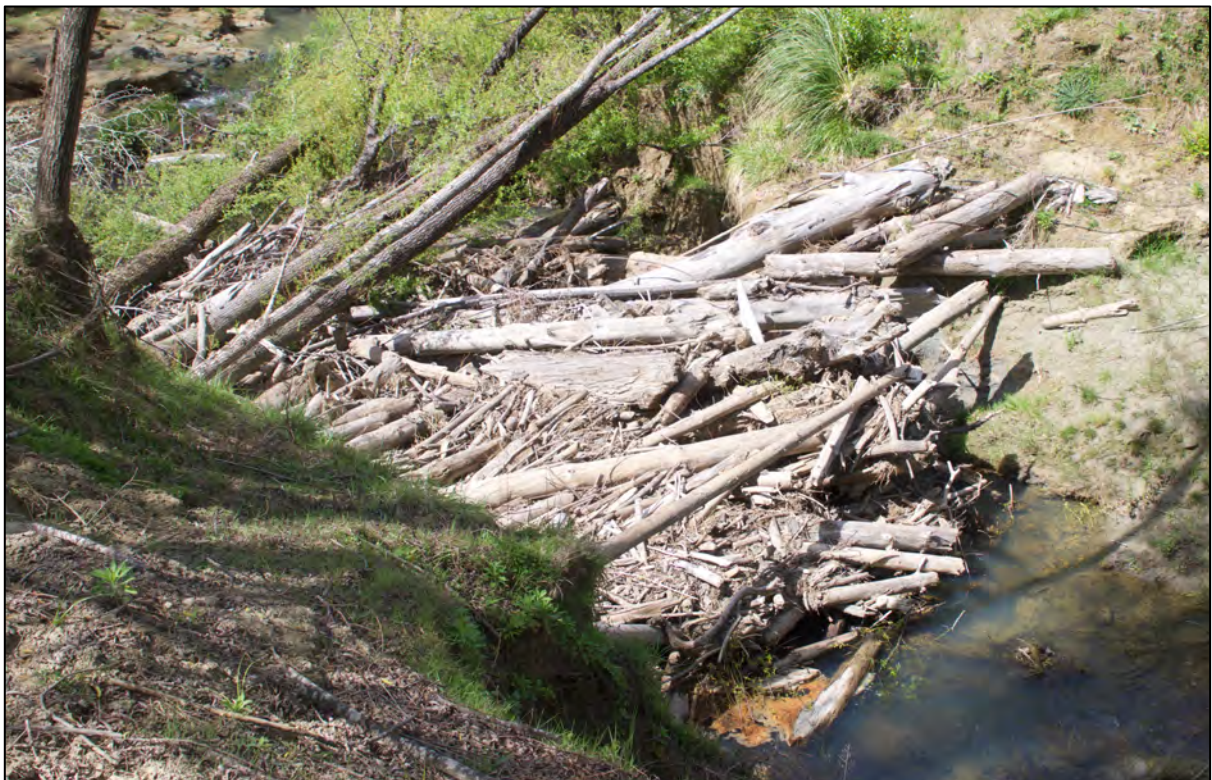
1. More information was required with respect to property boundaries to ensure that the erosion observed was occurring on the Gough property rather than an adjacent landowner,
2. The logjam primarily comprised pine logs and slash and the resulting erosion had caused some willows to fail *in situ* (**Figure Two**).
2. Further assessment was required to see whether or not it would be possible to use a digger to extract the logjam due to the incised nature of the river and also to determine an entry point for a digger,
3. The erosion is real (**Figure Three**), and the cause of the scouring was the logjam that arose because of the Queens Birthday storm.
4. Further, if the logjam was not removed that the eroded land protected, the scoured area will grow over time and would materially affect the Gough's property which has only limited flat land.

Figure Two. View of the logjam comprising pine logs and slash, and showing the collapsed willows.

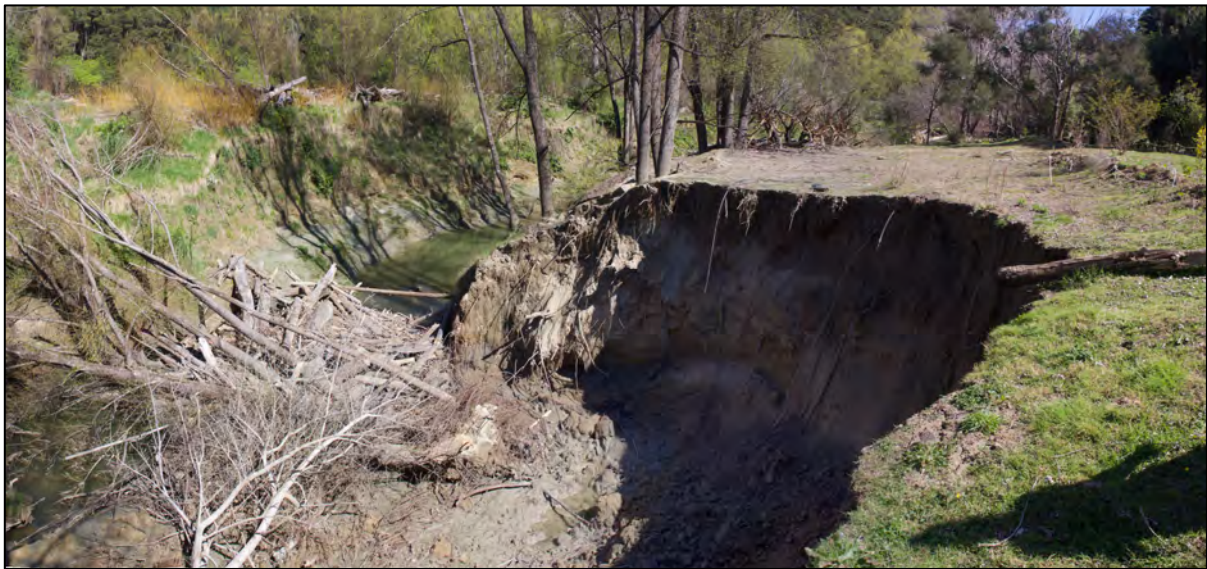
Figure Three. Composite panoramic photograph of the main area of erosion and the log jam on the Gough Property. There is a drop of approximately 3m from the top of the bank to the cut platform below.

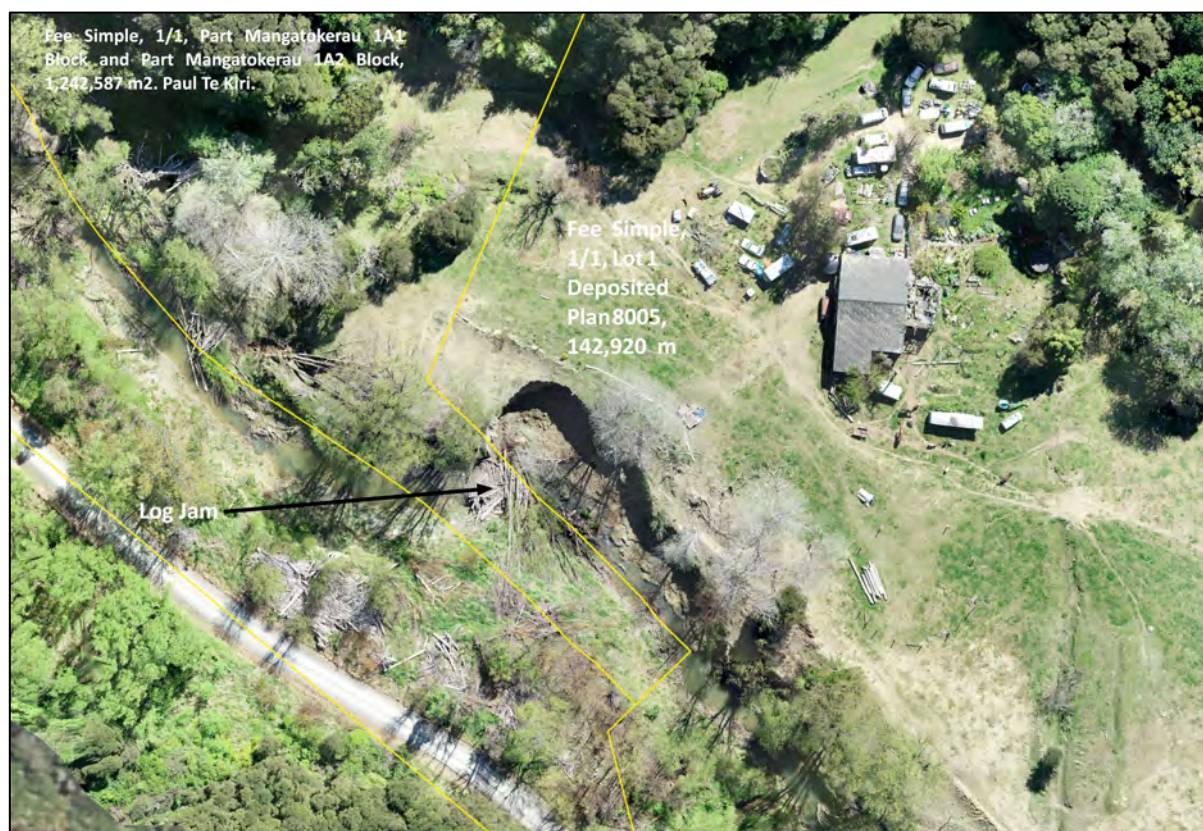
The drone mapping confirmed that the land being eroded downstream of the logjam was the property of Vernon and Linda Gough, and had been initiated at some stage after the January 2018 aerial imagery was acquired. It also established that the logjam itself was situated on the property belonging to Paul Te Kira. Further, the erosion was more extensive than had been identified by the Goughs and extended to close to Paroa Road.

Figure Five. Orthomosaic output showing the property boundaries and the position of the log jam and main area of erosion.

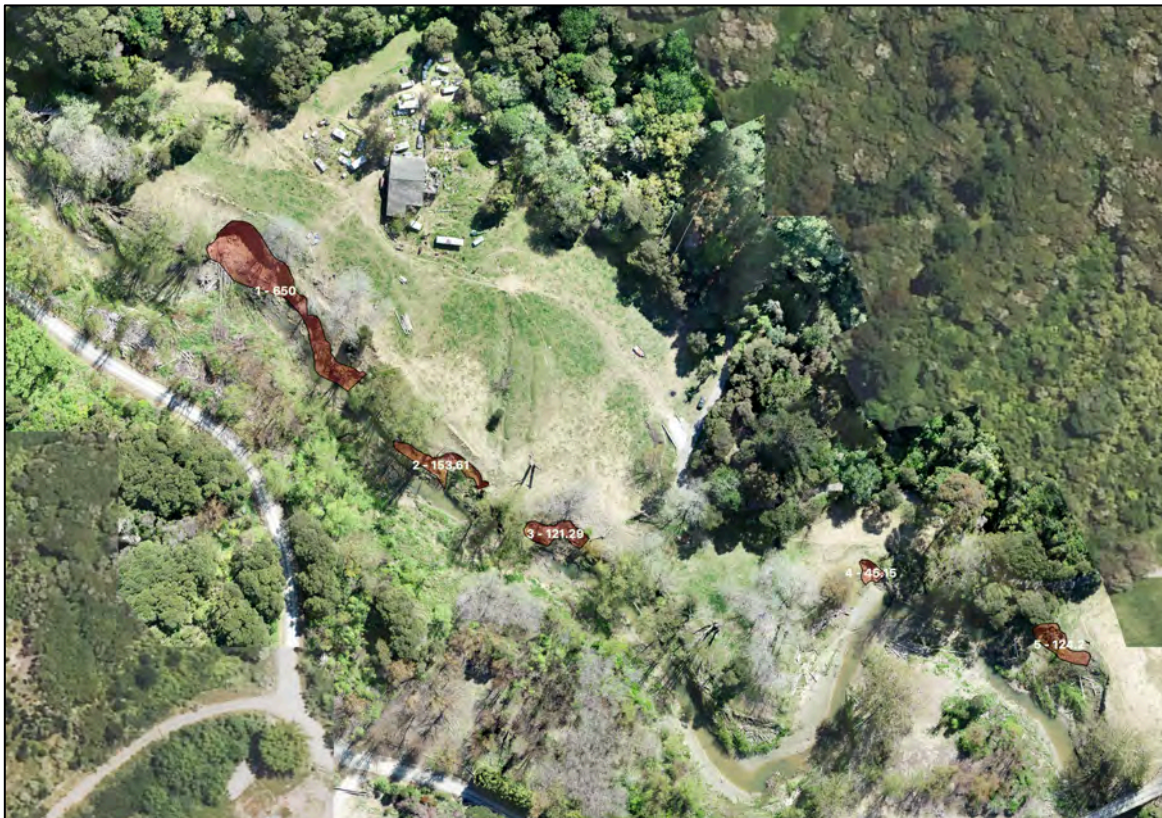
The edge of the banks of the Mangatokerau river based on the January 2018 and September 2019 imagery was then digitised and the areas lost to erosion calculated (**Figure Six and Table One**). This indicates that around 1094 m² have been lost between the two mapped dates.

Figure Six. Orthomosaic output showing the mapped areas of erosion and their areas.

Description	Area
1	Immediately below log jam	650
2	96 m below log jam	153.61
3	150m below log jam	121.29
4	330m below log jam	45.15
5	400m below log jam	124.2
	Total	1094.25

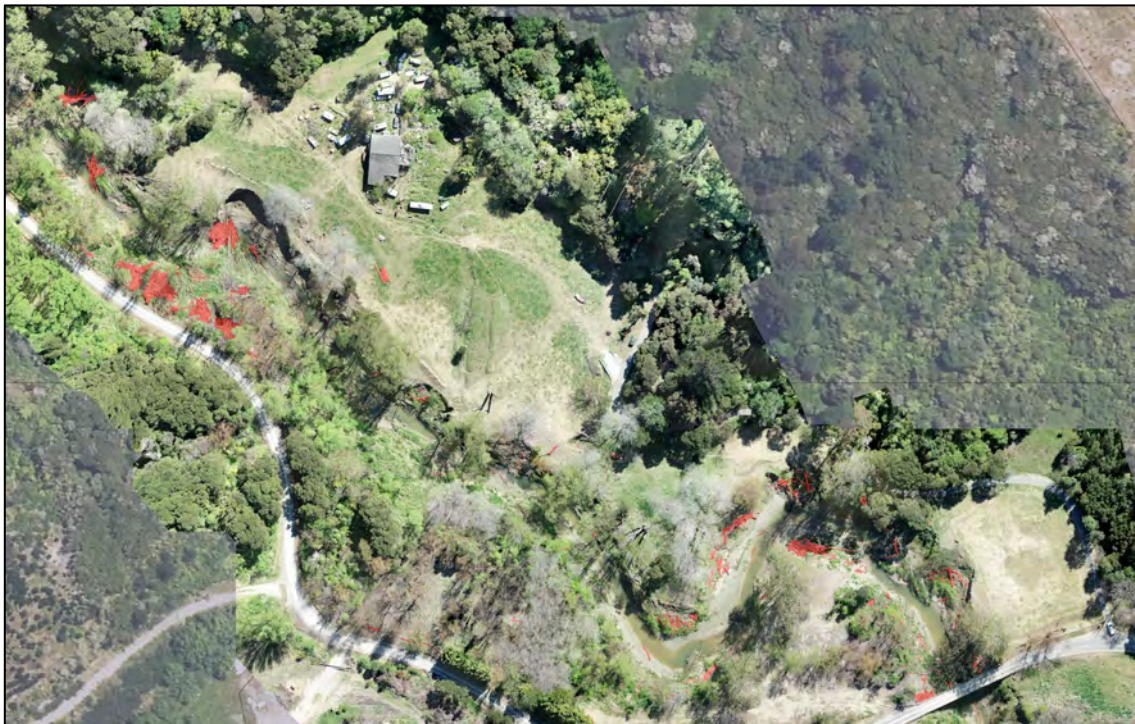
In addition to the identification of five areas of erosion downstream, the drone mapping was also used to map out the areas of forest harvest residues remaining after the Queens Birthdays 2018 storms (**Figure Seven**). This is out of scope of the restorative justice process as it was not raised during the Restorative Justice conference. It was raised as a possible issue by the Aratu Forestry Ltd representative during a site visit (see below) and hence is included here.

Figure Seven. *Distribution of harvest residues, Gough property.*

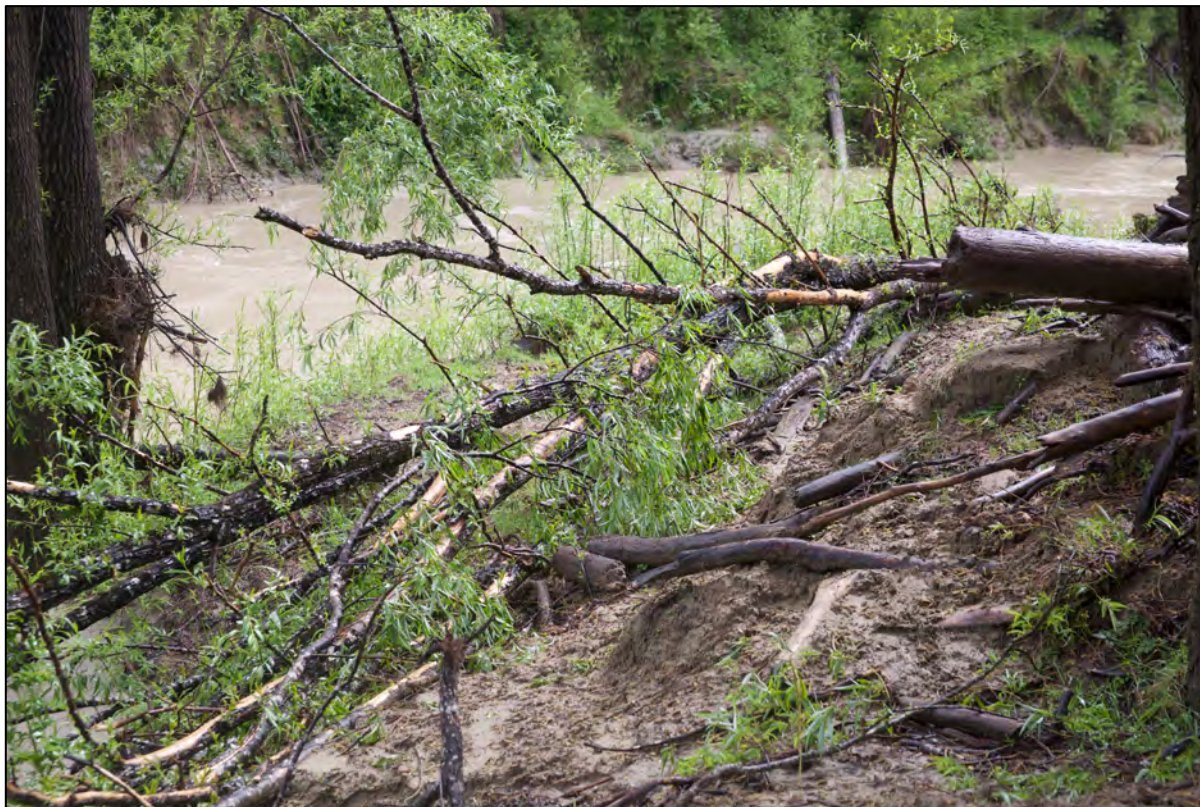
During the inspection, a track leading to the river was identified (**Figure Ten**). It was further assessed that with remediation, this track would allow access to the river bed for a digger. Several options for removing the logjam using a digger were then considered;

Figure Ten. View of access track (debris covered) to the riverbed.

- a. A chipper is placed at the base of the track with the digger used to feed logs to the chipper. The discharge from the chipper was then directed to a bin placed uptrack from the chipper,
- b. A long-reach digger is used to directly place logs on top of the river bank on either the true left (Goughs) or true right (GDC) side. The logs could then be either chipped onsite or relocated for disposal elsewhere.

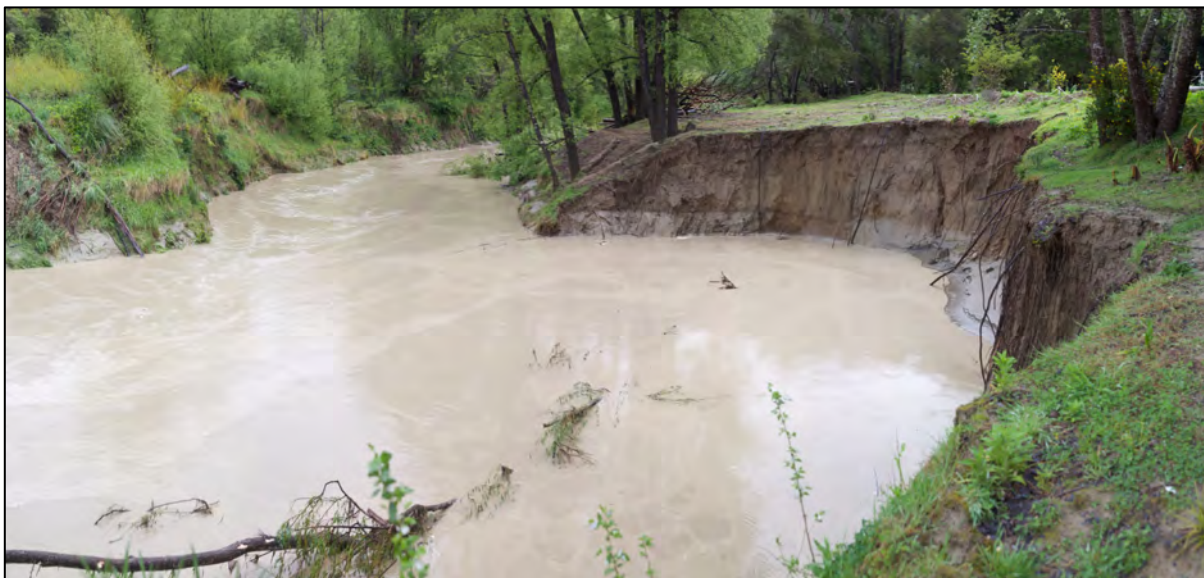
Figure Twelve shows the Mangatokerau at high flood flow at which time the logjam, if present would have been completely submerged and hence it could not be categorically confirmed that it had washed out. What was clear, however, was that the erosion of the riverbank had been exacerbated during the flood. Flow was also approximating laminar flow as the water levels were such that any impact of any logjam were subordinate to the flood height.

Figure Twelve. View of the logjam site and eroded embayment on the 15th October (refer to **Figure Three** for the state of the embayment prior to the 15th-16th October). While the relative lack of turbulence may have indicated that the logjam had flushed out, the evidence was not conclusive.

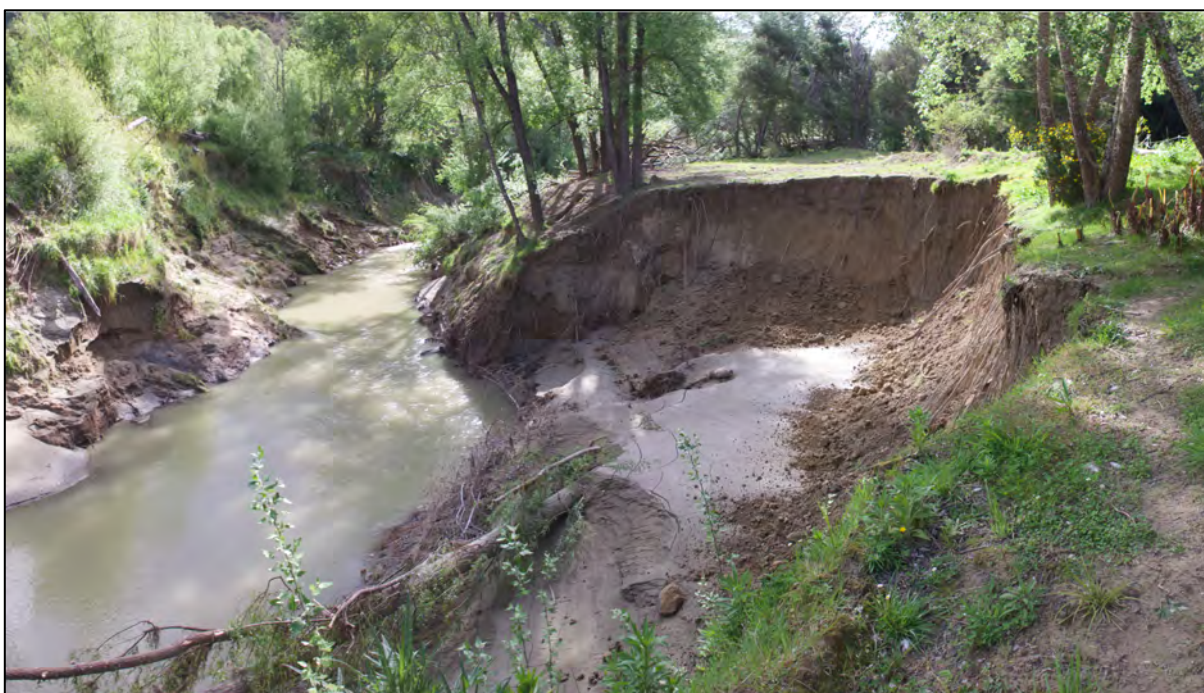
On the inspection of the 16th it was clear that the logjam had most likely been cleared and a further site visit on the 19th confirmed that the log jam had washed out (**Figure Thirteen**). This washout has made the remediation of the scour resulting from the logjam far more simple.

Figure Thirteen. View of the logjam site and eroded embayment on the 19th October once river levels had dropped confirming that the logjam had been flushed out.

Obviously as a result of the storm, it is no longer necessary to physically remove the logjam and the existing track can be used to place a digger at the scour site without impacting on the river more than was occurred naturally during the 15th-16th October storm.

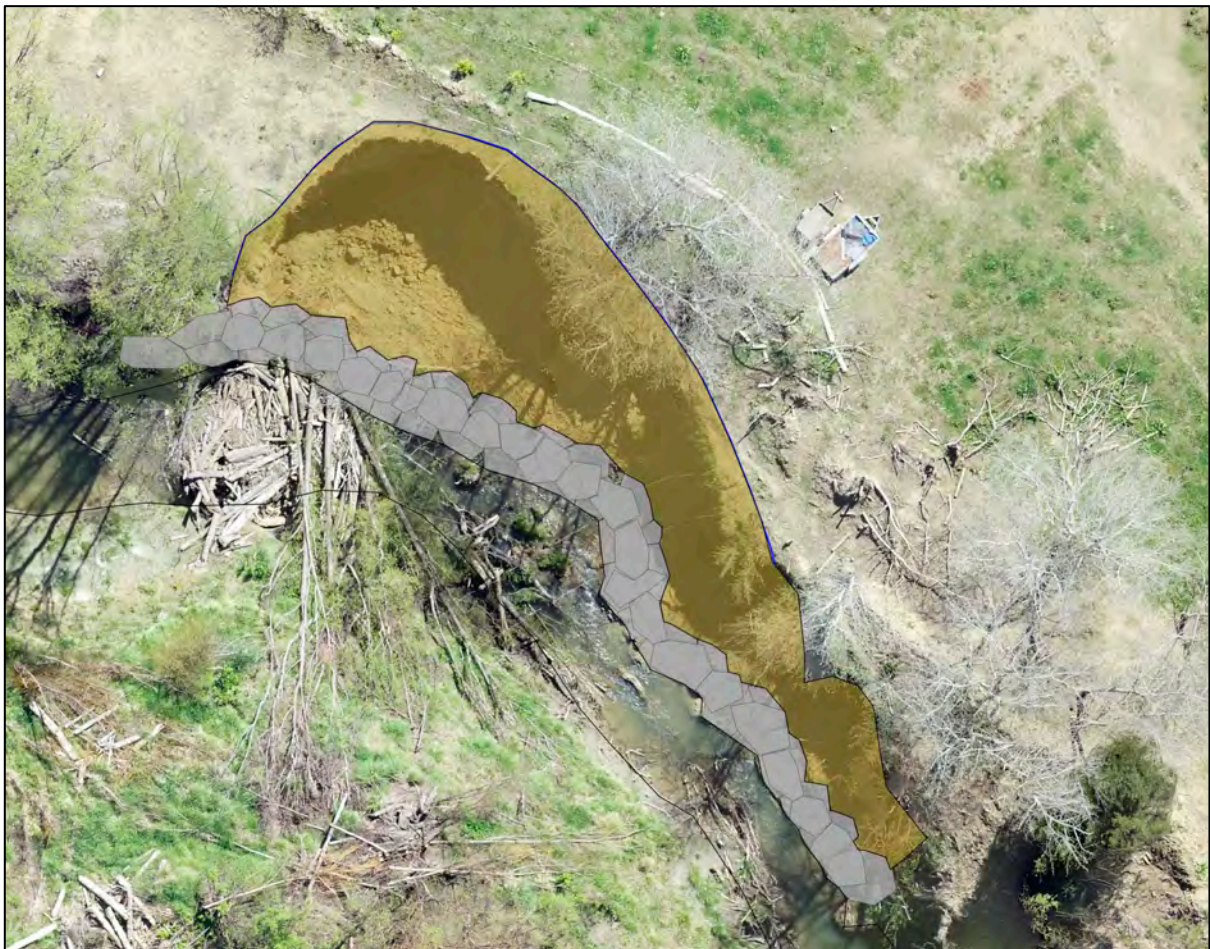
Figure Fourteen. Proposed remediation work at the Gough property, downstream Mangatokerau to mitigate scour resulting from the deposition of a logjam in the Queens Birthday storm 2018.

The recommended remediation is that a line of rip rap rock is placed along the natural line of the riverbank to provide a stable toe for the area of backfill behind (see **Figure Fourteen**). It is not considered necessary for a full revetment to be constructed. The length of rip rap required is between 40 and 50 metres. It is beyond the scope of this report to do a full cost assessment but the local cost of rip rap is around \$50 per tonne which equates to around \$100 to \$130 per cubic metre. Thus the material cost of the rip rap is around \$5,000 to \$6,500. Of course, the cost of the rock is only a small element of the total cost since the transport of the rock and the placement also needs to be considered. There is a quarry with suitable material within 5 kilometres, however, so transport costs will be manageable.

The rip rap toe is, however, only the first element of the remediation required. It is provisionally estimated that around 1,400 cubic metres of fill will be required in the backfill area. It is assumed that this back fill will comprise two one metre benched levels that are compacted over a geotextile membrane. An alternative is to use engineering grade polystyrene blocks as the base level to the backfill tied to the rip rap curtain to provide additional scour resistance. The backfill on top of that would comprise binding clays and a good soil layer to allow for a suitable substrate for vegetation growth with suitable root development to assist binding of the re-engineered riverbank.

Once the basic slope is reformed, it is recommended that the backfill is oversown with grass species to enhance soil binding. Additionally, it was observed that willows that have been toppled by the erosion event have experienced vegetative regrowth. It is recommended that this material is cut into 5m lengths and placed in the bottom layer of fill where it can regrow and develop a root network to facilitate soil binding. The top batter should be planted in native species such as Totara. The lower batter could also have interspersed Totara planted which over time could replace the willow which could then be poisoned once the Totara is established.

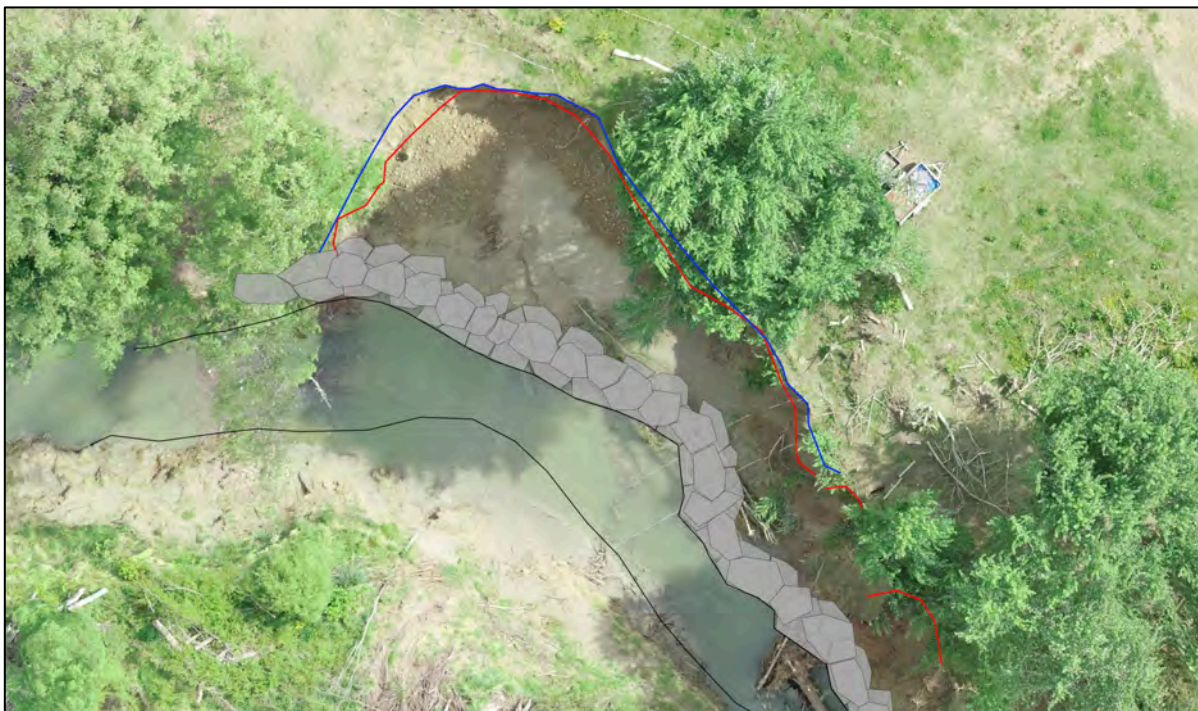
scour. This flight showed that not surprisingly there had been some further loss of material as a result of the 15th of October storm (**Figure Fifteen**) and this scour of the bank can now be expected to continue during high flow events in the future.

Figure Fifteen. View of the scour zone from the October 24th drone mapping showing the logjam removed and the areas of further erosion (blue line) arising from the 15th October flood.
