Isthmus Group Limited
Geotechnical Assessment Report for Stage 2 Resource Consent
Application
Titirangi Summit Project, Gisborne

Project Reference: 13364
24.08.2021
Revision: 1

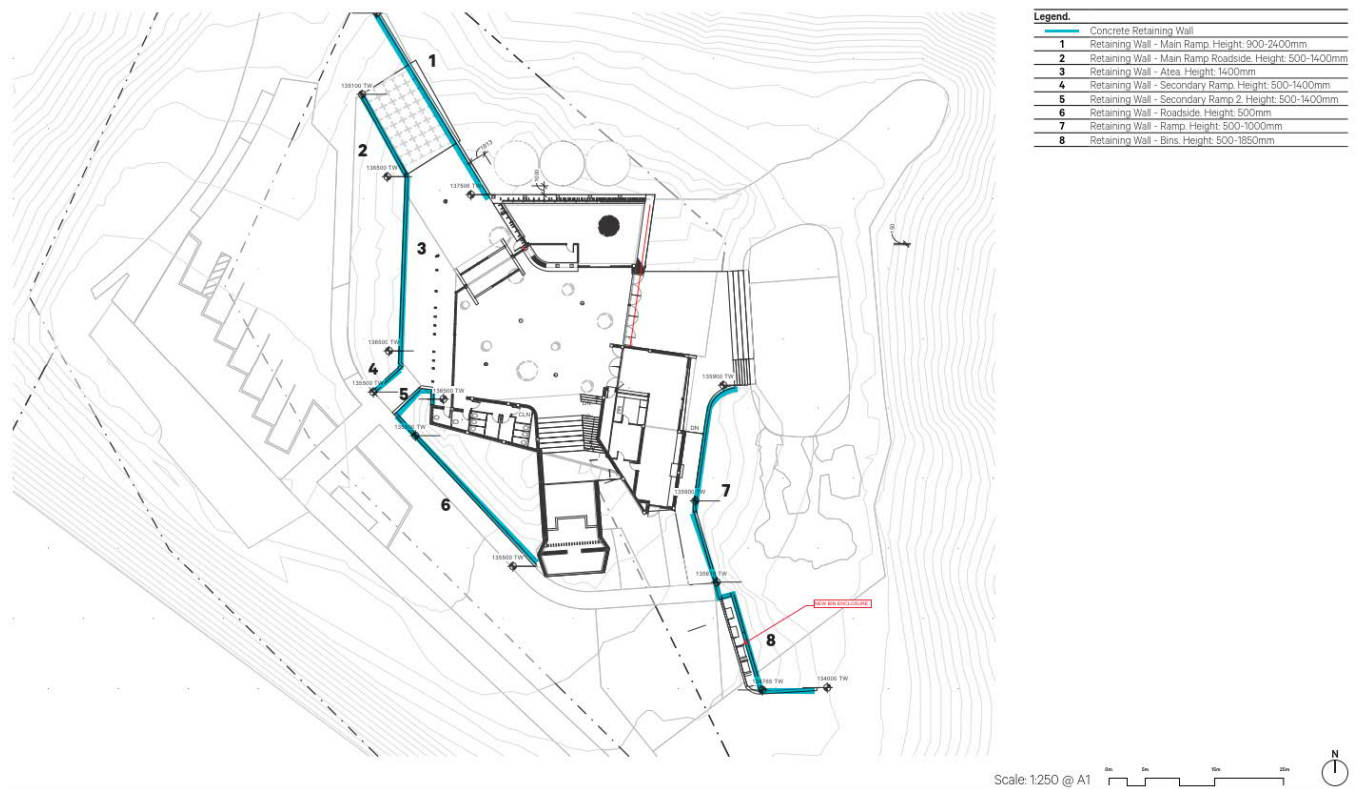
The building proposed extends beyond the generic 10m building cut platform setback that was recommended. However, the survey data shows that in most areas the slopes between the cut platform and adjacent ground are less than 1.0m in height. Following the recommendation to isolate structures by a distance five times the slope's height, the setback can be regarded as being no more than 5m. Elsewhere, retaining walls are proposed on the southeast side and around the north through southwest sides of the building to support slopes and fill (Figure 2). The siting of the building with the proposed engineered retaining walls, appears to comply with the recommendations of the geotechnical report (LDE Ltd, 2018).

Figure 2: Snip of Retaining Wall plan. Source: Isthmus Architects.

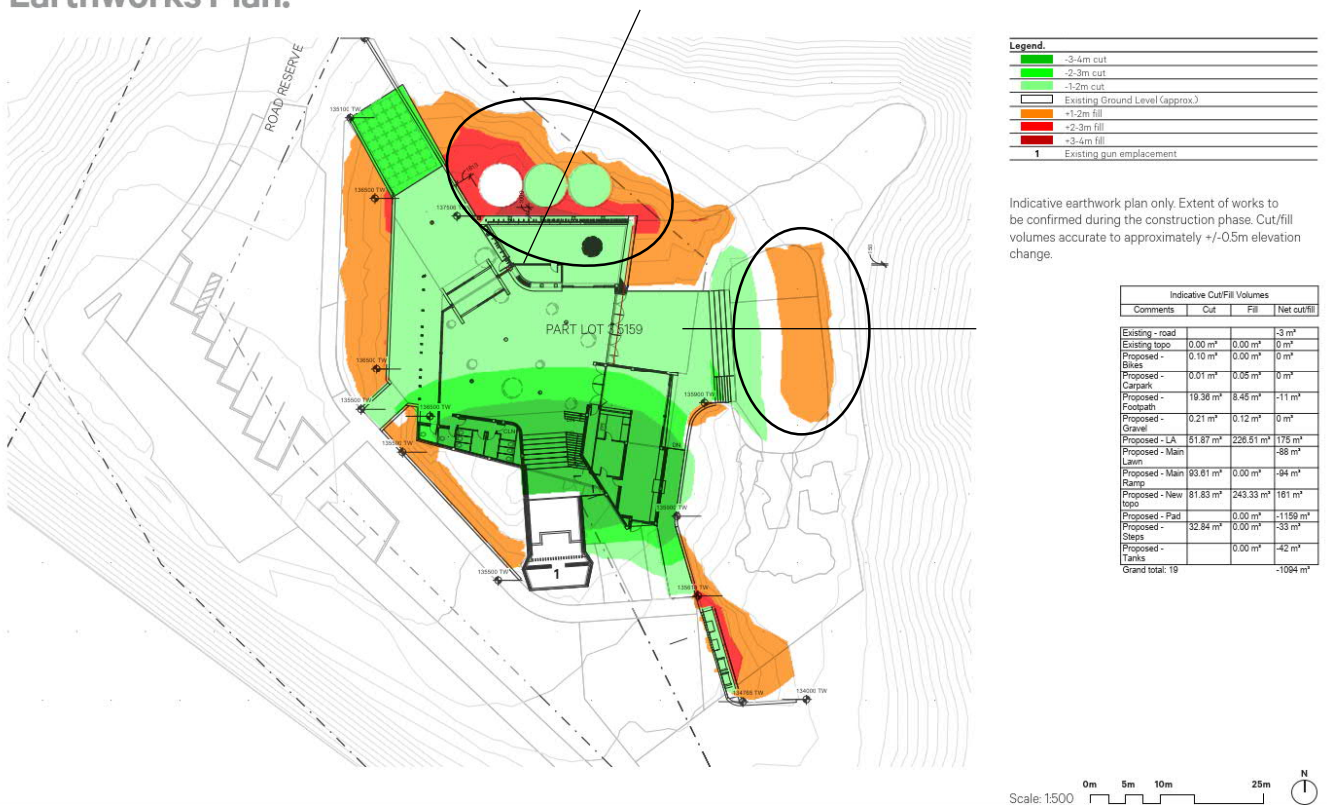
Placement of fill onsite was not recommended. Despite this, the landscape filling proposed in Stage 2 around the periphery of the building is generally considered minor and not likely to have ill effect on stability. In two areas the effects of the filling on the stability of the adjacent slopes must be considered by numerical modelling. These are on the north side of the building where the fill exceeds 2m and on the east side of the development adjacent to the night viewing platform (Figure 3).

Figure 3: Annotated snip of Cut/Fill earthworks Plan showing areas of filling (ovals) requiring geotechnical stability consideration and indicative cross sections (lines). Source: Isthmus Architects.

The recommended geotechnical assessment of the stability of the slopes with proposed filling is considered unlikely to change the scope or outcome of the Stage 2 resource consent application. If the works are found to pose an instability risk, the filling will be either omitted and the fill cut-to-waste, or additional mitigation measures recommended.

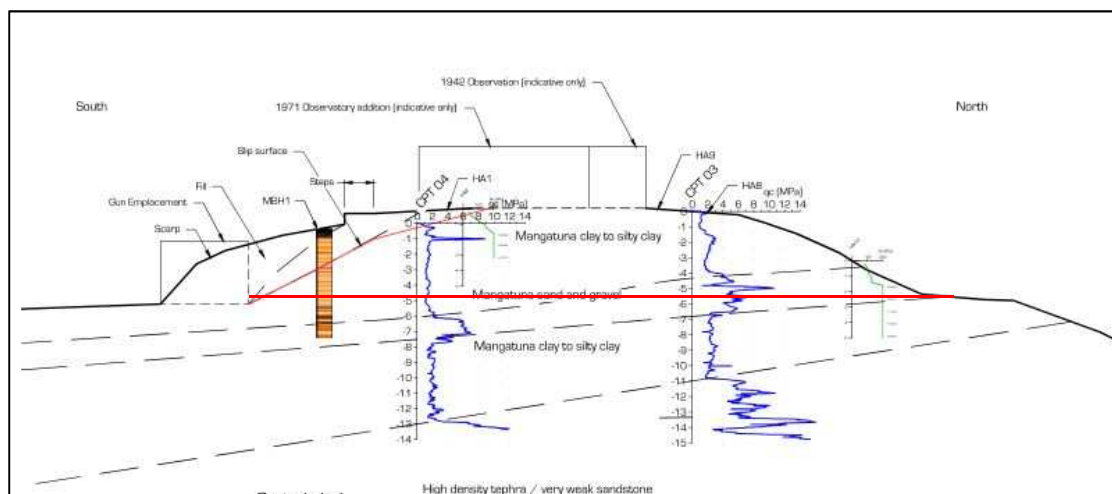
With the cutting down of the site and remediation of soils around the gun emplacement, all non-engineered fill, topsoil, rhyolitic tephra and most of the upper clay rich Mangatuna Formation is expected to be removed from the footprint of the new cut platform. This includes the unit containing the slip surfaces behind the gun emplacement. A portion of the upper clay-rich unit, the sand and gravel unit and the top of a lower clay-rich unit (all part of the Mangatuna Formation) are expected to be exposed at cut level (Figure 11).

Figure 7: North-South cross section through site showing approximate proposed cut level (red line).

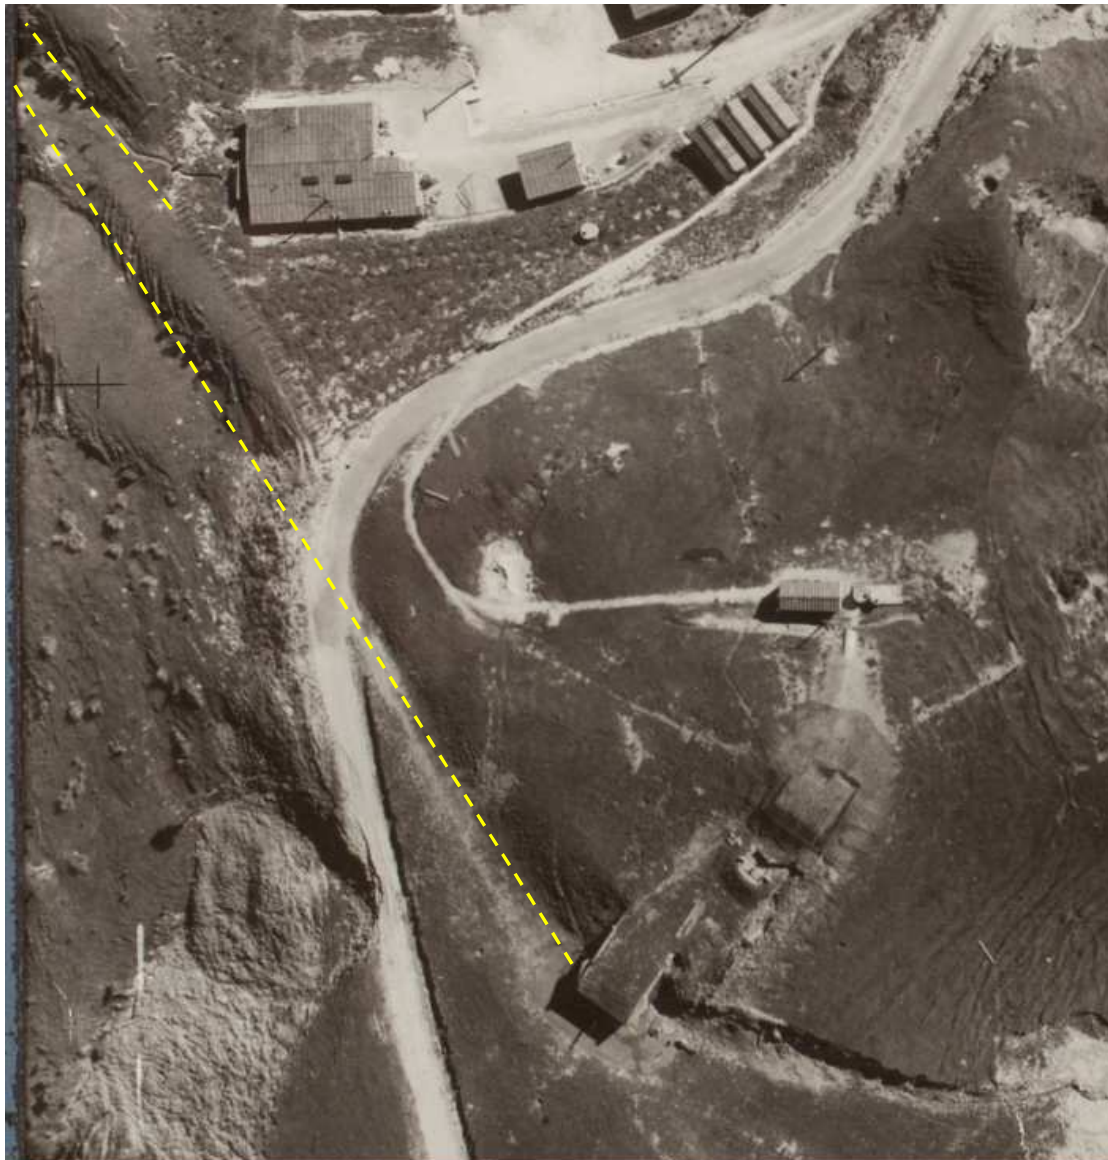
A generally lineal feature extending northwest from the gun emplacement through the area now occupied by the summit carpark and down the side of a spur within the 1943 image (Figure 8) initially suggests the presence of a fault, however aerial imagery taken in 1942 and 1953 show the first 60m of the feature is man-made and the remainder to be the headscarp of moderately deep-seated landslip zone within a gully to the west (Figure 9). There were no other features indicative of a fault trace encountered in our assessment. We therefore consider that the surface fault line rupture risk to be low.

Figure 8: 1943 image showing lineal feature extending northwest of the gun emplacement (image supplied courtesy of Tairāwhiti Museum).

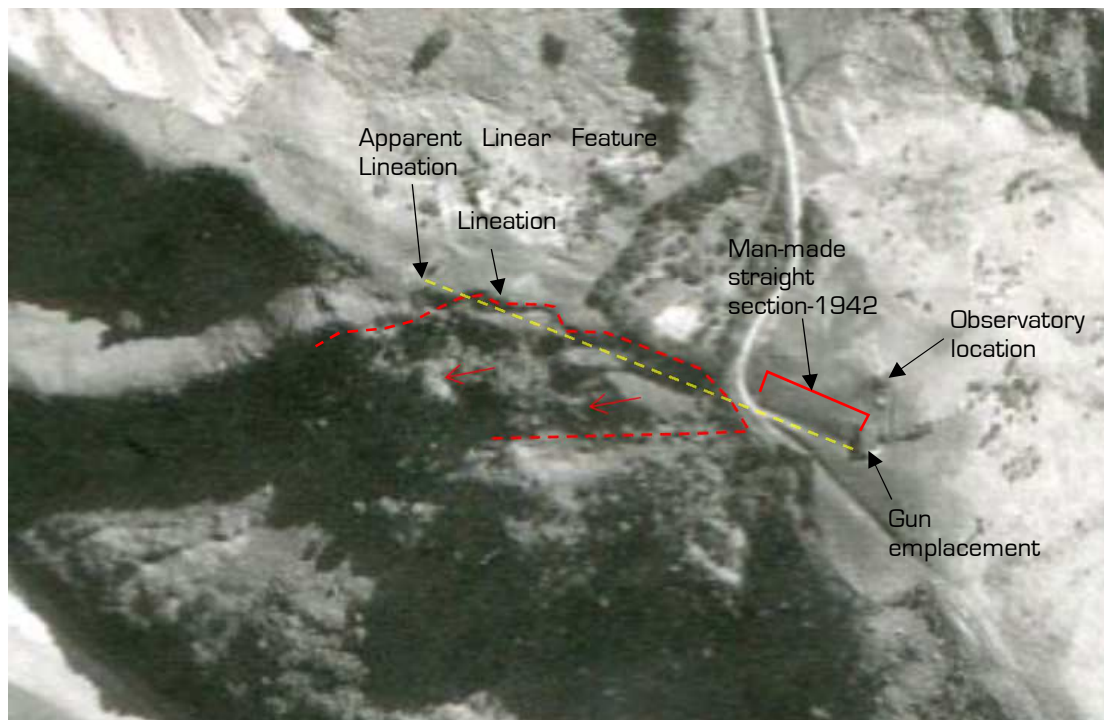
Figure 9: 1953 aerial image showing lineation to northwest of gun emplacement is combination of man-made earthworks and headscarp of isolated landslippage.

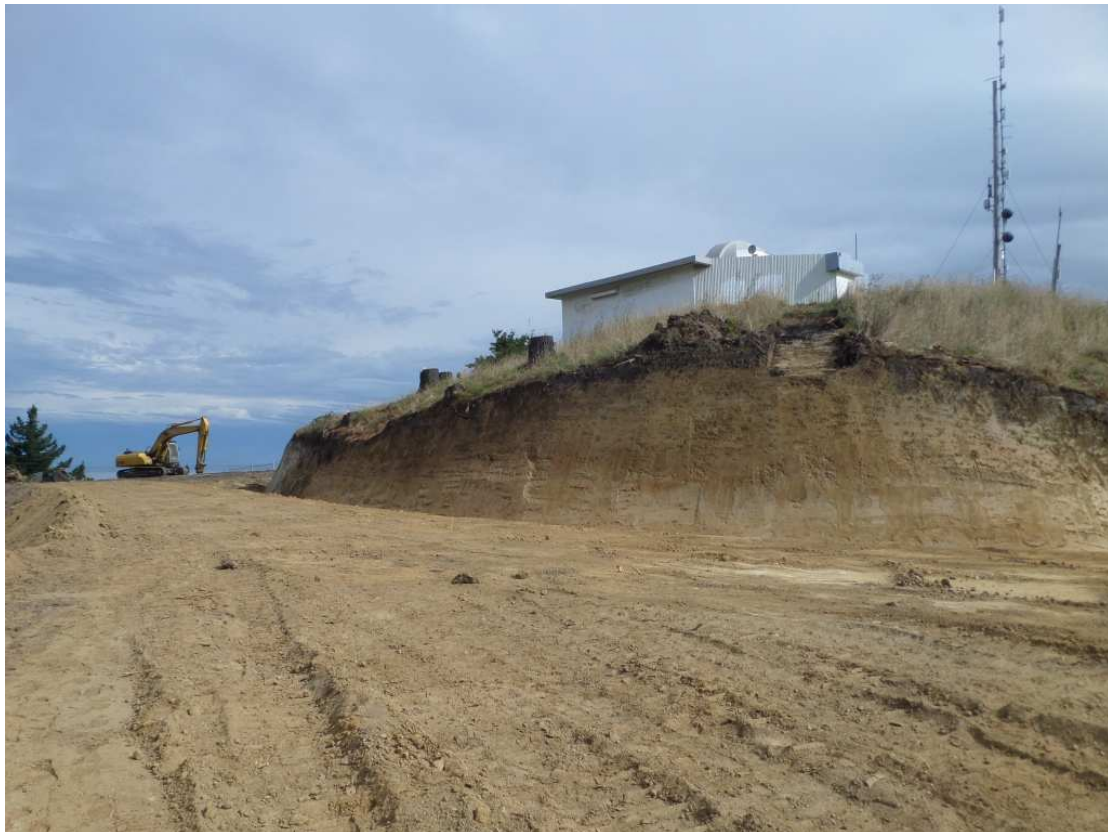
Figure 10: Eastern cut slope below observatory shortly after completion in 2015.

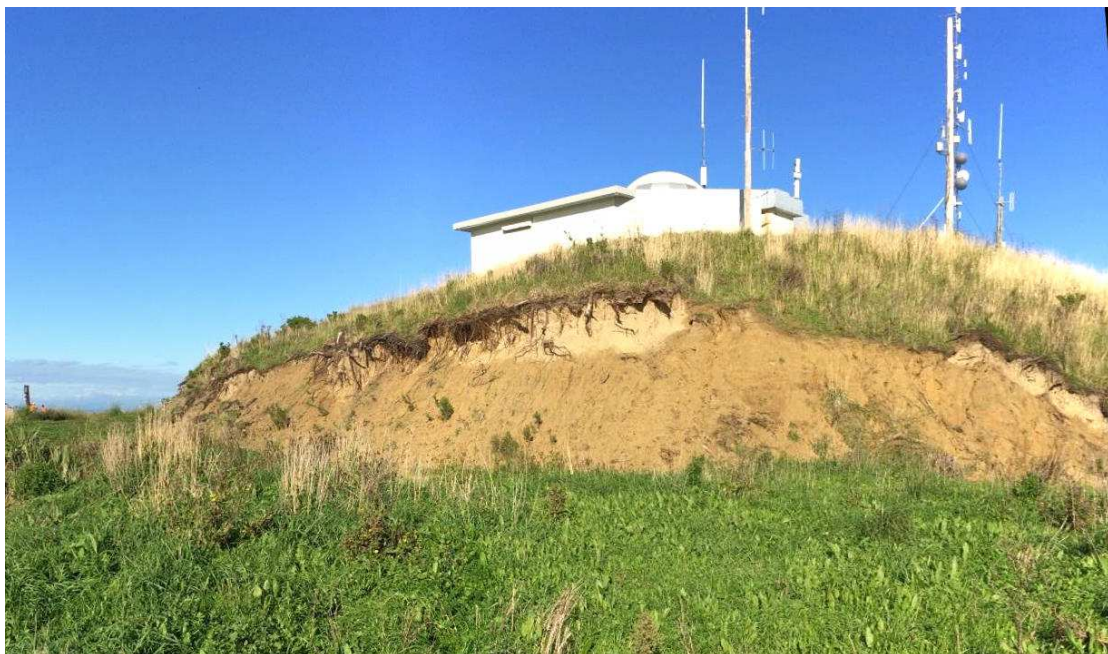
Figure 11: Eastern cut slope in May 2017 showing cut face affected by erosion and shallow seated landslippage since original earthworks.

Following the proposed earthworks the cut slopes will be reduced to less than 2m in height. Despite this, based on the nature of the materials exposed and their inclination to instability it is considered likely that these slopes will continue to recess unless preventative measures are undertaken.

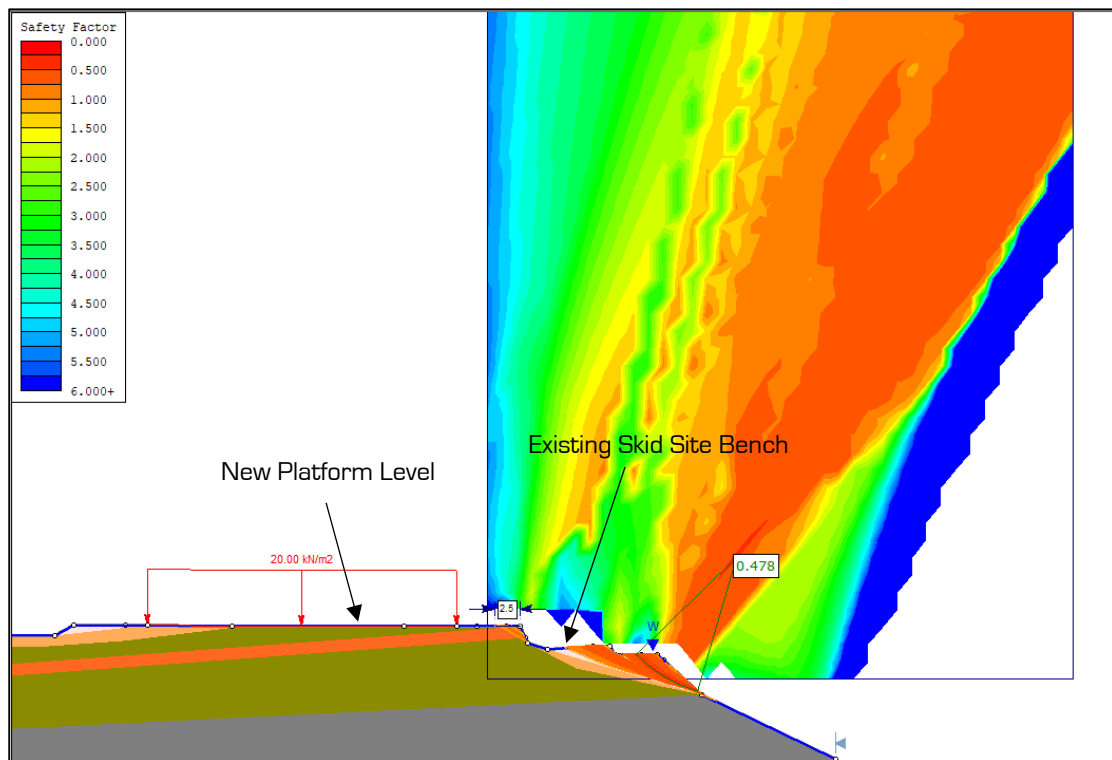
Figure 12: Eastern slope model under extreme groundwater conditions showing potential failure zones on edges of existing skid site bench and proposed new platforms.

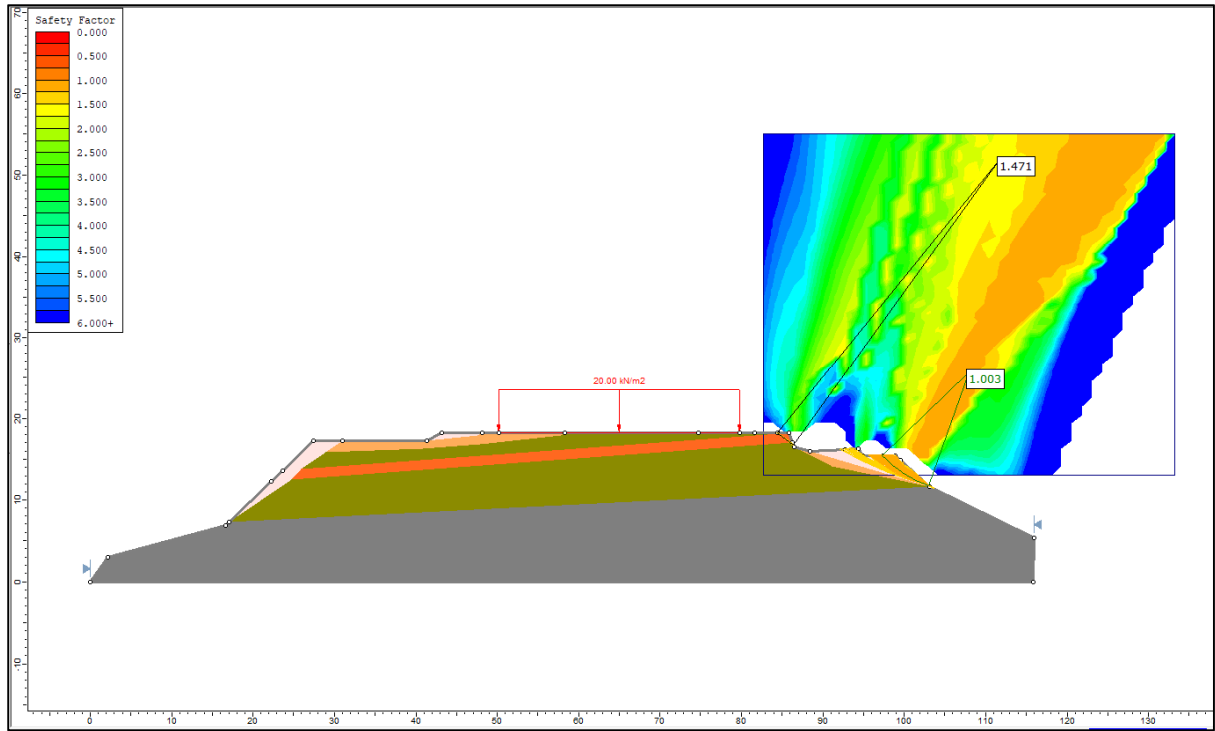
Rotational model east slope – Design/Prevailing groundwater condition showing FoS values <1.5

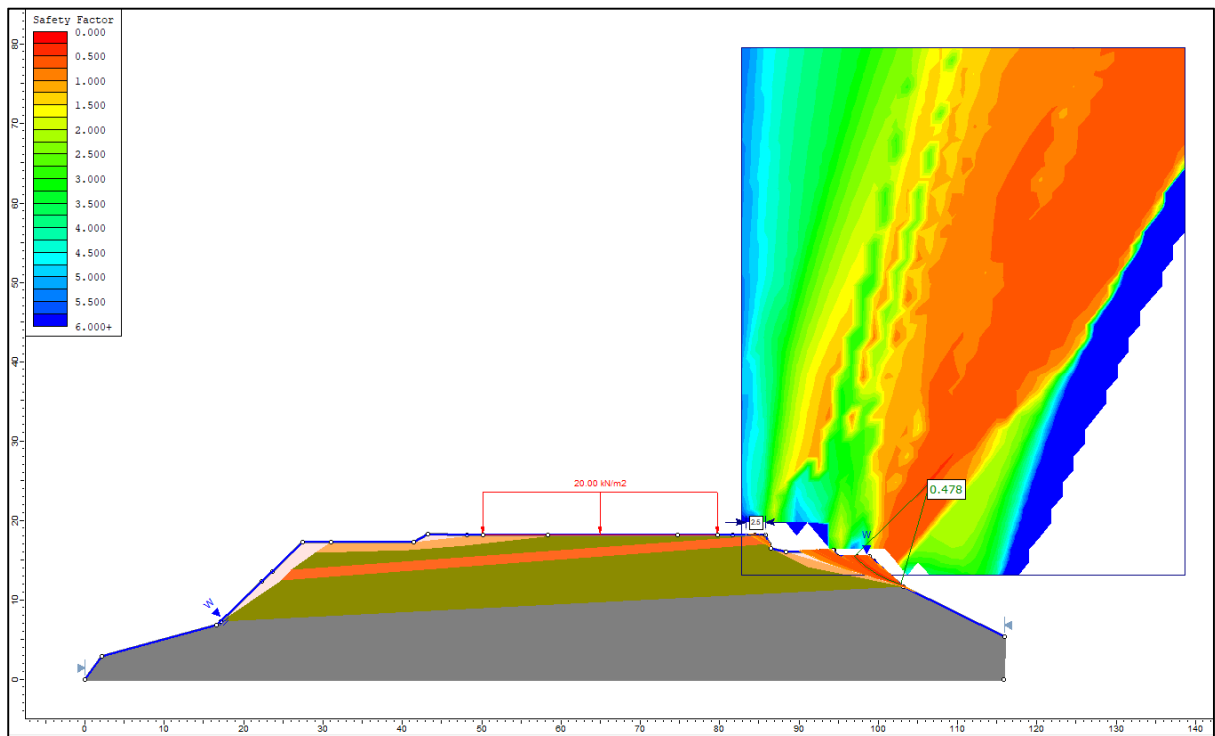
Rotational model east slope – Extreme groundwater condition showing FoS values <1.2

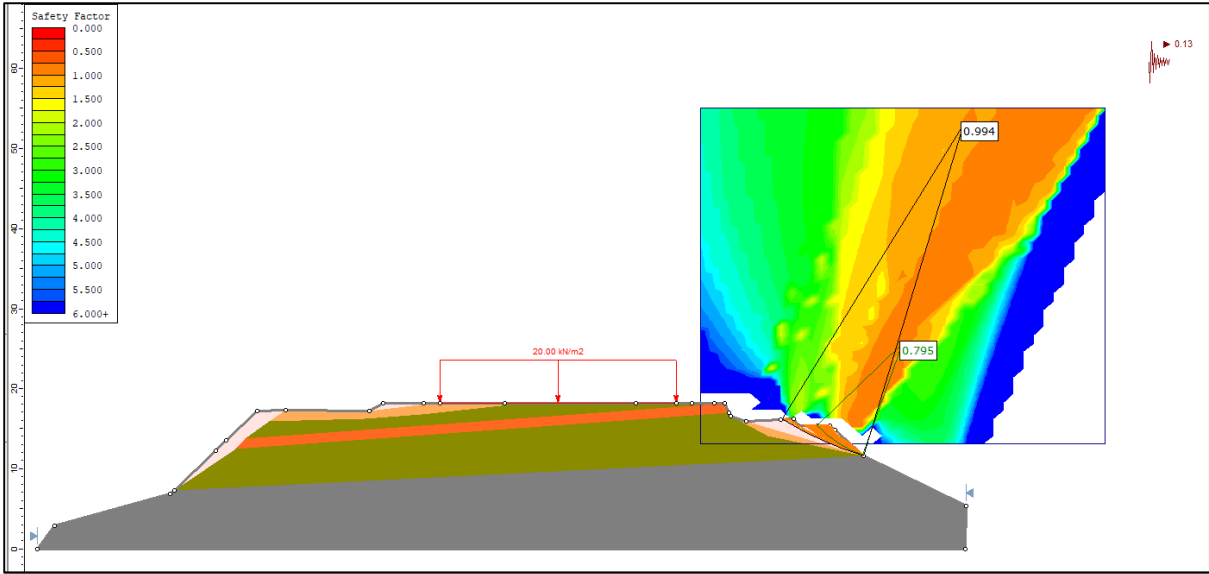
Rotational model east slope – SLS seismic condition showing FoS values <1.0

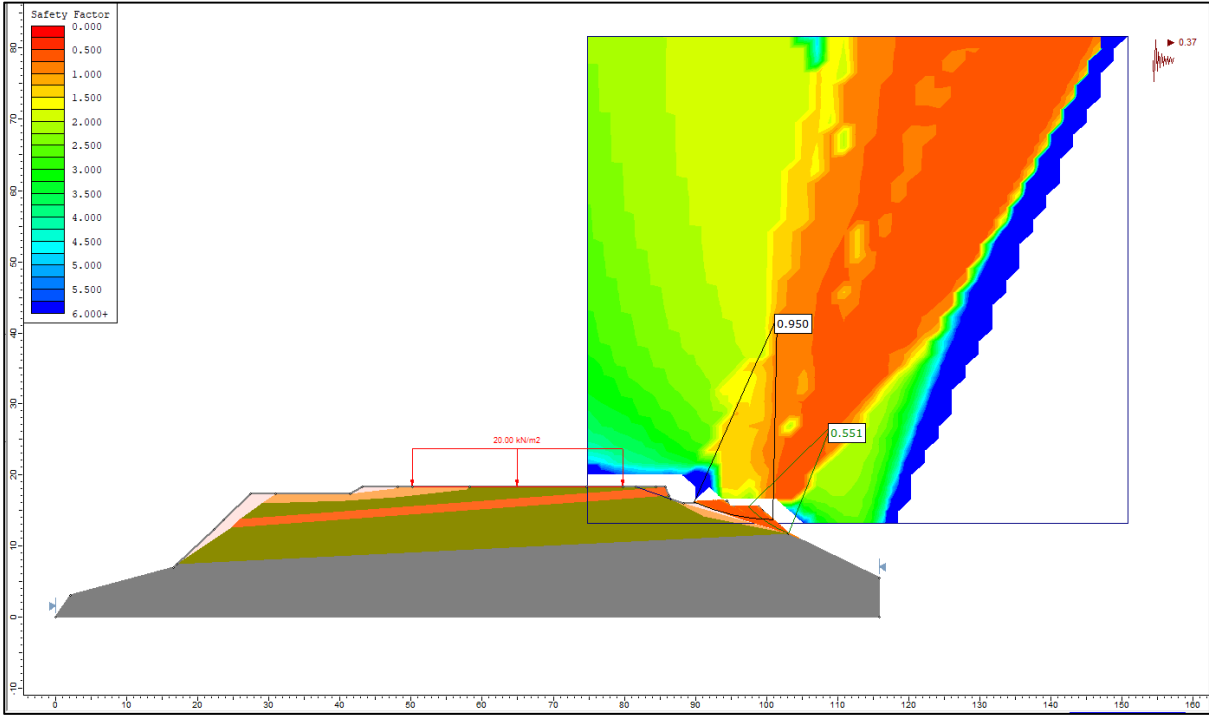
Rotational model east slope – ULS seismic condition showing FoS values <1.0

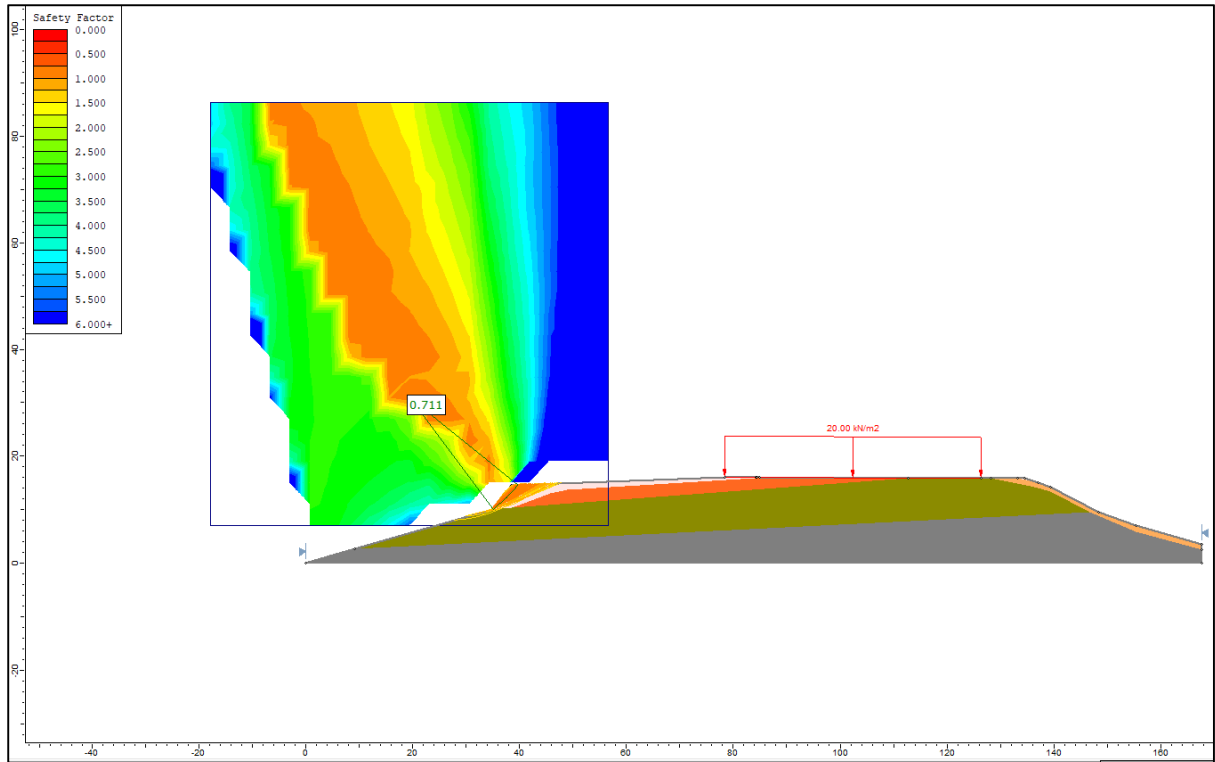
Rotational model south slope – Design/Prevailing groundwater condition showing FoS values <1.5.

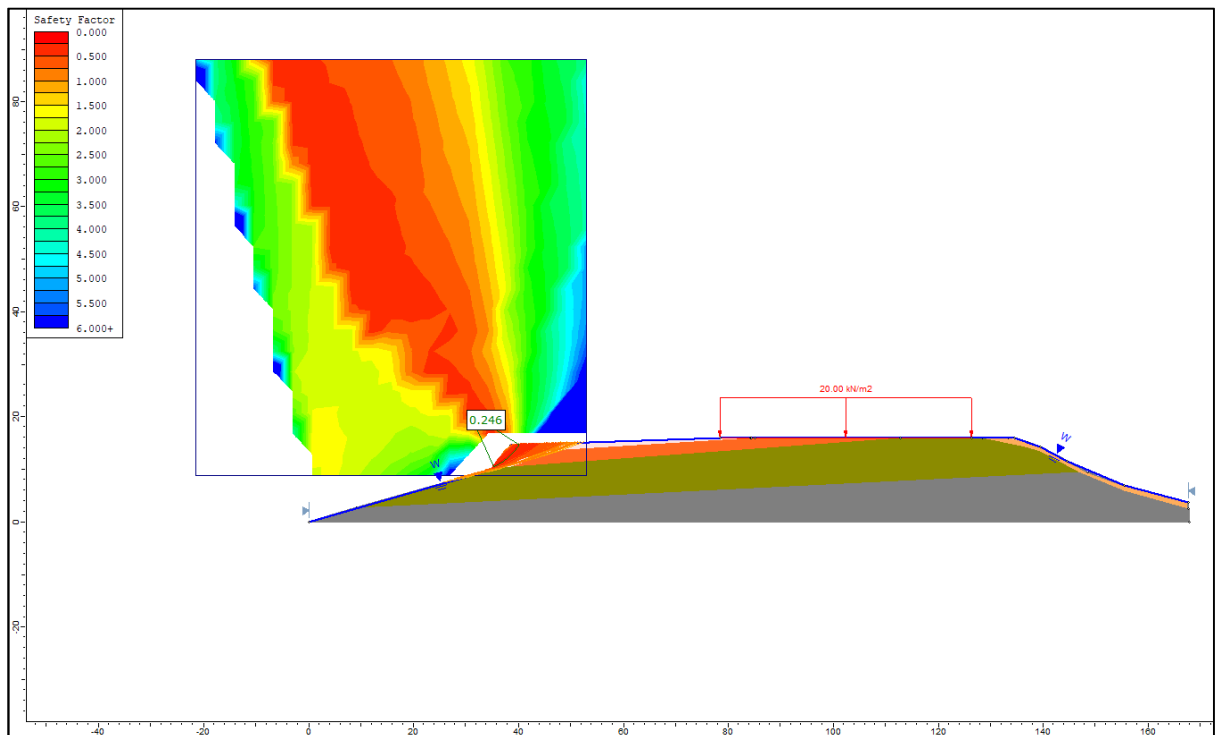
Rotational model south slope – Extreme groundwater condition showing FoS values <1.2.

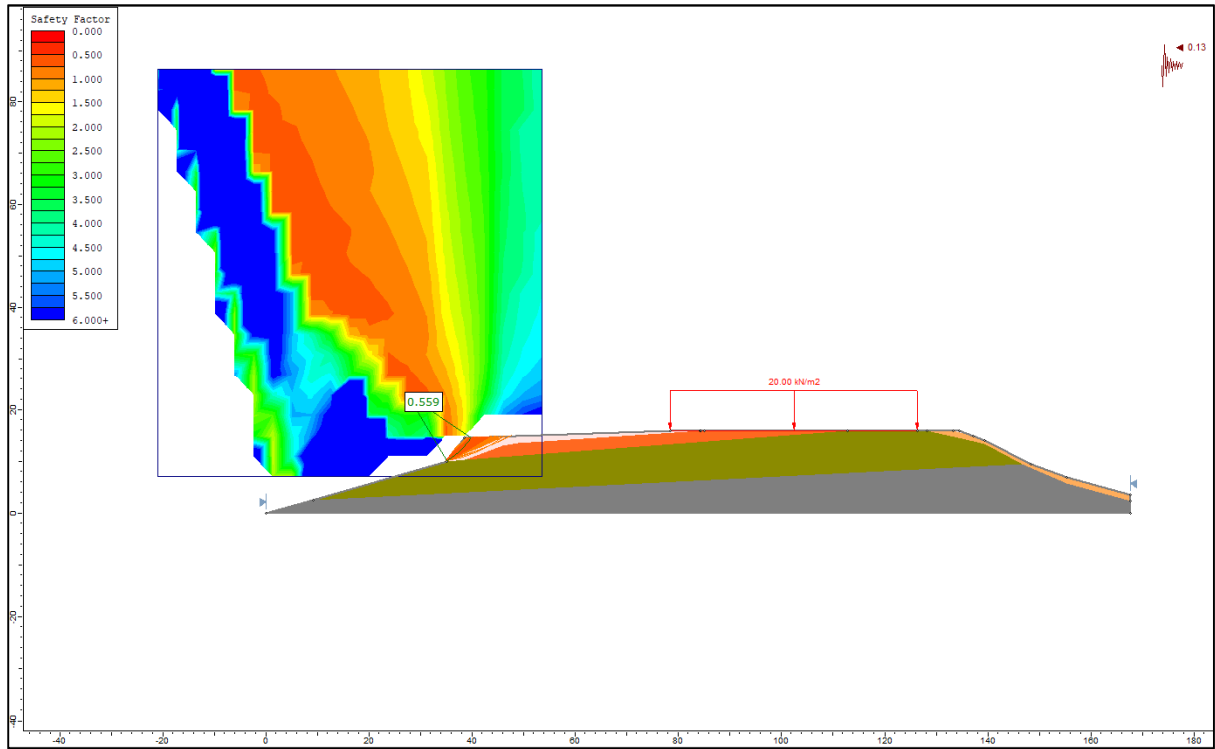
Rotational model south slope – SLS seismic condition showing FoS values <1.0.

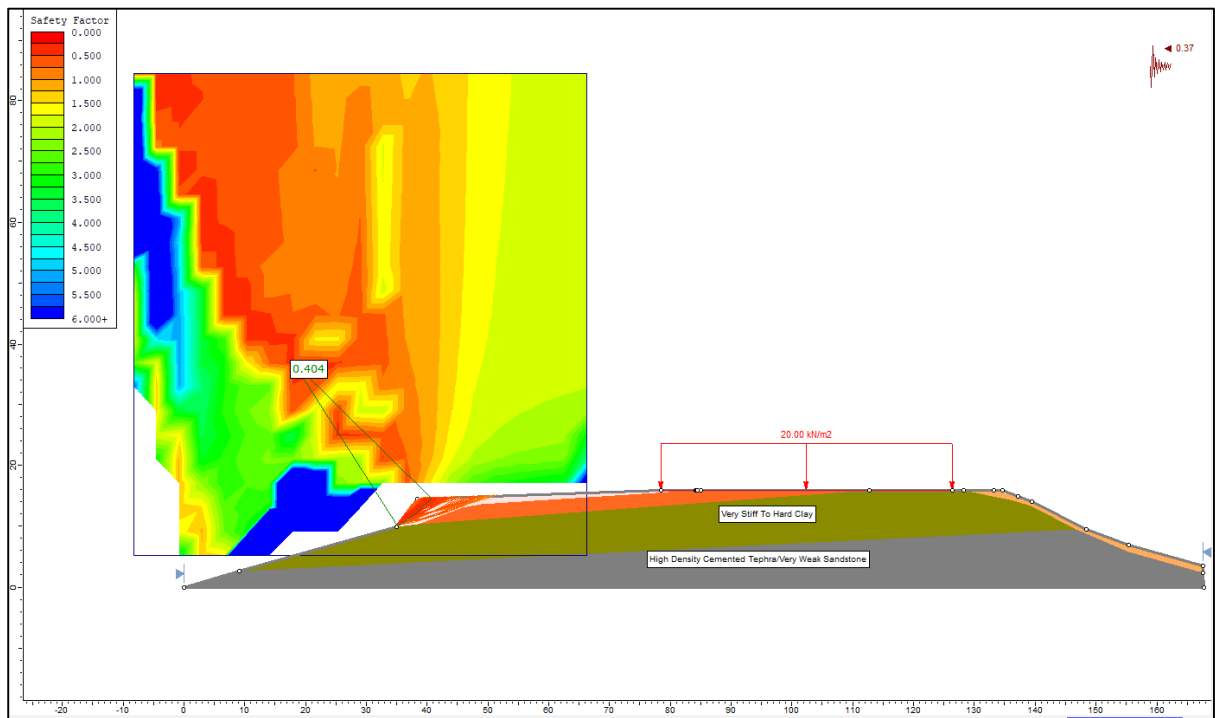
Rotational model south slope – ULS seismic condition showing FoS values <1.0.

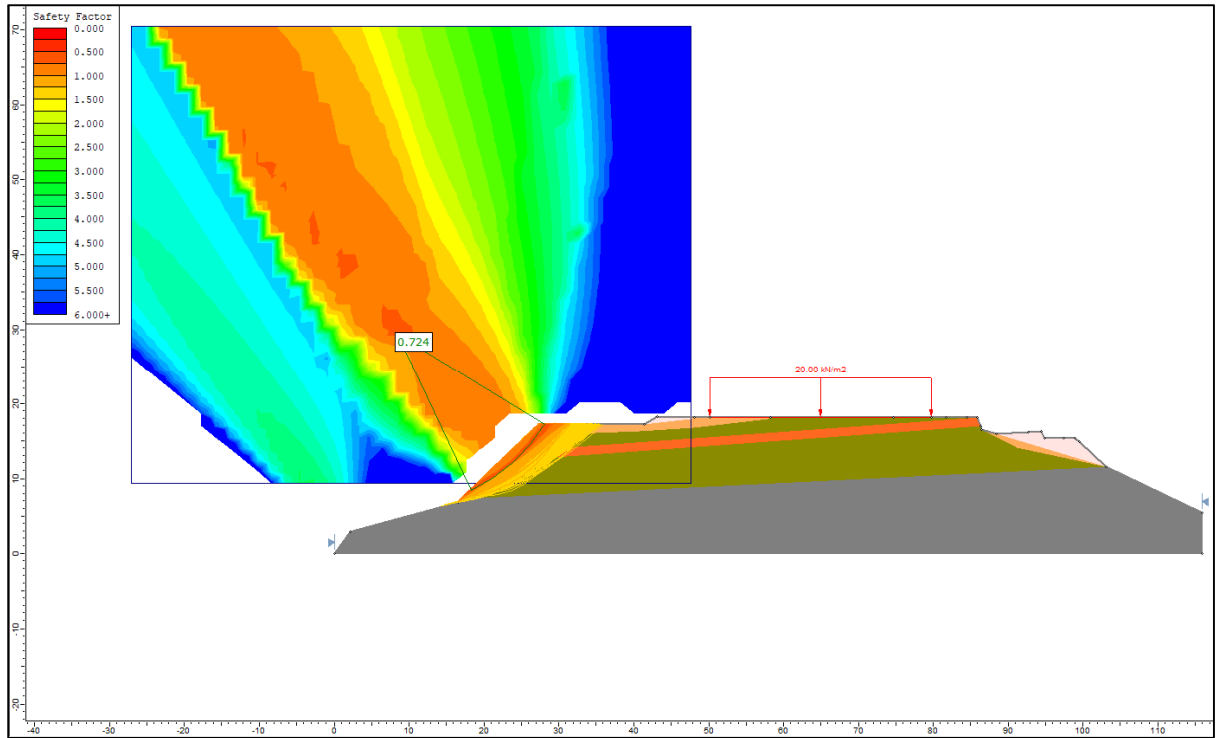
Rotational model southwest slope -Design/Prevailing groundwater condition showing FoS values <1.5.

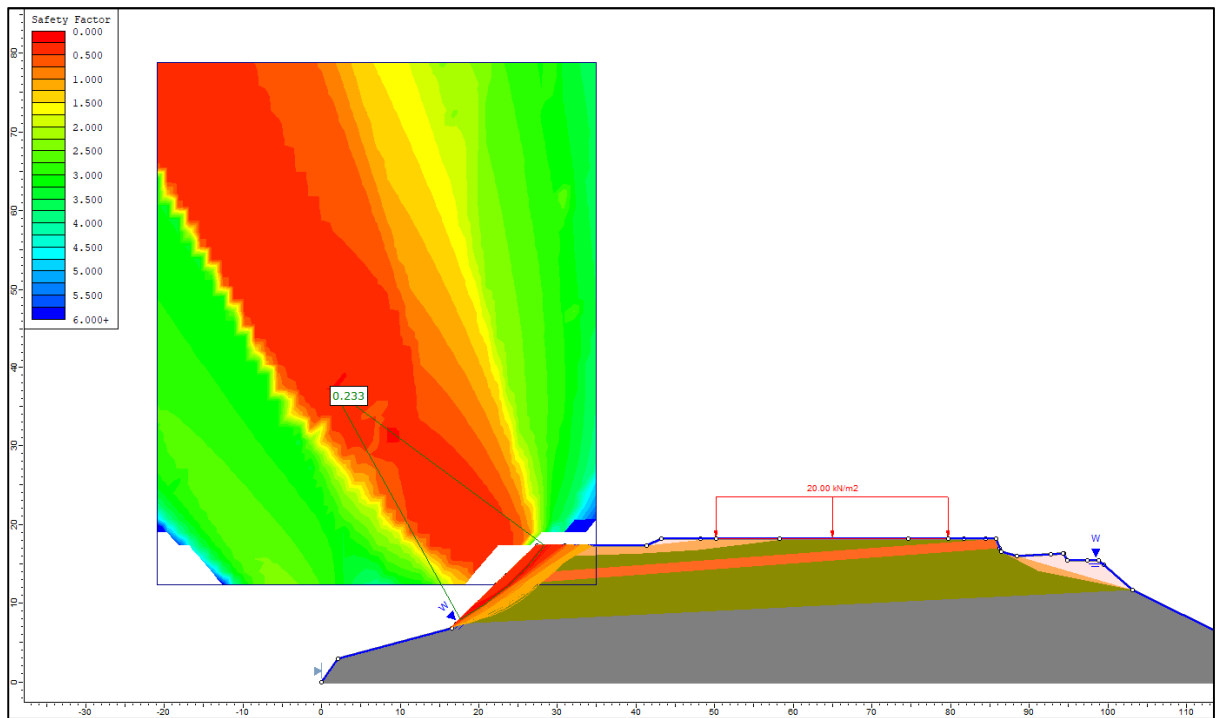
Rotational model southwest slope -Extreme groundwater condition showing FoS values <1.2

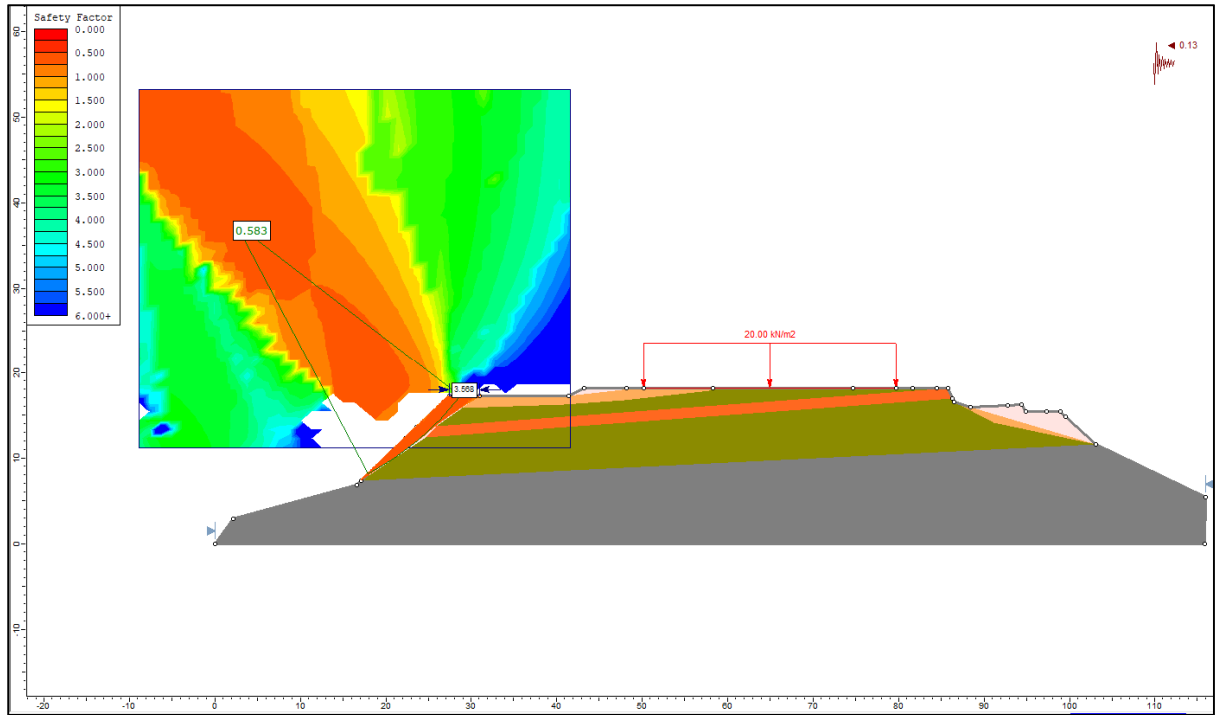
Rotational model southwest slope –SLS seismic condition showing FoS values <1.0

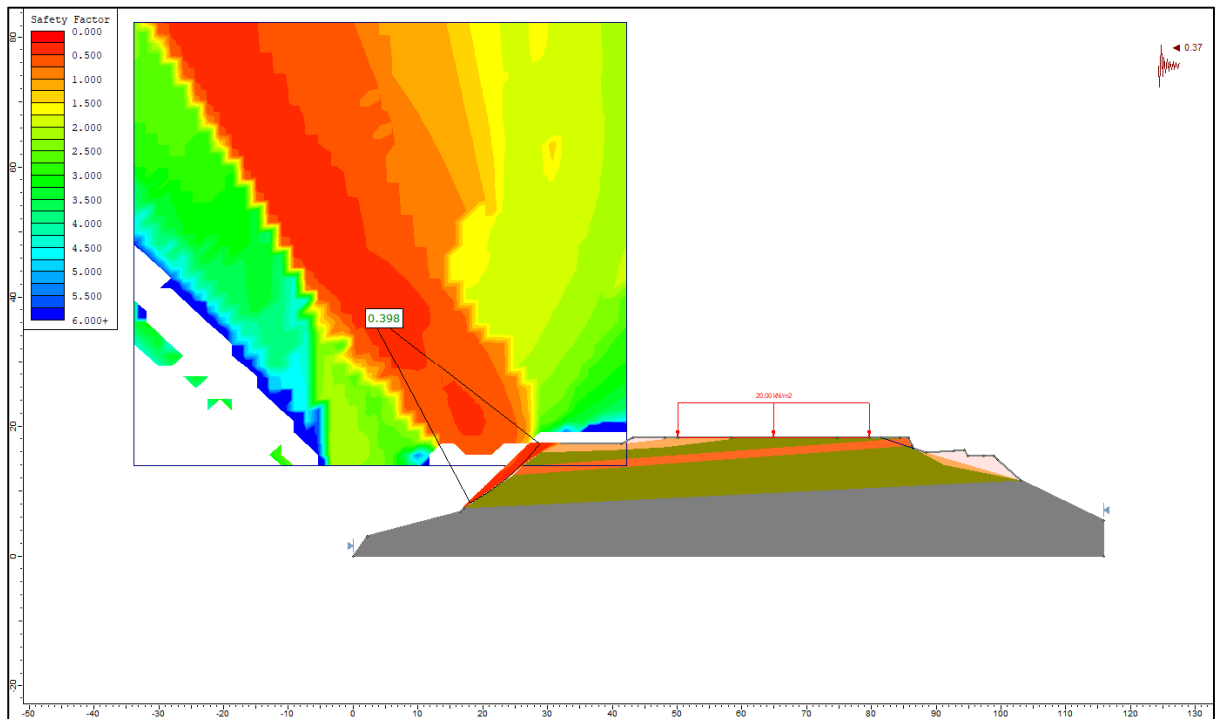
Rotational model southwest slope –ULS seismic condition showing FoS values <1.0.

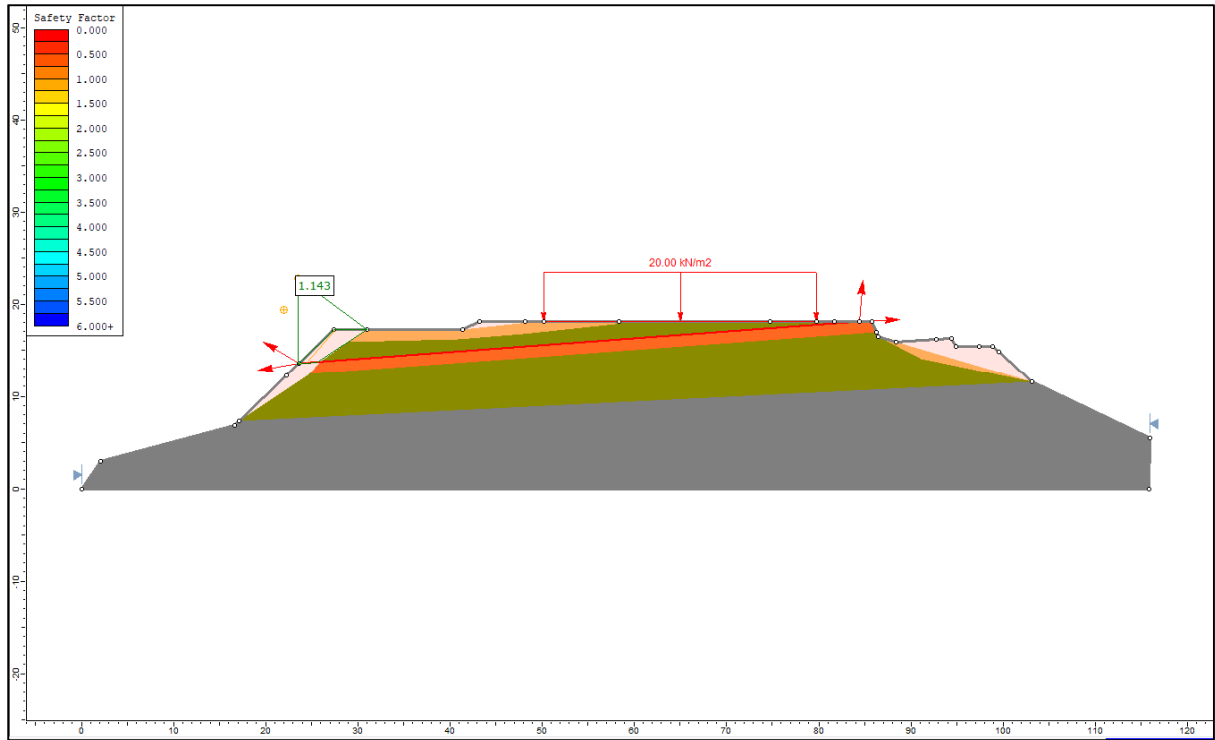
Translational model southwest slope -Design/Prevailing groundwater condition showing FoS values <1.5.

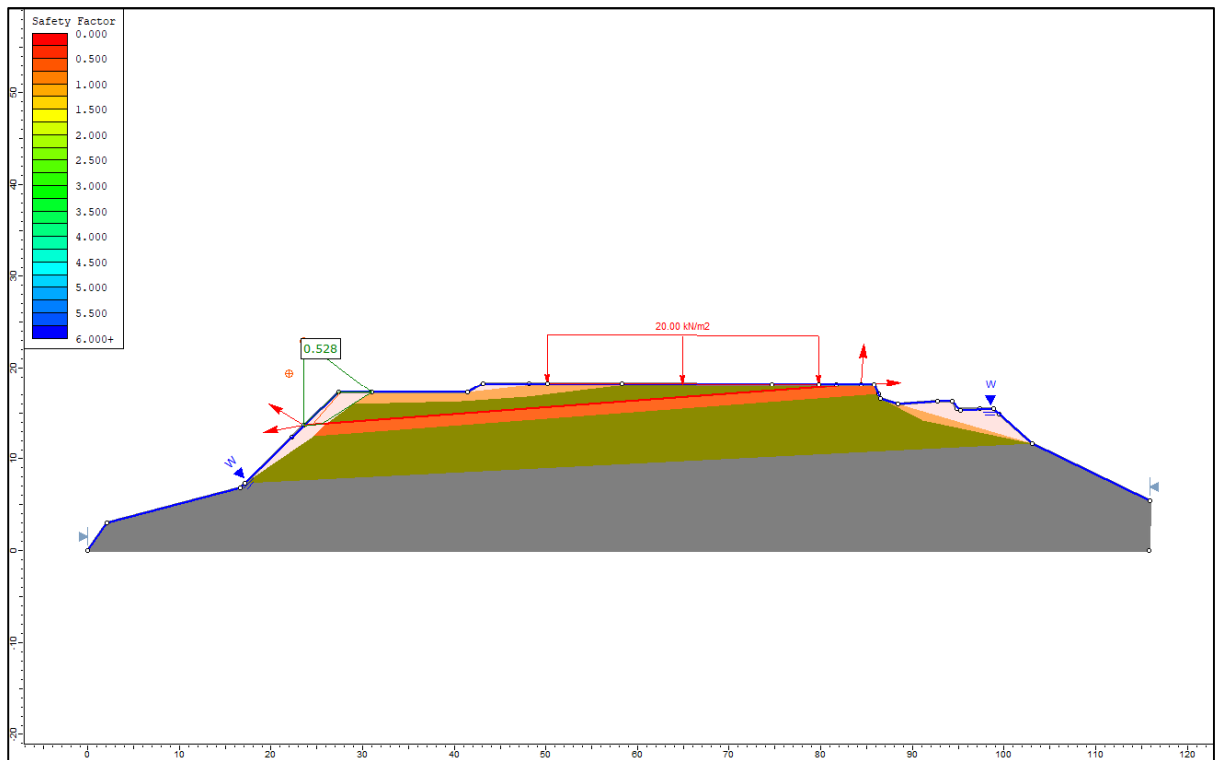
Translational model southwest slope- Extreme groundwater condition showing FoS values <1.2.
