**Forestry Harvest Residues  
on slopes in Makiri Forest  
and in the Upper Waipaoa Catchment  
after the Storm of 11<sup>th</sup>-12<sup>th</sup> June 2018**

**M.P Cave  
Principal Scientist  
Gisborne District Council**

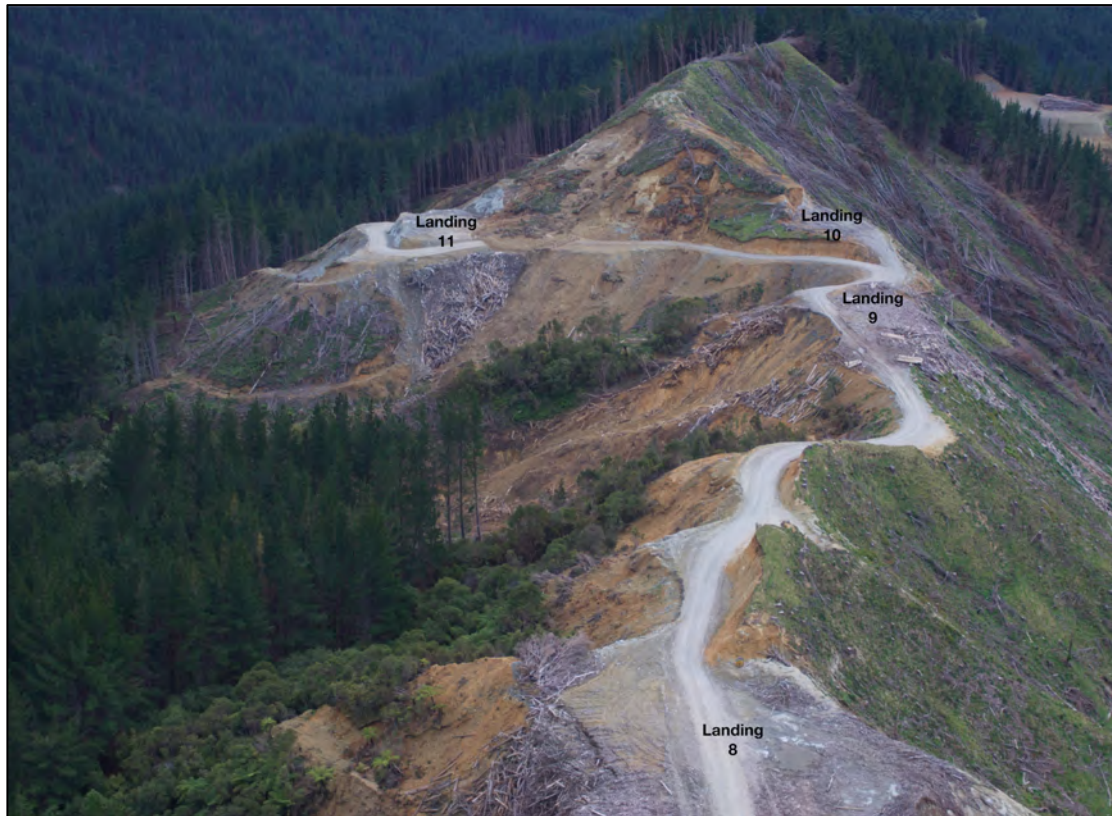
(Landings 8 through to 11) which showed signs of significant recent slope failures, birds-nests and slash migration. The forest was then inspected on the ground by warranted officers on the 10<sup>th</sup> of July 2018 which confirmed the assessment formed after the 7<sup>th</sup> of July flight.

**Figure Two.** View of Makiri West Road (7<sup>th</sup> July 2018) showing landings 8 through to 11. These landing numbers were assigned by GDC as the forest owner did not provide a map giving alternative names. The photograph shows that there were extensive birds-nests of harvest residues placed on slopes (particularly those slopes on the left) as well as extensive slope failures.

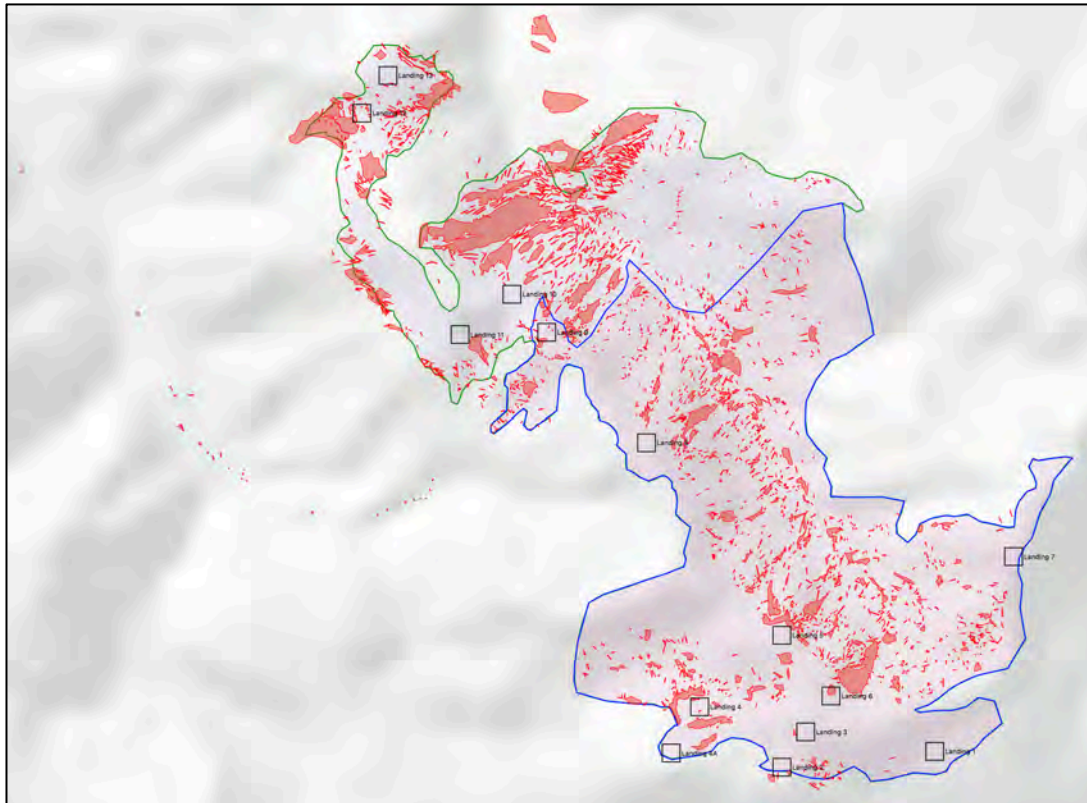
A total of 2544 discrete shapes associated with slash have been counted both within and beyond the forest. These comprise both individual logs and substantial areas where it is not possible to identify individual logs based on the high density of debris. On an area basis around 93,000 m<sup>2</sup> or 9.3 Ha of the forest is covered with slash (9.3% of the harvest area) (see **Figure Five**).

**Figure Five.** View of Makiri forest showing the mapped distribution of slash within the forest (Red outlined areas) and immediately downstream in an unnamed true left tributary of the Waihora River.

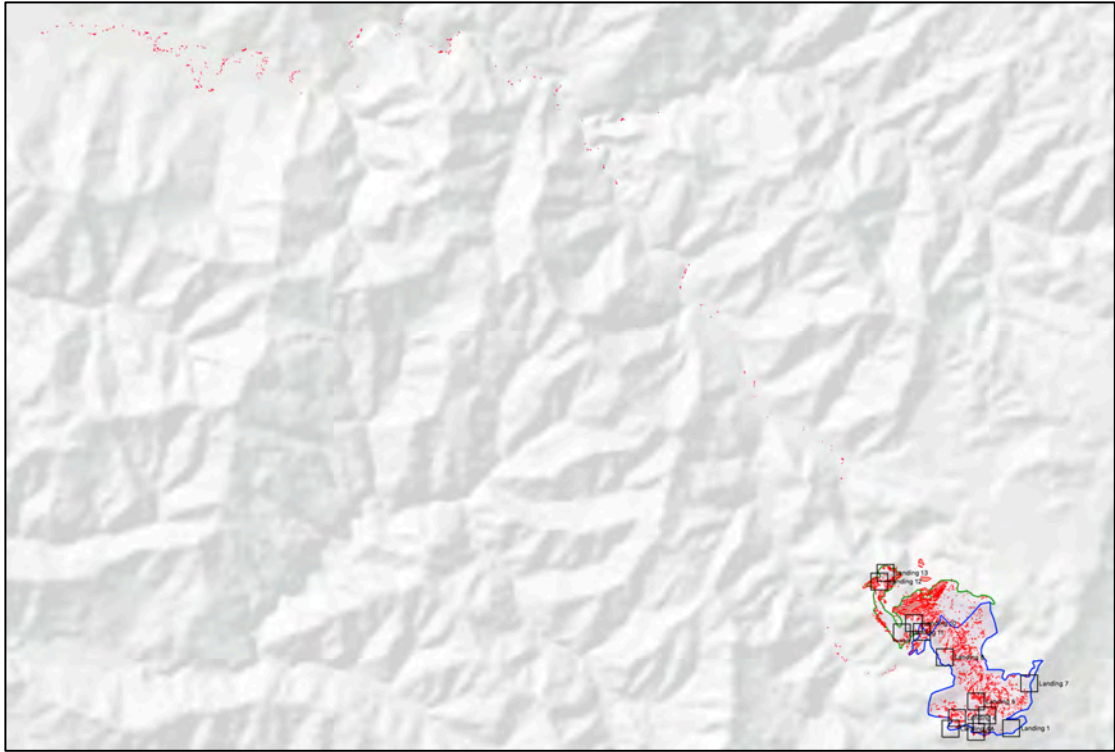
In addition, an area of around 3,812 m<sup>2</sup> (0.3812 Ha) of slash is located between the forest and the end of the high resolution satellite imagery near Kanakania (**Figure Six**). The Waihora River has not been traversed on foot due to the health and safety risk this would pose and as noted is partially in shadow. Thus the area of slash calculated is indicative only and the likely area of slash within the catchment is likely to be of an order of magnitude greater.

**Figure Six.** View of Makiri Forest (bottom right) and the slash debris in the Waihora River downstream of the forest. The larger red circles are the verification sites which were visited on the ground.

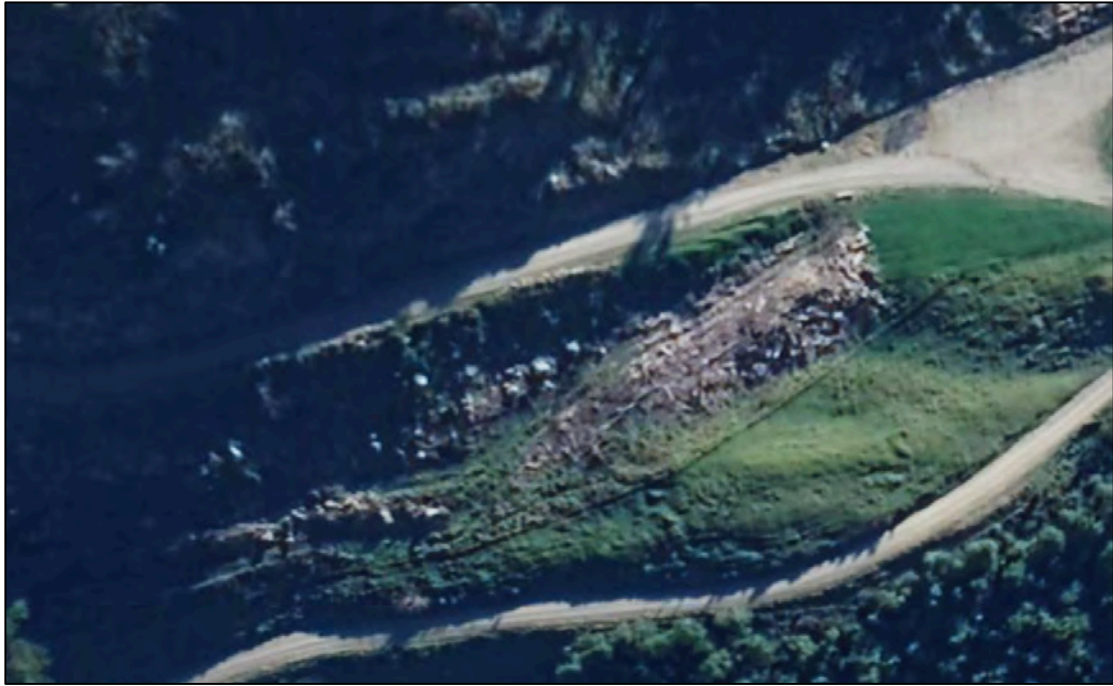
Landing 1 based on the July 13<sup>th</sup> 2018 satellite imagery is shown in **Figure Eight** below. This shows that the harvest practice was to stow harvest waste on the edge of the landing. In this instance, however, despite the significant volume of harvest residues left on the edge the risk of slash migration due to slope failure is minimal (**Figure Nine**).

**Figure Eight.** July 13<sup>th</sup> 2018 satellite image of Landing One, Makiri Forest.

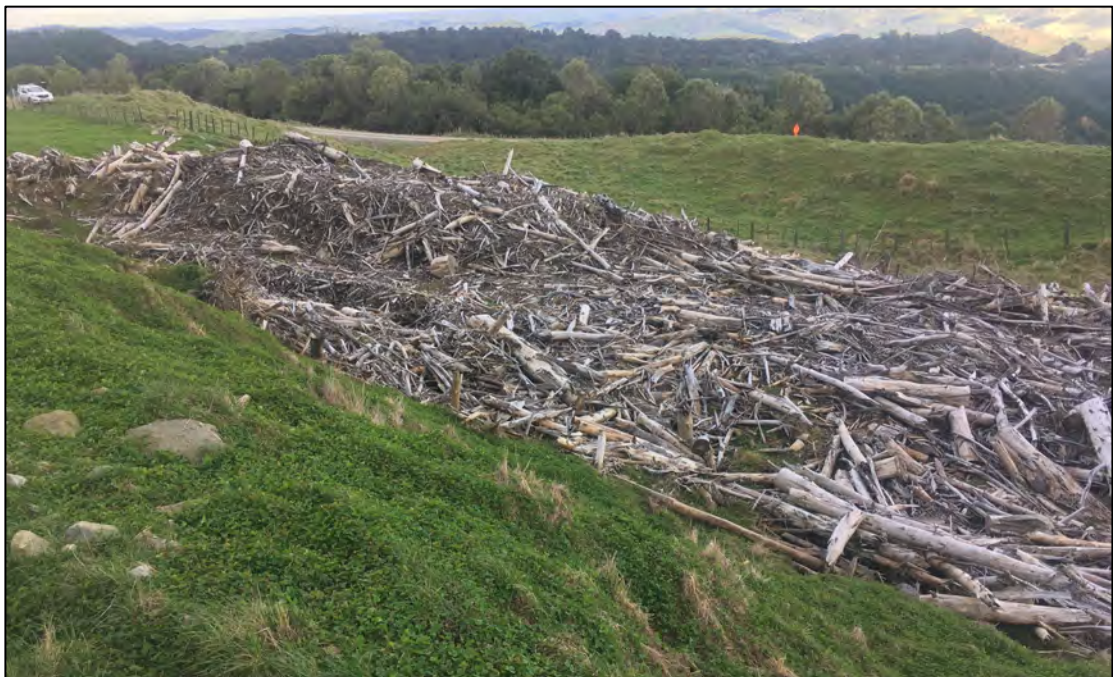
**Figure Nine.** Significant birdnest on the edge of Landing 1. Because of its location there is minimal risk from this site.

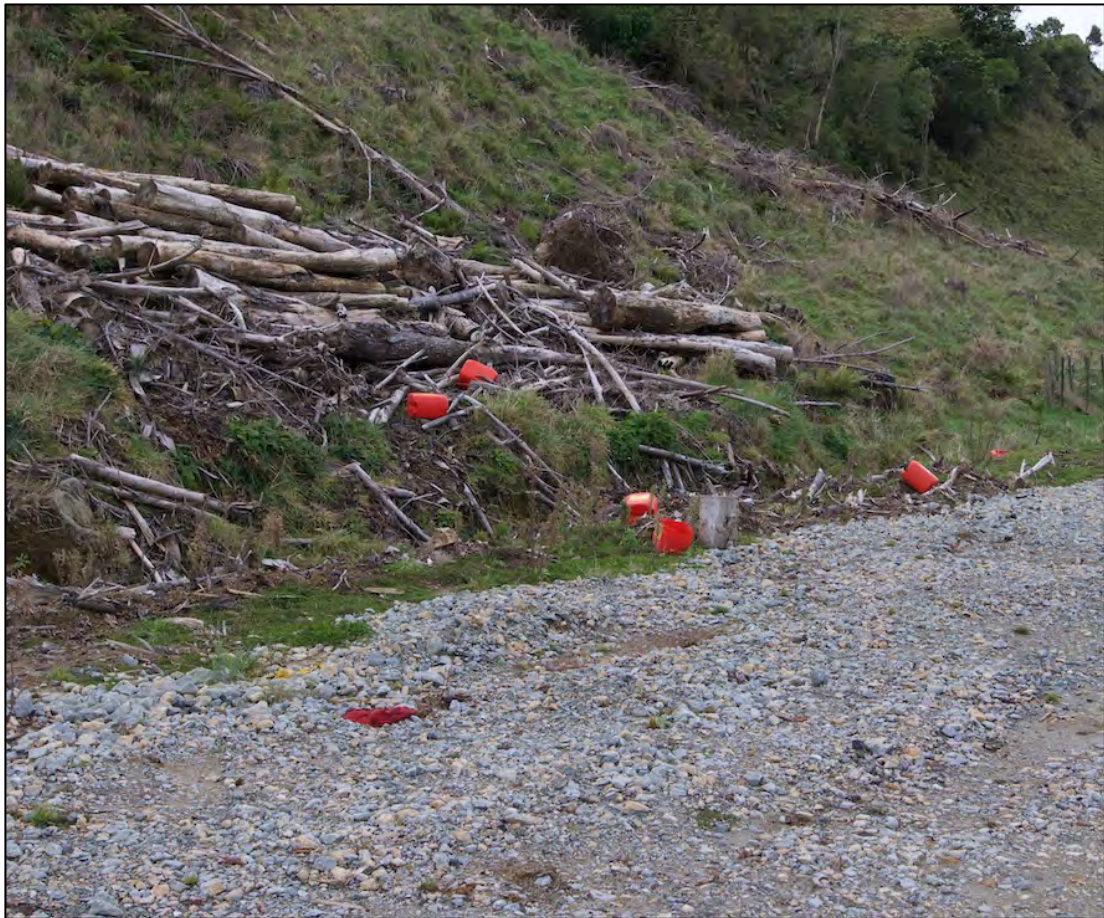
A characteristic observed in Makiri Forest was the poor house-keeping on the site with rubbish that should have been removed scattered on landings and areas adjacent (**Figure Ten**).

**Figure Ten.** Plastic containers abandoned on site adjacent to Landing 1. Similar waste was observed on a number of landings or the edges of roadways.

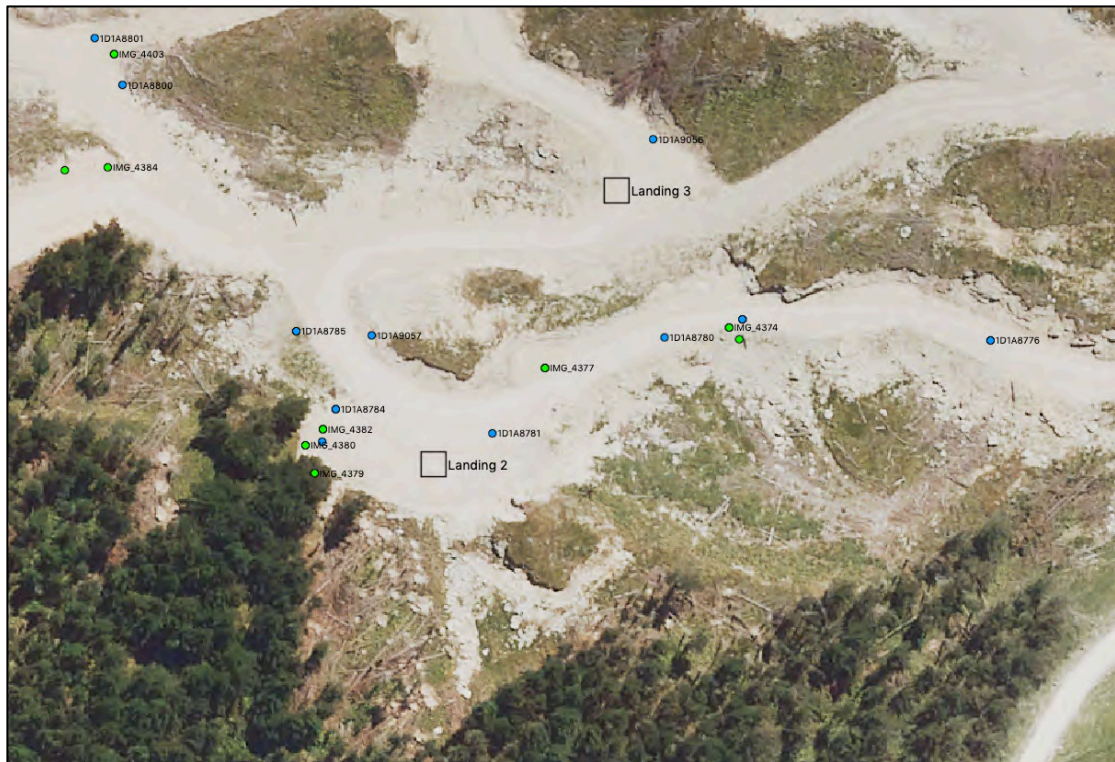
Landings 2 and 3 appear to be small skid sites used as short-term sites for harvesting from the planned roadway and as such the amount of material involved was small (**Figure Eleven**). As such, the overall volumes of slash on the slopes was quite low and the size of opened forest also quite low with slash from landing 2 unable to migrate to farmland below because of remaining un-harvested trees.

**Figure Eleven.** View of landings 2 and 3 showing photo locations and the location of slash on slopes below the site.

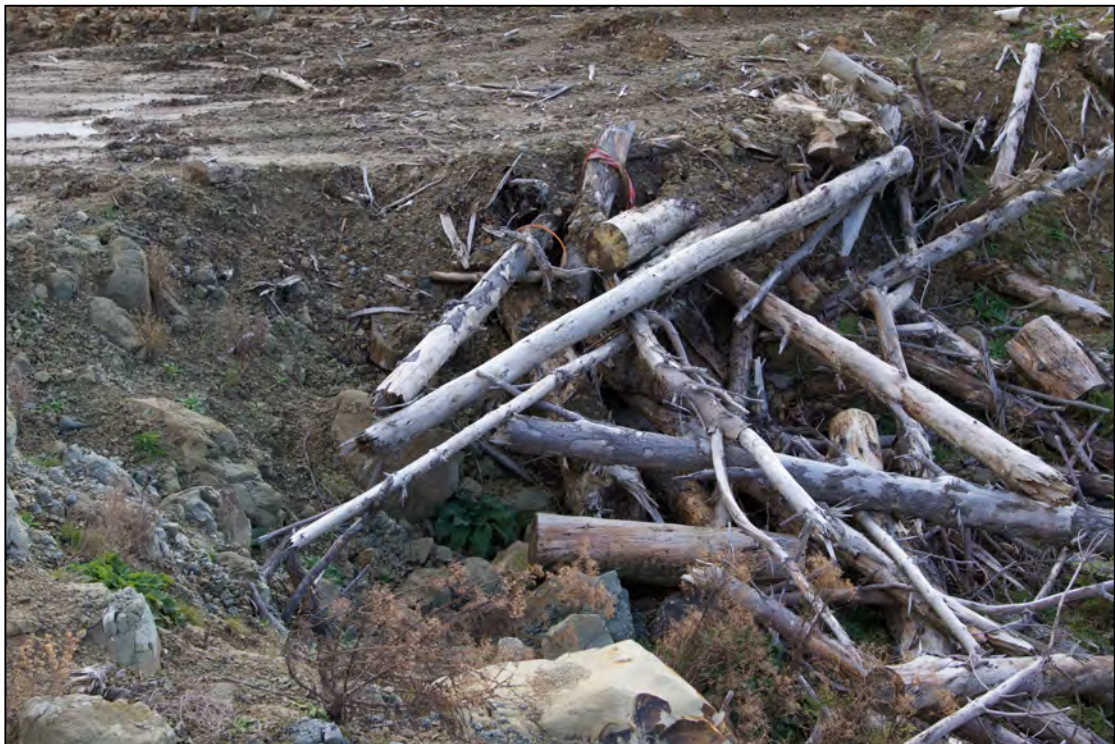
At Landing 3, a gully had been closed off by a road construction with a large culvert installed but this culvert had been largely blocked by logging slash (**Figure Twelve**) and there is further slash stowed in the gully that could exacerbate drainage long term.

**Figure Twelve.** View of gully below Landing 3 slash clogging the culvert.

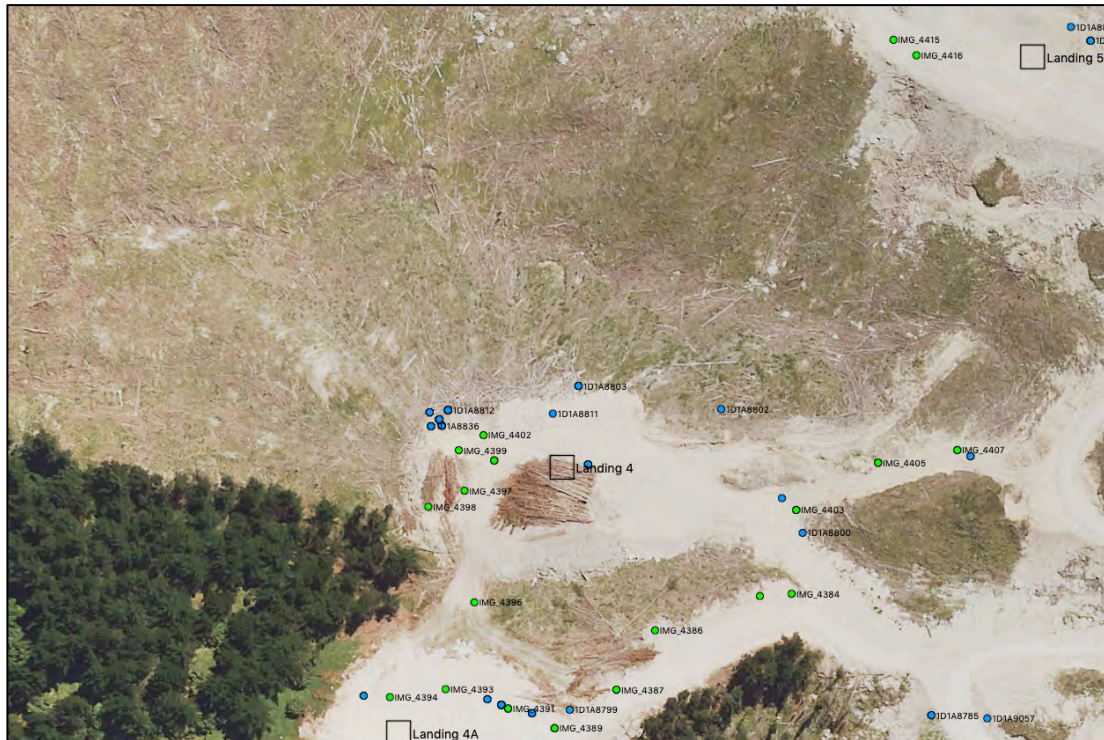
Landing 4 is located immediately north west of Landing 2. This landing was used for full harvest on the adjacent slopes and is characterised by a large slash birdsnest on its northern edge and extensive slash on the slopes below the landing as well as in the watercourse below the site (**Figure Thirteen**).

**Figure Thirteen.** January 2018 aerial photograph of Landing 4, Makiri Forest showing the distribution of slash on the edge of the landing as well as on adjacent slopes. Landing 5 is shown at the top right corner (see **Figure Fourteen**) below. Also shown are the geo-referenced locations and image numbers for the photographs taken on the landing.

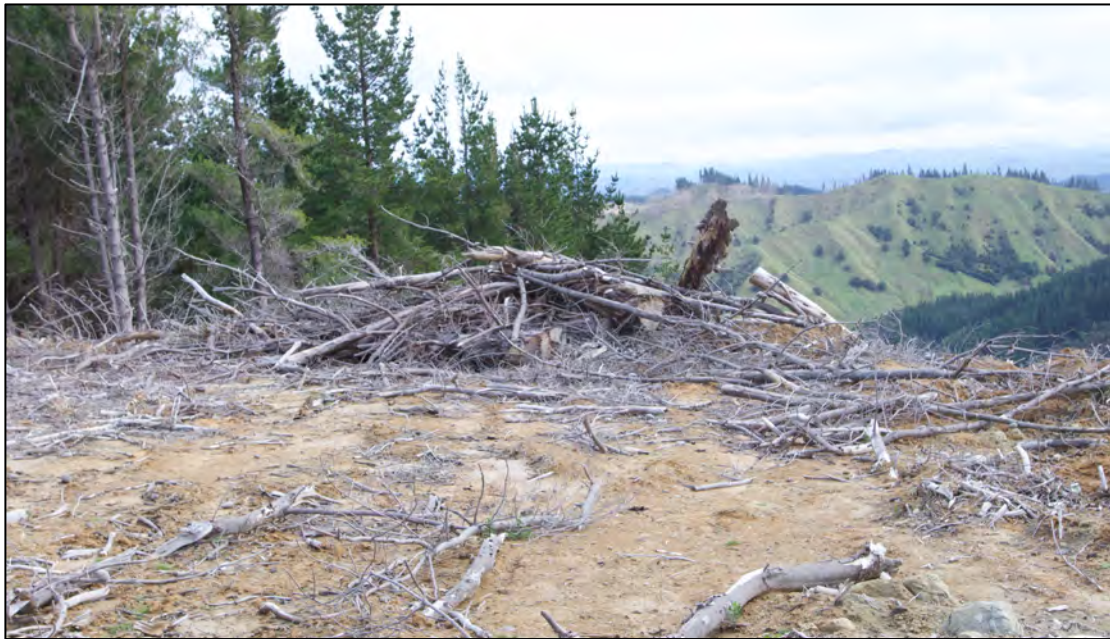
The volumes of slash at Landing 4 is evident in **Figure Fourteen** below which shows the extent of slash on the western end of the skid site. While some of this is relatively narrow diameter harvest waste it also includes a significant number of cut logs as is shown in **Figure Fifteen**. Forest harvest waste is also present on the northern edge of landing 4 where it forms a significant birdsnest (**Figure Sixteen**). Also evident in **Figure Sixteen** are the volumes of harvest waste on the adjacent slopes and below Landing 5 (top right of **Figure Sixteen**).

**Figure Fourteen.** Harvest waste stowed as a birdsnest on the western edge of Landing 4. While a significant amount of the material in this photograph is relatively small diameter slash it also includes cut logs as is shown in **Figure Fifteen** below.

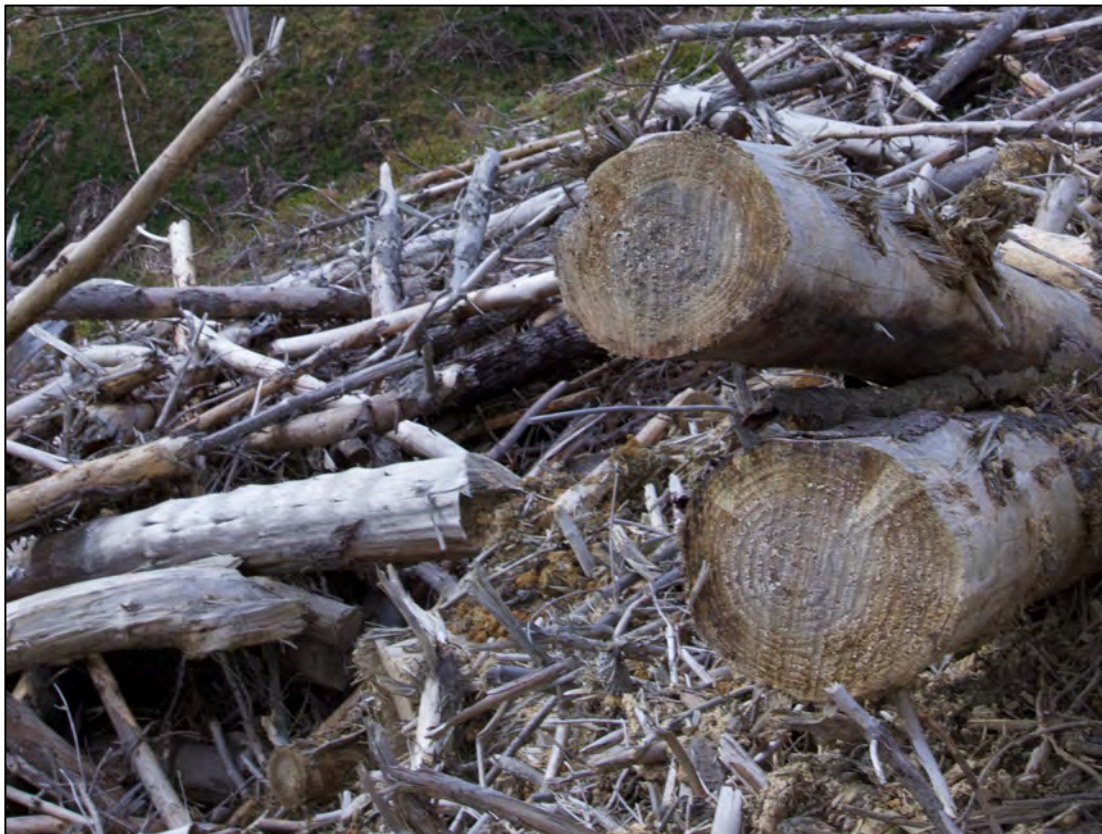
**Figure Fifteen.** View of the birds nest on the western end of landing 4 showing the cut logs incorporated in the debris.

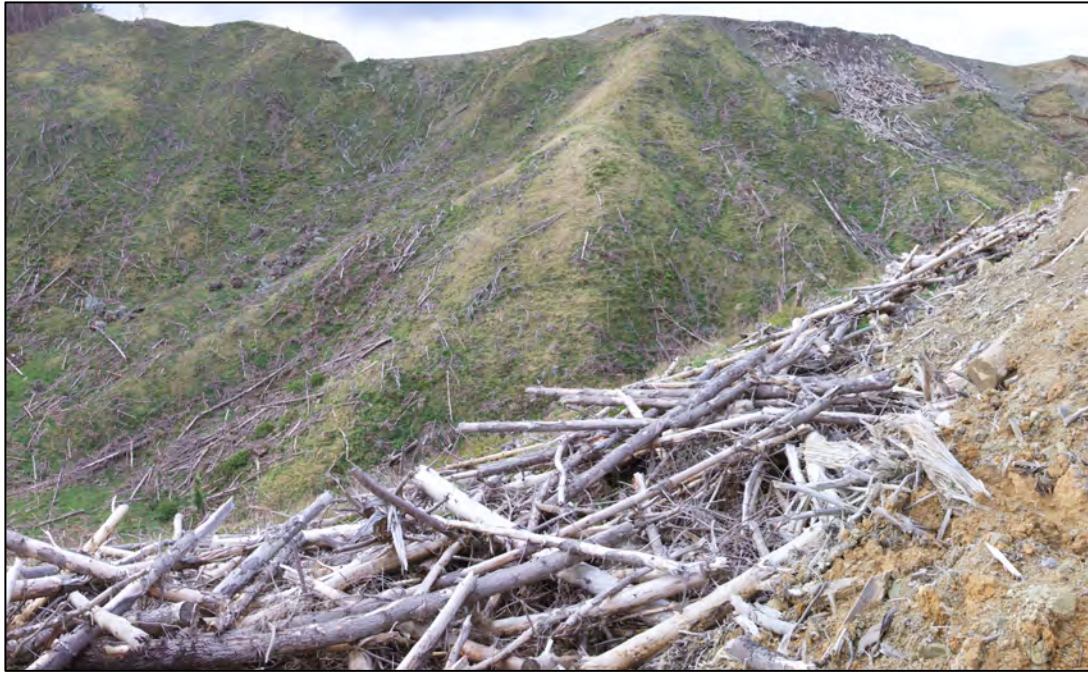
**Figure Sixteen.** View of large birds nest on northern slope immediately below Landing 4. Also evident is a birds nest at landing 5.

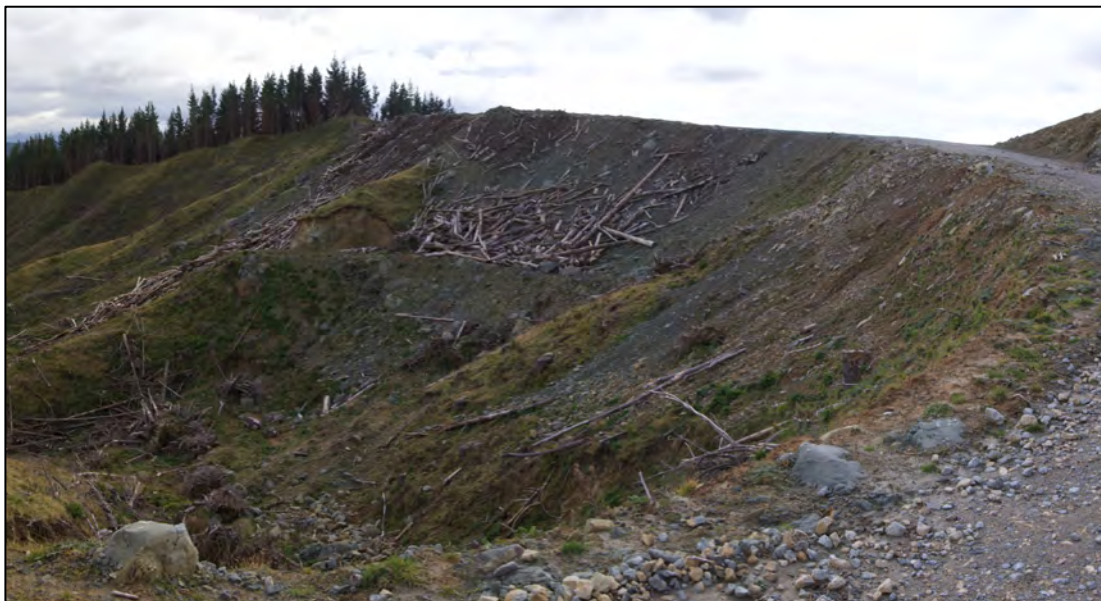
Landing 5 is shown in **Figure Seventeen** below. This shows that the harvest operators have attempted to use a bench to arrest the migration of harvest residues downslope from the landing. As is also evident from both **Figure Seventeen** and **Sixteen**, however, is that any bench if present was ineffective as the harvest residues beyond the bench have migrated downslope despite **Figure Sixteen** showing that the bench extended to as far as that harvest

residue material. Also evident in **Figure Seventeen** are the logs at the base of the gully at bottom left. While such material is often referred to as windthrow, this is clearly not the case as cut ends and de-limbing has clearly occurred.

**Figure Seventeen.** View of Landing 5 from main Makiri forest roadway showing slash accumulation on bench as well as slash that has migrated beyond any bench in the background. Trees discarded during the harvest operation are evident in the foreground at bottom left. The Landing 5 birds-nest shown in **Figure Sixteen** is the same as the background birds-nest in this image. (**Figure Seventeen** is a composite of images 1D1A8844 to 1D1A8848).

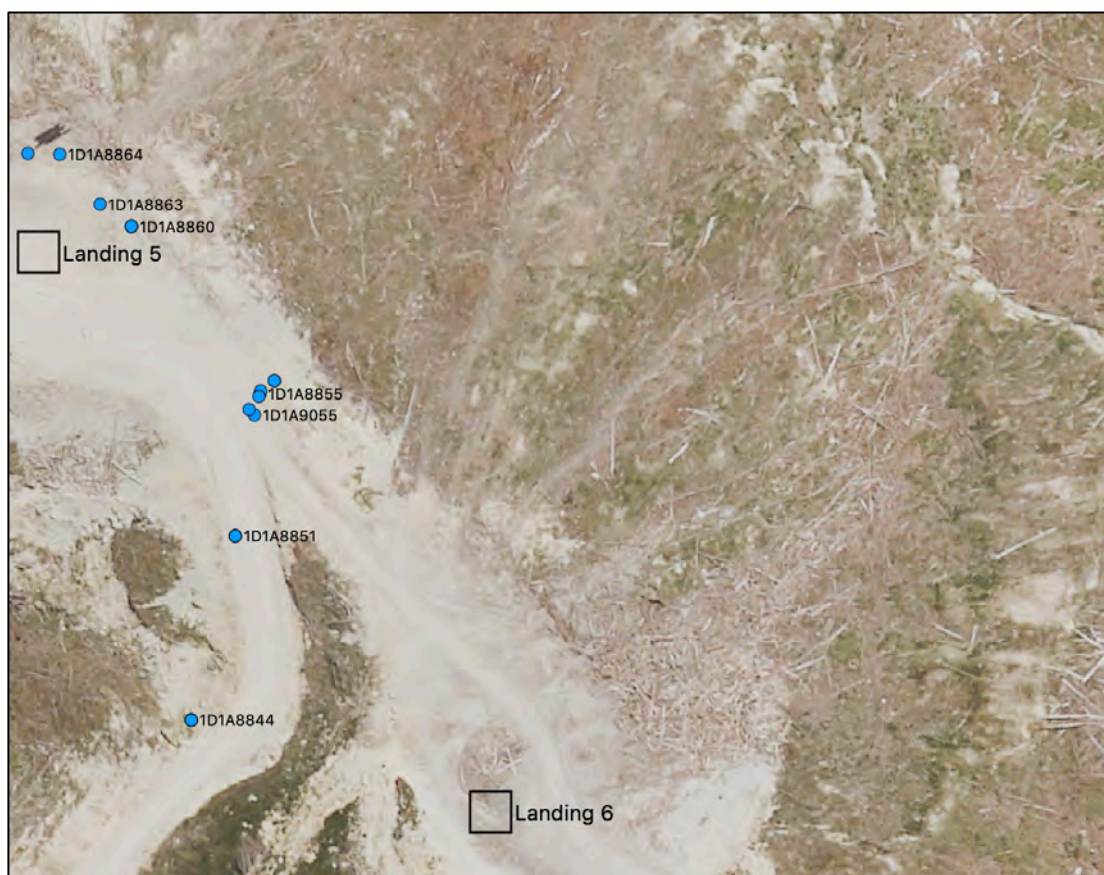
An aerial view of the section of forestry roadway between Landing 5 and Landing 6 is shown in **Figure Eighteen**. As this shows, Landing 6 has a large volume of harvest residue material that has been displaced downslope. The

pre-event aerial imagery (January 2018) suggests that there had been a limited post-harvest attempt to recover slash from the top of the slope after harvest but the bulk of the harvest residues remained beyond the reach of whatever machinery was employed. This remained the case in the 13<sup>th</sup> of July 2018 post-event satellite imagery but a satellite imagery between the end of August and December 2018 suggests that some clean up had been attempted but was largely ineffective as much of the slash was beyond the reach of whatever machinery was used.

**Figure Eighteen.** Aerial view of Landing 6 located south east of Landing 5 in Makiri Forest. Also shown are the geo-referenced locations where photographs were taken (Note that where numerous photographs are taken at one site the GIS does not show all photographic version numbers).

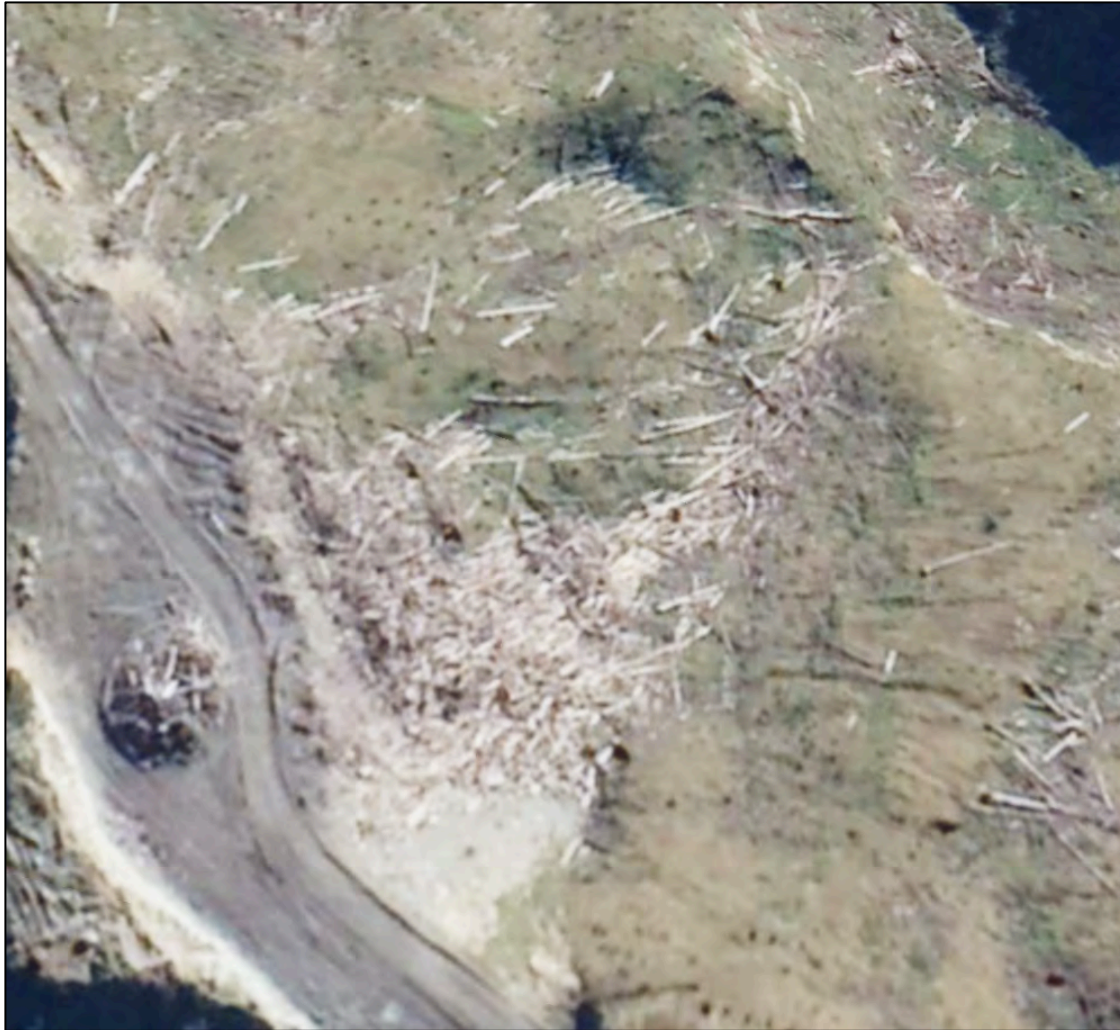
The same landing dated 13<sup>th</sup> July 2018 after the Queens Birthday storms is shown in **Figure Nineteen** below. As this image is based on satellite imagery it looks texturally different from the aerial imagery in **Figure Eighteen** but essentially shows the same story. The birds-nest at the edge of Landing Six is well evident as is the tail of slash distributed down the slope below the landing.

**Figure Nineteen.** 13<sup>th</sup> July 2018 satellite view of Landing 6 located south east of Landing 5 in Makiri Forest. This suggests that no landslide occurred at this particular site during the Queens Birthday or 11-12<sup>th</sup> June storms but there is a significant amount of slash that has migrated downslope from the landing and entered the watercourse at top right.

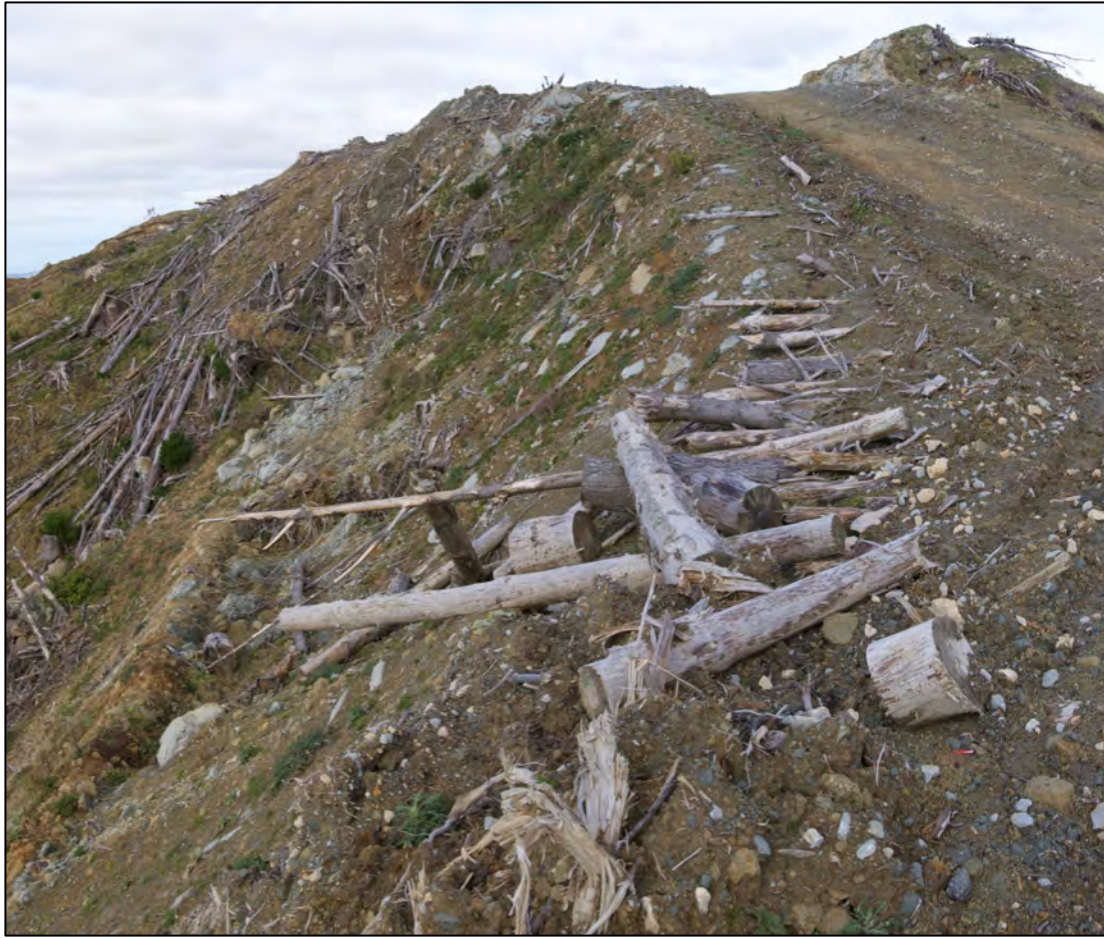
The use of corduroy logs to support the roadway between Landing 5 and 6 as shown in **Figure Twenty** below is significant. While this can be an effective short-term measure to provide support for operations, its stability long-term is constrained.

Corduroy support for roadways are prone to settling and water infiltration as the logs start to deteriorate and the logs move under the weight of machinery. In this instance a single log has been driven into the fill below the corduroy to help maintain stability but this has begun to rotate outwards indicating subsidence of the fill on the slope.

**Figure Twenty.** *Use of corduroy west of Landing 6 (in background). Use of such corduroy is not an effective long term means of supporting the roadway and in this instance a log has been driven into the fill slope below in an attempt to improve support but this has started to rotate downslope. Note the present of slovens mixed up with the corduroy. The loss of harvest residues downslope at Landing 6 is evident in the background.*

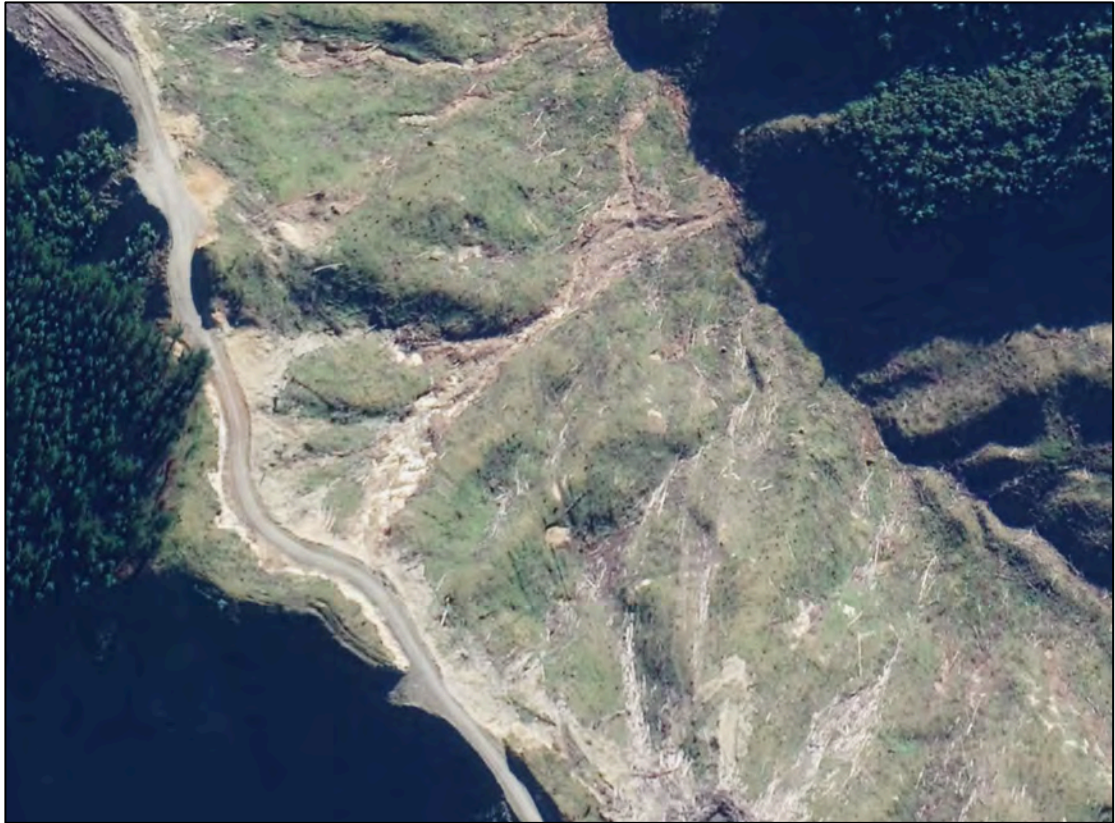
Significant slope failures and slash migration to the creek bed north of Makiri West Road is evident between Landings 5 and 8 based on 13<sup>th</sup> July 2018 satellite imagery (**Figures Twenty One and Twenty Two**). There is no indication of this slash migration or the slope failure in satellite imagery immediately pre-dating the Queens Birthday and 11-12<sup>th</sup> June storms (17<sup>th</sup> May 2018). In **Figure Twenty Two**, Two large clusters of harvest residues are evident in the creek at and immediately below the slope failure shown in **Figure Twenty One**.

**Figure Twenty One.** View of the slope north east of Makiri West Road showing extensive slash distributed on the slopes between Landings 5 and 8. Two clusters of slash in the creek bed are evident at the top of the image (13<sup>th</sup> July 2018 satellite). These two clusters are more evident of **Figure Twenty Two** below.

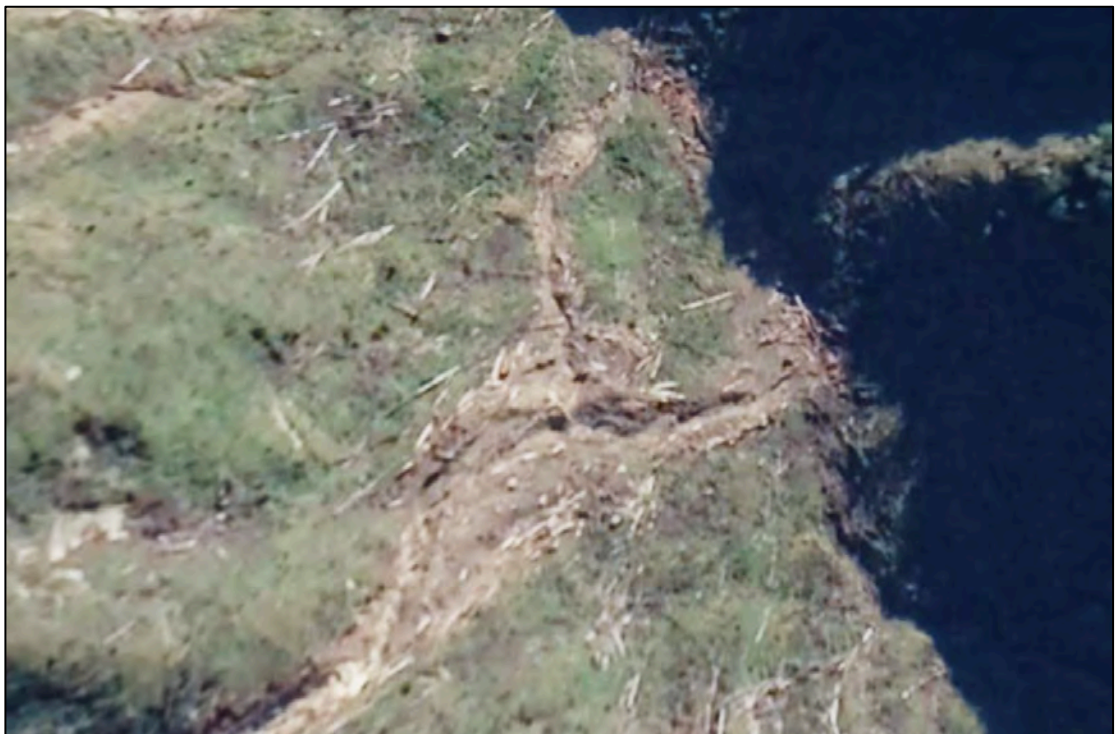
**Figure Twenty Two.** Detail of Figure Nineteen above showing the slash on the slope and in two clusters in the creek (13<sup>th</sup> July 2018). This slash and the clusters is not evident in the immediate pre-event imagery.

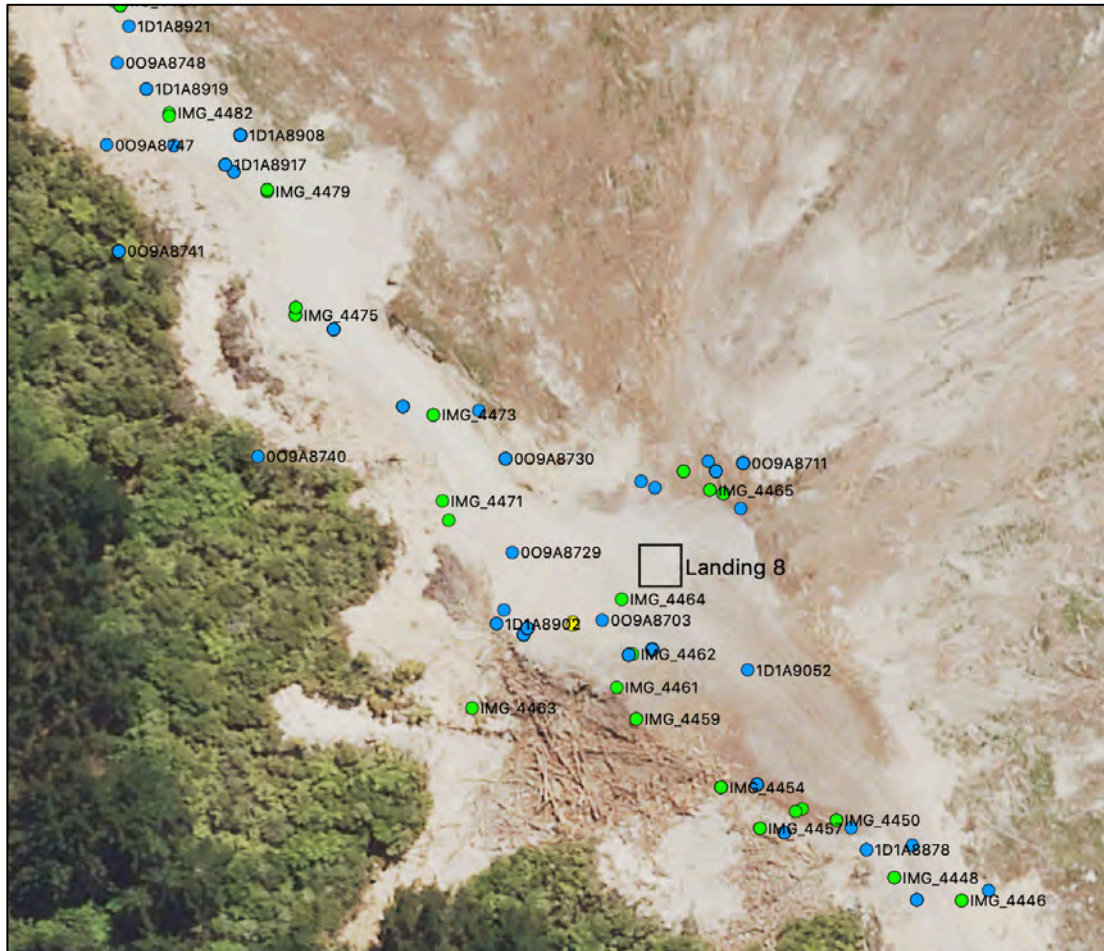
Landing 8 is located west of Landing 5 on Makiri West Road (see **Figure Seven**) Landing 8 was used to harvest logs from the north side of Makiri West Road is significant as it has experienced significant failure during the event. This Landing and the extensive photographs taken at and adjacent to the site are shown in **Figure Twenty Three** below.

**Figure Twenty Three.** January 2018 aerial image of Landing 8 showing the location of the many geo-referenced photographs taken in the vicinity of the Landing and the harvest residues that have collapsed.

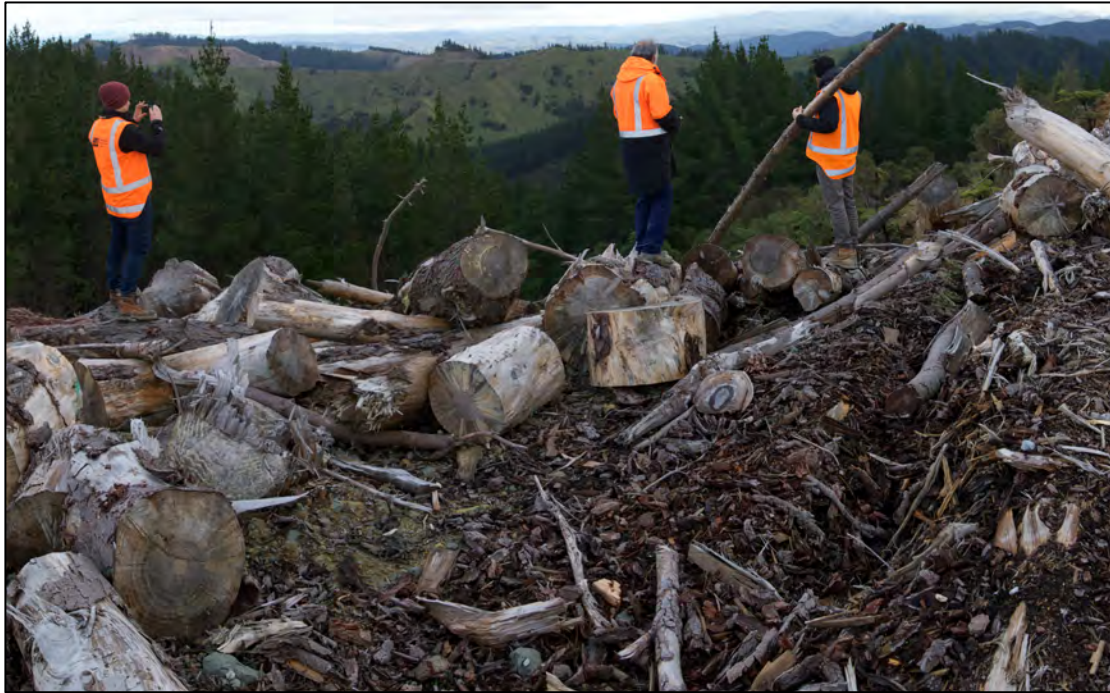
This site was characterised by the presence of a substantial birdsnest on the south western side. This comprised of harvest residues which includes dross (Waratah waste), slovens (short cut ends), and cut logs. Also evident at this site was a substantial tension crack (**Figure Twenty Four**). A wider view of the site is shown in **Figure Twenty Five**. This shows an obvious bench which has clearly failed. Comparison between satellite imagery dated 17<sup>th</sup> May 2018 (pre-event) and 13<sup>th</sup> July 2018 (post-event) shows that the failure occurred between the two dates. **Figure Twenty Five** also shows the steepness of the slope at the birdsnest and an apron of slash on the slope below the landing.

**Figure Twenty Four.** View of the birdsnest at Landing 8 showing the dross, slovens, cut logs and obvious tension crack at the right side of the photo.

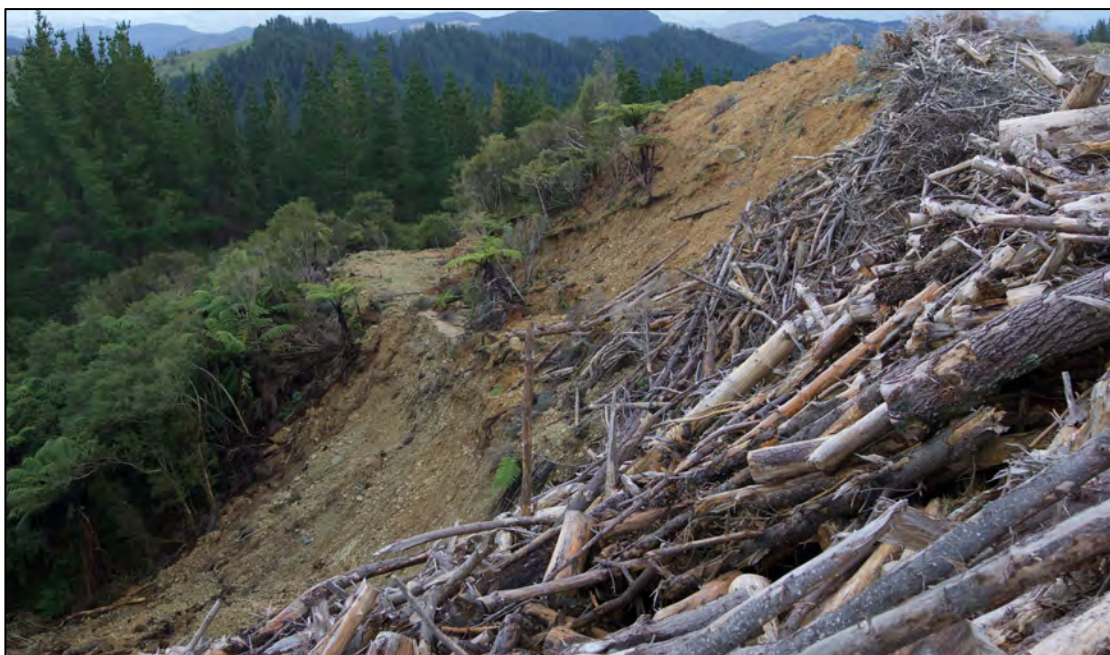
**Figure Twenty Five.** View of the south western side of Landing 8 looking west showing a failed bench in the middle ground and the slash apron extending down slope to the south.

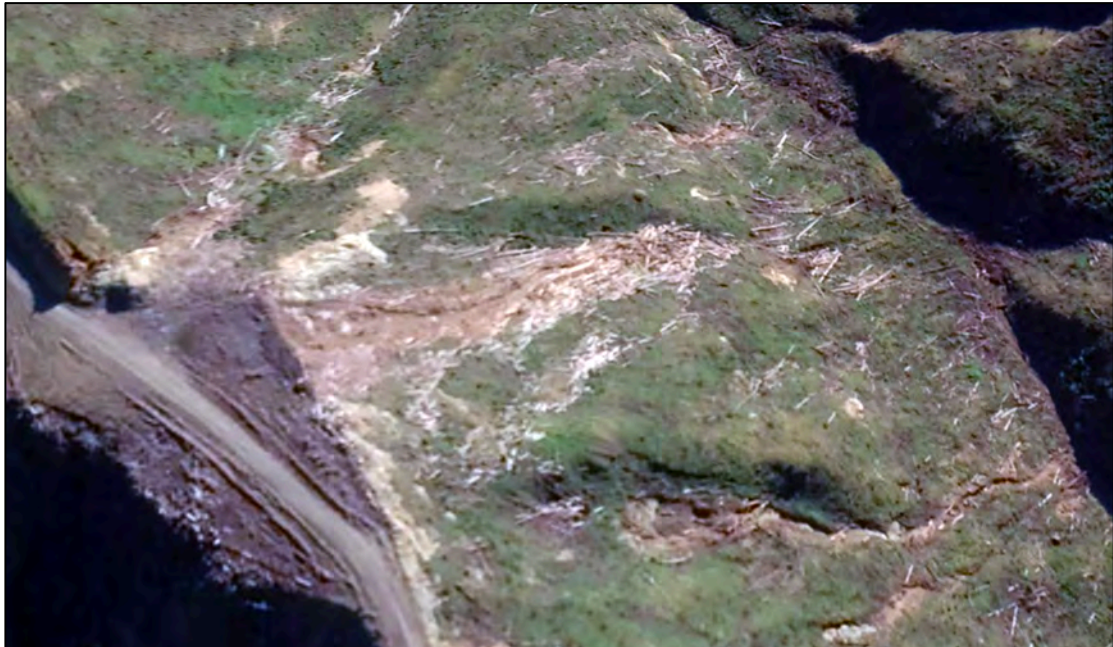
**Figure Twenty Six.** Satellite image of Landing 8 Makiri Forest dated 13<sup>th</sup> July 2018 (post Queens Birthday storms) showing the landing collapse on the northern eastern side with a significant volume of harvest waste collected on the slope as well as in the top of the tributary of the Waihora river (top right of image).
