**Forestry Harvest Residues  
on slopes in Makiri Forest  
and in the Upper Waipaoa Catchment  
after the Storm of 11<sup>th</sup>-12<sup>th</sup> June 2018**

**M.P Cave  
Principal Scientist  
Gisborne District Council**

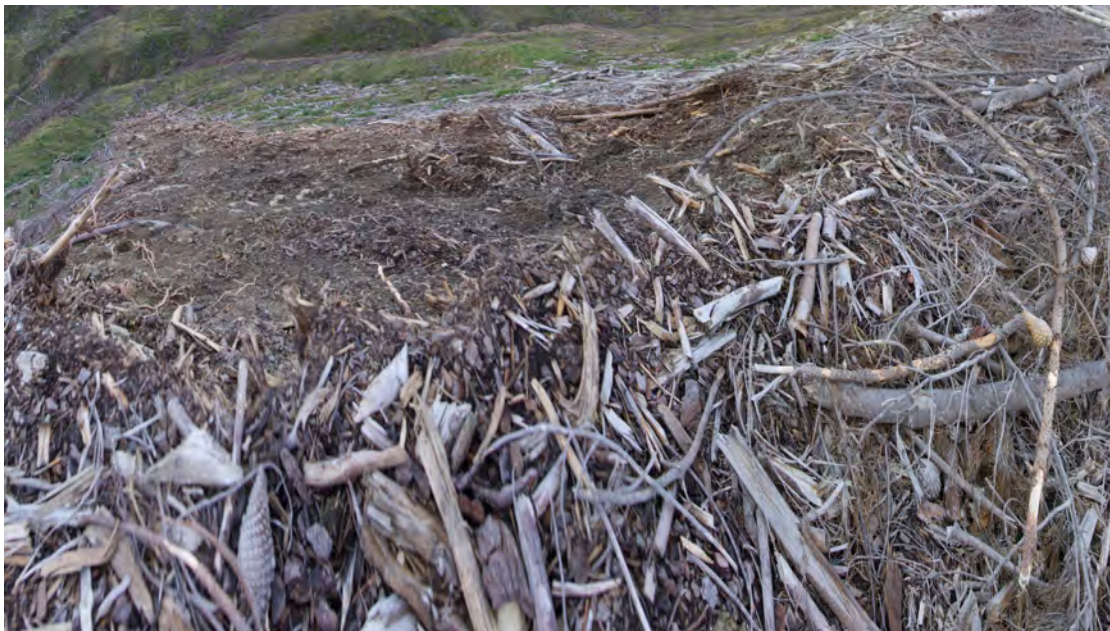
**Figure Twenty Seven.** View of the north eastern side of Landing 8 Makiri Forest showing the landing collapse with a significant volume of harvest waste displaced down the slope and also showing considerable harvest waste in the water course below.

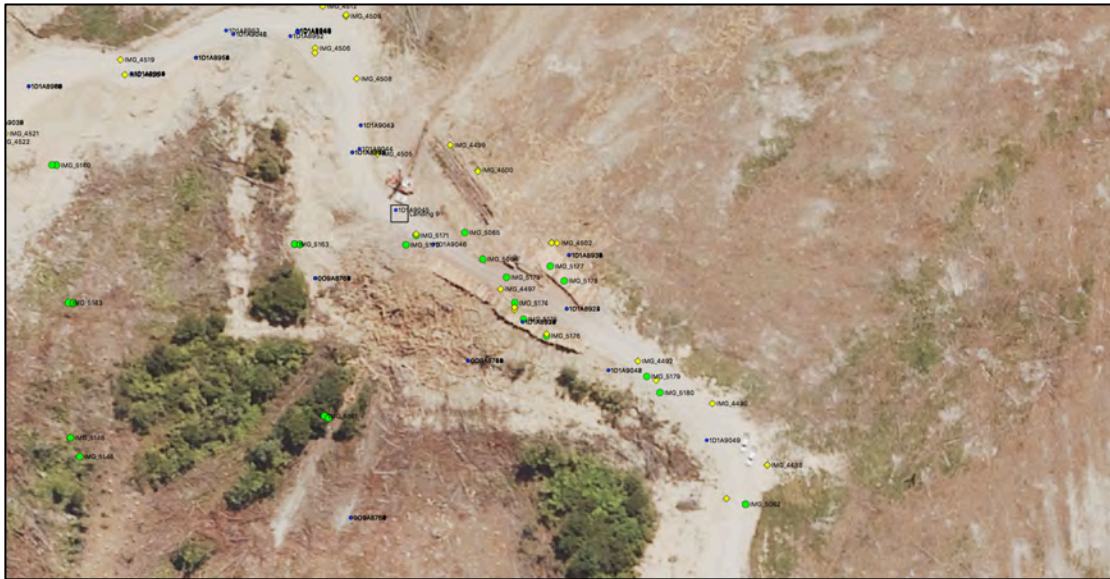
**Figure Twenty Eight.** View of Landing 9, Makiri Forest (12<sup>th</sup> December 2017) during active harvesting showing the birds nest of harvest waste immediately south-west of the landing and a significant volume of harvest waste scattered on the slope to the north-east. Also shown are the locations where photographs were taken on site.

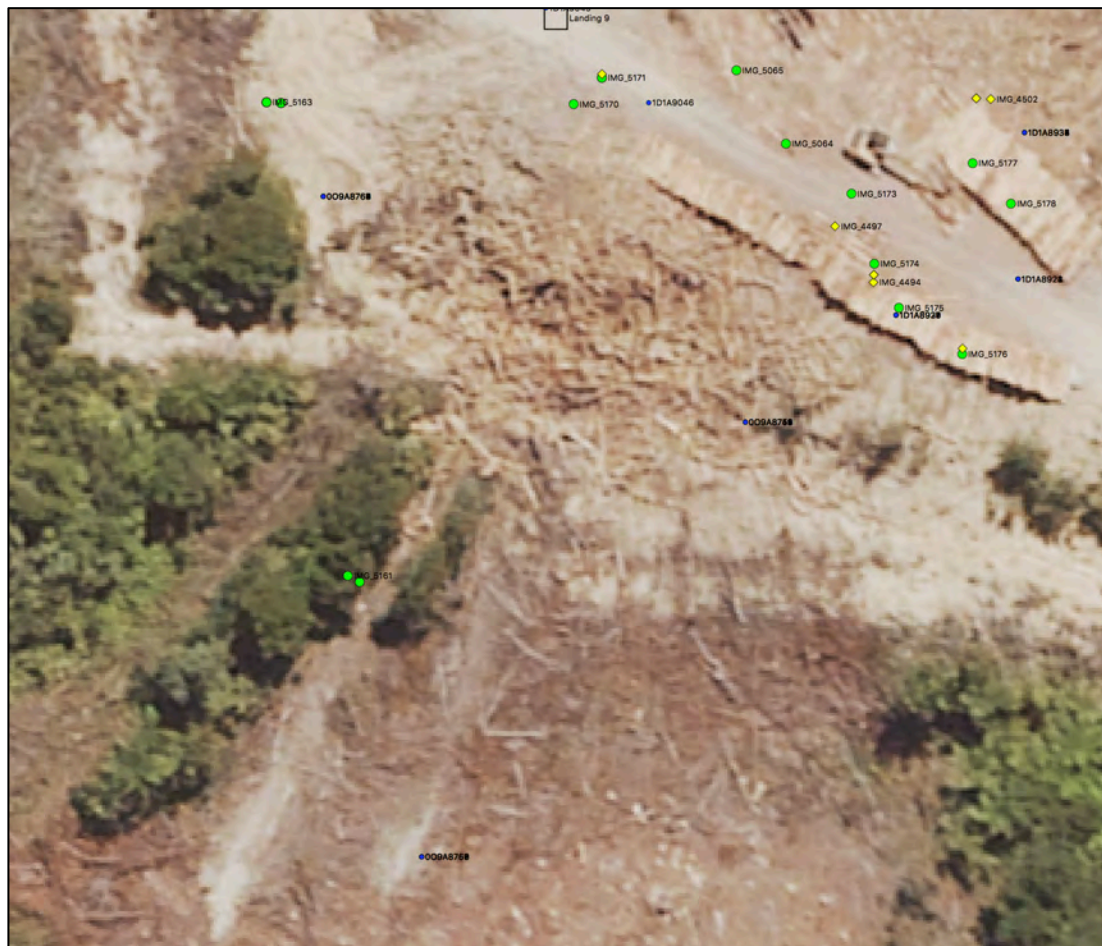
A closer look at the same image suggests that a bench was constructed to capture the harvest waste (**Figure Twenty Nine**), but this bench was ineffective however, as harvest waste can be seen distributed below the bench. There are also two small landslides that have been generated from the harvest waste below the bench. As was the case with Landing 8, considerable volumes of merchantable timber had been stacked on top of harvest waste at the edge of the landing (see Cave 2019, **Figure Thirty**). This is a risky practice as the loading on the landing edge can result in a slope failure if the loading forces exceed the strength of the materials on the landing edge. This risk is exacerbated if the ground becomes saturated after heavy rain.

**Figure Twenty Nine.** Detailed view of Landing 9 dated 12<sup>th</sup> December 2017 showing the merchantable logs stowed on the edge of the landing, the ineffectiveness of the bench in preventing migration of harvest waste and the presence of small slips below the bench.

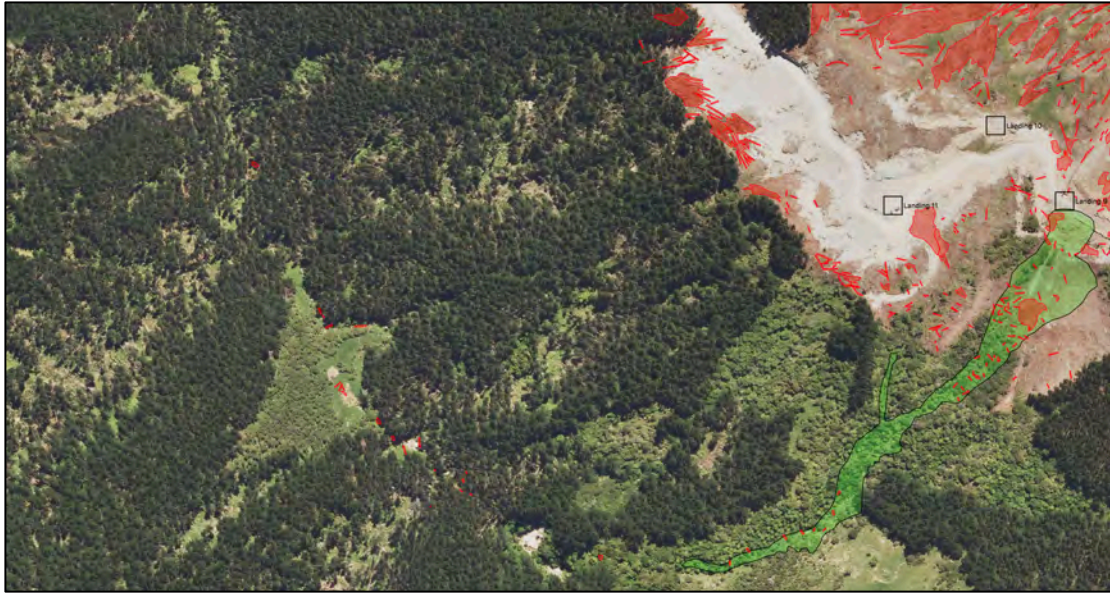
The migration of harvest waste down slope to the south-west from Landing 9 is shown in **Figure Thirty** below. This image overlays the position of the harvest waste from the 13<sup>th</sup> July 2018 on the 12<sup>th</sup> December 2017 aerial imagery. Also shown is the outline of the slope failure that postdates the December 2017 imagery.

**Figure Thirty.** View of the area south-west of Landing 9 showing the position of harvest waste that has migrated into the true left tributary of the Waihora River (red) and the outline of the slope failure from the 13<sup>th</sup> July 2018 satellite imagery plotted onto the 12<sup>th</sup> December 2017 aerial imagery.

5. The most significant failure and the one that resulted in the loss of the majority of the harvest residues that had been stored on site was Landing 9 which had a debris flow travel at least 550 metres down into the true left tributary of the Waihora Stream.

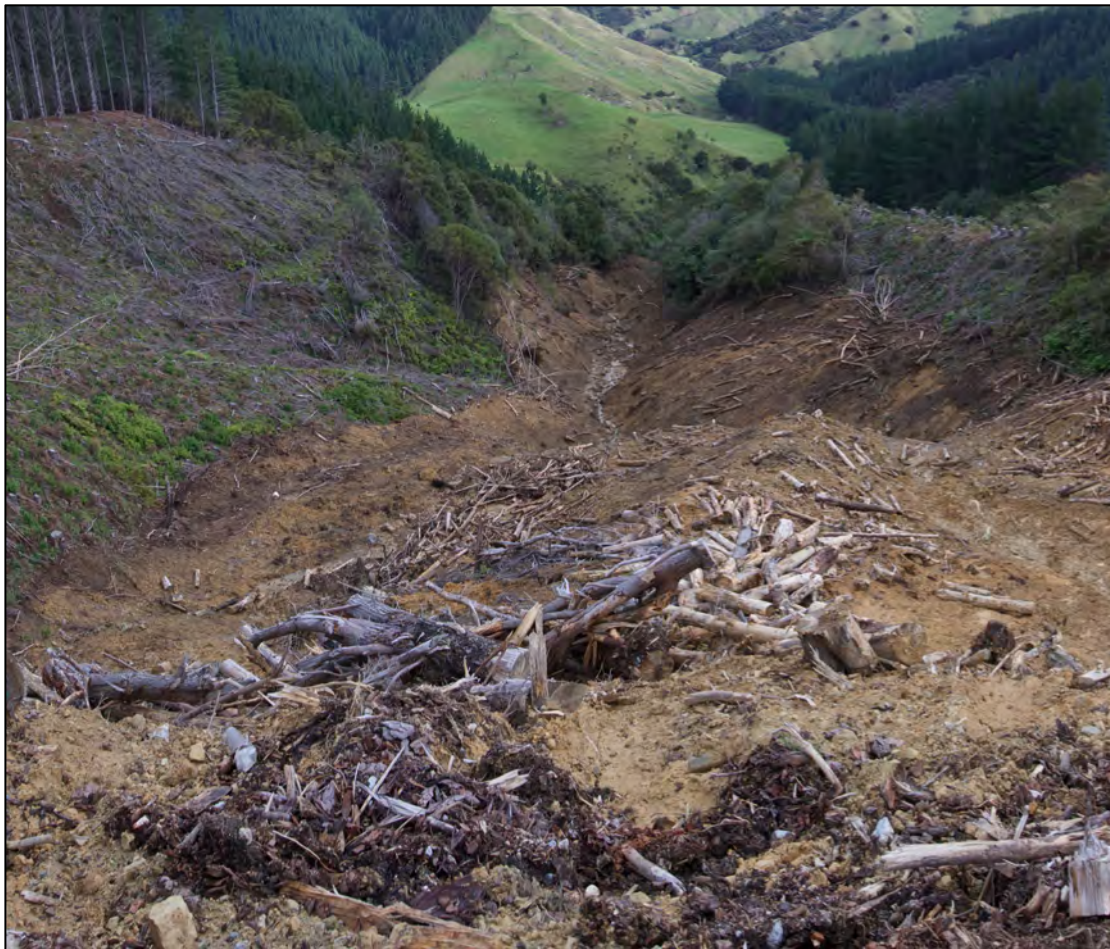
This image shows that the slope failure has the characteristics of a high-energy debris flow with logs perched high on the slope aligned with flow direction and obvious trim lines. In addition, the amount of harvest waste visible is considerably less than would be expected based on the pre Queens Birthday storms aerial imagery (December 2017) which shows a significant amount of slash in a birds-nest perched on the south-western slope. This indicates that the debris flow has allowed much of the slash to migrate further down the catchment.

**Figure Thirty One.** Composite image (photographs 1D1A8928 to 1D1A8930) south-west of Landing 9 showing the path of the debris flow and the pronounced trimlines of the debris flow edge. Only a remnant of the birds-nest identifiable in the 12<sup>th</sup> December 2017 aerial image remains.

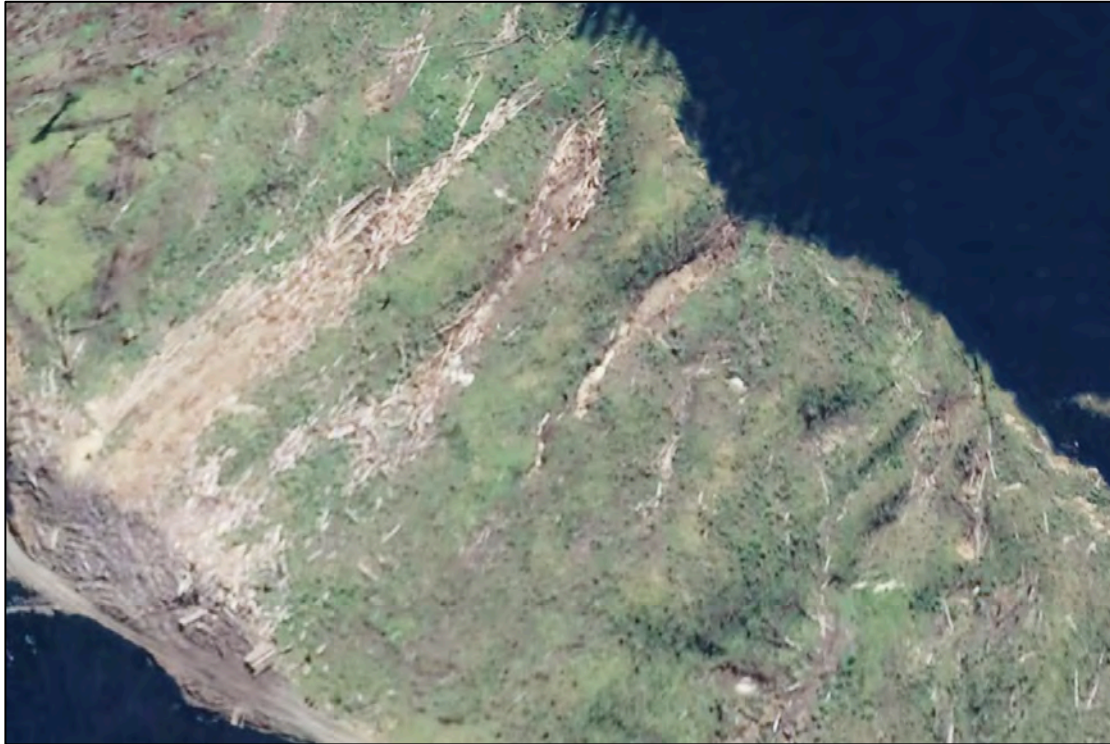
Harvest waste was also shed onto the slope north east of Landing 9 as indicated in the 13<sup>th</sup> July 2018 satellite imagery (**Figure Thirty Two**). Comparison of the May and July 2018 satellite imagery shows that the obvious slope failure on the north-east side occurred after the 17<sup>th</sup> of May 2018. The watercourse is in shadow in **Figure Thirty Two** but **Figure Thirty Three** shows the presence of harvest waste in the watercourse.

**Figure Thirty Two.** View of the north-east side of Landing 9 (13<sup>th</sup> July 2018 satellite ) showing the remnant birds-nest (bottom left) and the mobilization of harvest waste down slope.

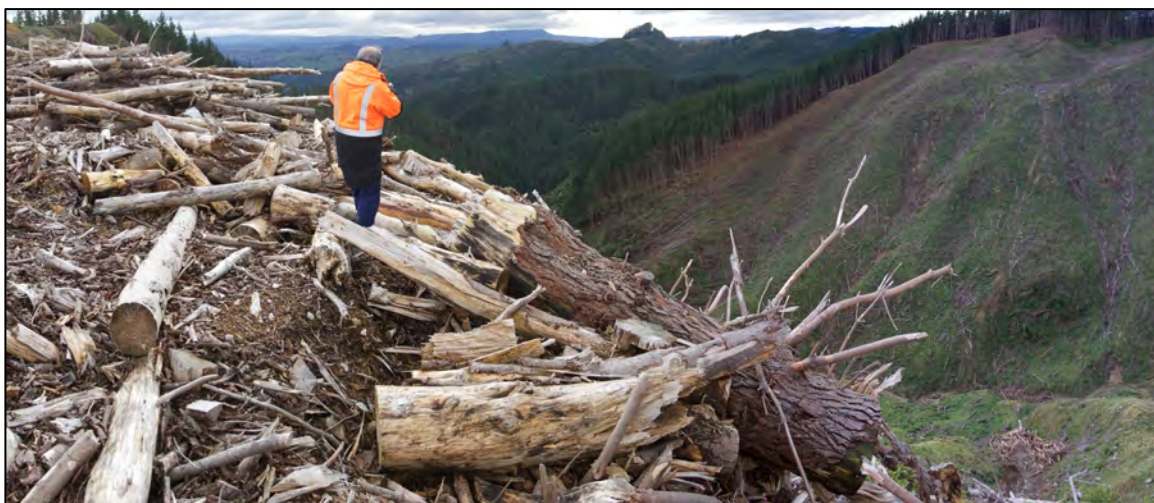
**Figure Thirty Three.** View of the north-east side of landing 9 (composite image 1D1A8933 to 1D1A8938) showing the remnant birds-nest. On the left of the large cut log on the far left a tension crack has developed. The base of the debris flow of harvest waste is evident on bottom right while the presence of harvest waste in the watercourse is also obvious.

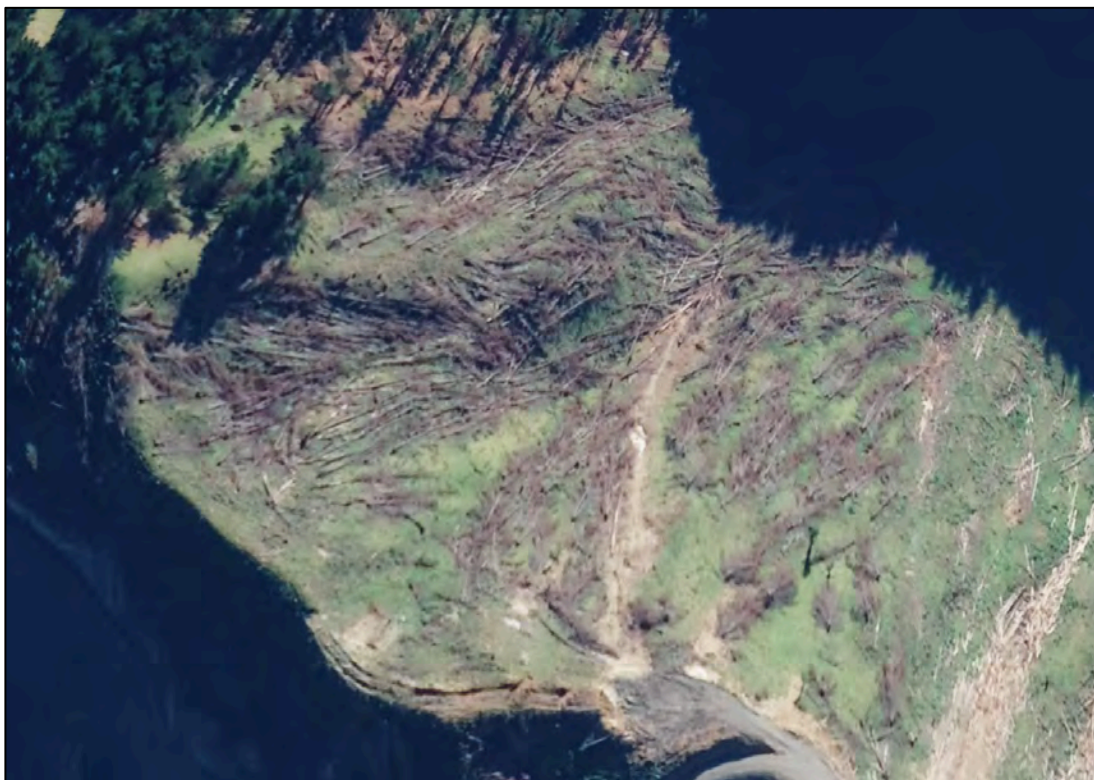
**Figure Thirty Four.** View of the northern side of Landing 10 showing the abandoned felled trees and the narrow debris-flow which has mobilised some trees on the slope 13<sup>th</sup> July 2018). Because of shadow this satellite image does not show whether or not the felled trees reached the watercourse.

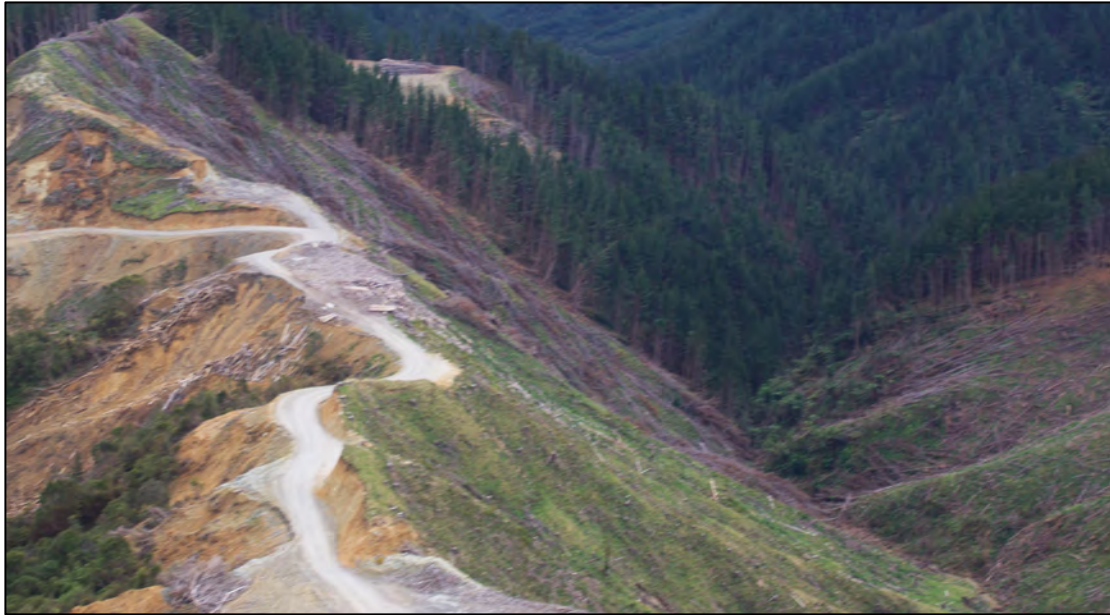
**Figure Thirty Five.** View of the northern side of Landing 10 showing the abandoned felled trees on the slope as well as in the watercourse. (Photograph 009A8487 7<sup>th</sup> July 2018 oblique aerial image).

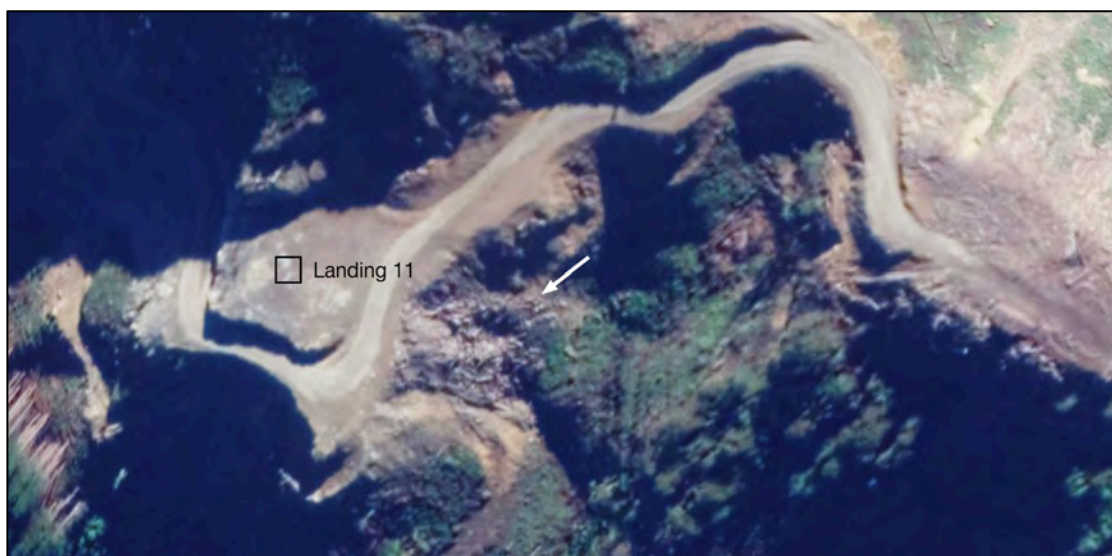
**Figure Thirty Six.** Satellite image (17<sup>th</sup> May 2018) of Landing 11 showing the harvest residues immediately below Makiri West Road.

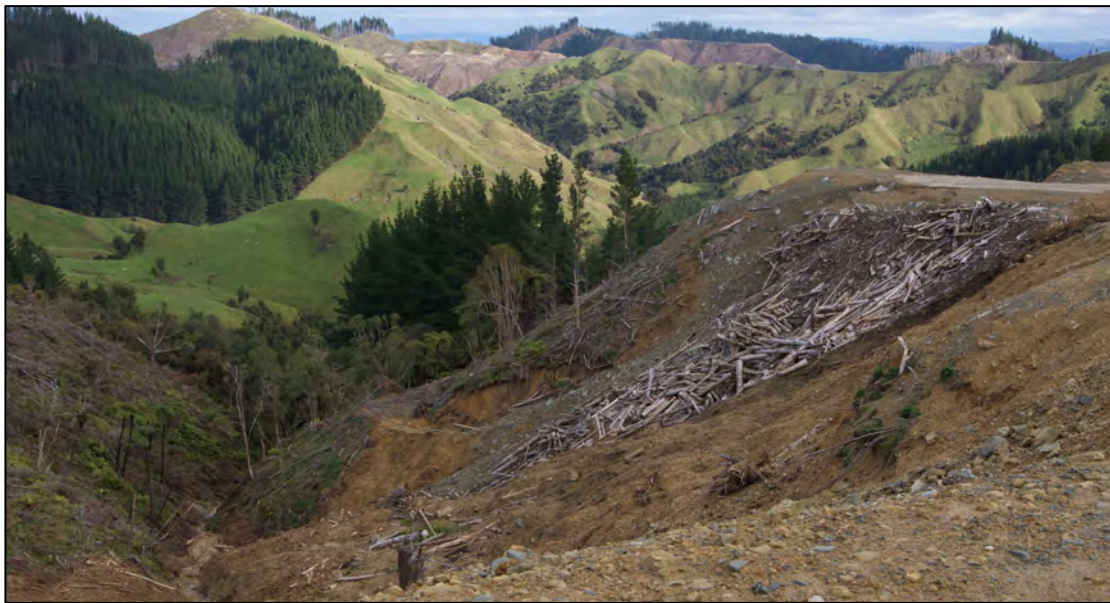
This landing was inspected on the ground by council officers on the 10<sup>th</sup> of July 2018 which confirmed the presence of a significant volume harvest residues as well as a debris flow originating at the site (**Figure Thirty Seven**). A closer examination showed that the birds-nest appeared to be sitting on a bed made up of corduroy logs (**Figure Thirty Eight**) but this has been undermined by a debris flow that resulted from a slope failure from the opposite site of the landing (**Figure Thirty Nine**).

**Figure Thirty Seven.** View looking west to the harvest residues at Landing 11. Also evident was a bench which does not appear to extend to the base of the birds-nest. Also evident is an expansive area lacking any vegetation cover and logs in the creek bed below the birds-nest.

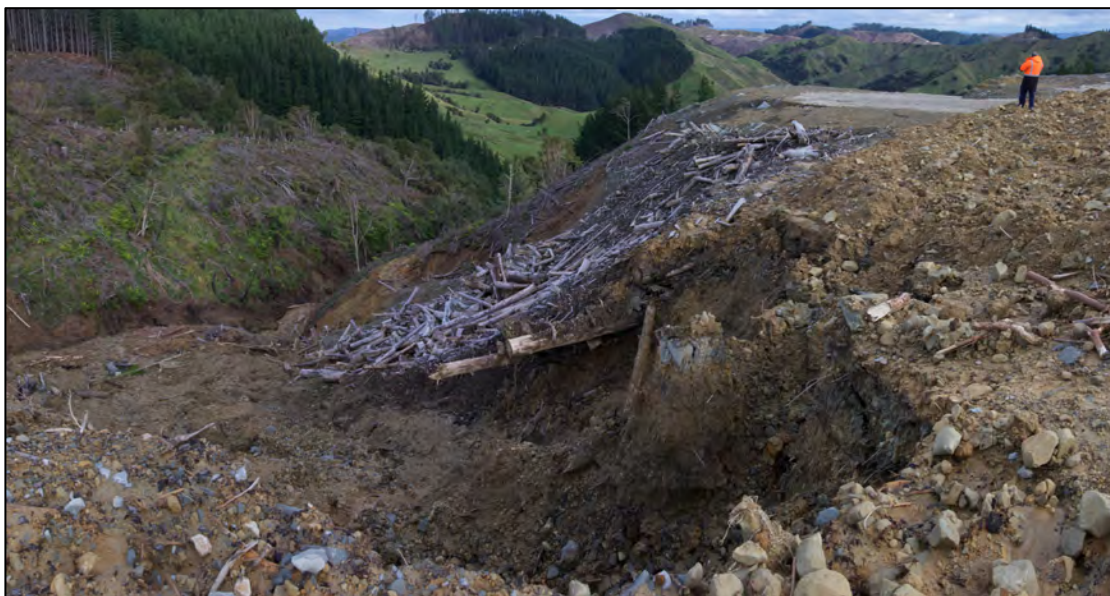
**Figure Thirty Eight.** View looking west to the harvest residues at Landing 11 showing the slash supported by corduroy logs. Also visible is the trimline for the debris flow from the site. This may have been a retaining wall of logs that has failed.

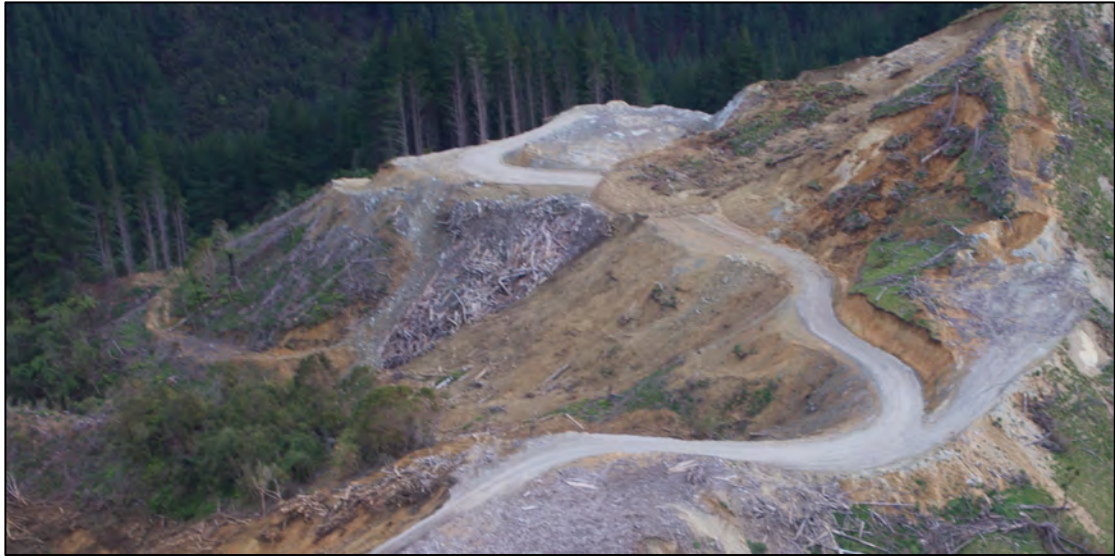
**Figure Thirty Nine.** View of Landing 11 (with Landing 9 at the bottom of the image and Landing 10 at far right) showing the failure from the top of the slope (top right) crossing the road. The edge of the debris apron for this event does not appear to have extended beyond the birds-nest but may have triggered a slope failure at the edge of the birds-nest.

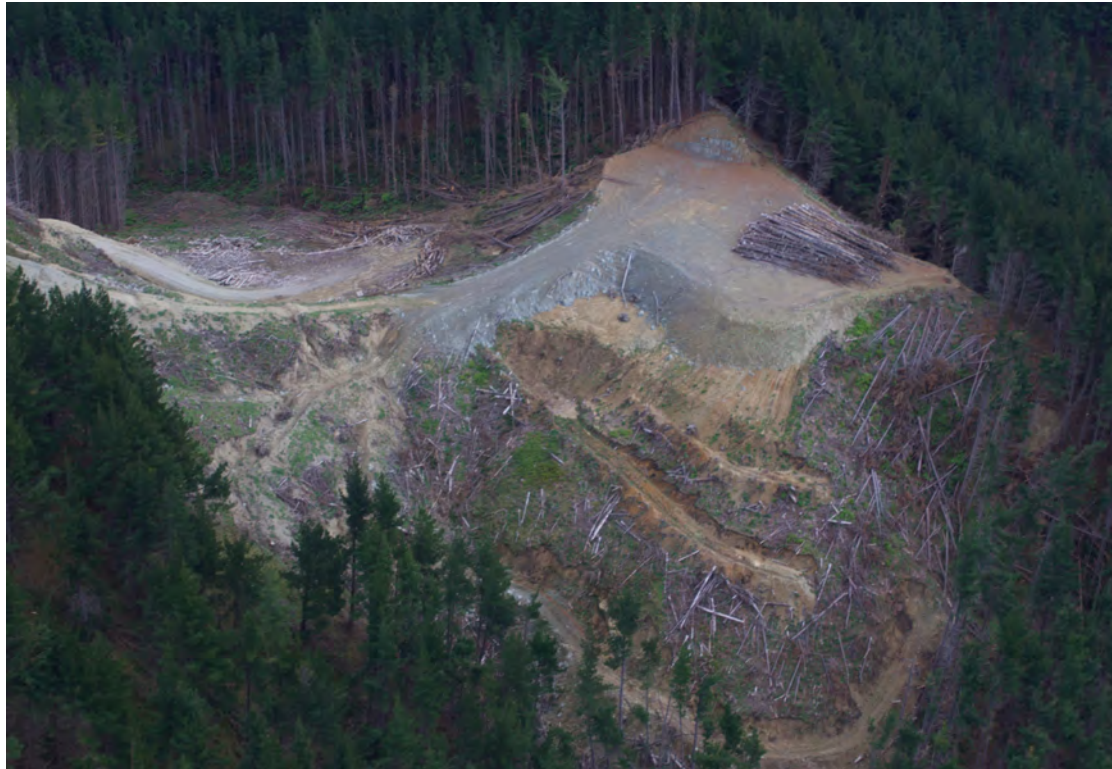
As a consequence, the forest development after Landing 11 did not result in conditions likely to result in the migration of harvest residues into environmentally risky situations. This did not necessarily mean that in-forest practices improved, indeed that wasn't the case. Rather, because harvest was confined to that necessary to develop the roadways, developments were such that migration of harvest residues to watercourses was less likely. Both landings are shown in **Figure Forty** below.

**Figure Forty.** Aerial view of Landings 12 (Top left) and 13 (right) [7<sup>th</sup> July 2018] showing a birds-nest on Landing 12 and felled to waste timber on both sites. No indication was found of harvest residues migrating beyond the roadlining corridor.

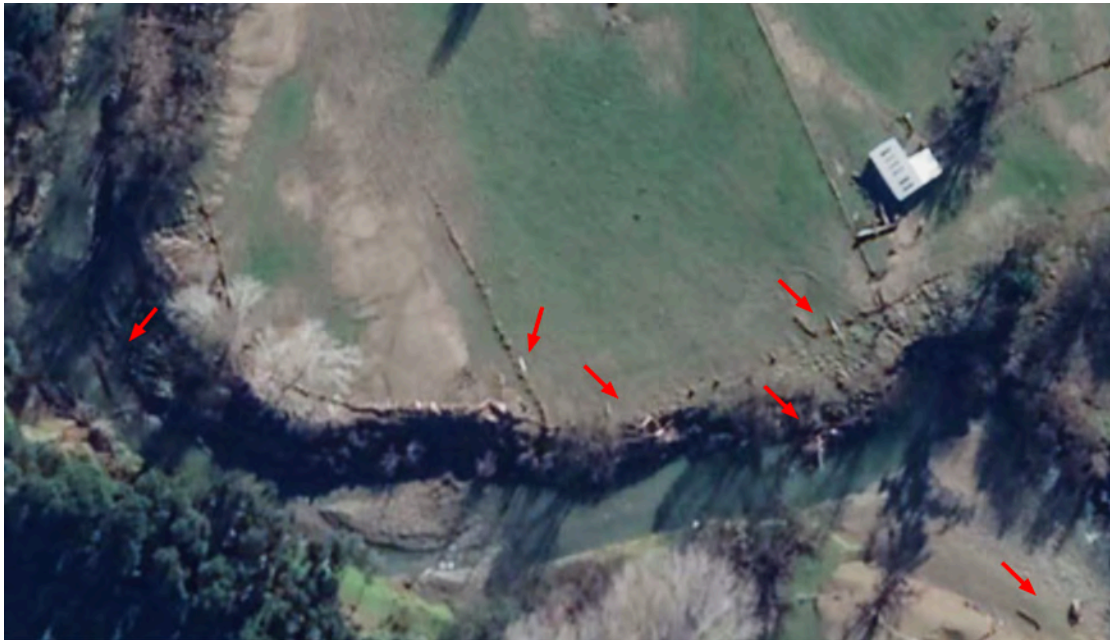
**Figure Forty Three.** Harvest residues identified from high resolution satellite imagery (13<sup>th</sup> July 2018) in the Waihora River downstream from Makiri Forest.

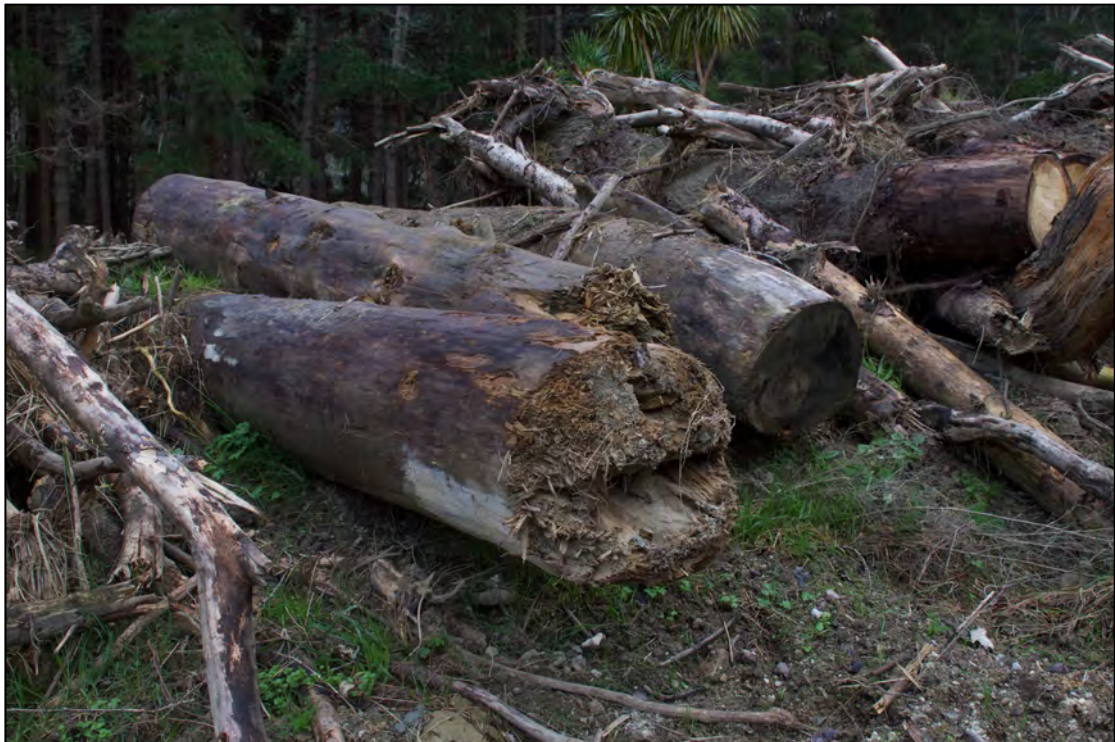
**Figure Forty Four.** Forestry logs that have been pulled from the Waihora river upstream of the Bruce Road Bridge (Image 1D1A6622).

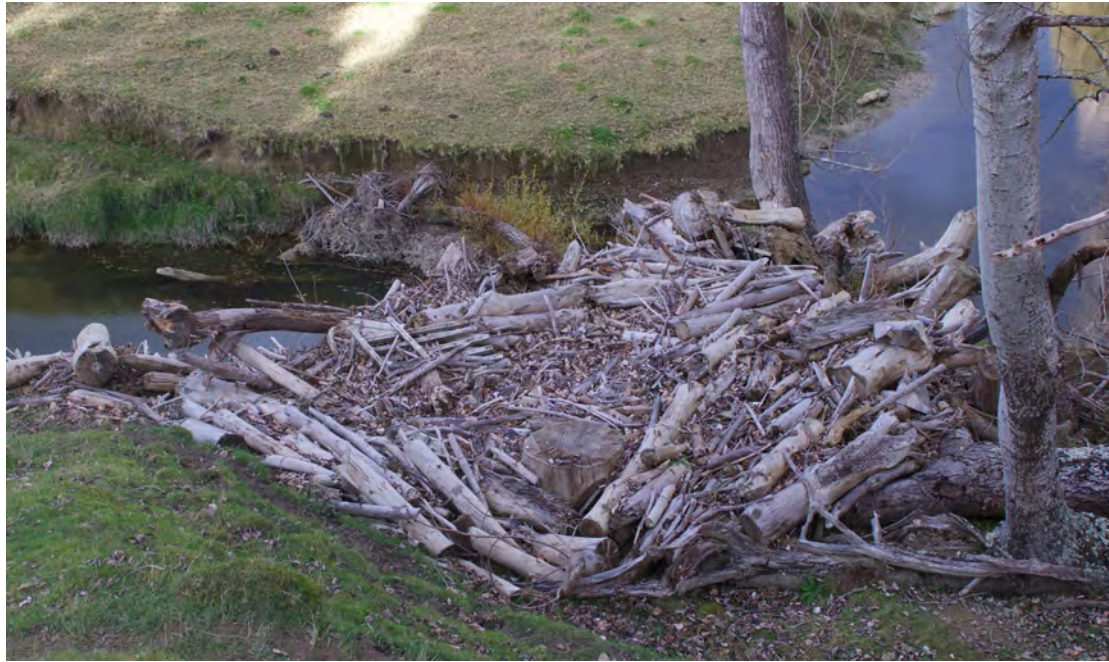
**Figure Forty Five.** Harvest residues as well as some willow caught up against trees on the banks of the the Waihora river (Image 1D1A6646).
