То:	Journeys - Gisborne District Council
From:	LDE
Сору:	
Subject:	Waihau Road RP 4.8
Date:	27/07/2023
Project Ref:	24813
Document ID:	349516
Revision Status:	Issued for information

LDE was asked by Gisborne District Council (GDC) to undertake a geotechnical inspection of a slip at approximately RP 4.8 on Waihau Road on Tuesday 27th June 2023.

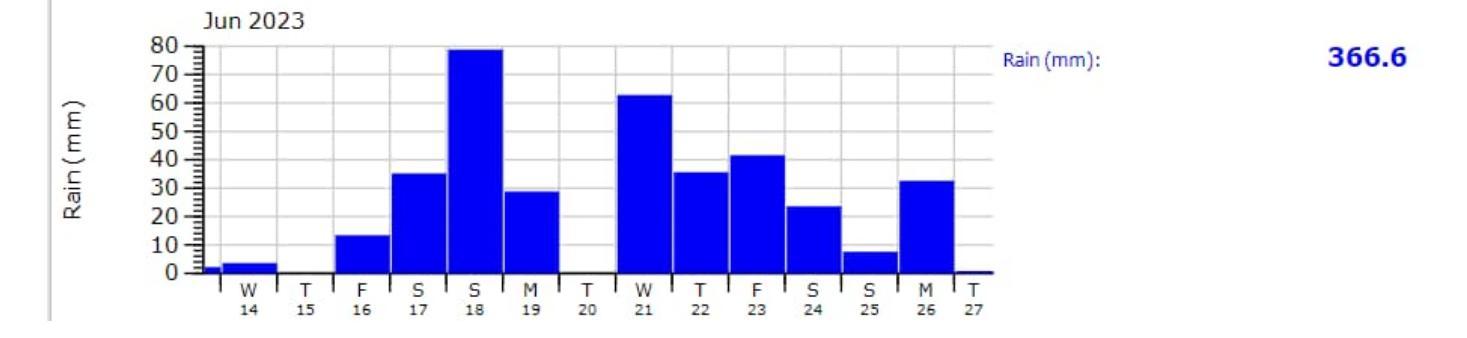
At the time of the initial inspection, the weather was fine. However, the region had been subject to a significant rainfall event in the proceeding fortnight, where up to 366.6 mm of rainfall has been recorded at a Pouawa gauge (Figure 1).

Figure 1: Pouawa Rural Fire Rain Gauge record (source: Harvest)

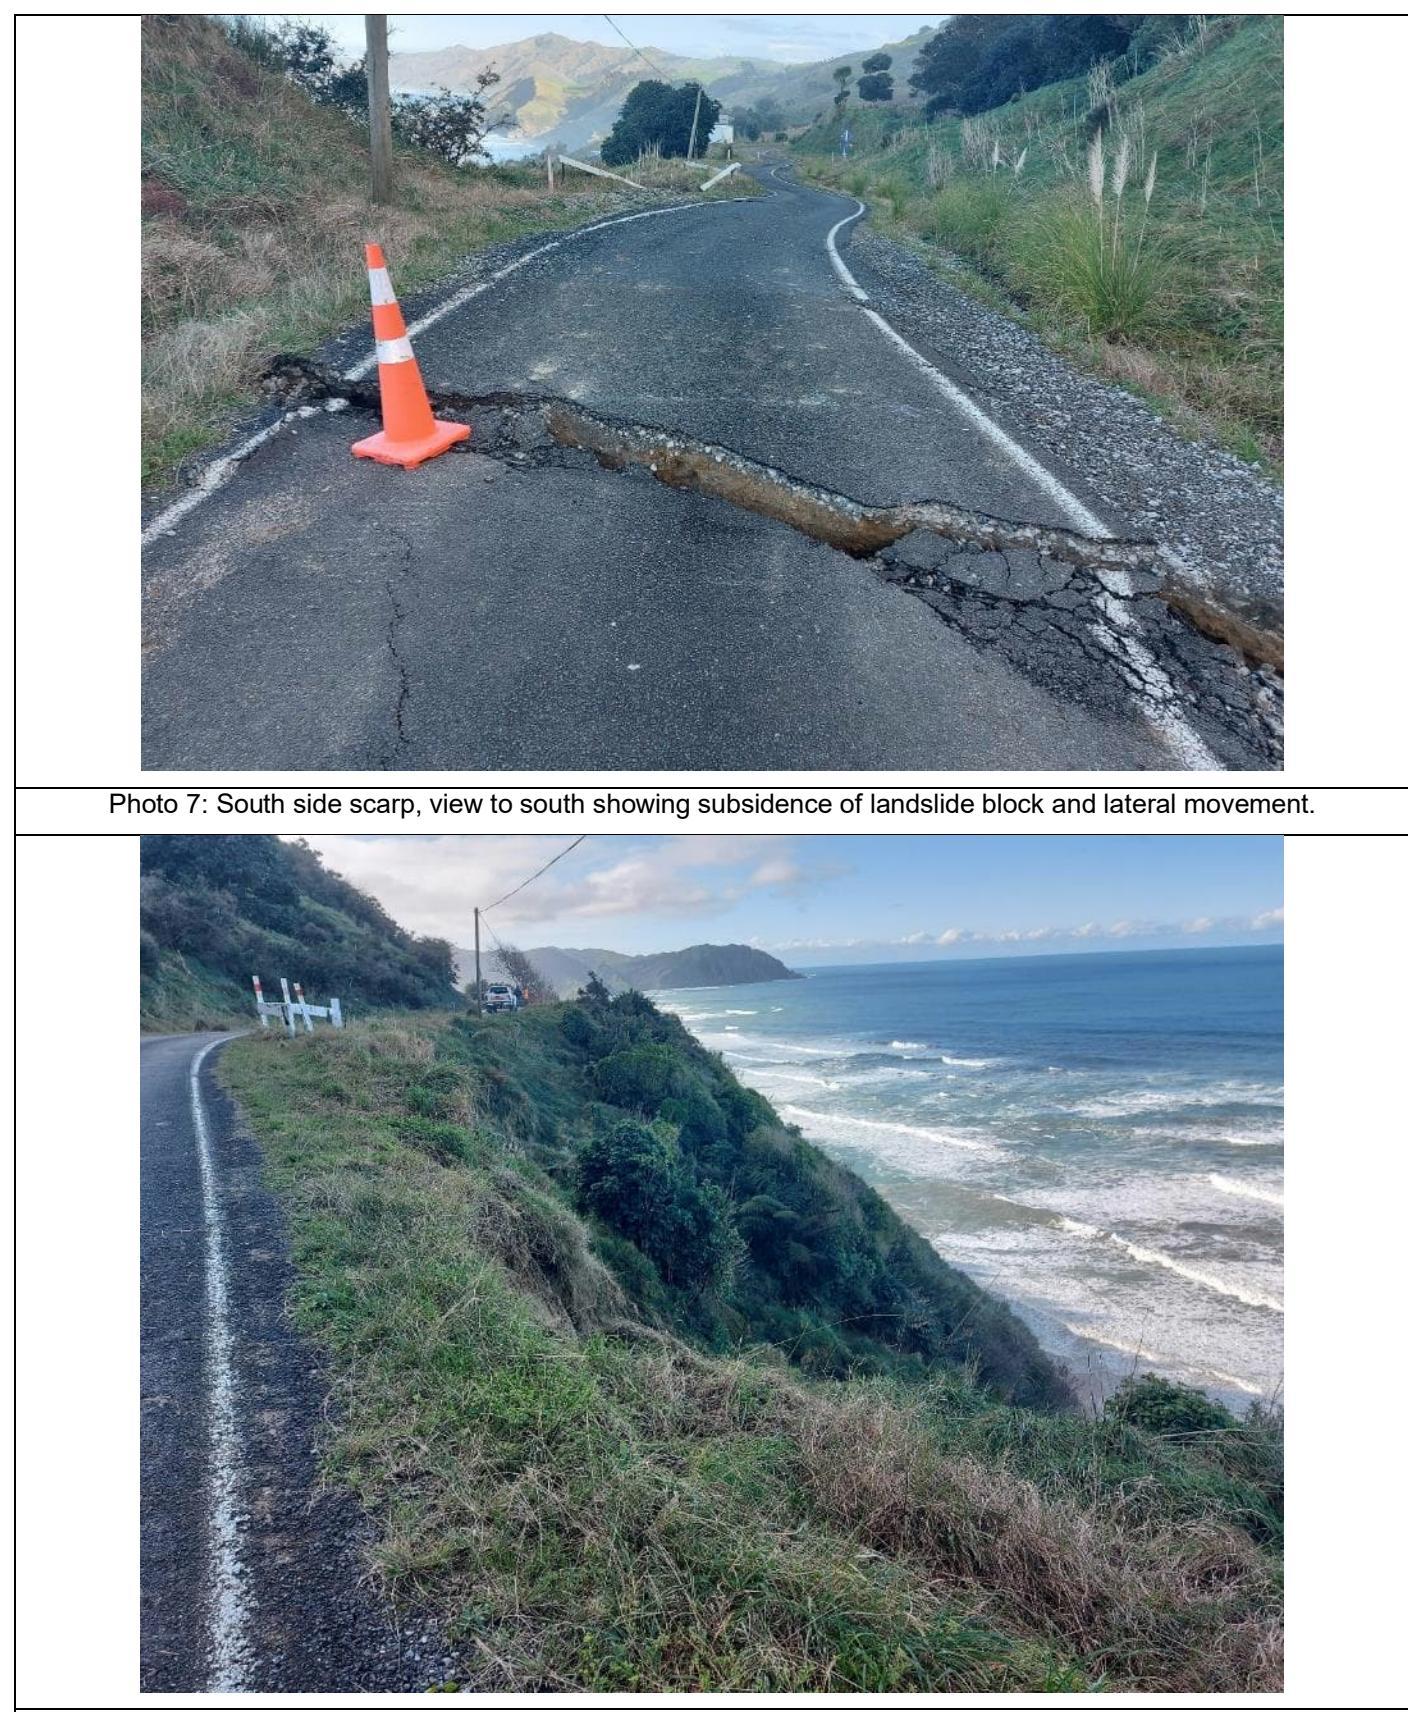
Photo 8: Within landslide block, tension cracking within shoulder, fresh scarp approximately 1m from pavement edge, view to north

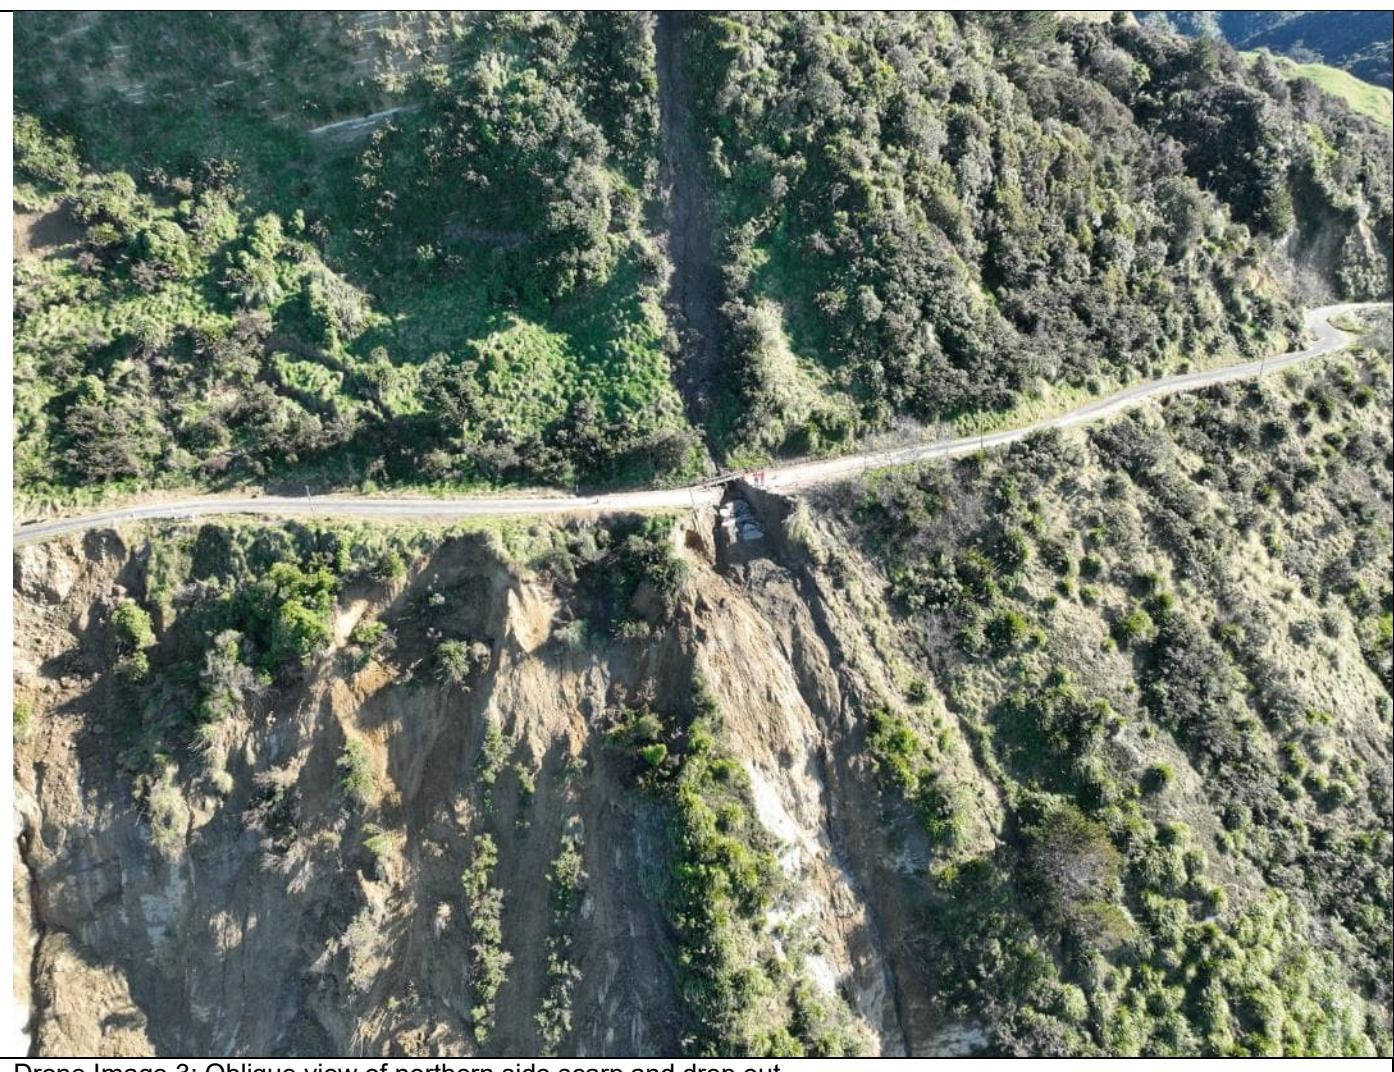
- The dropout is the northern side scarp of a larger landslide feature.
- The landslide is approximately 110m wide.
- The southern side scarp is located at approximately RP 4.688.
- There appeared to be a scarp near the base of the bluff above the road.
- It is likely the deformation at the northern side scarp was exacerbated by:
 - \circ $\;$ Debris flow/ overland flow from the slope above,
 - Overland flow from the road,
 - Scour from the adjacent culvert.

Drone Image 3: Oblique view of northern side scarp and drop out.

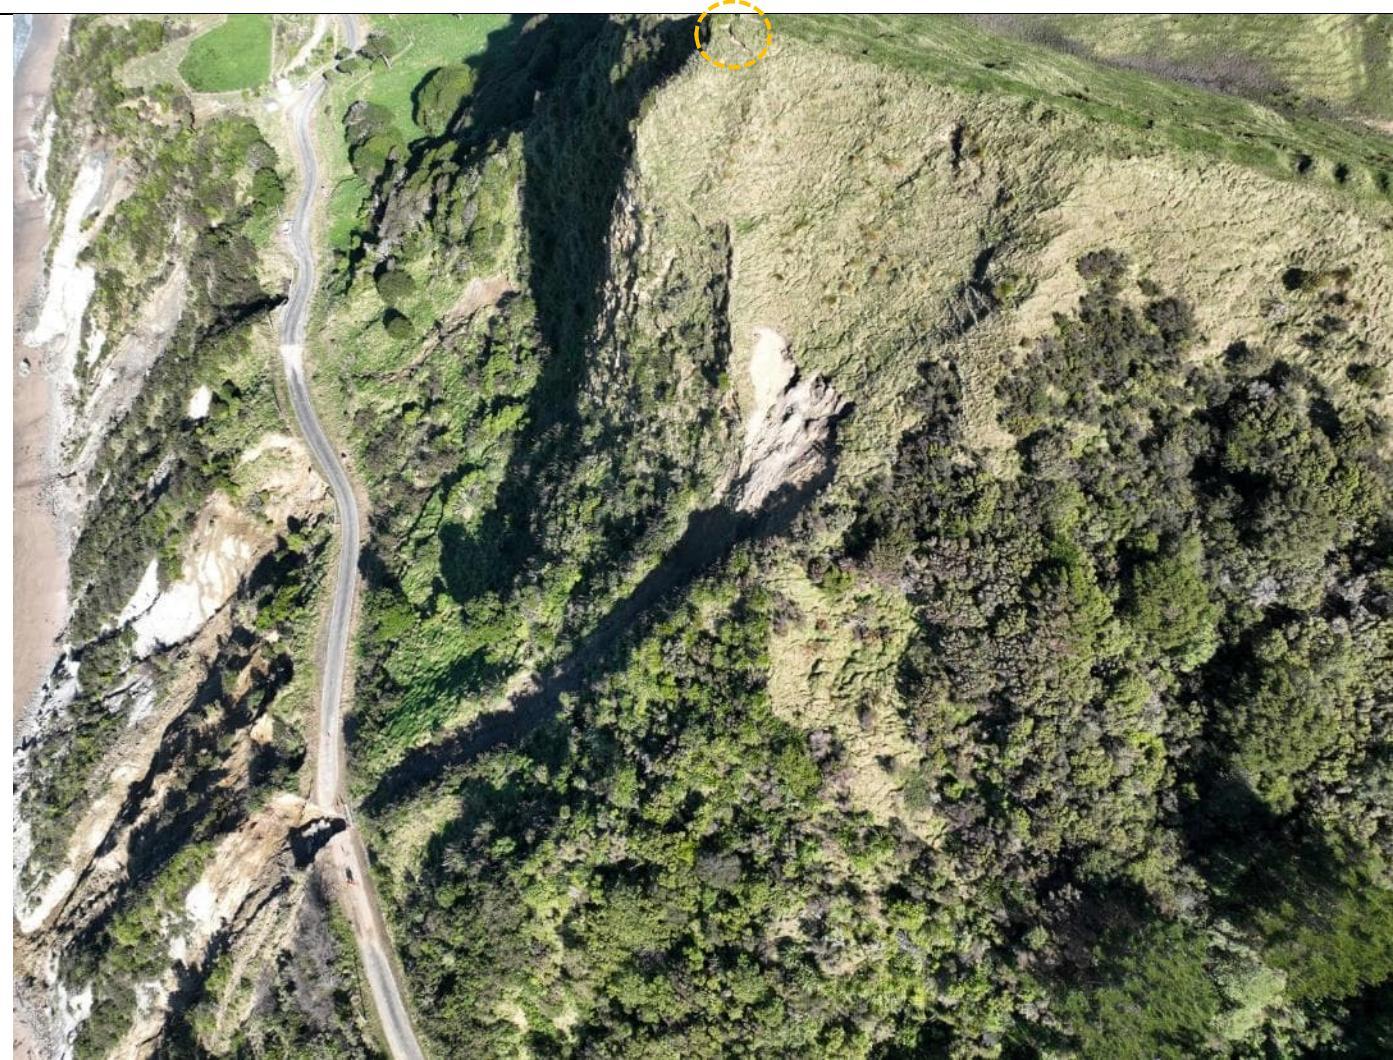
- A debris avalanche leading to a debris flow has occurred from an area above the bluff, and coincides with the northern sidescarp of the landslide, where significant scour has occurred.
- A headscarp has been confirmed along the toe of the bluff above the road.
- Debris flows along the (potential) side scarps of the wedge failure make it difficult to conclude on the failure mode.
- Significant debris appears to have dropped from the colluvial soil to rock interface and caused disturbance downslope obscuring any potential conclusive evidence of a global wedge failure.
- A wedge failure occurred in the bluffs below the site.

Drone Image 4: Oblique view showing debris avalanche slip and associated catchment above northern side scarp. Tension crack behind bluff circled (and enlarged image below).

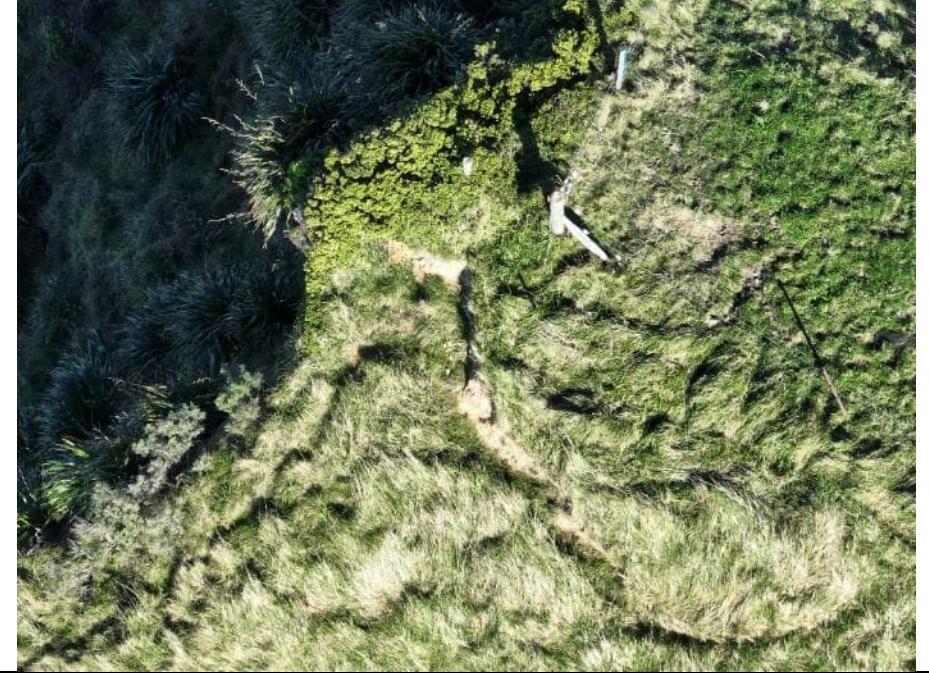
- It is possible the toe of the landslide is near to or at the base of the coastal cliff.
- Several sandstone features appear to be poorly supported within the upper bluff feature and without engineering measures pose a rockfall risk.
- Several defects (cracks) were observed subparallel to the upper bluff, which may lead to 'slabbing' failures and also pose a rockfall risk.
- From the drone imagery, there appears to be a significant tension crack behind the upper bluff.
- Arcuate features (scallops) are evident in the drone imagery along the edge of the bluff. Therefore, larger scale rock mass failures from the top of the bluff also pose a potential rockfall/ debris avalanche risk.

Drone Image 5: Tension crack behind bluff.

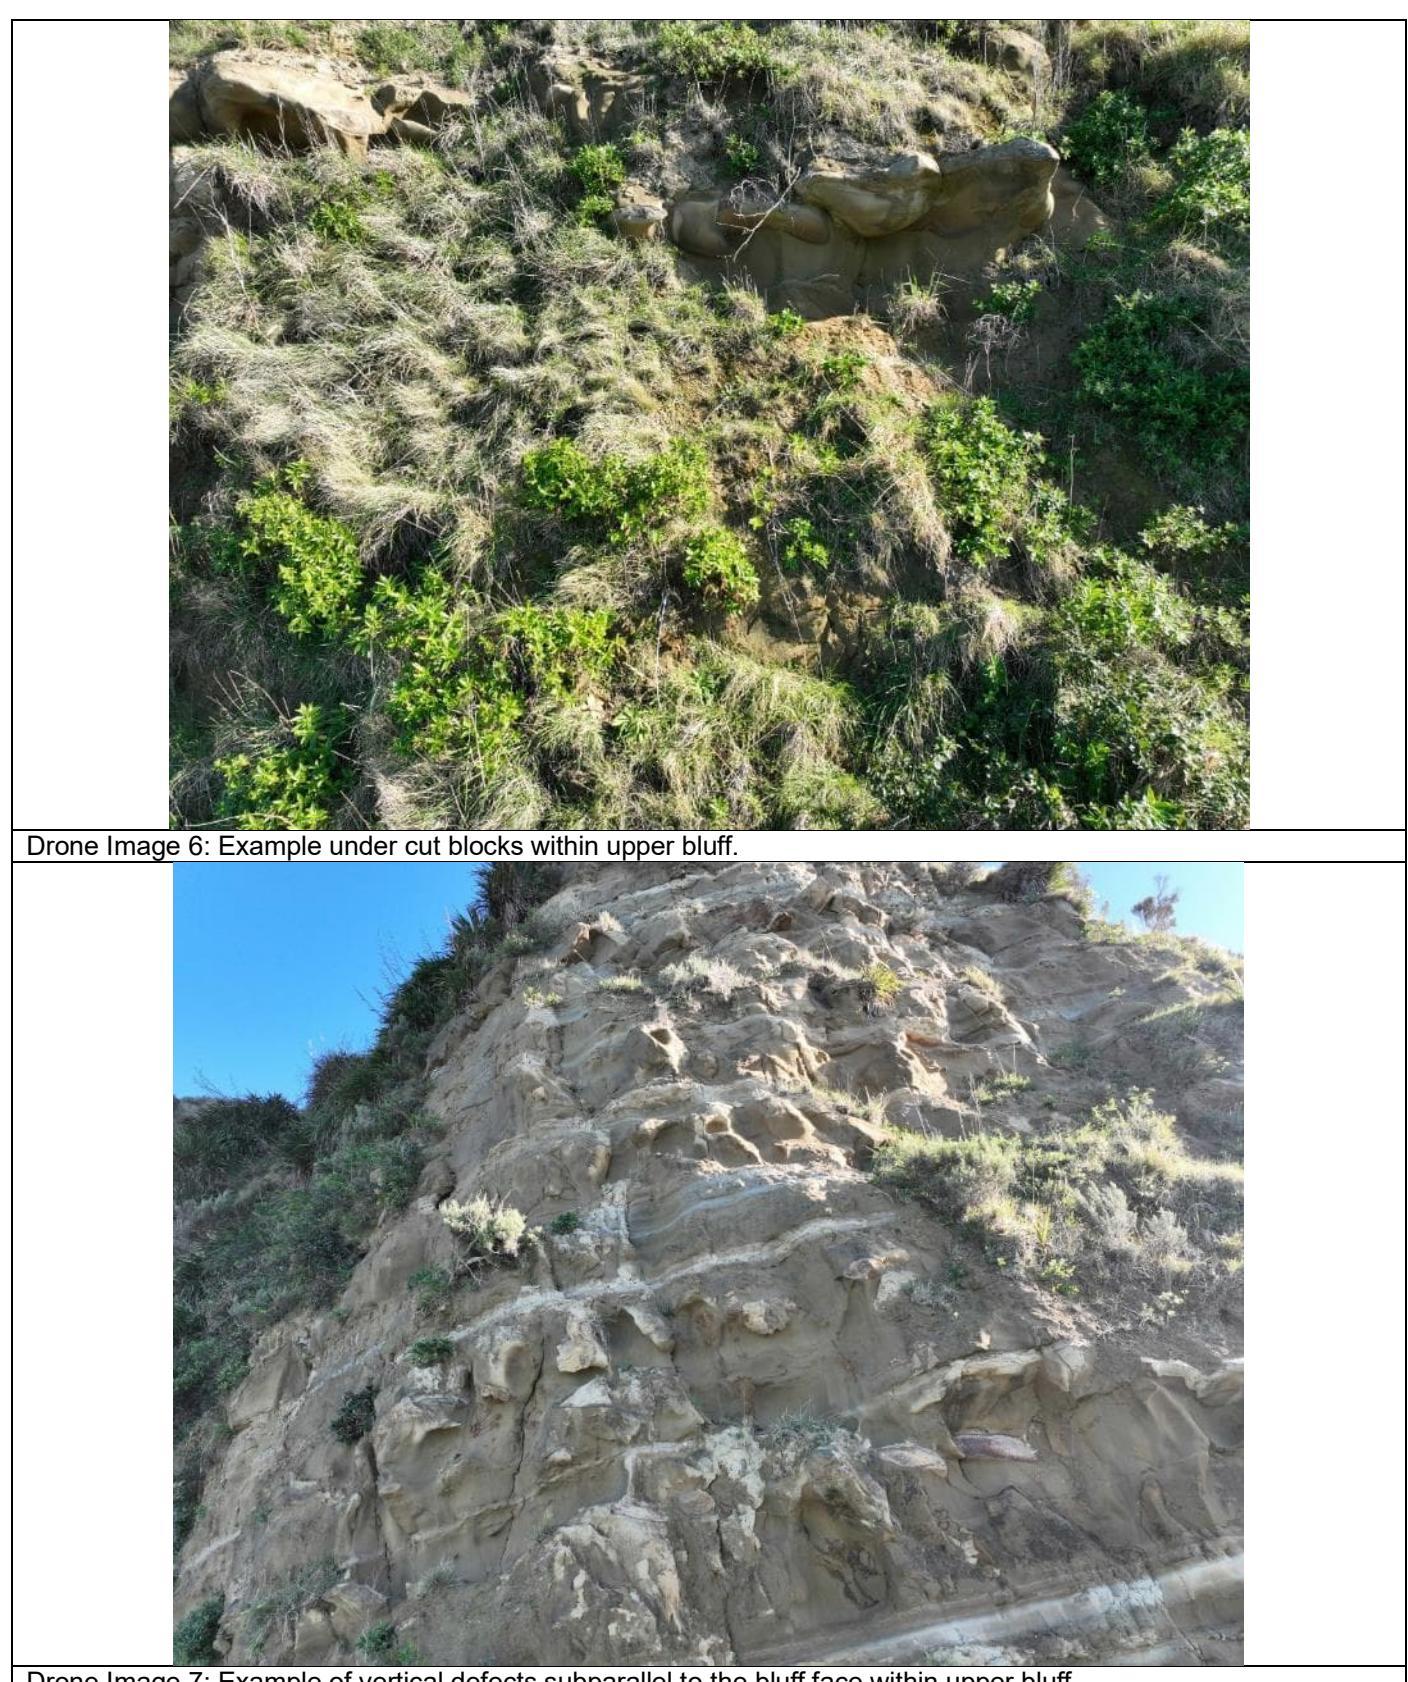
Drone Image 7: Example of vertical defects subparallel to the bluff face within upper bluff.
