## **Site Inspection Report**

Project:	19442 - GDC Tiniroto Road RP35.03 & 35.88		
Inspections Dates:	28/06/2023	Personnel:	Joel Pollock/ Caleb Glasson/ Bradley Clark (spotter)
	30/06/2023	Personnel:	Caleb Glasson/ Bradley Clark (spotter)
LDE Project Ref:	19442	Report by:	Joel Pollock
Client:	Gisborne District Council	Reviewer:	Rob Haskell

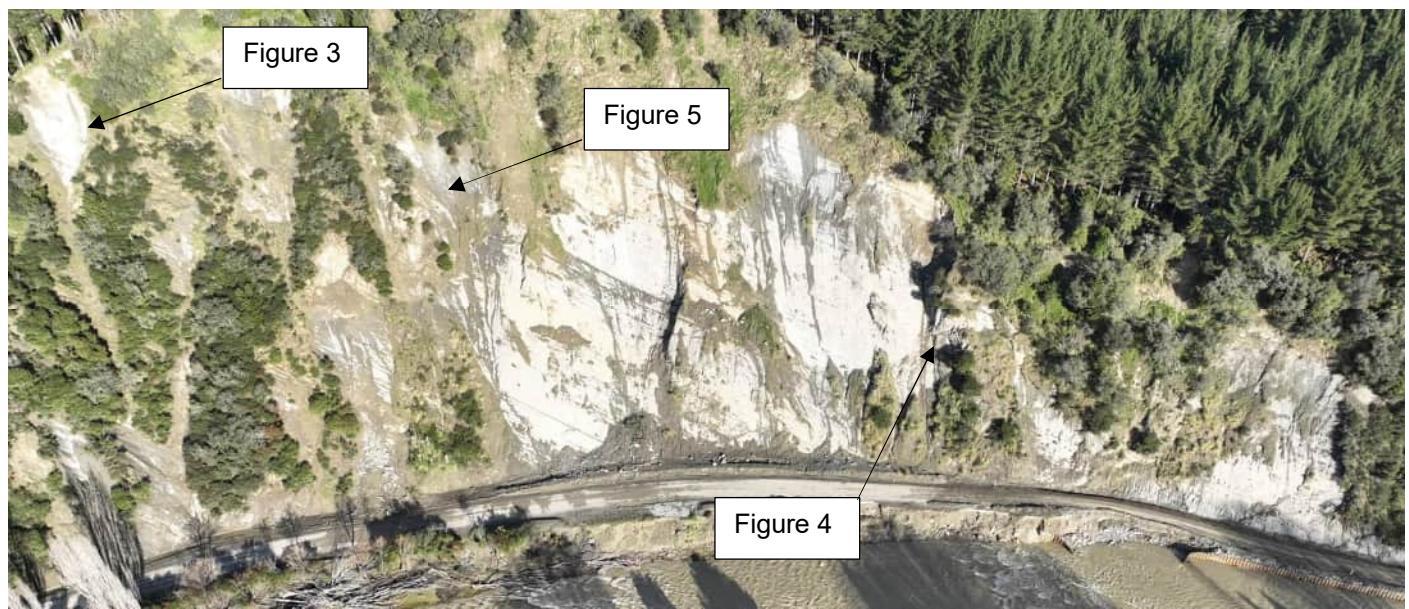
- between 350- 400m (370m) in length
- north-northwest facing,
- varying between 40- and 50-degrees slope
- road surface at 175m, top of bluff at 297m (122m face)

- broad concave shape
- vegetated more at the east extent, mainly clean rock in the central and west parts of the face
- bare rock to 2/3 of escarpment height

Figure 2: Bluff 1, viewed to south from UAV. Note bare rock faces, made clear by recent heavy rain events.

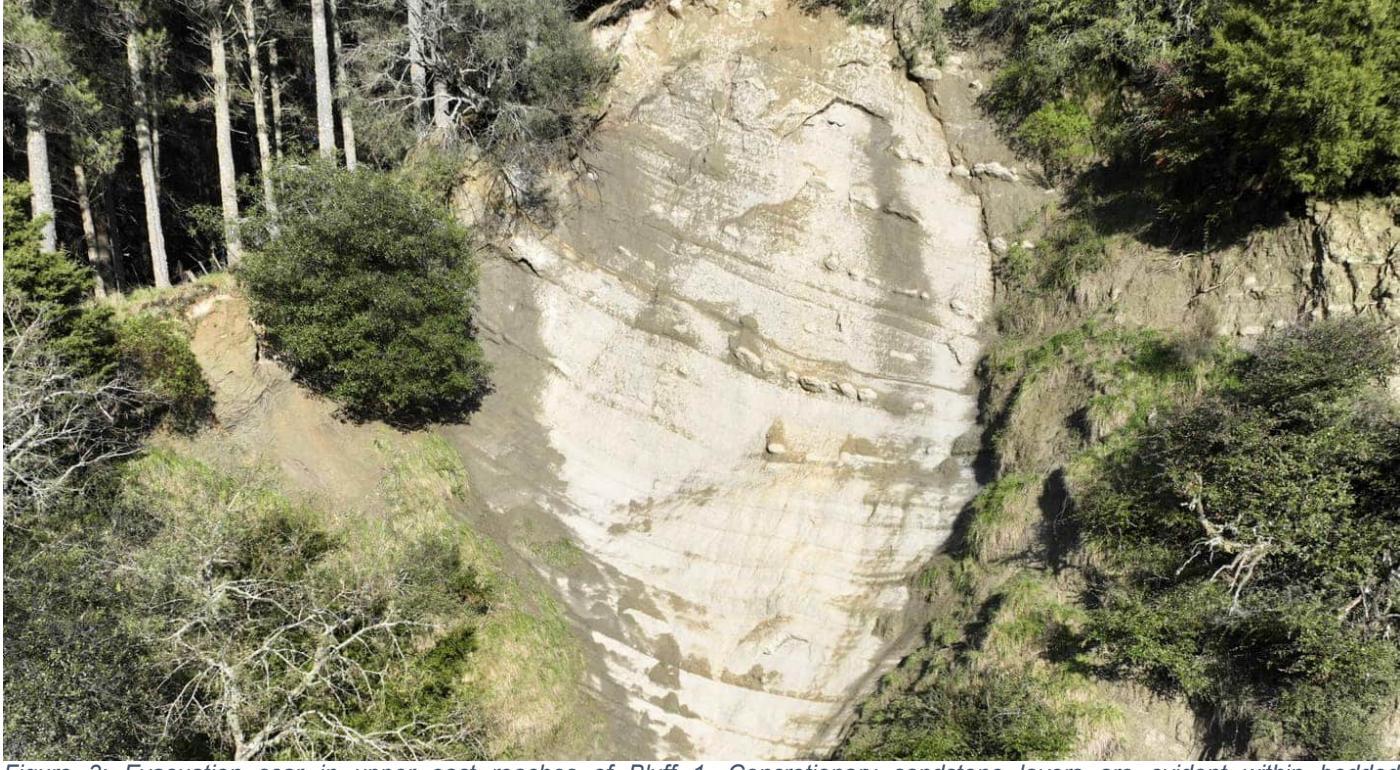
- bedded sedimentary rock, predominately thinly to moderately bedded mudstone with lesser sandstone, some concretionary sandstone beds in the upper reaches of the bluff (example in Figure 3)

Figure 3: Evacuation scar in upper east reaches of Bluff 1. Concretionary sandstone layers are evident within bedded mudstone/sandstone.

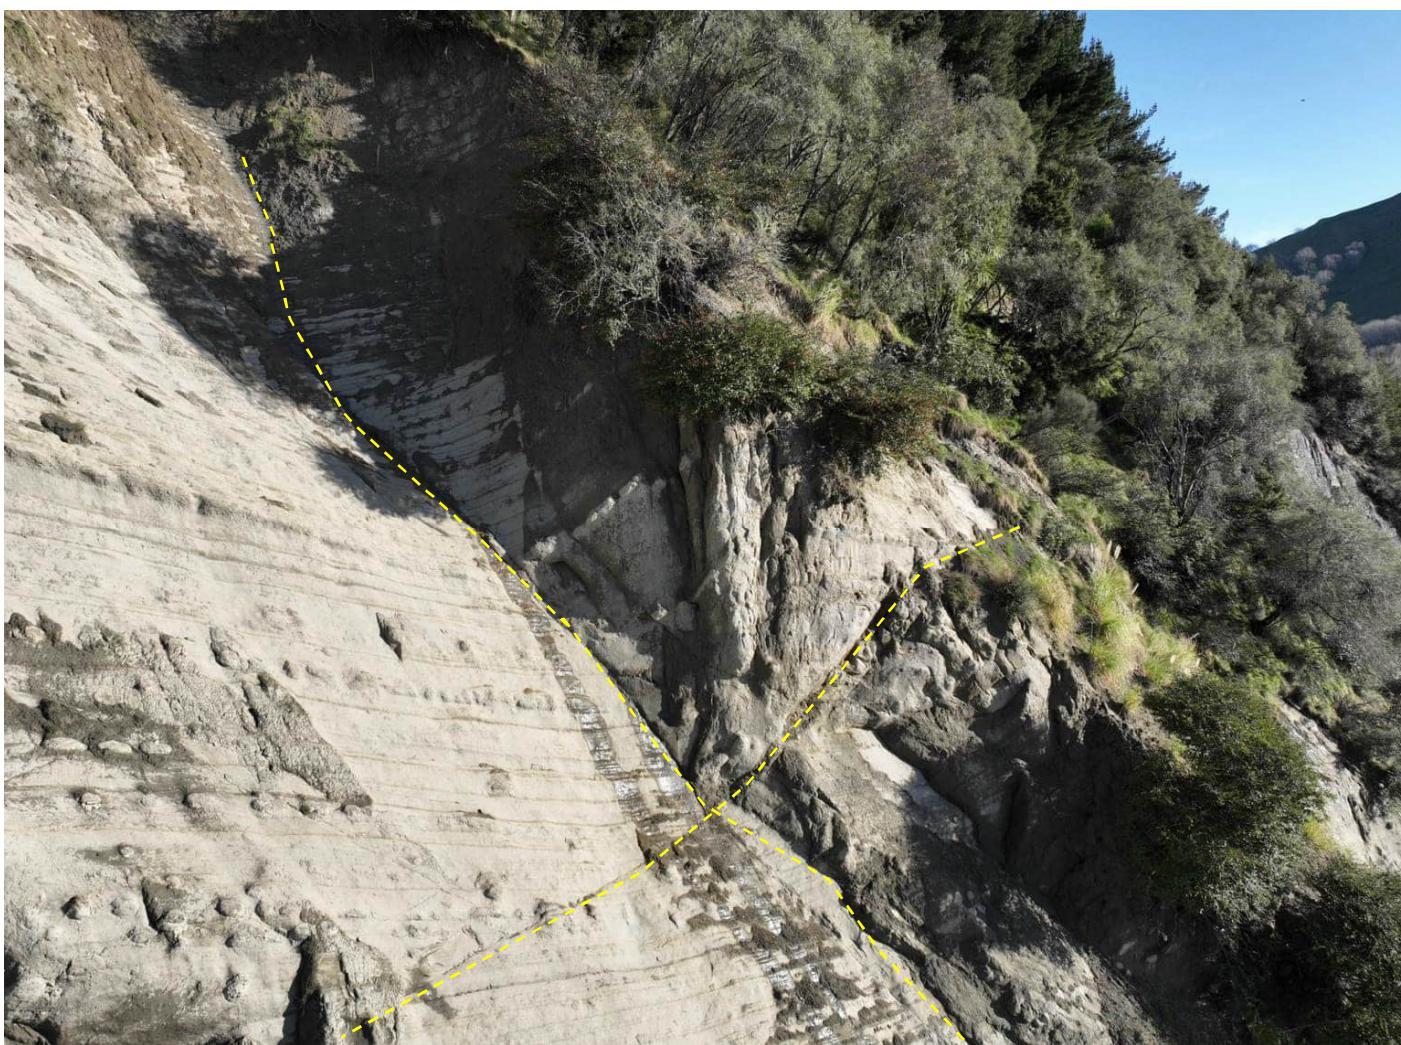
- steep defect following/controlling orientation of the bluff face, ~45 degrees striking east-west (Figure 4)
- exfoliation joint with weathering disparity across the defect

Figure 4: Example of joints (yellow dashed lines) through rock mass, including a defect following orientation of clean rock face, extending behind oversteepened blocks.

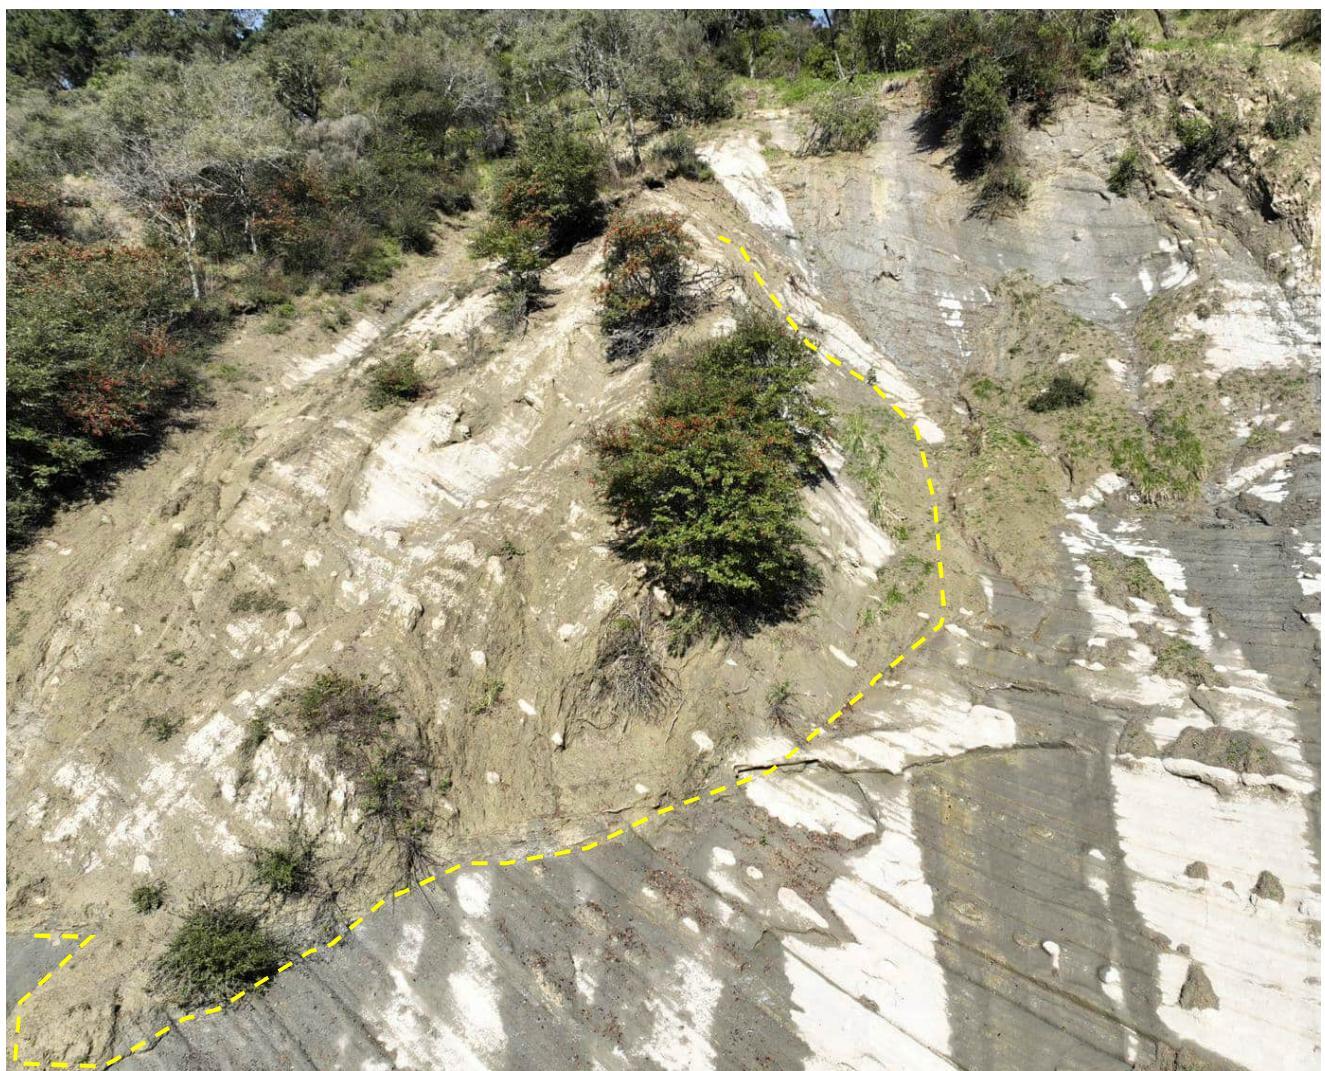
- water present in slope, in concave slope areas and seeping from behind (defect) in-situ, vegetated blocks (Figure 5)
- evidence of extensive tension cracking along top of bluff (Figure 6)

Figure 5: Example from upper bluff of highly weathered material (yellow dashed line) disparity to clean rock, assumed to be separated by persistent defect. Water is evidently seeping from weathered mass through defect.

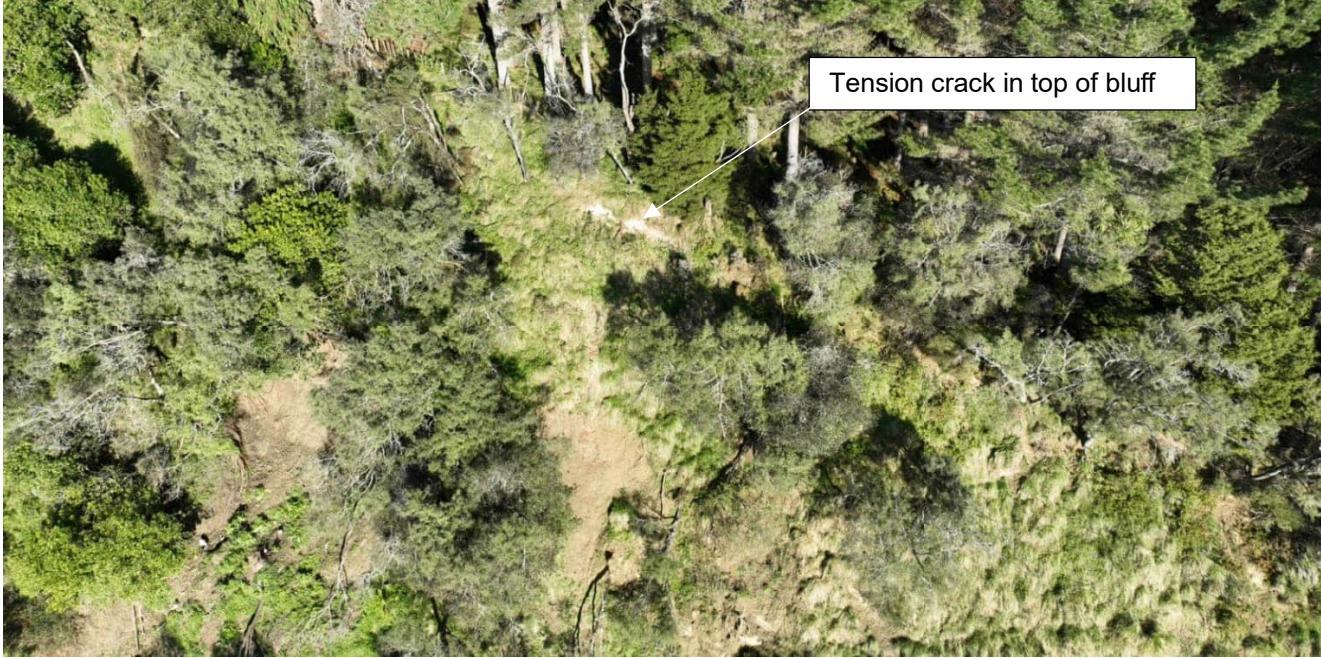
Figure 6: View looking down at top of Bluff 1, showing apparent tension crack/scarp.

observed at the top of the bluff, suggesting that as additional mid- and lower-bluff blocks come down the loss of support may cause a larger part of the upper slope to dislodge.

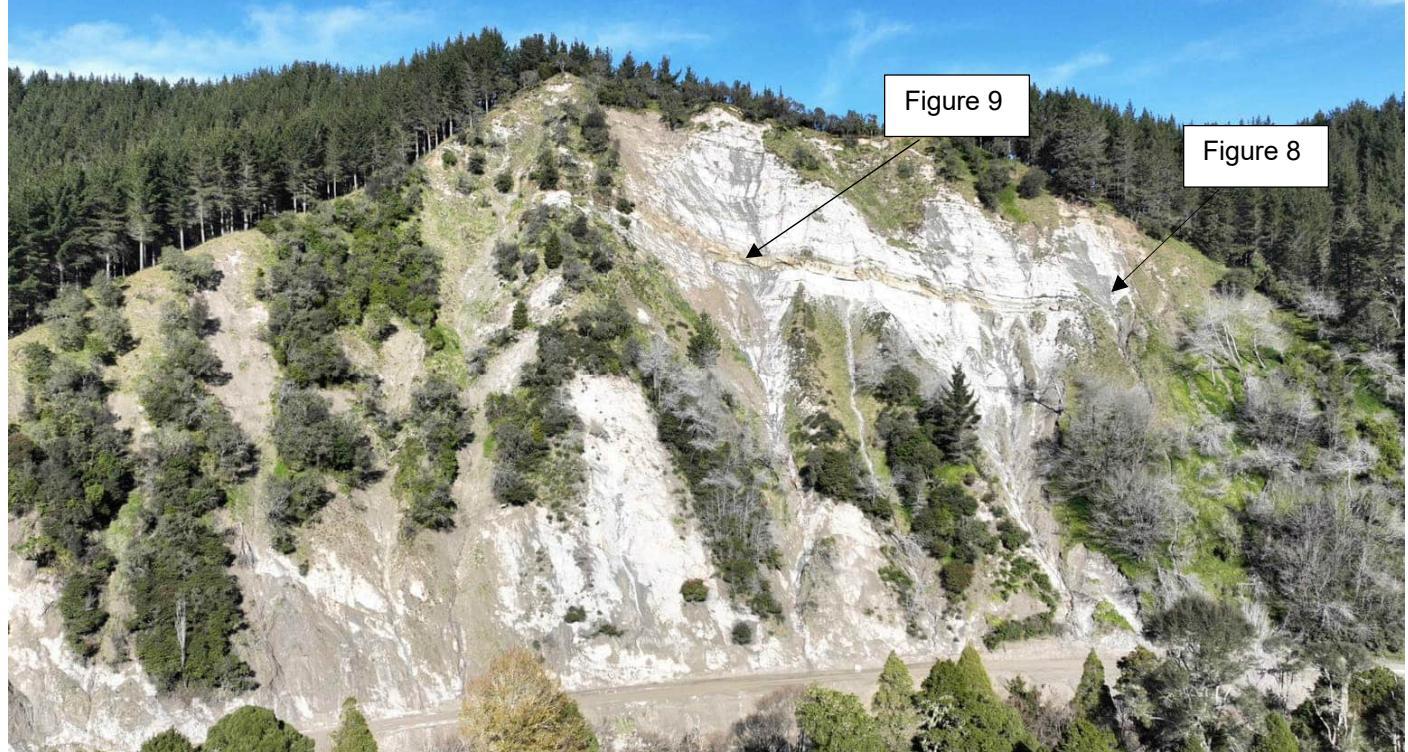
- approximately 350- 400m (360m) in length,
- north-west facing
- road surface at 170m, top of bluff (pinnacle) at 352m (182m maximum face height)
- semi-consistent 45-to-50-degree slope, with localised areas with steeper upper 1/3 face

Figure 7: Bluff 2, viewed to southeast from UAV.

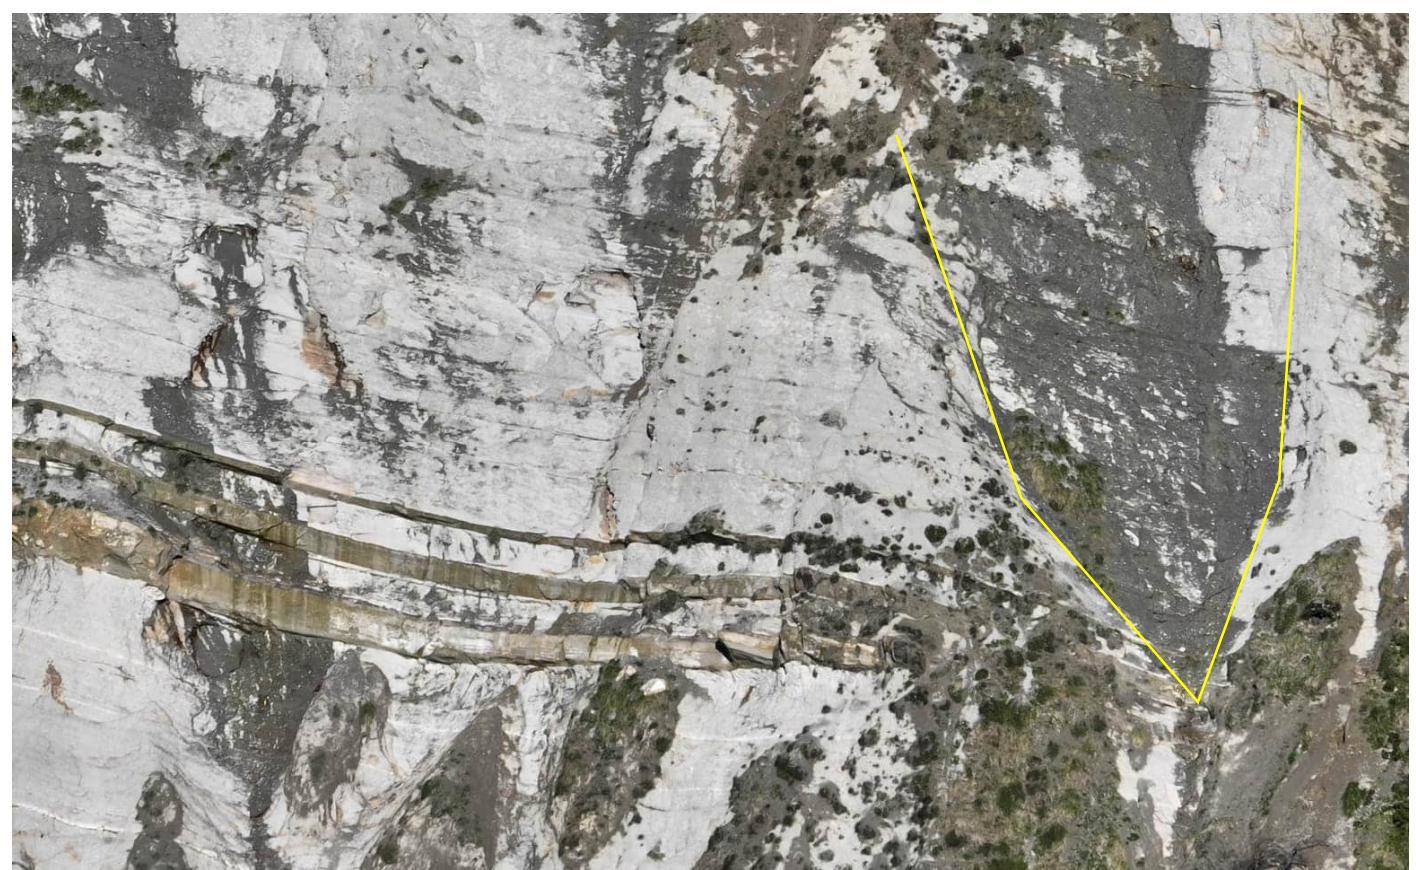
- protruding sandstone beds create hazard of large falling boulders of up to several cubic metres in size (Figures 8 and 9)
- intersecting persistent sets of defects (joints) that appear to form wedge failures, responsible for the formation of defined chutes between vegetated zones (Figure 8)

Figure 8: Bedded geology, with evidence of wedge failures (yellow line) indicative of intersections of defects. Flaggy sandstone (brown layers) protrudes from mudstone, refer to Figure 7 for scale. Example of wedge forming a small debris chute.

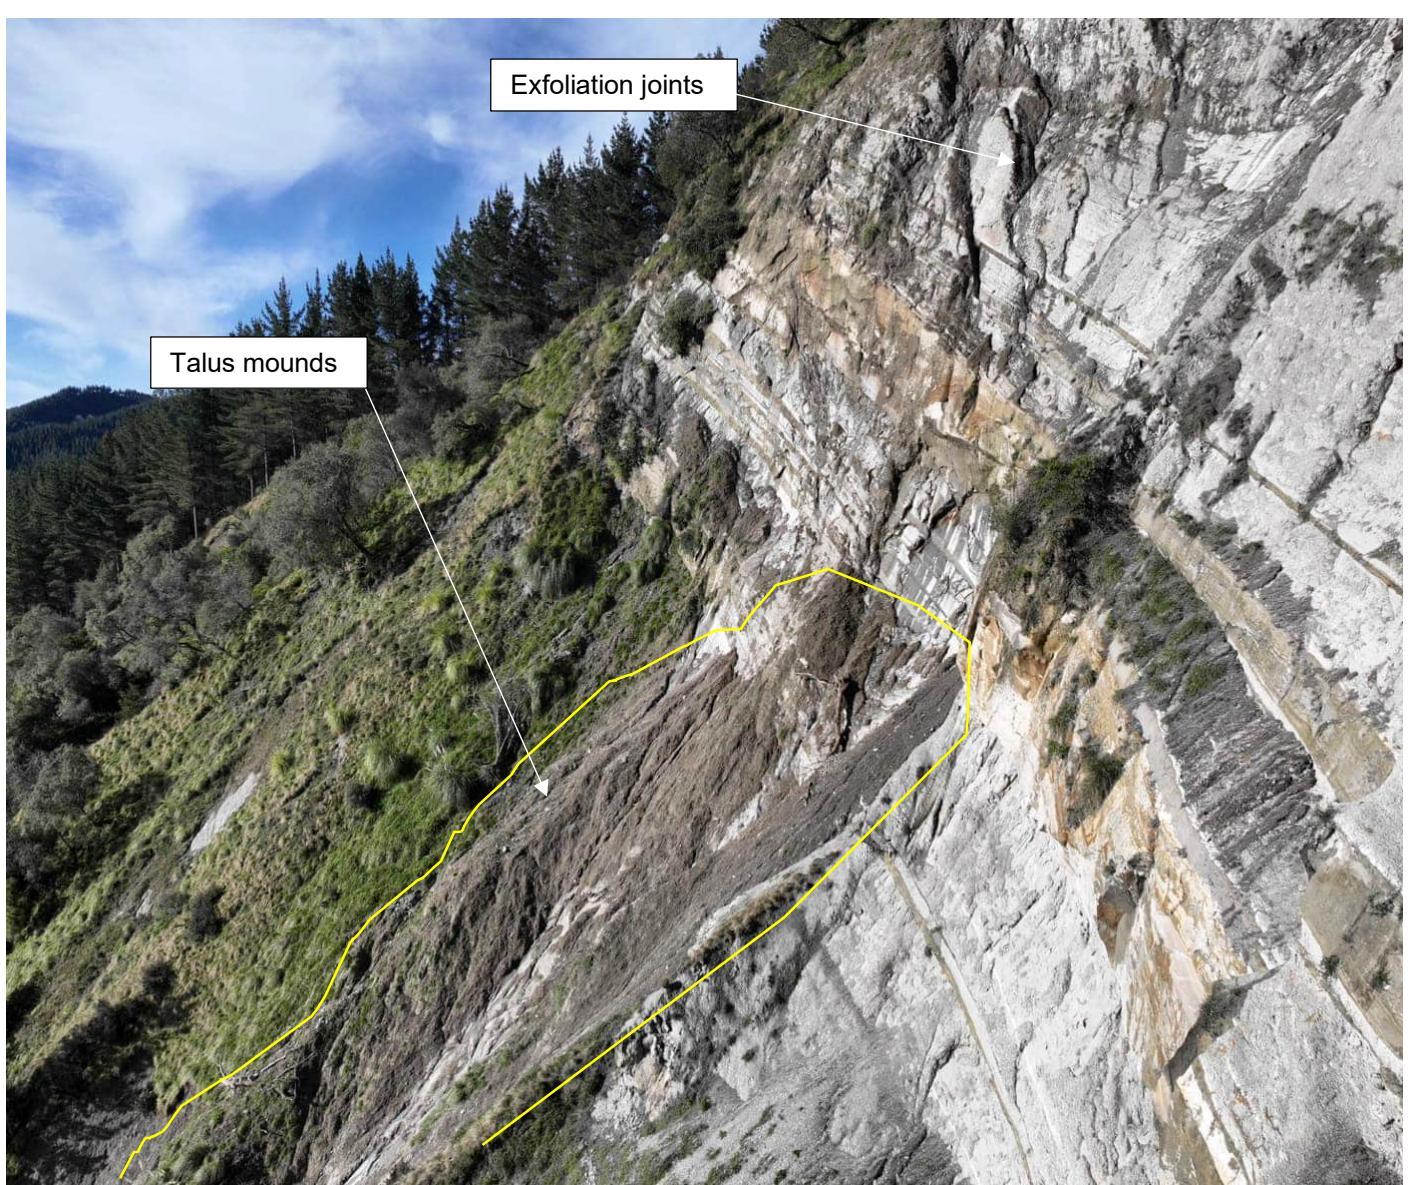
- evidence of dilated exfoliation joints in weathered mudstone layers (Figure 9)
- more vegetated in the west half of the escarpment
- bare rock to near-top of escarpment (huge height will lead to high velocity falling material)

Figure 9: View of upper slope to east. There is evidence of dilated weathering (exfoliation) defects in the overhanging rock. Talus is evident in mid to upper slope. The more competent sandstone (brown layers) protrudes and will likely fall in larger boulders.

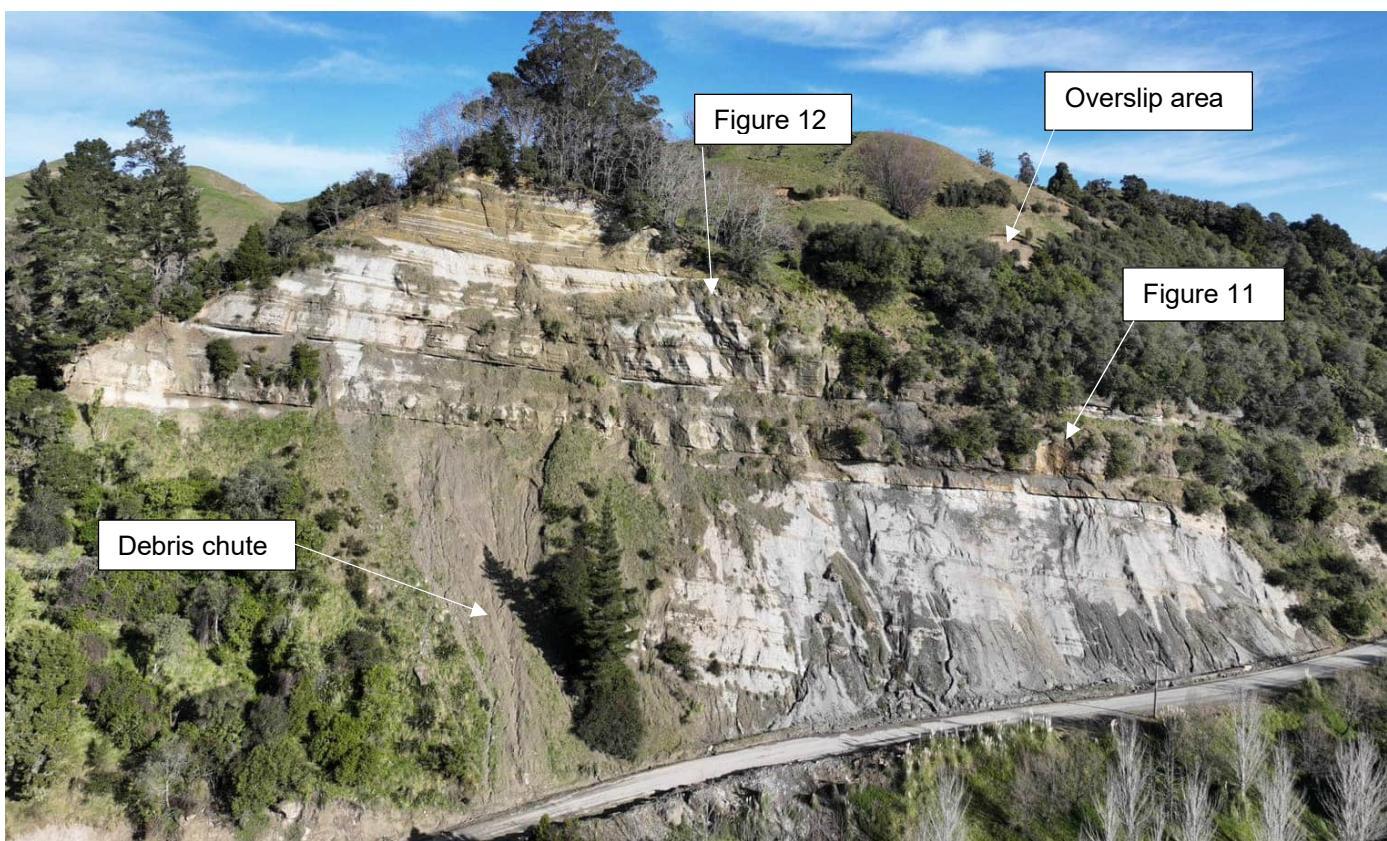
- approximately 200- 250m (235m) in length,
- north-northeast facing
- road surface at 185m (centre of bluff), top of bluff/pinnacle at 283m (~100m face)

Figure 10: View to southwest of Bluff 3.

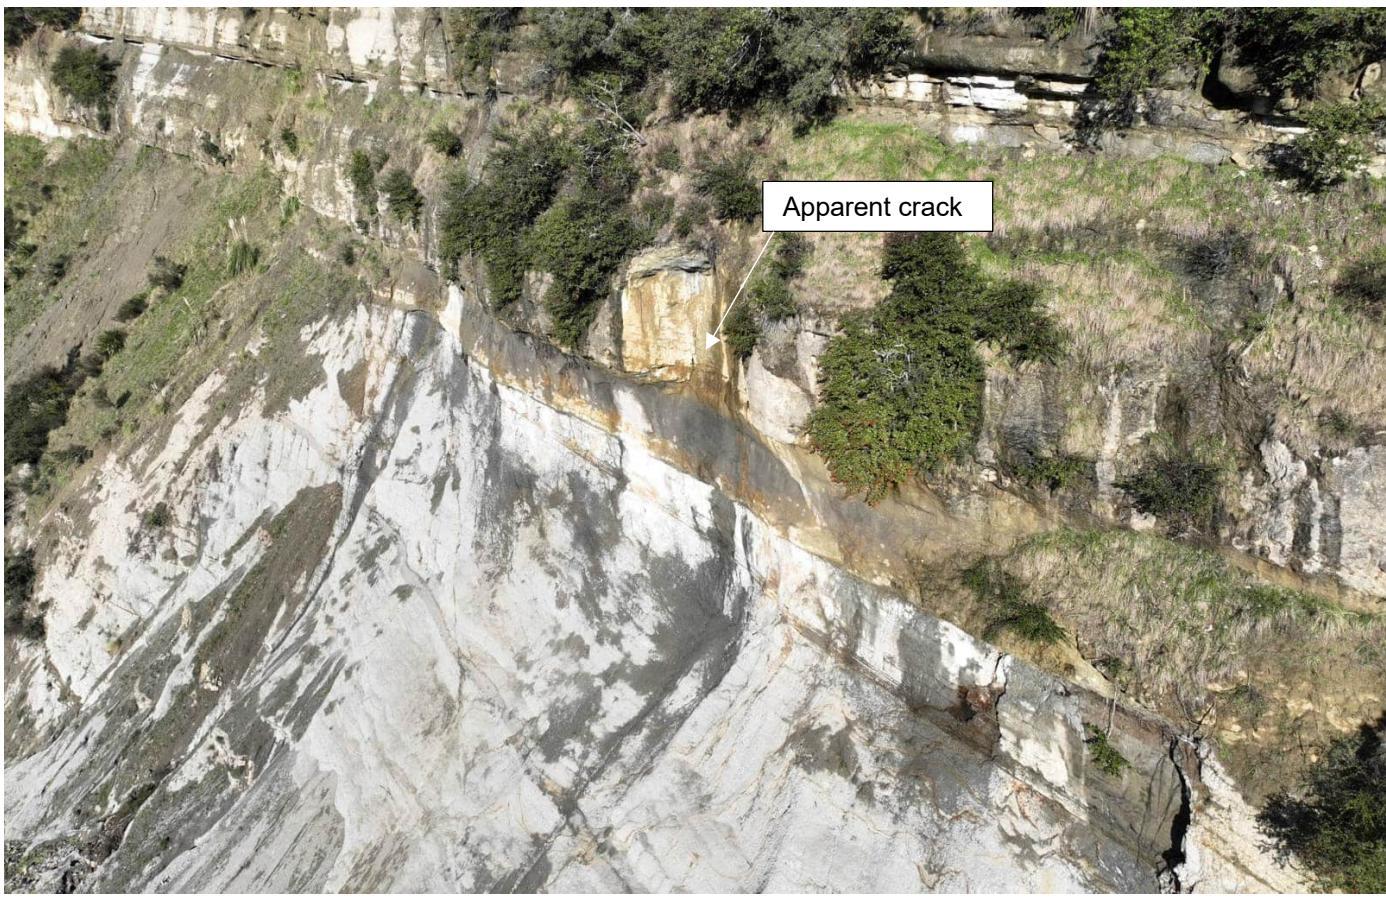
- lower bedding dip than Bluffs 1 and 2 apparent dip of 5 to 10 degrees to the southwest (into slope)
- steeper in the upper ½ to 1/3 (in the sandstone above the unconformity) with overhanging blocks (Figures 11 and 12)

- evidence of tension cracking, or dilation of joints, in overhanging blocks (Figures 11 and 12)
- evidence of localised intersecting defects forming smaller wedge failures along face

Figure 11: View to east of protruding competent sandstone layers.

Bluff 3 appears manageable in that overhanging blocks could be mapped and brought down with combinations of blasting and sluicing. The top of the bluff may also require regrading to a more stable grade to reduce the potential for over-steepened material to fall as the underlying mudstone weathers preferentially.

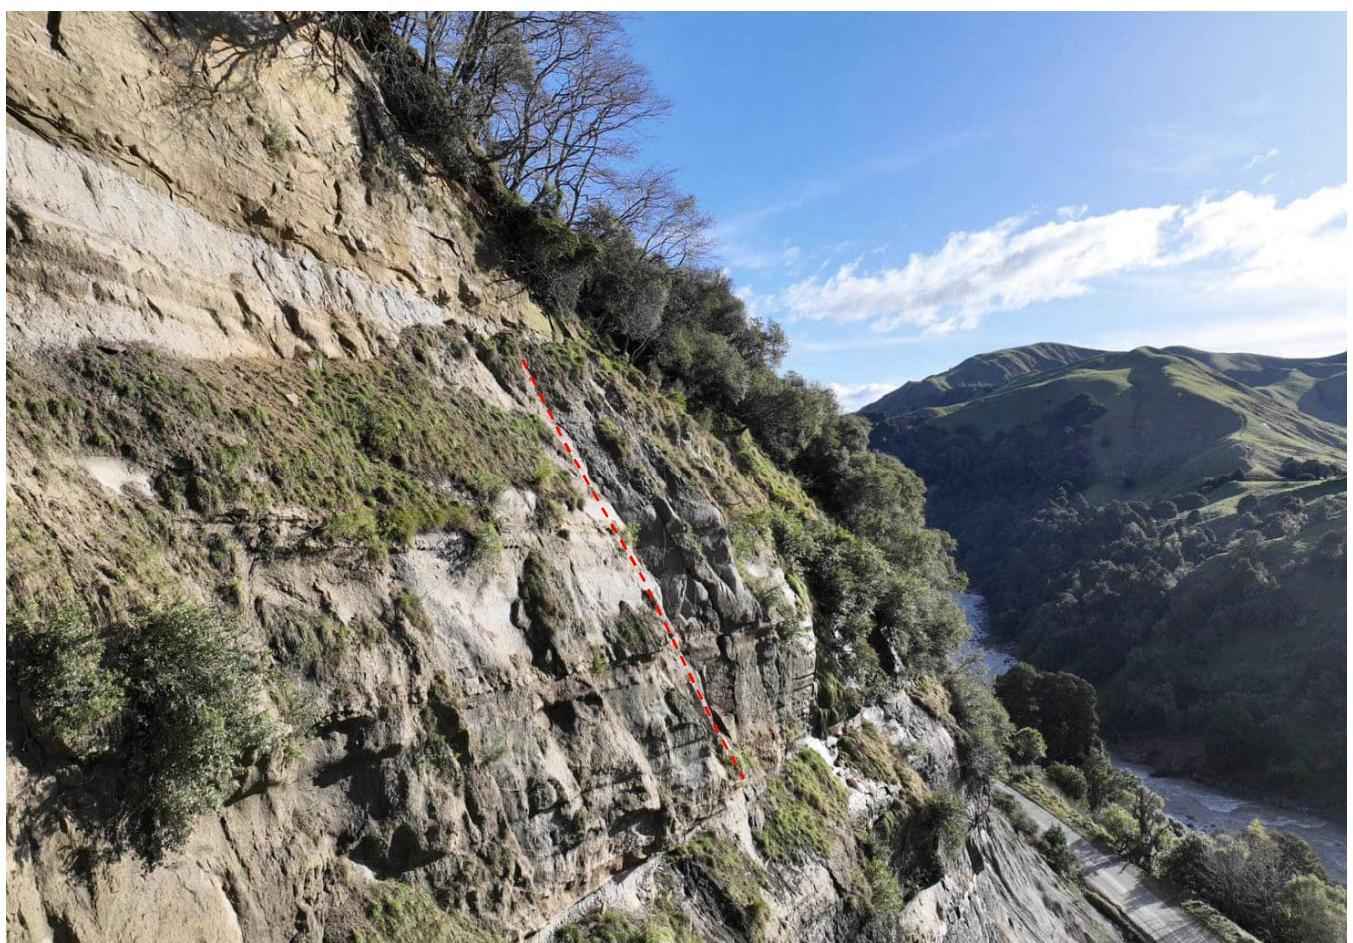
Figure 12: View to west showing another example of a possible exfoliation joint (red dashed) in large overhanging block.

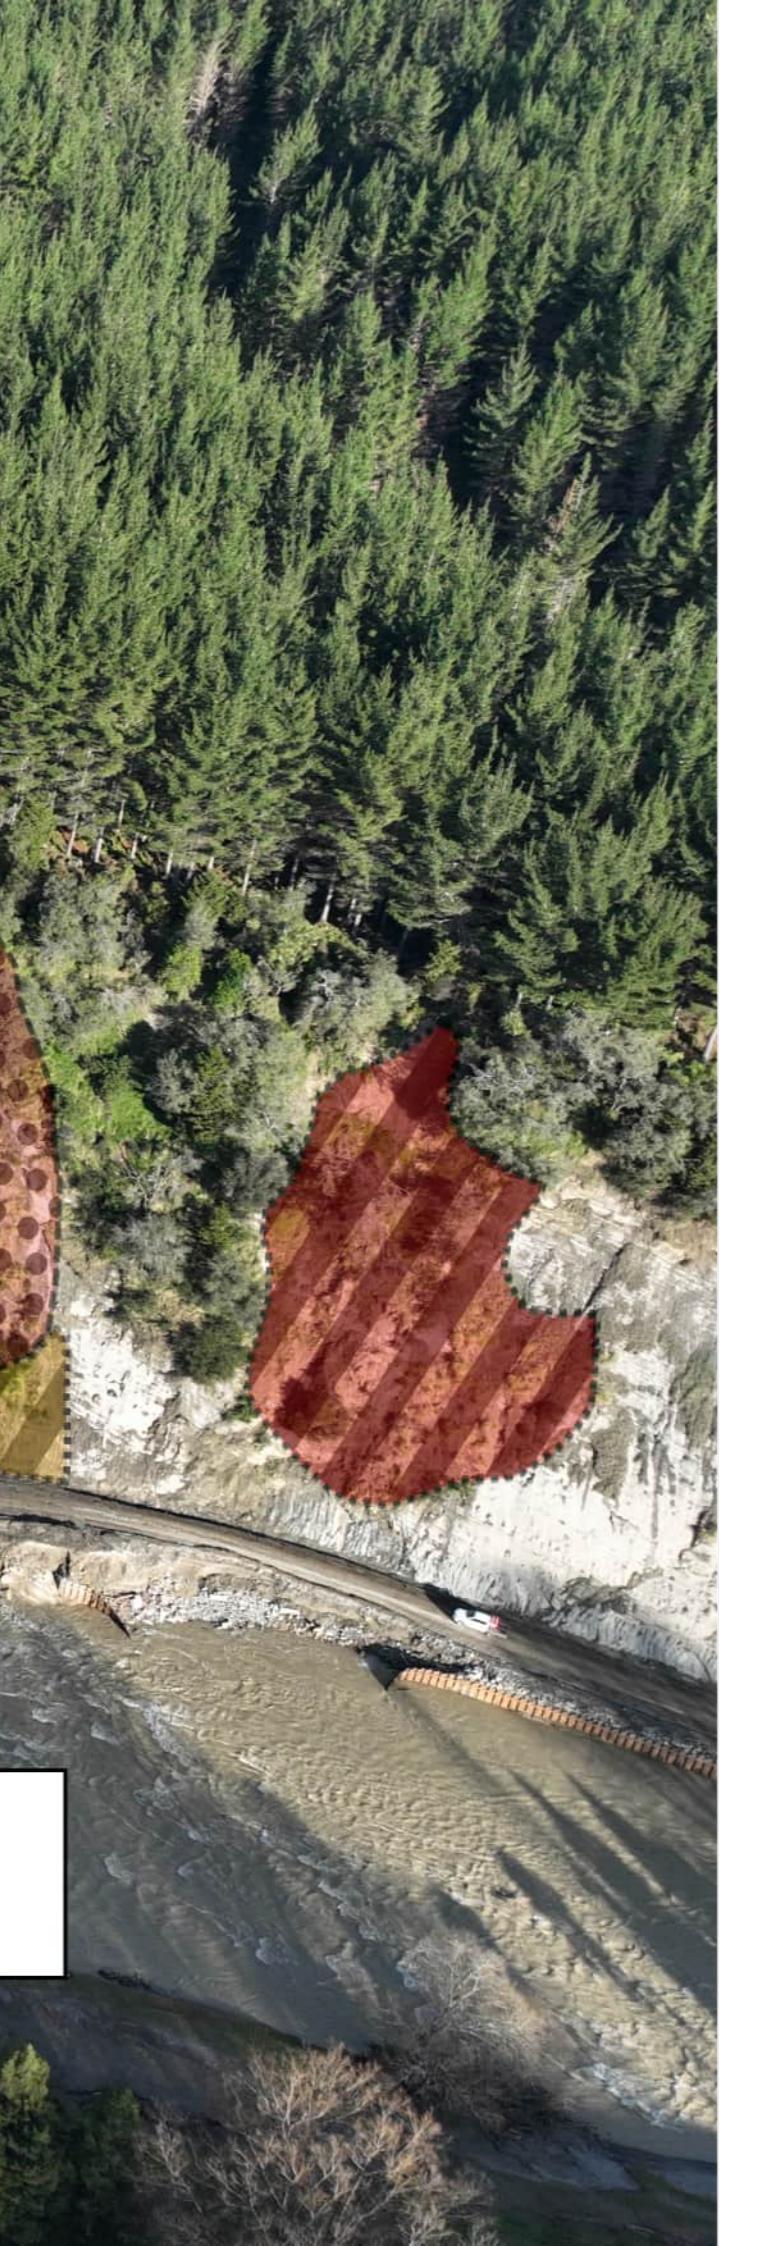
# Bluff 1: RP35.03

Hazard components of rock/block fall and debris flow were observed extensively throughout the bluff (refer to appended annotated image- Bluff 1). It is considered probable that large blocks and large volumes of material could reach the road with high velocity, even without significant rainfall events. Due to the potential consequence of the hazard being severe, all areas are considered either high or extreme risk, relative to the likelihood of occurrence.

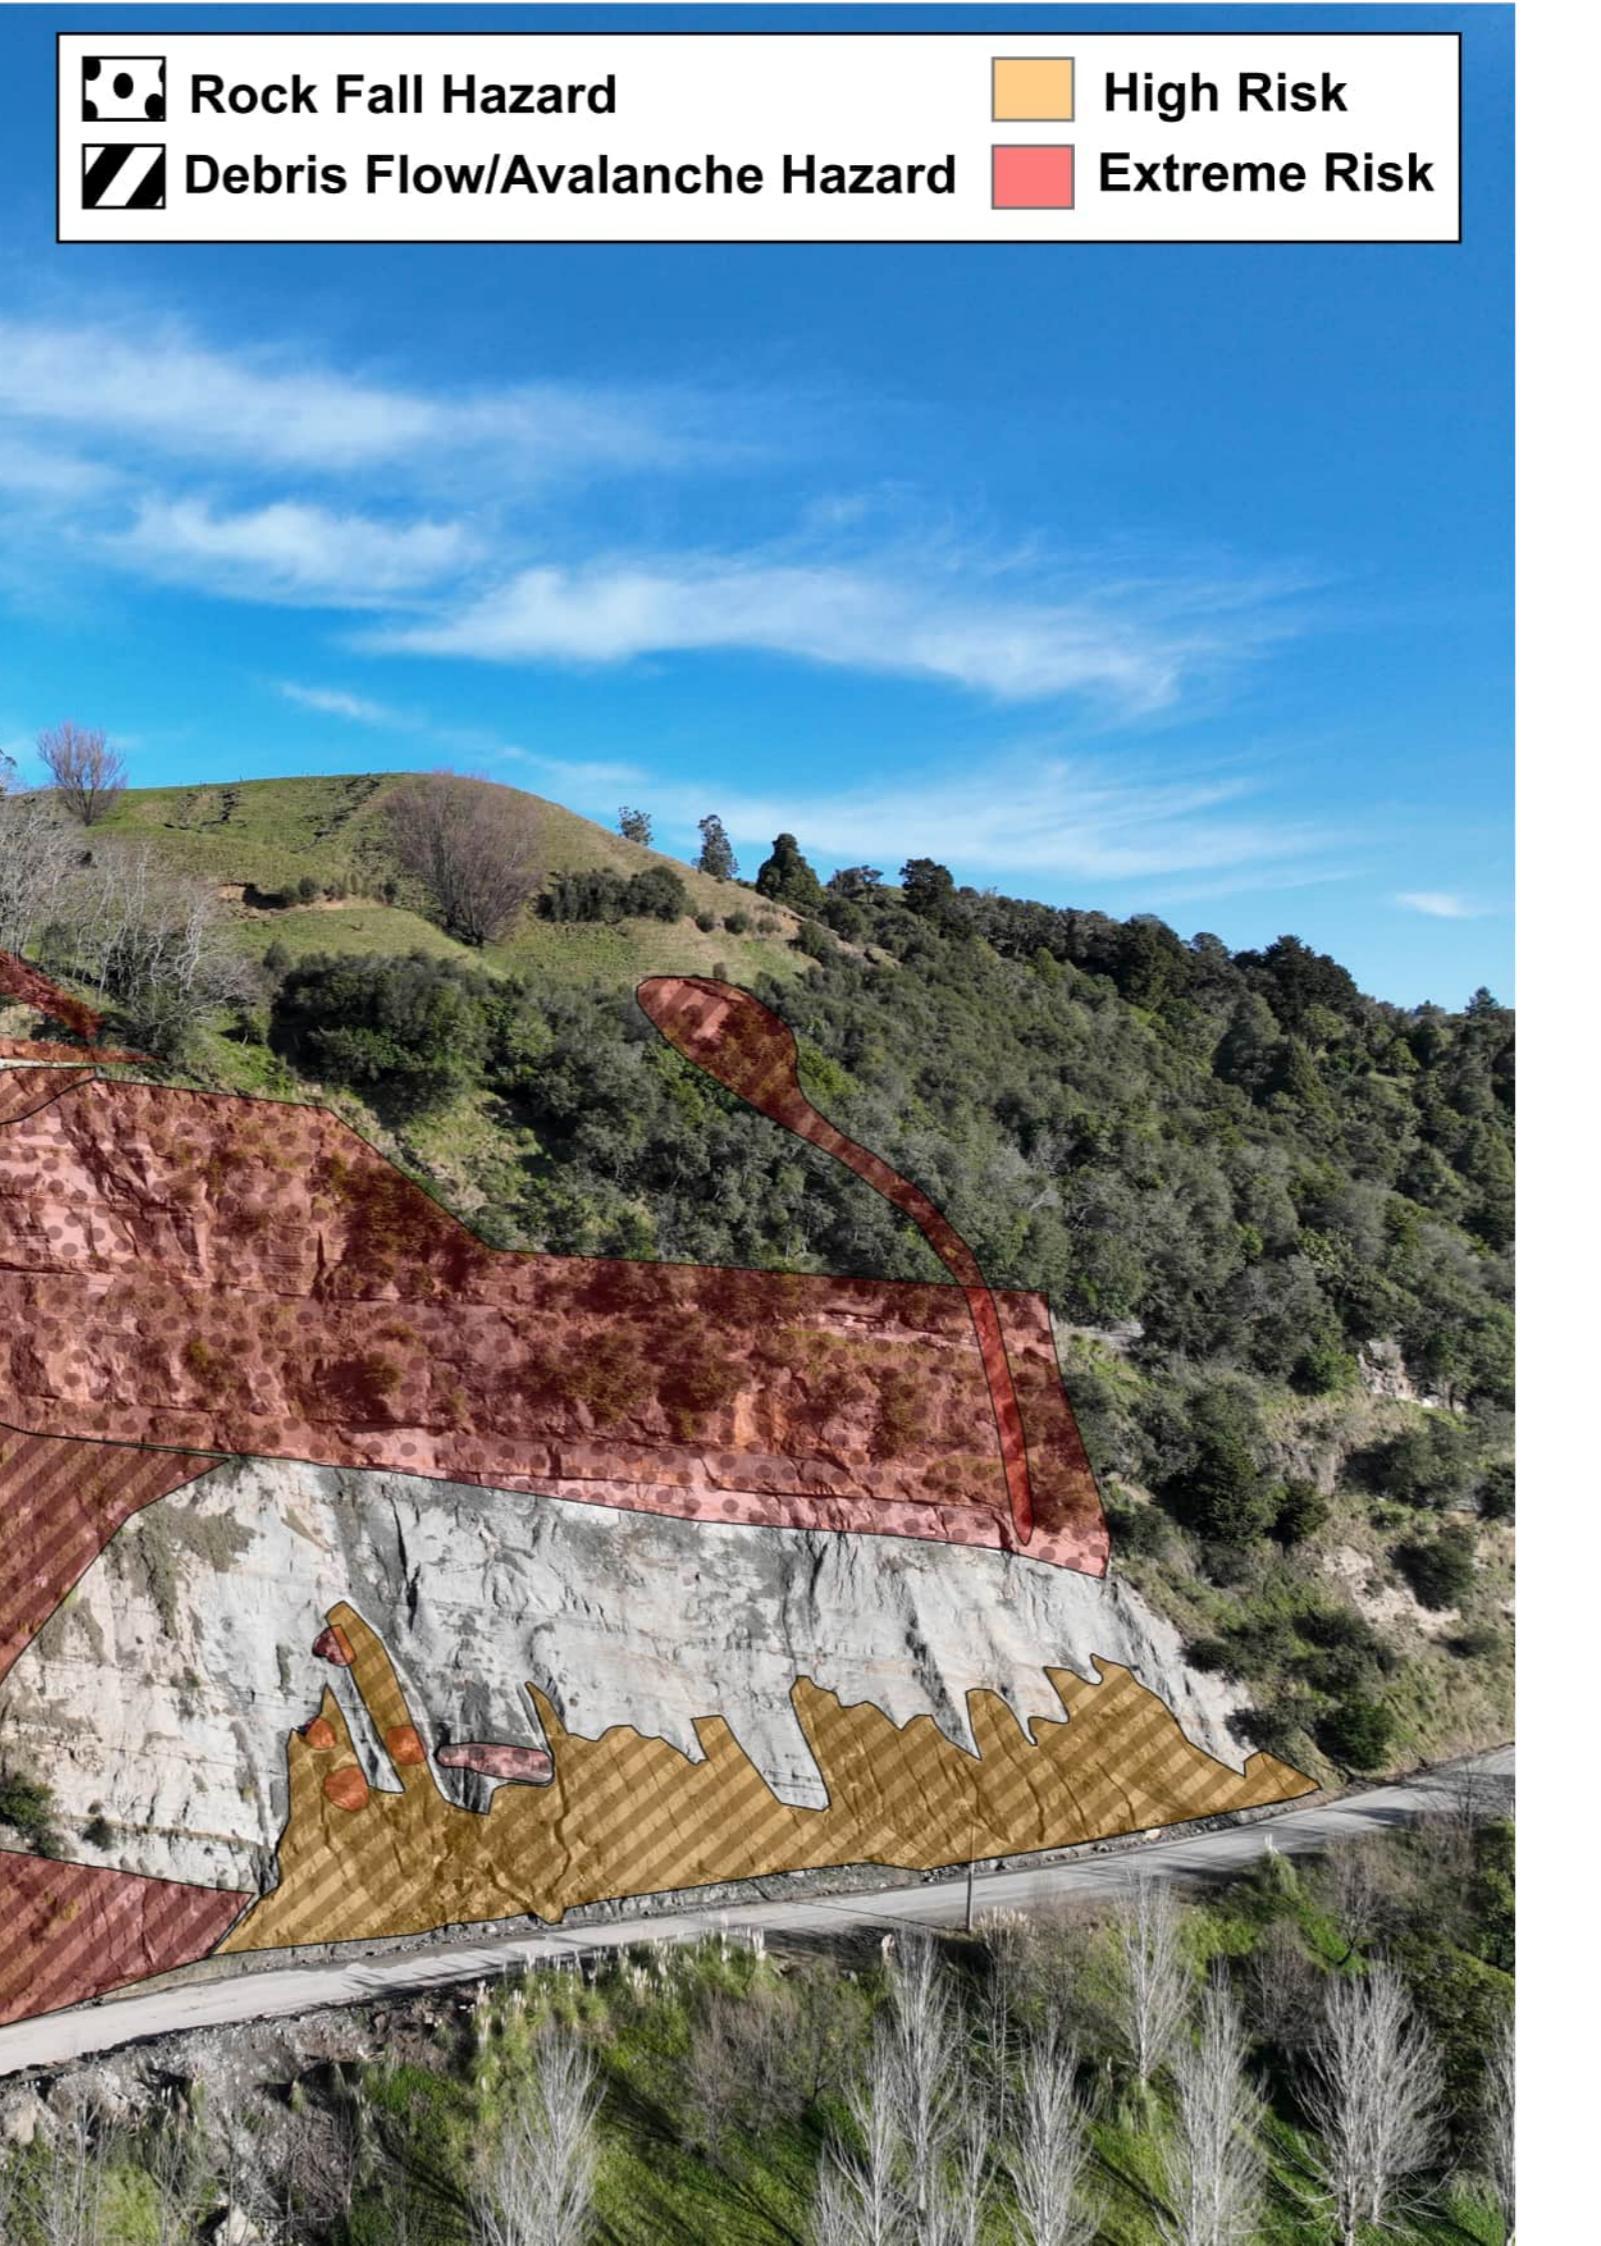
# Bluff 3: RP37.03

The principal hazard is considered rock/ block fall, with a lesser component of debris flow and runout.
