AGENDA/KAUPAPA

P O Box 747, Gisborne, Ph 06 867 2049 Fax 06 867 8076
Email service@gdc.govt.nz Web www.gdc.govt.nz

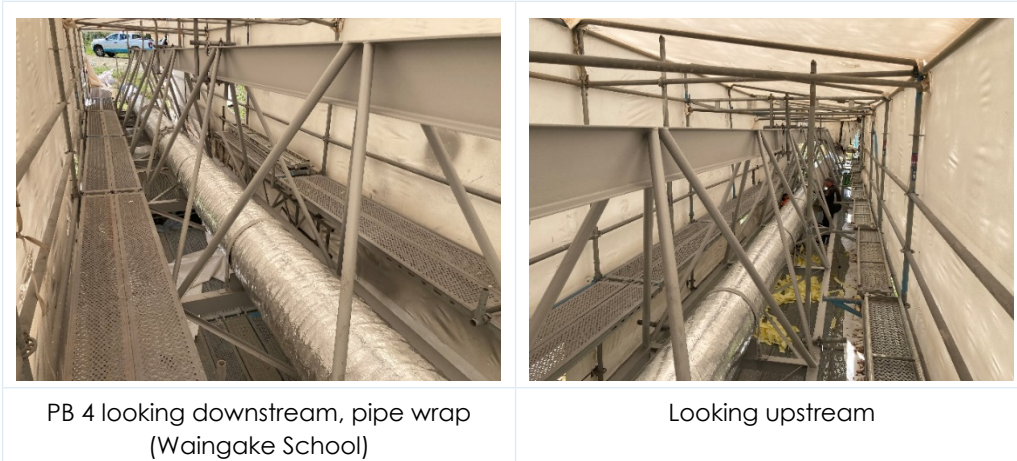
Year to date	Balance Committed	Total Spend	Remaining
\$989k	\$534k	\$1.523m	\$0

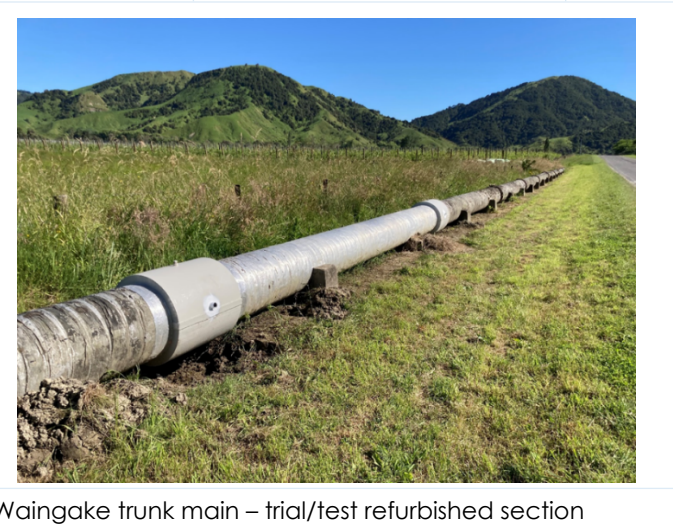
Waingake Treatment Plant UV

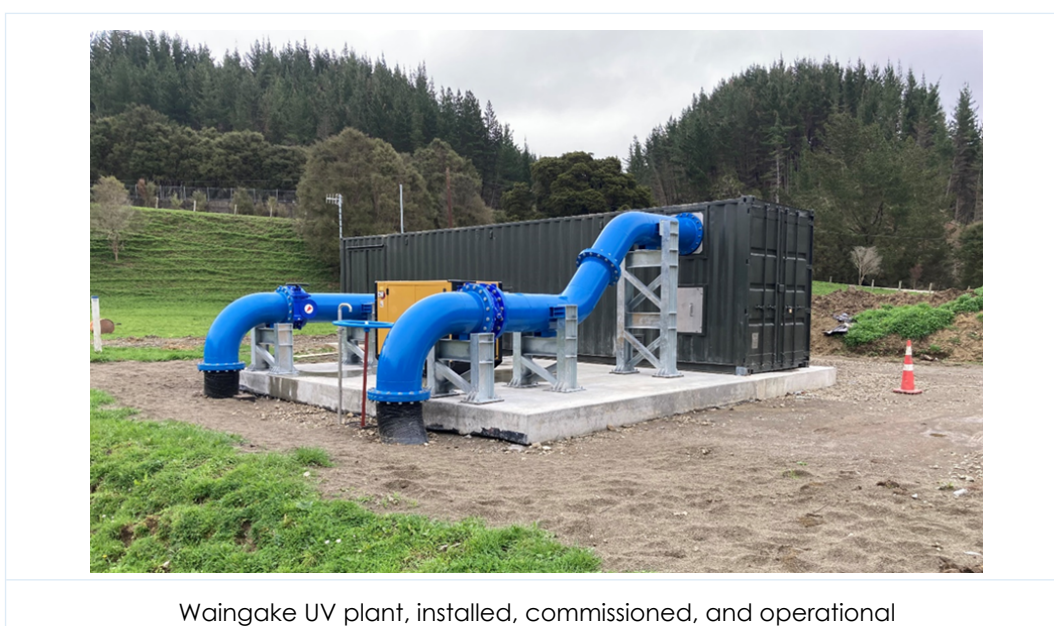
Residential Backflow Prevention

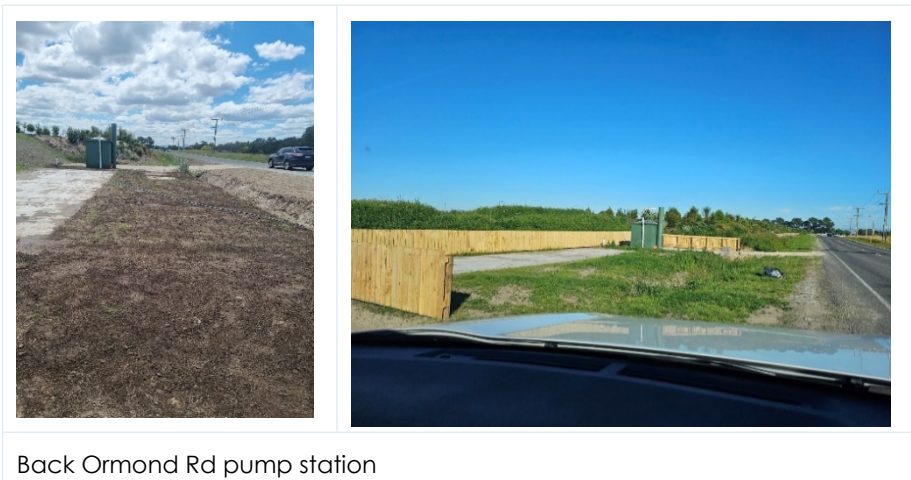
Wastewater Pump Station Renewals

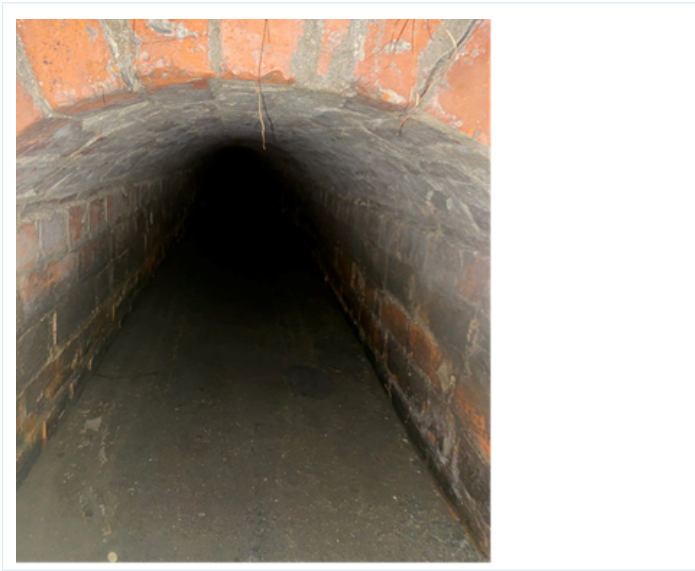
Childers Road / Disraeli Street brick stormwater channel

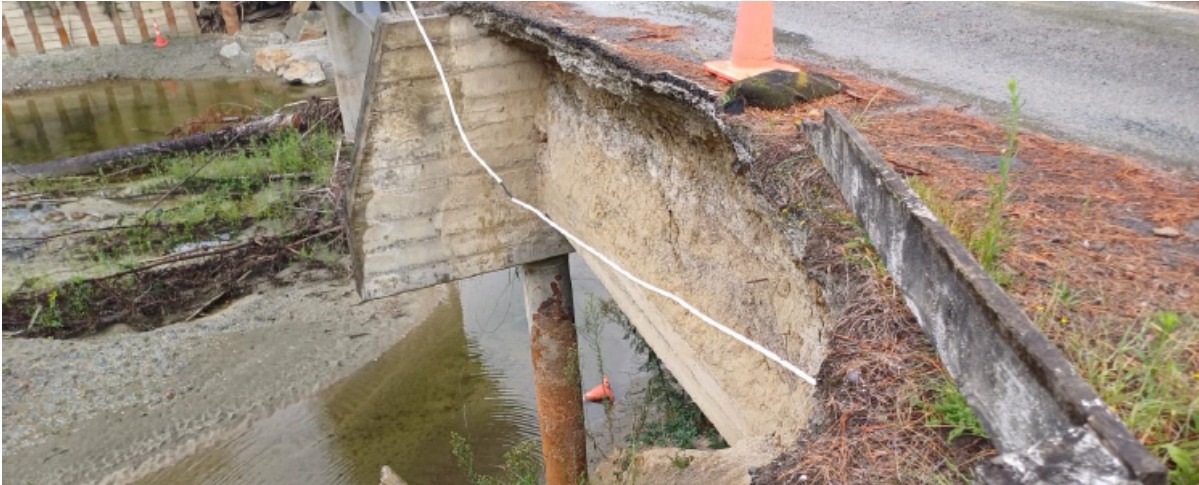
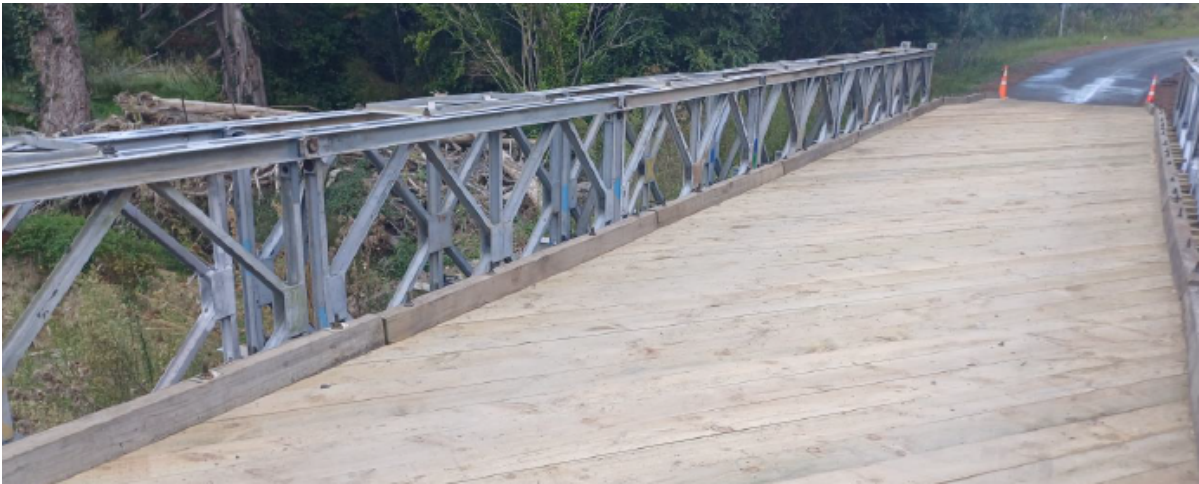
- 5. Other works include grading 256km of roads, and cleaning and jetting 198 culverts and heavy metalling on Takapau Road.

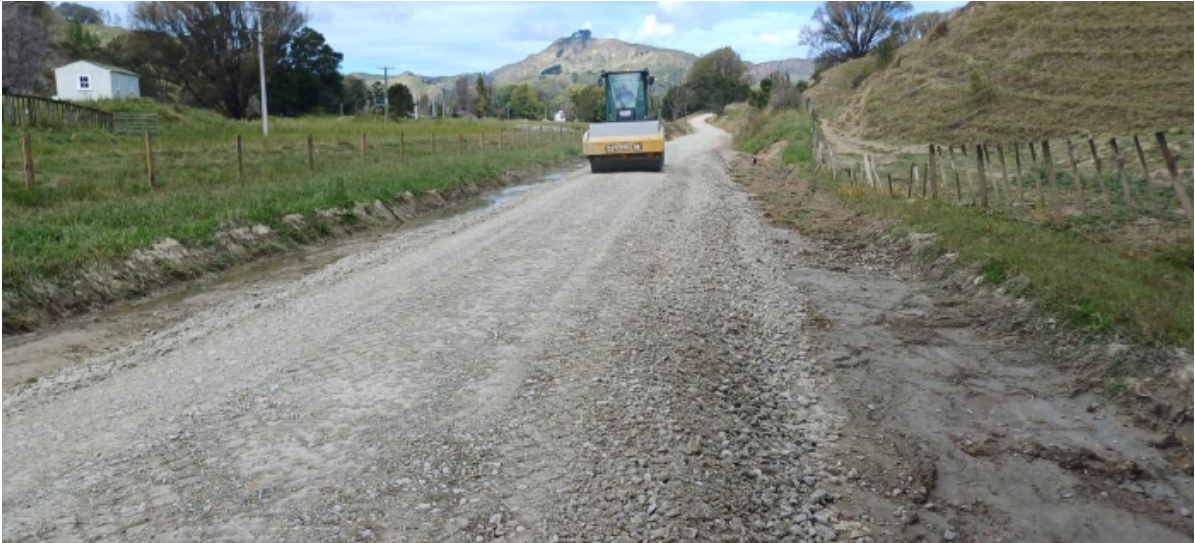
WAIPAOA and TURANGA CONTRACTS

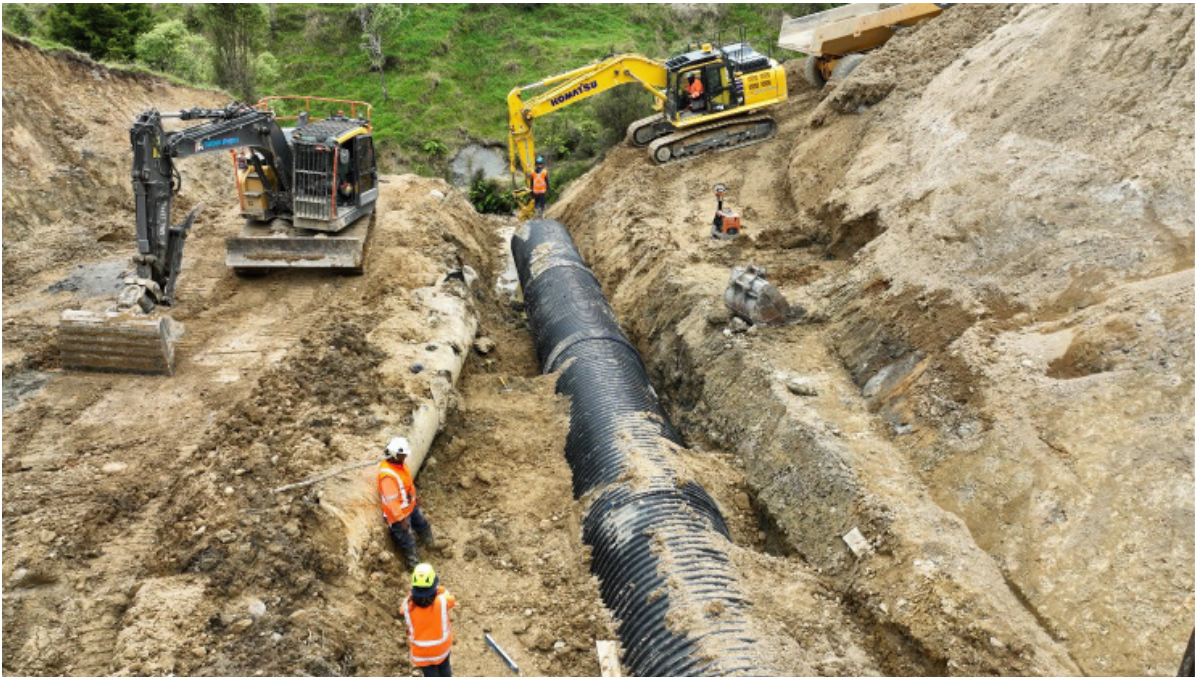
- 6. There is still a focus on cyclone repairs like this major culvert washout on Rakauora Road. Crews still are undertaking maintenance activities for instance 766 pothole repairs were completed, major dig outs on Tiniroto Road and footbridge maintenance activities.

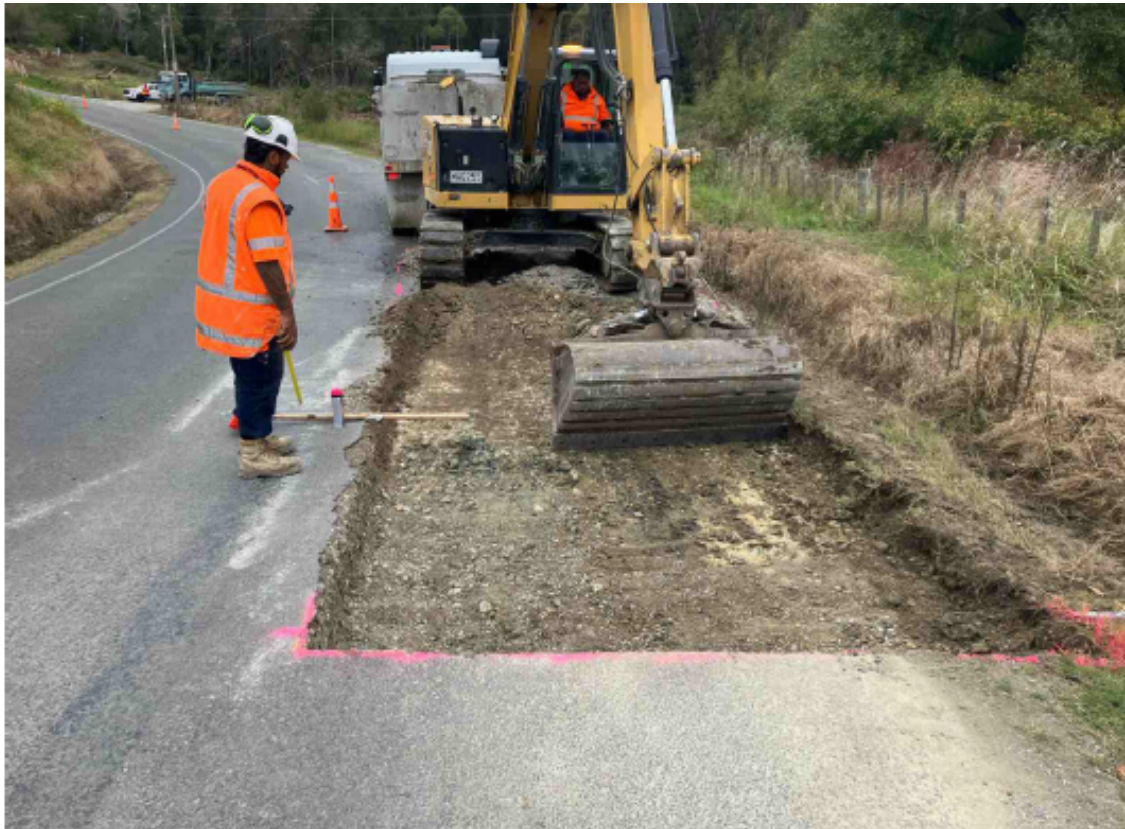
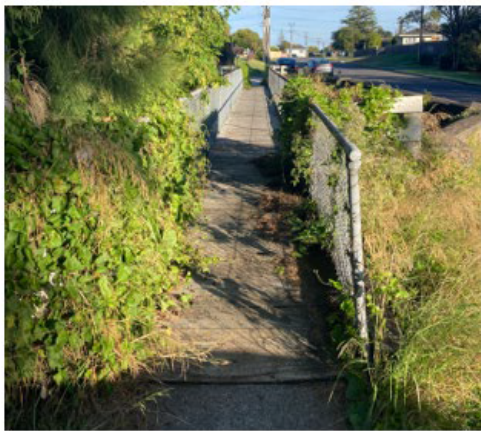
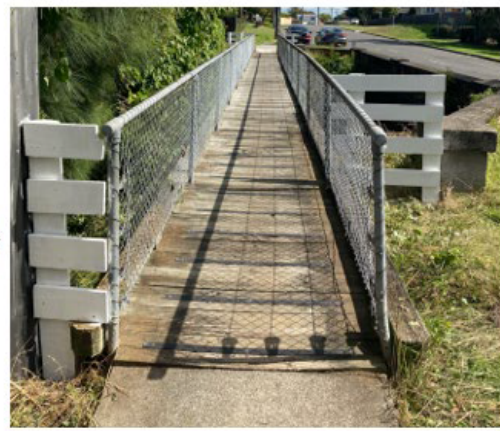
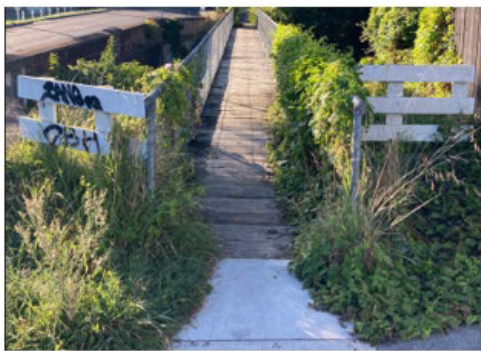
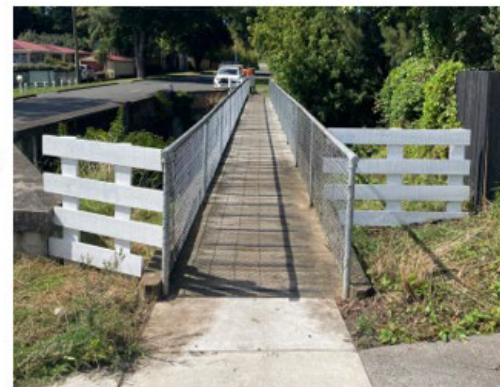
7. This month our contractors had an increase in anti-social behaviour. The teams were responding to events such as the library protest, numerous calls to the Palmerston/Derby Street project to replace traffic management and extensive clean up after boy racer events. The downside is our contractors must reprioritise planned work to these unplanned events.

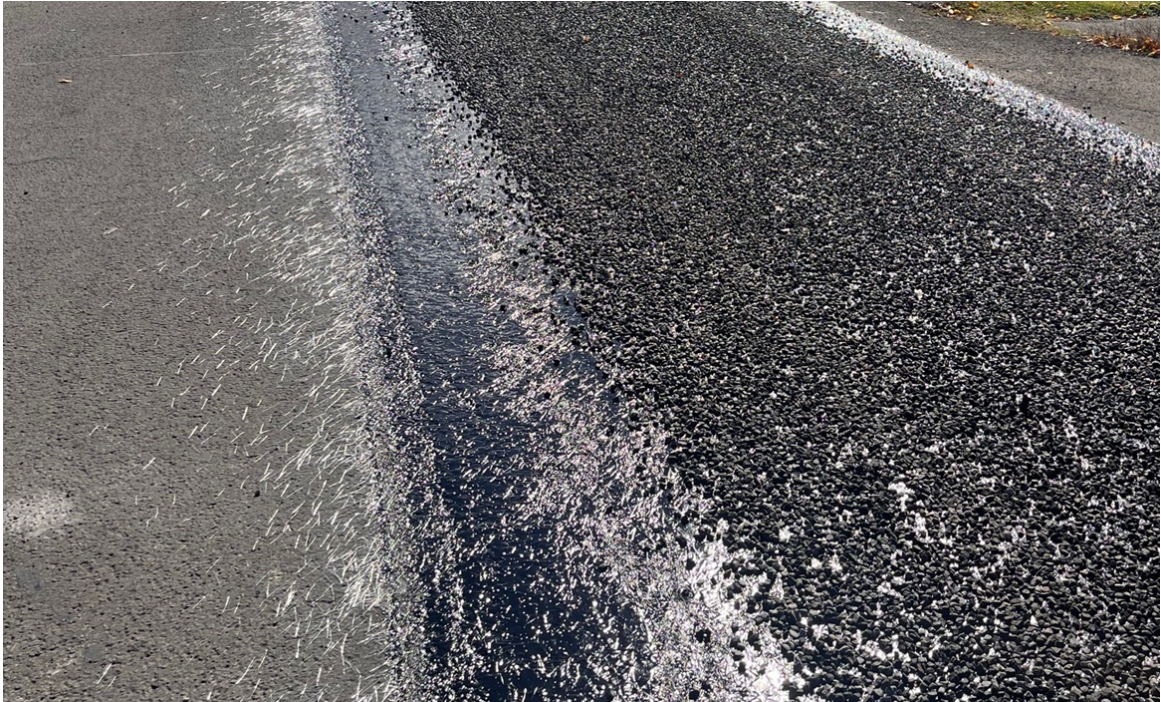
27. The total budget for the combined programme is \$15.4m (bridges are now included) and our finances show a 90% completion rate. The next 3 months will be focussed on landing on this budget line.

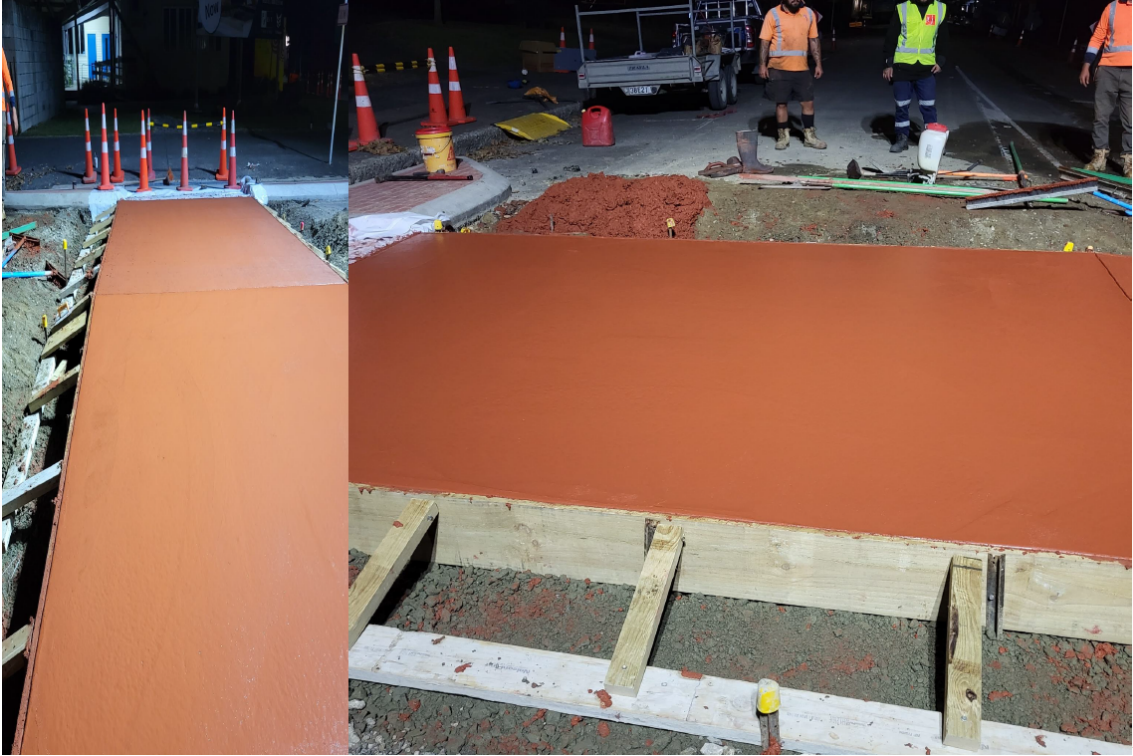
- 31. The safety improvements of Palmerston and Derby intersection is underway, with a goal of improved pedestrian access at this site. The scope of work includes kerb repairs and removal of existing pedestrian crossing points and installation of new raised pedestrian crossings and islands.
- 32. The cost of the project is \$380,000k and is programmed to be finished by the end of May.

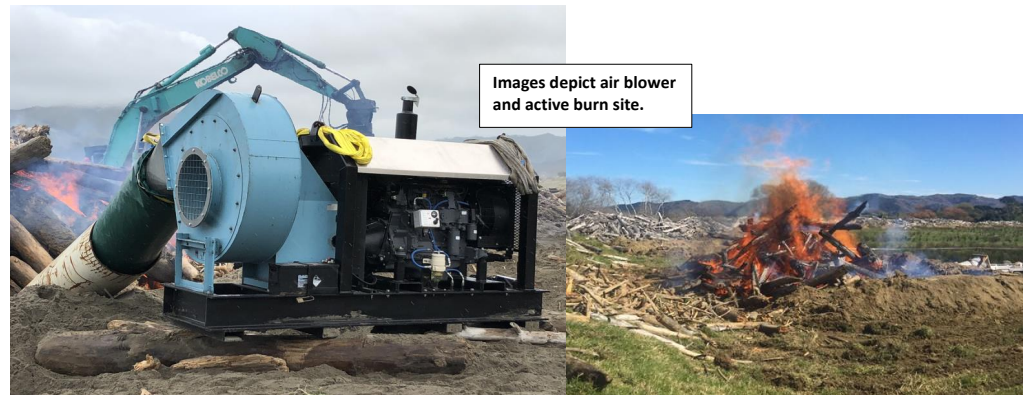
- GDC representatives to contact appropriate iwi and authority so they can enact their protocols and oversee the discovery and preservation process.

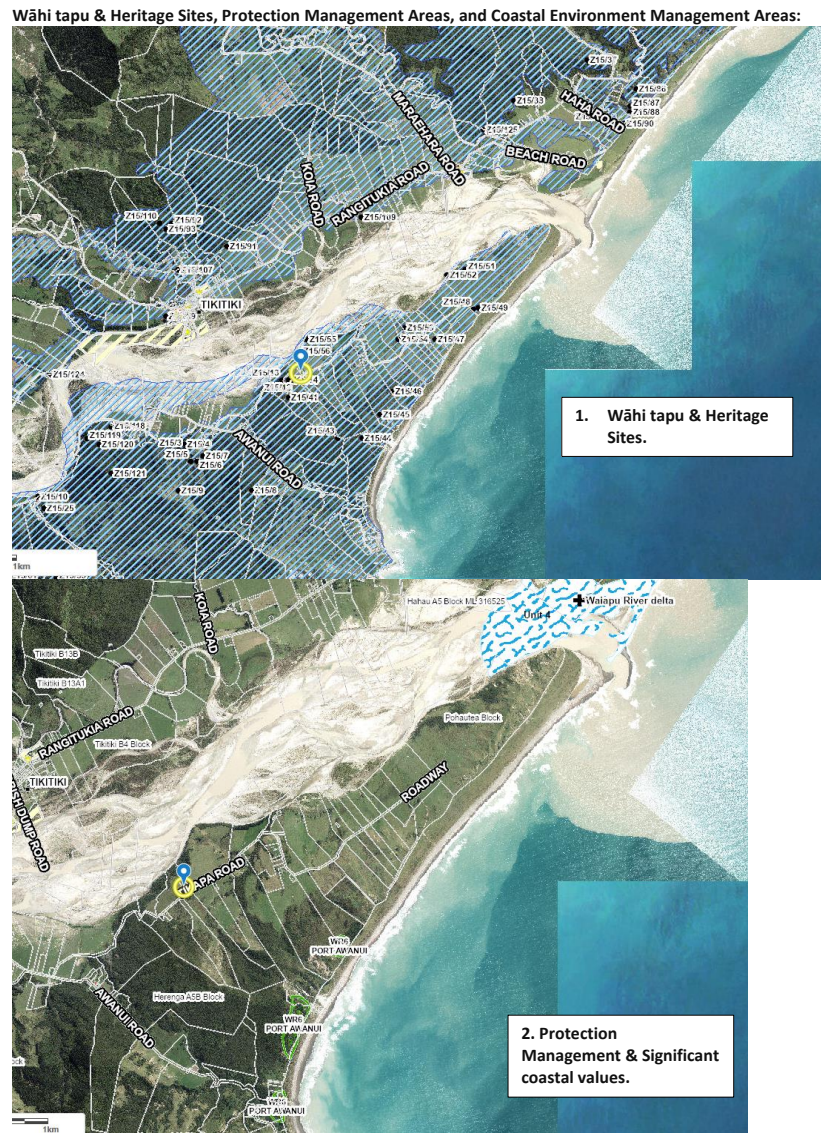
pests. A record of this cleaning shall be kept and made available to the Council on request.

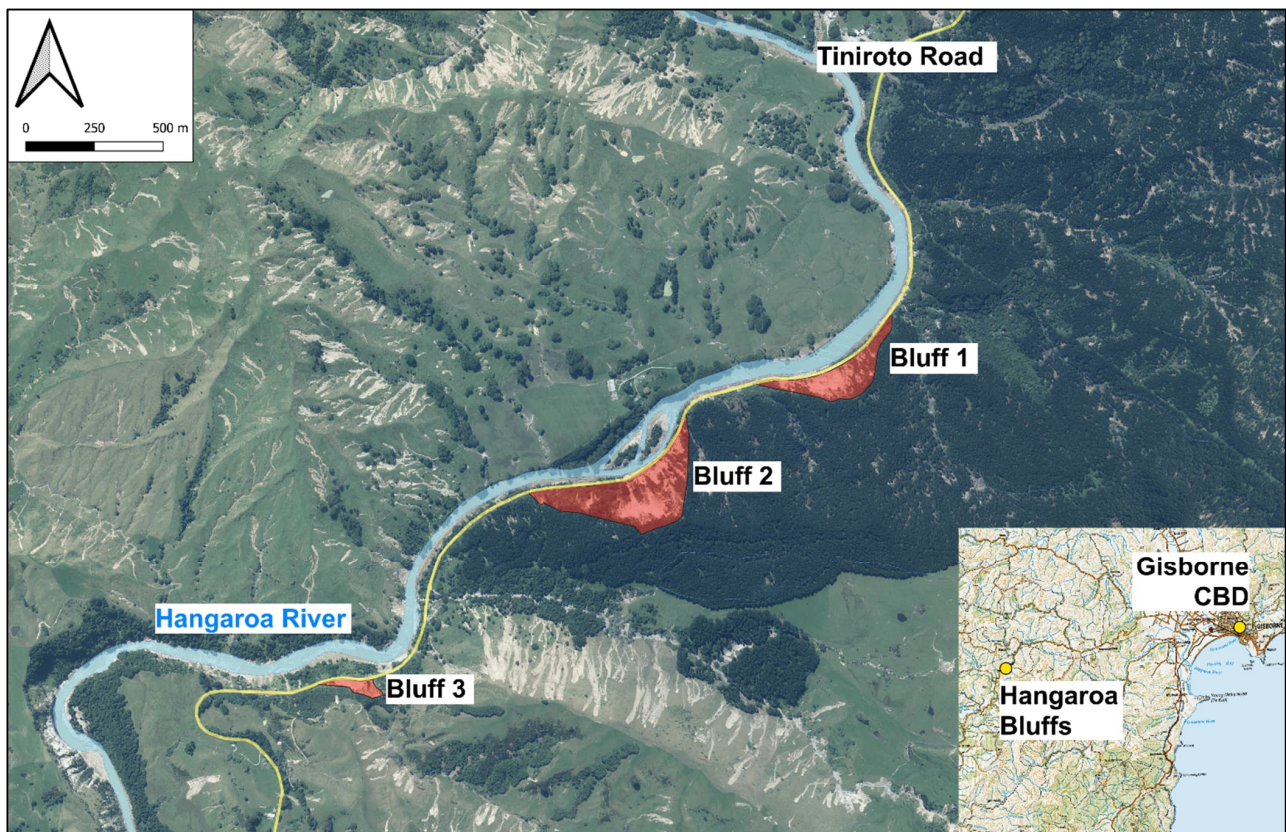
Figure 1: Location maps of the Hangaroa Bluffs.

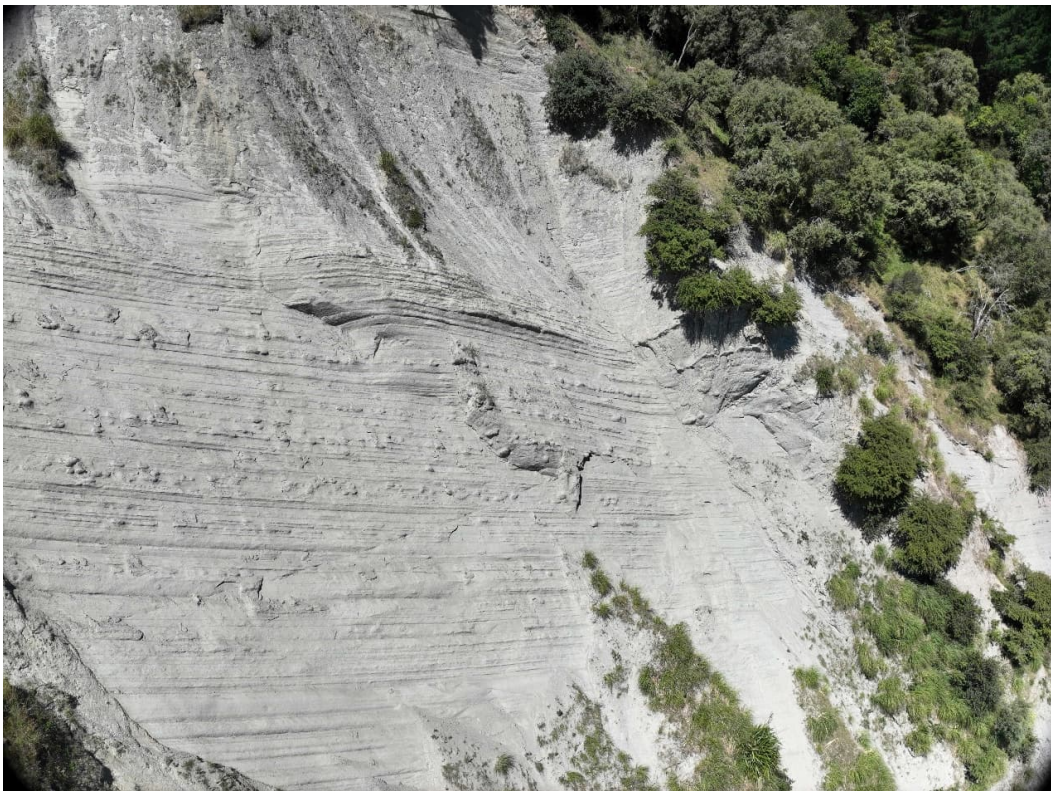
Figure 2: Oblique view to southwest of upper middle section of Bluff 1. Large blocks overhand areas where failure has already occurred, above a secondary defect.

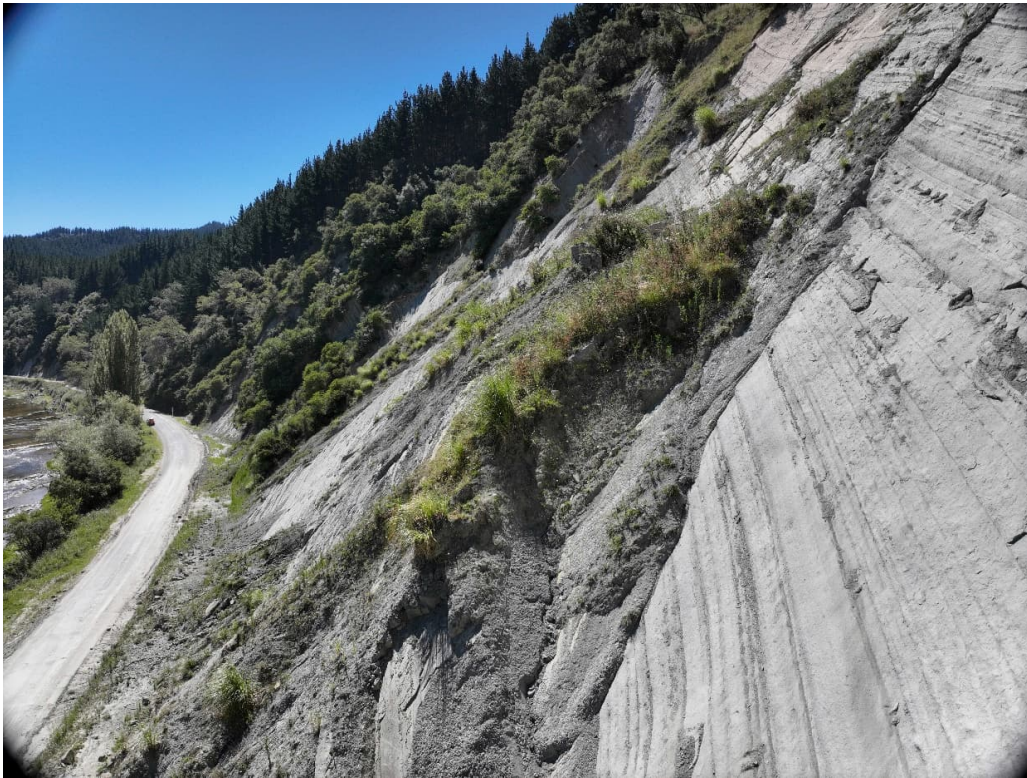
Figure 3: UAV view to east of Bluff 1 along planar (structural defect-controlled face). Perched blocks of weathered rock/soil and vegetation are evident, intersected by the pervasive defect. A remnant of an earth bund and accumulated sediment are evident at the slope toe.

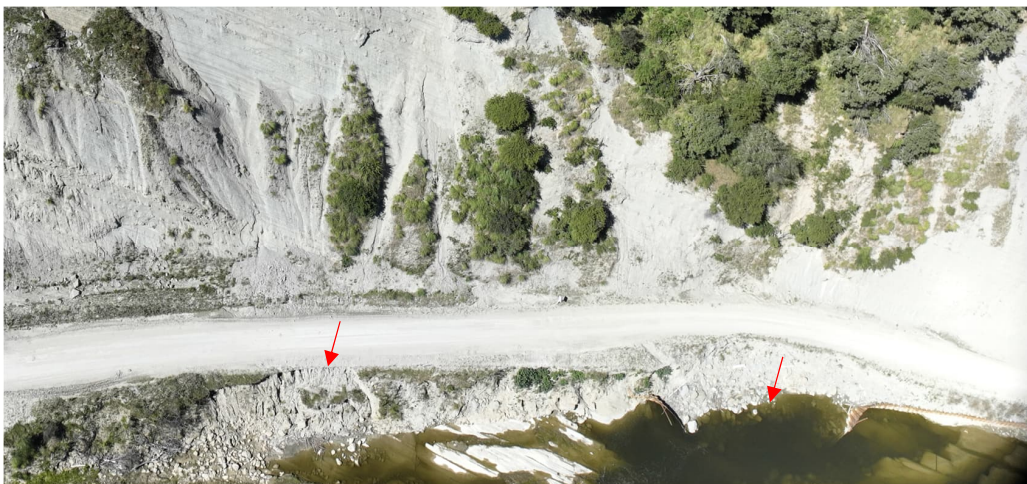
Figure 4: Mid to western extent of Bluff 1, showing with arrows areas where road width has been affected by a drop-out and the compromised sheet pile wall.

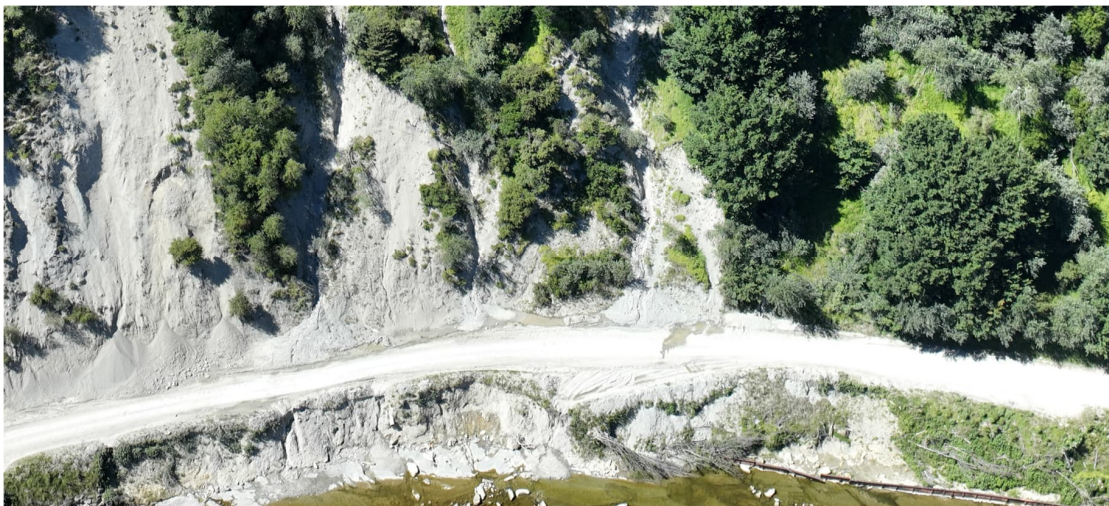
Figure 8: Dropouts along mid-section of Bluff 2. A culvert is visible in one of the dropouts, showing the extent of bank loss. Further west is a damaged section of retaining wall.

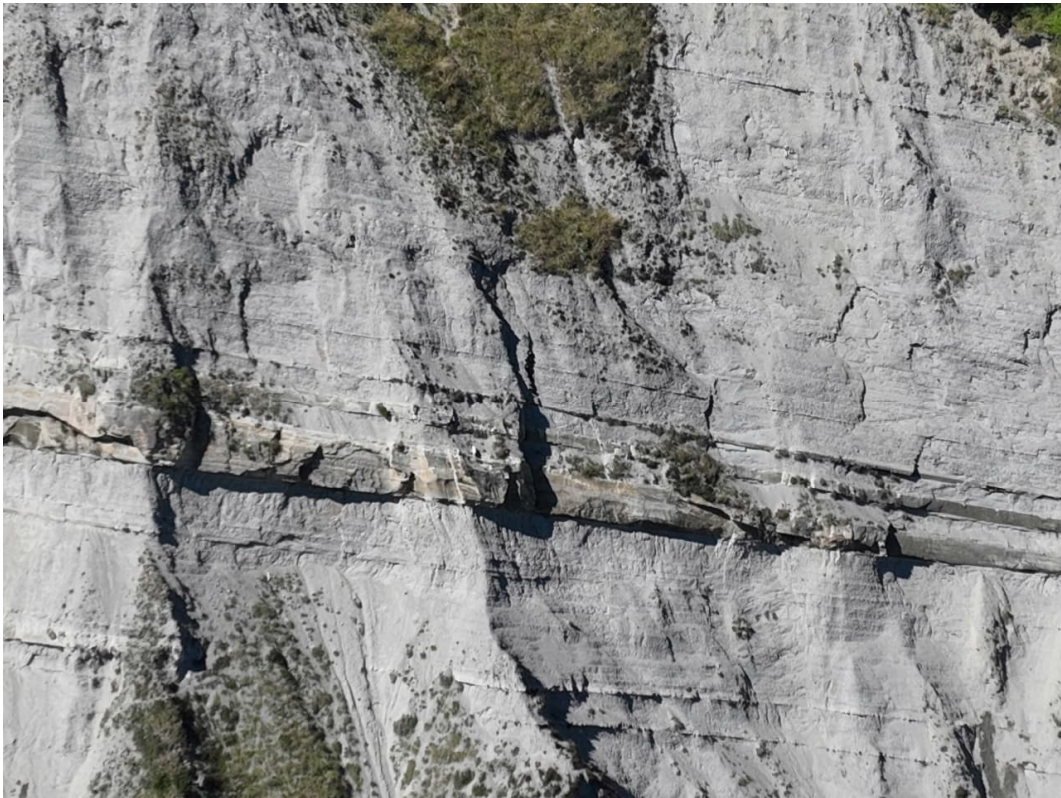
Figure 9: Overhanging sandstone bedding above more erodible mudstone in Bluff 2. Blocks fall from great height and are often channelled through the chutes into the roadway.

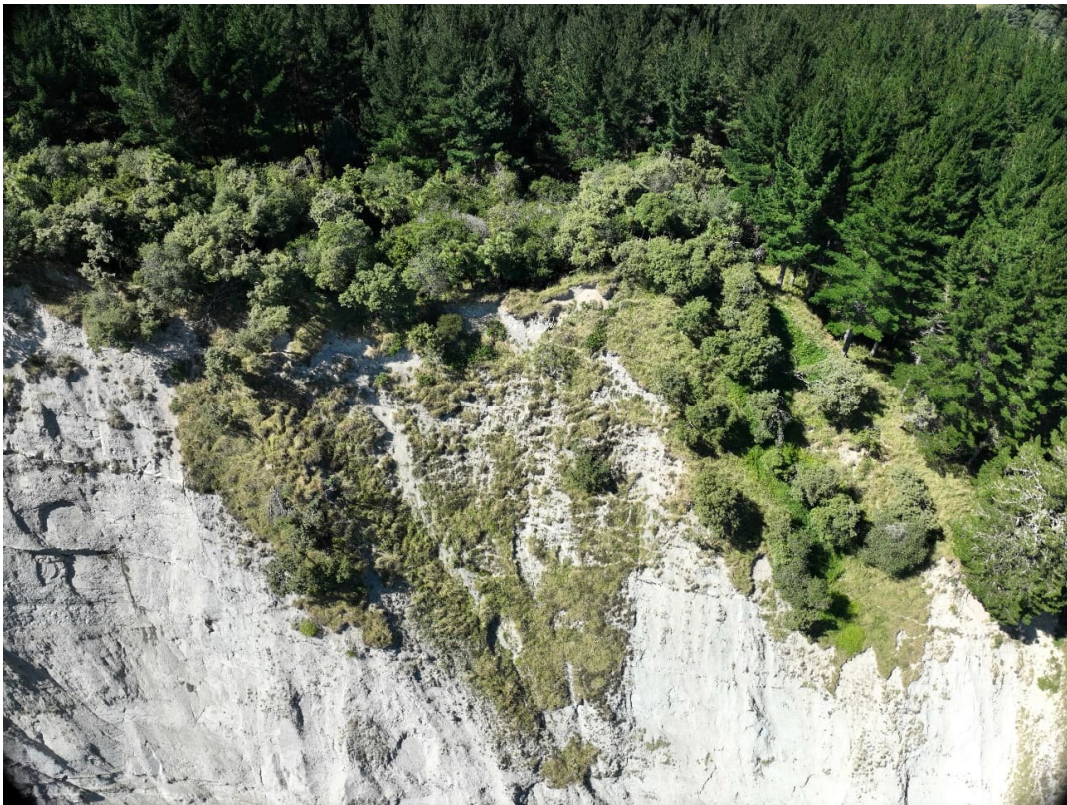
Figure 10: Displaced mass of residual soil and vegetation at the top (southwest) of Bluff 2. Future slide failure hazard.

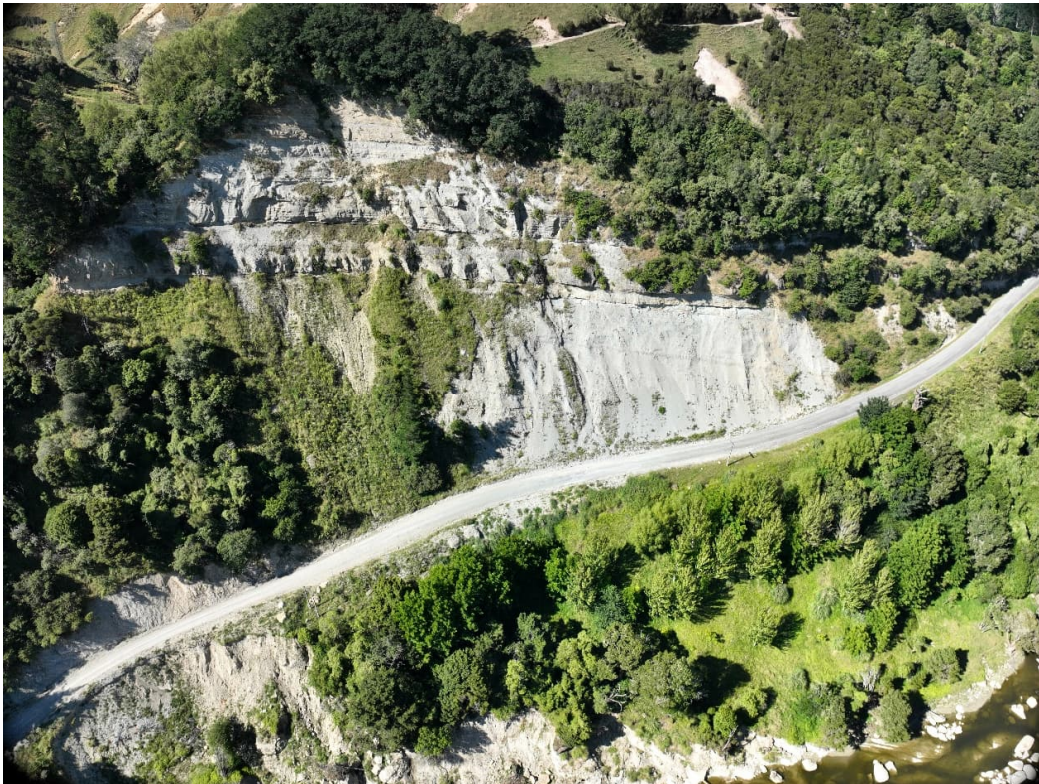
Figure 11: UAV to southwest of Bluff 3. Closer examination reveals large boulders that have reached the road or beyond in past events.

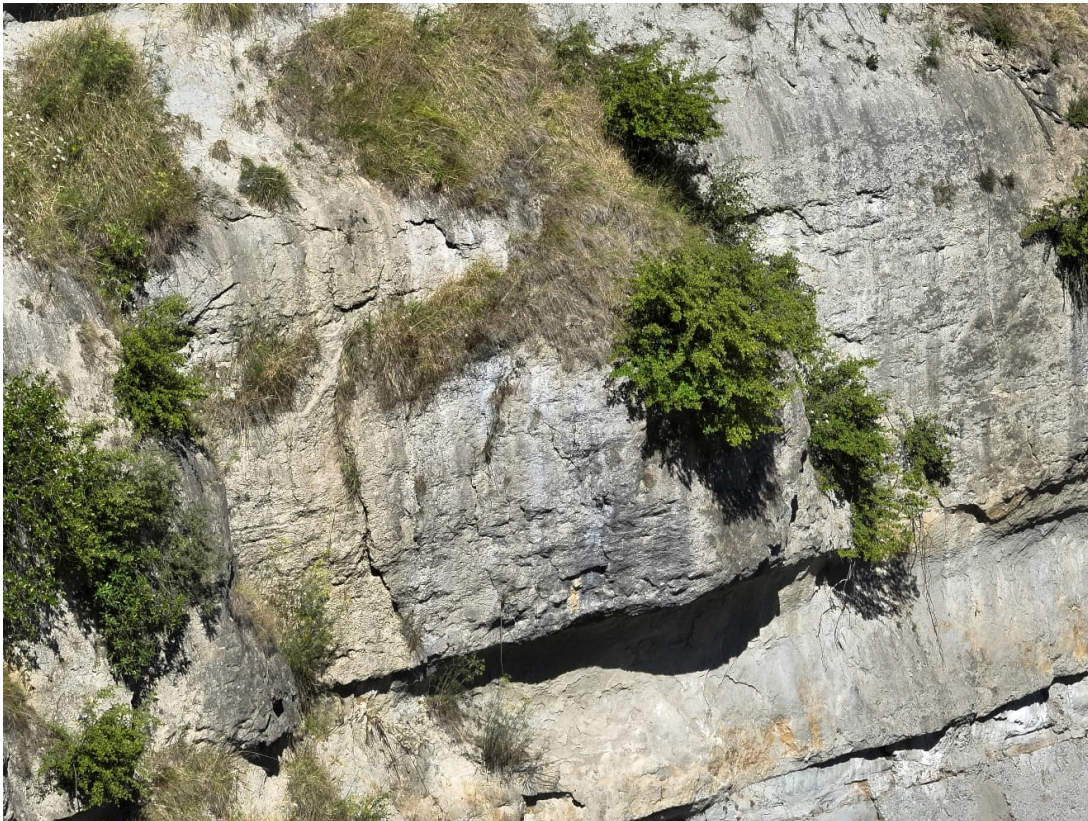
Figure 14: Close up, viewed to west, of dilated cracks in large block of overhanging sandstone.

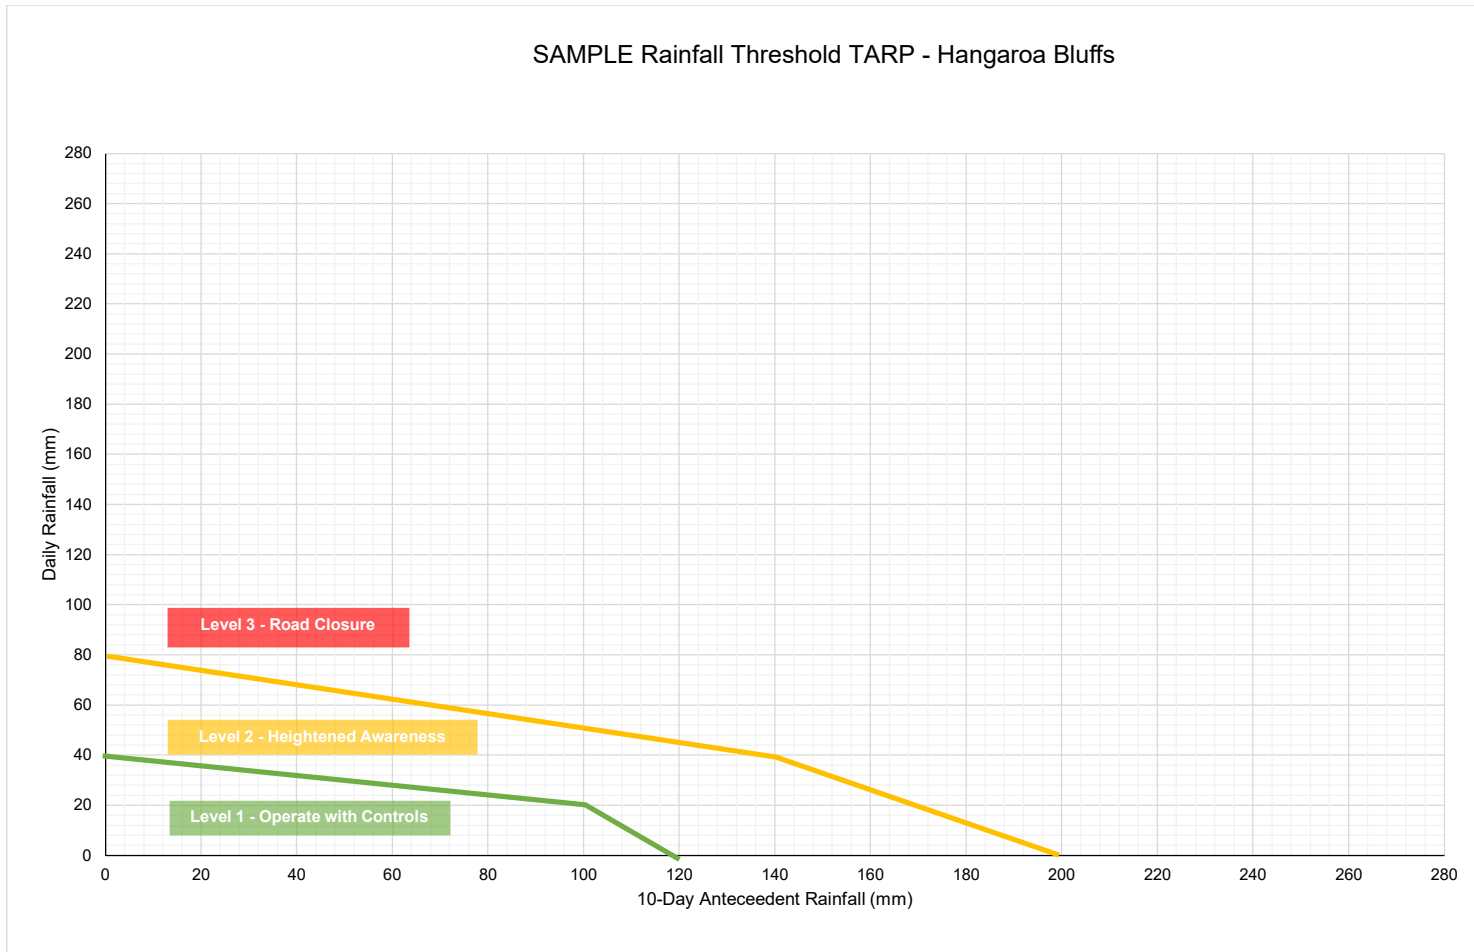
Figure 1: Gisborne regional rainfall TARP rainfall thresholds adopted for Hangaroa Bluffs. Trigger thresholds are derived from regional data and work done by Glade et al. (2000)¹ It is intended that this would be populated with site specific rainfall and instability data. Each data point would indicate whether instability occurred for an event with a given daily vs antecedent rainfall. Instability volumetric magnitude could also be indicated.

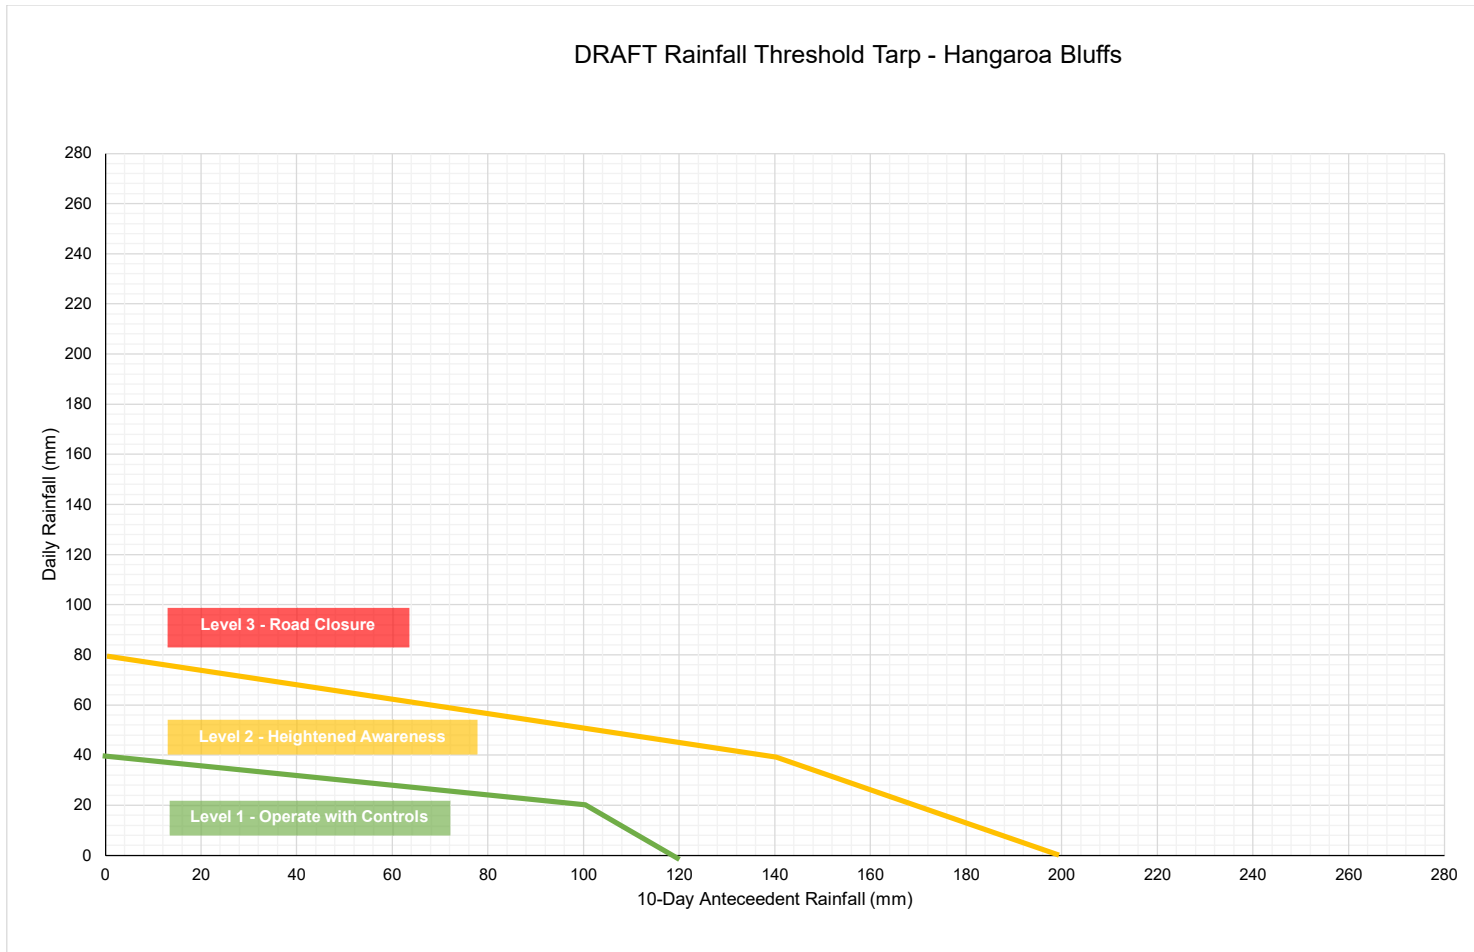
Figure 1: Gisborne regional rainfall TARP rainfall thresholds adopted for Hangaroa Bluffs. Trigger thresholds are derived from regional data and work done by Glade et al. (2000)¹ It is intended that this would be populated with site specific rainfall and instability data. Each data point would indicate whether instability occurred for an event with a given daily vs antecedent rainfall. Instability volumetric magnitude could also be indicated.

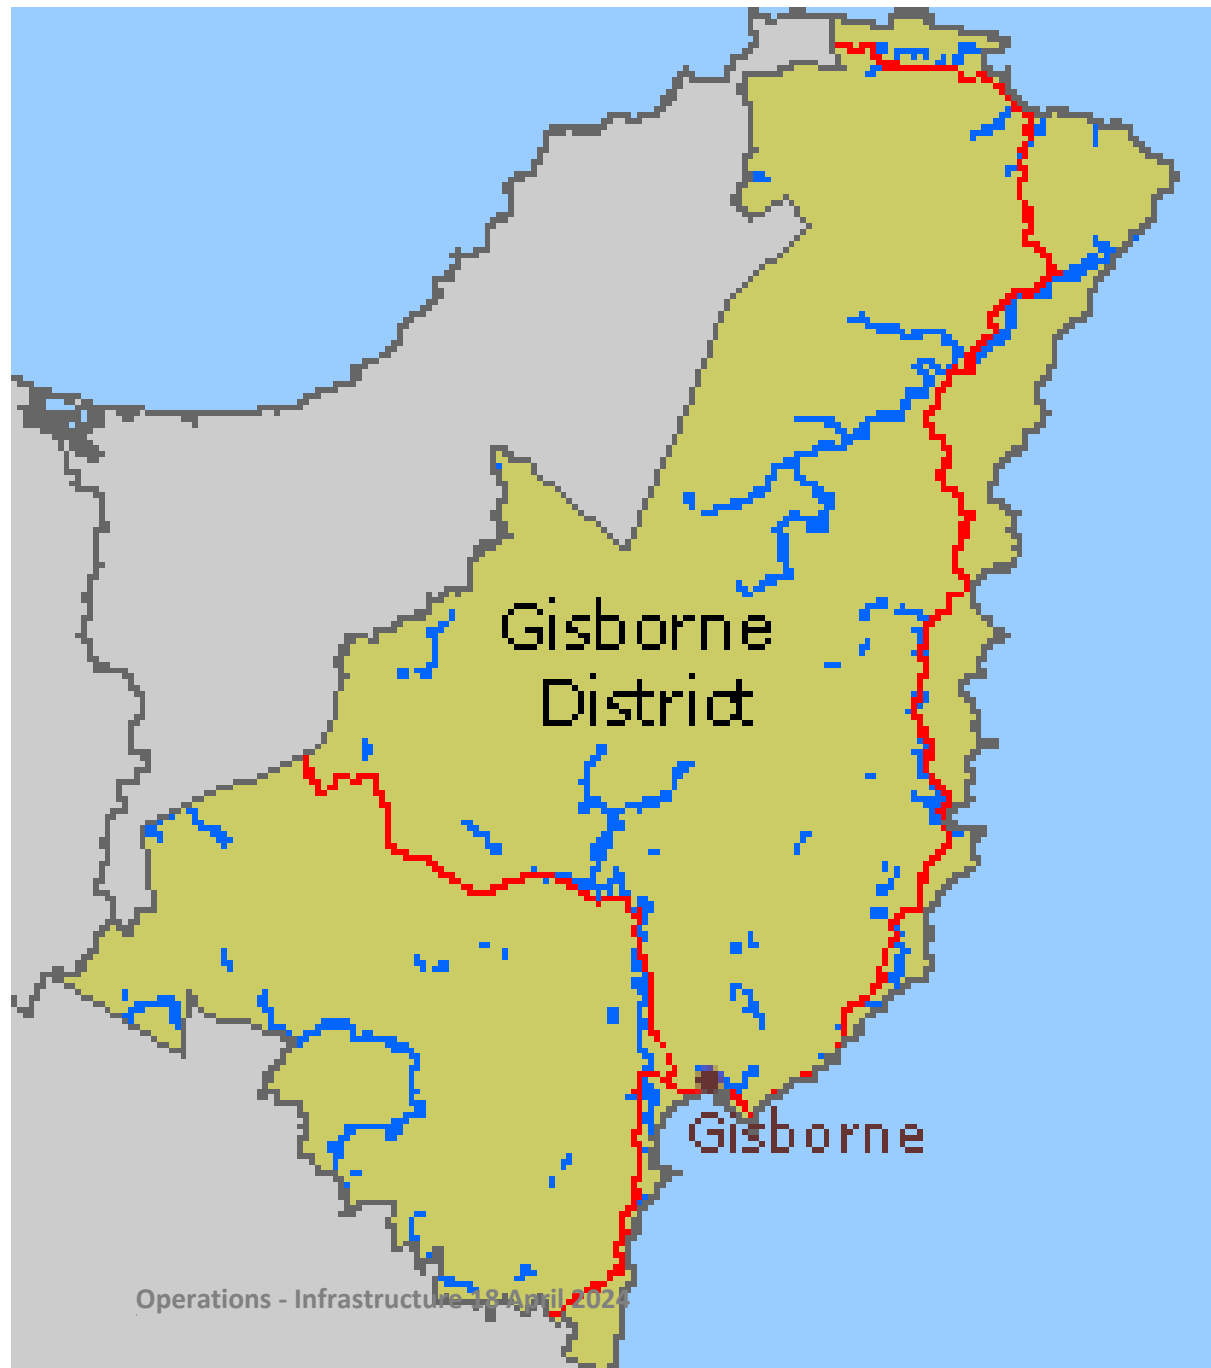
- Claimed \$19,449,178 EW + \$13,414,163 claimed under Minor Events W/C 140
- We reconciled Councils EW spend to the general ledger
- We requested a transaction list of all items claimed against the 140 Minor works and 141 Emergency works category related to Cyclone Gabrielle and other region North Island Weather Events expenditure.
- We selected a sample of transactions (Physical Works and Professional Services) and traced these back to the source documents to verify funding eligibility.
- We selected a sample of response activities through RAMM dispatch data recorded against the events.
- We established how physical works were procured and the value of the work performed by each supplier including contractors utilised for the Cyclone Gabrielle event.
