MAKORORI BEACH TOWNSHIP  
 COOK COUNTY  
 ENGINEERING GEOLOGY MAP LOT 14 TO LOT 43.

SCALES: 1:1000	
PROJECT	DRAWING
2535	FIG. 6
DATE DEC '83	DRAWN K.R. [Signature] CHK'D [Signature]

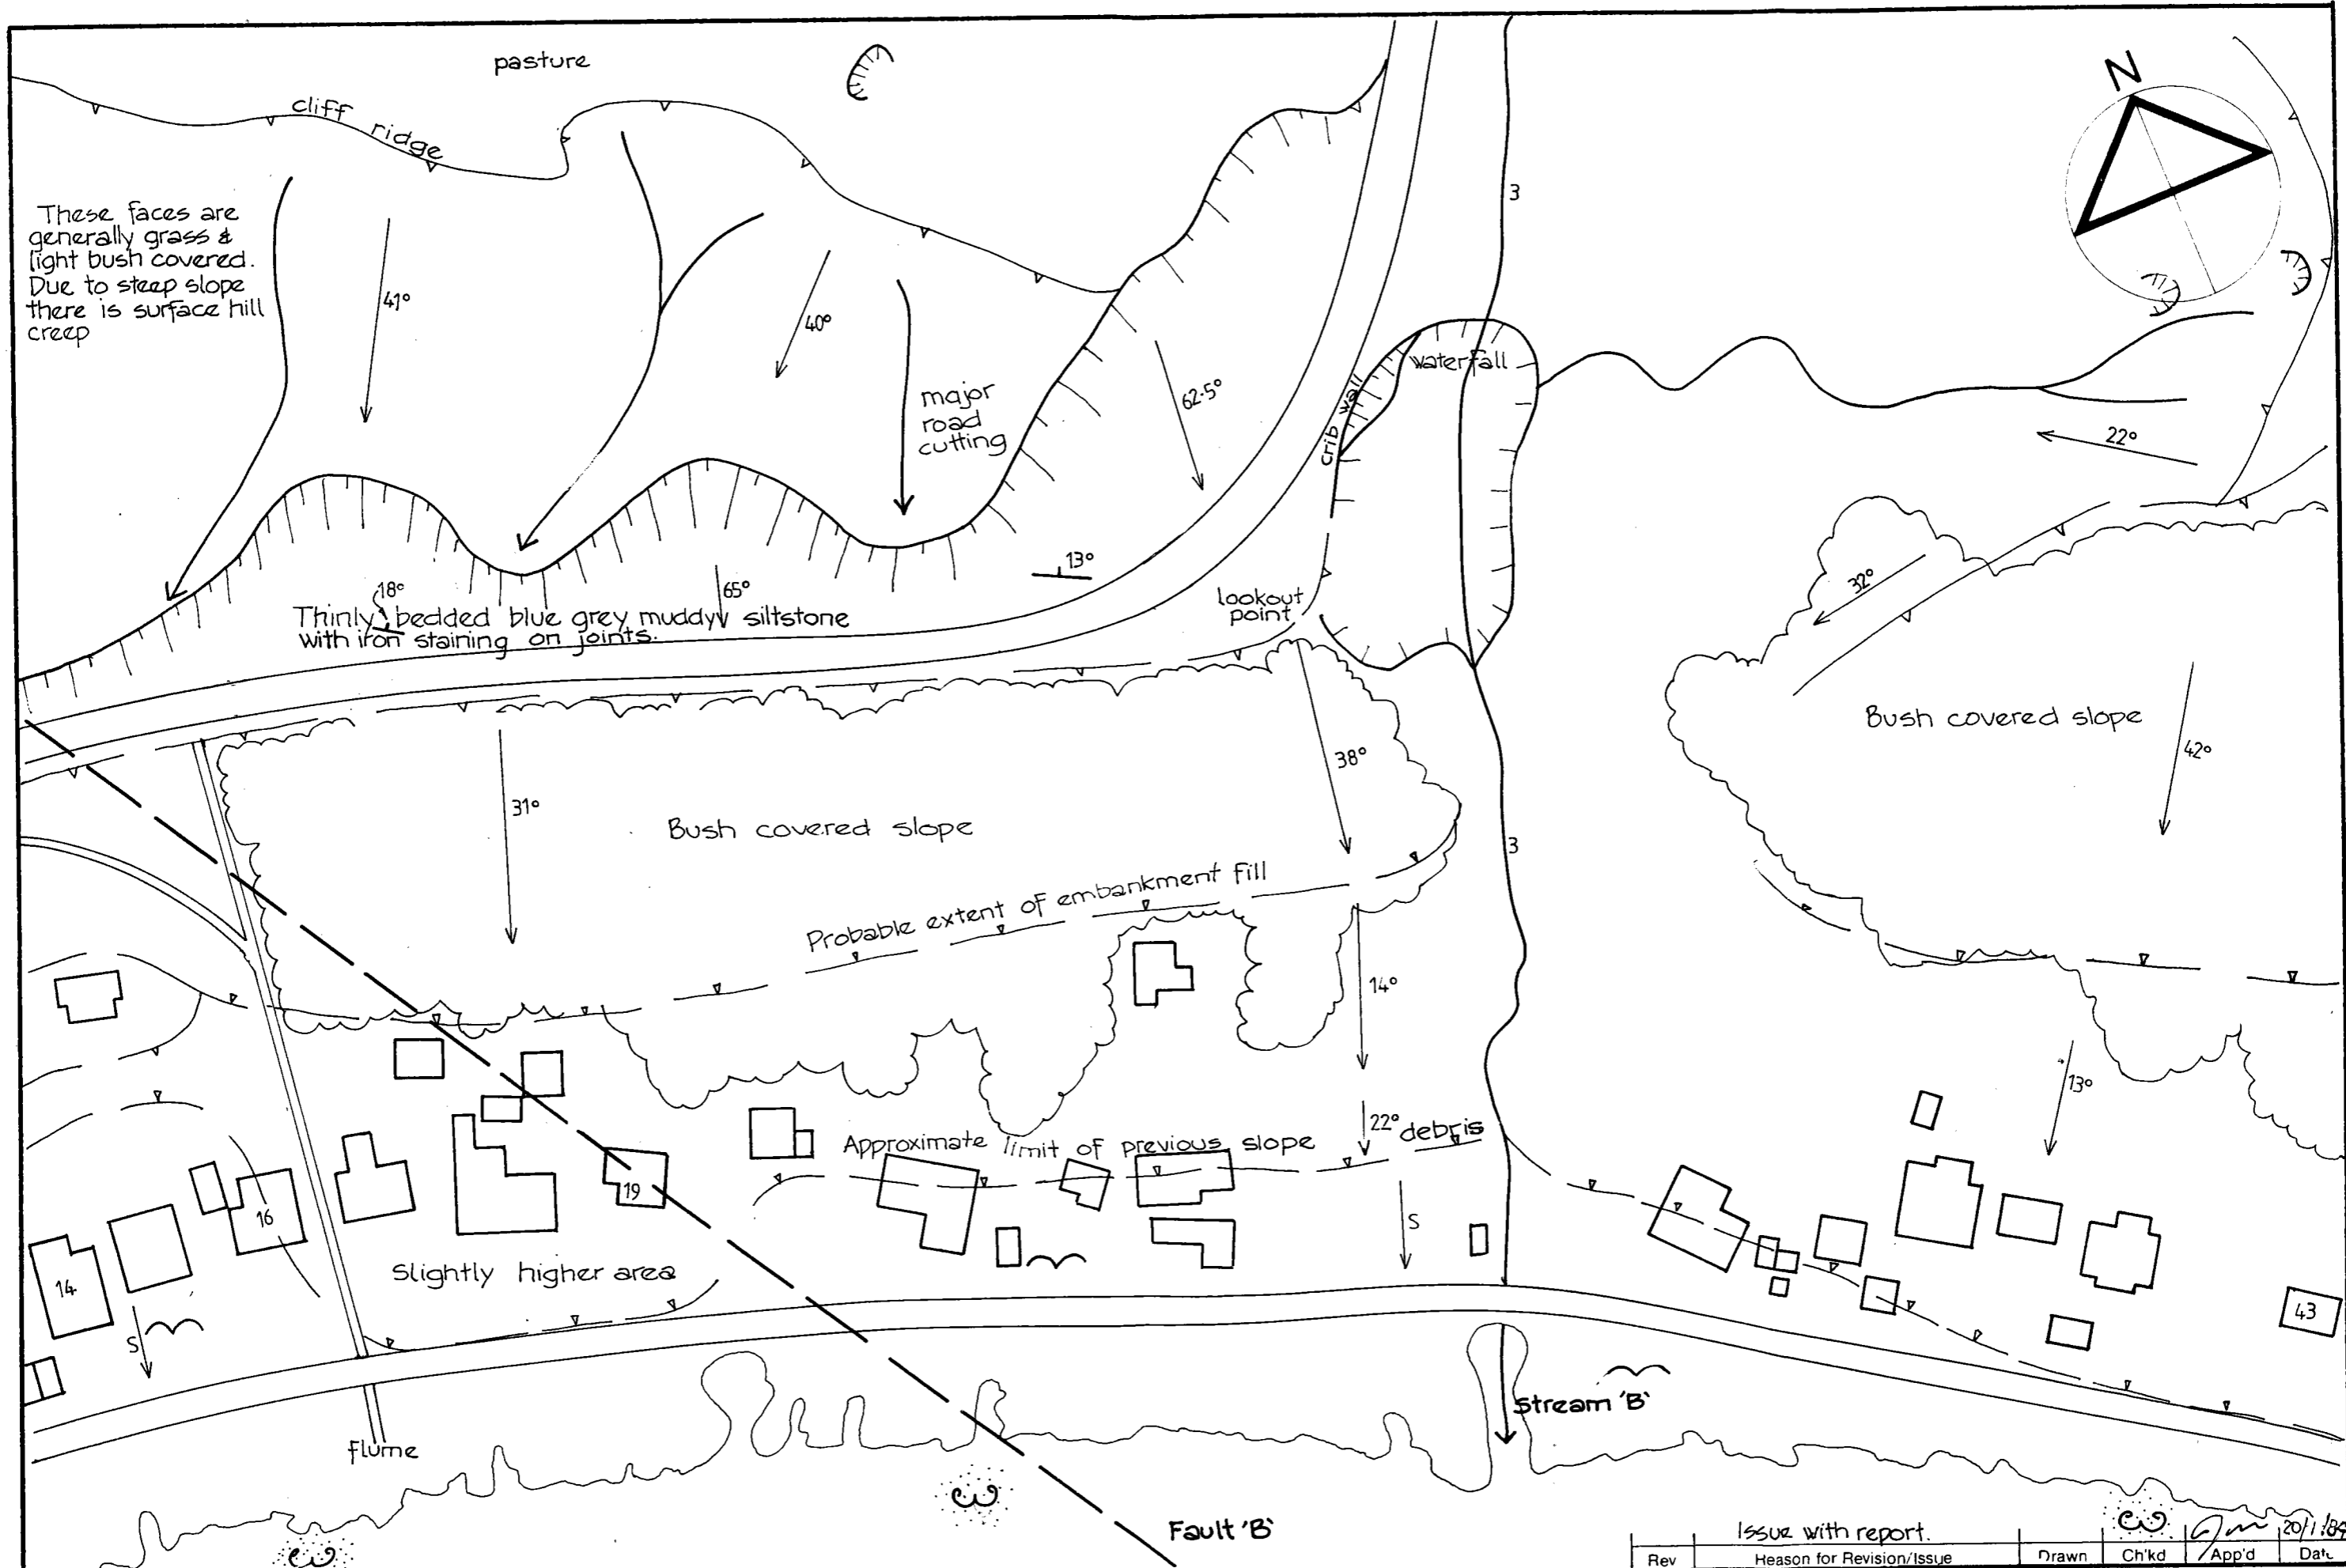
These faces are generally grass & light bush covered. Due to steep slope there is surface hill creep

Thinly bedded blue grey muddy siltstone with iron staining on joints.

Probable extent of embankment fill

Approximate limit of previous slope

Slightly higher area

Bush covered slope

Stream 'B'

Fault 'B'
