FRESH WATER RESOURCES

The Gisborne fresh water scene

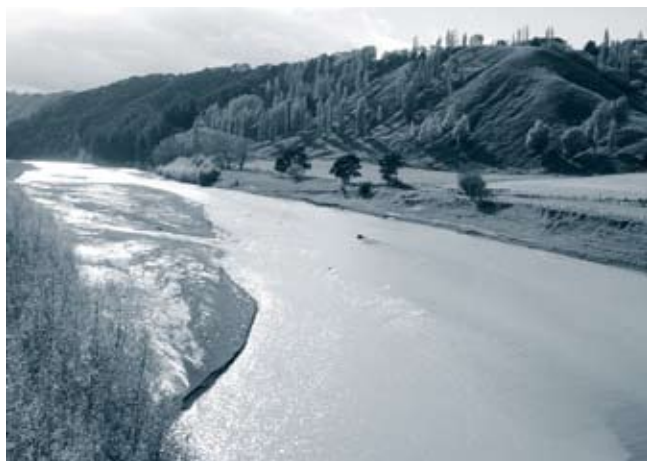
Above: The Waipaoa River is the main river entering Poverty Bay, and drains a 2,200km² catchment.

The Waipaoa River is the main river entering Poverty Bay, draining a catchment of approximately 2,200km². It is a high sediment-yielding river, annually depositing 15 million tonnes of sediment into Poverty Bay.

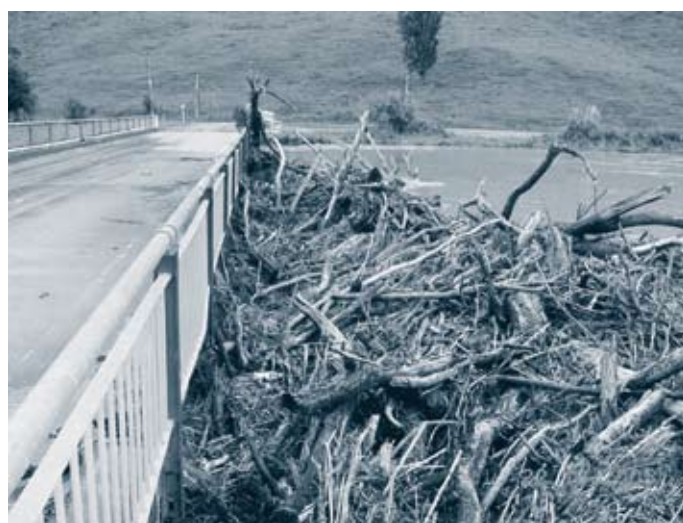
Above: Puha Bridge with captured debris after the 2005 Labour Weekend flood.

Surprisingly, no bridges were lost or had major damage, although many received damage to railings and captured large amounts of debris.
