the state of our environment

Published by Gisborne District Council

Gisborne 2009 and 2010

The Coastal environment

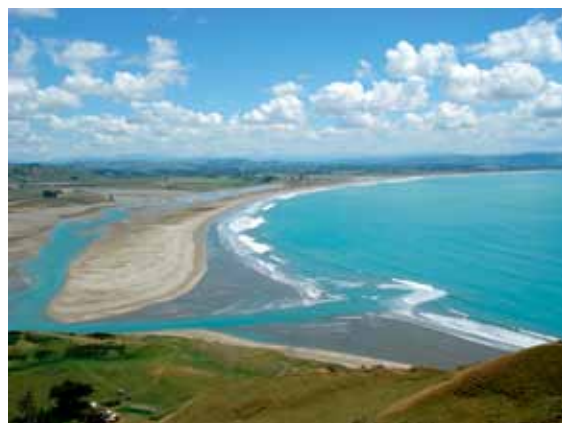
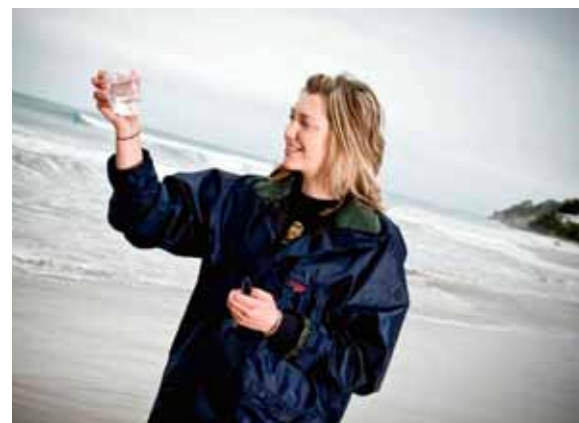
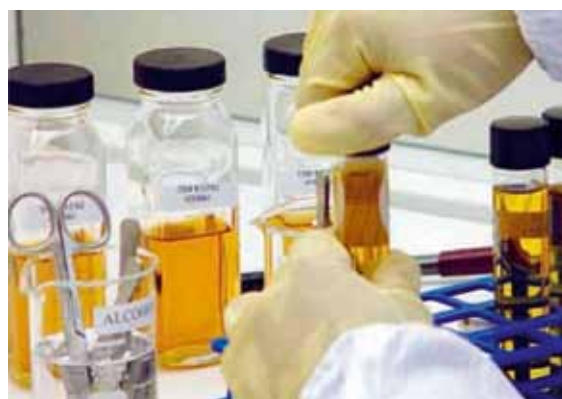
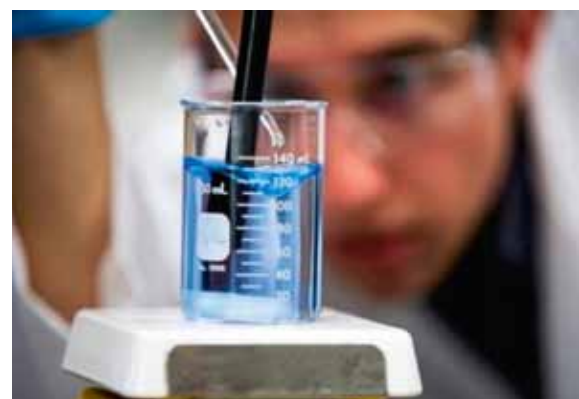
Of 1,016 coastal and marine water samples taken during 2009 and 2010, 52 samples exceeded first alert level (that is, they contained *enterococci* counts of between 140 and 280 bacteria per 100ml of water) and 116 exceeded the second alert level (*enterococci* counts greater than 280/100ml).

The samples were taken from twenty-six sites, of which twenty four provided one or more samples that exceeded quality guidelines at some time, mostly directly linked to periods of significant rainfall at sites known from past monitoring history to be rain-affected.

Sites where exceedences were recorded that were not directly caused by rainfall included Waipiro Bay and Tokomaru Bay (in December 2010), both Anaura Bay and Tolaga Bay (at the end of Wharf Road) in January of both years, Turihaua Beach (in January 2009 and November 2010), Makorori Beach settlement (in January and February 2009), Waikanae Beach opposite the Surf Club (six exceedences in February 2009, March and December 2010), and Midway Beach opposite the Surf Club (five exceedences in February 2009, March, November and December 2010).

The multiple exceedences at Midway Beach were believed to have been the result of a large amount of very fine driftwood floating in the water, on two occasions compounded by high-impact wave action stirring up sediment. At Waikanae Beach exceedences were mainly attributable to contamination from the Turanganui River and possibly even large ships in the port agitating the water.

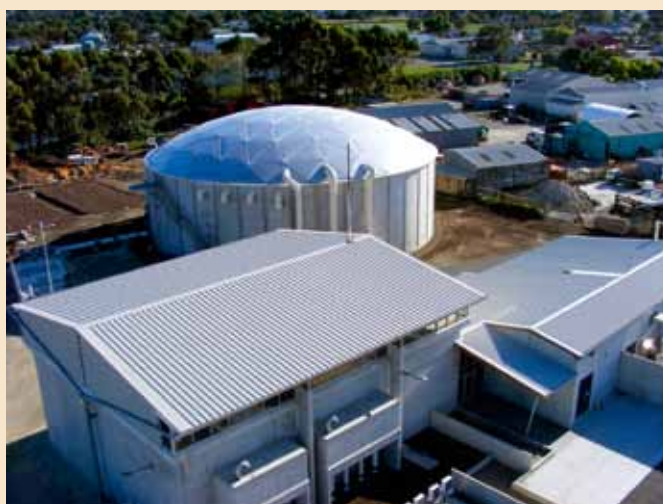
The new plant uses a biological trickling filter system to transform fine wastewater solids into plant-like matter in a process known as biotransformation. Domestic wastewater is first screened by one of 2 rotating drum screens (one is on duty, one on standby) and then passed through a vortex grit removal chamber. Two more drum screens are used for industrial wastewater. The screenings and grit removed from these stages have the water pressed from them before being bagged and trucked to a landfill at Paeroa.

The screened and de-gritted wastewater is then pumped up through the central column of the biological filter, to a height of 8m. The wastewater is distributed via 6 rotating arms, and trickles slowly through 10 layers of plastic blocks. These provide the large surface area necessary for the biological transformation to take place. The treated wastewater is then pumped via a new outfall pump station to the existing marine outfall, 1.8km out to sea. We expect to report on improved water quality in the vicinity of the outfall from 2011 onwards.

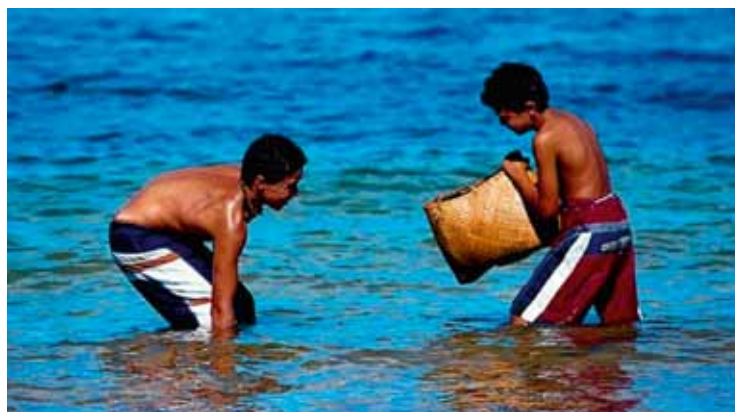
Two parameters are used to monitor the water quality at seven shellfish gathering sites, the seasonal median and maximum counts of faecal coliform bacteria per 100ml for 10% of the samples. Faecal coliforms are indicator organisms; their presence may indicate harmful bacteria, viruses or protozoa may also be present.

Only Pouawa complied with both monitoring criteria in 2009; Sponge Bay with just one. The remaining sites did not comply due mainly to rainfall carrying surface runoff.

In 2010 the Muriwai end of Wherowhero lagoon was non-complying and both Pouawa and Sponge Bay failed to meet one of the criteria. These results are similar to those recorded in previous years.
