**s92 Response – Te Karaka –, LR-2026-113441-00, LV-2026-113442-00, LL-2026-113442-00 & WS-2026-113444-00**

**Project** Te Karaka Stopbank Upgrade Project

**Subject** Response to Pine Hollow Family Trust submission matters relevant to road raising, access and drainage design

### Sun-Shadow Analysis

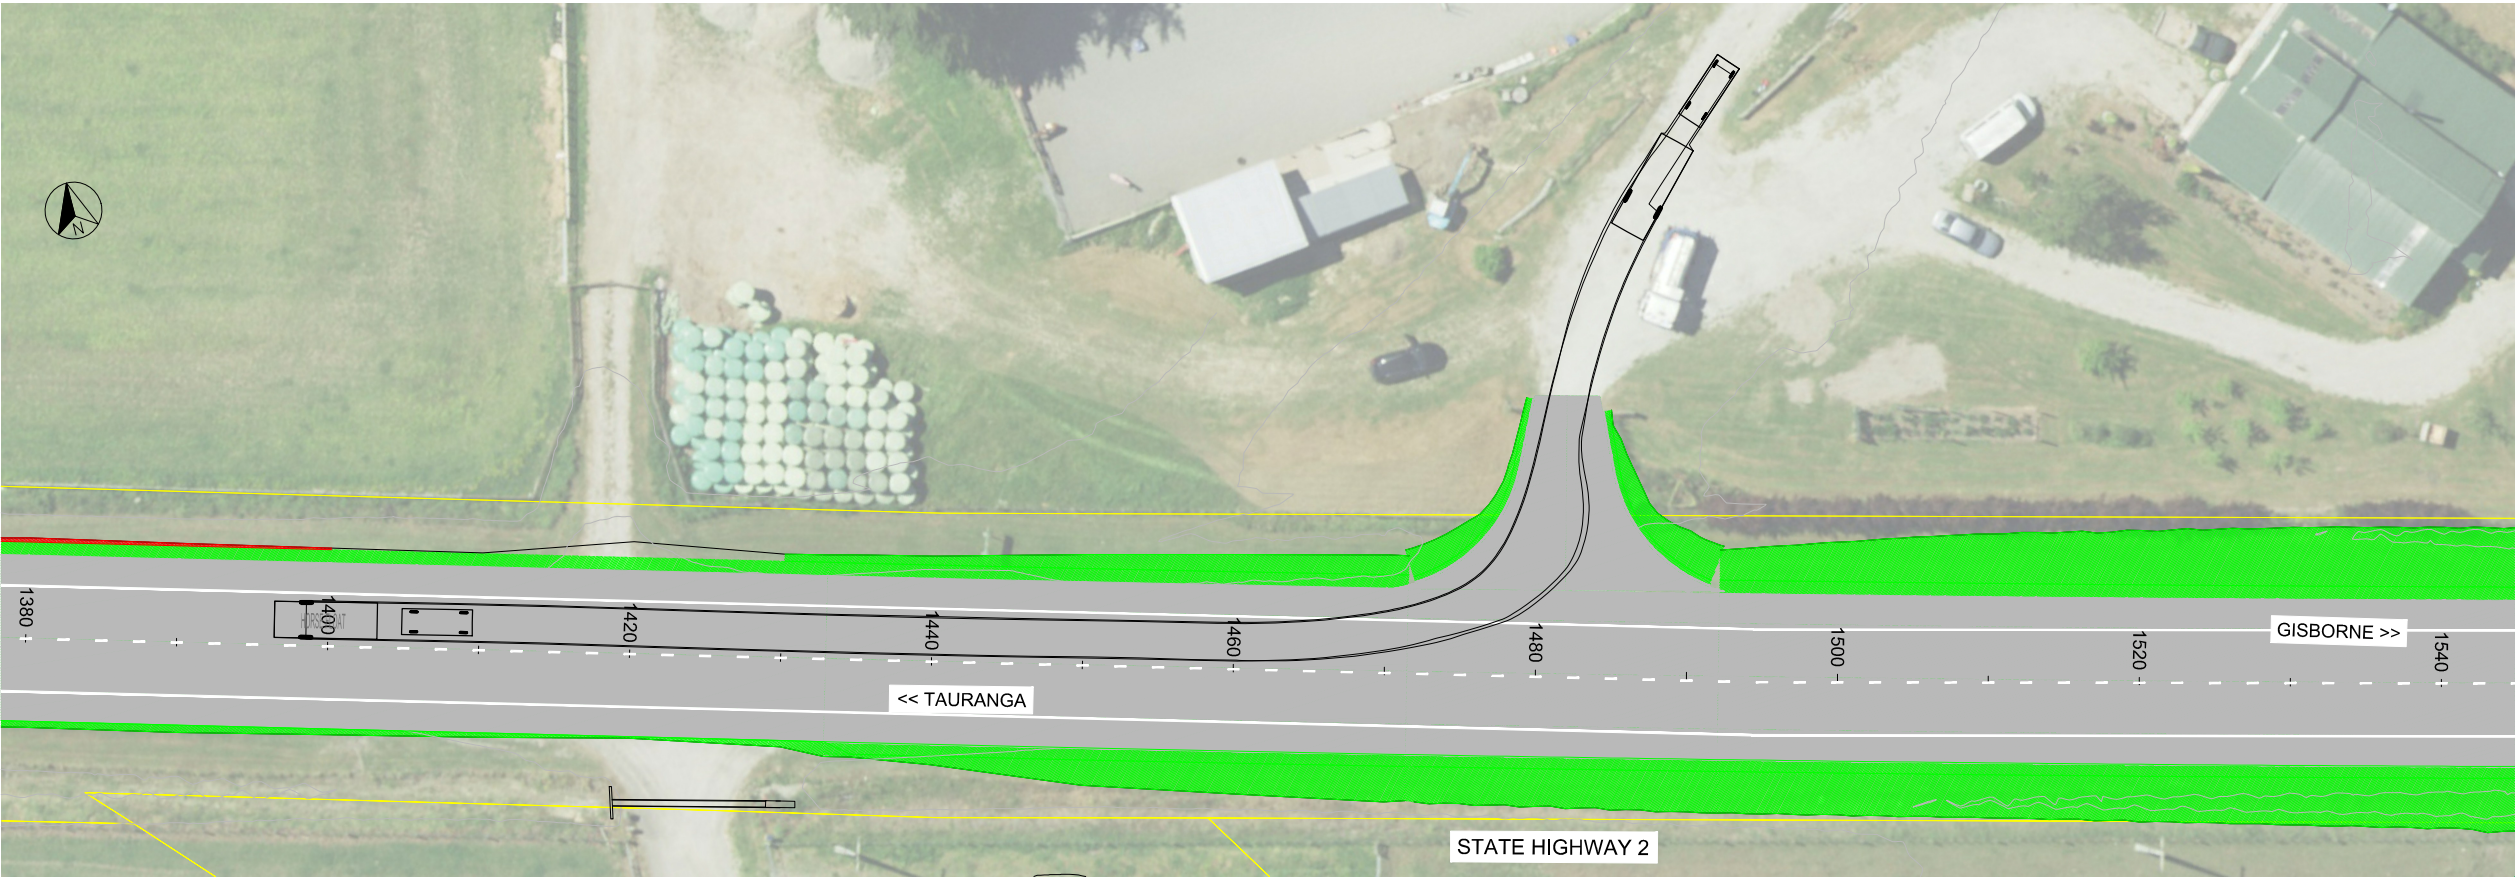
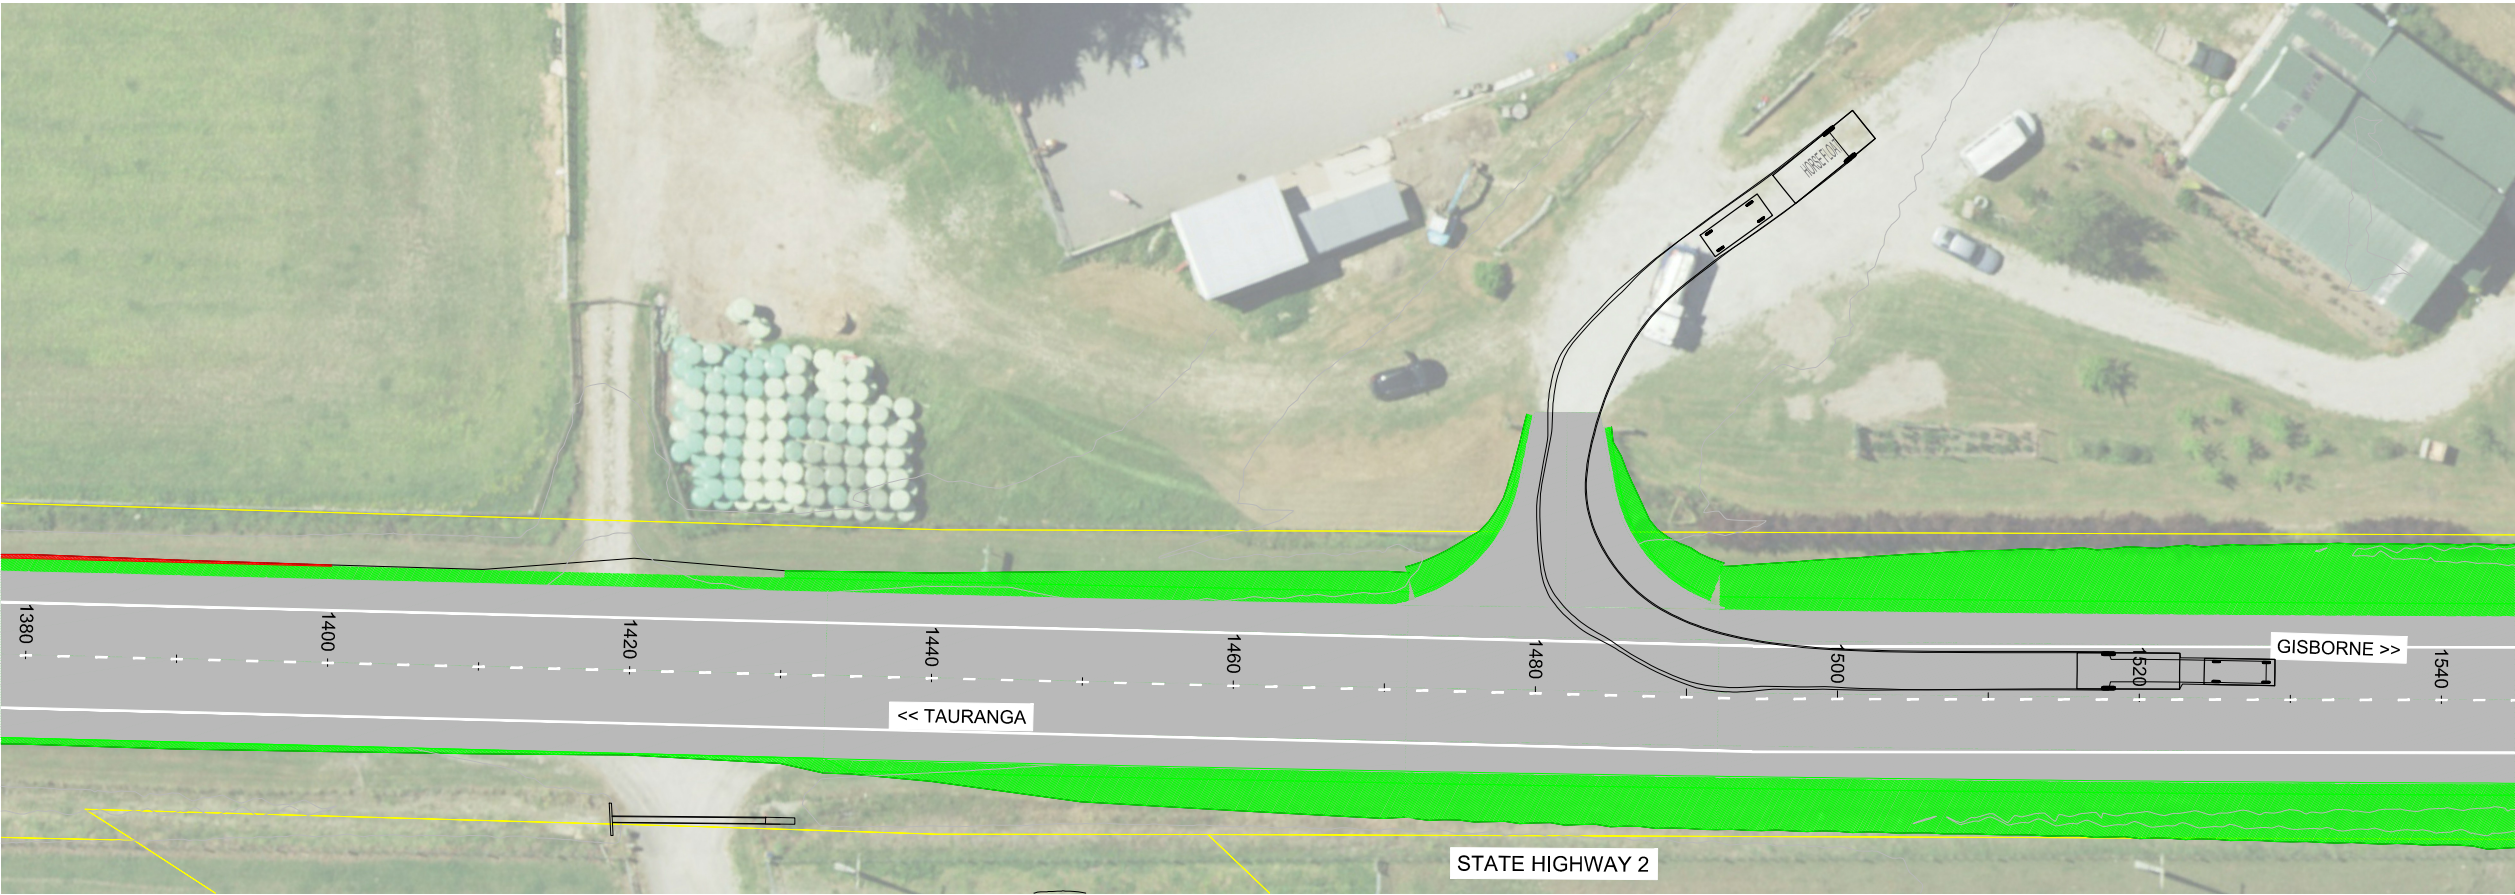
HORSE FLOAT  
Overall Length 13.103m  
Overall Width 2.400m  
Overall Body Height 3.550m  
Min Body Ground Clearance 0.206m  
Max Track Width 2.550m  
Lock-to-lock time 4.00s  
Curb to Curb Turning Radius 8.000m

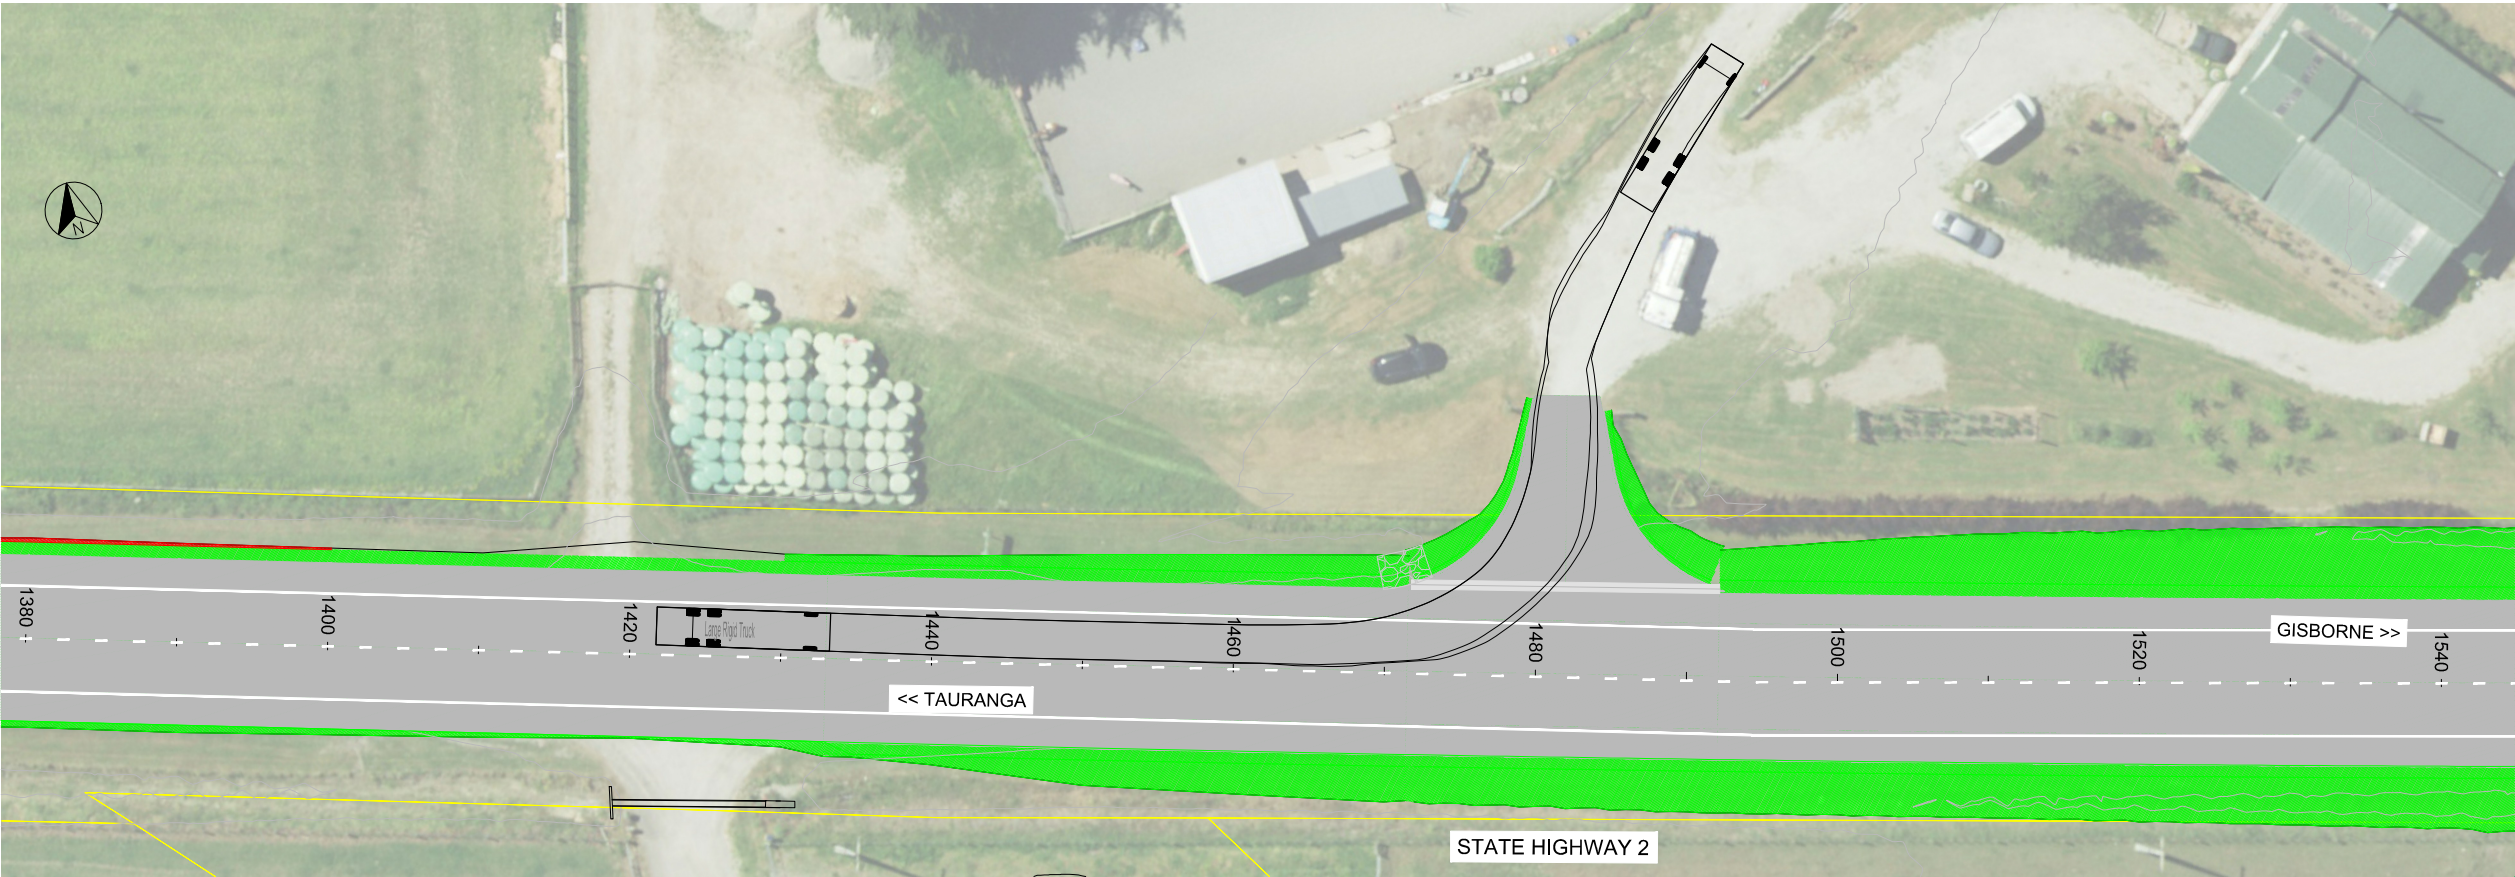
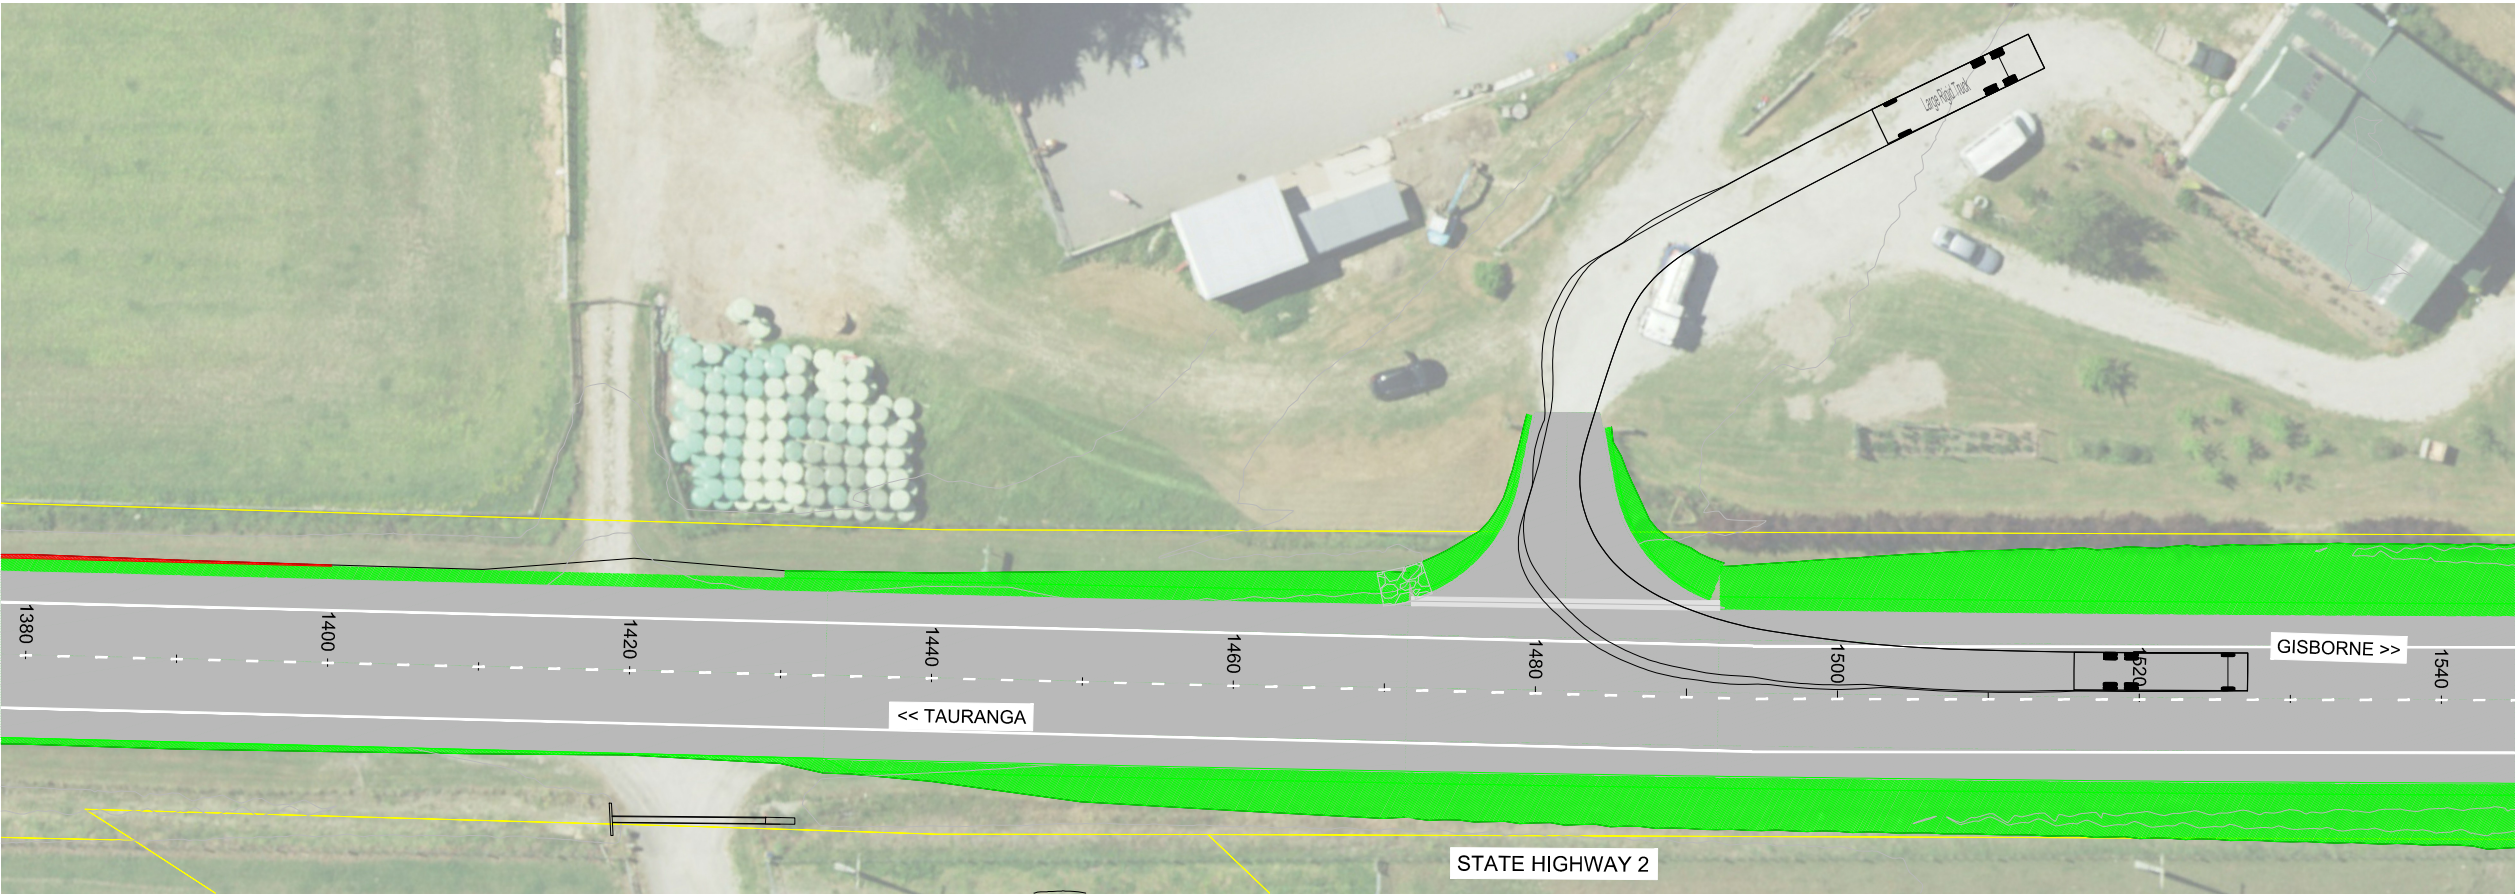
Large Rigid Truck  
Overall Length 11.500m  
Overall Width 2.500m  
Overall Body Height 3.832m  
Min Body Ground Clearance 0.427m  
Track Width 2.500m  
Lock-to-lock time 6.00s  
Wall to Wall Turning Radius 12.000m

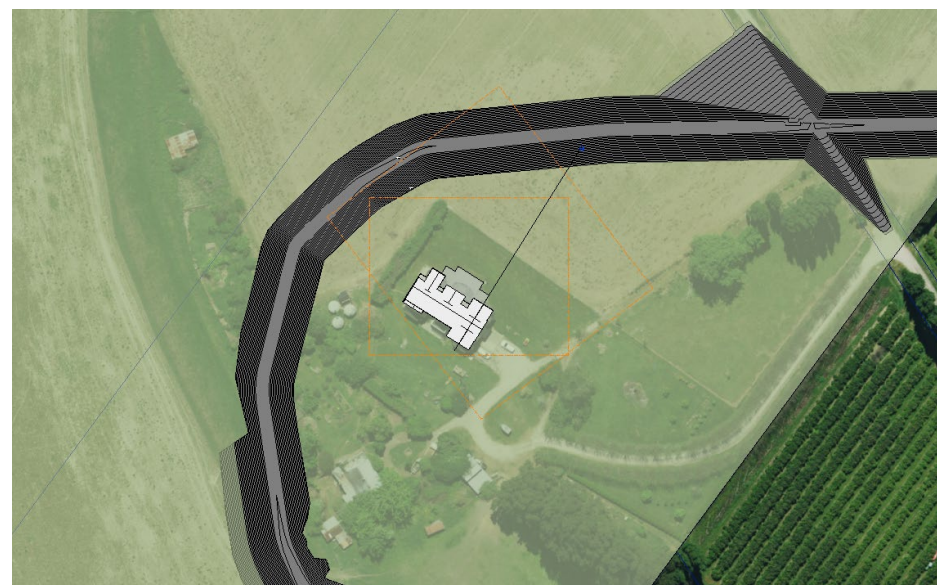
Fig. 3: Plan View: Revit model elements including indicative house (LINZ building outlines data and indicative 8m height). Shelter belt planting from aerial imagery. Stopbank topography from design team.

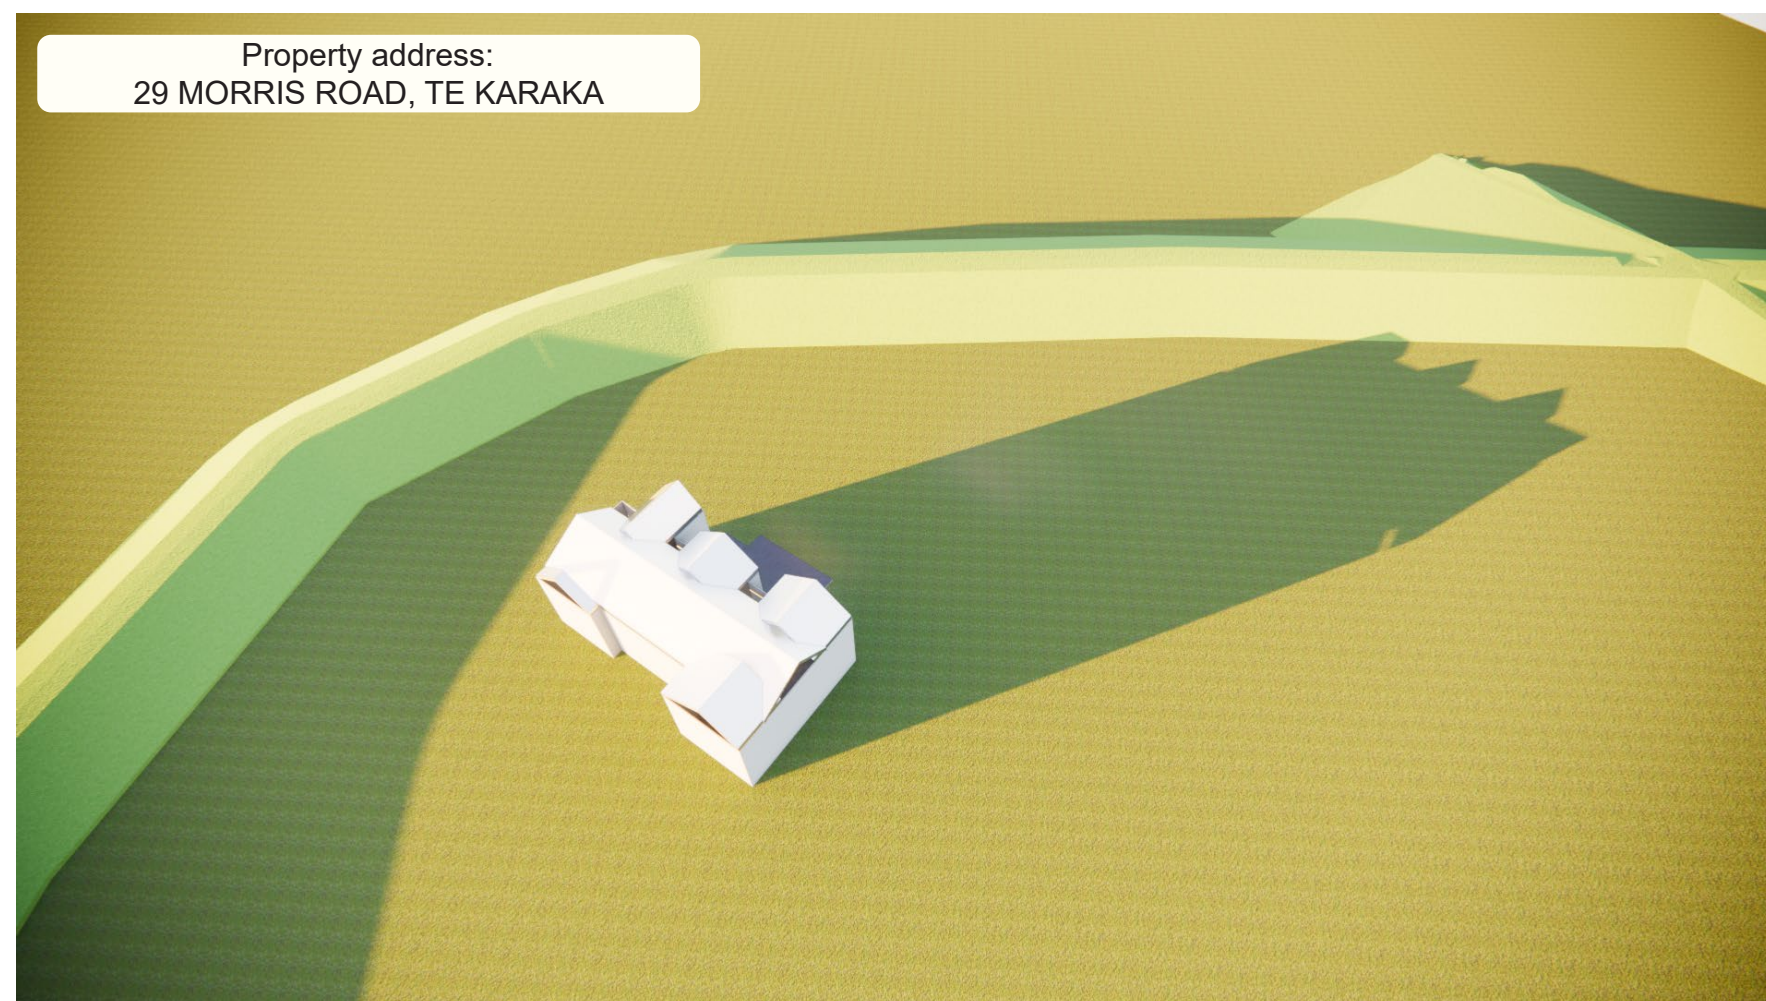
Fig. 5: (Shelter hedge removed) Summer solstice sun study finding shadow from stopbank reaches edge of the building at approximately 7:00 p.m. on the summer solstice.

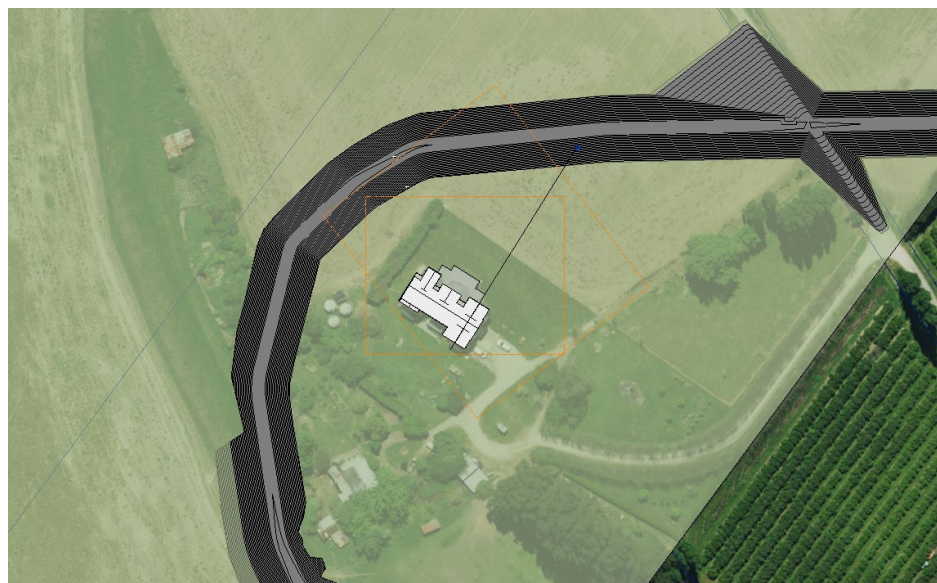
Fig. 8: Plan View: Revit model elements including indicative house (LINZ building outlines data and indicative 8m height). Shelter belt planting from aerial imagery. Stopbank topography from design team.

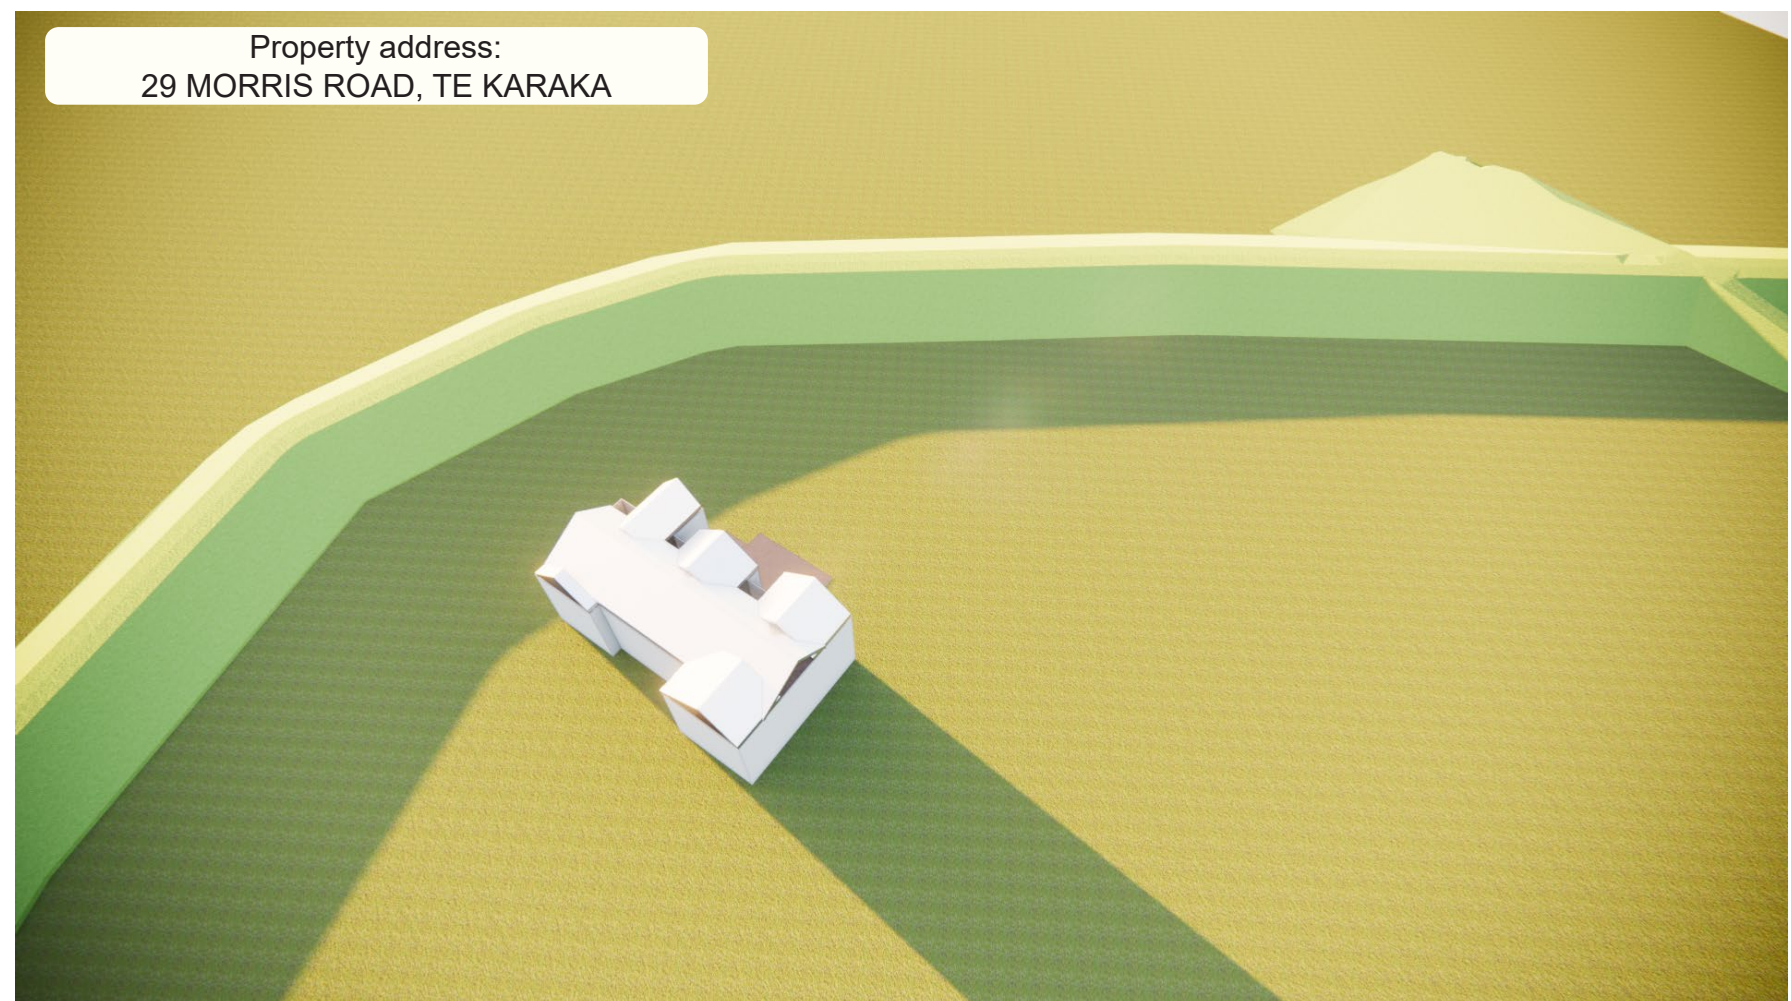
Fig. 10: (Shelter hedge removed) Winter solstice sun study finding shadow from stopbank reaches edge of the building at approximately 4:00 p.m. on the winter solstice.

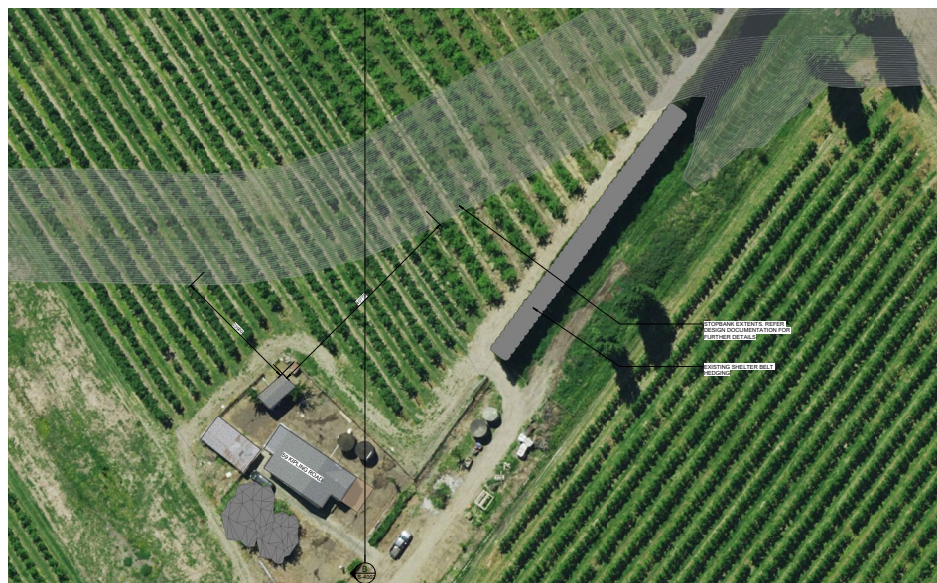
Fig. 13: Plan View: Revit model elements including indicative house (LINZ building outlines data and indicative 8m height). Shelter belt planting from aerial imagery. Stopbank topography from design team.

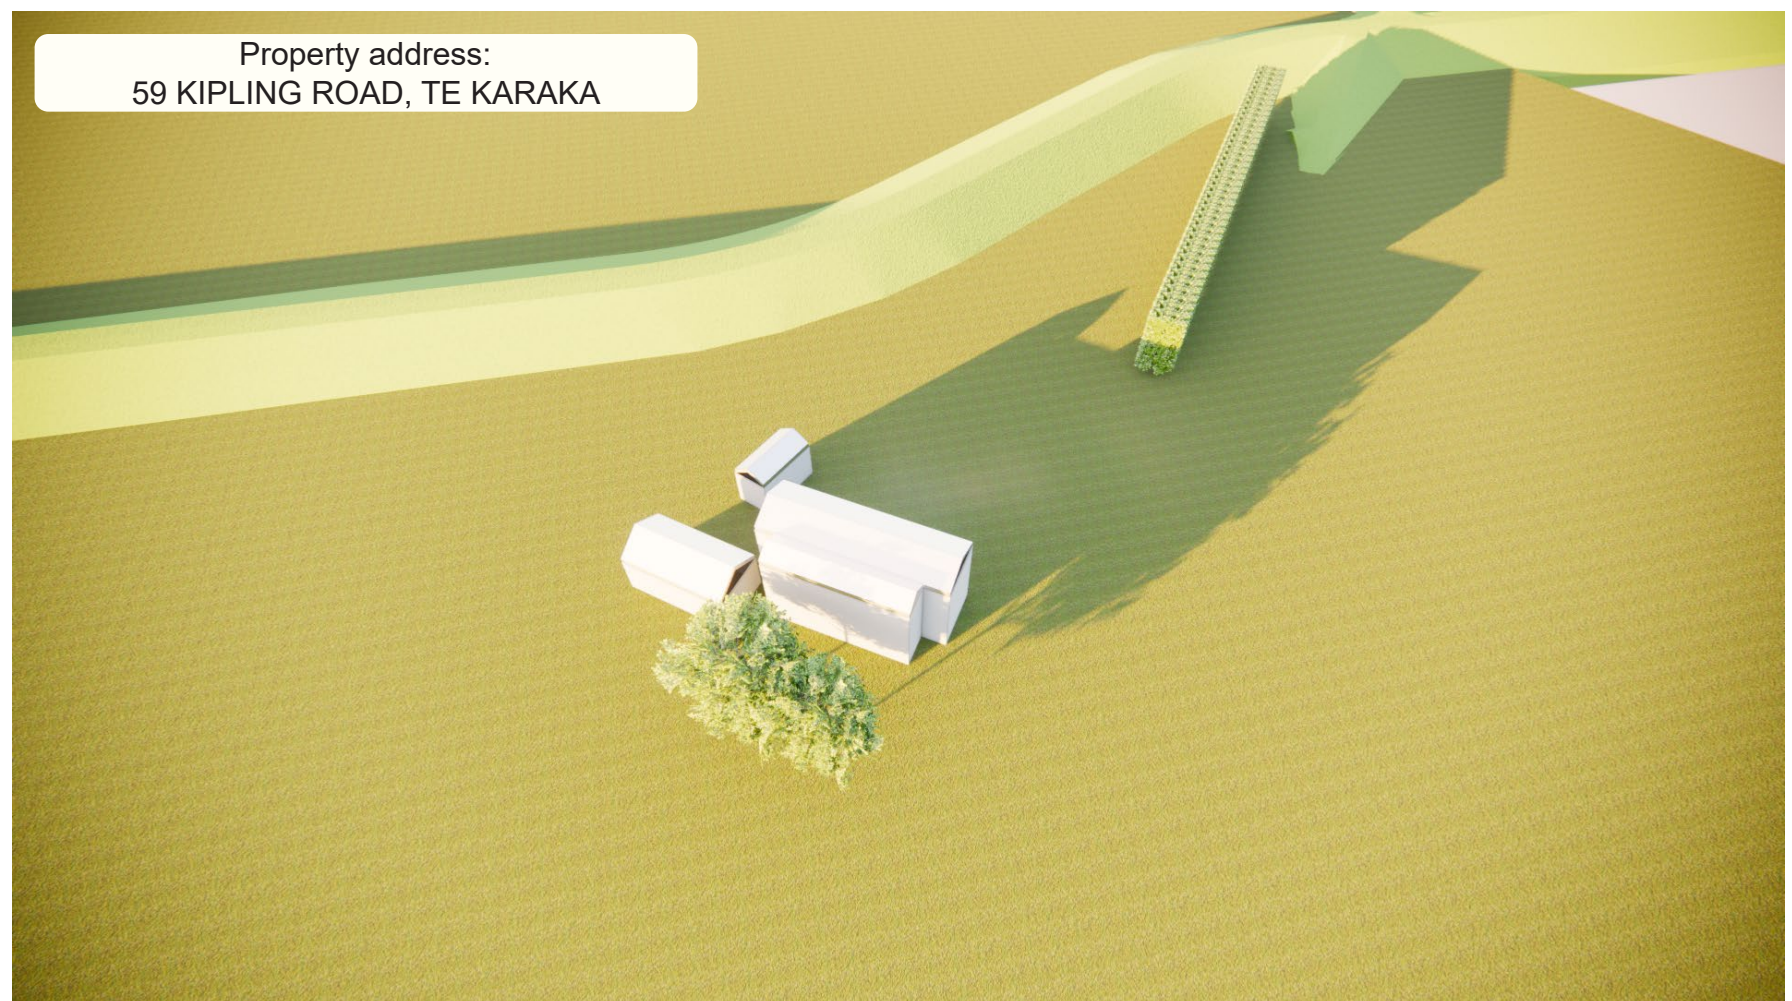
Fig. 15: Summer solstice sun study finding shadow from stopbank is in orientation away from the buildings. 7:00 p.m. on the summer solstice.

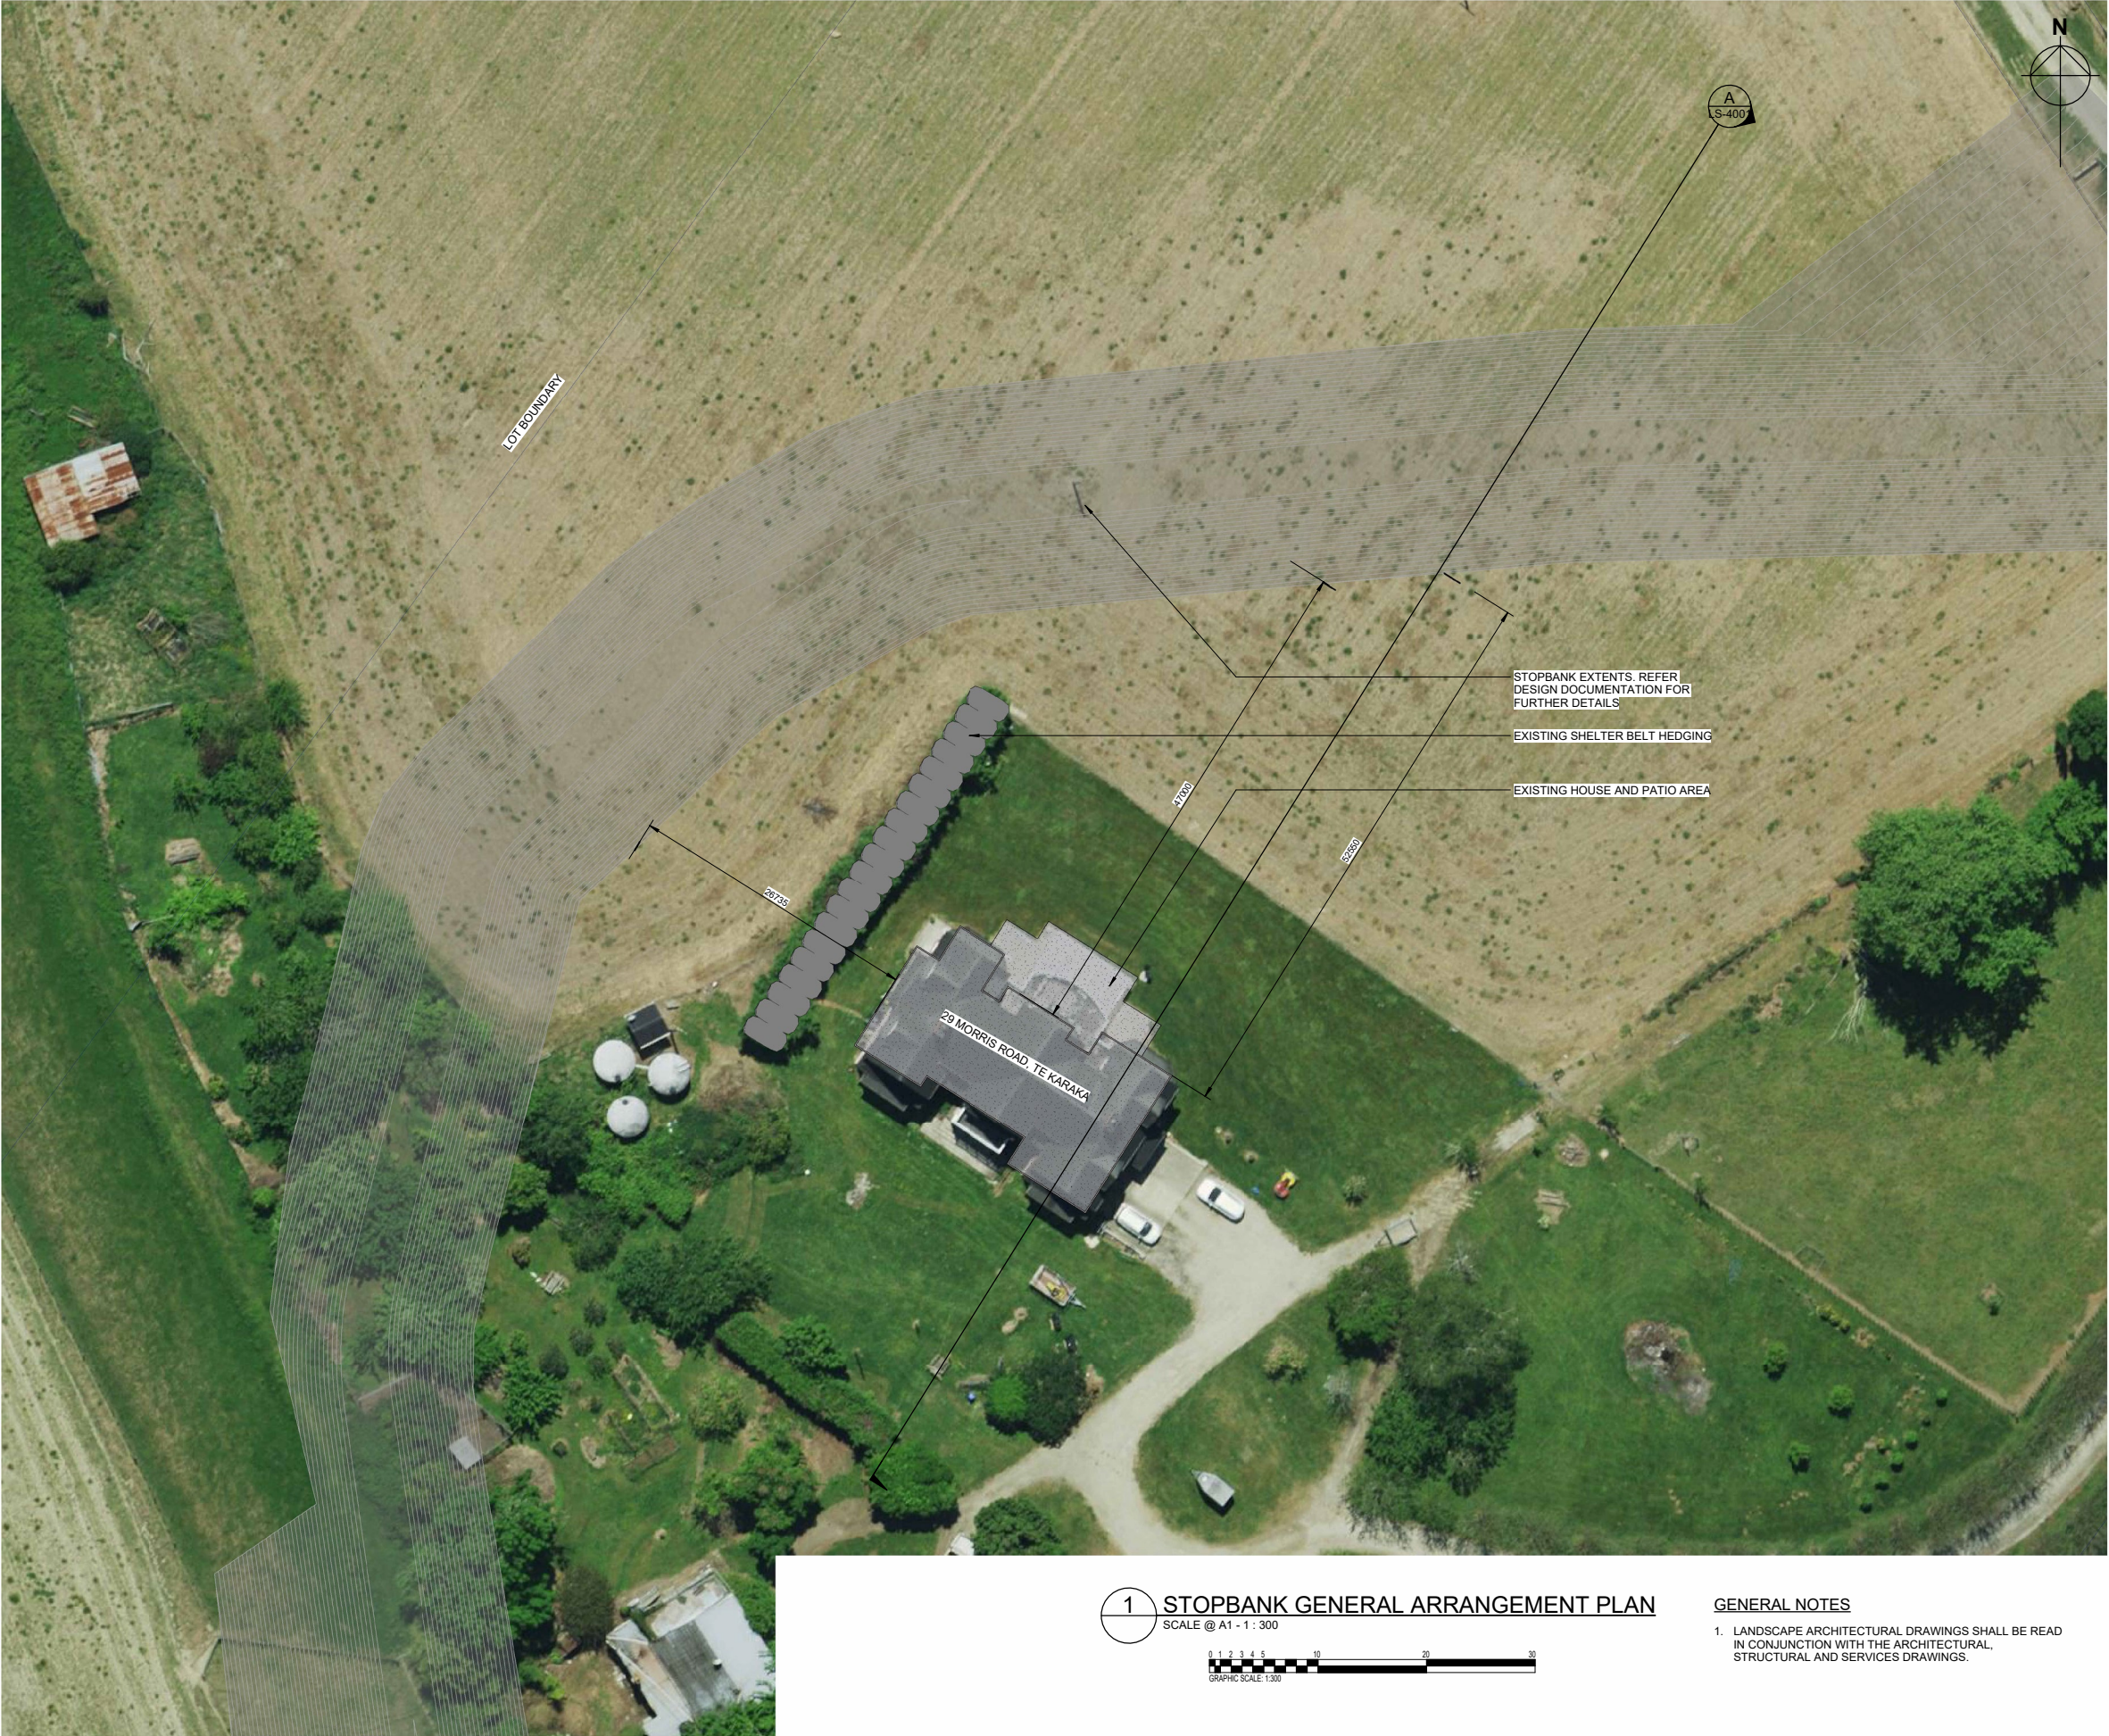
Fig. 16: Plan View of stopbank general arrangement in relation to the house and property. Stopbank is shown with low opacity to indicate the existing landscape underneath. Dimensions are indicative only and should be verified against design team documentation.
