**s92 Response – Te Karaka –, LR-2026-113441-00, LV-2026-113442-00, LL-2026-113442-00 & WS-2026-113444-00**

**Project** Te Karaka Stopbank Upgrade Project

**Subject** Response to Pine Hollow Family Trust submission matters relevant to road raising, access and drainage design

### Sun-Shadow Analysis

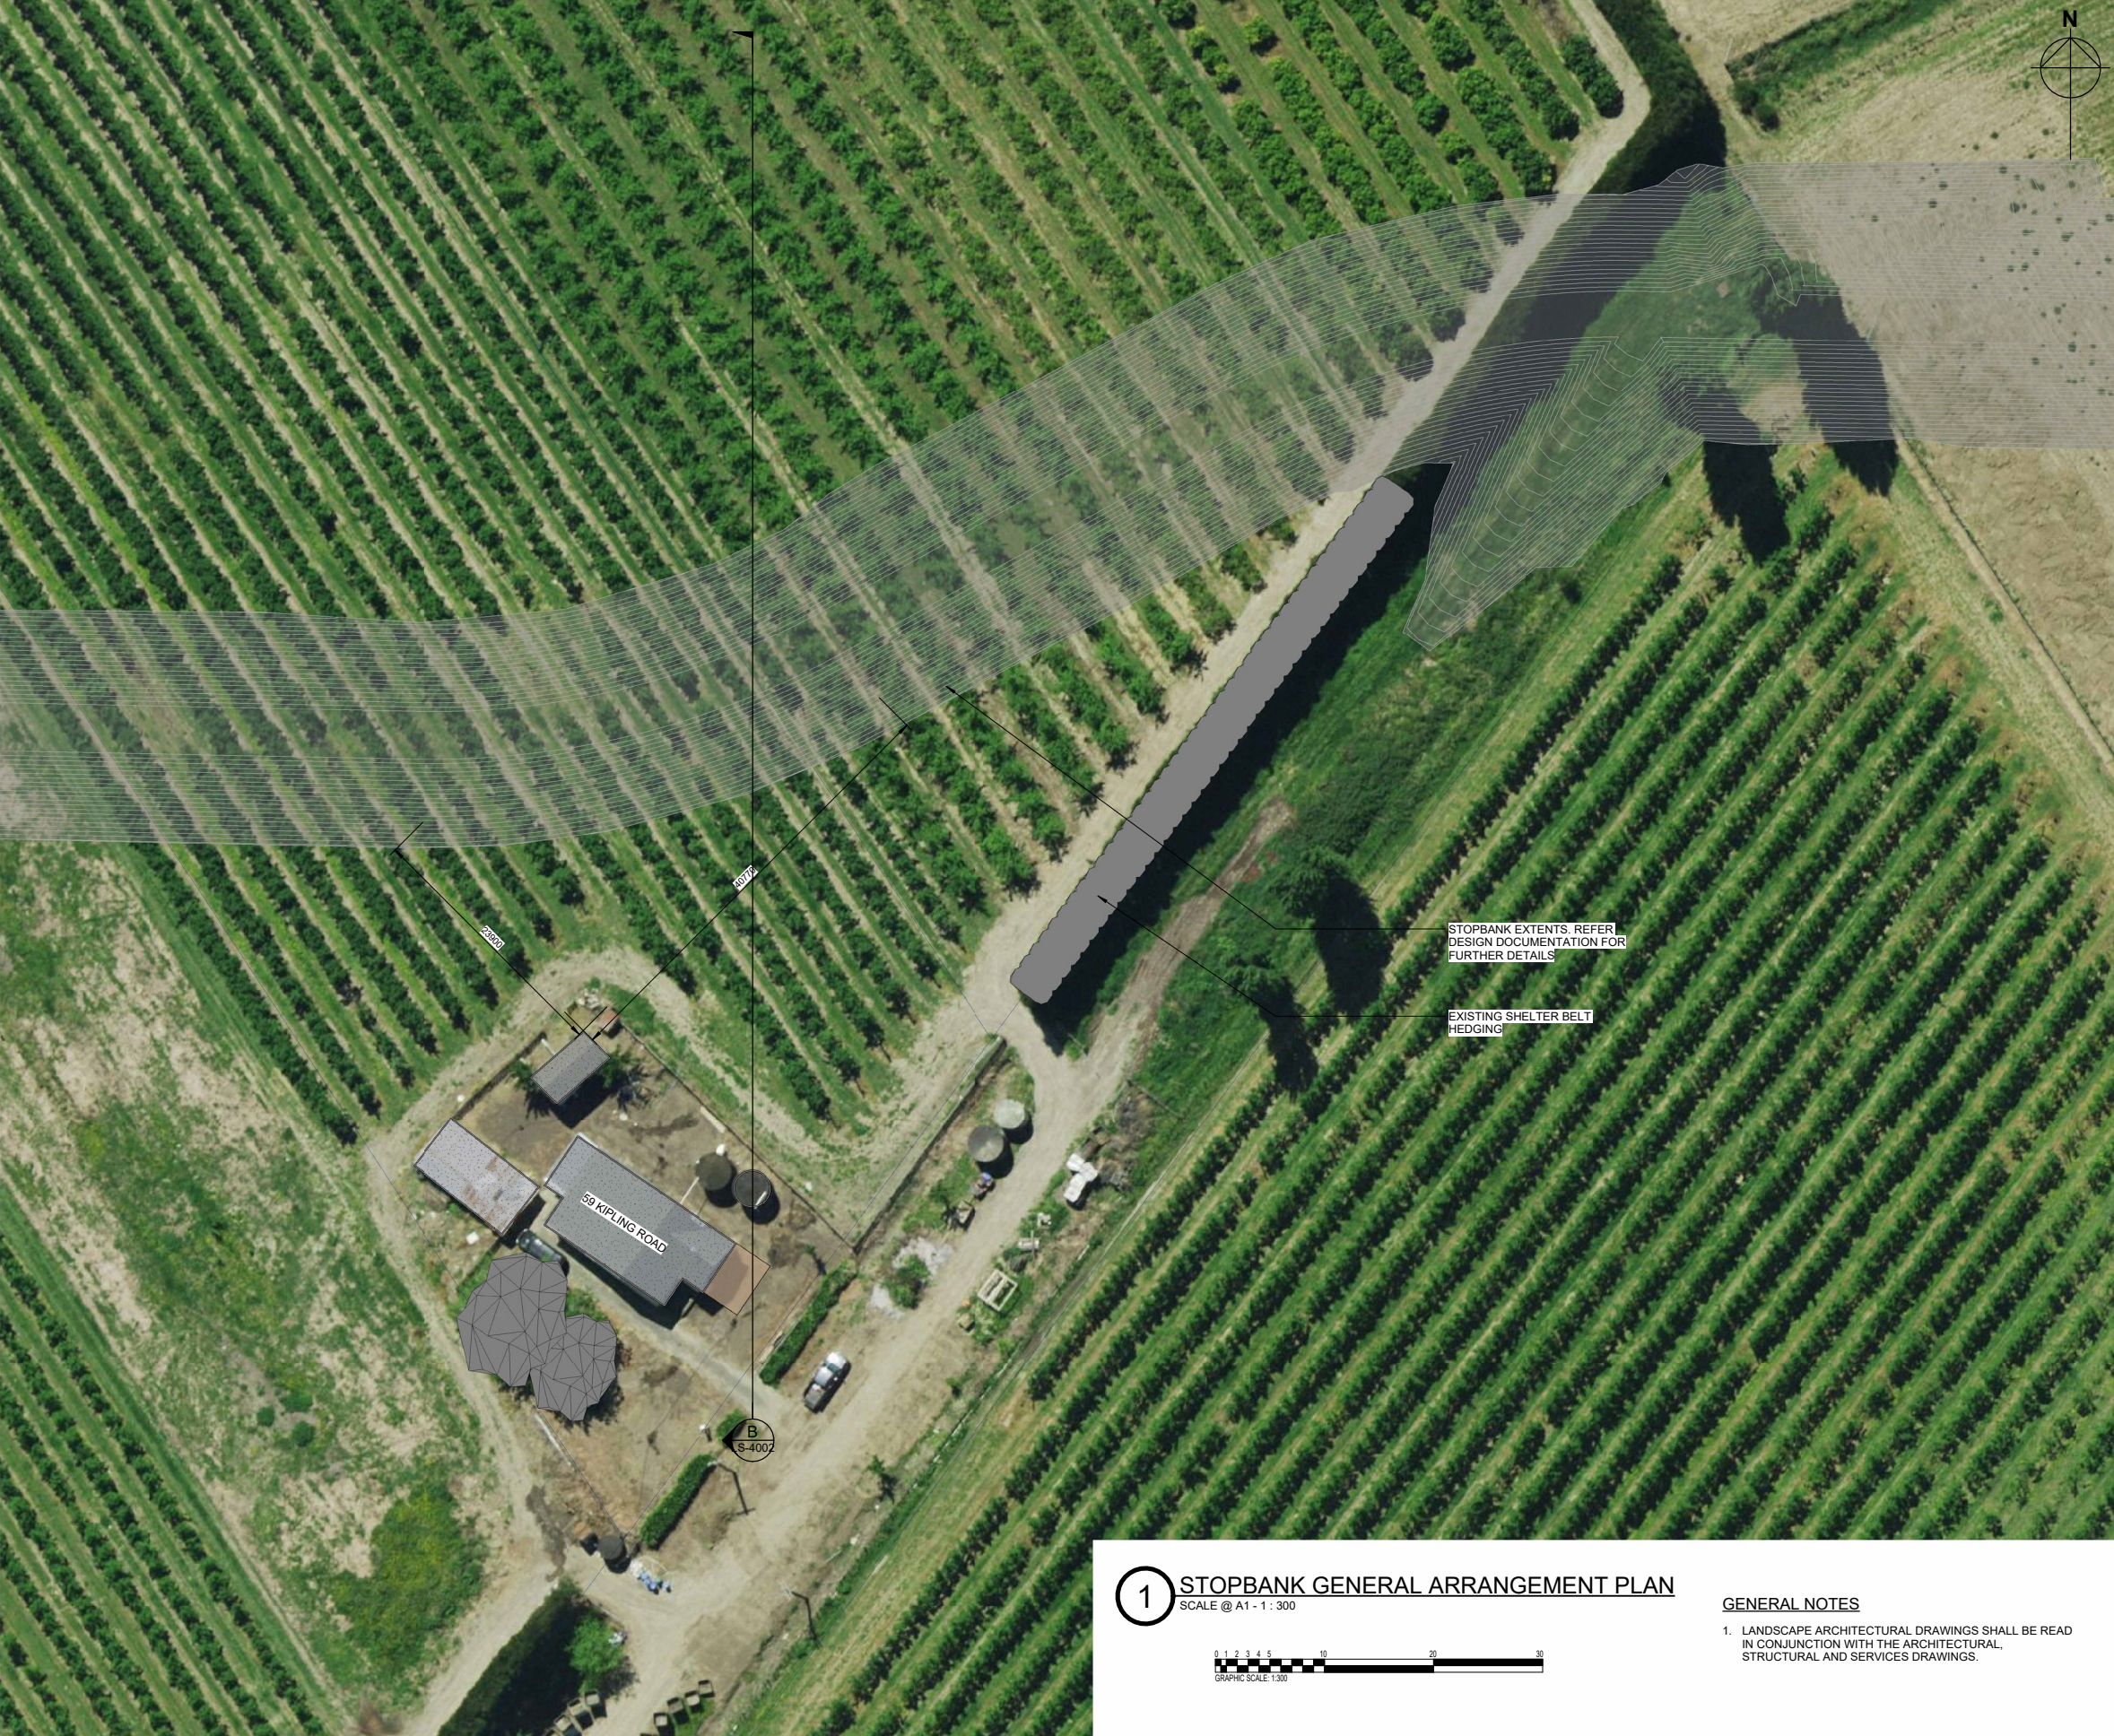
Fig. 17: Plan View of stopbank general arrangement in relation to the house and property. Stopbank is shown with low opacity to indicate the existing landscape underneath. Dimensions are indicative only and should be verified against design team documentation.
