# **Te Karaka Stopbank Upgrade**

## **Geotechnical Interpretive Report**

Gisborne District Council

31 March 2026

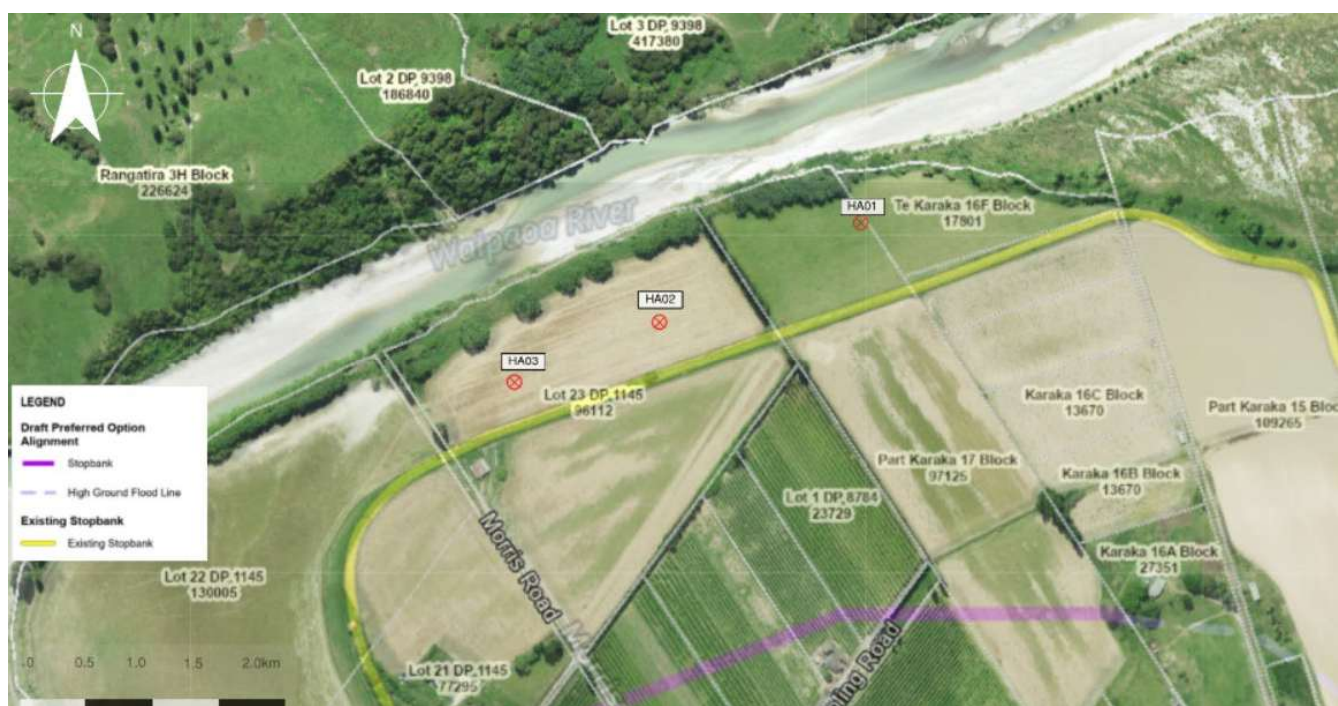
Figure 4 Location of WSP investigations – proposed fill material

GDC provided ground investigation data for the proposed stopbank fill material. The information provided comprises three hand augered drillholes undertaken by WSP in May 2025, approximately 500 m northeast of the central section of the proposed stopbank alignment. The location of HA01, HA02, and HA03 is shown in Figure 4 and logs are included within Appendix B.

The hand auger logs indicated near-surface silty soils with minor sand and clay, underlain by predominantly clayey silt and silty clay to the termination depth of approximately 2 m BGL. The soils were generally described as firm, becoming stiff with depth, and exhibit moderate to high plasticity. Minor sand content was present throughout, locally with coarse sand grains evident. Groundwater was not encountered within the investigations. The soil description presented on the logs were consistent with fine-grained alluvial soils typical of the Te Karaka area.

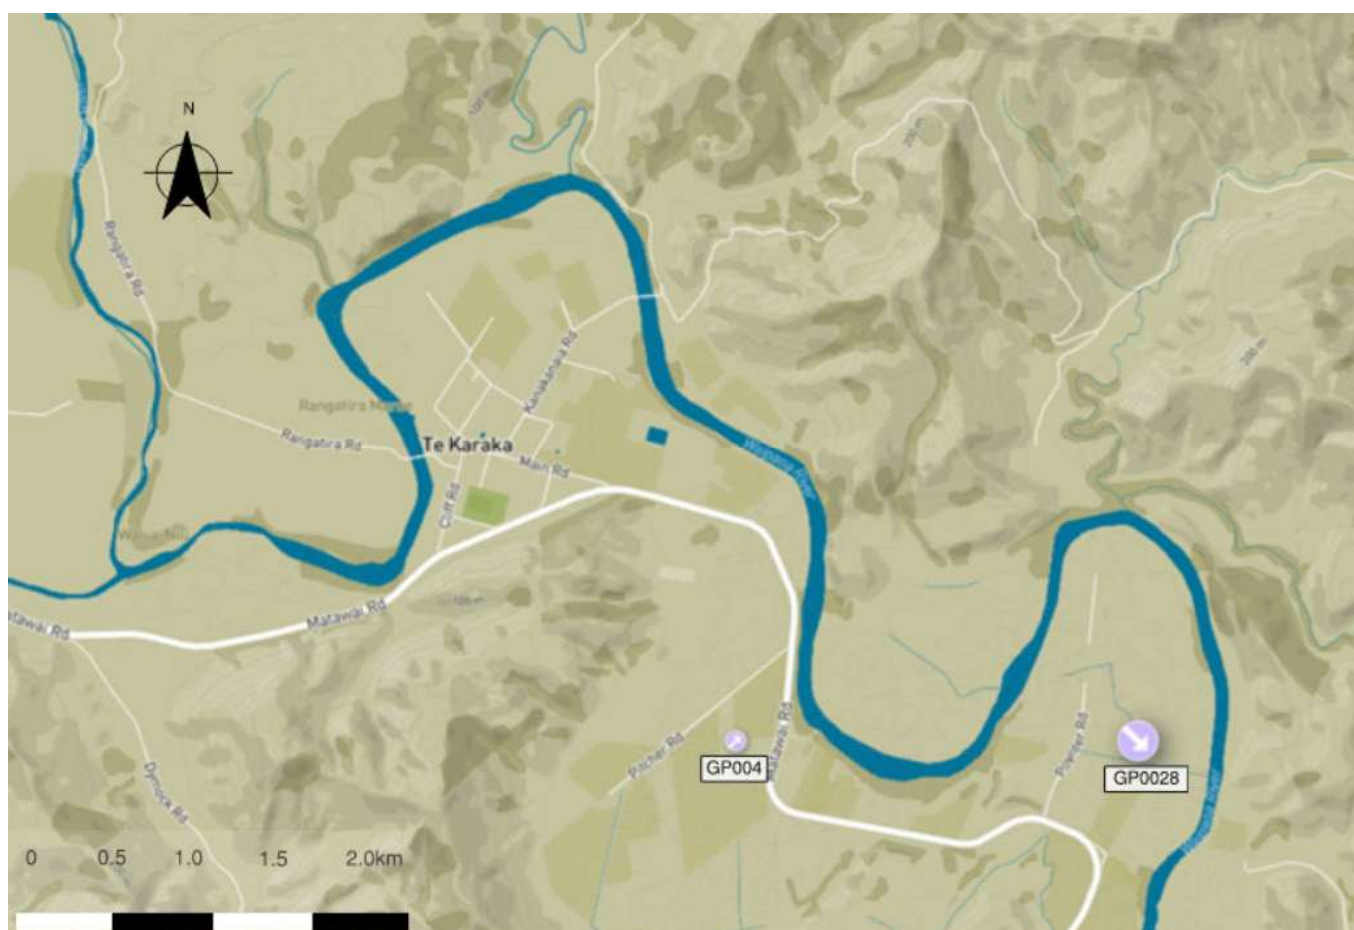
The GDC groundwater monitoring website<sup>3</sup> was reviewed to identify groundwater information relevant to the Te Karaka area. Two groundwater monitoring wells (GP0004 and GP0028) are located in the vicinity of Te Karaka township. Well GP0004 is situated to the south of Te Karaka, near the Waipaoa River, and Well GP0028 is located to the east of Te Karaka township. Figure 5 and Table 2 shows the location and well details respectively.
