# Ecological Impact Assessment

## Te Karaka Flood Scheme Upgrade

### Te Kaunihere o Te Tāirawhiti - Gisborne District Council

SLR Project No.: 880.016774.00001

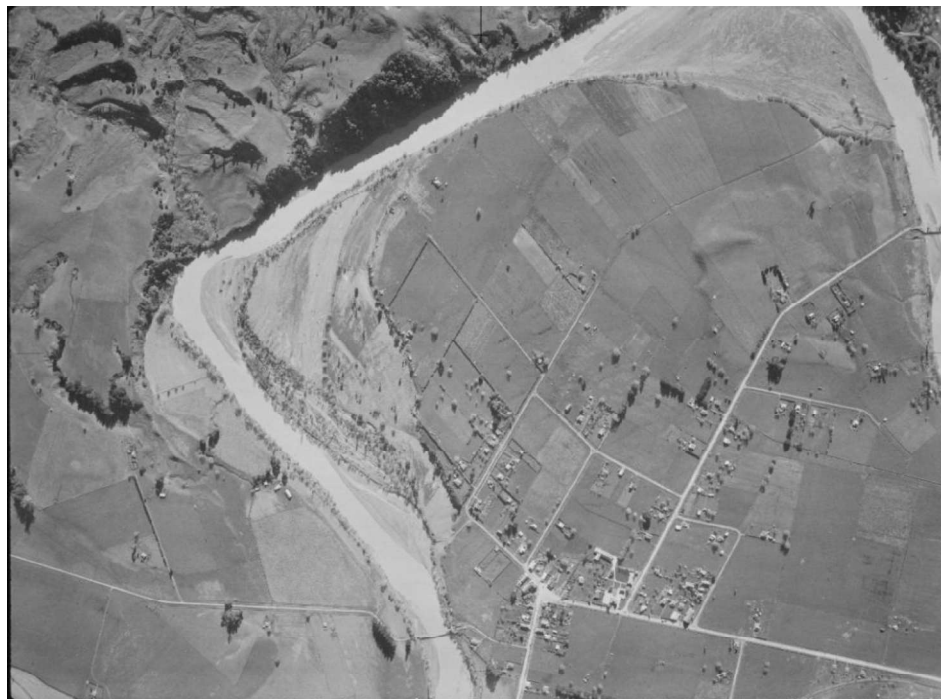
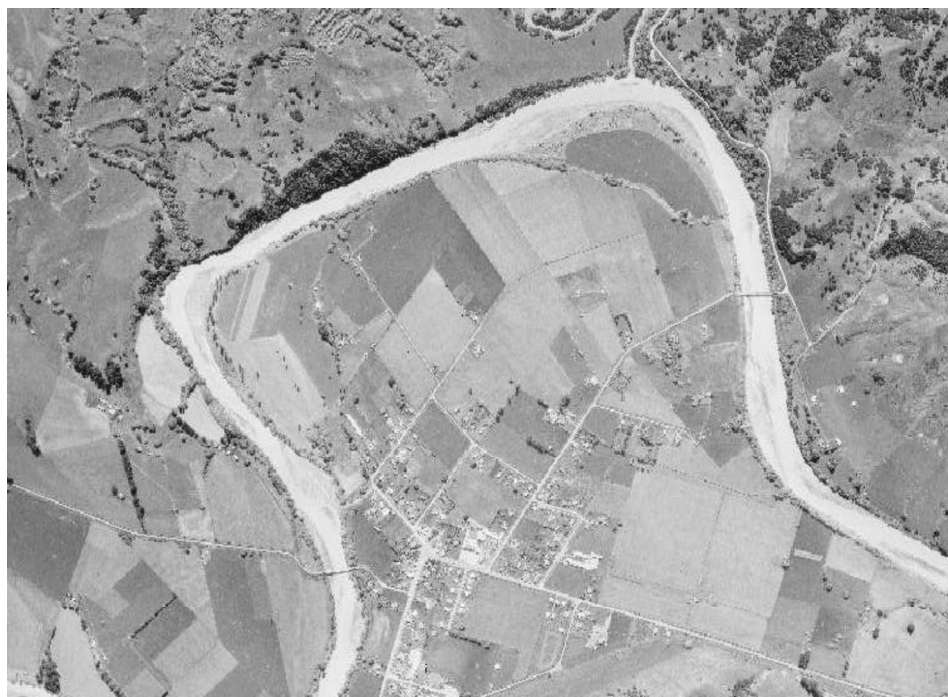
**Figure 1. Te Karaka in 1948, prior to the building of the flood control scheme in the 1950s, and in 1969. <http://retrolens.nz> and licensed by LINZ CC-BY 3.0.**

Te Karaka in 1948 prior to the flood scheme being built.

Te Karaka in 1969 after flood scheme built.

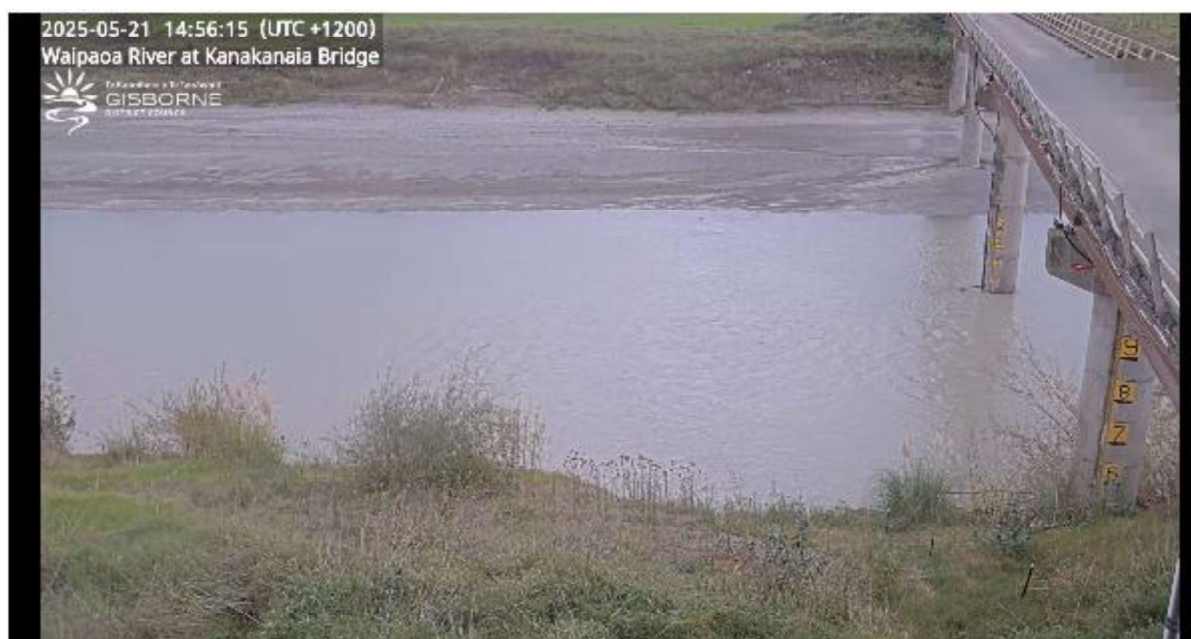
**Figure 3. Screenshot from the river webcam at Kanakanaia Bridge, Te Karaka.**

The area of the proposed flood scheme expansion is agricultural and predominantly made up of grazed pasture and cropland with residential buildings and associated amenity planting. The area on the north side of the existing stopbank is used for sheep grazing. A screenshot from the GDC river webcam at the Kanakanaia Bridge on the east side of the community shows rank grass in the riparian zones (Figure 3)

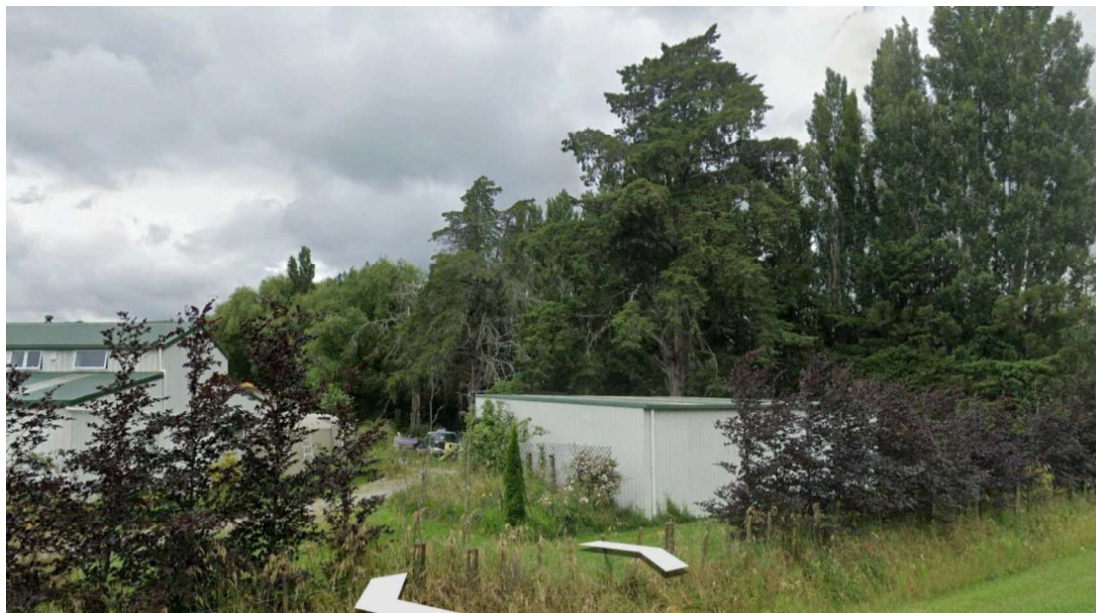
**Figure 4. Photo taken of some of the proposed trees intended for removal. (Source GDC)**

There are sections of large exotic trees that are intended for removal (Figure 2 and Figure 4). These are situated around the Rangatira Bridge, adjacent to SH2 on the western side of the site, and adjacent to the stopbank on the eastern side next to the existing dwelling.

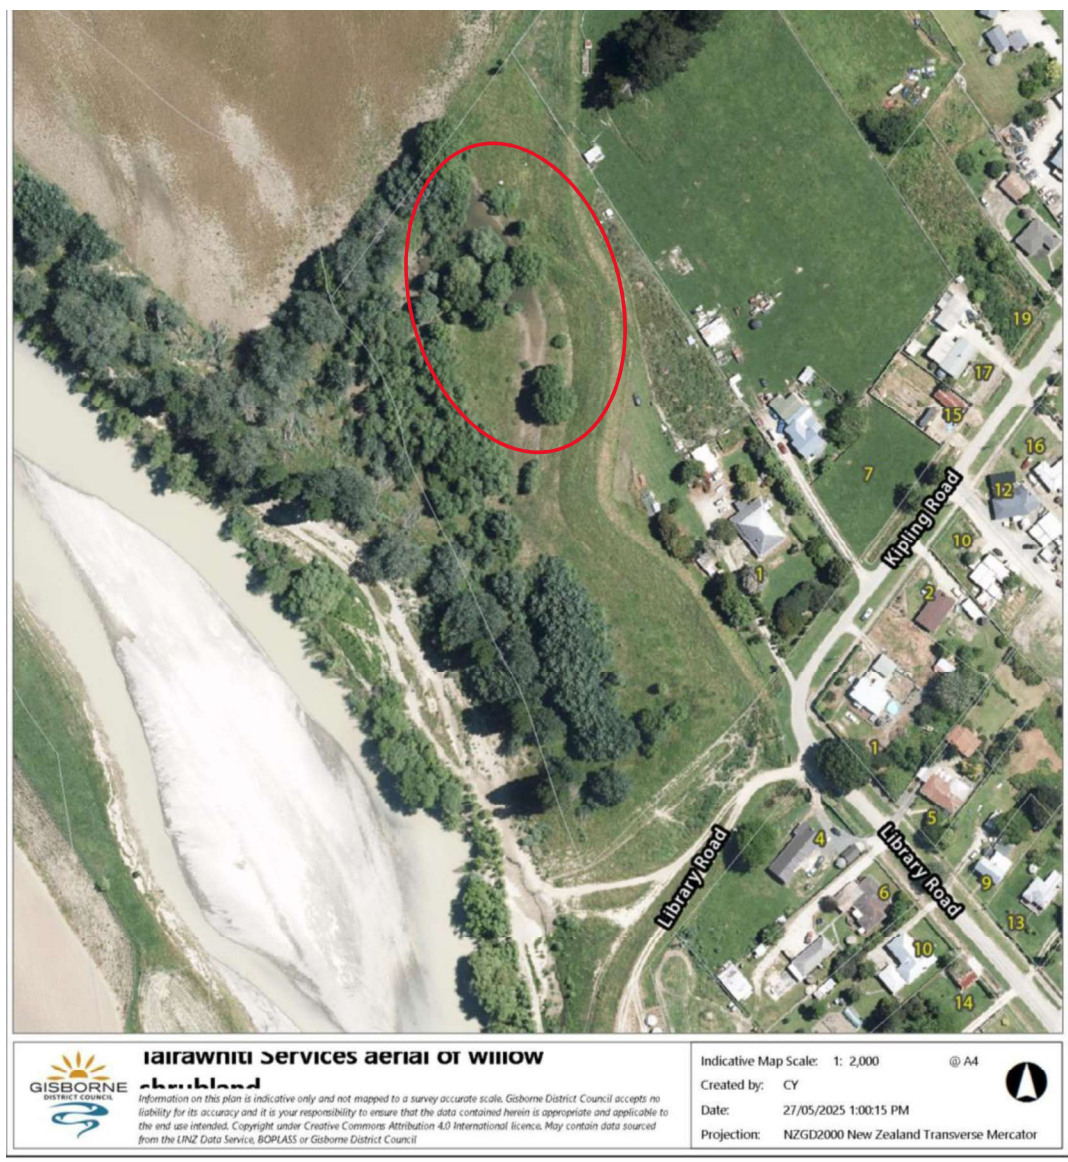
**Figure 6. Image of wet area from the Tairāwhiti Services aerial imagery.**

A small area of standing water in the willow shrubland area can be seen on the Tairawhiti Services map (Figure 6) The same area on Google Earth and ArcGIS pro aerial imagery shows up as a 0.1 ha darker green patch however it was not detected during the field visit. It remains unclear if it is a wetland or an area that ponds during heavy rain as part of an

overland flow path. The area is outside of the works area and is discussed further in Section 4.4.2.

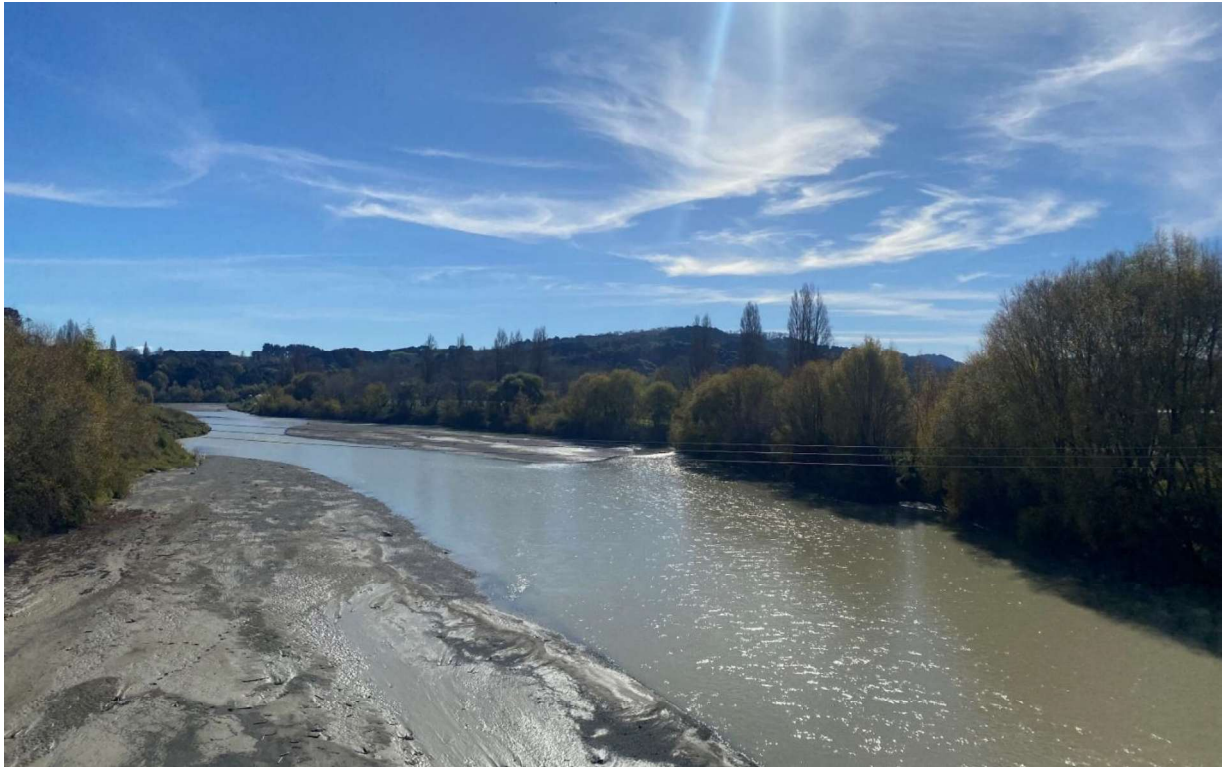
**Figure 7. Waipaoa River taken from the track that splits off from Kipling Rd. March 2025 (Red dot on Figure 2).**

The reach that creates a U around Te Karaka is constrained on both banks by intensive agricultural land use and is characterised by shallow, incised stream banks. Riparian vegetation is generally sparse, consisting predominantly of rank grasses, with scattered exotic trees such as grey willow (*Salix cinerea*), crack willow (*Salix fragilis*) and hybrid poplar (*Populus deltoides* × *yunnanensis*) (Figure 7).

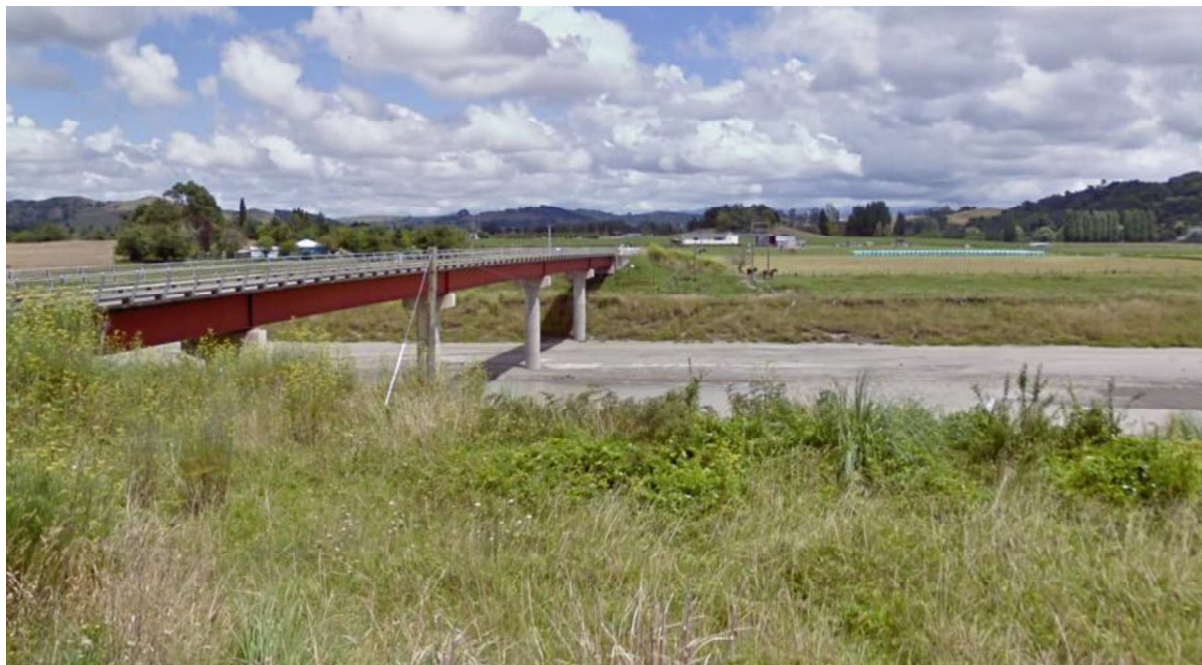
**Figure 8. Kanakanaia bridge over the Waipaoa River looking west towards Te Karaka (2010).**

The state of environment and NIWA water quality sampling location closest to Te Karaka on the Waipaoa River is at the Kanakanaia Bridge where GDC conducts State of the Environment monitoring. There is little shading of the river. The following section refers to data collected at this location (Figure 8).
