**Te Karaka SH2 Road Raising**  
**Preliminary Design Stage Safe System Audit Report**  
**Prepared for Gisborne District Council**

**REVISION 0 - SEPTEMBER 2026**

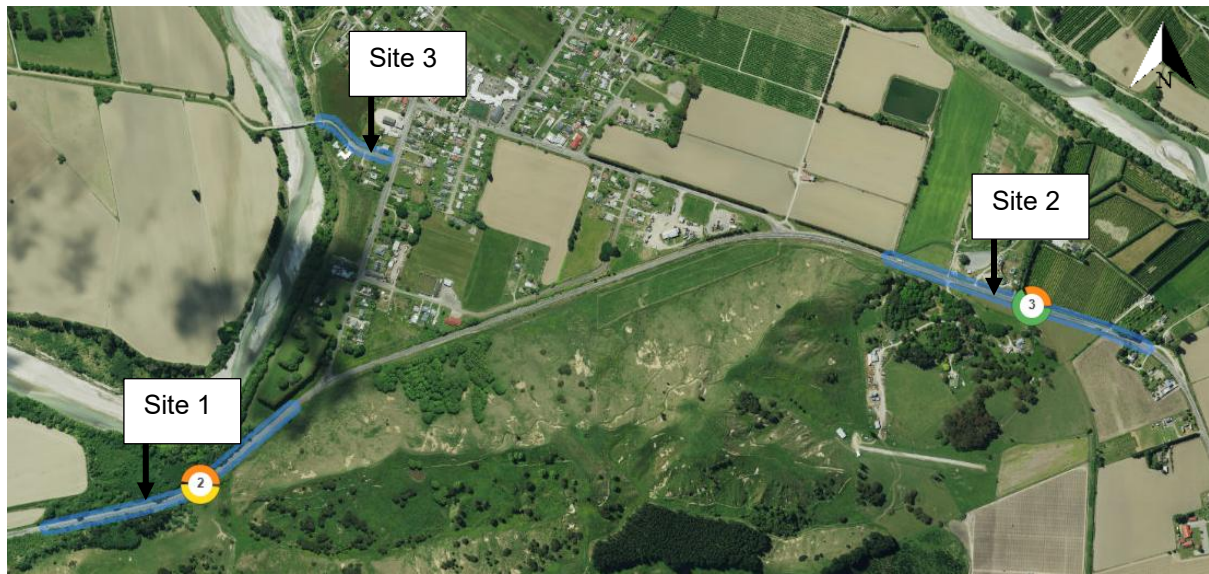
Figure 4.1-1: Extent of safety assessment and crash locations

The crash history for the road raising project was assessed to assist the SSA team in understanding the road's safety performance. A 10-year CAS assessment was undertaken from 2016 to 2026 to date. The crash location map is shown in Figure 4.1-1, and the summary of the crashes is presented in Table 4.1.1.

Overall, although in relative low frequency, the crash records indicate a loss-of-control crash type pattern on the sites subject to the proposed road raising.

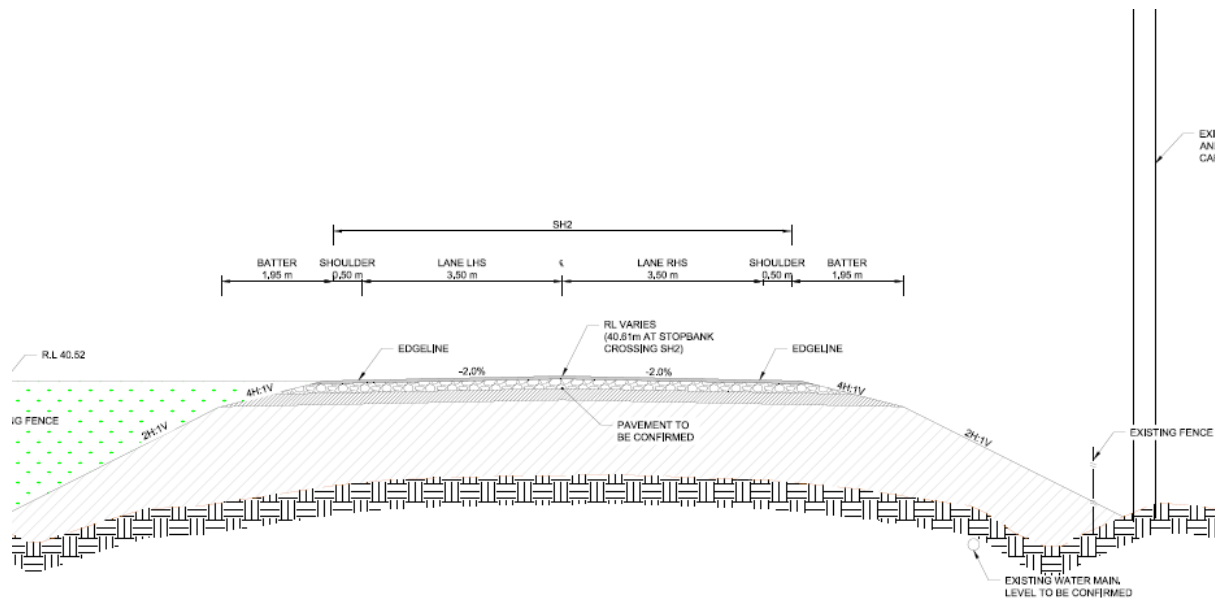
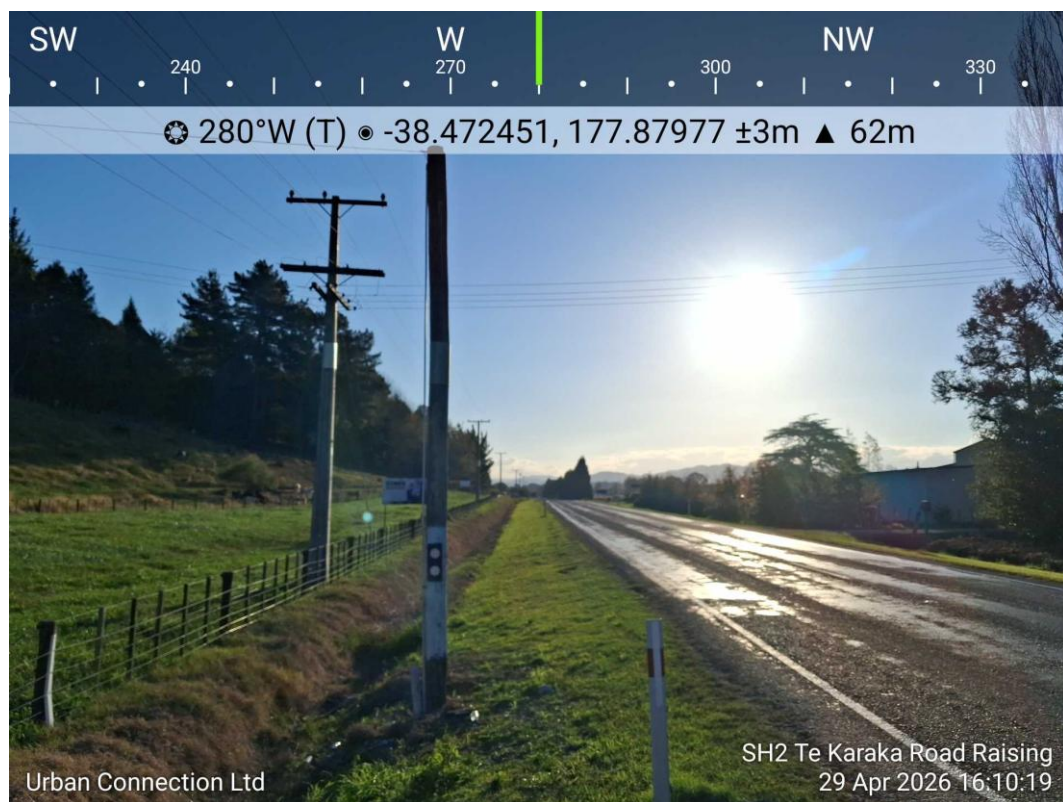
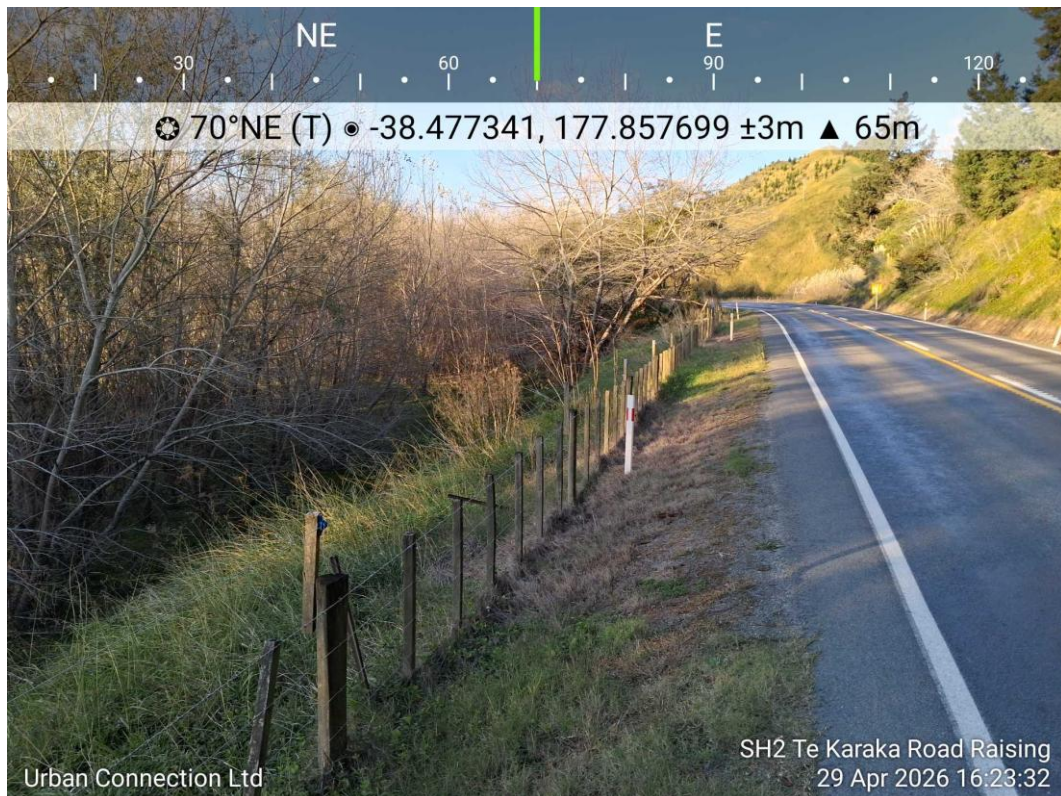
**Figure 5.1-3: Drop-off into ditch / drain on SH2 (Site 1)**

At both SH2 sites, the proposed road raising will result in a roadside environment that provides limited opportunity for drivers to recover if they leave the carriageway.

The typical cross-section indicates 0.5 m shoulders and a roadside batter arrangement comprising a short 1.95 m wide 1:4 slope, followed by a 1:2 slope. While the initial 1:4 batter may provide some limited traversable width, it is not sufficient to function as a forgiving roadside. The narrow shoulder further reduces the available recovery area. In combination, this means an errant vehicle may have little opportunity to regain control before encountering a steeper slope that increases the potential for loss of control, rollover, or descent into the roadside.

This is of particular relevance at Site 01, where a drain / ditch with a noticeable drop-off is present on the north side of the road, together with rigid roadside objects including trees. A curved is also present along this site, which in general terms results in a higher likelihood of loss of control crashes. At Site 02, non-frangible power poles are present near the road, predominantly on the southern side, although one is also located on the northern side. While most of these poles appear to sit outside the road reserve, two are relatively close to the carriageway. In these locations, the proposed cross-section may not only provide limited recovery space, but may also direct errant vehicles toward existing roadside hazards. The current preliminary design information does not clearly show how these hazards would be addressed as part of the works.

Of relevance, SH2 sites sit within a high-speed rural environment, and the existing crash history includes loss of control crashes some with high severity outcomes. While the affected lengths are relatively localised, an unforgiving roadside at these locations may increase the severity of outcome where a vehicle departs the carriageway. The combination of narrow shoulder width, limited traversable batter width, steeper outer slopes, and existing roadside hazards may therefore provide a reduced margin for driver error than would be desirable on a 100 km/h state highway.

It is acknowledged that the proposal is not entirely dissimilar to the existing cross-section and roadside environment. However, the raised road levels would increase the height of roadside drops relative to the existing situation, which may increase crash severity if a vehicle leaves the carriageway. There remains a risk that the proposed works could introduce or retain a roadside condition in which some errant vehicles would have limited opportunity to recover before encountering a rollover hazard or rigid roadside object.

1. *Identify roadside hazards within the project extent and confirm whether these should be removed, relocated, or protected.*
2. *Review the proposed cross-section at both SH2 sites, including whether additional recovery width can be achieved through shoulder widening and / or flatter roadside slopes, or alternatively whether roadside barrier protection is required.*

| <p><b>Design Team Response:</b> <i>Noted. The designer accepts that the road raising increases the height difference from the new road to the bottom of the batter slope. Designer to review the recommendations to test the feasibility for shoulder widening, noting that this may encroach into private land. Notwithstanding this the designer will also investigate the inclusion of a safety barrier. This work is to be undertaken as part of the detailed design phase.</i></p> | |
| <b>Client Decision:</b> | <i>Client preference is for inclusion of a safety barrier as suggested by the design team at WSP.</i> |
| <b>Action Taken:</b> | <b>Designer to include a safety barrier.</b> |

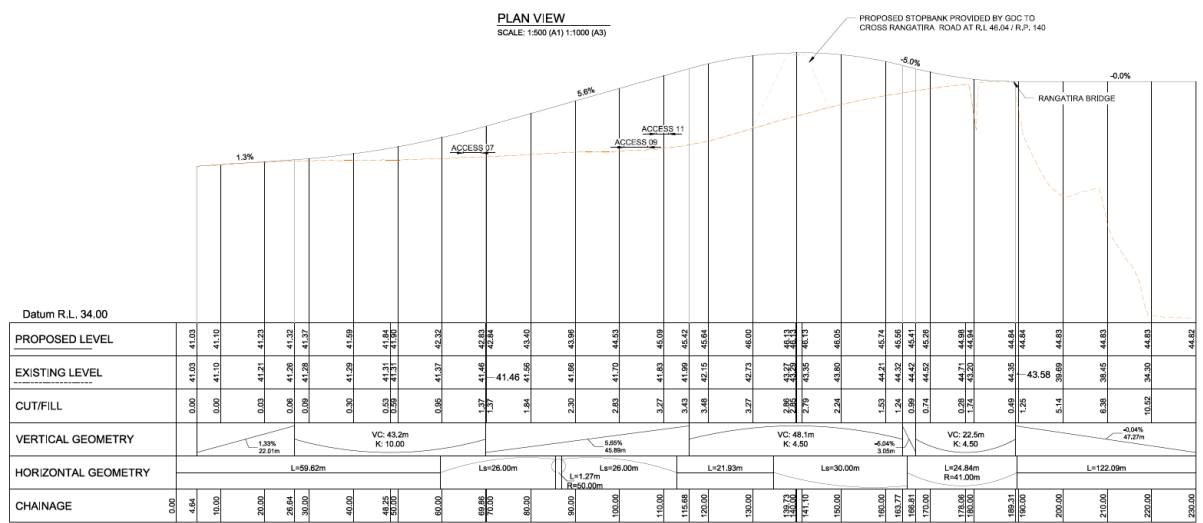
Figure 5.1-4: Vertical Alignment on the approach to the Rangatira Bridge

The proposed road raising adjacent to the bridge introduces a crest in the approach to the stopbank crossing, which reduces forward visibility toward the bridge for westbound traffic and reduces the ability of eastbound drivers who have just crossed the bridge to see approaching westbound vehicles compared to the existing situation. This reduction in visibility is not the concern in isolation given the low operating speeds in this area.

The road is also raised by up to approximately 3.5 m near its highest point, effectively increasing the drop-off and severity risk in the immediate vicinity of the bridge relative to the existing situation. At this stage, no barrier protection or other specific roadside treatment is shown to manage that increased risk.

1. Review the proposed cross-section and verge treatment to ensure that vehicles can safely manoeuvre when encountering opposing traffic on the approach to the bridge.
2. Review the raised embankment roadside treatment near the bridge, including whether barrier protection, flatter slopes or other mitigation is required to address the increased drop-off hazard.
3. Confirm that the final bridge approach arrangement provides a clear, legible and safe operating environment for drivers approaching from both directions.

| <b>Probability Rating:</b> | <b>Severity Outcome Rating:</b> |
|---|---|
| <p><b>Design Team Response:</b> Agree with SAT. The following actions are suggested to be undertaken during detailed design. Response to point 1 – Designer to test opportunity to widen lanes and shoulder on horizontal curve to allow more forgiveness when two vehicles pass one another. Response to point 2 – Designer to include safety barriers to improve delineation of the horizontal curve and to prevent vehicles from leaving the road. Response to point 3 – Designer to include appropriate advanced warning and curve warning signage to alert drivers.</p> | |

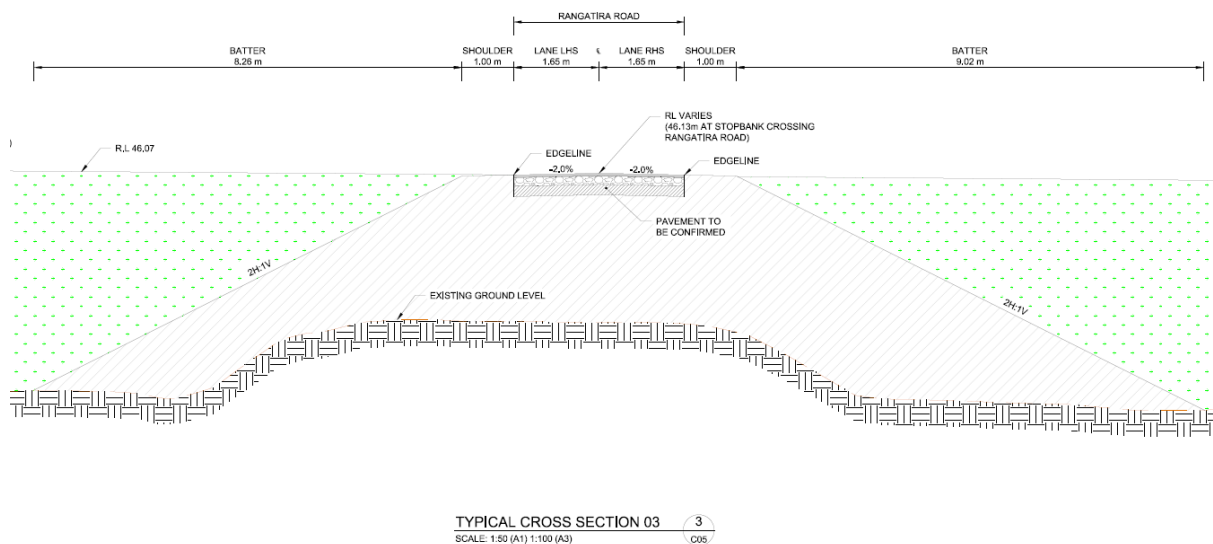
Figure 5.1-5: Proposed Cross-section on the approach to the Rangatira Bridge

The more important issue is the way this reduced visibility combines with the proposed bridge approach cross-section. The carriageway is proposed to be approximately 3.3 m wide, with 1.65 m lanes, 1 m verges on either side, and steep 1:2 embankment slopes beyond. This means that when opposing vehicles meet on the approach to the bridge, there is limited width available for manoeuvring and no clearly formed passing area to enable one vehicle to move aside in a controlled manner, particularly if one or more heavy vehicles are involved. While the 1 m verge may provide some nominal space for evasive tracking, it is unformed and sits immediately adjacent to a steep drop. As such, it would provide only limited practical refuge, may deteriorate over time if repeatedly used by vehicles, and may bring vehicles uncomfortably close to the edge hazard.

As a result, there remains a risk that drivers meeting near the bridge approach may be required to make late or constrained manoeuvres within a narrow and unforgiving environment. If a vehicle departs the carriageway, the steep embankment slopes and unprotected drop-offs may increase the likelihood of rollover or a more severe run-off-road outcome. The single-lane bridge arrangement and priority-controlled operation further increase the importance of providing a clear and forgiving approach where drivers can see, assess and respond safely to the presence of other vehicles.

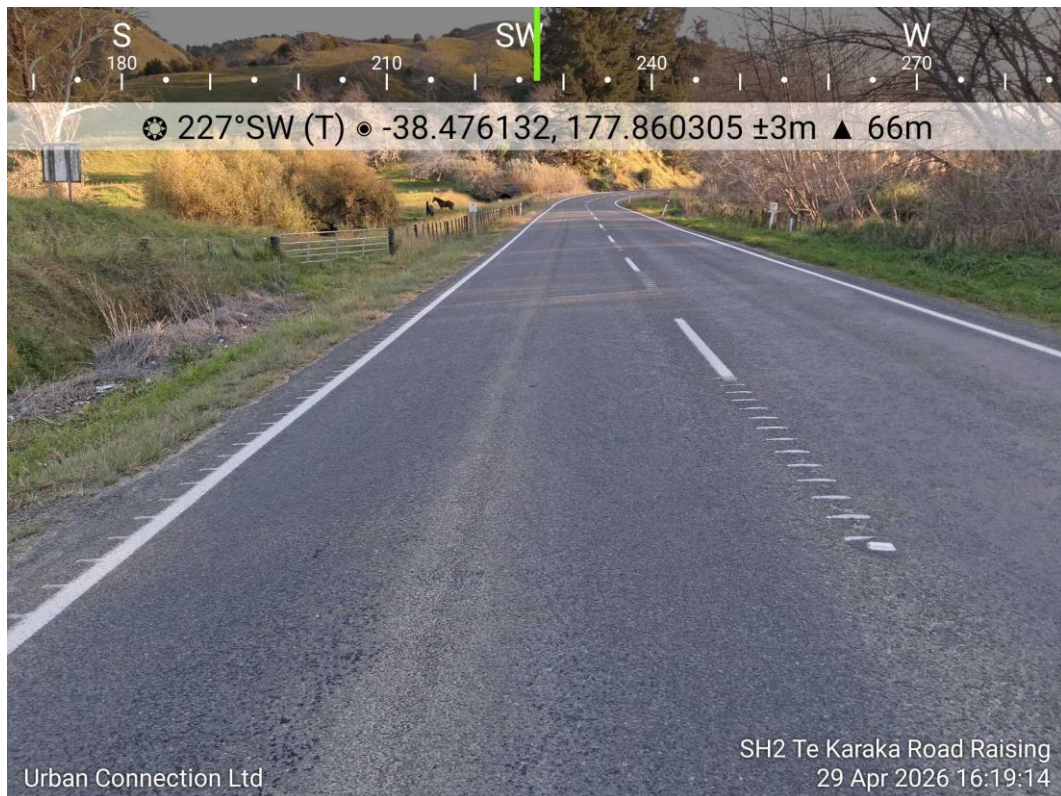
During the site visit, it was noted that audio tactile profiled markings are currently present at Site 01. These should be addressed as part of the detailed road marking design. It was also observed that a single chevron sign is currently provided on the curve at Site 01, whereas where chevron delineation is required, a series of signs would typically be expected rather than a single isolated sign.

**Figure 5.1-6: Existing ATP markings on site 1**

| <b>Design Team Response:</b> Point 1 – Agree with SAT. Point 2 – Noted and designer to include specific details on how the ATP will merge with the existing road. Point 3 – Agree with SAT. Designer to revisit existing signage locations and amend to align with overall project intent. Point 4 – Agree with SAT. New road layout to include no passing lines due to the vertical alignment changes potentially impacting forward visibility. | |

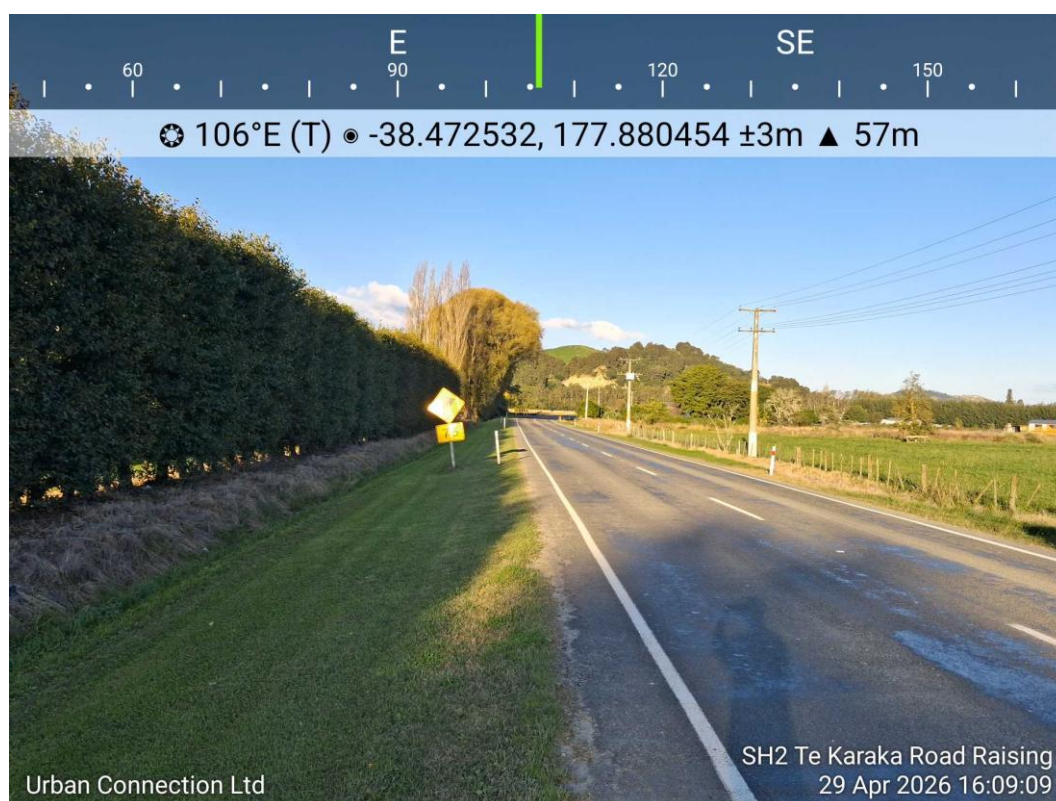
More generally, the proposed road raising may affect the visibility and effectiveness of existing signs as road levels and vertical alignment change. This includes signs such as the existing curve warning sign with 75 km/h advisory speed at Site 02, and also the priority signs associated with the single-lane operation of Rangatira Bridge, where changes in road level may affect their visibility on approach. These matters should be assessed as the design develops.

Figure 5.1-8: Existing curve and speed advisory sign on site 2

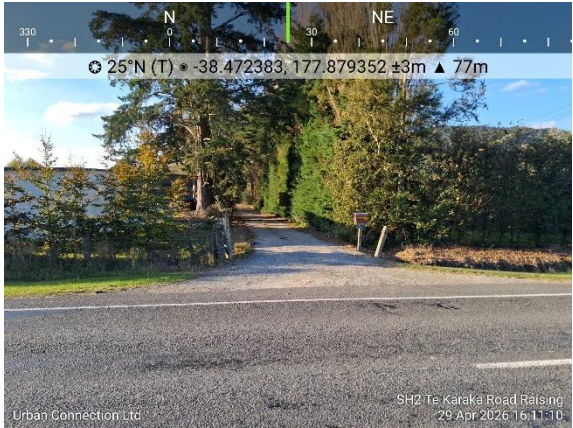
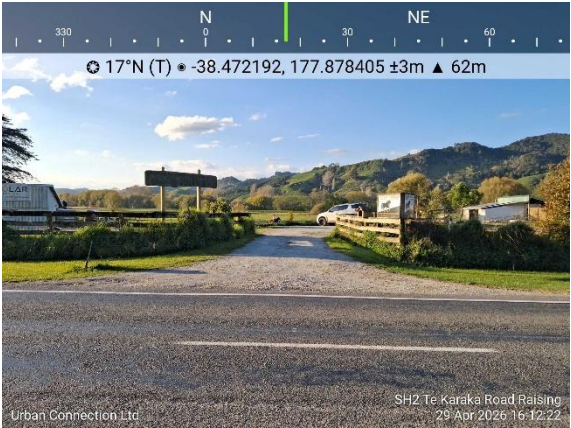
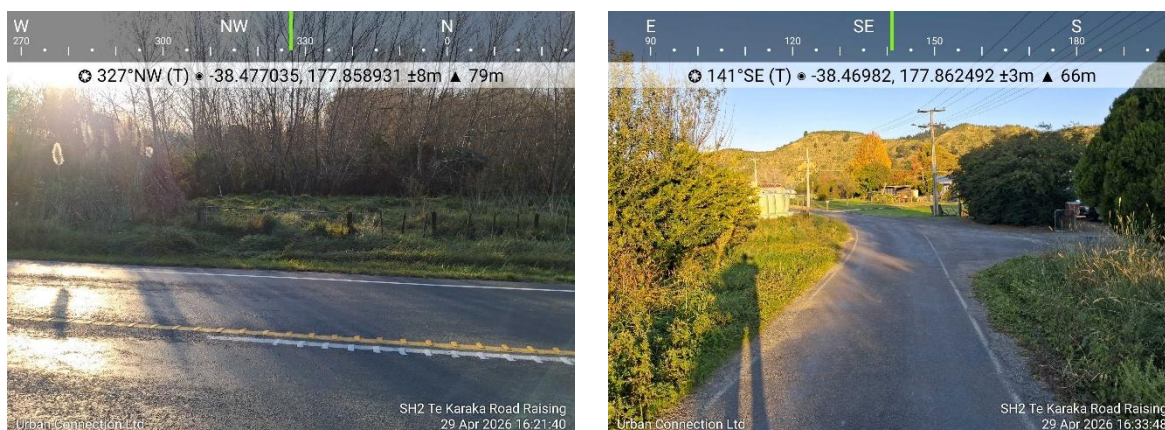
A number of accessways and / or gates on SH2 and Rangatira Road are expected to be affected by the proposed road raising. At this stage, the preliminary design information does not clearly show how these access points would tie into the proposed road levels and whether they are to be sealed as part of this project.

This should be reviewed as the design develops to confirm that vehicle movements to and from these accessways and gates remain suitable. In particular, steepened access gradients or abrupt tie-ins may make entry and exit movements more difficult, and could delay safe vehicle entry and exit, particularly in wet or slippery conditions.

**Figure 5.1-9: Accessways and gates on SH2 and Rangatira Road**

1. Review all affected accessways and gates as part of the next design stage.
2. Confirm that tie-ins to the proposed road levels provide suitable gradients and vehicle manoeuvring conditions for safe entry and exit.
3. Confirm that all affected driveways are to be sealed.

| <b>Design Team Response:</b> Noted. SAT may not be aware that some properties are to be relocated / demolished as part of the stopbank improvements and as such driveway access is not required. Designer to ensure that all properties that remain are appropriately designed to ensure they are fit for purpose and to no introduce safety risks. | |

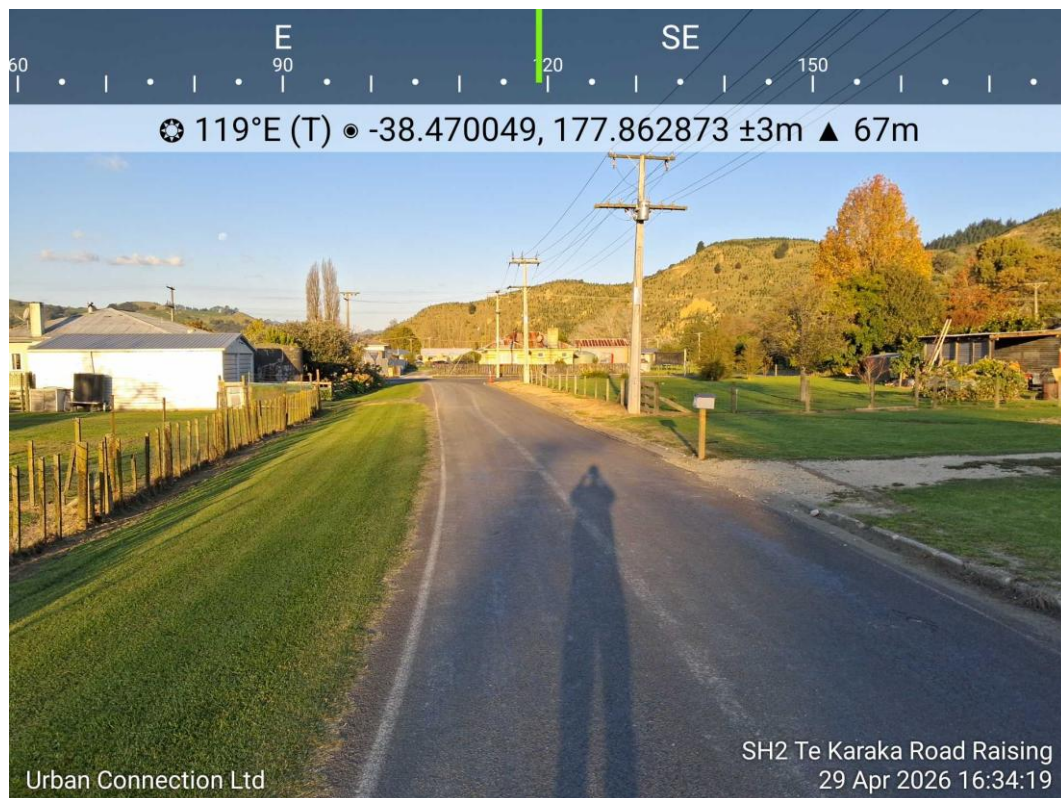
The proposed road raising is expected to affect existing utilities at a number of locations, particularly overhead power lines, as the change in road level may reduce the available clearance relative to the existing situation. While this is acknowledged in parts of the design information, the current preliminary design does not clearly show how utility constraints would be addressed.

This is relevant on both SH2 and Rangatira Road, where overhead power infrastructure is present within or adjacent to the project area. It is important that the effect of the raised road profile on overhead clearances is reviewed as the design develops, including at locations where vehicles may track closer to the road edge or use adjacent verges and accessways. More generally, other existing services and utilities within the project extent should also be reviewed to confirm whether protection, adjustment, or relocation is required.

**Figure 5.1-10: Overhead power cables on Rangatira Road**

| <b>Probability Rating:</b> | <b>Severity Outcome Rating:</b> |
|---|---|
| <p><b>Design Team Response:</b> Noted. Design team has taken into consideration the overhead powerlines, but has not considered the reduced clearance due to the raising of the road. Designer to revisit the clearance requirements and if not achievable, include provision for engaging with utility company to determine the appropriate remedial measure, most likely the reinstatement of a new powerpole and foundation once the new road has been constructed.</p> | |
