MANGAOPORO RIVER MEAN BED LEVEL TRENDS; 1958 TO 2015.

This is one of a series of reports on river bed level trends in the Waiapu catchment, Ruatoria, commissioned by the Environmental section and the (former) Roding section of the Gisborne District Council.

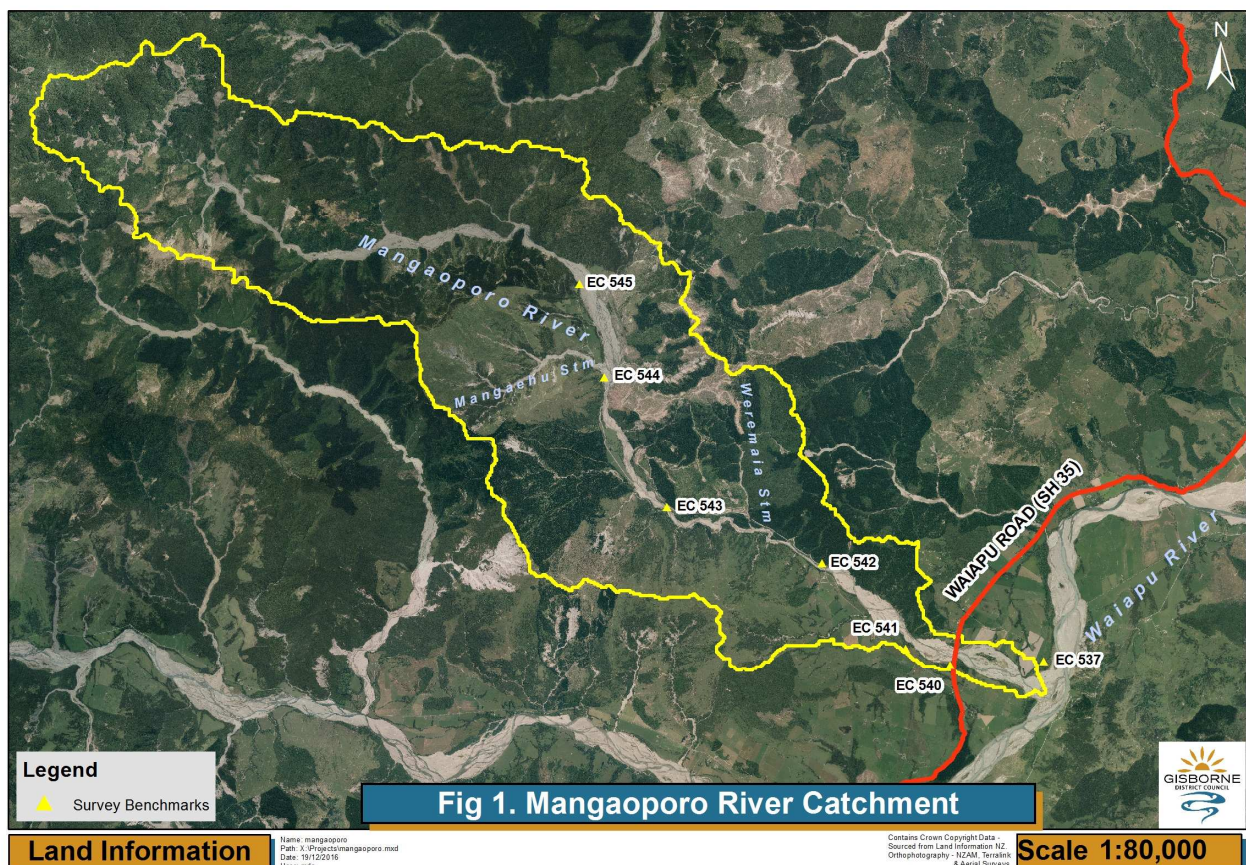
Figure 1 shows the 72.6 km² Mangaoporo River catchment. The Mangaoporo River has its headwaters on the eastern flank of Raukumara, and flows in a south easterly direction some 23 kilometres to its confluence with the Waiparu River, where it discharges its bed load into a massive shingle fan.

The mean bed level trends in this report cover only the lower half of the Mangaoporo river channel where the surveyed cross sections are located, as shown in Fig.1. This surveyed length of the river can be divided into three reaches, each with different characteristics. Firstly, the upstream reach between EC545 and EC 543 has a wide braided floodplain, followed by a narrow single thread reach between EC543 and EC542, and finally another (even wider) depositional zone and shingle fan between EC542 and the Waiparu river.

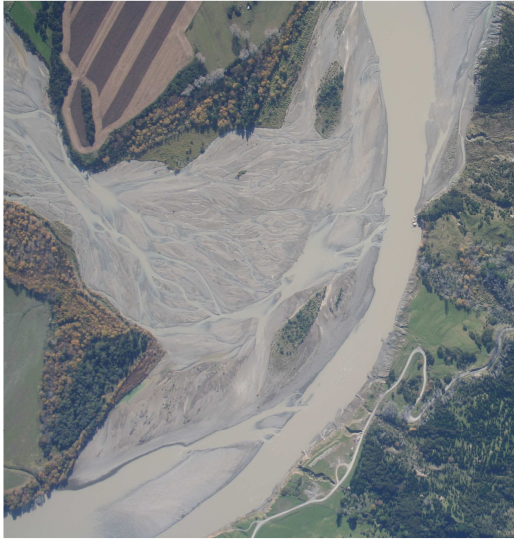
There is a vast shingle fan at the confluence of the two rivers which measures some 1.5 kilometres wide and extends into the Waipua River by some 430 metres (see Fig. 9). This has forced the Waipua River into the true right bank at Kaiinanga hill over many years. In the 1990's and early 2000's the Gisborne District Council constructed a series of rock groynes to prevent the erosion of the right bank and protect Waioamatatini Road.

Fig. 9. *Mangaoporo River shingle fan in the Waipua River.*
Photo: G Swain, 30 May 2011.

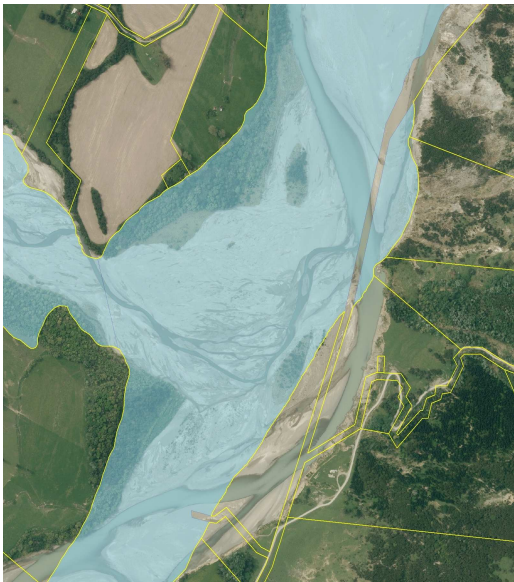
Fig. 10. *Mangaoporo River fan showing historic river course (shaded blue) within cadastral boundaries.*

Figure 10 shows the cadastral boundaries of the Mangaoporo and Waipua rivers in the vicinity of the shingle fan. The river boundaries were probably surveyed in the early 20th century. The original Waioamatatini Road legal boundaries are now in the active bed of the Waipua River.
