Eastland Port Te Toka a Taiau Location Spatial Analysis Report

Te Toka-a-Taiau location spatial analysis

17th December 2019

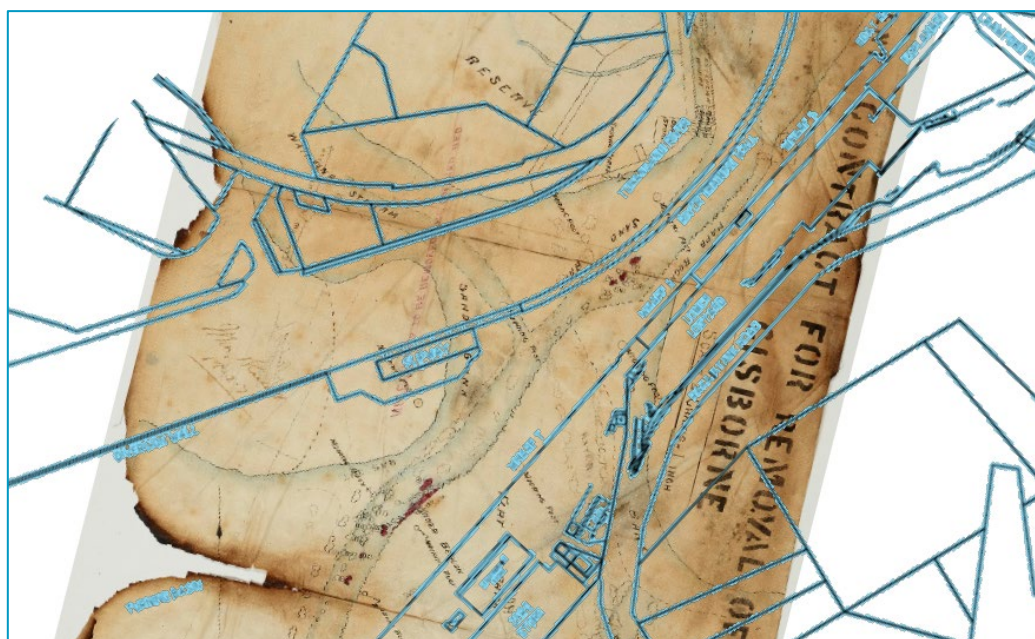
Figure 1. EPL has found Te Toka-a-Taiau (red coloured rocks in Turanganui River) was most likely located opposite Wharf 6 just off the River training wall, and in between the original back lead navigation light on the River training wall, and its relocated position to the south west within the harbour.

From this analysis it has been found that Te Toka-a-Taiau was most likely located in a position opposite what is now called Wharf 6 adjacent to the River training wall, and in between the original Back lead navigation light on the River training wall, and the relocated position of it in the harbour.

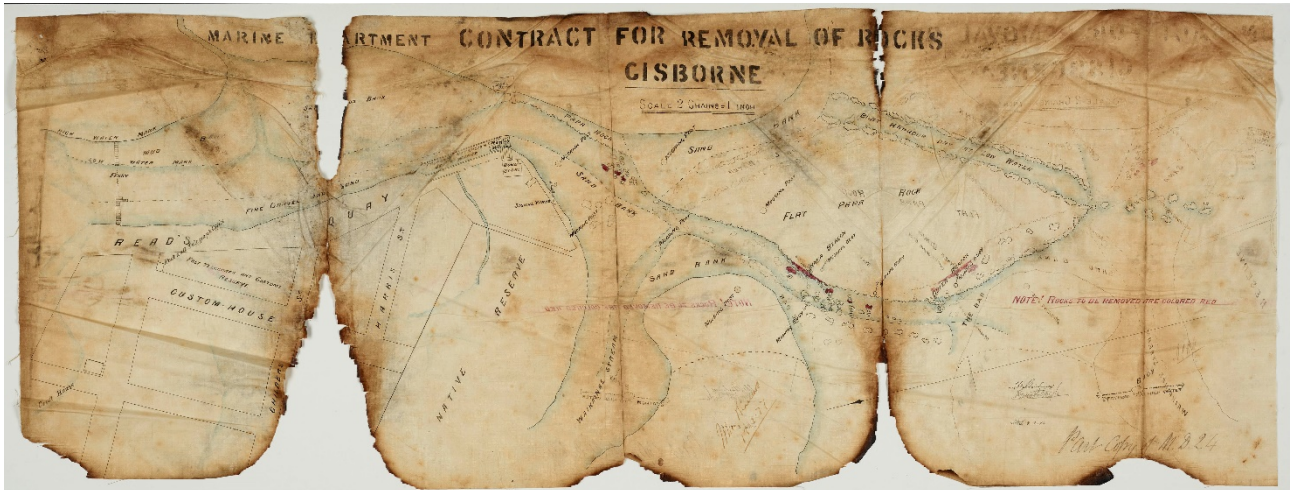
Figure 6. Marine department contract for removal of rocks Gisborne 8th February 1876. There are several rocks coloured red to be removed from the Turanganui River clumped in two distinct clumps.

The best geographic location reference Spedding found was the *Marine department contract for removal of rocks 1876* (figure 6). An electronic copy of this was obtained from the National Library of NZ for analysis.

1876 Marine department Contract for removal of rocks Gisborne

- The most critical part of information as it is the only map with some level of survey data and therefore scale which illustrates the rocks of Te Toka-a-Taiau as a feature.

- Charted for the removal of this rock and others close to the mouth of the Turanganui River it has good annotations of the reefs, sand banks and water courses as they were at that time.

- There is an issue though in that while the surveyed street map is to scale and fits to the streets of Gisborne at that time, and the natural features of the reefs, sand banks and water courses fit with how they would have been at that time, but the two data features do not fit with each other.

- The natural features are the most important piece of data presented and are considered to take precedent over the surveyed street map.
- The Contract does not accurately match the survey street map but why should it? Whoever drew this wouldn't have been concerned with the street map so it shouldn't be considered accurate in this aspect.

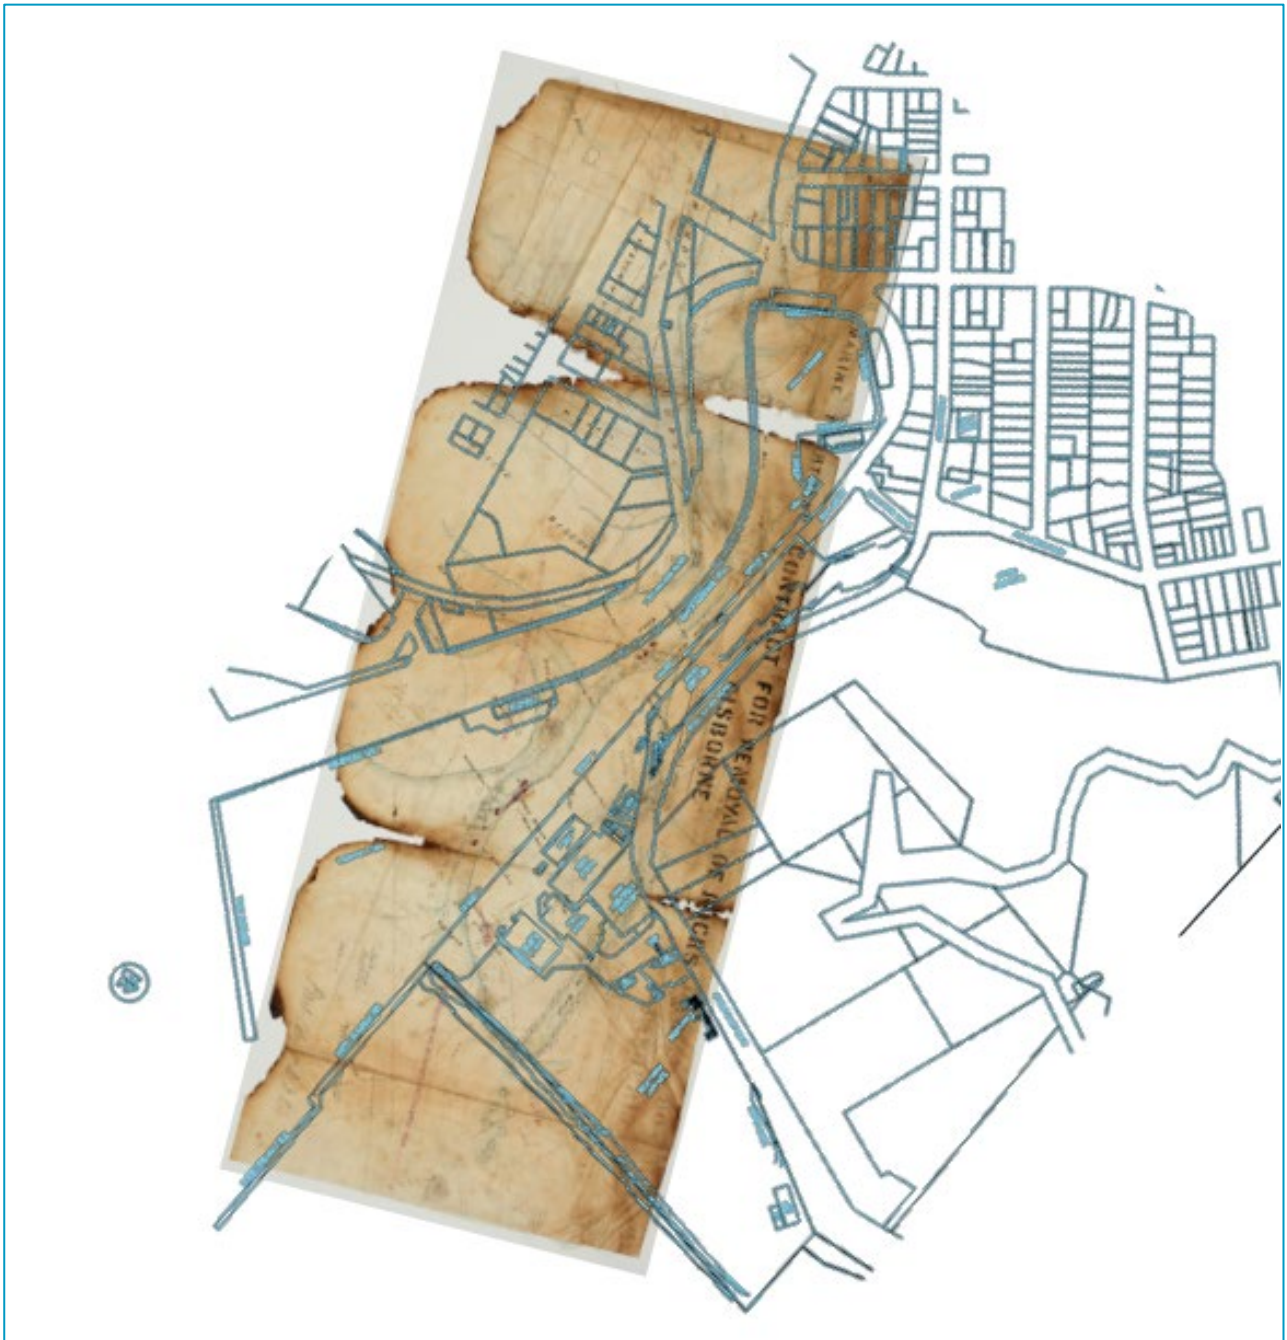
The Contract for Removal has been overlaid over the Eastland Port asset map in figure 8. It shows the rocks removed to be opposite Wharf 6 and approximately in between the recently relocated back lead navigation mark and the original back lead navigation mark which was on the river training wall. The orientation and positioning of the combined Contract and EPL asset map is a result of the spatial analysis under taken.

Figure 8. Marine department Contract for removal of rocks Gisborne 8th February 1876 with EPL asset map overlaid.

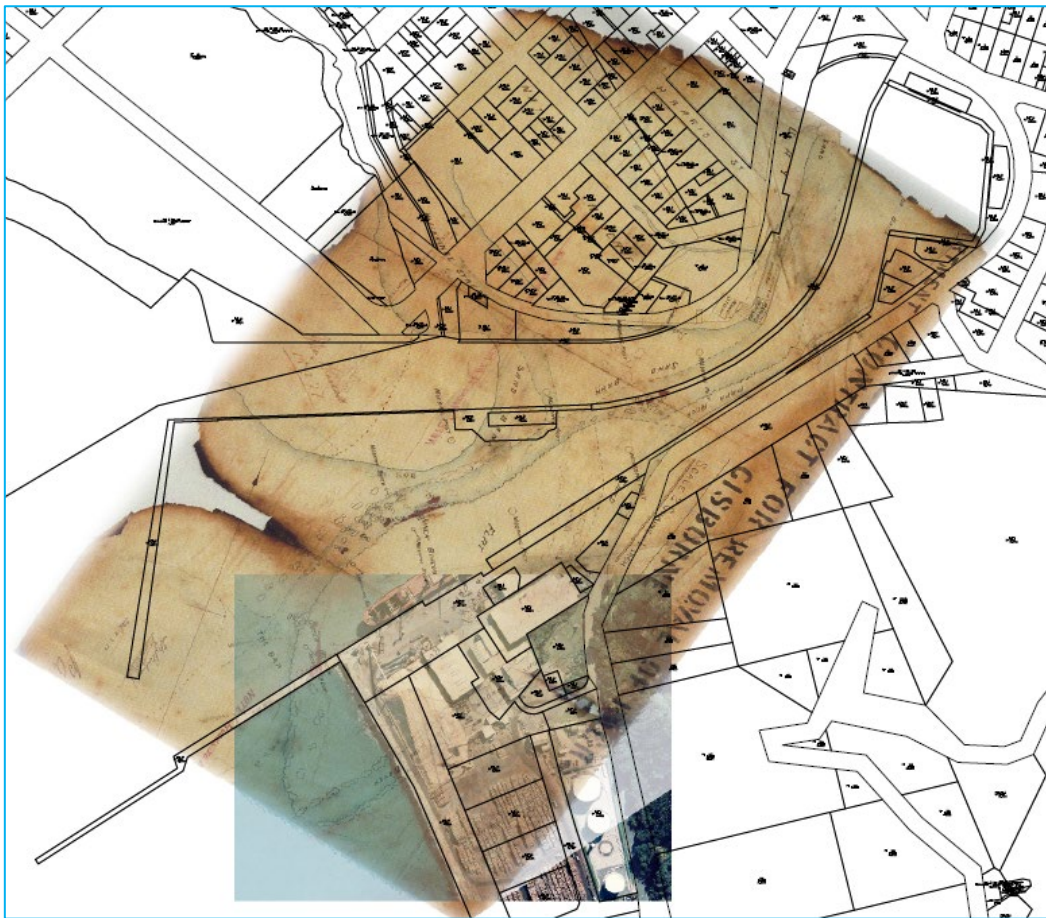
Figure 9. Blackburne 2006 spatial analysis of the *1876 Marine department Contract for Removal of Rocks Gisborne* to locate Te Toka-a-Taiau

In 2006 James Blackburne from Historic Places Tairāwhiti undertook a similar exercise to try and establish the most likely location of Te Toka-a-Taiau. Blackburne found the most likely location of Te Toka-a-Taiau to be within the same general vicinity as EPL but believed the location to be approximately 20 metres westward underneath what is now the River training wall (figure 9).

With only the *1876 Marine department Contract for removal of rocks Gisborne* as reference material Blackburne used a different technique of analysis. The 1876 drawing was stretched to align key features with known and matching features of 2006 in particular land boundaries. Like EPL, Blackburne found the 1876 drawing did not align perfectly and came to the same conclusion that some of the land features were most likely indicative only².

It was noted by Blackburne that Te Toka-a-Taiau was located in the middle of the map therefore stretching of the 1876 drawing was unlikely to have a major bearing on the location as it would have been distorted the least.
