## APPENDIX 10: ARCHAEOLOGICAL ASSESSMENT

### **ARCHAEOLOGICAL ADVICE – PROPOSED FLOOD PROTECTION WORKS, TE KARAKA, GISBORNE DISTRICT**

As requested, we have carried out a desk-based review and field inspection to determine if archaeological site(s) may be affected by the proposed flood protection works at Te Karaka, Gisborne (Figure 1).

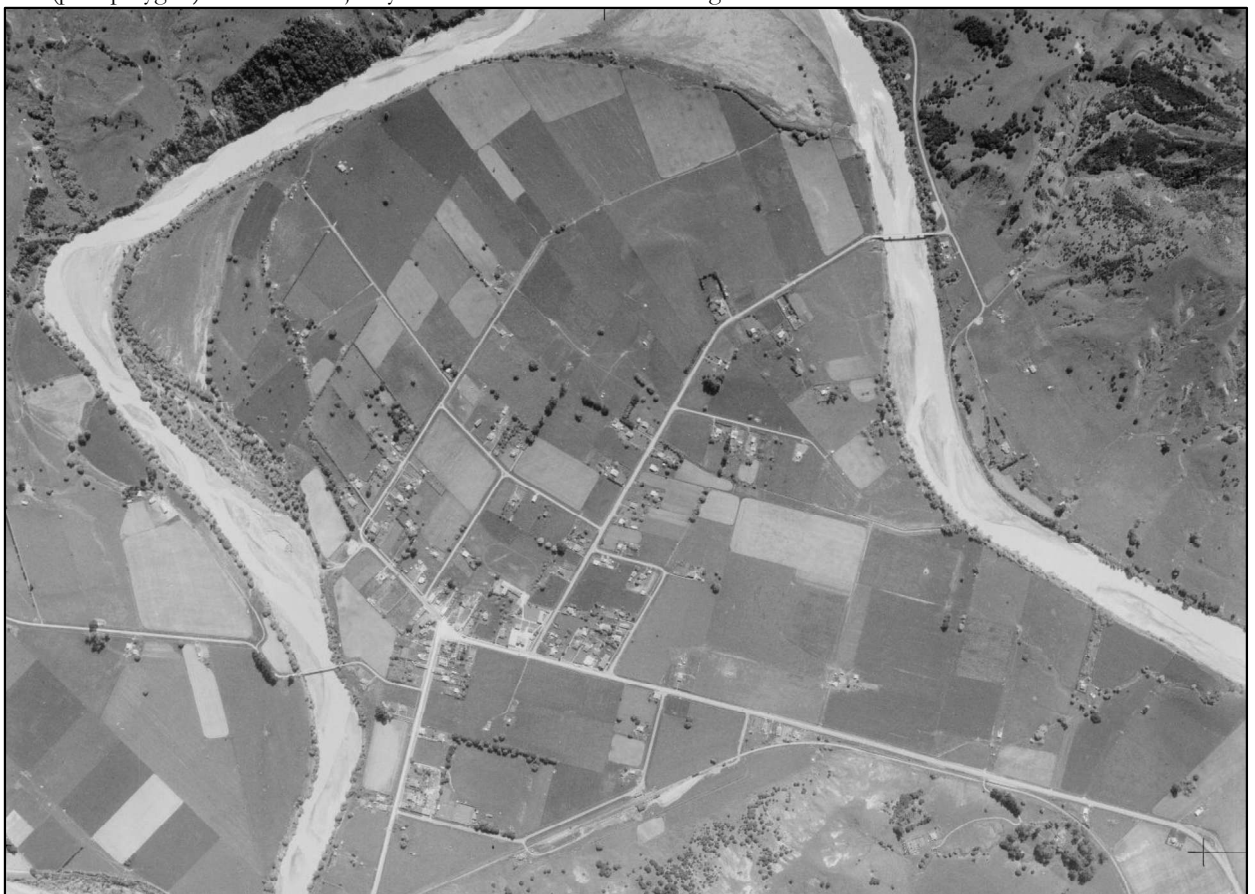
The earliest available historic photograph of the project area was taken in 1949 (SN225 640 2) and shows Te Karaka in the early stages of development (Figure 4). The surrounding river terrace had been developed, largely into pasture. Between 1949 and the present-day little changed, save for further urban development and the construction of additional roading. No potential unrecorded archaeological sites were observed using historic aerial photography.

**Figure 4** – SN225 640 2 from 1949 showing the early development of the Te Karaka township. Source: Retrolens.

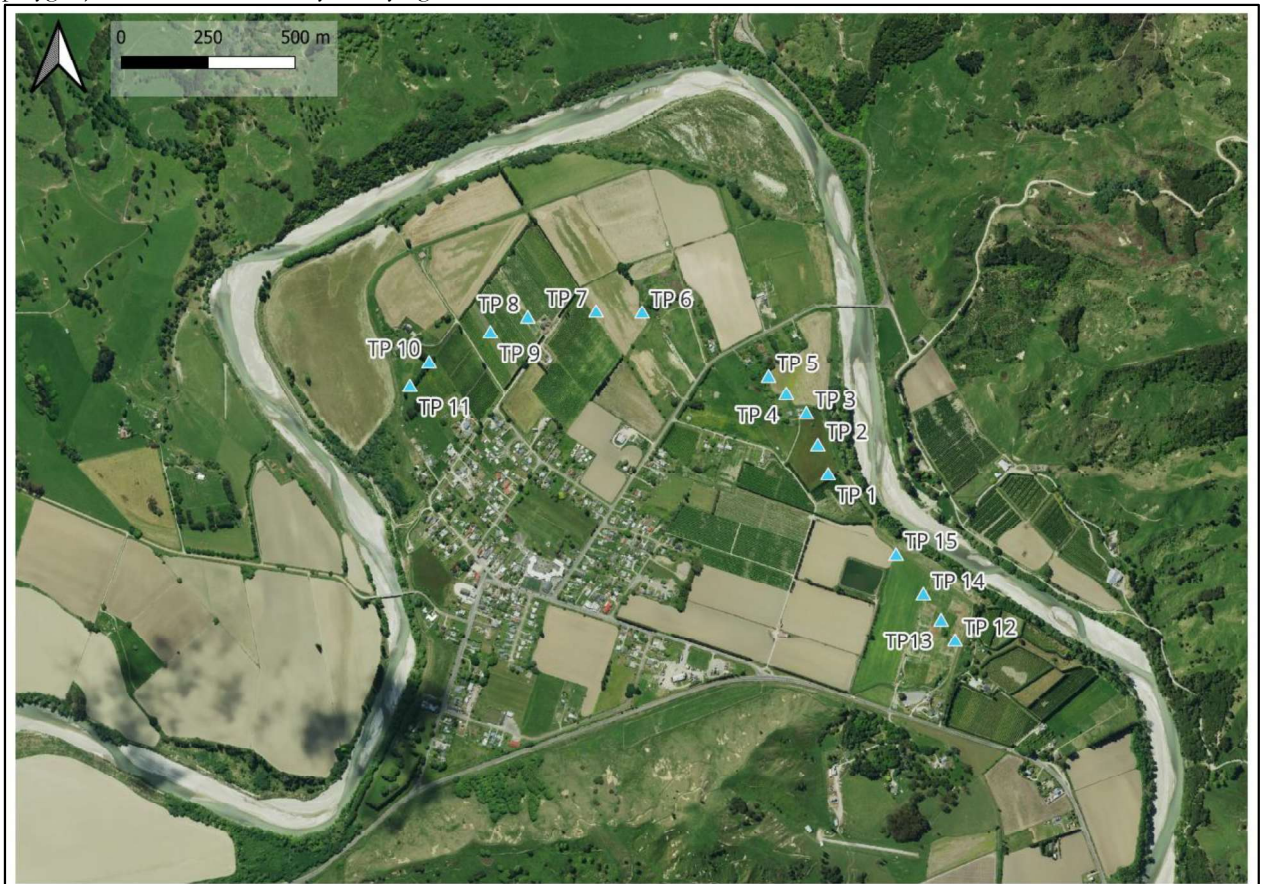
Fifteen test pits were excavated across the site (Figure 6). The location of these test pits was chosen based on accessibility and aimed to be representative of any variation within the project area. Test pits largely focused on the northern and eastern extents of the project area, as the western alignment follows the path of the existing stopbank.

**Figure 6** – Map showing the location of test pits (blue triangles). Source: LINZ.

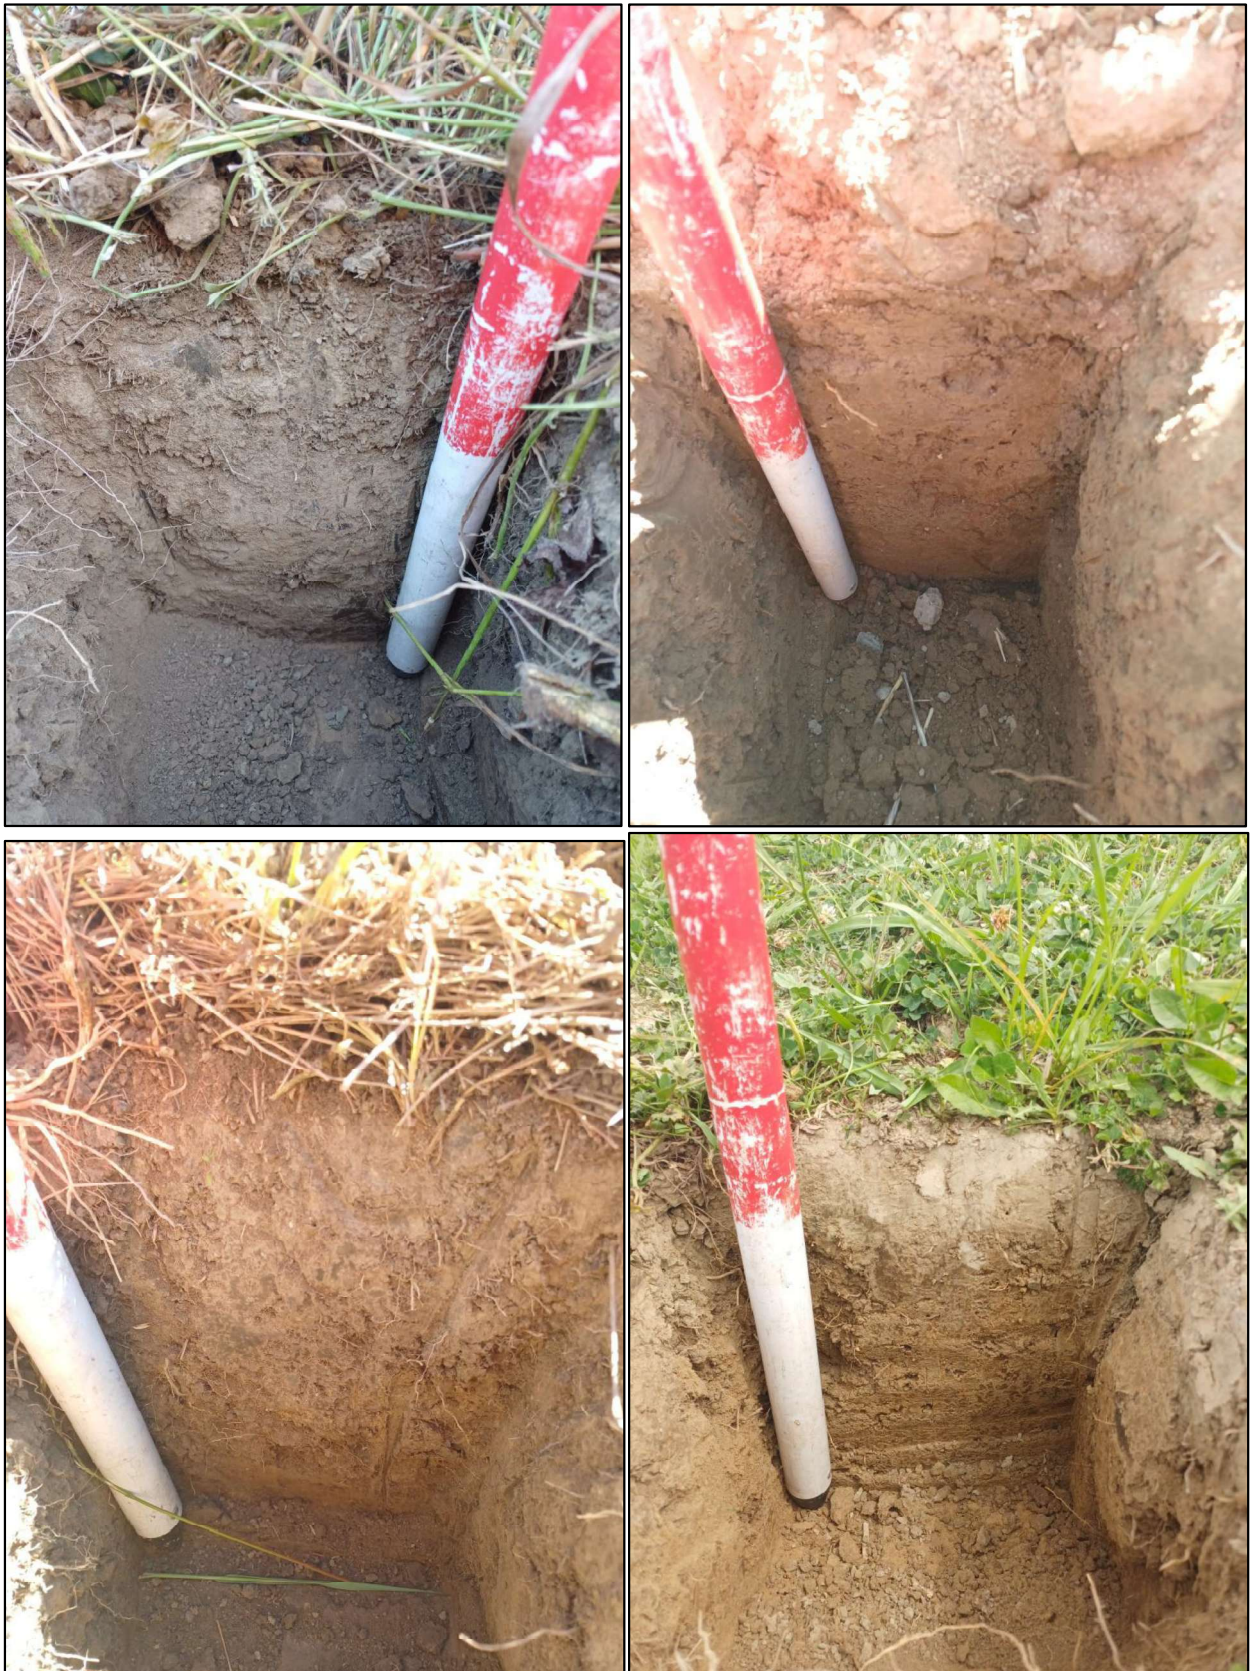
Test pits 1-5 revealed 100mm topsoil overlying compact grey silt (Figure 7). Test pit 6 was made up of 100mm topsoil overlying 200mm of grey-brown silt, over compact light grey-brown silt. Test pit 7 was 100mm of topsoil over compact grey-brown silt. Test pits 8-11 had limited topsoil and comprised of grey-brown compact silt. Test pits 12-15 were made up of 100mm of topsoil overlying compact light grey-brown silt.

**Figure 7** – Photos of test pits. Top left: Test Pit 1, Top right: Test Pit 7, Bottom left: Test Pit 8, Bottom right: Test Pit 14. Source: InSitu Heritage 2025.

1. No recorded archaeological sites will be affected by the proposed works. The likelihood of encountering intact unrecorded archaeological features during the proposed works is assessed to be very low, due to unfavorable soils and flooding risk.
2. Given this very low probability, having an Archaeological Site Discovery Protocol in place during all earthworks will provide sufficient safeguard to ensure that if archaeological deposits are encountered, they are appropriately managed and recorded.
