Te Toka-a-Taiau location spatial analysis

24th January 2020

This analysis comprises of a series of historical maps, photos and surveys, overlaid with Eastland Port's current asset map, to attempt to establish the original location of Te Toka-a-Taiau.

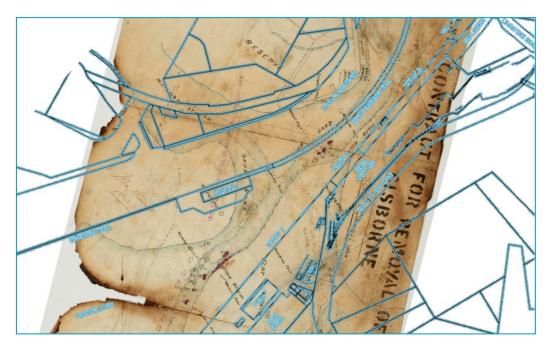
Figure 1. EPL has found Te Toka-a-Taiau (red coloured rocks in Turanganui River to the north) was most likely located opposite Wharf 6 just off the River training wall, in the vicinity of the original back lead navigation light on the River training wall, and its relocated position to the south west within the harbour.

From this analysis it has been found that Te Toka-a-Taiau was most likely located in a position opposite what is now called Wharf 6 adjacent to the River training wall, in the vicinity of the original Back lead navigation light on the River training wall, and the relocated position of it in the harbour.

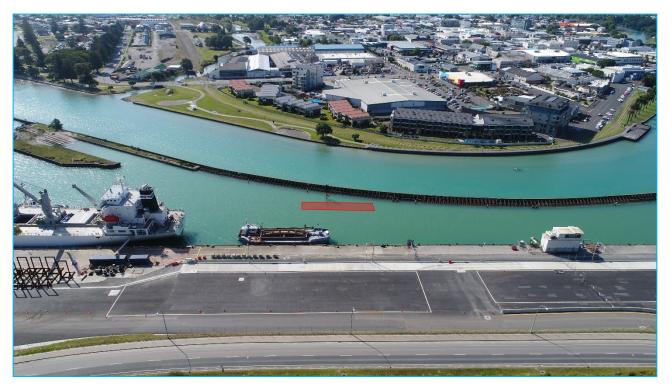
Figure 2. EPL believe the series of three rocks shown on the *Contract for Removal of Rocks 1876* believed to be Te Toka-a-Taiau were located in the area highlighted in red or within close vicinity (Note: This has not been surveyed but is EPL's best estimate of the location)

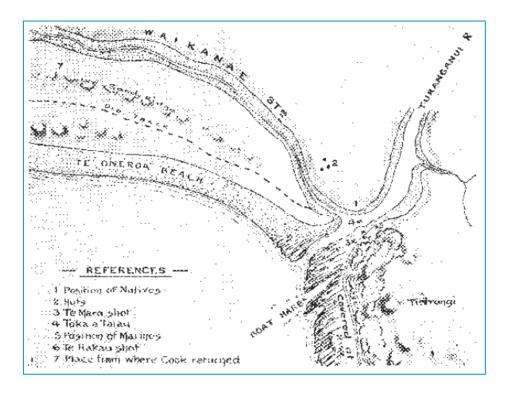
Figure 5. Drawing by William Leonard Williams depicting events after the arrival of the Endeavour. Extracted from page 20 of *The Turanganui River – A brief history* by Michael Spedding. Williams places Te Toka-a-Taiau in the centre of the Turanganui River, just to the east of the confluence of the Waikanae Stream.

- Figures 3 and 4 provide some views of the origins of Te Toka-a-Taiau, outlines its use as a tribal boundary and mooring post, and its removal in 1877 by the Harbour Board.
- Figure 5 is a drawing by William Leonard Williams, showing a location map of the events that transpired when the H.M.S Endeavor arrived in Turanganui-a-kiwa. Williams places Te Toka-a-Taiau in the centre of the Turanganui River, just to the east of the confluence of the Waikanae Stream.
- Figure 6 provides some confidence as to the accuracy of William Williams sketch and introduces the map *Marine department Contract for Removal of rocks 1876*.

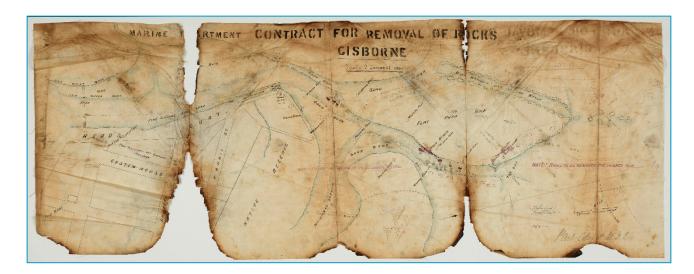
Figure 7. Marine department contract for removal of rocks Gisborne 8th February 1876. There are several rocks coloured red to be removed from the Turanganui River clumped in two distinct clumps.

The best geographic location reference Spedding found was the *Marine department contract for removal of rocks* 1876 (figure 7). An electronic copy of this was obtained from the National Library of NZ for analysis.

- The most critical part of information as it is the only map with some level of survey data and therefore scale which illustrates the rocks of Te Toka a Taiau as a feature.

- Charted for the removal of this rock and others close to the mouth of the Turanganui River it has good annotations of the reefs, sand banks and water courses as they were at that time.

- There is an issue though in that while the surveyed street map is to scale and fits to the streets of Gisborne at that time, and the natural features of the reefs, sand banks and water courses fit with how they would have been at that time, but the two data features do not fit with each other.

- The natural features are the most important piece of data presented and are considered to take precedent over the surveyed street map.
- The Contract does not accurately match the survey street map but why should it? Whoever drew this wouldn't have been concerned with the street map so its shouldn't be considered accurate in this aspect.

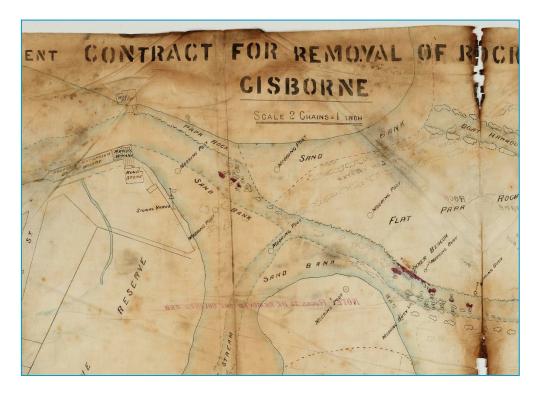
Figure 8. Extract of Marine department Contract for removal of rocks Gisborne 8th February 1876. The clump of red rocks to the east of the confluence of the Waikanae Stream is consistent with William Williams sketch and understanding of Te Toka-a-Taiau, rather than the clump to the west closer to the mouth of the Turanganui River.

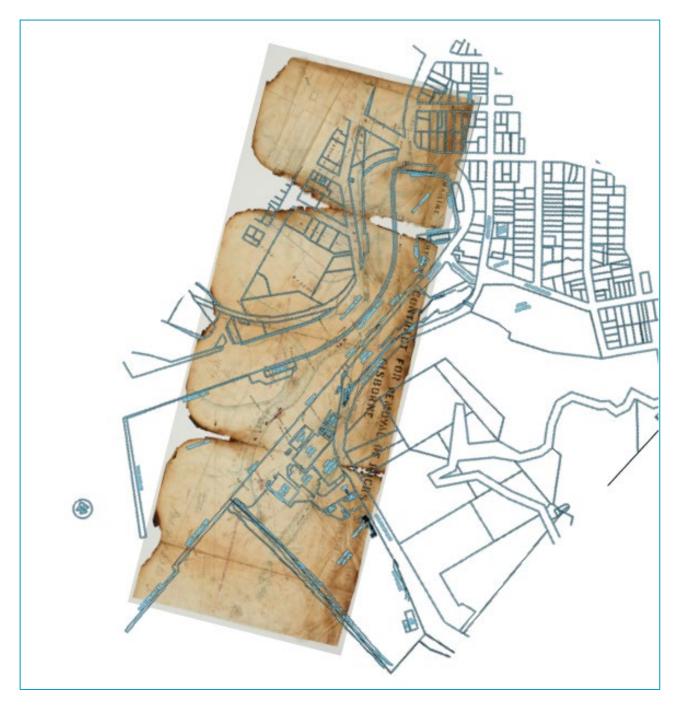
Figure 9. Marine department Contract for removal of rocks Gisborne 8th February 1876 with EPL asset map overlaid.

The Contract for Removal has been overlaid over the Eastland Port asset map in figure 9. It shows the rocks removed to be opposite Wharf 6 and approximately in between the recently relocated back lead navigation mark and the original back lead navigation mark which was on the river training wall. The orientation and positioning of the combined Contract and EPL asset map is a result of the spatial analysis under taken.

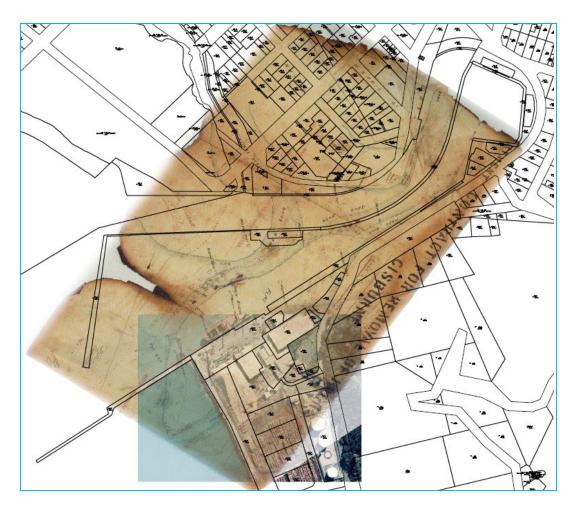
Figure 10. Blackburne 2006 spatial analysis of the 1876 Marine department Contract for Removal of Rocks Gisborne to locate Te Toka-a-Taiau

In 2006 James Blackburne from Historic Places Tairāwhiti undertook a similar exercise to try and establish the most likely location of Te Toka-a-Taiau. Blackburne found the most likely location of Te Toka-a-Taiau to be within the same general vicinity as EPL but believed the location to be approximately 10 metres westward underneath what is now the River training wall (figure 10).

With only the 1876 Marine department Contract for removal of rocks Gisborne as reference material Blackburne used a different technique of analysis. The 1876 drawing was stretched to align key features with known and matching features of 2006 in particular land boundaries. Like EPL, Blackburne found the 1876 drawing did not align perfectly and came to the same conclusion that some of the land features were most likely indicative only².

It was noted by Blackburne that Te Toka-a-Taiau was located in the middle of the map therefore stretching of the 1876 drawing was unlikely to have a major bearing on the location as it would have been distorted the least.
