Before Gisborne District Council Under In the matter the Resource Management Act 1991 (the RMA) of applications by Gisborne District Council for resource consents to modify a stopbank at Te Karaka

Statement of evidence Daniel Moran 88 Rangatira road ,Te karaka

Subject : R M consenting conditions sort Rangatira Bridge in relation property 88 Rangatira rd Te karaka in regards stopbank upgrade 21/09 /26 and other stake holder on road along with bridge beneficiary users

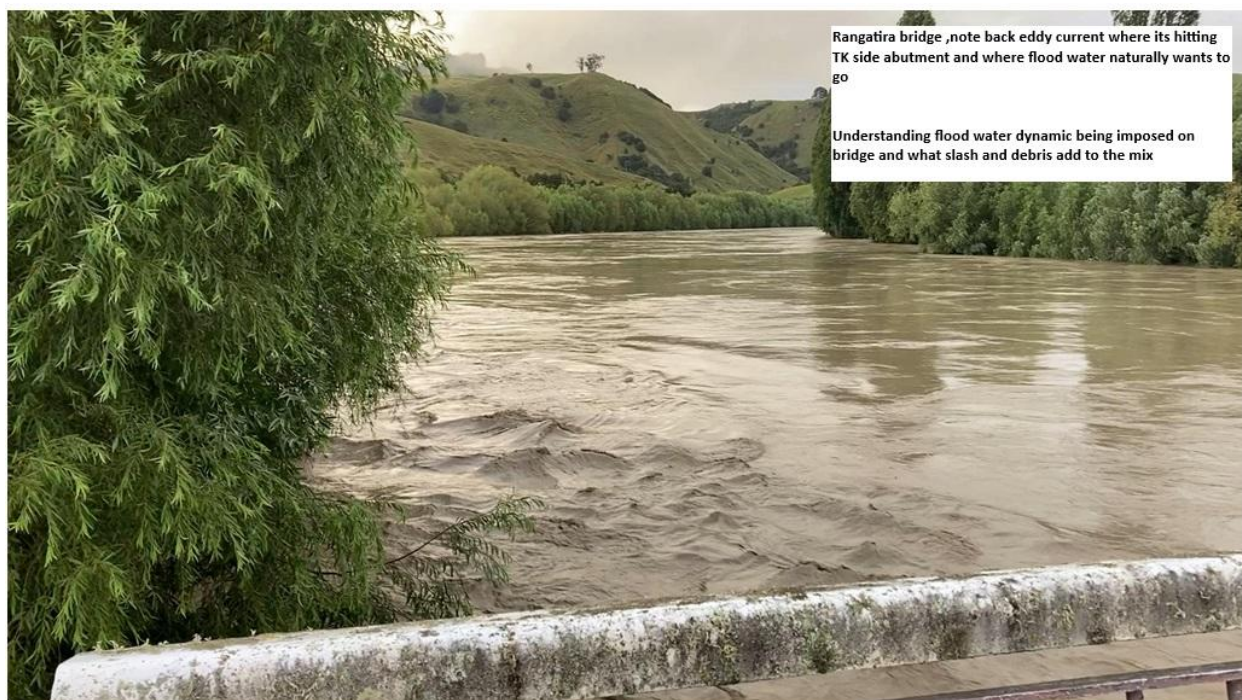
**A 2.5 meter stop bank increase with potentially more height increase to come as the river bed level aggrades and rises ,puts river levels over the top of the bridge guard rail in the for-ground at 1.3 meters above the deck the deck level below the deck is 1.900mm of beam**

**Thats nearly a 3.5 meter high dam extending the width of the Rangatira bridge when in full over design flood**

- **2.1 The "Dam" Effect:** If the stopbank is raised by **2.5 meters**, and the river level rises above the bridge deck, the combination of the 1.9-meter beam depth and the 1.3-meter guard rail creates a **3.5-meter solid barrier**.
- **2.2 The Slash Trap:** During an over-design flood event, this barrier will act as a massive rake, catching forestry slash, worsening the backwater effect upstream, and placing immense structural load on a 60-year-old bridge.
- **2.3 The Policy Contradiction:** It is deeply frustrating that NZTA is willing to fund and support raising the state highway to match the new stopbank, yet they are not proactively addressing the vulnerability of the bridge structures themselves under the same project scope.

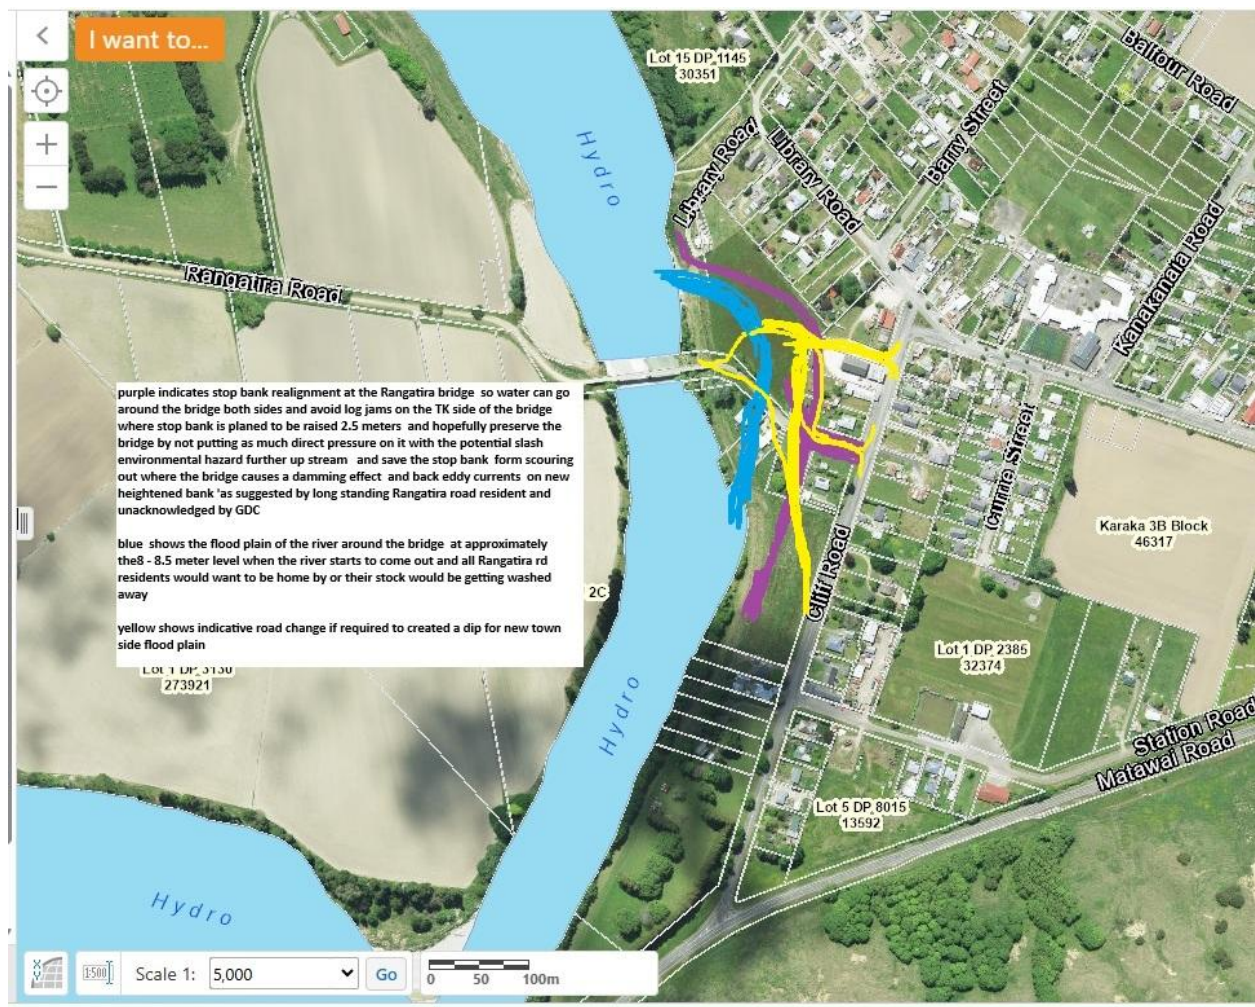
Perhaps the bridges could be raised during the stopbank project under the same resource consent by just replacing the piles and piers and craning the existing beams and deck onto new higher structures able to take new loads , potentially could cut costs by  $\frac{1}{3}$  to  $\frac{1}{2}$  of getting bridges to correct heights to future proof the infrastructure life span

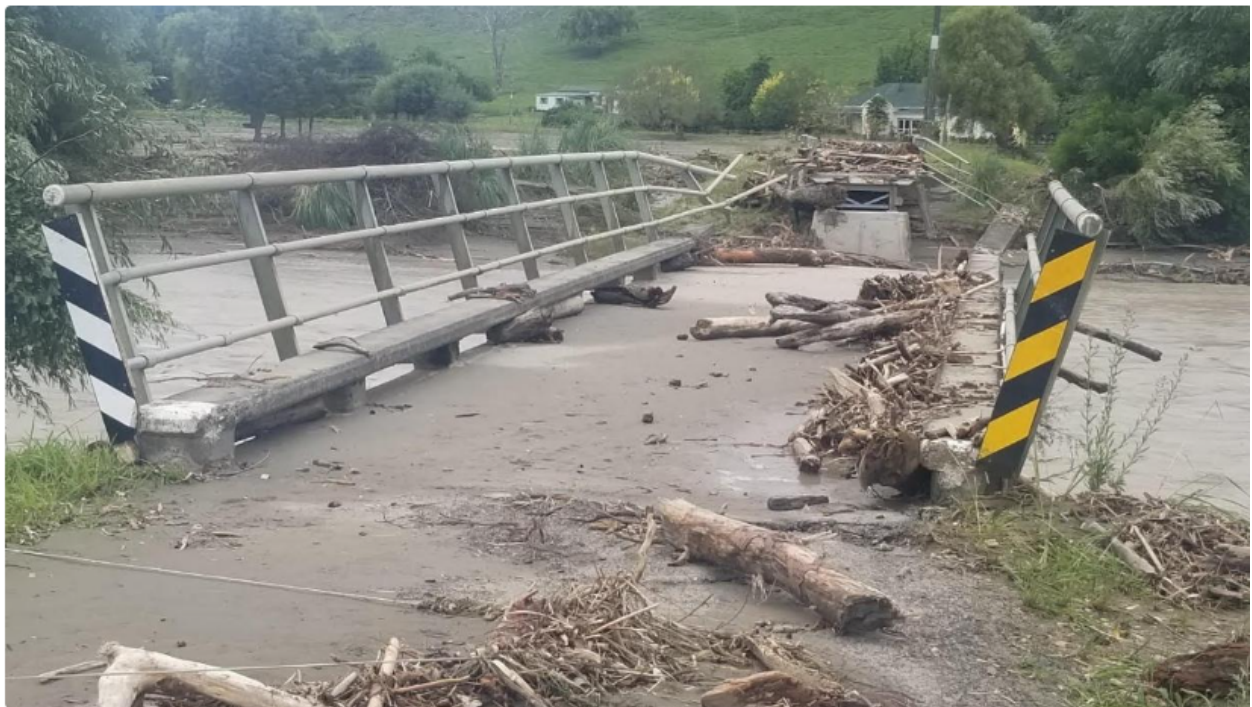
The old Mangatal Access Bridge across Waipaoa River was washed away during cyclone Gabrielle. Photo: Supplied / Not-For-Syndication

- **Upstream Debris Catchments / Deflectors:** Order the applicant (Gisborne District Council) to design and install heavy-duty debris catcher piles or floating boom deflectors upstream of the Rangatira Bridge to catch woody biomass before it hits the bridge piers.
- GDC had one but it broke in Gabriel being the Mangati access bridge

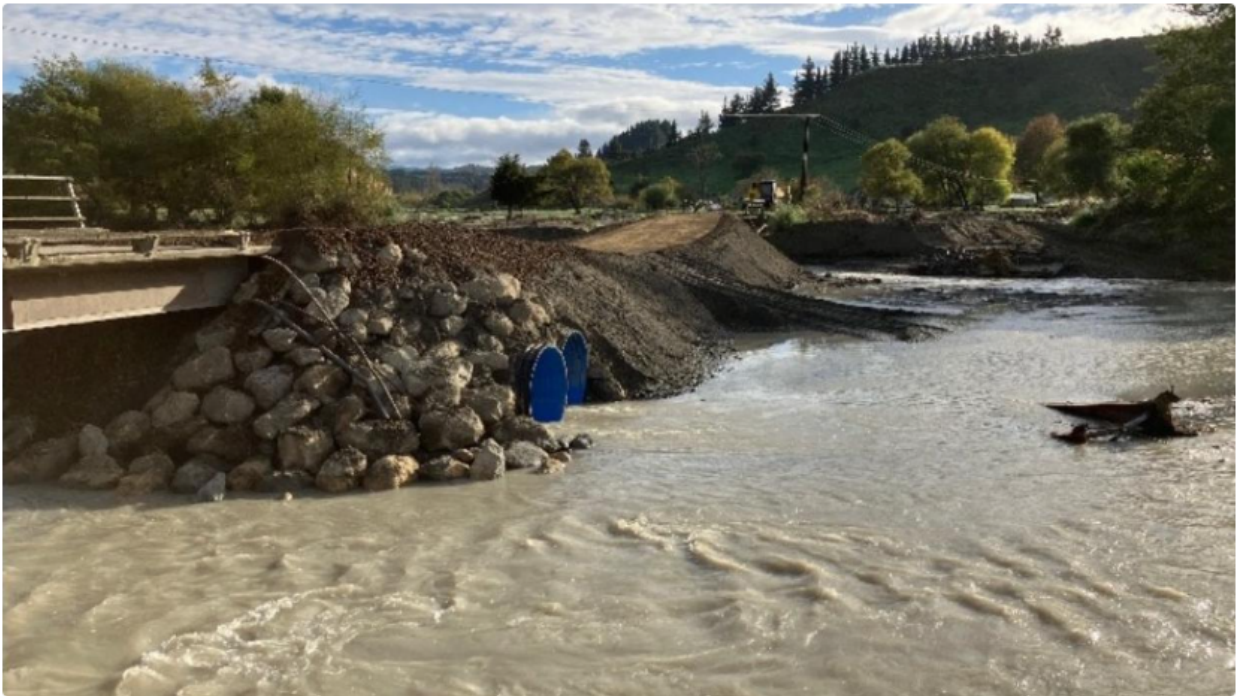
The temporary causeway on Te Kowhai Rd at Whatatutu in rural Gisborne has been washed away, less than a month after it opened. Photo: Supplied / Not-For-Syndication

The GDC response on the Waipoa ,at Te kowhai road, below demonstrates their understanding of a rivers water power by creating dams ,whether it be by slash/debris or causeways that limit flood channel flow

A \$200,000 temporary causeway in [rural Gisborne](#) that opened less than a month ago has been washed away, cutting off one resident from the rest of the world.

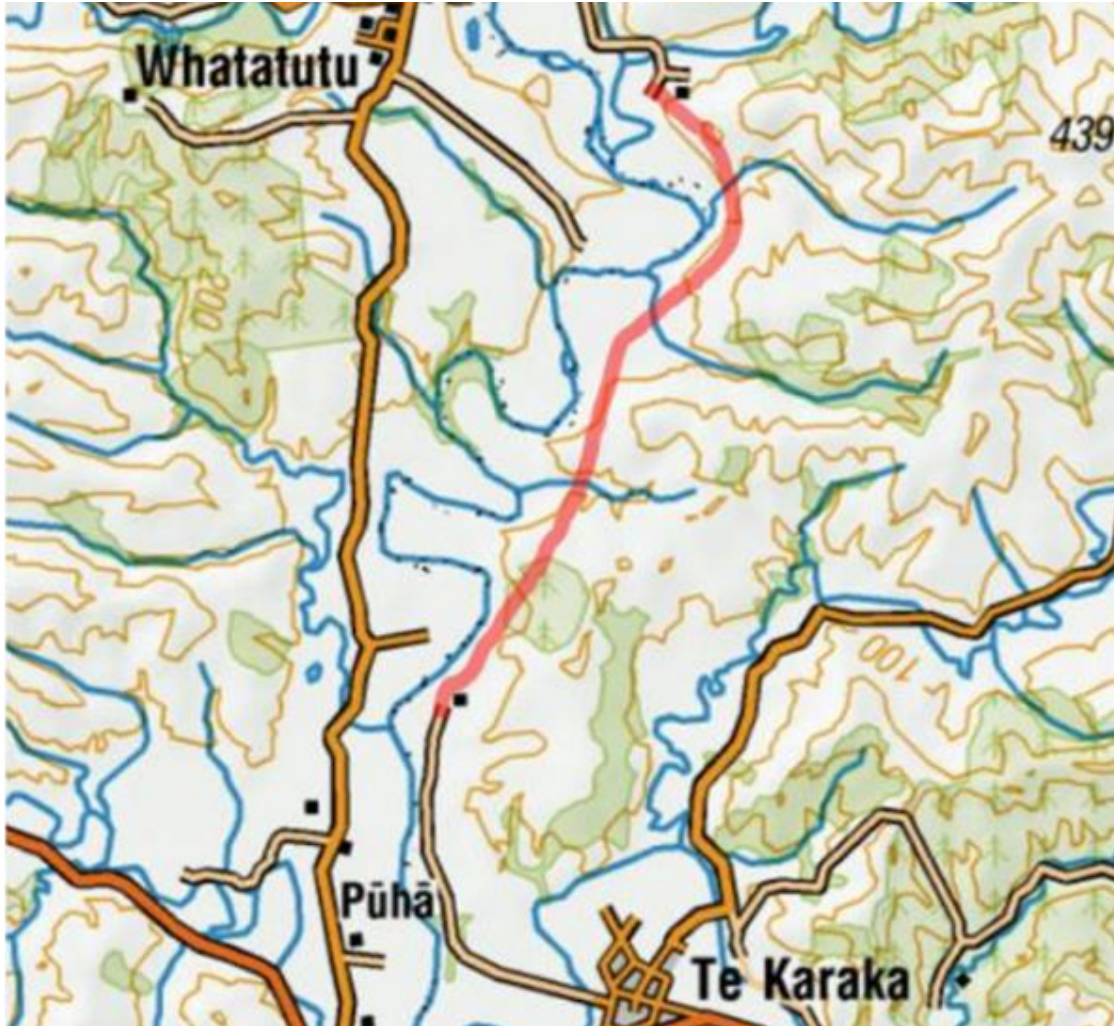
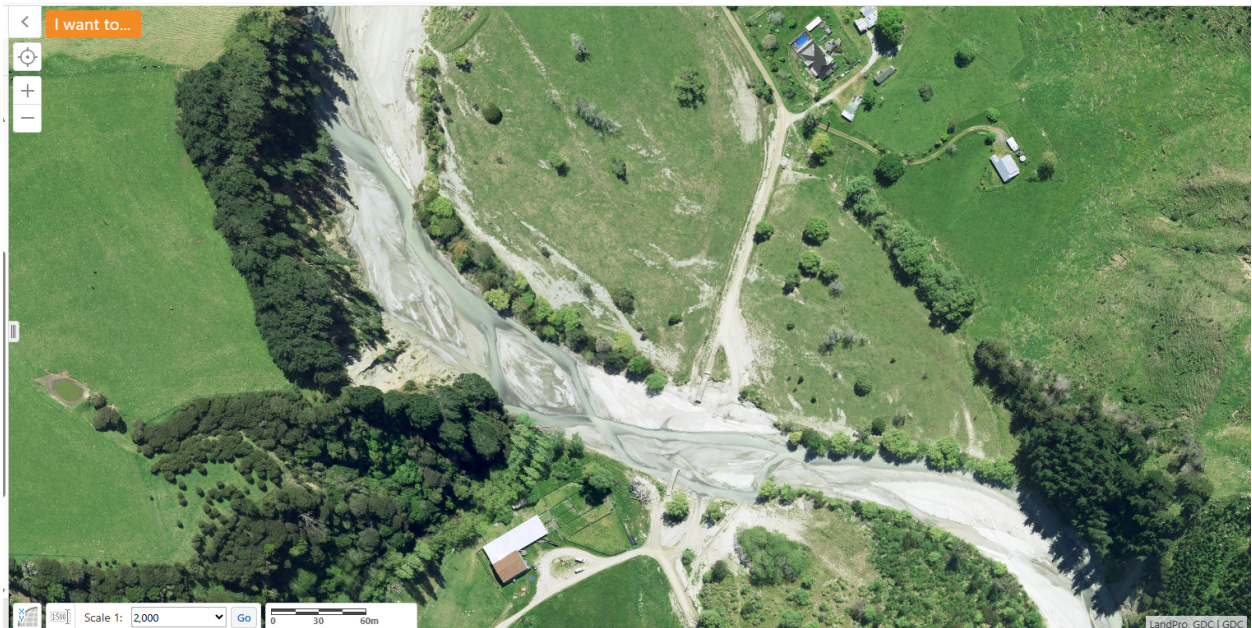
- Three alternative road routes were identified.
- Between them, this allowed for four possible access points to Rangatira Road & Kanakanai Road.
- Time estimates for emergency road construction ranged from 2-4 weeks.

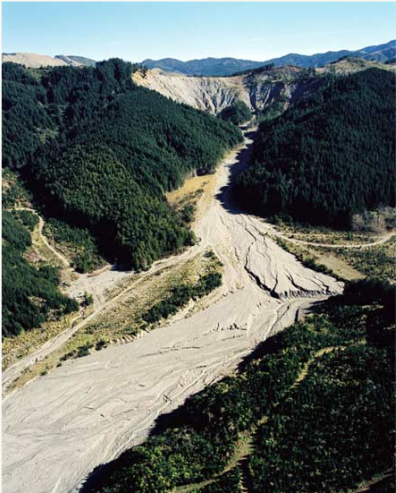
## Erosion: Tarndale slip

Said to be the most massive slip in the southern hemisphere, the 40-hectare Tarndale slip in Mangatū played its part in promoting the afforestation of the Mangatū Block as a way of preventing further such occurrences. At one point the slip occupied almost the entire valley; by the time of this photo (2000) some of it had been reclaimed by forest.

Erosion = Agridation = eventual bridge loss ,Tarndale has expanded so much that when we drove across to view it 12 -14 years ago that part of the road is gone and you could actually see the remnants of a tar seal out in the middle of the now bare ridge between the two river valleys is now well gone

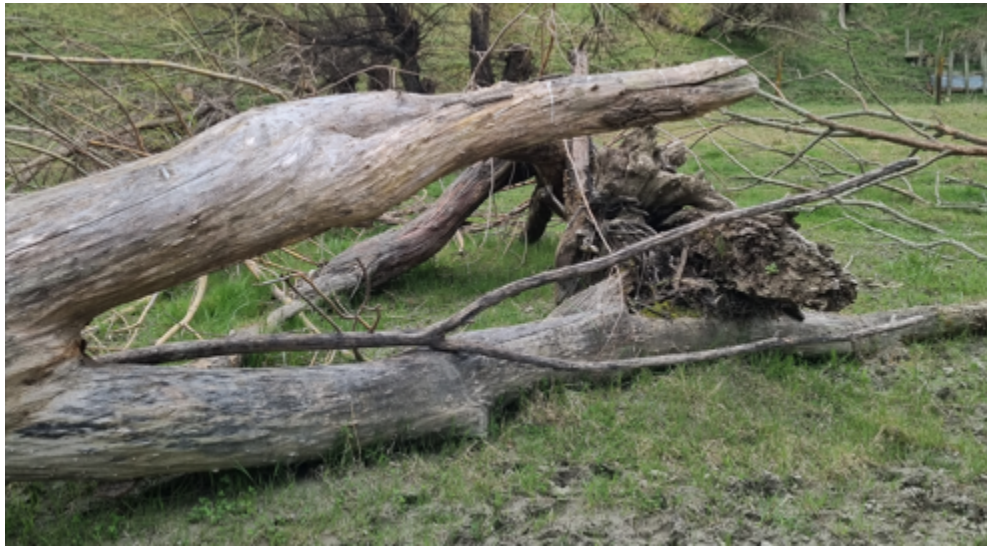
Photos below is an examples of woody debris and forestry slash ,still on the river bank and 88 rangatira road, the first example is from the winter flood following Gaberiel

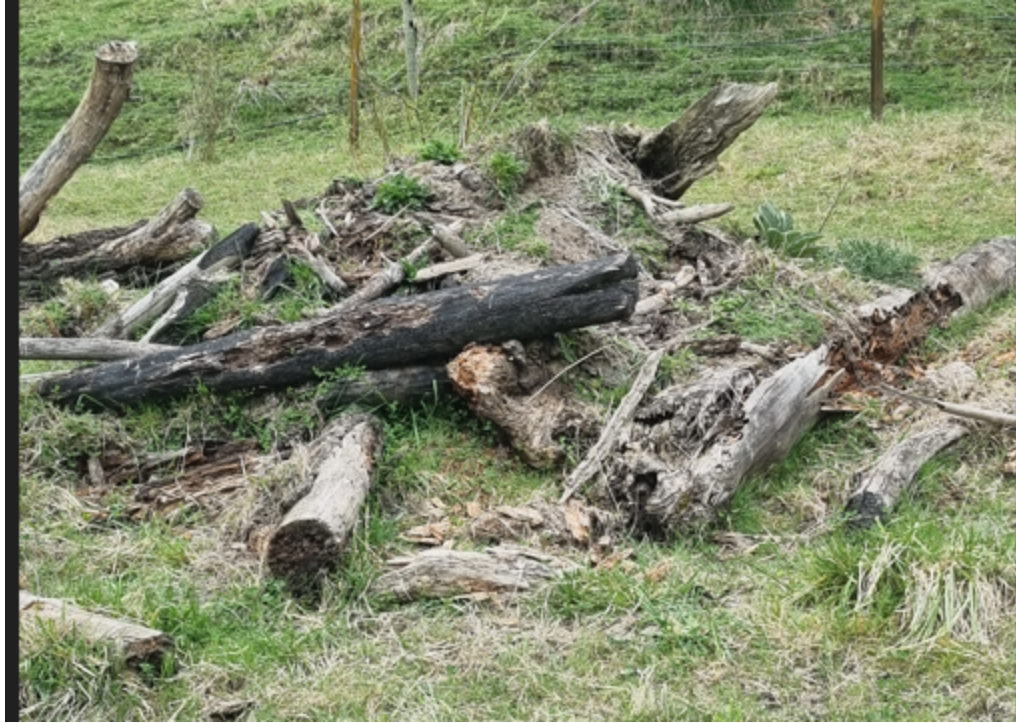
Second example is the remnants of a Gaberiel burn heap at the river bend below the bridge , this consisted of whole pine trees 14 to 20 meters long with intact root balls , base/stump widths of 300mm plus that appear to be were washed out of upstream gullies as they were standing

These whole pines that maintain their length as they progress down the river systems are a concern to me when they get hung up in the super structures of bridges a little bit different to the normally cut to length forestry slash

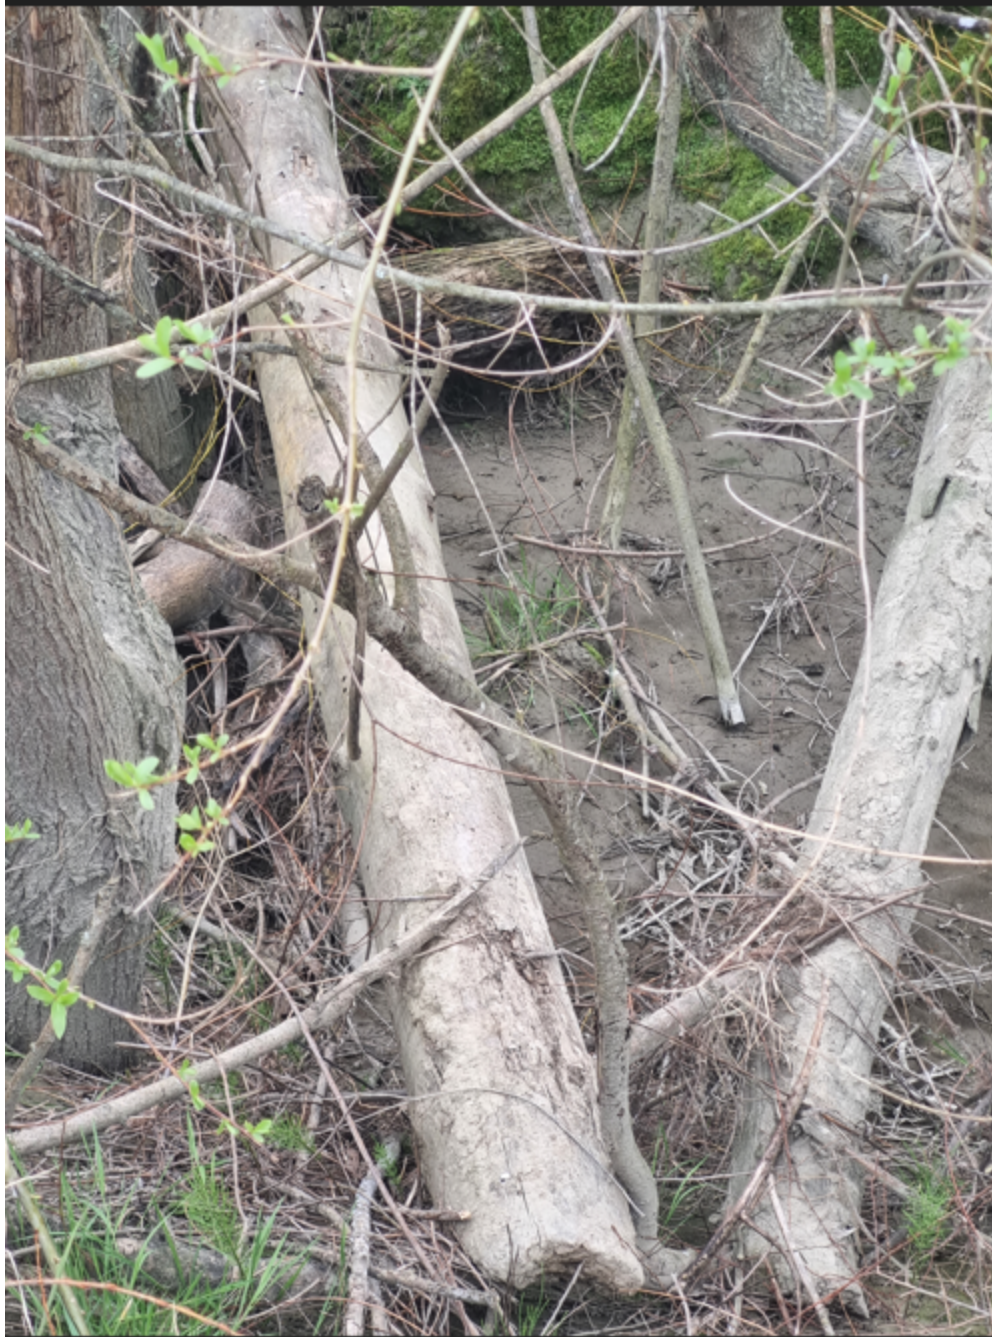
Above Example of larger piece of forestry slash following Gabriel still in a drain at 88 Rangatira

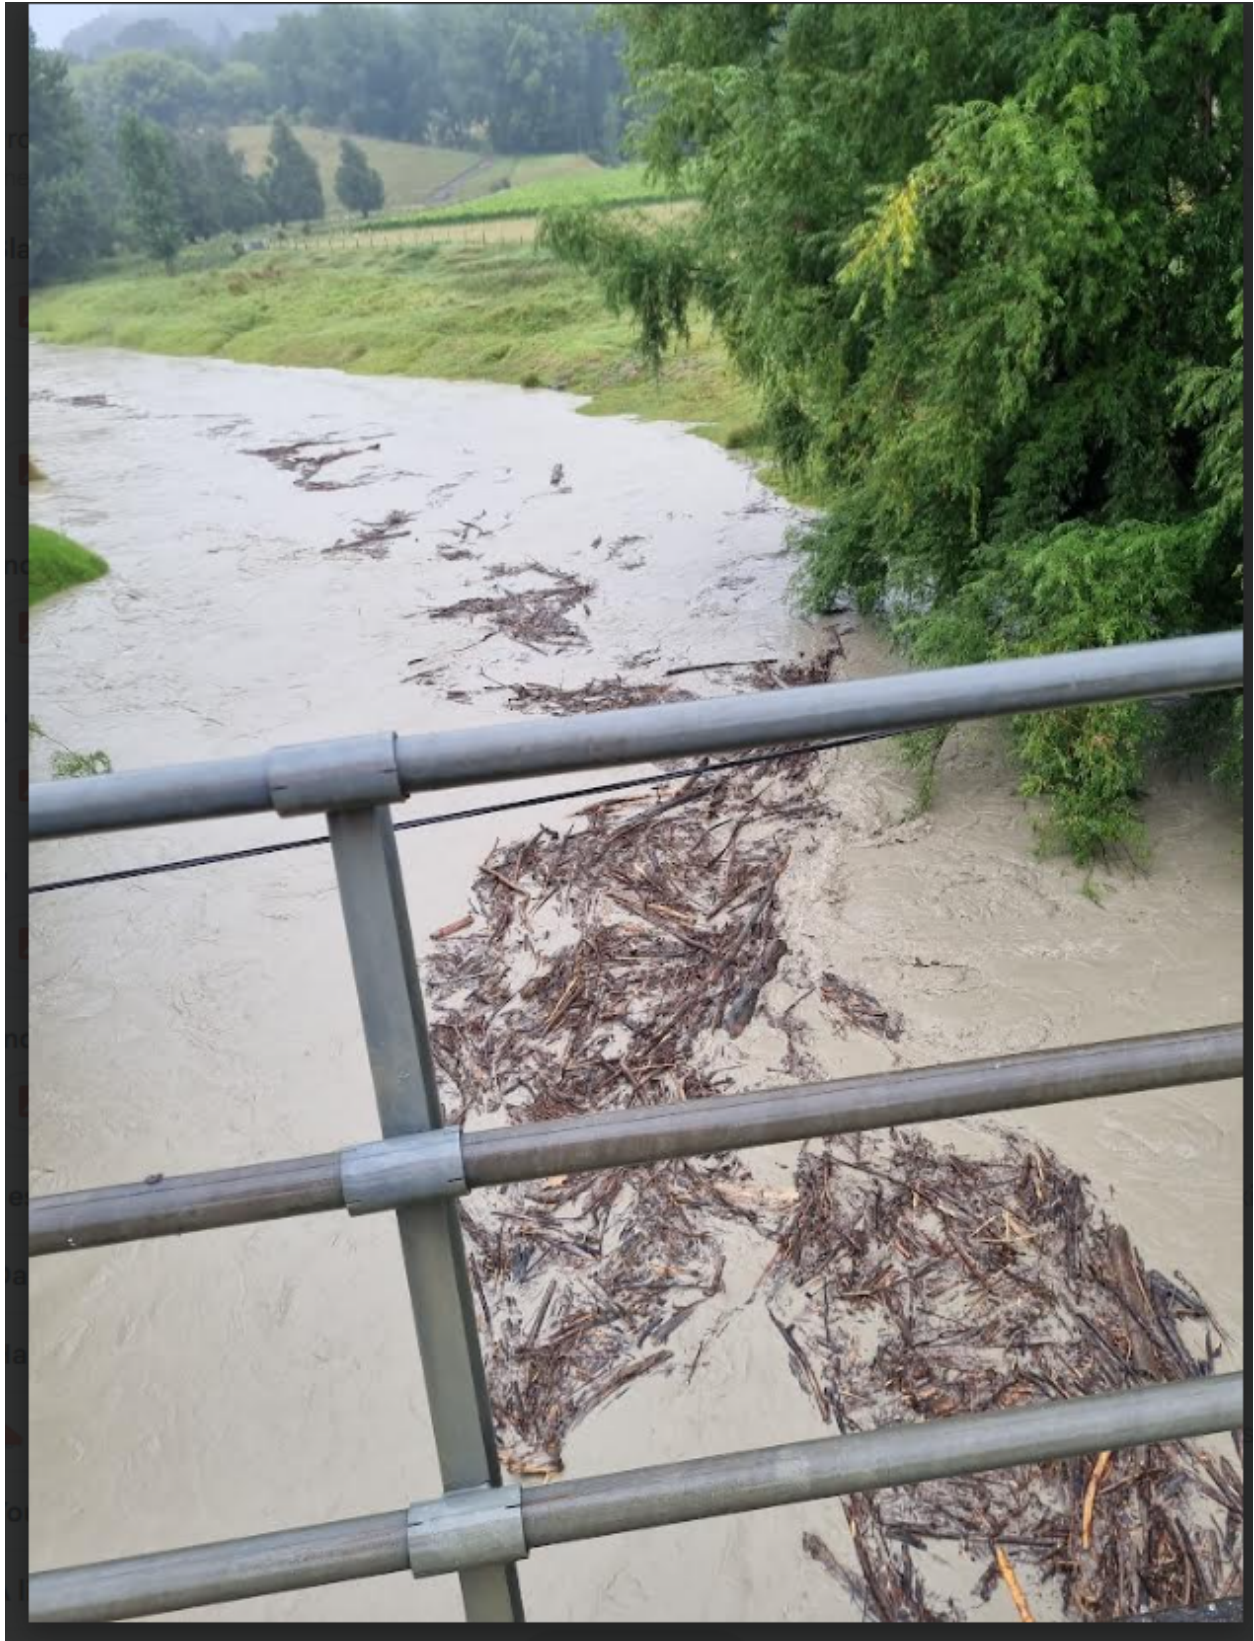
Below Slash /debries coming down kanakaniaha stream early jan 2026 ( 3 january 2026 )
