4Sight Maintenance Dredging and Disposal

Ecology and Water Quality Report

**GISBORNE PORT: MAINTENANCE DREDGING &
ASSOCIATED DISPOSAL OF DREDGED MATERIAL**
Port Navigation Channel, Vessel Turning Basin and
Wharves 4-8

Resource Consent Application
Assessment of Environmental Effects
Ecology and Water Quality Report

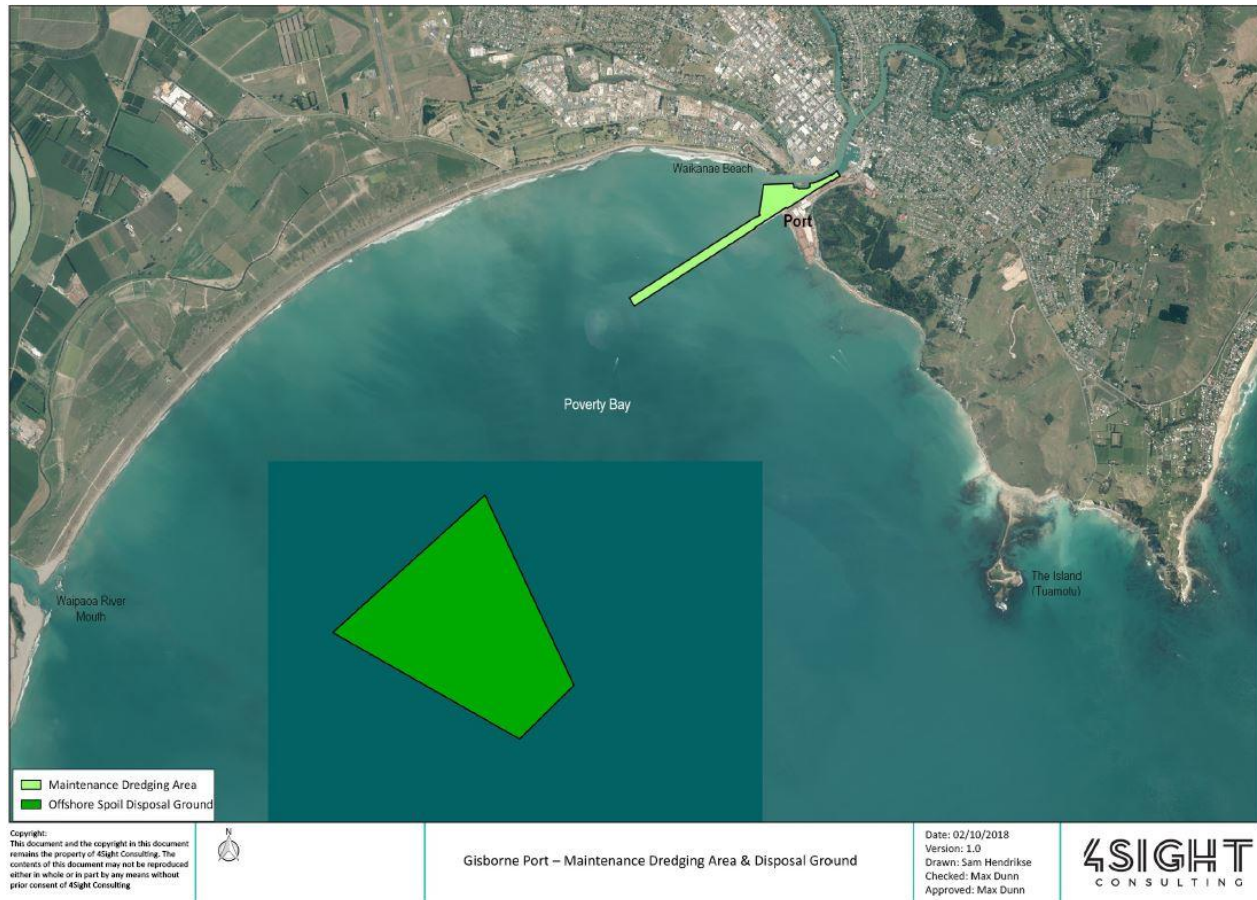
Figure 2: Maintenance dredged footprint within the port and Offshore Disposal Ground

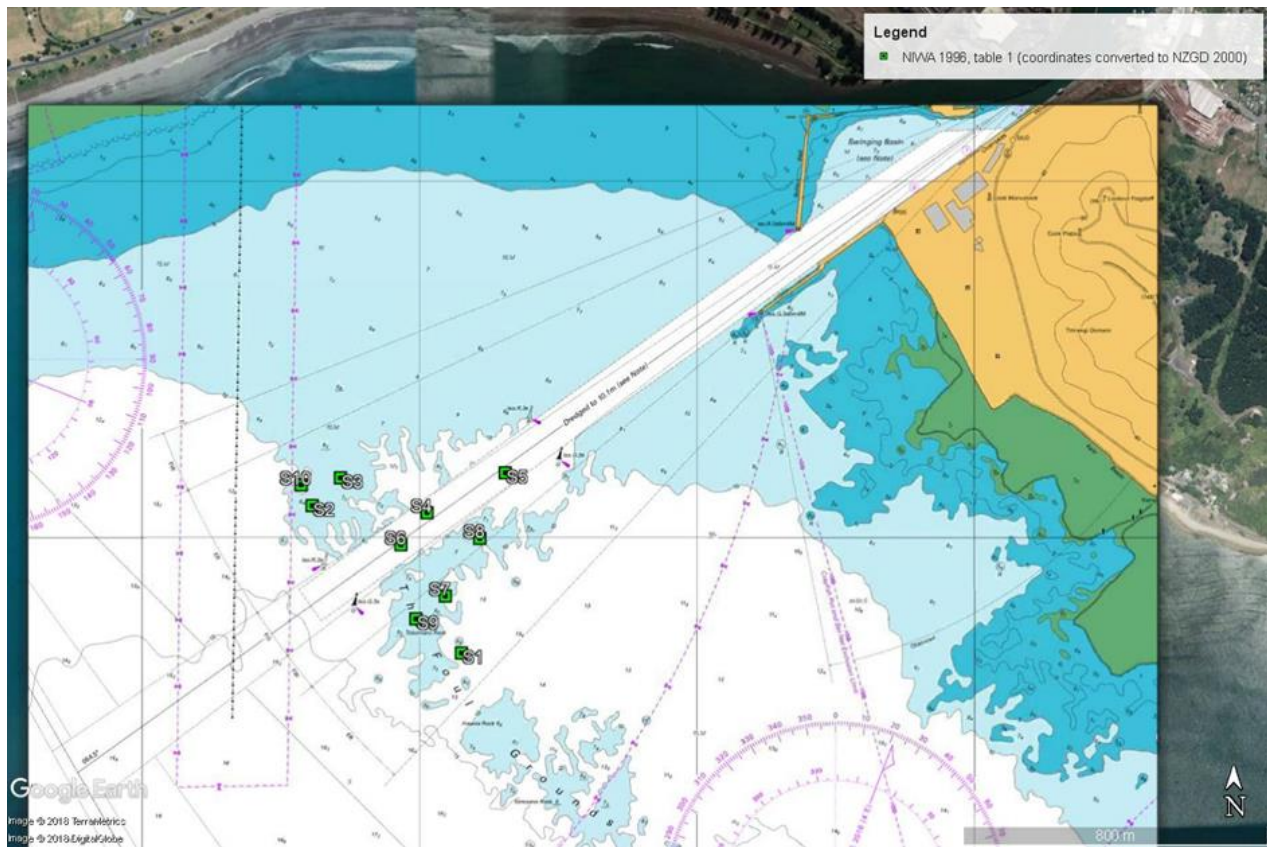
Figure 4: PNC and 'reef' sampling locations (Cole et al., 1997)

¹² Several of the locations are somewhat different to those shown in the plan in the original report (specifically sites 1b, 6, 7 and 9). However, the coordinates are consistent with the narrative in the report. The location of the reef areas is confirmed as that reported in the Marine and Earth Sciences (2016) report (refer Figure 4 of this EWQR).

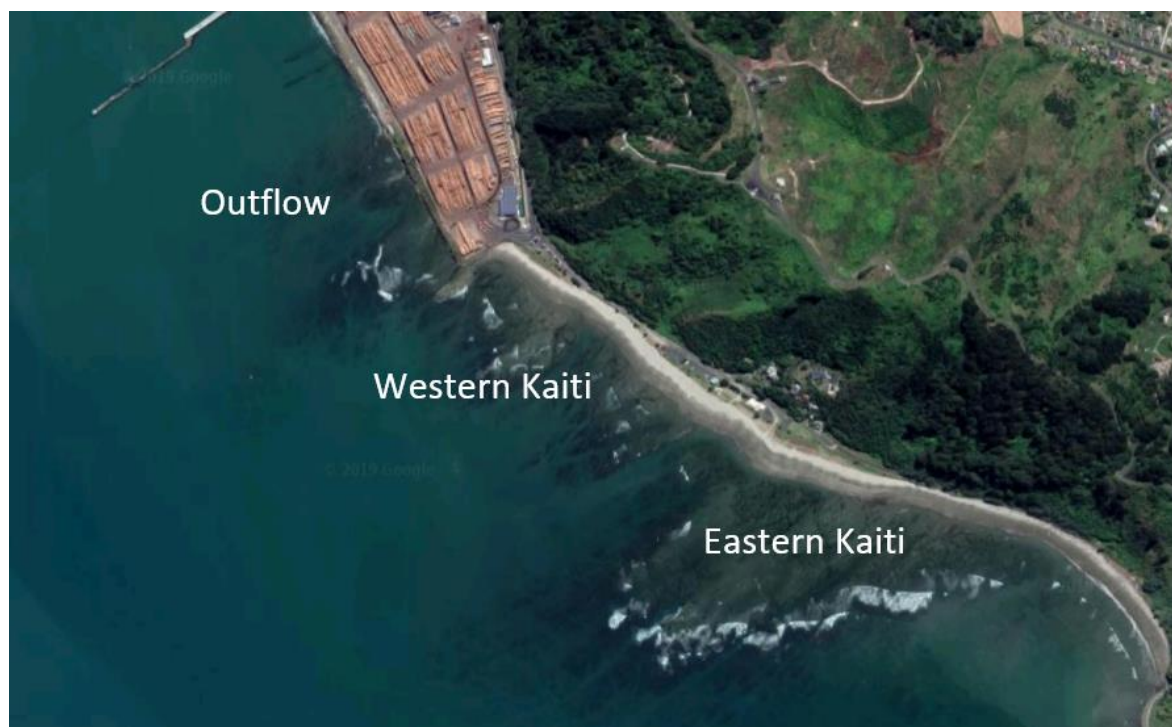
4Sight undertook a survey of the exposed intertidal reef south east of the port navigation channel breakwater in September 2019. The three regions of the reef surveyed are identified below as 'Outflow' (the reef habitat closest to the Eastland Southern Logyard discharge); 'Western Kaiti' and 'Eastern Kaiti'. These intertidal zones are potentially in the zone of influence of the plume field from decant water from maintenance dredging in the PNC. The survey is detailed in Appendix E to this report.

Figure 6: Intertidal Sampling Areas South East of the Port (2019)

Each site covered slightly different parts of the shore. Specifically, due to access and the narrower shore at this point the 'Outflow' site was restricted to mostly the 'mid tide zone'; the 'Western Kaiti' site covered high, mid and low tide sites; and the 'Eastern Kaiti' site covered the low and mid tide.

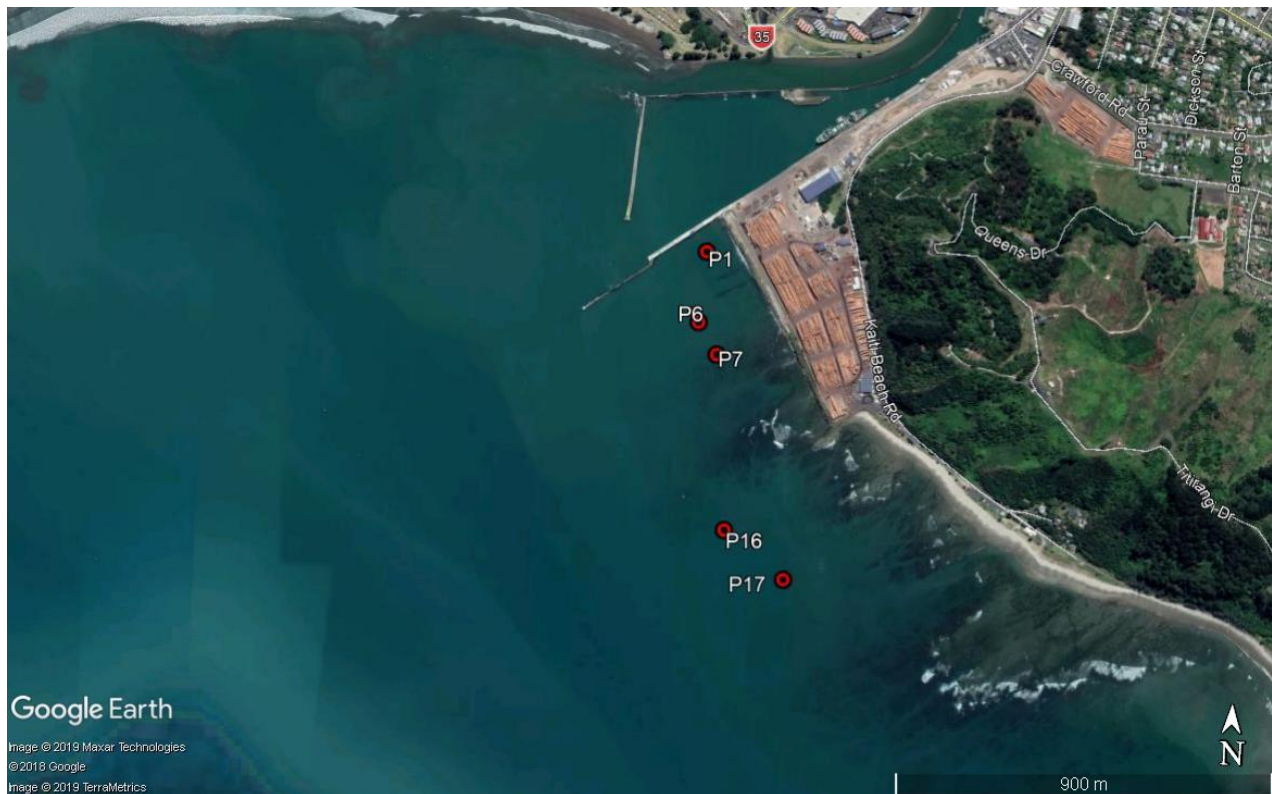
Figure 8: Kaiti Reef offshore benthic sampling sites P1, P6, P7, P16 and P17

This benthic survey is fully reported in Appendix F of this report. The coarseness of the substrate constrained sampling. However, sediment texture and quality were able to be assessed from five sites identified in the **Error! Reference source not found.** sampling plan as P1, P6, P7, P16 and P17.

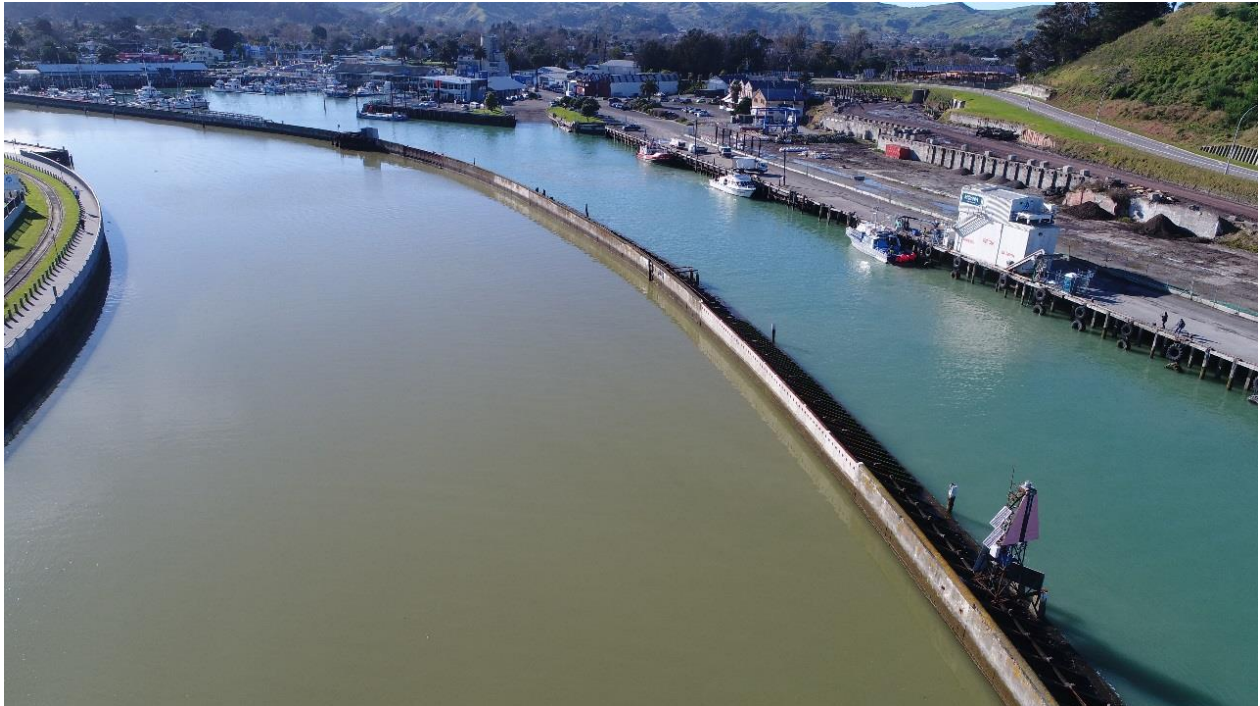
Figure 11: Turanganui River and inner port area (photo taken 05/07/2017, 10:37am).

As noted, the port area is influenced by routine ship and tug movements and catchment storm events (including natural discharges via the Turanganui River and Kopuawhakapata Stream, and discharges from the Southern Logyard). Otherwise and typically, water quality at the port is influenced by relatively 'clean' coastal waters. Even at times of apparently good water quality in the port basin, it is not unusual for the waters of the adjacent Turanganui River on the northern side of the training wall to be highly turbid. This situation is shown in Figure 11, which is a drone photograph taken early on a flood tide on 05 July 2017.

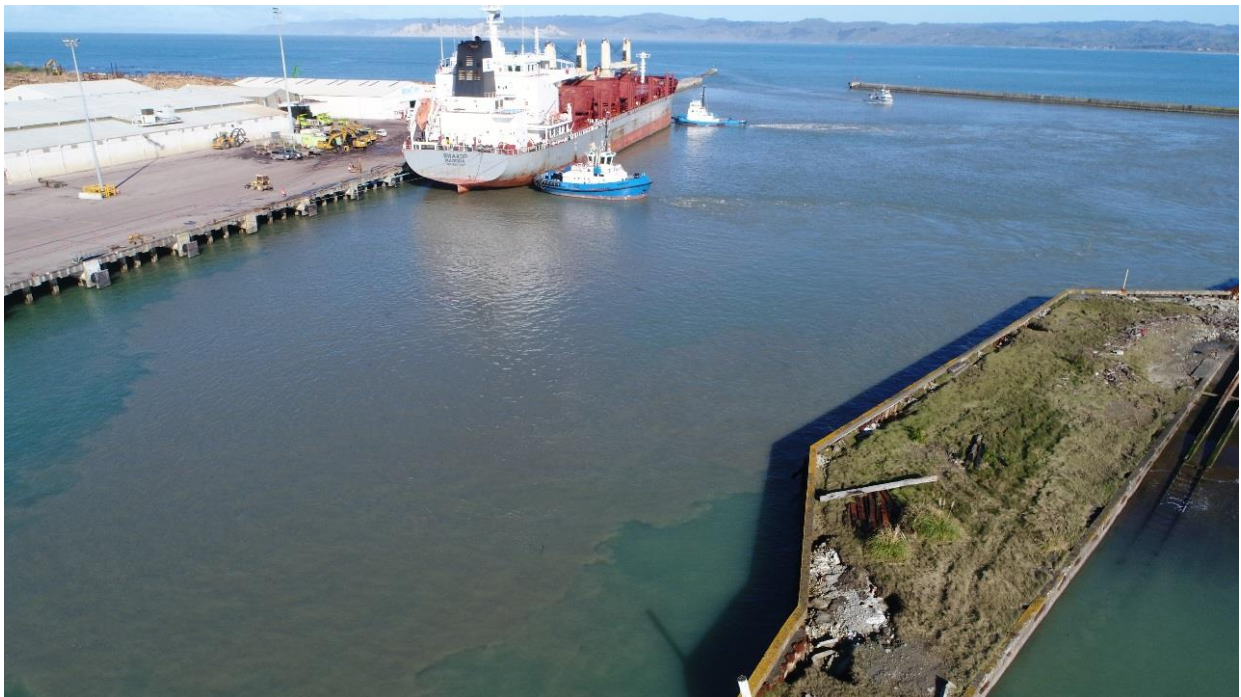
Figure 12: Turbidity generated by tug activity within the port basin (photo taken 05/07/2017, 10:38am).

above. It is clear that existing permitted operations, as illustrated by Figure 12, cause the water quality standard (e) (i.e. 'The natural colour and clarity of the water shall not be changed to a conspicuous extent') to be exceeded.

- It is noted that dispersion footprints associated with fine material may seem significant but based on the modelling, plume edges are often associated with suspended sediment concentrations that are in the order of 1-10 mg/l, which can be smaller than background concentrations due to natural river discharges or other sources such as ship movements (MetOcean, April 2018; page 41; para 2; see also Figure 12 of this EWQR).

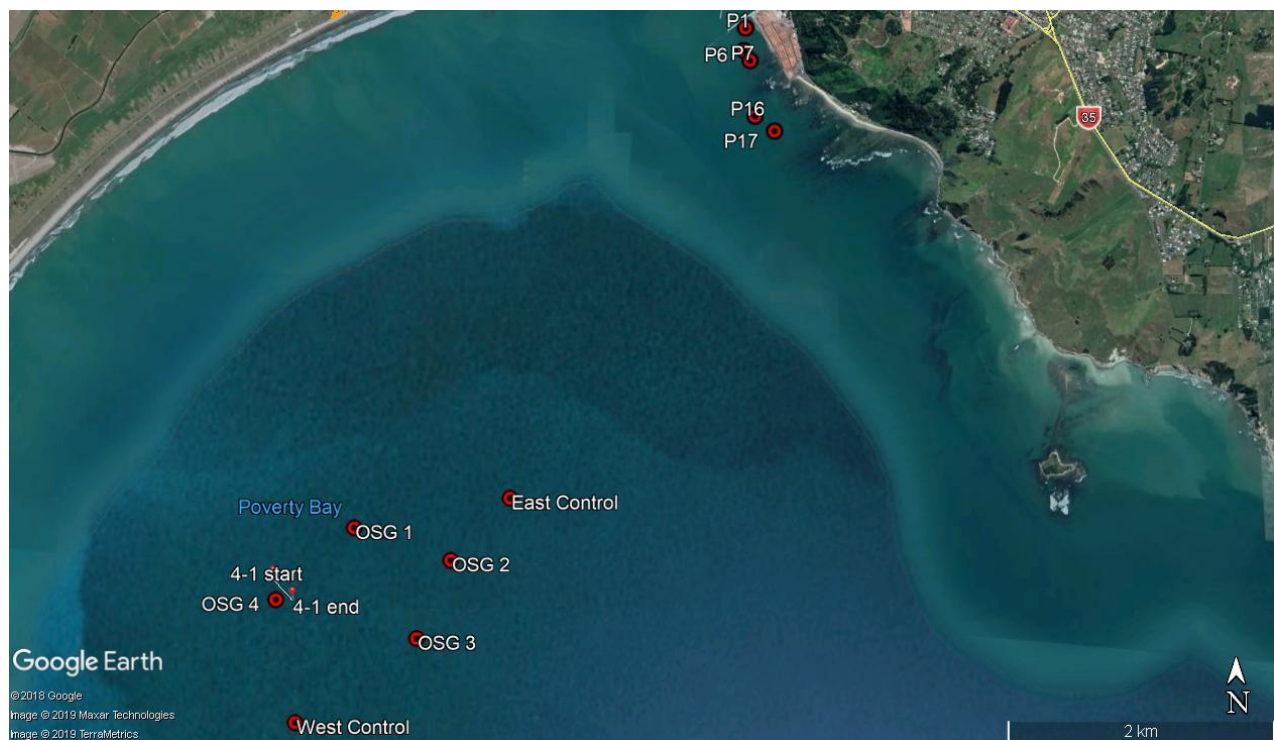
The ODG seabed sampling sites (OSG 1-4) and reference sites (East and West control) for the 2019 survey, are shown in Figure 13 (the Kaiti Reef sampling sites referred to in section 3.1.6.5 above (P1, P6, P7, P16 and P17 are also shown to the north).

Figure 13: Sampling sites at and near the ODG

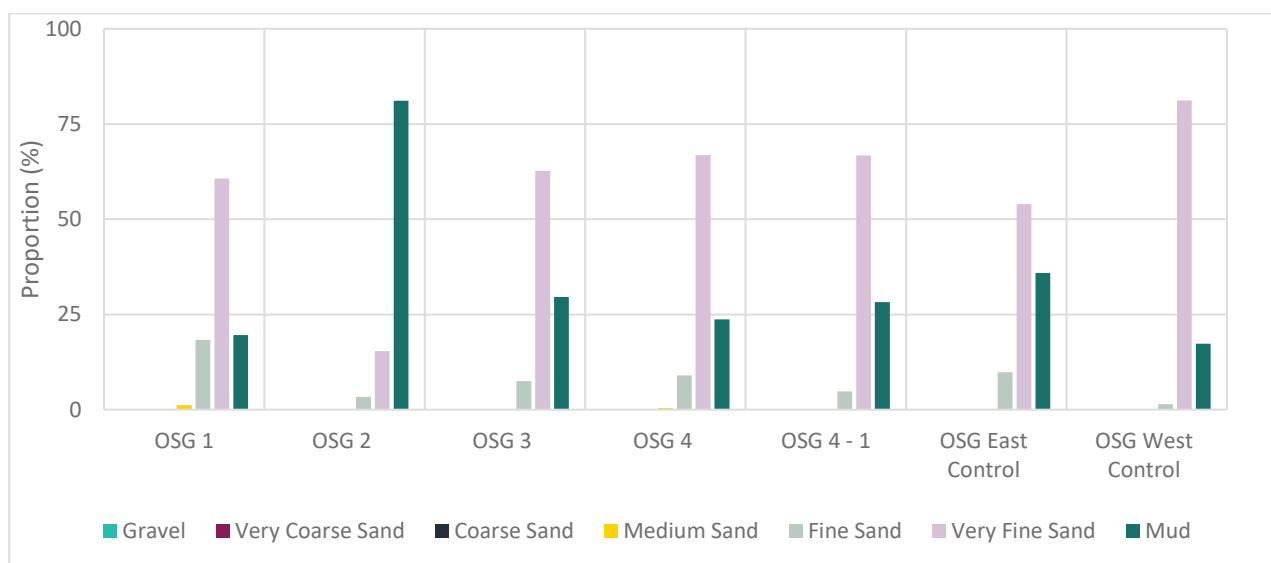
All sites, except OSG 2, had very similar particle size distribution profiles. In general, the samples were comprised predominantly of very fine sand, followed by a smaller component of mud and fine sand. OSG 2 had a higher proportion of mud compared to the other sites.

Figure 14: Particle size distribution at the Offshore Disposal Ground

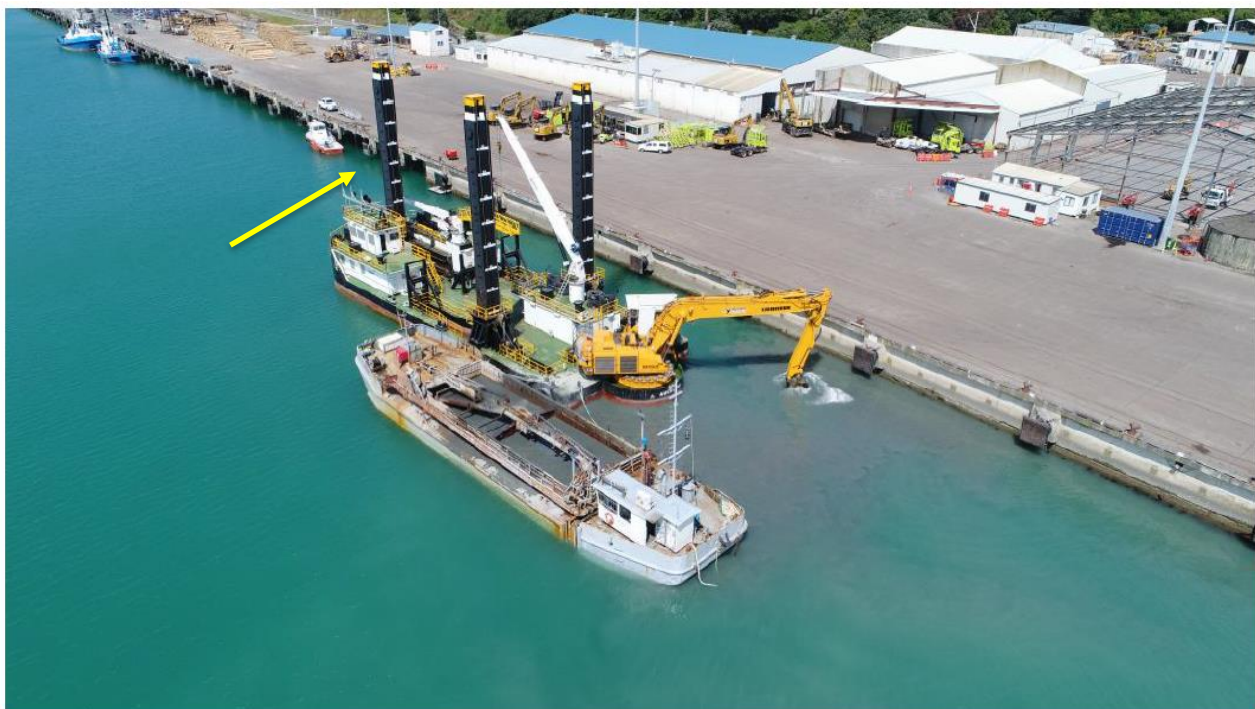
Figure 15: Backhoe loading Pukunui at Port Gisborne (Source MetOcean, April 2018; Figure 3.44).

(Yellow arrow is discussed in text below)

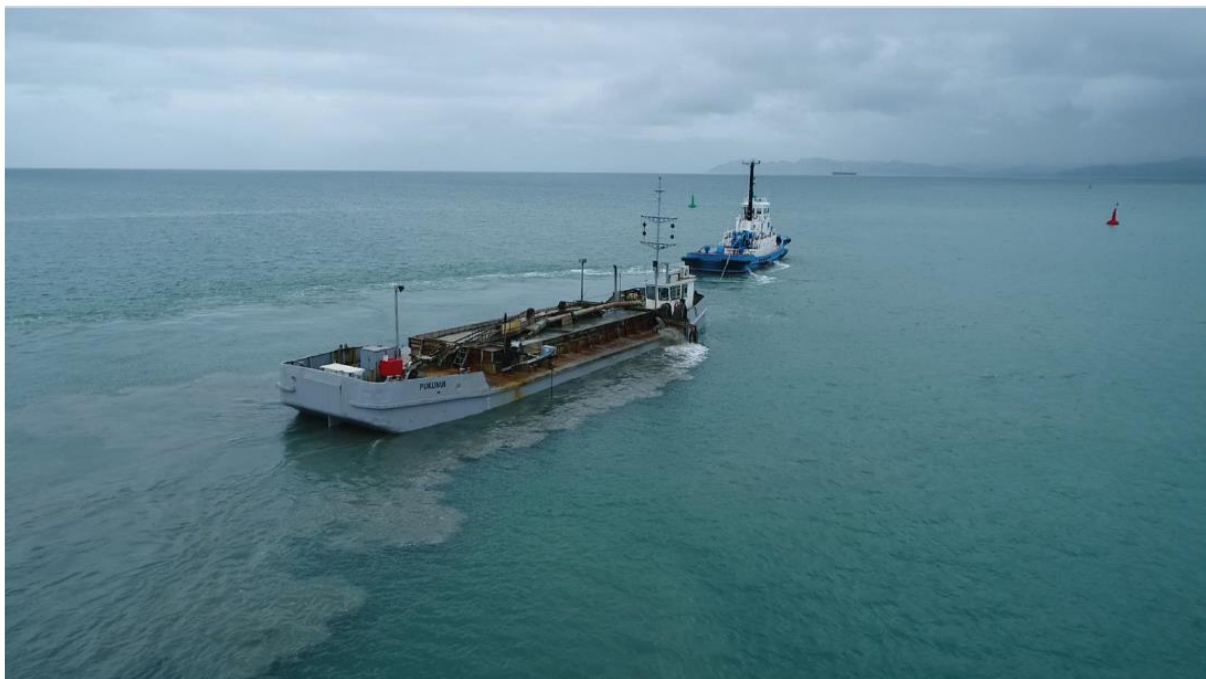
Figure 16: TSHD Pukunui operating within the outer PNC (Source MetOcean (November, 2019); Figure 3.9)

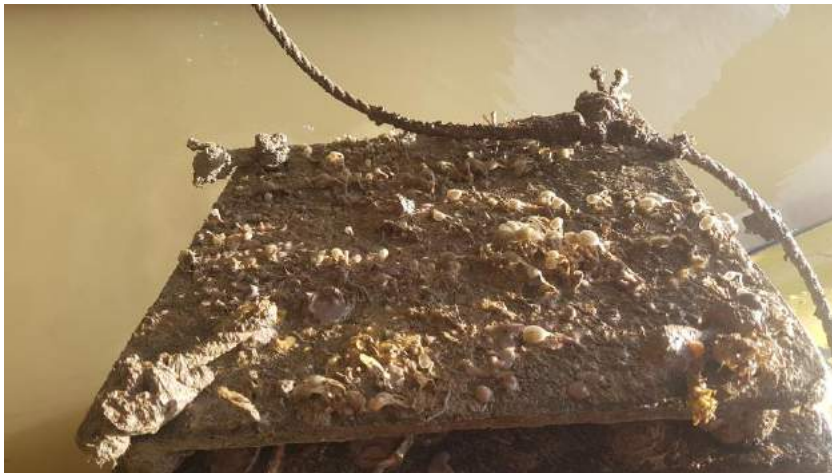
Photo 4: Crevice collector retrieved from Wharf 6

Sub-tidal biota was also inspected on old 'crevice collectors' and spat rope that was found suspended from these wharves. Photographs of these are also shown in Appendix A. The crevice collectors are tiers of plywood plates that provide refuge and settlement substrate for marine life. These surfaces were heavily silted. Encrusting and sessile biota observed on the collectors and rope included solitary and compound ascidians and oysters. Mobile invertebrates included half crabs (*Petrolisthes* sp.), decorator crabs (*Notomithrax* sp.) and a small conger eel (*Leptocephalus vereauxi*). No pueruli, juvenile crayfish or shrimps were observed.

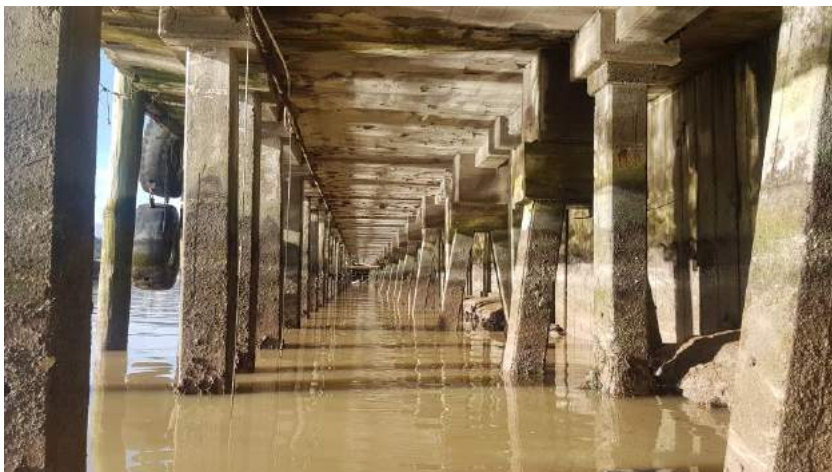
Photo 6: Wharf 6 looking east showing a fender (timber) pile, line of front concrete piles and rear raking piles

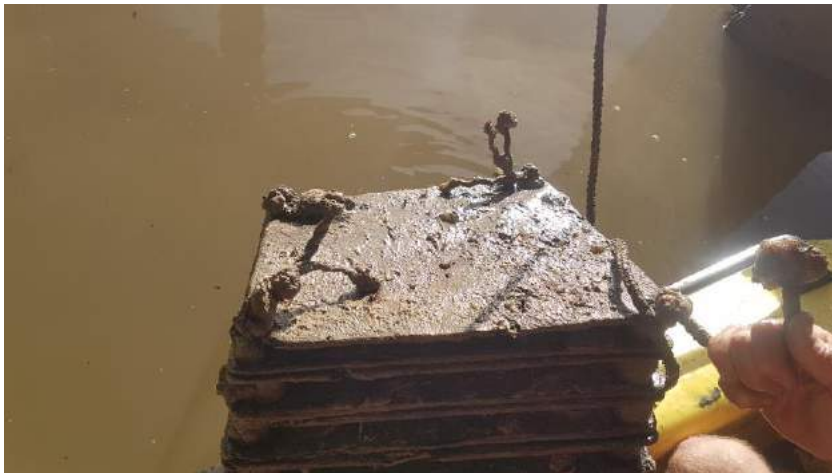
Photo 7: Crevice collector heavily silted

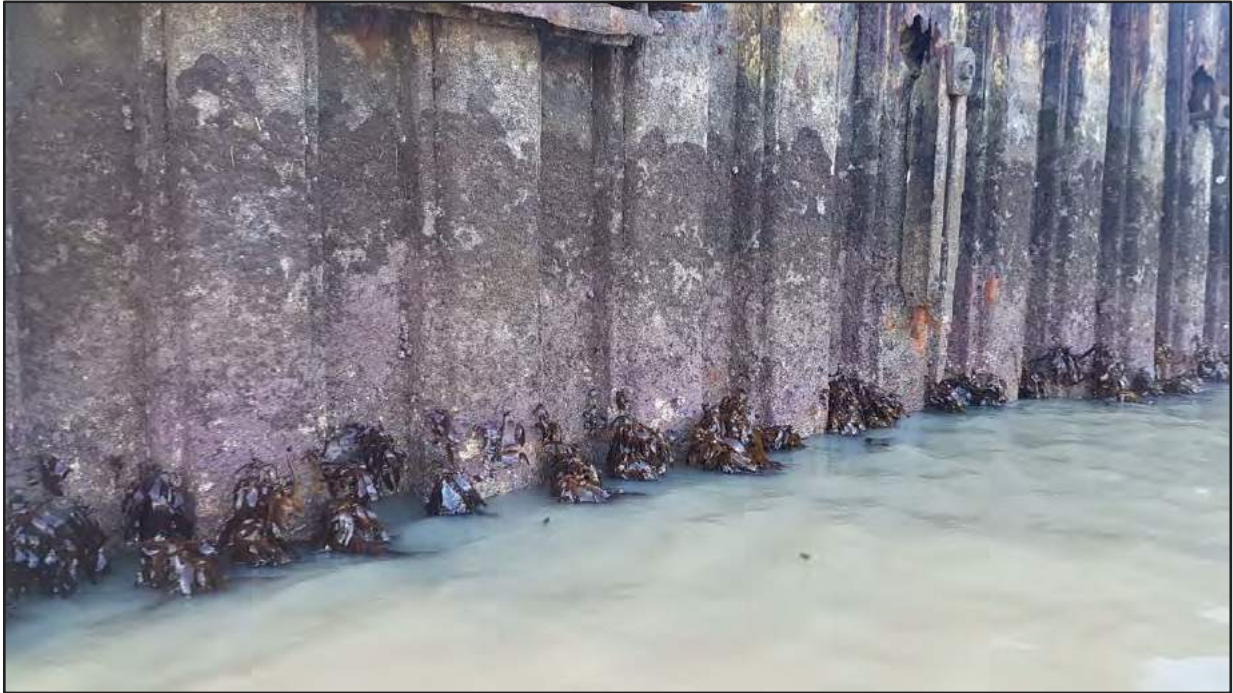
Photo 1: Marine growth on southern steel sheet piles (port side).

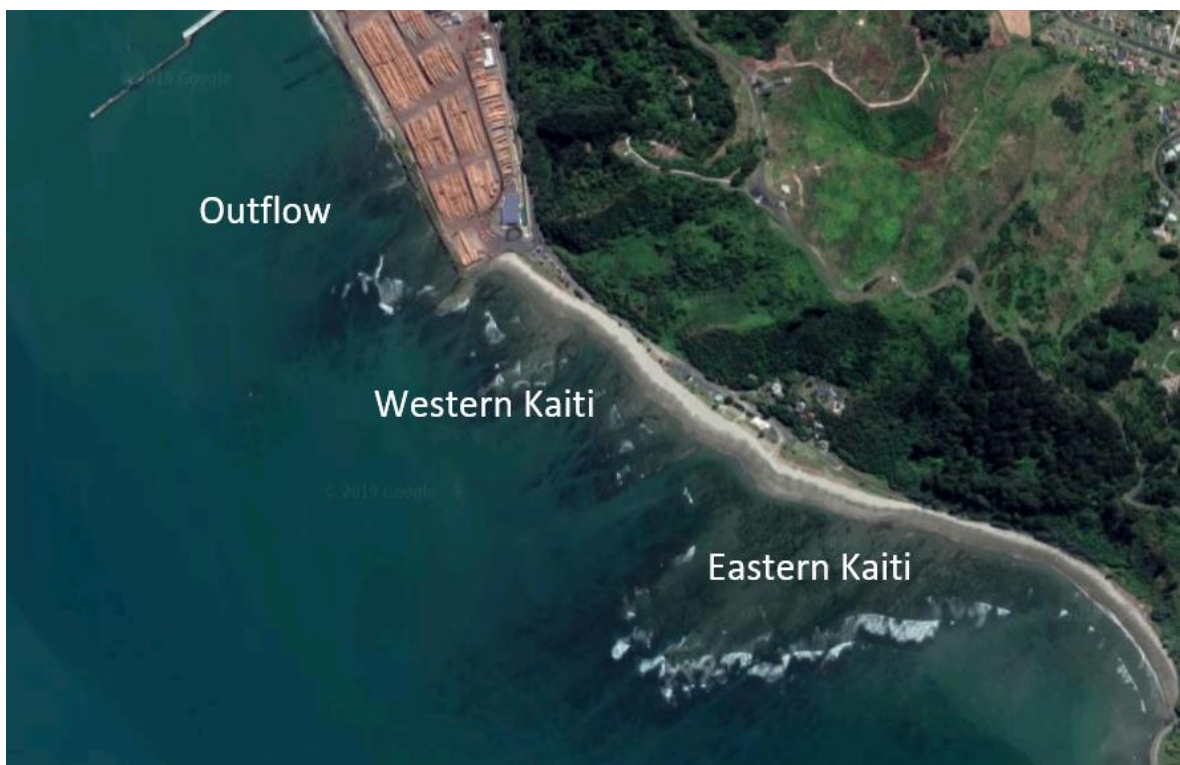
Fig 1: Location of transects along Kaiti Beach.

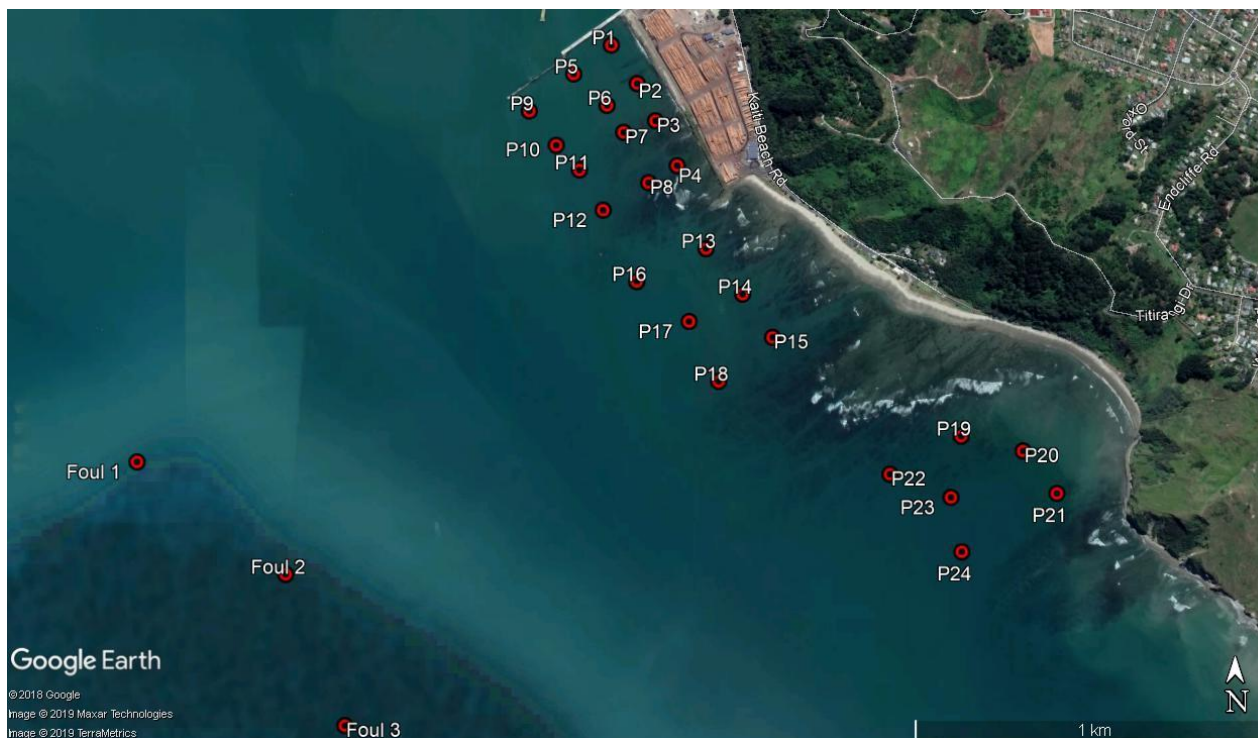
To characterise sediment quality off the Kaiti Reef, sediment samples were collected from five sites (P1, P6, P7, P16 and P17) (Figure 1). The survey off Kaiti Reef initially included 27 sites arranged in a grid pattern within the area of interest (Figure 2).

Figure 2: Seabed sediment sampling sites adjacent to the Kaiti Reef

Samples were only able to be collected from sites P1, P6, P7, P16 and P17. Samples were not able to be collected from the other sites due to the substrate characteristics (e.g. it was either rock or a hard, compacted sand that the PONAR grab could not effectively sample).

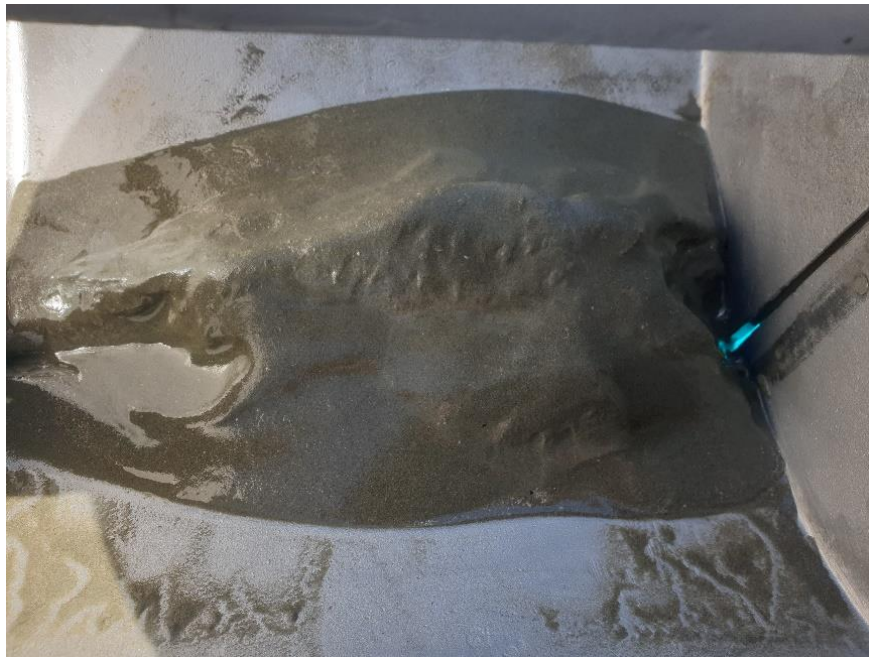
For sites P20, P21, P23 and P24, samples were able to be taken, but these were not subject to further physicochemical analysis. However, a brief assessment was made of the general sediment characteristics. A typical seabed sediment sample is shown in Figure 3.

Figure 3: Typical PONAR grab seabed sample

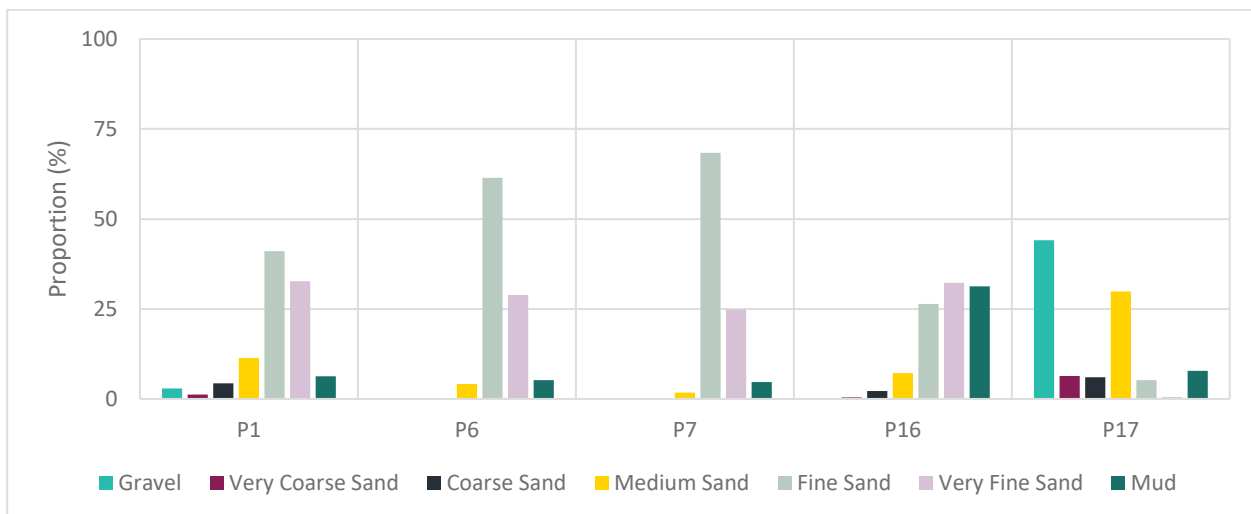
Figure 5: Kaiti Reef particle size distribution

The samples P1 – P16 were comprised predominantly of fine sand and very fine sand, followed by varying levels of mud and medium sand. Coarse sand, very coarse sand and gravel were minor components of these samples. The particle size distribution of P17 was notably different compared to the other samples, being comprised predominantly of gravel and medium sand.

The particle size distribution of each of the Kaiti Reef sites is presented in Figure 5 below.
