**Eastland**  
Port

## Twin Berth Seawall Redevelopment

Detailed Site Investigation (DSI)

August 2022

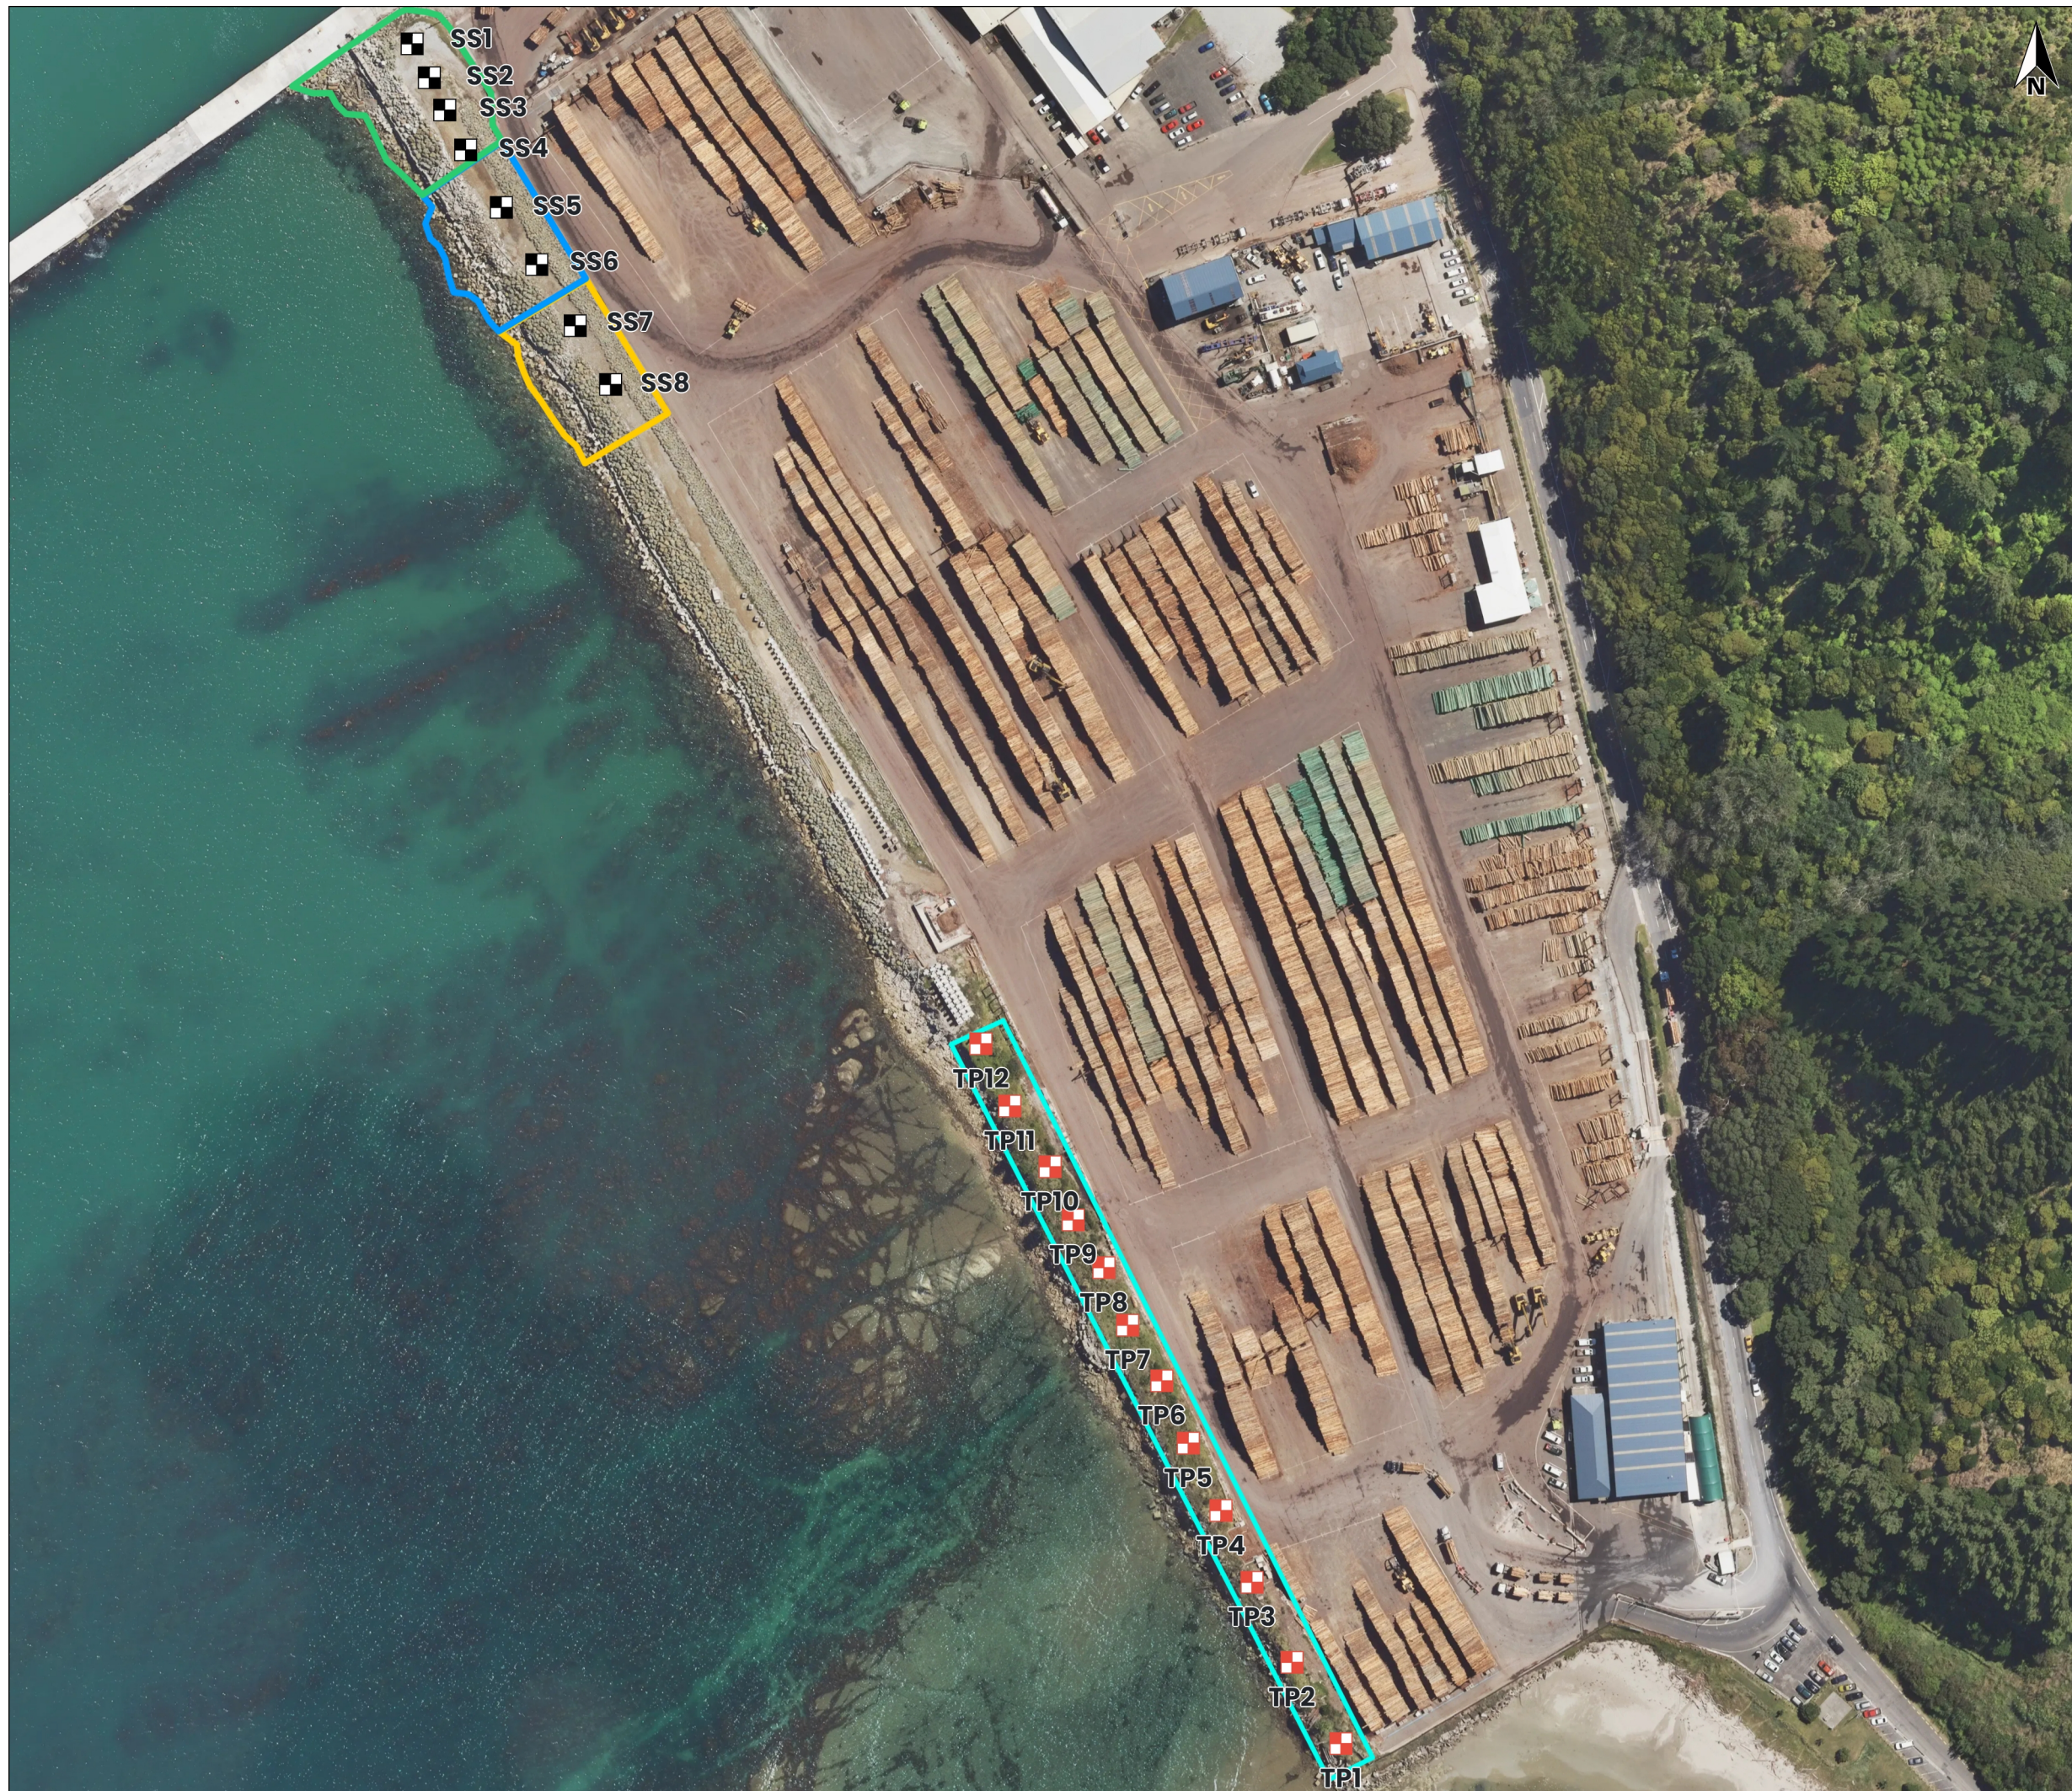
Soil sampling within the area of proposed stormwater works in the southern part of the Site has not been undertaken as part of this investigation. Previous investigations (refer to Section 3.1) have characterised soils in this area. As such, soil sampling of this location is not repeated as part of this investigation.

- Sampling Locations (4Sight, 2021)
- Sampling Locations (EAM, 2021)
- ◊ Section 1
- ◊ Section 2
- ◊ Section 3
- ◊ EAM Investigation Area

- **Asbestos:**
  - Asbestos was identified in seven samples (SS2\_0.0, SS2\_0.5, SS3\_1.0, SS5\_1.0, SS7\_1.0, SS8\_0.5 and SS8\_2.5) consisting of chrysotile (white asbestos) and amosite (brown asbestos) in the form of both ACM debris and loose fibres; and,
