4Sight Coastal Processes Memo

Memorandum

То:	Cassandra Ng
From:	Sam Morgan
Date:	21 January 2019
Subject:	Tuahine Cres Seawall - Coastal Processes and Impact Assessment

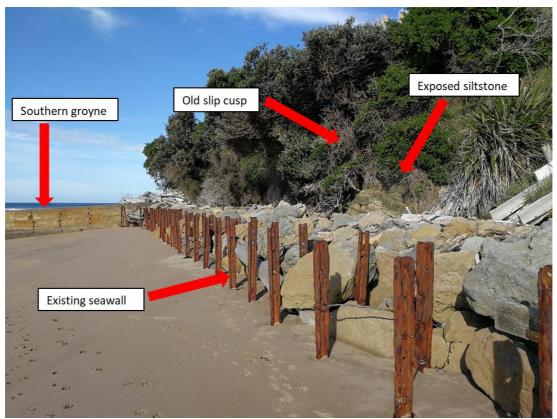
Figure 3: Subject site of proposed new seawall.

It is recognized is that both bounding headlands are actively eroding due to the relatively soft nature of the siltstone cliff face, and is considered to be eroding at a rate of approximately 0.4m/yr⁵. The subject site marks the transition from the sandy beach environment to the abutting cliff. The composition of sand material reflects the nature of backshore parent rock at the subject site, as can be seen in **Figure 3**

below. As illustrated in the image there is an exposure of siltstone formation migrating into an old slip face as you move toward the southern groyne. Beyond the groyne the cliff quickly rises to height in excess of 20m and up toward a peak of approximately 100m. Erosion at the site has been controlled to date by the existing seawall providing protection to the toe of the slope. This has prevented undermining of the rock face and removal of any talus material which ultimately lead to further over steepening of the existing slopes. Sand levels in front of the wall are known to fluctuate depending on climatic conditions, where northeast wind and swell events are thought to deliver sand to this part of the beach, which is then trapped by the southern groyne.

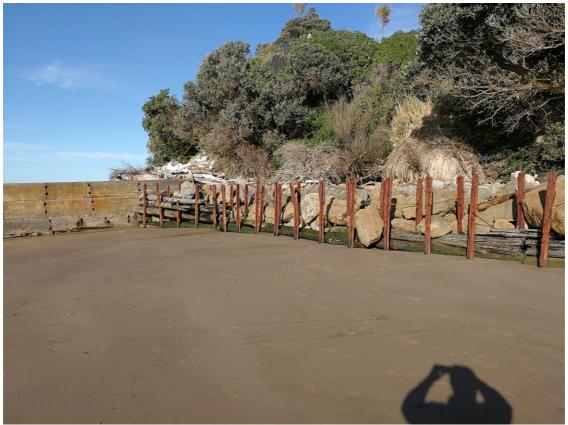
Figure 5: Sand levels at the site on 10.08.2018.

At the site itself sand levels are known to fluctuate, presumably in response to changing weather, swell and corresponding current regimes. **Figure 5** shows lower sand levels at the site on the 10th of August 2018 that followed a 5 day period of northeast swell activity. Conversely **Figure 6** shows relatively high sand levels on the 20th of November 2018 following during a long period of relatively small east swell that was preceded by period of calm conditions. Details of swell conditions for these periods are contained within **Appendix A**.

As observed in **Figures 5 & 6** wave reflection currently does not appear to be significantly impacting the site. The impact of existing (and proposed) structural wave reflection is complicated by the adjoining groyne which is much more likely to have a substantive impact on sand retention at this part of the beach. This is due to the shore perpendicular orientation of the groyne and its solid-state nature.

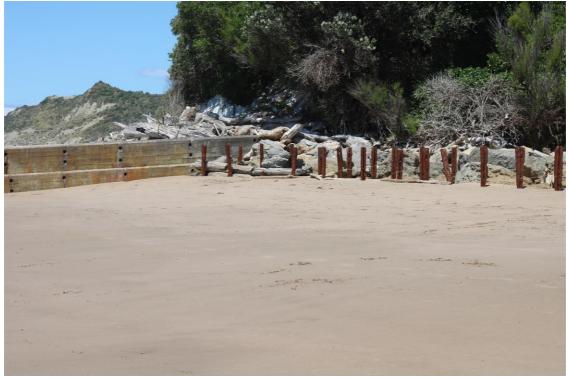
Figure 6: Sand levels at the site on 20.11.2018
