# Analysis of Rainfall for the storm events of 3<sup>rd</sup> - 4<sup>th</sup> June. East Coast Tairāwhiti

Draft report  
10 November 2018  
Dr Murry Cave

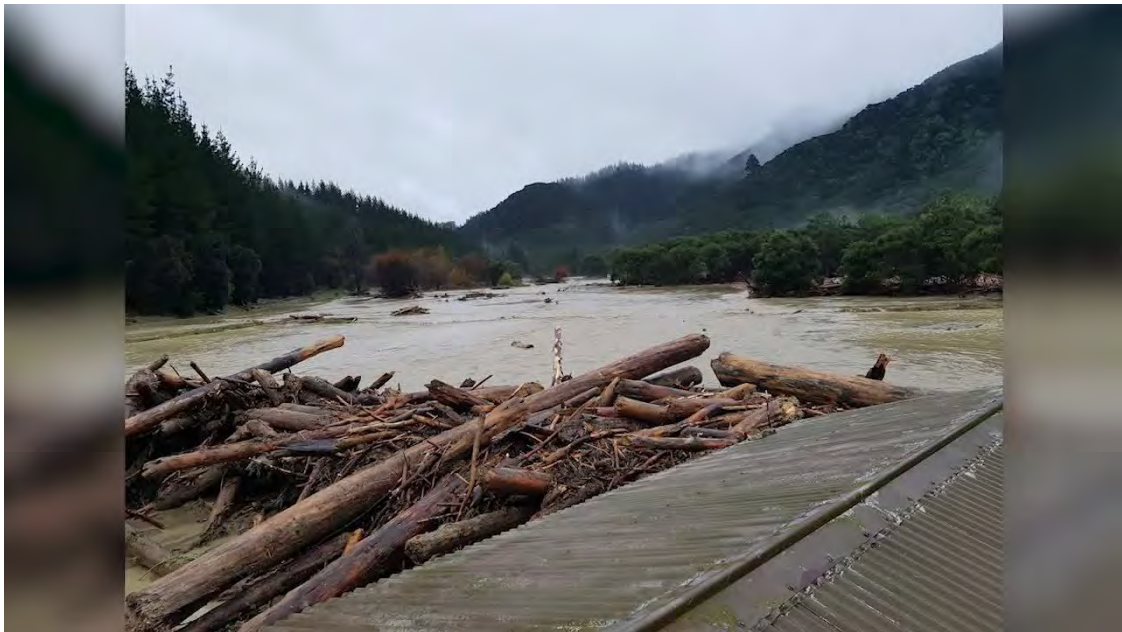
*View of the flooding in the Mangatokerāu valley from the roof of the Te Kiri House. 4<sup>th</sup> June 2018.*

- h. In the Mangatokerau tributary an extremely large mass of harvest residues and cut logs travelled down valley with one family rescued after climbing onto the roof of their house in the middle of the night. One other dwelling was knocked off its foundations.

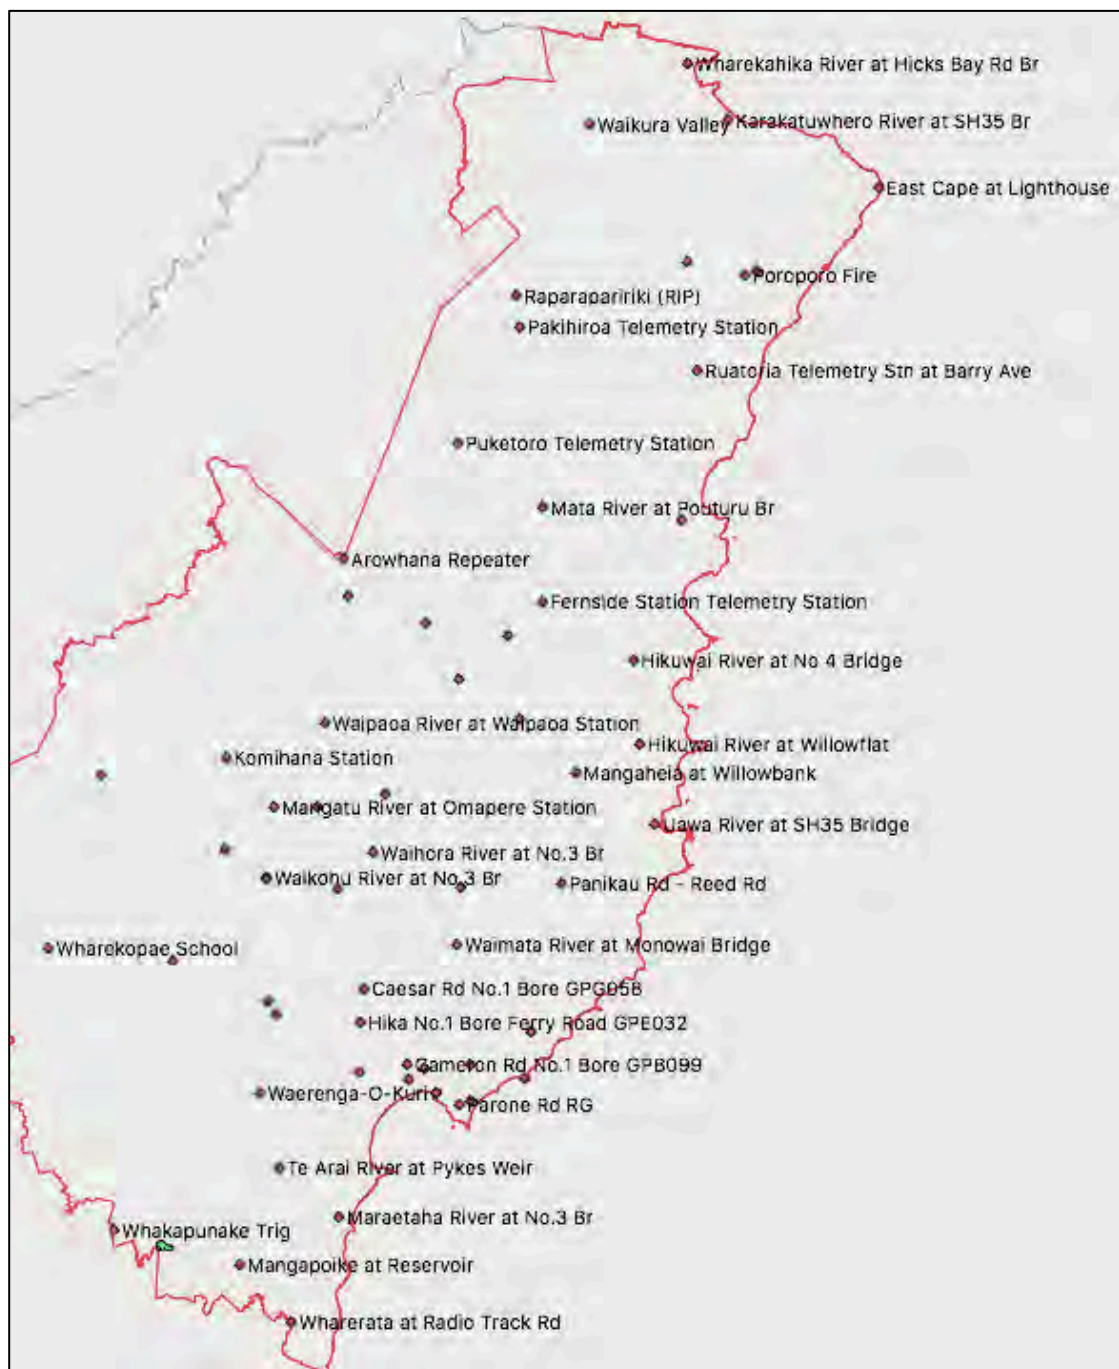
**Figure Five.** Location of rain gauges within East Coast/Tairāwhiti.

This analysis of rainfall data for the East Coast Tairāwhiti Region is based on 59 rain gauges distributed across the area from Hicks Bay in the north to the top of the Wharērata in the south. There is a gap in coverage in the west while coverage to the north may be too coarse to adequately define rainfall distribution across the area (**Figure Five**). Raw rainfall data is presented as **Appendix One**.

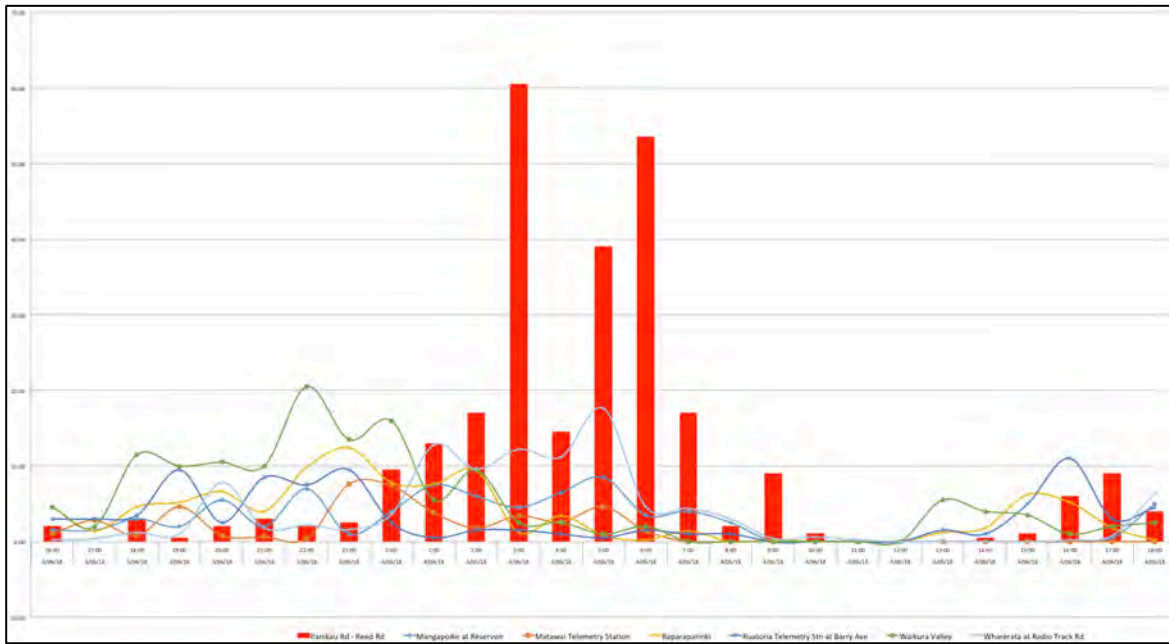
**Figure Seven.** Precursor rainfall accumulation for the north of the District (Waikura Valley, Ruatoria, Raparaririki) and Mangapoike, Matawai and Wharerata compared with the Panikau at Reed Road Gauge (Red) in the south of the Pakarae Catchment.

Rainfall accumulation in the north appears to have started around the same time at 3 to 4pm, with some stations then recording steady rain from then until early in the morning of the 4<sup>th</sup> of June. In the Waikura Valley, for example, steady rain fell from 4pm, was heavy from 6pm through to 1am on the 4<sup>th</sup> while Raparapaririki and Ruatoria had steady rain from 4pm until early morning on the 4<sup>th</sup>. The Mata, Poroporo and Puketoro stations had steady rain from 4pm while at Te Puia steady rain accumulation began at 7pm on the 3<sup>rd</sup> (Figure Seven).

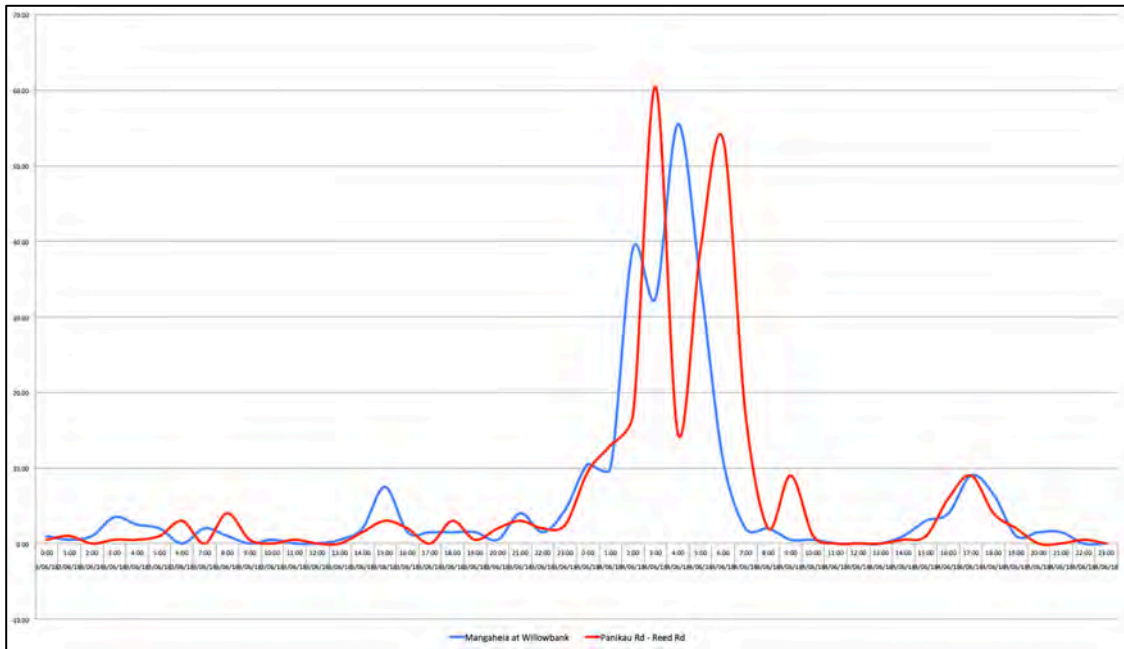
**Figure Nine.** Rainfall accumulation for the Panikau-Reed Road (red) and Mangaheia at Willowbank (Blue) Gauges. Note that the scale on the left (in mm) indicates that peak accumulation was about twice that of other gauges (see **Figure Six**).

The data suggests that an intense short-duration rain cell hit at Mangaheia slightly earlier (2:30am) than at Panikau (2:50am) but didn't last as long. Total rainfall at Mangaheia was also lower at 150.5mm for the intense storm interval

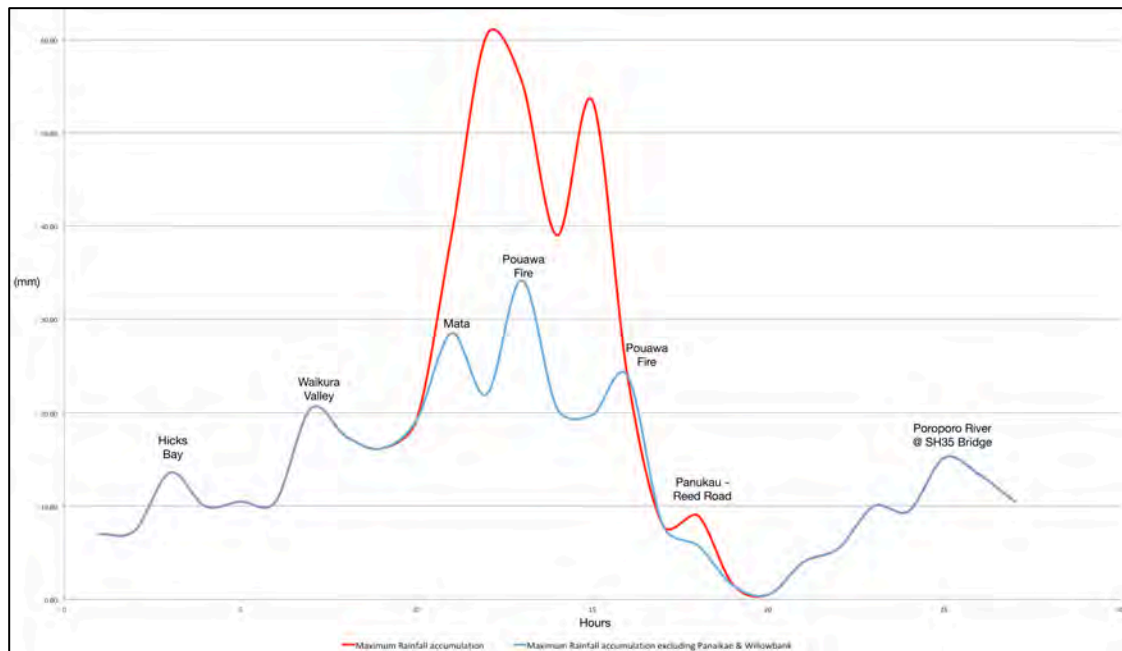
**Figure Ten.** Maximum hourly rainfall accumulation for the Panikau-Reed Road Gauge (red) superimposed on the background Queens Birthday rainfall event (Blue). The background rainfall suggests heavy rain started in the north and then moved south through Mata. Note the Pouawa Fire peaks occurring slightly later than the overall maxima recorded at the Panikau Reed Road Gauge.

compared with 184.5mm at Panikau for the same period. Excluding these two gauges, the event rainfall had a maximum peak intensity of 35mm/hour with this peak occurring from 3-4 am on the 4<sup>th</sup>. The Queens Birthday storm was thus quite complex with what appeared a relatively small event with rainfall spreading from north to south colliding with a secondary orographic rain cell between Gisborne City and Uawa. This rain cell caused intense rain that was fortuitously captured by the Panikau-Reed Road and Mangaheia at Willowbank gauges (**Figure Ten**).

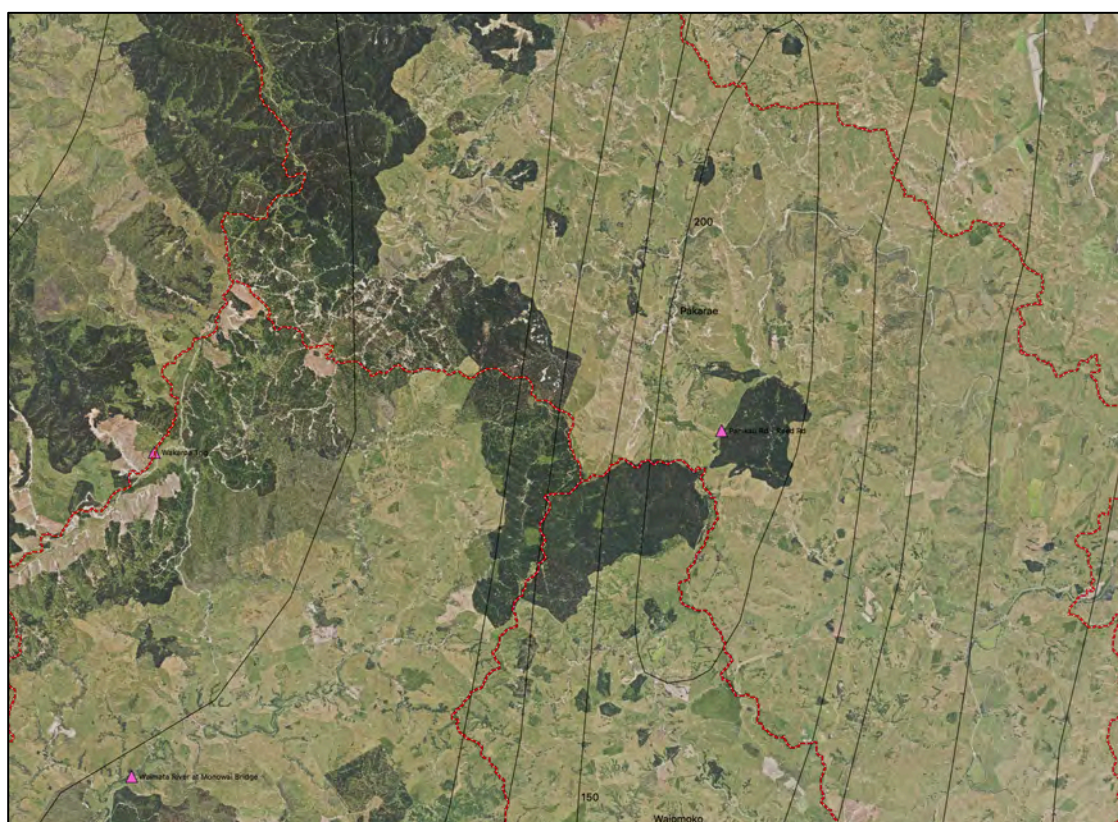
**Figure Eighteen.** December 2017 aerial photograph of the Panakau-Reed Road rain gauge site overlain with the catchment boundaries and 6 hour rainfall accumulation. There are two forests immediately adjacent with Baywood forest on the right and Pukerewa on the left.

What has faded from many people's minds is that there was a significant impact further south in the Pakarae and Waiomoko Valleys close to the Panikae-Reed Road rain gauge which received the highest rainfall during the event. Although less comprehensively documented than the events in Uawa, an inspection of the Waiomoko Valley soon after the event, plus several aerial overflights and now satellite imagery dated 25<sup>th</sup> August 2018 is available. Thus an assessment of the impacts of the storm on forestry at the centre of the storm near the Panikau-Reed Road rain gauge allows for the storm impacts to be put in context (**Figure Eighteen**).

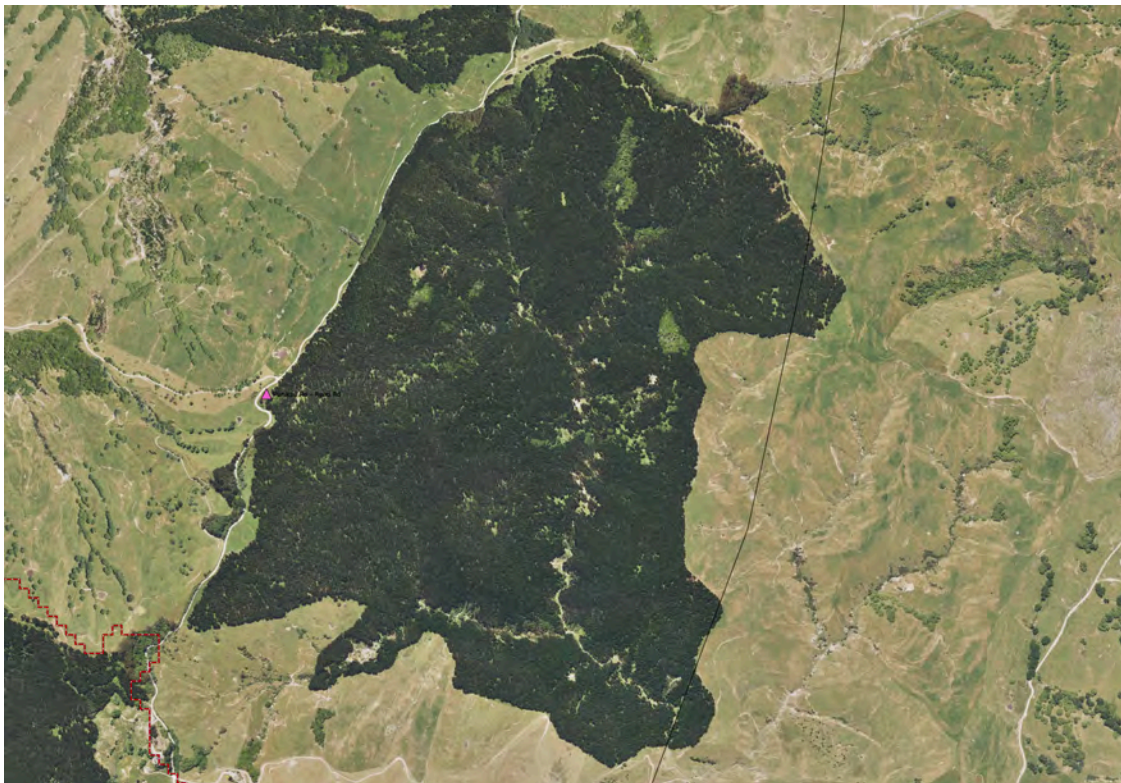
**Figure Nineteen.** View of Baywood Forest (close up of Figure Eighteen) showing the condition of the forest over the summer of 2017-2018. The forest is unharvested and in good Condition.

The coincidence of GDC flying new aerial imagery over the summer of 2017-2018 and the new satellite imagery from 25<sup>th</sup> August 2018 allows us to assess the before and after damage in the affected region. Baywood Forest was at the epicentre of the event situated immediately east of the Panikau-Reed road rain gauge at the southern edge of the Pakarae catchment. The forest falls almost entirely within the area that would have received +200mm of rain over the 6 hours of most intense rain. A view of the forest from the new GDC aerial imagery is shown in **Figure Nineteen** below.

The forest has not been harvested and appears to be in good condition. The age of the forest is uncertain but it has a closed canopy with only a few very small areas of disturbance. The forest appears to be owned by Forest Enterprises Ltd but does not have any current consents.

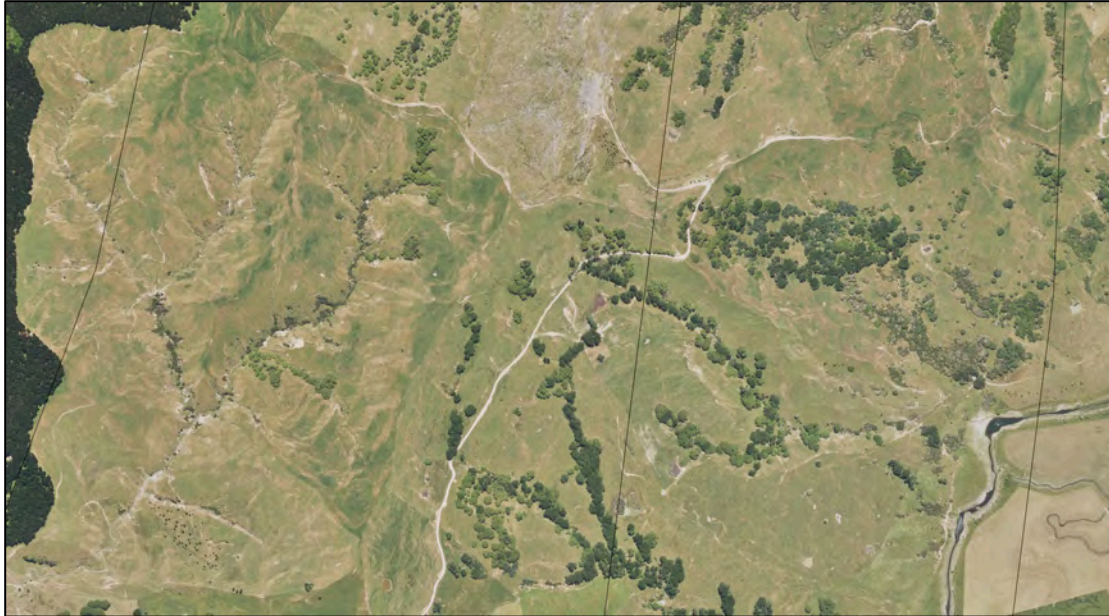
**Figure Twenty One.** GDC December 2017 aerial image of the area immediately east of Baywood Forest showing the pre-existing level of slips prior to the Queens Birthday storm.

The analysis of the images indicates that there has been a noticeable increase in the number of slips on pasture although the overall scale of slipping is minor compared what has been found in the recently harvested forests further north. Also evident on the Google Earth image is the significant volume of silt that has been deposited on the river flats downstream of the forest (**Figure Twenty Three**). When these flats are examined closely it is clear that some woody debris has been deposited (**Figure Twenty Four**) but the provenance of this material has not been established. The volume of material is low compared with what has been observed in the Uawa catchment which may suggest that this material comprises largely willow and poplar debris.

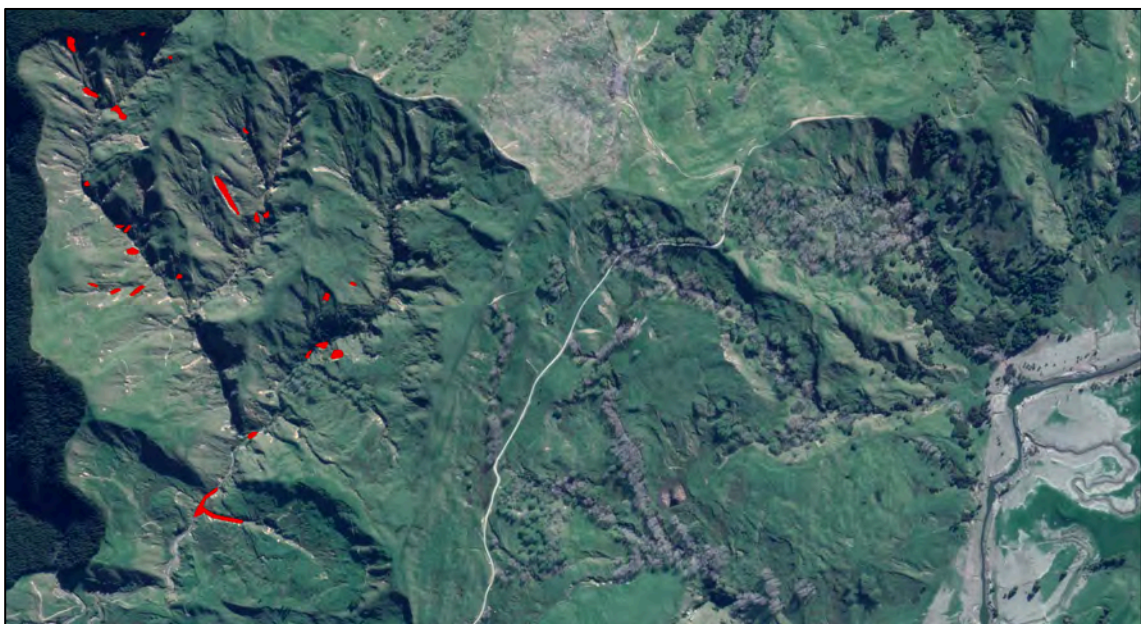
**Figure Twenty Two.** Post Queens Birthday storm Google Earth image of the same area as above dated August 25<sup>th</sup> 2018 showing the pre-existing slips (red), the extent of new, largely mid slope landslides and the silt deposition on the river flats.

slipping of pasture through mid slope failures. Erosion of riverbanks is probably also a contributor. Relatively speaking, however, these mid slope failures do not represent large-scale slope failures such as occurred during Cyclone Bola but do appear to be more prevalent to that observed on farmland further north in the Uawa Catchment. The woody debris present on the river flats have no obvious forestry source and are most likely willow and poplar.

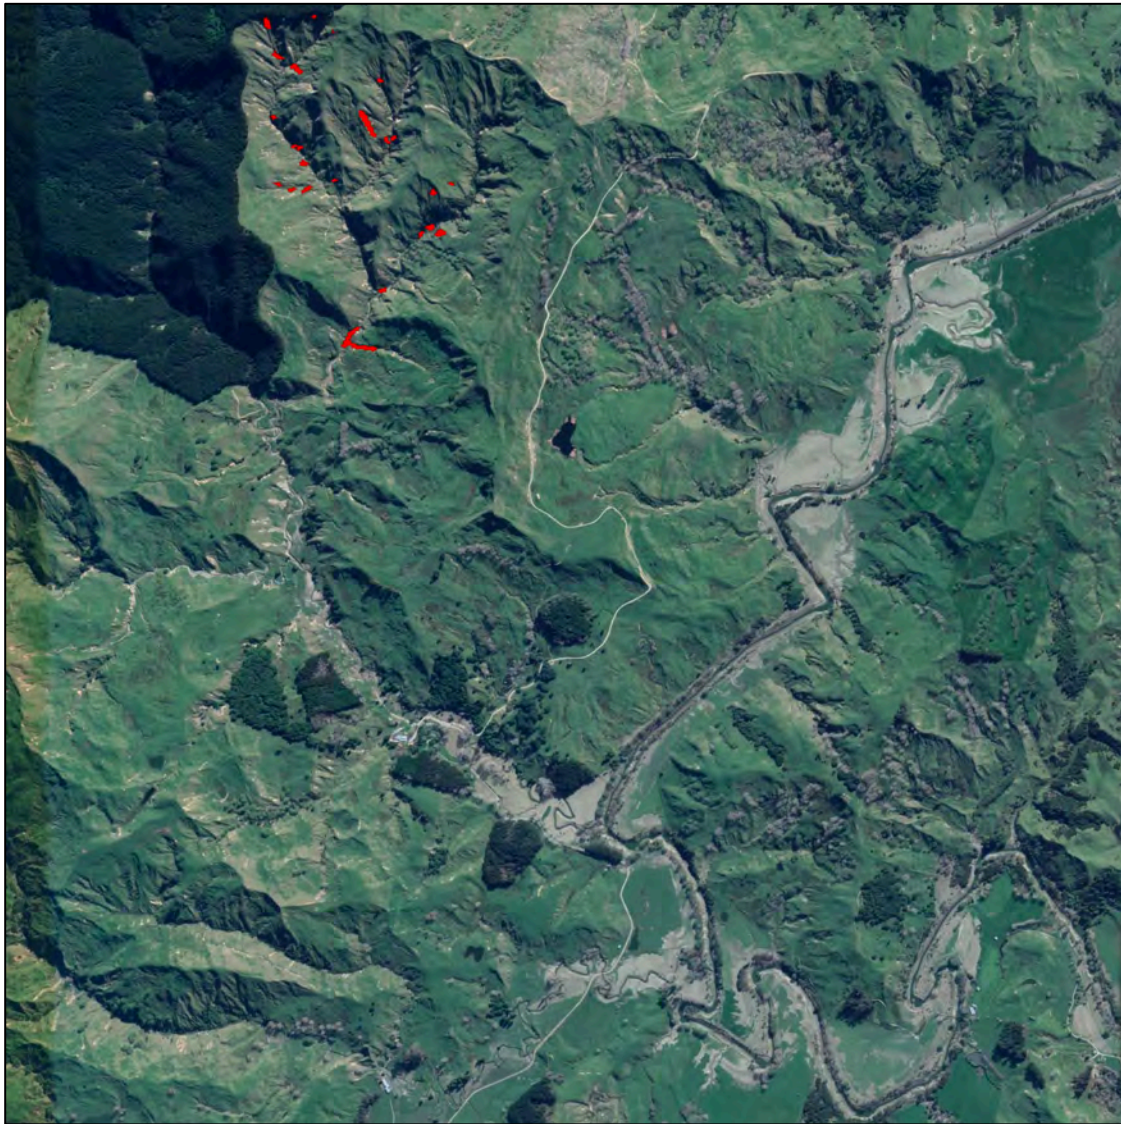
**Figure Twenty Three.** View of the catchment east of the Baywood Forest showing the extent of silt deposition on the river flats.

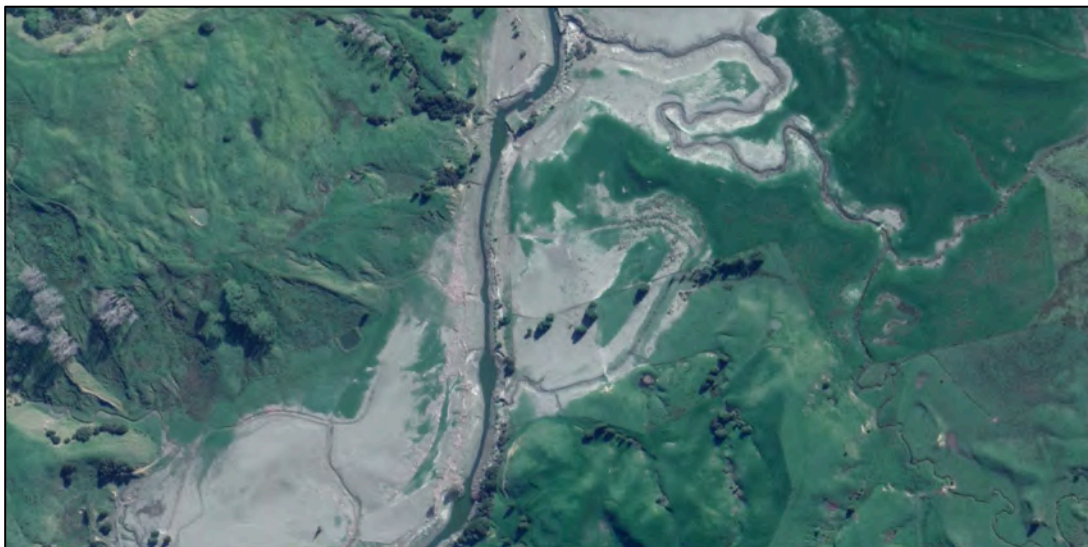
**Figure Twenty Four.** Enlarged view of the river flats showing obvious woody debris deposited on the on the true left bank of the river flood plain (middle left).

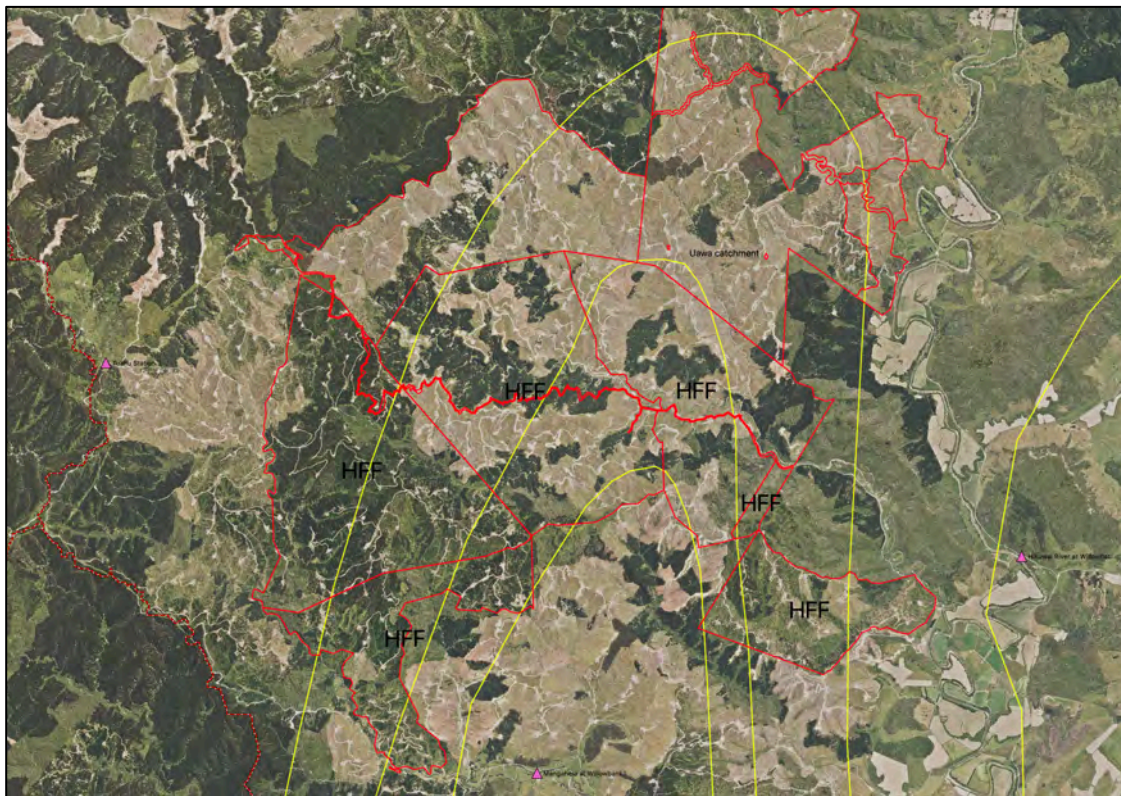
**Figure Twenty Five.** Te Marunga Forest (Hikurangi Forest Farms) showing the rainfall accumulation within the forest (150mm in centre out to 50mm over a large part of the forest).

The rainfall accumulation contours for the Te Marunga Forest is shown in **Figure Twenty Five** below. This suggests that the forest was north of the main rainfall accumulation with much of it experiencing between 50 and 150mm over a 6-8 hour window. Notably one area that experienced heavy damage (Hesketh Road) occurs in the 50mm band with a significant area occurring within the 100mm band.

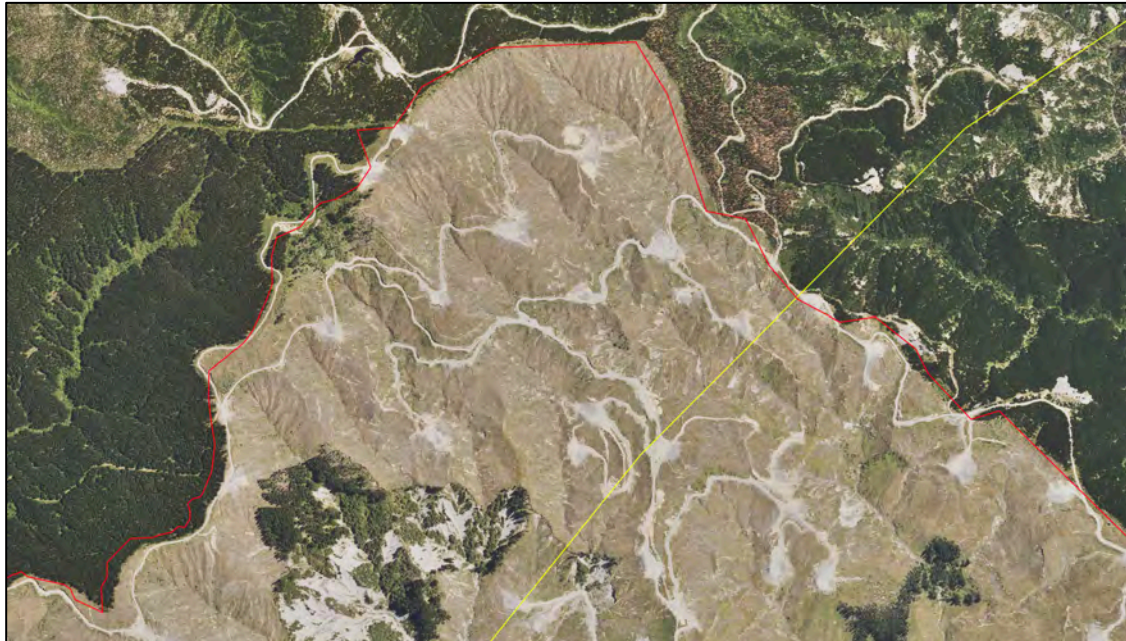
**Figure Twenty Seven.** Aerial Photograph of the Hesketh Road area (December 2017) showing the skid locations and ground conditions pre-Queens Birthday Storm. The yellow line is the 50mm rainfall contour.

Despite the Te Marungi Forest receiving considerably less rainfall than the Baywood Forest adjacent to the Panikau-Reed Road rain gauge, the damage within the harvest area was significant with multiple collapses of landings. To gain an understanding of the impacts, a comparison of the December 2017 GDC aerial imagery with the 25 August 2018 satellite imagery was undertaken (**Figures Twenty Seven and Twenty Eight**).

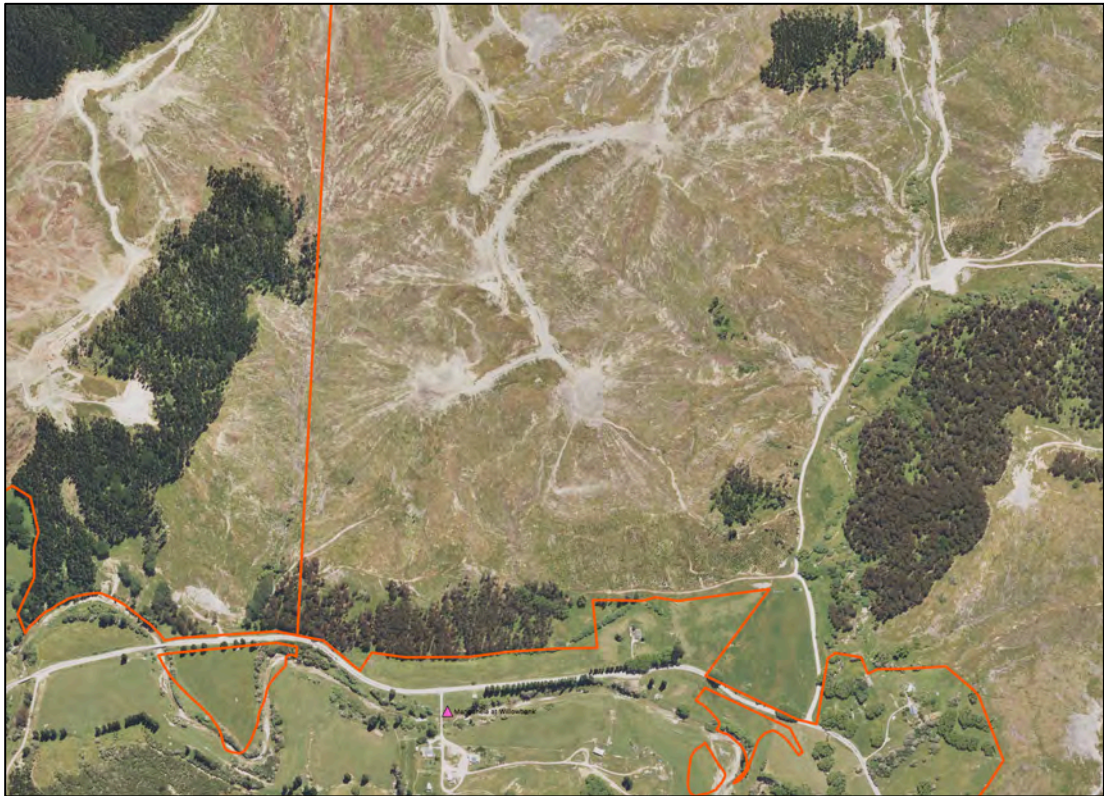
**Figure Thirty.** December 2017 aerial photograph of the south end Uawa Forest (Timbergrow Ltd-Ernslaw) showing the pre-storm landscape for the Mangaehia River and Mangatoitoi stream (right).

As for the Te Marunga Forest, the pre- and post-storm imagery shows a marked contrast in level of storm damage occurring within recently harvested forest compared with either closed canopy forest or farmland pasture (**Figures Thirty and Thirty One**).

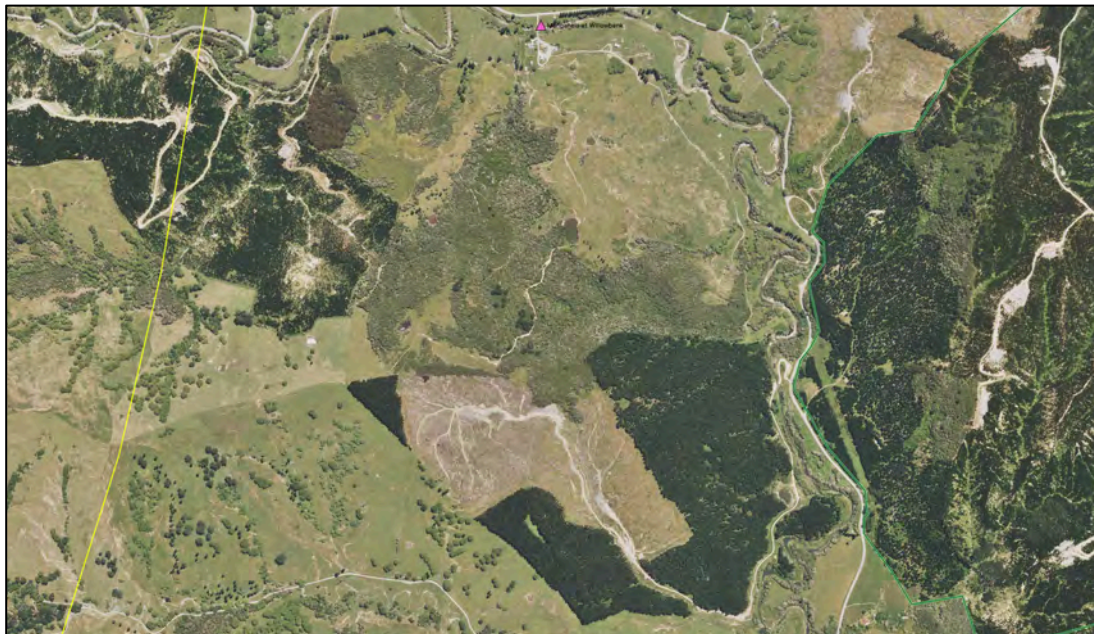
*Figure Thirty Two. Willowbank Forest and adjacent farmland. December 2017.*

The pre-storm December 2017 landscape is shown in **Figure Thirty Two** below while the post-storm image showing landslide impacts are shown in **Figure Thirty Three**.

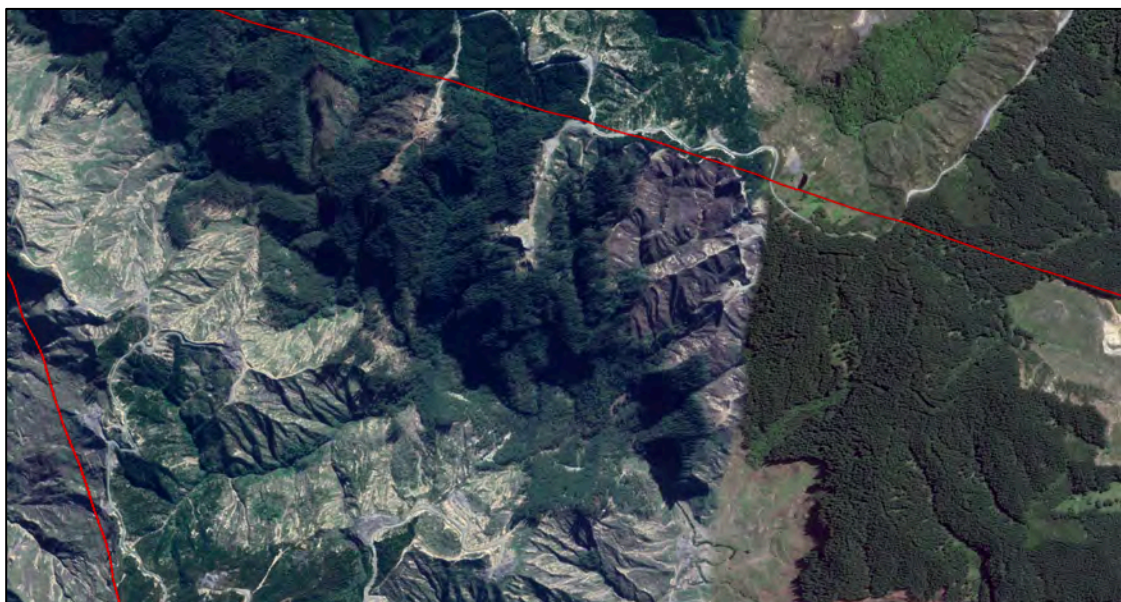
**Figure Thirty Five.** Close up view of Paroa Forest with August 2018 satellite imagery on the left and January 2017 satellite imagery of the right. Extensive landsliding is evident in the recently harvested areas on the bottom left while the closed canopy mature trees at top have remained largely unaffected by the Queens Birthday storm.

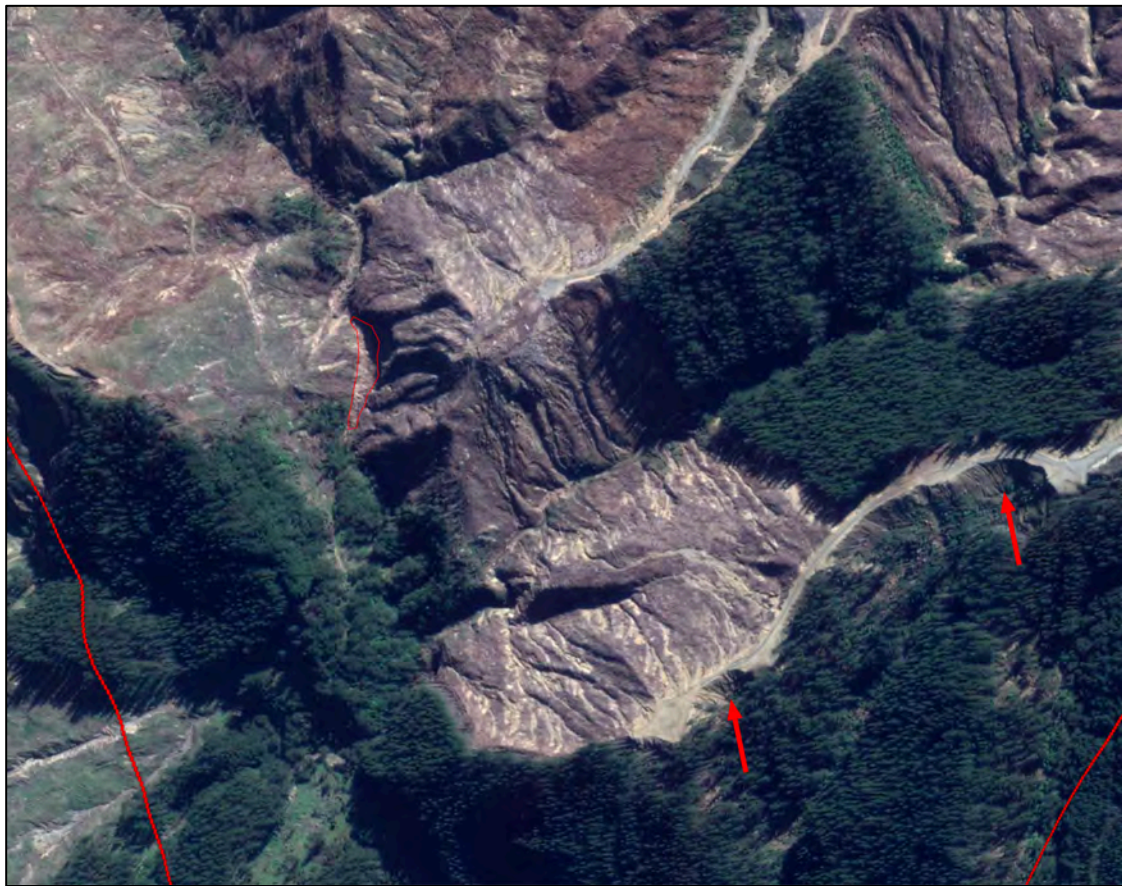
**Figure Thirty Six.** Detailed August 2018 view of part of Paroa Forest showing the location of a large amount of harvest residues in the stream bed (middle) with unbenched batters arrowed.
