## Overview of Evidence

### Item 1: The Hill, the actual historical name of our hill is called: Waihora

## Item 2: Hydrodynamics, Siltation, Erosion — Refuting the "Small Corner" Claim

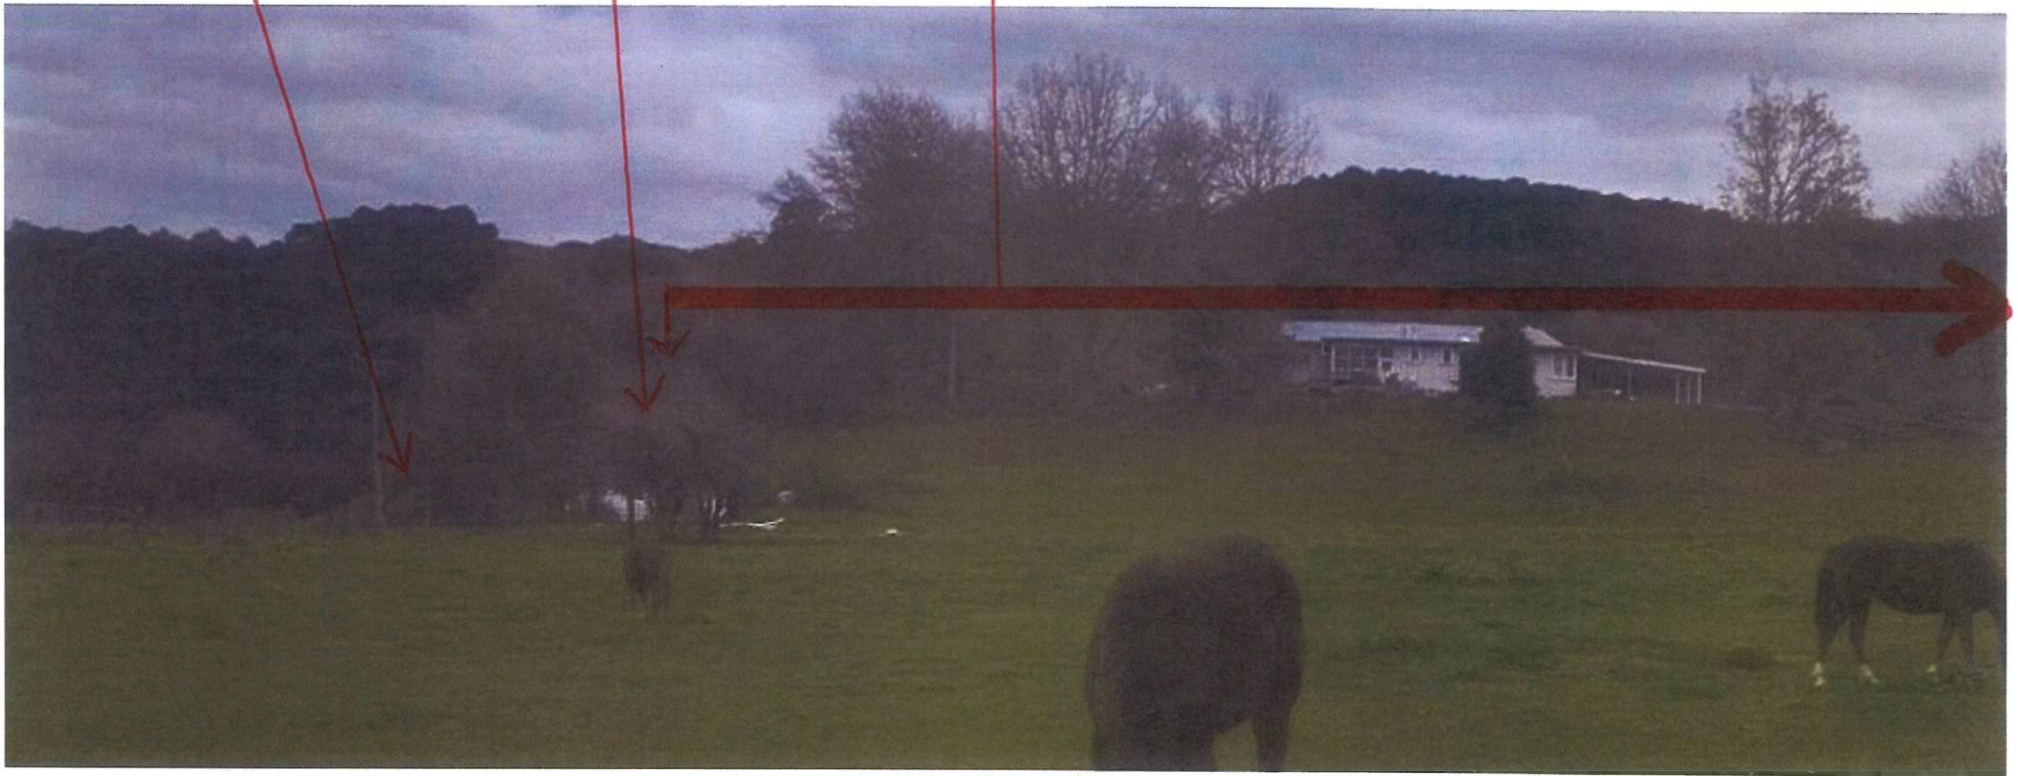
Photo 3 – Photo taken of the front of the hill, approx. three quarters of the hill, on Te Karaka 16A/81 Kanakanaia Road, with Wi Pere Trust on the left-side. The hill could not fit into one photo.

The property boundary is here this is the same in photo 1.

This is Wi Pere Trust part of the hill.

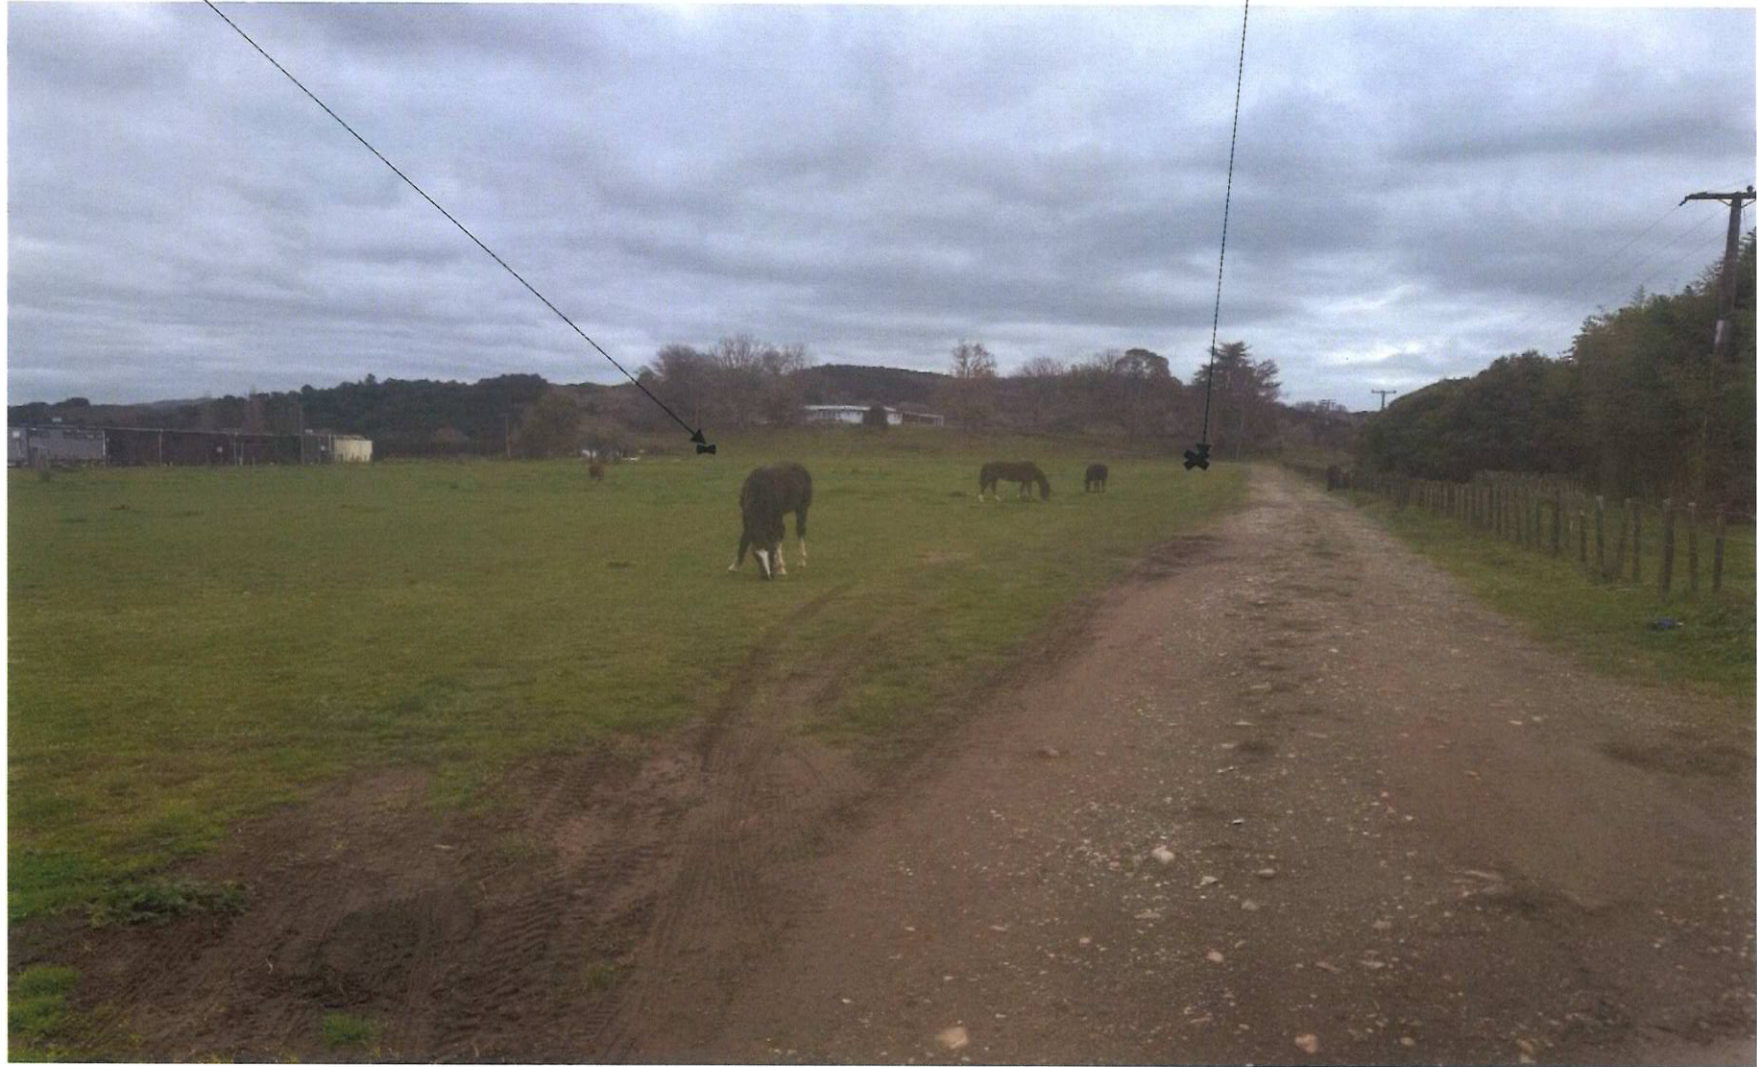
Original bore from my tipuna

1<sup>st</sup> bore my parents put down

The black cross near the bottom on the right is where the first bore my tipuna put down, the burnt house is where the original Coaching Inn was standing. My parents decided to build a lodge house on the original site, which is the burnt house in the photo. That bore was investigated to reopen it, the conclusion was the bore would be better placed at the site on page 3.

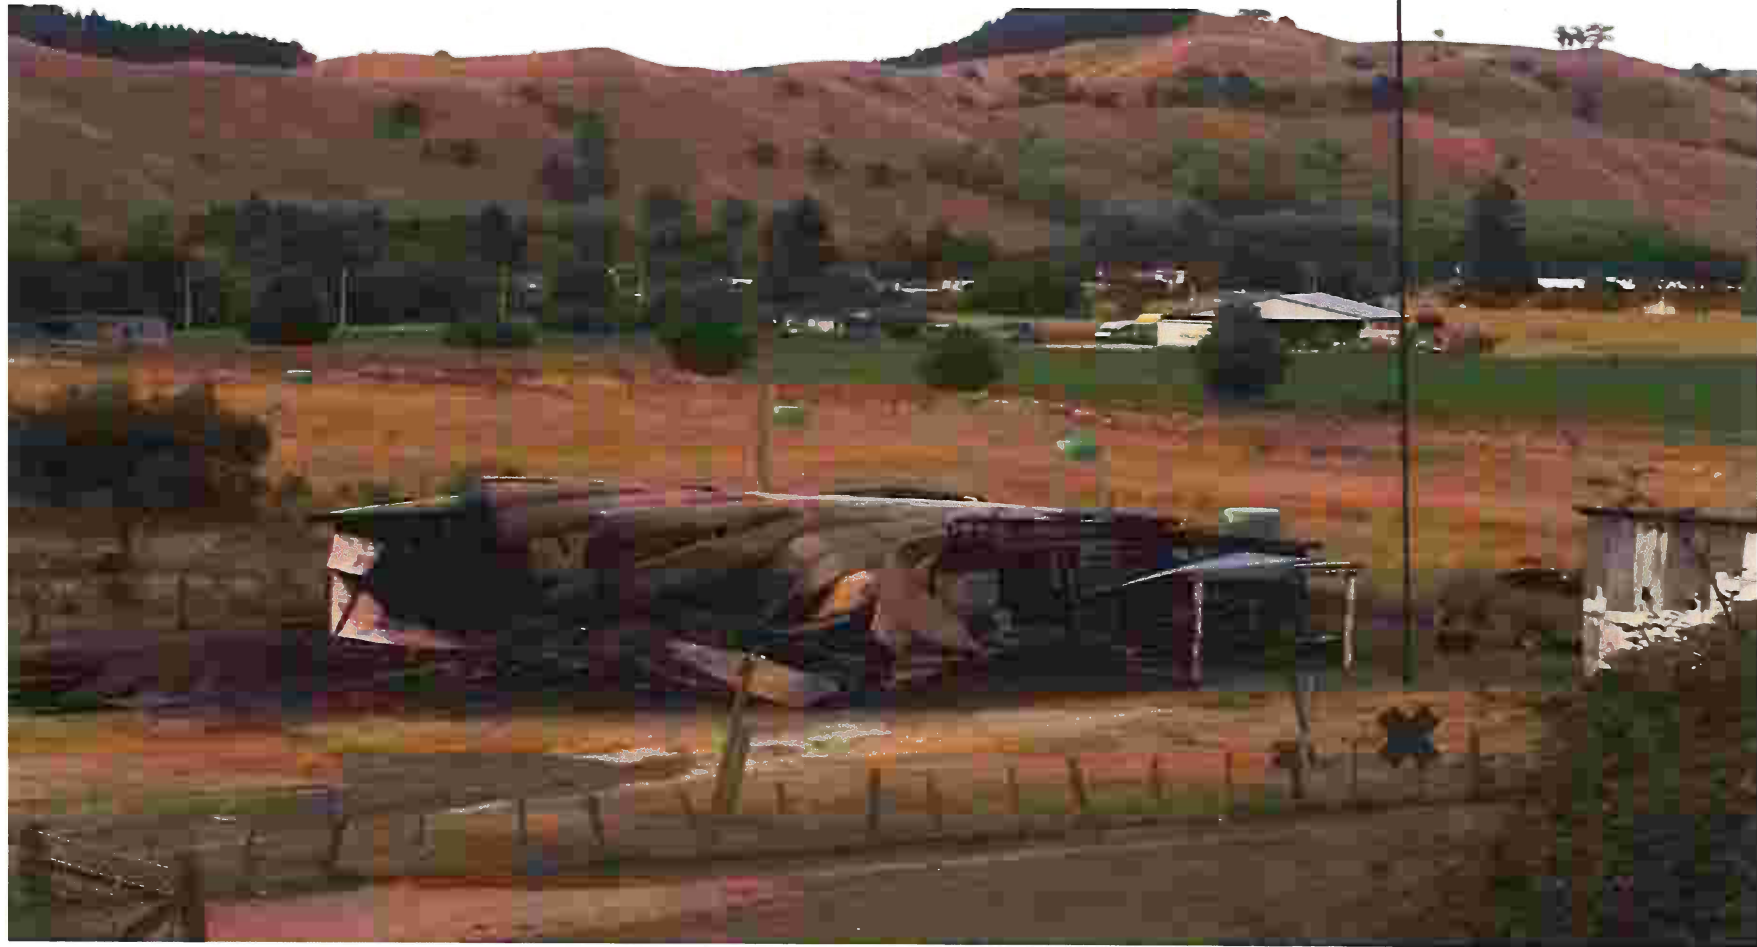
Original bore of my tipuna

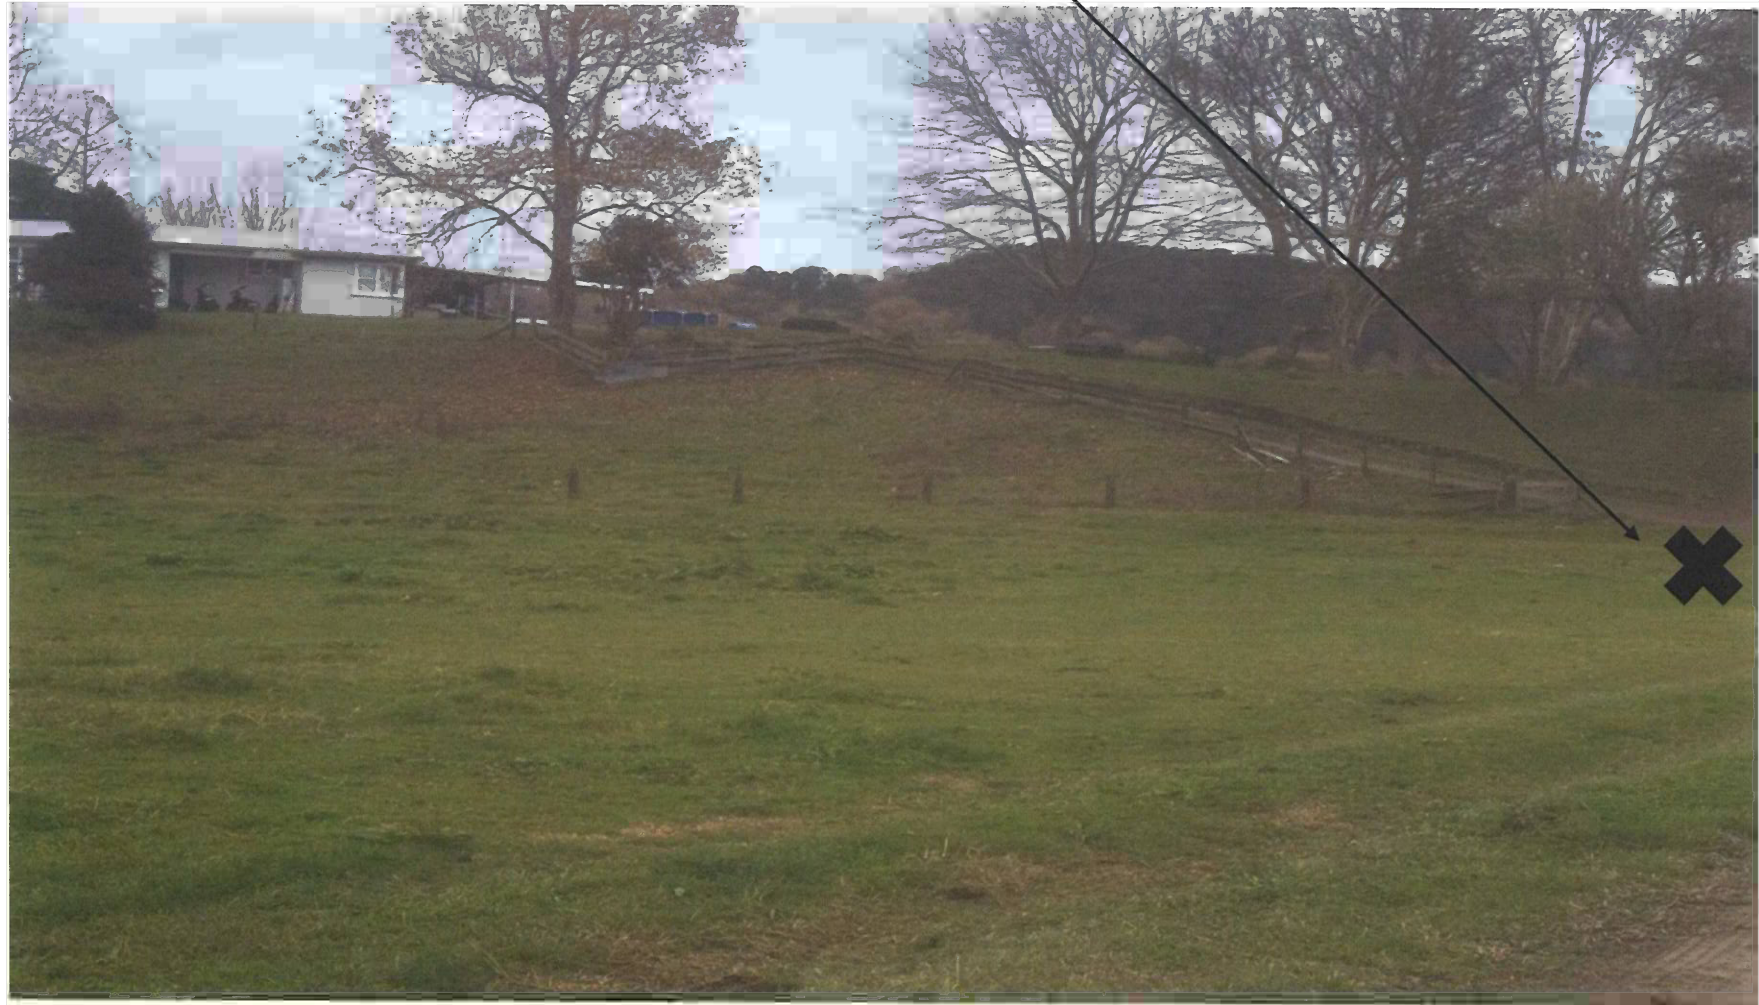
Photo 5 The black cross in the right side of the picture is approx. where the 2<sup>nd</sup> bore had been placed.

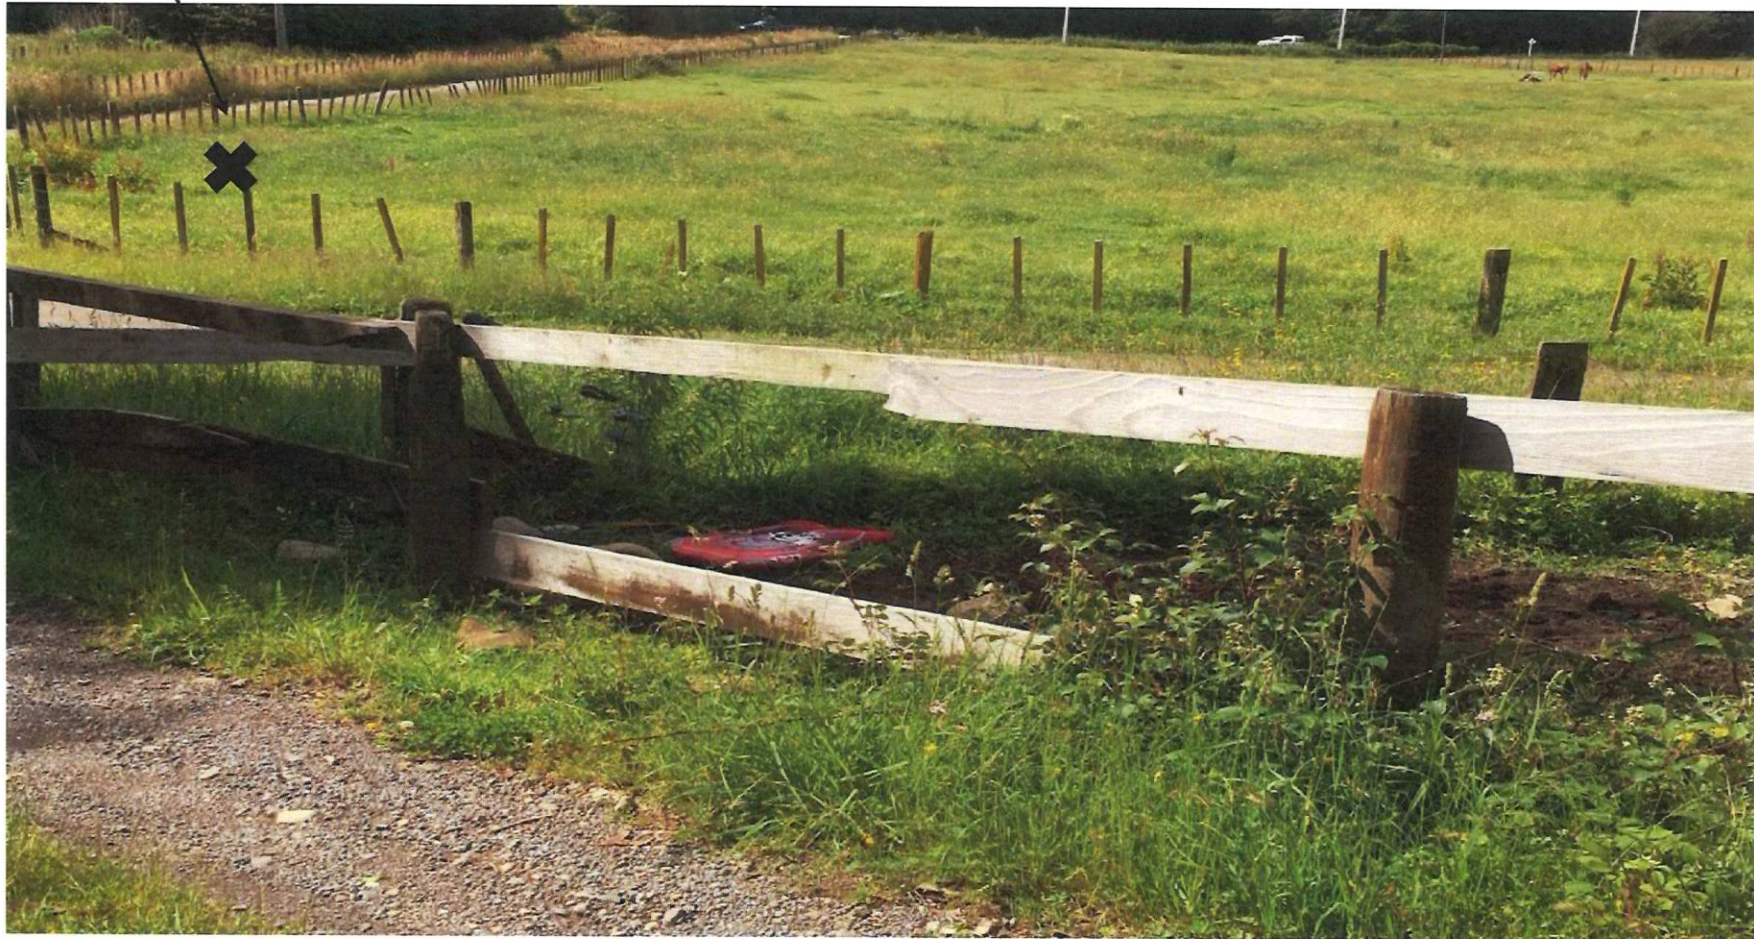
The black cross is approx. where the 2<sup>nd</sup> bore was placed and is the same as picture on page 1.

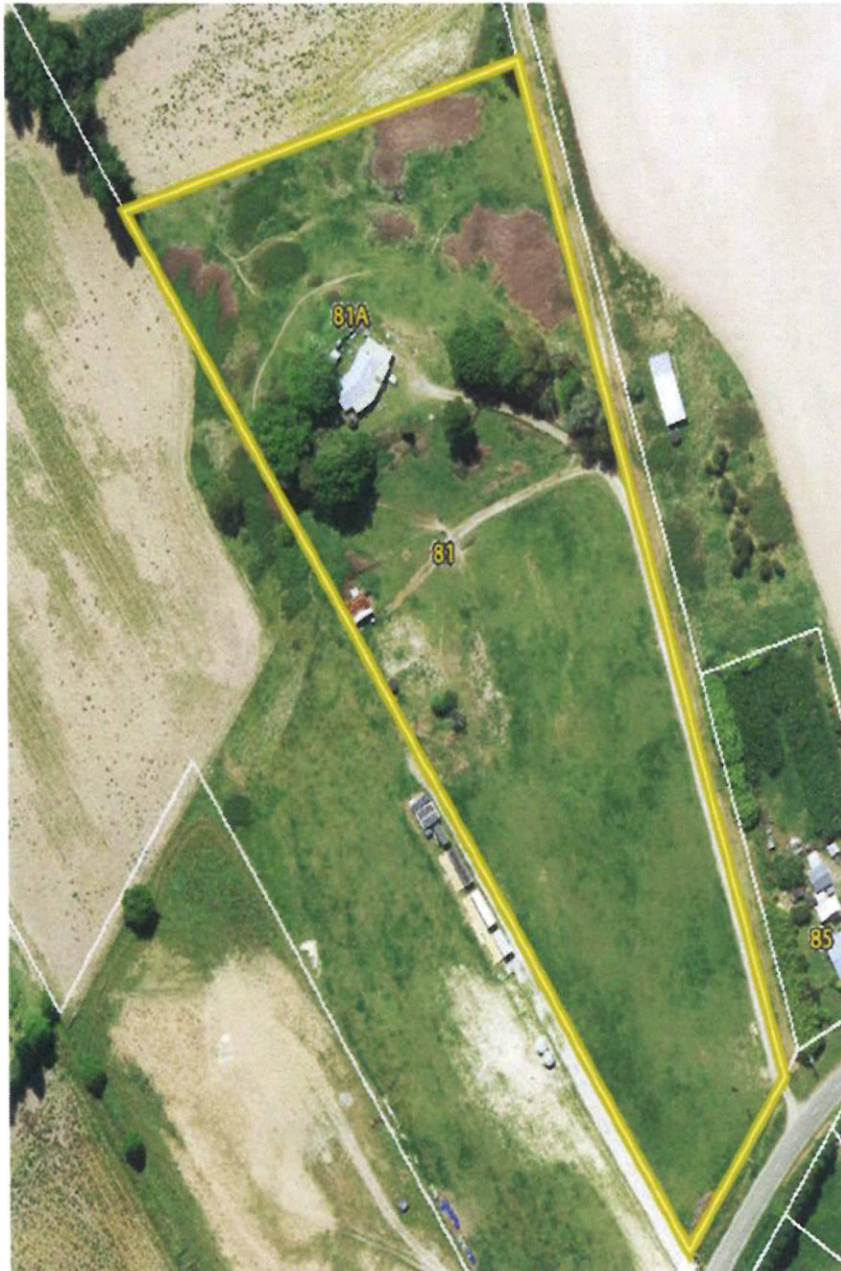
Behind the yellow line across the ditch, it was originally Te Karaka 16A  
up to the shed.

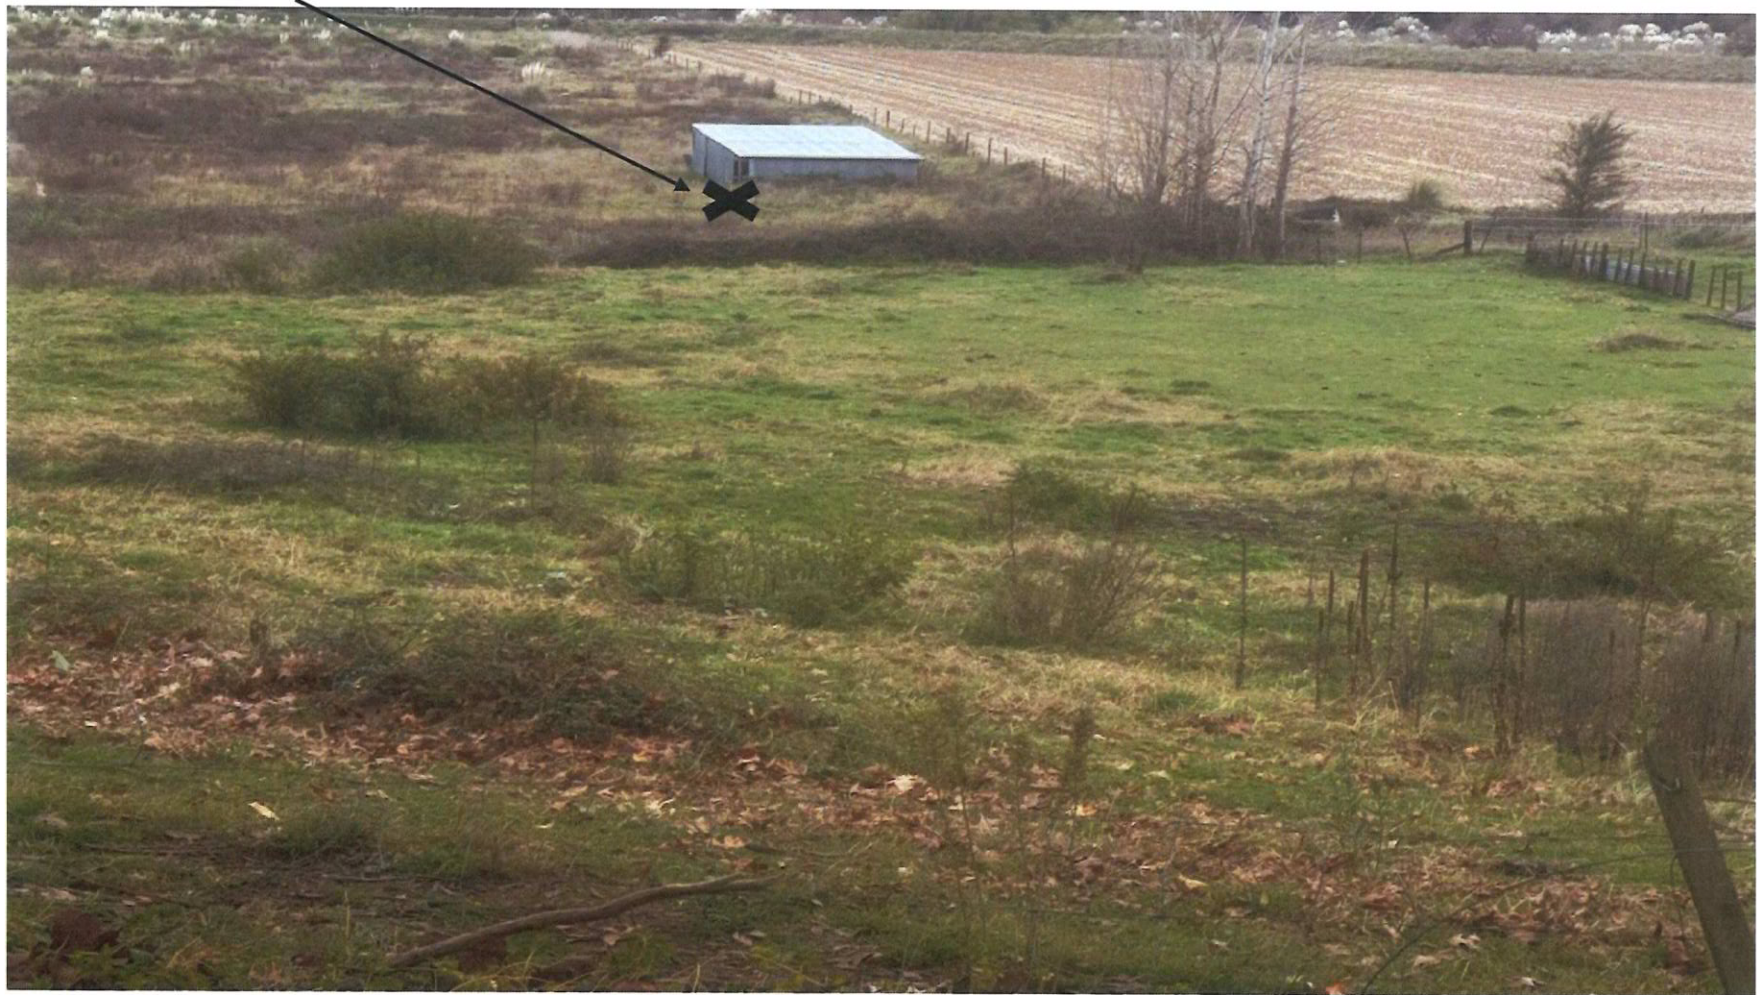
Approx position of the 3<sup>rd</sup> bore

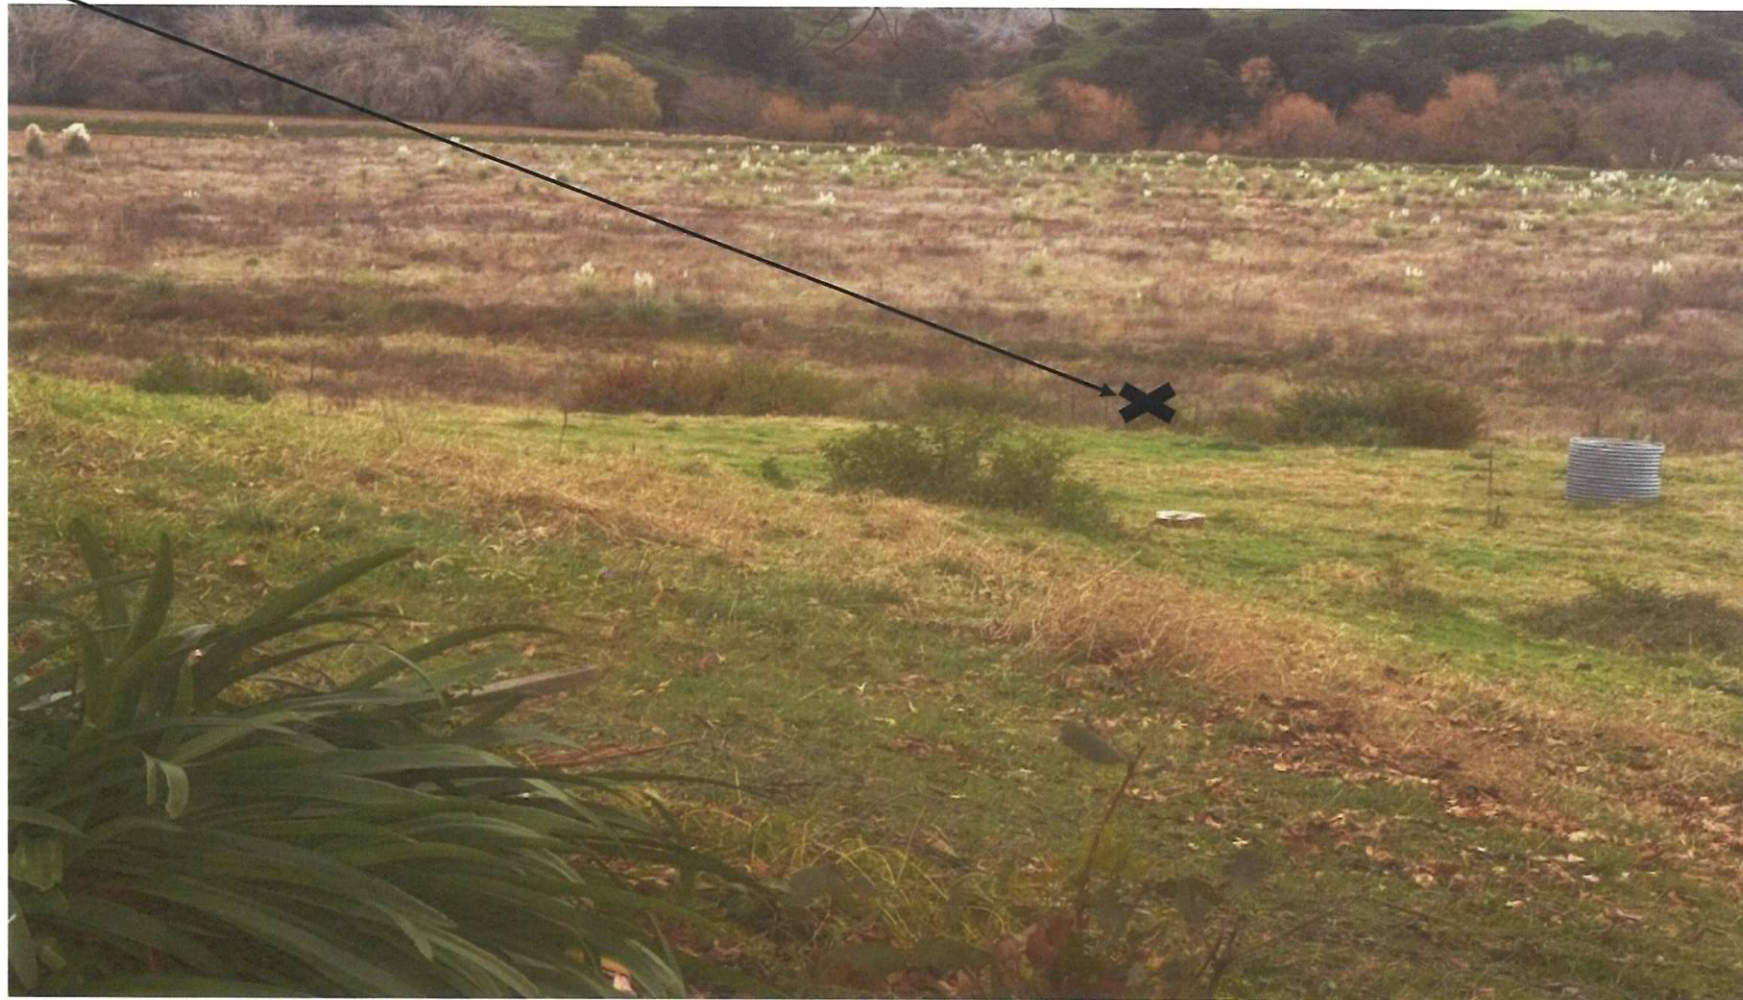
Approx. place of 4<sup>th</sup> bore, this bore was originally part of Te Karaka 16A, which now sits behind the yellow line on page 5 photo.
